# CULTURAL LANDSCAPE REPORT

FORT WADSWORTH

GATEWAY NATIONAL RECREATION AREA

Prepared by PaleoWest, LLC

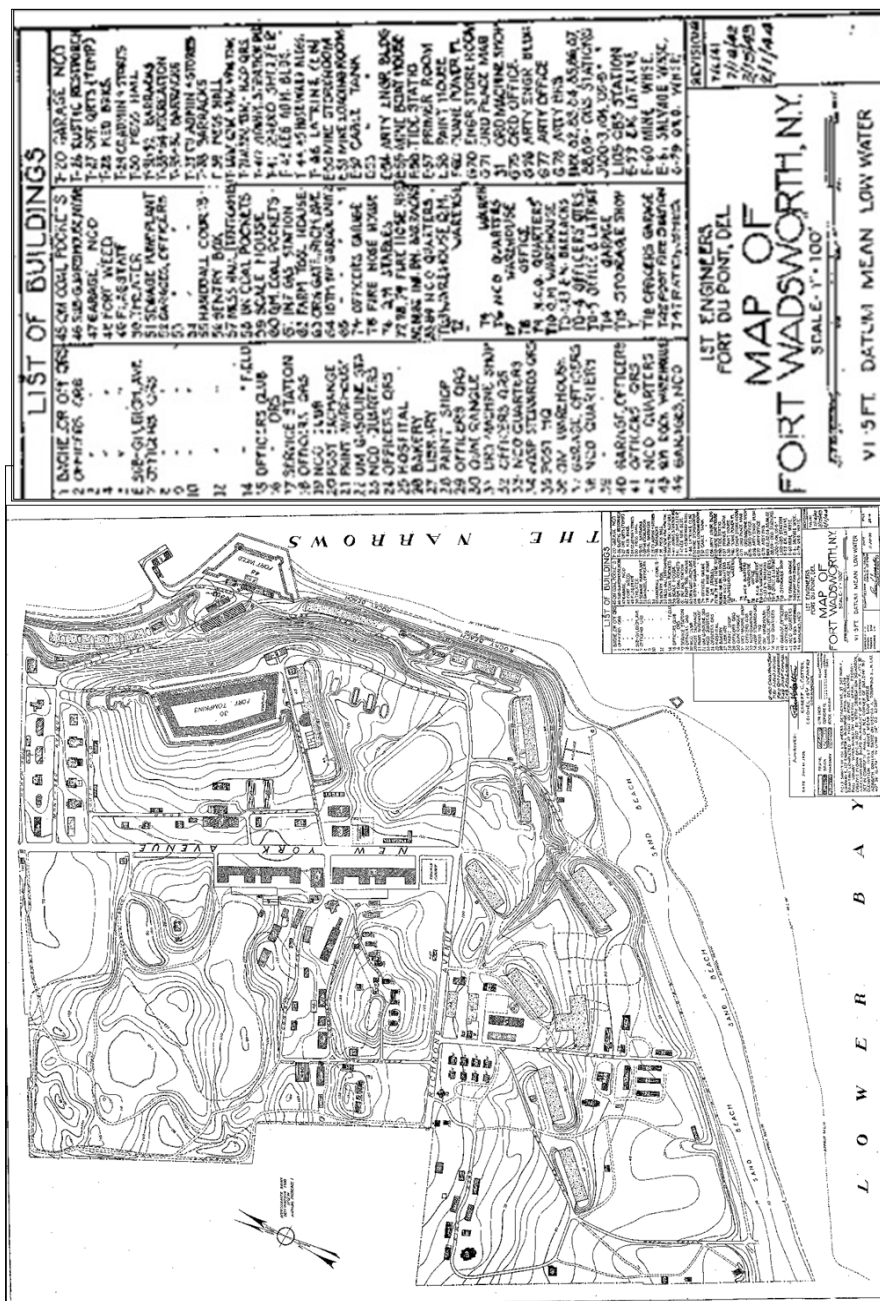
Figure 2.55. 1944 Map of Fort Wadsworth. Note the Civilian Conservation Corps projects including the running track south of Fort Tompkins which replaced an earlier pond (National Park Service)

Besides the batteries described above, there was little permanent construction at Fort Wadsworth during World War II. Instead, military needs were met with existing and temporary buildings. Fort Wadsworth was dotted with dozens of temporary buildings by 1944. Most were constructed west of New York Avenue and south of Richmond Avenue (Now Battery Road). Temporary buildings included housing, offices, shops, and storage. Tennis must have remained a popular recreational activity at the post, as a tennis/handball court was just northwest of the intersection of New York Avenue and Richmond Avenue. A running track and athletic field constructed by the Civilian Conservation Corps across from the tennis courts on the east side of New York Avenue replaced a pond seen in earlier maps (Figure 2.55).

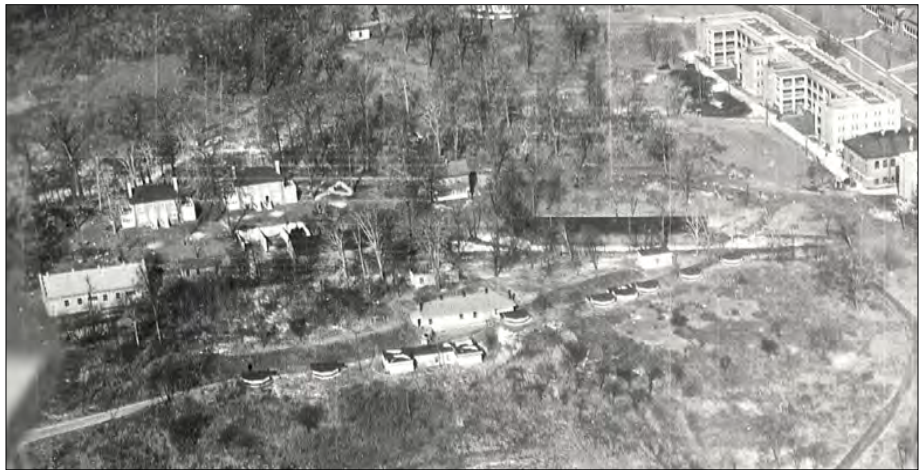
**Figure 2.56.** Oblique aerial photograph of the area west of New York Avenue, early 1940s. Note the wooded areas in contrast to the open landscape in the central core of the post (National Archives and Records Administration).

The area west of New York Avenue was moderately developed in the 1920s and 1930s, but the landscaping remained mostly unaltered and naturally wooded (Figure 2.56). The older developed portions of the Fort Wadsworth landscape remained largely open throughout the 1940s (Figure 2.57). Although there were several new buildings within the central core of the post, the landscape would have been recognizable to someone who had visited decades earlier. The east-facing steep hillside between Battery Weed and Fort Tompkins was kept clear of woody vegetation, and a network of diagonal foot trails linked the area around Battery Weed with Fort Tompkins. The area west of the brick infantry barracks was a mix of unmaintained wooded areas and some small, cleared areas near buildings. Much of the rest of the fortification's landscape was kept open. The only exception by the mid-1940s were trees and shrubs growing on the eastern slopes shielding the concrete gun platforms. Trees and other designed plantings were confined to Mont Sec Avenue and a corridor along New York Avenue and Richmond Avenue (Figure 2.58).

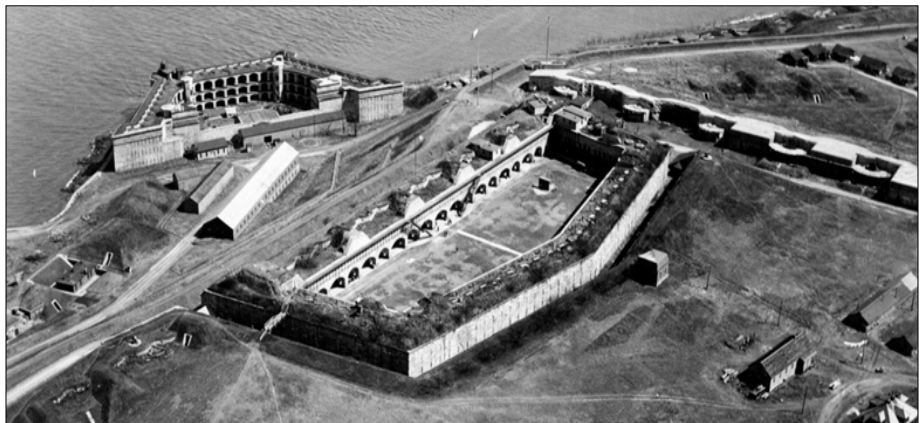
**Figure 2.57.** Oblique aerial photograph of Fort Tompkins and Battery Weed, early 1930s. Note the open, cleared landscape with roads and trails cross the grassy areas (National Archives and Records Administration).

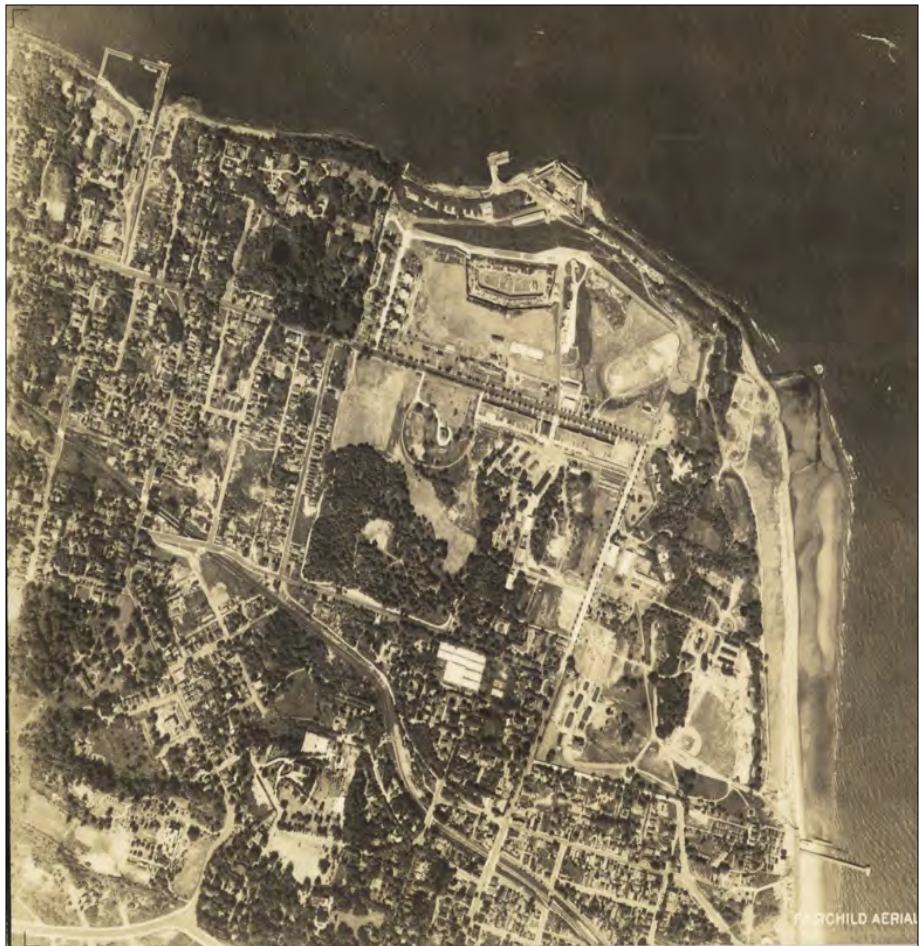
Figure 2.58. Aerial photograph of Fort Wadsworth, 1942, Note the Civilian Conservation Corps-era landscaping along the main roads. Some woody vegetation is beginning to encroach the west side of Fort Tompkins, but the central core of the post is generally clear of non-ornamental trees and shrubs (Gateway National Recreation Area Collections, Image 20614).

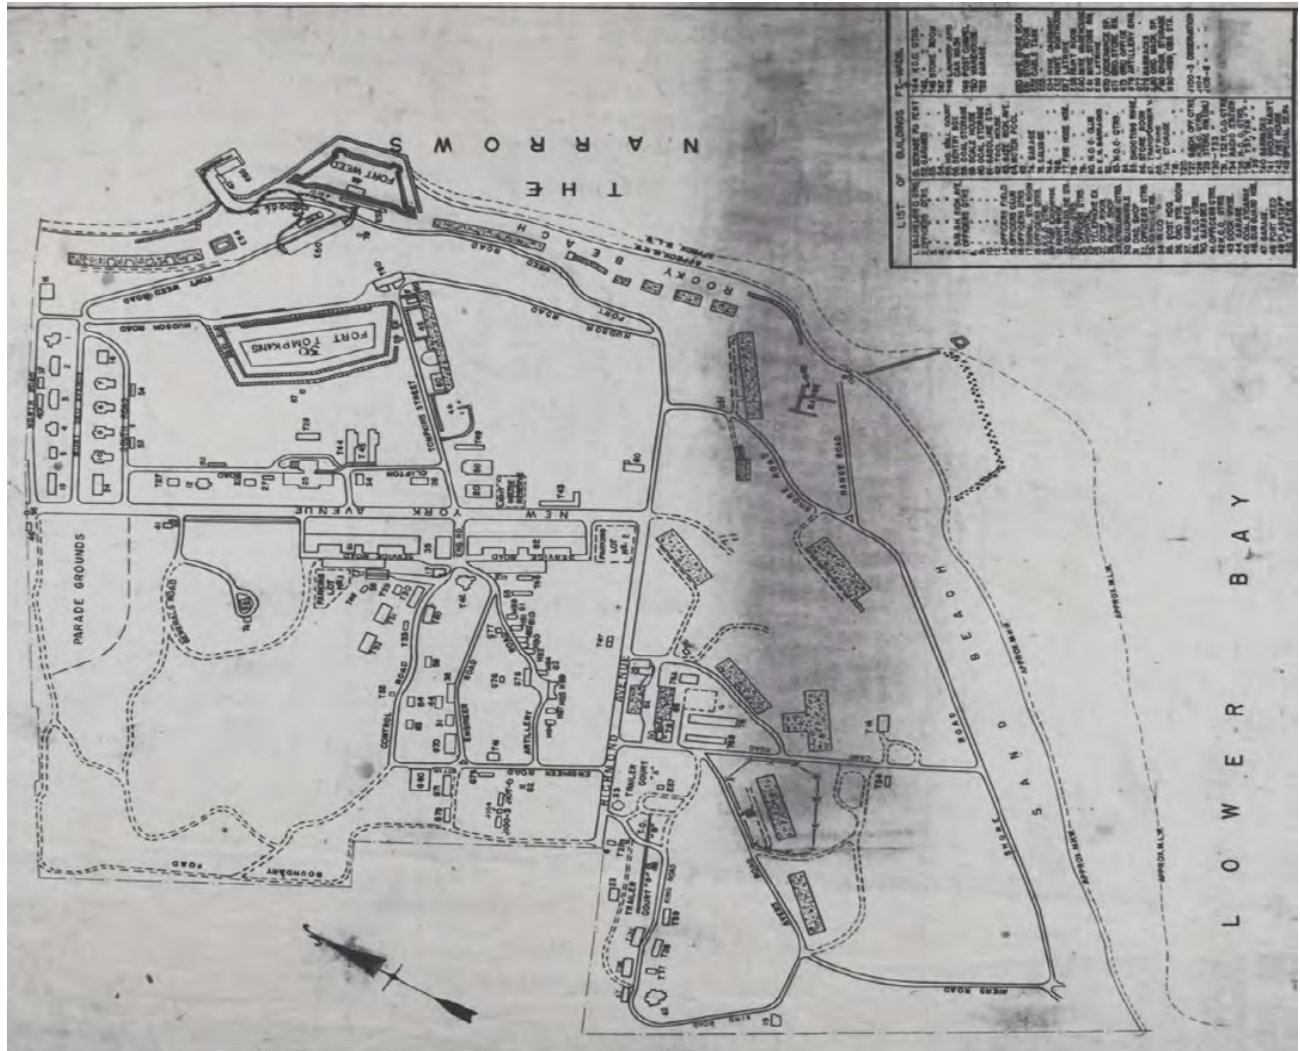
Figure 2.61. Map of Fort Wadsworth, 1951. Note the Trailer Court at the corner of Richmond Avenue and Camp Road (National Archives and Records Administration).

Fort Wadsworth became home to one of the most unique but inauspicious residential properties in New York City in 1948. A trailer park or camp was established on the installation to house up to forty military families from units of the Army Signal Service and other military branches (Figure 2.60 and Figure 2.61). The trailers were south of Richmond Avenue, where the army had constructed some “tar paper barracks” during World War II. This may have also been the previous location of the Works Progress Administration/ Civilian Conservation Corps camps and the Italian Service Unit camp. Each trailer pad was equipped with electrical, sewage, and water hookups. A former World War II training building was relocated to the trailer park to serve as a central heating and sanitation building. Although the trailers were usually occupied by Army families, they were also used by Marines, Air Force, Navy, and Coast Guard. Trailer parks were not uncommon in the United States after World War II, but New York City municipal code barred the establishment of trailer parks. Fort Wadsworth, which was Federal land, was the location of the only New York City trailer park established in the post-war era. The trailers were occupied until 1965, when more permanent housing was constructed.<sup>107</sup>

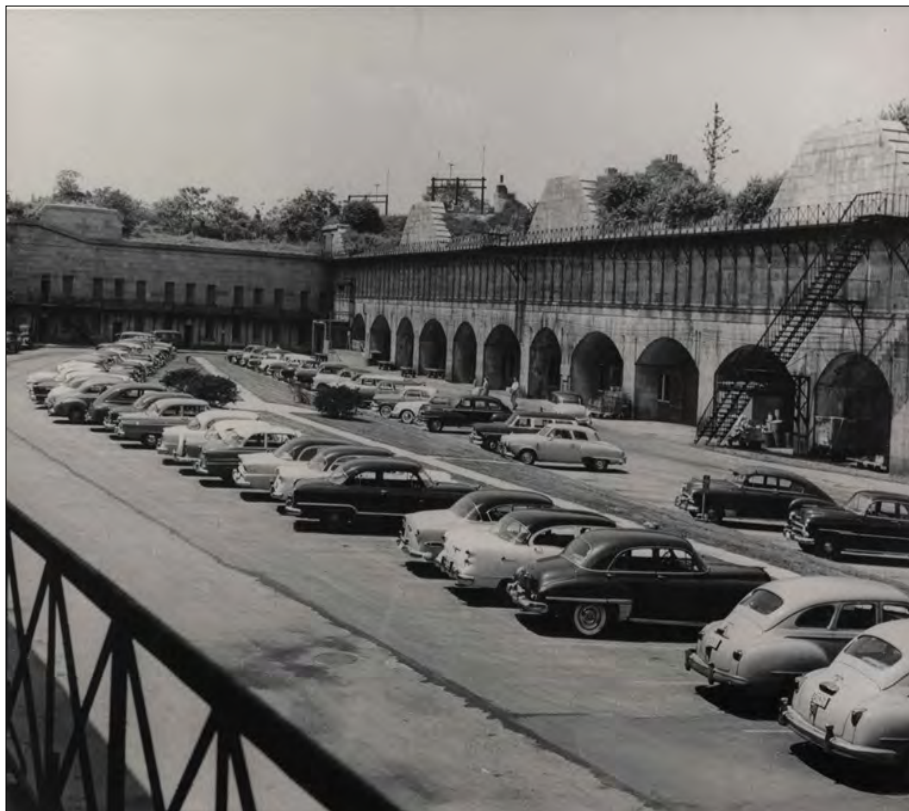
**Figure 2.62. Photograph of the interior of Fort Tompkins, 1950s. Note the parade ground with modified central median and curbing for automobile parking. Woody vegetation is growing on the fort's roof (Gateway National Recreation Area Collections, Image19389).**

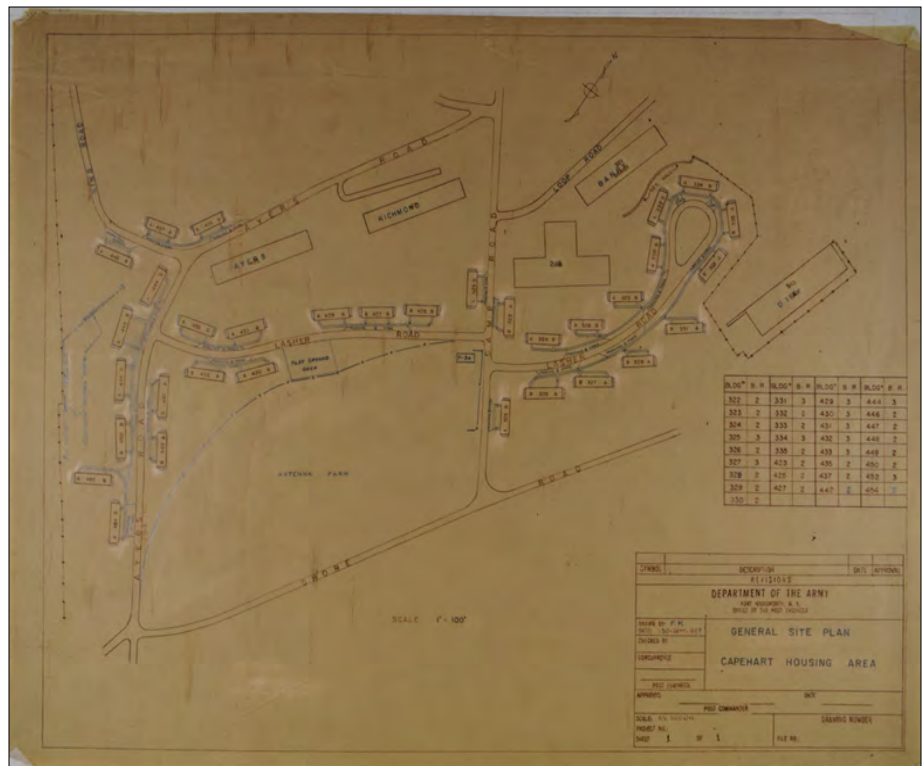
**Figure 2.63. Map of Fort Wadsworth titled General Site Plan Capehart Housing Area, 1959. The proposed housing development included 66 buildings at the southwestern corner of the post (Gateway National Recreation Area Collections).**

Housing was a continual challenge at Fort Wadsworth. The trailer park established in 1948 was a temporary solution. The Army proposed the construction of 66 houses at the southwestern corner of Fort Wadsworth in the 1950s to address the shortage of adequate housing (Figure 2.63). Known as Capehart housing, the units were based on standardized designs built at military installations throughout the United States in the late 1950s and early 1960s.

The new housing was built on a portion of the post south of Battery Ayers, Battery Richmond, and Battery Barry. The housing site was relatively flat and open prior to the construction of the housing. Various temporary storage buildings and sheds were previously near the eastern end of the development in the 1930s, 1940s, and early 1950s. A baseball field occupied much of the building site in the 1940s. The siting of the Capehart housing was likely influenced by topography and existing land use; however, a much more intrusive project in its final planning stages in the 1950s probably also played a significant role in the Army's decision to construct the housing at the southwest corner of the post.

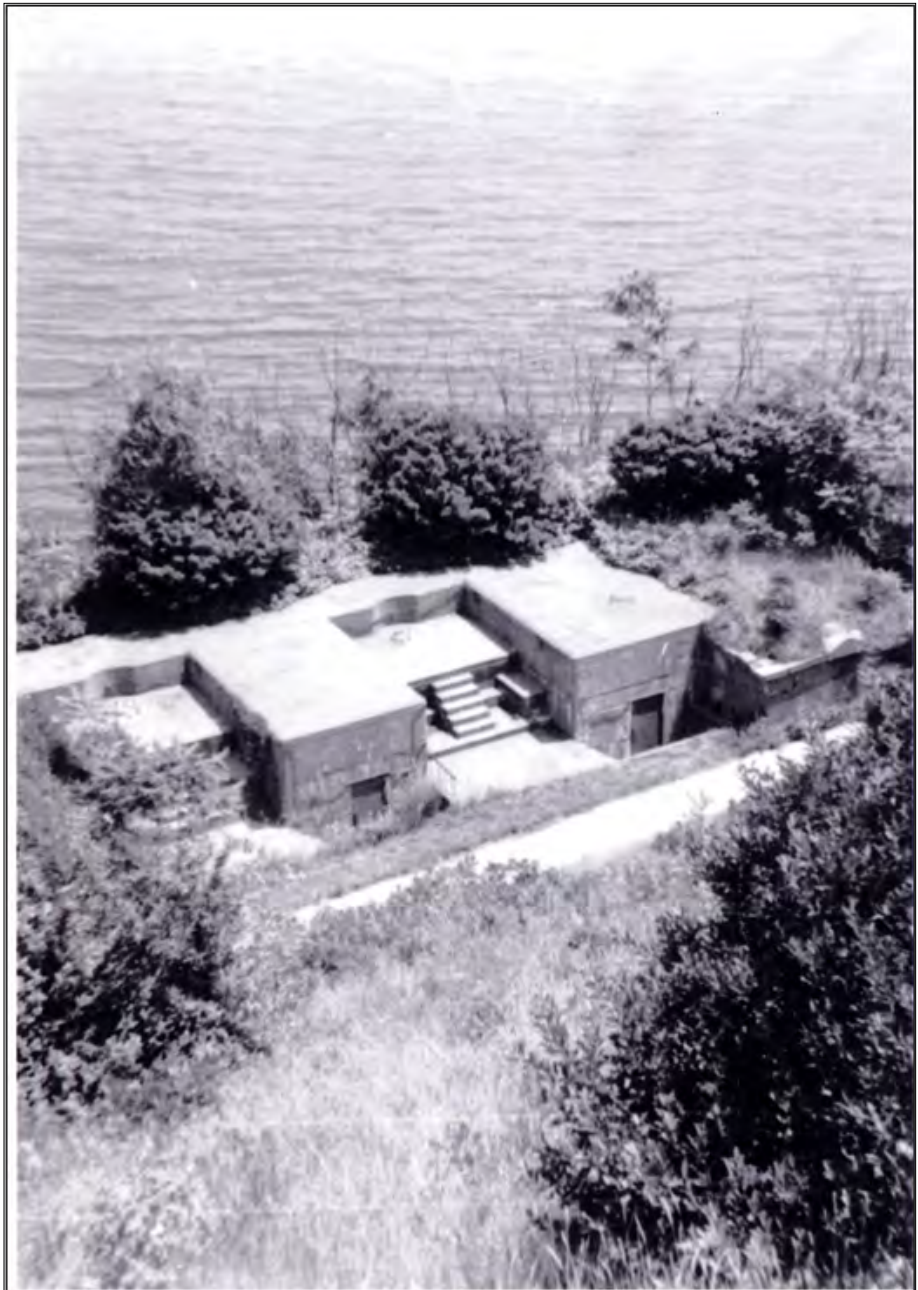
Figure 2.64. Photograph of an Endicott Era Battery, 1949. Note the growth of young woody vegetation encroaching on the battery (Gateway National Recreation Area Collections, Image 18699).

Figure 2-64. Photograph of an Endicott Era Battery, 1949. Note the growth of young woody vegetation encroaching on the battery (Gateway National Recreation Area Collections, Image 18699).

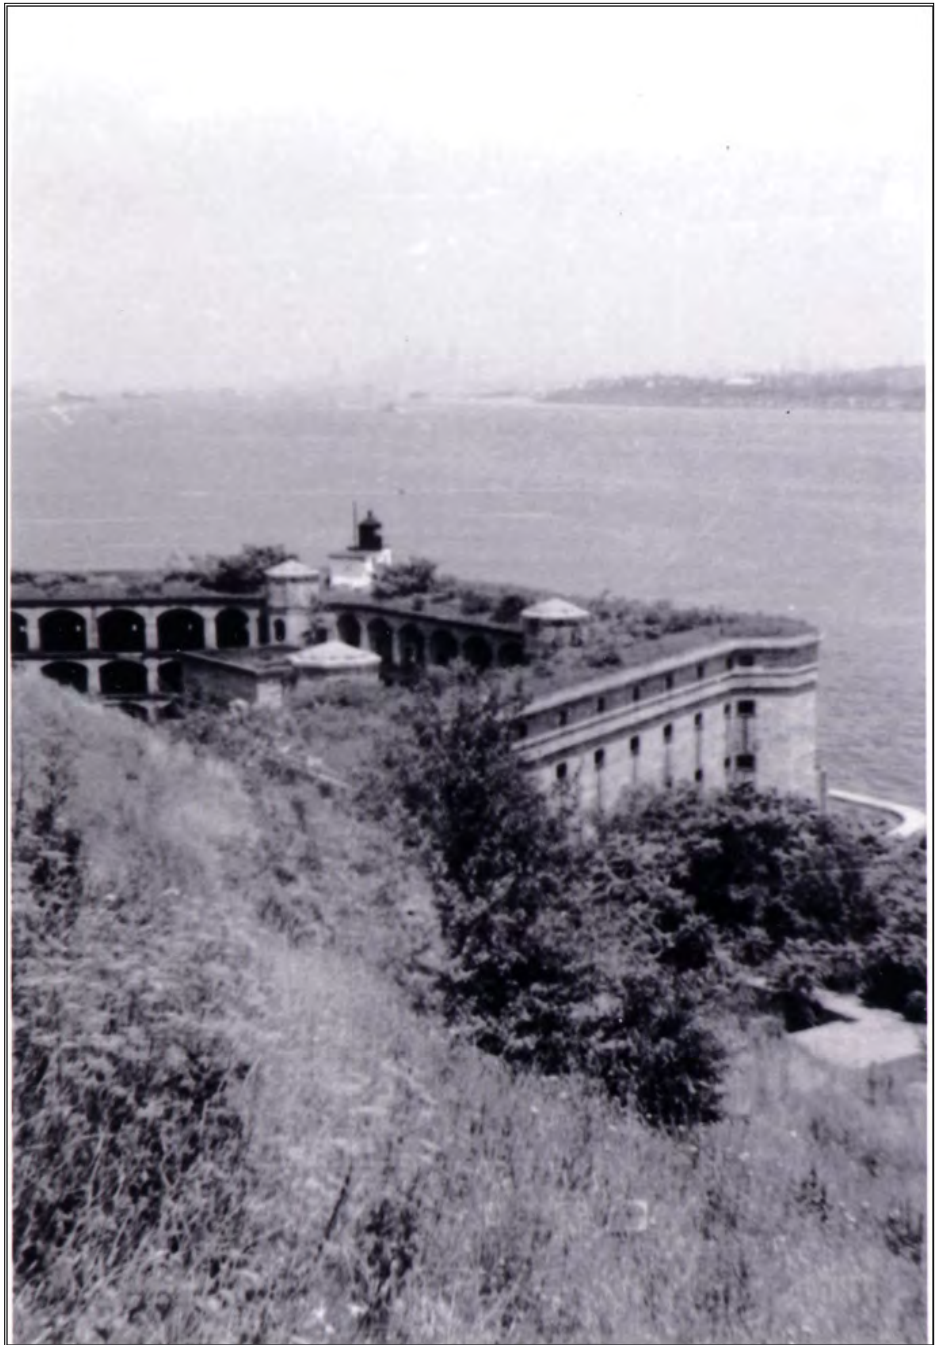
**Figure 2.65. Photograph of Battery Weed and the engineered slope between the forts, 1959. Note the woody vegetation and tall grass growing on the formerly cleared and mowed hillside; the roof of Battery Weed is shrouded in shrubs (Gateway National Recreation Area Collections, Image 18698).**

Figure 2-65. Photograph of Battery Weed and the engineered slope between the forts, 1959. Note the woody vegetation and tall grass growing on the formerly cleared and mowed hillside; the roof of Battery Weed is shrouded in shrubs (Gateway National Recreation Area Collections, Image 18698).

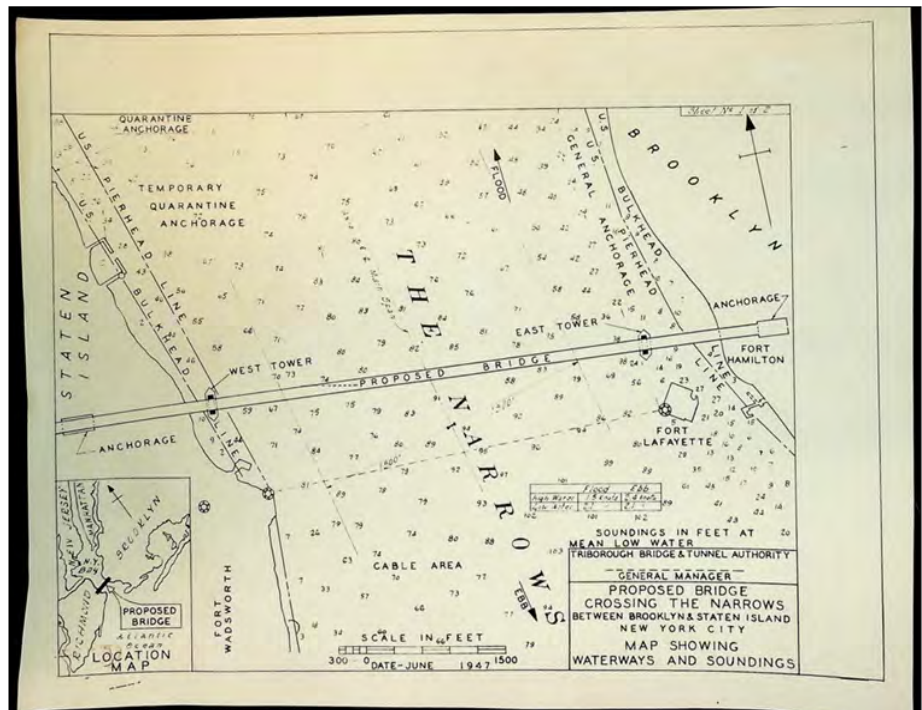
**Figure 2.66. Map of a proposed bridge crossing the Narrows, June 1947. The proposed alignment would have avoided Fort Wadsworth (Courtesy of MTA Bridges and Tunnels Special Archive).**

Initially, the City proposed that the bridge cross onto Staten Island just north of Fort Wadsworth (Figure 2.66). This arrangement was eventually revised to a location crossing directly through Fort Wadsworth. A 1960 report presented the justification for the Fort Wadsworth site. Principal considerations were to minimize the disruption of existing communities and the determination that the destruction of properties that contribute to the local tax rolls should be kept to a minimum. A second consideration was topography and “its relationship to type

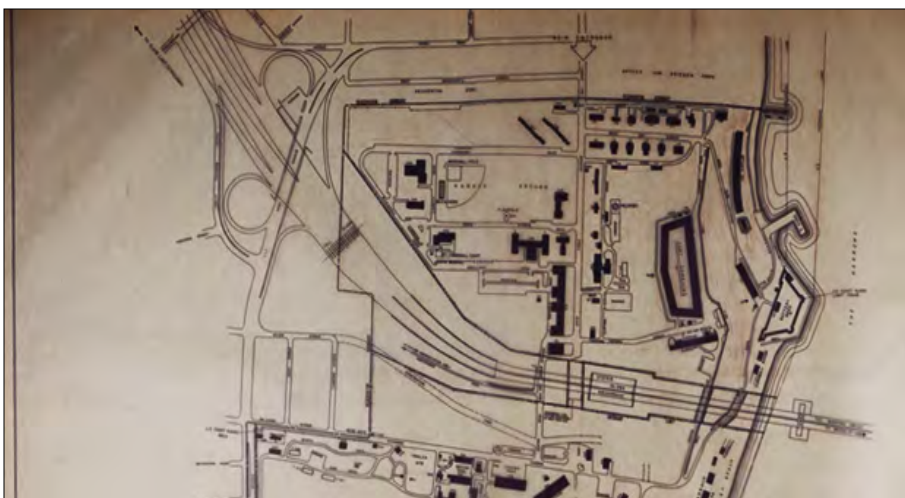
Figure 2.67. Detail of the Fort Wadsworth General Site Map, 1962. Note the bridge right-of-way (outgrant) cutting through the post (Gateway National Recreation Area Collections).

Negotiations between the Army and the Triborough Bridge and Tunnel Authority included the determination of the bridge and road right-of-way (outgrant) through the post (Figure 2.67). There were several buildings within the right-of-way that would be razed during the construction of the bridge. As mitigation for the demolitions, the Authority agreed to replace several buildings at Fort Wadsworth with new structures.<sup>115</sup>

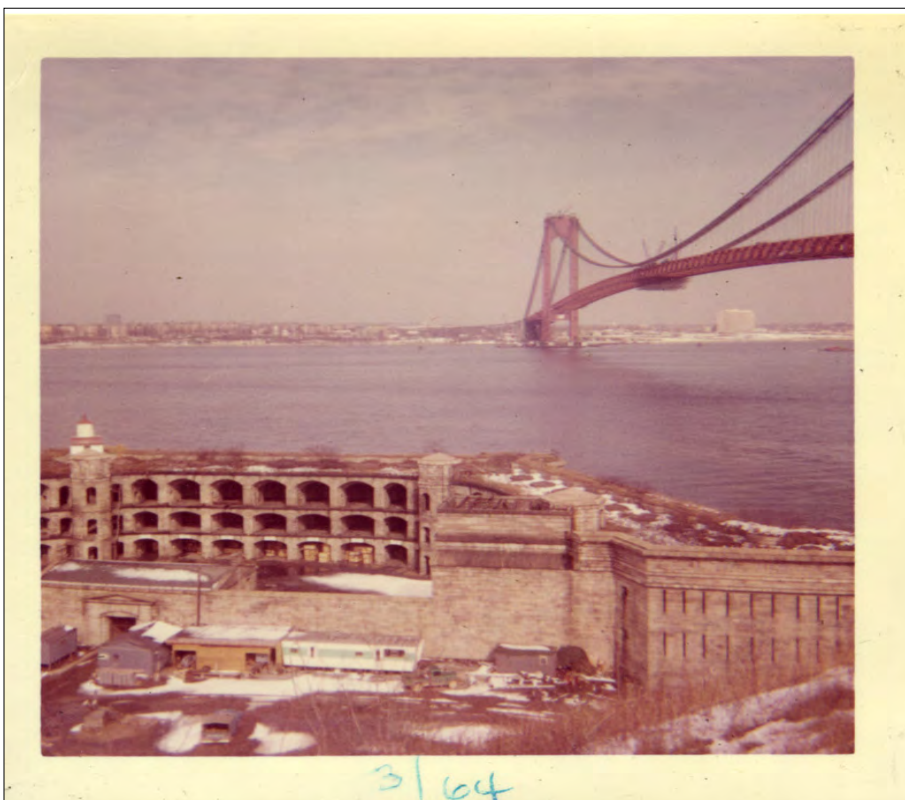
Figure 2.68. Photograph from Fort Tompkins looking towards Battery Weed, March 1963. Note the temporary buildings and construction staging along the western wall of Battery Weed; the fortification's interior was used for storage (Gateway National Recreation Area Collections, Image 21915-3-64(3)).

Figure 2-68. Photograph from Fort Tompkins looking towards Battery Weed, March 1963. Note the temporary buildings and construction staging along the western wall of Battery Weed; the fortification's interior was used for storage (Gateway National Recreation Area Collections, Image 21915-3-64(3)).

Figure 4-16. Historic photograph of Battery Weed and the Verrazzano-Narrows Bridge from Fort Tompkins, March 1963. Note the construction equipment along the western wall near the salleyport on top of the foundations of the previous cable tank buildings (Gateway National Recreation Area Collections, Photo 21915-3-64(3)).

Bridge construction began in 1959 and was completed by 1964. During this time, Fort Wadsworth became a busy construction site. Equipment staging areas were established inside the installation, including at Battery Weed (Figure 2.68). The bridge components were truly massive. For example, anchorages on Staten Island, which became prominent structures on the Fort Wadsworth landscape, were up to 150 feet tall and “one half the size of a large city block.” They were sunk 50 to 75 feet below the ground surface to ensure structural integrity. Excavation for the anchorages required removing vast amounts of soil in the south-central portion of Fort Wadsworth. The project also resulted in the scraping and leveling a large section of the central-west portion of the post for the bridge approaches (Figure 2.69 and Figure 2.70).<sup>116</sup>

Figure 4.16. Historic photograph of Battery Weed and the Verrazzano-Narrows Bridge from Fort Tompkins, March 1963. Note the construction equipment along the western wall near the salleyport on top of the foundations of the previous cable tank buildings (Gateway National Recreation Area Collections, Photo 21915-3-64(3)).

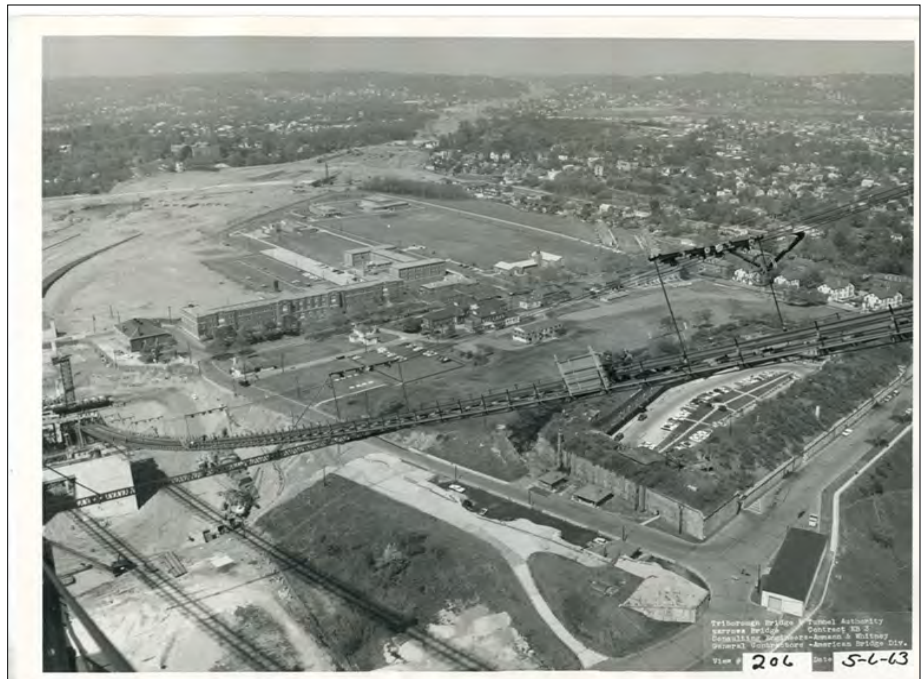
Figure 2.69. Aerial photograph depicting excavation for the bridge anchorage and clearing for the bridge approaches, May 1963 (Courtesy of MTA Bridges and Tunnels Special Archive, Photo NB-3-206).

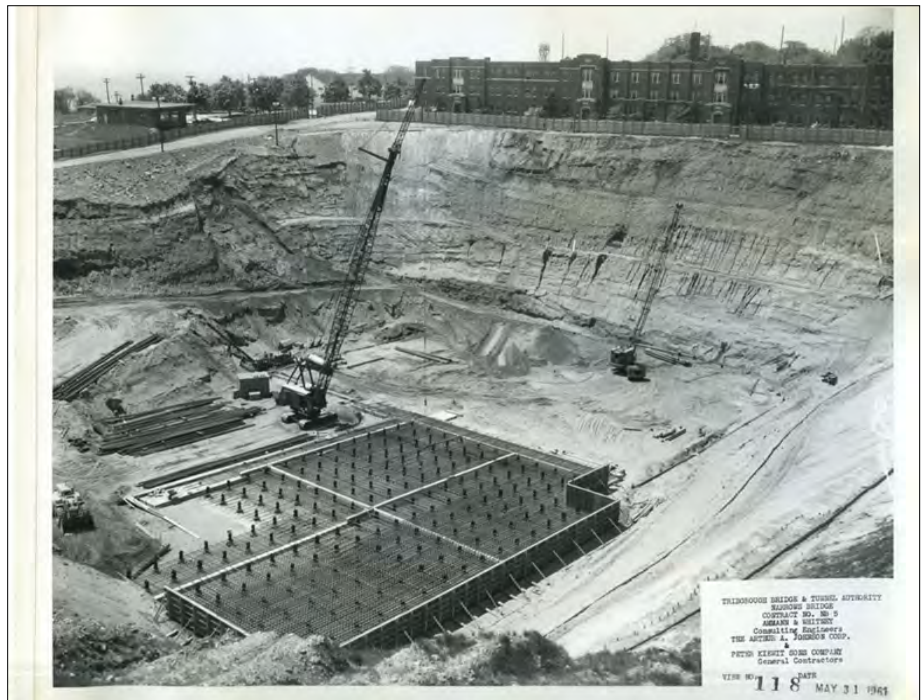
Figure 2.70. Photograph of excavations for the bridge anchorage, May 1961. Note the remaining 1931 Infantry Barracks are visible in the background (Courtesy of MTA Bridges and Tunnels Special Archive, Photo NB-5-118).

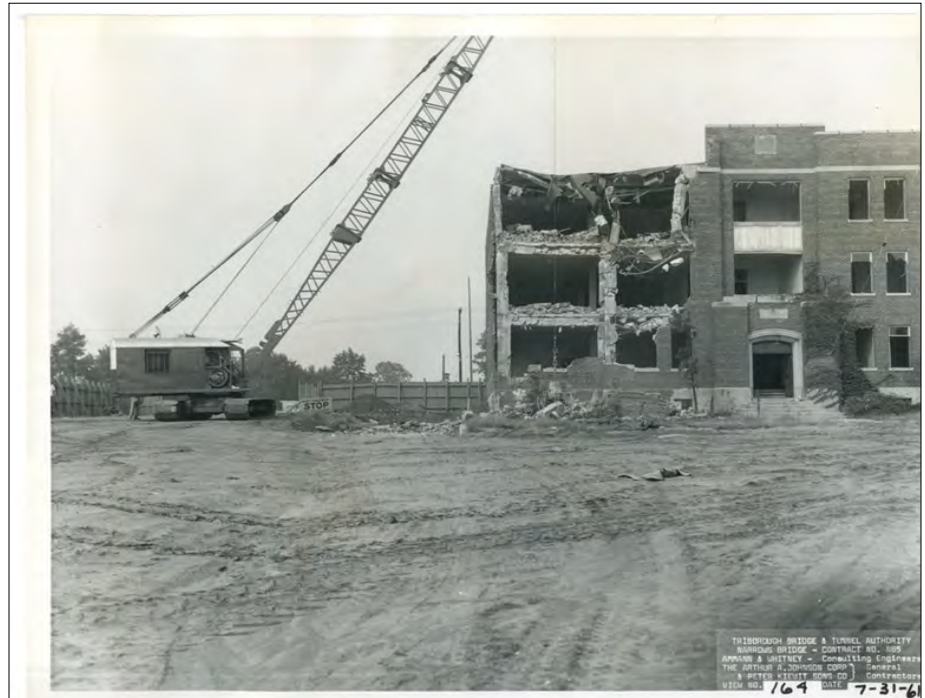
**Figure 2.71.** Photograph of the demolition of the 1931 Infantry Barracks at the southern end of Building 210, June 1961 (Courtesy of MTA Bridges and Tunnels Special Archive, Photo NB-5-164).

Bridge construction resulted in the demolition and partial demolition of nearly 50 buildings and structures at Fort Wadsworth. Most were temporary buildings constructed during World War II, but over 20 permanent buildings were also removed. These included one of the 1931 infantry barracks, the Post HQ, Coast Guard housing and garage, Officer's Quarters, Non-Commissioned Officer's Quarters, the theater, the post exchange, the ordnance shop, garages, storerooms, handball courts, and a flagpole (Figure 2.71). Most of the Battery Turnbull and the Glacis Mortar Battery were buried during construction, and a portion of Battery Duane was demolished (Figure 2.72).<sup>117</sup>

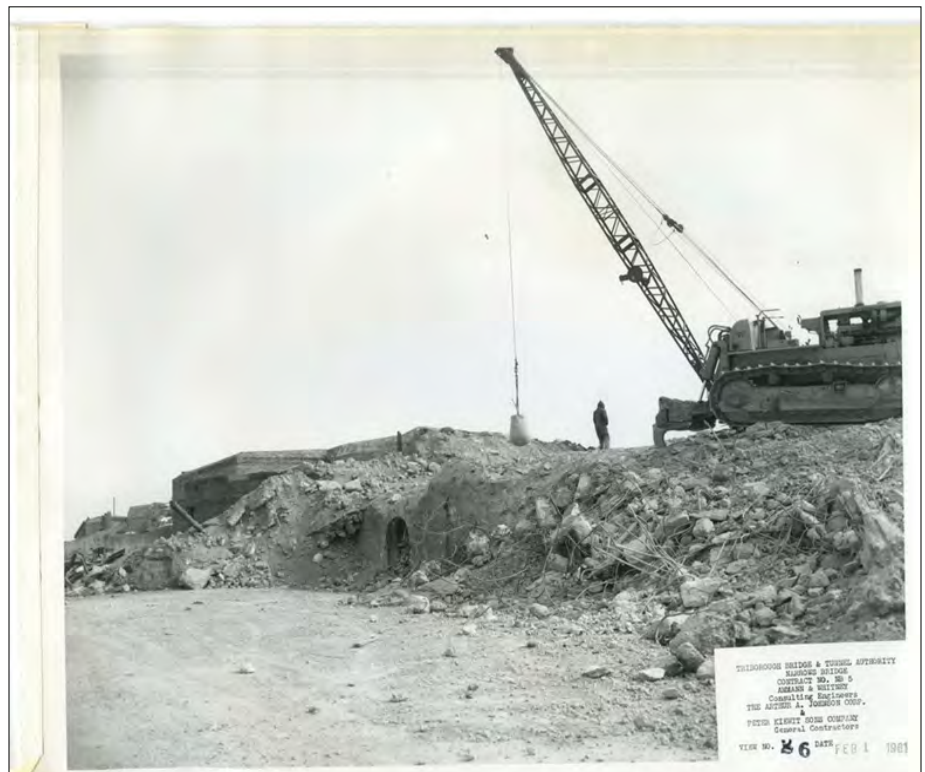
**Figure 2.72.** Photograph of the partial demolition of Battery Duane, February 1961 Courtesy of MTA Bridges and Tunnels Special Archive, Photo NB-5-26).

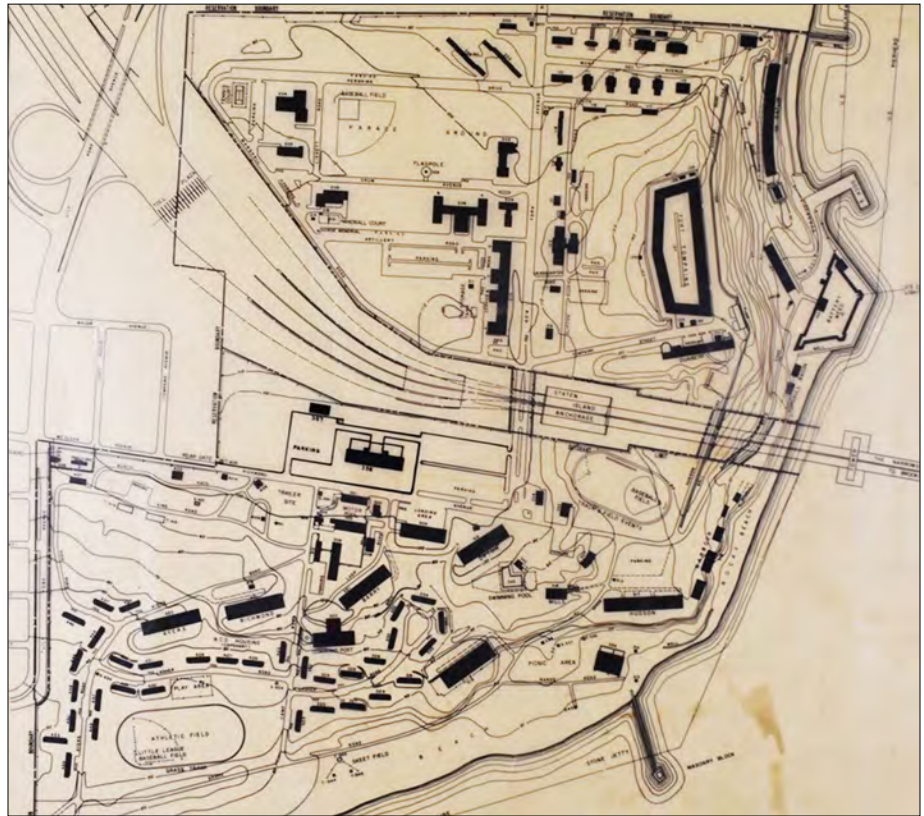
Figure 2.73. Detail of Fort Wadsworth General Site Map, circa 1970. The map includes new buildings constructed by the Metropolitan Transportation Authority (Gateway National Recreation Area Collections).

The agreement between the United States and the Triborough Bridge and Tunnel Authority allowing the construction of the bridge included stipulations that the Authority build several buildings and structures at Fort Wadsworth. The Authority built new Coast Guard housing and an office/garage at the western edge of Fort Wadsworth near the current location of the Navy Lodge. Other new buildings included a theater, post exchange, multi-purpose building, dispensary, enlisted men's barracks, chapel, and a handball court west of New York Avenue (Figure 2.73). They built new officer's quarters along New York Avenue on the east and west sides of the road. A garage addition was constructed behind quarters on

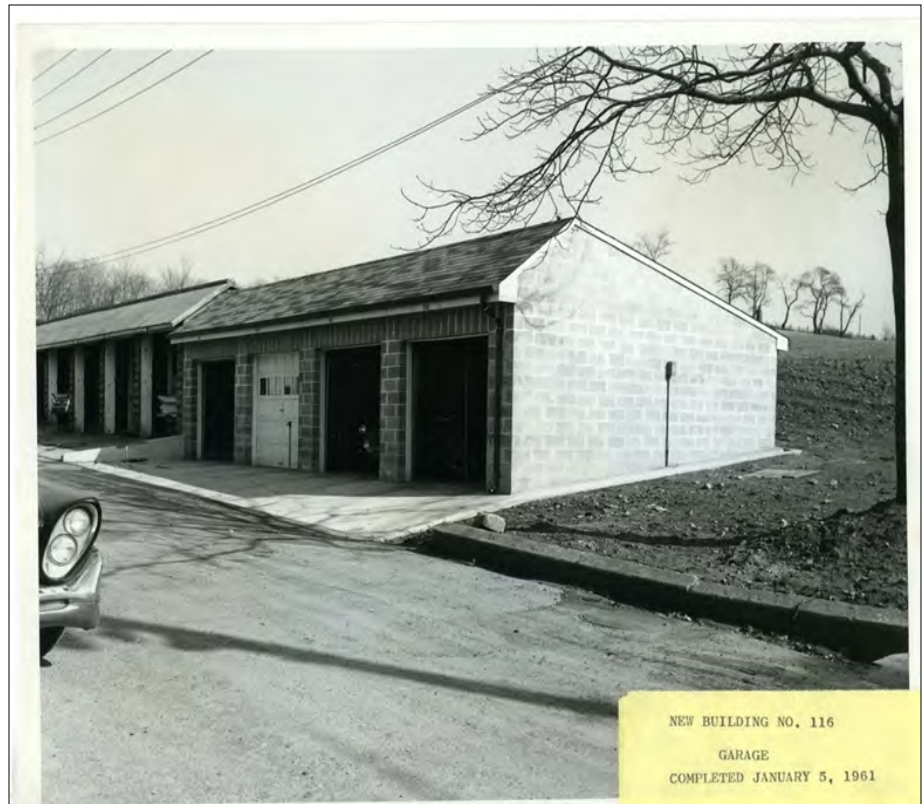
Figure 2.74. Photograph of new Building 116, a garage, completed January 5, 1961 (Courtesy of MTA Bridges and Tunnels Special Archive)

the south side of Mont Sec Avenue (Figure 274). The Authority built another garage near the officer's quarters east of New York Avenue (Figure 2.75). They also constructed a large warehouse south of Richmond Avenue. Other smaller buildings and structures built by the Authority included a range and warehouse,

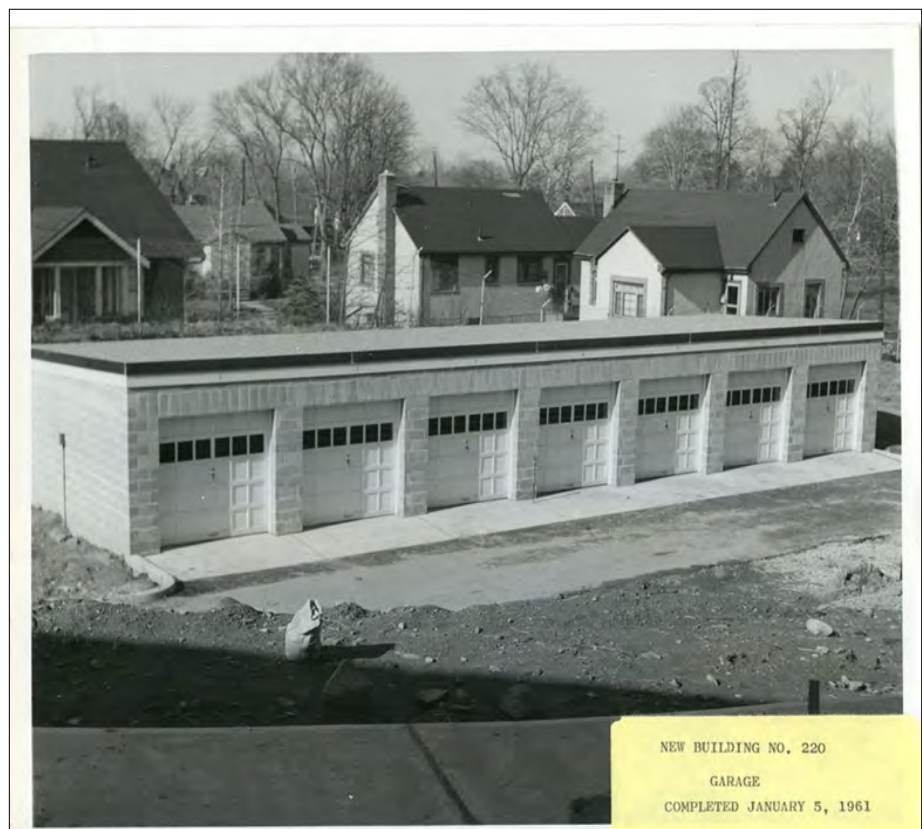
Figure 2.75. Photograph of new Building 220, a garage, completed January 5, 1961 (Metropolitan Transportation Authority Bridges and Tunnels Archives).

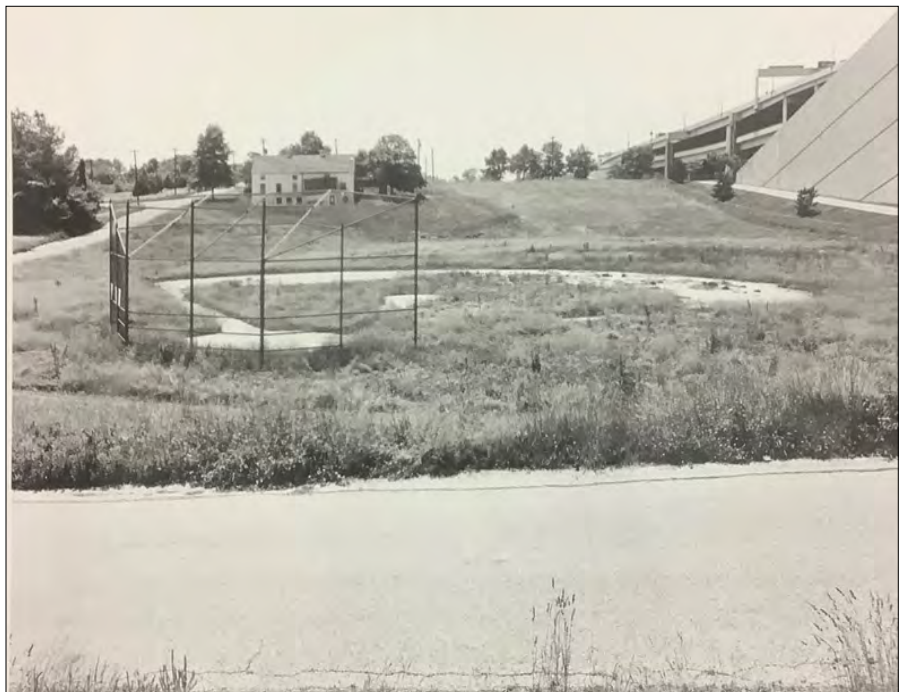
**Figure 2.77. Photograph of the overgrown and disused baseball field just south of the Verrazzano-Narrows Bridge in roughly the location of the former pond, mid-1970s (Gateway National Recreation Area Collections).**

In 1975, the Army made an unprecedented move to limit public access. Previously, local civilians were allowed to freely use the installation’s “baseball field, and picnic, beach and camping areas” south of the Verrazzano-Narrows Bridge (Figure 2.77). However, new regulations required that residents apply for access with a formal letter and that permission would only be permitted on “very rare occasions.”<sup>121</sup> But only a year later, the public was back. In 1976, the toll plaza of the Verrazzano-Narrows Bridge, just outside the Federal installation, became the starting line for the New York City Marathon. In subsequent years, the post became a staging area for the race.

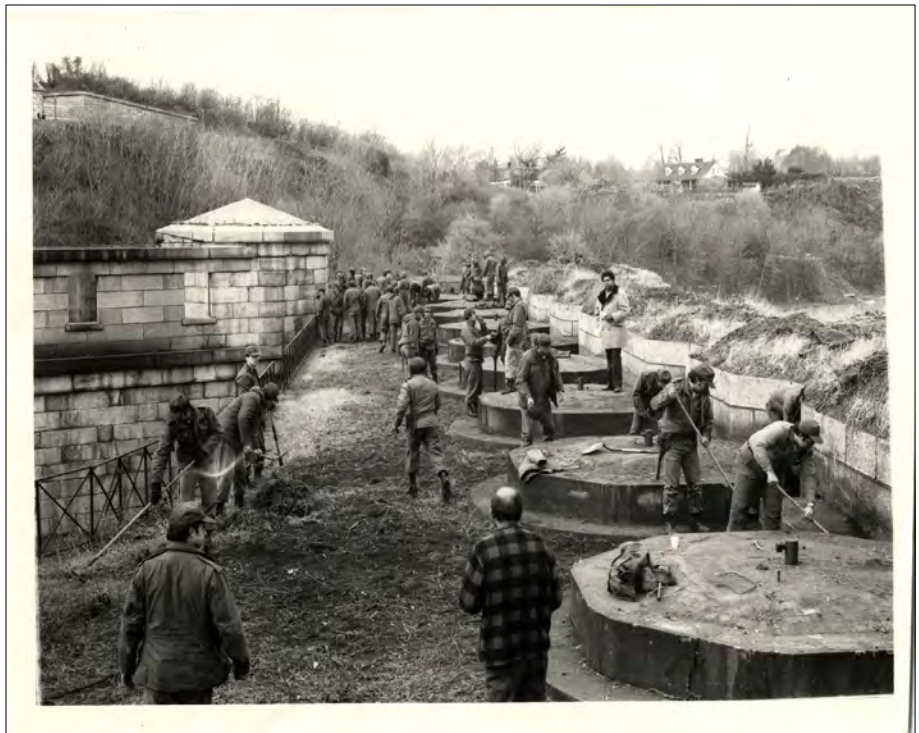
Figure 2.78. Photograph of the National Guard 101st Cavalry assisting in the clearing of Battery Weed, November 18, 1973. Note the extensive vegetation along the bluffs in the background (Gateway National Recreation Area Collections, Image 20726).

Figure 2-78. Photograph of the National Guard 101st Cavalry assisting in the clearing of Battery Weed, November 18, 1973. Note the extensive vegetation along the bluffs in the background (Gateway National Recreation Area Collections, Image 20726).

Fort Wadsworth was generally in stasis in the 1960s and 1970s. Some minor construction occurred at the post in the 1970s; for example, the athletic fields were renovated in the late 1970s.<sup>127</sup> However, the Army undertook no major projects. Although the main post quadrangle west of Fort Tompkins was kept mowed, there is no evidence that the overall landscape of Fort Wadsworth was actively managed during the 1960s and 1970s (Figure 2.78). Aerial photographs from the 1970s indicate that previously cleared areas between Battery Weed and Fort Tompkins had become overgrown with vegetation (Figure 2.79). The Endicott Era batteries were also inundated with dense thickets of trees, shrubs, and invasive vines.

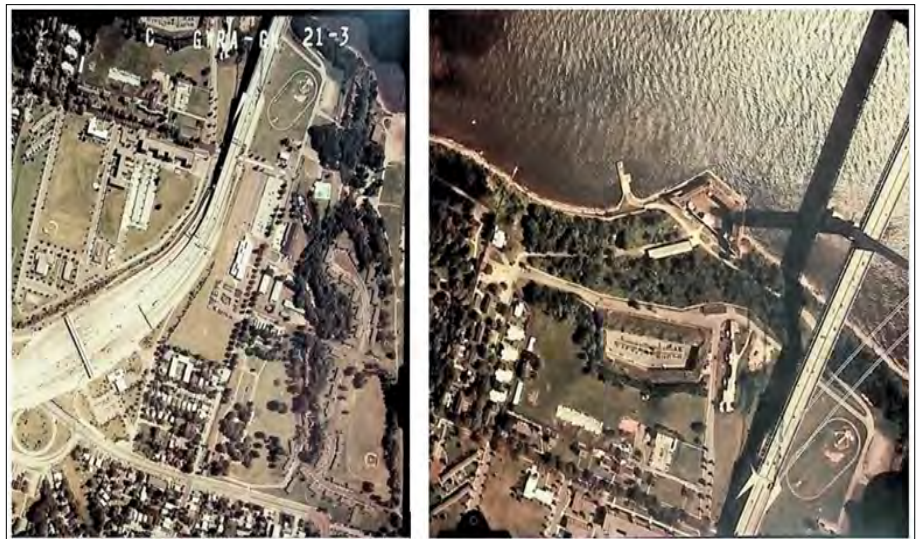
Figure 2.79. Aerial photographs of Fort Wadsworth, 1975. Note the vegetation growing on the slope between Battery Weed and Fort Tompkins (Gateway National Recreation Area Collections, Images 30667 & 30668).

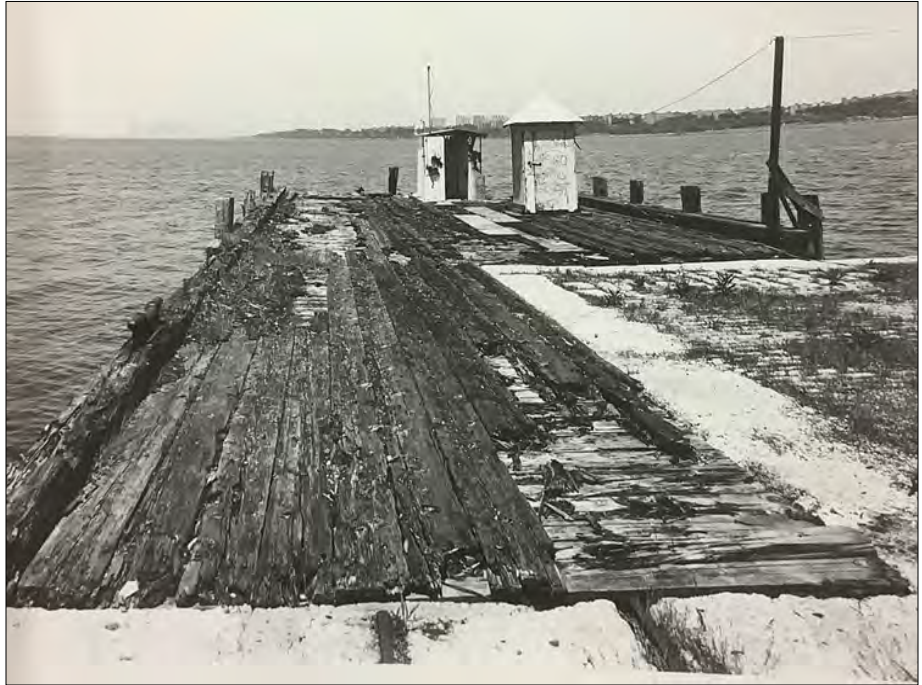
**Figure 2.80. Photograph of the dock in disrepair, 1970s (Gateway National Recreation Area Collections).**

The acquisition of Fort Wadsworth remained an unrealized goal in the late 1970s. A 1979 General Management Plan for the recreation area makes this clear. In it, the National Park Service writes that there are “several old structures of major historic significance, including Fort Tompkins, Battery Weed, and a number of heavy gun emplacements.” The authors also note the presence of an “ill-maintained dock and large open shed” (Figure 2.80). However, they note:
