# CULTURAL LANDSCAPE REPORT

FORT WADSWORTH

GATEWAY NATIONAL RECREATION AREA

Prepared by PaleoWest, LLC

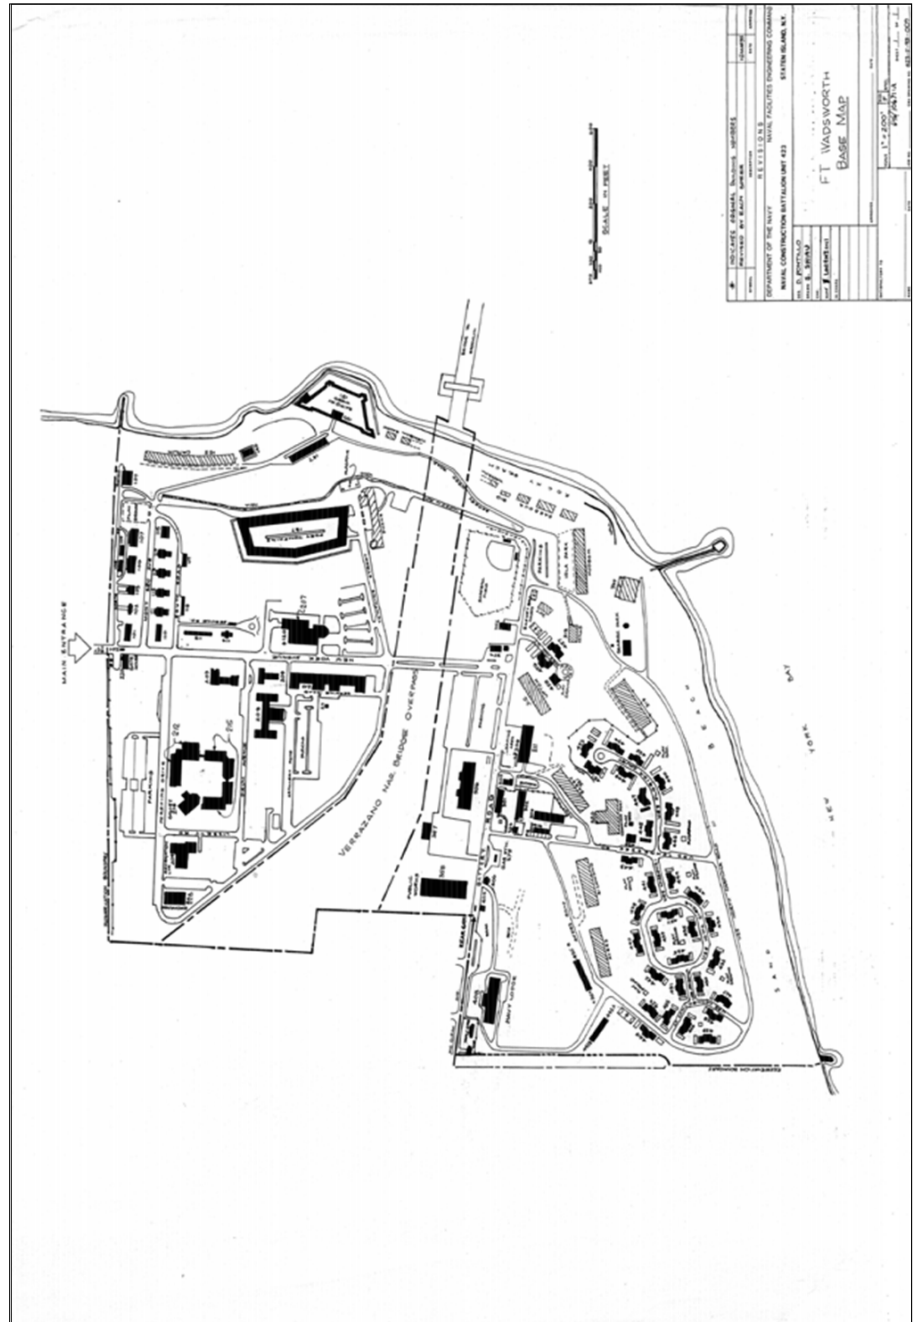
Figure 2.81. Fort Wadsworth Base Map, 1993. The map shows new Navy construction concentrated in the southern portion of the post (National Park Service Technical Information Center).

The final EIS for the United States Navy's use of Fort Wadsworth was less ambitious, but it did propose significant construction. Post-wide, the Navy undertook a major construction effort costing approximately \$2 million between the mid-1980s to the mid-1990s (Figure 2.81). The first building, constructed in 1989, was a housing unit (Building 435) south of Battery Ayers. Workers erected several buildings in 1990. These include the north gatehouse (Building 201) and Junior Officer Housing (Buildings 456, 457, and 458), constructed near Battery Upton. The Navy razed several buildings east of New York Avenue and constructed a large administrative building (Building 120) in 1993. The building currently serves as the National Park Service Visitors Center and administrative offices.<sup>148</sup> The Navy Lodge hotel, which remains in use, was also constructed during this time near the Coast Guard housing that was constructed by the Triborough Bridge Authority in the early 1960s.

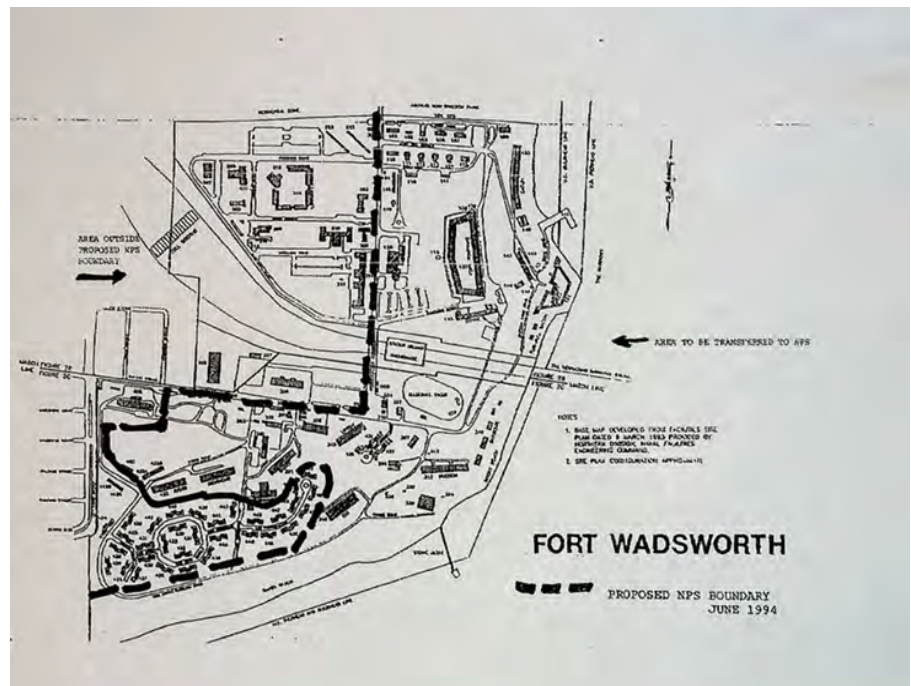
Figure 2.82. Map titled Fort Wadsworth: Proposed NPS Boundary, 1994. Note the proposed boundary eliminated most new Navy construction (Gateway National Recreation Area Collections).

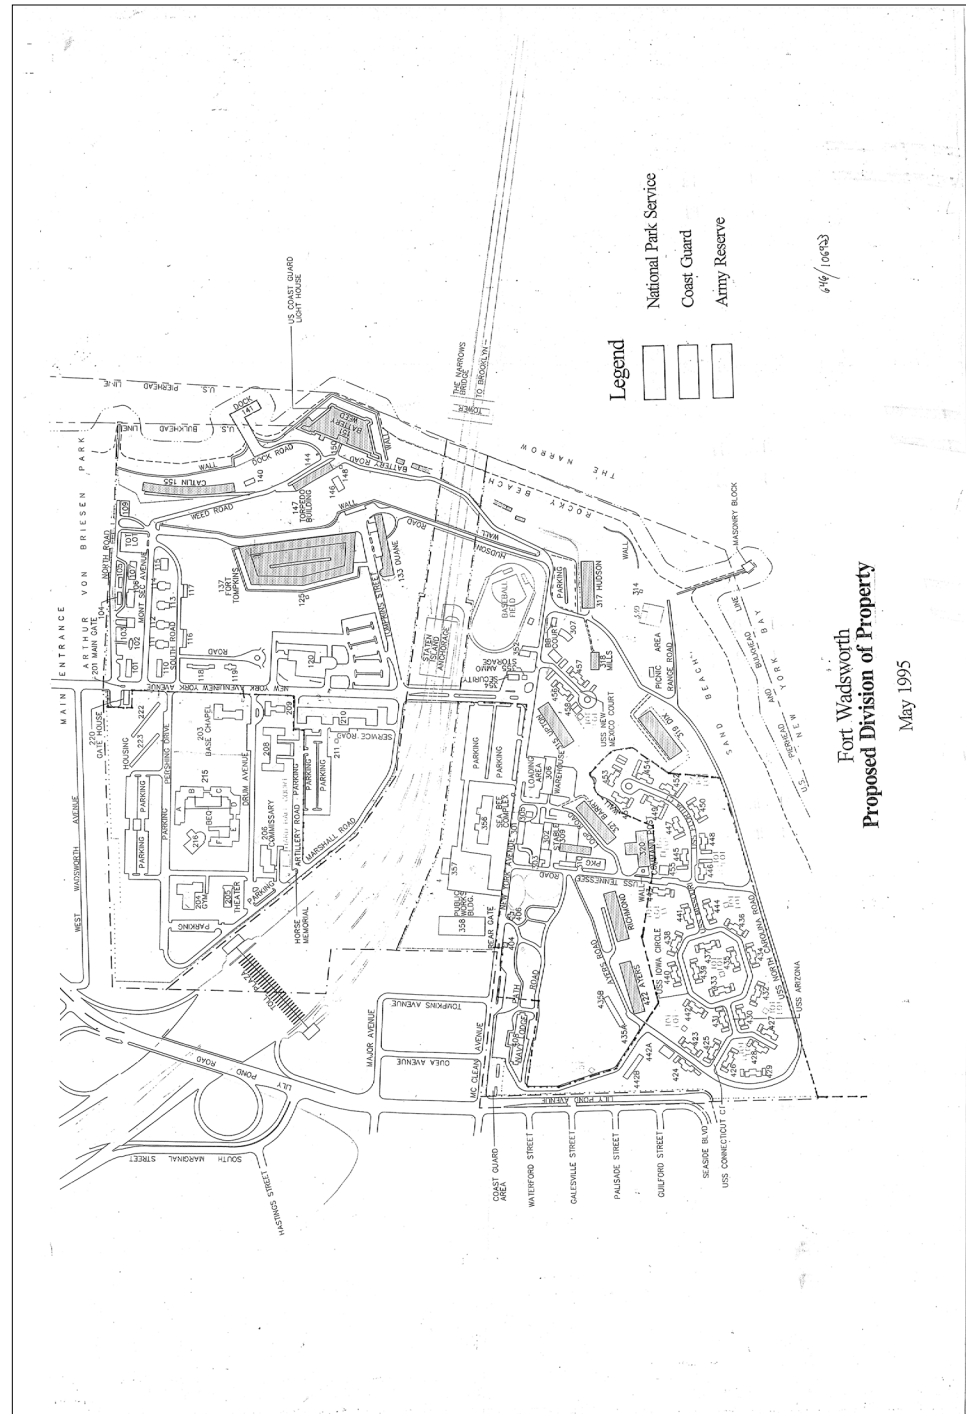
**Figure 2.83. Map titled Fort Wadsworth Proposed Division of Property, 1995. The map illustrates the proposed boundaries between the National Park Service, Coast Guard, and Army Reserves (National Park Service Technical Information Center).**

Negotiations between the Department of the Interior, the Navy, and the Base Realignment and Closure Commission continued into 1995.<sup>155</sup> Final boundaries were proposed in May 1995. The historic core of Fort Wadsworth was to become National Park Service property. Most of the area west of New York Avenue and north of Battery Road, excluding Building 210 and associated parking lots, would become Army Reserve property. The southwest corner of Fort Wadsworth was proposed to become Coast Guard property (Figure 2.83). This layout reflects the ultimate division of the property at the former military installation.

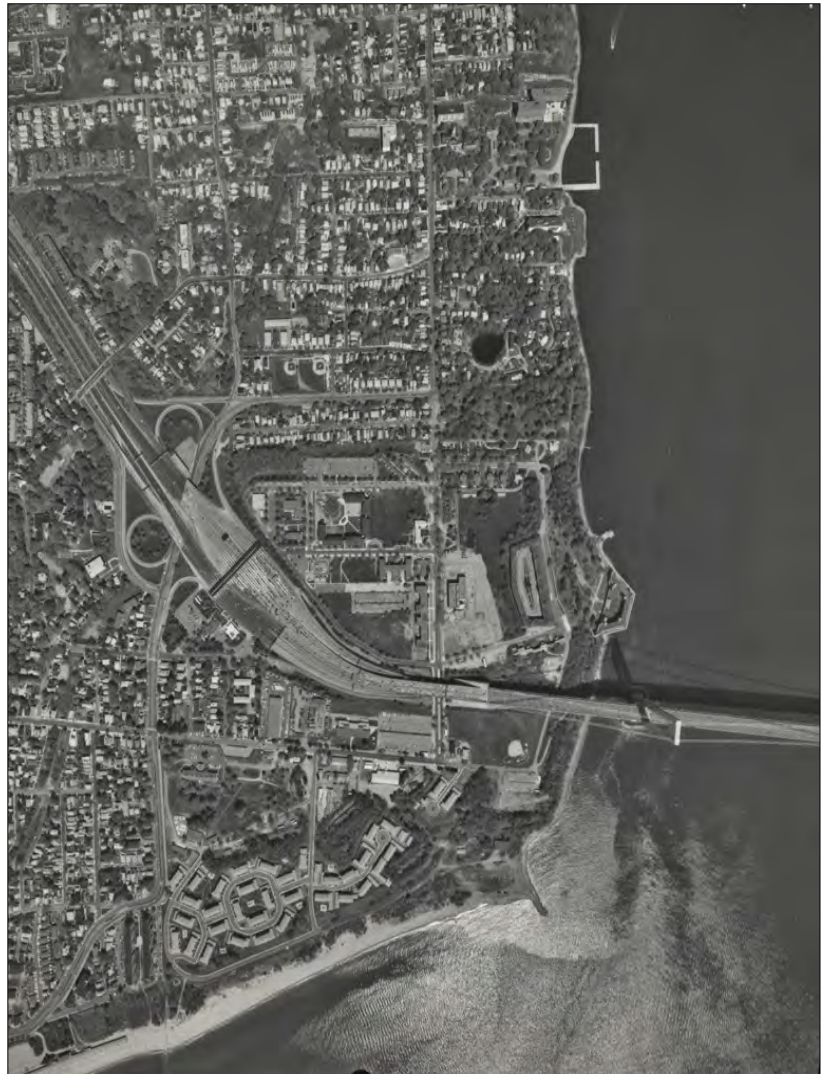
**Figure 2.84.** Aerial photograph of Fort Wadsworth, 1993. The photograph captures the late 20th-century alterations to the post prior to National Park Service acquisition (Gateway National Recreation Area Collections, Image 30654).

Late twentieth century alterations in the Fort Wadsworth landscape predating the National Park Service acquisition of the property are apparent in a 1993 aerial photograph (Figure 2.84). Large, new, modern buildings were constructed in the area north of the bridge approaches and west of New York Avenue. The former post hospital and nearby pre-World War II buildings east of New York Avenue were replaced by a large postmodern administrative building inconsistent with the architectural style of the surrounding buildings. The small, simple ranch-style Capehart housing at the southwest portion of the installation was replaced by a much larger complex of multi-family residential buildings. The new construction resulted in significant damage to nearby batteries. The central core of the base was kept clear of vegetation, but trees, shrubs, and vines continued to encroach on many of the historic properties, including the batteries, the hillside between battery Weed and Fort Tompkins, and along the north side of Fort Tompkins. Trees were also found overtaking the formerly cleared parade ground near the north boundary of the fort. The loss of street trees planted by the Works Progress Administration and Civilian Conservation Corps in the 1930s is also evident.

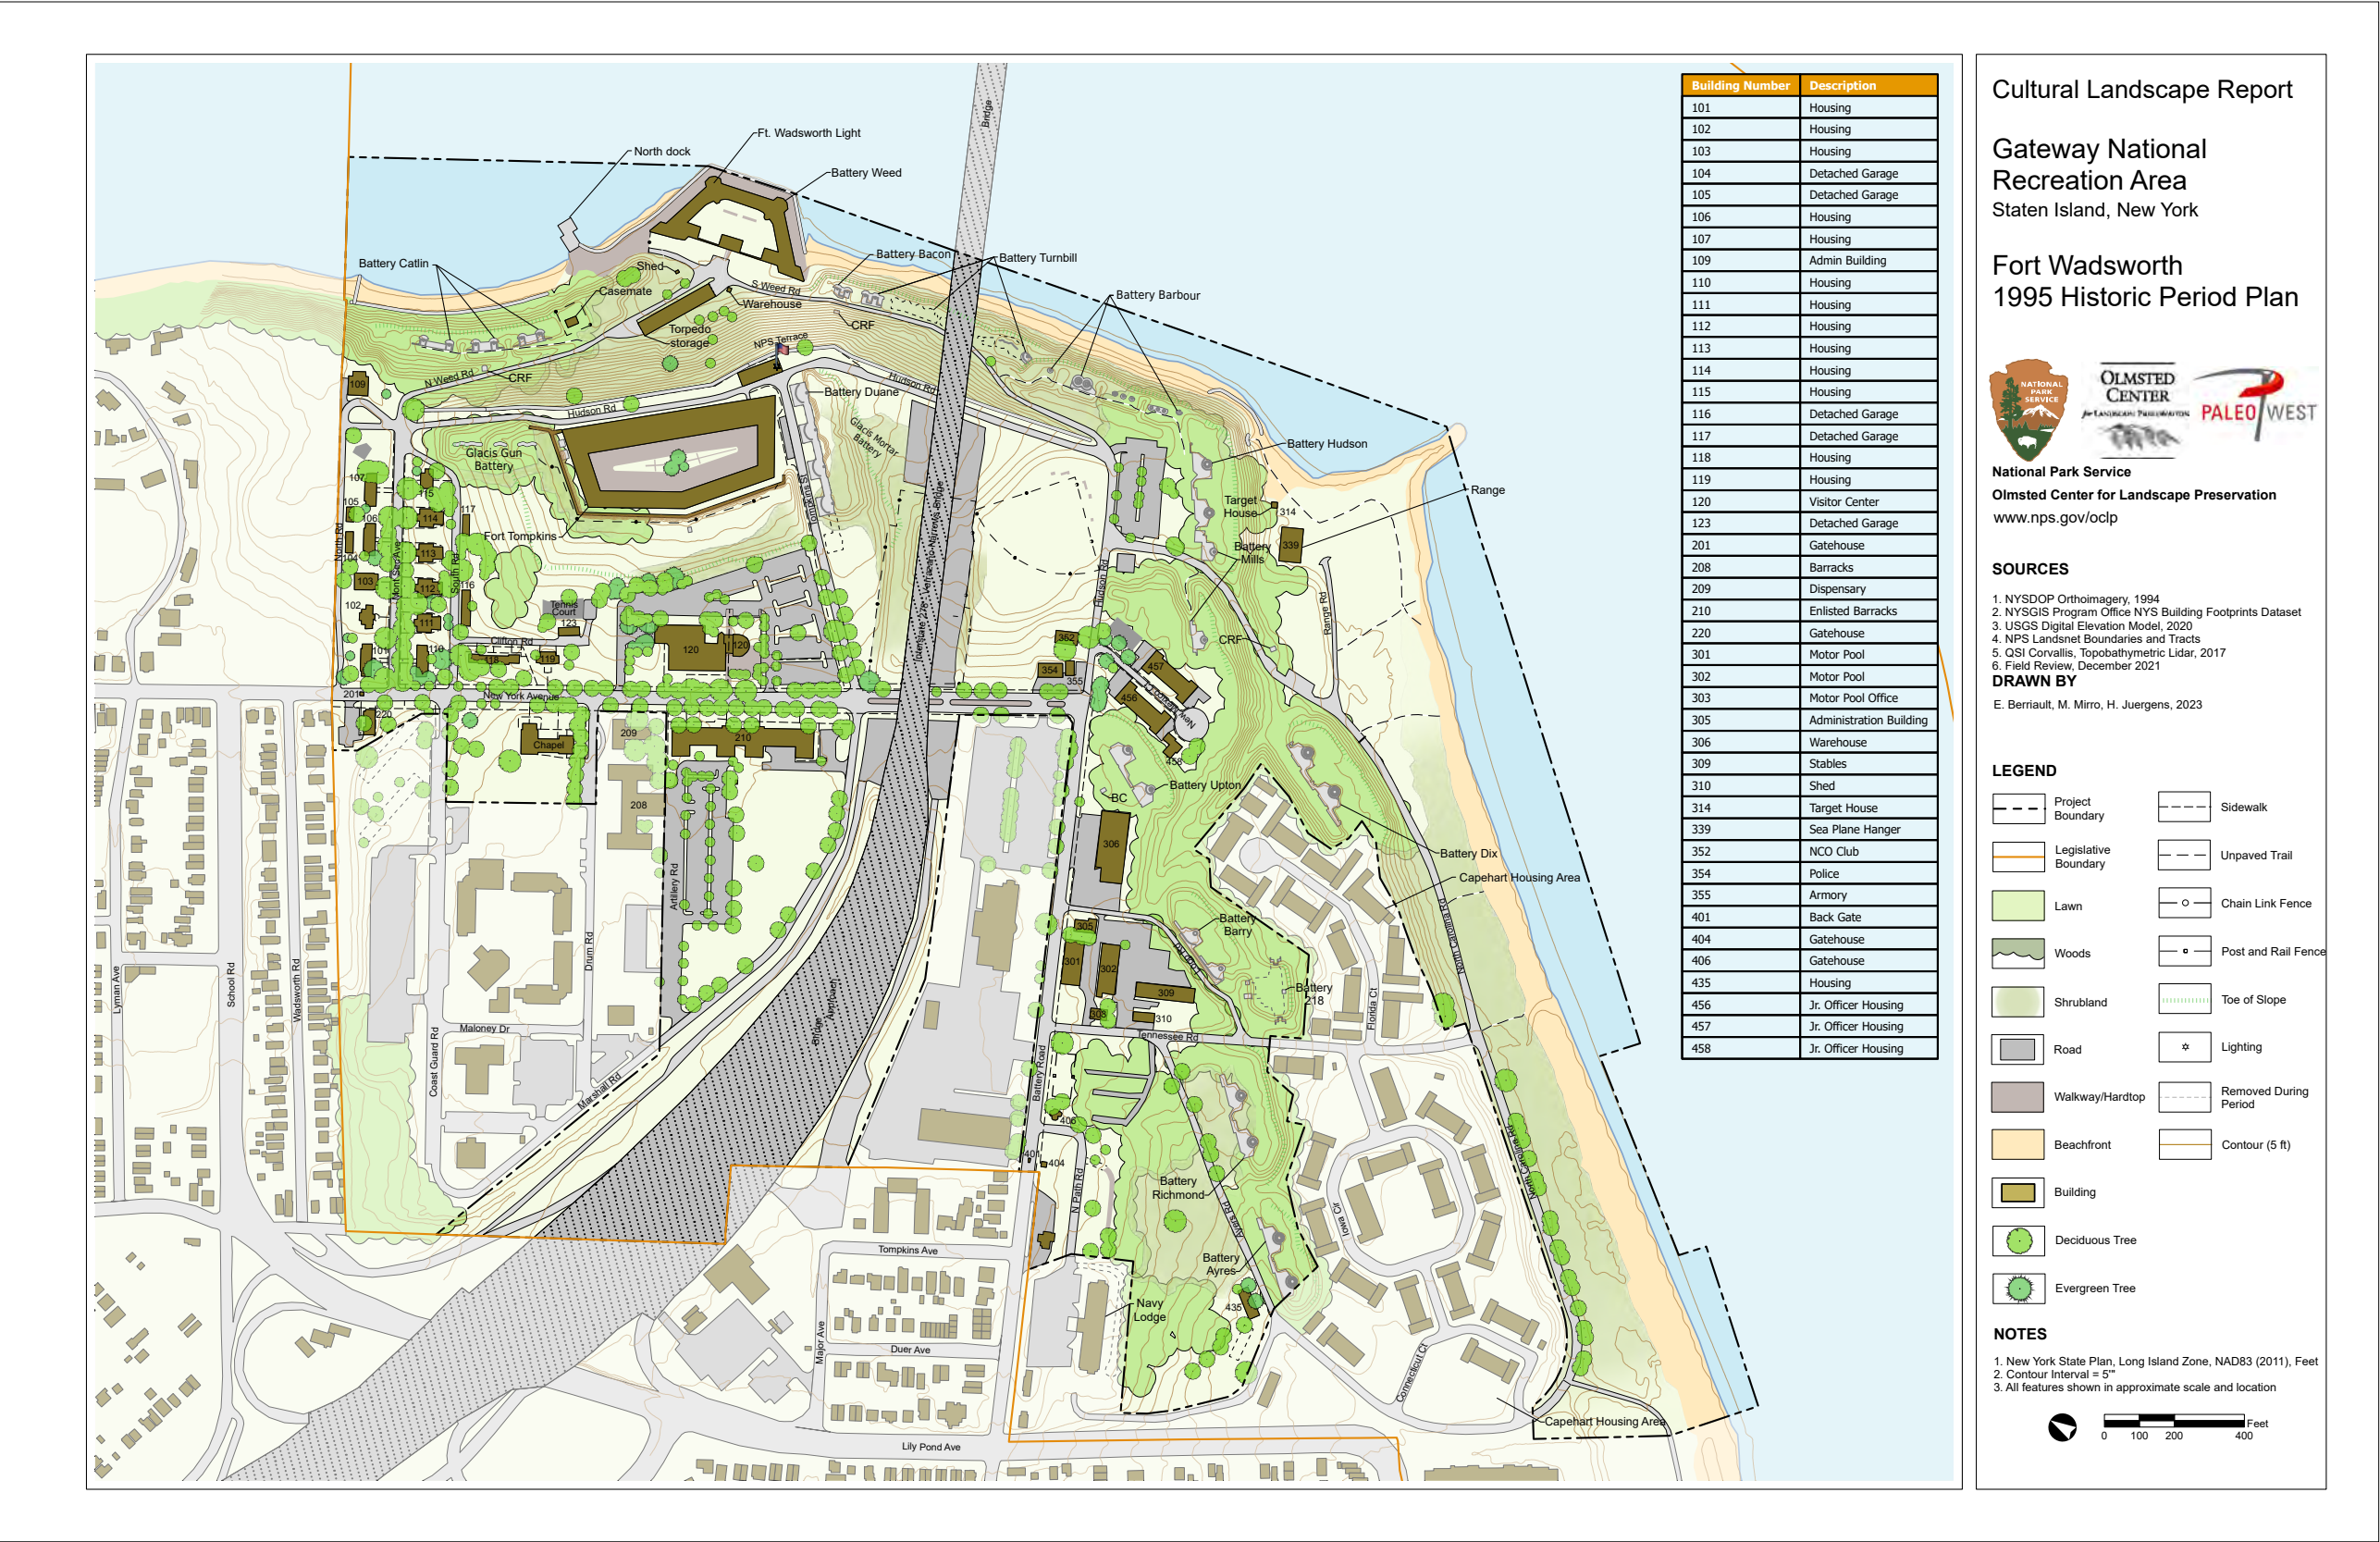
Figure 2.85. 1995 Historic Period Plan

Buildings in the Coastal North area include a new north gatehouse (Building 201). Housing lines both sides of Mont Sec Avenue and Clifton Road (Buildings 101–110, 117–119, and 123). Garages sit adjacent to the housing. The former Headquarters and surrounding buildings are replaced with a postmodern style large administrative building (Building 120) and parking lot.

Buildings in the Coastal South area include new Junior Officer Housing (Buildings 456, 457, and 458) constructed near Battery Upton. Navy housing units located south of Battery Ayers replace the former Capehart housing. A new Navy Lodge

Circulation routes rely on road access. The North Dock has fallen out of use at this time. New York Avenue is the main road running north to south that divides the Coastal North from the Inland North area. Mont Sec Avenue is flanked by North and South Roads. Sidewalks and Oriental Plane trees line both sides of Mont Sec Avenue. Hudson Road runs north to south on the east side of Fort Tompkins. A retaining wall runs along Hudson Road. North and South Weed Roads run down the bluffs to Battery Weed. Dock Road connects from the battery to the North Dock. Shore Road and Range Road wind down from Hudson Road to the southern coastline. The main road running east to west which divides the Coastal South from the Inland North area is Battery Road (formerly Richmond Avenue). Coastal South area batteries and Navy housing are accessed by Loop Road, Tennessee Road, King Road, and Ayers Road. USS Florida Court and USS New Mexico Court connect to housing. Circulation in the Inland North area consists of Coast Guard Road, Drum Road, and Artillery Road running perpendicular to New York Avenue with Maloney Drive and Marshall Road connecting them.

The Verrazzano-Narrows Bridge area cuts through Fort Wadsworth, across the Coastal North and Inland North areas.

Leading up to the National Park Service administration of Fort Wadsworth, parts of the landscape were subject to modern development. Changes occur largely in the Coastal South and Inland North areas. These portions of the Coastal South and Inland North areas remain in the control of the Department of Defense. Although largely unaltered during this period, the new postmodern administrative building on the east side of New York Avenue had a significant impact on the Coastal North area. The broad spatial organization remains consistent from the previous period, with fortifications occupying strategic locations on the landscape, a primary fort at the high point of the bluff, and batteries and redoubts below. The Verrazzano-Narrows Bridge dominates the views and vistas of the site interrupting the original spatial organization (Figure 2.85).

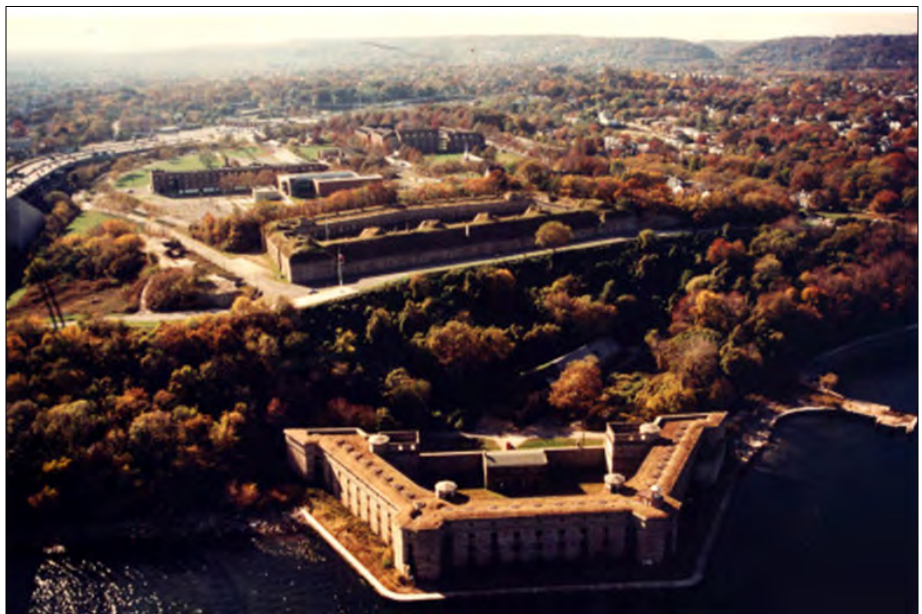
**Figure 2.87. Aerial photograph of Fort Wadsworth, 1995. Note the thick woody vegetation in the areas between Battery Weed and Fort Tompkins and West of Fort Tompkins. These areas were historically kept clear of trees and shrubs (National Park Service).**

to the torpedo building and areas between the batteries and the shoreline” that were “critical for understanding the military use of the fort.”<sup>160</sup> Dense tree and shrub growth obscured views from the overlook that had long been a celebrated vantage point (Figure 2.87). The landscape that had historically been maintained as an open grassy engineered slope was no longer recognizable. Vegetation also shrouded many of the batteries and support buildings that were constructed on the post prior to World War II. Therefore, the removal of intruding vegetation was of immediate concern, and in 1994, park staff felled trees to reestablish the historic scenic view.<sup>161</sup> The National Park Service also constructed a terrace for visitor use in 1995. The terrace consists of a concrete paved area with modern benches, a flagpole, and wayside exhibits (Figure 2.88). Other projects between 1995 and 1997 included the development of visitor center exhibits, waysides, road and sidewalk repairs, and modifications to Building 210 to allow the building’s use for office space.<sup>162</sup> No additional new construction has occurred under National Park Service management.<sup>163</sup>

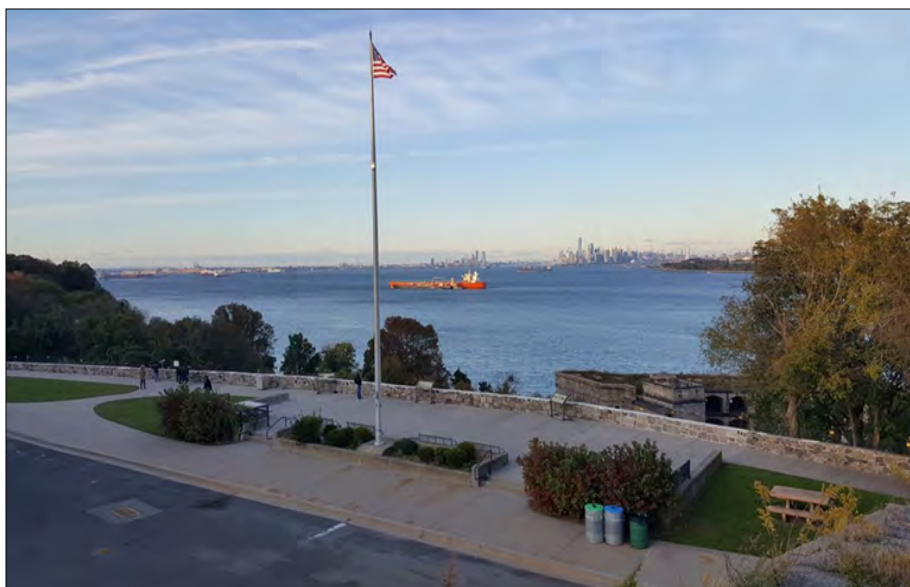
Figure 2.88. Aerial photograph of Fort Wadsworth, 1995. Note the thick woody vegetation in the areas between Battery Weed and Fort Tompkins and West of Fort Tompkins. These areas were historically kept clear of trees and shrubs (National Park Service).

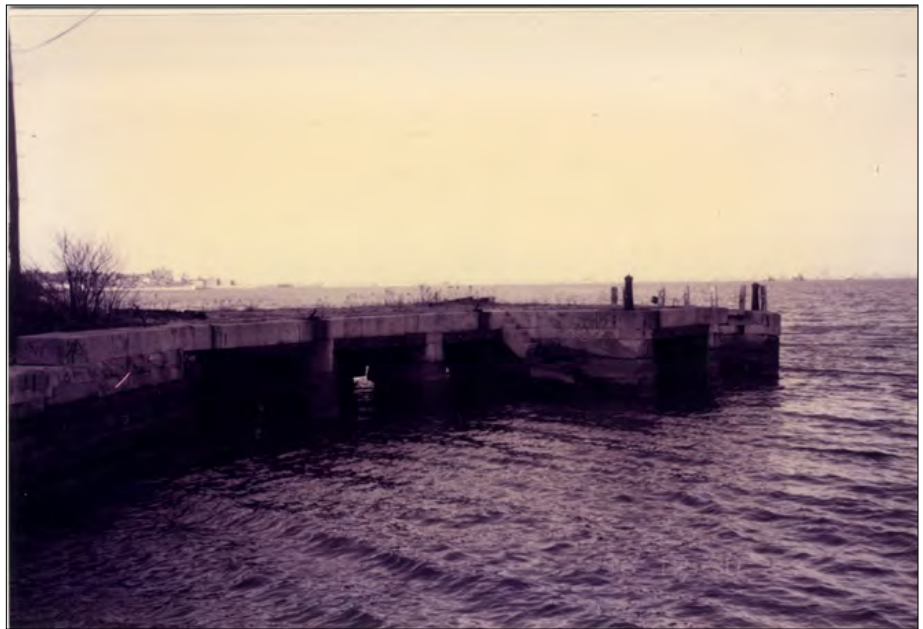
**Figure 2.92.** Photograph of the dock north of Battery Weed looking north, circa 1995. Note the general state of disrepair with vegetation on the decking, damaged piers, and deteriorating stonework (Gateway National Recreation Area Collections, Image 31082).

Figure 2-92. Photograph of the dock north of Battery Weed looking north, circa 1995. Note the general state of disrepair with vegetation on the decking, damaged piers, and deteriorating stonework (Gateway National Recreation Area Collections, Image 31082).

Stabilization work was completed on Battery Weed and Fort Tompkins in the late 1990s and early 2000s. Volunteers repaired the Fort Wadsworth Light in 2004.<sup>167</sup> The National Park Service completed a Historic Structure Report for Battery Weed pier and seawall in 2006. The analysis determined that the seawall was in “fair condition” even though nine “localized areas” of the wall had partially collapsed and mortar between the seawall’s masonry blocks have eroded over time. The outermost bents supporting the dock were in poor condition. There were two areas of deck collapse and moderate to severe settling and tilting of the deck, and granite columns and blocks (Figure 2.92). Recommended repairs included the reconstruction of the collapsing seawall sections and the repointing of all seawall joints. Suggested repairs to the dock included the reconstruction of the outboard sections. If reconstruction was not found feasible, the report authors offered that the dock should be dismantled and “stored for future use.” They recommended that the entire top of the dock be covered “with a thin concrete leveling pad,” with an anti-skid surface. The granite blocks and columns required repair and repointing, and the bottom of the structure needed to be sealed to protect it from the elements. The report also notes that any free-standing timber piers should be removed and a perimeter railing installed around the dock for safety and code requirements.<sup>168</sup>

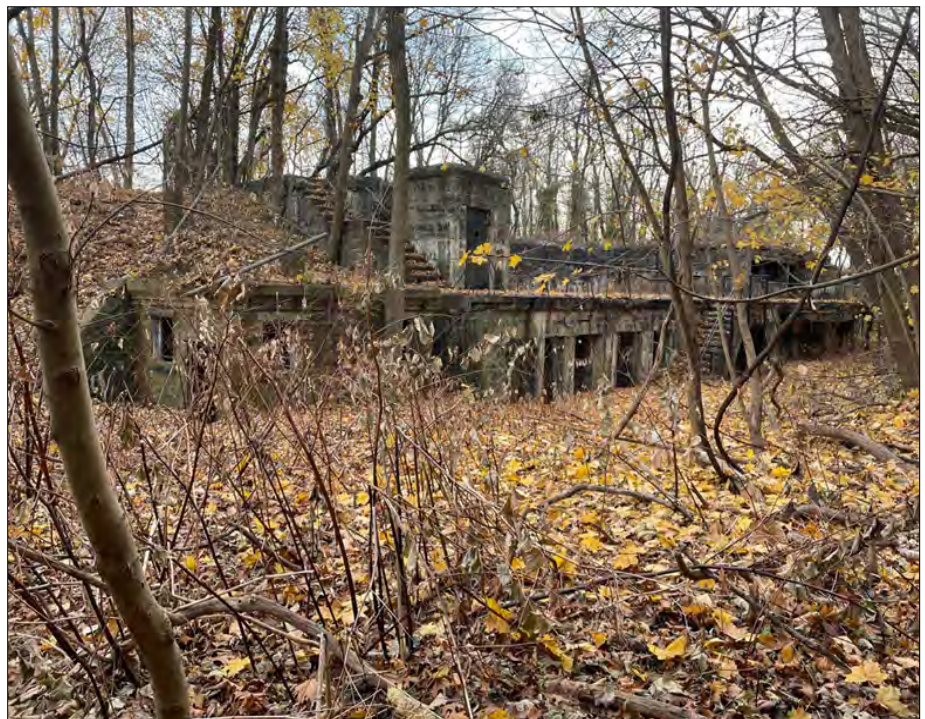
**Figure 2.94. Figure 2 94.**  
**Photograph of Battery Dix, the**  
**least deteriorated of the Endicott**  
**Era batteries, December 2021**  
**(PaleoWest).**

An Historic Structure Report for Battery Dix was published in 2021. The battery was selected for the report because it was considered to be the “most well-preserved of the four Fort Wadsworth 12-inch gun batteries” (Figure 2.94). Nonetheless, the neglected state of the battery was evident in the fact that the National Park Service had to clear debris from the structure to allow access to the interior. Even with the vegetation removal, field crews were not able to enter the rooms on the east end of the battery.<sup>182</sup> The report noted that the battery was suffering from concrete deterioration and ferrous metal corrosion stemming from:

*Poor water management and drainage as well as inadequate passive ventilation, all of which are typical issues for Endicott Era batteries. In addition, for the past 75-years, the structure has been completely unmaintained. Persistent water infiltration from the exterior and high humidity within the exterior have saturated the structure consistently, likely causing both chemical and mechanical failure of*

*the concrete as well as corrosion of the ferrous metal structural and decorative elements.*<sup>183</sup>

The authors stressed that the condition of the battery was primarily the result of a pattern of long-term inattention. Specifically, the vegetation that grew around the structure prevented the battery from drying after rainfall. Plant debris covered portions of the battery, and several feet of soil accumulation made portions of the structure inaccessible.<sup>184</sup> The authors suggested that the National Park Service work to stabilize the emplacements and structure and reestablish the historic landscaping and access paths. They proposed that this approach, a middle ground between the full restoration of the battery and stabilization that only addresses immediate safety and structural concerns, as the most cost-effective way in which the National Park Service can provide public access to the structure. It would also allow visitors to view the battery in its current condition and historic form.<sup>185</sup>

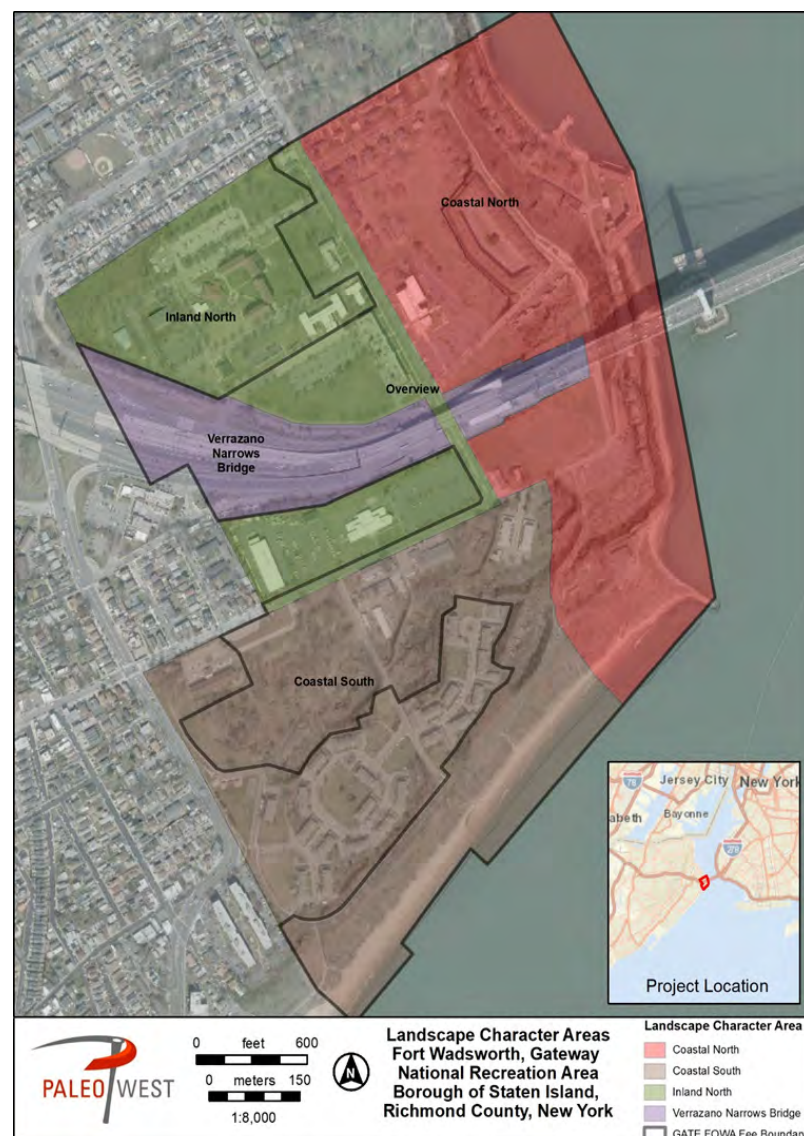
**Figure 3.1. Landscape Character Areas of Fort Wadsworth**

Detailed notes are presented below documenting the existing conditions of the historic landscape, organized according to four Landscape Character Areas (Figure 3.1). These landscape character areas are, Coastal North and Coastal South, which are characterized by their immediate adjacency and relationship to the coastline; the Inland North that has been interrupted by the Coast Guard presence; and the Verrazano-Narrows Bridge with its associated access roads.

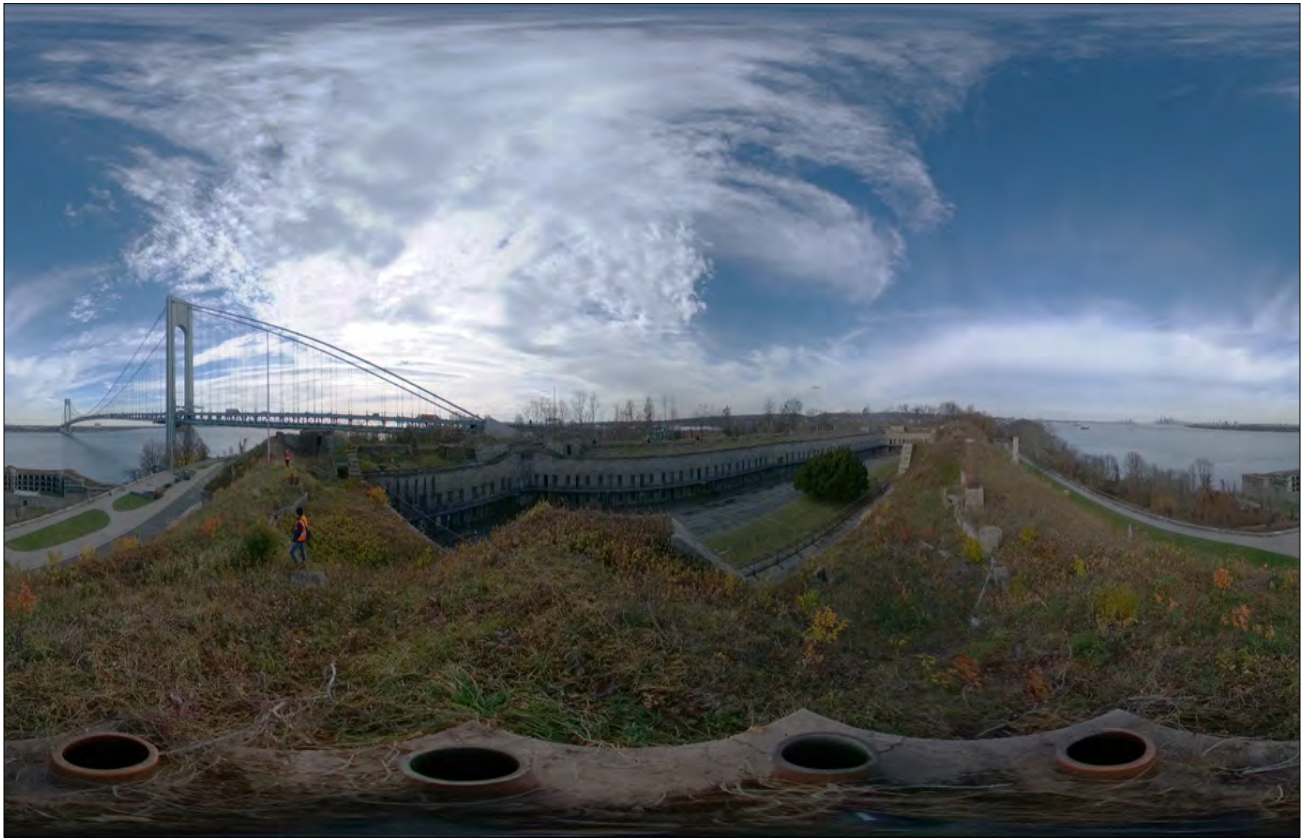
**Figure 3.2. A 360-degree photograph of Fort Wadsworth from atop the former coal smokestack on Fort Tompkins. Note the extensive vegetation but extant viewsheds looking over The Narrows**

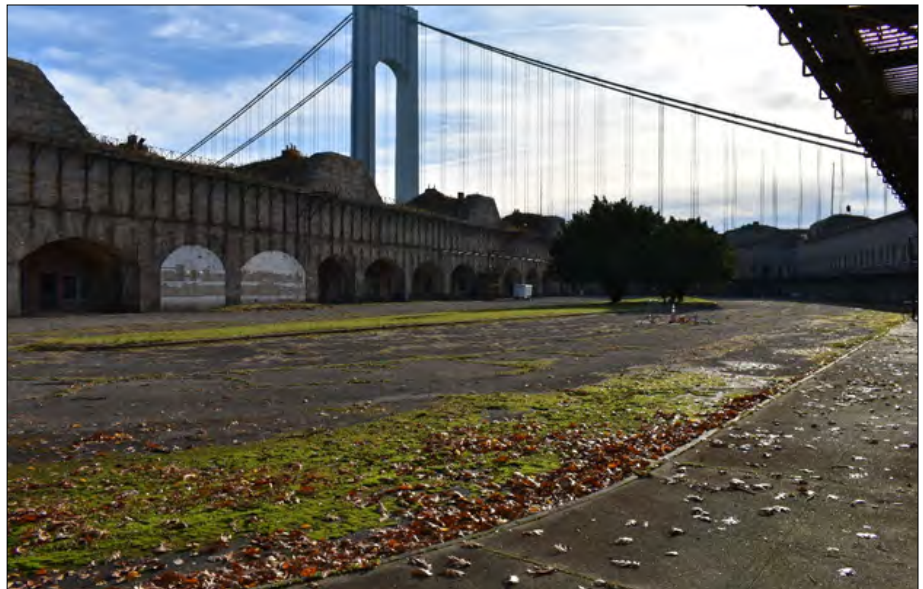
Figure 3.3. Photograph of the interior of Fort Tompkins, facing south (PaleoWest 2021).

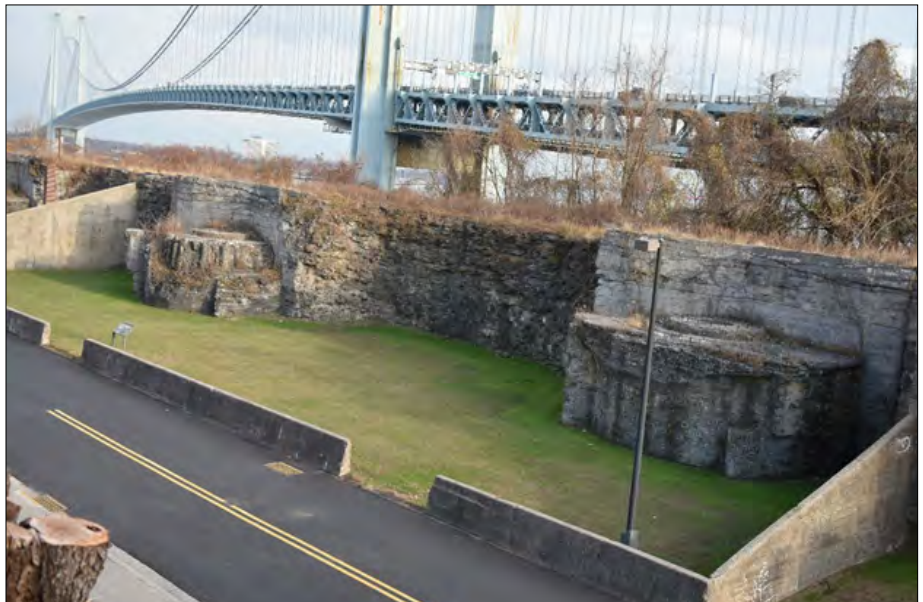
Figure 3.4. Photograph of Battery Duane, facing south from the Fort Tompkins west glacis (PaleoWest 2021).

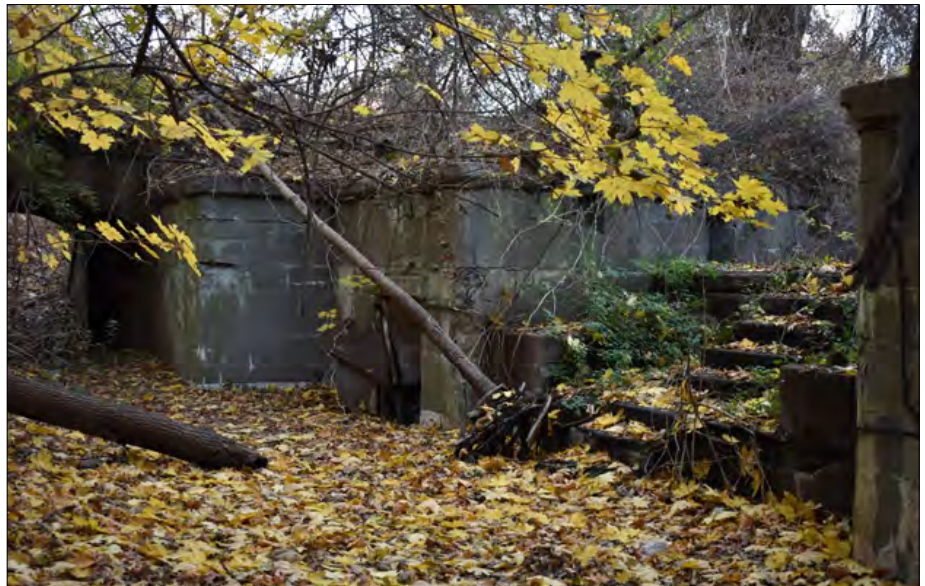
**Figure 3.7. Photograph of the Torpedo Storage building, facing southeast from Weed Road. Note the missing roof (PaleoWest 2021).**

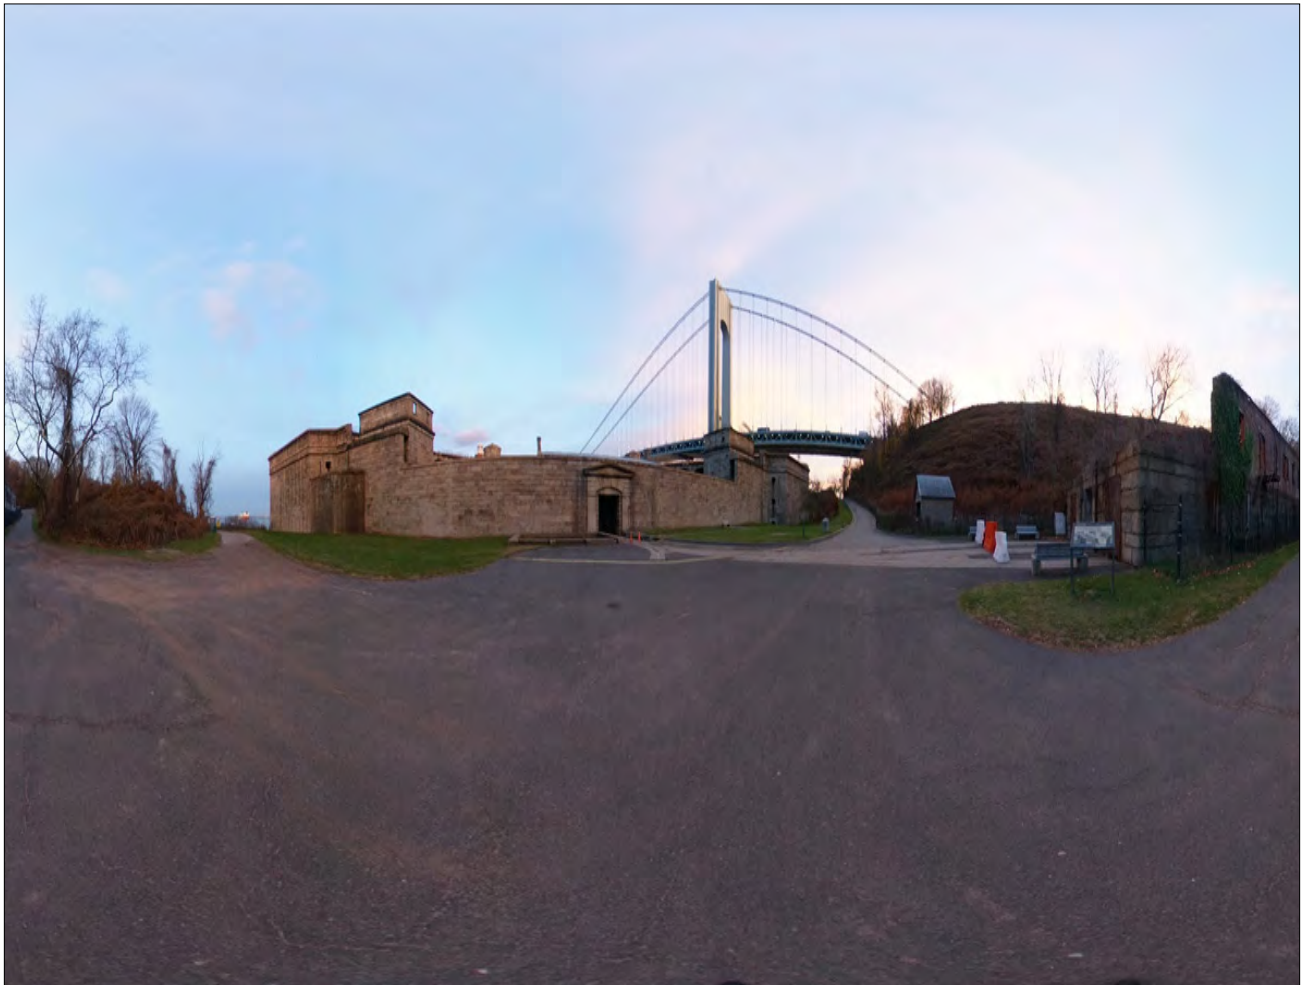
**Figure 3.8. 360-degree photograph of the intersection of Battery Weed Road and Dock Road near Battery Weed (PaleoWest 2021).**

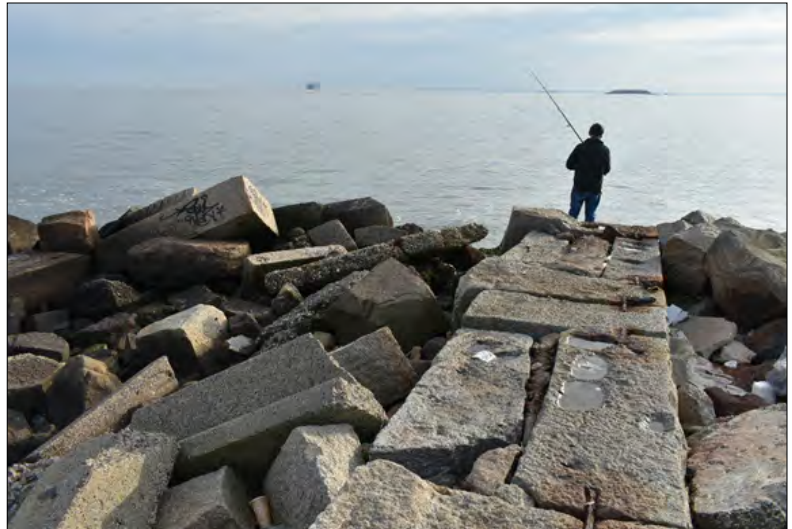
Figure 3.9. Photograph of the south jetty with cut stone and building debris, used by visitors as an unofficial fishing pier, facing southwest (PaleoWest 2021).

The South Wharf Jetty, built in 1858, is extant but in significantly deteriorated condition. It no longer reflects its historic military purpose and is extant as somewhat of a visual mystery as to what its original design and construction was. A wharf is indicated as early as 1809 in the Williams plan and the existing jetty is shown in similar but slightly altered configurations on plans from 1882 to 1897, and again in 1938. A stone breakwater was a part of the feature in the 1800s; however, this is now underwater. How this functioned for military use is not clearly understood, but boat access was a significant part of the historic circulation system for Fort Wadsworth. The South Wharf Jetty retains integrity of location, setting, materials, workmanship, feeling, and association. However, it has been damaged and deteriorated by what appears to be dumping of building material waste from the demolition of the batteries by in the 1990s as well as the harsh shore environment subject to storms and hurricane forces.

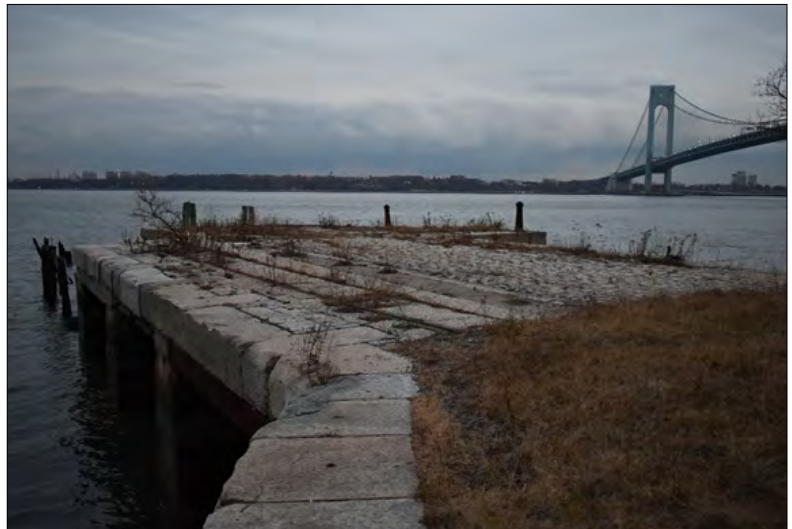
Figure 3.10. Photograph of the North Dock, facing east (PaleoWest 2021).

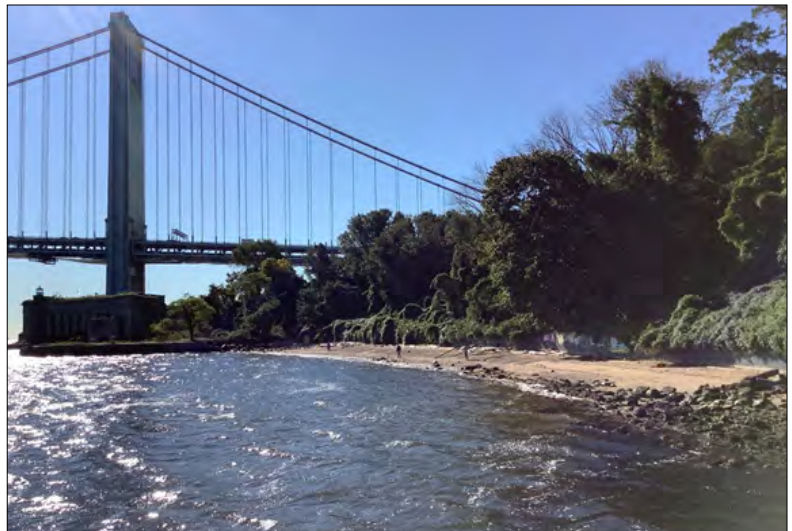
**Figure 3.11. Photograph of Battery Weed and the northern shoreline from the northern park limits, facing south. Note the heavy vegetation along the bluff and remains of the Battery Weed North Dock (PaleoWest 2021**

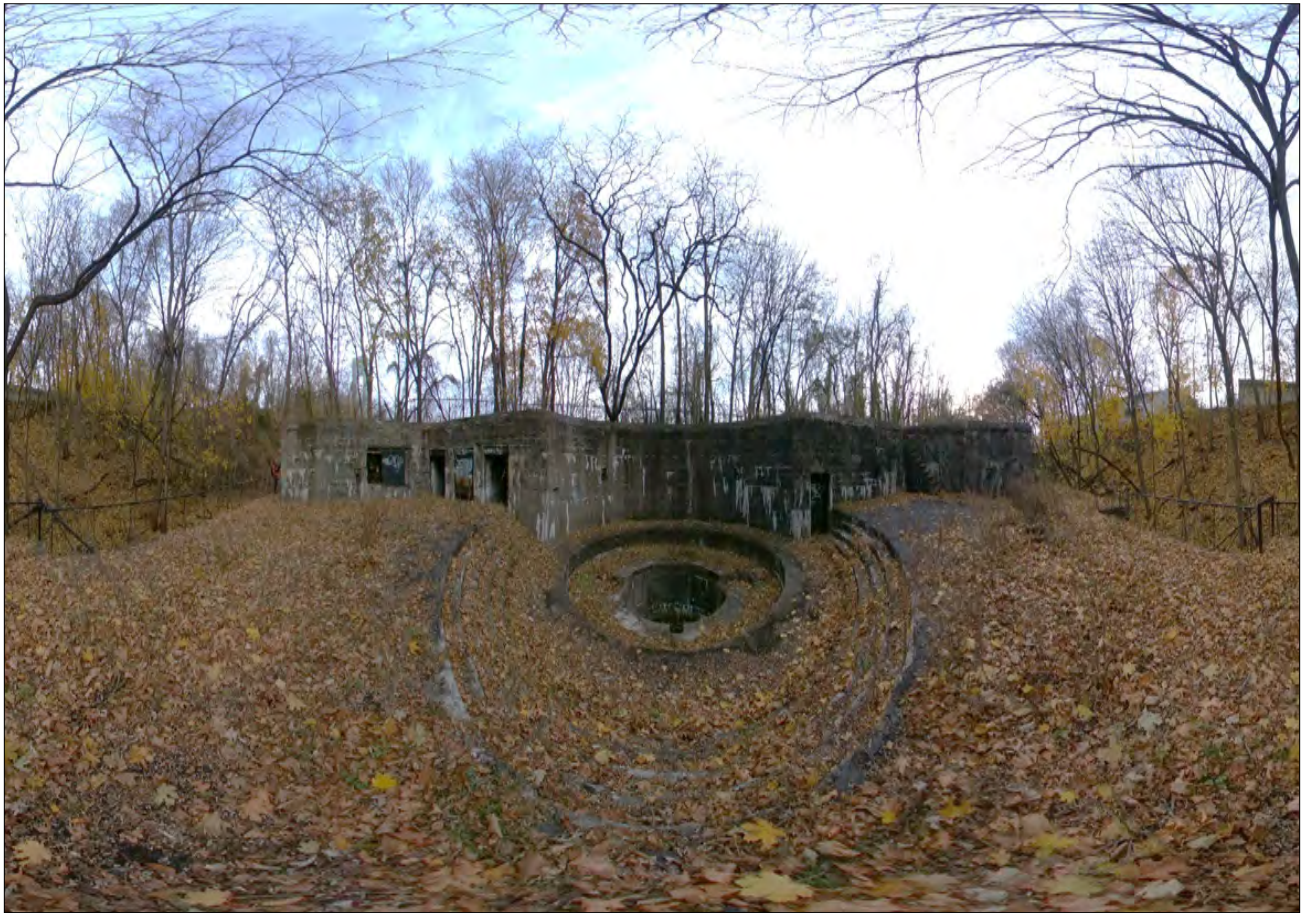
**Figure 3.13.** 360-degree photograph of the interior of Battery Dix. Note the existing chain link fencing (PaleoWest 2021).

The batteries in the proximity of the newer housing south of the Verrazzano-Narrows Bridge are enclosed by chain link fencing, which has been in place for many years and damaged by fallen trees or other cuts in the fence. The batteries appear to have been damaged from grading operations as part of the construction of the housing in which fill material was pushed into the first level of the battery and the battery parade. It appears that construction of the housing included efforts to partially destroy and fill in the batteries as a part of the grading for the housing. The entire area surrounding the batteries was then fenced off and seemingly abandoned. Continued lack of active intervention to preserve the remains of the batteries is subjecting them to increasing threats of deterioration and disappearance.
