# CULTURAL LANDSCAPE REPORT

FORT WADSWORTH

GATEWAY NATIONAL RECREATION AREA

Prepared by PaleoWest, LLC

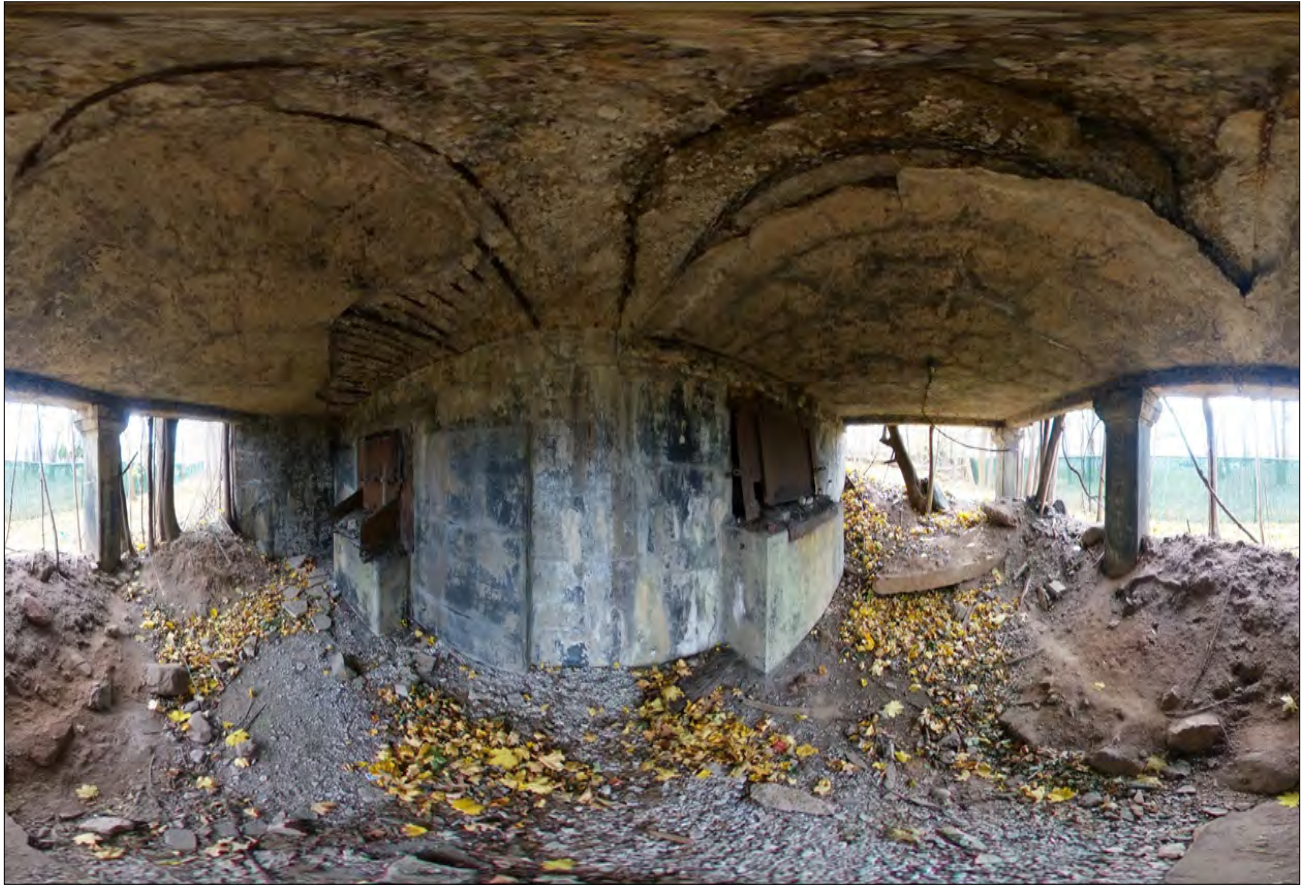
**Figure 3.14.** 360-degree view of interior of Battery Upton [deterioration of concrete and other structural elements is apparent].

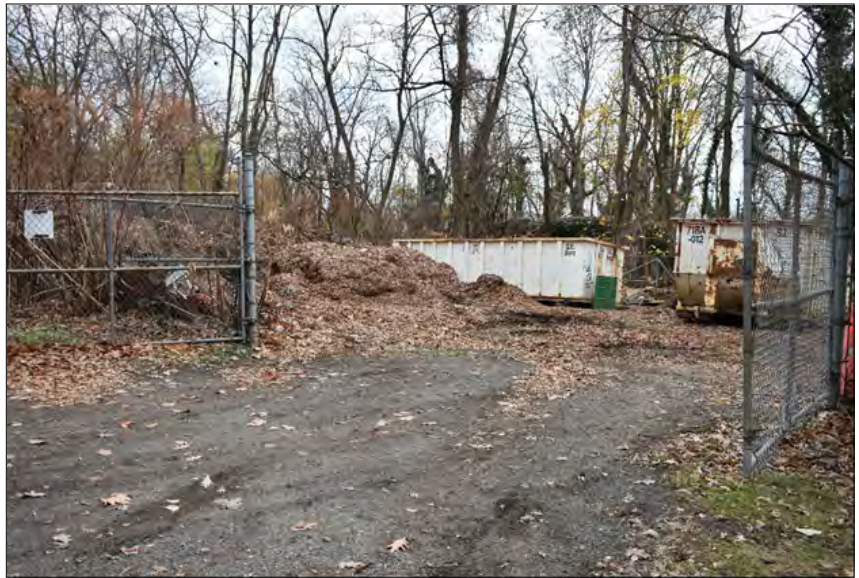
**Figure 3.19. Photograph illustrating the materials condition at Battery Ayers, facing south (PaleoWest 2021).**

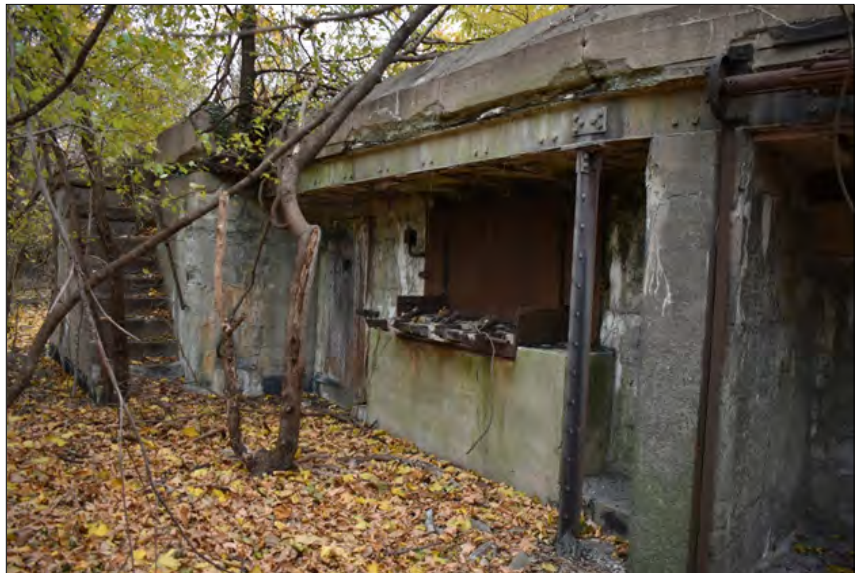
**Figure 3.20. Photograph of Battery Ayers, illustrating fenced condition and vegetation overgrowth typical of the coastal batteries, facing south from Ayers Road (PaleoWest 2021).**

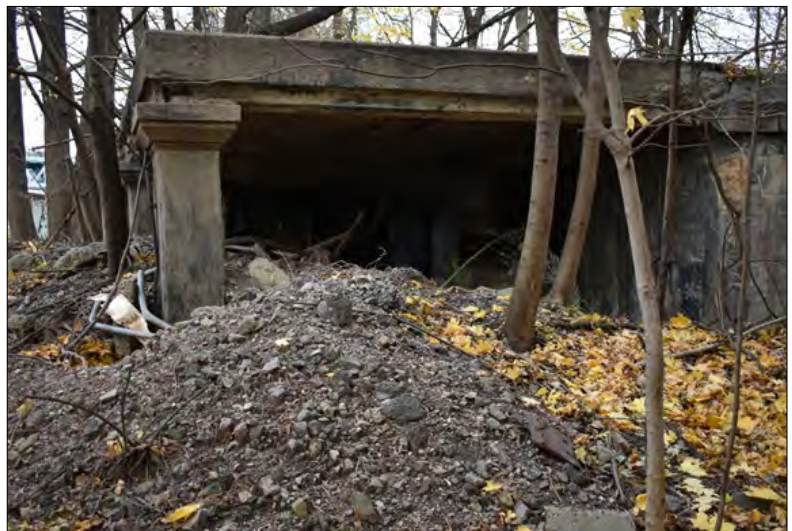
Figure 3.22. Photograph of Battery Dix, south of the Coast Guard housing, with the lower level buried in fill, facing west (PaleoWest 2021).

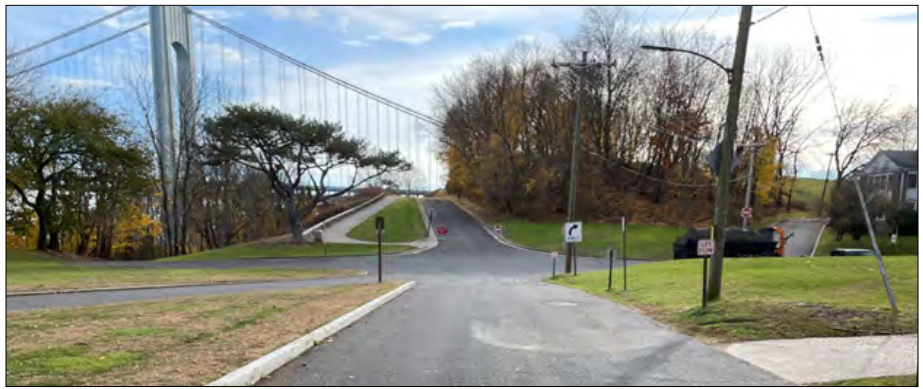
**Figure 4.2.** Photograph of Battery Weed Road, looking south (PaleoWest 2021).

North Battery Weed Road was realigned circa 1863, and South Battery Weed Road circa 1847 and 1863 serving as the original access to South Cliff Battery. It is likely that the original alignment of Battery Weed Road may date to at least circa 1809 where it appears on the Williams map of proposed fortifications. Battery Weed Road provides the only road access from the upper bluff fort and batteries to the shore fortifications. It is likely that Battery Weed Road is the oldest extant road circulation on the Fort Wadsworth military landscape. Both North and South Battery Weed Road retain a high degree of integrity to their original location, design, setting, feeling, and association. The original material was not asphalt, but it was paved during the Fort Wadsworth historic period of significance. Some loss of integrity has occurred because of modern road improvements and the introduction of modern small-scale features such as signing, curb and gutter, and road stripping.

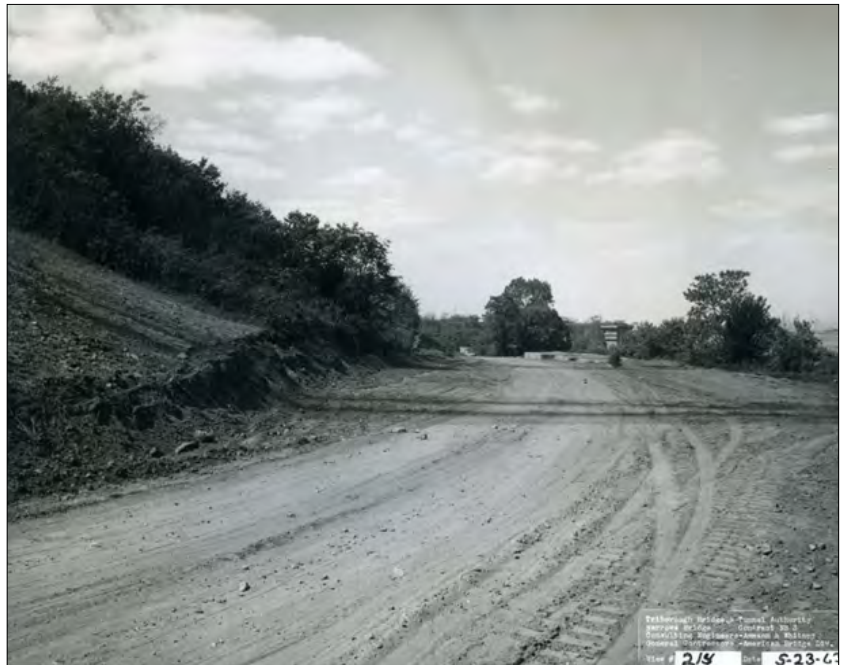
Figure 4.7. Historic photograph looking along Battery Weed Road, March 23, 1963, facing north during the construction of the Verrazzano-Narrows Bridge. Note the top of Battery Weed in the distance and overgrown vegetation on the bluff to the west. The road was unpaved at the time. (Metropolitan Transit Authority Bridges and Tunnels Archive, Photo NB-3-214).

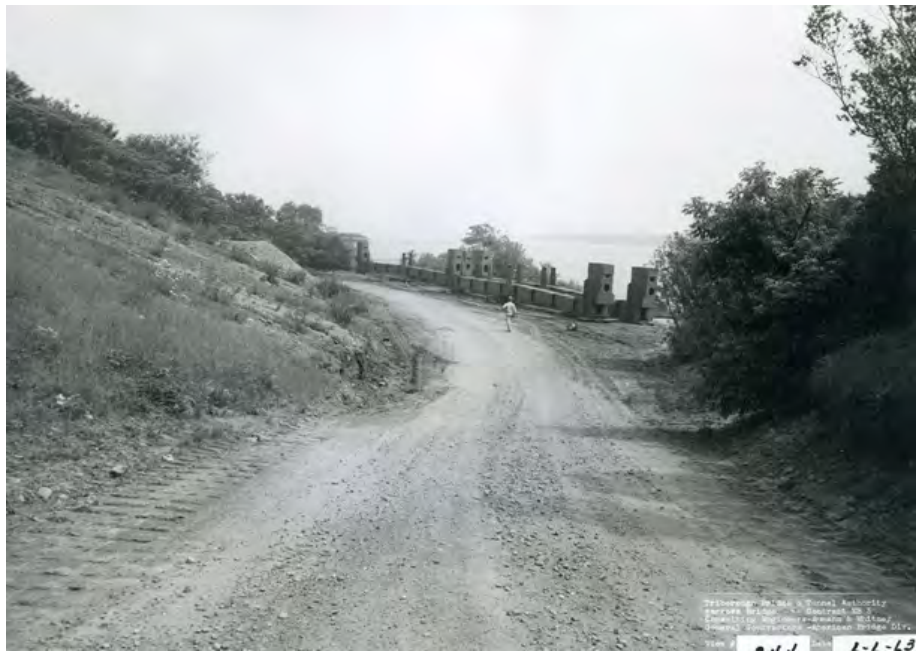
**Figure 4.8. Historic photograph looking along Battery Weed Road facing northeast, 1963. Note sections of Verrazzano-Narrows Bridge decking waiting to be lifted into place from the widened roadway. Many of Fort Wadsworth's historic roads were utilized during construction of the bridge in the 1960s. (Metropolitan Transit Authority Bridges and Tunnels Archive, Photo NB-3-244).**

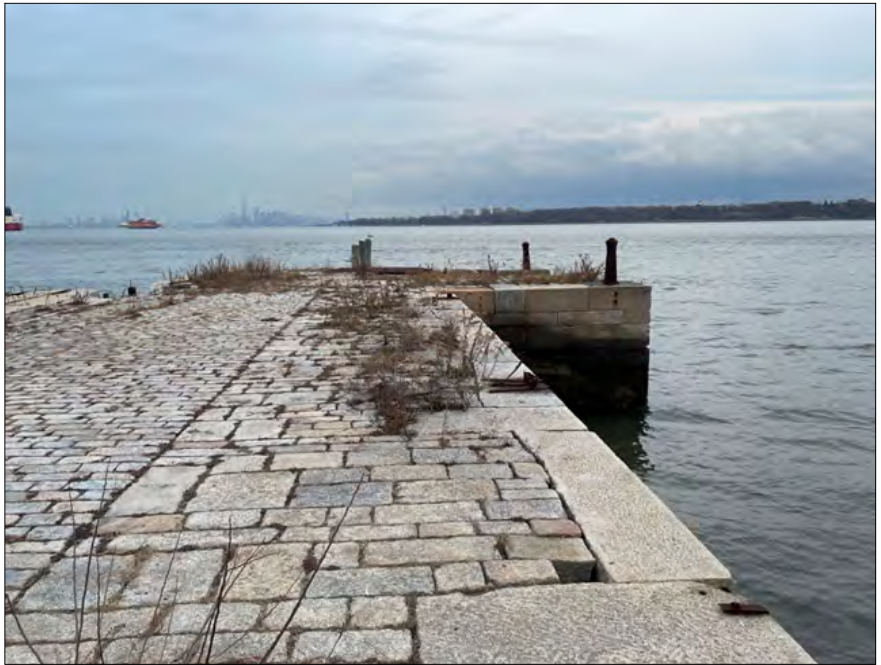
Figure 4.11. Photograph of the Battery Weed North Dock, facing northeast (PaleoWest 2021).

The earliest access to the military landscape of Fort Wadsworth included a ferry landing site in the vicinity of the North Dock. Water transport for people as well as building materials and supplies was essential to the use and development of Fort Wadsworth. The ferry landing site preceded the North Dock that exists today, constructed circa 1858. The existing dock, although severely deteriorated, retains a high degree of integrity of location, setting, design, material, workmanship, feeling, and association. The existing dock with its massive cut stone granite blocks strongly conveys its historic period of significance.

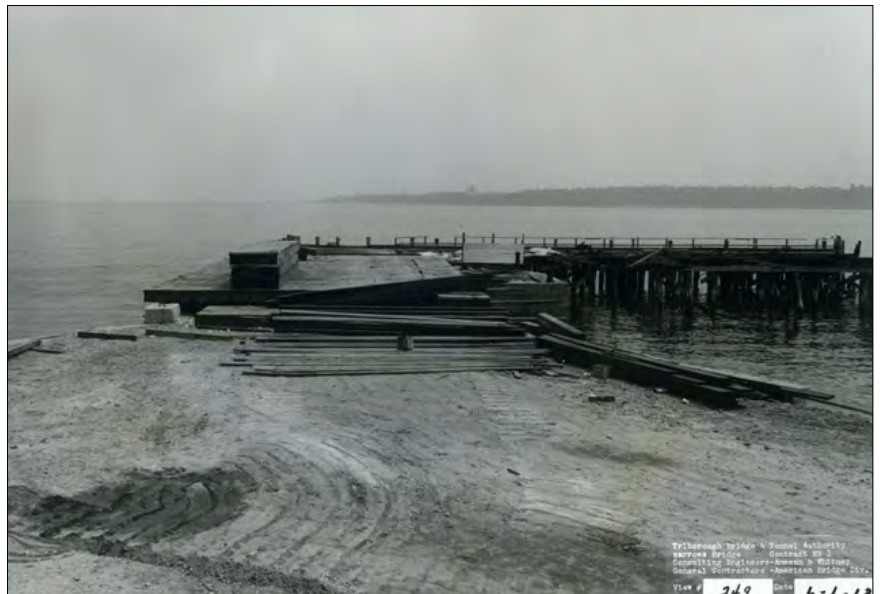
Figure 4.12. Historic photograph of the Battery Weed North Dock, facing northeast, taken June 6, 1963 during construction of the Verrazzano-Narrows Bridge. Note the addition of new decking and reinforcements to support the use of the dock during bridge construction (Metropolitan Transit Authority Bridges and Tunnels Archive, Photo NB\_3\_249).

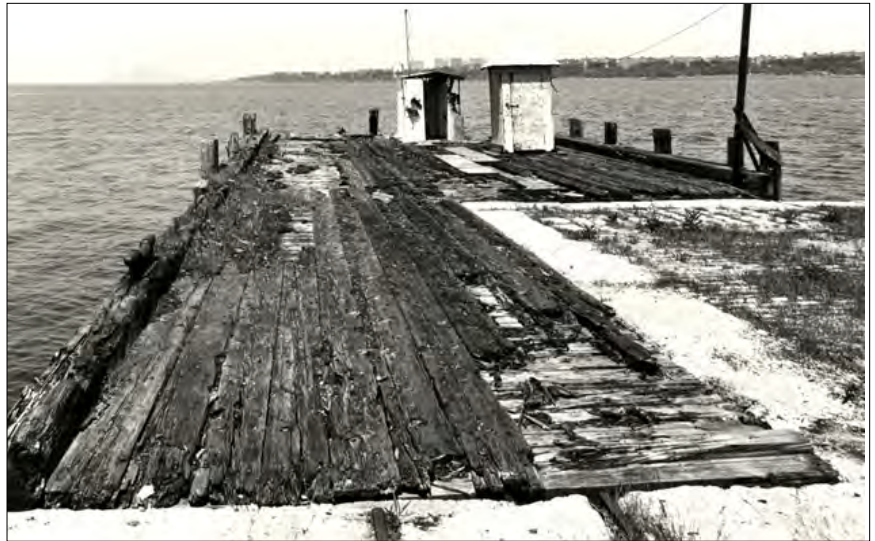
**Figure 4.13.** Historic photograph of the Battery Weed North Dock, facing northeast, circa 1980s. Note the sheds placed during the Verrazzano-Narrows Bridge construction in the 1960s (Gateway National Recreation Area Collections, Photo 29593)

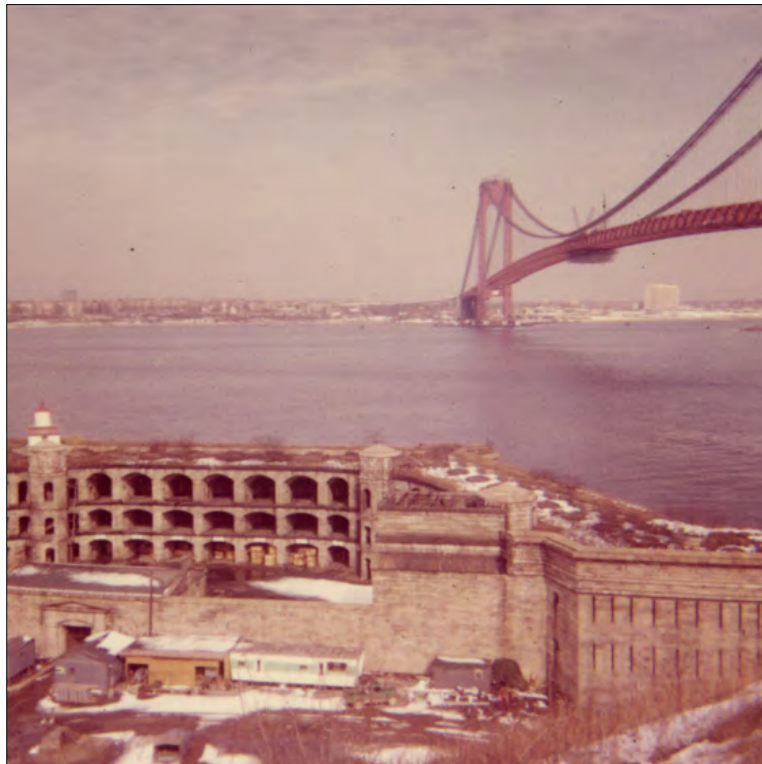
Figure 4.16. Historic photograph of Battery Weed and the Verrazzano-Narrows Bridge from Fort Tompkins, March 1963. Note the construction equipment along the western wall near the salleyport on top of the foundations of the previous cable tank buildings (Gateway National Recreation Area Collections, Photo 21915-3-64(3)).

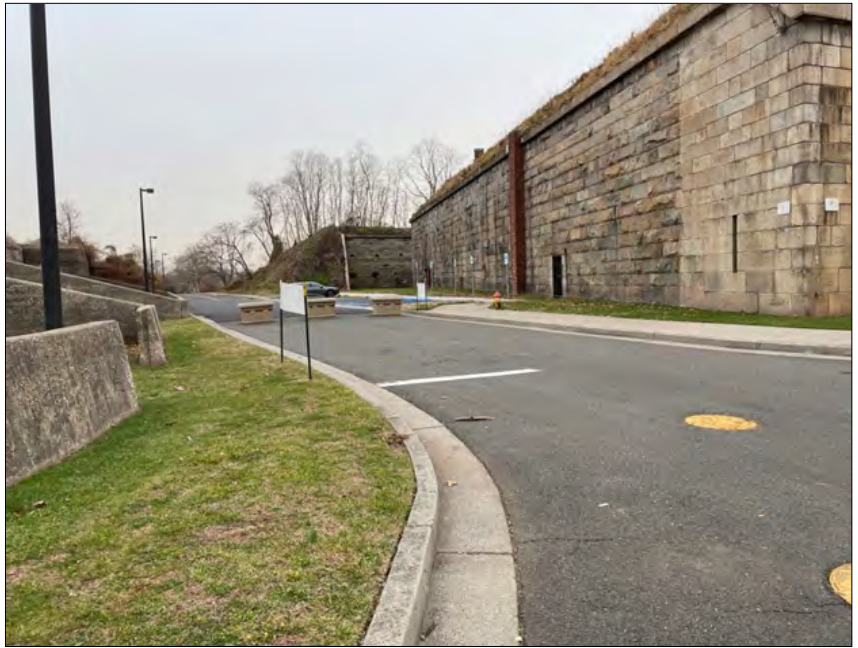
Figure 4.18. Photograph of the south wall of Fort Tompkins and Battery Road, facing west (Battery Duane to the left). Vegetation has been largely cleared from atop Fort Tompkins (PaleoWest 2021)..

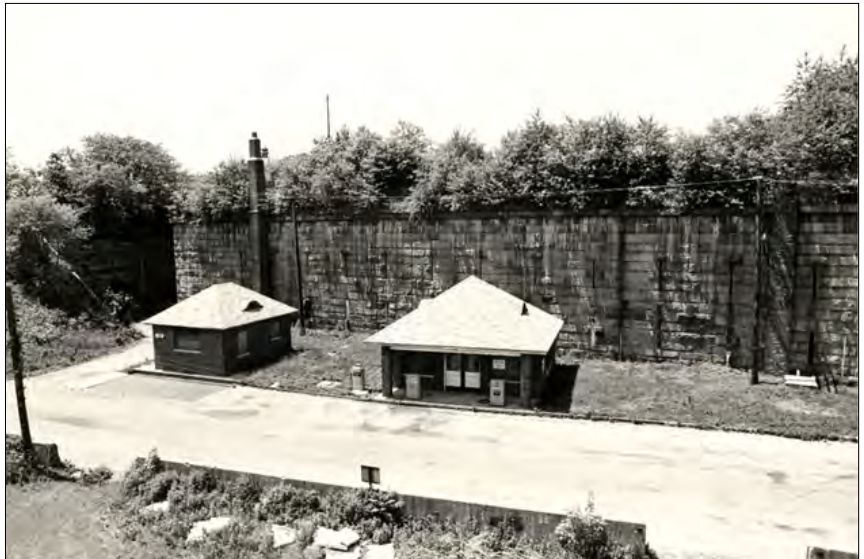
Figure 4.19. Historic photograph of the west wall of Fort Tompkins and Battery Road, facing northwest circa 1950. Note the two outbuildings present at that time, including a fueling station. Substantial vegetation covers the top of Fort Tompkins (Gateway National Recreation Area Collections, Photo 29597).

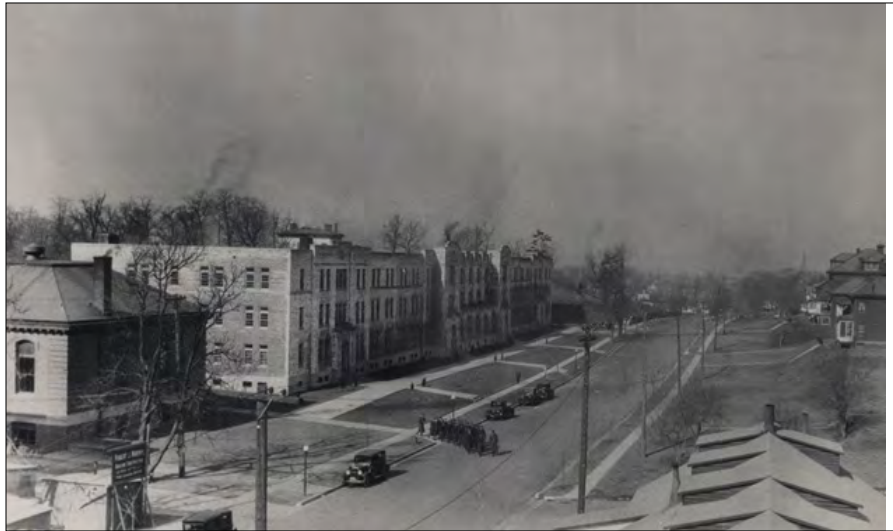
Figure 4.23. Historic photograph of New York Avenue, facing north, circa late 1930s; with Building 210 in the background at left. At right and just out of frame is the current location of present-day Visitor Center and parking lot; note the sidewalks and circulation patterns are largely unchanged; however, the southern portion of Building 210 was demolished in the 1960s (Gateway National Recreation Area Collections, Photo 19358).

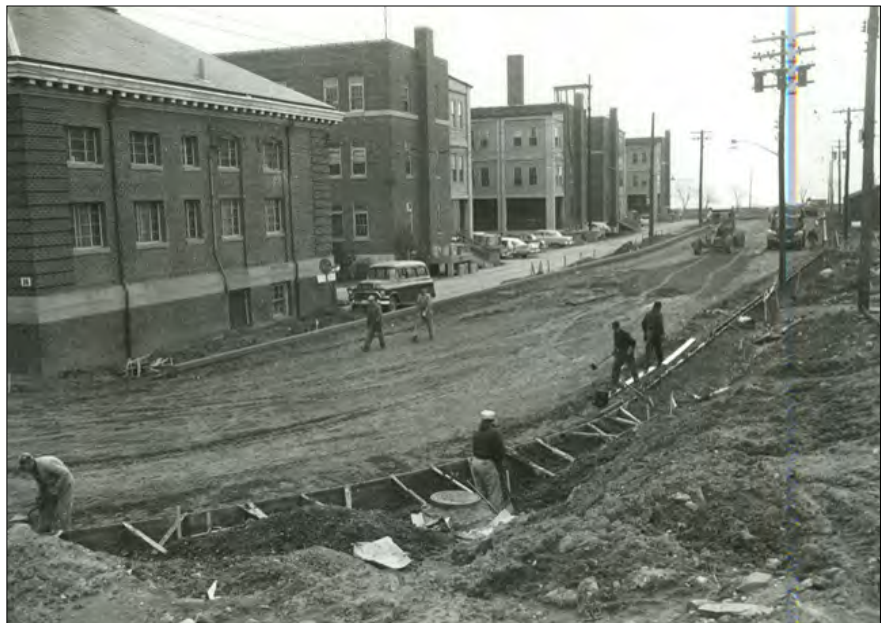
**Figure 4.25. Historic photograph of rear of Building 210, circa 1960. The road was constructed as part of re-route of traffic during construction of the Verrazzano-Narrows Bridge and is now partially used as a parking area for staff and Park Police (Metropolitan Transit Authority Bridges and Tunnels Archive, Photo NB-5-52).**

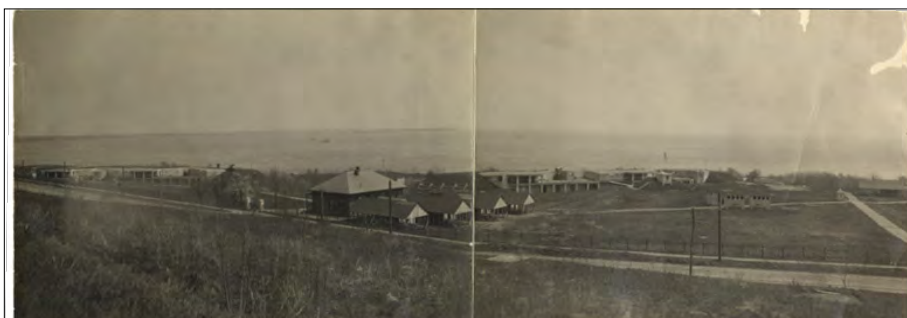
**Figure 4.26.** Historic photograph illustrating the extensive vegetation clearing south of the battery control structures and north of Battery Road. This historic view had a significant and specific function in the historic military landscape. The battery control structures supported the Endicott batteries to the south (Gateway National Recreation Area Collection, Photo 20618 (2

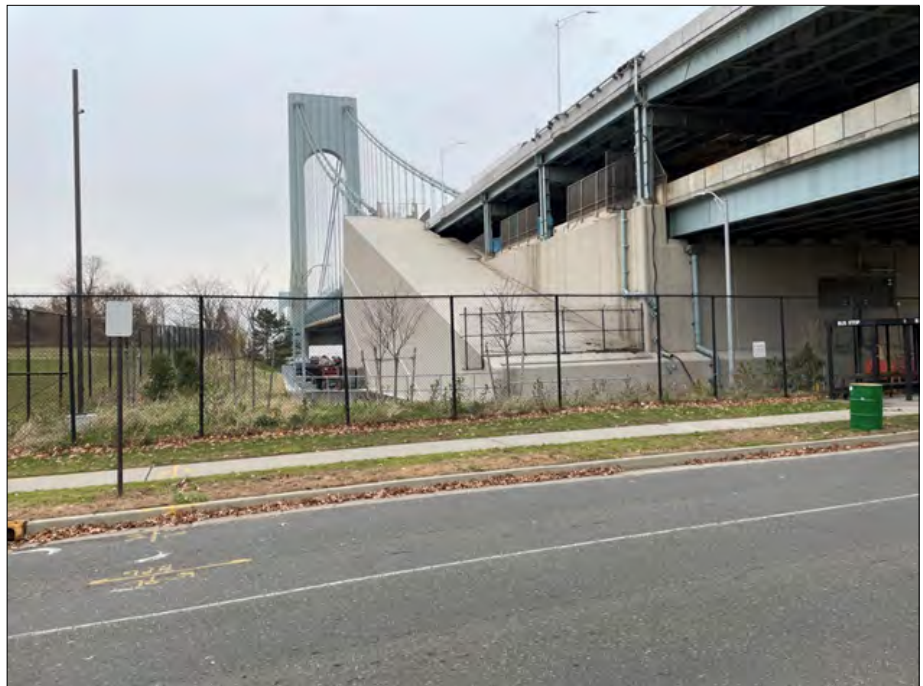
**Figure 4.27. Photograph of the western anchor for the Verrazzano-Narrows Bridge, facing southwest (PaleoWest 2021).**

The Verrazzano-Narrows Bridge Landscape Character Area encompasses the massive footprint of the bridge within historic Fort Wadsworth. The bridge construction in 1964 created a significant zone of destruction within and adjacent to this footprint. There are no historic landscape features extant within this landscape character area and therefore there is no historic integrity remaining.

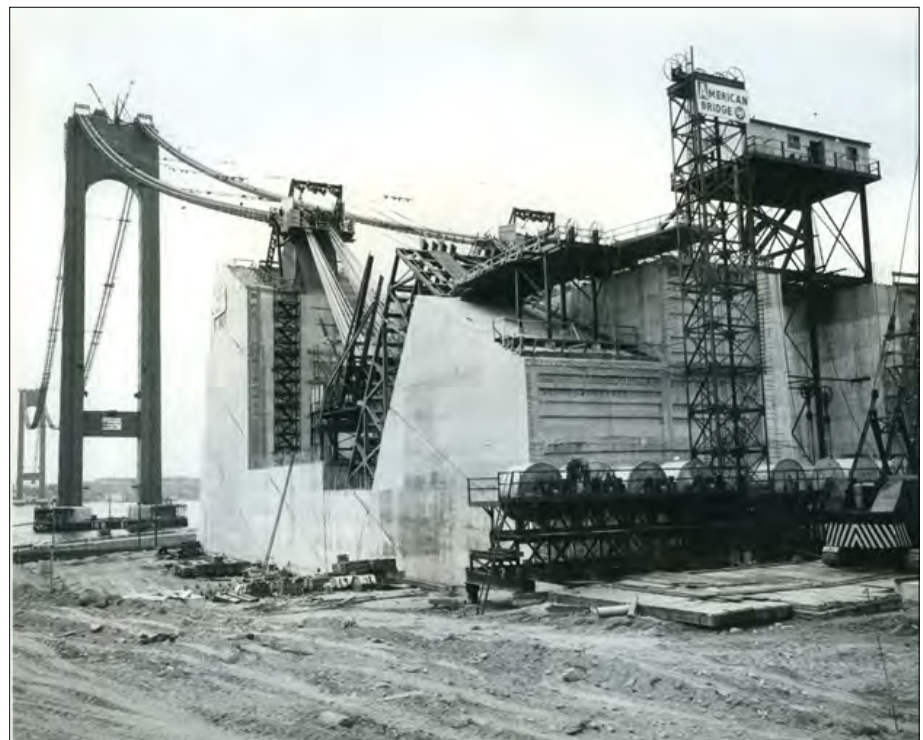
**Figure 4.28. Historic photograph of the west anchor for the Verrazzano-Narrows Bridge, 1963, facing southeast (Metropolitan Transit Authority Bridges and Tunnels Archives, Photo NB\_3\_209).**

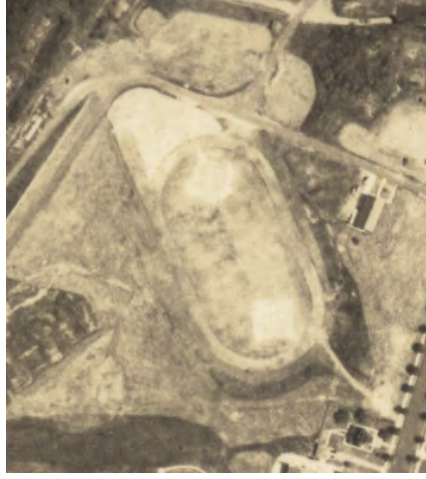
| Resource Name | NR District Nomination | NY CRIS No / NPS | Evaluation Narrative (Historic Period) | Existing Conditions and Historic Graphic Reference |
|---|---|---|---|---|
| Athletic Field | | | A running track and athletic field constructed by the CCC in 1939 on the east side of New York Avenue. It replaced a natural pond seen in historic maps. The field went through numerous renovations including post WWII and 1970s. It now exists as a topographic remnant, a level field in the southeast corner hosting the baseball field. | |

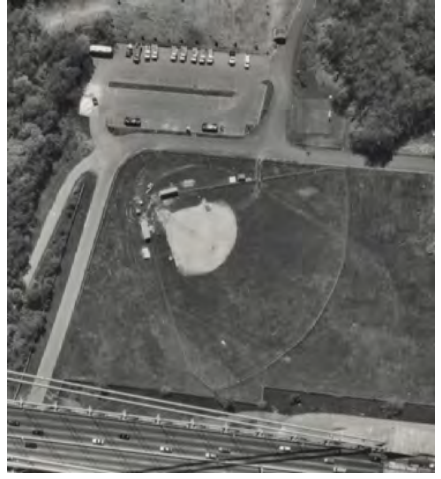
| Resource Name | NR District Nomination | NY CRIS No / NPS | Evaluation Narrative (Historic Period) | Existing Conditions and Historic Graphic Reference |
|---|---|---|---|---|
| Baseball Field | Non-contributing | N/A | <p><b>Historic Condition:</b> Built 1956. Concrete block dugouts are set at the southeast corner of the field.</p> <p><b>Evaluation:</b> Non-contributing Structure.</p> | |

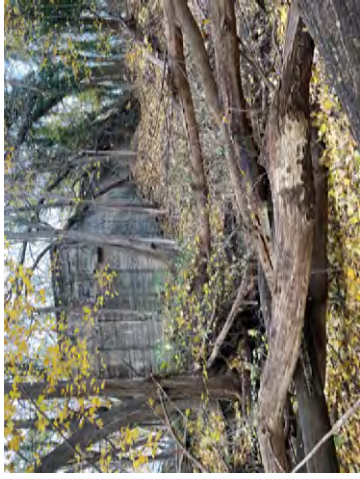
| Resource Name | NR District Nomination | NY CRIS No / NPS | Evaluation Narrative (Historic Period) | Existing Conditions and Historic Graphic Reference |
|---|---|---|---|---|
| Battery 218 | Contributing | 41223 | <p><b>Historic Condition:</b> Built 1943. Designed as an earth-covered structure, the World War II battery is now overgrown with trees. The concrete battery consists of an east-west traverse magazine complex flanked by two open, circular gun mounts intended for 6-inch guns on pedestal mounts (never emplaced at this location).</p> <p><b>Evaluation:</b> The battery is in poor condition. The exterior is overgrown with trees. Condition problems with the battery's interior include collapsed utility conduits, peeling paint, corroded or missing metal fixtures (e.g., doors and lights), and a collapsed wood floor.</p> | |

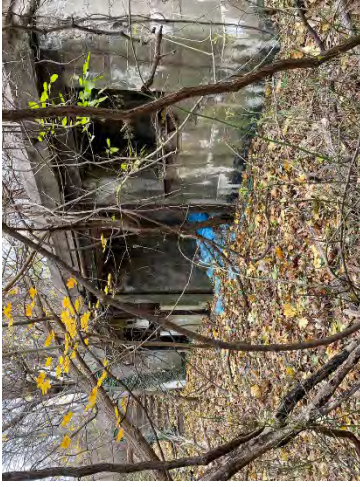
| Resource Name | NR District Nomination | NY CRIS No / NPS | Evaluation Narrative (Historic Period) | Existing Conditions and Historic Graphic Reference |
|---|---|---|---|---|
| Battery Ayers | Contributing | 41245,<br>GATE00271 | <p><b>Historic Condition:</b> Built 1900. The two-level Endicott Period battery has an approximately 275-ft-long plan. The parade of the battery is partially filled and occupied by Ayres Road.</p> <p><b>Evaluation:</b> The battery is in poor condition with broken and spalling concrete and heavily corroded metal fixtures.</p> | |

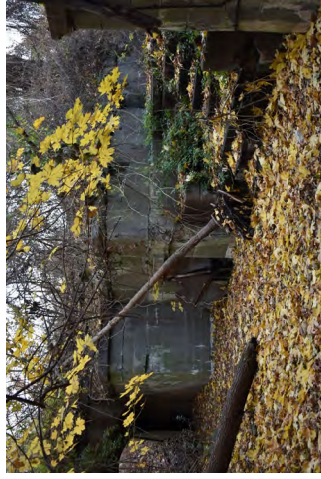
| Resource Name | NR District Nomination | NY CRIS No / NPS | Evaluation Narrative (Historic Period) | Existing Conditions and Historic Graphic Reference |
|---|---|---|---|---|
| Battery Bacon | Contributing | 41220,<br>GATE00258,<br>GATE00269 | <p><b>Historic Condition:</b> One of three batteries built in 1899 as a reconstruction of South Cliff Battery. A two-level, reinforced concrete structure designed for two guns.</p> <p><b>Evaluation:</b> The station is in poor condition, with spalling concrete and corroded reinforcement.</p> | |

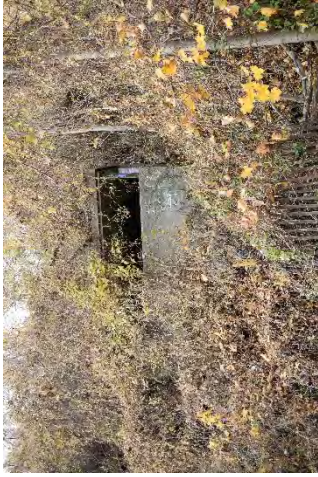
| Resource Name | NR District Nomination | NY CRIS No / NPS | Evaluation Narrative (Historic Period) | Existing Conditions and Historic Graphic Reference |
|---|---|---|---|---|
| Battery Bacon Coincident Range Finder Station (CRF) | Contributing | 41225 | <p><b>Historic Condition:</b> Built 1917, west of Battery Bacon. The station is a small, concrete bunker on a rectangular plan.</p> <p><b>Evaluation:</b> The station is in poor condition, with spalling concrete and corroded reinforcement.</p> | |

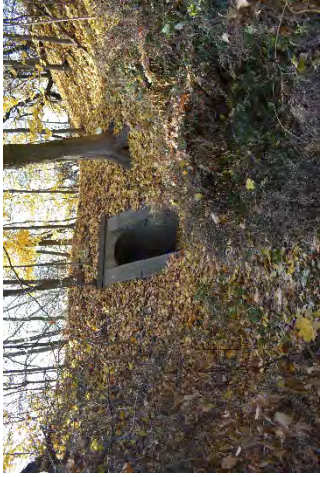
| Resource Name | NR District Nomination | NY CRIS No / NPS | Evaluation Narrative (Historic Period) | Existing Conditions and Historic Graphic Reference |
|---|---|---|---|---|
| Battery Barbour | Contributing | 41218, GATE00266 | <p><b>Historic Condition:</b> One of three batteries built in 1899 as a reconstruction of South Cliff Battery. This single-level battery had four structurally distinct concrete emplacements for 4.7-inch and 6-inch pedestal-mounted guns.</p> <p><b>Evaluation:</b> The battery is in poor condition. The northerly and southerly emplacements are non-extant or buried, leaving elements of emplacement number 3, to the north, and number 2, to the south.</p> | |

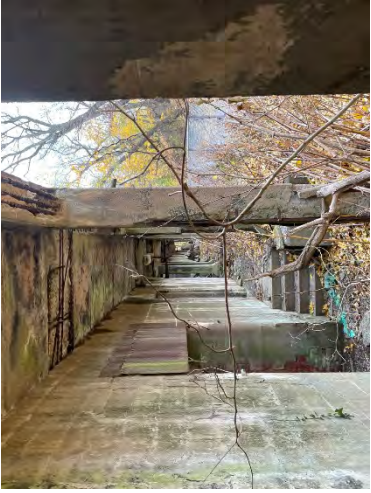
| Resource Name | NR District Nomination | NY CRIS No / NPS | Evaluation Narrative (Historic Period) | Existing Conditions and Historic Graphic Reference |
|---|---|---|---|---|
| Battery Barry | Contributing | 41224, GATE00265 | <p><b>Historic Condition:</b> Built 1897. Battery Barry is a two-level structure designed to accommodate two 10-inch guns on disappearing carriages.</p> <p><b>Evaluation:</b> The structure is in poor condition. The concrete is cracked and spalling, and the metal fixtures are corroded and broken. The blast apron and parapet are overgrown with trees. There is no interior access.</p> | |

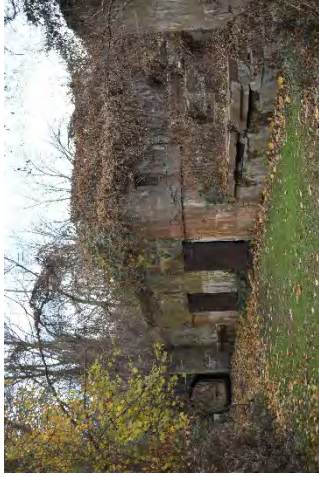
| Resource Name | NR District Nomination | NY CRIS No / NPS | Evaluation Narrative (Historic Period) | Existing Conditions and Historic Graphic Reference |
|---|---|---|---|---|
| Battery Catlin | Contributing | 41216,<br>GATE00257,<br>GATE00274 | <p><b>Historic Condition:</b> Built 1902. Endicott/Taft Period Battery Catlin faces east and is composed of three pairs of two-level, concrete gun emplacements flanked by earth-covered traverses. Both levels are almost completely exposed. Battery Catlin was constructed for six 3-inch guns on pedestal mounts, of which none remain.</p> <p><b>Evaluation:</b> Battery Catlin is in poor condition, due to the overgrowth of vegetation, corrosion of the metal fixtures, rot in the wood trim components, and efflorescence and erosion of the concrete.</p> | |

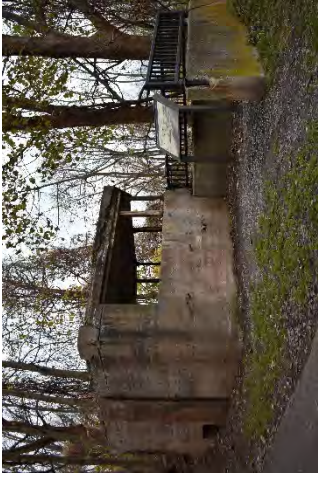
| Resource Name | NR District Nomination | NY CRIS No / NPS | Evaluation Narrative (Historic Period) | Existing Conditions and Historic Graphic Reference |
|---|---|---|---|---|
| Battery Catlin Coincident Range Finder Station (CRF) | Contributing | 41225 | <p><b>Historic Condition:</b> The Coincident Range Finder Station was built in 1917 behind Battery Catlin and adjacent to Battery Weed Road. This resource consists of a small, one-level, concrete bunker on a rectangular plan.</p> <p><b>Evaluation:</b> The Coincident Range Finder Station is in poor condition due to spalling concrete, corroded metal reinforcing bars, and corrosion of the roof struts. However, this resource still retains its historic character and contributes to the Fort Wadsworth Historic District.</p> | |

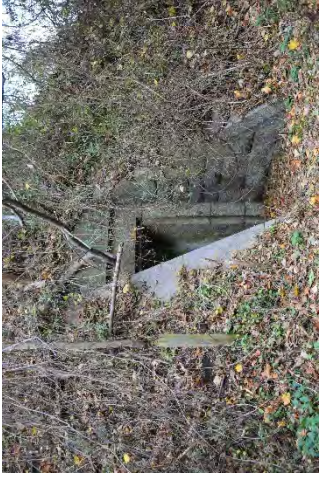
| Resource Name | NR District Nomination | NY CRIS No / NPS | Evaluation Narrative (Historic Period) | Existing Conditions and Historic Graphic Reference |
|---|---|---|---|---|
| Battery Catlin Magazine | Historic Associated Feature | 41231 | <p><b>Historic Condition:</b> Built 1902 as a reconstruction of the North Cliff Battery (1862). Endicott/Taft Period resource consists of an earth-covered concrete arched room accessed via a staggered corridor. The entry faces north and is fitted with a heavy bronze-studded wood door that is flanked with projecting granite wingwalls and topped by a beveled lintel.</p> <p><b>Evaluation:</b> Battery Catlin Magazine is in fair condition, with vegetation overgrowth and decay of wood components being the primary condition issues.</p> | |

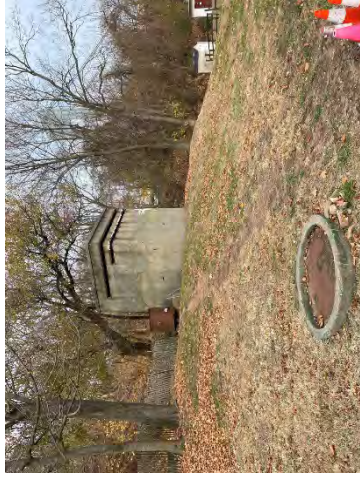
| Resource Name | NR District Nomination | NY CRIS No / NPS | Evaluation Narrative (Historic Period) | Existing Conditions and Historic Graphic Reference |
|---|---|---|---|---|
| Battery Command and Coincident Range Finder Station (BC & CRF) | Contributing | 41225 | <p><b>Historic Condition:</b> Built 1942. This two-level concrete bunker has a compact, 13-by-13-ft plan with an attached retaining wall projecting from the northwest corner. Two closely spaced observation slits wrap around the south elevation of the building. These are reinforced along their edges with a steel L-channel frame.</p> <p><b>Evaluation:</b> The building is in good condition.</p> | |

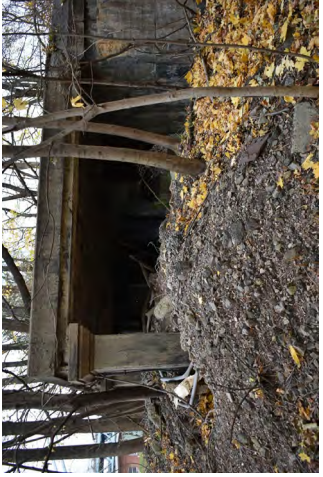
| Resource Name | NR District Nomination | NY CRIS No / NPS | Evaluation Narrative (Historic Period) | Existing Conditions and Historic Graphic Reference |
|---|---|---|---|---|
| Battery Dix | Contributing | 41222, GATE00272 | <p><b>Historic Condition:</b> Built 1902. The concrete Endicott Period battery is about 280 ft long and lies on a northeast-southwest trending footprint that faces the lower bay, with the open battery parade elevation to the north. This two-level structure was designed for two 12-inch guns on disappearing carriages.</p> <p><b>Evaluation:</b> The structure is in poor condition with degraded concrete and broken and corroded metal fixtures. The blast apron and parapet is overgrown with trees.</p> | |

**Figure 2.94. Figure 2 94.**  
**Photograph of Battery Dix, the**  
**least deteriorated of the Endicott**  
**Era batteries, December 2021**  
**(PaleoWest).**

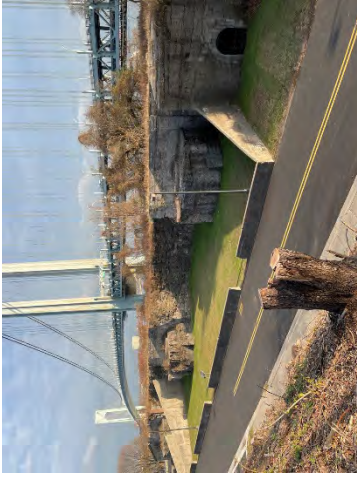
| Resource Name | NR District Nomination | NY CRIS No / NPS | Evaluation Narrative (Historic Period) | Existing Conditions and Historic Graphic Reference |
|---|---|---|---|---|
| Battery Duane | Contributing | 41214,<br>GATE00263 | <p><b>Historical Condition:</b> Battery Duane was constructed from 1895 to 1897 and is located at the former south glacial slope of Fort Tompkins and faces southeast with its parade at the former location of the Fort Tompkins ditch. This two-level Endicott Period battery measures about 350 ft long and 75 ft wide in plan. The historically exposed structural elements are almost entirely visible. The battery was constructed for five 8-inch guns on disappearing carriages, perhaps the first to be used in Endicott-period construction. The structure is entirely poured concrete, excepting the north end, which has a granite ashlar wall. One emplacement is now missing, as is a substantial portion of the upper, loading platform level. Sloping concrete walls, which are additions to accommodate the structure's later use as a coal pocket, extend off the north side. A magazine is located in the southwest corner of the work. The magazine interior has unfinished poured concrete ceilings, walls, and floors. All ceilings are arched. Doorways are trimmed with granite block.</p> <p><b>Evaluation:</b> Battery Duane is classified as a site due to the loss of substantial amounts of its historic concrete work. Battery Duane is in poor condition with deteriorating concrete and an overgrowth of vegetation; however it still retains its historic character and contributes to the Fort Wadsworth Historic District.</p> | |

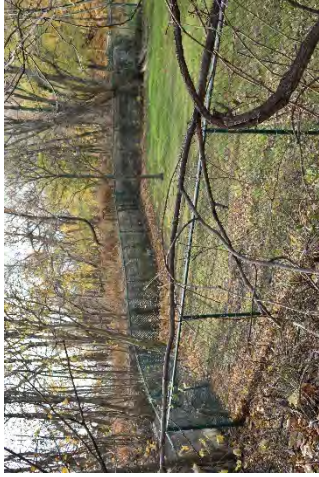
| Resource Name | NR District Nomination | NY CRIS No / NPS | Evaluation Narrative (Historic Period) | Existing Conditions and Historic Graphic Reference |
|---|---|---|---|---|
| Battery Hudson | Contributing | 41241,<br>GATE00235,<br>GATE00267 | <p><b>Historic Condition:</b> Built 1876, modified 1899. The L-shaped site is divided into physically and historically distinct components: the north leg is an intact post-Civil War barbette battery, while the south leg is a partially buried Endicott Period structure.</p> <p><b>Evaluation:</b> There is no interior access. The battery is in poor condition with problems that include cracked and broken concrete and corroded and broken metal fixtures.</p> | |

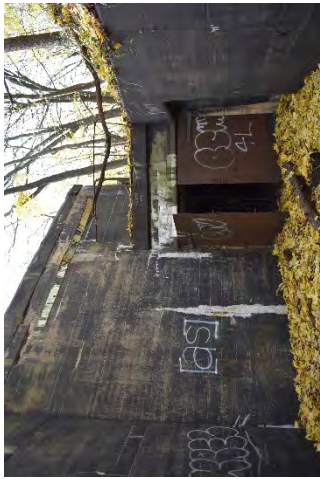
| Resource Name | NR District Nomination | NY CRIS No /NPS | Evaluation Narrative (Historic Period) | Existing Conditions and Historic Graphic Reference |
|---|---|---|---|---|
| Battery Mills | Contributing | 41221,<br>GATE00270 | <p><b>Historic Condition:</b> Built 1899. The two-level Endicott Period battery was constructed with the majority of its lower level below the surrounding earthworks.</p> <p><b>Evaluation:</b> The visible remains are in poor condition with cracked and spalled concrete and corroded metal fixtures.</p> | |

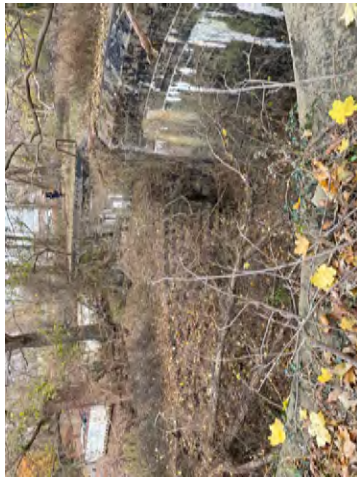
| Resource Name | NR District Nomination | NY CRIS No /NPS | Evaluation Narrative (Historic Period) | Existing Conditions and Historic Graphic Reference |
|---|---|---|---|---|
| Battery Richmond | Contributing | 41226,<br>GATE00268 | <p><b>Historic Condition:</b> Built 1898. The approximately 250-ft-long, concrete, Endicott Period structure is set on a northeast-southwest trending footprint overlooking the lower bay. Battery Richmond is designed for two 12-inch caliber guns on disappearing carriages.</p> <p><b>Evaluation:</b> The interior is not accessible. The structure is in poor condition with broken and spalling concrete and corroded and broken metal fixtures.</p> | |

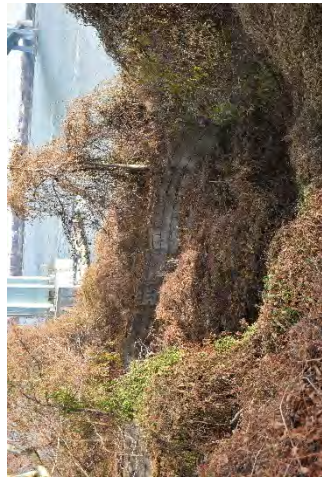
| Resource Name | NR District Nomination | NY CRIS No /NPS | Evaluation Narrative (Historic Period) | Existing Conditions and Historic Graphic Reference |
|---|---|---|---|---|
| Battery Turnbull | Contributing | 41219,<br>GATE00258,<br>GATE00273 | <p><b>Historic Condition:</b> One of three batteries built in 1899 as a reconstruction of South Cliff Battery. A six-gun battery, only two emplacements (numbers 5 and 6) remain. The historical footprints of the other emplacements are within the Interstate 278/Verrazano Narrows Bridge right-of-way.</p> <p><b>Evaluation:</b> These emplacements appear to have been demolished or are under construction-related fills. The structure is in poor condition, with degraded masonry and corroded metal elements.</p> | |

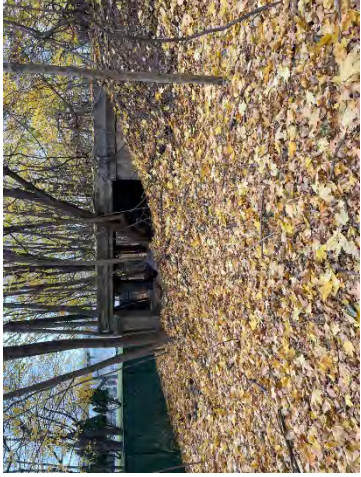
| Resource Name | NR District Nomination | NY CRIS No / NPS | Evaluation Narrative (Historic Period) | Existing Conditions and Historic Graphic Reference |
|---|---|---|---|---|
| Battery Upton | Contributing | 41217,<br>GATE00264 | <p><b>Historic Condition:</b> Built 1896, the visible remains of an approximately 125-ft-long, concrete battery for two 10-inch guns on disappearing carriages. About three-quarters of the two-level Endicott Period battery are buried in fill.</p> <p><b>Evaluation:</b> Battery Upton's visible remains are in poor condition and heavily overgrown with vegetation. The concrete is cracked and spalled and the metal fixtures are corroded.</p> | |

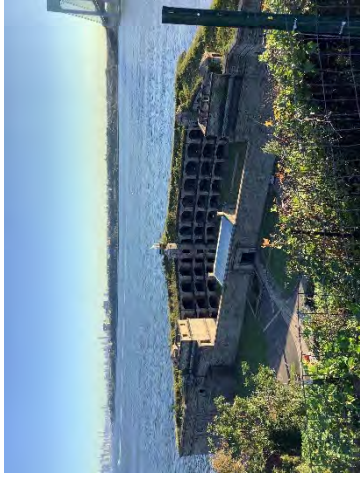
| Resource Name | NR District Nomination | NY CRIS No / NPS | Evaluation Narrative (Historic Period) | Existing Conditions and Historic Graphic Reference |
|---|---|---|---|---|
| Battery Weed | Contributing | 41198,<br>GATE00243,<br>NR 72000908 | <p><b>Historic Condition:</b> Battery Weed was constructed in 1847. It consisted of a granite structure located on a high point on the east side of the fort to provide seaward defenses.</p> <p><b>Evaluation:</b> Battery Weed retains its historic character and is a contributing element to the Fort Wadsworth Historic District. Battery Weed is in fair condition excepting the upper magazines, which are without roofs and in poor condition.</p> | |

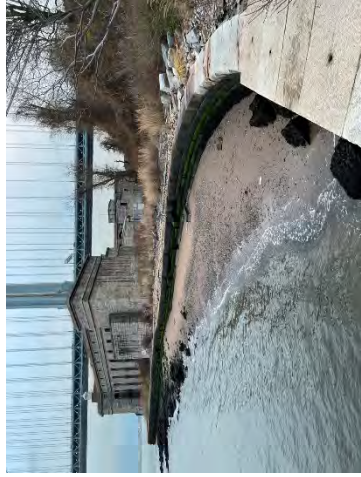
| Resource Name | NR District Nomination | NY CRIS No / NPS | Evaluation Narrative (Historic Period) | Existing Conditions and Historic Graphic Reference |
|---|---|---|---|---|
| Battery Weed Seawall | Historic Associated Feature | 41170 | <p><b>Historic Condition:</b> The Battery Weed Seawall was constructed from 1855 to 1871 and defines the outside of the moat on the seaward fronts. This coursed granite ashlar structure runs below all three seaward fronts and extends north to the North Dock.</p> <p><b>Evaluation:</b> The Battery Weed Seawall retains its historic character and is a historic associated feature to Battery Weed.</p> | |

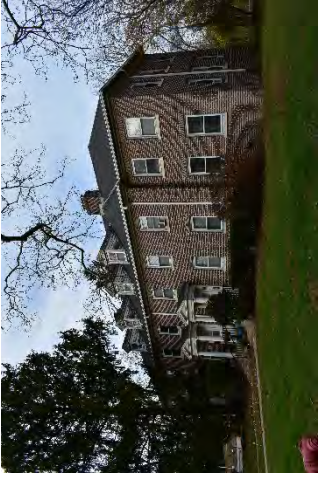
| Resource Name | NR District Nomination | NY CRIS No / NPS | Evaluation Narrative (Historic Period) | Existing Conditions and Historic Graphic Reference |
|---|---|---|---|---|
| Building 101 Housing | Contributing | 41175 | <p><b>Historic Condition:</b> Built 1933. Housing is a two-story, Colonial Revival duplex.</p> <p><b>Evaluation:</b> The houses are all occupied and kept in good condition.</p> | |

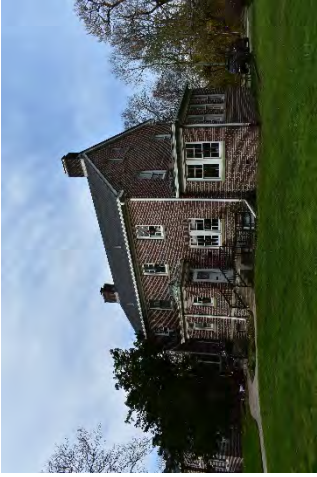
| Resource Name | NR District Nomination | NY CRIS No / NPS | Evaluation Narrative (Historic Period) | Existing Conditions and Historic Graphic Reference |
|---|---|---|---|---|
| Building 102 Housing | Contributing | 41176 | <p><b>Historic Condition:</b> Built 1939. Housing is a two-story, four-bay by two-bay, Colonial Revival duplex with two one-story, flat-roofed wings.</p> <p><b>Evaluation:</b> The houses are all occupied and kept in good condition.</p> | |

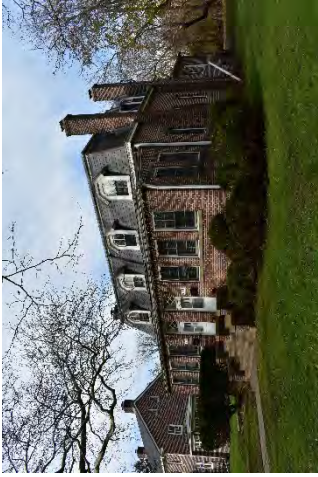
| Resource Name | NR District Nomination | NY CRIS No / NPS | Evaluation Narrative (Historic Period) | Existing Conditions and Historic Graphic Reference |
|---|---|---|---|---|
| Building 103 Housing | Contributing | 41177 | <p><b>Historic Condition:</b> Built 1870. Housing is a one-and-one-half-story, Second Empire duplex. It has a four-bay by three-bay, mansard-roof main block; a projecting one-story entry enclosure with a shed roof; and a one-story rear ell with a shallow gable roof.</p> <p><b>Evaluation:</b> The houses are all occupied and kept in good condition.</p> | |

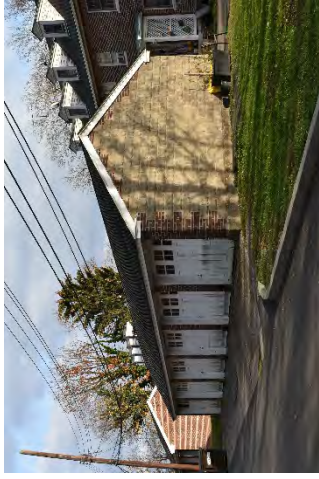
| Resource Name | NR District Nomination | NY CRIS No / NPS | Evaluation Narrative (Historic Period) | Existing Conditions and Historic Graphic Reference |
|---|---|---|---|---|
| Building 104 Detached Garage | Contributing | 41178 | <p><b>Historic Condition:</b> Built 1936. The side-gable building has an asphalt-shingled roof with overhanging wood plank soffits and cornice returns. Six vehicle bays flanked by brick piers and corner quoins fill the north elevation.</p> <p><b>Evaluation:</b> The building is in good condition with a new roof and well-kept trim and masonry.</p> | |

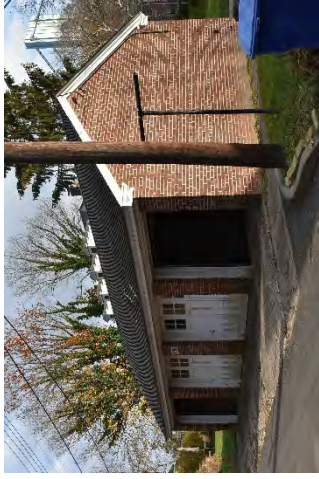
| Resource Name | NR District Nomination | NY CRIS No / NPS | Evaluation Narrative (Historic Period) | Existing Conditions and Historic Graphic Reference |
|---|---|---|---|---|
| Building 105 Detached Garage | Contributing | 41179 | <p><b>Historic Condition:</b> Built 1932. The side-gable building has an asphalt-shingled roof with overhanging wood plank soffits and cornice returns. Four vehicle bays flanked by brick piers and corner quoins fill the north elevation.</p> <p><b>Evaluation:</b> The building is in good condition with a new roof and well-kept trim and masonry.</p> | |

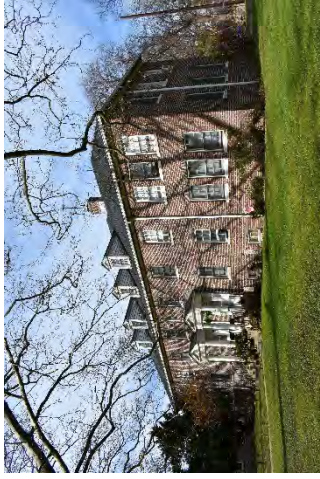
| Resource Name | NR District Nomination | NY CRIS No / NPS | Evaluation Narrative (Historic Period) | Existing Conditions and Historic Graphic Reference |
|---|---|---|---|---|
| Building 106 Housing | Contributing | 41180 | <p><b>Historic Condition:</b> Built 1933. Housing is a two-story, Colonial Revival duplex. Identical to Building 101.</p> <p><b>Evaluation:</b> The houses are all occupied and kept in good condition.</p> | |

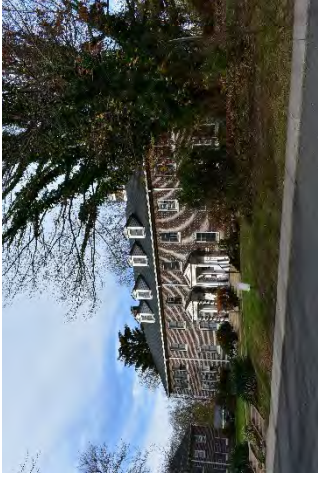
| Resource Name | NR District Nomination | NY CRIS No / NPS | Evaluation Narrative (Historic Period) | Existing Conditions and Historic Graphic Reference |
|---|---|---|---|---|
| Building 107 Housing | Contributing | 41181 | <p><b>Historic Condition:</b> Built 1933. Housing is a two-story, Colonial Revival duplex. Identical to Building 101.</p> <p><b>Evaluation:</b> The houses are all occupied and kept in good condition.</p> | |

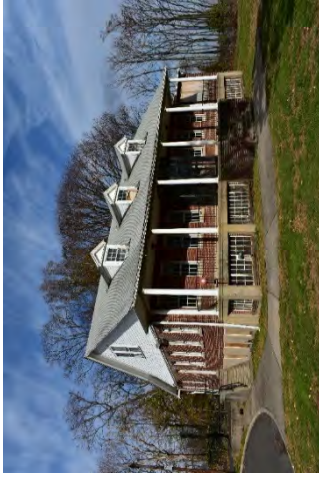
| Resource Name | NR District Nomination | NY CRIS No / NPS | Evaluation Narrative (Historic Period) | Existing Conditions and Historic Graphic Reference |
|---|---|---|---|---|
| Building 109 Administration/ Officer's Club | Contributing | 41182 | <p><b>Historic Condition:</b> Built 1938. The nine-bay by six-bay, Colonial Revival building is one-and-one-half stories in height and has a raised concrete water table. The building replaced a previous building with the same number in the same location.</p> <p><b>Evaluation:</b> It is currently vacant and in fair condition. Some exterior trim is broken or rotting, and there are isolated areas of interior paint and plaster failure.</p> | |

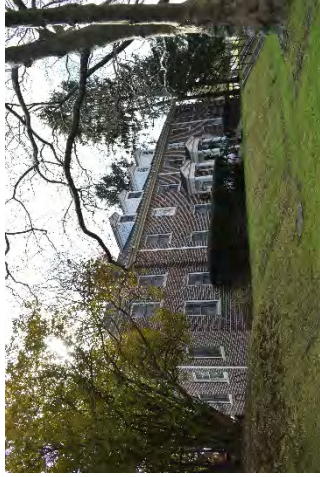
| Resource Name | NR District Nomination | NY CRIS No / NPS | Evaluation Narrative (Historic Period) | Existing Conditions and Historic Graphic Reference |
|---|---|---|---|---|
| Building 110 Housing | Contributing | 41183 | <p><b>Historic Condition:</b> Built 1933. Housing a two-story, Colonial Revival duplex. Identical to Building 101.</p> <p><b>Evaluation:</b> Building 110 is in good condition.</p> | |

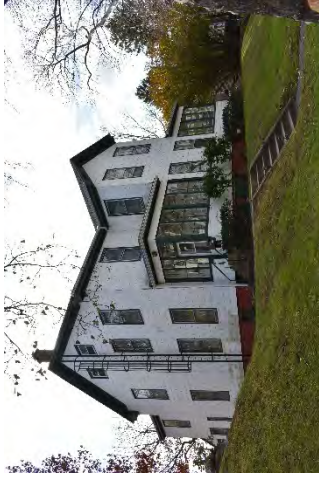
| Resource Name | NR District Nomination | NY CRIS No / NPS | Evaluation Narrative (Historic Period) | Existing Conditions and Historic Graphic Reference |
|---|---|---|---|---|
| Building 111 Housing | Contributing | 41184 | <p><b>Historic Condition:</b> Built 1890. Housing with a cruciform plan with enclosed porches set in the interior returns of the front elevation.</p> <p><b>Evaluation:</b> Building 111 is in fair condition; peeling paint, missing shingles, and minor masonry problems in the foundations are the primary visible condition issues.</p> | |
