# CULTURAL LANDSCAPE REPORT

FORT WADSWORTH

GATEWAY NATIONAL RECREATION AREA

Prepared by PaleoWest, LLC

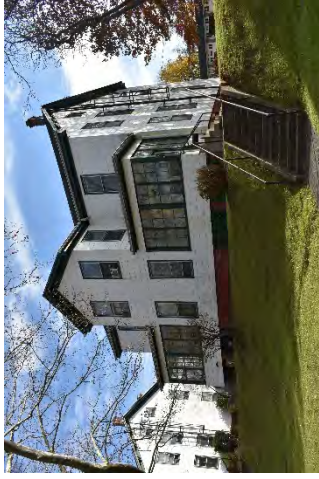
| Resource Name | NR District Nomination | NY CRIS No / NPS | Evaluation Narrative (Historic Period) | Existing Conditions and Historic Graphic Reference |
|---|---|---|---|---|
| Building 112 Housing | Contributing | 41185 | <p><b>Historic Condition:</b> Built 1890. Housing with a cruciform plan with enclosed porches set in the interior returns of the front elevation. Identical to Building 111.</p> <p><b>Evaluation:</b> Building 112 is in fair condition; peeling paint, missing shingles, and minor masonry problems in the foundations are the primary visible condition issues.</p> | |

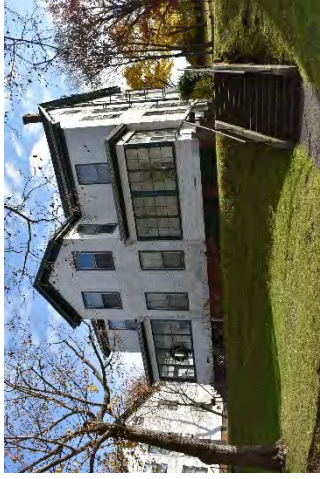
| Resource Name | NR District Nomination | NY CRIS No / NPS | Evaluation Narrative (Historic Period) | Existing Conditions and Historic Graphic Reference |
|---|---|---|---|---|
| Building 113 Housing | Contributing | 41186 | <p><b>Historic Condition:</b> Built 1890. Housing with a cruciform plan with enclosed porches set in the interior returns of the front elevation. Identical to Building 111.</p> <p><b>Evaluation:</b> Building 113 is in fair condition; peeling paint, missing shingles, and minor masonry problems in the foundations are the primary visible condition issues.</p> | |

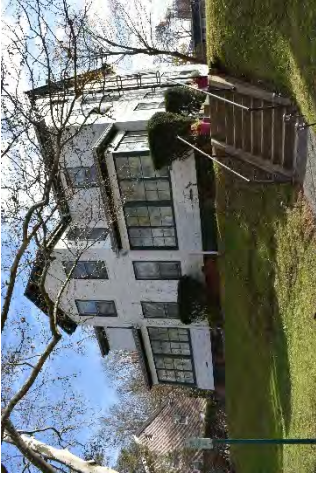
| Resource Name | NR District Nomination | NY CRIS No / NPS | Evaluation Narrative (Historic Period) | Existing Conditions and Historic Graphic Reference |
|---|---|---|---|---|
| Building 114 Housing | Contributing | 41187 | <p><b>Historic Condition:</b> Built 1890. Housing with a cruciform plan with enclosed porches set in the interior returns of the front elevation. Identical to Building 111.</p> <p><b>Evaluation:</b> Building 114 is in good condition.</p> | |

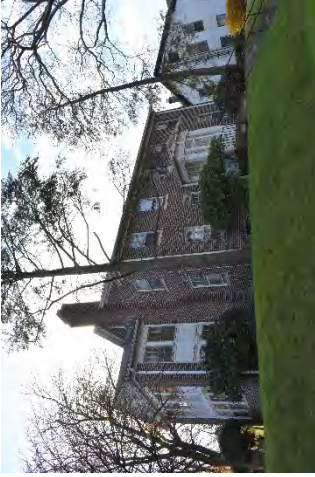
| Resource Name | NR District Nomination | NY CRIS No / NPS | Evaluation Narrative (Historic Period) | Existing Conditions and Historic Graphic Reference |
|---|---|---|---|---|
| Building 115 Housing | Contributing | 41188 | <p><b>Historic Condition:</b> Built 1933. Housing with a cruciform plan with enclosed porches set in the interior returns of the front elevation. Identical to Building 111.</p> <p><b>Evaluation:</b> Building 115 is in fair condition; peeling paint, missing shingles, and minor masonry problems in the foundations are the primary visible condition issues.</p> | |

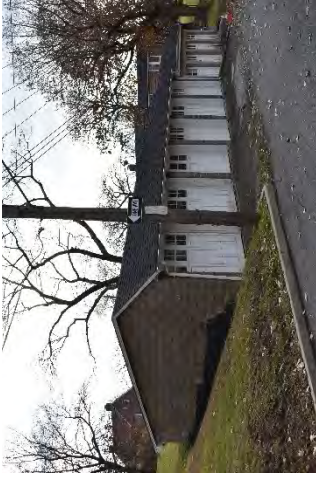
| Resource Name | NR District Nomination | NY CRIS No / NPS | Evaluation Narrative (Historic Period) | Existing Conditions and Historic Graphic Reference |
|---|---|---|---|---|
| Building 116 Detached Garage | Contributing | 41189 | <p><b>Historic Condition:</b> Built 1935. Building 116 is a ten-bay garage that steps down in elevation at its midpoint to accommodate the road gradient. garages are similar to Building 104 in appearance, materials, and massing, except that they have asymmetrical pent-gable roofs. Both are constructed of concrete block and have recently installed, vertical-lift vehicle doors that mimic the appearance of wood panel doors.</p> <p><b>Evaluation:</b> The buildings are actively maintained and in good condition.</p> | |

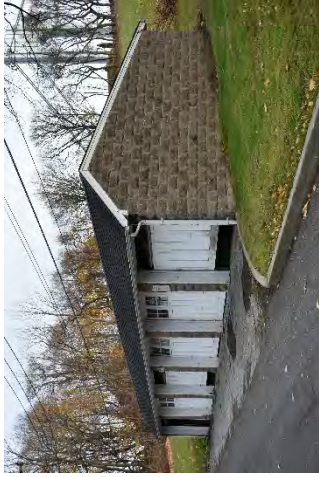
| Resource Name | NR District Nomination | NY CRIS No / NPS | Evaluation Narrative (Historic Period) | Existing Conditions and Historic Graphic Reference |
|---|---|---|---|---|
| Building 117 Detached Garage | Contributing | 41190 | <p><b>Historic Condition:</b> Built 1935. Building 117 has six bays. Garages are similar to Building 104 in appearance, materials, and massing, except that they have asymmetrical pent-gable roofs. Both are constructed of concrete block and have recently installed, vertical-lift vehicle doors that mimic the appearance of wood panel doors.</p> <p><b>Evaluation:</b> The buildings are actively maintained and in good condition.</p> | |

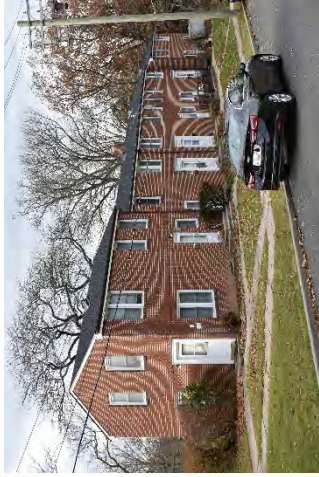
| Resource Name | NR District Nomination | NY CRIS No / NPS | Evaluation Narrative (Historic Period) | Existing Conditions and Historic Graphic Reference |
|---|---|---|---|---|
| Building 118 Housing | Non-contributing | N/A | <p><b>Historic Condition:</b> Built 1960. The long, rectangular, two-story building consists of five single-family units attached end-to-end with party walls.</p> <p><b>Evaluation:</b> Non-contributing Building</p> | |

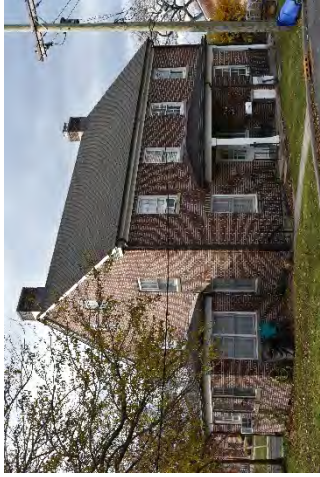
| Resource Name | NR District Nomination | NY CRIS No / NPS | Evaluation Narrative (Historic Period) | Existing Conditions and Historic Graphic Reference |
|---|---|---|---|---|
| Building 119 Housing | Contributing | 41191 | <p><b>Historic Condition:</b> Built 1939. The Colonial Revival brick duplex is identical in appearance to Building 102, except that it has a raised basement to accommodate the sloping site.</p> <p><b>Evaluation:</b> The residence is occupied and maintained in good condition.</p> | |

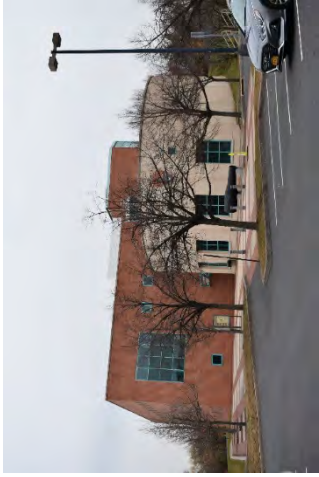
| Resource Name | NR District Nomination | NY CRIS No / NPS | Evaluation Narrative (Historic Period) | Existing Conditions and Historic Graphic Reference |
|---|---|---|---|---|
| Building 120 Offices, Administration, Visitor Center | Non-contributing | N/A | <p><b>Historic Condition:</b> Built 1994. The Post-Modern, steel frame office consists of a three-story, brick main block and a one-story, semi-cylindrical, stucco-clad wing connected to the main block by a low entry hyphen and stair tower.</p> <p><b>Evaluation:</b> Non-contributing Building</p> | |

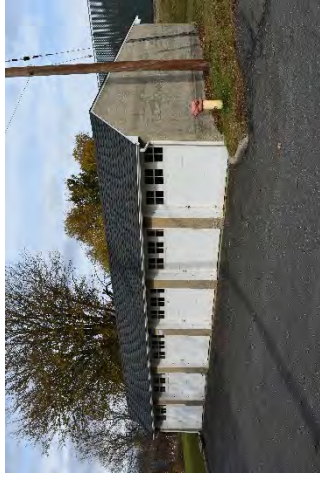
| Resource Name | NR District Nomination | NY CRIS No / NPS | Evaluation Narrative (Historic Period) | Existing Conditions and Historic Graphic Reference |
|---|---|---|---|---|
| Building 123 Garage | Contributing | - | <p><b>Historic Condition:</b> Built 1936. The six-bay cast concrete structure has an asymmetrical shed roof clad in asphalt shingles and rests on a concrete slab. The original vehicle doors have been replaced with vertical-lift units that approximate the appearance of swinging wood panel doors.</p> <p><b>Evaluation:</b> The building is in good condition.</p> | |

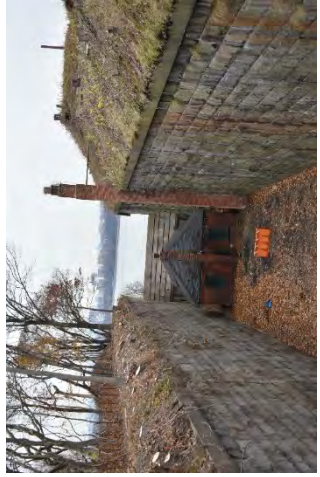
| Resource Name | NR District Nomination | NY CRIS No / NPS | Evaluation Narrative (Historic Period) | Existing Conditions and Historic Graphic Reference |
|---|---|---|---|---|
| Building 138 Water Closet | Contributing | 41193 | <p><b>Historic Condition:</b> Building 138 was constructed in 1900 at the northeast end of the Fort Tompkins trench. Building 138 is a two-bay by two-bay former bathroom. It has a hipped pyramidal roof covered with asphalt shingles and exposed rafter tails. The brick walls are topped with a plank cornice and pierced with segmental arch window and door openings that face east and west. A brick chimney is centered on the west elevation. Window sills are granite. The window sash has been removed, and the openings are covered with plywood.</p> <p><b>Evaluation:</b> Building 138 is vacant and in poor condition. Despite being partially overgrown with vegetation, a failing roof, and highly degraded interior finishes, Building 138 retains its historic character and contributes to the Fort Wadsworth Historic District.</p> | |

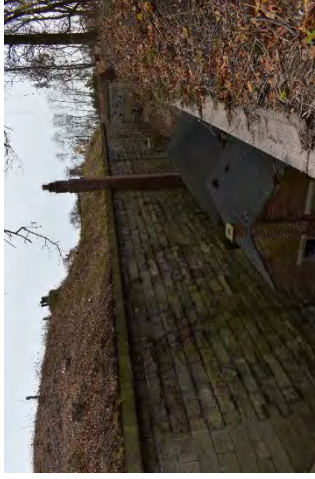
| Resource Name | NR District Nomination | NY CRIS No / NPS | Evaluation Narrative (Historic Period) | Existing Conditions and Historic Graphic Reference |
|---|---|---|---|---|
| Building 139 Water Closet | Contributing | 41194 | <p><b>Historic Condition:</b> Building 139 was constructed in 1891 at the northeast end of the Fort Tompkins trench. Building 139 is a two-bay by three-bay, side gable former bathroom. The roof is covered with asphalt and has shallow overhangs under which are set a combination of ogee-profile and flat wood plank trim. Two south-facing entries without doors have concrete lintels and wood plank surrounds. Pairs of symmetrically disposed, rectangular window openings are placed in the west, north, and east elevations. The openings have a combination of precast-concrete, wood, and stone sills and lintels.</p> <p><b>Evaluation:</b> Building 139 is vacant and in poor condition. Despite being partially overgrown with vegetation, a failing roof, and highly degraded interior finishes, Building 139 retains its historic character and contributes to the Fort Wadsworth Historic District.</p> | |

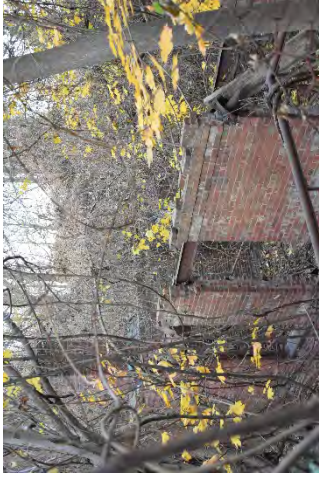
| Resource Name | NR District Nomination | NY CRIS No / NPS | Evaluation Narrative (Historic Period) | Existing Conditions and Historic Graphic Reference |
|---|---|---|---|---|
| Building 140 Mining Casemate | Contributing | 41195, GATE00275 | <p><b>Historic Condition:</b> Building 140 was built in 1904 within the footprint of the old North Cliff Battery. Building 140 served as the mine control facility which replaced the facility at Battery Weed.</p> <p><b>Evaluation:</b> Building 140 is in poor condition due to its ruinous state, however it still retain elements of its historic character and contributes to the Fort Wadsworth Historic District.</p> | |

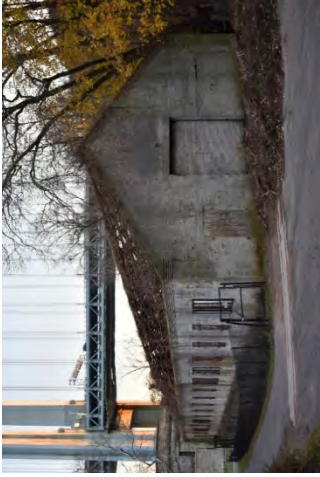
| Resource Name | NR District Nomination | NY CRIS No / NPS | Evaluation Narrative (Historic Period) | Existing Conditions and Historic Graphic Reference |
|---|---|---|---|---|
| Building 147 Torpedo Storage | Contributing | 41196 | <p><b>Historic Condition:</b> Building 147 consists of a torpedo storage building built from 1892 to 1894. It is located south of the two cable tank sites, across Battery Weed Road. This three-bay by eighteen-bay, stone and brick warehouse has a long narrow footprint. The building is on a sloping site and is one story in height with an exposed basement level. It has a gable roof constructed of riveted iron trusses, brick walls with corbelled cornices on the first floor, and a quarry-faced, granite ashlar basement level. The basement-level walls are lined with sandstone. The regularly spaced window openings have granite sills and lintels and sheet metal shutters, but are missing their sash, frames, and brickmolds. Openings for the mine tram and for personnel are located on the north gable end but lack their original doors. Three openings for mine trams are placed on the south elevation. The east and west openings retain heavy iron doors mounted on strap hinges and pintles. The center opening has a replacement, vertical-lift, roll door.</p> <p><b>Evaluation:</b> Building 147 is in poor condition. It lacks a roof and has extensive fire damage, however it still retains its historic character and contributes to the Fort Wadsworth Historic District.</p> | |

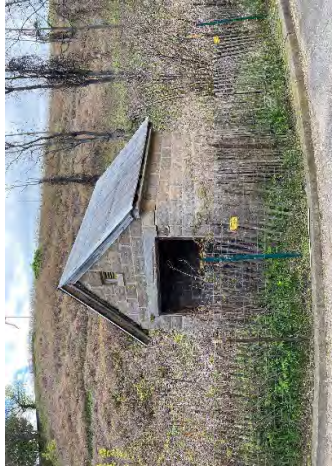
| Resource Name | NR District Nomination | NY CRIS No / NPS | Evaluation Narrative (Historic Period) | Existing Conditions and Historic Graphic Reference |
|---|---|---|---|---|
| Building 148 Fire Hose House | Contributing | 41197 | <p><b>Historic Condition:</b> Building 148 was constructed as a Fire House in 1939. It is located about 25 ft southeast of Building 147. The utilitarian building has an asphalt-shingled, side-gable roof; rusticated concrete block walls; and a slab foundation.</p> <p><b>Evaluation:</b> Building 148 is in poor condition with heavily worn and missing roof shingles, multiple cracks in the walls, and missing roof trim and doors, however it still retains its historic character and contributes to the Fort Wadsworth Historic District.</p> | |

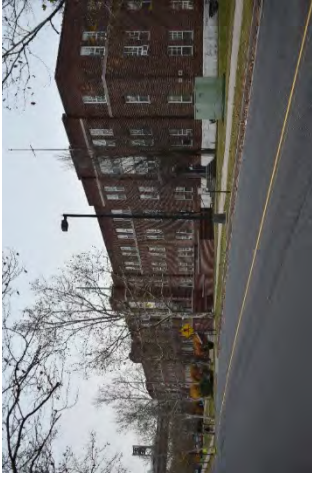
| Resource Name | NR District Nomination | NY CRIS No / NPS | Evaluation Narrative (Historic Period) | Existing Conditions and Historic Graphic Reference |
|---|---|---|---|---|
| Building 210 Infantry Battalion Barracks | Contributing | 41199 | <p><b>Historic Condition:</b> Built 1929. The three-story, Neo-Classical building has an approximately 400-ft-long by 40-ft-wide footprint with shallow eaves extending from the rear (west) of the building.</p> <p><b>Evaluation:</b> The building is well maintained and in good condition.</p> | |

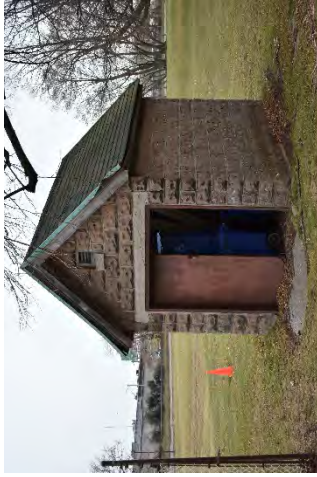
| Resource Name | NR District Nomination | NY CRIS No / NPS | Evaluation Narrative (Historic Period) | Existing Conditions and Historic Graphic Reference |
|---|---|---|---|---|
| Building 211 Fire Hose House | Contributing | 41200 | <p><b>Historic Condition:</b> Built 1939 a rusticated concrete block shed located behind Building 210.</p> <p><b>Evaluation:</b> Building 211 is in fair condition, with a large crack in the rear wall and worn and missing shingles.</p> | |

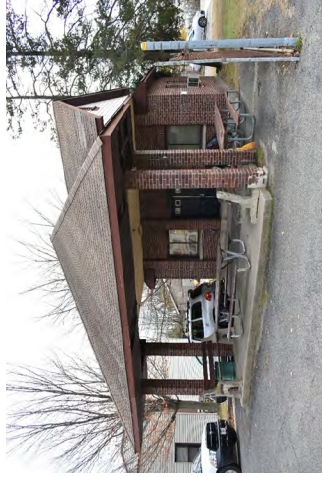
| Resource Name | NR District Nomination | NY CRIS No / NPS | Evaluation Narrative (Historic Period) | Existing Conditions and Historic Graphic Reference |
|---|---|---|---|---|
| Building 303/304 Motor Pool Office | Contributing | 41203 | <p><b>Historic Condition:</b> Built 1938. Building 303/304 is a former gas station with a cross-hip roof on top of a brick store building or office.</p> <p><b>Evaluation:</b> The building is in good condition.</p> | |

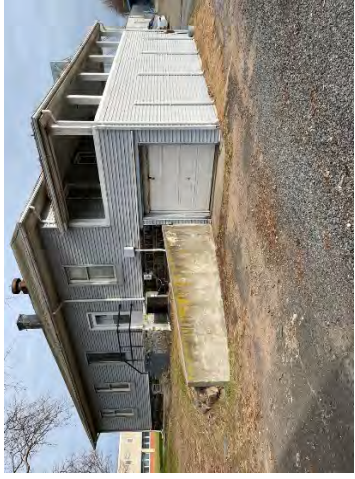
| Resource Name | NR District Nomination | NY CRIS No / NPS | Evaluation Narrative (Historic Period) | Existing Conditions and Historic Graphic Reference |
|---|---|---|---|---|
| Building 305 Administration | Contributing | 41204 | <p><b>Historic Condition:</b> Built 1900. The compact rectangular bungalow has a hip roof surfaced with asphalt shingles and pierced by a brick chimney and a sheet metal vent.</p> <p><b>Evaluation:</b> The building is maintained in good condition.</p> | |

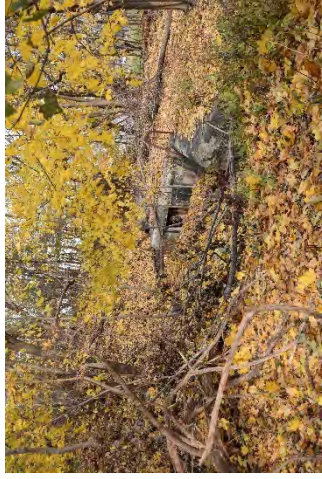
| Resource Name | NR District Nomination | NY CRIS No / NPS | Evaluation Narrative (Historic Period) | Existing Conditions and Historic Graphic Reference |
|---|---|---|---|---|
| Building 307 Ready Magazine | Historic Associated Feature | 41205 | <p><b>Historic Condition:</b> Built 1876. Building 307's visible remains are composed of two, roughly parallel earth mounds with west-facing entries.</p> <p><b>Evaluation:</b> Poor Condition</p> | |

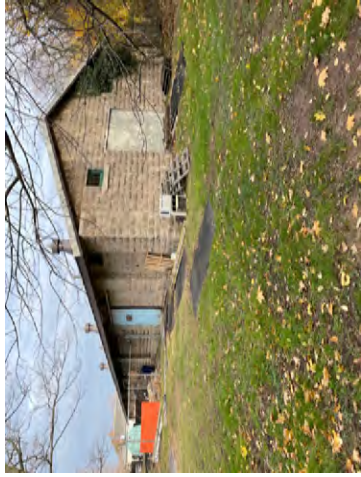
| Resource Name | NR District Nomination | NY CRIS No / NPS | Evaluation Narrative (Historic Period) | Existing Conditions and Historic Graphic Reference |
|---|---|---|---|---|
| Building 309 Stables | Contributing | 41206 | <p><b>Historic Condition:</b> Built 1931. Building 309 is a long rectangular building east of Building 310. It has a gable roof clad in corrugated concrete panels with three sheet metal vents on the ridge line.</p> <p><b>Evaluation:</b> The building is in fair condition.</p> | |

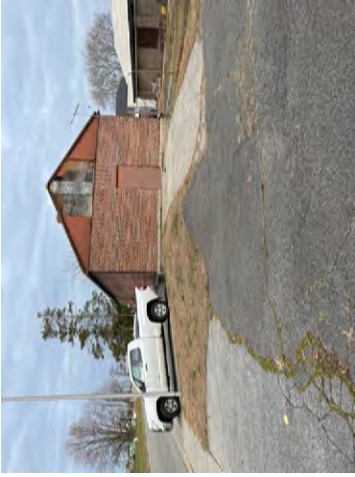
| Resource Name | NR District Nomination | NY CRIS No / NPS | Evaluation Narrative (Historic Period) | Existing Conditions and Historic Graphic Reference |
|---|---|---|---|---|
| Building 310 Storage Shed | Contributing | 41207 | <p><b>Historic Condition:</b> Built 1927 as part of a maintenance complex.</p> <p><b>Evaluation:</b> The building is in fair condition.</p> | |

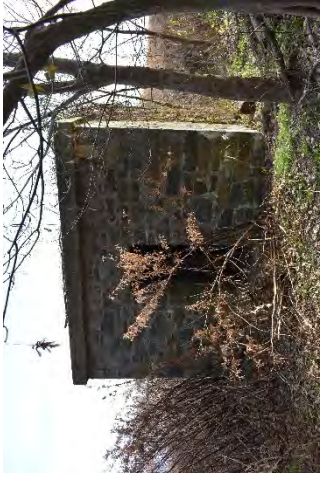
| Resource Name | NR District Nomination | NY CRIS No / NPS | Evaluation Narrative (Historic Period) | Existing Conditions and Historic Graphic Reference |
|---|---|---|---|---|
| Building 314 Target House | Contributing | 41209 | <p><b>Historic Condition:</b> A one-bay by one-bay shed with a flat concrete slab roof and concrete slab floor. The walls are random mortared rubblestone that match the firing range partition in materials and workmanship.</p> <p><b>Evaluation:</b> The building is in fair condition. Debris is piled around it, the door is stuck open, and the interior is partially open to the weather.</p> | |

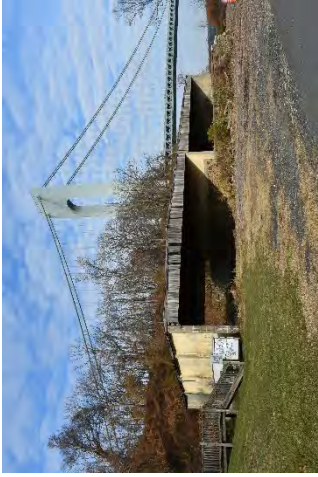
| Resource Name | NR District Nomination | NY CRIS No / NPS | Evaluation Narrative (Historic Period) | Existing Conditions and Historic Graphic Reference |
|---|---|---|---|---|
| Building 339 Rifle and Pistol Range | Contributing | 41210 | <p><b>Historic Condition:</b> Built 1941. Building 339 is a large rectangular shed under a shallow, asymmetrical gable roof with a wood plank fascia. The roof is a modern addition.</p> <p><b>Evaluation:</b> The building is in poor condition, with a deteriorating roof and isolated areas of broken wall masonry.</p> | |

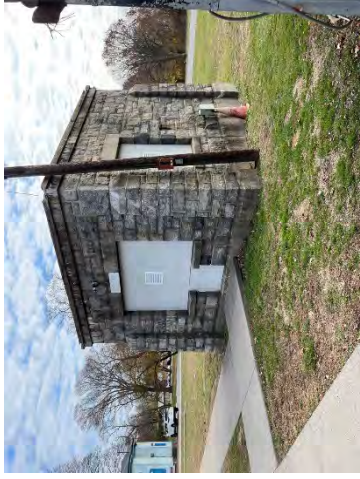
| Resource Name | NR District Nomination | NY CRIS No / NPS | Evaluation Narrative (Historic Period) | Existing Conditions and Historic Graphic Reference |
|---|---|---|---|---|
| Building 404 Gatehouse | Contributing | 41212 | <p><b>Historic Condition:</b> Built 1939. The square, one-story, one-bay by one-bay building has a flat concrete slab roof, random granite ashlar walls, and a concrete slab foundation. Shallow buttresses project from the corners of the building, and a stone chimney is incorporated into the southeast corner.</p> <p><b>Evaluation:</b> The building is vacant and in good condition.</p> | |

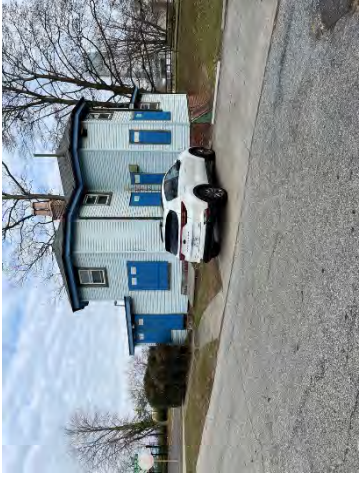
| Resource Name | NR District Nomination | NY CRIS No / NPS | Evaluation Narrative (Historic Period) | Existing Conditions and Historic Graphic Reference |
|---|---|---|---|---|
| Building 406 Gatehouse | Non-contributing | 41213 | <p><b>Historic Condition:</b> Built 1855-65. The Italianate wood-frame residence was heavily altered in the modern period. It has a compact cruciform plan with an enclosed porch on its northwest corner and a one-story ell on its southeast corner (both added in 1937).</p> <p><b>Evaluation:</b> The interior has been altered with drop ceilings, wood wall paneling, and replacement window casings in some rooms.</p> | |

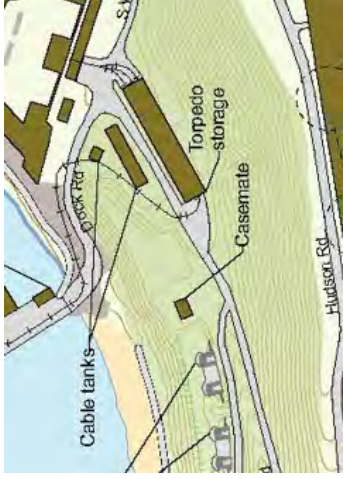
| Resource Name | NR District Nomination | NY CRIS No / NPS | Evaluation Narrative (Historic Period) | Existing Conditions and Historic Graphic Reference |
|---|---|---|---|---|
| Building T-143 Cable Tank | Contributing | N/A | <p><b>Historic Condition:</b> Building T-143 consists of a Cable Tank constructed in 1899.</p> <p><b>Evaluation:</b> The visible portions of Building T-143 are in poor condition due to decayed and crumbling concrete, however it still retains its historic character and contributes to the Fort Wadsworth Historic District.</p> | |

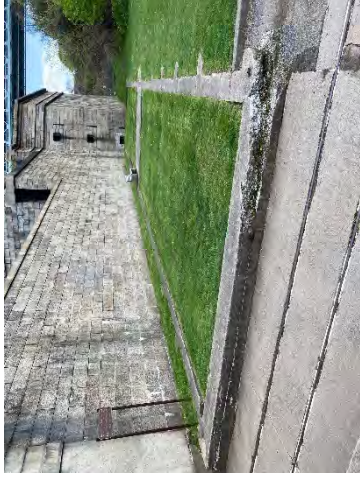
| Resource Name | NR District Nomination | NY CRIS No / NPS | Evaluation Narrative (Historic Period) | Existing Conditions and Historic Graphic Reference |
|---|---|---|---|---|
| Cable Storage Tank Foundations | Contributing | 642845 | <p><b>Historic Condition:</b> Two Cable Storage Tanks were constructed in 1905 in the lawn flanking the Battery Weed sallyport, formerly known as tanks T-146 and T-149.</p> <p><b>Evaluation:</b> The cast concrete foundations are in good condition, with generally sound concrete. No other part of the structures are extant. The Cable Storage Tanks retain their historic character and contribute to the Fort Wadsworth Historic District.</p> | |

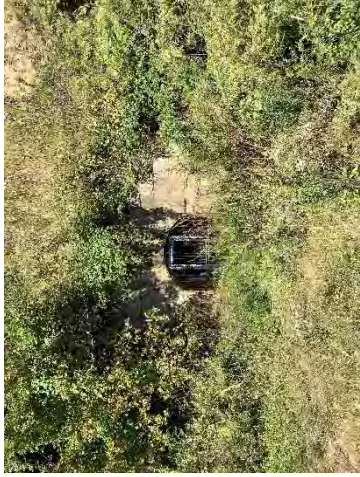
| Resource Name | NR District Nomination | NY CRIS No / NPS | Evaluation Narrative (Historic Period) | Existing Conditions and Historic Graphic Reference |
|---|---|---|---|---|
| Experimental Battery | Contributing | 41327 | <p><b>Historic Condition:</b> Built 1865-75. Built into the bluff north of the south Wharf/Jetty.</p> <p><b>Evaluation:</b> Visible portions of the resource are in poor condition.</p> | |

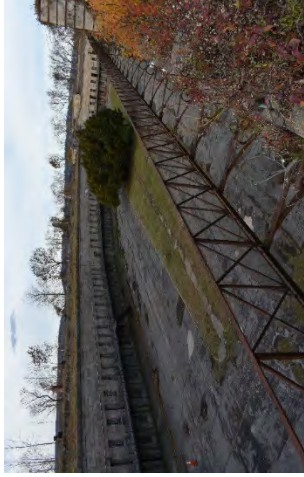
| Resource Name | NR District Nomination | NY CRIS No / NPS | Evaluation Narrative (Historic Period) | Existing Conditions and Historic Graphic Reference |
|---|---|---|---|---|
| Fort Tompkins | Contributing | 41192,<br>GATE0256,<br>NR 74001300 | <p><b>Historic Condition:</b> Fort Tompkins was rebuilt from 1859-1876. The structure occupies the highest point of land in Fort Wadsworth and has a commanding view extending from the lower to the upper New York Bay and directly overlooking the Narrows and Fort Weed. Fort Tompkins replaced a Second System fortification of the same name completed in 1817 on the same location, which in turn had replaced a British fort constructed about 1782. The present Fort Tompkins was constructed between 1859 and 1876 in coordination with Battery Weed. Because of Fort Wadsworth's site topography, Battery Weed was designed strictly to provide seaward defenses, and Fort Tompkins was designed to provide landward defense and to garrison artillery troops. The structure was designed by engineers working under Joseph C. Totten, chief engineer of the Army Corps of Engineers. Engineer John G. Barnard superintended the bulk of construction.</p> <p><b>Evaluation:</b> Fort Tompkins retains its historic character and contributes to the Fort Wadsworth Historic District. The fort is in generally fair condition, but certain casemates are in poor condition with highly degraded architectural finishes. The roof is failing, and the barbette battery is overgrown with vegetation and also in poor condition.</p> | |

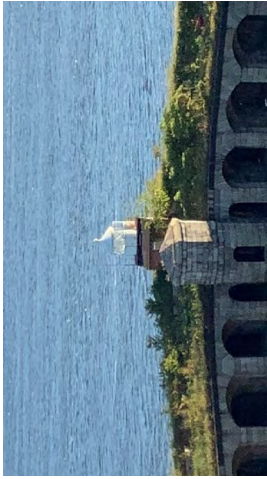
| Resource Name | NR District Nomination | NY CRIS No / NPS | Evaluation Narrative (Historic Period) | Existing Conditions and Historic Graphic Reference |
|---|---|---|---|---|
| Fort Wadsworth Light | Contributing | 41243 | <p><b>Historic Condition:</b> The light from the Fort Tompkins Lighthouse was relocated to Battery Weed and renamed the Fort Wadsworth Light in approximately 1903. The light was moved because the Fort Tompkins lighthouse was determined to be too far inland to be effective. Also known as The Battery Weed Light Station.</p> <p><b>Evaluation:</b> The Battery Weed Light Station retains its historic character and contributes to the Fort Wadsworth Historic District. This resource is in fair condition and the original lens and keeper's dwelling are no longer extant. The lighthouse was restored in 2002–2005 through an NPS-volunteer partnership. The Battery Weed Light Station is significant at the local level under Criterion A in the area of Maritime History due to its important associations with the system of navigational aids in New York Harbor.</p> | |

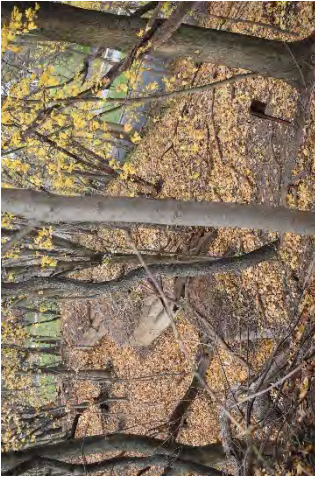
| Resource Name | NR District Nomination | NY CRIS No / NPS | Evaluation Narrative (Historic Period) | Existing Conditions and Historic Graphic Reference |
|---|---|---|---|---|
| Glacis Gun Battery | Contributing | 41326, GATE00262 | <p><b>Historic Condition:</b> The Glacis Gun Battery was constructed in 1874 off the northeast corner of Fort Tompkins near the east end of South Road. This open barbette battery from the post-Civil War era consists of three emplacements containing a total of five gun platforms that step down the slope of the glacis on a north-south axis. The emplacements are divided by earth traverses containing concrete, barrel-arched magazines. The magazine entries are fitted with heavy bronze-studded wood doors flanked with projecting granite wingwalls and topped by beveled triangular lintels. The earth parapets are backed by stepped, breast-height walls of coursed granite ashlar. The rear of the battery is open, with no rear paradoss.</p> <p><b>Evaluation:</b> The overall configuration of the emplacements, parapet walls, and magazines are readily discernible, and at least one magazine is accessible for inspection. However, the earthworks are overgrown with trees and the gun platforms are no longer visible due to accumulated natural debris. For these reasons, the structure is in poor condition. However, the Glacis Gun Battery still retains its historic character and contributes to the Fort Wadsworth Historic District.</p> | |

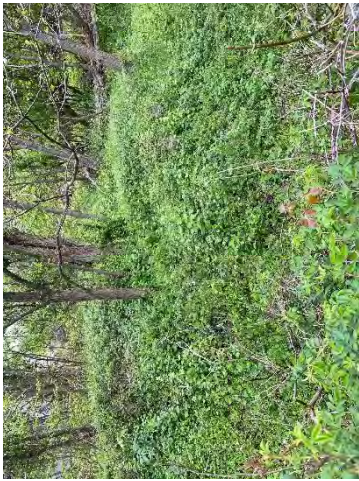
| Resource Name | NR District Nomination | NY CRIS No / NPS | Evaluation Narrative (Historic Period) | Existing Conditions and Historic Graphic Reference |
|---|---|---|---|---|
| Glacis Mortar Battery | Contributing | 654700,<br>GATE00260 | <p><b>Historic Condition:</b> The Glacis Mortar Battery was built from 1871 to 1872 located at the toe of the south glacis flank of Fort Tompkins, south of Battery Duane. The Battery consists of a mortared fieldstone berm measuring about 10 ft wide and 20 ft long. The berm's long axis runs east-west. The top of the feature is arched and parged with mortar.</p> <p><b>Evaluation:</b> The open mortar pits and earth-covered magazines are almost completely buried in non-historic fill deposits likely associated with the Verrazano Narrows Bridge. The battery is in poor condition; however it still retains its historic character and contributes to the Fort Wadsworth Historic District.</p> | |

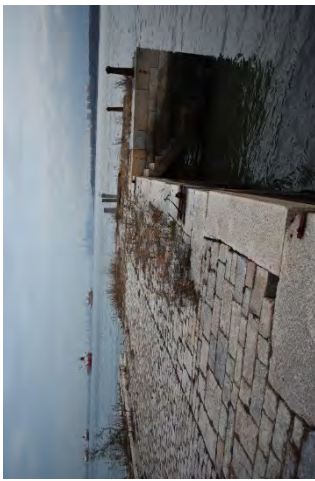
| Resource Name | NR District Nomination | NY CRIS No / NPS | Evaluation Narrative (Historic Period) | Existing Conditions and Historic Graphic Reference |
|---|---|---|---|---|
| North Dock | Contributing | 41215 | <p><b>Historic Condition:</b> The North Dock was constructed from 1850 to 1858 and is located at the north end of Dock Road. This stone masonry pier is about 40 ft wide and 80 ft long. Transverse granite block columns support an iron and brick jack arch system that creates the deck. The wearing surface of the pier is granite paving stone and block with large coping stones around the perimeter. Two bollards adapted from cannon barrels are mounted on the south side, and remnants of a wood pile pier are present at the east end.</p> <p><b>Evaluation:</b> The structure is in poor condition with crumbling masonry components and heavily corroded iron reinforcing beams, however it still retains its historic character and contributes to the Fort Wadsworth Historic District.</p> | |

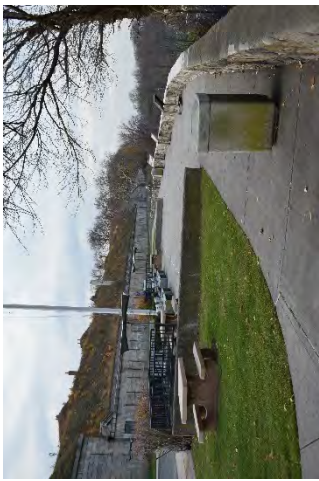
| Resource Name | NR District Nomination | NY CRIS No / NPS | Evaluation Narrative (Historic Period) | Existing Conditions and Historic Graphic Reference |
|---|---|---|---|---|
| NPS Terrace | Non-contributing | N/A | <p><b>Historic Condition:</b> Built 1995. The NPS Terrace is a concrete-paved structure furnished with an aluminum flagpole, benches, and multiple NPS wayside interpretive panels.</p> <p><b>Evaluation:</b> Non-contributing Structure.</p> | |

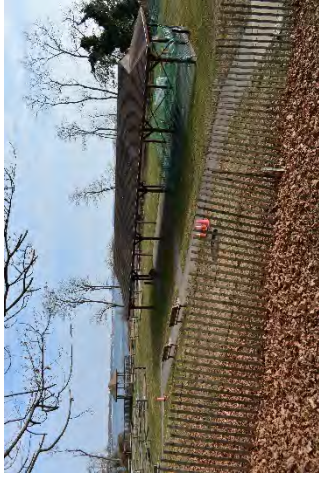
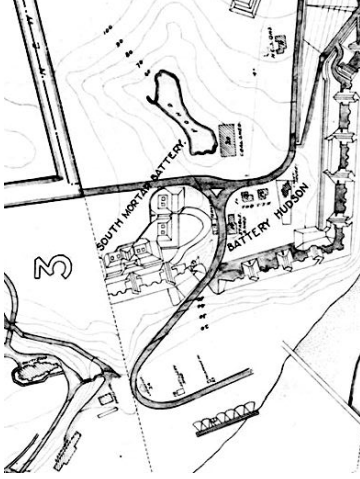
| Resource Name | NR District Nomination | NY CRIS No / NPS | Evaluation Narrative (Historic Period) | Existing Conditions and Historic Graphic Reference |
|---|---|---|---|---|
| Pavilion | Non-contributing | N/A | <p><b>Historic Condition:</b> Built 1958. The Pavilion is an open-sided shelter with a hip roof, wood post and beam frame, and a slab floor.</p> <p><b>Evaluation:</b> Non-contributing Structure.</p> | |

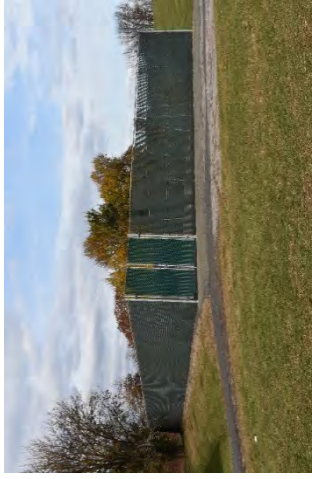
| Resource Name | NR District Nomination | NY CRIS No / NPS | Evaluation Narrative (Historic Period) | Existing Conditions and Historic Graphic Reference |
|---|---|---|---|---|
| South Mortar Battery | Contributing | GATE00261 | <p><b>Historic Condition:</b> Built 1871. covered way or similar arched, poured concrete opening and an approximately 10-ft-wide by 20-ft-long cast concrete berm set on an east-west axis. The berm's concrete has a coarse rounded aggregate matrix.</p> <p><b>Evaluation:</b> Poor Condition</p> | |

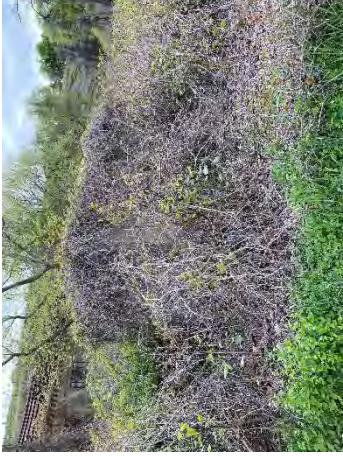
| Resource Name | NR District Nomination | NY CRIS No / NPS | Evaluation Narrative (Historic Period) | Existing Conditions and Historic Graphic Reference |
|---|---|---|---|---|
| Transformer Building | Non-contributing | 41325 | <p><b>Historic Condition:</b> Built in 1940 as a small square utility shed located just north of the Battery Weed Road-Dock Road intersection. It is constructed of cast concrete with a slab roof and unadorned walls.</p> <p><b>Evaluation:</b> Non-contributing structure, heavily obscured by vegetation.</p> | |

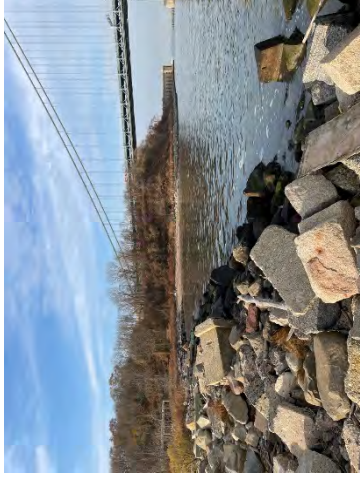
| Resource Name | NR District Nomination | NY CRIS No / NPS | Evaluation Narrative (Historic Period) | Existing Conditions and Historic Graphic Reference |
|---|---|---|---|---|
| Wharf/Jetty | Contributing | 41229 | <p><b>Historic Condition:</b> Built 1858. The structure projects about 175 ft southeast into the ocean at the mouth of the Narrows and is about 30 ft wide. Most of the jetty consists of large irregular stone blocks. A low granite block wall at its outer end is bound with heavy beds of mortar and iron cramps.</p> <p><b>Evaluation:</b> The jetty is in poor condition</p> | |

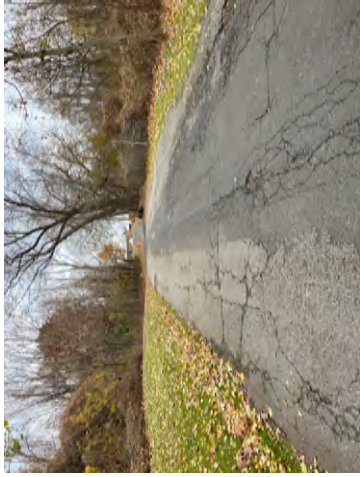
| Resource Name | NR District Nomination | NY CRIS No / NPS | Evaluation Narrative (Historic Period) | Existing Conditions and Historic Graphic Reference |
|---|---|---|---|---|
| Ayres Road | Historic Associated Feature | N/A | <p><b>Historic Condition:</b> Built 1900. Narrow lanes providing access from Battery and Tennessee roads to the Endicott Period batteries.</p> <p><b>Evaluation:</b> Fair condition.</p> | |

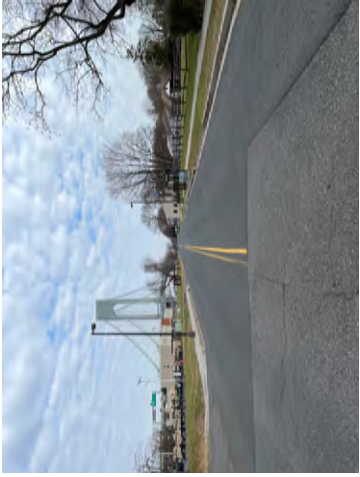
| Resource Name | NR District Nomination | NY CRIS No / NPS | Evaluation Narrative (Historic Period) | Existing Conditions and Historic Graphic Reference |
|---|---|---|---|---|
| Battery Road | Historic Associated Feature | N/A | <p><b>Historic Condition:</b> Built before 1854. Battery Road is a two-lane thoroughfare west of the New York Avenue intersection but narrows east of that point. It is flanked by a concrete sidewalk on the south side.</p> <p><b>Evaluation:</b> The road is in fair condition, with multiple areas of cracked pavement.</p> | |

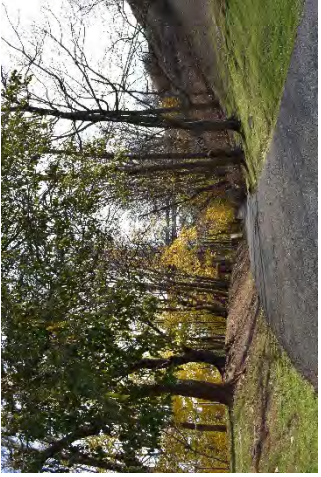
| Resource Name | NR District Nomination | NY CRIS No / NPS | Evaluation Narrative (Historic Period) | Existing Conditions and Historic Graphic Reference |
|---|---|---|---|---|
| Battery Weed Road | Historic Associated Feature | 41235 | <p><b>Historic Condition:</b> Built 1847. Battery Weed Road descends as a single lane from the east end of Mont Sec Avenue behind Battery Catlin to Battery Weed. Portions of the road adjacent to Battery Weed are flanked with concrete curbs and a metal guardrail.</p> <p><b>Evaluation:</b> The road is in good condition.</p> | |

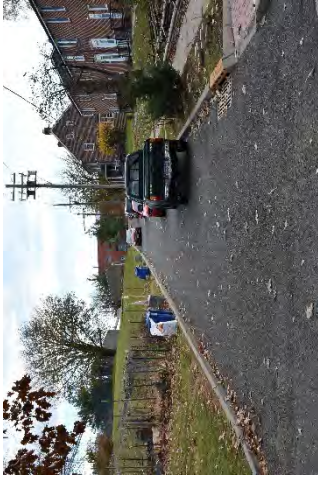
| Resource Name | NR District Nomination | NY CRIS No / NPS | Evaluation Narrative (Historic Period) | Existing Conditions and Historic Graphic Reference |
|---|---|---|---|---|
| Clifton Road | Historic Associated Feature | N/A | <p><b>Historic Condition:</b> Built 1910. A narrow paved service lane with concrete curbs that extends south from South Road to parallel New York Avenue. This lane was longer during the historic period and was truncated by construction outside the district's period of significance.</p> <p><b>Evaluation:</b> It is currently in poor condition due to recent utility line excavations.</p> | |

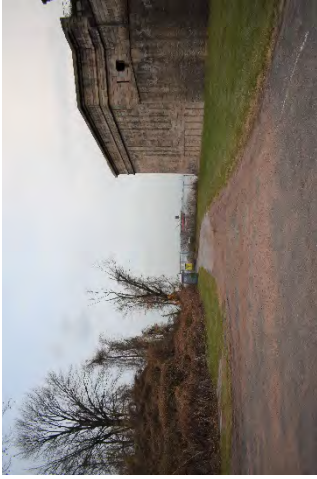
| Resource Name | NR District Nomination | NY CRIS No / NPS | Evaluation Narrative (Historic Period) | Existing Conditions and Historic Graphic Reference |
|---|---|---|---|---|
| Dock Road | Historic Associated Feature | 41236 | <p><b>Historic Condition:</b> Built 1850.</p> <p><b>Evaluation:</b> In poor condition and missing most of its pavement due to damage from Hurricane Sandy in 2012, partially covered with eroded slope material and overgrown with vegetation</p> | |

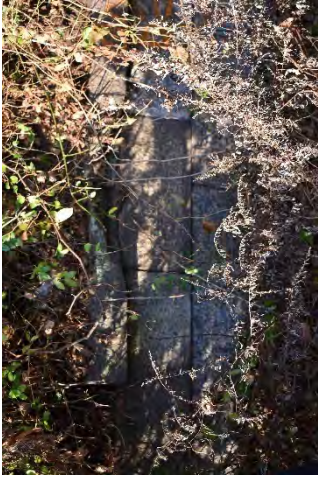
| Resource Name | NR District Nomination | NY CRIS No / NPS | Evaluation Narrative (Historic Period) | Existing Conditions and Historic Graphic Reference |
|---|---|---|---|---|
| Engineered Slope Sustaining Wall | Historic Associated Feature | N/A | <p><b>Historic Condition:</b> Built 1848, a dry-laid granite block structure on the west side of the road, at the toe of the slope near Battery Weed.</p> <p><b>Evaluation:</b> Fair Condition, largely obscured by vegetation and fill.</p> | |

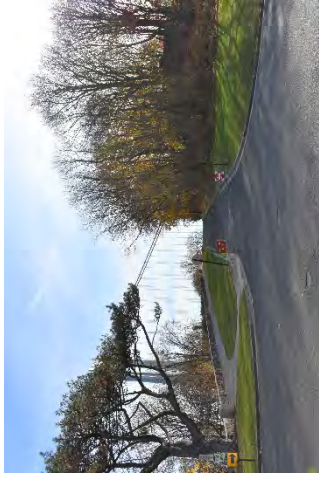
| Resource Name | NR District Nomination | NY CRIS No / NPS | Evaluation Narrative (Historic Period) | Existing Conditions and Historic Graphic Reference |
|---|---|---|---|---|
| Hudson Road | Historic Associated Feature | 41237 | <p><b>Historic Condition:</b> Built 1871, a two-lane road with concrete curbing and a concrete sidewalk until it passes the Fort Tompkins gorge</p> <p><b>Evaluation:</b> Hudson Road is in good condition, with minimal cracking or other damage in the roadway surface or curbing.</p> | |

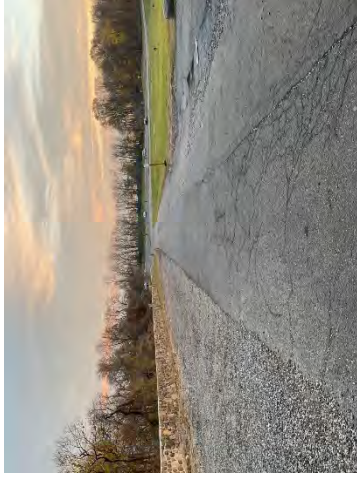
| Resource Name | NR District Nomination | NY CRIS No / NPS | Evaluation Narrative (Historic Period) | Existing Conditions and Historic Graphic Reference |
|---|---|---|---|---|
| Hudson Road Wall | Historic Associated Feature | 41242 | <p><b>Historic Condition:</b> Built 1938. This mortared rubblestone structure has been repaired in multiple locations with granite paving stones.</p> <p><b>Evaluation:</b> The Hudson Road Wall is in fair condition, with limited areas of spalled mortar pointing.</p> | |

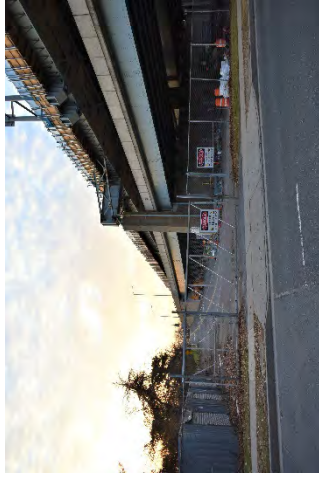
| Resource Name | NR District Nomination | NY CRIS No / NPS | Evaluation Narrative (Historic Period) | Existing Conditions and Historic Graphic Reference |
|---|---|---|---|---|
| Interstate 278/Verrazano Narrows Bridge right-of-way | Outside | N/A | Construction completed 1964. The roadway and bridge interrupted the historic fabric of the landscape. | |

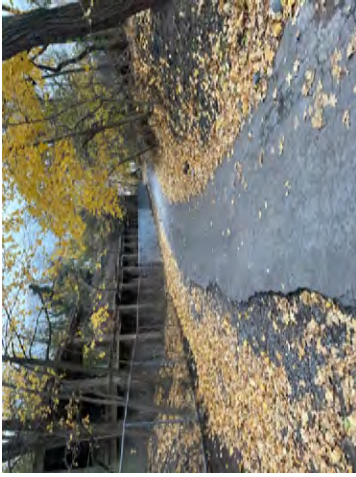
| Resource Name | NR District Nomination | NY CRIS No / NPS | Evaluation Narrative (Historic Period) | Existing Conditions and Historic Graphic Reference |
|---|---|---|---|---|
| Loop Road | Historic Associated Feature | N/A | <p><b>Historic Condition:</b> Built 1897. Narrow lanes providing access from Battery and Tennessee roads to the Endicott Period batteries.</p> <p><b>Evaluation:</b> Loop Road is in poor condition due to its degraded asphalt and the impingement of gravel and debris.</p> | |

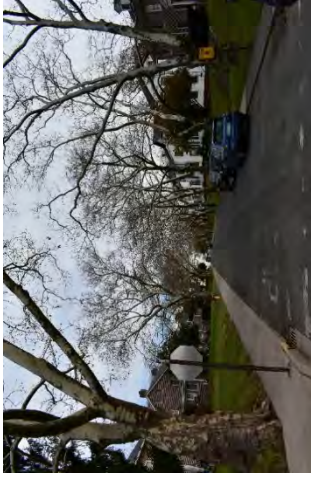
| Resource Name | NR District Nomination | NY CRIS No / NPS | Evaluation Narrative (Historic Period) | Existing Conditions and Historic Graphic Reference |
|---|---|---|---|---|
| Mont Sec Avenue | Historic Associated Feature | 41233 | <p><b>Historic Condition:</b> Built 1870. Road to access Buildings 101-114. Mont Sec Avenue is an asphalt-paved, two-lane road lined with London Plane trees, concrete curbs, and sidewalks.</p> <p><b>Evaluation:</b> The road is in poor condition, with numerous small pot-holes, patches, and cracks.</p> | |

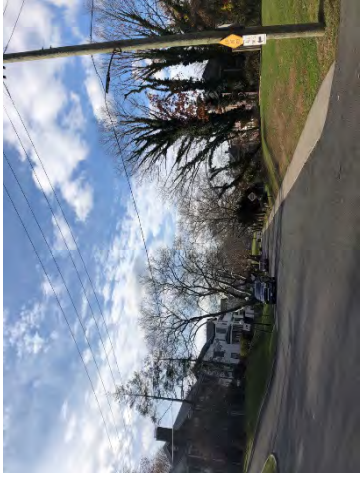
| Resource Name | NR District Nomination | NY CRIS No / NPS | Evaluation Narrative (Historic Period) | Existing Conditions and Historic Graphic Reference |
|---|---|---|---|---|
| Mont Sec Avenue Pedestrian Walkways | Historic Associated Feature | 41232 | <p><b>Historic Condition:</b> Built 1880</p> <p><b>Evaluation:</b> The road is in poor condition, with numerous small pot-holes, patches, and cracks.</p> | |

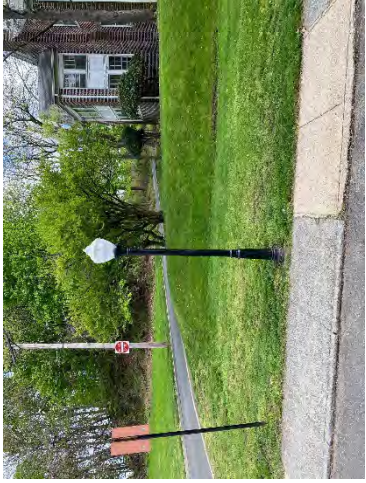
| Resource Name | NR District Nomination | NY CRIS No / NPS | Evaluation Narrative (Historic Period) | Existing Conditions and Historic Graphic Reference |
|---|---|---|---|---|
| Mont Sec Avenue Street Lights | Historic Associated Feature | 41234 | <p><b>Historic Condition:</b> Built 1885</p> <p><b>Evaluation:</b> The street lights are in fair condition.</p> | |

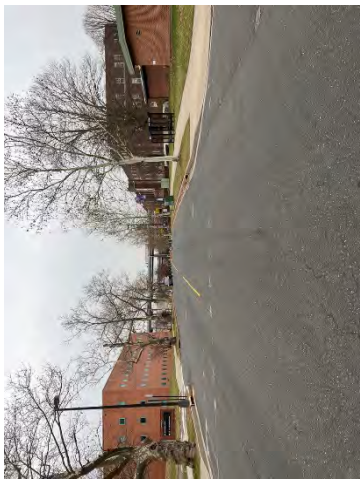
| Resource Name | NR District Nomination | NY CRIS No / NPS | Evaluation Narrative (Historic Period) | Existing Conditions and Historic Graphic Reference |
|---|---|---|---|---|
| New York Avenue | Historic Associated Feature | N/A | <p><b>Historic Condition:</b> Built before 1854. New York Avenue is a wide boulevard flanked by London Plane trees and by sidewalks separated from the roadway with grass shoulders.</p> <p><b>Evaluation:</b> The avenue is in fair condition, with multiple areas of cracked pavement and asphalt patches</p> | |

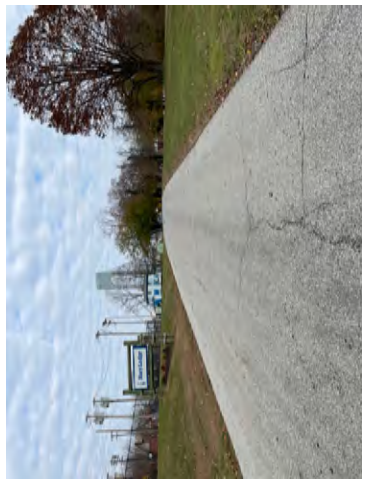
| Resource Name | NR District Nomination | NY CRIS No / NPS | Evaluation Narrative (Historic Period) | Existing Conditions and Historic Graphic Reference |
|---|---|---|---|---|
| North Path Road | Non-contributing | N/A | <p><b>Historic Condition:</b> Built 1990.</p> <p><b>Evaluation:</b> Non-Contributing Feature</p> | |

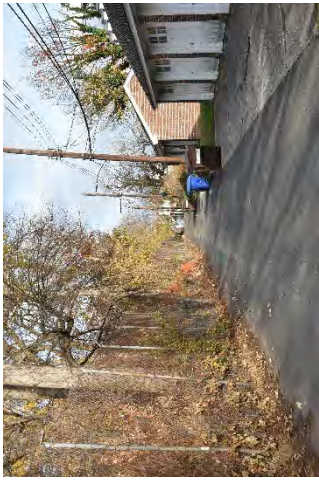
| Resource Name | NR District Nomination | NY CRIS No / NPS | Evaluation Narrative (Historic Period) | Existing Conditions and Historic Graphic Reference |
|---|---|---|---|---|
| North Road | Historic Associated Feature | N/A | <p><b>Historic Condition:</b> Built 1870-1889. These service lanes provide access to garages at the rear of the residences.</p> <p><b>Evaluation:</b> North Road is in good condition with minimal cracking or disintegration of the roadway</p> | |

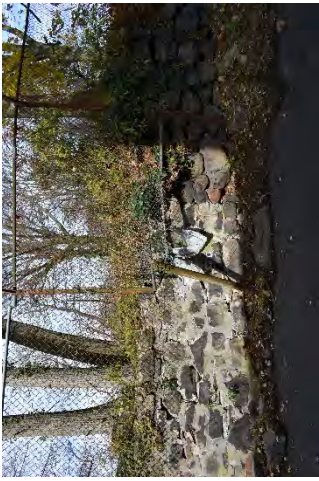
| Resource Name | NR District Nomination | NY CRIS No / NPS | Evaluation Narrative (Historic Period) | Existing Conditions and Historic Graphic Reference |
|---|---|---|---|---|
| North Road Stone Wall | Historic Associated Feature | N/A | <p><b>Historic Condition:</b> North Road is bounded on one side by a roughly 3-ft-high, random-laid, mortared stone wall that is in fair condition.</p> | |

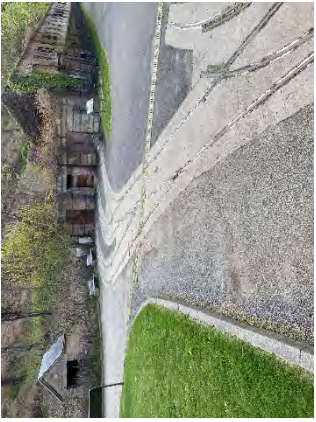
| Resource Name | NR District Nomination | NY CRIS No / NPS | Evaluation Narrative (Historic Period) | Existing Conditions and Historic Graphic Reference |
|---|---|---|---|---|
| Rail Tracks | Contributing | 41244 | <p><b>Historic Condition:</b> Narrow Gauge Rail Tracks were constructed between 1892 and 1894 to the west and north of Battery Weed, at the foot of Battery Weed Road. These tracks connected multiple buildings, sites, and structures associated with the storage, assembly, and deployment of mines.</p> <p><b>Evaluation:</b> Portions of the track system not set in the roadways are overgrown with vegetation, and some sections are missing. The tracks are in poor condition; however they still retain their historic character and contribute to the Fort Wadsworth Historic District.</p> | |

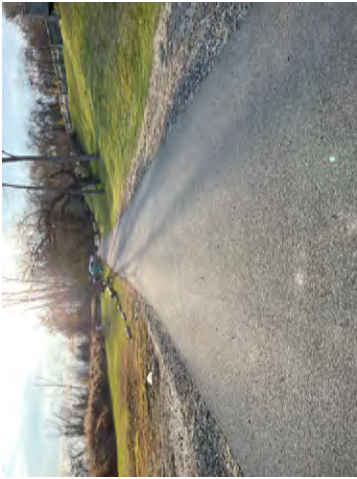
| Resource Name | NR District Nomination | NY CRIS No / NPS | Evaluation Narrative (Historic Period) | Existing Conditions and Historic Graphic Reference |
|---|---|---|---|---|
| Range Road | Historic Associated Feature | N/A | <p><b>Historic Condition:</b> Built 1858. Range Road intersects with Shore Road near Battery Dix and runs east as a gravel lane to access the beach at the extreme southeast corner of the reservation.</p> <p><b>Evaluation:</b> Range Road is in poor condition, with numerous potholes and eroded areas in the gravel surfacing.</p> | |

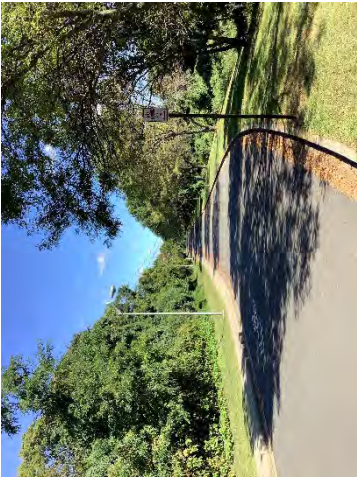
| Resource Name | NR District Nomination | NY CRIS No / NPS | Evaluation Narrative (Historic Period) | Existing Conditions and Historic Graphic Reference |
|---|---|---|---|---|
| Shore Road | Historic Associated Feature | N/A | <p><b>Historic Condition:</b> Built 1900. Shore Road descends the south bluff as a winding one-lane road from Battery Road in the southeast corner of the reservation to the vicinity of Battery Dix and then passes out of the historic district.</p> <p><b>Evaluation:</b> The road is in fair condition, with some minor cracking and patching of asphalt.</p> | |

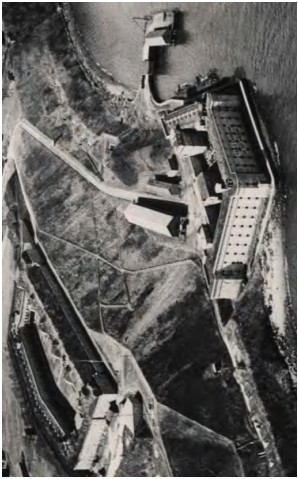
| Resource Name | NR District Nomination | NY CRIS No / NPS | Evaluation Narrative (Historic Period) | Existing Conditions and Historic Graphic Reference |
|---|---|---|---|---|
| Slope Walks | Historic Associated Feature | N/A | <p><b>Historic Condition:</b> Built 1893. rise up the bluff from Battery Weed Road to Fort Tompkins.</p> <p><b>Evaluation:</b> The full condition of these walkways is unknown because much of their surfaces is covered with soil and vegetation. The walks are clearly still visible on LIDAR surveys.</p> | |

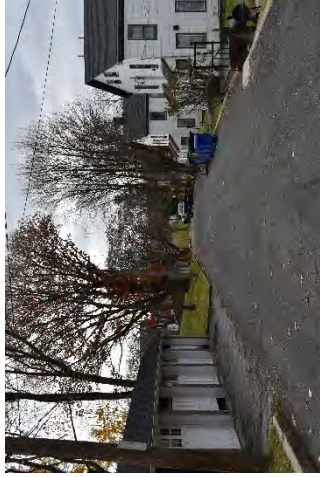
| Resource Name | NR District Nomination | NY CRIS No / NPS | Evaluation Narrative (Historic Period) | Existing Conditions and Historic Graphic Reference |
|---|---|---|---|---|
| South Road | Historic Associated Feature | N/A | <p><b>Historic Condition:</b> Built 1870-1889. These service lanes provide access to garages at the rear of the residences.</p> <p><b>Evaluation:</b> South Road is in fair condition due to some potholes and pavement disintegration along the curb lines.</p> | |

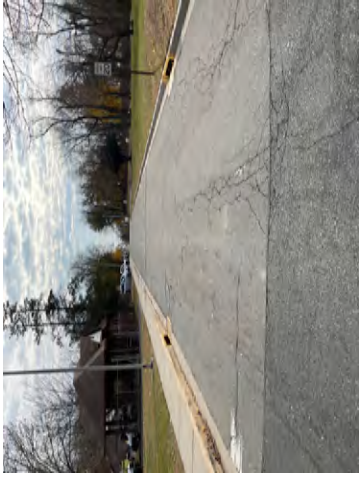
| Resource Name | NR District Nomination | NY CRIS No / NPS | Evaluation Narrative (Historic Period) | Existing Conditions and Historic Graphic Reference |
|---|---|---|---|---|
| Tennessee Road | Historic Associated Feature | N/A | <p><b>Historic Condition:</b> Built before 1874. A two-lane road extending south from Battery Road and is flanked at its north end by a concrete sidewalk.</p> <p><b>Evaluation:</b> This roadway is in good condition.</p> | |

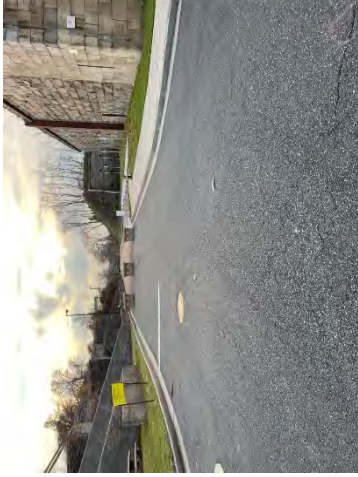
| Resource Name | NR District Nomination | NY CRIS No / NPS | Evaluation Narrative (Historic Period) | Existing Conditions and Historic Graphic Reference |
|---|---|---|---|---|
| Tompkins Street | Historic Associated Feature | N/A | <p><b>Historic Condition:</b> Built 1896. the former location of the Fort Tompkins ditch</p> <p><b>Evaluation:</b> Tompkins Street is in fair condition, with some asphalt patches and cracking present.</p> | |

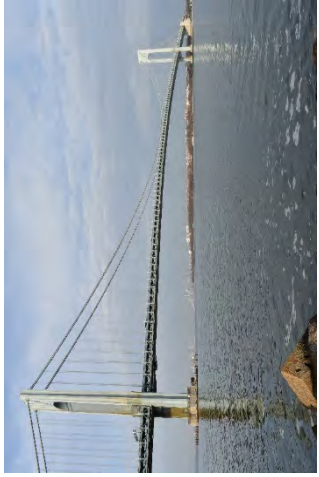
| Resource Name | NR District Nomination | NY CRIS No / NPS | Evaluation Narrative (Historic Period) | Existing Conditions and Historic Graphic Reference |
|---|---|---|---|---|
| Verrazzano-Narrows Bridge | Outside | N/A | <p>The construction of the Verrazzano-Narrows Bridge significantly altered Fort Wadsworth's landscape. The most striking change was the construction of the anchorage and bridge that approached directly through the center of the installation. Other changes were the loss of a variety of buildings and the addition of new buildings. Fort Wadsworth was effectively divided into two zones, one north of the bridge where Battery Weed, Fort Tompkins, and other easily recognizable historic buildings were located, and the southern zone that housed simpler buildings, maintenance and storage facilities, and additional housing.</p> | |

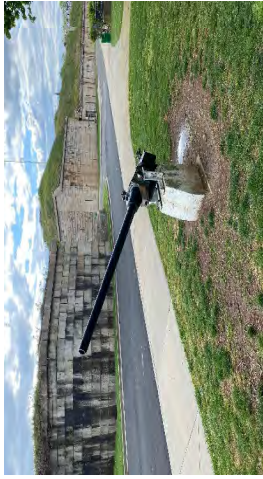
| Resource Name | NR District Nomination | NY CRIS No / NPS | Evaluation Narrative (Historic Period) | Existing Conditions and Historic Graphic Reference |
|---|---|---|---|---|
| Armaments | | | The emplaced guns made Fort Wadsworth one of the nation's most significant coastal military fortifications. Only one small gun still exists in the park. | |

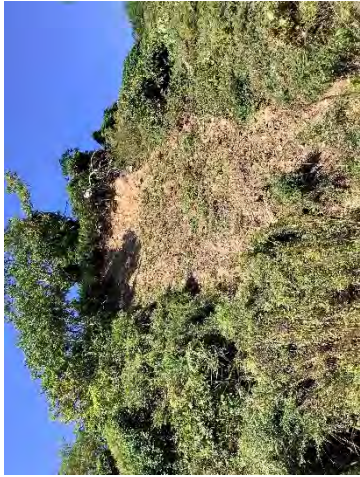
| Resource Name | NR District Nomination | NY CRIS No / NPS | Evaluation Narrative (Historic Period) | Existing Conditions and Historic Graphic Reference |
|---|---|---|---|---|
| Bluffs | | | <p><b>Historic Condition:</b> The bluffs represent a significant natural feature of Fort Wadsworth that retain integrity despite various alteration over the last two centuries.</p> <p><b>Evaluation:</b> Good condition with some areas showing degradation from erosion. Vegetation coverage is heavy in most areas.</p> | |
