# CULTURAL LANDSCAPE REPORT

FORT WADSWORTH

GATEWAY NATIONAL RECREATION AREA

Prepared by PaleoWest, LLC

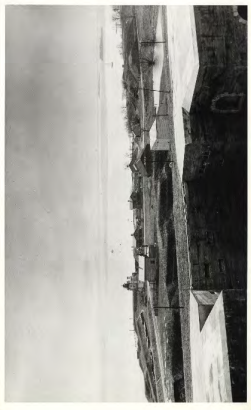
| Resource Name | NR District Nomination | NY CRIS No / NPS | Evaluation Narrative (Historic Period) | Existing Conditions and Historic Graphic Reference |
|---|---|---|---|---|
| Endicott Battery Foreslopes | | | <p><b>Historic Condition:</b> Endicott Era batteries were constructed with earthen foreslopes that served to protect and conceal the fortifications.</p> <p><b>Evaluation:</b> Poor condition. Largely obscured by overgrown vegetation.</p> | |

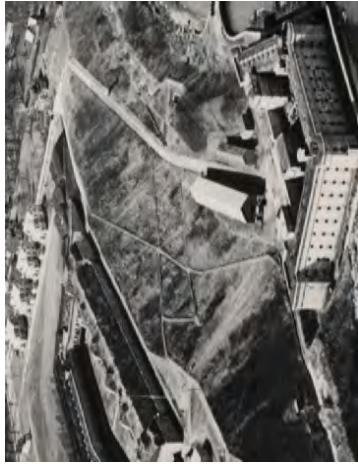
| Resource Name | NR District Nomination | NY CRIS No / NPS | Evaluation Narrative (Historic Period) | Existing Conditions and Historic Graphic Reference |
|---|---|---|---|---|
| Engineered Slope | | | <p><b>Historic Condition:</b> Appear throughout the period of significance in various forms.</p> <p><b>Evaluation:</b> Poor to fair condition</p> | |

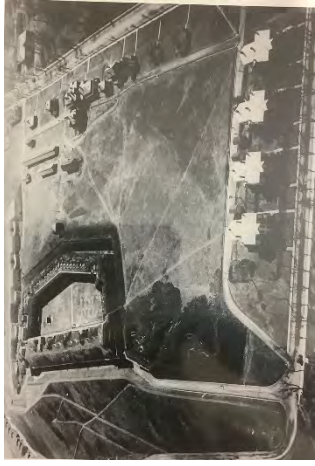
| Resource Name | NR District Nomination | NY CRIS No / NPS | Evaluation Narrative (Historic Period) | Existing Conditions and Historic Graphic Reference |
|---|---|---|---|---|
| Fort Tompkins Glacis | | | <p><b>Historic Condition:</b> Moderate vegetation growth</p> <p><b>Evaluation:</b> Fair condition</p> | |

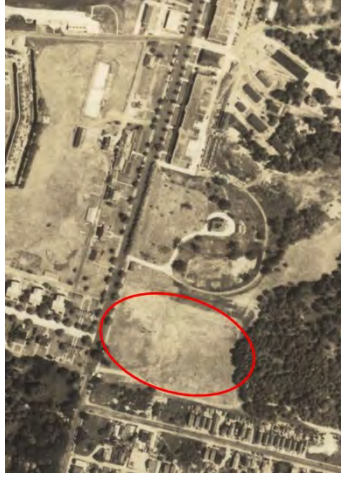
| Resource Name | NR District Nomination | NY CRIS No / NPS | Evaluation Narrative (Historic Period) | Existing Conditions and Historic Graphic Reference |
|---|---|---|---|---|
| Parade Ground | | | <p>A swamp area was drained by engineers and the ground leveled in 1925. The Parade Ground remains as a topographical remnant in the form of a level field adjacent to Building 220.</p> | |

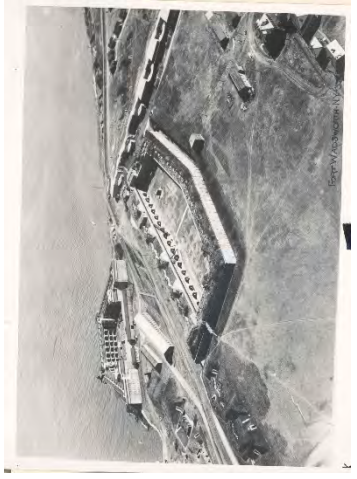
| Resource Name | NR District Nomination | NY CRIS No / NPS | Evaluation Narrative (Historic Period) | Existing Conditions and Historic Graphic Reference |
|---|---|---|---|---|
| Cleared Vegetation | | | <p><b>Historic Condition:</b> For much of the period of significance, the Fort Wadsworth bluffs and areas surrounding military buildings were cleared of vegetation.</p> <p><b>Evaluation:</b> Poor condition. Vegetation has not been cleared to historic levels and obscures much of the historic landscape.</p> | |

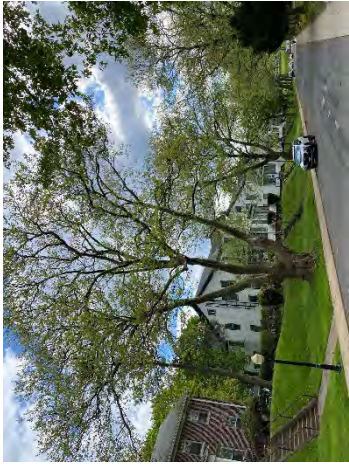
| Resource Name | NR District Nomination | NY CRIS No / NPS | Evaluation Narrative (Historic Period) | Existing Conditions and Historic Graphic Reference |
|---|---|---|---|---|
| Mont Sec Avenue London Plane Trees | | | Rows of London Plane trees were installed along the housing corridor as part of the CCC and WPA projects in the 1930s. The plantings are largely intact. | |

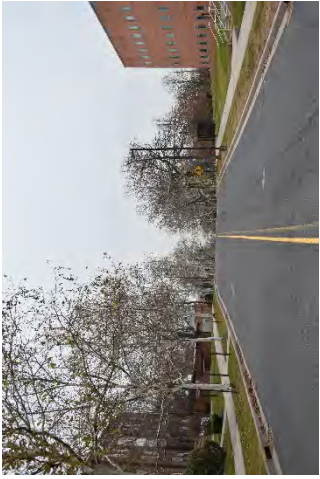
| Resource Name | NR District Nomination | NY CRIS No / NPS | Evaluation Narrative (Historic Period) | Existing Conditions and Historic Graphic Reference |
|---|---|---|---|---|
| New York Avenue Formal Plantings | | | Formal landscaping was installed along the main street as part of the CCC and WPA projects in the 1930s. The plantings are largely intact except where interrupted by construction of the Verrazano-Narrows Bridge. | |
