# Status of Climate and Water Resources at Gila Cliff Dwellings National Monument

*Water Year 2016*

Natural Resource Report NPS/SODN/NRR—2018/1615

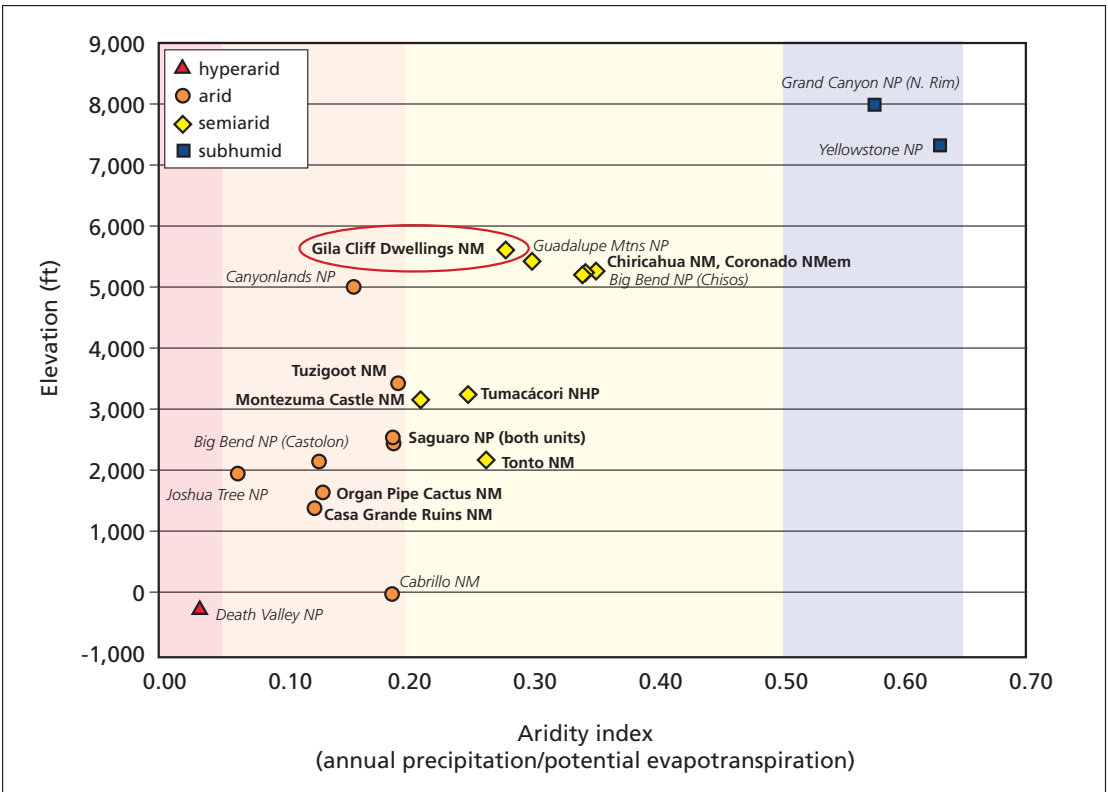
Figure 2-1. Aridity index vs. elevation of selected southwestern national parks, including Gila Cliff Dwellings National Monument. Figure from Hubbard and others (in prep).

An Aridity Index (UNEP 1992), based on the long-term average annual precipitation relative to the average annual potential evapotranspiration, can be a useful tool for contrasting the local climate of national parks (Figure 2-1). Used globally to classify climate zones, aridity index seeks to answer the question “How dry is dry?” (Tsakiris and Vengelis 2005). Using the period of record (1957–present), the climate of Gila Cliff Dwellings NM is classified as semi-arid.

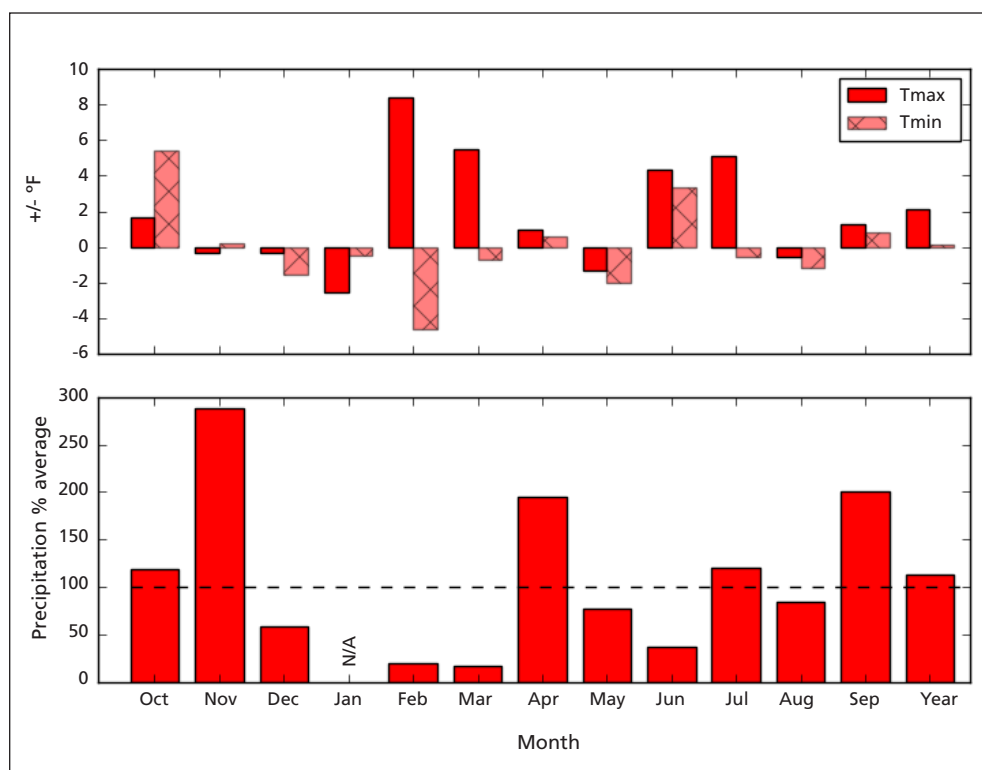
Figure 2-2. Departures from 30-year (1981–2010) normal minimum and maximum air temperature and precipitation, Gila Cliff Dwellings National Monument. Graphics generated by climateanalyzer.org.

Data quality during WY2016 was excellent, with missing values on only five days, all in January. Overall annual precipitation was 113% of normal for Gila Cliff Dwellings NM (18.35" vs 16.26").

Overall precipitation was essentially normal (104% or +0.29") for the fall and winter of WY2016. Rainfall in February and April represented less than 20% of normal. November was dramatically wetter than normal, with 288% of the 1981–2010 normal rainfall levels (Figure 2-2). Fall and early winter air temperatures were generally close to normal ( $\pm 2.5^\circ\text{F}$ ). The mean monthly maximum temperature was unusually high in February and March ( $+8.4^\circ\text{F}$  and  $+5.5^\circ\text{F}$ , respectively). The mean monthly minimum temperature was lower than normal for both months, demonstrating a larger than normal diurnal temperature range (up to  $59^\circ\text{F}$  in a single day). As is usually the case, mean monthly low temperatures were below freezing from November to March.

Overall precipitation was above average (119%, 1.80") for the spring and summer months in WY2016. April and September were 200% wetter than normal. June rainfall was only 36% of normal. September had the highest monthly precipitation for the year, extending the duration of the monsoon season (Figure 2-3). Warm-season maximum and minimum air temperatures were close to normal ( $\pm 2^\circ\text{F}$ ), except in June and July, which were warmer than normal.

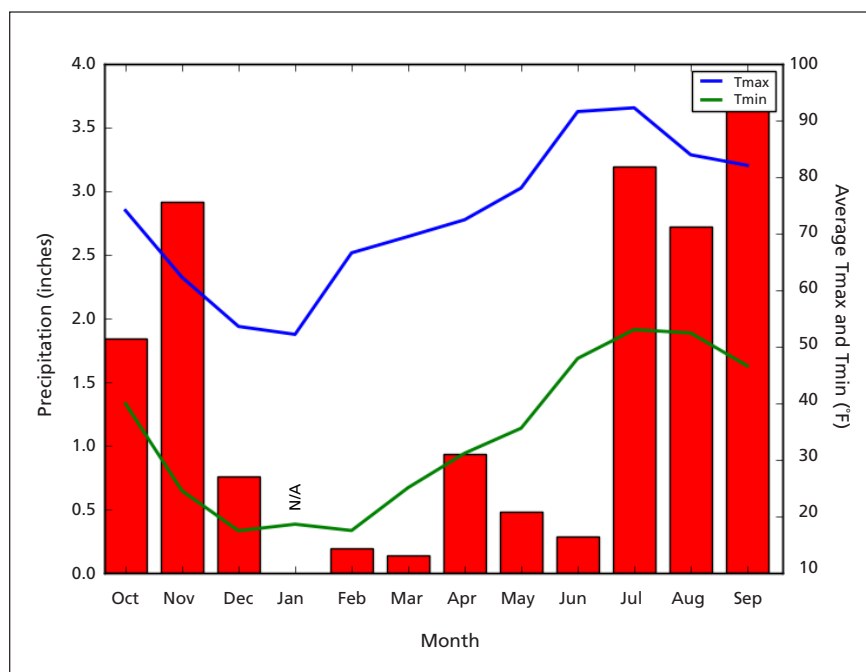
Figure 2-3. Climogram for water year 2016, Gila Cliff Dwellings National Monument. "n/a" = insufficient data to generate reliable precipitation totals. Graphics generated by climateanalyzer.org

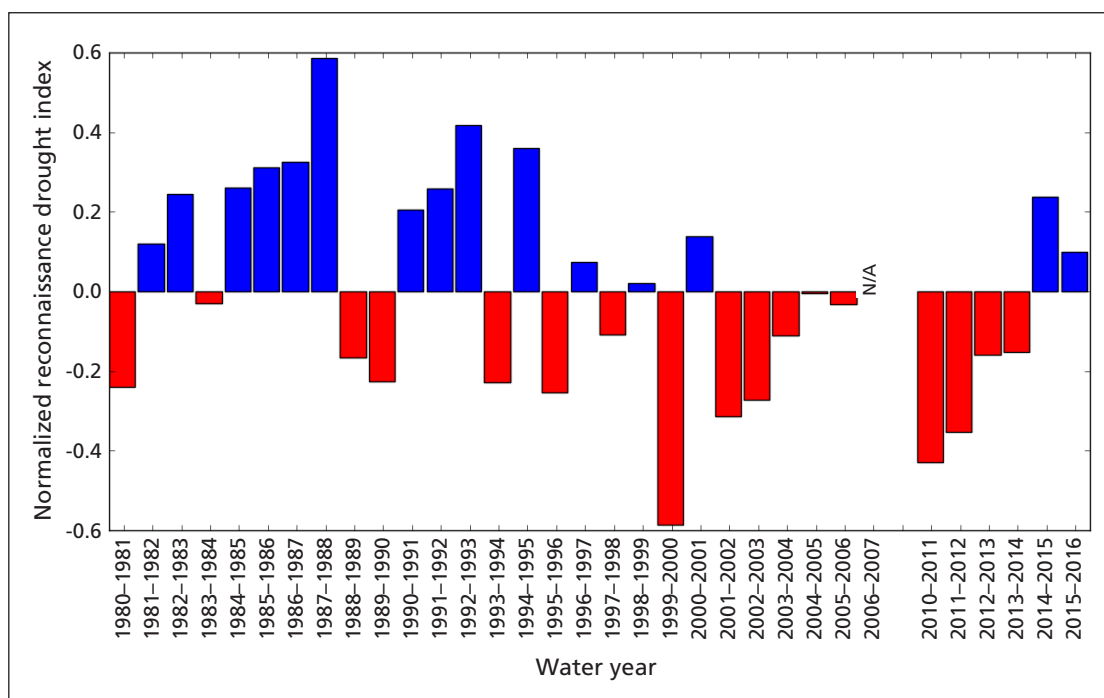
Figure 2-4. Reconnaissance drought index (RDI), Gila Cliff Dwellings National Monument, water years 1981–2016. “n/a” = insufficient data to generate reliable RDI estimates. The station was abandoned from 2007 to 2009. Graphics generated by climateanalyzer.org.

evapotranspiration over shorter periods of time (seasons to years). The reconnaissance drought index for Gila Cliff Dwellings NM reflects the extended regional drought since 2000 (Figure 2-4), although conditions at the park began recovering in WY2015 and continued in WY2016, from the perspective of both precipitation and evaporative demand. However, the five-year moving mean of total annual precipitation from 1981 to 2016 (Figure 2-5) suggests that the last two "wet" years have been insufficient to remedy the multi-year precipitation deficit.

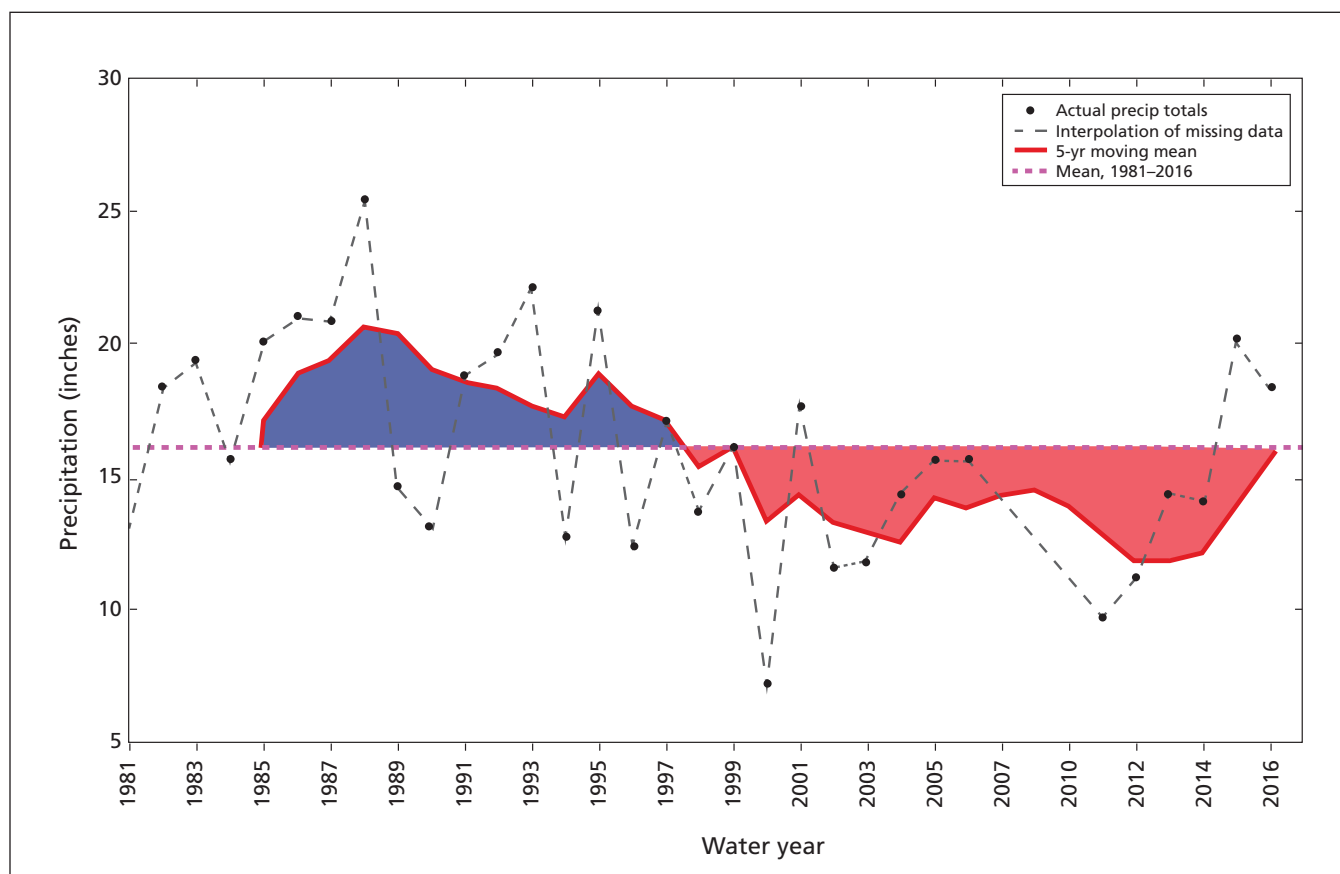
Figure 2-5. Five-year moving mean of annual precipitation, Gila Cliff Dwellings National Monument, 1981–2016. The moving mean (solid red line) is based on a timeseries with 11% (4 of 36) missing values, and includes the current year and previous four years. Blue and red fields represent water surplus and deficit. Missing years are linearly interpolated (dashed grey lines). The station was abandoned from WY2007–2010. Graphics generated by climateanalyzer.org.

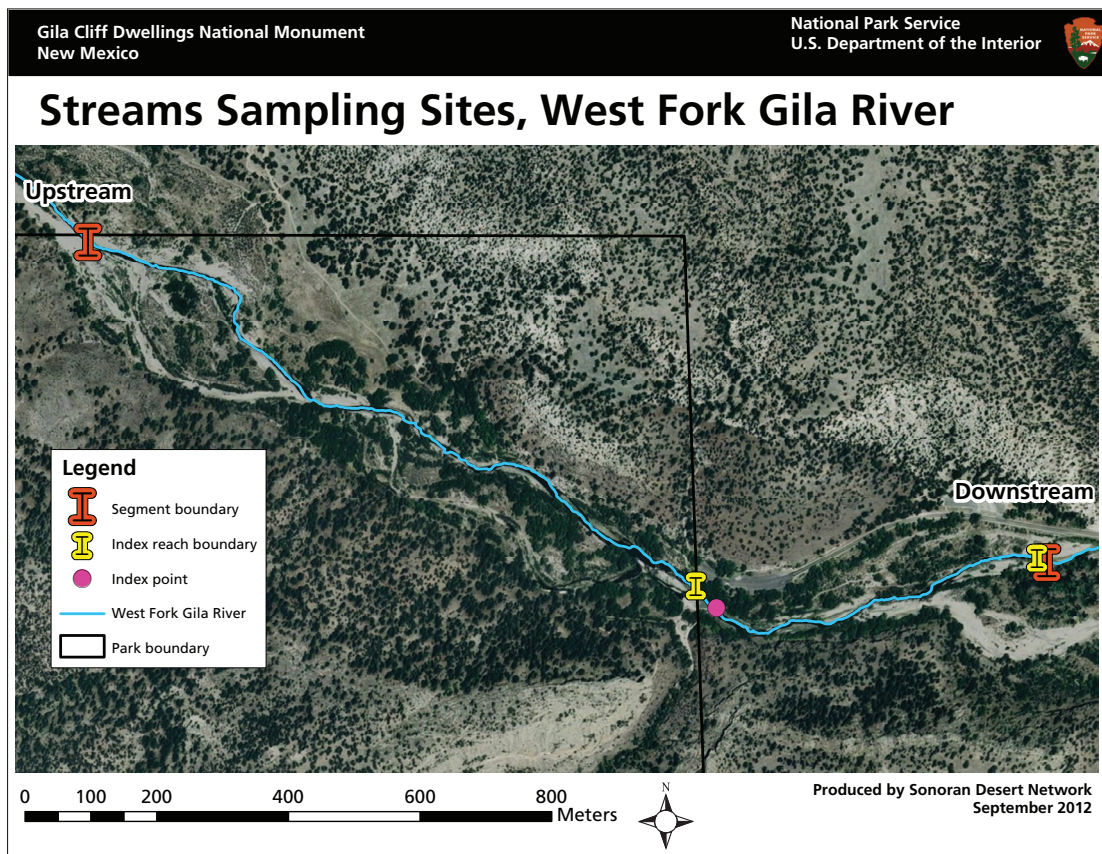
Figure 3-1. Index sampling location, Gila Cliff Dwellings National Monument.

In WY2016, Sonoran Desert Network (SODN) staff made four sampling visits to the West Fork Gila River at Gila Cliff Dwellings NM. Water quality monitoring occurred at the pedestrian bridge near the park's eastern boundary (Figure 3-1).

Sampling is conducted at the West Fork Gila River index site (for water quality, quantity, and discharge), and at the index reach (macroinvertebrates). The index site is located adjacent to the visitor contact station. The index reach is located downstream of the contact station (see Figure 3-1).

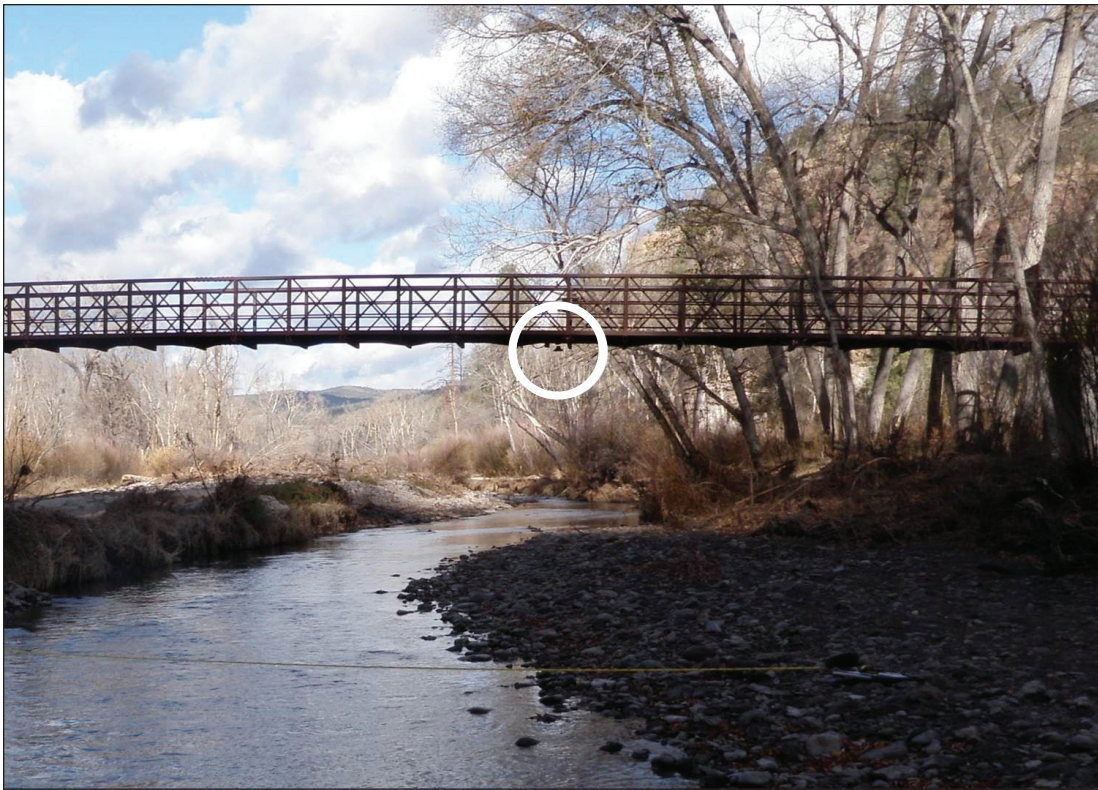
Figure 3-2. Location of the radar gauge at Gila Cliff Dwellings National Monument. The radar emitter (center of white circle) is not stationed over the center of the stream due to channel movement.

SODN uses a radar water-level telemetry system to measure water quantity at Gila Cliff Dwellings NM. A Waterlog radar gauge is mounted to the bottom of the footbridge across the West Fork Gila River (Figure 3-2). Every 15 minutes, the gauge sends a pulse of electromagnetic energy down toward the surface of the river and measures the reflected energy to determine the distance from the radar to the water surface (Sauer and Turnipseed 2010), thereby measuring the elevation of the water. This instrument is attached to a Waterlog data recorder and a Sutron telemetry system using the National Weather Service GOES satellite system. This allows for remote real-time access and logging of water-level data (Sauer and Turnipseed 2010).

The USGS and SODN have partnered to operate a stream gauge at the West Fork Gila River index site (USGS 09430010). This gauge functioned only intermittently during WY2016. The active river channel under the footbridge moved closer to the left bank over the last year (see Figure 3-2). SODN staff repeatedly moved the radar emitter to accommodate this movement, but measurements still fell outside the QA/QC (quality assurance/quality control) proscription for the data. Technical issues with the radar emitter also resulted in missing data. We could not derive information from the existing dataset to generate an adequate stream stage-to-discharge relationship (Rantz et al. 1982). This gauge came back online in November 2016 and will provide data for WY2017 onward.

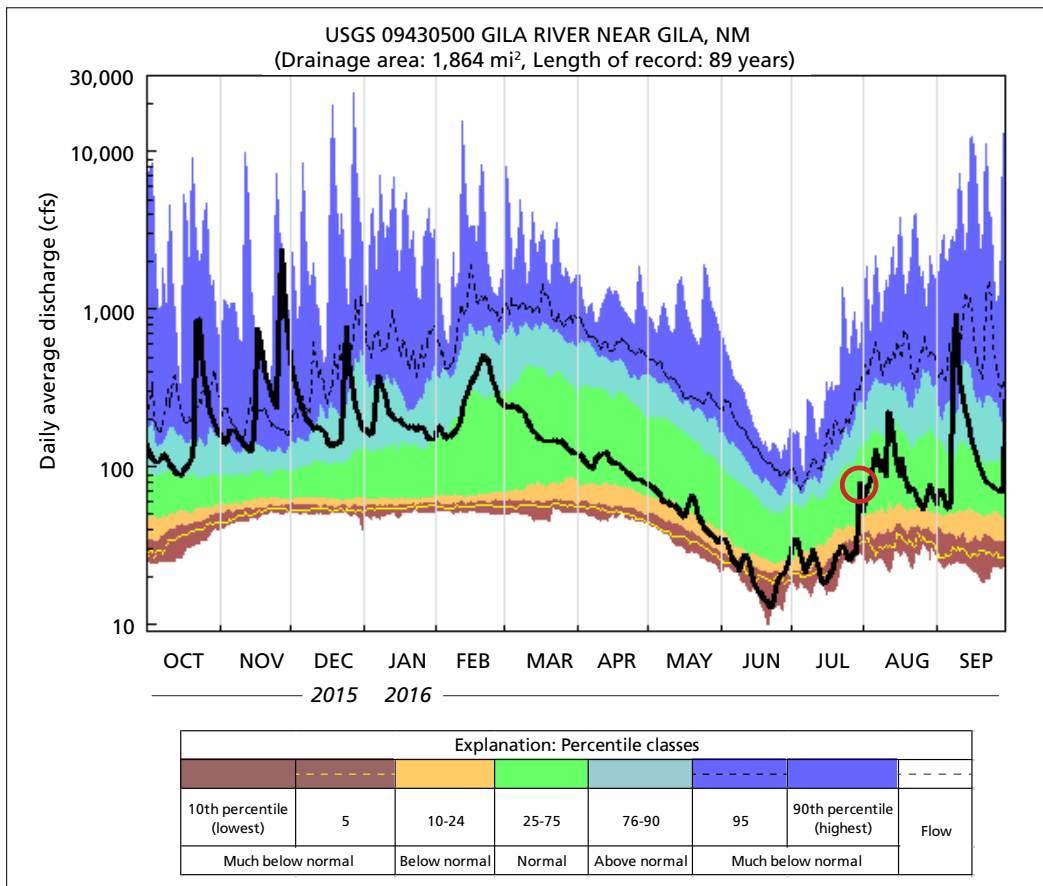
Figure 3-3. Hydrograph for Gila River near Gila, New Mexico, water year 2016. The solid black line represents mean daily discharge. The various colors represent the range of data, coded by percentile range. The red circle indicates the flow event discussed. This figure can be downloaded at [http://waterdata.usgs.gov/nwis/inventory?agency\\_code=USGS&site\\_no=09430500](http://waterdata.usgs.gov/nwis/inventory?agency_code=USGS&site_no=09430500).

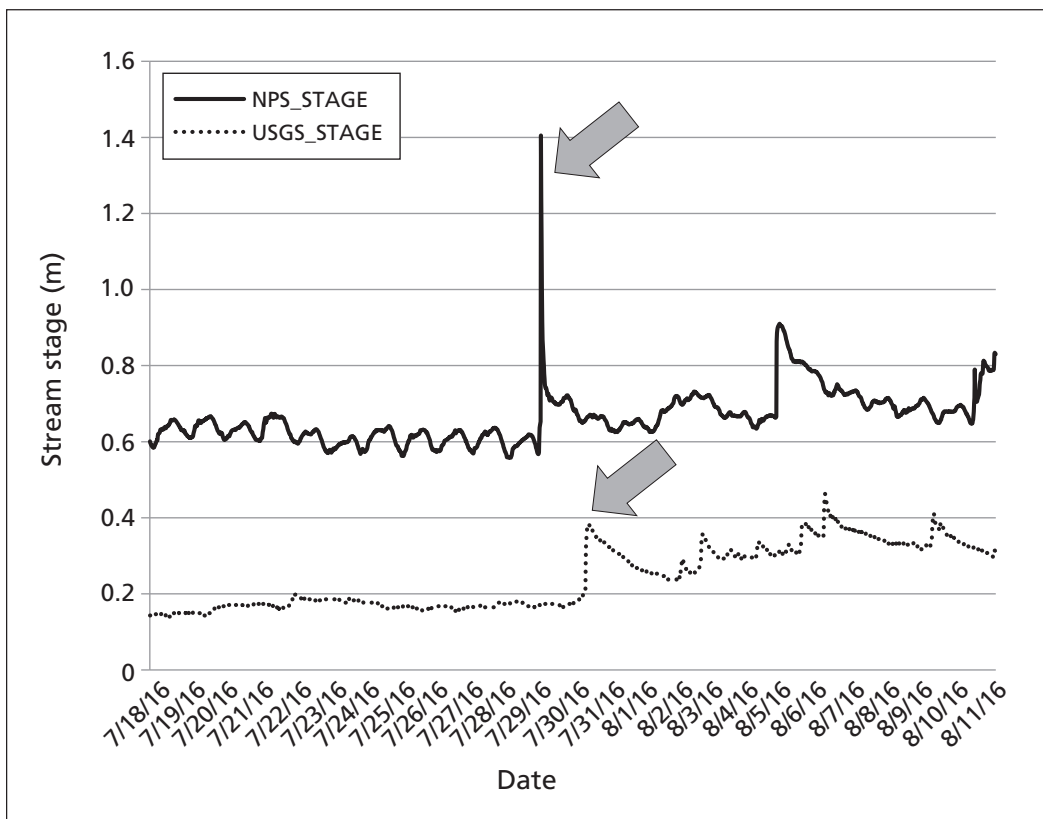
Figure 3-4. Stream stage, West Fork Gila River (black line, NPS sonde) and Gila River (dotted line, USGS gauge), July 18–August 11, 2016. The arrows identify the pulses of water discussed in this section.

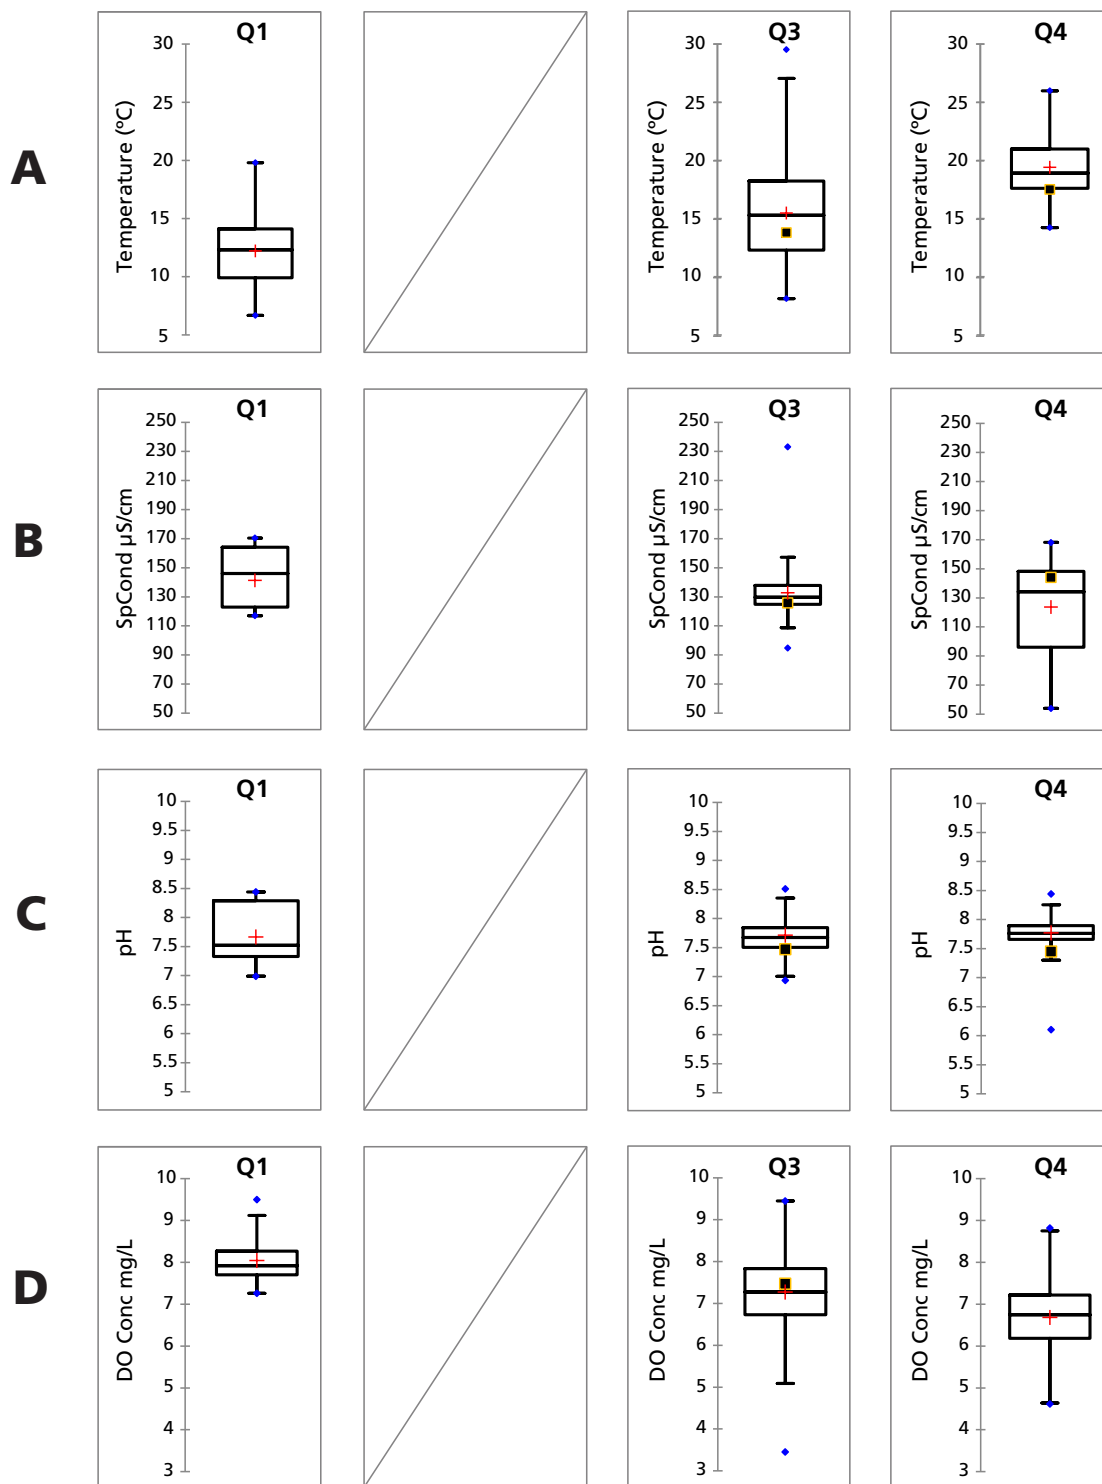
Figure 3-5. Data on (A) water temperature, (B) specific conductivity, (C) pH, and (D) dissolved oxygen concentration from the West Fork Gila River index site, Gila Cliff Dwellings National Monument, WY2011–2016. Dark squares indicate median values for WY2016. Blue dots indicate maximum and minimum, whiskers indicate limits, and the box indicates the bounds of the first and third quartiles. The line in the box indicates the median, while the red cross is the mean. (Note that dark squares are absent for all Q1 values and for DO in Q4. Because the dissolved oxygen probe malfunctioned during the Q4 deployment, these data were not available or did not meet QAI/QC standards. No data are available for Q2.)

mately two weeks during quarters 3 and 4 to collect measurements of temperature, pH, specific conductivity, and dissolved oxygen data at 15-minute intervals. Over 5,600 measurements were collected (3,324 during Q3, May 5–June 9, and 2,277 in Q4, July 18–August 10). The sonde was not deployed during the first two quarters of WY2016 due to a change in streamflow that isolated the sonde mount from the active stream channel, and concern over possible damage to the sonde by ice.

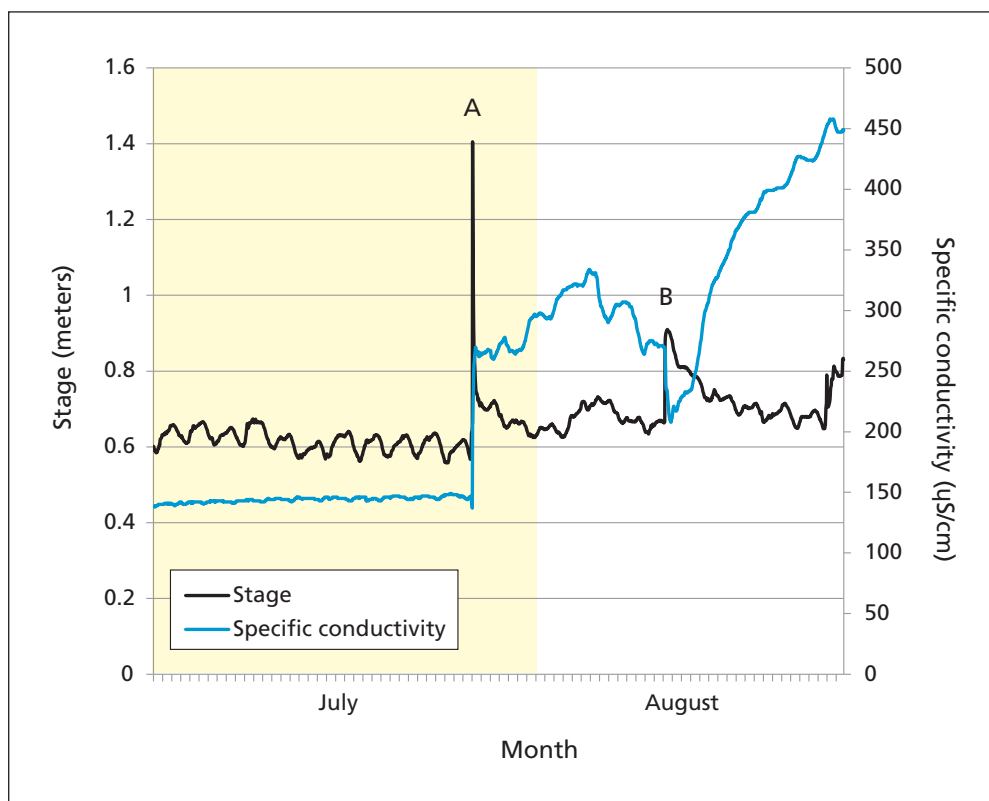
Figure 3-6. Stream stage and specific conductivity during sonde deployment, West Fork Gila River, Gila Cliff Dwellings National Monument, fourth quarter, water year 2016. Flow event A occurred on July 29. Flow event B occurred on August 4.

In Figure 3-6, flow event A increased specific conductivity from approximately 125  $\mu\text{S}/\text{cm}$  to above 300  $\mu\text{S}/\text{cm}$ . Flow event B showed an

initial decrease in specific conductivity (SC), from 275  $\mu\text{S}/\text{cm}$  to 200  $\mu\text{S}/\text{cm}$ , possibly associated with water not originating from a sediment-rich source (e.g., areas with extensive exposed bedrock or vegetation that prevents easy entrainment of sediment). The flow following the initial pulse of water was likely high in sediment and salts, as demonstrated by the increase in specific conductivity—to a value above 450  $\mu\text{S}/\text{cm}$ .

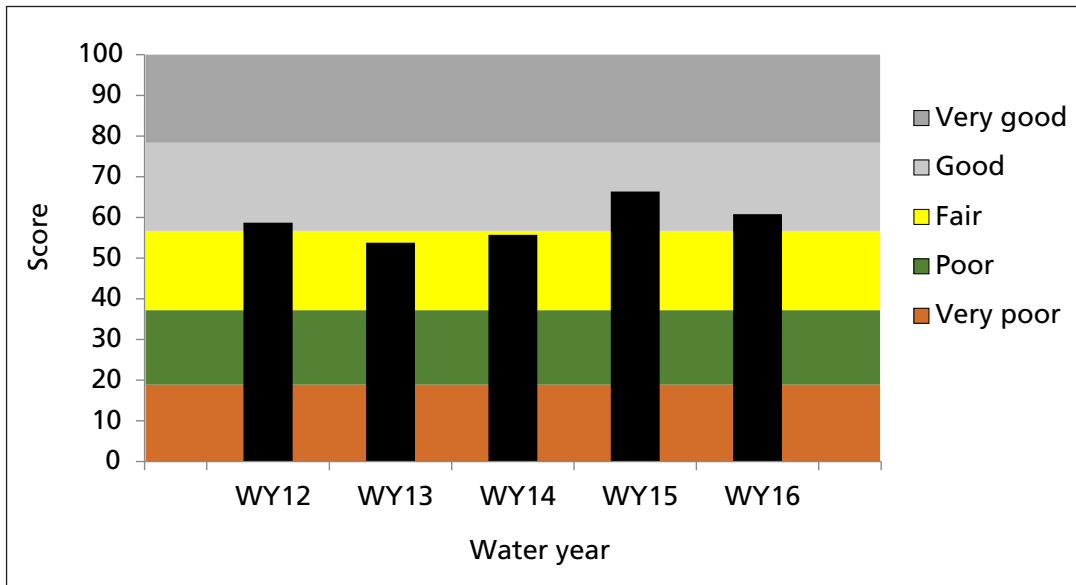
Figure 3-7. New Mexico Stream Condition Indices for Gila Cliff Dwellings National Monument, calculated from derived macroinvertebrate metrics, water years 2012–2016.

The State of New Mexico uses the New Mexico Stream Condition Indices (NMSCI; Jacobi et. al 2006) to meet EPA mandates. In WY2016, the indices were measured at 60.78 (Figure 3-7). This placed Gila Cliff Dwellings NM in the “Good” category, falling in the top 25% of index sites in the “high-elevation small watershed” category.
