## NATIONAL REGISTER OF HISTORIC PLACES REGISTRATION FORM

historic name JOHNSON LAKE MINE HISTORIC DISTRICT

other names/site number 26WP2019

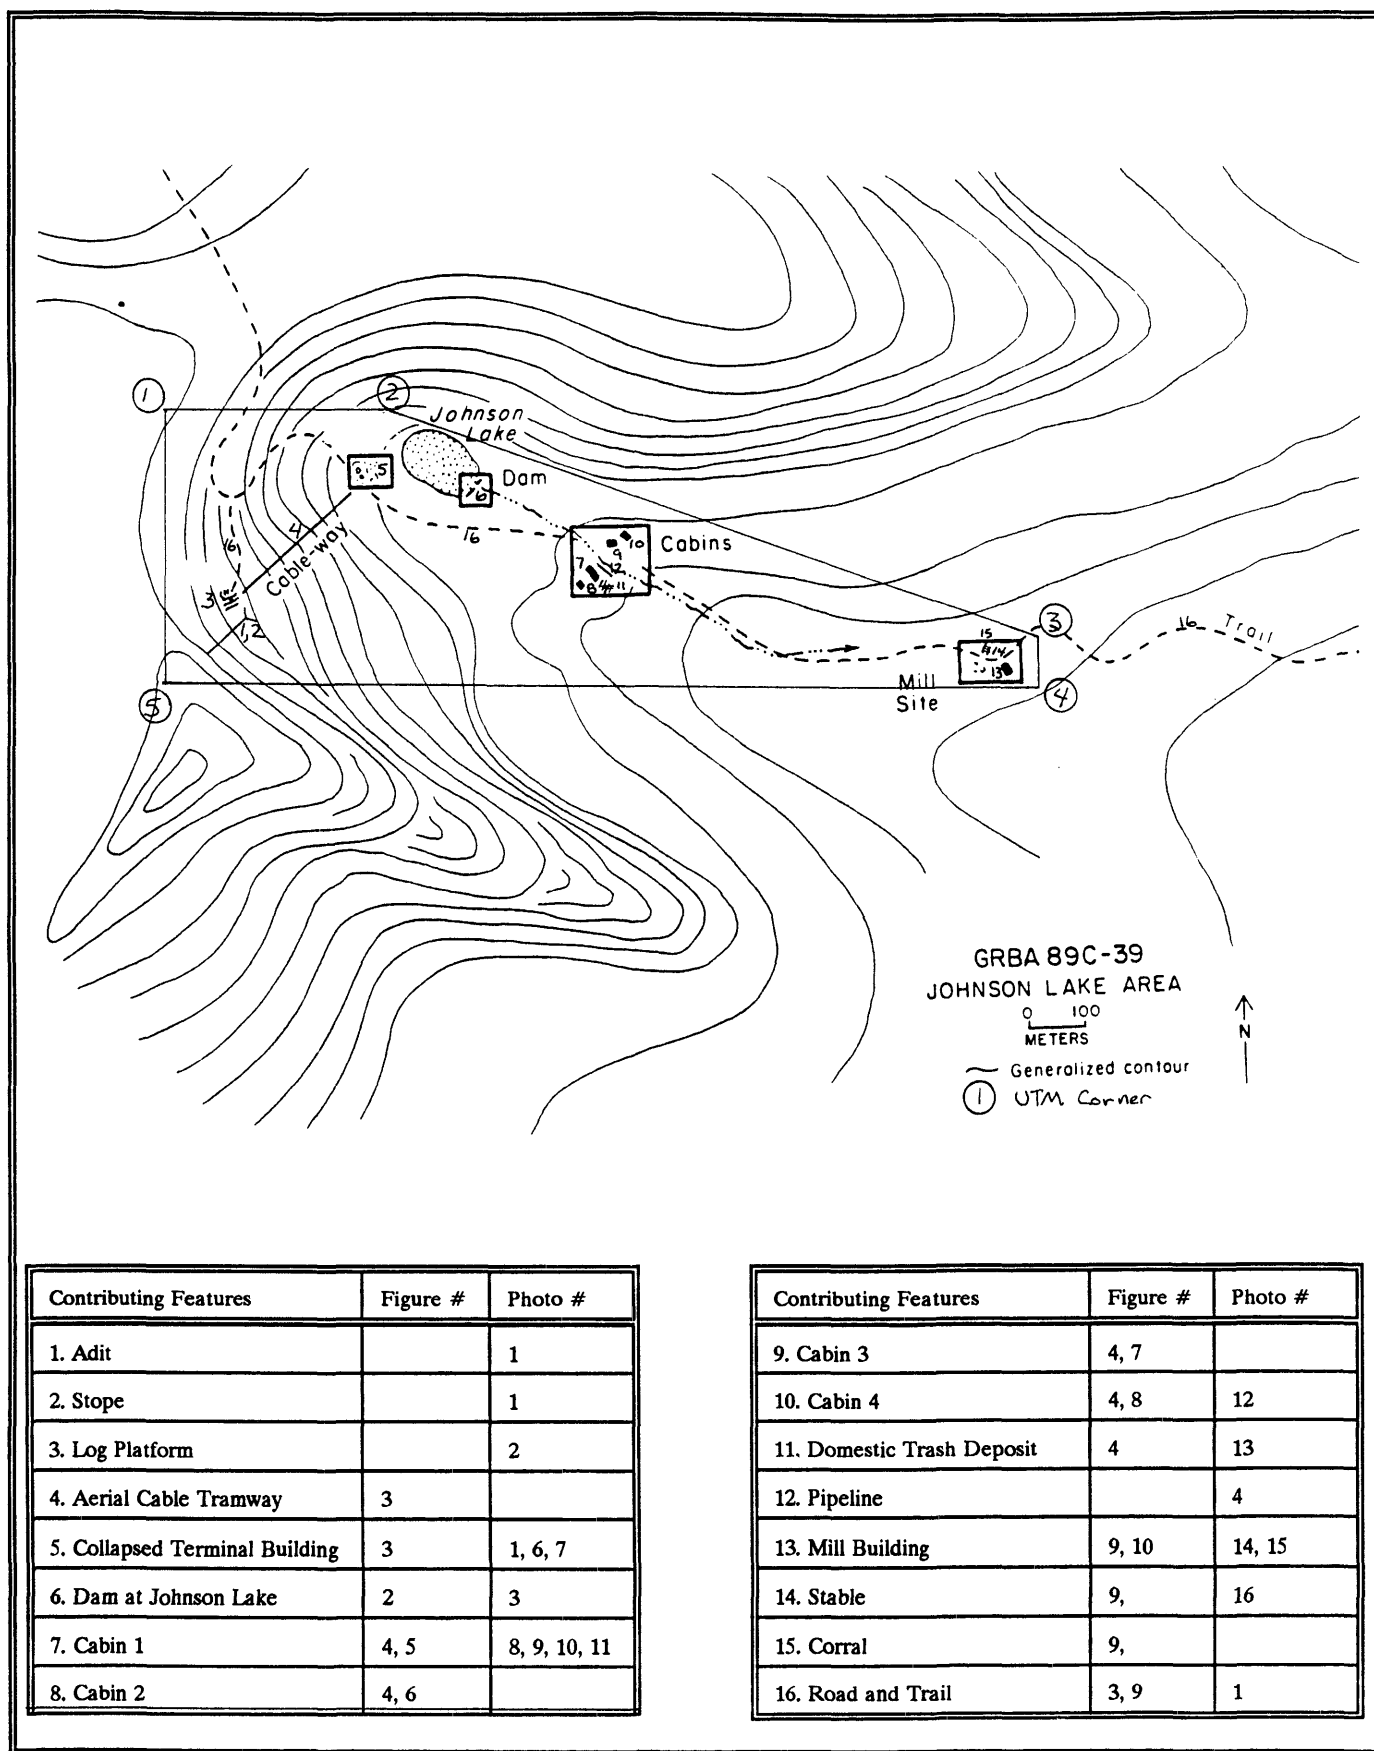
Figure 1. Plan map of Johnson Lake Mine Historic District. Contributing features are numbered. See table for key.

The elevations of and distances between the features of the Johnson Lake Mine Historic District are summarized in the table below. See Figure 1 for a plan map and Photo 1 for an overview of the setting of the mine and collapsed tramway building. The distances are discussed below under "linear systems".

The source of the tungsten ore is, of course, the most important natural feature of the mine site. Tungsten ore occurs as scheelite or hubernite in quartz veins. The mine adit follows a quartz vein located on the steep mountain ridge southwest of the lake. (See Figure 1 and Photos 1 and 2.)

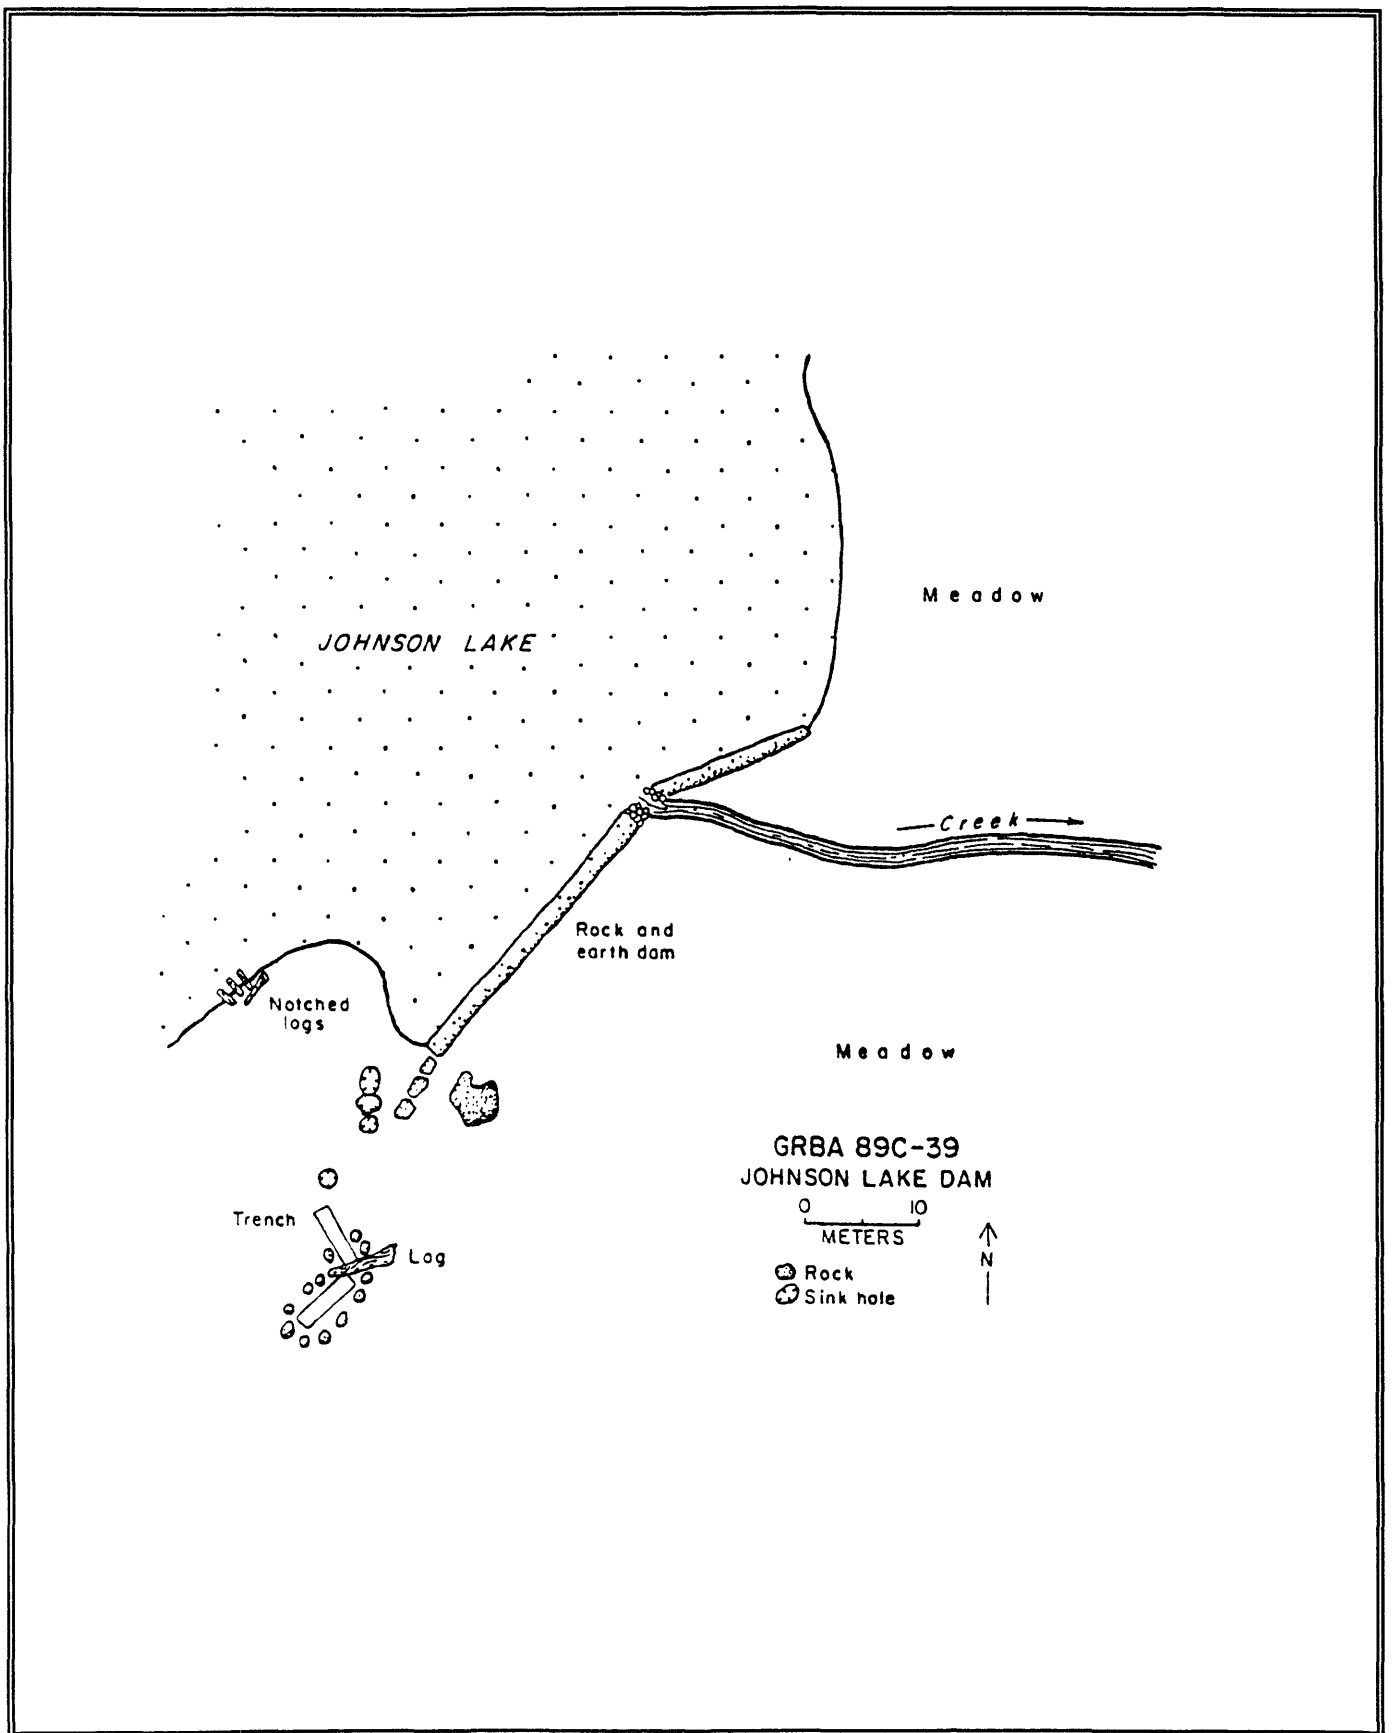
Figure 2. Plan map of dam at Johnson Lake

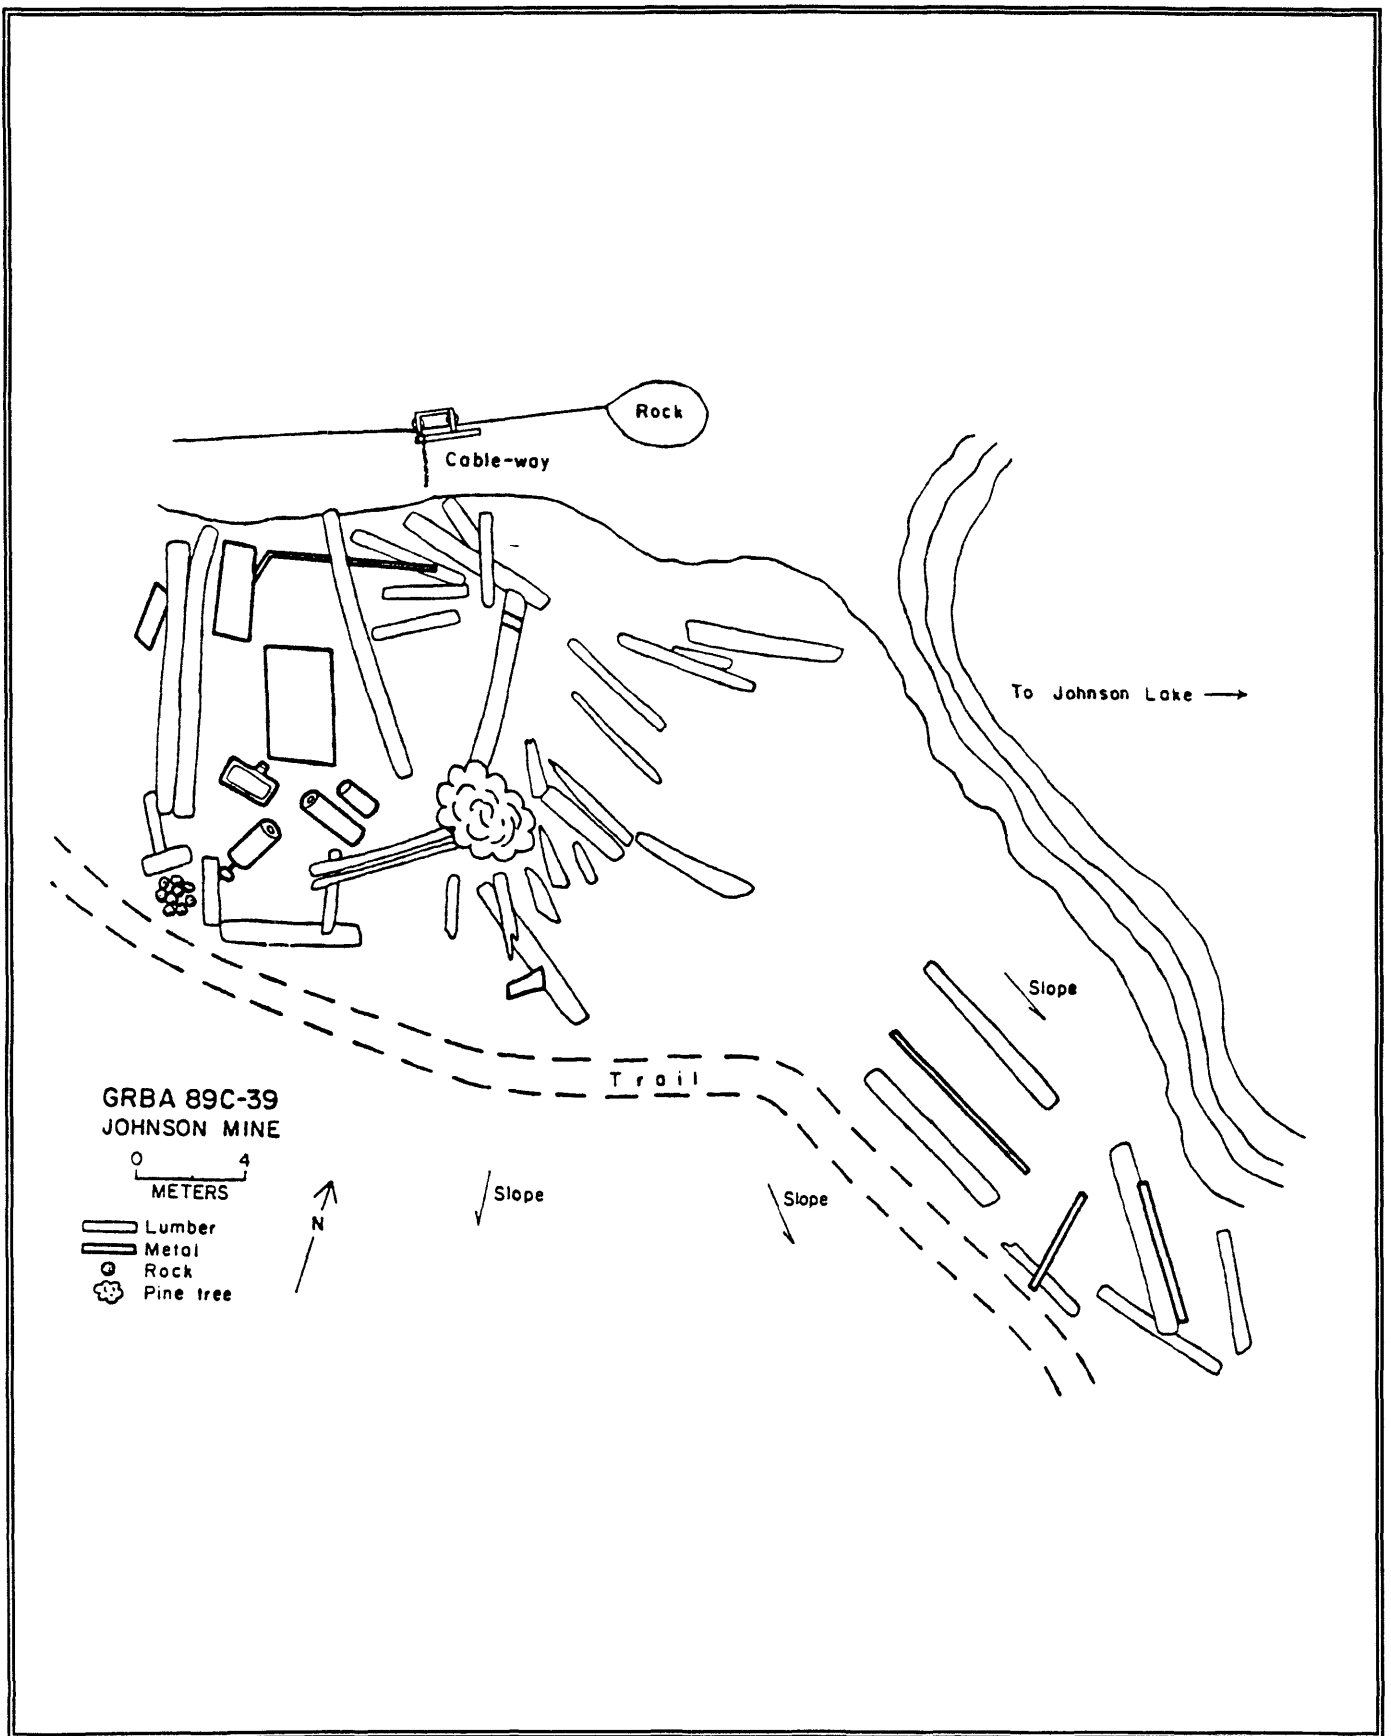
Figure 3. Plan map of the collapsed tramway terminal.

**Tramway Terminal:** The building at the lower end of the cable-way has collapsed. Building materials and machinery associated with this building are strewn all along the east-facing slope between the tramway terminus and Johnson Lake. Figure 3 is a plan map of the remains of the collapsed building. See Photos 6 & 7. There are at least 50 large logs as well as lumber, machine parts, buckets, cans and corrugated steel sheets. A "Beaver" brand flathead motor, boiler parts, pipe, rusted cable of the same gauge used for the tramway and planks of wood with nails also were noted.

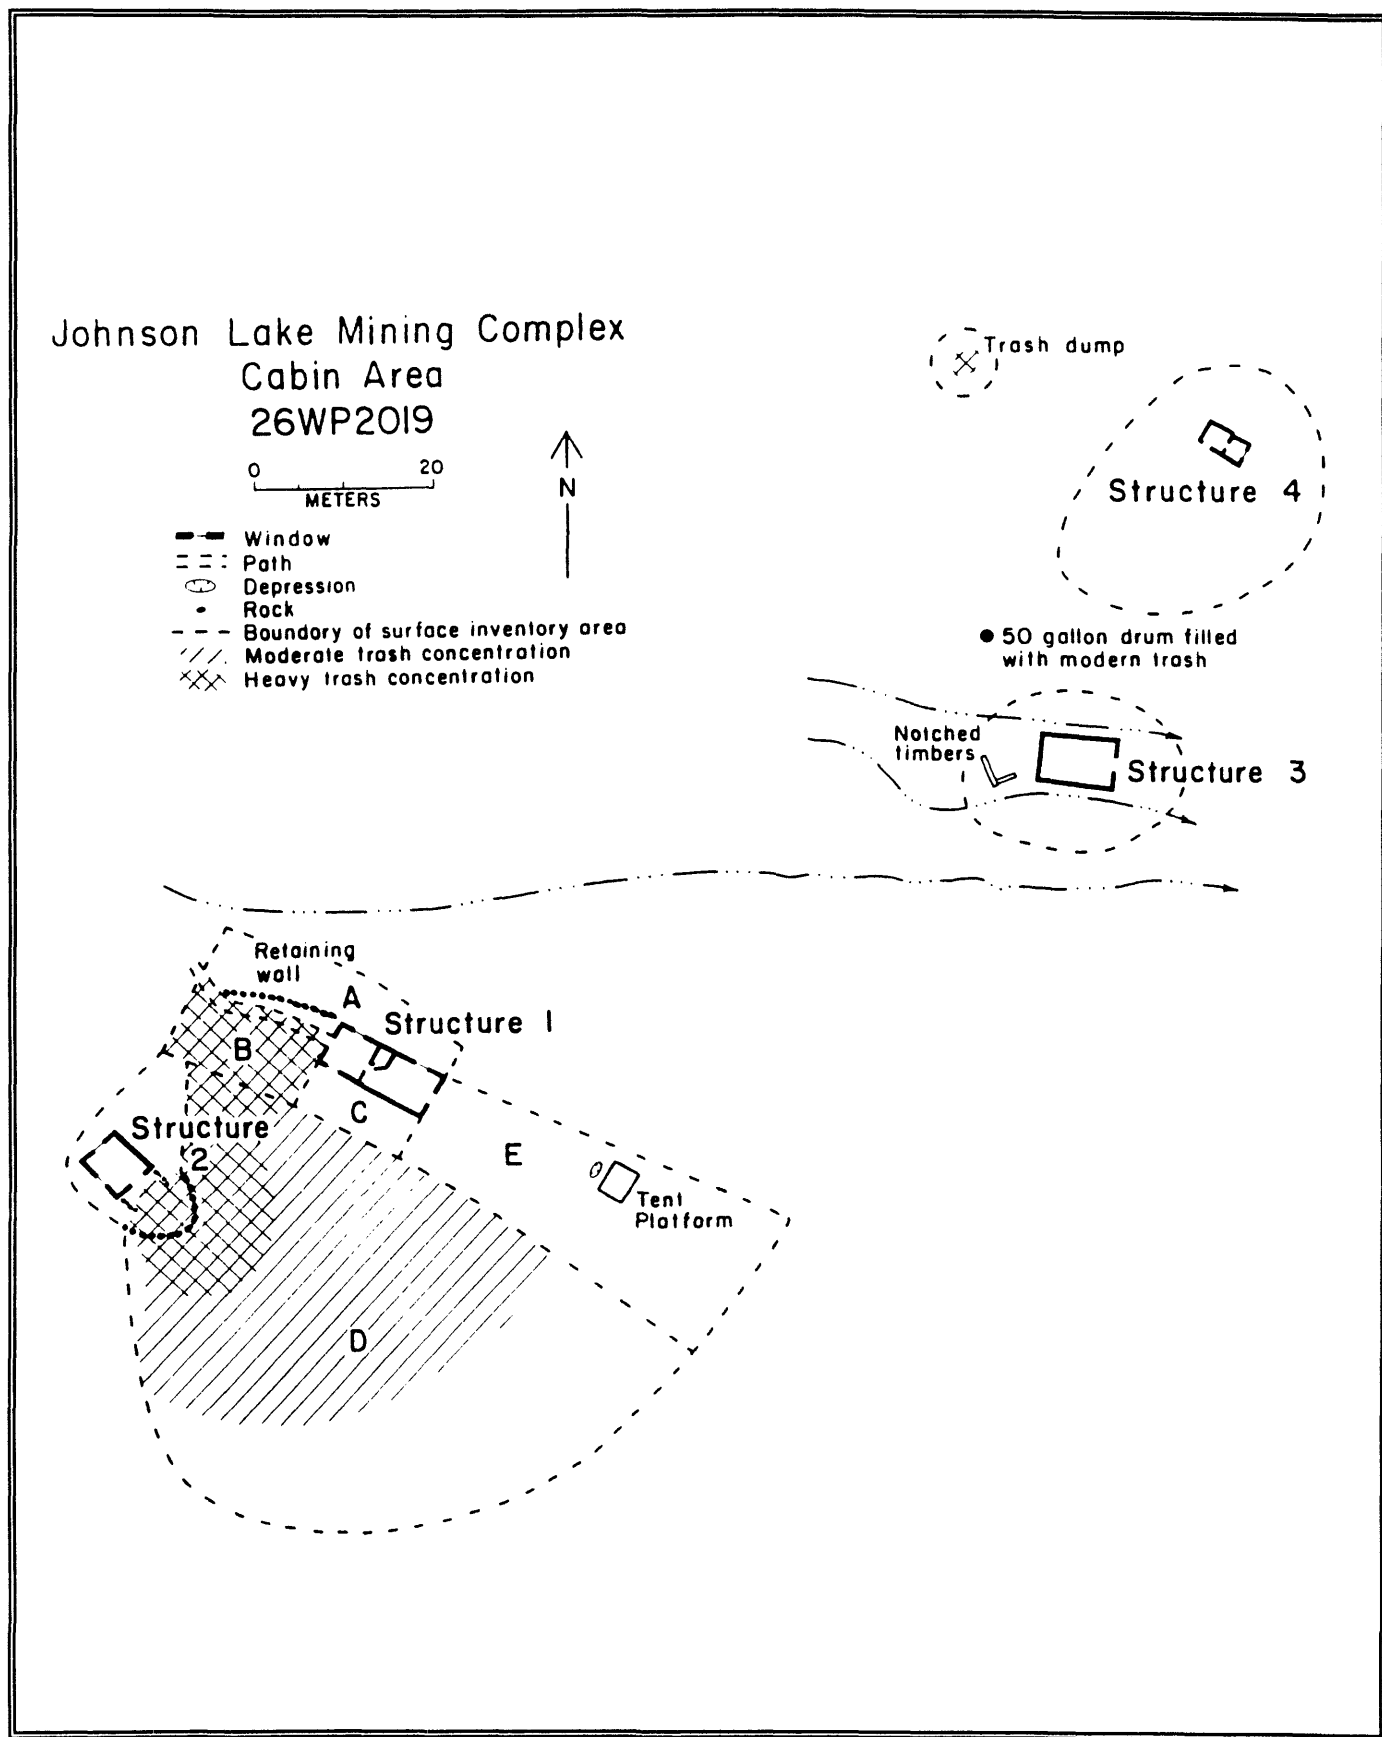
Figure 4. Plan map of the residential area at Johnson Lake Mine Historic District.

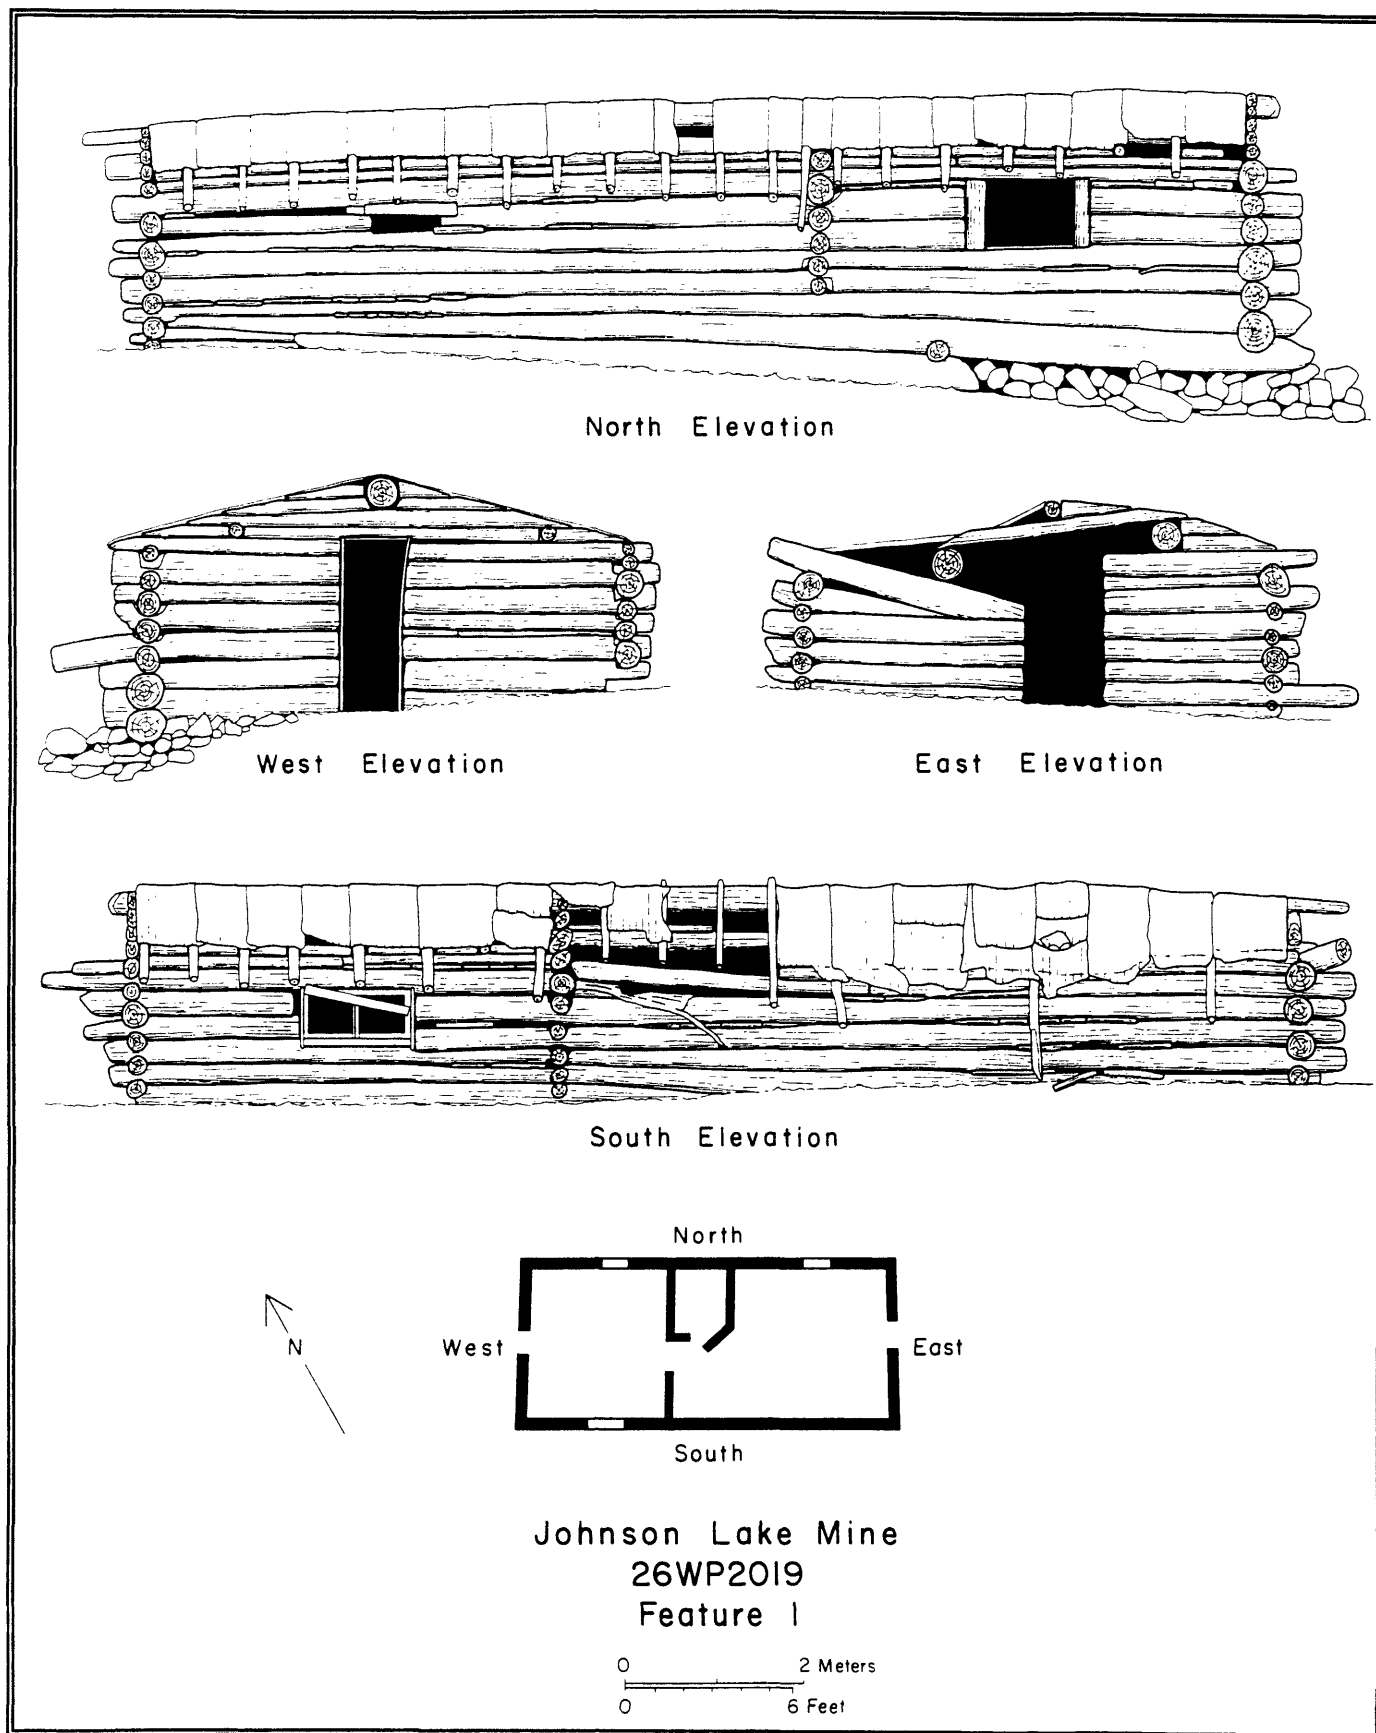
Figure 5. Elevation drawings of Cabin 1.

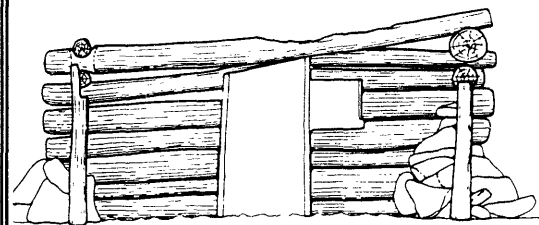
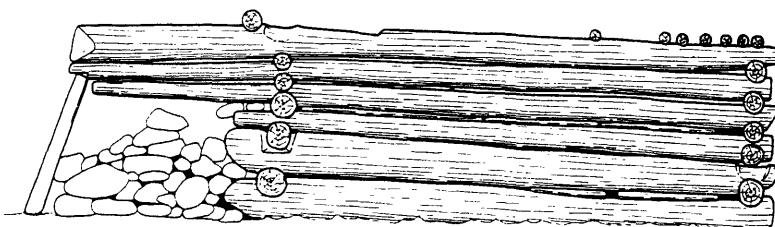
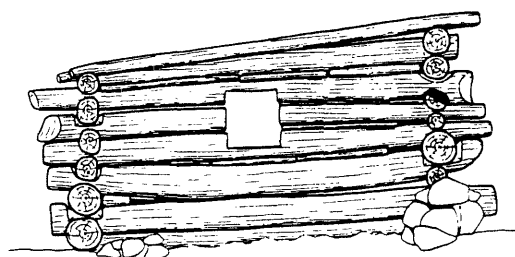
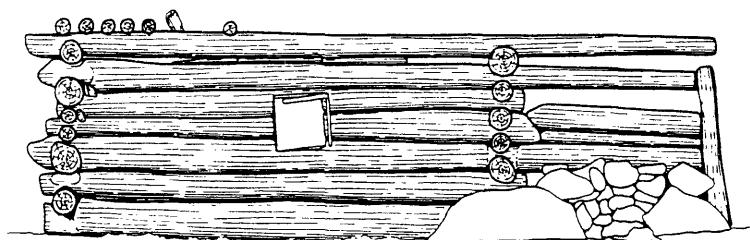
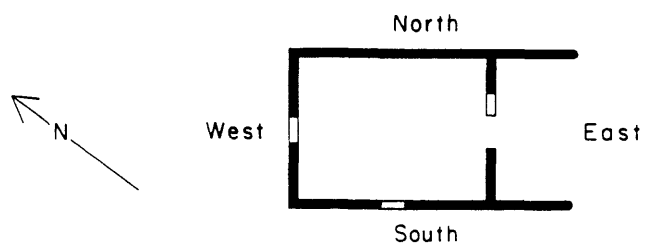
Johnson Lake Mine  
26WP2019  
Feature 2

Figure 6. Elevation drawings of Cabin 2.

**Cabin 2:** Located 20 m southwest of Cabin 1, Cabin 2 measures 5 m by 8 m with walls 1.7 to 1.9 m high; it has no roof. See Figure 6. The building is an almost square room built of logs with a second, attached room or porch on the southeast side with a stone foundation several courses high and topped with logs. Windows are present in three walls. A small retaining wall forms a flat area southeast of the cabin.

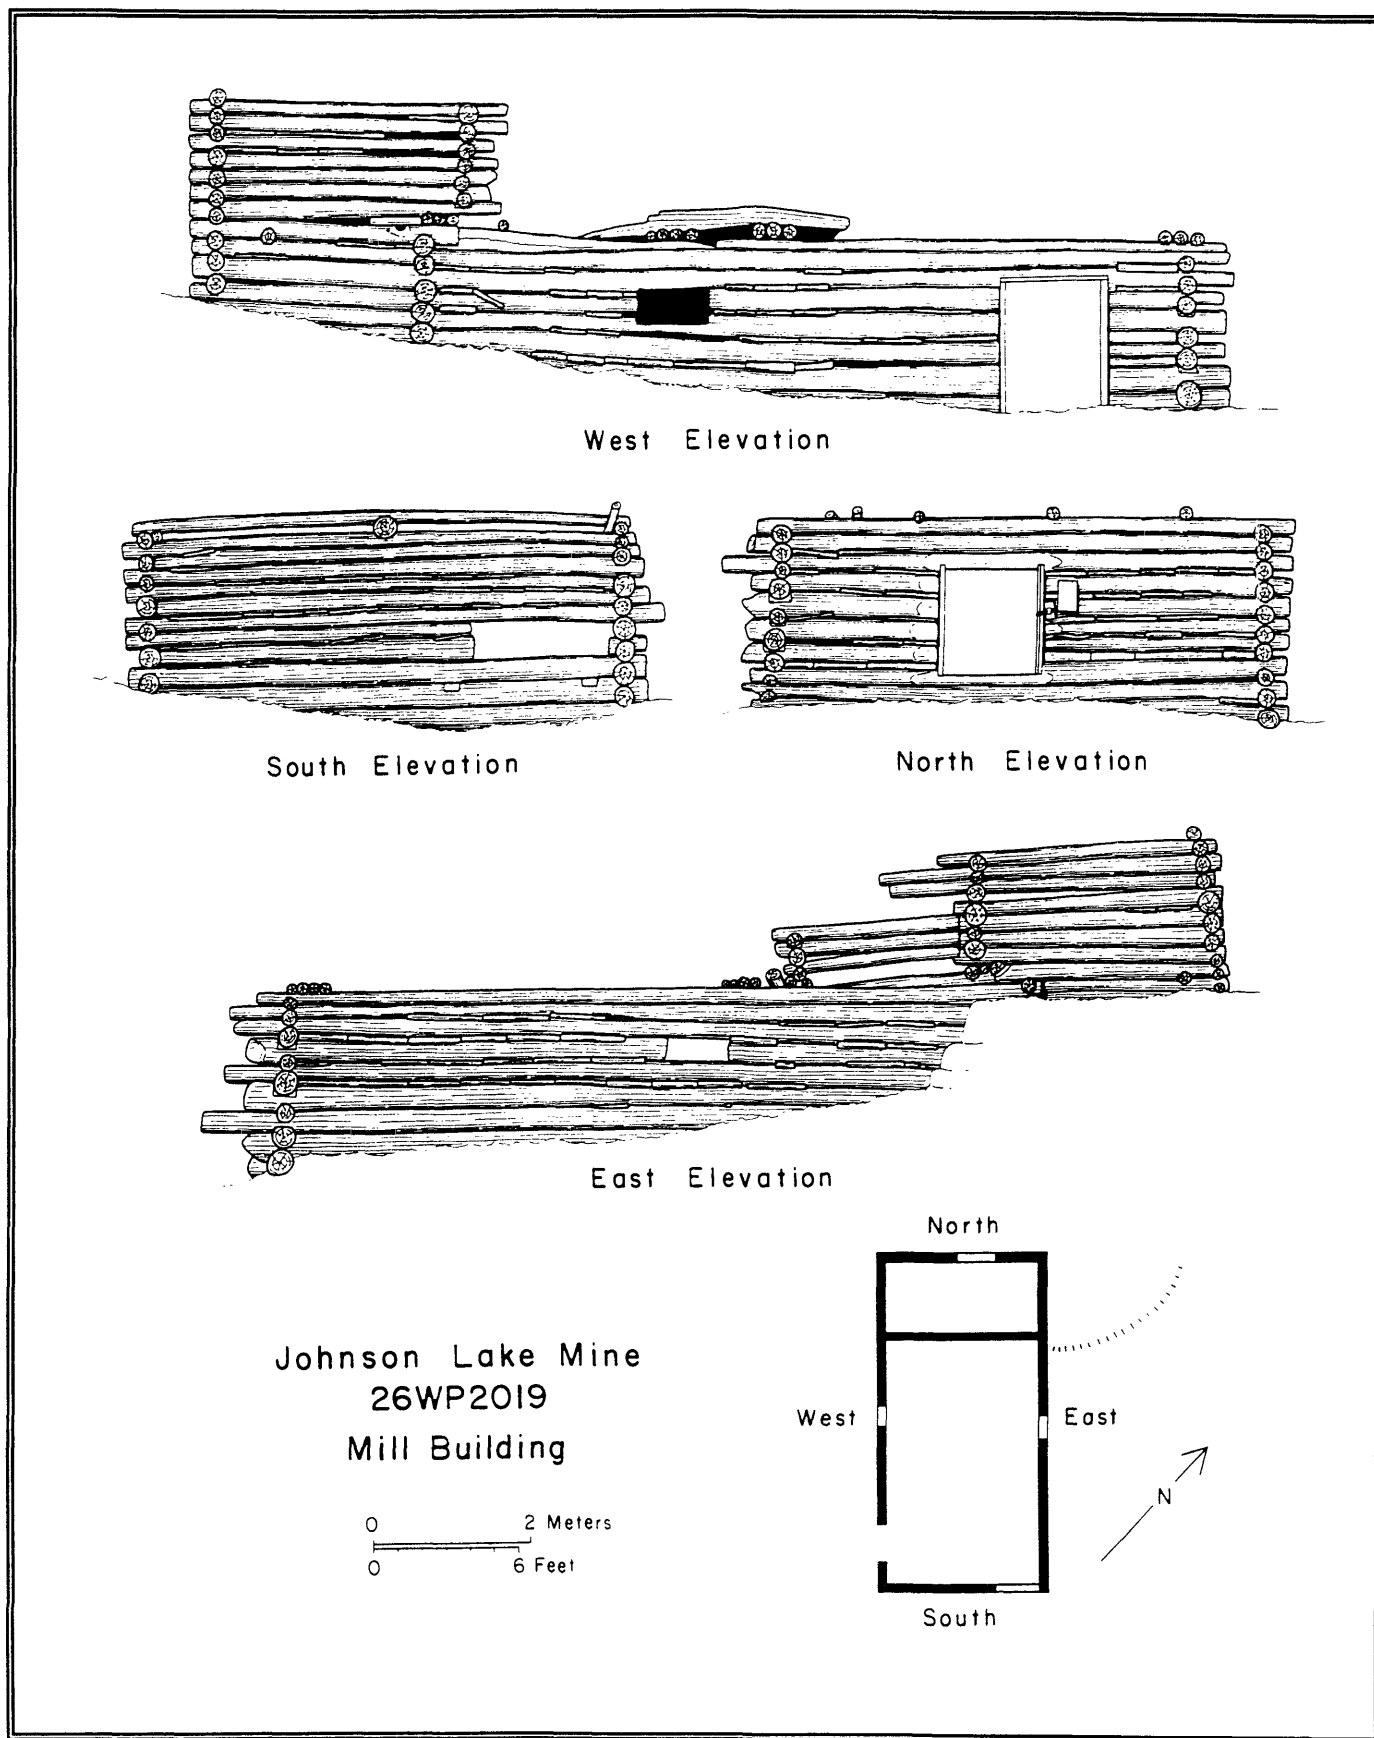
Figure 10. Elevation drawings of mill building.

The ore probably entered at the front of the building, was processed on one or both levels and then probably passed out through a hole at the lower level at the rear of the mill. The flattened area outside the rear of the mill is built up with rocks on the east side. The sandy material on the platform behind the mill may be the remains of tailings. The mill building is hazardous but could be stabilized.

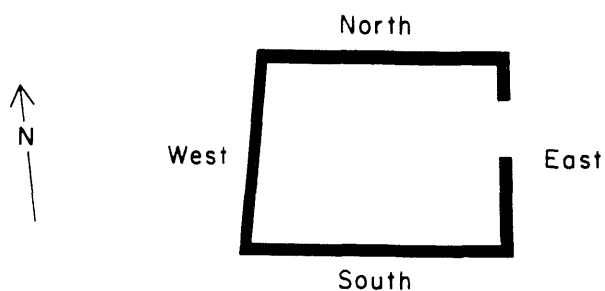
Johnson Lake Mine  
26WP2019  
Feature 3

Figure 7. Elevation drawings of Cabin 3.

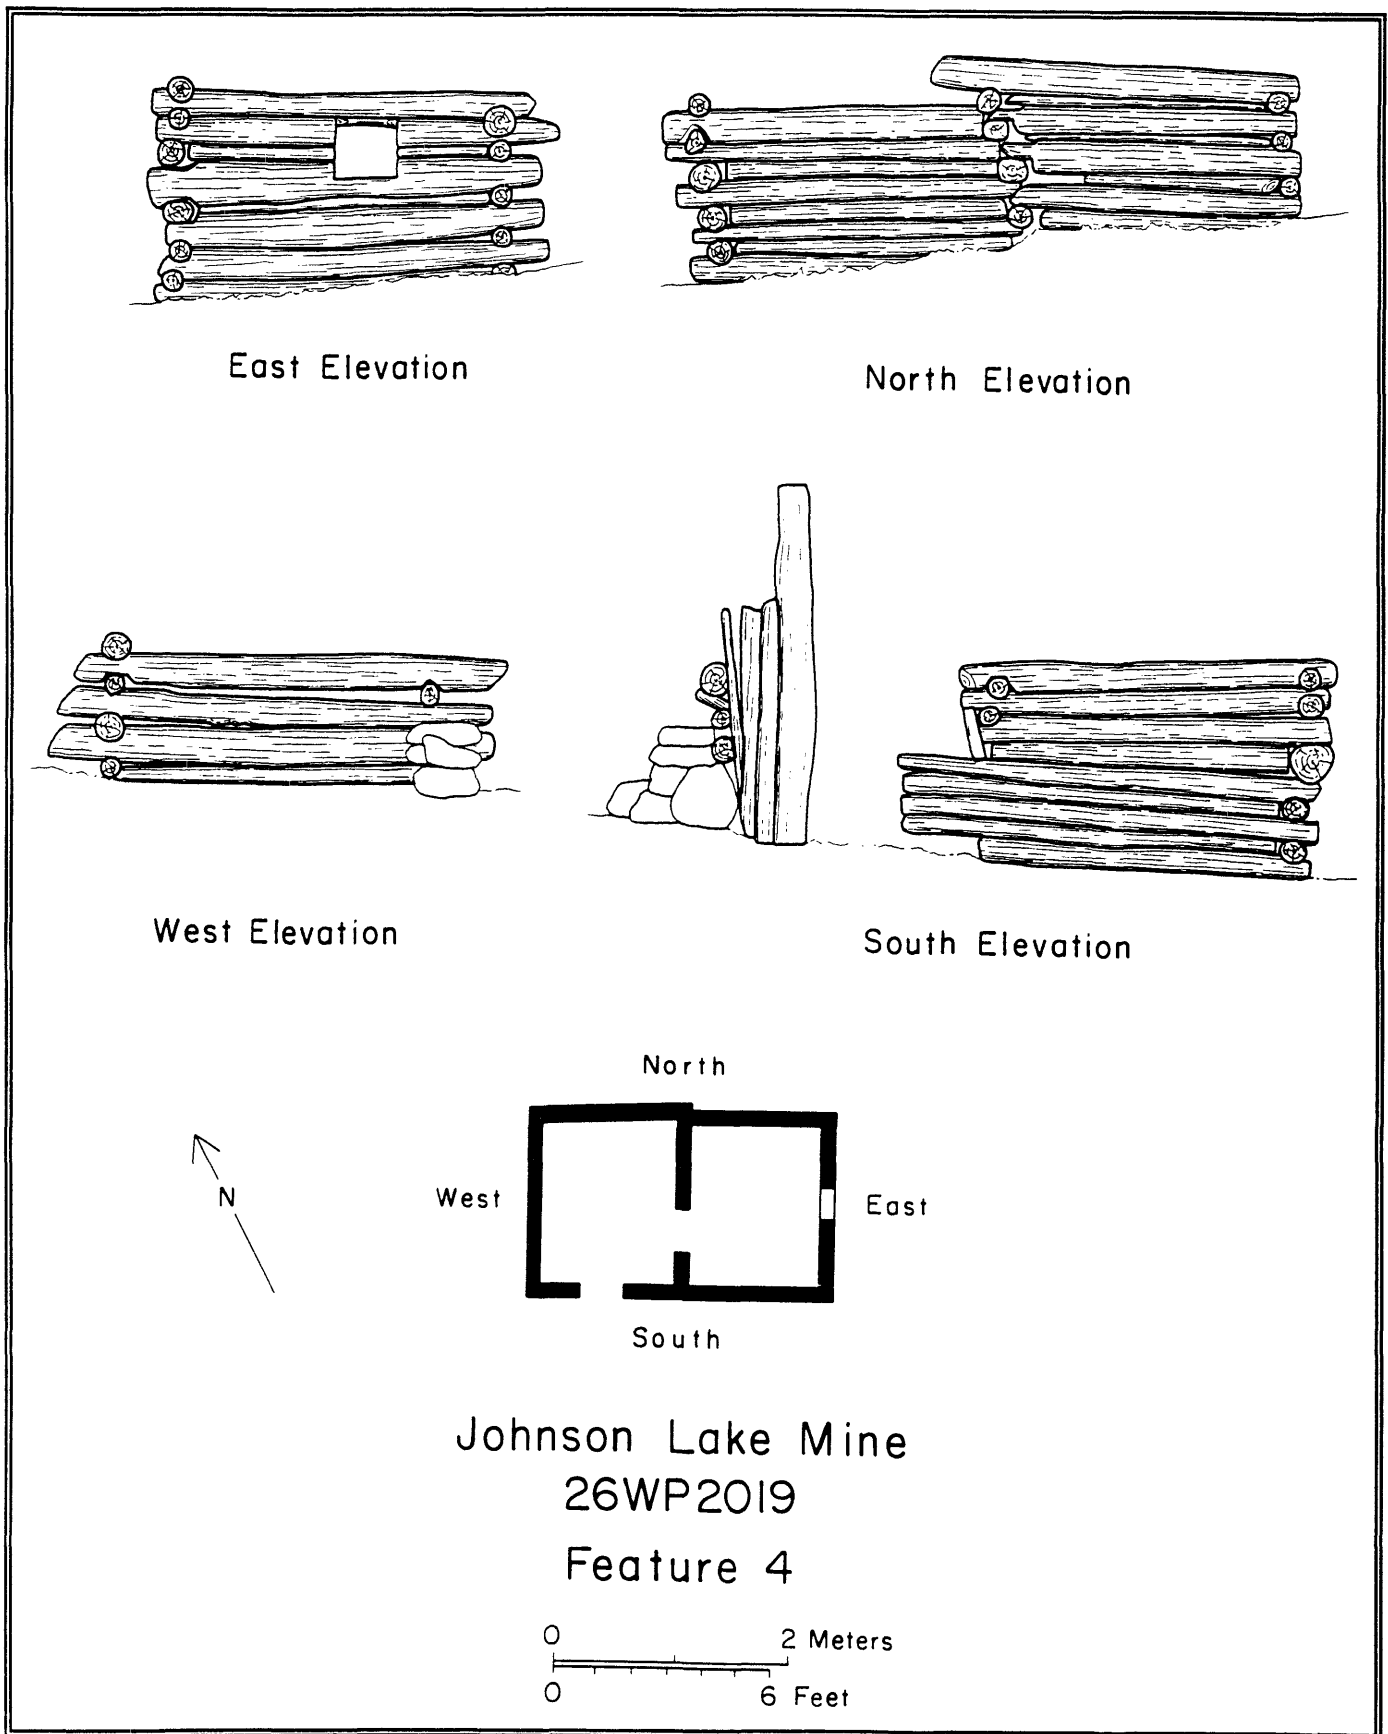
Figure 8. Elevation drawings of Cabin 4.

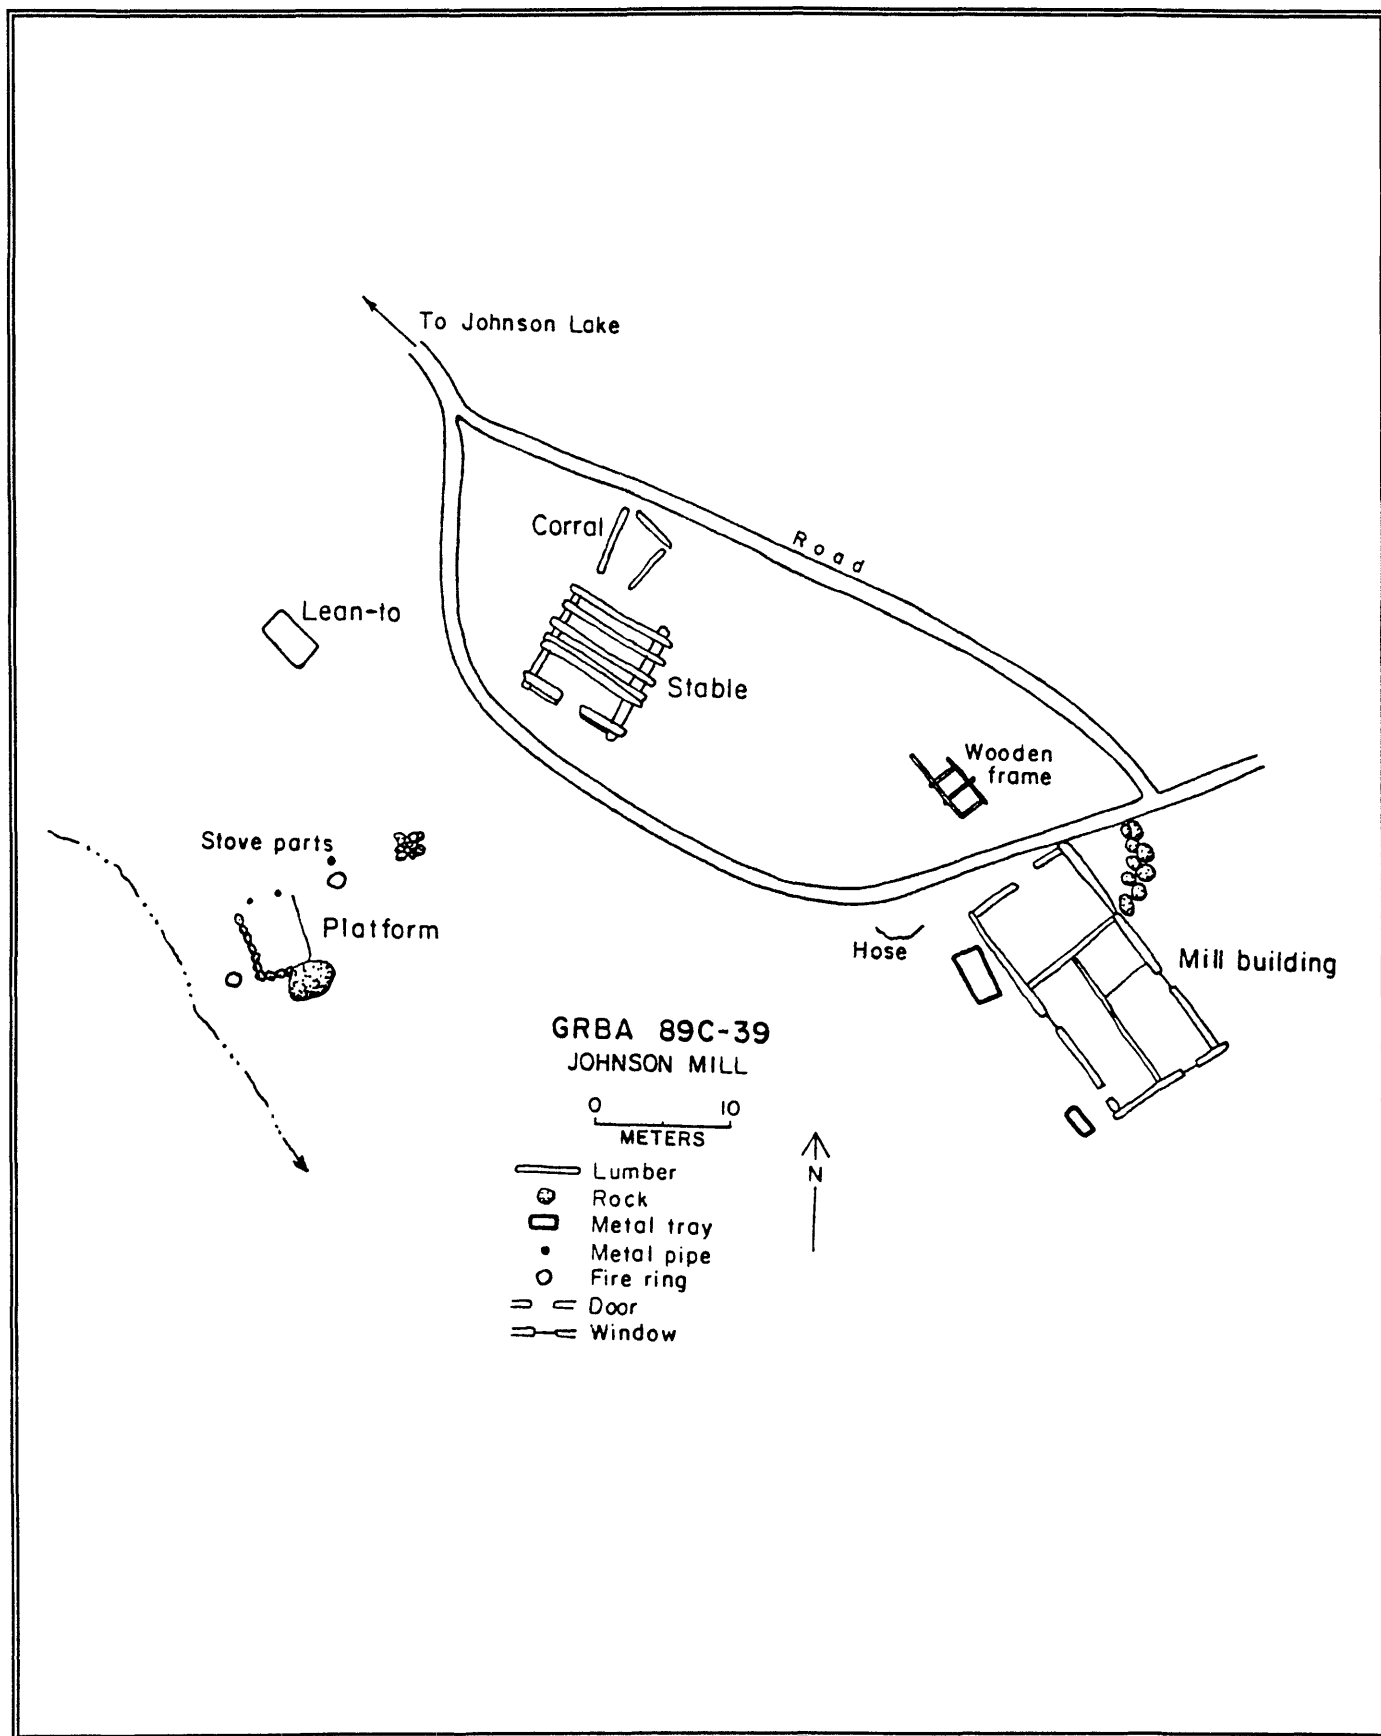
Figure 9. Plan map of mill area at Johnson Lake Mine Historic District.
