National Park Service  
Cultural Landscapes Inventory

Revised: 9/2021

Bright Angel Peninsula Historic District  
Grand Canyon National Park

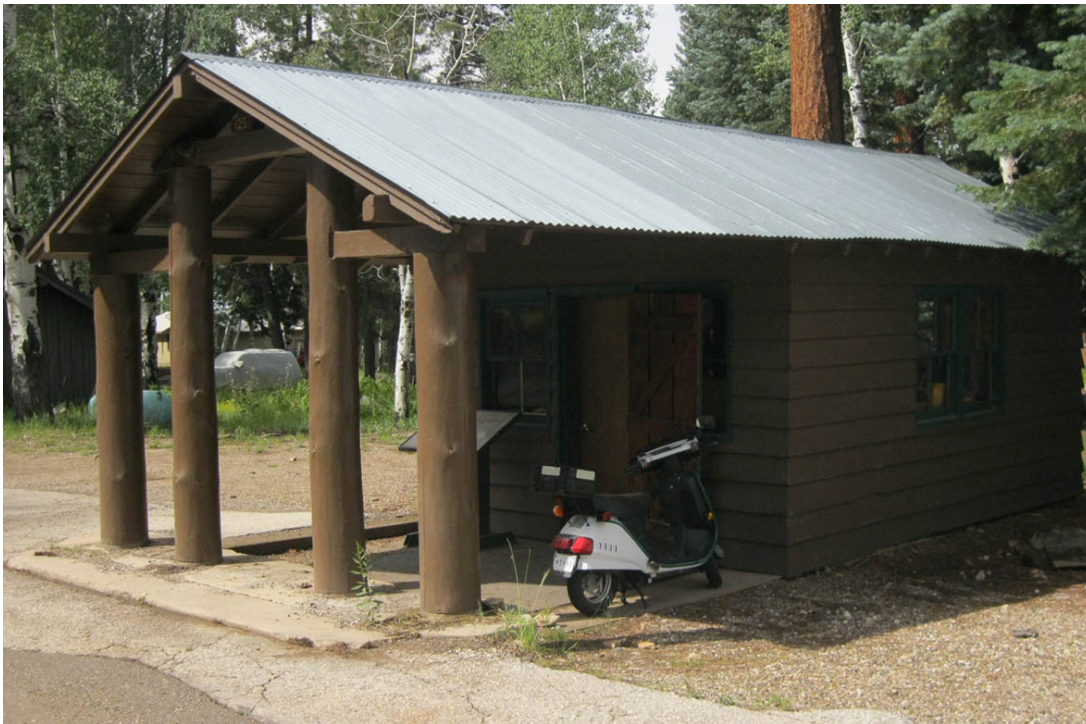
*The Rustic-style Gas and Oil Station is located in the Headquarters, Housing, and Maintenance Sub-Area, looking west, August 2010. Source: National Park Service.*

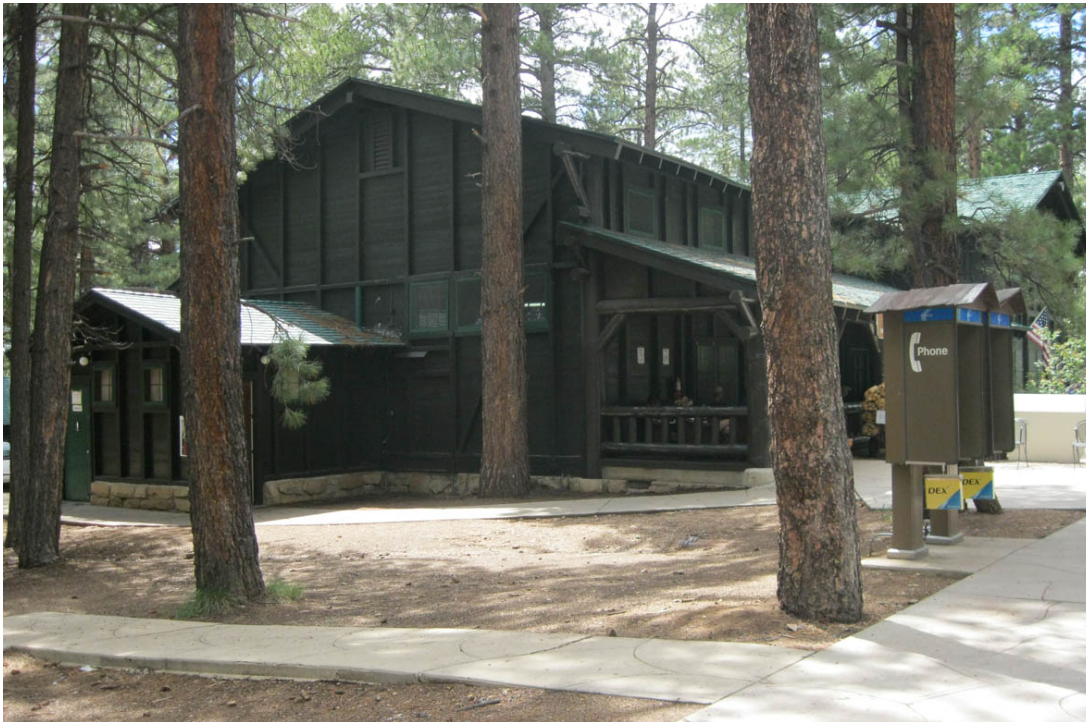
*The Camper Store, a Rustic-style building, serves as the cornerstone of the Campground Sub-Area, looking west, August 2010. Source: National Park Service.*

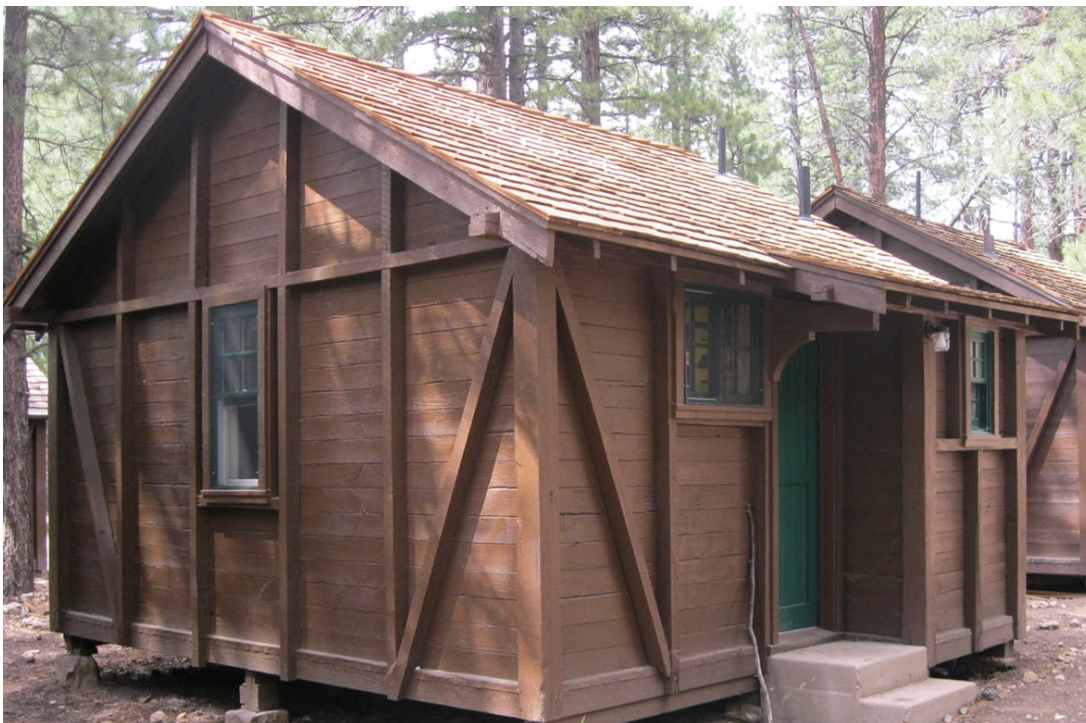
*The exposed-frame cabins are located north of the Camper Store within the Campground Sub-Area, looking east, August 2010. Source: National Park Service.*

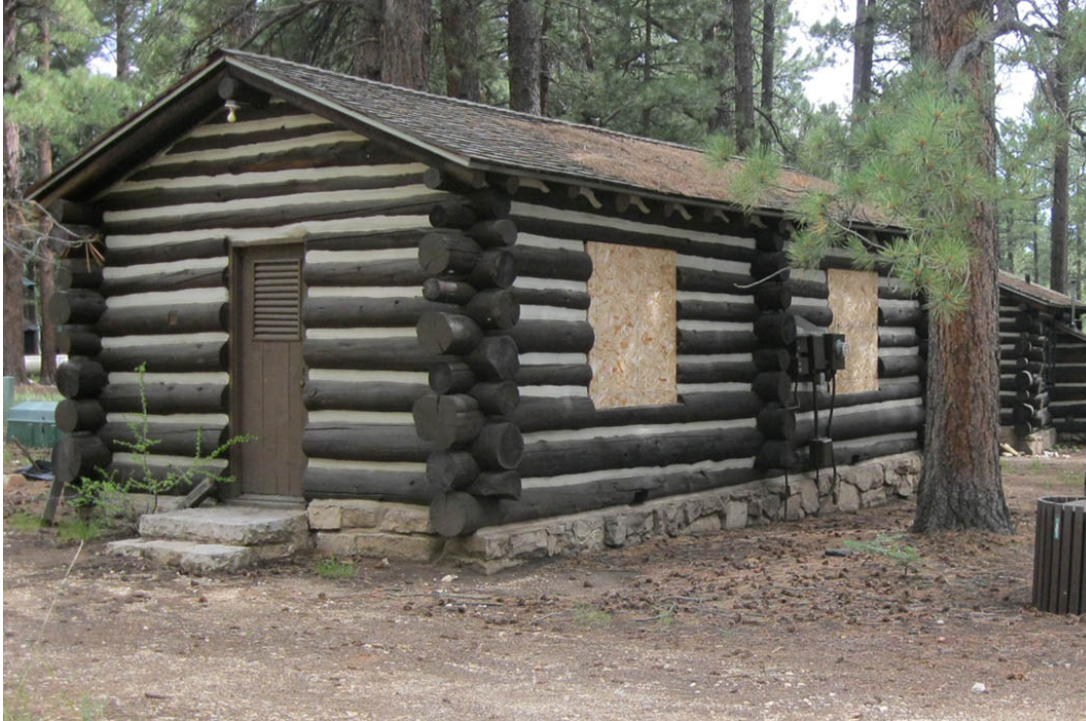
*The duplex cabins are situated west of the exposed-frame cabins within the Campground Sub-Area, looking west, August 2010. Source: National Park Service.*

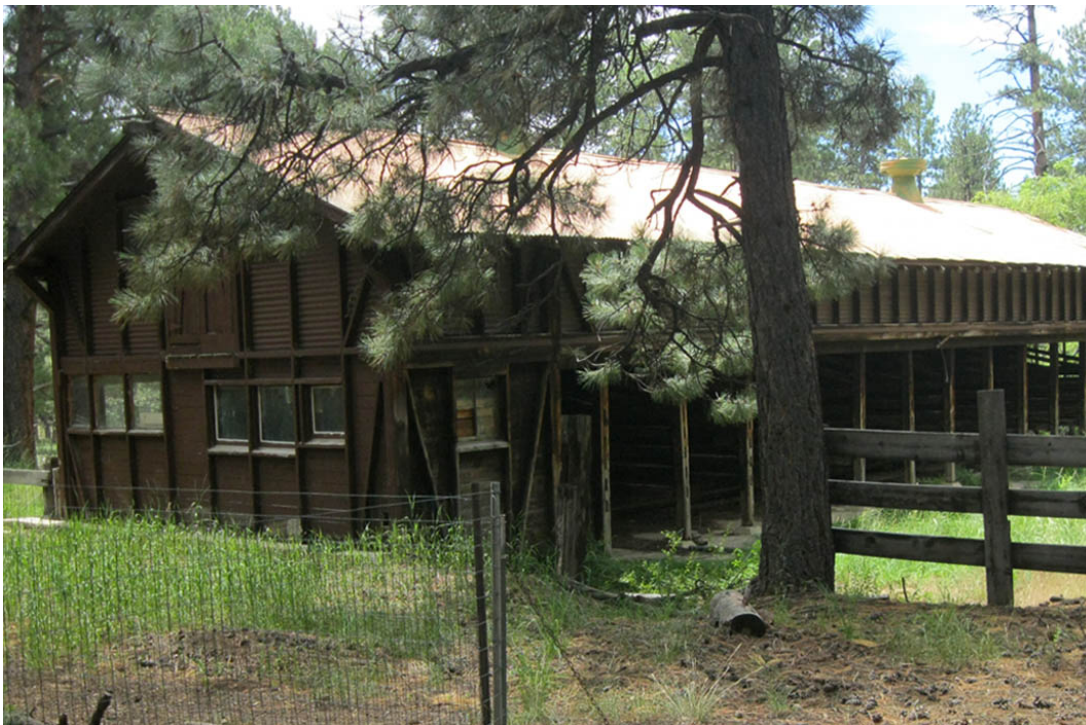
*The Mule Stable anchors the western border of the Concessionaire Sub-Area, looking west, August 2010. Source: National Park Service.*

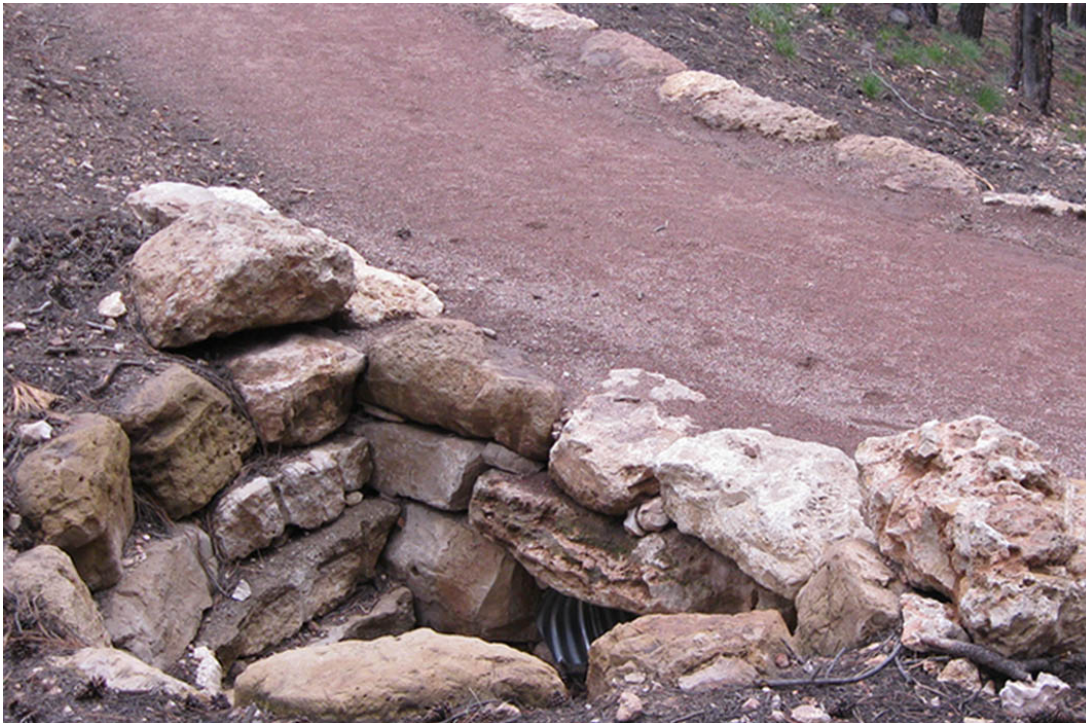
*The Bridle Trail leads from the Campground Sub-Area to the Grand Canyon Lodge, along the Entrance Road, looking south, August 2010. Source: National Park Service.*

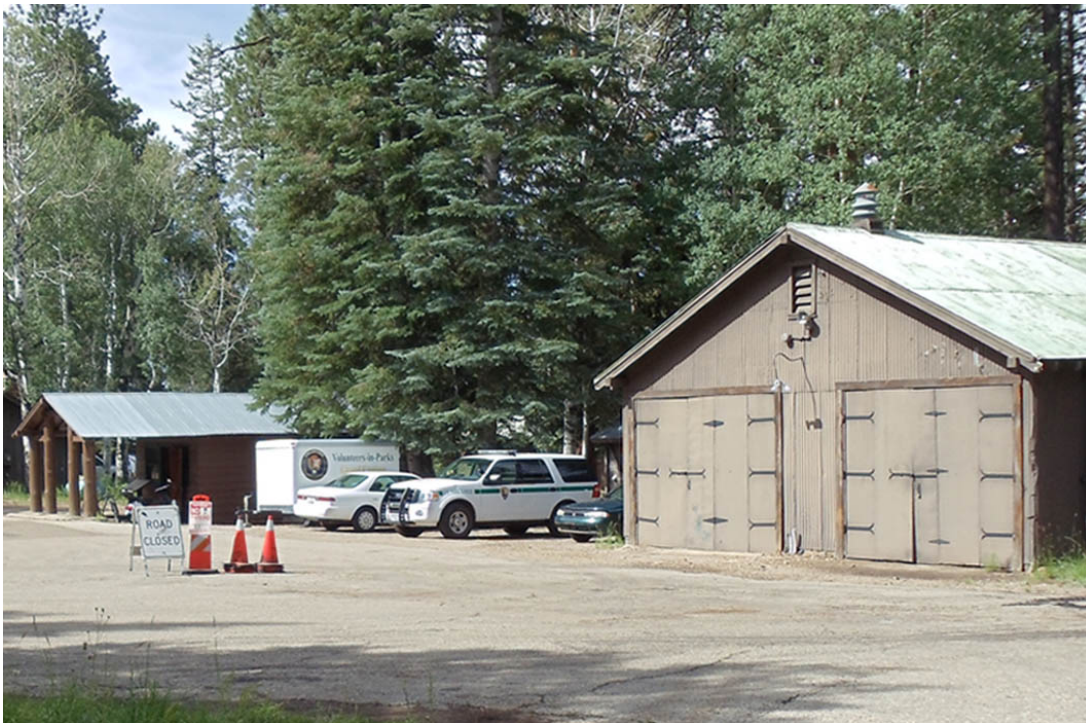
*The terminus of the inner loop road at the Maintenance node within the Headquarters, Housing, and Maintenance Sub-Area, looking west, August 2010. Source: National Park Service.*

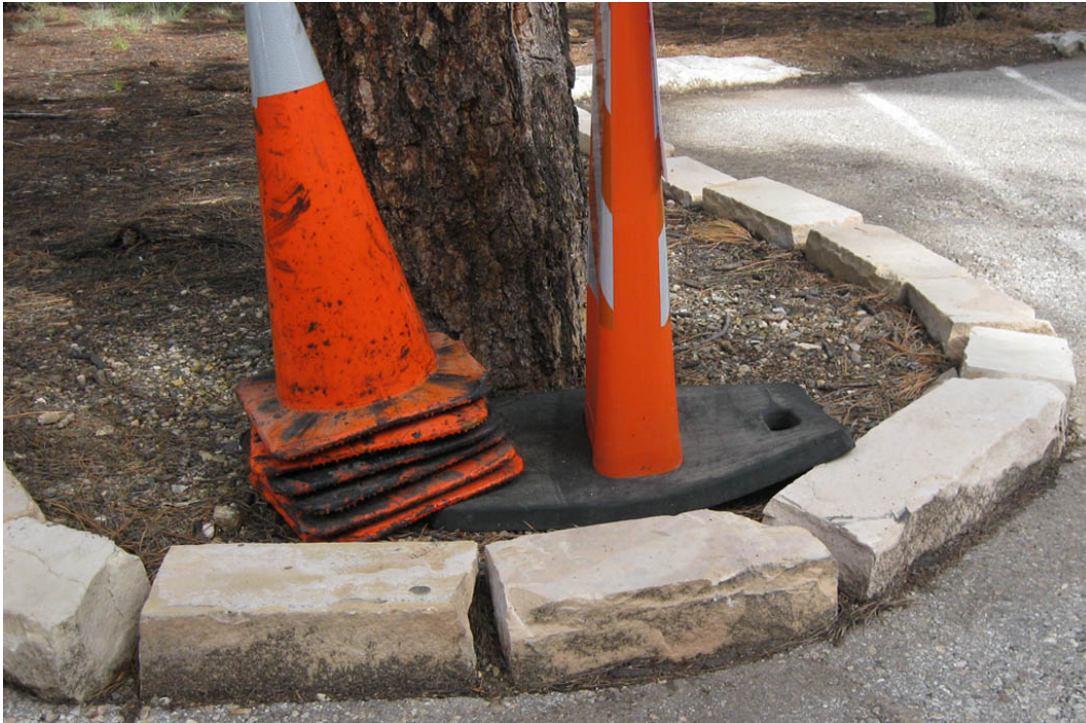
*Sandstone curbing lines the edges of the Camper Store parking node within the Campground Sub-Area, looking southeast, August 2010. Source: National Park Service.*

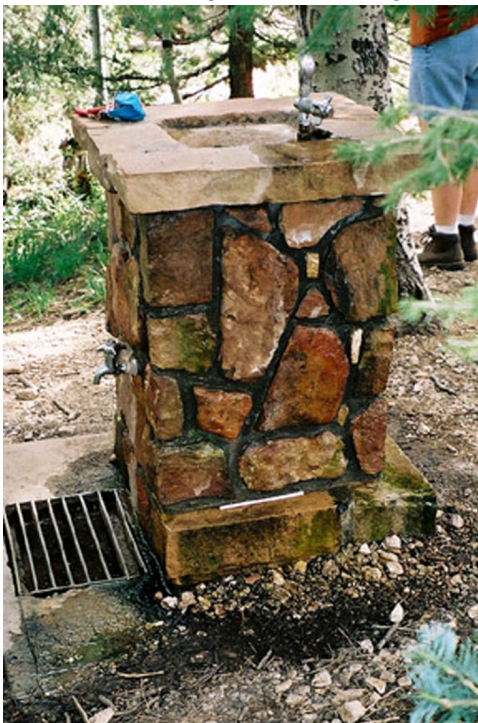
*CCC-era stone drinking fountain located south of the Camper Store in the Campground Sub-Area, looking south, August 2010. Source: National Park Service.*
