National Park Service  
Cultural Landscapes Inventory

North Rim Entrance Road Corridor  
Grand Canyon National Park

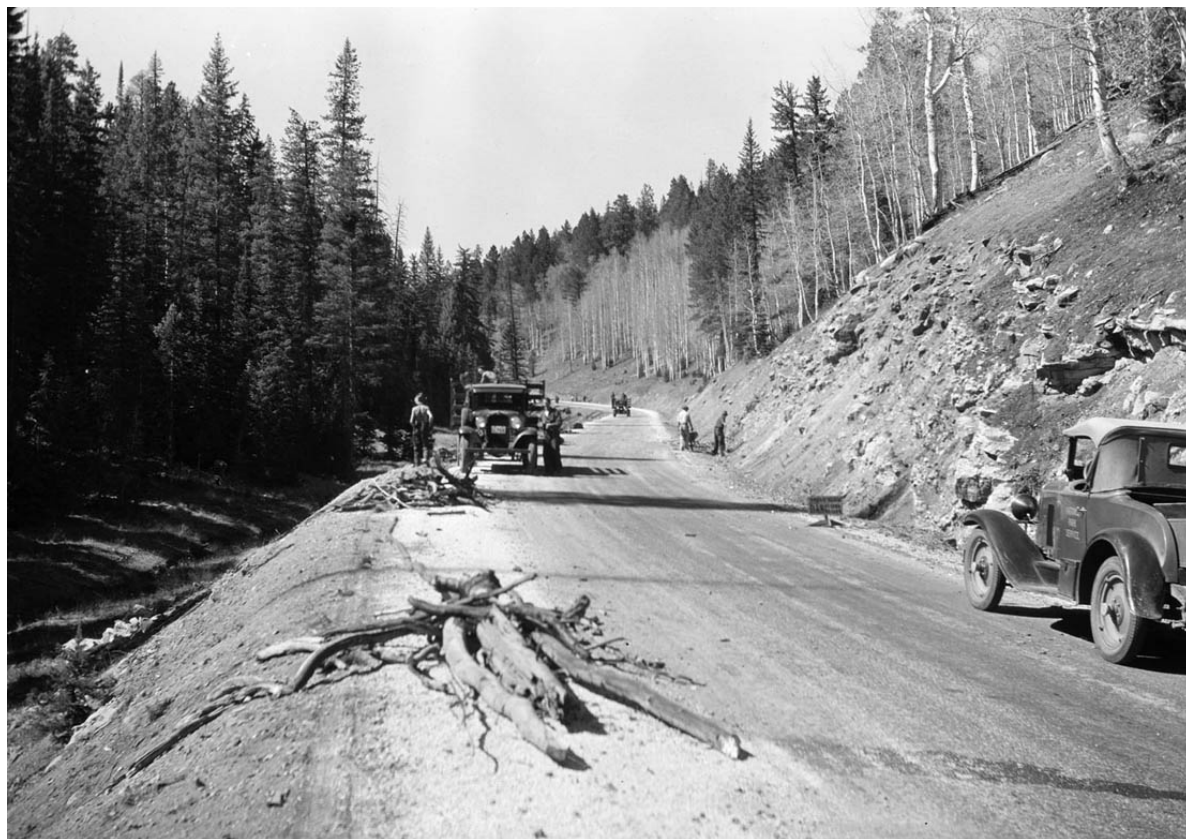
*North Rim Entrance Road construction, circa 1935. (GRCA Museum Collection Catalog #02950).*

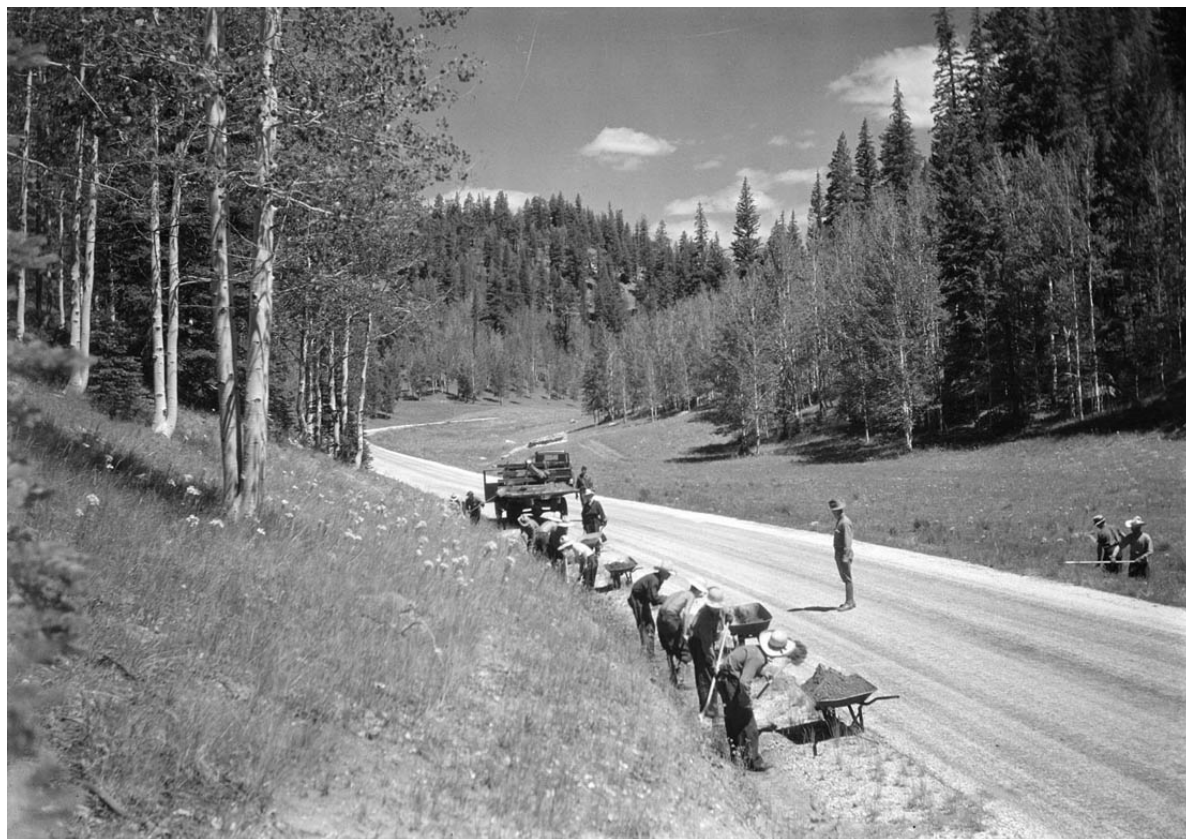
*North Rim Entrance Road construction by CCC workers, July 1937. (GRCA Museum Collection Catalog #02940).*

From the moment they arrived at the North Rim and setup camp at Neal Spring in May 1933, CCC forces were employed each summer season through 1941 in maintenance of North Rim Entrance Road and construction and repair of road-related structures such as the entrance sign. Park administrators appreciated the combination, of nearly unlimited manpower and ample recovery act funds at North Rim, where roads follow along the base of steep canyon slopes and require attention after each winter season to clear slides, clean out ditches, and repair shoulders and surfacing. In some cases CCC crews completed projects with perennial effects such as slope rounding and revegetation to help prevent slides and building guardrails along dangerous segments of roadway.

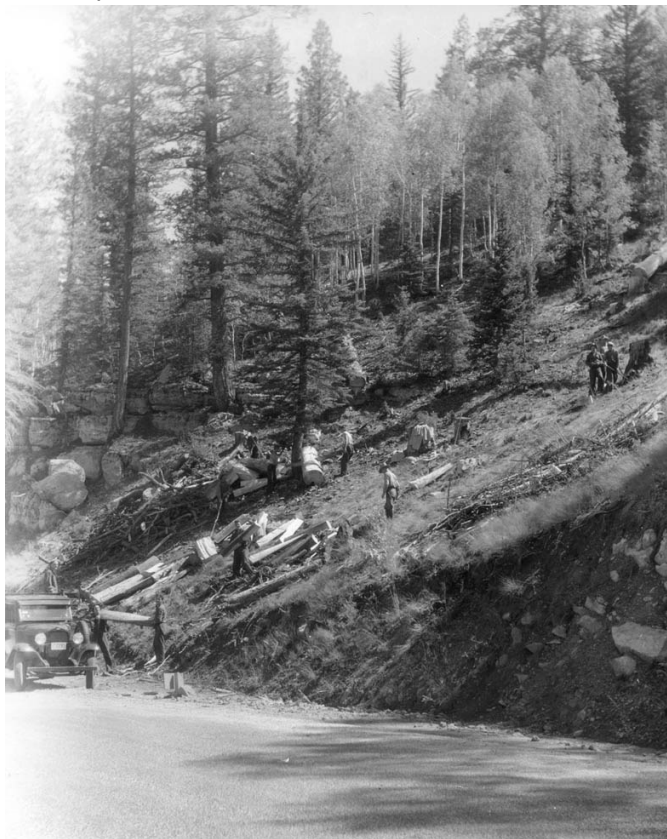
*CCC workers clearing brush beside the North Entrance Road corridor. (GRCA Museum Collection Catalog #7986).*

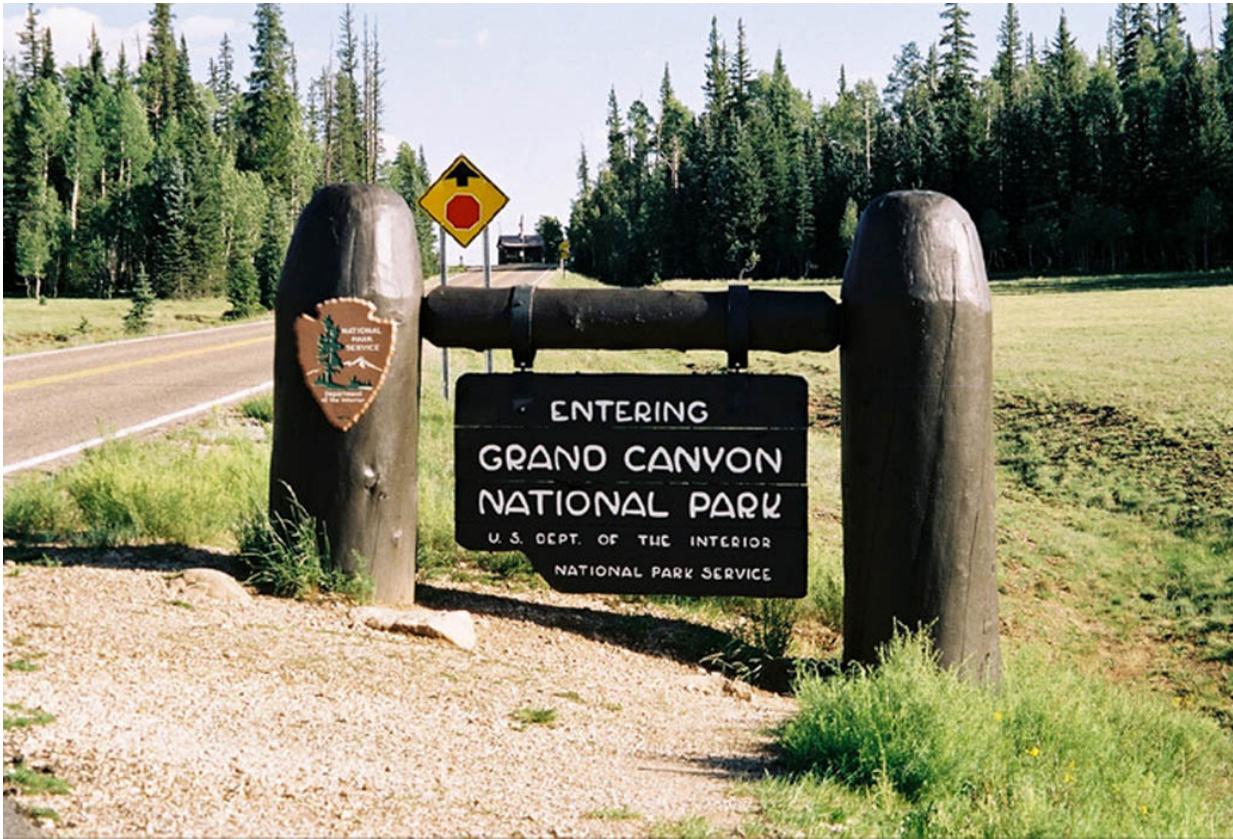
*Modern day Entrance Sign. (Source: North Rim Developed Area Cultural Landscape Report, 2004).*

Another early addition to the North Entrance Road environment is the North Entrance Sign, designed with an elaborate construction drawing in 1938 and constructed by CCC crews in October 1939 at a cost of 46 man days and \$31.67. The sign seen today is no doubt original, but varies somewhat from its design. The massive peeled whole log posts, horizontal beam, heavy metal straps, masonry base of weathered stone (now buried slightly), sign, and wording are identical to 1938 drawings, but a few features such as a third, shorter massive log fronting the west post are missing. The appeal of this unusual rustic entrance sign is untarnished by its brown painted surface today; it may, in fact, have been painted immediately upon construction.

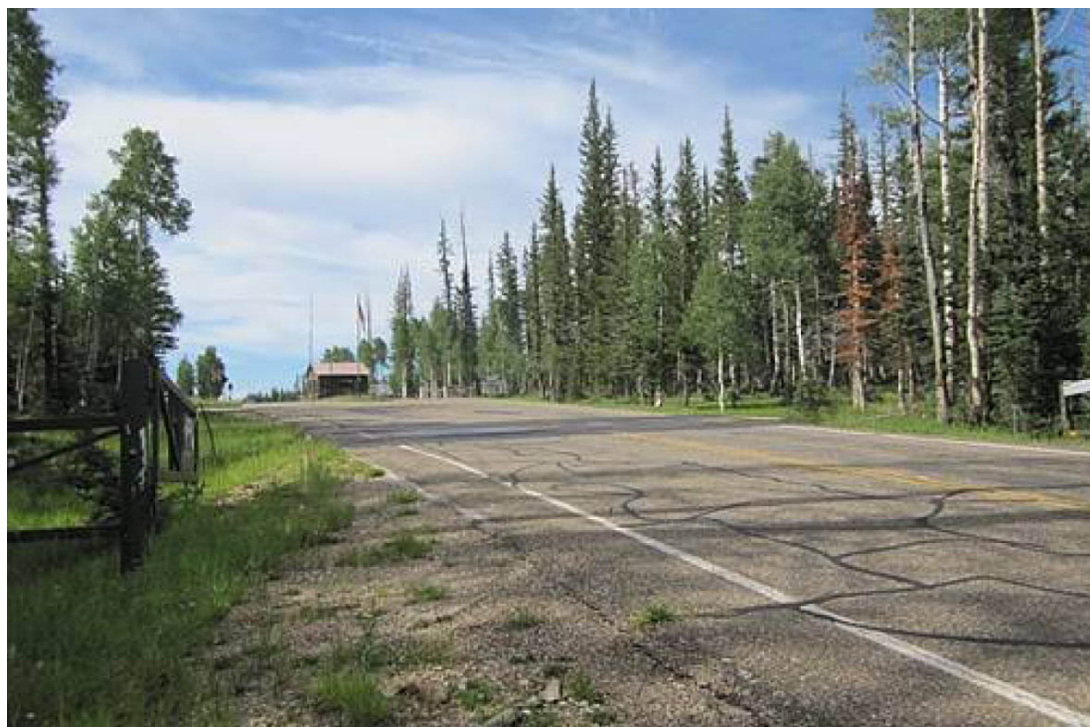
*View of the Entrance Station from the north. Photograph by Meaghan Heisinger, August 2010.*

As constructed in 1928, the Entrance Station reflected the "trapper variation" (much favored by Stephen Mather) of rustic style architecture with rough-hewn whole logs of variable lengths overlapping at each of its four corners. Carports over both the entrance and exit sides of the structure formed a continuous line with the original shake shingle roof and were supported by massive peeled logs at each corner. The earliest photograph found during research for this project depicts Ranger Ed Laws standing in front of this remarkable structure two years after construction. Its covered entrance concept remained unique at Grand Canyon until construction of the new South Entrance Station in the late 1980s.

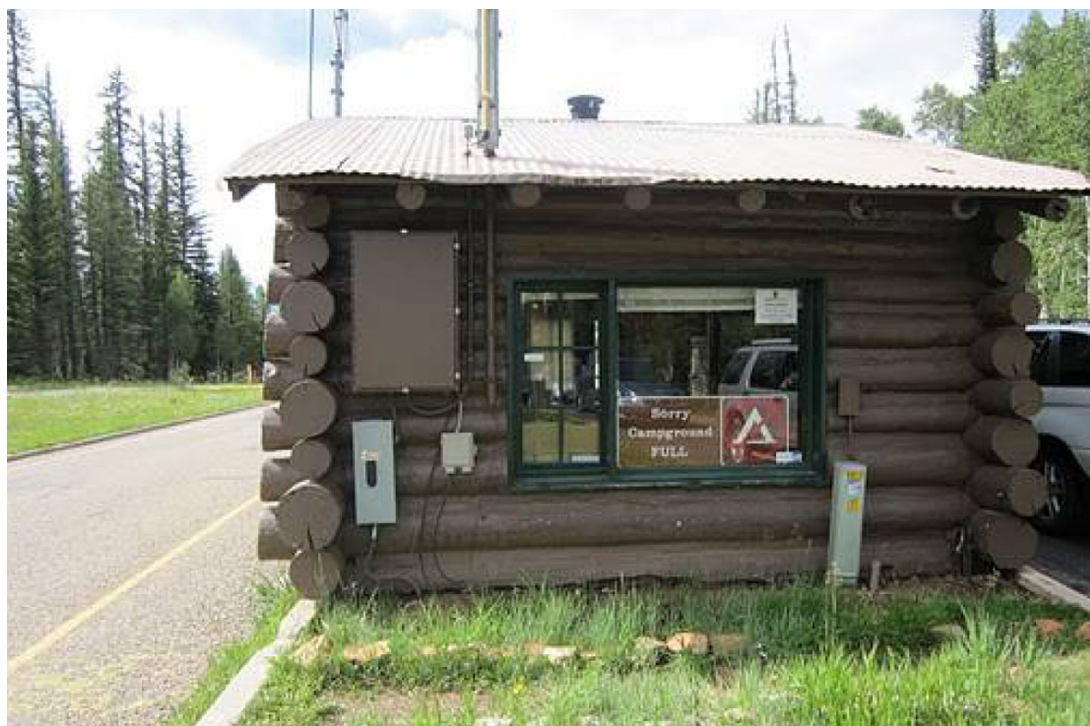
*Entrance Station. Photograph by Meaghan Heisinger, August 2010.*

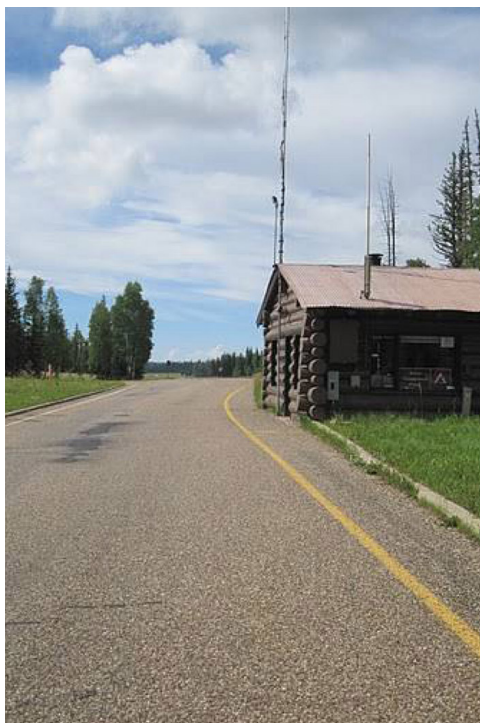
*Entrance station showing views to south along the Entrance Road as one enters from the north.  
Photograph by Meaghan Heisinger, August 2010.*

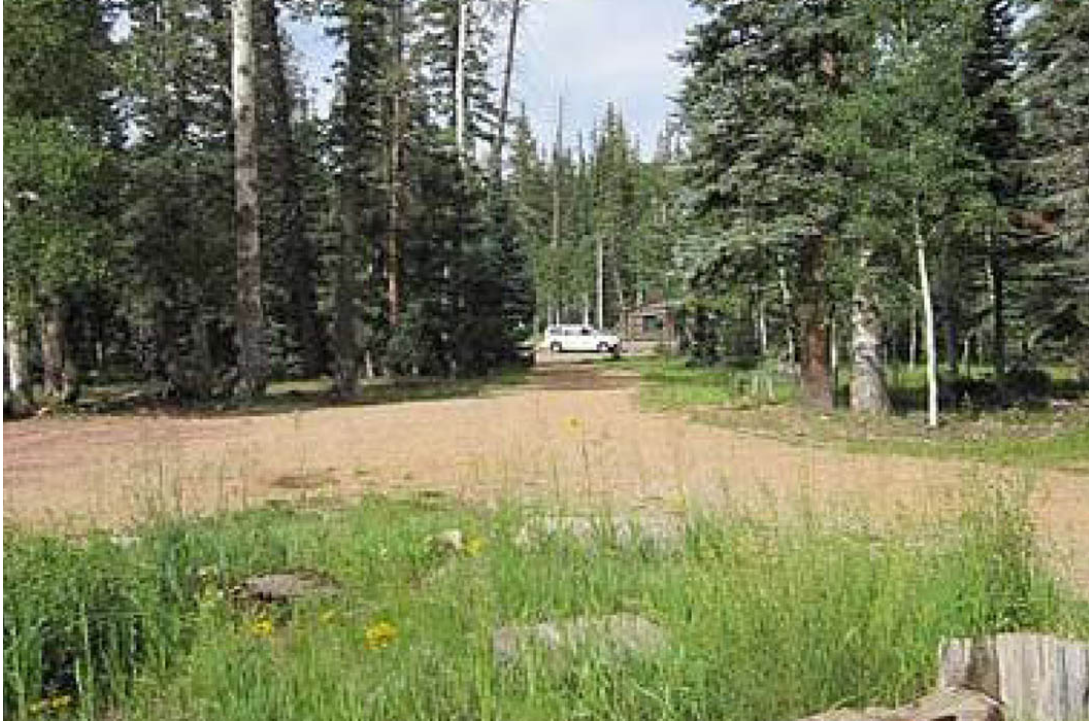
*View from the Employee Residence west toward the Entrance Road, showing seclusion of the area from the adjacent Entrance Road and Entrance Station. Photograph by Meaghan Heisinger, August 2010.*

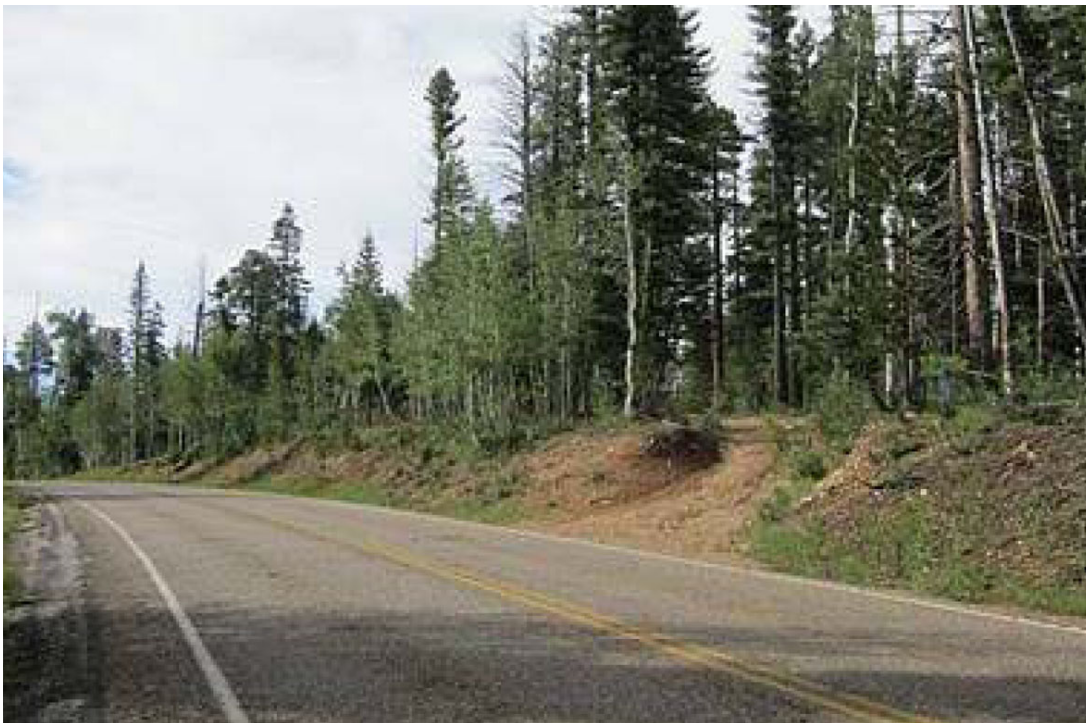
*View of the intersection between the post-1930 Entrance Road with the pre-1930 alignment of the Entrance Road (dirt road leading up the hillside). Photograph by Meaghan Heisinger, August 2010.*

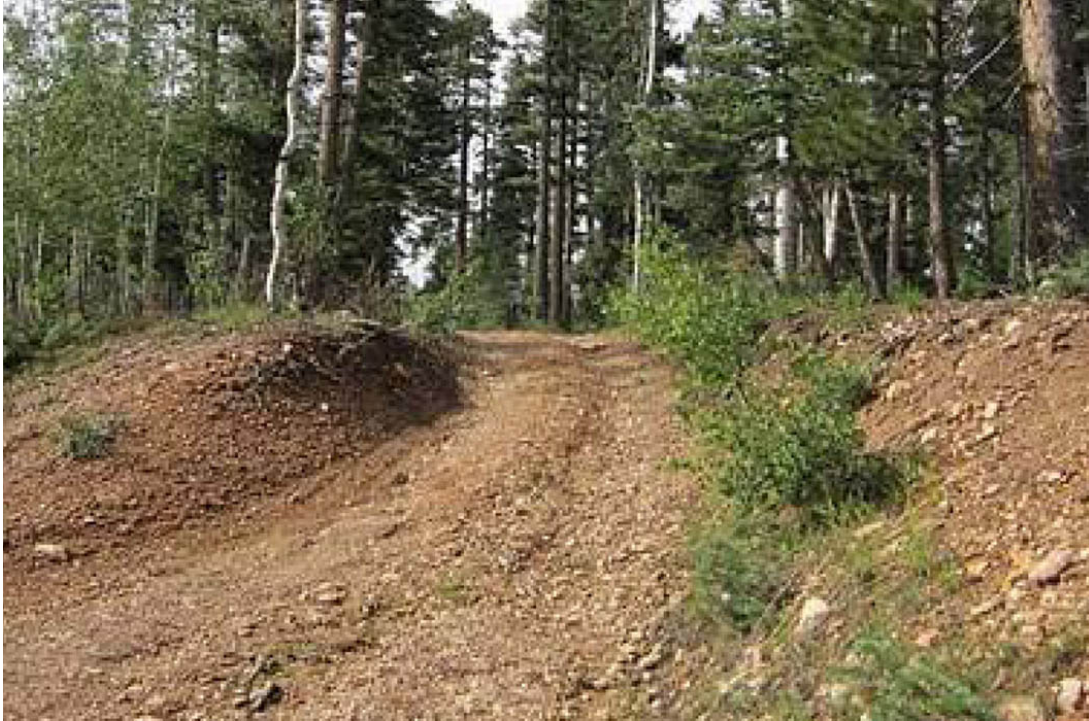
*The original pre-1930 Entrance Road now called the W1a, or Range Road. Photograph by Meaghan Heisinger, August 2010.*

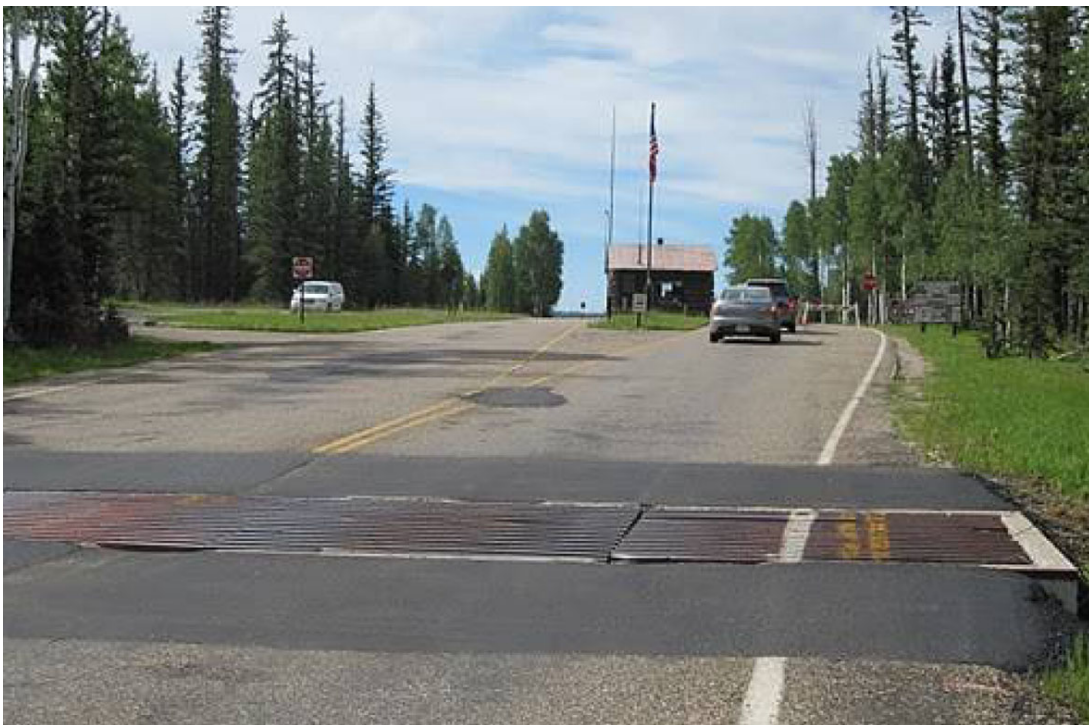
*Entrance Station, displaying the curbed asphalt-paved parking lot to the left and the cattle guard in the forefront. Photograph by Meaghan Heisinger, August 2010*

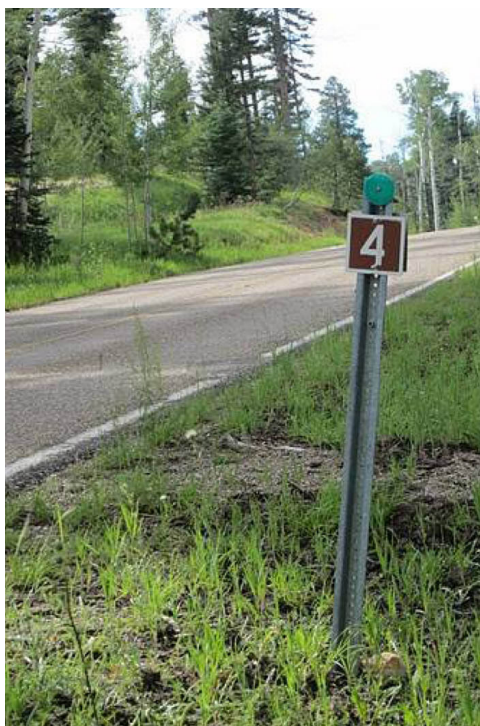
*Mile marker sign along the Entrance Road. Photograph by Meaghan Heisinger, August 2010.*

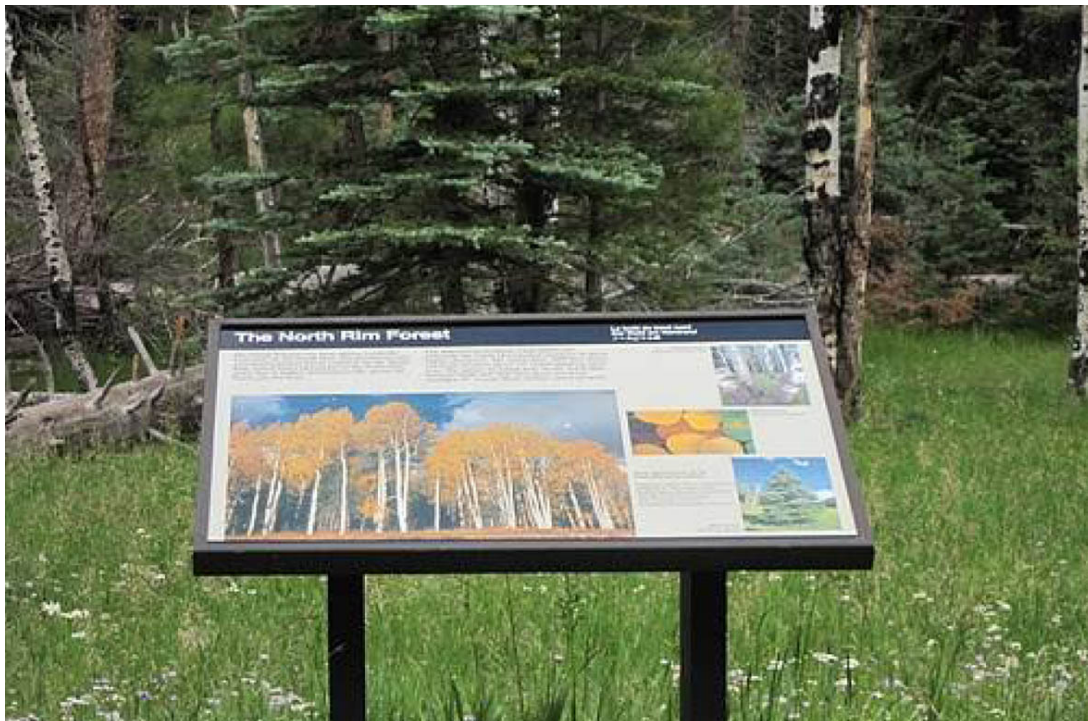
*Interpretive sign in the picnic area/parking lot located near Lindberg Hill. Photograph by Meaghan Heisinger, August 2010.*

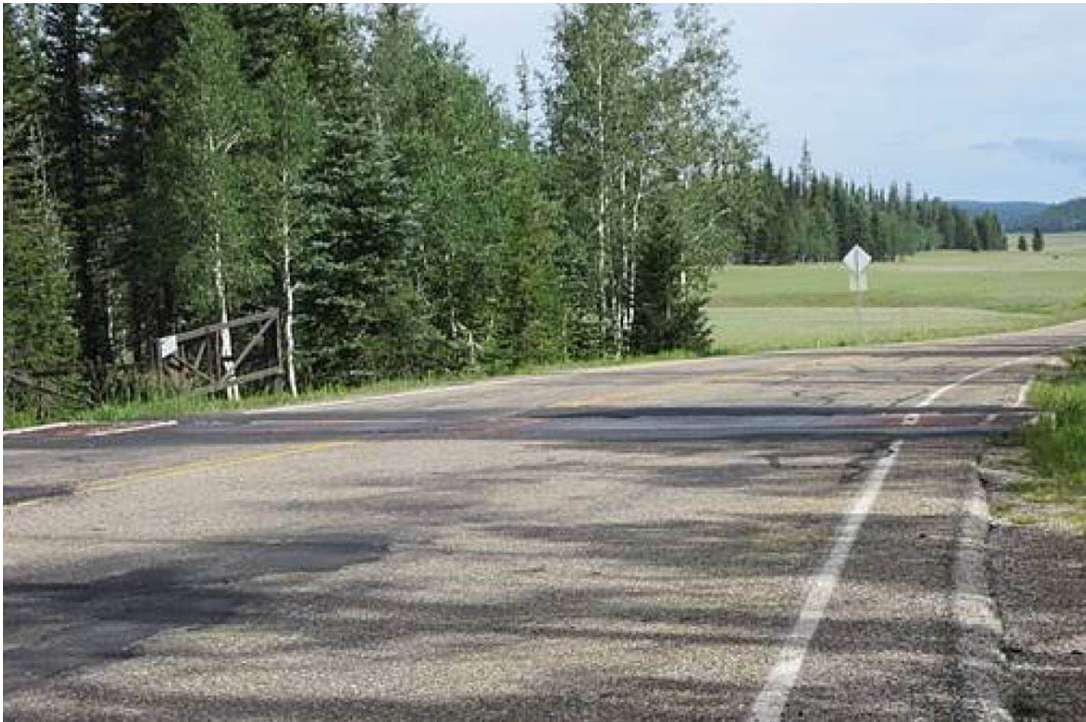
*View to the north from the Entrance Station displaying the cattle guard and iron gate.  
Photograph by Meaghan Heisinger, August 2010*
