GRAND CANYON LODGE, PIONEER CABIN  
Grand Canyon National Park  
North Rim  
Grand Canyon National Park  
Coconino County  
Arizona

HABS No. AZ-135-E

**HISTORIC AMERICAN BUILDINGS SURVEY**

**GRAND CANYON LODGE, PIONEER CABIN  
HABS No. AZ-135-E**

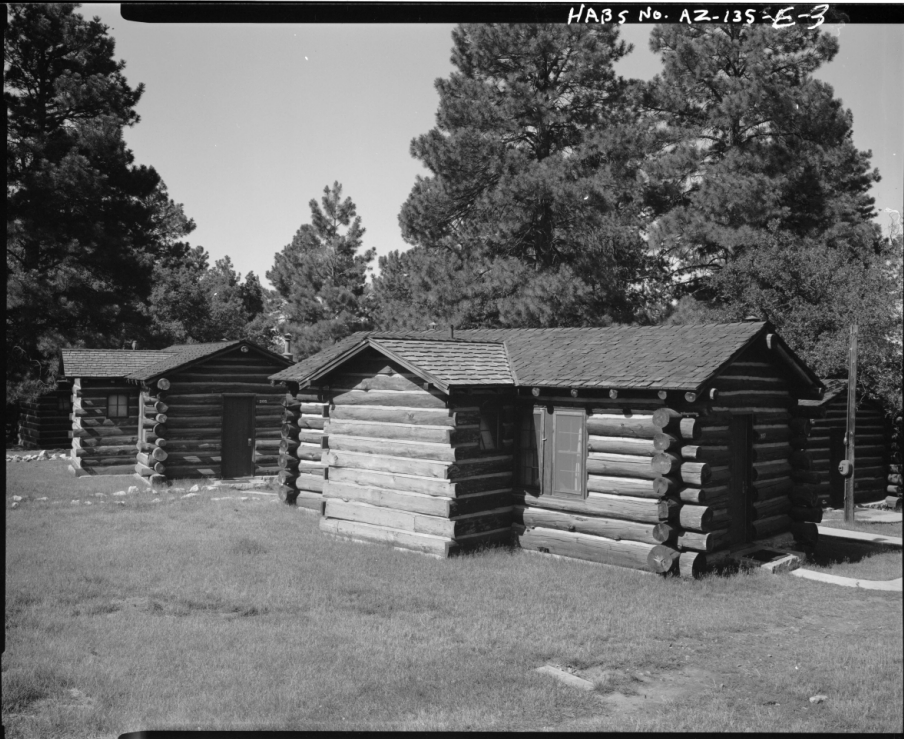
HABS No. AZ-135-E-3

| AZ-135-E-3 | PIONEER CABIN, LOOKING SOUTHWEST |

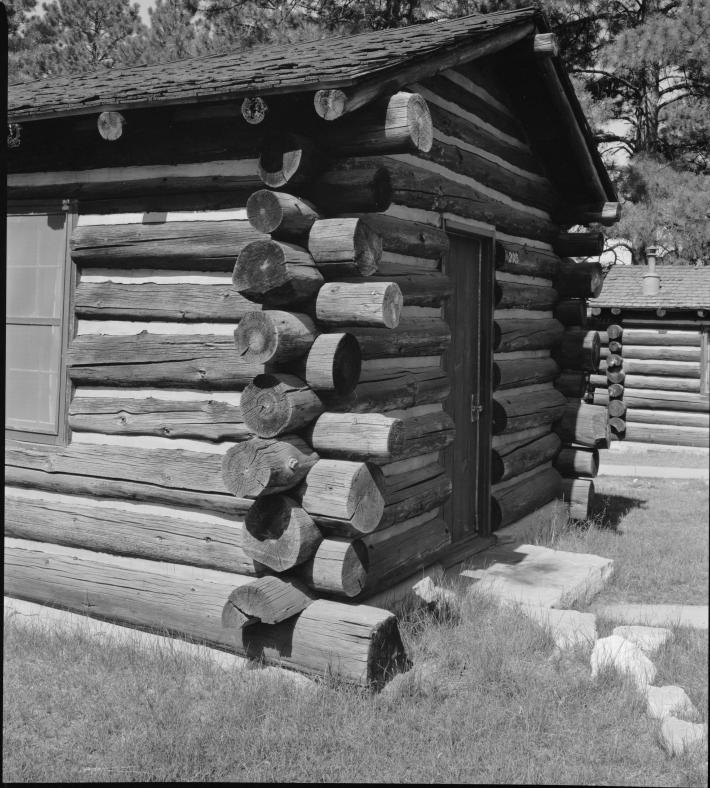
HABS AZ-135-144

| AZ-135-E-4 | DETAIL OF CORNER OF PIONEER CABIN, LOOKING SOUTHWEST |

2. Wall Construction, Finish, Color: Peeled logs, with notched ends, projecting approximately one foot. Joints between logs chinked with lime and sand mortar on diamond patterned metal lath. Near the center of each long side there are logs projecting through the wall at a cross partition. A small projection on one side, housing a water heater, has half-log siding with lime mortar chinking.

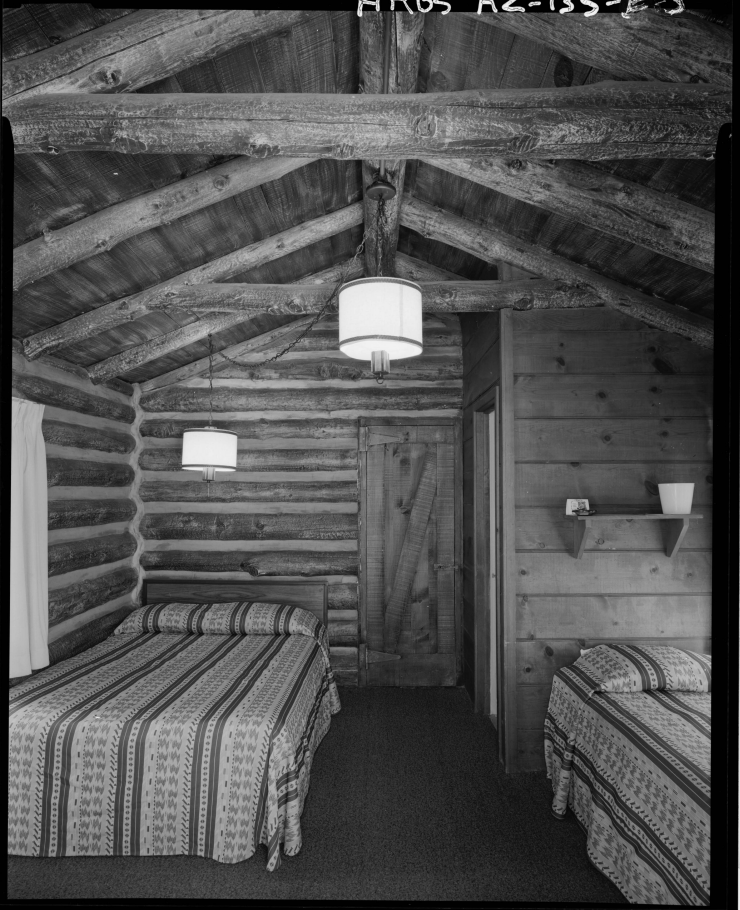
HABS AZ-135-E-5

| AZ-135-E-5 | INTERIOR VIEW OF PIONEER CABIN, FROM DOORWAY |

3. Walls and Ceiling Finish: Walls in the bedroom are exposed, peeled logs with horizontal, wide-board, beaded planks on the bathroom wall, having narrow corner boards. Ceilings in the bedrooms are exposed log structure with
