GRAND CANYON INN & NATIONAL PARK HEADQUARTERS,  
RESIDENCE

HABS No. AZ-144-B

## HISTORIC AMERICAN BUILDINGS SURVEY

### GRAND CANYON INN & NATIONAL PARK HEADQUARTERS, RESIDENCE (GRAND CANYON INN & NATIONAL PARK HEADQUARTERS, BUILDING 101)

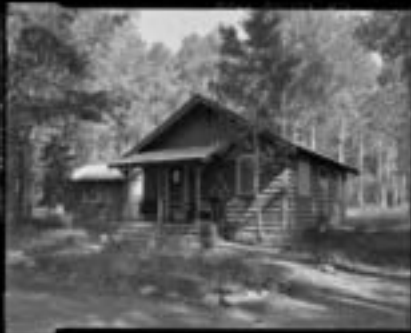
PA 66 P2-144-3-1

| AZ-144-B-1 | RESIDENCE, LOOKING NORTHEAST WITH OUTBUILDING IN<br>BACKGROUND |

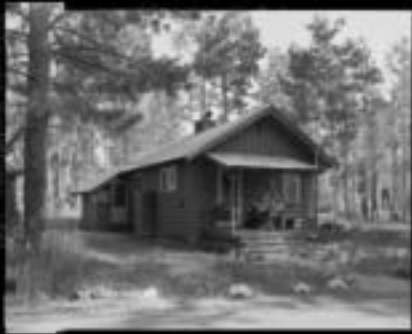
HABS-A2-147-2-3

| AZ-144-B-2 | RESIDENCE, LOOKING NORTH |
