GRAND CANYON INN & NATIONAL PARK HEADQUARTERS,  
BUNK HOUSE

HABS No. AZ-144-F

WRITTEN HISTORICAL AND DESCRIPTIVE DATA

HISTORIC AMERICAN BUILDINGS SURVEY  
GRAND CANYON INN & NATIONAL PARK HEADQUARTERS,  
BUNK HOUSE

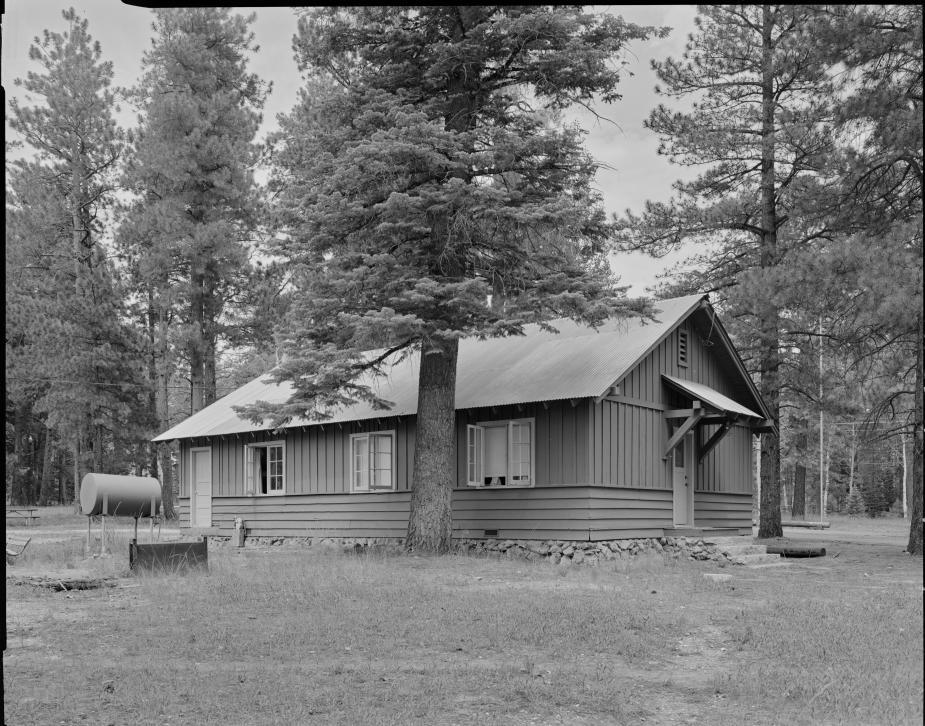
AZ-144-F-1

BUNK HOUSE, LOOKING NORTHEAST
