GRAND CANYON NATIONAL PARK ROADS,  
BOULDER STREET HEADWALL No. 1  
Grand Canyon National Park  
Grand Canyon Village  
Coconino County  
Arizona

HAER No. AZ-35-D

## GRAND CANYON NATIONAL PARK ROADS, BOULDER STREET HEADWALL NO. 1 HAER No. AZ-35-D

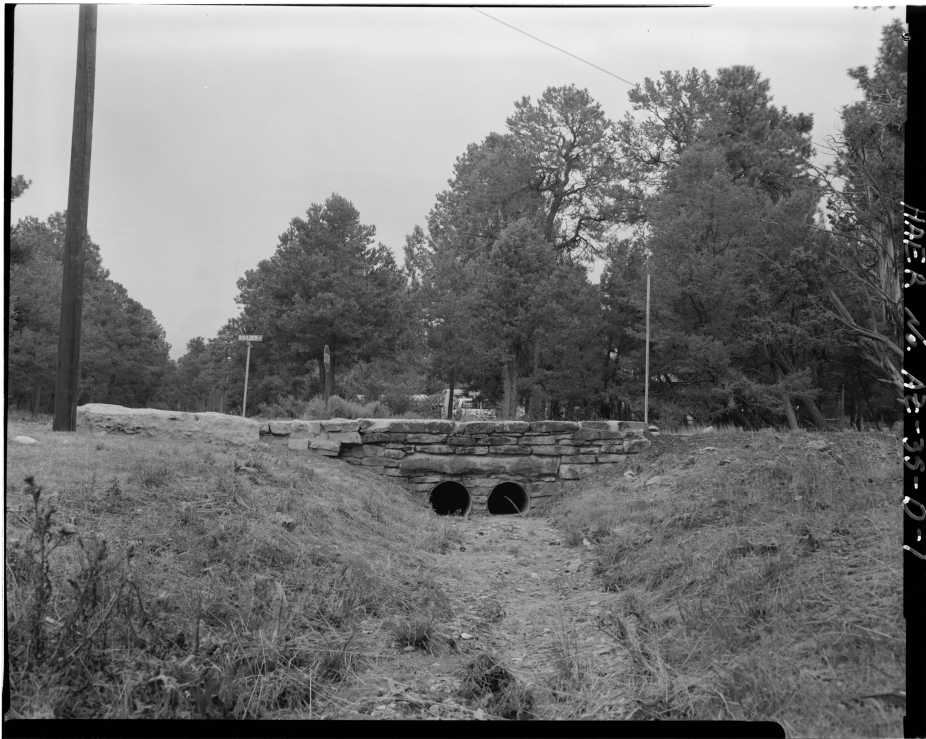
HAER 16. A2-35-0-1

AZ-35-D-1 DISTANT VIEW OF HEADWALL AS SEEN LOOKING TO THE SOUTH

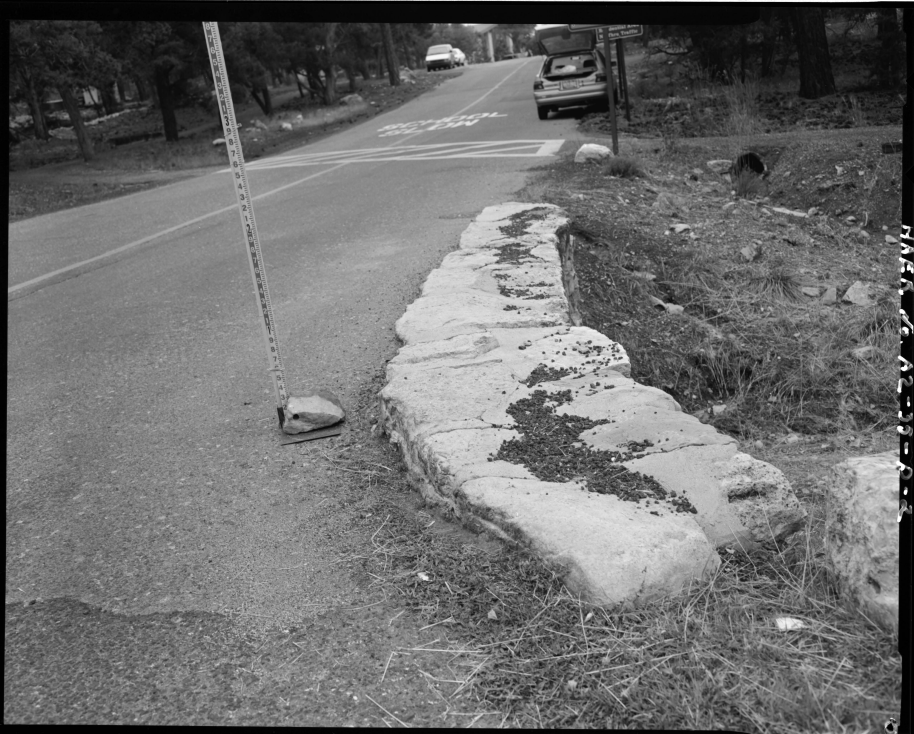
NA 6. 2. 22. 6. 5

AZ-35-D-2 VIEW OF THE TOP OF THE HEADWALL LOOKING WEST

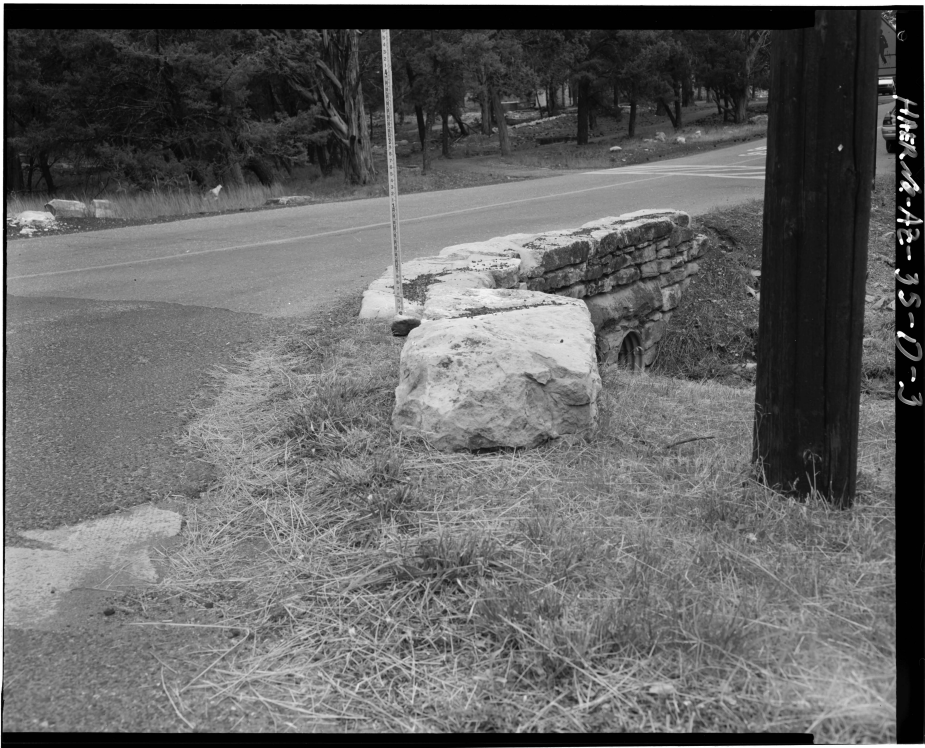
Hillside-A2-35-D-3

AZ-35-D-3 VIEW OF THE TOP OF THE HEADWALL, INCLUDING OFFSET  
SECTION OF WALL, LOOKING WEST

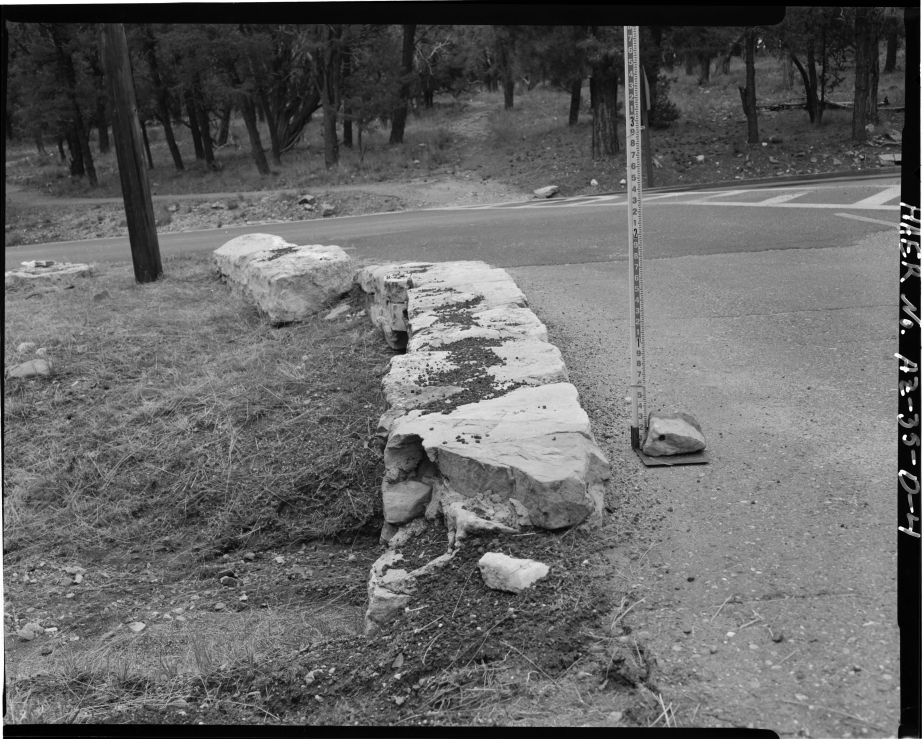
FILE NO. A2-35-D-4

AZ-35-D-4 VIEW OF THE TOP OF THE HEADWALL LOOKING EAST

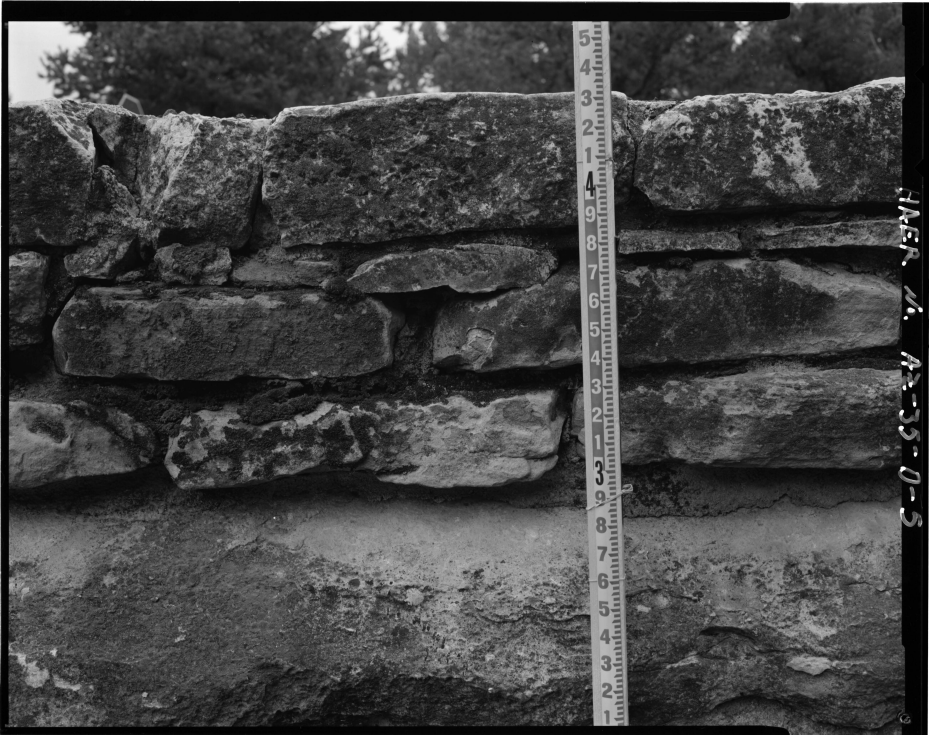
HER. N. A-35-0-5

AZ-35-D-5 DETAILED VIEW OF MASONRY WORK OF THE HEADWALL  
LOOKING TO THE SOUTH

The headwall is located along Boulder Street at the northwest corner of the intersection of that street with Center Road. It is approximately 19' long, 4'6" at its highest point, and 2' thick. The top of the wall extends 6" above the roadway surface forming a short curb. The wall is of roughly-cut, quarried, rectangular sandstone and limestone and crudely-mortared. It is in excellent condition with no signs of bulging, buckling, nor cracking. The wall conceals two side-by-side 24" C.M.P. culverts which carry storm water running south to north within the drainage ditch under Boulder Street. This ditch along the west side of Center Road continues down to Apache Street Headwall Nos. 1 and 2 and beyond. An interesting and attractive feature of this headwall is the massive rectangular stone placed above the corrugated metal pipes. Detractive features are the clumsy bit of reconstruction on the east end and the 8' boulder which is beginning to slip down the slope.
