GRAND CANYON NATIONAL PARK ROADS,  
APACHE STREET HEADWALL No. 2  
Grand Canyon National Park  
Grand Canyon Village  
Coconino County  
Arizona

HAER No. AZ-35-F

## GRAND CANYON NATIONAL PARK ROADS, APACHE STREET HEADWALL NO. 2 HAER No. AZ-35-F

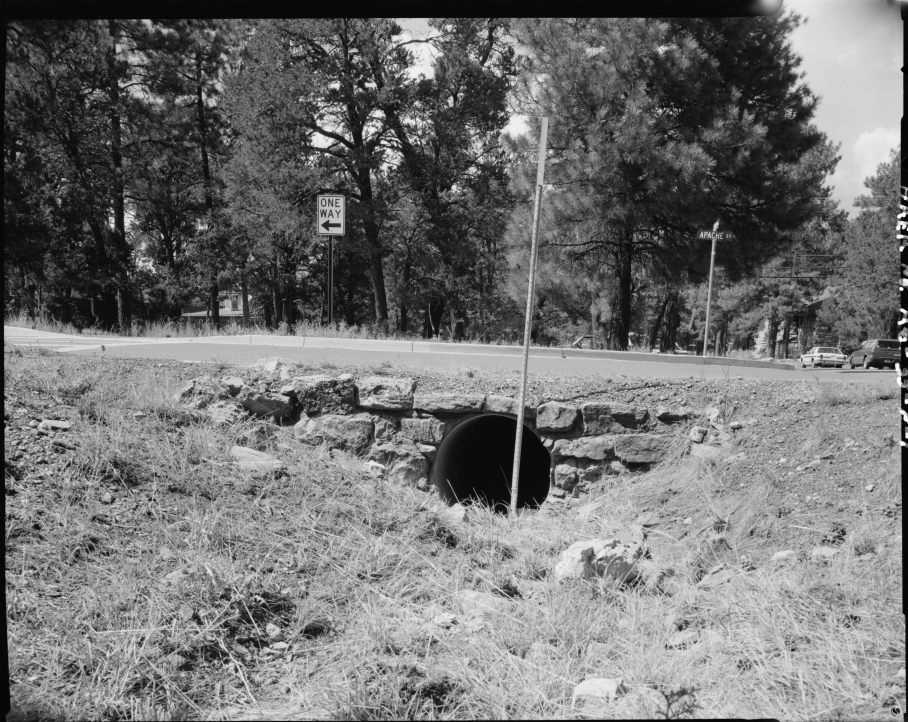
AZ-35-F-1 DISTANT VIEW OF HEADWALL AS SEEN LOOKING TO THE NORTH

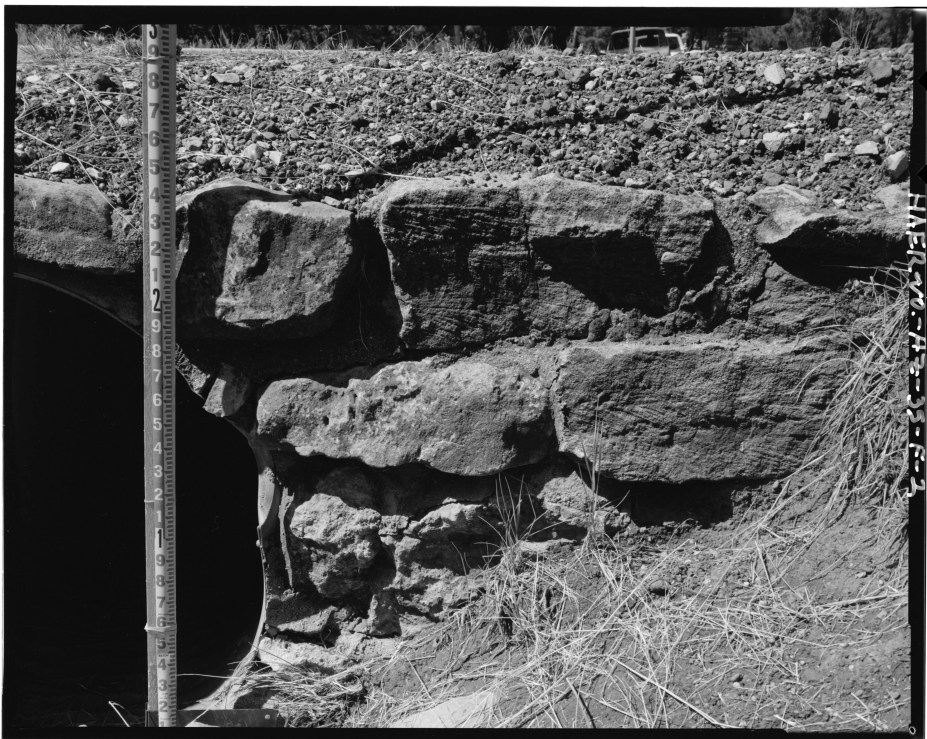
is approximately 11'0" long and 3'0" high at the center of the 30" C.M.P. culvert opening. The wall is approximately three feet back from the roadway curb with intervening gravel and grass cover, but the wall top is at the approximate level of the roadway. It is of roughly-cut, rectangular sandstone and limestone, crudely-mortared. The wall serves the 30" pipe culvert which carries storm water in a south to north direction beneath Apache Street. It is in fair condition with some cracking and flaking of the mortar noted.

AZ-35-F-2 DETAILED VIEW OF MASONRY WORK OF THE HEADWALL  
LOOKING TO THE NORTH
