VILLAGE LOOP ROAD  
(Grand Canyon Route #9)  
(Village Access Road)  
Grand Canyon Village  
Grand Canyon National Park  
Coconino County  
Arizona

HAER No. AZ-41

VILLAGE LOOP DRIVE  
(Grand Canyon Route #9)  
(Village Access Loop)  
HAER No. AZ-41

**Project Information:** Documentation of Village Loop Drive is part of the NPS Roads and Bridges Recording Project, conducted in summer 1994 under the co-sponsorship of Grand Canyon National Park and HABS/HAER. This report was researched and written by Michael F. Anderson, HAER Historian, September 1994.

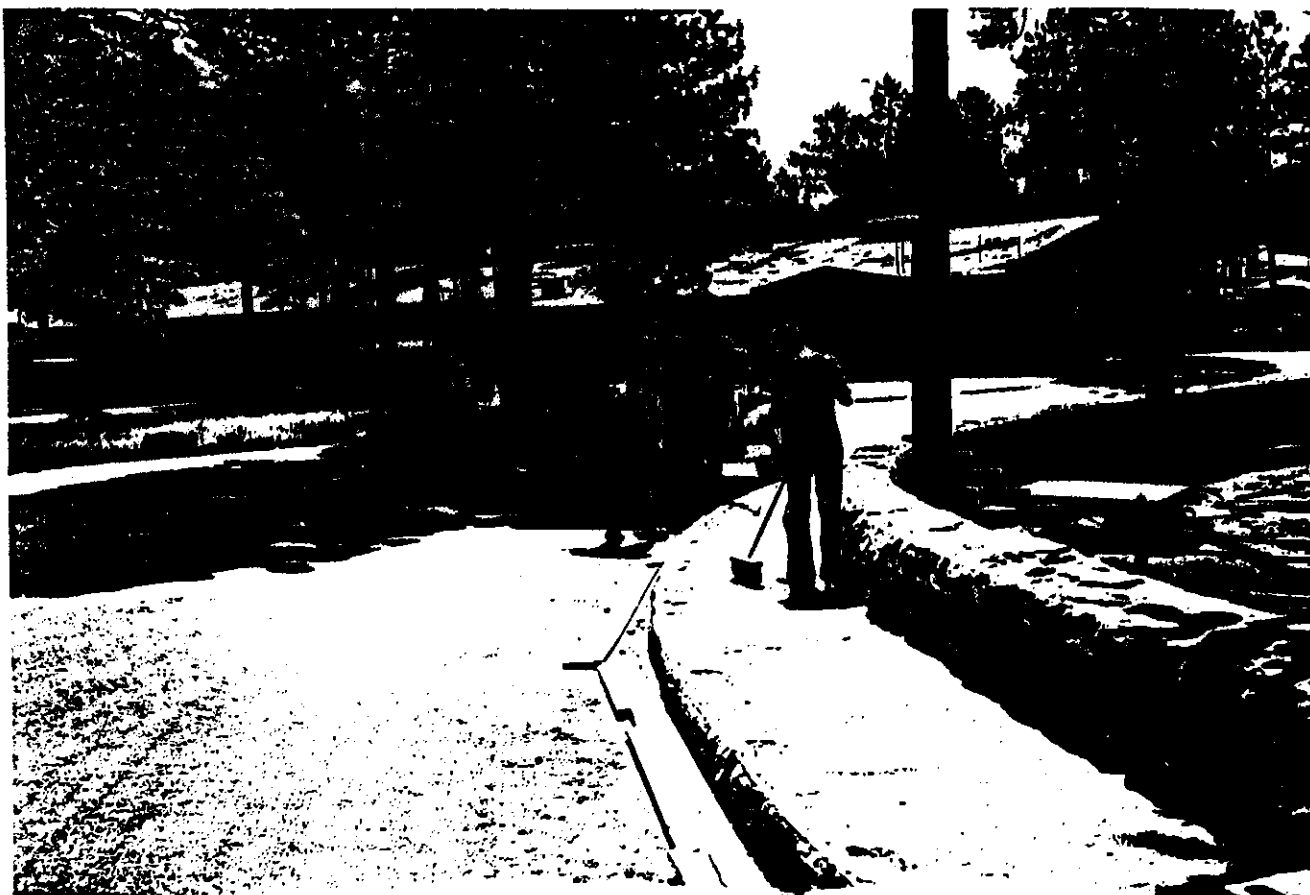
Figure 3. CCC crews surfacing the walkway beside the railroad terminal wall at the old Fred Harvey garage, September 1937. Note the landscaped traffic island on the left. This intersection with the South Entrance Road has changed little since 1935. (GRCA Image #336, GCSC)

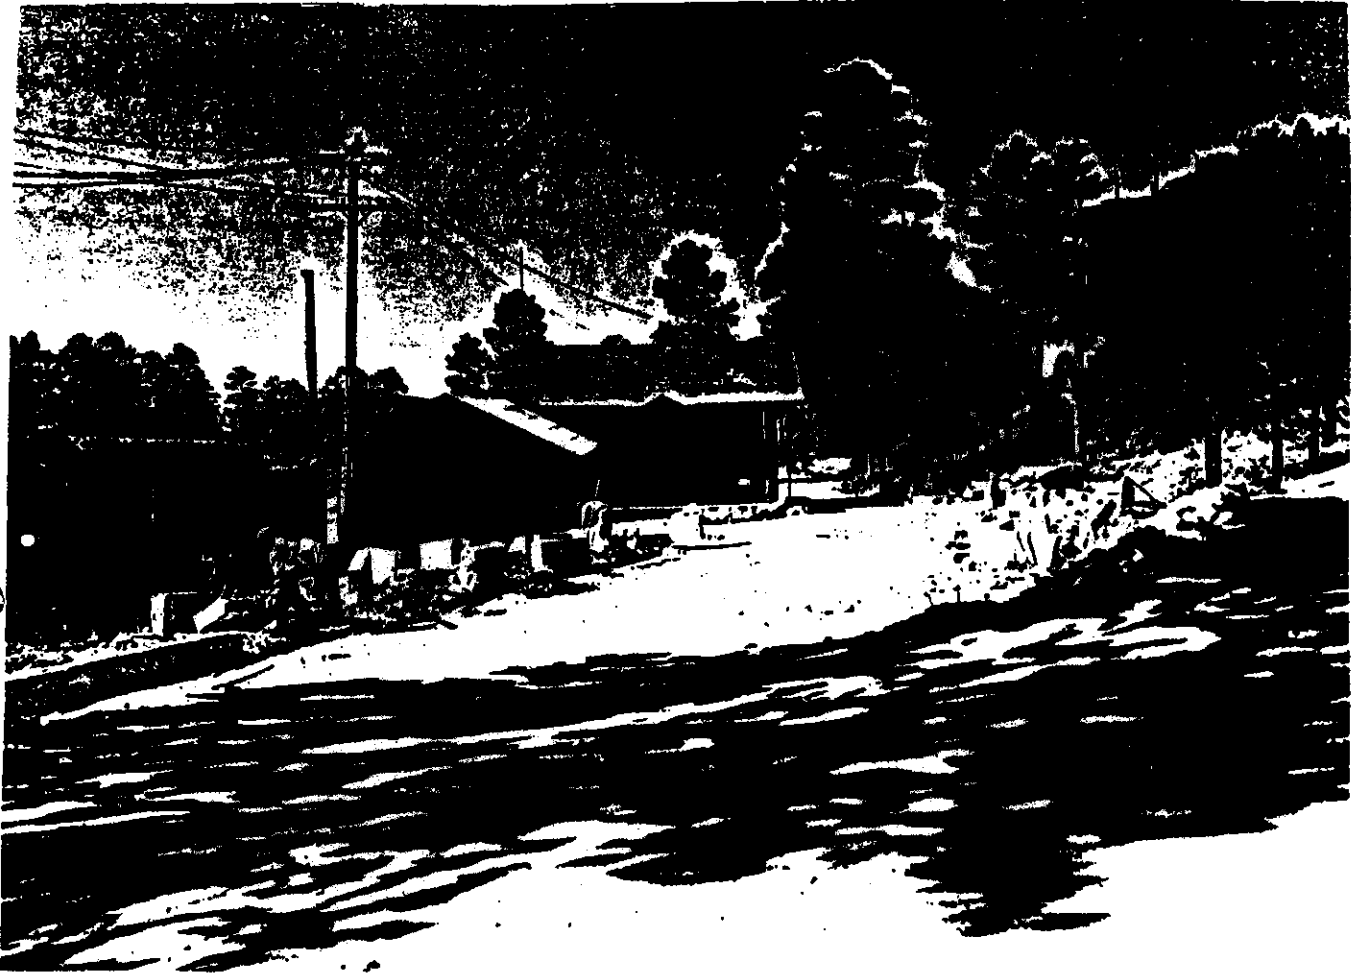
Figure 9. Construction project of 1934-35 at the east end, facing west beyond the RR depot. Old alignment on the far right foreground. Masons at work on wall and curbing. Note the old warehouse east of the depot, no longer standing. (GRCA Image #9392, GCSC)

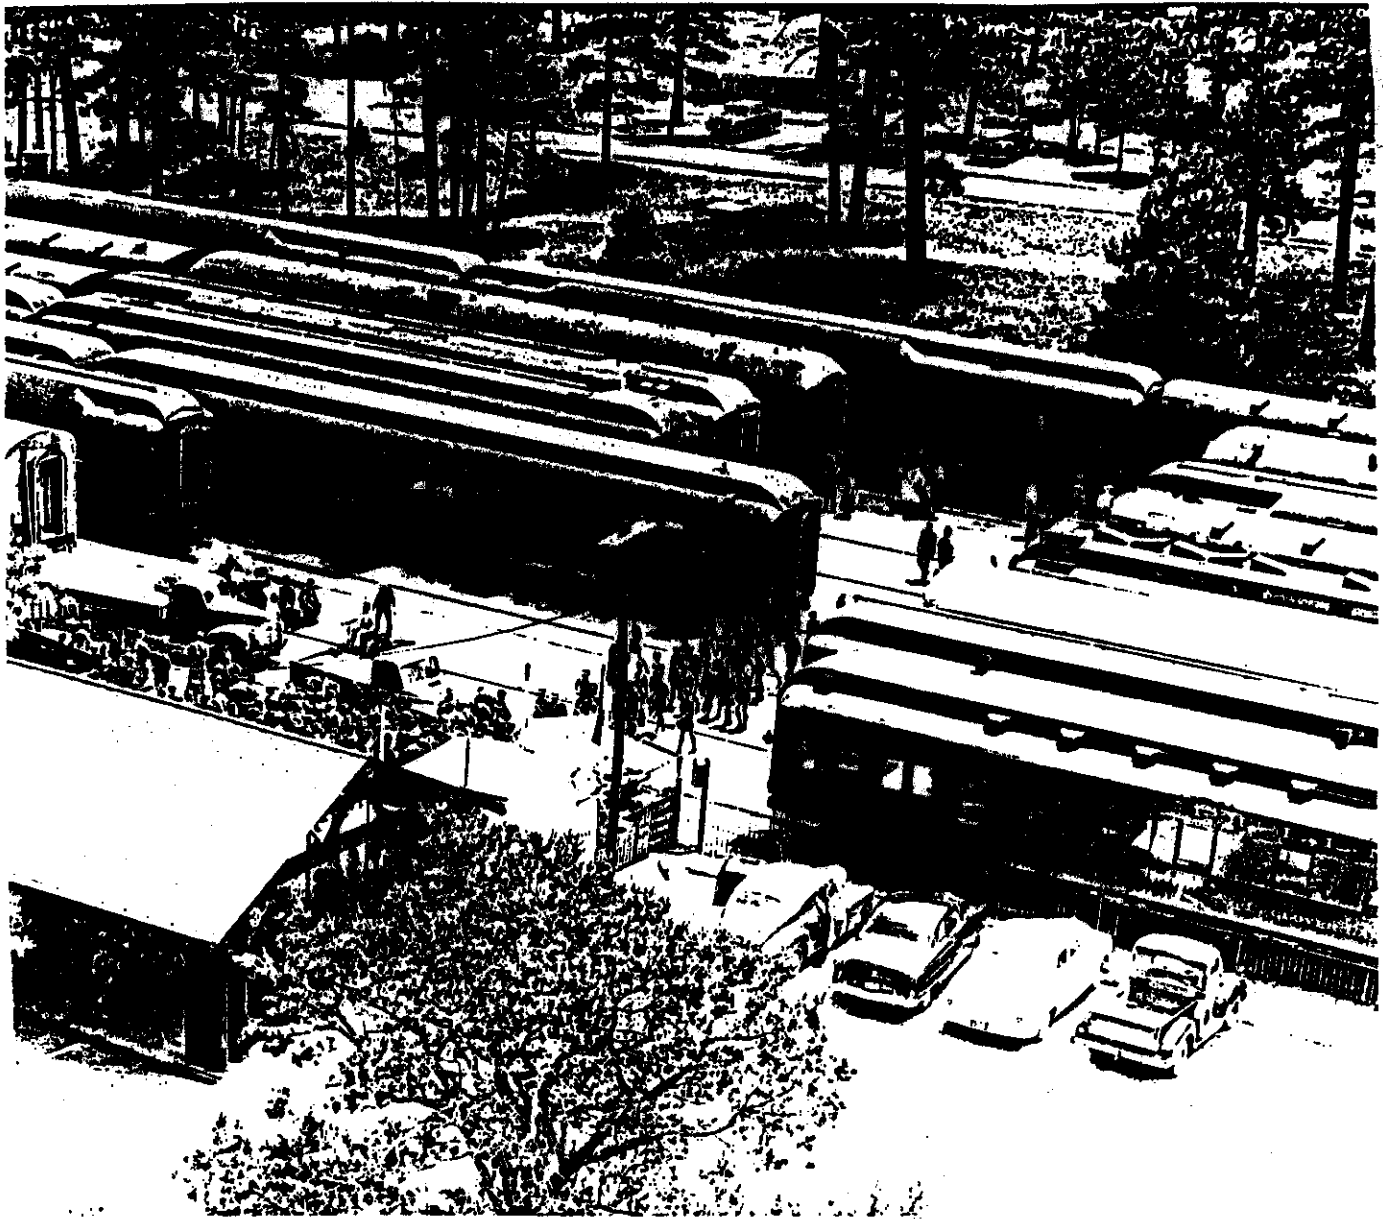
Figure 10. Village Loop in July 1953. Note depot and parking area in the foreground. Divided road segment of Village Loop in the background with parking among the trees of the island. (GRCA Image #2574, GCSC)

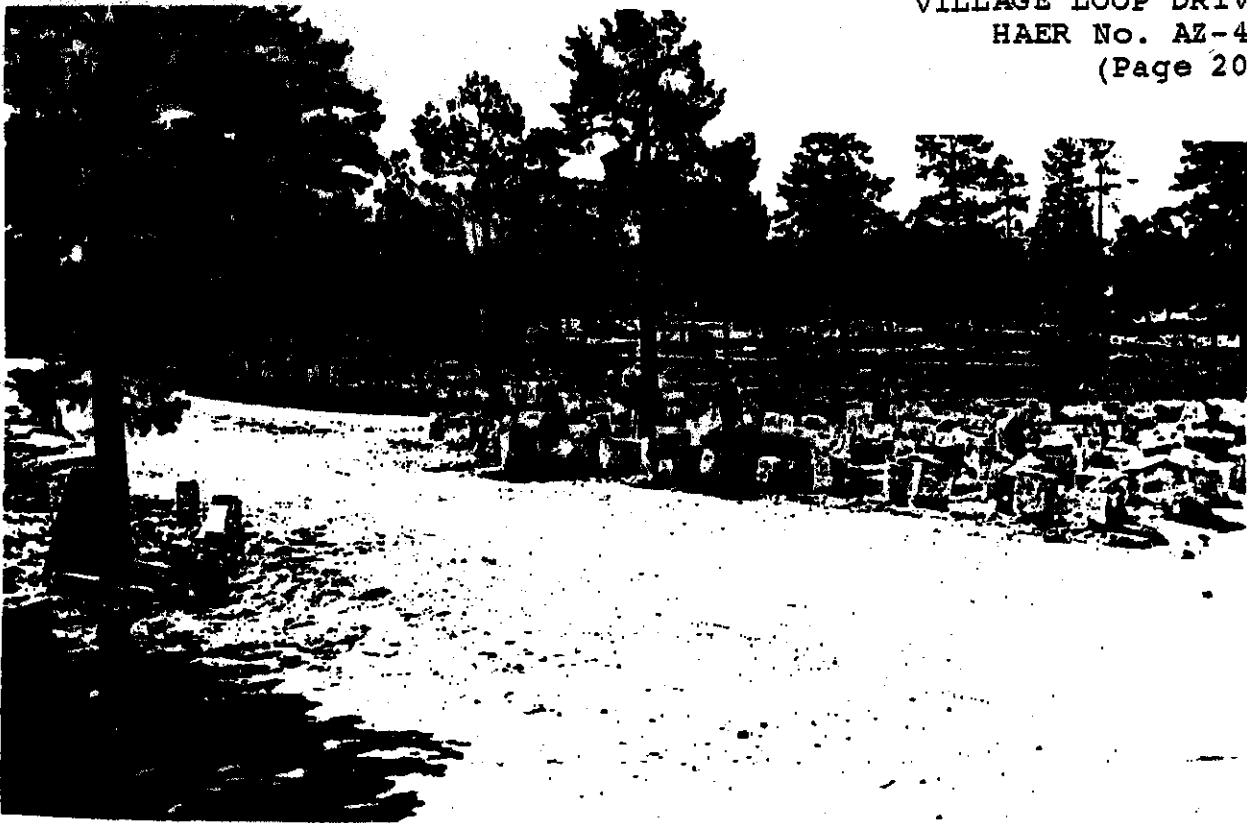
Figure 11. Village Loop construction at Station 26, facing southeast from the first pullout of West Rim Drive, 1935. Masons working on walls and curbs. (GRCA Image #2981, GCSC)

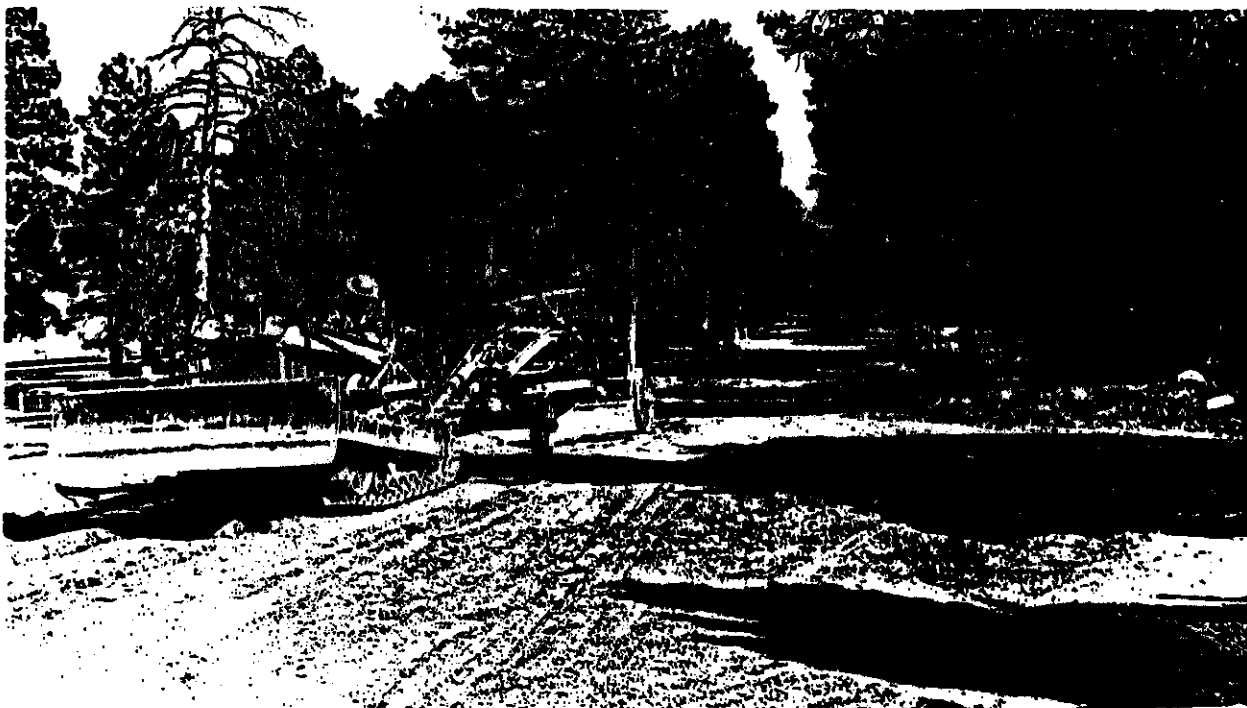
Figure 12. Public Works Administration crews at work on 1935-36 minor roads project (Figure 4). This photograph is facing east, with the divided road in the background. Note the mule corral on the far left of the equipment. (GRCA Image #14017, GCSC)

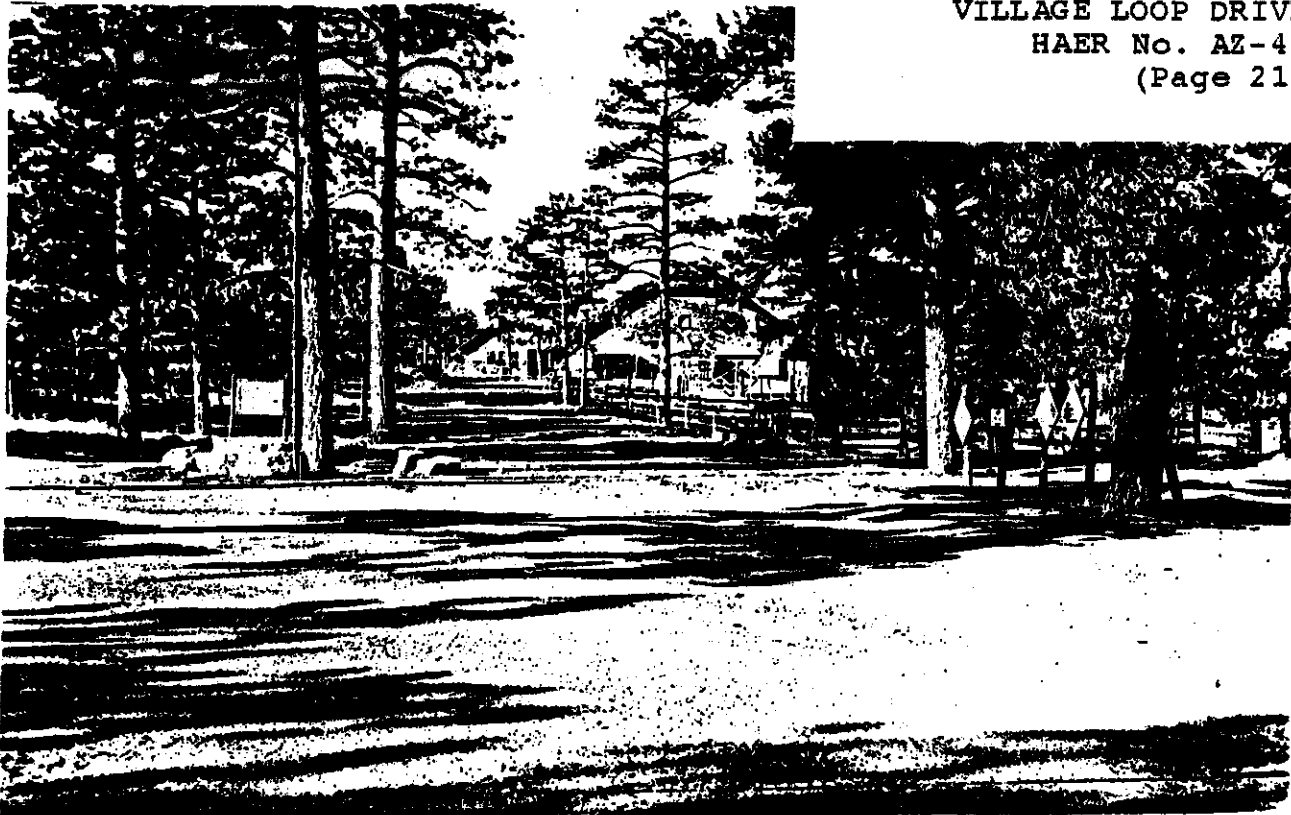
Figure 13. Village Loop facing west to the mule corral and barn from the intersection with Center Road, ca. 1935. Note the highway signs on right, small traffic island on left. Bypass road today runs through the corral area. (GRCA Image #2977, GCSC)

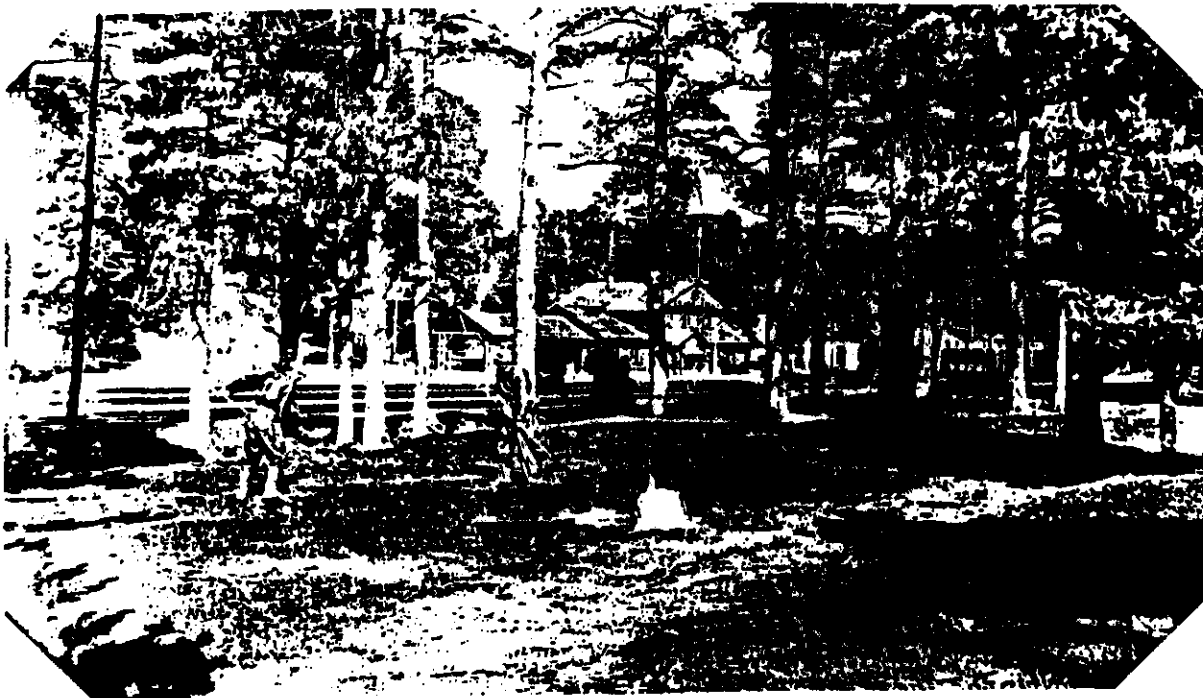
Figure 16. CCC landscaping project between Village Loop and the RR tracks, late 1934. Note the RR depot through the trees. (CCC Reports photo, GCSC)

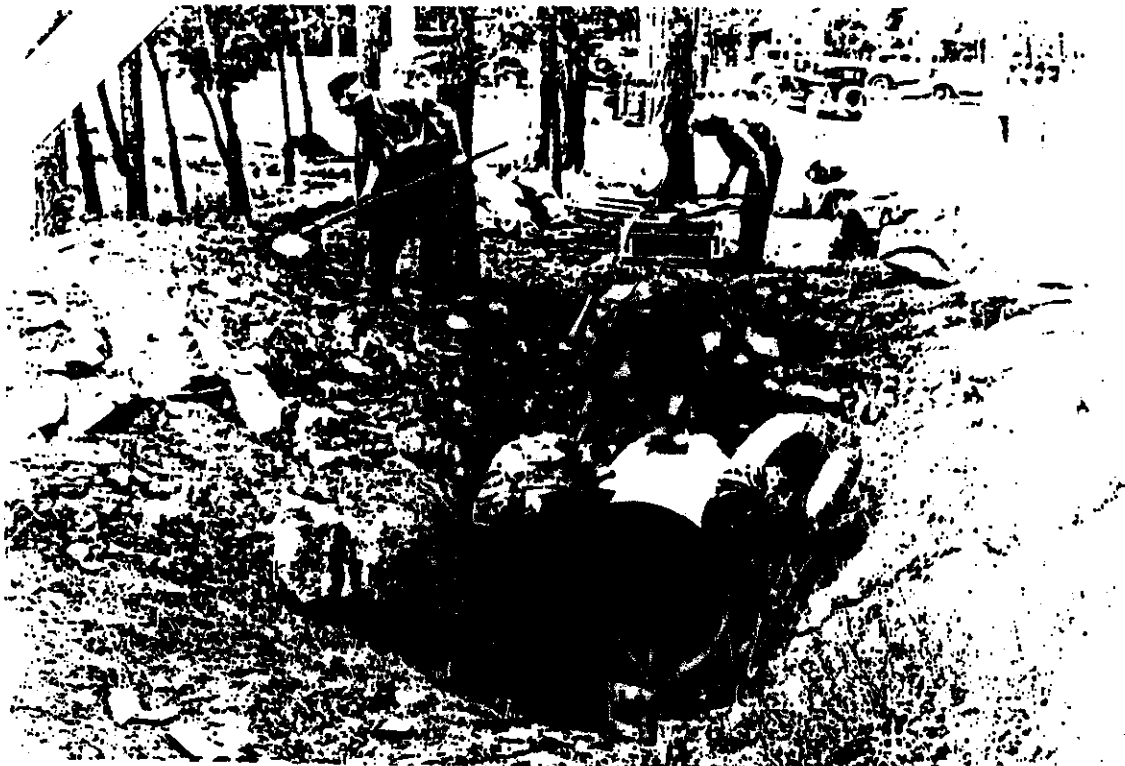
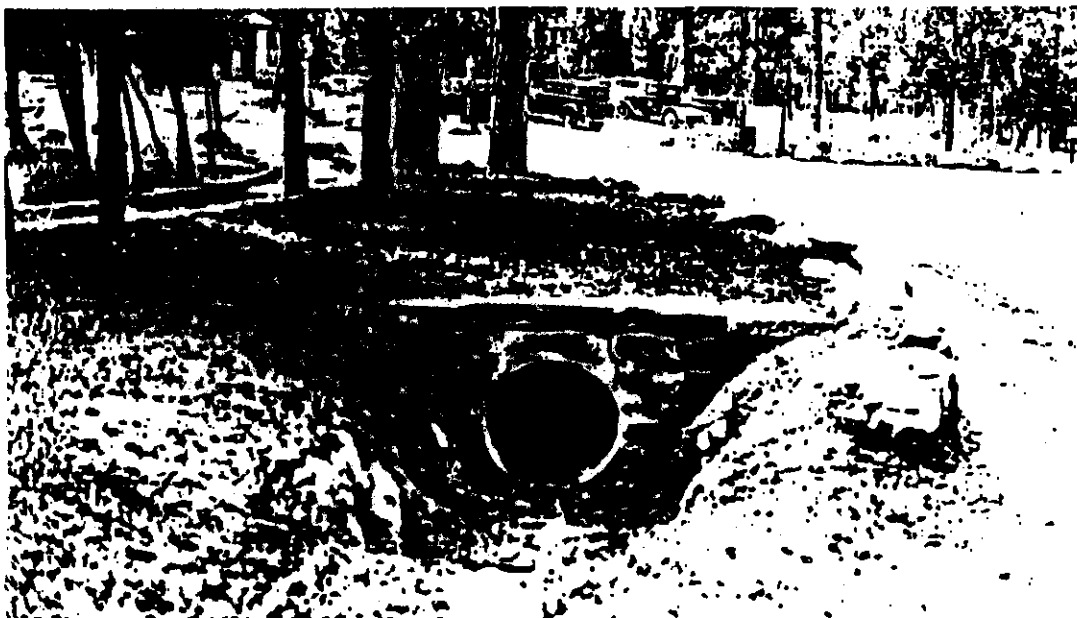
Figure 17-18. Construction of culvert headwall on the southeast corner of Village Loop and Center Road, September 1934. This headwall is being replaced in 1994 construction project. (CCC Reports photo, GCSC)

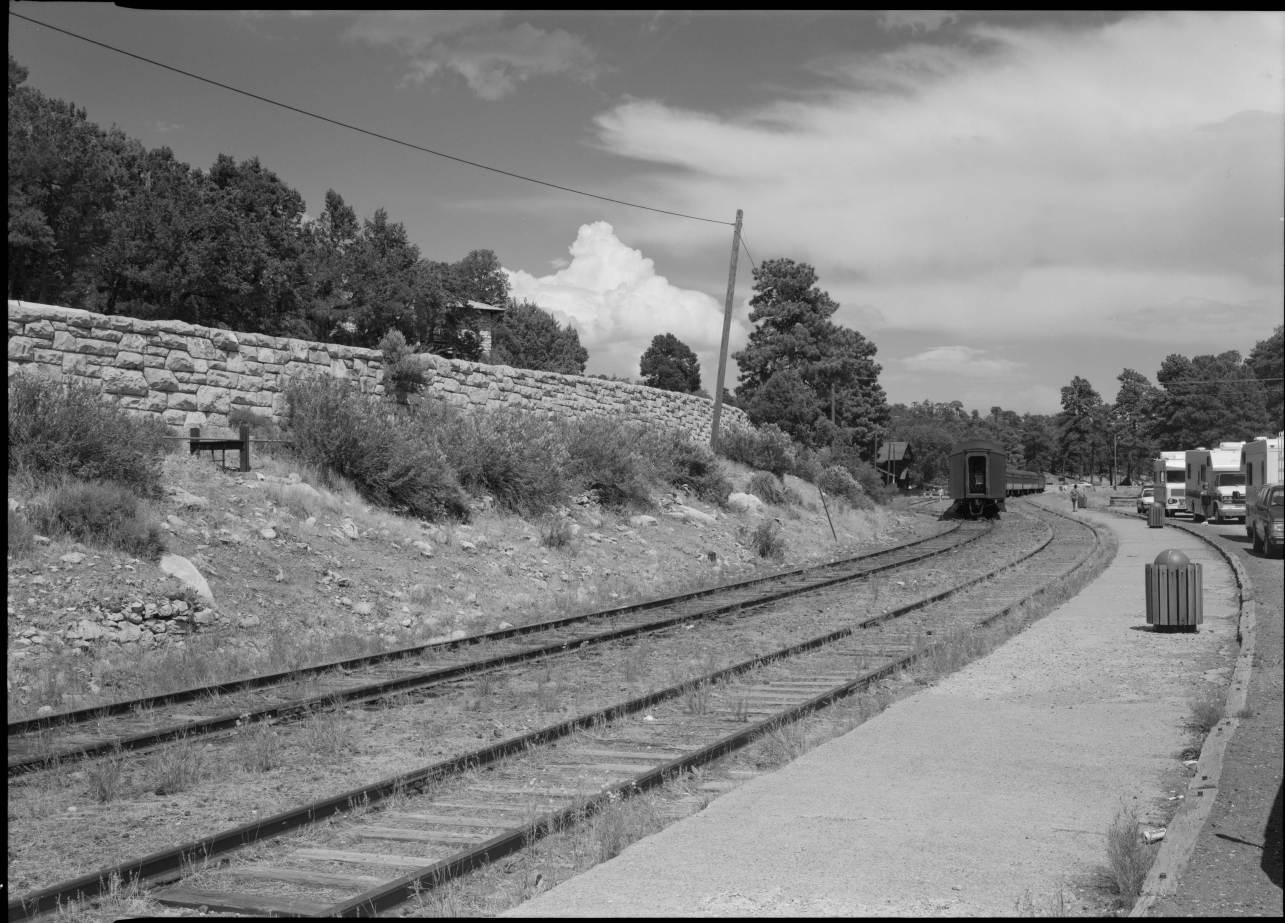
- AZ-41-11 RAILWAY CROSSING ON LOOP ROAD, FACING NW. START OF WEST RIM DRIVE IN BACKGROUND.
- AZ-41-12 RAILWAY TRACKS AND INNER LOOP ROAD, FACING E. POWERHOUSE IN BACKGROUND.
