NORTH ENTRANCE ROAD  
(Grand Canyon Route #4)  
Between Little Park and Bright Angel Point  
Grand Canyon National Park  
Coconino County  
Arizona

HAER No. AZ-43

## NORTH ENTRANCE ROAD (Grand Canyon Route #4) HAER No. AZ-43

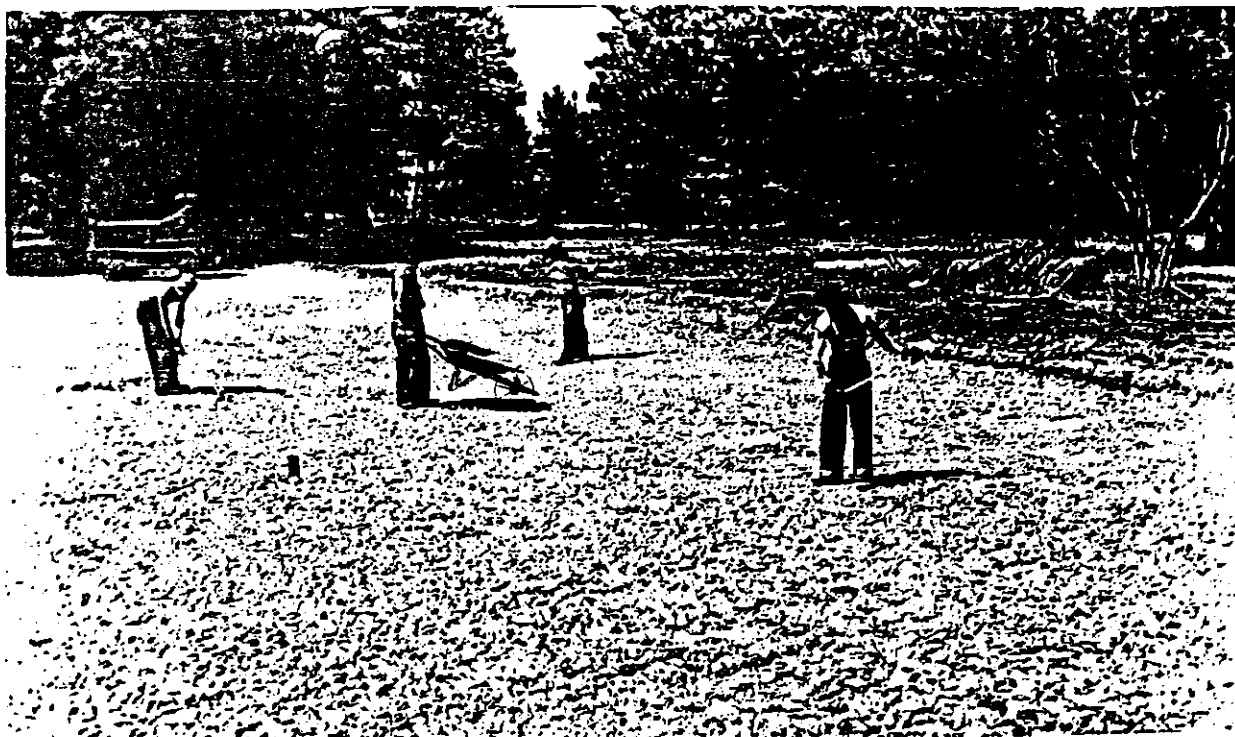
Figure 11. CCC Bright Angel Point parking lot project, July 1935.  
(GRCA Image #2921, GCSC)

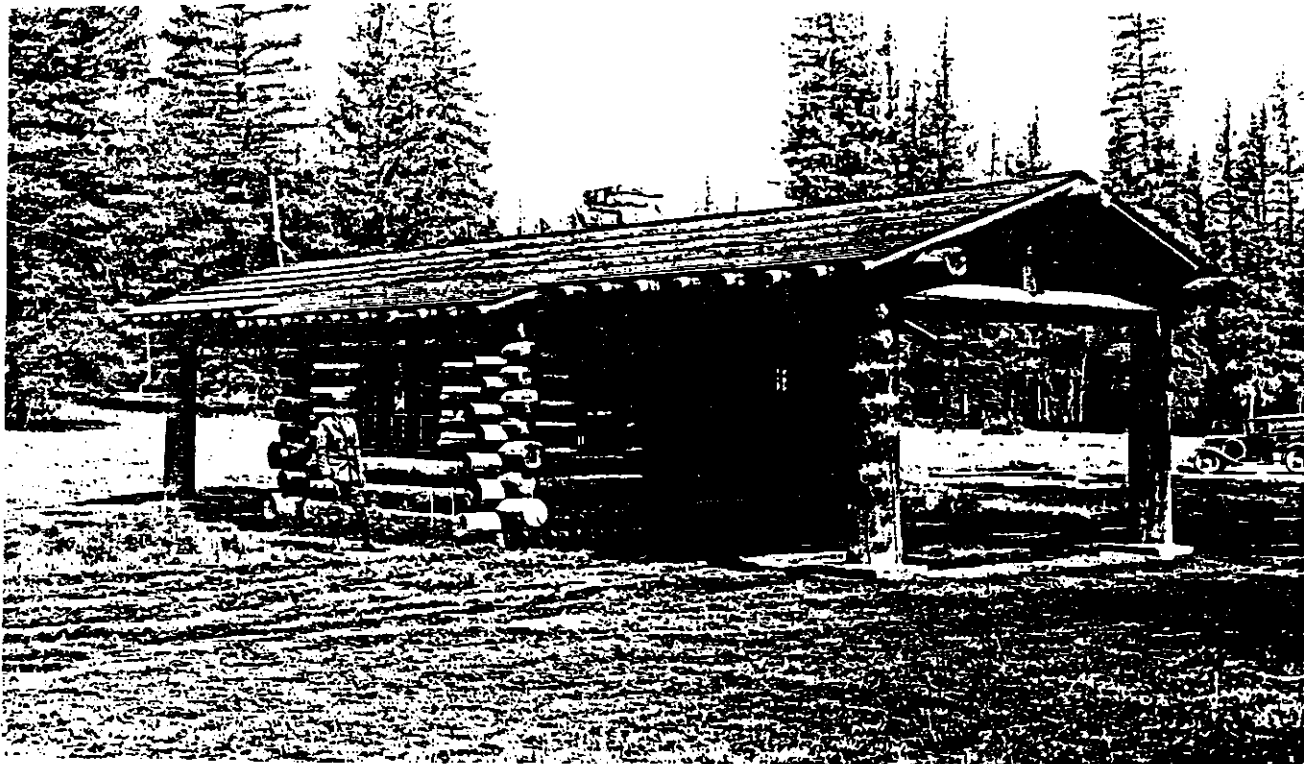
Figure 15. The 1928 north entrance station. This photo taken 14 July 1930 with NPS ranger Ed Laws on the left. (GRCA Image #3824, GCSC)

As constructed in 1928, the entrance station reflected the "trapper variation" (much favored by Stephen Mather) of rustic style architecture with rough-hewn whole logs of variable lengths overlapping at each of its four corners. Carports over both the entrance and exit sides of the structure formed a continuous line with the original shake shingle roof and were supported by massive peeled logs at each corner. The earliest photograph found during research for this project depicts Ranger Ed Laws standing in front of this remarkable structure two years after construction.<sup>15</sup> Its covered entrance concept remained unique at Grand Canyon until construction of the new South Entrance Station in the late 1980s.

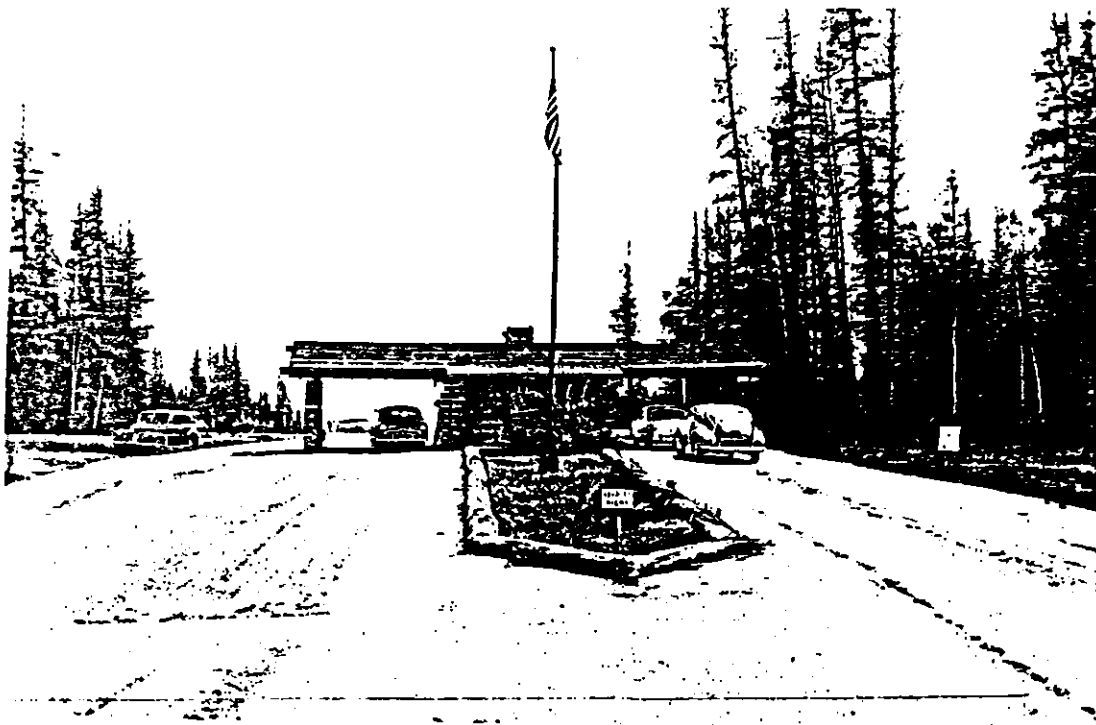
Figure 17. Entrance station, June 1949. (GRCA Image #1767, GCSC)

By 1949, the pine seedlings beside the cabin had reached the eaves of the roof and the site had acquired a few more signs (35 mph speed limit), but otherwise appeared the same as in the 1930s. The first major alterations to the building took place in 1954. The original fireplace which had stood in the structure's center was replaced by an oil stove and the masonry chimney replaced with a standard metal stove-type chimney. The old wooden floor and center partitions were torn out and a concrete floor poured. The ceiling was lowered by installing new rafters and placing a wall board ceiling. New sectional doors, electrical wiring, windows, and outlets were installed, and the whole structure "painted" (apparently stained, at least on the outside) inside and out. The station's exterior remained basically untouched, other than the new chimney arrangement and stain.<sup>17</sup>

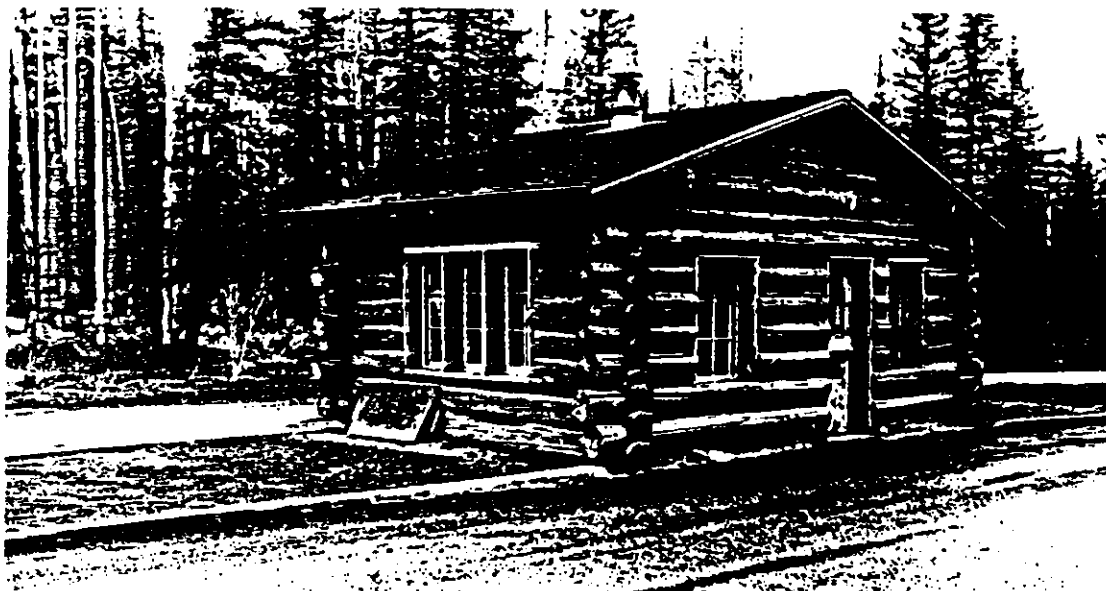
Figure 18. Entrance station in 1950s or 1960s, but date unknown.  
(GRCA Image #10018, GCSC)

Between 1954 and 1964 the station lost its carports and had begun to acquire more traffic and information signs as well as the ugly day-glow orange "dunce caps" which to this day are used to funnel traffic alongside the station. Between 1964 and 1983, the shake shingle roof was replaced or overlaid with corrugated metal, and light fixtures, signs, and other odd entrance paraphernalia attached themselves to the structure. The traffic channelization island was reconfigured (shortened and tapered toward the ends) and log curbing was replaced (perhaps years earlier) by concrete curbing. This is basically how the entrance station appears today: the cabin, an anachronism rather than an adjunct of the forest and the site itself an unappealing portal for park visitors.<sup>18</sup>
