NATIONAL REGISTER OF HISTORIC PLACES  
REGISTRATION FORM

historic name: The Highlands Historic District

other name/site number: Highlands Ranch/Smithsonian #48TE1144

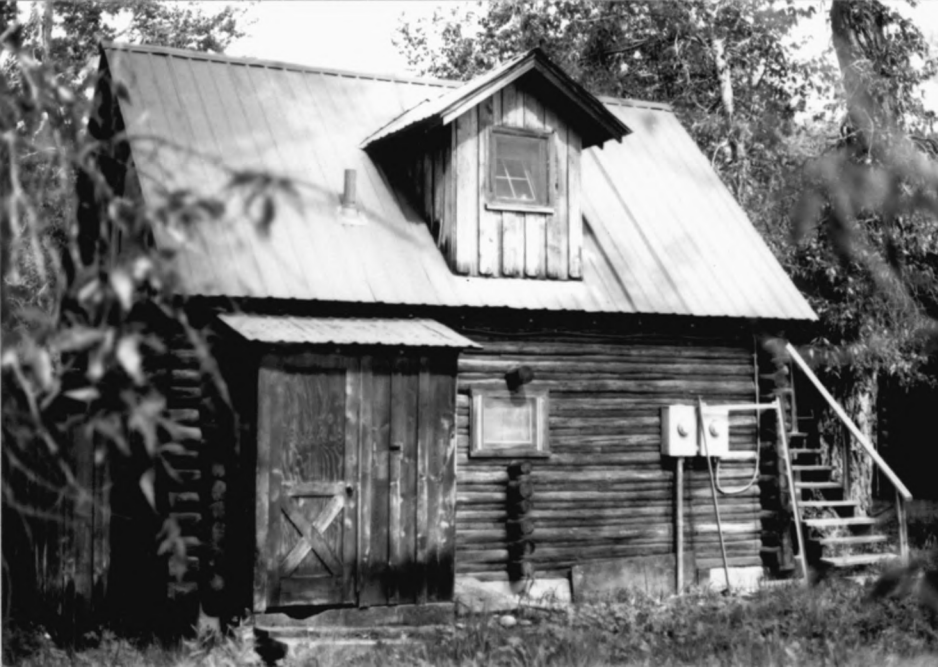
Cabin  
GRTE/1049  
The Highlands H.D.  
GRTE, Tetar Co, WY  
Photographer: HRA, 1995  
View to: NW

Jenkins constructed building #1049 for use as a horse barn at his South Park ranch. Ca. 1947, the barn was moved to The Highlands and converted to a "triplex" guest cabin. Duplex cabin #1049 is a rectangular, one and one-half story log building with a cross-gable roof, constructed on a concrete-wall foundation. The corners are joined with ventral saddle-notches (with flush-cut log ends), and the exterior walls are chinked with split poles. The frame gable ends are finished with 12" boards and 6" battens with decorative scalloped ends. Enameled metal panels cover the steep roof which features exposed milled lumber rafter ends. The east slope of the roof has an intersecting gable-roofed dormer with an adjacent metal pipe-vent.

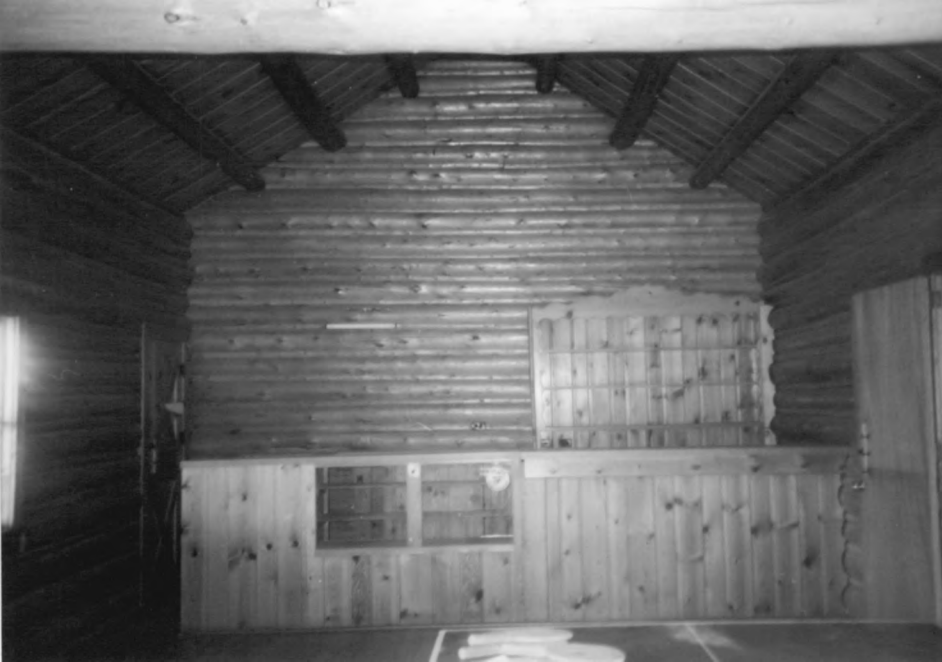
GRTE/1032

Main Lodge

The log component housed The Highlands lounge and commissary. This component is constructed of saddle-notched logs finished with chopper-cut ends, and rests on a concrete-wall foundation. Features within the side-gable roof include wide eaves, exposed log purlins with chopper-cut ends, and an exterior brick/stone chimney, topped with a metal hood. All doors and windows within this component are trimmed with 5" boards.

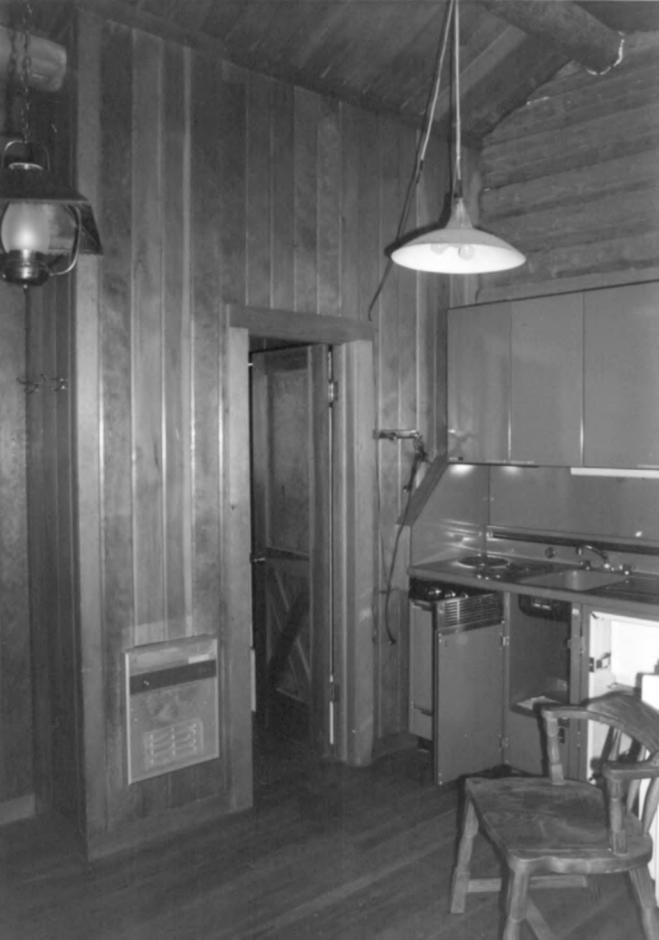
GRTE/1054

Cabin

Building #1054 is a square, one-story, log building with a cross-gable roof, constructed on a concrete-wall foundation. The corners are joined with ventral saddle-notches with chopper-cut log ends. Exterior walls are chinked with split poles. The roof is covered with enameled metal panels and features exposed log purlins with chopper-cut ends, and a metal pipe-vent in the east slope.

Two-inch oak flooring, varnished, covers the bedroom floors. Exterior walls are log. Knotty-pine paneling covers the interior walls, with the exception of the north wall of the north bedroom which is faced with plywood. The ceiling is open, exposing the milled-lumber (4"x6" purlins) and the tongue-and-groove ceiling planks; these planks are stained green in the bedroom and are varnished in the kitchen. Quarter-round trim and a decorative scalloped board finishes the wall/ceiling junction. Vertical plank with X brace doors lead from the kitchen to the bathroom and from the bedroom to the bathroom.

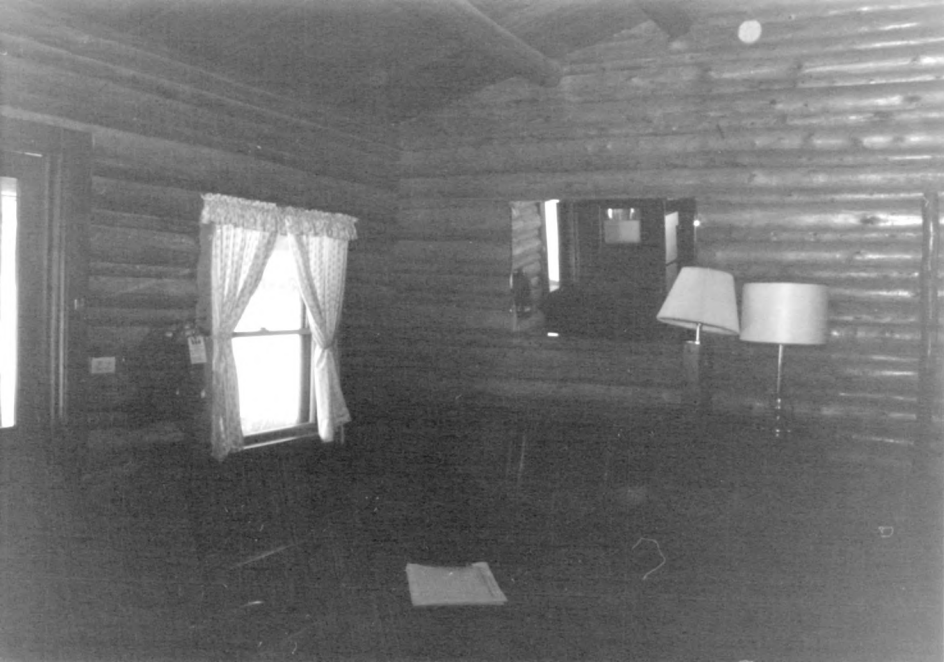
Cabin  
GRTE/1053  
The Highlands H. D.,  
GRTE, Teton Co., WY  
Photographer: HRA, 1995  
View to NW  
JCBW 2#6

Building #1053 is a square, one-story, log building with a cross-gable roof, constructed on a concrete wall foundation. The corners are joined with ventral saddle-notches with chopper-cut log ends. Exterior walls are chinked with split poles. The roof is covered with enameled metal panels and features exposed log purlins with chopper-cut ends, and a metal pipe-vent in the east slope.

Two-inch oak flooring, varnished, covers the bedroom floors. Exterior walls are log. Knotty-pine paneling covers the interior walls, with the exception of the north wall of the north bedroom which is faced with plywood. The ceiling is open, exposing the milled-lumber (4"x6" purlins) and the tongue-and-groove ceiling planks; these planks are stained green in the bedroom and are varnished in the kitchen. Quarter-round trim and a decorative scalloped board finishes the wall/ceiling junction. Vertical plank with X brace doors lead from the kitchen to the bathroom and from the bedroom to the bathroom.

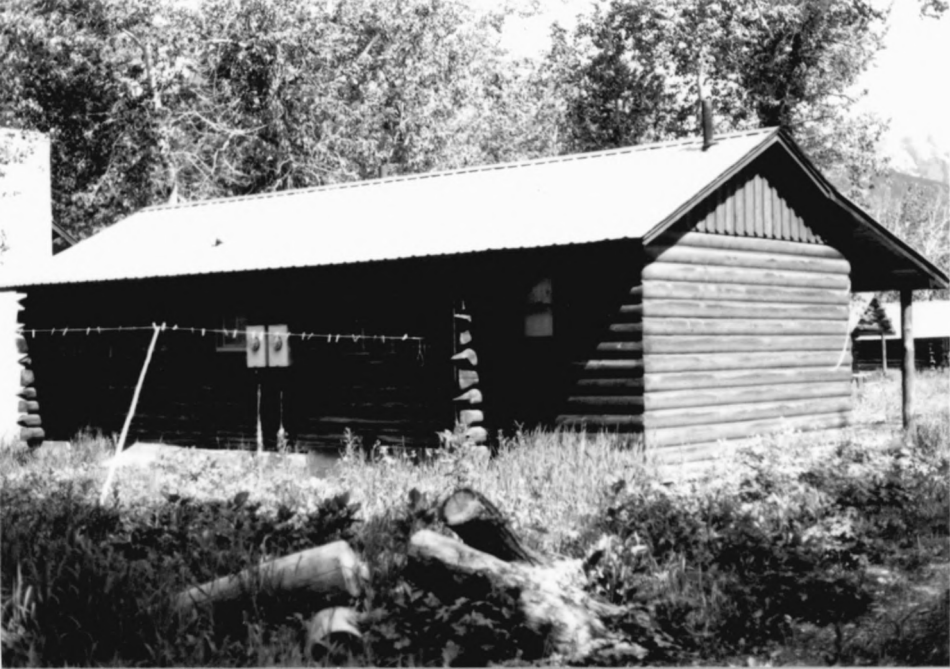
Cabin  
GRTE/1046  
The Highlands H.Q.  
GRTE, Teton Co, WY  
Photographer: HRA, 1945  
View to NW  
Location of neg: NPS, Denver, CO  
JC BW/4 # 7

Charles Byron Jenkins constructed the log component of this cabin in 1940 at his South Park Ranch. The building was moved to The Highlands ca. 1949 and converted, with construction of the frame bathroom addition, to a duplex. Cabin #1046 is a rectangular, one-story, log building with a frame addition located on the east end. The original building and the addition are both constructed on concrete wall foundations, and a cross-gable roof covers both components. The log component is joined at the corners with ventral saddle-notches with chopper-cut log ends, and is chinked on the exterior with split poles. The exterior walls of the frame component are covered with horizontally placed imitation log siding, with board-and-batten finish in the gable end. Enameled metal panels cover the roof, which features two metal pipe-vents in the south slope and one in the north slope.

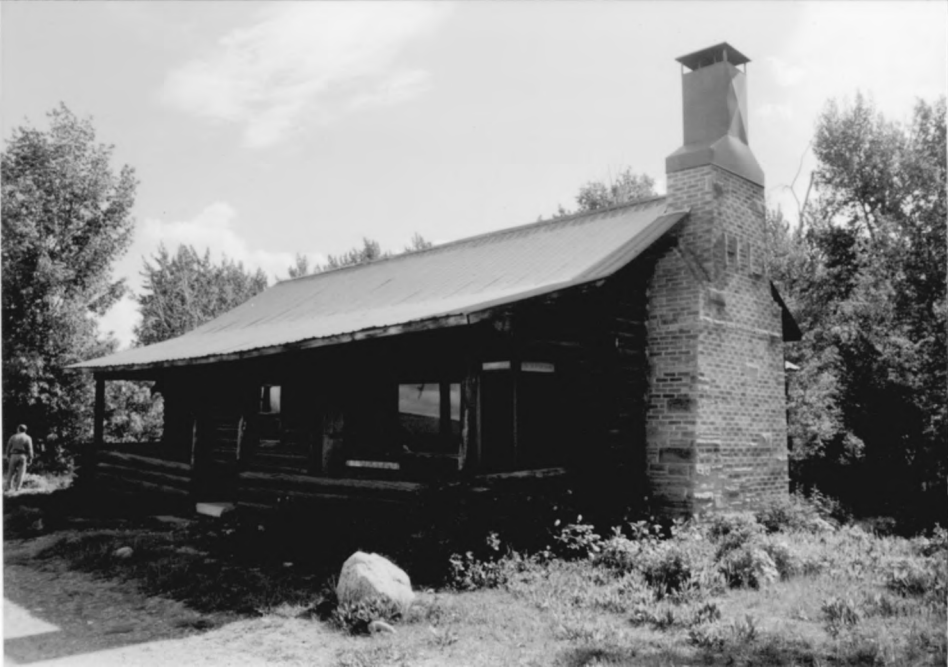
Resource No.: GRTE/1032

Resource Name: MAIN LODGE

Two double-leaf doors, both constructed of knotty-pine vertical planks with X braces and secured with the original forged hinges and latches, provide immediate access to the lounge area (central door) and commissary area (south door). Exterior and interior walls are log with quarter-pole chinking. The ceiling is open, exposing the log purlins, beams, and 12" knotty-pine ceiling planks. Narrow oak planks, varnished, cover the floor; this flooring matches that found in the dining room. Windows and doors are trimmed with 5" butt-joint trim, varnished; windows incorporate a 5" window sill. A custom-made bear-trap light fixture (shown in 1950s photographs) is centered over the lounge area, near the fireplace. In contrast to the brick exterior, the interior chimney wall/fireplace is faced with cut and coursed limestone block, secured with terra-cotta colored mortar. A modern Shrader stove insert now fills the fire box. A log slab forms the mantle. Two built-in seats are located at either side of the hearth.

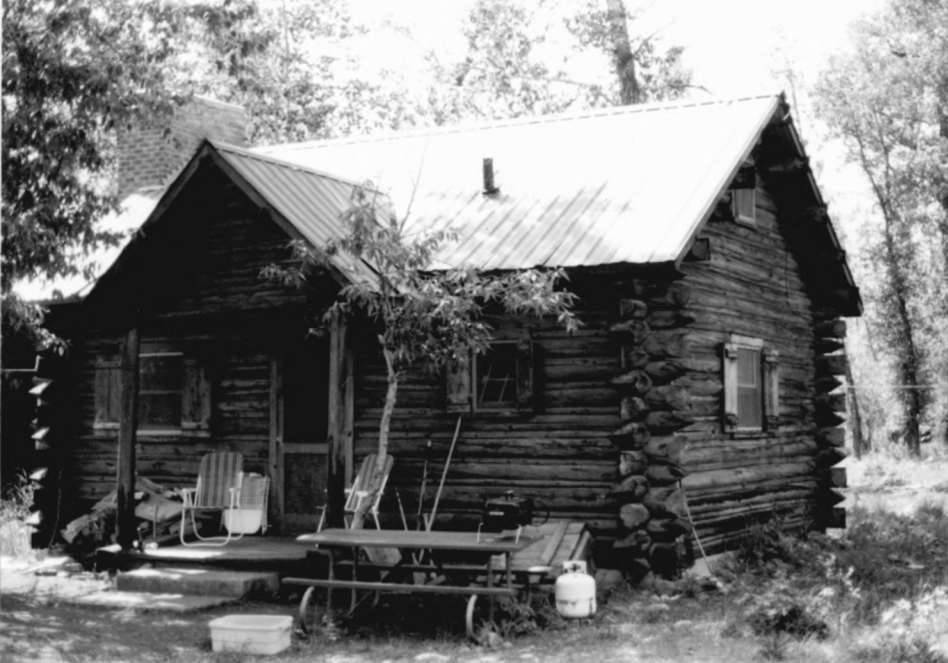
GRTE/1045

Cabin

Cabin #1045 is a rectangular, one-story, log building with a cross-gable roof, constructed on a concrete wall foundation. The corners of the building are joined with ventral saddle-notches, finished with chopper-cut log ends. The exterior walls are chinked with split poles. The roof is covered with enameled metal panels, and features exposed log purlins with chopper-cut ends, a metal pipe-vent on the north slope and an exterior brick chimney on the east elevation.

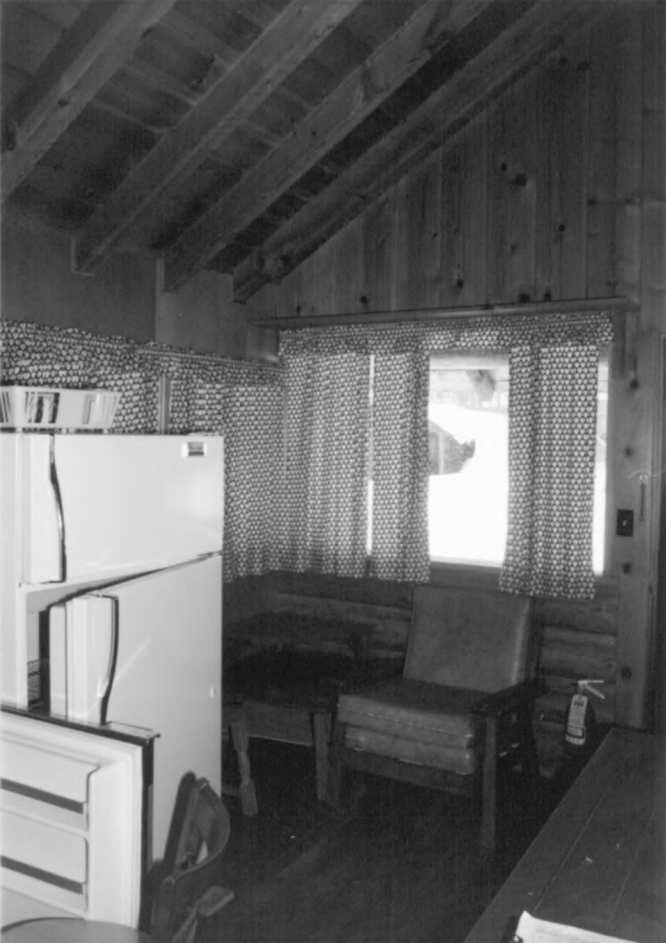
Cabin  
GRTE/1052  
The Highlands H.D.,  
GRTE, Teton Co., WY  
Photographer: HRA, 1995  
View To SW  
Location of Hwy: NPS Denver Co  
JCBW 2 #12

Cabin #1052 is a square, one-story, log building constructed on a concrete wall foundation. The corners are joined with ventral saddle-notches with chopper-cut log ends. Exterior walls are chinked with split poles. The front-gable roof is covered with enameled-metal panels and features exposed 4" X 8" milled-lumber rafter ends, and a small metal pipe-vent in the south slope. The frame gable ends are covered with wood shingles.

Two-inch oak flooring, varnished, covers the bedroom floors. Exterior walls are log. Knotty-pine paneling covers the interior walls, with the exception of the north wall of the north bedroom which is faced with plywood. The ceiling is open, exposing the milled-lumber (4"x6" purlins) and the tongue-and-groove ceiling planks; these planks are stained green in the bedroom and are varnished in the kitchen. Quarter-round trim and a decorative scalloped board finishes the wall/ceiling junction. A vinyl accordion door separates the kitchen and bedroom. Vertical plank with X brace doors lead from the kitchen to the bathroom and from the bedroom to the bathroom.

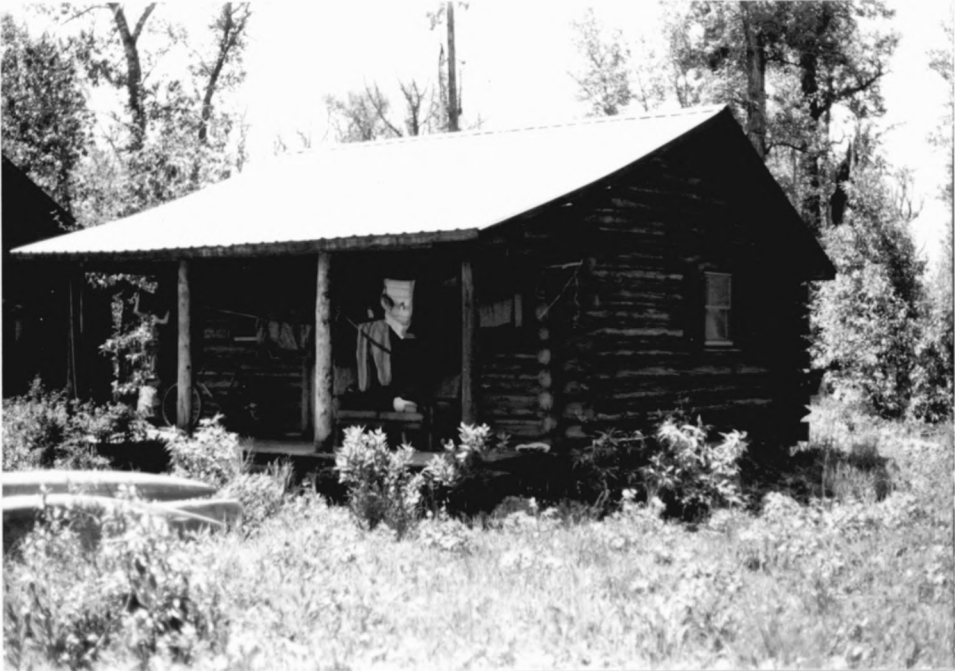
GRTE/1044

Cabin

Cabin #1044 is located at the south end of the building complex -- one of three buildings in an east/west oriented row. Constructed as one of two Highlands "Housekeeping Cabins," the original kitchen was removed in the late 1950s. This is a square, one-story, log building with a cross gable roof, constructed on a concrete wall foundation. The corners are joined with ventral saddle notches; the walls are chinked with split poles; and, the log ends are finished with copper-cut ends. The roof features exposed purlins with chopper-cut ends, and a metal pipe vent in the south slope.

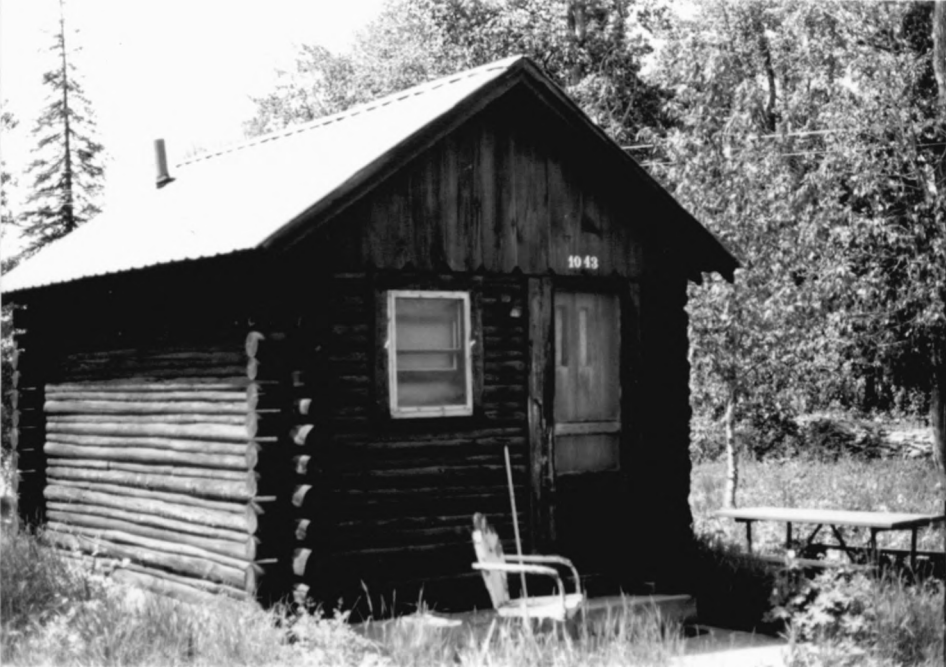
Cabin  
GRTE/1043  
The Highlands H.D.  
GRTE, Teton Co., WY  
HRA, 1995

Ca. 1947, Jenkins moved this small cabin from his South Park ranch (where it had been constructed as a refrigerator house) to The Highlands where it served as a guest cabin. Cabin #1043 is a small, rectangular, one-story log building with a front-gable roof, constructed on a concrete-wall foundation. The corners of the building are joined with ventral saddle notches, the log ends are cut flush, and the walls are chinked with split poles. The frame gable ends are finished with 12" tongue-and-groove boards with a decorative cut at the bottom. Enameled metal panels cover the roof which features a metal pipe vent in the east slope.

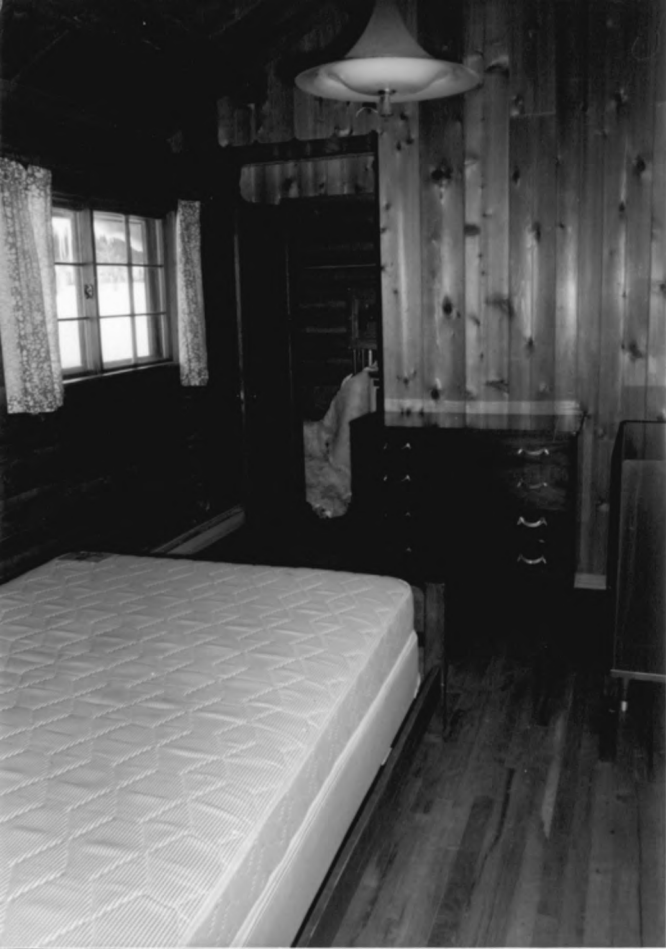
GRTE/1051

Cabin

Like "sister cabin" #1042, cabin #1051 was moved from Wilson to The Highlands ca. 1965. Cabin #1051 is a rectangular, one-story, log building with a front-gable roof constructed on a concrete block foundation. The building is joined at the corners with ventral saddle-notches with log ends that flare slightly at the bottom. The exterior walls are chinked with split poles. The roof is covered with enameled metal panels and features a metal pipe-vent in the north slope.

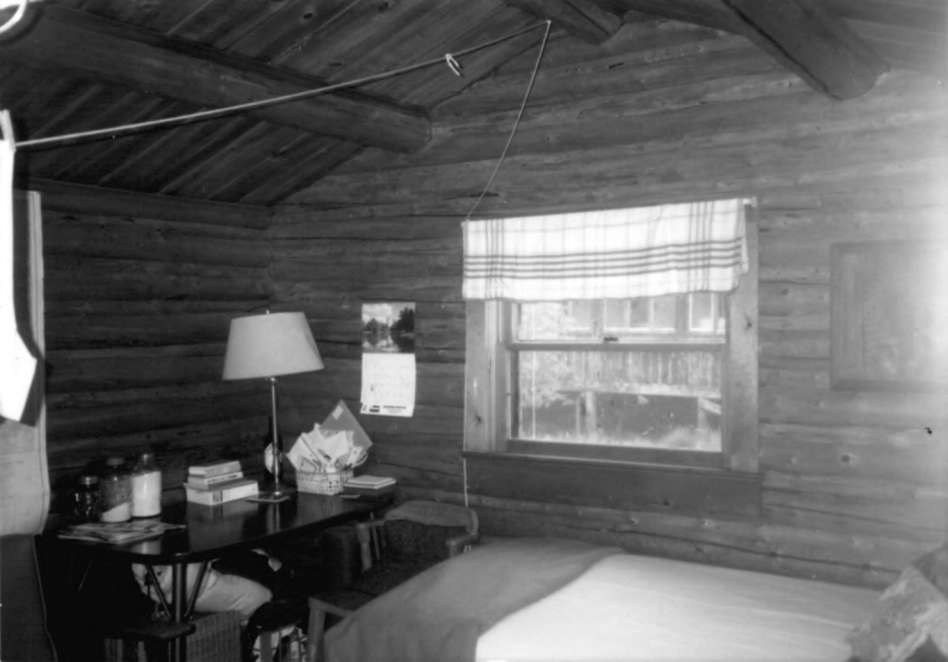
GRTE/1035

Cabin interior

Cabin #1035 represents the northern-most building in a north/south oriented row of six cabins located on the west side of a central grassy courtyard; it may represent the Sensenbach's original homestead cabin. This is a small, rectangular, one-story notched-log building, constructed on a concrete-wall foundation and joined at the corners with ventral saddle notches. The exterior walls are chinked with split poles and the log ends are cut flush. The cross-gable roof is covered with enameled metal panels, and features exposed rafter ends and a metal pipe vent in the south end of the west slope.

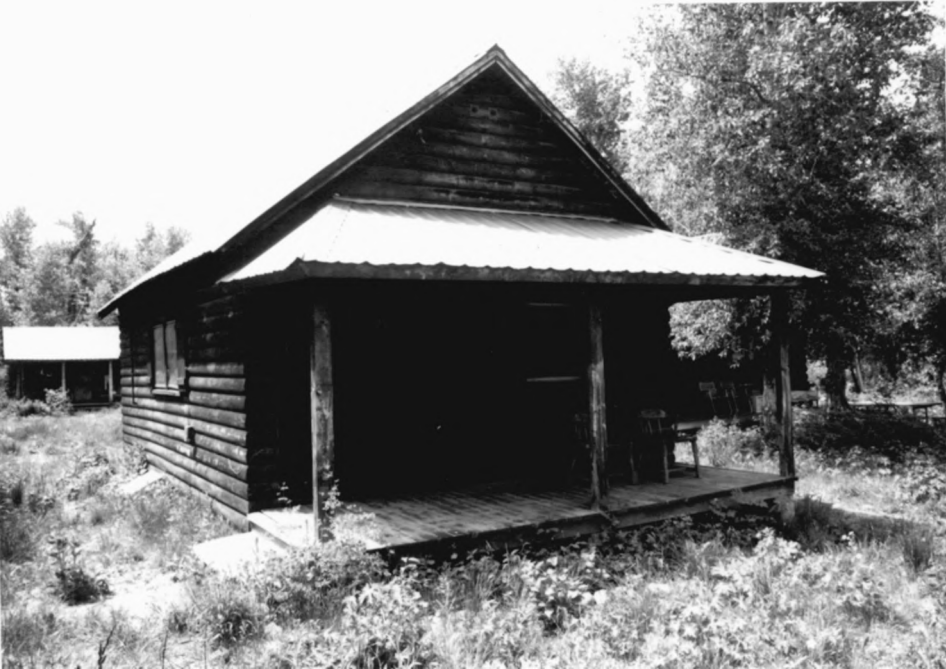
Cabin  
GRTE/1041

Cabin #1041, historically used during the summer months as a tourist "Housekeeping Cabin" [with kitchen] and during the winter months as a caretakers cabin, is located directly behind (west) of cabin #1040. The original kitchen was removed in the 1960s. This is a one-story frame building with a front-gable roof, constructed on a concrete wall foundation. The exterior walls are covered with imitation log siding, and the roof with enameled metal panels. An open porch with a half-hipped roof, and constructed on concrete

Frame cabin #1041 contains a large central room, small bath, and closet. Wall-to-wall carpeting, paired with modern 2" baseboards, covers the floor of the central room. Interior and exterior walls are finished with 5" tongue-and-groove knotty-pine paneling. The ceiling is vaulted, exposing the log ridgepole, rafters, and two milled-lumber beams, all stained black. In contrast to other cabins within the complex, the knotty-pine ceiling planks are stained white (rather than varnished) and stand in stark contrast to the black-stained rafters and ridgepole.

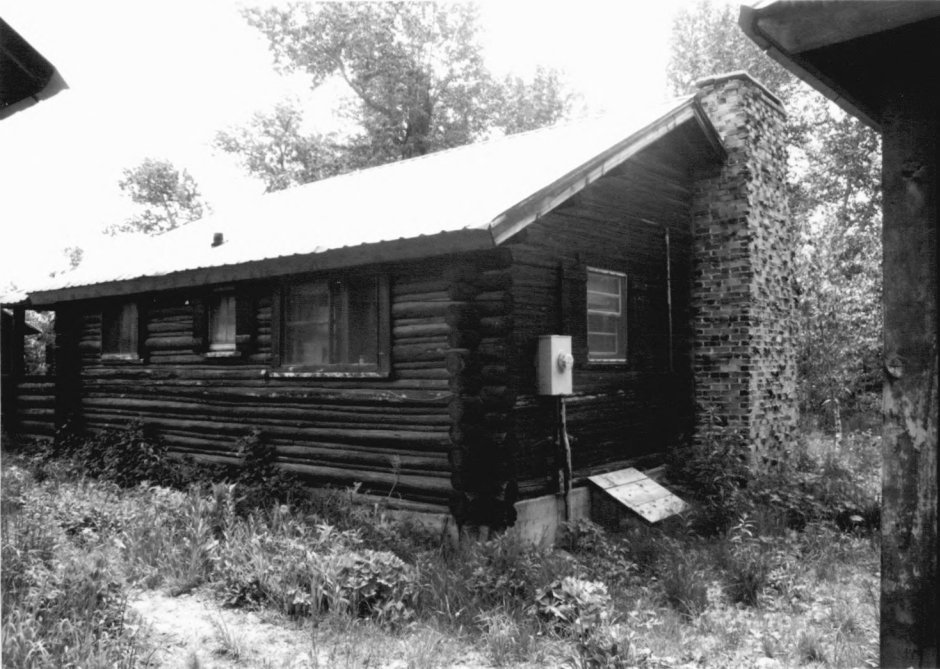
Cabin  
GRTE/1040  
The Highlands H.P.  
GRTE, Teton Co., WY  
HRA, 1995  
View to SE

Cabin #1040 is the southern most building within a series of six cabins positioned in a north/south-oriented row on the west side of a central grassy courtyard. This is a rectangular, one-story log building, joined at the corners with ventral saddle notches, and constructed on a concrete-wall foundation. The exterior walls are chinked with split poles, and the log ends are cut flush.

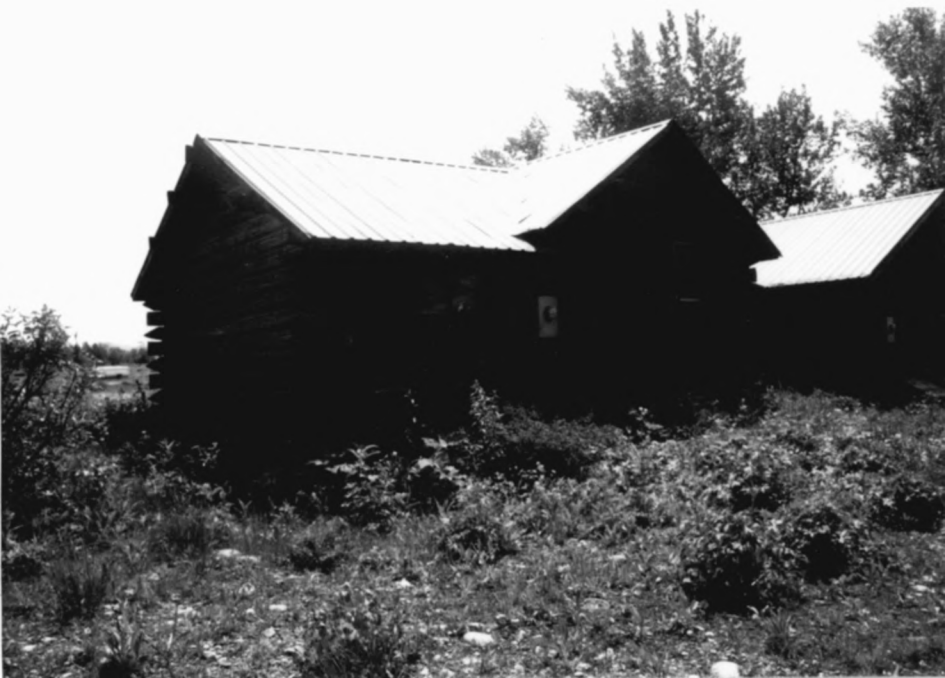
GRTE/1039

Cabin

Cabin #1039 is a one-story, "L"-shaped, log building constructed on a concrete wall foundation. The exterior log walls are chinked with split poles and feature copper-cut log ends. The intersecting gable roof is covered with enameled metal panels, has exposed log purlins with chopper-cut log ends, and a metal pipe vent in the south slope of the east/west oriented gable.

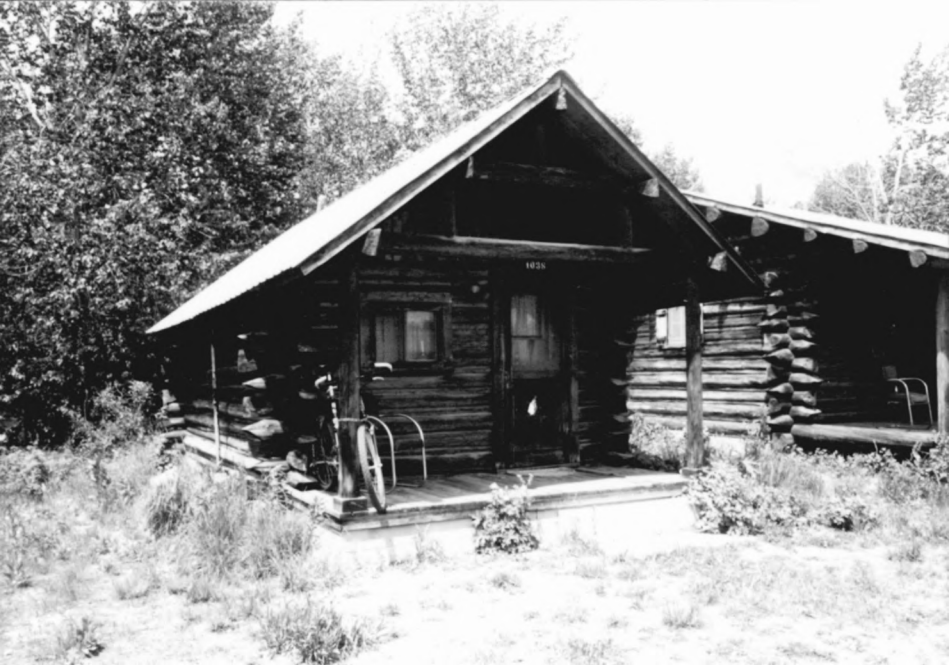
GRTE/1038

Cabin

Cabin #1038 is a rectangular, one-story, log building joined at the corners with ventral saddle notches, and constructed on a concrete wall foundation. The exterior log walls feature chopper-cut log ends and split pole chinking; the wood-frame gable ends are finished with boards and battens. The front-gable roof is covered with enameled metal panels, and has exposed log purlins with chopper cut ends.

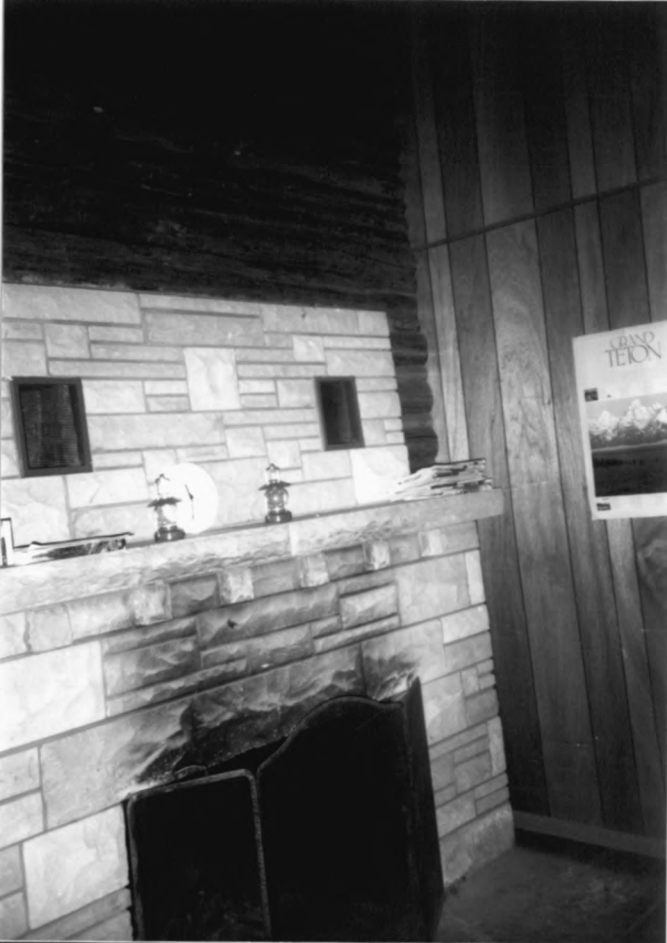
Duplex Cabin  
GRTE/1050

A substantial replacement for the Sensenbach's presumably modest homestead cabin, residence #1050 was originally located in the northeast corner of the site. Ca. 1947, Jenkins moved the building to its current location where it served first (1947-1952) as The Highlands kitchen, dining room, and "employee quarters" (housing Jenkins and his wife Jeanne). Ca. 1952, following completion of the frame additions to building #1032, the building was once again remodeled, this time to a large four-bedroom, two-bath guest cabin. Ca. 1972, NPS crews converted the building to a duplex.

This is a one-story log building with a frame addition on the east elevation. Both components are constructed on concrete-wall foundations. The addition and a partial porch on the west elevation give the building an irregular footprint. The log component is joined at the corners with ventral saddle-notches with flush-cut log ends, and is chinked on the exterior with split poles. The cross-gable roof features exposed log purlins, a small metal pipe-vent on the west slope, and an exterior brick chimney that projects above the north elevation eave.

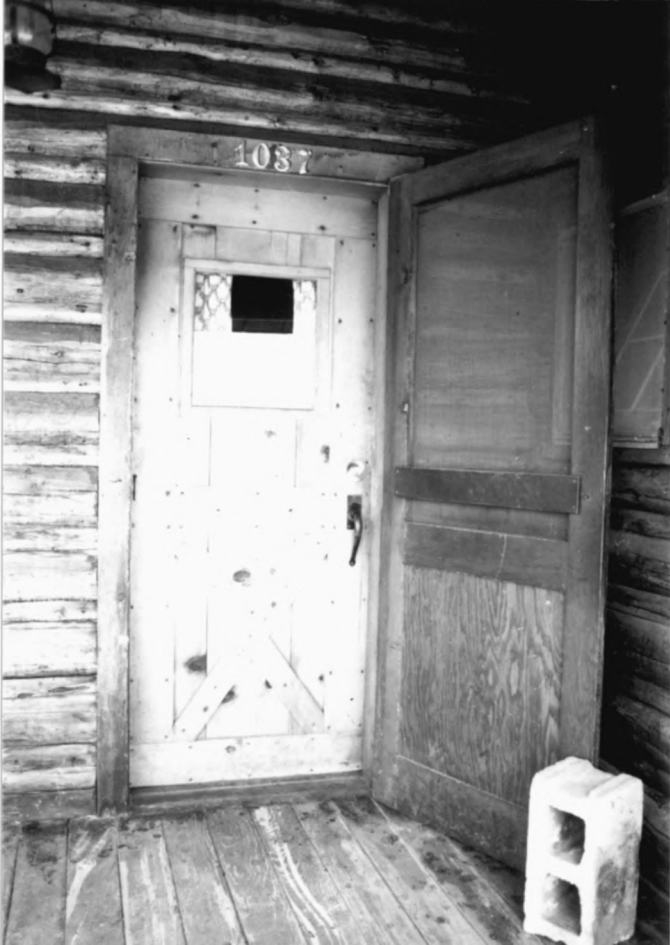
GRTE/1037

Door detail

Cabin #1037 is a one-story log building joined at the corners with ventral saddle notches, and constructed on a concrete wall foundation. The log walls feature chopper-cut log ends and split pole chinking. The side-facing salt box roof is covered with enameled metal panels, and features exposed log purlins with chopper-cut ends, and a metal pipe-vent in the east slope.

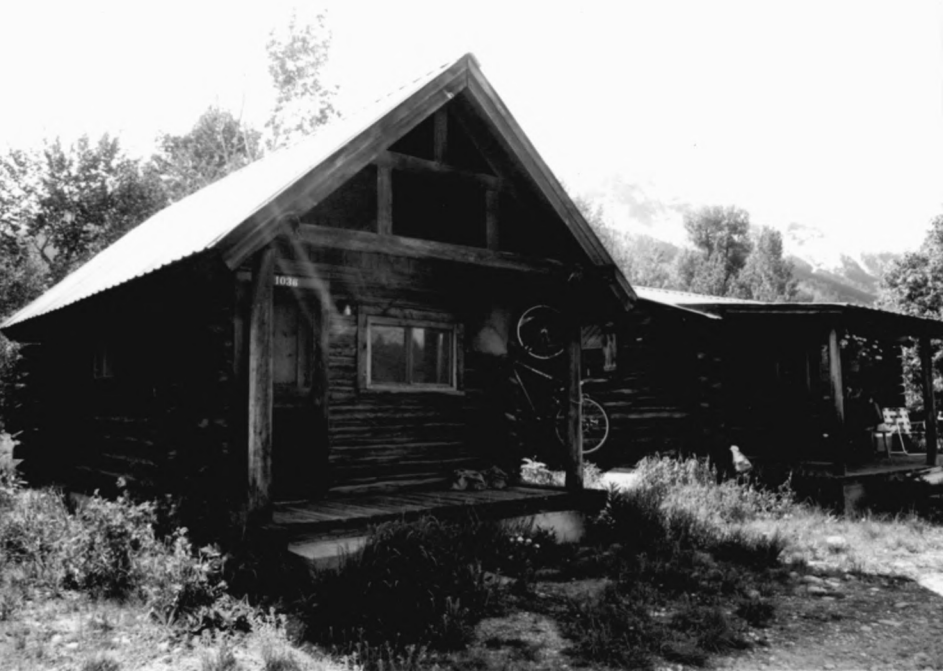
GRTE/1036

Cabin

Cabin #1036 is one of a series of six buildings positioned in a north/south-oriented row, on the west side of a central grassy courtyard. This is a small, rectangular, one-story log building joined at the corners with ventral saddle notches, and constructed on a concrete-wall foundation. The exterior walls feature split pole chinking and copper-cut log ends. The front-gable roof is covered
