# Shoreline Change at Gulf Islands National Seashore, Florida and Mississippi

## *2018–2022 Data Summary*

Natural Resource Data Series NPS/GULN/NRDS—2022/xxxx

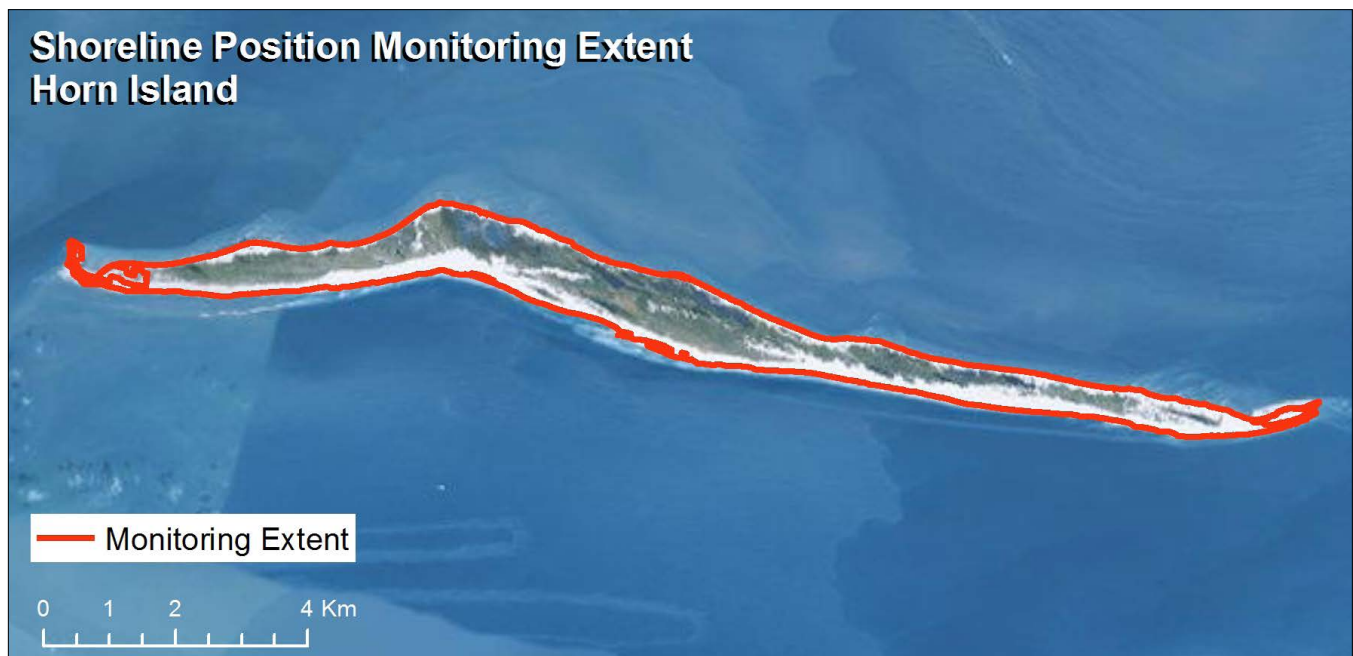
**Figure 1.** Shoreline Position monitoring extent—Horn Island.

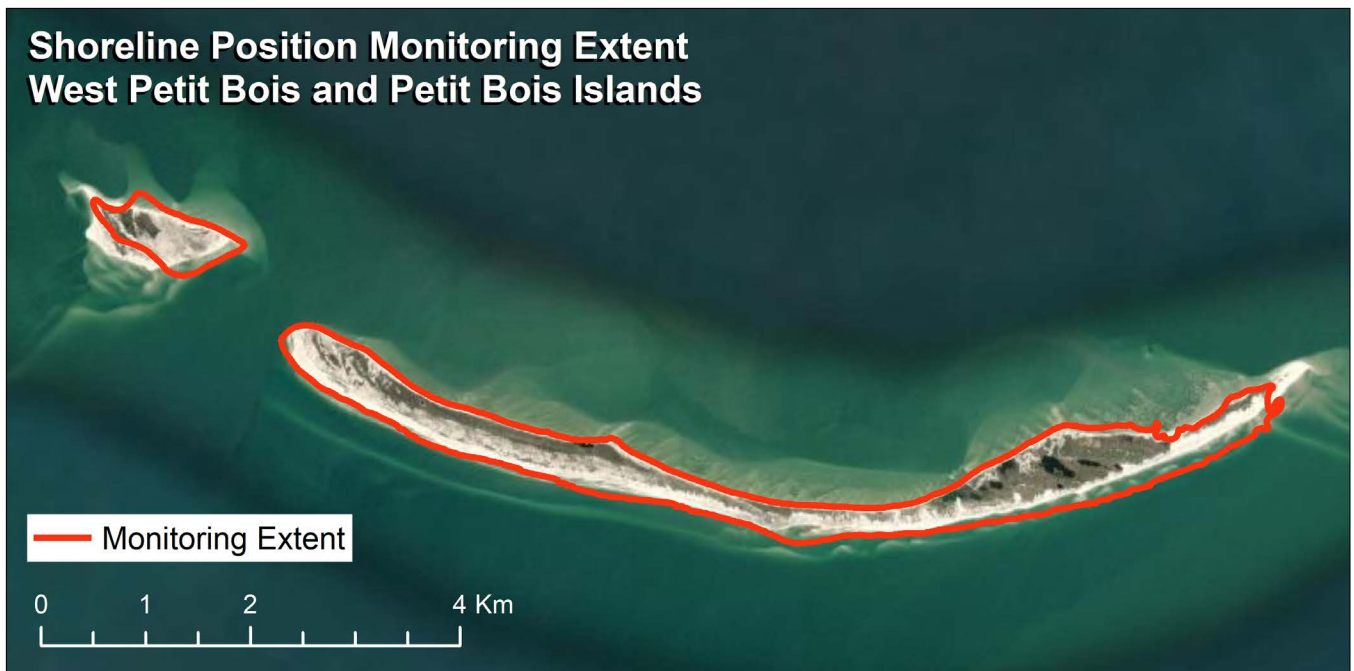
**Figure 2.** Shoreline Position monitoring extent—West Petit Bois Island, Petit Bois Island.

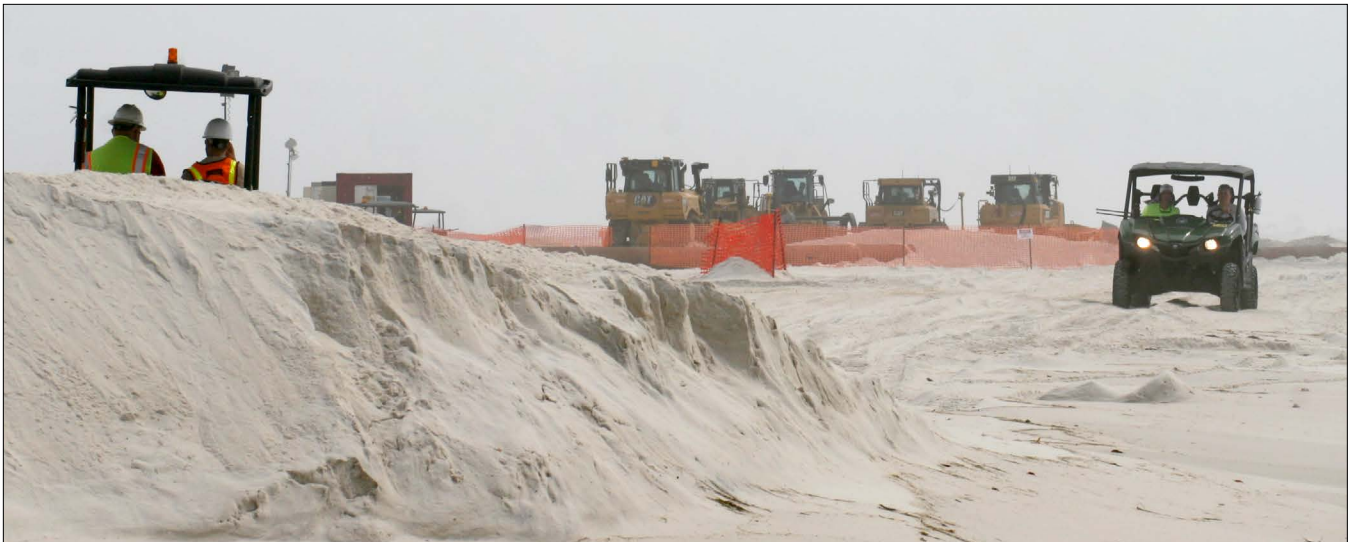
**Figure 14.** Heavy equipment and enclosure fencing associated with restoration work at Perdido Key.
