George Washington Memorial Parkway - North Visual Resource Inventory & Assessment

Spout Run to the Capital Beltway

Daniel Schaible, NCRO Cultural Resource Specialist

November, 2014

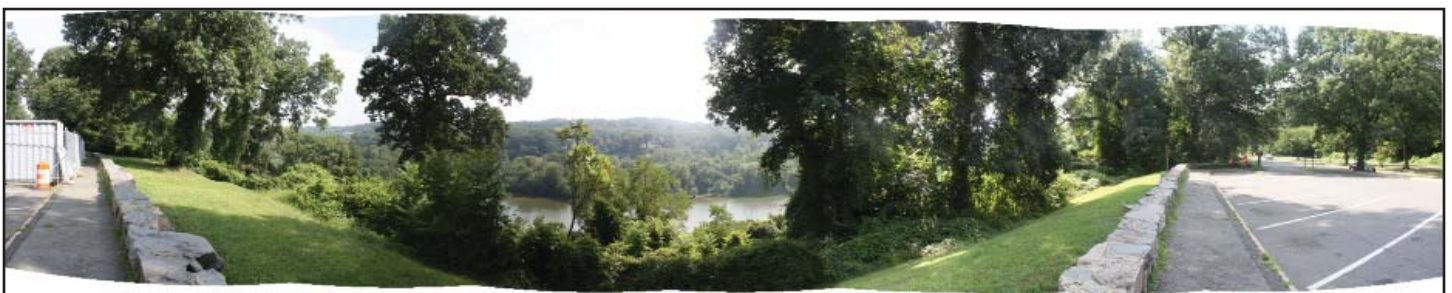
Panoramic vista from Scenic
Overlook #1, Northbound (2013,
NCRO).

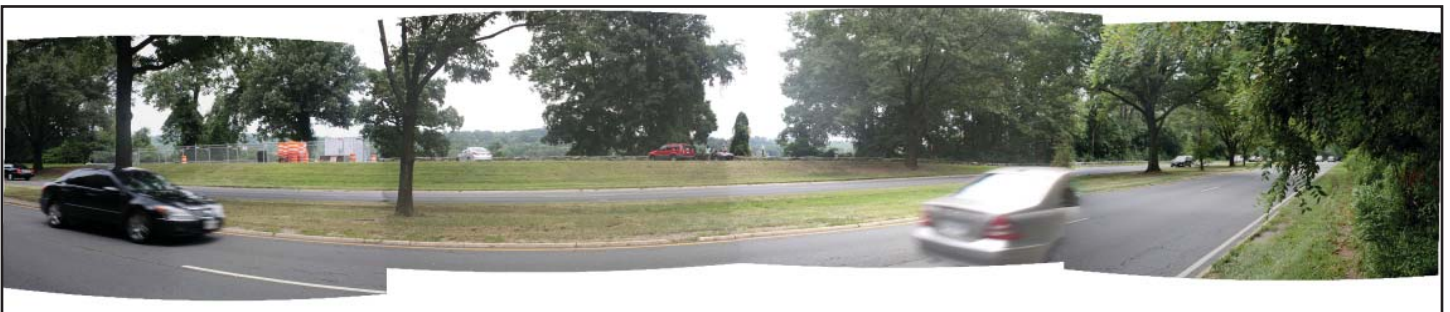
Panoramic vista from Scenic
Overlook #1, Southbound (2013,
NCRO).

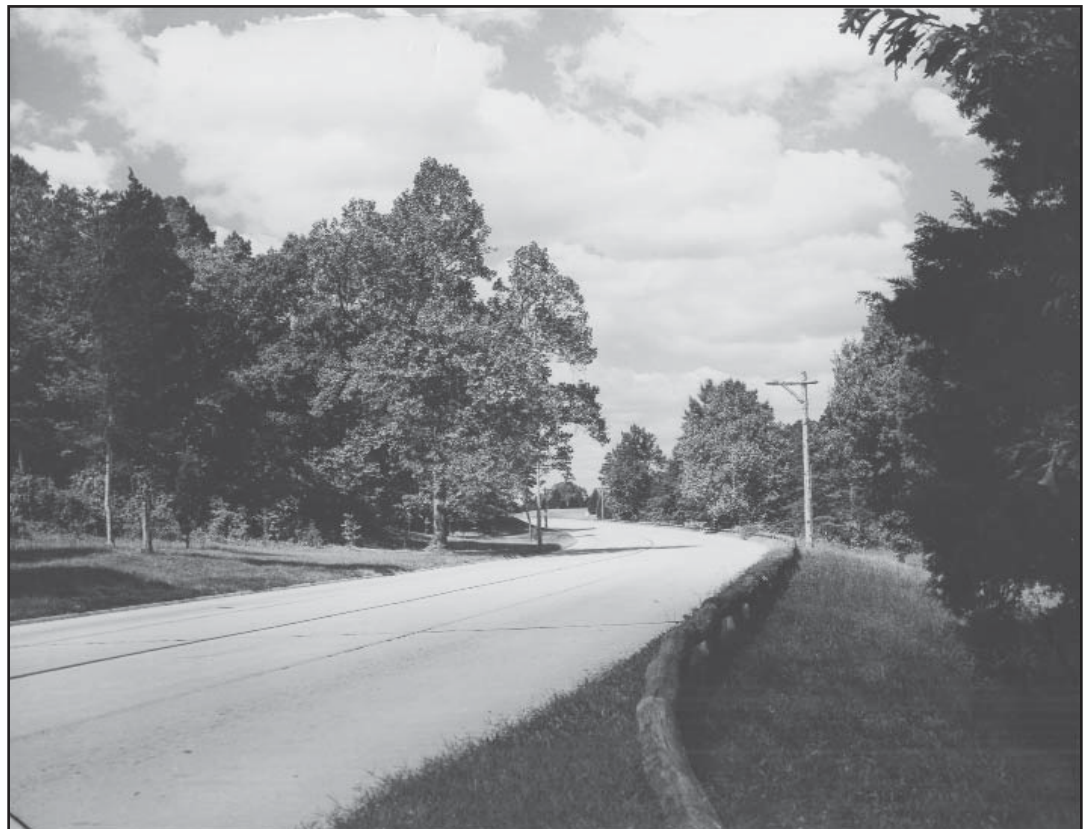
Figure 1.0. 1949 photograph of the Mount Vernon Memorial Highway portion of the road, which was constructed in the late 1920s and early 1930s, well in advance of the northern portions of the GWMH. In historic photographs, this section of the Parkway is easily differentiated from the northern section by its wooden guardwall and street light, concrete paving, and its relatively tighter curves (Image courtesy of the NPS Museum Resource Center, George Washington Memorial Parkway images).

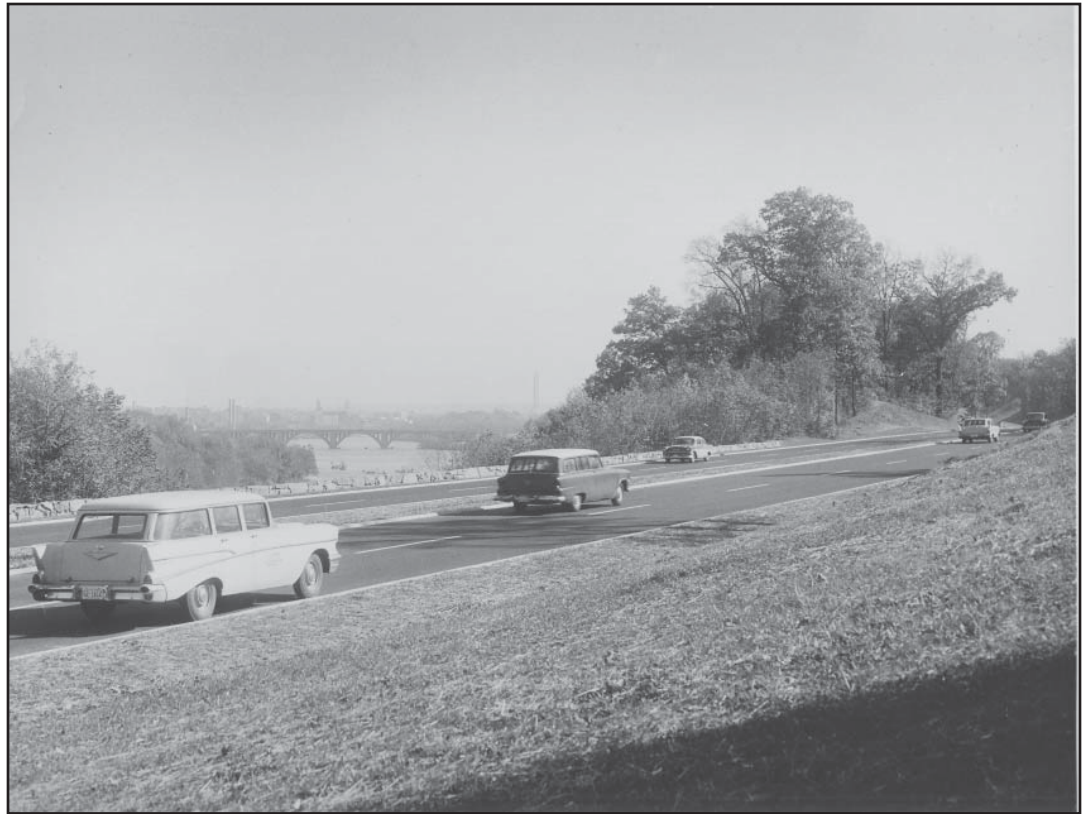
Figure 1.3. A 1959 photograph shows the recently completed north parkway, highlighting the designed vistas that were created along the corridor. This vista is largely grown in with encroaching vegetation, and is now only visible as a filtered view in the winter months once trees have dropped their leaves. (Image courtesy of the NPS Museum Resource Center, Box 12A, PH12 PF13 GWMP).

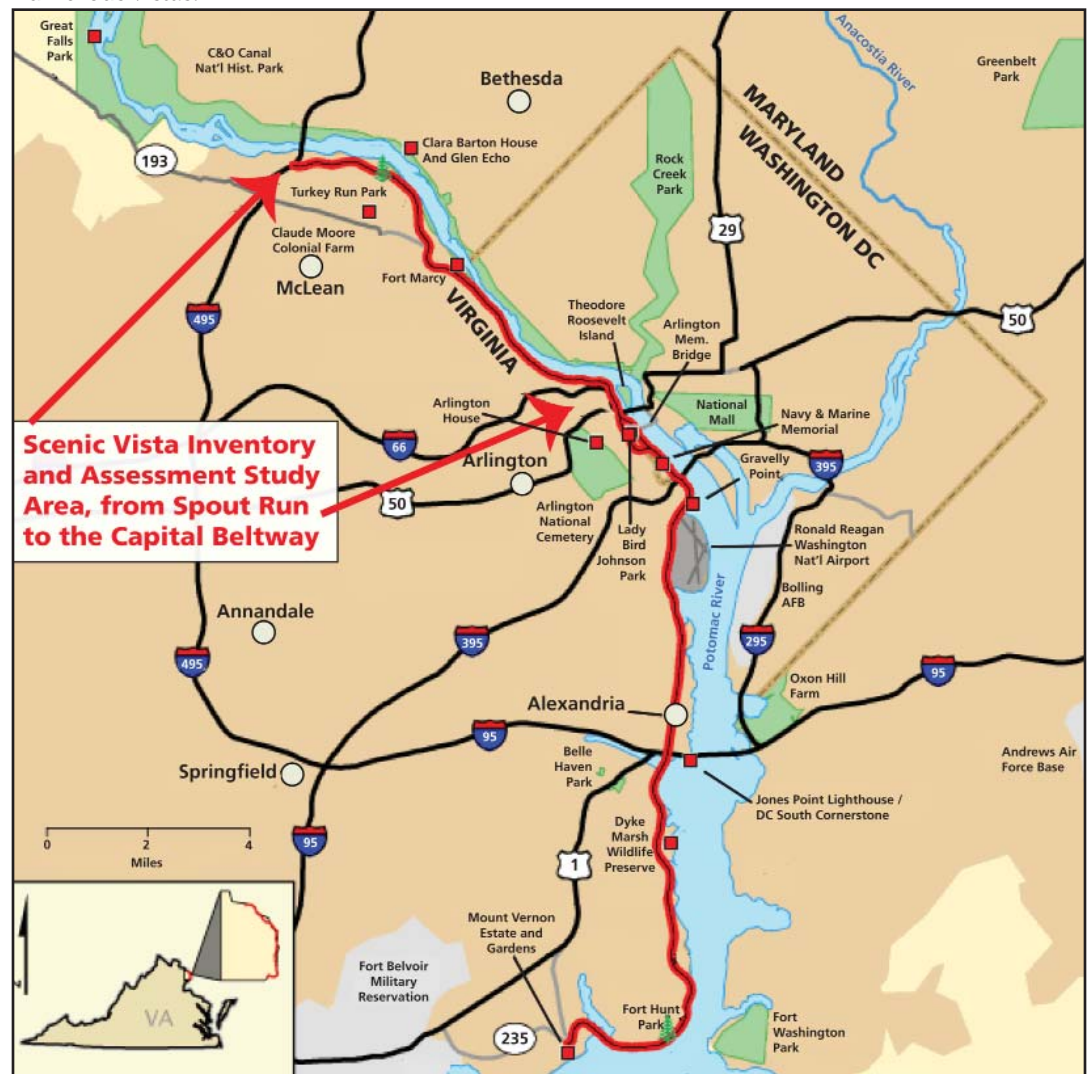
Figure 1.4. Overall map of the George Washington Memorial Parkway extending from Mount Vernon in the South to the Capital Beltway. The Visual Resource Inventory and Assessment spans roughly the northern 10 miles of the Parkway, as indicated by the red arrows. The base map is provided by FHWA's America's Byways Program.

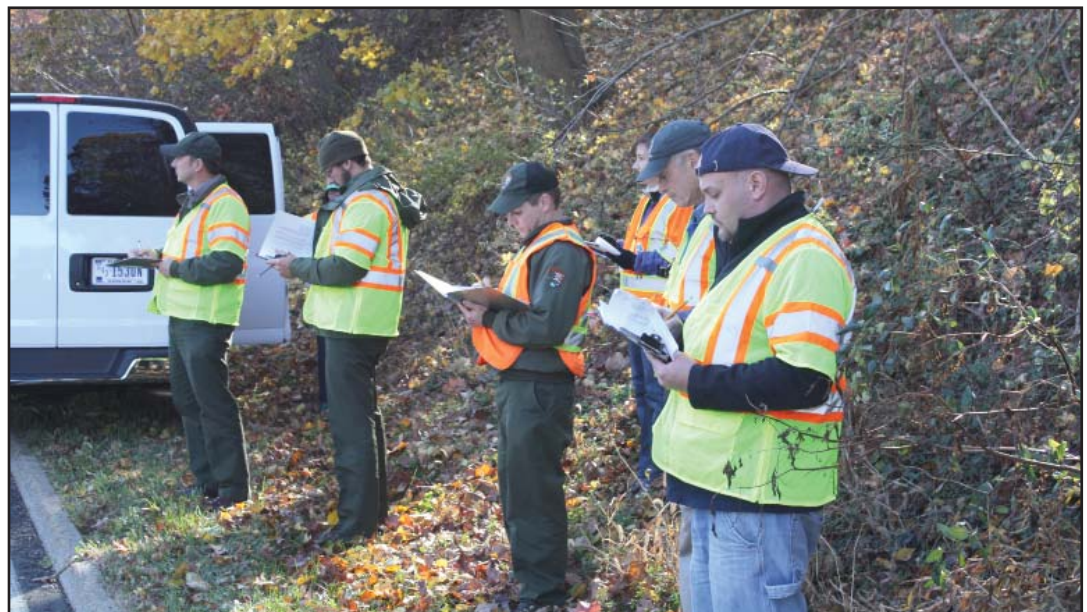
Figure 1.7. Photograph showing the VRA team conducting assessments along the GWMP. Assessments would typically take about 5 minutes to conduct per vista (2013, NCRO).

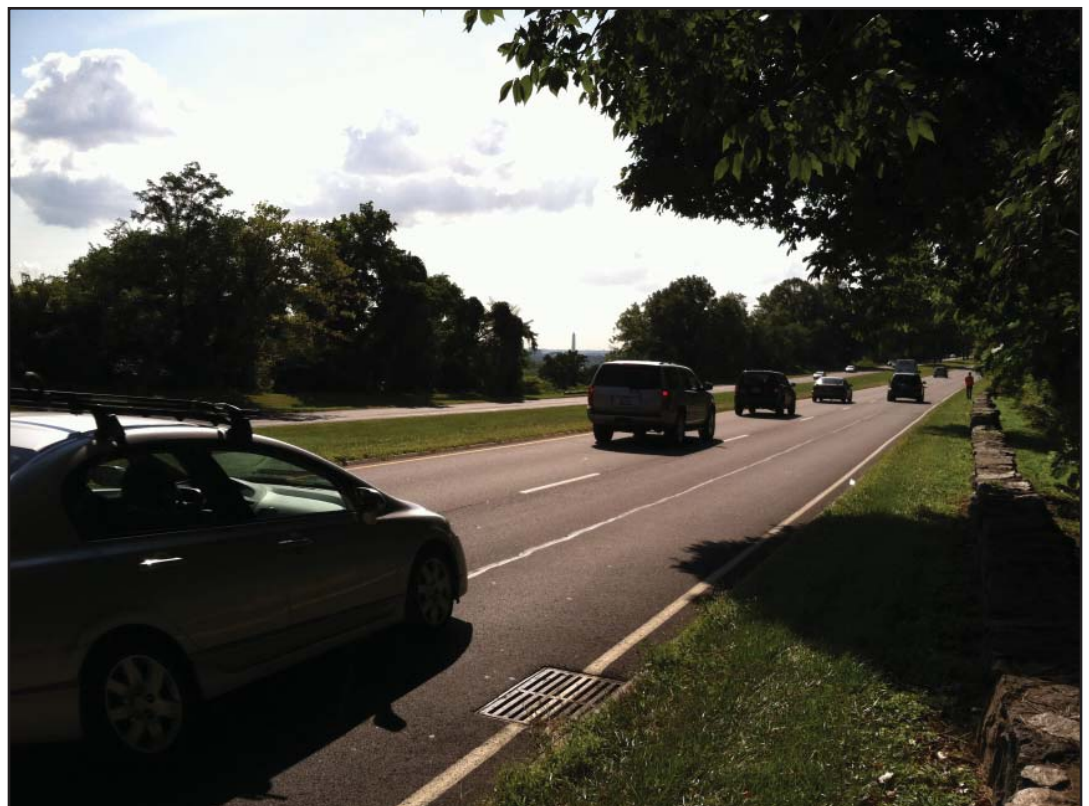
Figure 1.8. Representative photograph of a superior scenic class vista: Washington Monument SB. Superior vistas tend to be those that feature an open view toward the Potomac Gorge and often include a complimentary built feature, such as a monument, bridge, or college campus (2013, NCRO).

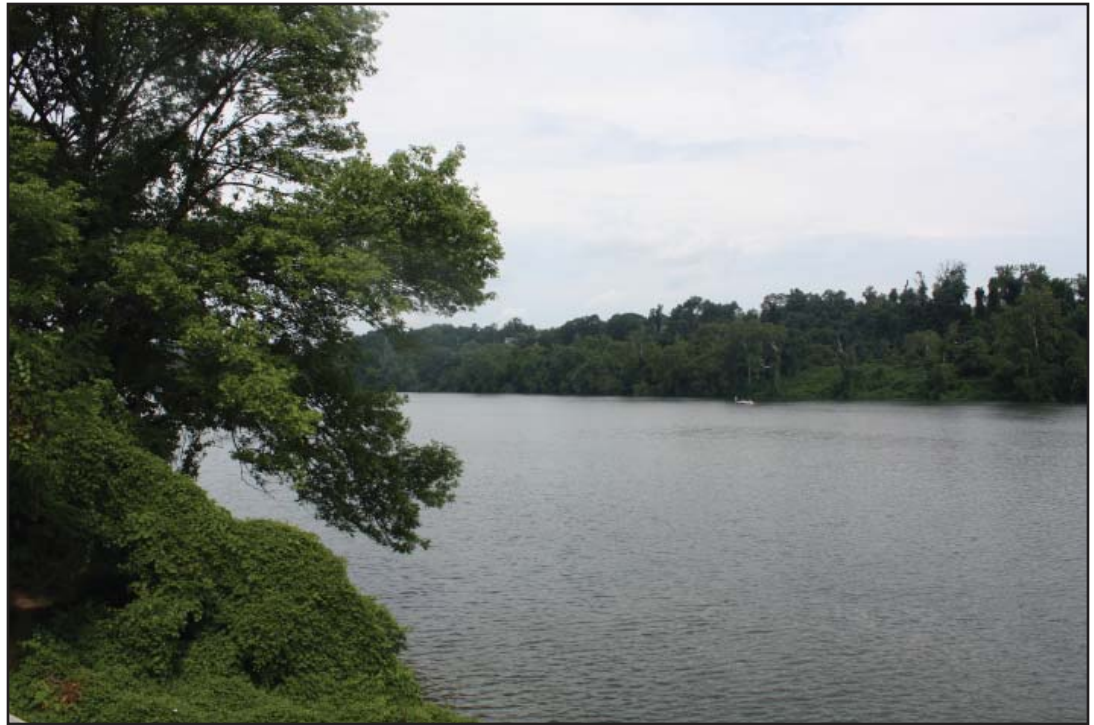
Figure 1.9. Representative photograph of a high scenic class vista: Spout Run NB. High scenic class vistas tend to have good exposure and connectivity to the Potomac, but may or may not have a complimentary built feature (2013, NCRO).

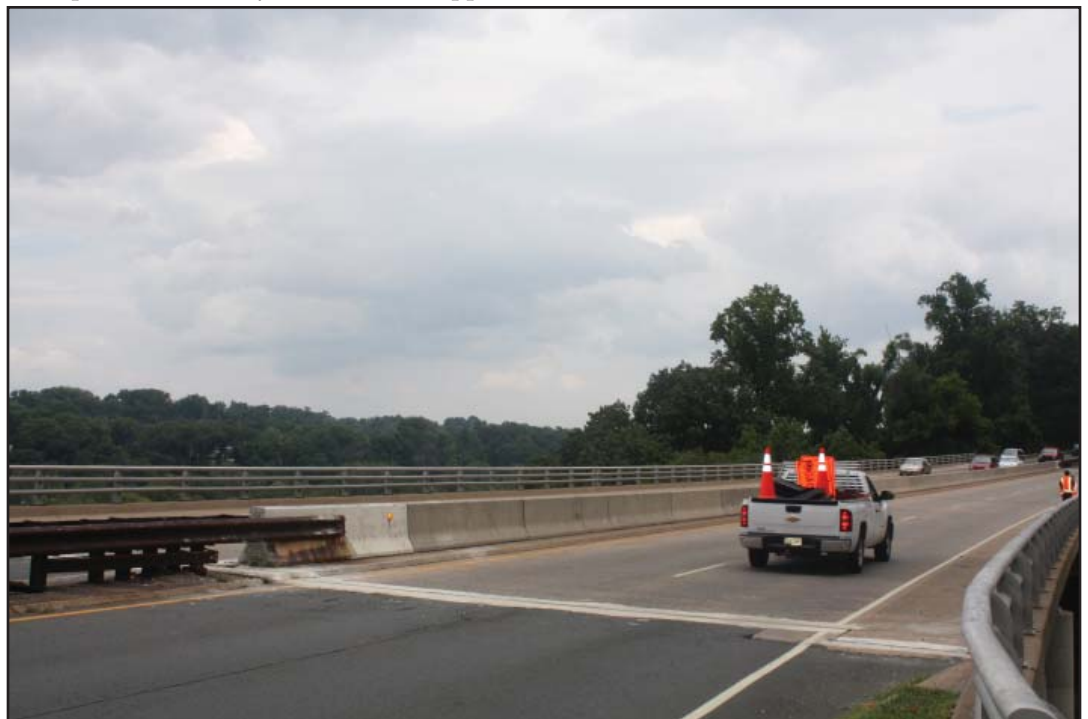
Figure 1.10. Representative photograph of a medium scenic class vista: Donaldson Run SB. Medium and low scenic class vistas tend to have diminishing visual connectivity to the river, are often partially obstructed, and generally do not feature any complimentary built features (2013, NCRO).

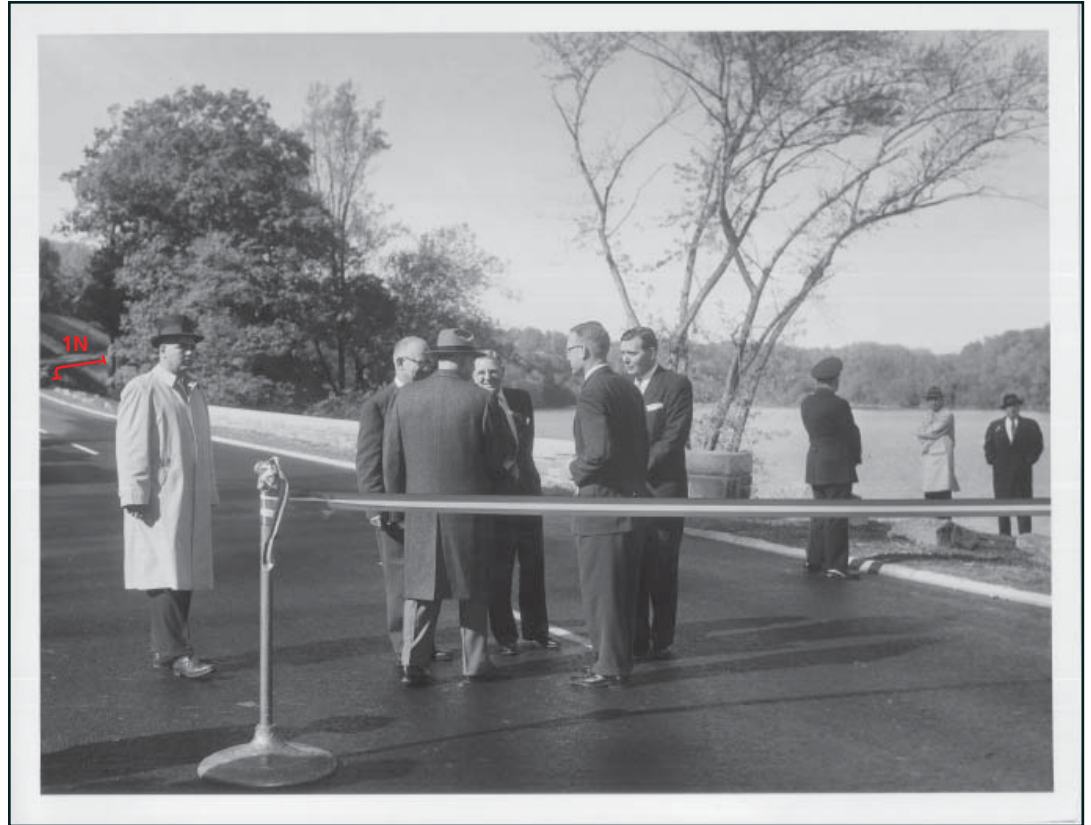
PP-1. President Eisenhower at the ribbon-cutting dedication of the northern Parkway. Open vista conditions can be seen at and just after the Spout Run Bridge as can a dense stand of vegetation near the beginning of the 1N guardwall. (Image courtesy of the NPS Museum Resource Center, Box 12a, PH12 PF13, GWMP; Photo by Abbie Rowe, National Park Service) 1959.

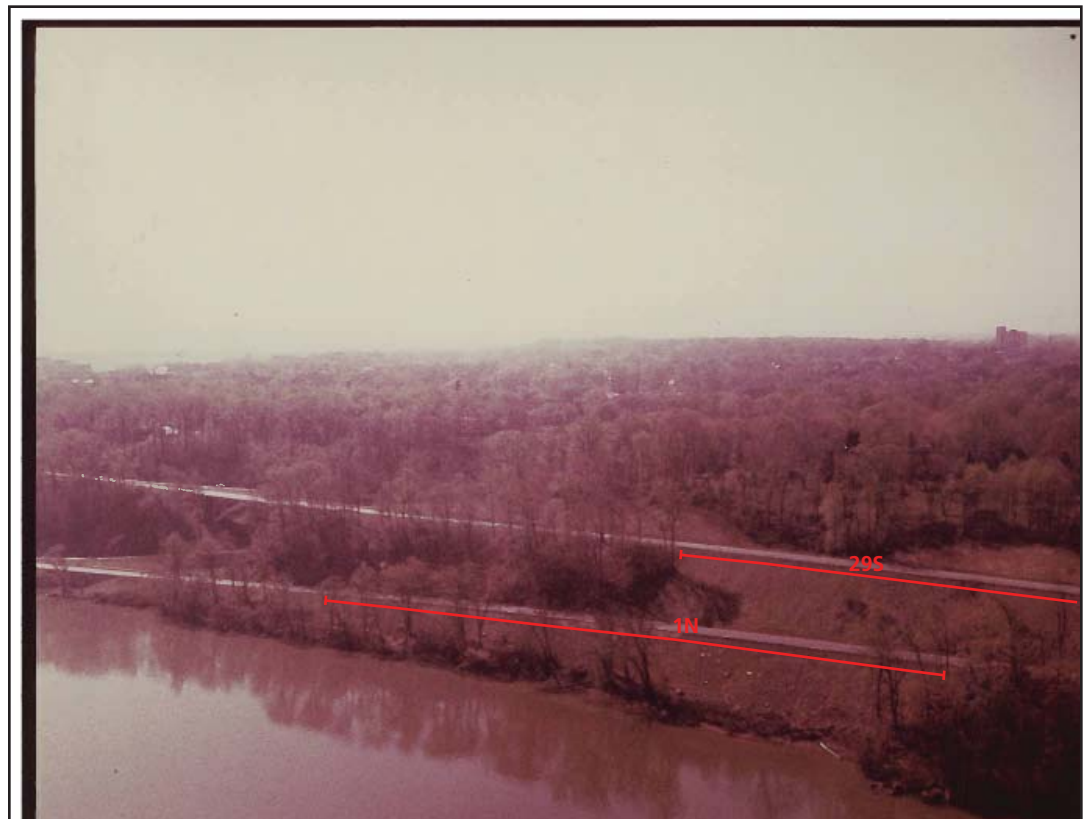
PP-2. Aerial photograph believed to be from the early 1960s due to the lack of vegetation in the grade-divided median adjacent to guardwall 29S. This image very clearly depicts the once open SB vista along guardwall 29S, as well as the open vista immediately following Spout Run Bridge, and the canopy vista that transitions into an open vista adjacent to guardwall 1N. (Image courtesy of the GWMP CRM Program Archives, GWMP General Views 1960-1969 Folder) 1960-1969.

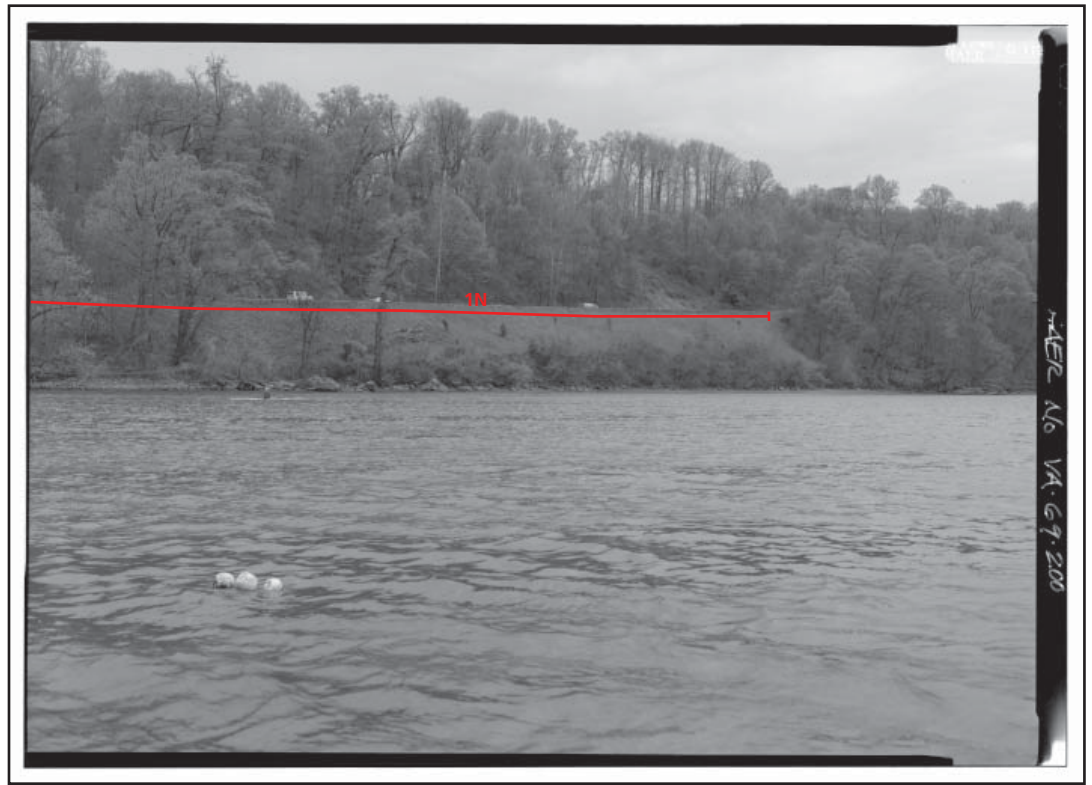
PP-3. 1994 HAER photograph that appears to depict additional vegetation growth along the southern canopy section of the vista adjacent to guardwall 1N. However, the northern open section of this vista appears to be open as is seen in PP-2. (Image courtesy of HAER, VA-69-200) 1994.

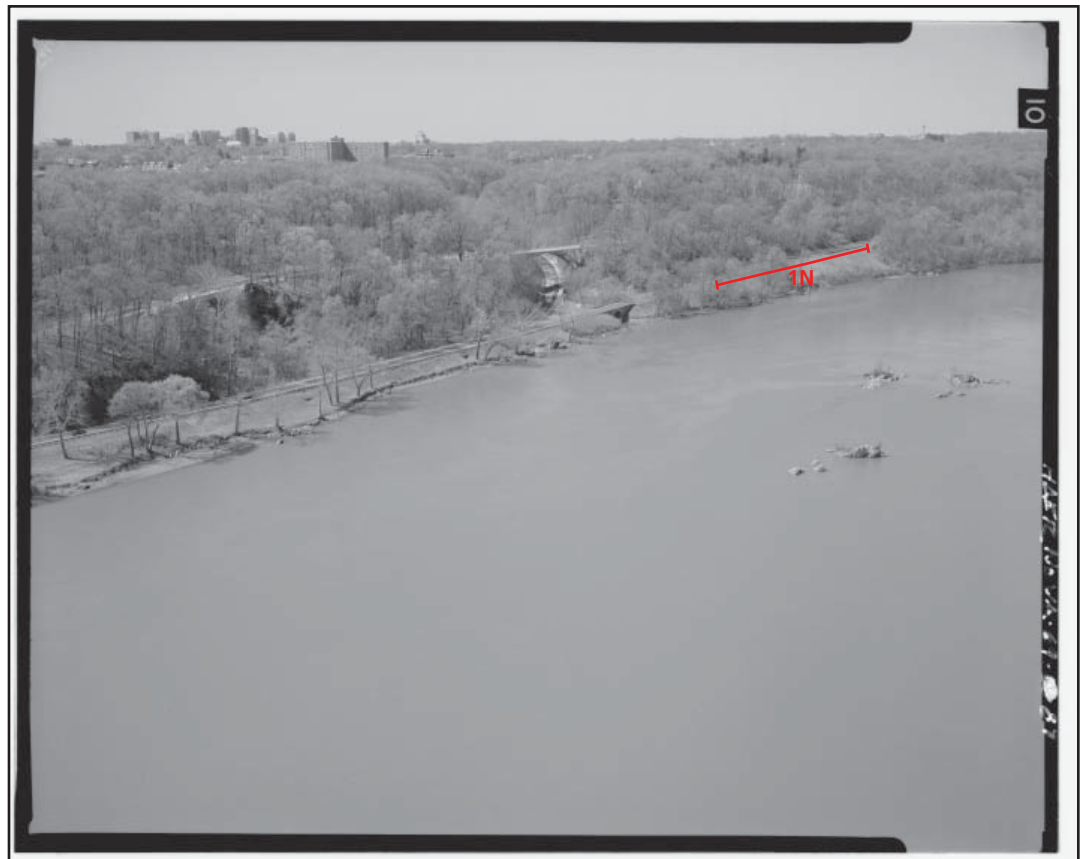
PP-4. 1994 HAER aerial photograph depicting the vista opening immediately following the Spout Run Bridge, as well as open vista conditions at the northern terminus of the 1N guardwall. By this time the grade divided median has grown in substantially since the 1960s (See picture PP-2) and guardwall 29S is not visible through the encroaching trees. (Image courtesy of HAER, VA-69-87) 1994.

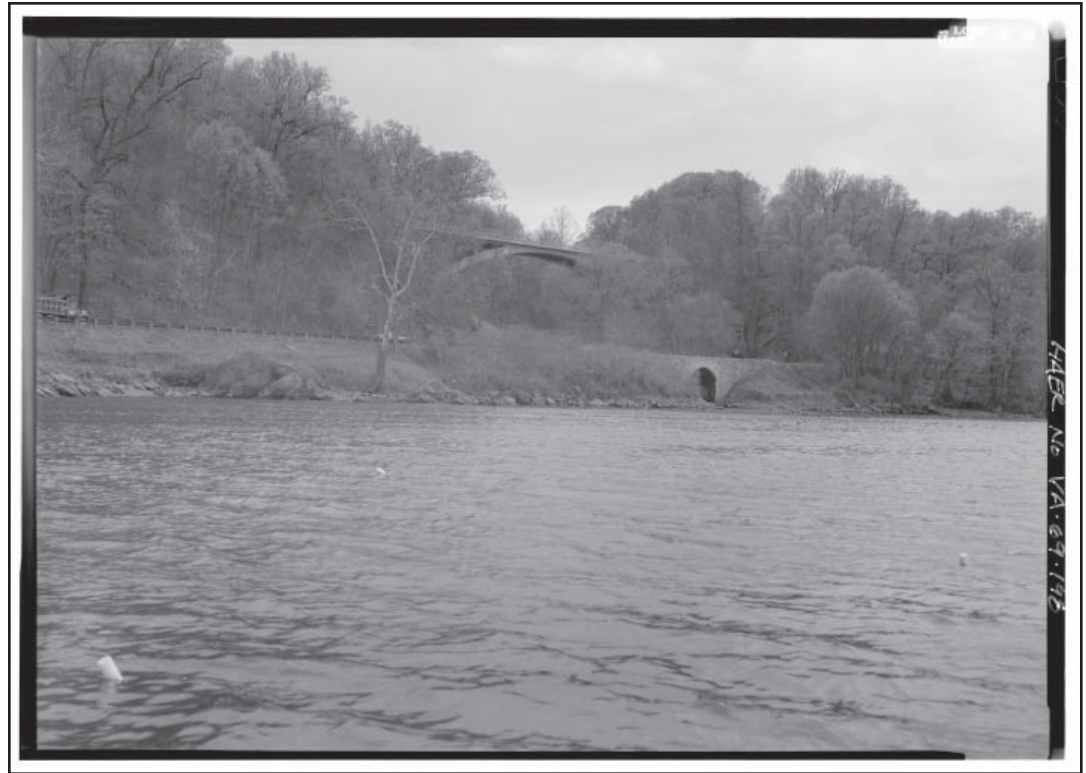
PP-5. 1994 image depicting open vista conditions associated with the Spout Run Bridge crossings, both NB and SB. (Image courtesy of HAER, VA-69-198) 1994.

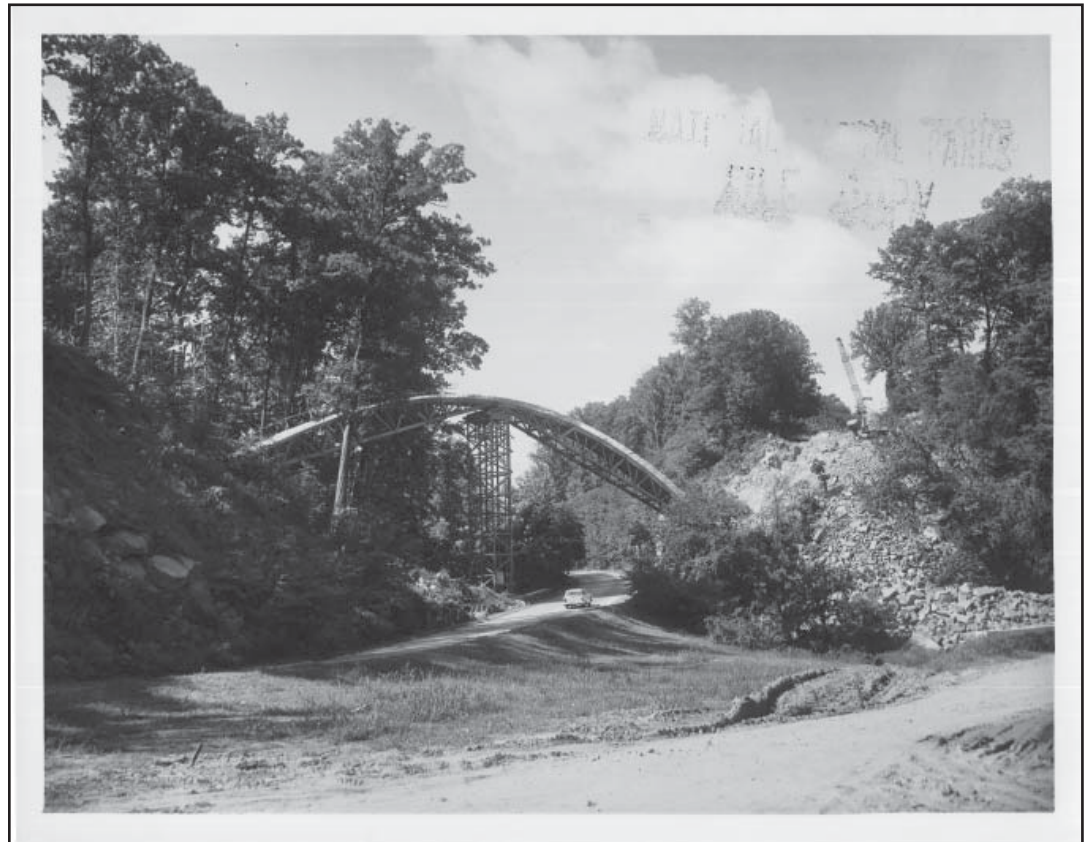
PP-6. Construction of the Spout Run SB bridge, showing that existing vegetation was retained on either side of the ravine, creating a relatively short vista opening at this bridge crossing (Image courtesy of the NPS Museum Resource Center, Box 12b, PH12 PF14, GWMP Folder 2) 1958.

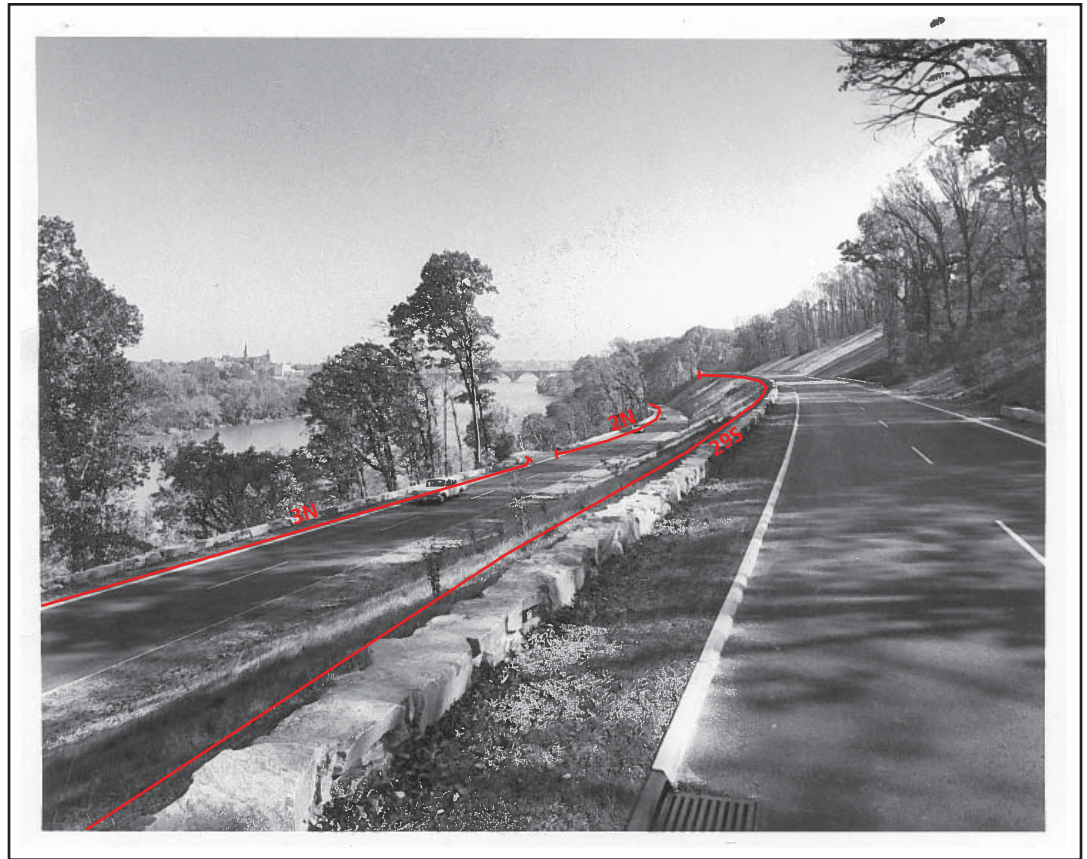
PP-7. Historic conditions along the 29S guardwall were open, in stark contrast to the vegetation that has now become established in the median. Also depicted are the open conditions adjacent to the northern portion of guardwall 1N and the established vegetation along the southern portion of guardwall 2N. (Image courtesy of the GWMP CRM Program Archives, GWMP General Views 1960-1969 Folder) 1961.

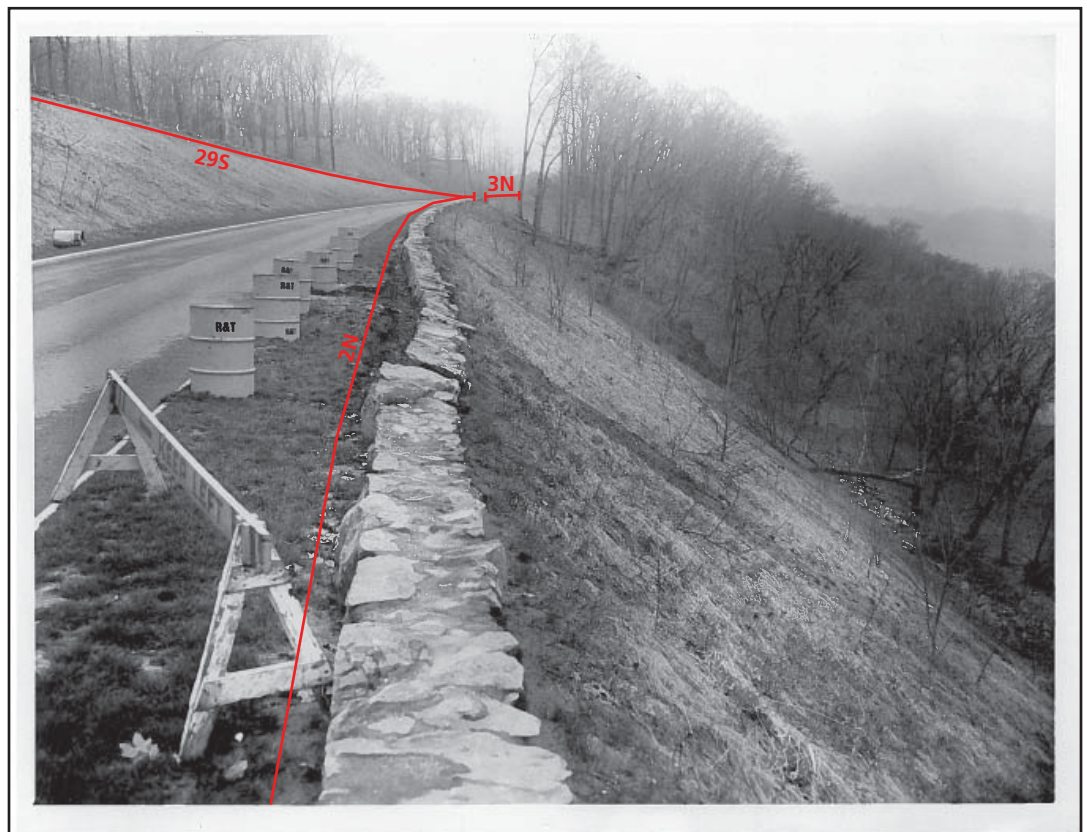
PP-8. 1961 image clearly depicting largely open conditions along the northern portion of the 2N guardwall. This area has now become established with vegetation, which may have been deliberately allowed to help address the roadbed slumping that is evidenced in this photograph. This photograph also suggests open vista conditions adjacent to guardwall 3N as seen in the distance. (Image courtesy of the NPS Museum Resource Center, Box 12a, PH12 PF12, GWMP) 1961.

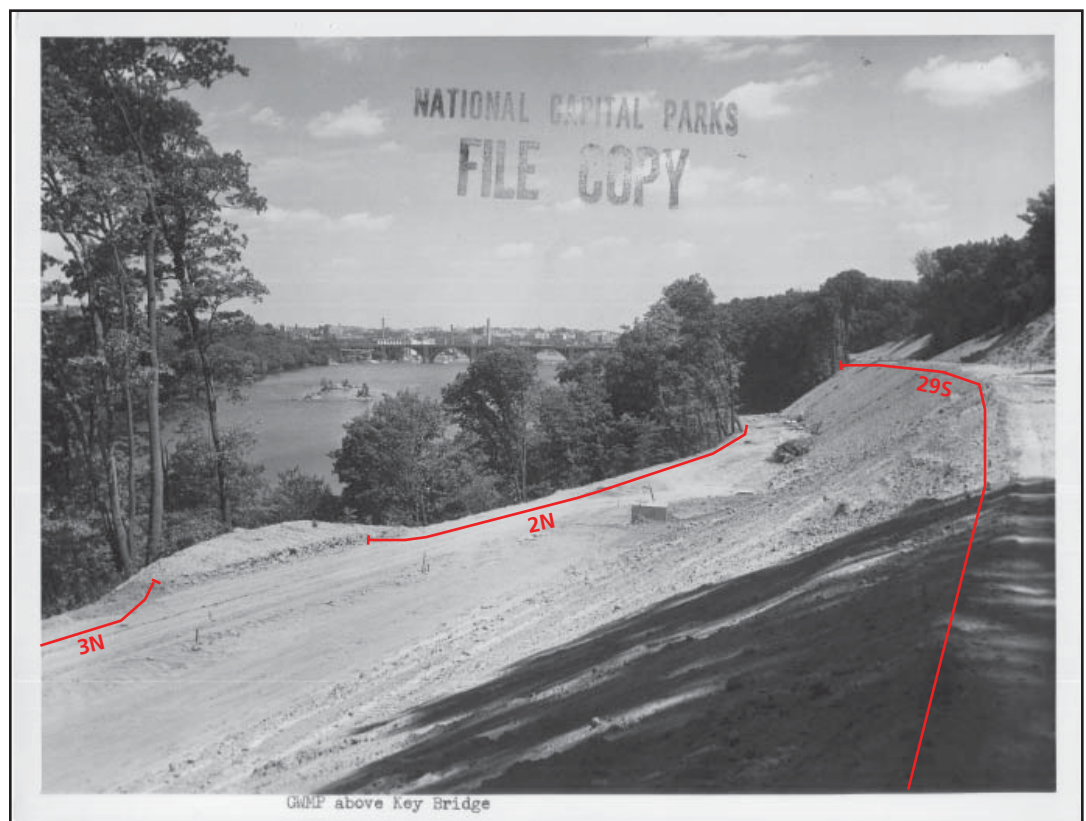
PP-10. Although this photo precedes the construction of guardwalls, the grading and topography along this section infer where the future guardwalls would be constructed. This image depicts the open conditions adjacent to guardwall 29S as well as the open conditions along the northern portions of guardwall 2N. (Image courtesy of the NPS Museum Resource Center, Box 12a, PH12 PF13, GWMP; Photo by Abbie Rowe, National Park Service) 1957.

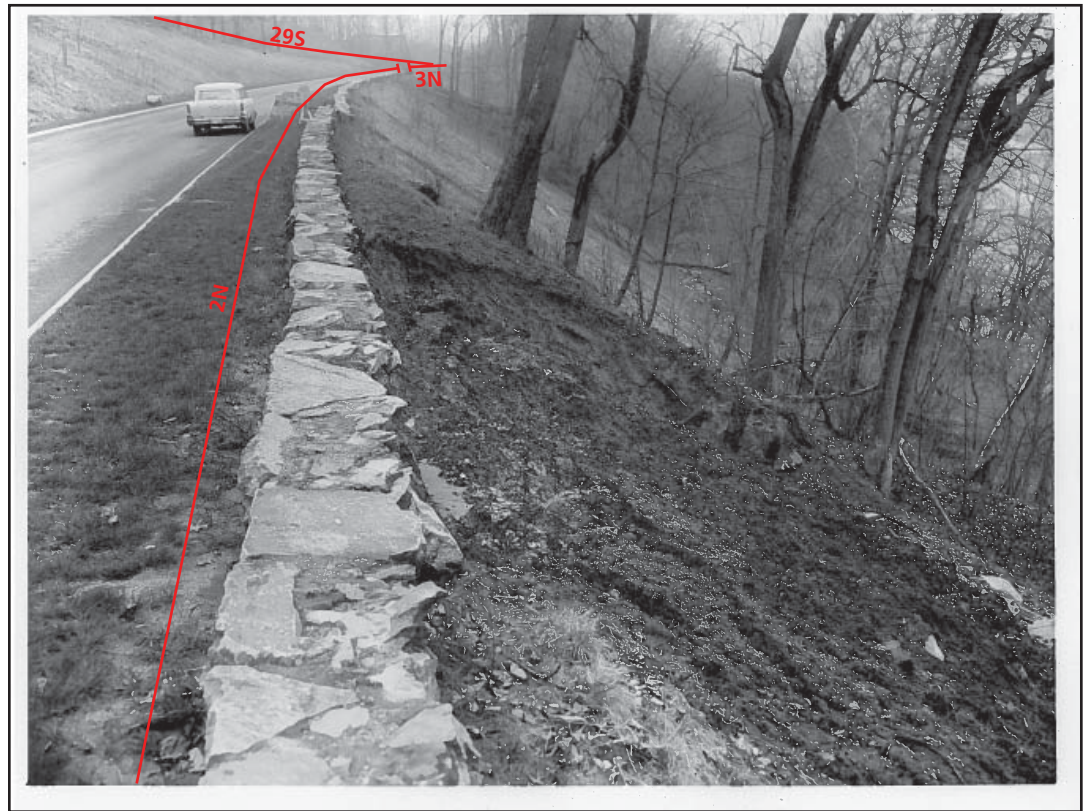
PP-11. 1961 image depicting two areas of erosion and slumping, in the foreground and midground respectively. This image also clearly shows established vegetation along the southern portion of guardwall 2N that transitions into open slopes. This photo also suggests open conditions adjacent to guardwall 3N, which is barely visible in the distance. (Image courtesy of the NPS Museum Resource Center, Box 12a, PH12 PF12, GWMP) 1961.

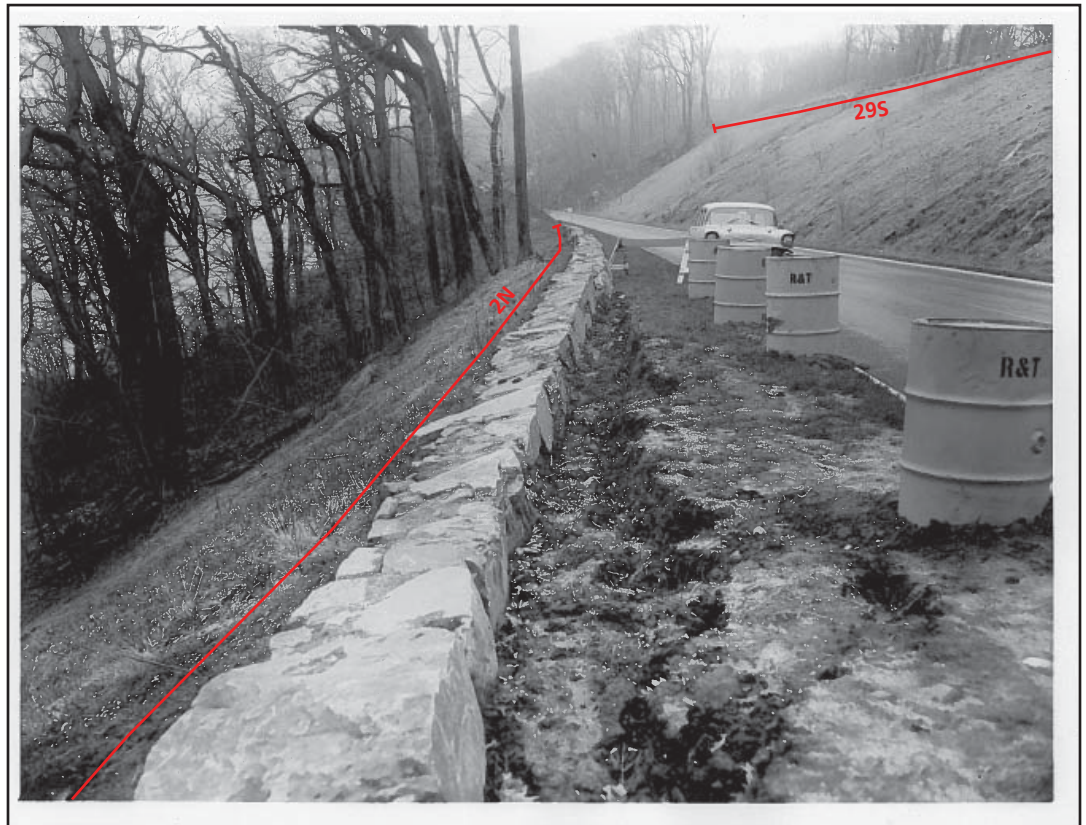
PP-12. Slumping seen along guardwall 2N, as well as the established vegetation at the southern terminus of the guardwall before transitioning to an open vista. (Image courtesy of the GWMP CRM Program Archives, GWMP Construction/Repairs 1960-1969 Folder) 1961.

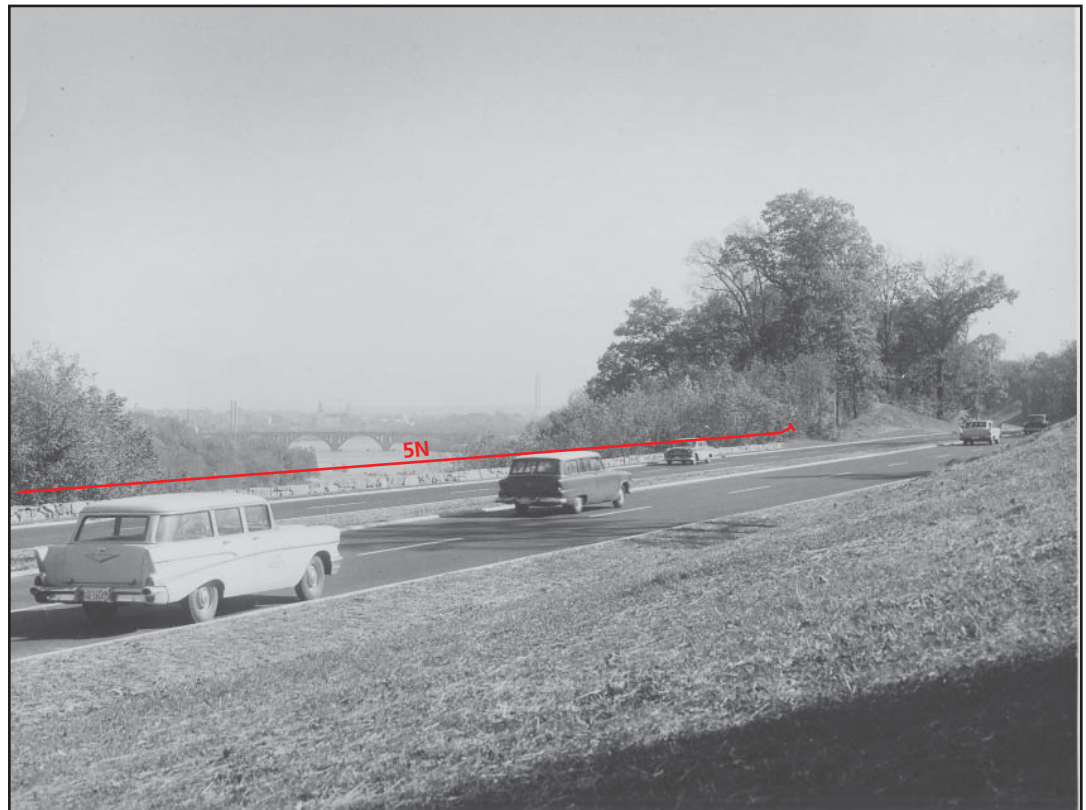
PP-14. This is the same vista over guardwall 5N that is visible as PP-13, over guardwall 5N, but shot with a wider perspective. Obstructing vegetation is visible along the northern portion of the guardwall creating a fairly discrete brief vista in this location. Also, the guardrail of Windy Run Bridge can be seen in the background in the far southern visible extent of the Parkway, helping locate this vista. (Image courtesy of the GWMP CRM Program Archives, GWMP General Views 1960-1969 Folder) 1959.

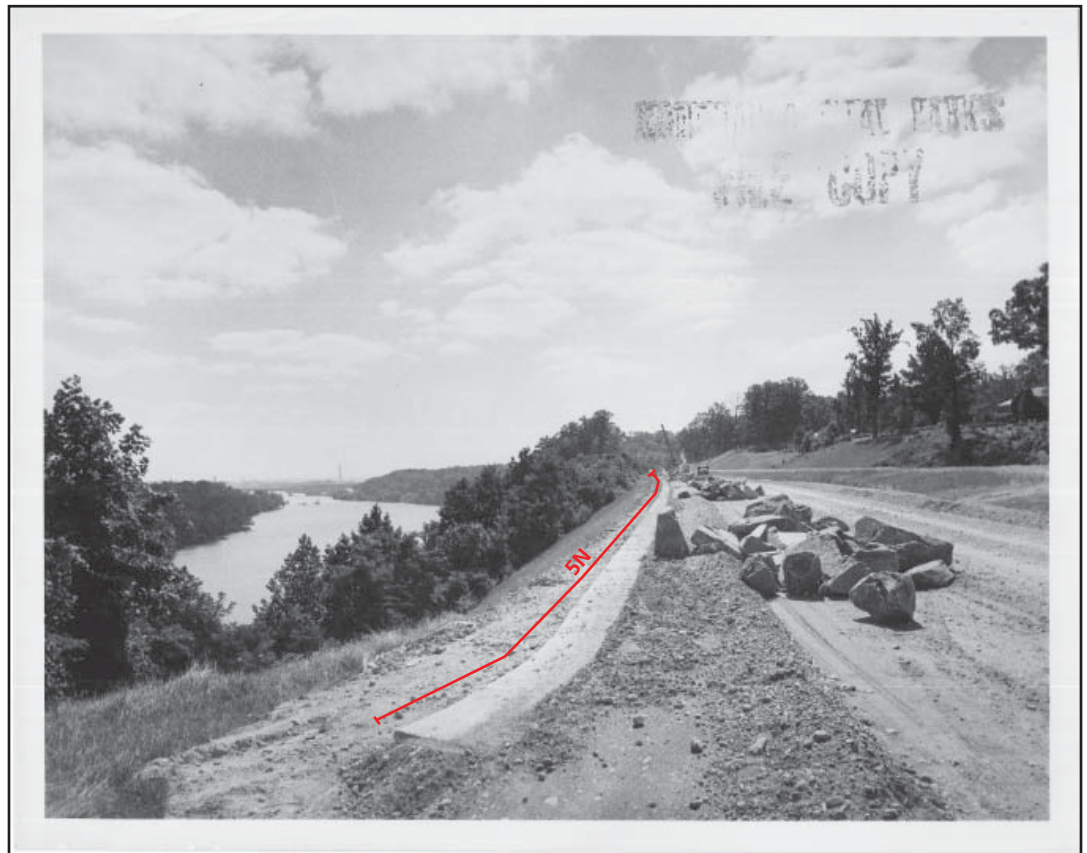
PP-15. Another vista taken from the oft-photographed vantage looking over the southern extent of guard-wall 5N, again showing a relatively brief vista window between established vegetation. (Image courtesy of the NPS Museum Resource Center, Box 12b, PH12 PF15, GWMP Folder 3; Photo by Abbie Rowe, National Park Service) 1959.

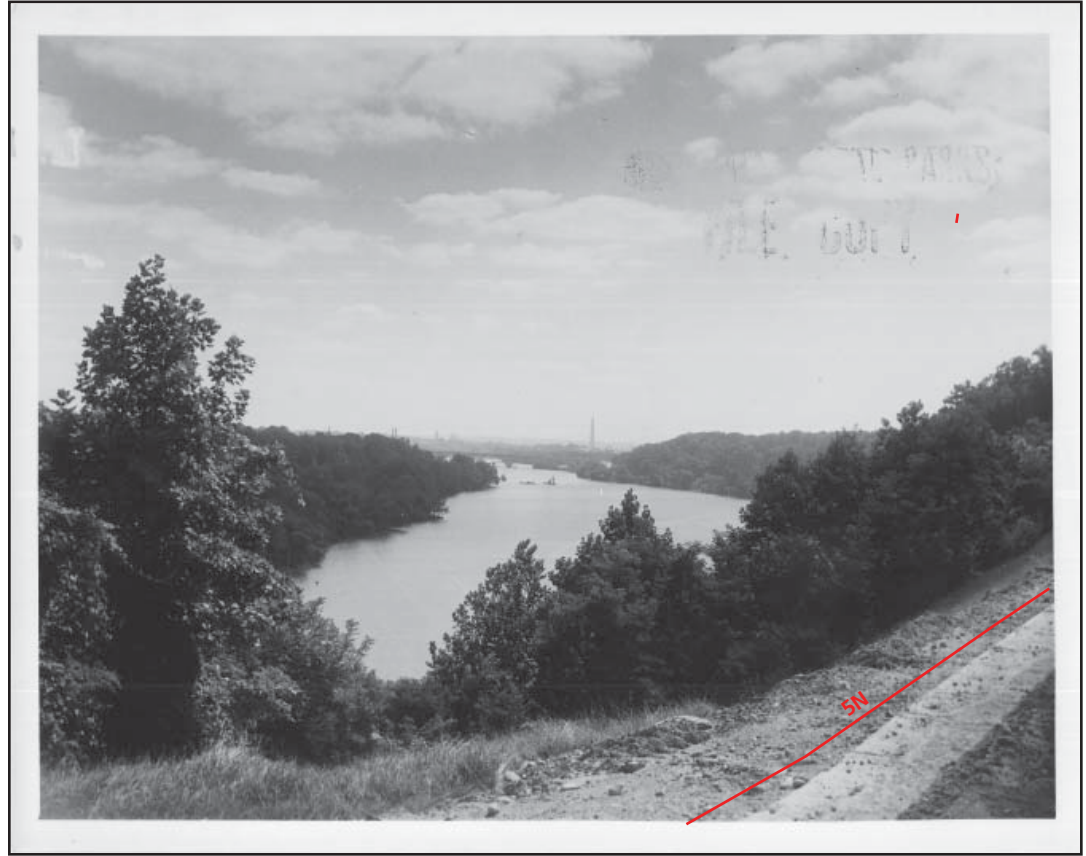
PP-16. Photograph taken from the northern end of guardwall 5N during Parkway construction. This image shows an open vista along the northern extent of guardwall 5N, with mature vegetation towards the center of the guardwall (Image courtesy of the NPS Museum Resource Center, Box 12b, PH12 PF14, GWMP Folder 2; Photo by Abbie Rowe, National Park Service) 1958.

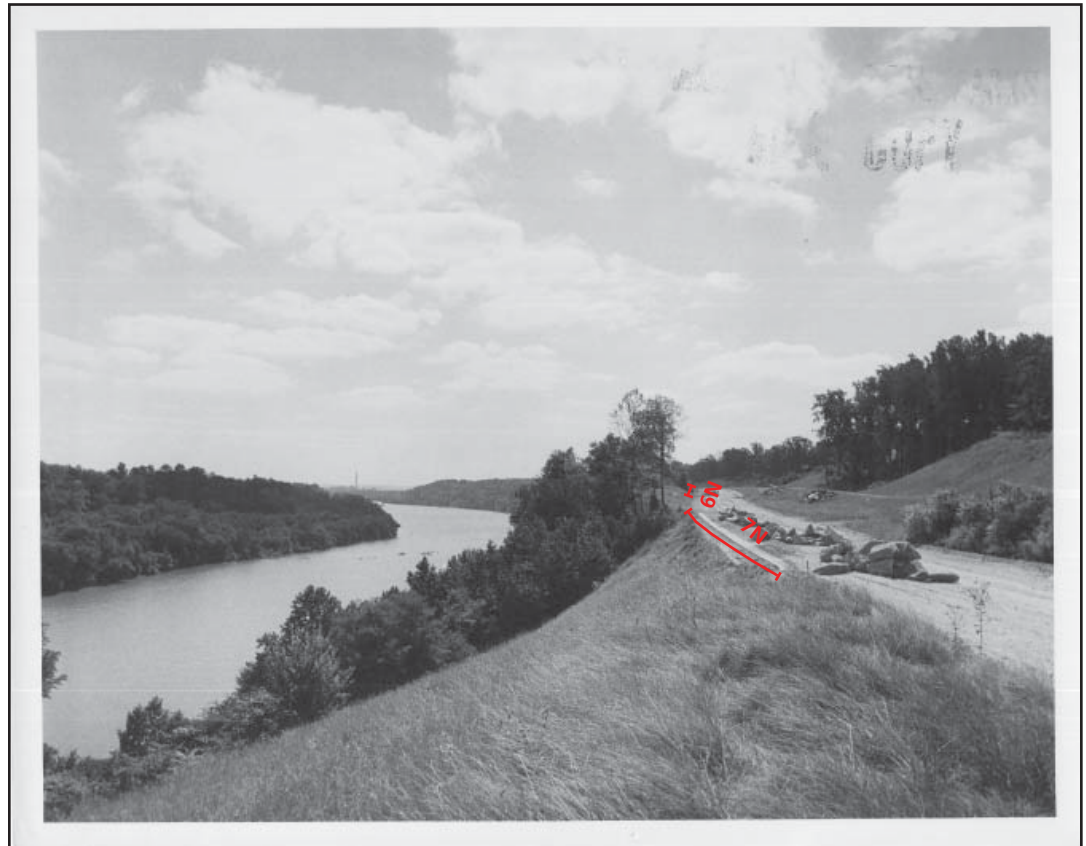
PP-18. Photograph taken during Parkway construction depicting sweeping vistas associated with guardwalls 7N (midground) and 6N (background). The vistas over these guardwalls remain largely unobstructed. (Image courtesy of the NPS Museum Resource Center, Box 12a, PH12 PF13, GWMP; Photo by Abbie Rowe, National Park Service) 1958.
