George Washington Memorial Parkway - North Visual Resource Inventory & Assessment

Spout Run to the Capital Beltway

Daniel Schaible, NCRO Cultural Resource Specialist

November, 2014

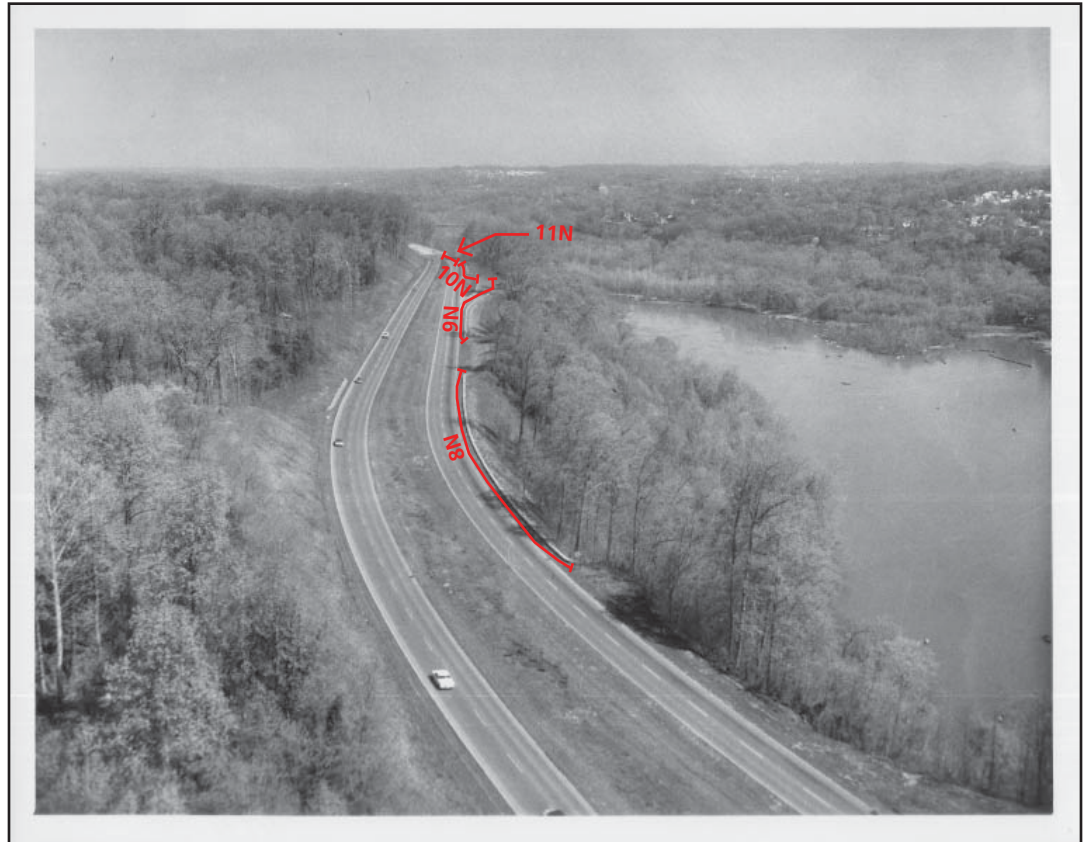
PP-19. Oblique aerial image from 1962 that captures four separate guardwalls. While the angle of the photograph and distance of the guardwalls make verification difficult, the image appears to depict vistas over the northern portion of guardwall 8N, and over guardwall 11N looking over the Donaldson Run Bridge. Potential vistas over guardwalls 9N and 10N are inconclusive based on the photograph, although there is other evidence that supports their presence. (Image courtesy of the NPS Museum Resource Center, Box 12b, PH12 PF16, GWMP Folder 4; Photo by Abbie Rowe, National Park Service) 1962.

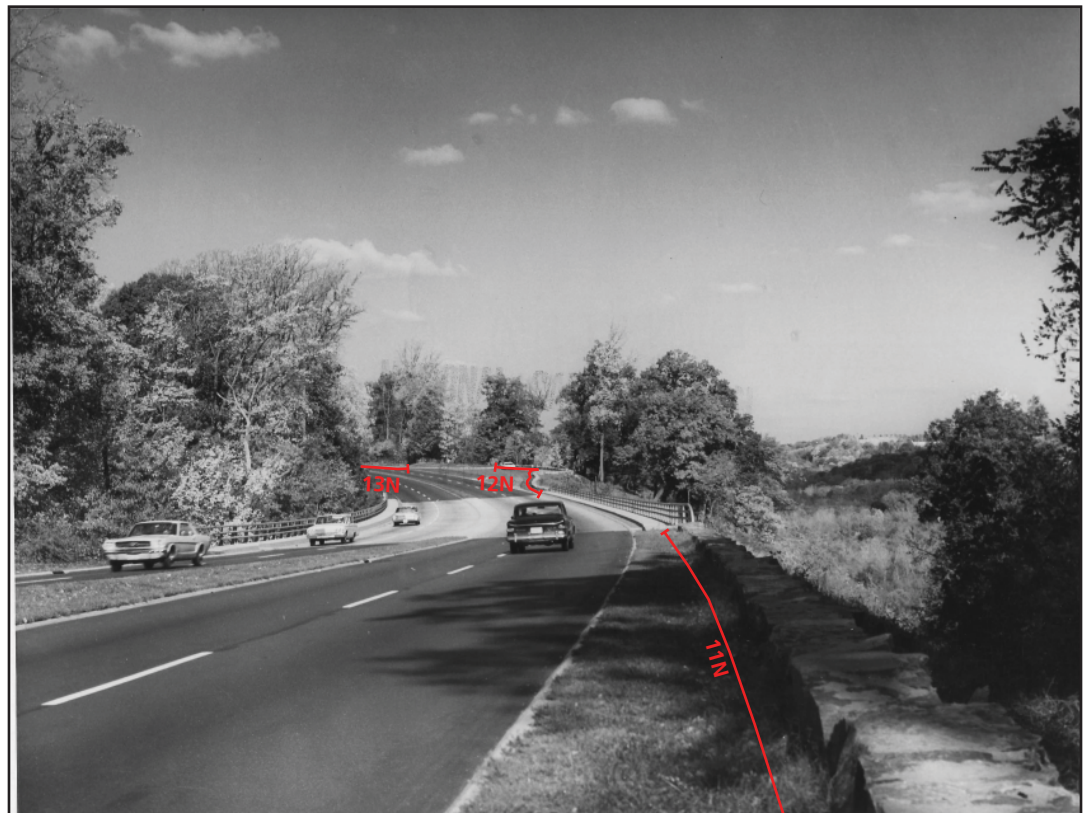
PP-20. 1965 photo approaching the Donaldson Run Bridge, clearly depicting vistas over guardwall 11N approaching the bridge, at the bridge itself, and at Overlook #2 (12N). The southern extent of guardwall 13N appears to be obstructed by vegetation. (Image courtesy of the NPS Museum Resource Center, GWMP; Photo by Abbie Rowe, National Park Service) 1965.

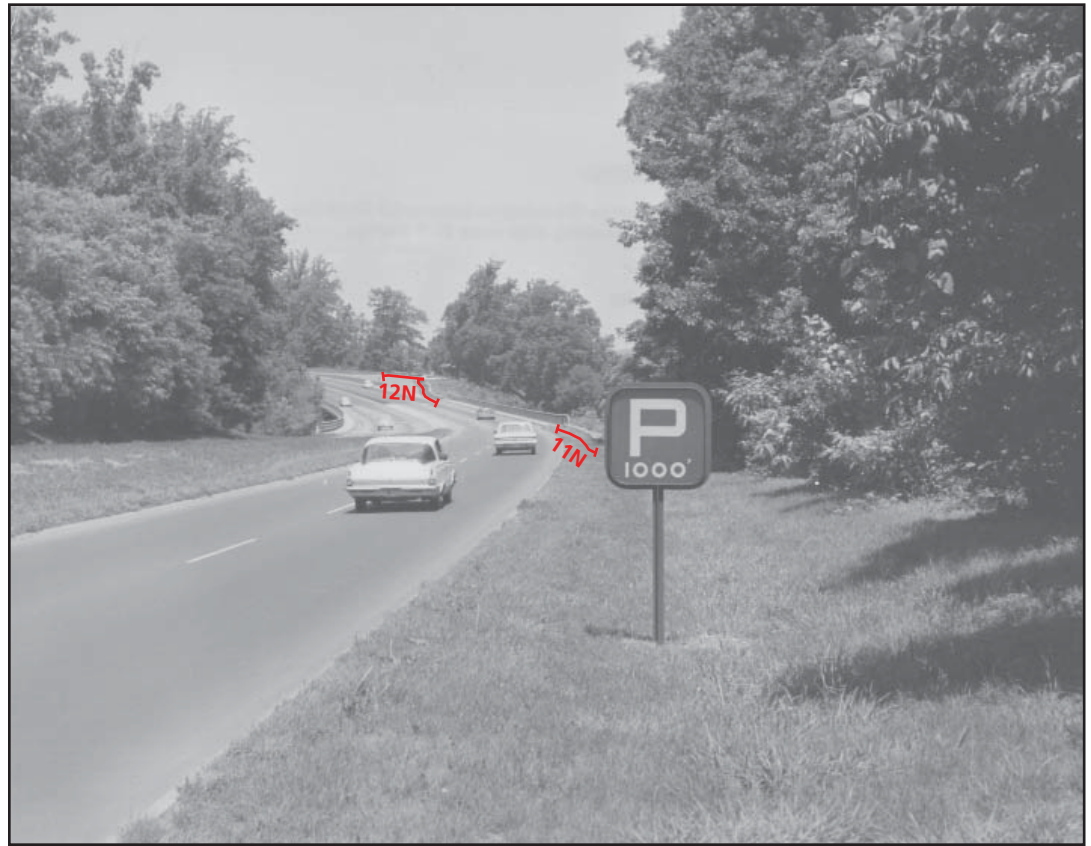
PP-21. 1968 photo depicting the new sign announcing parking at the overlook in 1000', as well as vistas over the Donaldson Run Bridge and Overlook 2. (Image courtesy of the NPS Museum Resource Center, GWMP; Photo by Cecil W. Stoughton, National Park Service) 1968.

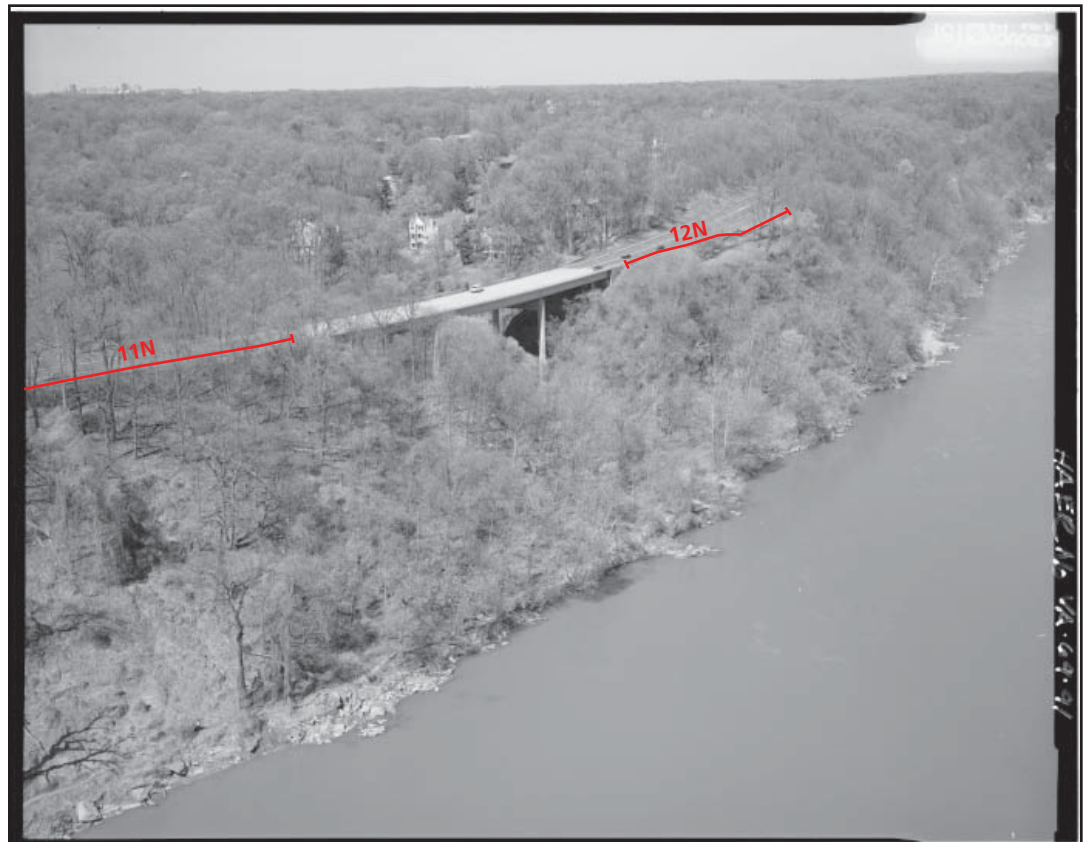
PP-22. 1994 aerial showing Donaldson Run Bridge. While it is difficult to appreciate the directional vista over guardwall 11N towards Donaldson Run Bridge, it is easy to appreciate the vista over the bridge itself and the canopy vista at the Overlook 2. (Image courtesy of HAER, VA-69-91, mislabeled as Windy Run Bridge) 1994.
