Historic Structures (Ruins) Report.

The Large and Small Arsenal Buildings

Harpers Ferry  
National Monument

Charles W. Snell  
Historian (Park Supervisory)  
November 5, 1959  
17 Pages  
Project No. HF-97

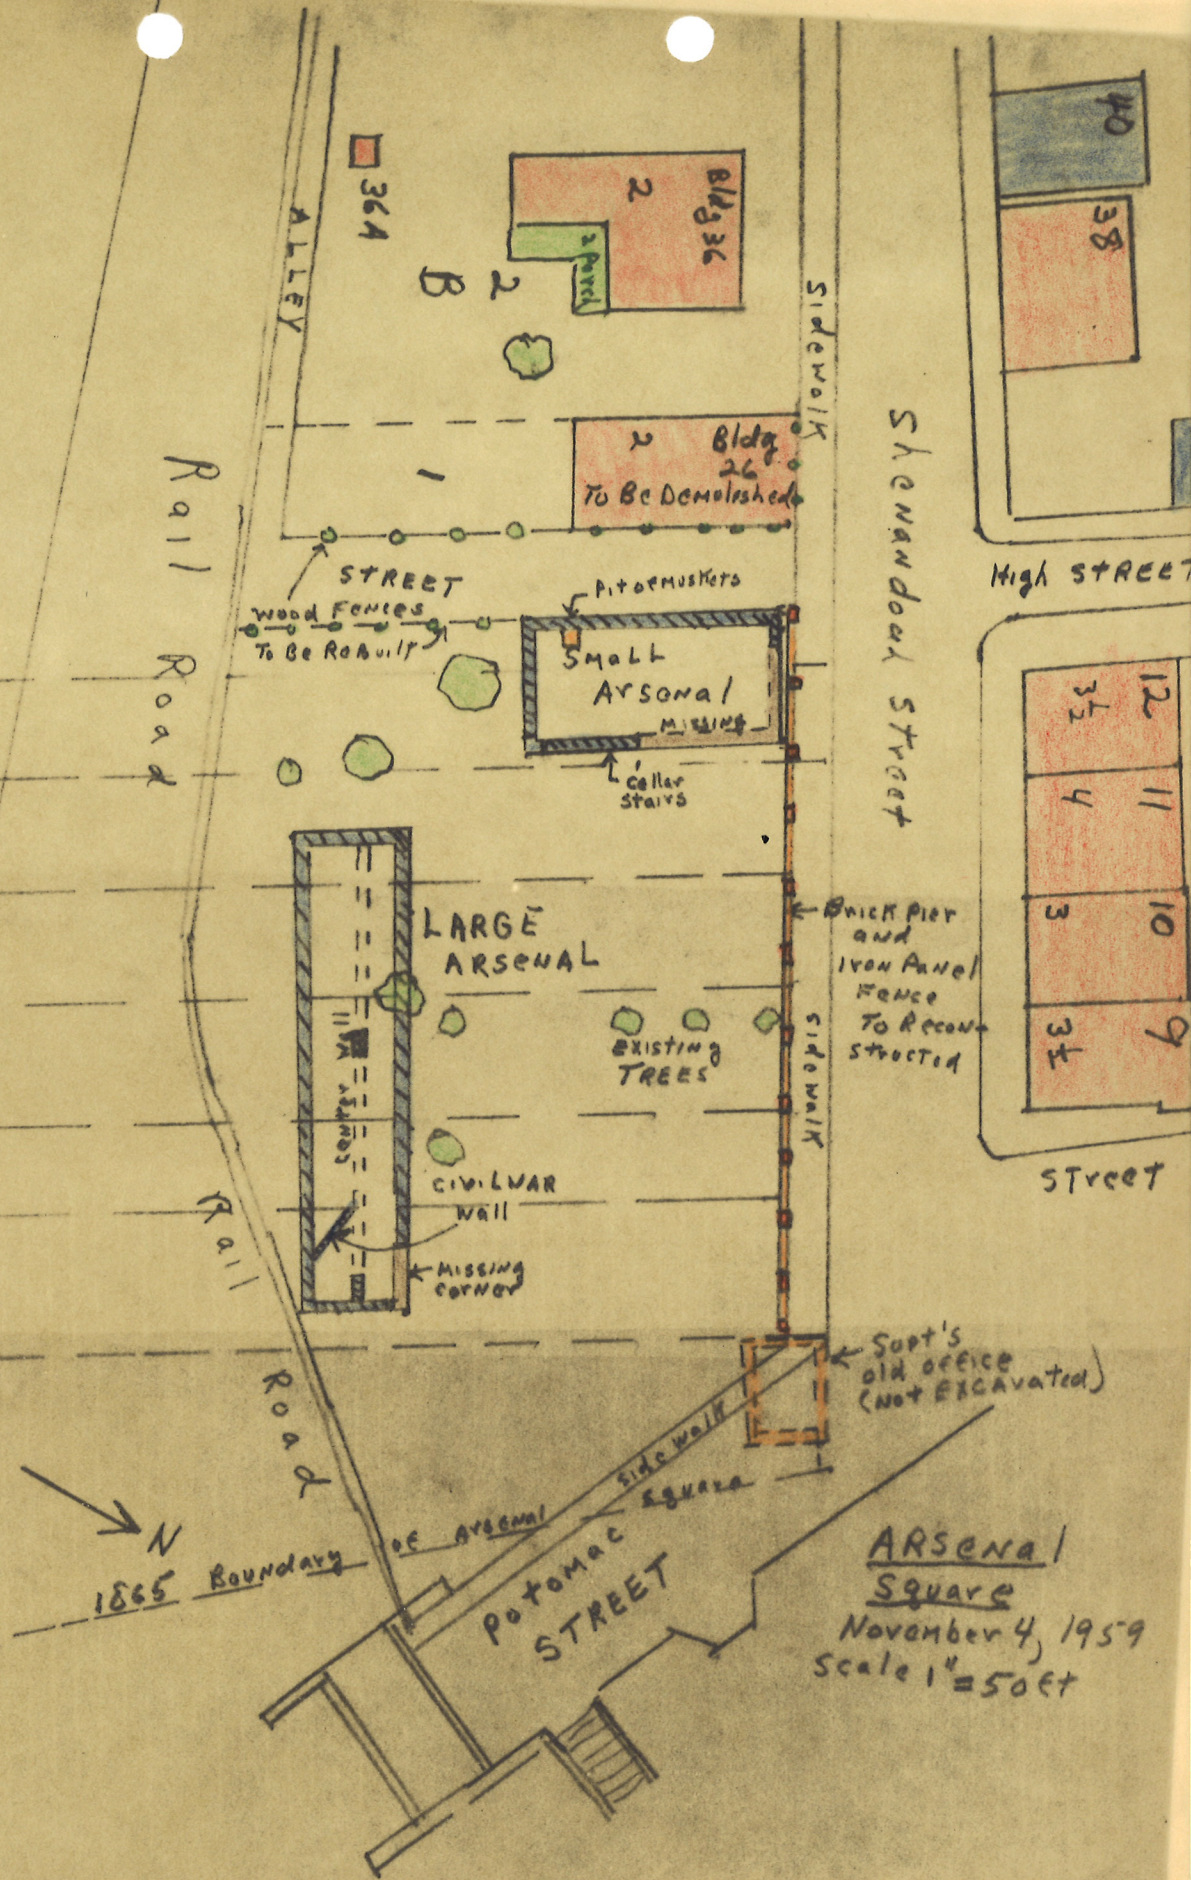
ARSENAL  
Square  
November 4, 1959  
Scale 1" = 50 ft

8. CONCLUSIONS AND RECOMMENDATIONS. On the following page of this report will be found a map that illustrates existing conditions in the Arsenal Square as of November 4, 1959. The remains of the Large and Small Arsenals, as uncovered by Archeologists Edward McM. Larrabee and William Hershey in July and August of 1959, are shown on this map.

1. To return the scene more nearly to its appearance in the 1859-65 period, it is recommended that non-historic Bldg. No. 26, a two story brick structure, be demolished.

2. It is suggested that present grade of the Arsenal Square be reduced to its 1861 level.
3. That the original foundations or footings of the two Arsenal buildings be stabilized and that a portion of the brick walls of the buildings be reconstructed for exhibit purposes.
4. That the historic brick pier and iron pal/ing fence be reconstructed along the Shenandoah Street front of Arsenal Square. A wood pal/ing fence should also be rebuilt along the west end of the square.
5. It is recommended that the area be seeded, drained, and planted with trees, following the 1859 photographs.
6. It is recommended that a trailside exhibit be situated at the Arsenal Square to assist in the proper interpretation of that area.

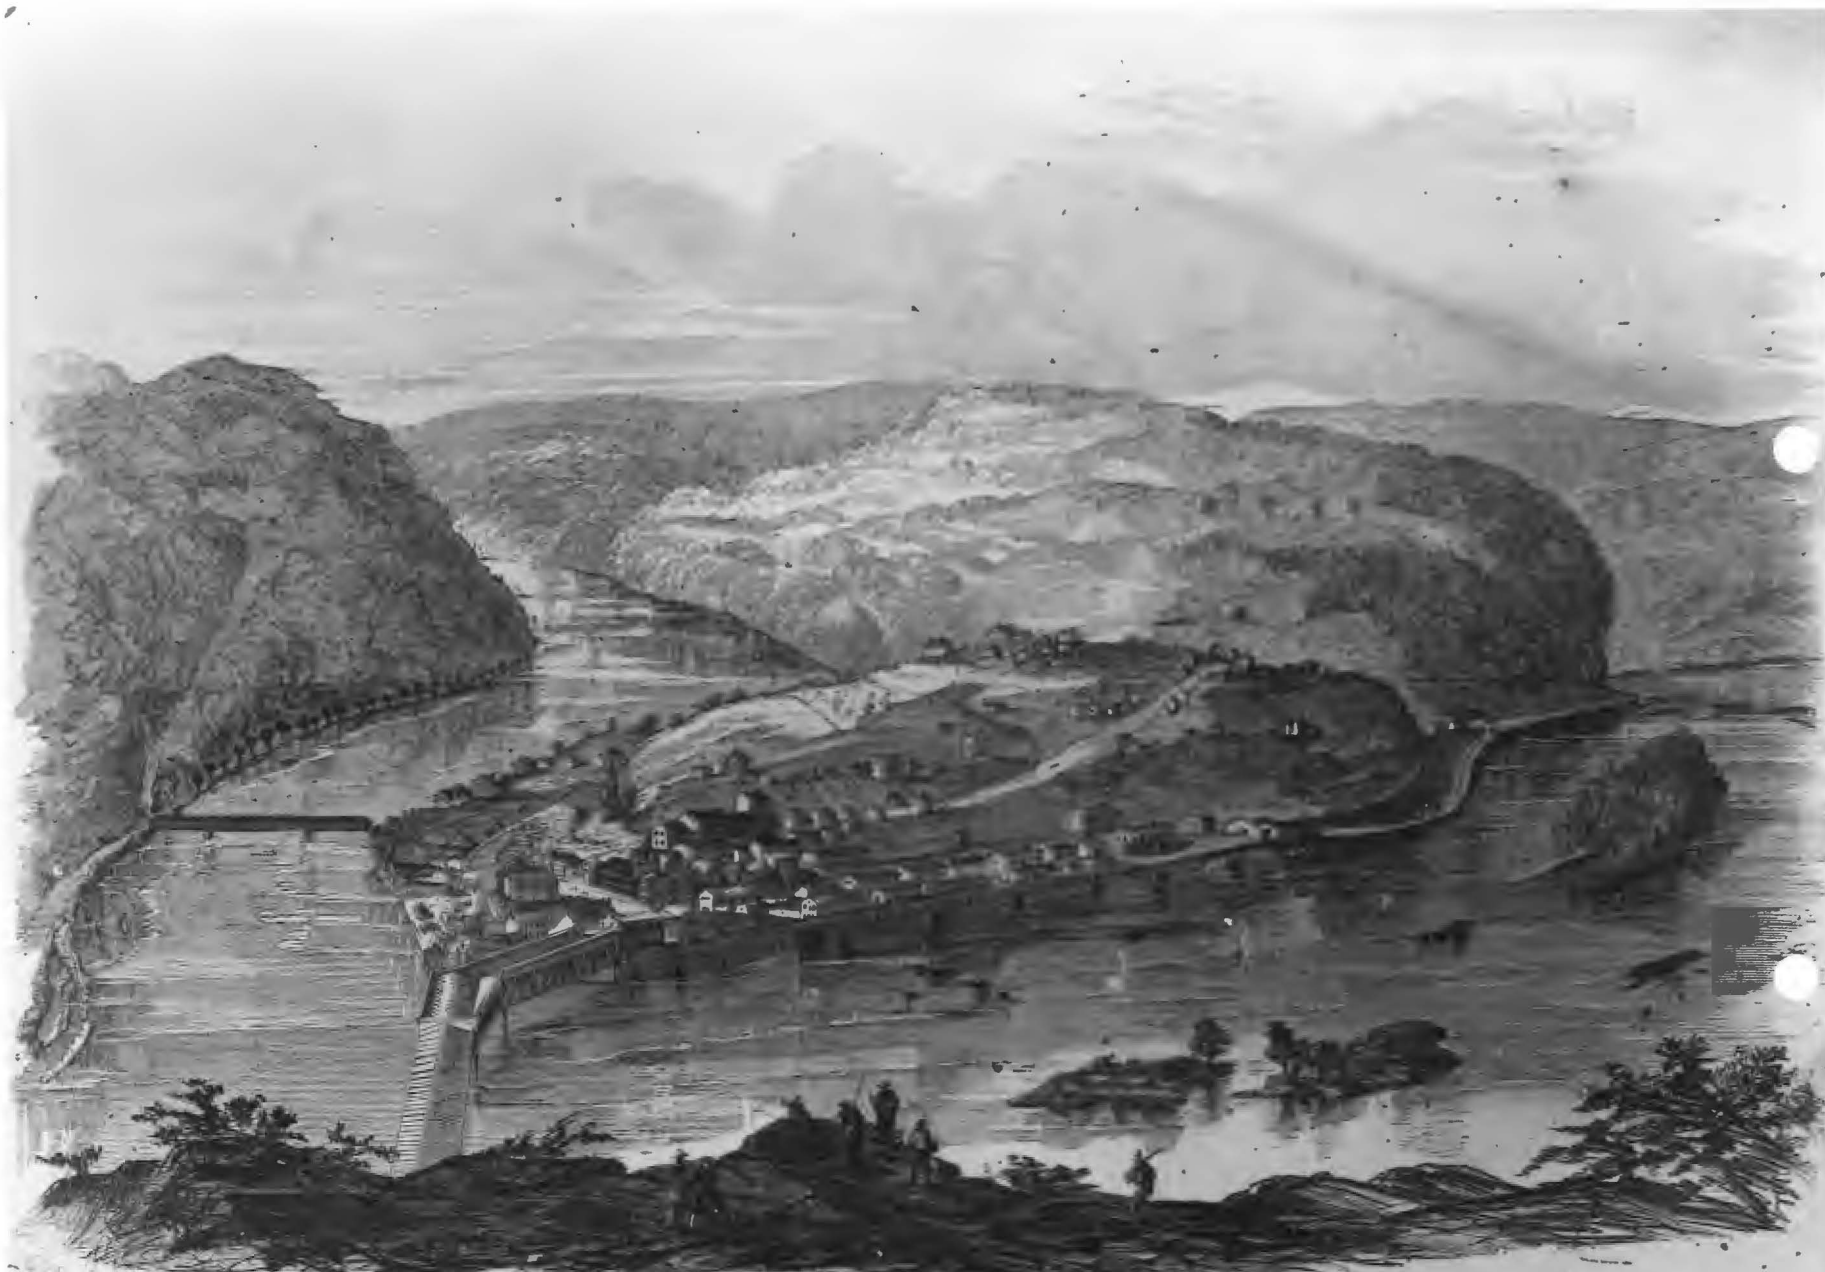
From Frank Leslie's Illustrated Newspaper,  
November 19, 1859, page 395.  
Harpers Ferry Negative No. HF-491A.

"View of Harper's Ferry, Jefferson Co.,  
Virginia, and Surrounding Country--From  
a Sketch by our Artist," 1859.

This view made from Maryland Heights is the finest and most accurate in detail of all the general sketches of the town that were published in 1859 as a result of the John Brown Raid.

Just beyond the Y in the Potomac River Bridge can be seen the Large Arsenal (with five windows in the east end) running parallel to the Shenandoah River. Beyond and to the right of the Large Arsenal stands the Small Arsenal. Note to the right, just across Shenandoah Street, Bldgs. No. 10, 11, and 12 with their two story covered porches.

VIEW OF HARPEL'S FERRY, JEFFERSON CO., VIRGINIA, AND SURROUNDING COUNTRY.—FROM A SKETCH BY SAMUEL J. ARNOLD.

7. See Print HF-491A in Appendix I of this report.

9. See Photographs HP-66, HP-491A in Appendix I of this report.

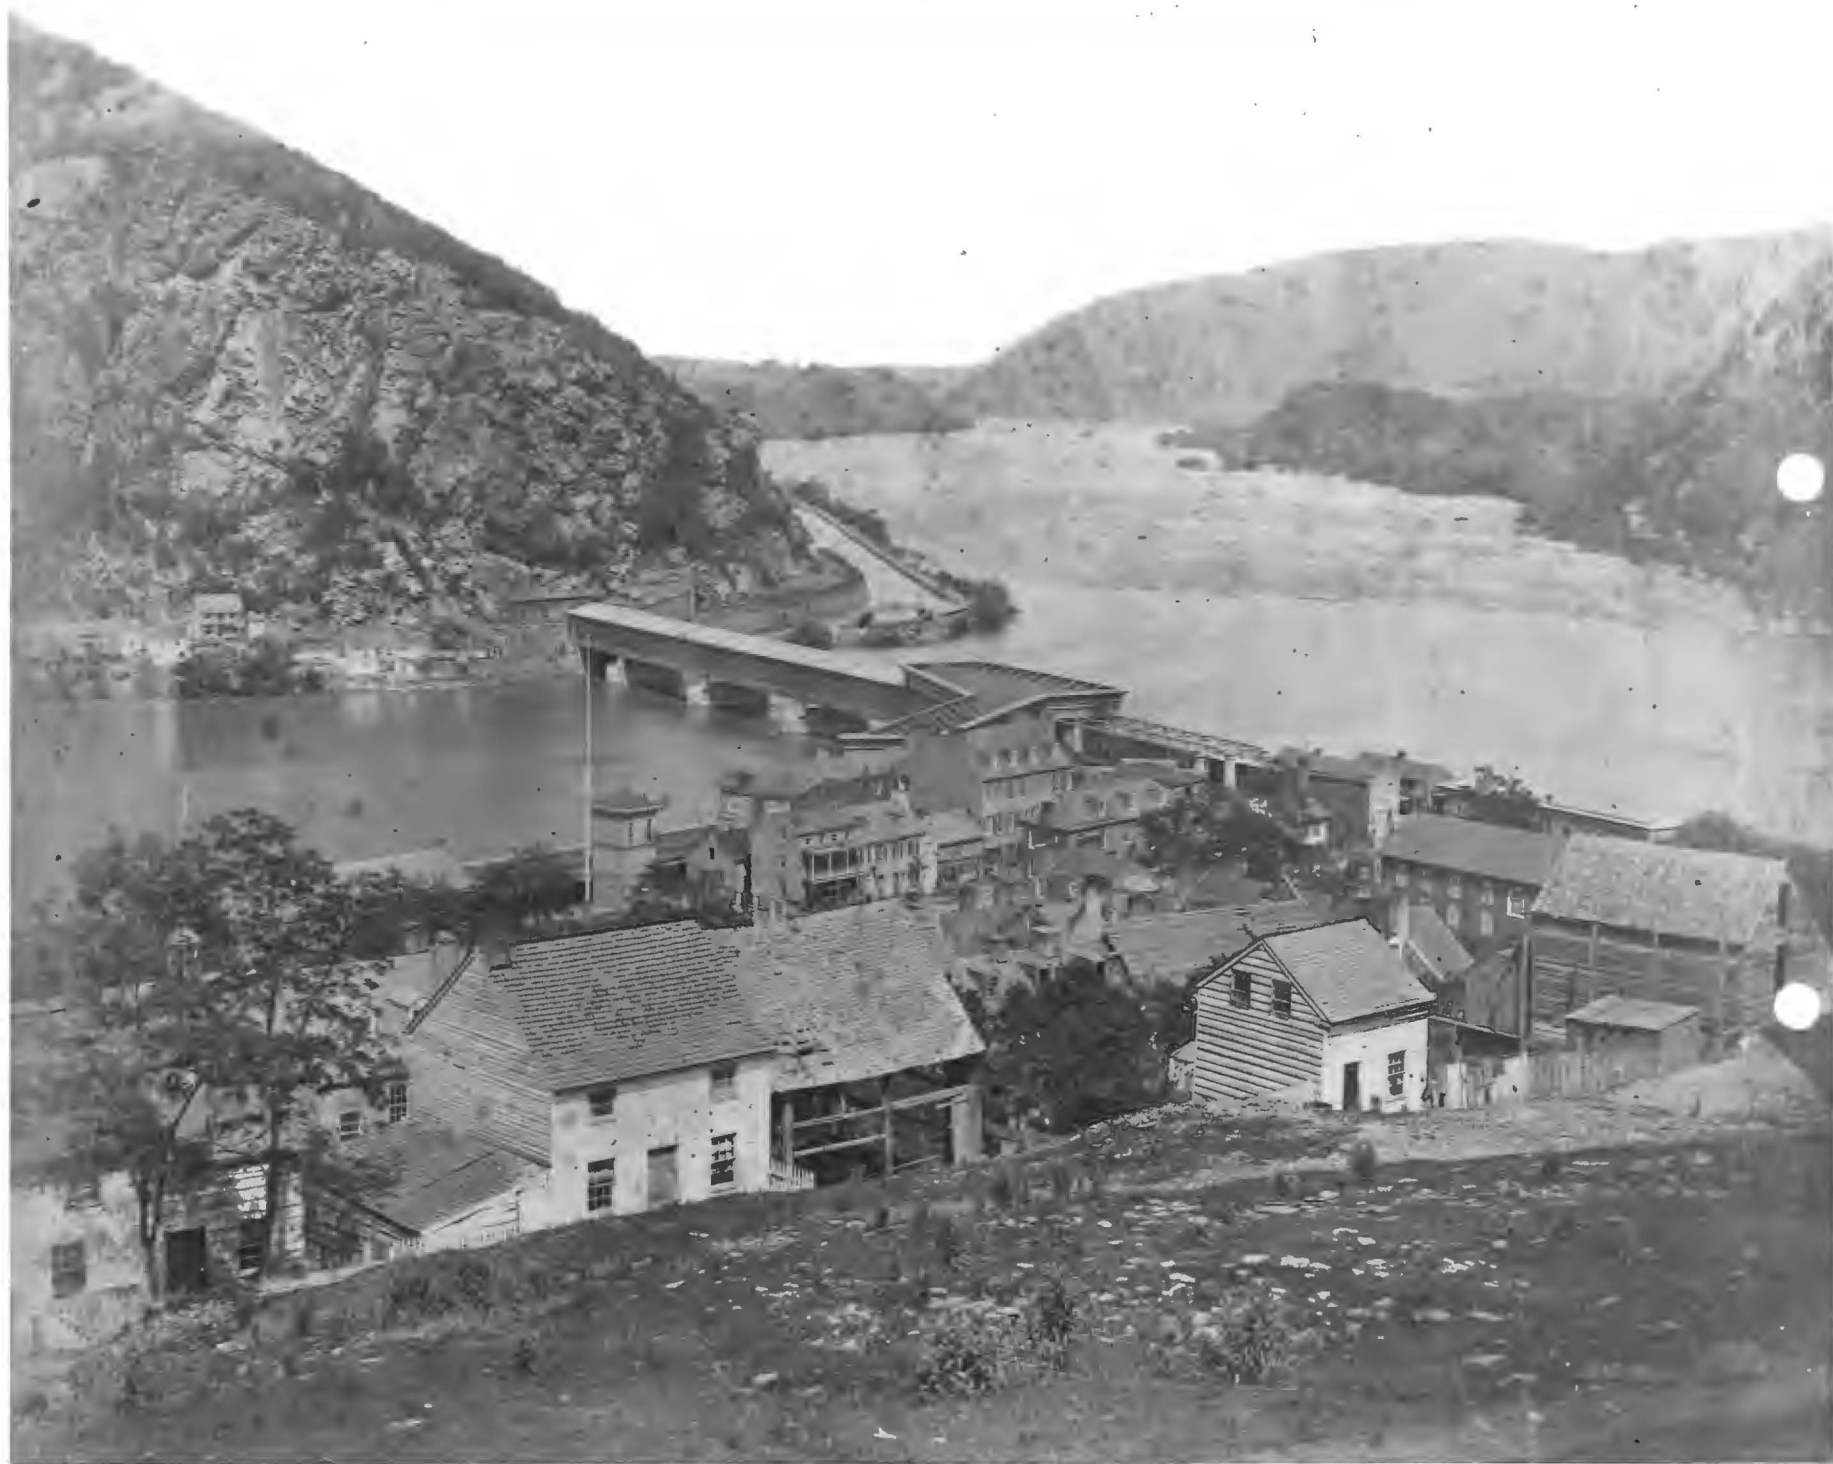
Harpers Ferry Negative No. HF-66.

"Harper's Ferry from Camp Hill, 1859"

Looking to the right of the photograph, just to the left of the wooden shed, is the second and part of the first story of the Large Arsenal. Note the arched windows and slate roof. This view shows most of the central section (note the projection) and the east wing of the Large Arsenal.

4. Smith, Report, page 9-see HF-21, 1806 print; also HF-66; HF-533 in Appendix I of this report. The archeologists were not able to check out fully the existence of this projection because a large tree covered this critical sector.

5. Smith, Report, page 8-print HF-21; page 10, HF-66 and HF-533 in Appendix I of this report.

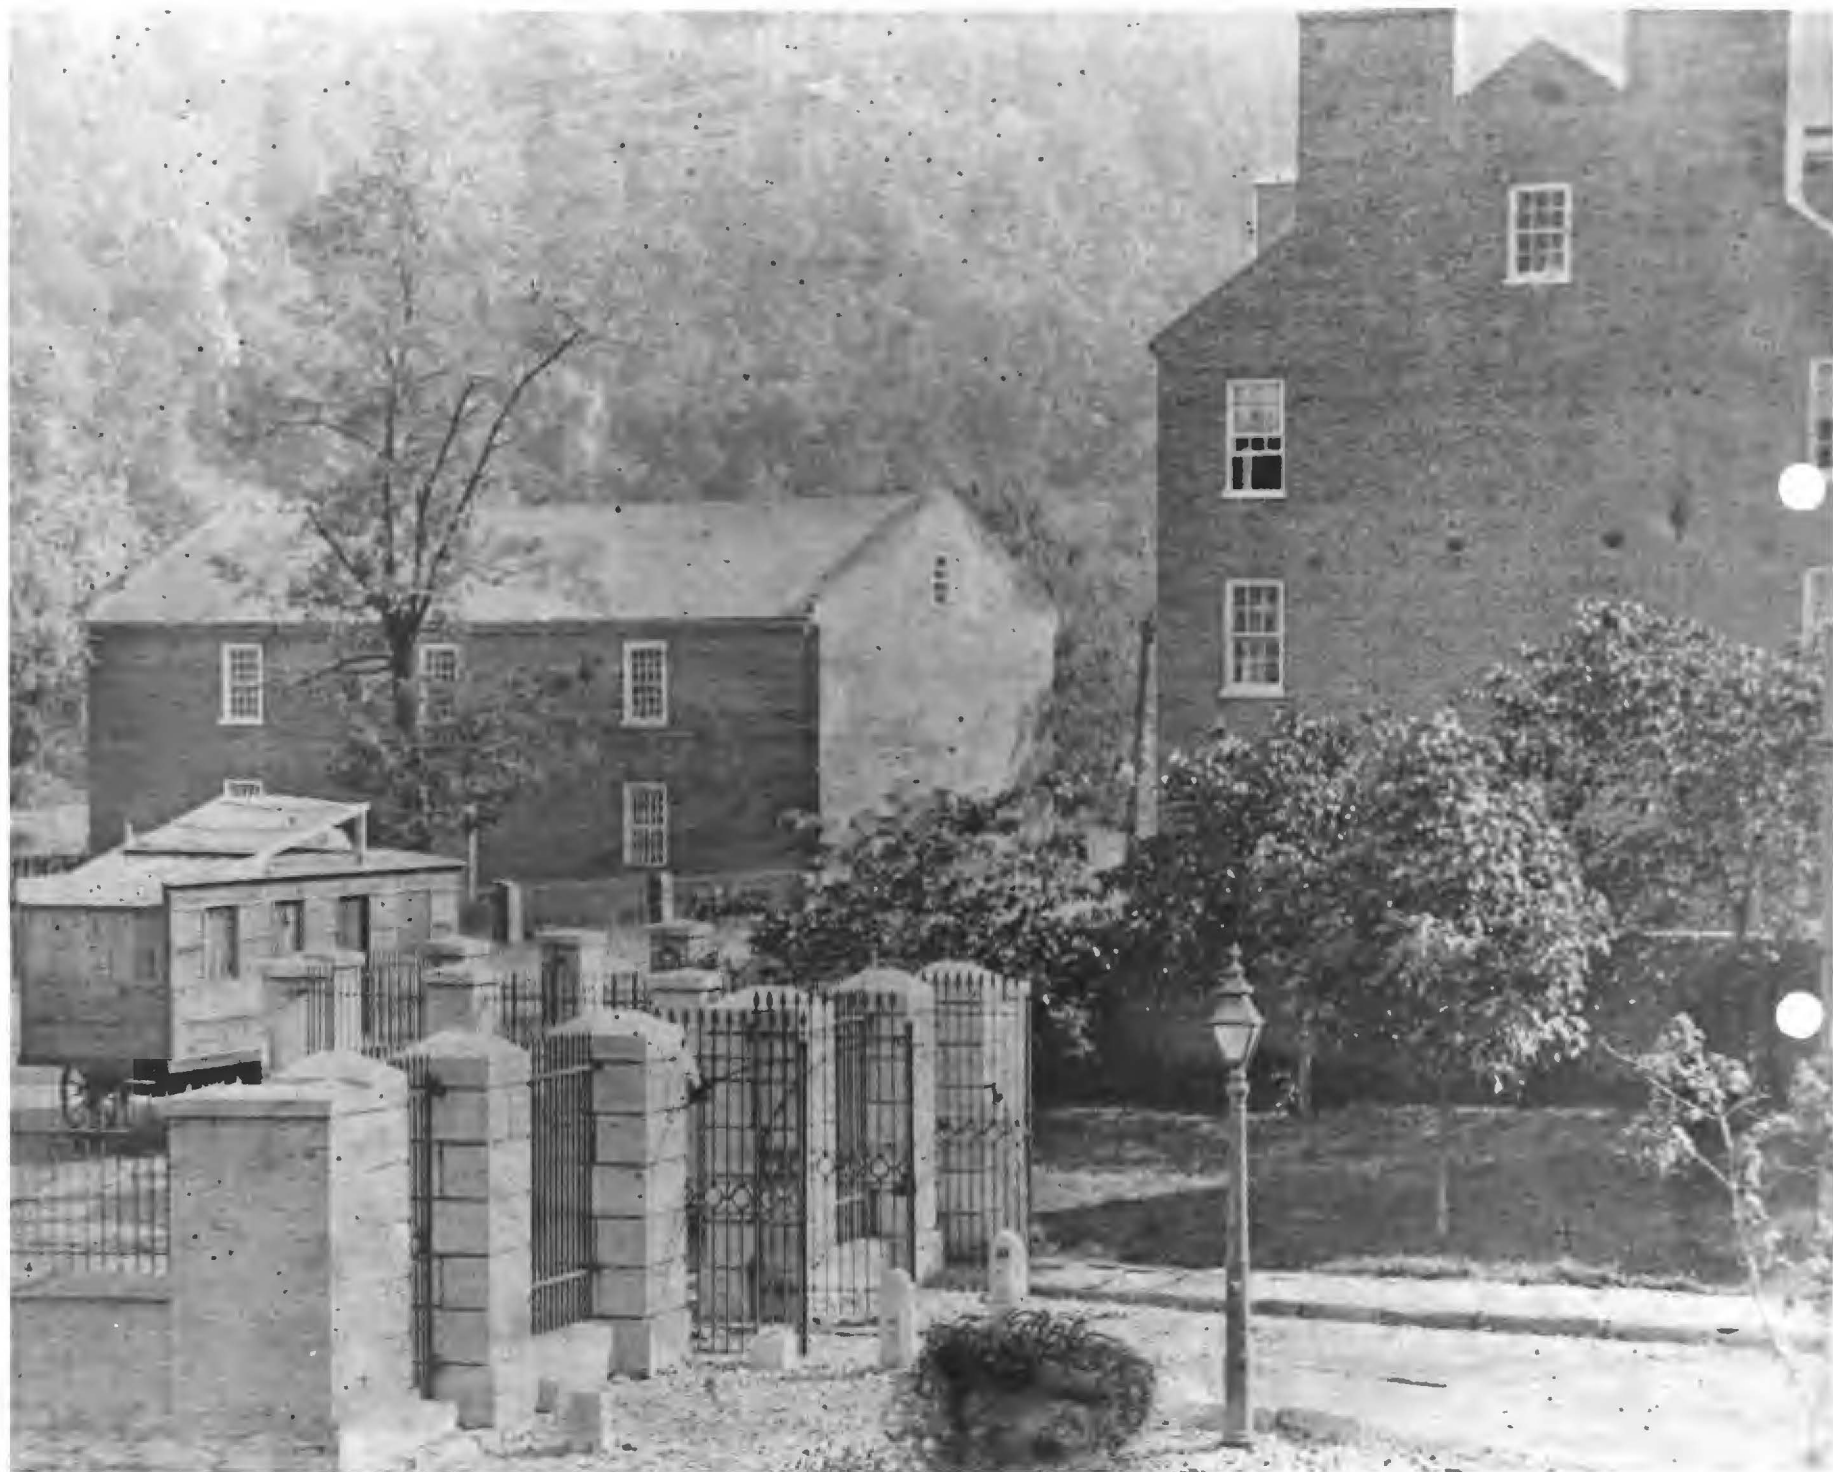
Harpers Ferry Negative No. HF-90.

Gate to the Armory Yard, 1859

This view is taken from just within the entrance of the Market Factory yard and looking south across Shenandoah Street into Arsenal Square. The large  $3\frac{1}{2}$  story brick building to the right of the photo is Bldg. No. 9.

Across the Shenandoah Street and just to the left of Bldg. No. 9 stands the Small Arsenal. Note the three windows in the second story on the east side, and also two windows and a door on the first floor (door partially hidden by the tree). In the north wall, one window may be seen. A fine brick pier and iron panel fence encloses the street front of the Arsenal Square, and to the left of the Small Arsenal is to be seen a portion of the wood paling fence that enclosed the yard on the west side.

21. Photograph HF-90 and print HF-533 in Appendix I of this report.

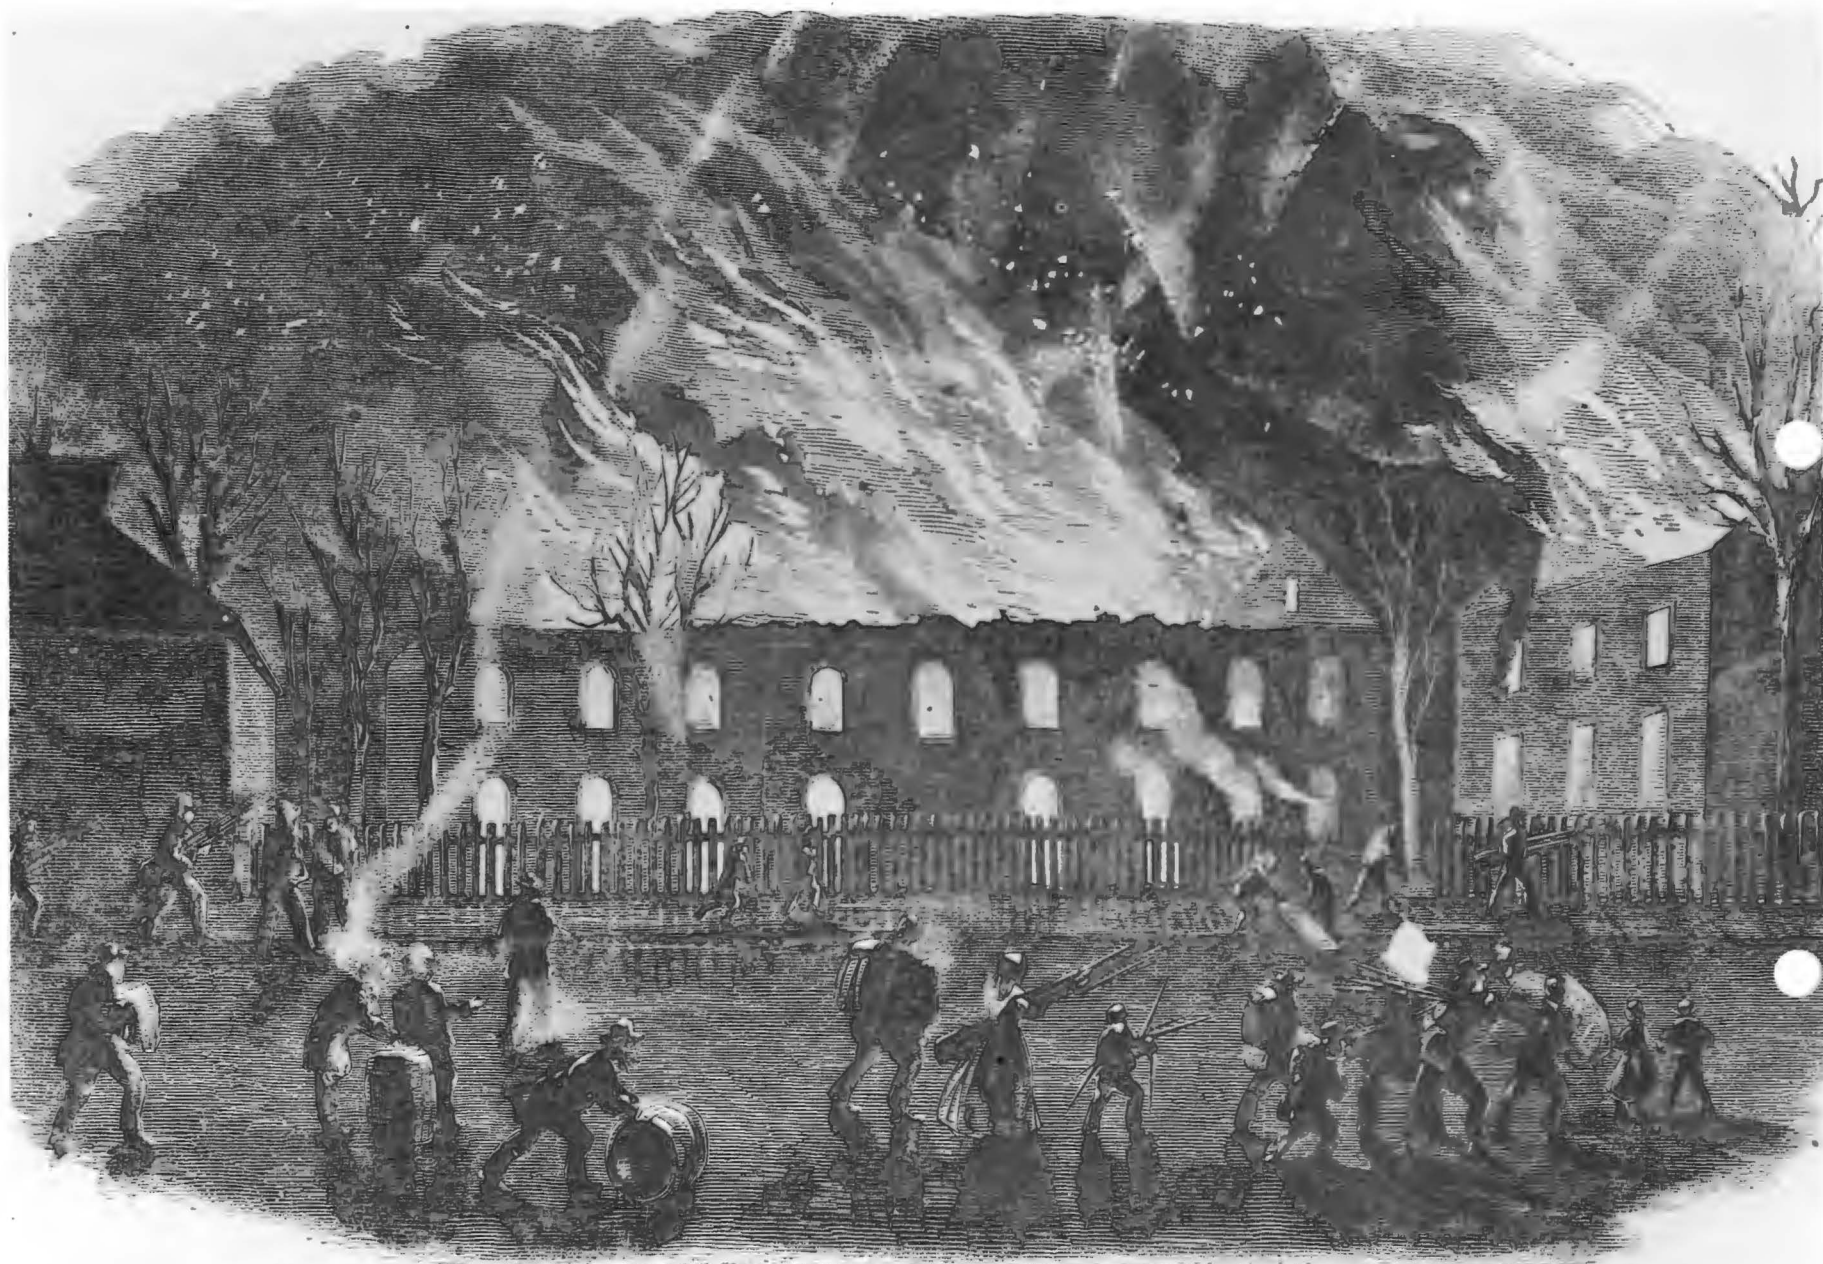
From Harper's Weekly, May 11, 1861, page 293.  
Harpers Ferry Negative No. HF-533.

"The Burning of the United States Arsenal  
at Harper's Ferry, 10 P.M. April 18, 1861.  
(Sketched by D. H. Strother).

The building, brick, one story, to the left of the sketch, is the Superintendent's Old Office; the structure in the center is the Large Arsenal, and that to the right is the Small Arsenal.

Note the location of doors and windows in the Large Arsenal, also what seems to be a projection in the center of the structure (beginning just beyond the third window from the left and ending at the sixth window from the left on the second floor). The sketch seems to be quite accurate in detail except for the fence that runs along the street front (compare with HF-30, page 16 of this report).

THE BURNING OF THE UNITED STATES ARSENAL AT HARPER'S FERRY, 10 P.M. APRIL 18, 1861.—[SKETCHED BY D. H. STROTHER.]

15. See print HF-533 in this report; also Smith, Report, page 47, 1861 print HF-4.
