National Park Service  
Cultural Landscapes Inventory

Civilian Conservation Corps Haleakala Crater Trails  
District  
Haleakala National Park

**Civilian Conservation Corps Haleakala Crater  
Trails District  
Haleakala National Park**

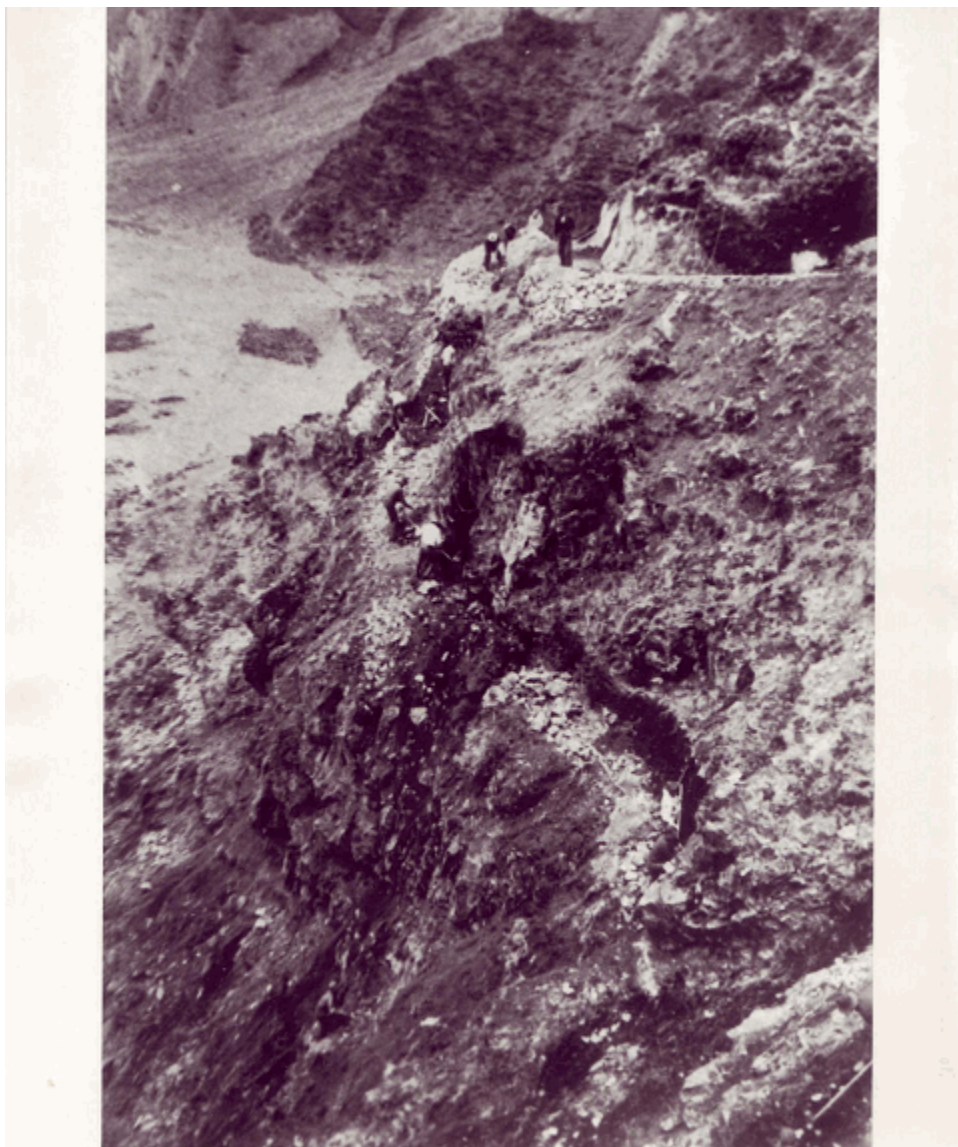
*CCC crews working on the Halemau'u Trail switchbacks, 1937 (Haleakala National Park archives).*

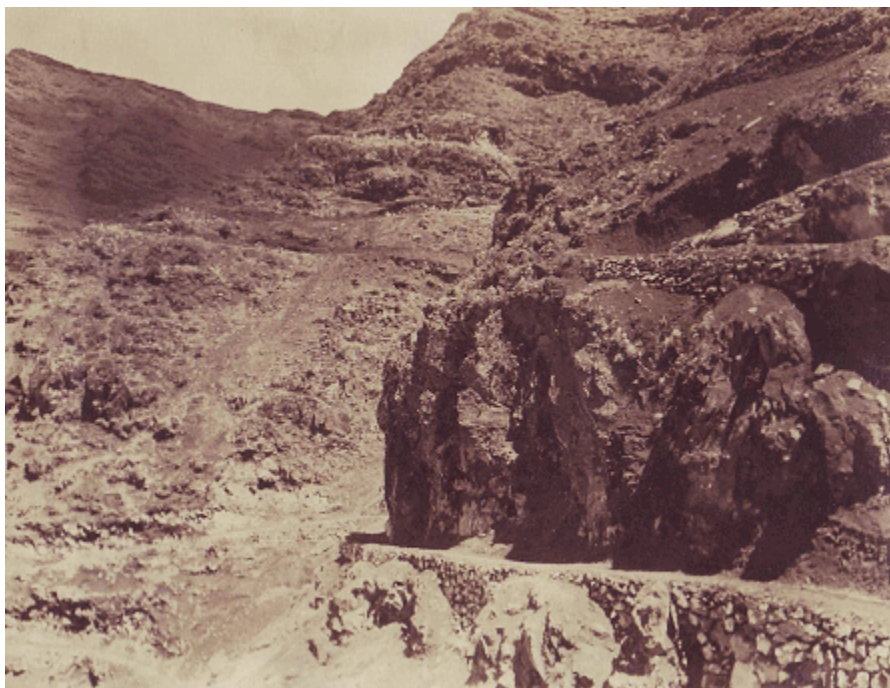
*Halemau'u Trail switchbacks, 1937 (Haleakala National Park archives).*

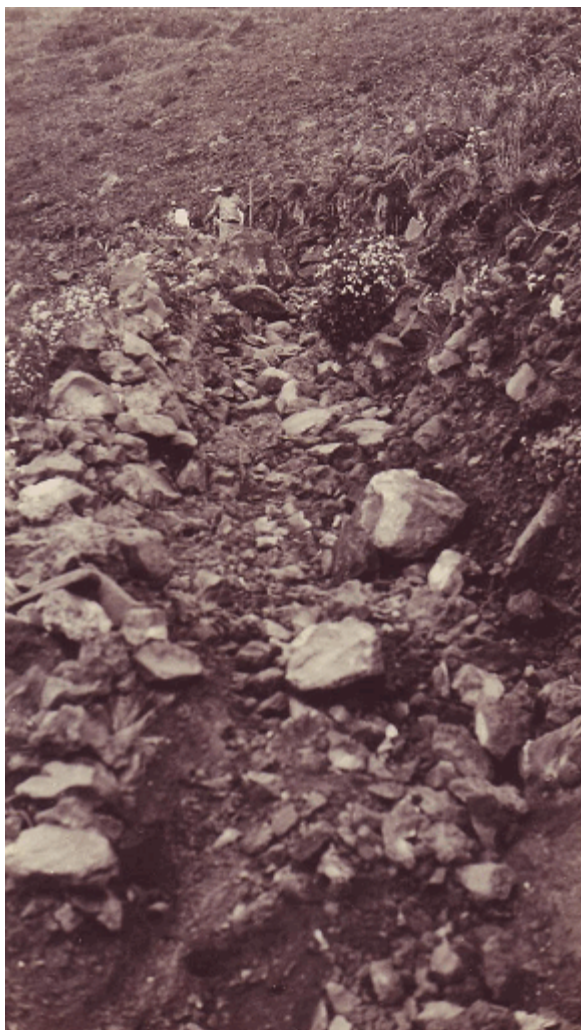
*Halemau'u Trail storm damage, 1937 (Haleakala National Park archives).*

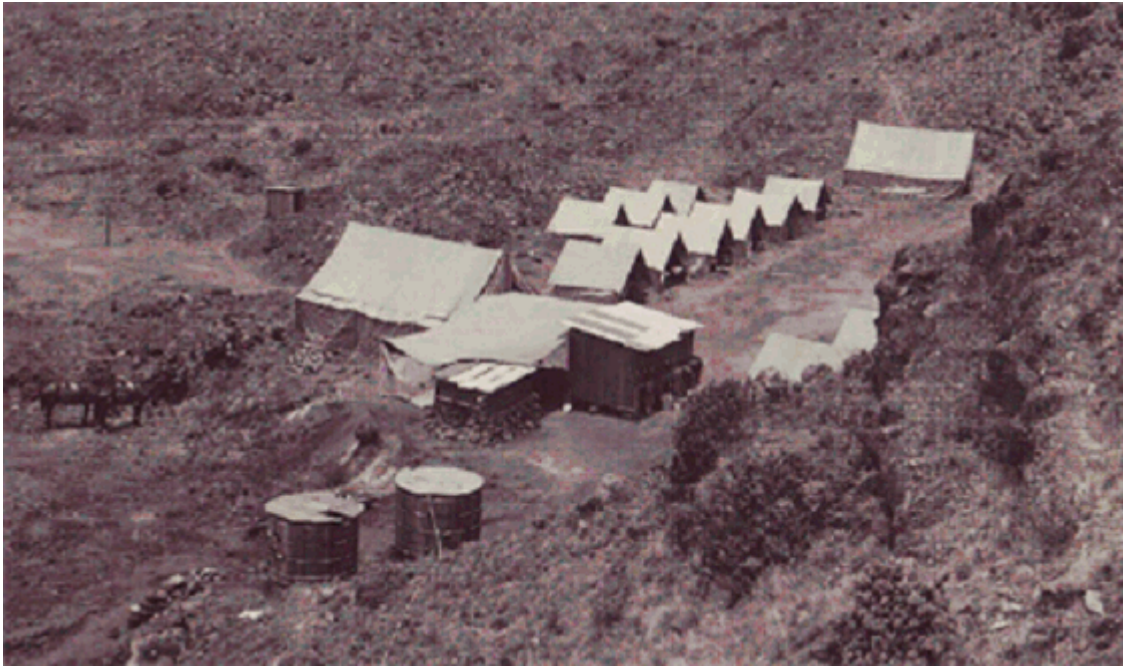
*Historic photo of a CCC camp at Holua, 1937. Note the two water tanks located in the foreground. One of these tanks was presumably moved to the secondary developed area at Holua near the shed and campground (HALE photo collection).*

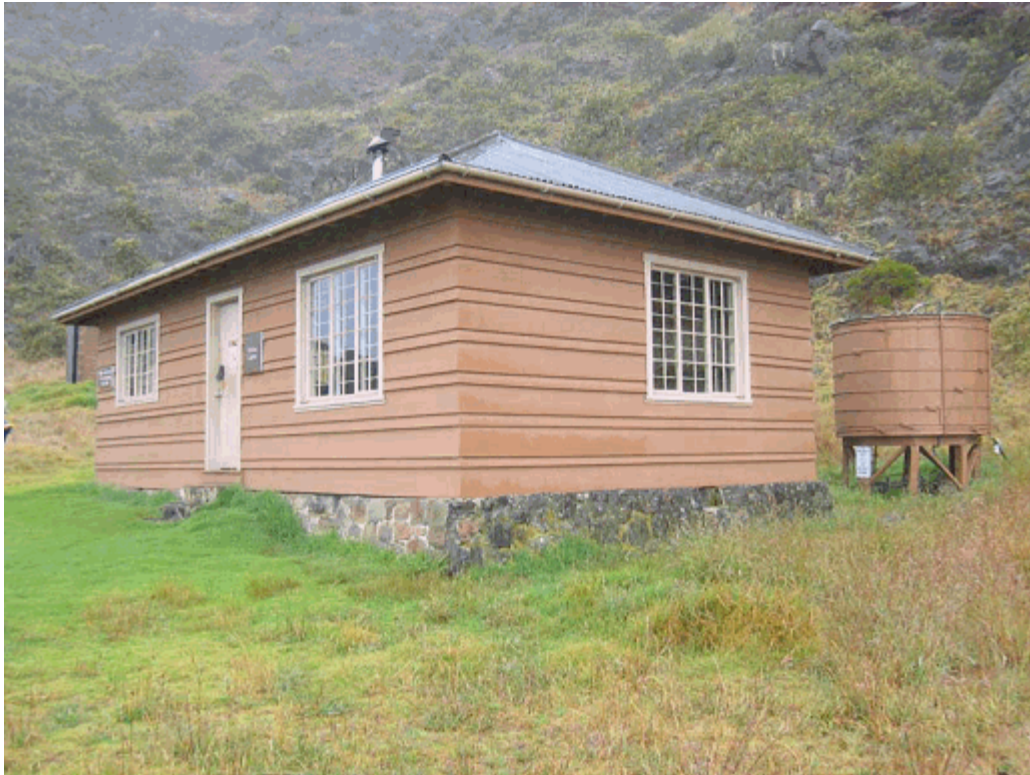
*Buildings and Structures #1: Holua Cabin and water tank, located in the northwest portion of Haleakala Crater at the foot of the towering, 3,000-foot Leleiwi Pali (PWRO, 2008).*

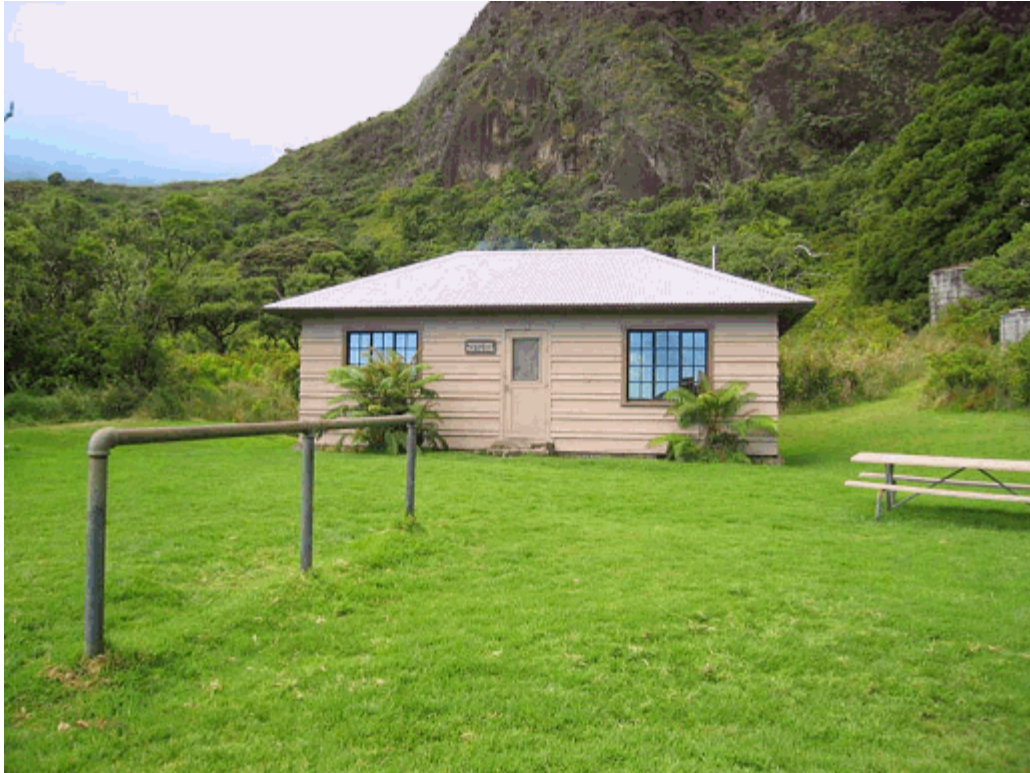
*Buildings and Structures #3: The Paliku Patrol Cabin, located a short distance northeast of the Paliku Cabin in Haleakala Crater. Note the two water tanks situated on the slope behind the cabin (PWRO, 2008).*

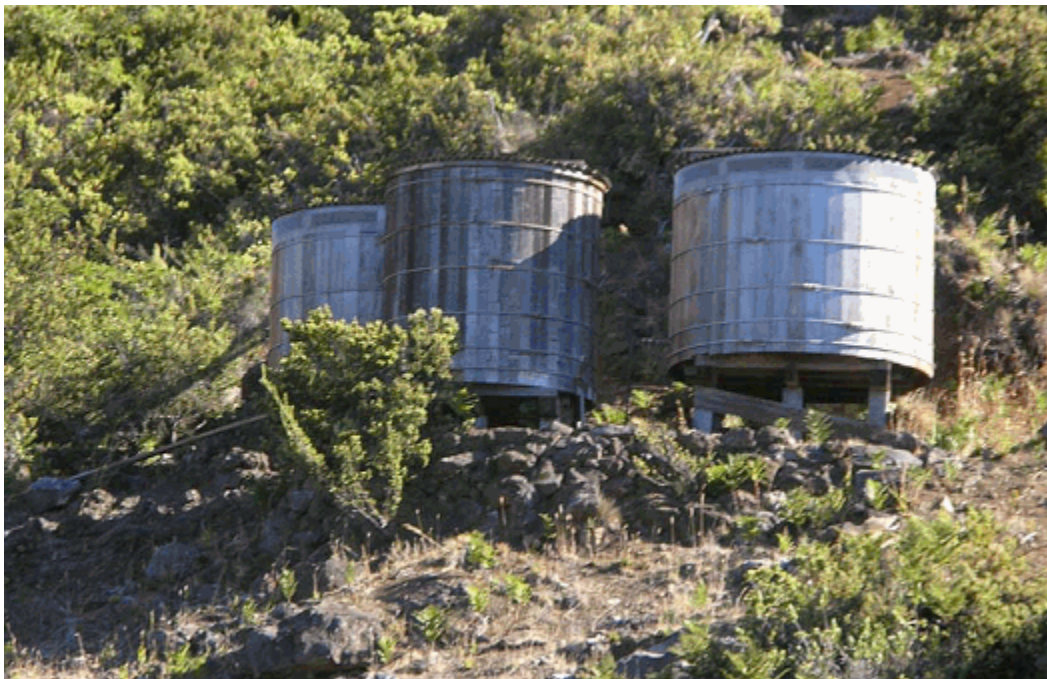
*Buildings and Structures #5: Kapalaoa water tanks, located on a slope a short distance west of the Kapalaoa Cabin. In 2006, the middle tank was rehabilitated, while the two remaining tanks were replaced in-kind (PWRO, 2008).*

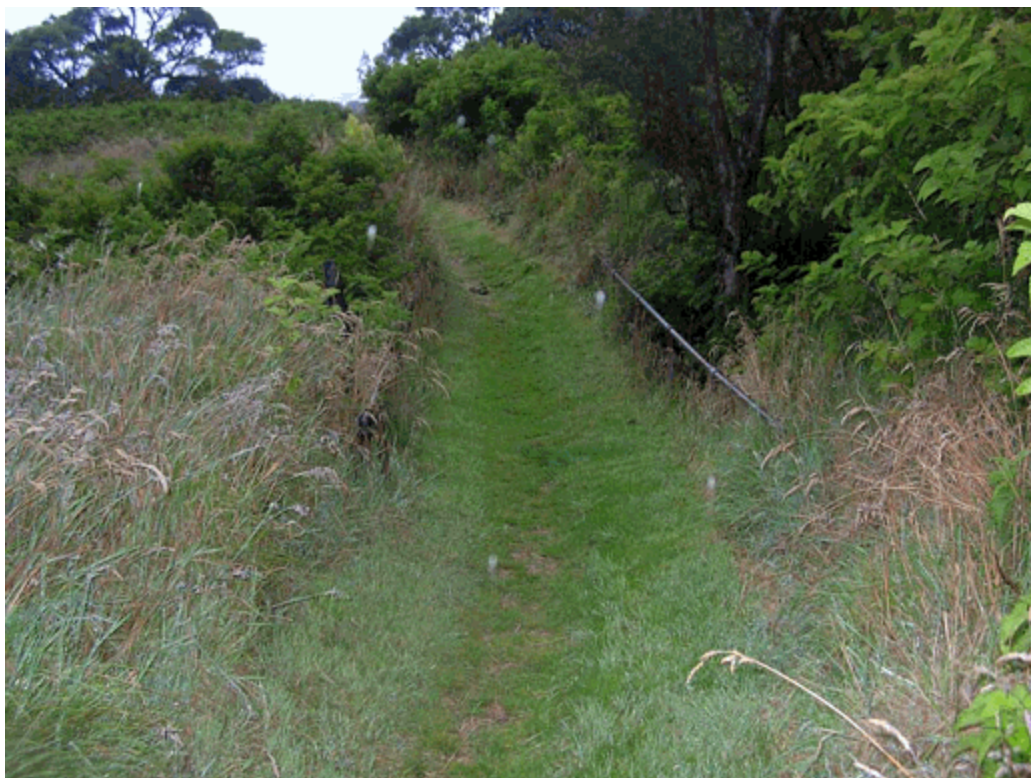
*Buildings and Structures #6: The Paliku Footbridge was constructed by the CCC in 1937 to provide pedestrian access to the Paliku Patrol Cabin from Paliku Cabin (PWRO, 2008).*

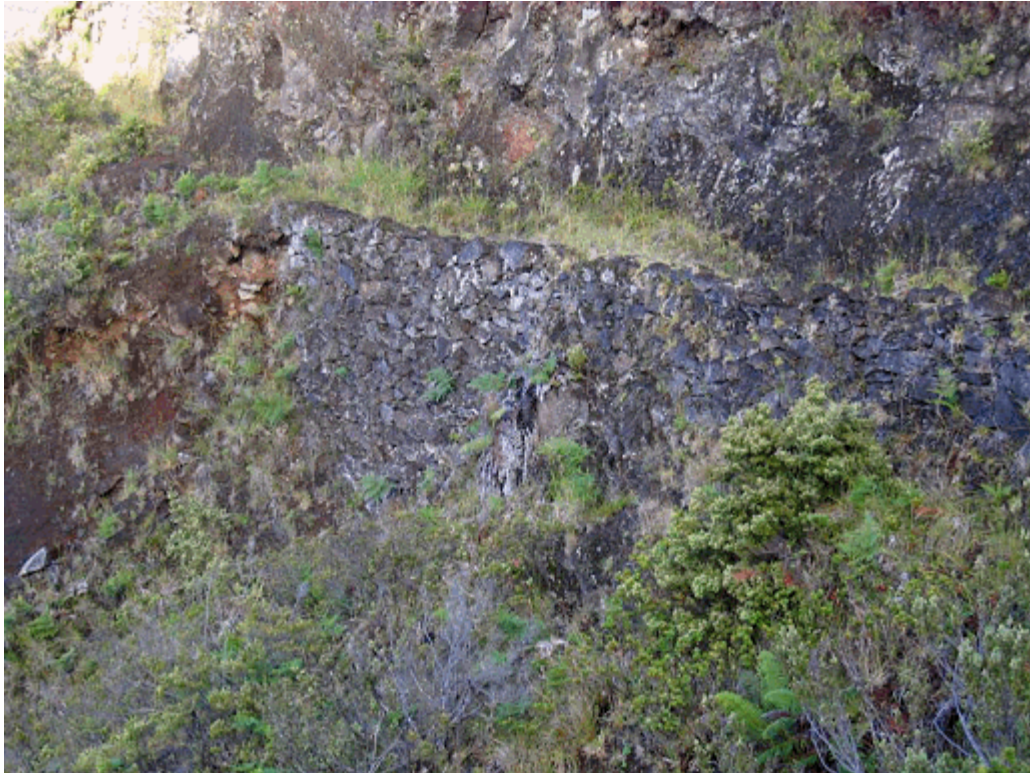
*Buildings and Structures #7: Stone retaining wall associated with the Halemau'u switchbacks. Note the rustic character of the wall as it seamlessly blends with its surrounding environment (PWRO, 2008).*

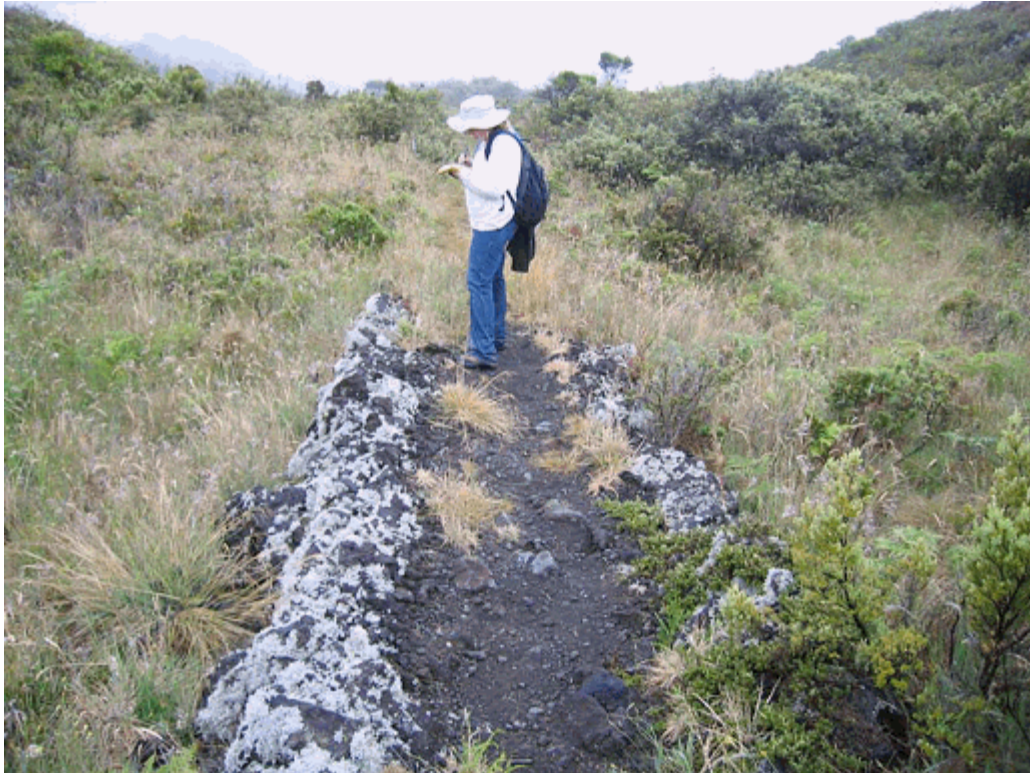
*Buildings and Structures #8: Lichen-covered stone causeway located along the Kaupo Trail (PWRO, 2008).*

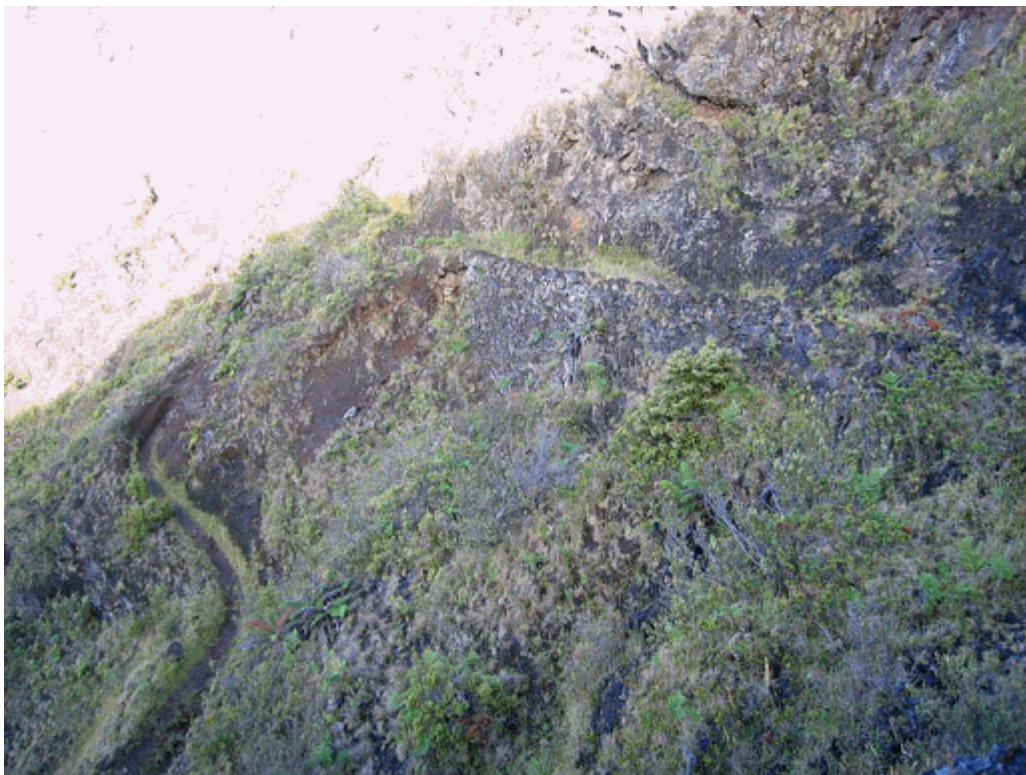
*Circulation #4: Switchbacks and associated stone retaining walls along the Halemau'u Trail as it ascends out of the crater. Notice how the trail follows the topography, while blending with the natural environment (PWRO, 2008).*

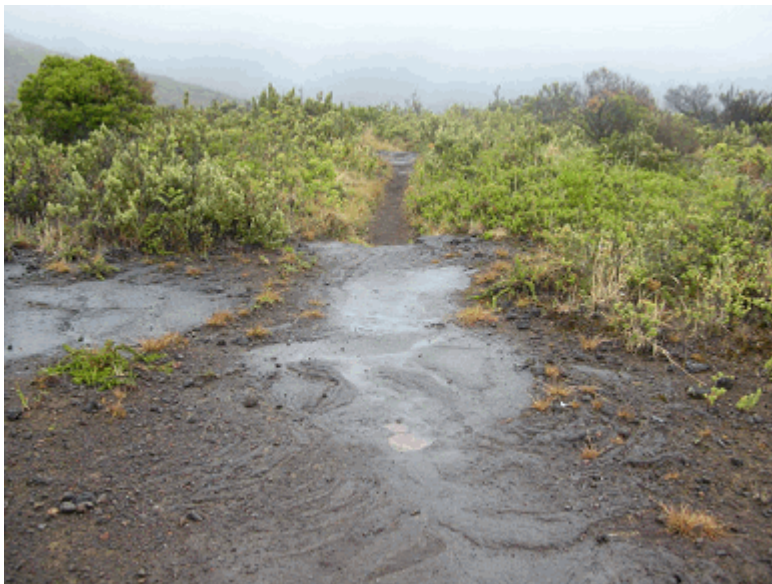
*Circulation #5: Character of Halemau'u Trail as it traverses across the eastern crater behind 'O'ilipu'u. In this area, the trail incorporates areas of smooth lava known as pahoehoe into its alignment.*

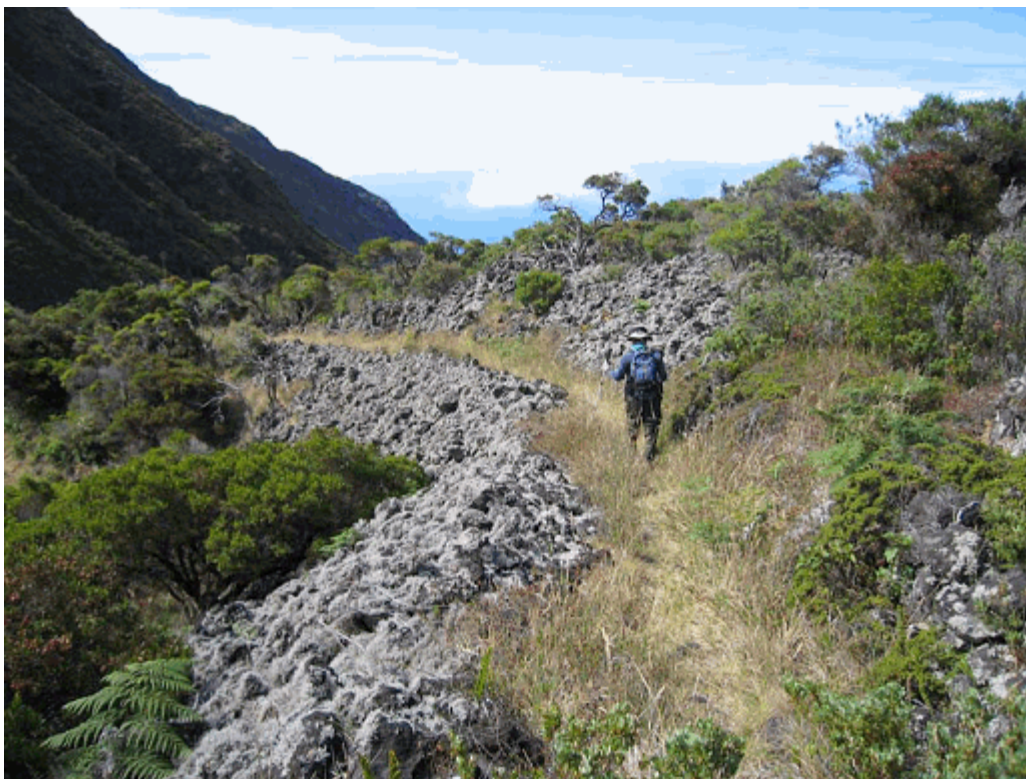
*Circulation #6: Lichen-covered rip rap retaining wall along Kaupo Trail (PWRO, 2008).*

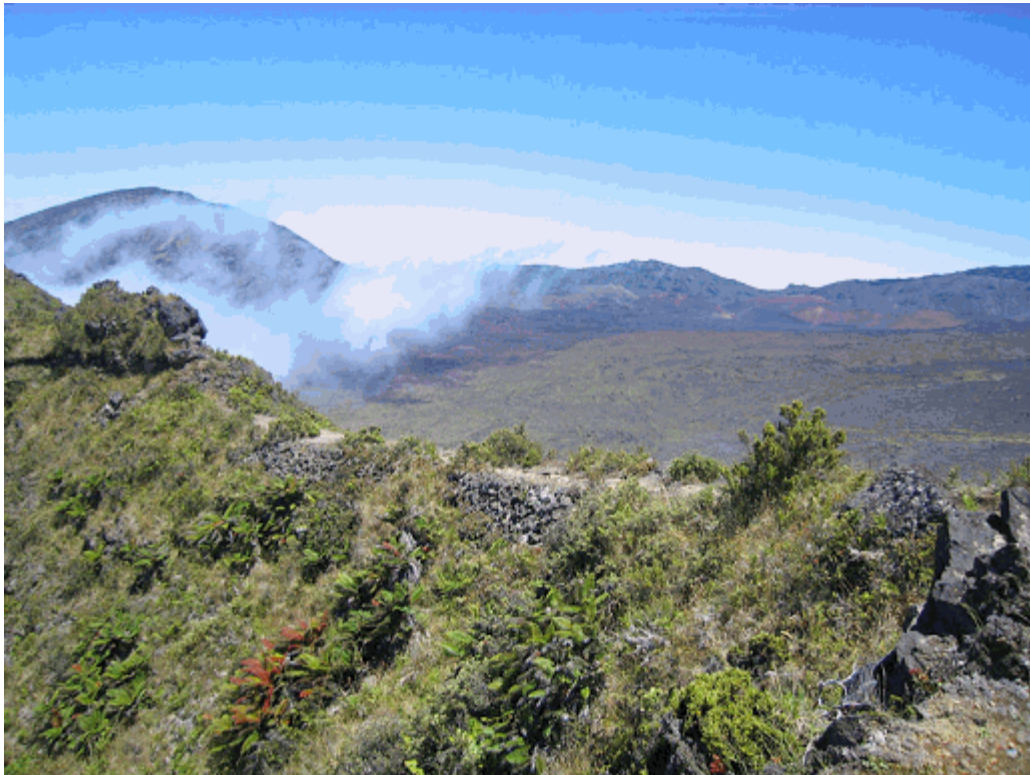
*Views and Vistas #2: View of Halekala Crater from the Halemau'u Trail. In this photo, the trail crosses Rainbow Bridge, a spectacular natural feature that was improved by the CCC during the period of significance (PWRO, 2008).*
