# **HOPEWELL FURNACE NATIONAL HISTORIC SITE**

## **HISTORIC RESOURCE STUDY FINAL**

Prepared for  
the National Park Service

by Robinson & Associates, Inc.

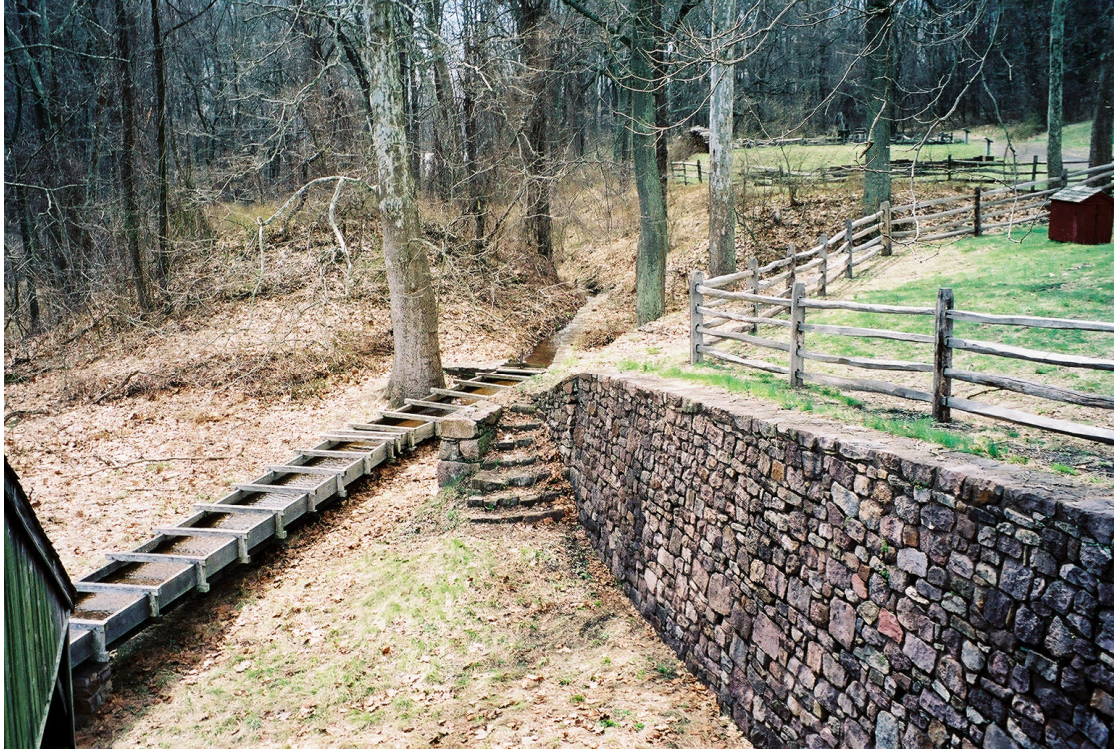
Figure 3 – The reconstructed West Head Race, originally built circa 1805. (Robinson & Associates photograph, 2003.)

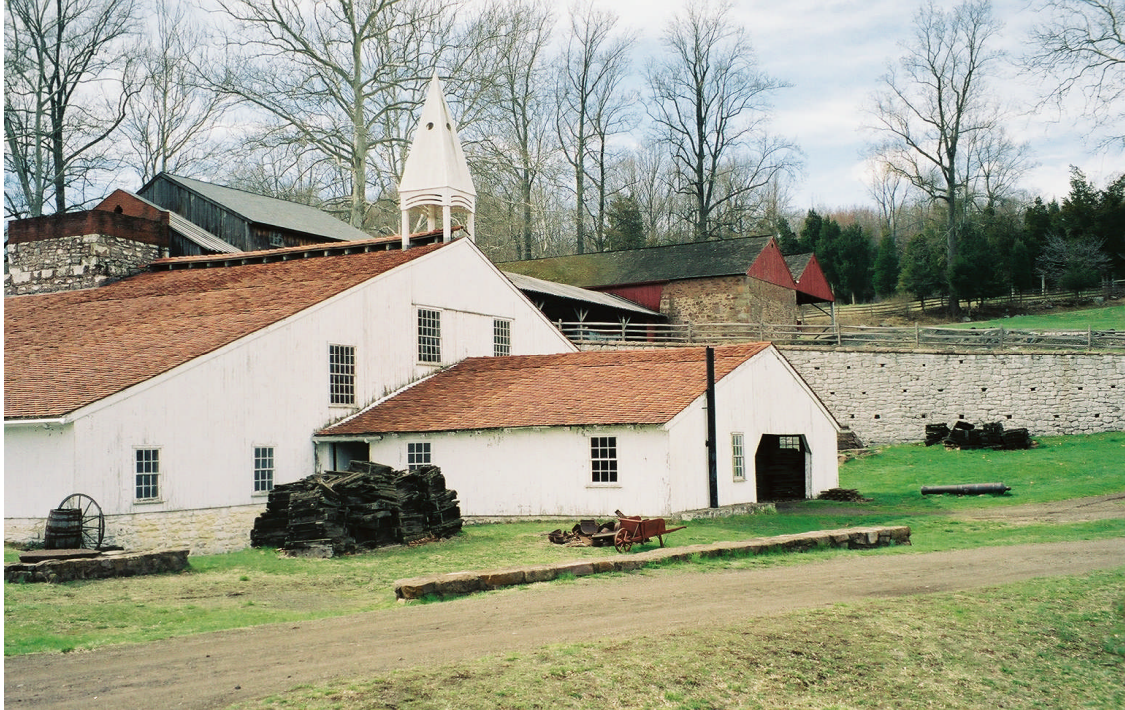
Figure 4 – The reconstructed furnace complex at Hopewell, including the Cleaning Shed, Cast House, Molding Sheds, Furnace Stack, Bridge House, Wheel House, Connecting Shed, and Charcoal House. (Robinson & Associates photograph, 2003.)

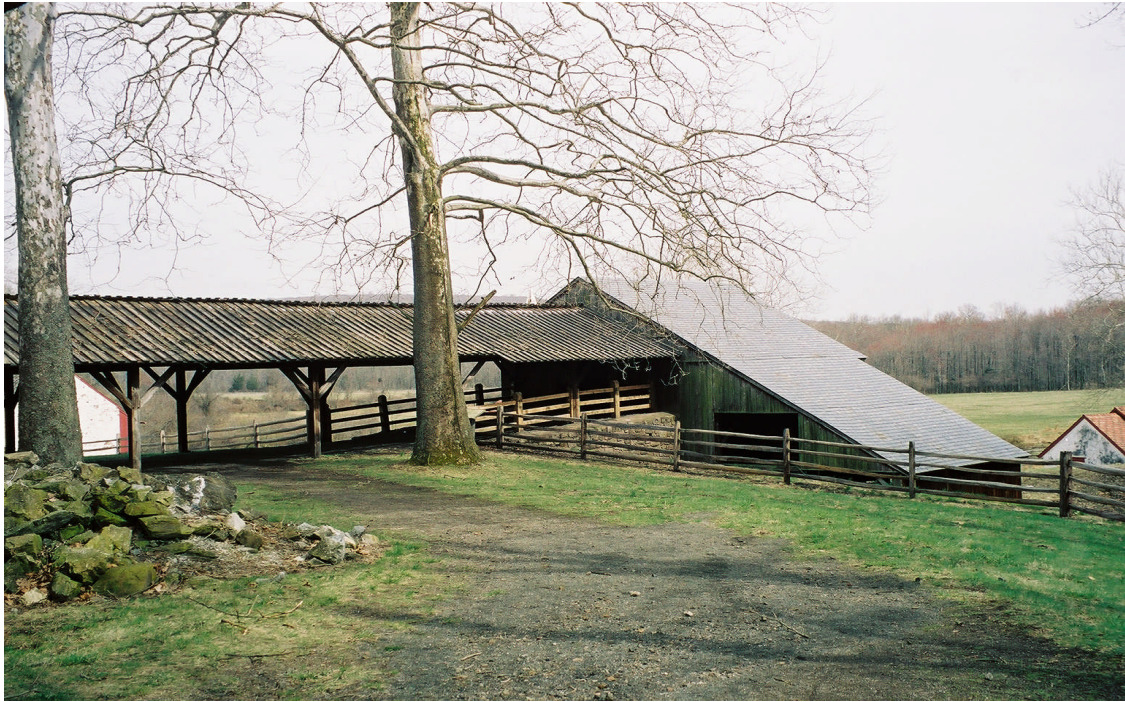
Figure 5 – The Wheel House, Bridge House, and Connecting Shed, reconstructed to their appearance in 1879. (Robinson & Associates photograph, 2003.)

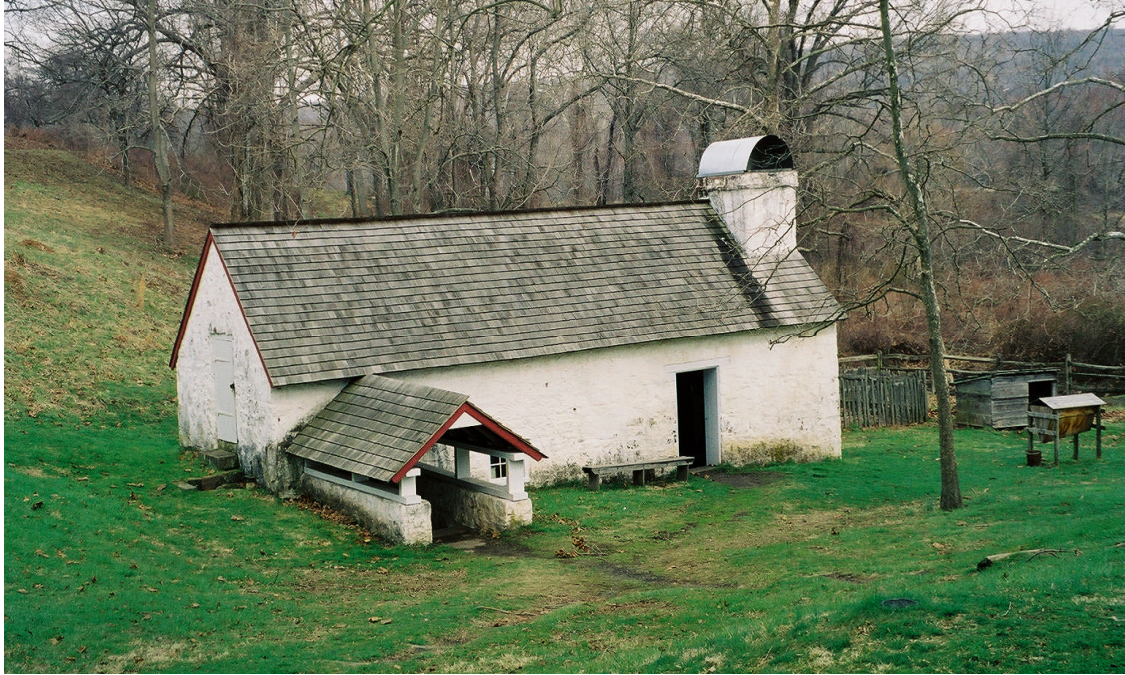
Figure 7 – Spring House on the grounds of the Ironmaster’s House. (Robinson & Associates photograph, 2003.)

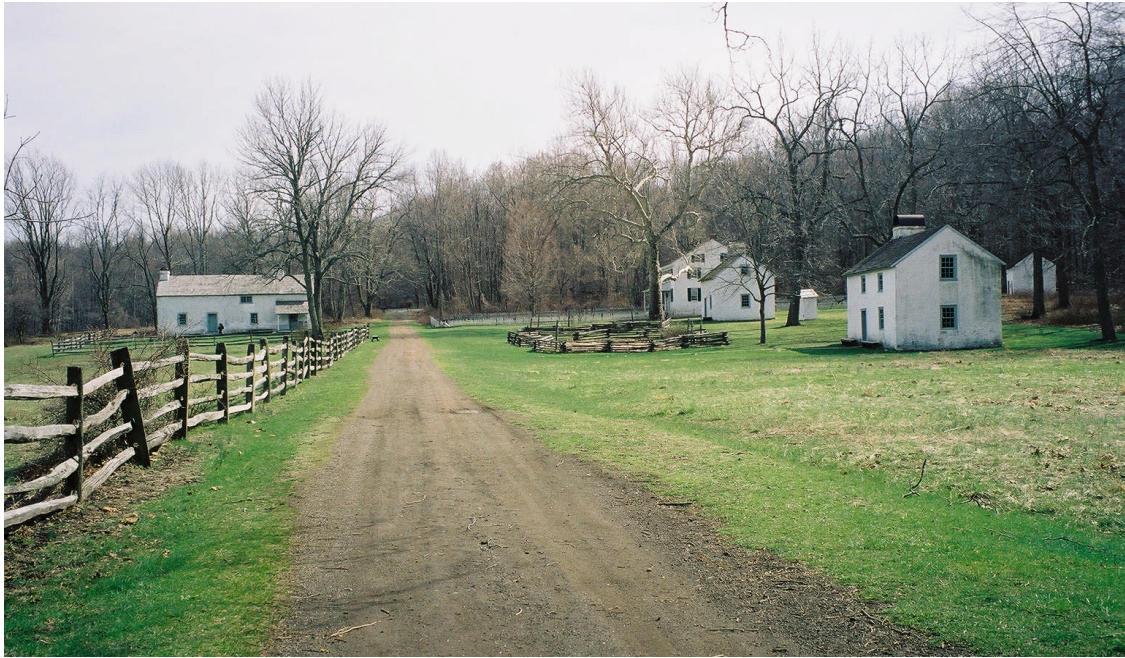
Stone tenant houses constructed and owned by the furnace are represented in the village by four buildings still extant south of the furnace complex and another east of the village along the Reading-Coventry Forge Road. (Figure 8) The dwelling known as the Boarding House stands on the east side of the Birdsboro-Warwick Road, while three tenant houses were built west of the road. The original portion of the Boarding House (1770-1830) stood two stories high and measured 29 by 19 feet. It was marked by stone quoins at its corners and had a central chimney

Figure 8 – Tenant housing along the Birdsboro-Warwick Road. (Robinson & Associates photograph, 2003.)

(the only furnace house with such a feature) that divided the house into two rooms. A one-story stone addition, 10 by 15 feet and known as a “cave,” was constructed on the south side of the house for storage since the dwelling had neither a usable cellar nor attic. A 23-by-19-foot addition was later attached to the east end of the house (1830-1870), and the entire structure plastered, masking the differences between the two building campaigns.<sup>107</sup> Two of the tenant houses, Nos. 1 and 2, also have caves for storage, a circumstance occasioned by the high water table of the ground on which they were built. Tenant House No. 1 (1820-1850) is the northernmost of the extant tenant houses. It measures 30 by 18 feet and stands two stories tall.<sup>108</sup>

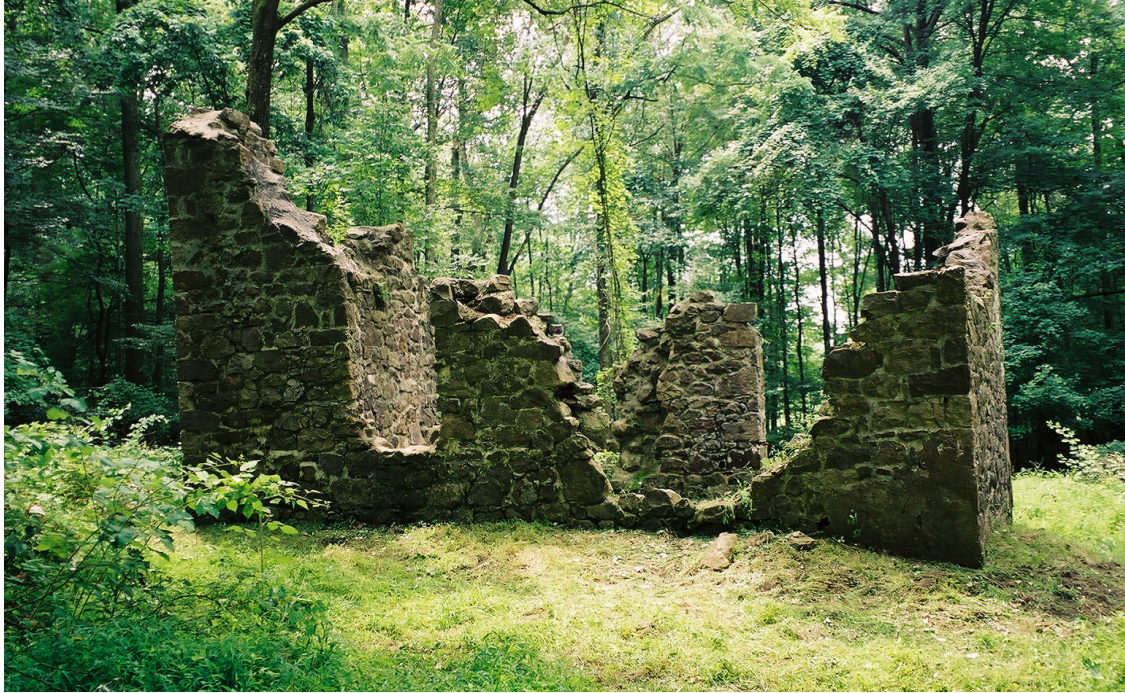
<sup>119</sup> Apple, "Historic Base Map Documentation," I-29; List of Classified Structures website. The Woodlot House is perhaps inappropriately named. Its name was derived from its association with a CCC woodlot that was nearby, not from its relation to the furnace.

Figure 9 – Ruins of the Woodlot House, a furnace-owned tenant house outside the village. (Robinson & Associates photograph, 2003.)

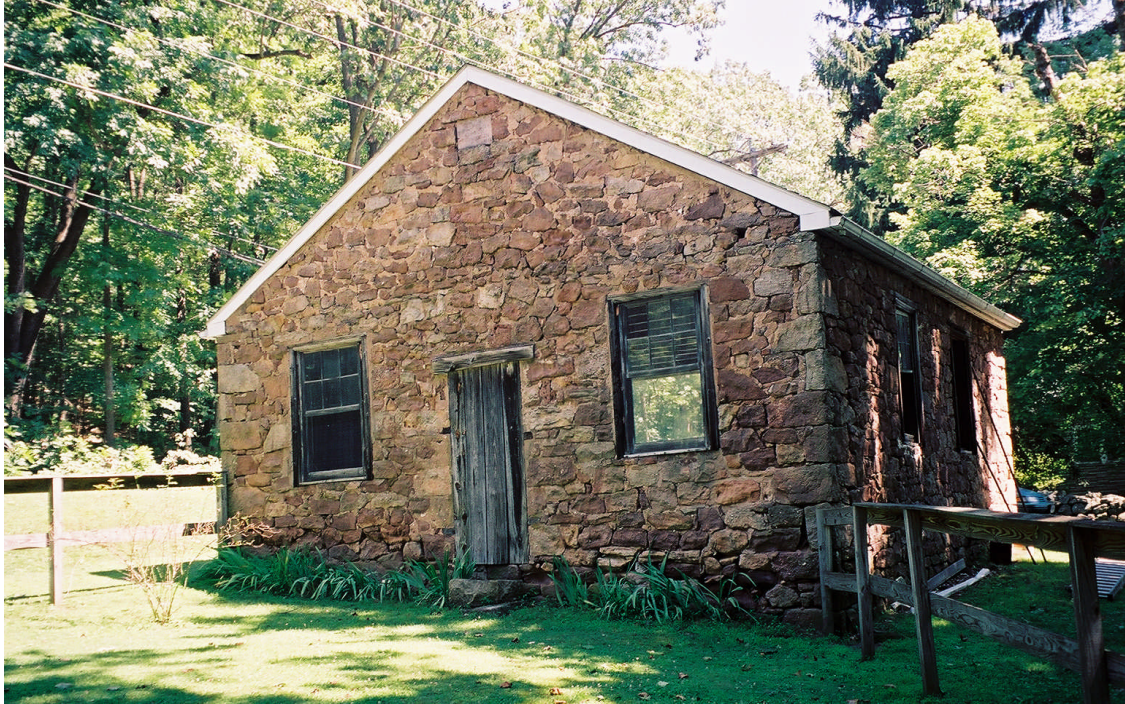
Figure 12 – Mount Frisby African Methodist Episcopal Church, now a garage, which served the needs of African Americans living in the Six Penny Creek area. (Robinson & Associates photograph, 2003.)

in Pennsylvania to form their own communities. The community near Six Penny Creek grew large enough to form its own church, Mount Frisby African Methodist Episcopal Church, by 1856. (Figure 12) This stone church was built for the congregation on land owned by Isaac Cole, and it served as a stop on the Underground Railroad. The church, later used as a garage, still stands, and its cemetery also remains. Cole, along with another African American veteran of the Union army in the Civil War, James Jackson, is buried in the cemetery, which is the oldest African American cemetery in Berks County. The remains of a two-story stone house, likely to have been built in the nineteenth century, stand near the church. Both the church and the house are owned by the Cole family.<sup>134</sup>

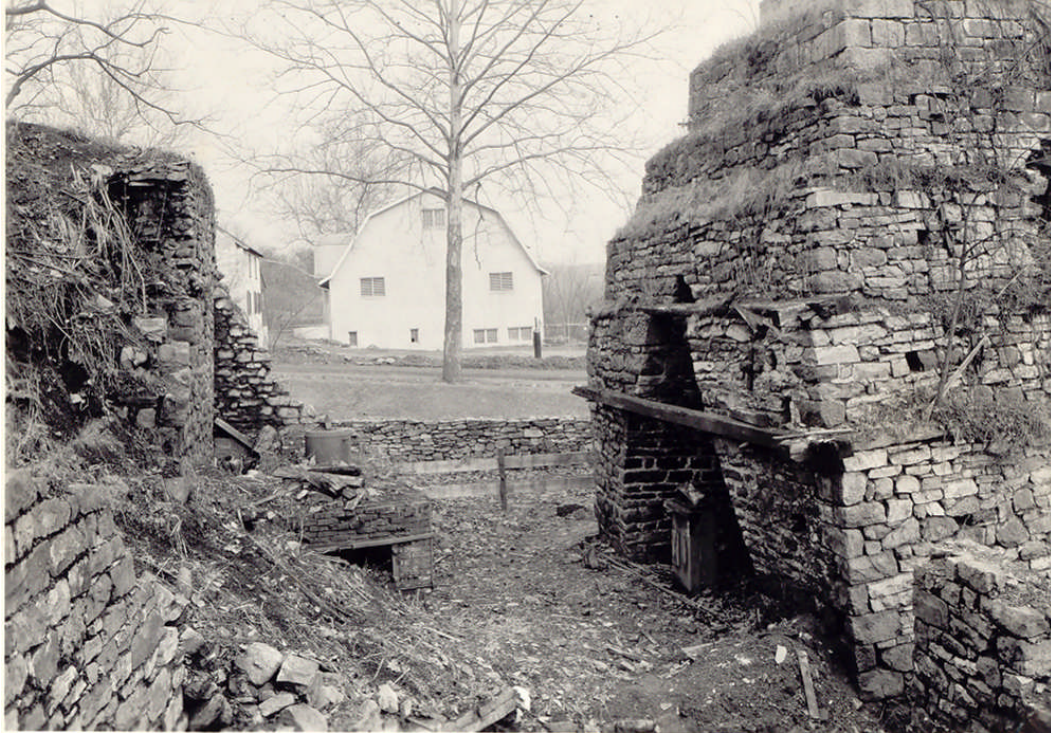
The biggest change in the village landscape resulting from the move to dairy farming took place in 1926, when the Barn was completely reconstructed and doubled in size. (Figure 13) Grading between the Barn and the Ironmaster's House had already taken place in 1922, leveling this area,

Figure 13 – The modern dairy barn, as seen beyond the ruins of the furnace stack in 1935. (Jack Anderson, Hopewell Furnace National Historic Site Archives, temporary box no. 2.)

and light wells were constructed to illuminate the first floor of the Ironmaster's House at the same time. The reconstructed Barn reused portions of the stone walls from the previous building, but all the framing elements were replaced. The straw house on the south side was demolished, but its round stone pillars served as foundation piers for the new portion of the building, which was constructed of cinderblocks. A gambrel roof covered the expanded Barn, and the combination of the old stone walls and new cinderblock construction was stuccoed over for a unified appearance.

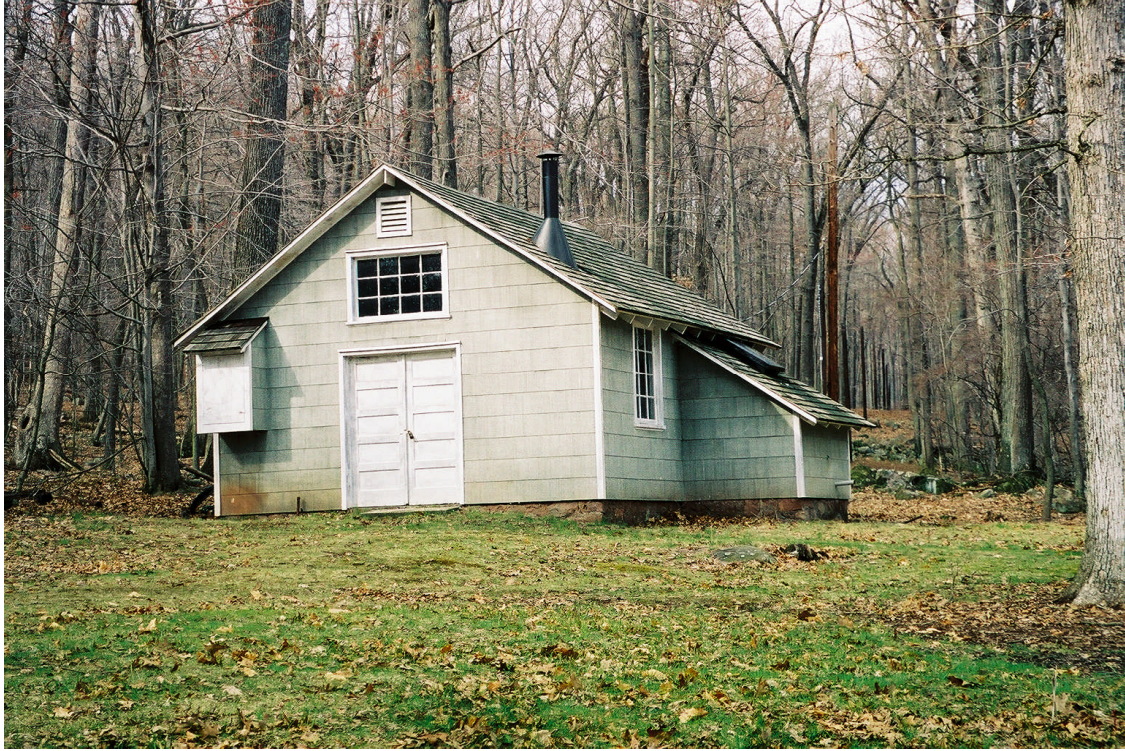
Figure 16 – Civilian Conservation Corps Pump House. (Robinson & Associates photograph, 2003.)

Three of the CCC buildings remain in use today. A one-story, frame pump house (now building No. 51) built in 1935 stands near Quarters 98 and 99. (Figure 16) One-story cinderblock buildings were built in 1941 for use as an oil house (No. 66) and a storage building (No. 67) in the utility court north of the camp. In addition, the concrete pad of the CCC firehouse can also be seen near Quarters 98 and 99. Other remnants of the camp are buried below ground near the present maintenance building. These include concrete slabs and foundations for the mess hall, infirmary, and canteen near the current maintenance building. In the original utility area northeast of the camp itself, the YCC building was constructed on the site of a larger CCC building, the foundations of which are still visible. Between the utility area and the camp was a parade ground that today is an open field. The remains of CCC Camp SP-7/NP-4 have not yet been evaluated through archeological research. Their contributing/noncontributing status therefore remains to be determined.<sup>156</sup>

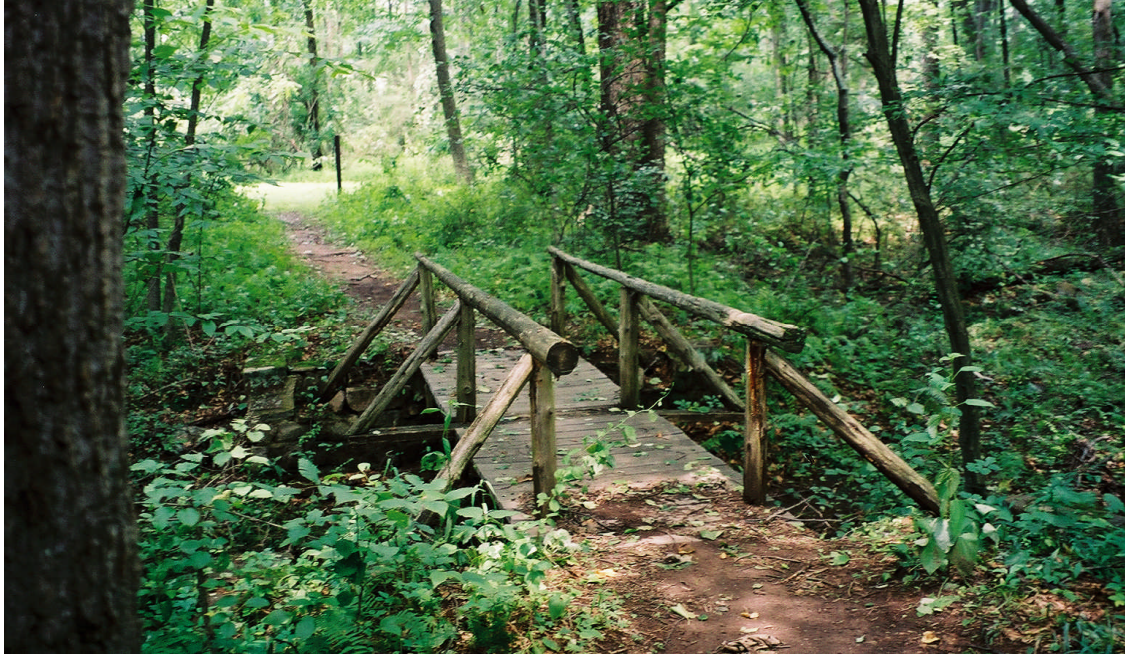
Figure 19 – CCC-constructed vehicle bridge near Baptism Creek Picnic Area, now supporting a pedestrian bridge. (Robinson & Associates photograph, 2003.)

| Figure 19 | CCC-constructed vehicle bridge foundations near Baptism Creek Picnic Area, now supporting a 1998 pedestrian bridge | 76 |

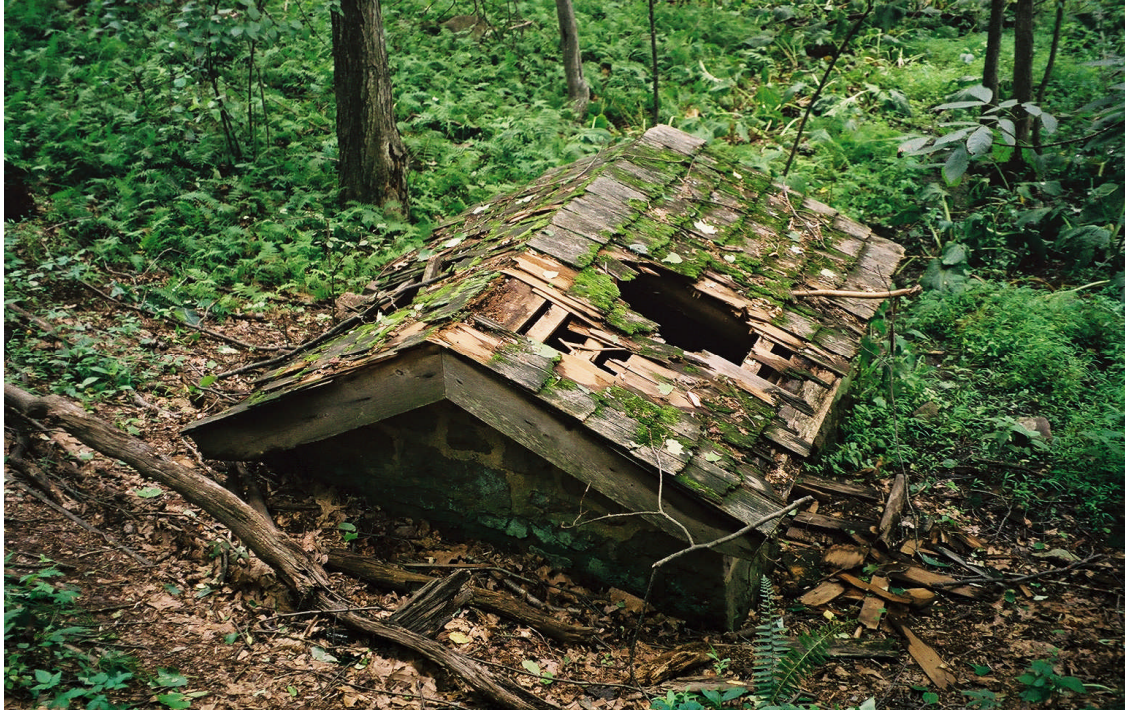
Figure 20 – CCC-constructed springhouse near Baptism Creek Picnic Area. (Robinson & Associates photograph, 2003.)

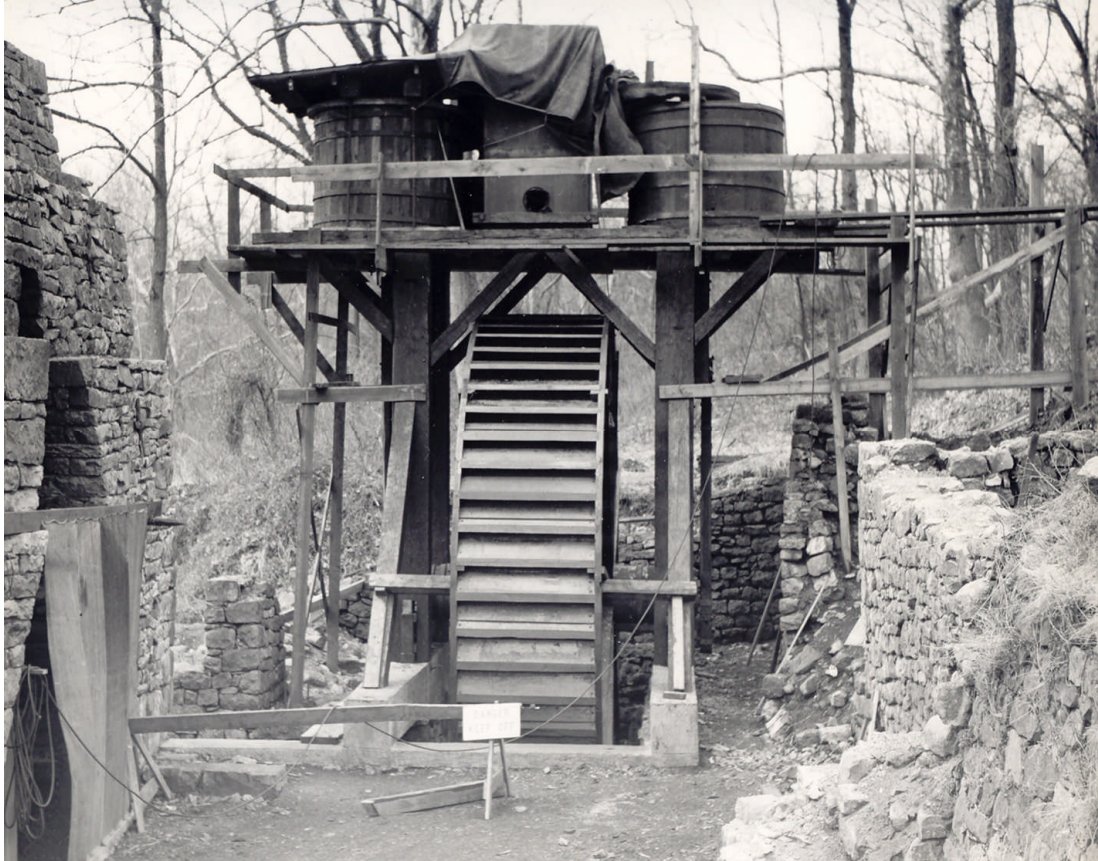
Figure 22 – Blast machinery and water wheel, 1951. (Hopewell Furnace National Historic Site Archives.)

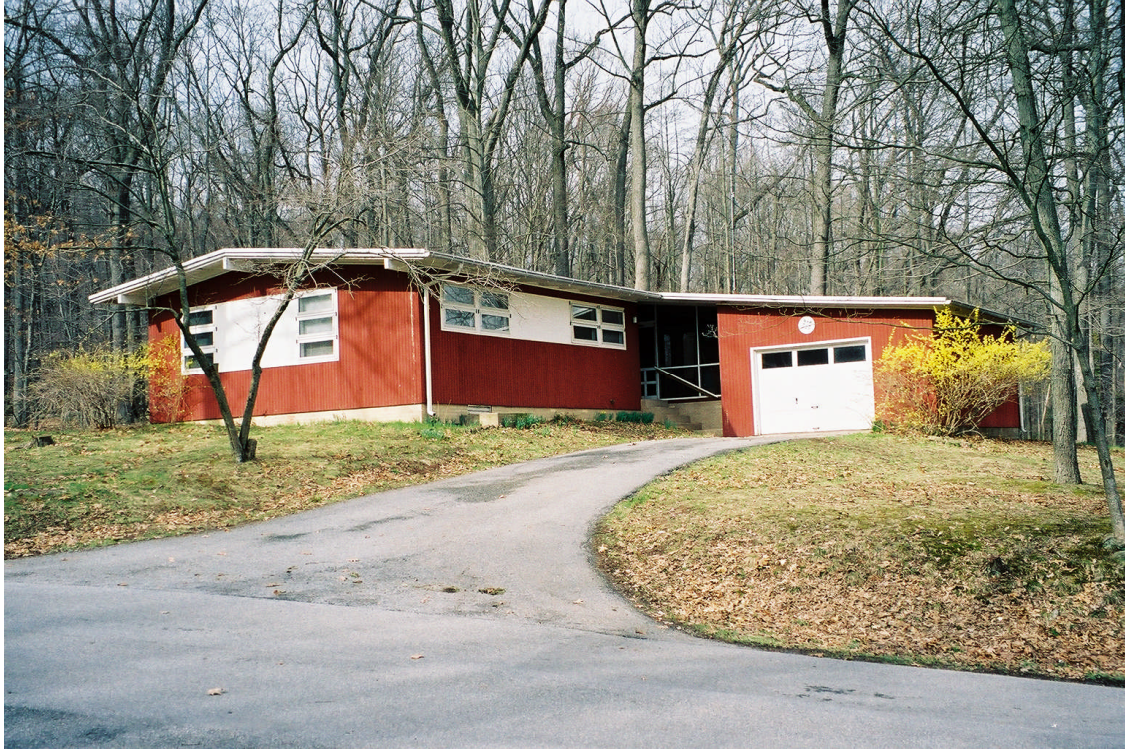
Figure 23 – Quarters 99, constructed during the Mission 66 program.  
(Robinson & Associates photograph, 2003.)

throughout the United States in the quarter century after World War II, the one-story, three-bedroom houses featured vertical wood siding, low-pitched roofs, banked windows, and attached garages.<sup>234</sup> The maintenance building was constructed of concrete and concrete block over a steel frame. It was intended to contain a fire house, a warehouse, an office, a carpentry shop, artifact storage, and a vehicle maintenance area within its 94-foot length.<sup>235</sup> The residences were completed and occupied by the end of 1958, while the maintenance building was accepted by the park from the contractor on January 15, 1959. (Figure 23) The residences and the cinderblock maintenance building, all three of which are still in use, were built north of the parking area where CCC Camp NP-4 once stood.<sup>236</sup>

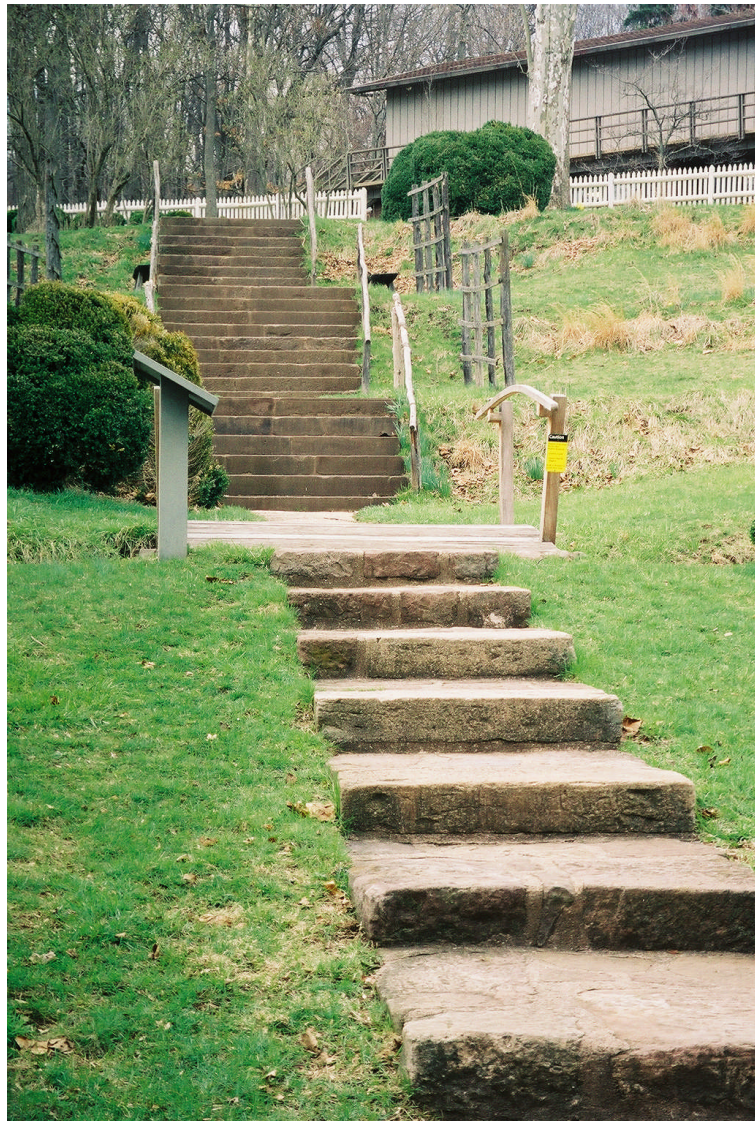
Figure 25 – Stone steps (foreground) north of the Ironmaster’s House.  
(Robinson & Associates photograph, 2003.)

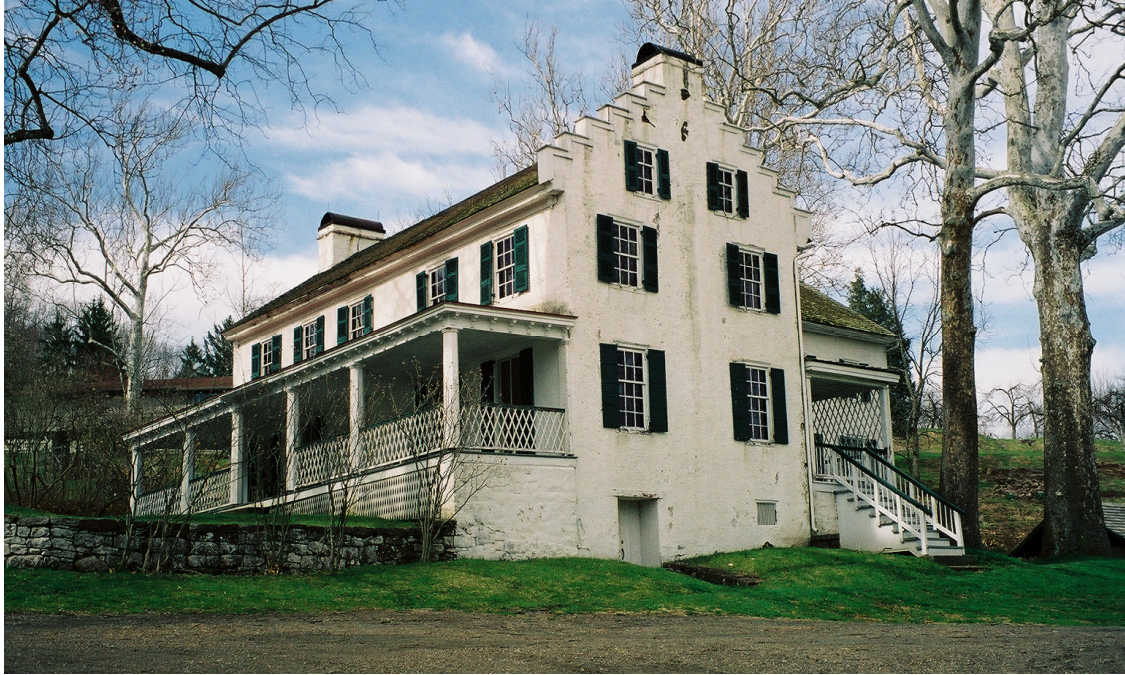
Figure 26 – The Ironmaster's House, renovated in 1980-81.  
(Robinson & Associates photograph, 2003.)

House had been concluded. The treatment, which included structural reinforcement as well as restoration, was completed in November 1980.<sup>276</sup> (Figure 26)

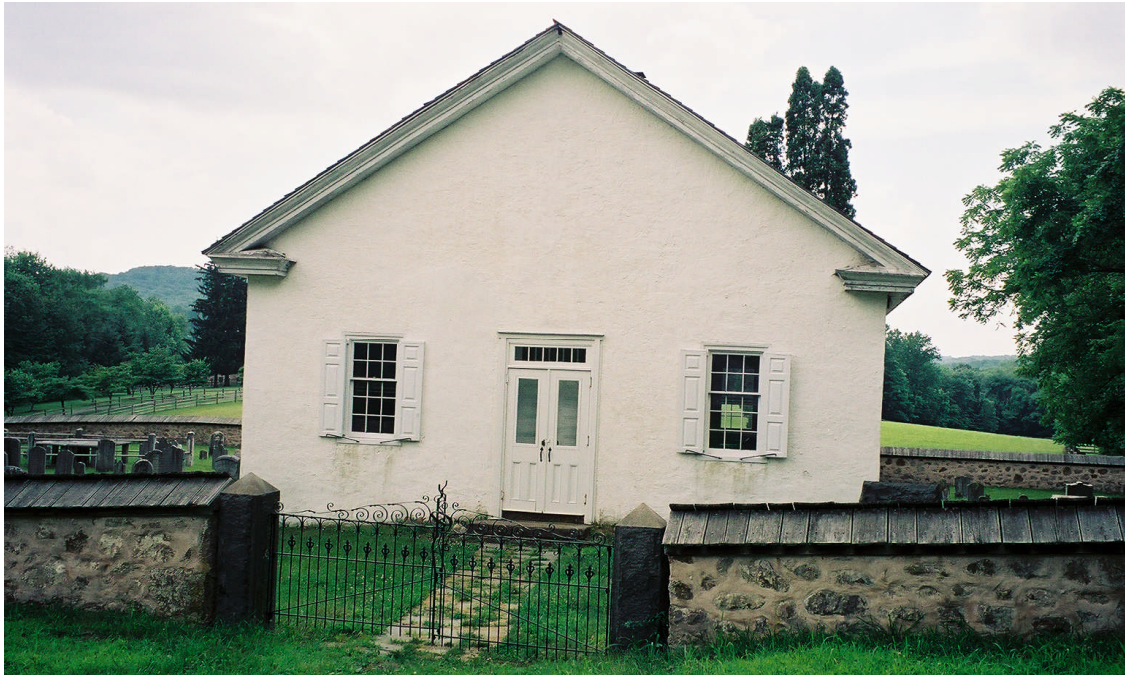
Figure 27 – Bethesda Church, renovated in 1982. (Robinson & Associates photograph, 2003.)

wall, and the replacement of its cement coping with one constructed of wood.<sup>278</sup> (Figure 27) The ruins of both the Schoolhouse and Greenhouse were stabilized in 1977.<sup>279</sup> Also during the 1970s, the park replaced the CCC-era reservoir with a new 50,000-gallon tank, and placed telephone and electrical cables in the village underground while removing utility poles. Other buildings and structures, previously preserved, restored, or reconstructed, required additional attention as the result of deterioration caused by time or natural forces. The East Head Race was damaged by Hurricane Agnes in 1972, but was not repaired until 1984. This work was performed by members of the Youth Conservation Corps, which had a building constructed as its headquarters in 1978 east of the road from the maintenance area to the utility area. The water wheel, originally reconstructed in 1952, was reconstructed again in 1987.<sup>280</sup> The Charcoal House roof was replaced between October 1989 and September 1990, the Connecting Shed roof during fiscal year 1999. The Charcoal Kiln ruins were stabilized that same year.<sup>281</sup>
