James Cant Ranch  
Dayville vic.  
Grant County  
Oregon

HABS No. OR-142

Addendum To  
Cant Ranch  
John Day Fossil Beds National Monument  
East side of State Route 19, north of US 26  
Grant County  
Oregon

JAMES CANT RANCH  
HABS NO. OR-142 (Page 1)

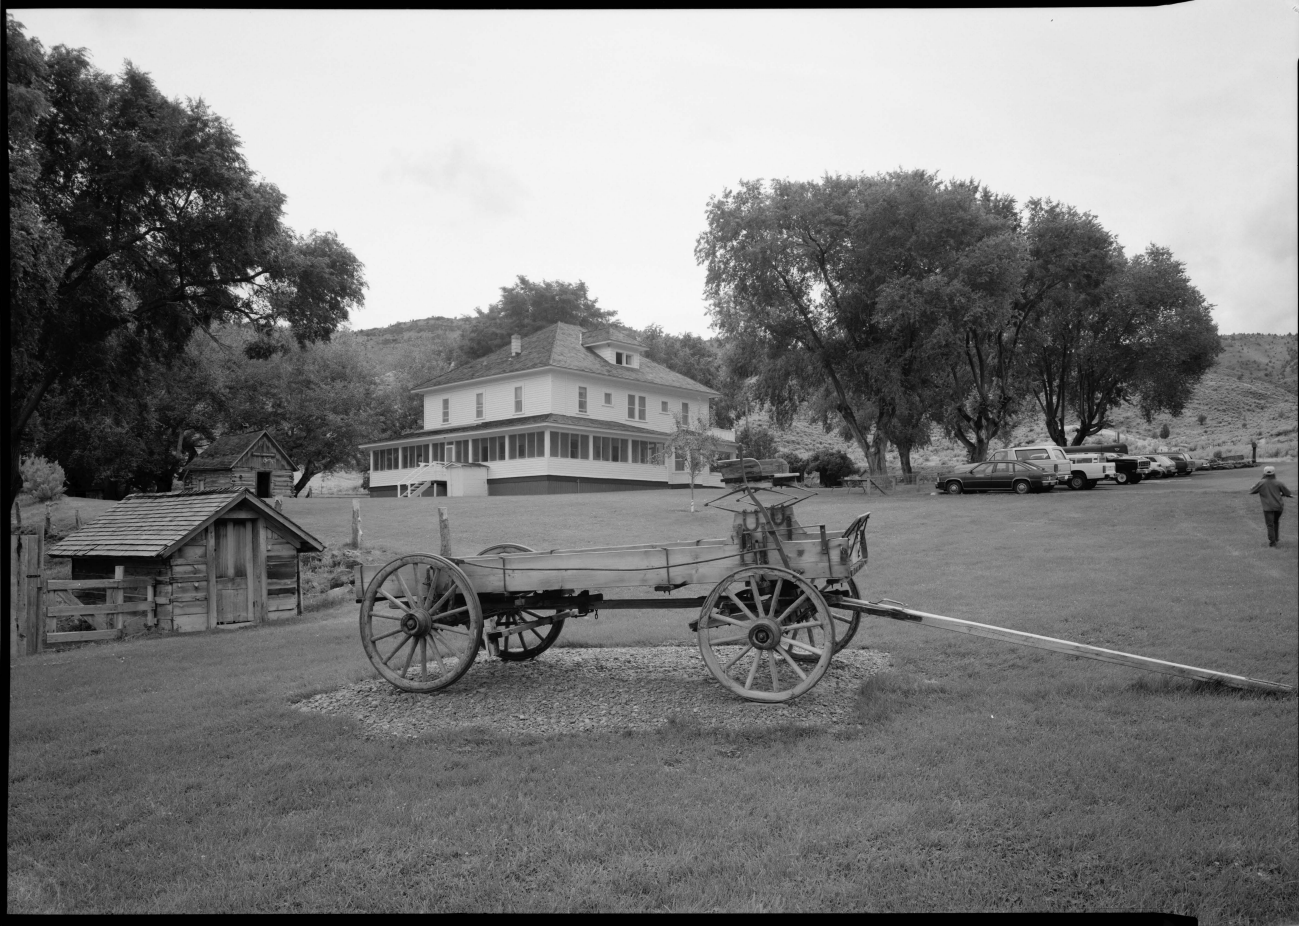
HABS NO. OR-142-1

- OR-142-1 James Cant Ranch, view from NE showing House, Log Cabin and Feed Storage Shed
- OR-142-2 James Cant Ranch, view from SE showing House, Log Cabin and Bunkhouse

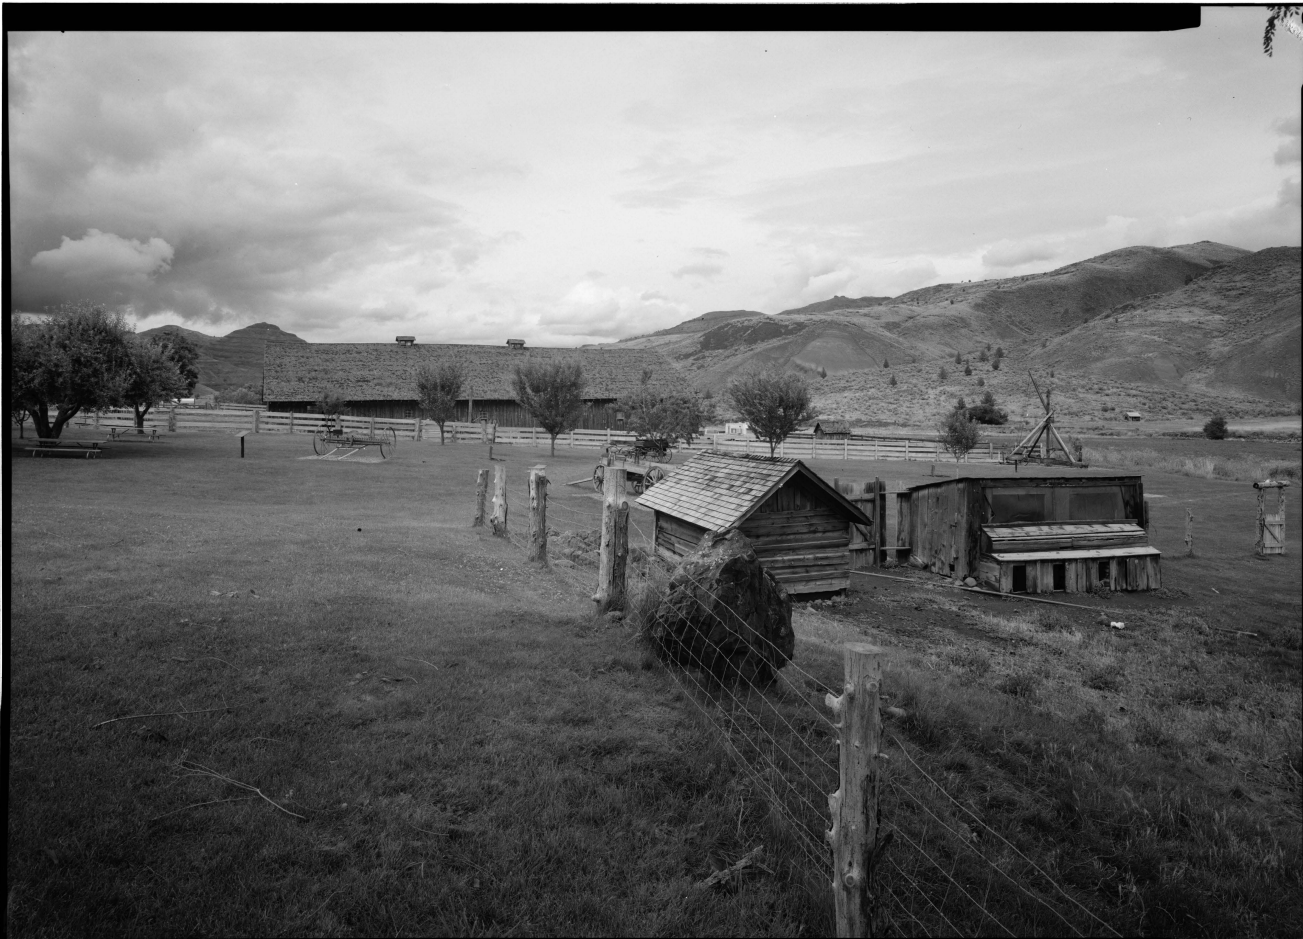
HABS No. OR-142-3

- OR-142-3 James Cant Ranch, view from NW showing Feed Storage Shed and Chicken Coop (in foreground), Barn, and Watchman's Hut
- \* OR-142-A-1 James Cant Ranch, House, Front Elevation, view from west.
