National Park Service  
Cultural Landscapes Inventory

John Fitzgerald Kennedy NHS Landscape  
John Fitzgerald Kennedy National Historic Site

Plan of Existing Conditions, 2025 edits

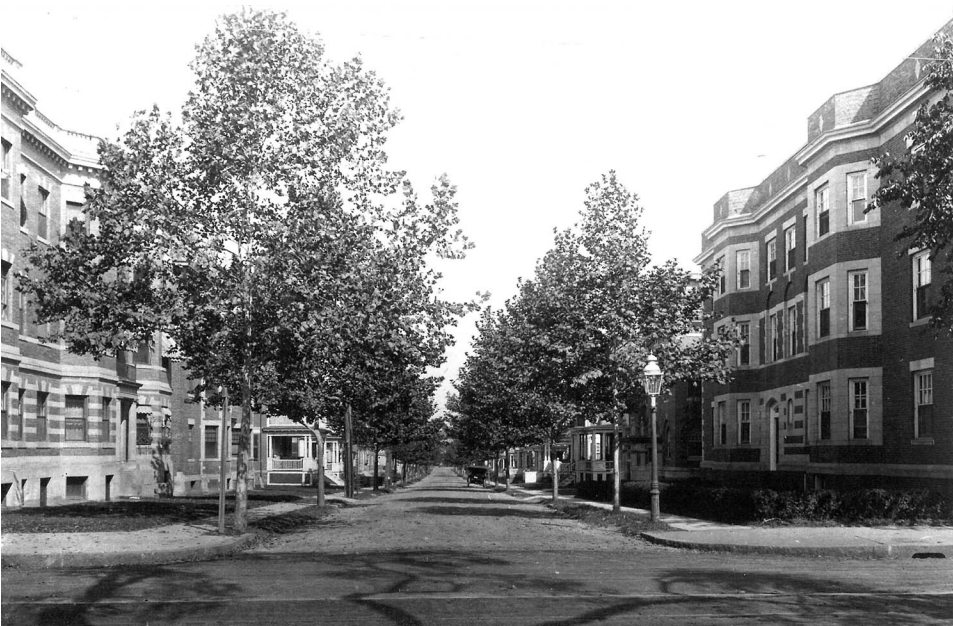
Figure 2. View from the intersection of Harvard and Beals Streets, looking northeast down Beals Street, circa 1910s. Plane-trees were selected by the town for Beals. At this time, Beals has no curbs or pavement (Stanley Album, Brookline Public Library).

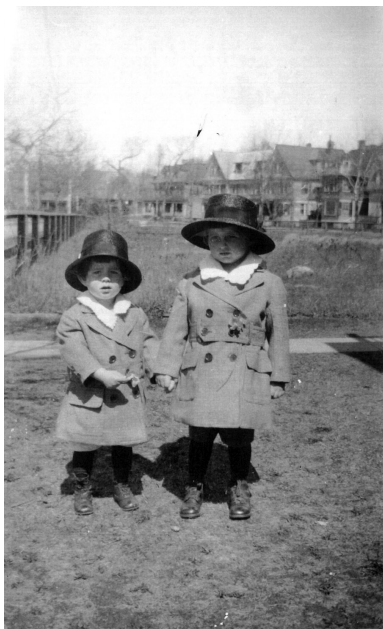
*Figure 3. John F. and Joseph P. Kennedy Jr., circa 1919. Looking northeast toward the intersection of Beals and Stedman Streets (Kennedy Family Collection, copyright John F. Kennedy Library Foundation).*

During the Kennedy's tenure at 83 Beals, the number of homes on the northeastern half of the Beals Street development did not change. Many of the lots on the north side also remained undeveloped. The Kennedys benefitted from the openness offered by the undeveloped lots to the north and northeast of their property. For pedestrians, concrete sidewalks were located on both the north and south sides of Beals Street, while the street remained unpaved with no curbing. The Kennedy Family Collection photographs capture the character of the open area where Beals and Stedman Streets intersect. The lots appear overgrown with tall grass and young saplings, yet the open space is expansive compared to the dense development to the southwest of the house (Figure 3).

formal, paved pedestrian or vehicular surfaces installed at 83 Beals. For circulation from the front to rear yards, the northeast side concrete walkway extended perpendicular from the sidewalk and proceeded southeast past the house to the rear yard, back door, and basement. This walk was narrower than the sidewalk and followed the perimeter of the house on the northeast and southeast facades. The walk flared out to form a landing at the wooden stairs for the rear entry and continued southeast of the stairs to provide access to the bulkhead steps and basement (Figure 5, see also Figure 3).

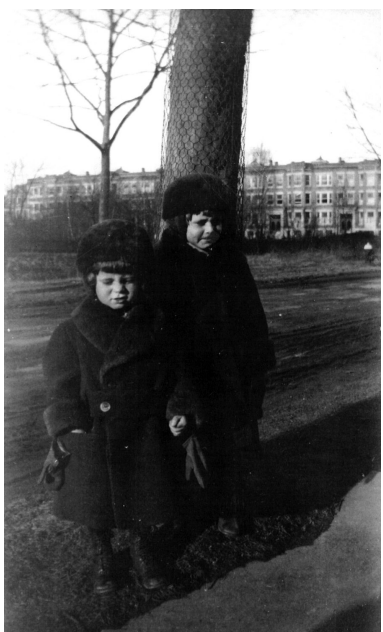
*Figure 4. John F. and Joseph P. Kennedy Jr., 1919, taken from the front of 83 Beals and looking north. The plane-tree has chicken wire around its trunk as a protective measure (Kennedy Family Collection, copyright John F. Kennedy Library Foundation).*

The photographs provide additional information on the street trees along Beals Street and associated tree lawn—the three-foot wide strip of grass set between the street and sidewalk. The plane-tree directly in front of 83 Beals is shown with chicken wire wrapped around its trunk as a protective measure (Figure 4). It was a common practice for the town to install either wood or wire guards to protect street trees from horses that might gnaw on their bark (Cummings, 1938: 14). The plane-trees lined both sides of the street and continued to mature and cast shade along the streets. Individual yards along Beals Street, however, remained unadorned perhaps due to the frequent changes in ownership and the high number of rental units.

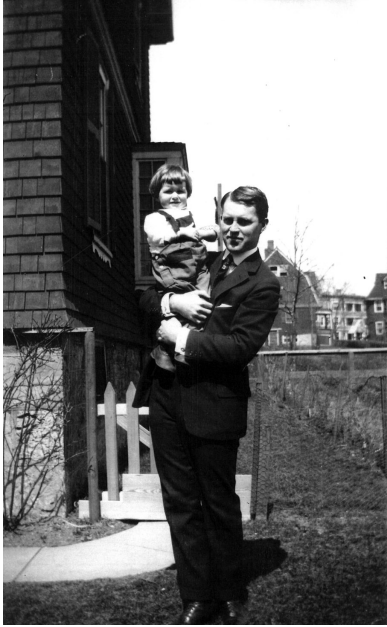
*Figure 5. Joseph P. Kennedy Sr. and Joseph P. Kennedy Jr., undated, likely 1917. By the east corner of the house at 83 Beals, a concrete walk provided access to the rear yard (Kennedy Family Collection, copyright John F. Kennedy Library Foundation).*

The front yard vegetation included lawn and the plane-tree in the tree lawn along Beals Street, which was the only tree on-site. No foundation plantings were established in the front yard. In a similar fashion, the side yard consisted primarily of lawn with no plantings along the house foundation or property line. The rear yard contained lawn immediately past the concrete walk and foundation plantings in a narrow bed on the northeastern side of the rear facade. The three plants shown in the photograph of the rear yard, two healthy and one struggling, have the branching characteristics of roses (*Rosa* sp.) (see Figure 5).

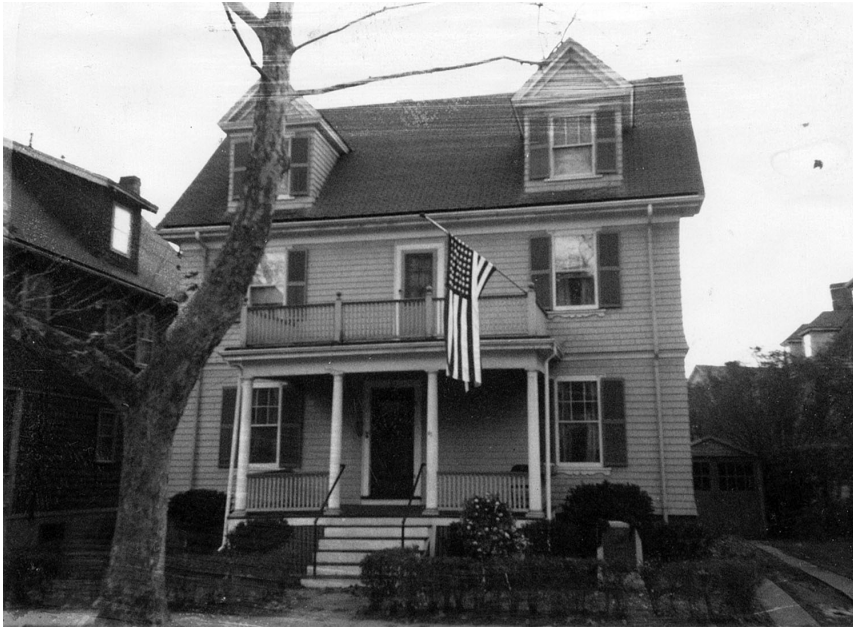
*Figure 6. View of northwest elevation, December 9, 1963, confirming the installation of the privet hedge, commemorative marker, and yew planting. At this time, wreaths were maintained beside the marker, draped in black bunting (JOFI Management Records).*

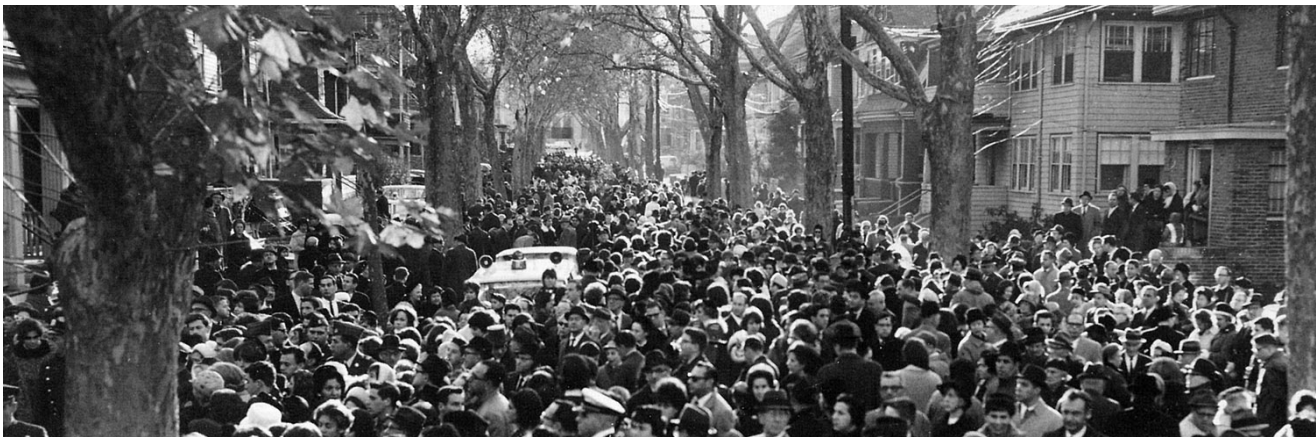
*Figure 7. View looking southwest on Beals Street, November 25, 1963. The plane-tree in the left foreground is the street tree in front of 83 Beals (Jean Kramer, Brookline, Massachusetts: A Pictorial History, Boston: Historical Publishing Company, 1989).*

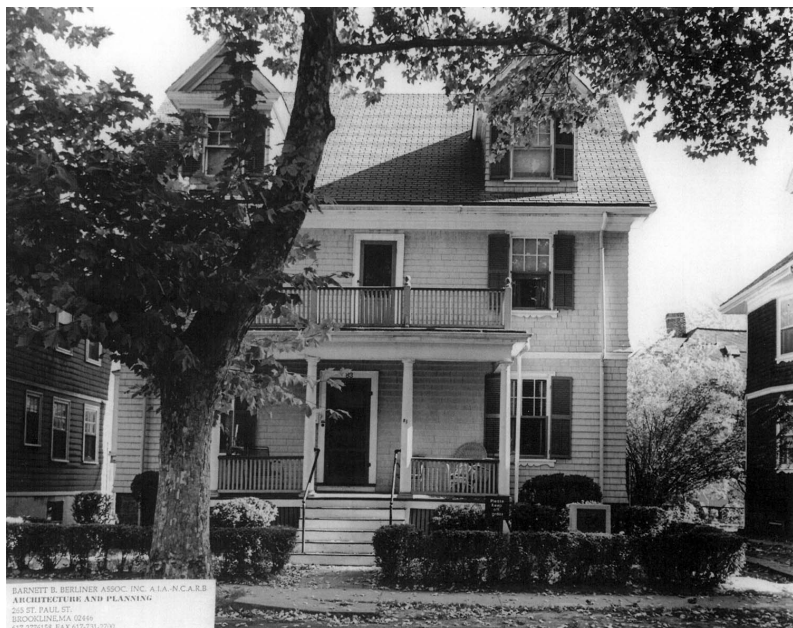
*Figure 8. View of northwest elevation, October 1964, shows the privet hedge, commemorative marker, yew planting, and sod installation (Irene Shwachman, 1964, Private collection of Mr. Robert Berliner, copies reside in the JOFI Management Records).*

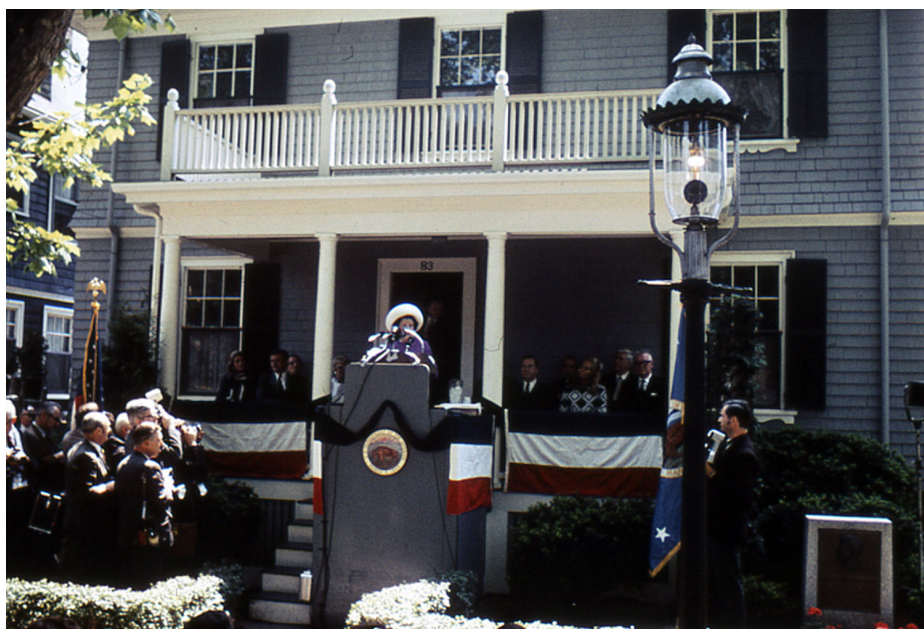
Figure 11. View of northwest elevation, Dedication Ceremony, May 29, 1969, showing small-scale features and vegetation added during the 1960s: gas light, marker, privet, yew and arborvitae , front lawn, and geraniums (JOFI Management Records).

Similar to other residential properties, many changes following the dedication ceremony concerned vegetation. In the 1976 Management Plan, alterations to vegetation listed for 1969 include the transplanting of five arborvitae from the front of the house to the basement entrance, the removal of lilac shrubs from the northeast side of the house, and the addition of four yews to the front of the house. Photographs from the 1969 dedication event show three of the five arborvitae were present at the front of the house. Photographs from early 1975 show the removal of the arborvitae and the addition of four yews to the front of the house (Figure 13, see also Figures 11 and 12) (Kennedy National Historic Site Historic Resources Management Plan, 1976: 602).

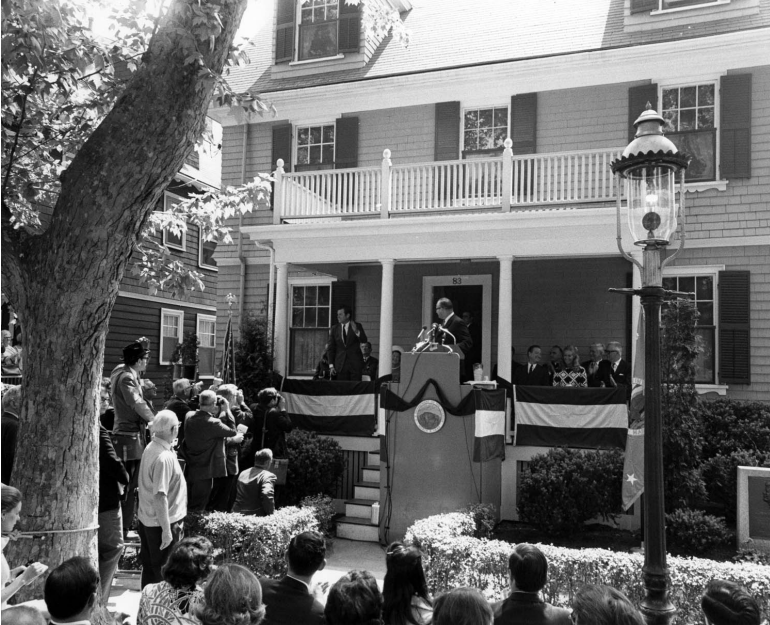
*Figure 12. View of northwest elevation, Dedication Ceremony, May 29, 1969. Note the Department of the Interior flag to the right of the podium set on a pedestal and not installed into the landscape (JOFI Management Records).*

For the dedication event, a podium was set up on the entry walk. In photographs showing the podium and front facade of the house, a United States flag is visible on the left and a Department of the Interior flag is visible on the right. Additional photographs show these flags on pedestals and not installed into the landscape (Figure 12). Therefore, the installation of the flagpole near the commemorative marker took place after the dedication event.

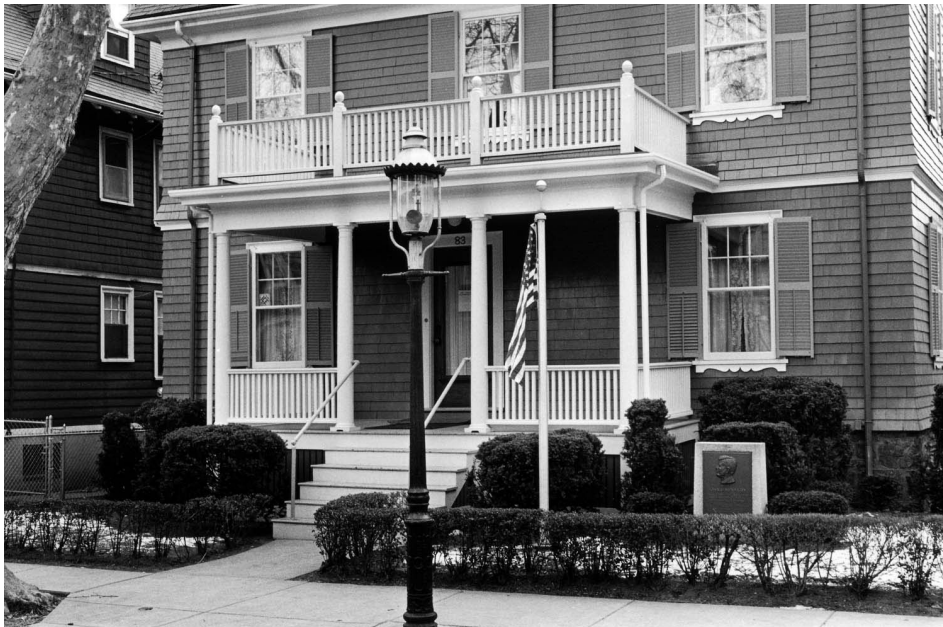
*Figure 13. View of northwest elevation in January 1975. Most arborvitae have been transplanted to the side yard and additional yews have been planted. Note the gas light and flagpole (JOFI Management Records).*

In addition to circulation and vegetation changes, the flag and flagpole were added to the front of the house after the dedication. Two purchase orders in the site's management records verify the flagpole's installation. The park ordered the flag and flagpole in late August 1969. This was quickly followed by an early September order to install the flagpole. At the earliest, the flagpole was added to the site four months after the dedication (see Figure 13) (JOFI Management Records: Box 8, Folder 2).

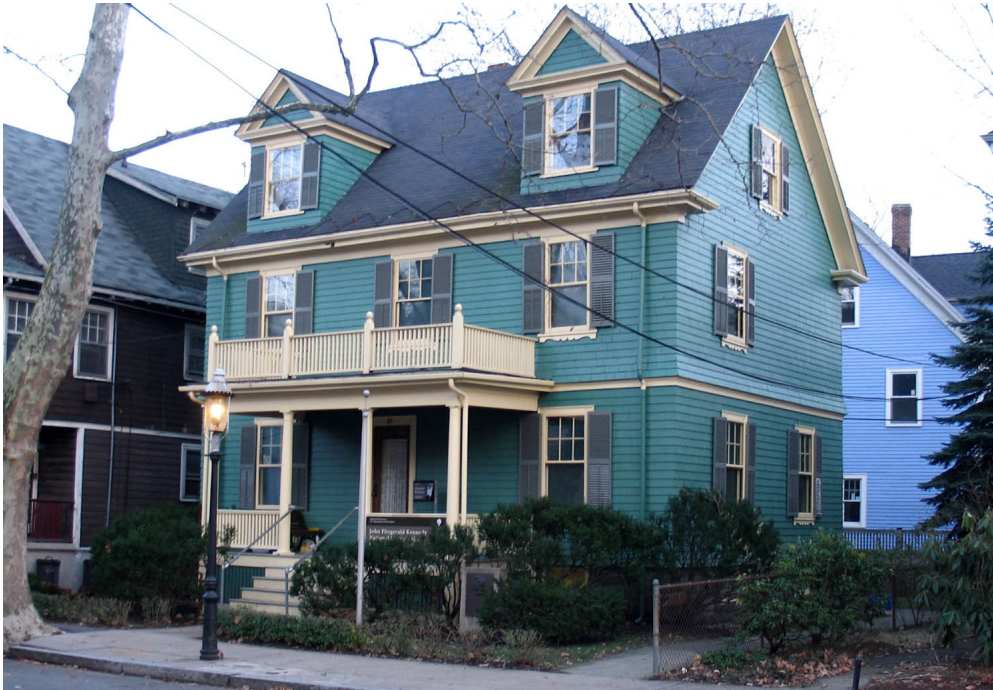
The existing conditions of the site's spatial organization are minimally changed since 1969, but more altered since 1920. The spatial organization of the site reflects its condition in the 1960s, with the lot coverage, setback, and physical relationship of the house to the yard and to Beals Street largely unchanged, and therefore contributes to the character of the historic landscape despite its alteration since 1920 (Figures 14 and 15) (CLR, draft May 2011: 216-217).

*Figure 14. View of 83 Beals Street showing physical relationship to neighboring properties and Beals Street, building setback, and front yard walkway and entrance. Note the plane-tree in tree-lawn area in front of the house (OCLP, 2008).*

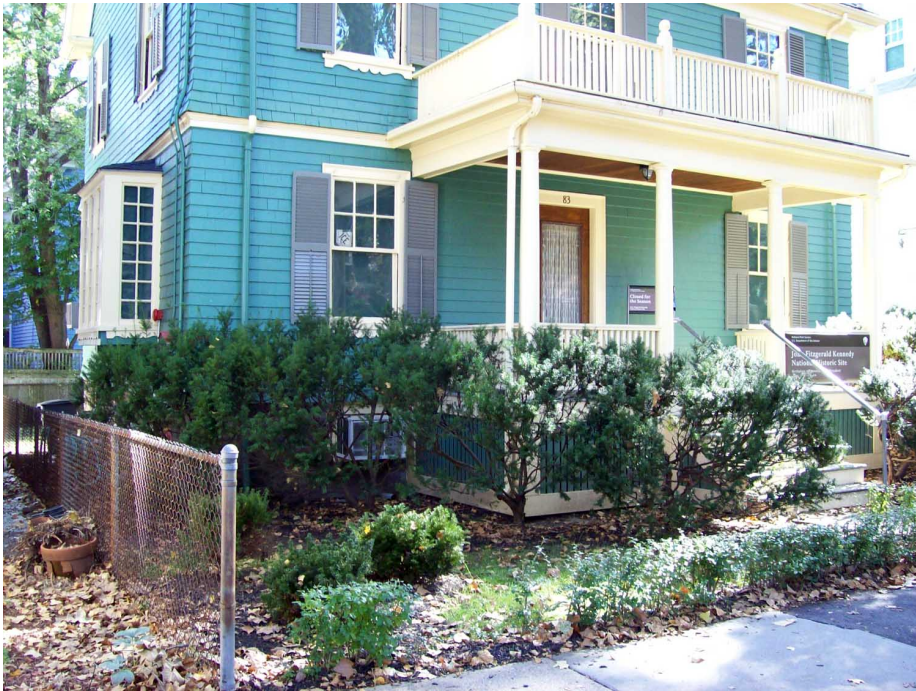
Privet Hedge along Sidewalk. The privet hedge is healthy and well tended at approximately eighteen inches in height and twelve inches in width. Its short height allows views to the marker from many vantage points. Due to the excessive shading in the front yard by the overhanging plane-tree, the hedge appears thin. The separate hedges on both sides of the front yard are not uniform in width and as maintenance has been performed throughout the years, single plants have been removed due to damage or death, leaving holes in the otherwise continuous hedge. The privet hedge was installed by the Town of Brookline as one of the first elements of the commemorative landscape in the 1960s period of significance. This feature therefore contributes to the character of the historic landscape (Figure 16) (CLR, draft May 2011: 217).

*Figure 16. North corner of the front yard showing the porch, partially obscured by a row of yews. An incomplete low privet hedge lines the sidewalk. The property is separated from the neighboring property by a chain link fence (OCLP, 2008).*

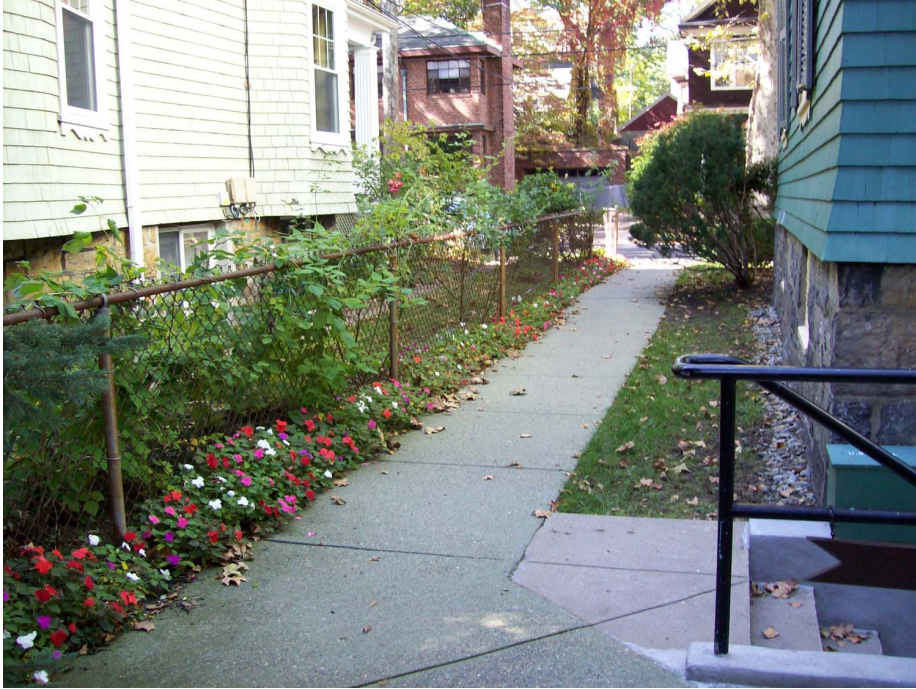
southwest side yard is now comprised of a one-foot drain strip, three-foot sod strip, four-foot walk, and an eight-inch planting bed along the fence. An additional planting bed of about three feet lies on the other side of the fence. The side yard is used to access the rear yard and visitor entrance to the basement. While the southwestern side yard experiences some shade, the effects are not nearly as severe as in the rear yard. On the side yard, the lawn is in fair condition. As the presence of lawn in the southwest side yard at the dedication ceremony is undetermined, it is not a contributing feature to the character of the historic landscape (Figure 18) (CLR, draft May 2011: 219).

**Annuals along Southwest Side Yard.** The annuals are planted in an eight-inch wide bed along the concrete walkway, which provides visitor access to the basement entrance. The National Park Service began planting annuals along the fence in the late 1980s and has continued to the present. Annual plantings line the park side of the fence, while rose, raspberry, and perennial plantings are planted on the neighbor's side. The lawn is in fair condition as are the impatiens—the annuals typically planted along the fence. The annuals planted in the southwest side yard were not present at the site in either of the periods of significance and are not a contributing feature (see Figure 18) (CLR, draft May 2011: 219-220).

*Figure 18. View from the rear yard of the park toward Beals Street showing the chain-link fence, side yard, and walk used to access the visitor center in the basement (right). The park maintains impatiens along the fence and the neighbor maintains roses,*

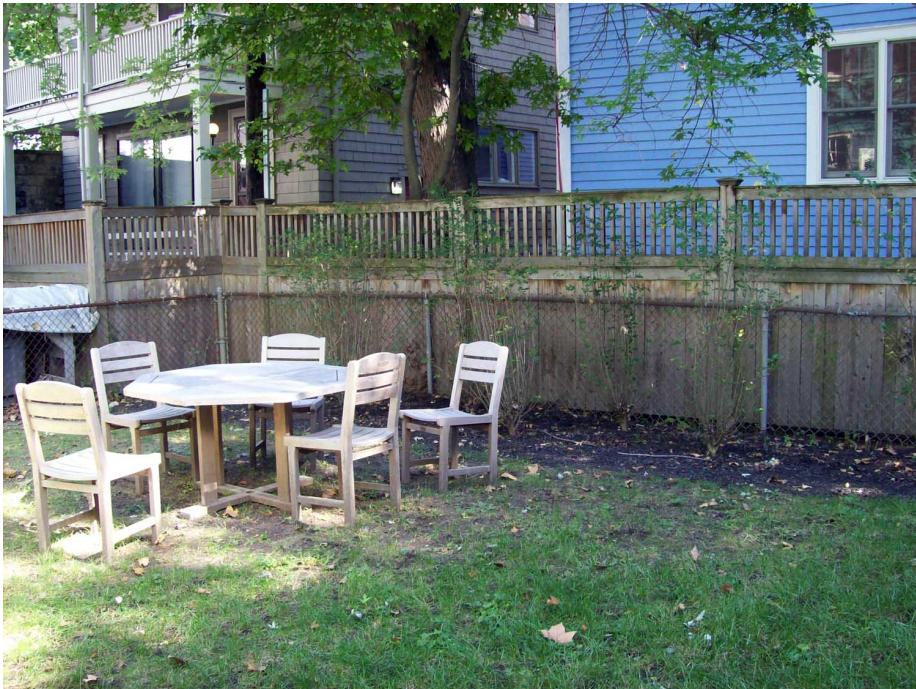
**Privet and Mulched Planting Bed.** The park installed a staggered row of privets, three feet apart and consisting of fifteen plants in total, in a six foot wide bed at an undetermined date after the dedication ceremony. At present in the rear yard, a large silver maple and a leggy pin oak overhang the property line from the rear adjacent parcel. The trees capture much of the light and soil moisture in the rear yard. Understory plantings, including the row of privet are stressed due to lack of light and moisture. Intended for screening, the privet is thin and ineffective. The privet, known for their hardiness and vigor, appear ragged due to the difficult growing conditions. A large silver maple was recently removed from the neighboring lot at the south corner of the 83 Beals property. Thus, the condition of the privets may improve. The mulched planting bed and privets were planted at an unknown date after the periods of significance and are not contributing features (Figure 19) (CLR, draft May 2011: 220).

*Figure 19. View of the east corner of the rear yard and lawn area. A chain link fence and wood board fence separate the park from the neighboring properties. A row of privets is thin and barely visible in front of the board fence (OCLP, 2008).*

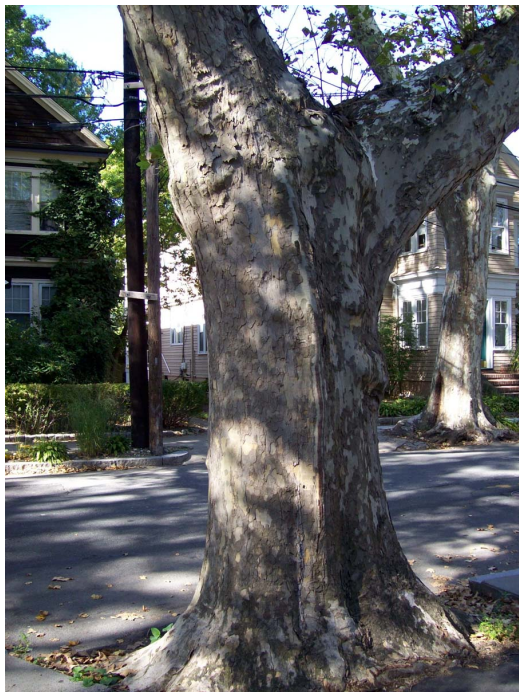
*Figure 20. Plane-tree in the tree-lawn in front of 83 Beals. The tree was planted circa 1900 and continues to thrive (OCLP, 2008).*

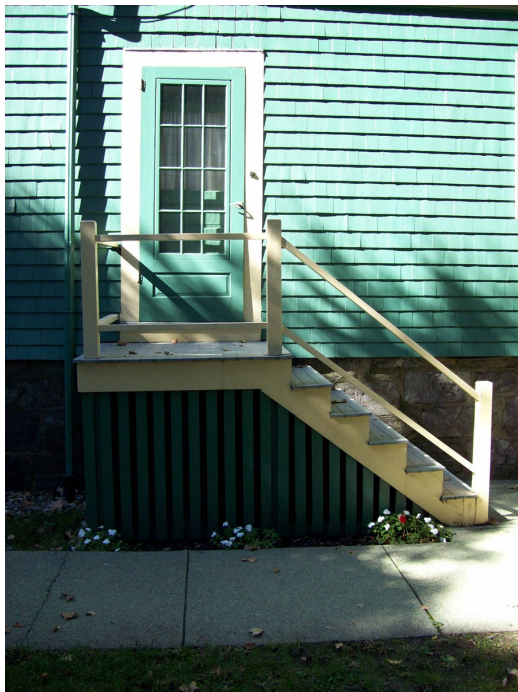
*Figure 21. Wooden steps leading to rear entrance of the house (OCLP, 2008).*

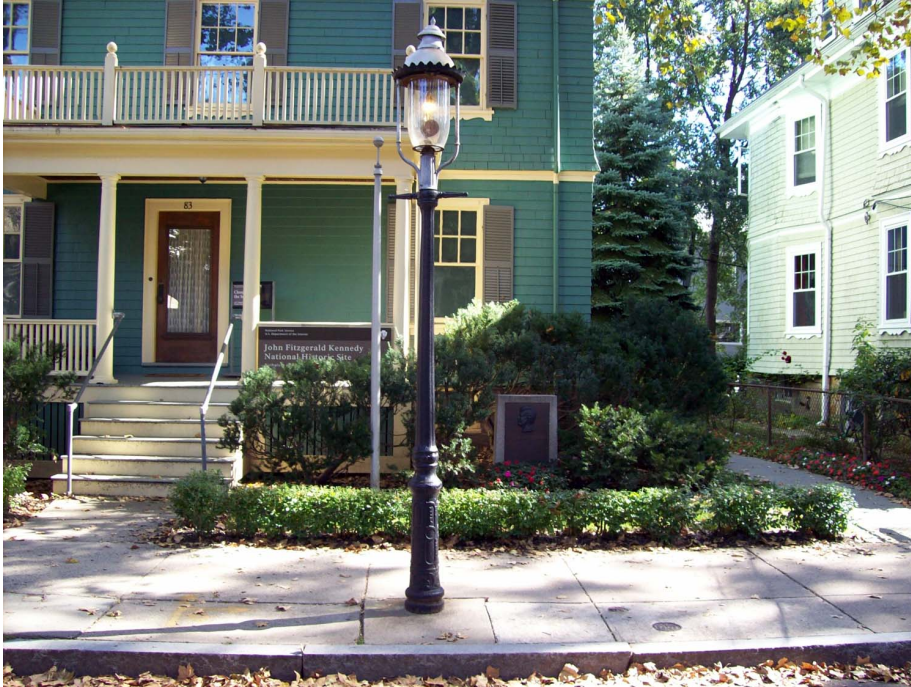
*Figure 22. The southwest side of the front yard includes small-scale features that distinguish the house from others on the street: the park sign mounted to the front porch, the commemorative marker, the flagpole, and the gas light (OCLP, 2008).*

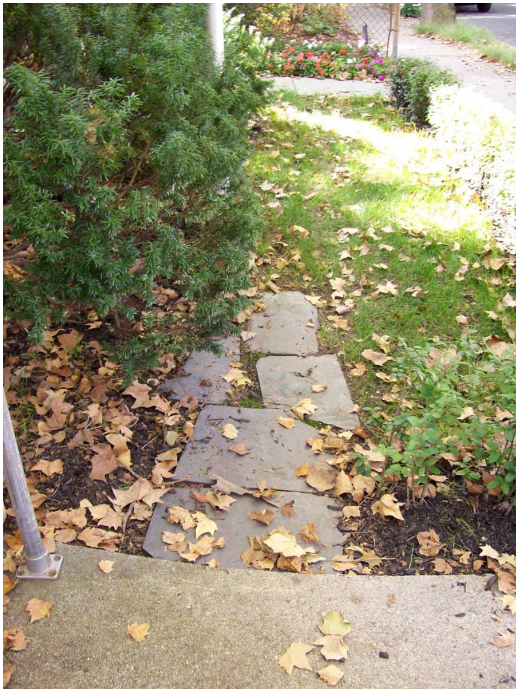
*Figure 23. Close-up of the flagstone pavers on the southwest side of the front yard that lead to the base of the flagpole (OCLP, 2008).*

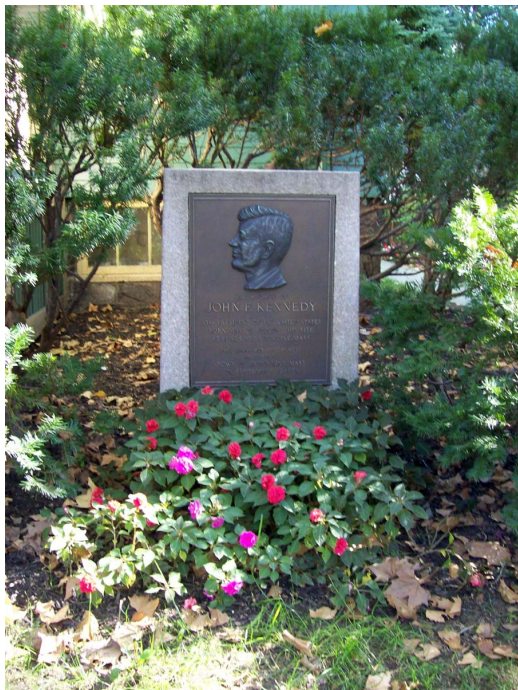
*Figure 24. Commemorative marker in the front yard installed by the Town of Brookline in 1961 with annuals (OCLP, 2008).*
