# CULTURAL LANDSCAPE REPORT FOR JOHNSTOWN FLOOD NATIONAL MEMORIAL

NATIONAL PARKS OF WESTERN PENNSYLVANIA

CAMBRIA COUNTY, PENNSYLVANIA

Olmsted Center for Landscape Preservation  
National Park Service, Boston, Massachusetts, 2021

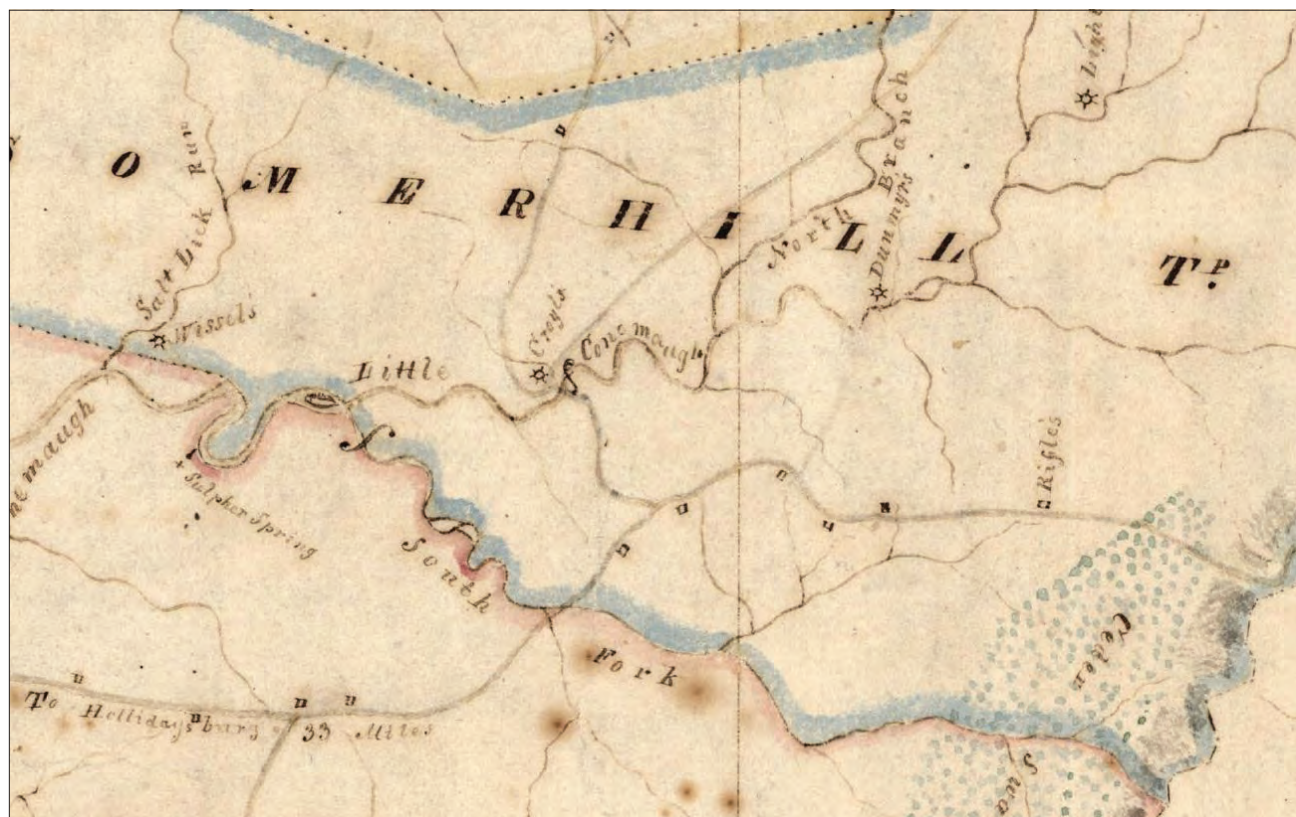
**Figure 1.9.** This map shows development during the time that Reverend Reese Lloyd and Reverend William Smith owned the lands that became the Western Reservoir. *Map of Cambria County, Melish-Whiteside, 1821*, (Collections of the Pennsylvania State Archives).

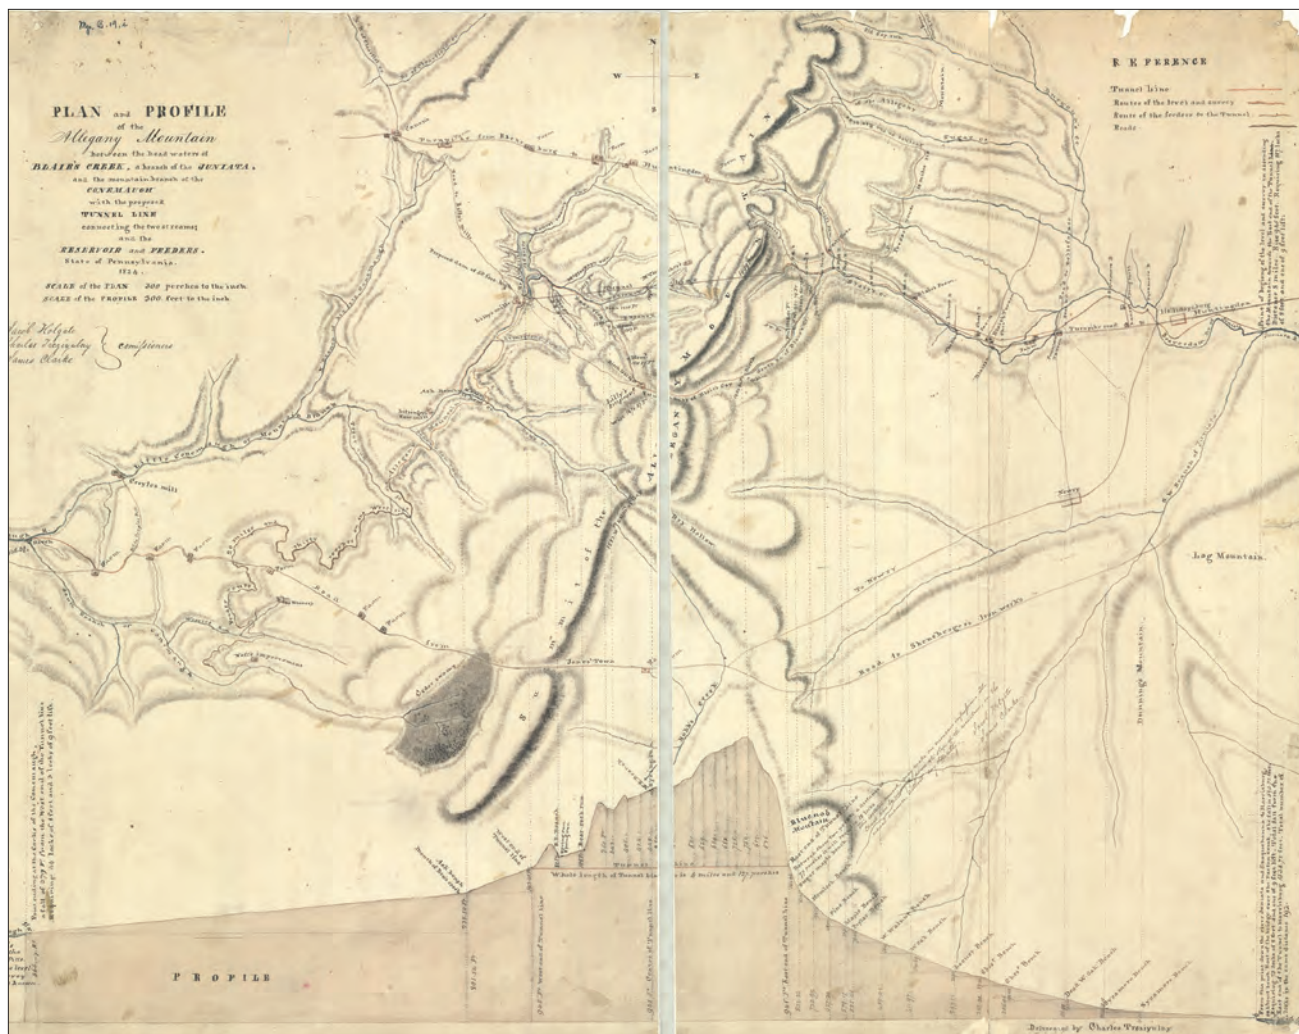
**Figure 1.10.** Interestingly, this map illustrates development, including roads and mills, in Cambria County in 1824, which was prior to the construction of the Main Line. *Plan and Profile of the Allegheny Mountain between the head waters of Blair's Creek, a branch of the Juniata, and the mountain branch of the Conemaugh with the proposed Tunnel Line connecting the two streams; and the Reservoir and Feeders. State of Pennsylvania, 1824, Jacob Holgate, Charles Treziulny, Map Book 19.* (Collection of the Pennsylvania Historical and Museum Commission)

completed a survey and initial design plans for a railroad and canal system through Pennsylvania (Figures 1.10 and 1.11). In 1826 the Commonwealth began construction of the Main Line of Public Works, a system which stretched across southern Pennsylvania between Philadelphia and Pittsburgh, to provide access to the timber, mining, agricultural, and manufacturing resources of the central and western portions of the state. Even as early as 1826, the Conemaugh River's seasonal low water level concerned the canal's engineers (Figures 1.12 and 1.13).

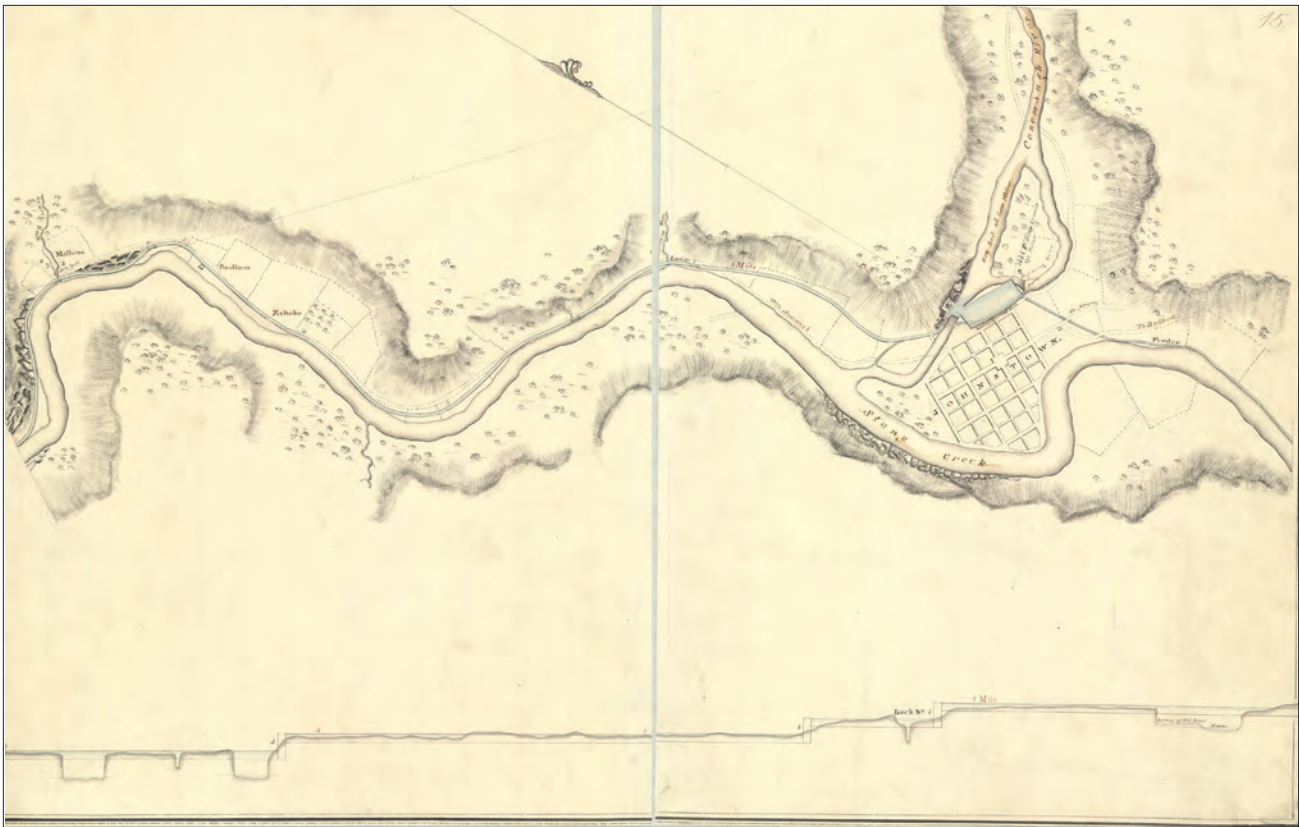
**Figure 1.12.** This section entitled, *From Laurel Run, 4 miles to Johnstown, from Map and Profile of the Proposed Route For a Railway & Canal From The Head Of Juniata Canal To The Head Of Kiskiminitas Feeder*, the area where the Conemaugh River flows into Johnstown is visible. Surveyed 1826 by G. P. Olmsted, Assistant Engineer, Book 9, Page 15 (Collections of the Pennsylvania Historical and Museum Commission).

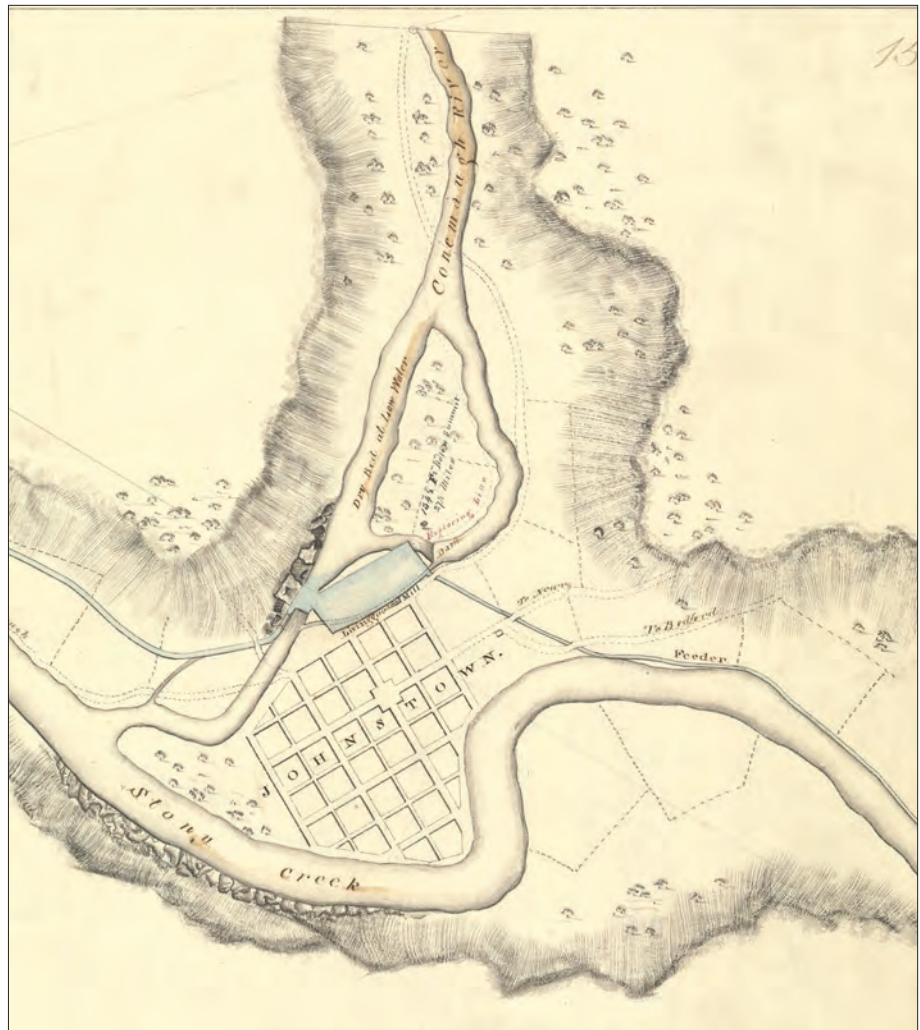
Figure 1.14. The branches of the Main Line Canal are illustrated in this map from *The Amazing Pennsylvania Canals* by William Shank, 1965. (Historical Society of York County, Pennsylvania).

The five principal sections of the system, from east to west, included the Columbia and Philadelphia Railroad (Philadelphia to the Susquehanna River at Columbia, 81.6 miles), Eastern Division (canal from Columbia to Clarks Ferry along the Susquehanna River, 44.5 miles), Juniata Division (canal from Clarks Ferry to Hollidaysburg along the Juniata River, 127.5 miles), Allegheny Portage Railroad (Hollidaysburg to Johnstown, 36.7 miles), and the Western Division (canal from Johnstown to Pittsburgh, 104.25 miles). The Commonwealth finally completed the 394-mile Main Line in 1834 (Figure 1.14).<sup>36</sup>

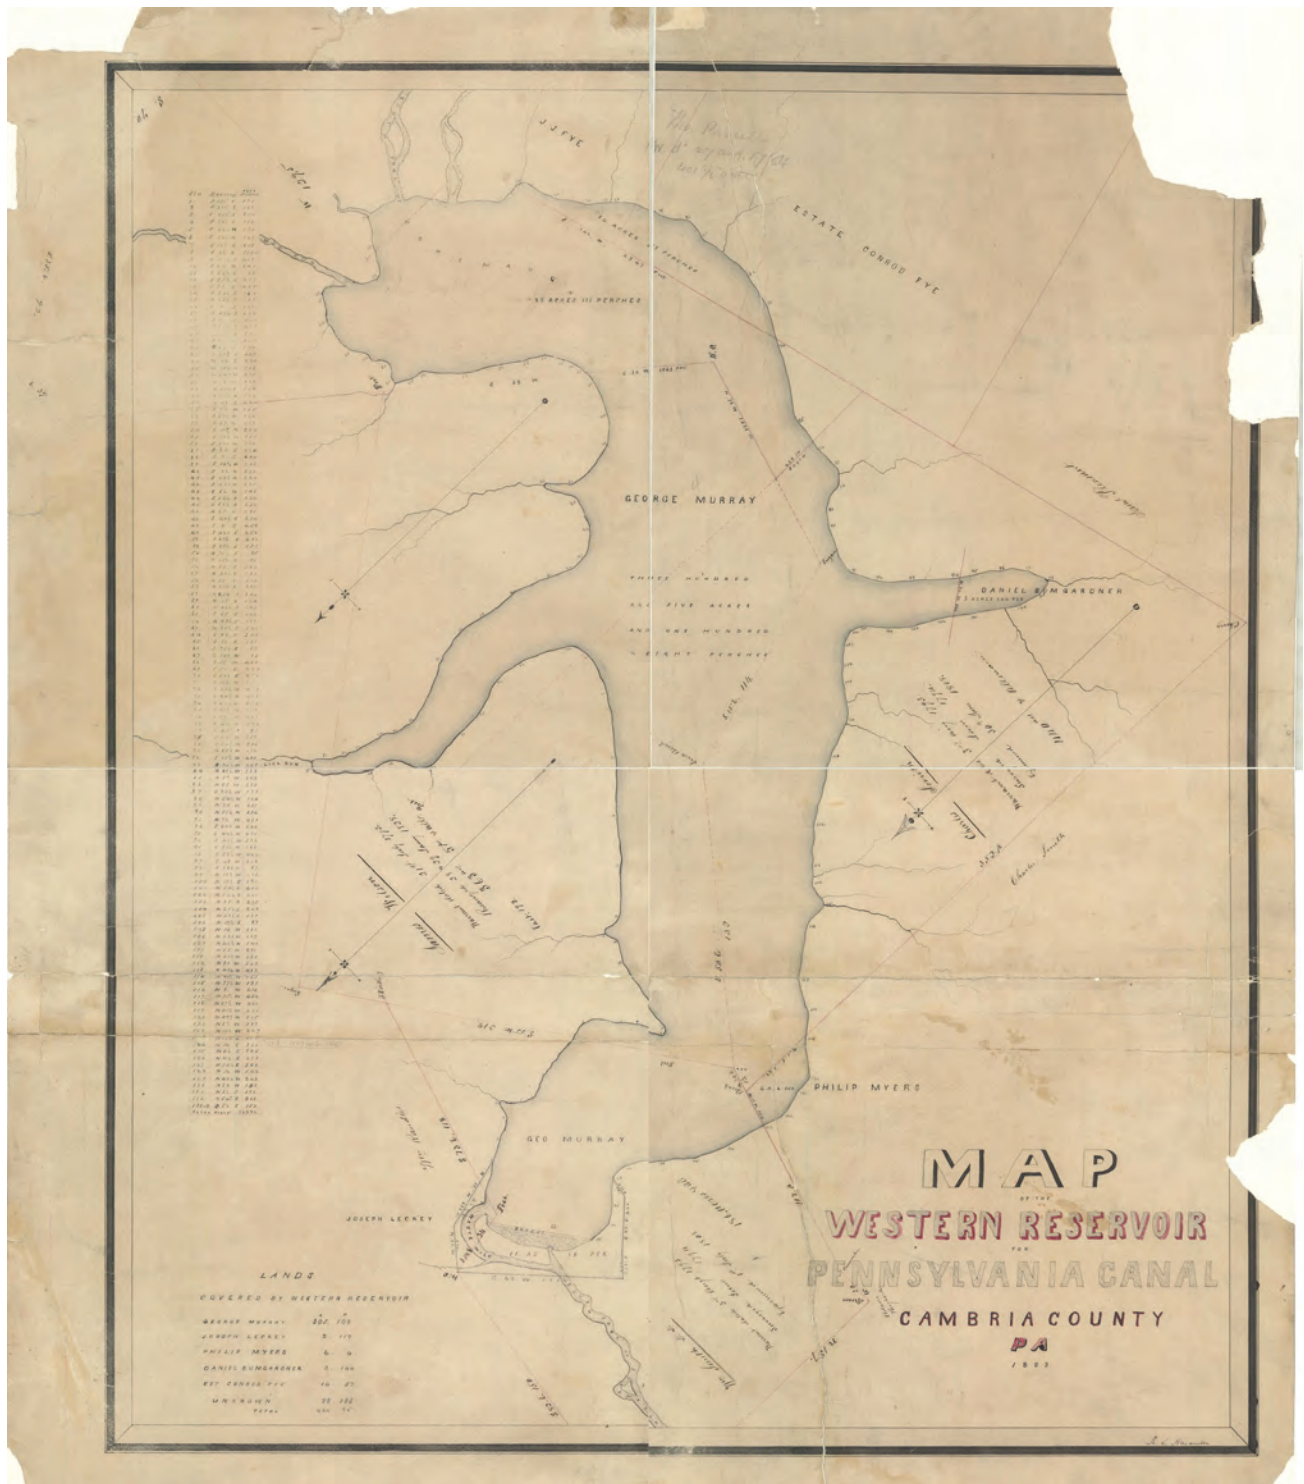
**Figure 1.18. Map of the Western Reservoir For Pennsylvania Canal, Cambria County, Pa., 1853, R. S. Alexander. (Collection of the Pennsylvania Historical and Museum Commission)**

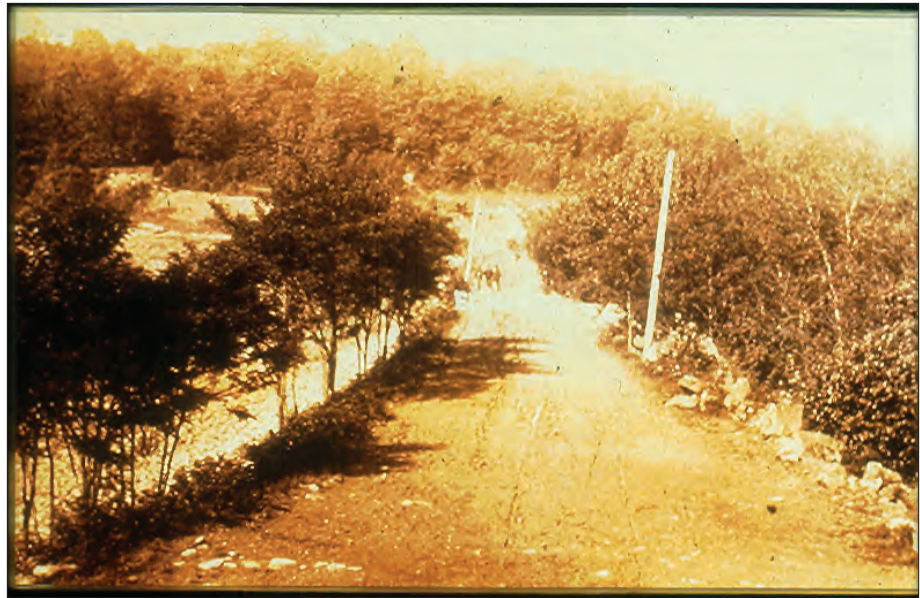
Figure 1.25. A detail from a photograph of the trestle bridge over the spillway looking southeast immediately after the flood, 1889. (Johnstown Flood National Memorial Archives)

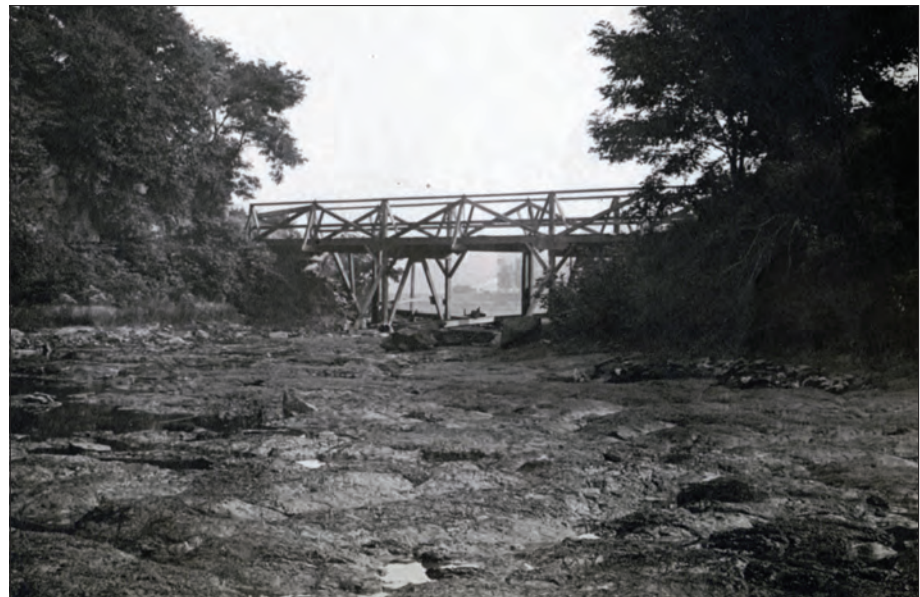
Figure 1.26. Note the wooden boom in the lake near the spillway bridge, looking southeast. (Louis Semple Clarke Collection, Johnstown Area Heritage Association)

attached to the bridge's support posts over the spillway to prevent their stocked fish from escaping the lake during high water. A V-shaped log boom was installed in front of the spillway to prevent debris from blocking the screens (Figure 1.26). During periods of water flow through the spillway, these features impaired water flow.<sup>81</sup> To prevent fish from swimming out of the lake and to the frustration of local farmers, the club also erected screens or dams at the mouths of the four tributary streams that drained into Lake Conemaugh, including Rorabaugh's Creek, Muddy Run, South Fork, and Topper's Run.<sup>82</sup> Finally, the opening of the remaining stone culvert was boarded up with hemlock planks.

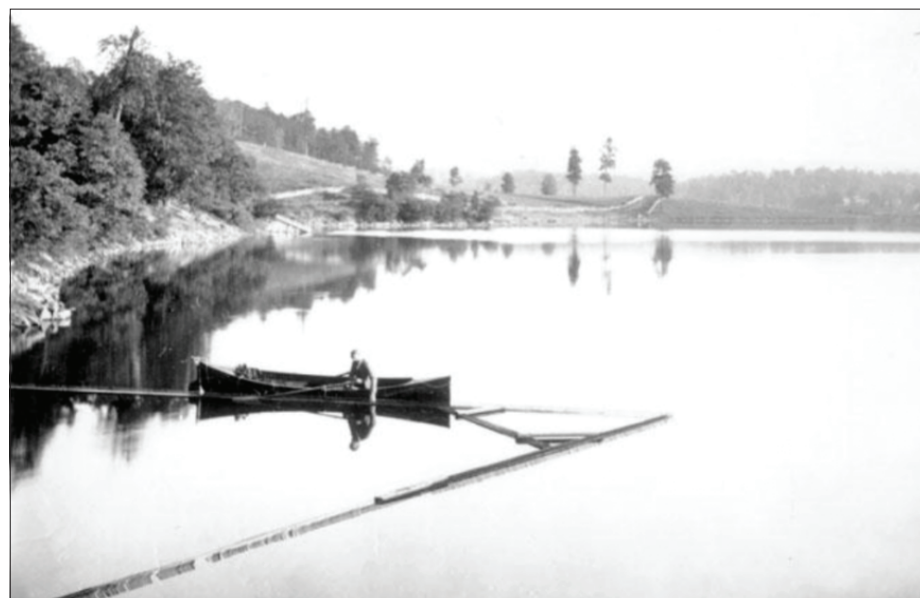
**Figure 1.27.** In the center of the photograph, the western face of the dam illustrating the smaller rip rap stones used in its construction, and the blocked stone culvert is visible circa. 1880s. The carriage drive climbing the hill west of the dam is also visible in the upper right hand corner of the photograph. (Louis Semple Clarke Collection, Johnstown Area Heritage Association)

In June 1881, heavy rains caused uneasiness among Johnstown residents. Rumors that the dam was breaking on the morning of June 10th prompted the Cambria Iron Company to send two of its engineers to inspect the dam. They reported that the lake's water was two feet below the crest of the dam and the spillway was diverting excess water, but there were no leaks. Around the same time, Robert Pitcairn, the division head of the Pennsylvania Railroad between Altoona and Pittsburgh and a member of the South Fork Fishing and Hunting Club, took several of his engineers to inspect the dam. His primary concern was that the leaks at the bottom of the dam would increase. Ruff accompanied the men and claimed that the rumored leaks were springs from the hillsides at either end of the dam. When Ruff promised to take remedial action, Pitcairn was satisfied, although he asked his men to continue periodic inspections (Figure 1.27).<sup>83</sup>

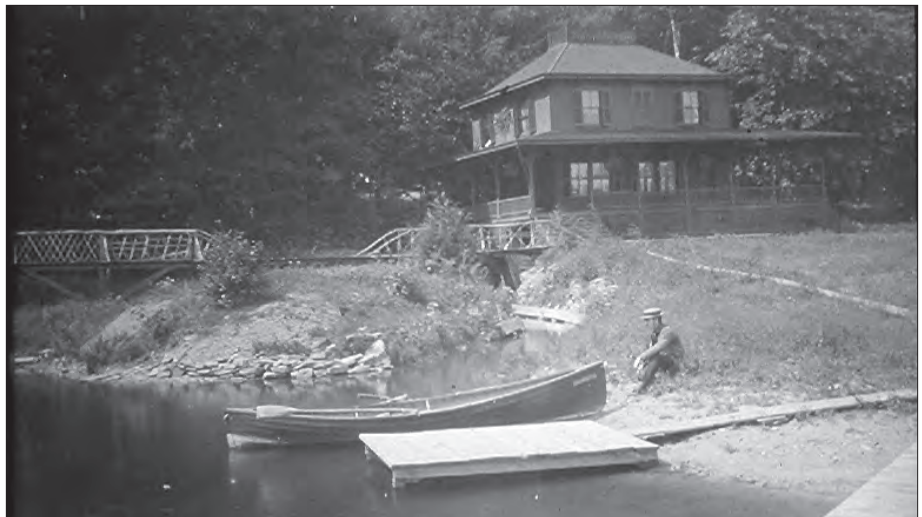
Figure 1.43. Rusticated bridges over the streams near the Clarke cottage. (Louis Semple Clarke Collection, Johnstown Area Heritage Association)

branches formed into patterns of horizontals and diagonals (Figure 1.43). A few ornamental garden beds, designed in the Victorian bedding out style, grew along the boardwalk (Figure 1.44). But most of the landscape around the cottages was native vegetation, the thick woods cleared of some undergrowth but left wild to encourage interaction with the natural environment (Figures 1.45 – 1.47). The houses set at the edge of the woods while grass and wildflower meadows grew in front of the homes to the lakeshore. There were likely two main reasons for the rustic, naturalistic appearance of the landscape. The first was that the resort was new, less than ten years old, with construction occurring throughout its short history and leaving little time for bedding out annuals and turf lawns. Secondly, the contrast between the rusticated wild aesthetic of the resort landscape and agrarian utilitarian countryside would have appealed to many club members.<sup>93</sup> A local writer for the *Johnstown Tribune* revealed her distain of the wild aesthetic when she wrote, “the cottages are built in a damp, bad smelling woods. The Rorabaugh farm lies open to the sun and the breeze and is susceptible of any degree of artificial beautifying,” (Figure 1.48).<sup>94</sup> By 1889 there were sixty-eight families in the club’s membership, including those of some of the most prominent financiers of the time, Andrew Carnegie, Andrew Mellon, and Henry Clay Frick. If they wanted to “artificially beautify” their homes, they likely would have done so.

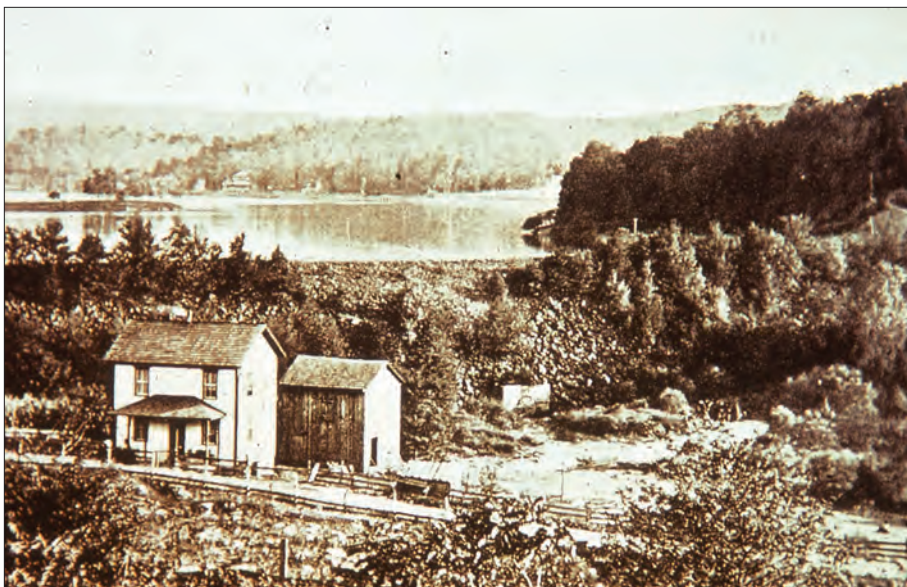
Figure 1.51. This farmhouse, which was likely owned by Joseph Lecky (Leahey), was located on the downstream side of side on the northeast corner of the dam, down the hill from Lake View Farm. The area of the dam repaired by the South Fork Fishing and Hunting Club is characterized by rip wrapped stones. (Johnstown Flood National Memorial Archives)

that ran through the conveyed tract, guaranteeing future owners of the farm the right of way (Figure 1.51).<sup>99</sup>

Figure 1.61. View south into the empty lakebed from the breached dam, standing near the farmhouse in figure 1.51, and showing some of the vast gravel bar resulting from the dam's destruction. (Johnstown Flood National Memorial)

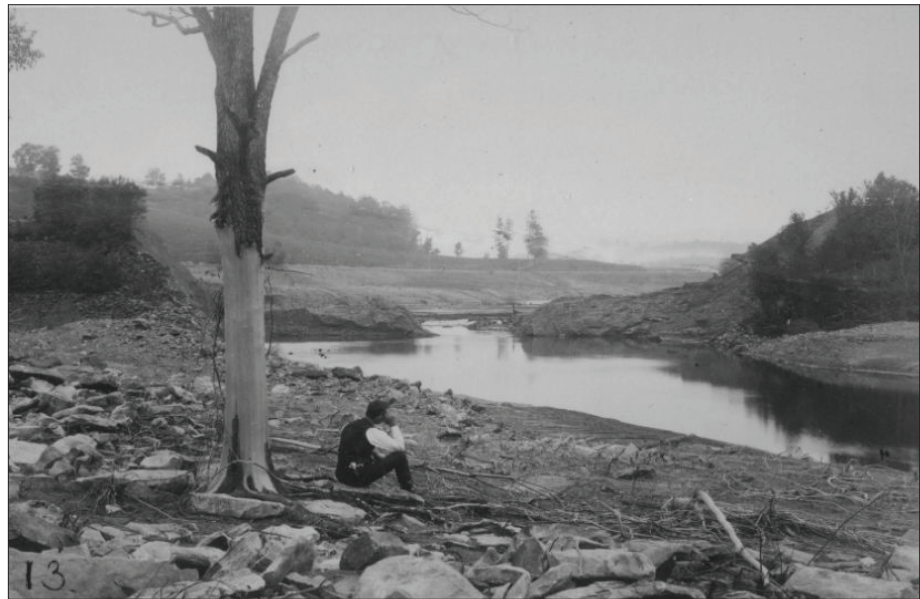
**Figure 1.55.** The South Fork Dam Sluice Gate, following the flood, looking south through the breach in the dam, circa July 1889. ((Johnstown Flood National Memorial).

At 3:15 the dam failed completely. According to Parke, “The dam did not break. It simply moved away.” Another observer said, “The whole dam seemed to push out all at once. No, not a break, just one big push.” Those on hand estimated the lake was reduced to a stream in about 45 minutes (Figures 1.54 and 1.55).<sup>115</sup> As the dam pushed away the pressure was released and a wall of water thirty to forty feet high

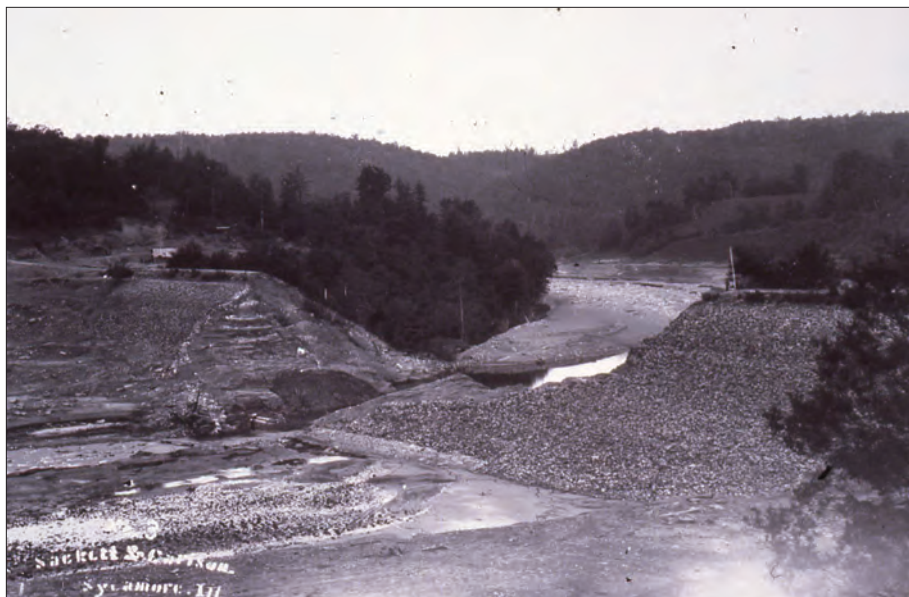
Figure 1.63. The view looking northwest through the dam breach from the hillside south of Lake View Farm. (Johnstown Flood National Memorial).

In the immediate aftermath of the tragedy, investigations by editors and engineers of a leading professional engineering journal, *Engineering News and American Railway Journal*, identified four primary causes for the failure of the reconstructed dam. These were the (1) lowering of the crest; (2) central sag in the crest; (3) closing of the bottom culvert; and (4) obstruction of the spillway.<sup>124</sup> Just days after the dam failure, their preliminary findings were quoted in the New York Times which brought the question of fault in the disaster to the national stage. Yet on June 5<sup>th</sup>, 1889, a committee led by James B. Francis was appointed by the American Society of Civil Engineers to visit the South Fork Dam and investigate the cause of its failure (Figures 1.63 – 1.70). In their findings, published in 1890, they argued

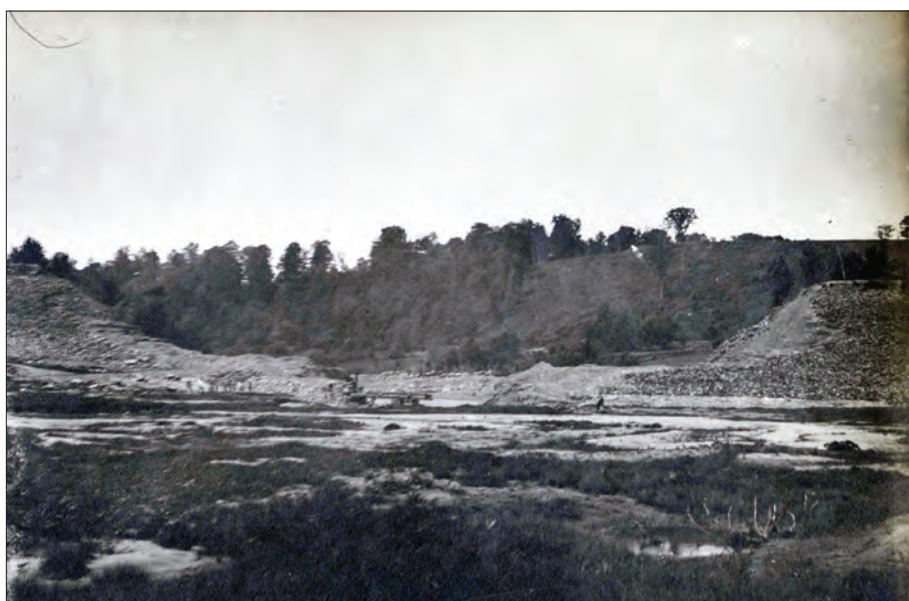
Figure 1.64. The South Fork Dam, edge of the South Abutment (West edge of the dam break), July 28, 1889. (Johnstown Flood National Memorial)

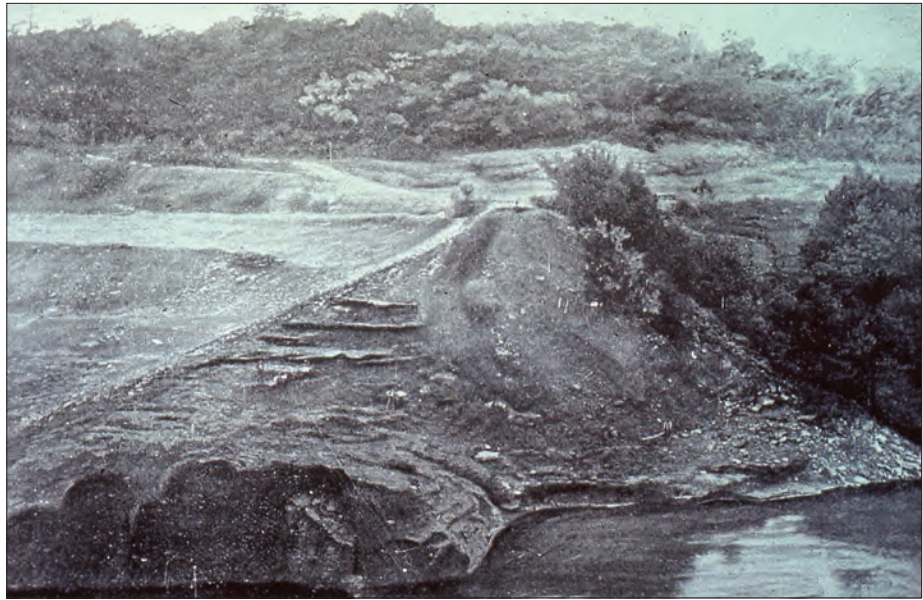
Figure 1.66. The view looking south towards the breach in the dam and the empty lakebed of Lake Conemaugh, from the hillside north of the dam. The carriage road climbing the hill side is clearly visible in the upper right hand corner. (Johnstown Flood National Memorial)

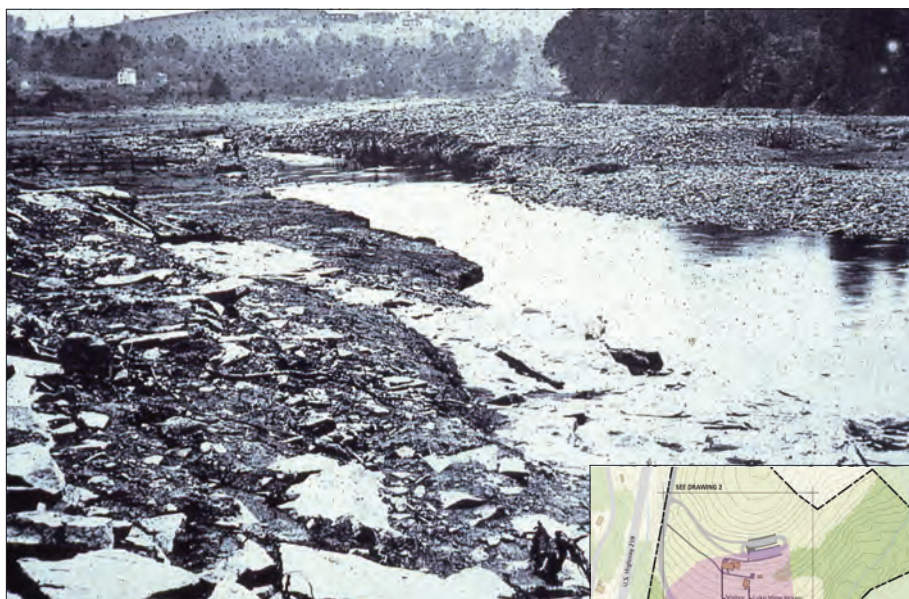
Figure 1.67. This photograph, circa 1889, was taken shortly after the failure of the South Fork Dam, Lake View Farm is visible in the distance, as is the smaller farmhouse by the north abutment on the left. The approximate cone of view of the photograph is illustrated in the accompanying map. (Johnstown Flood National Memorial)

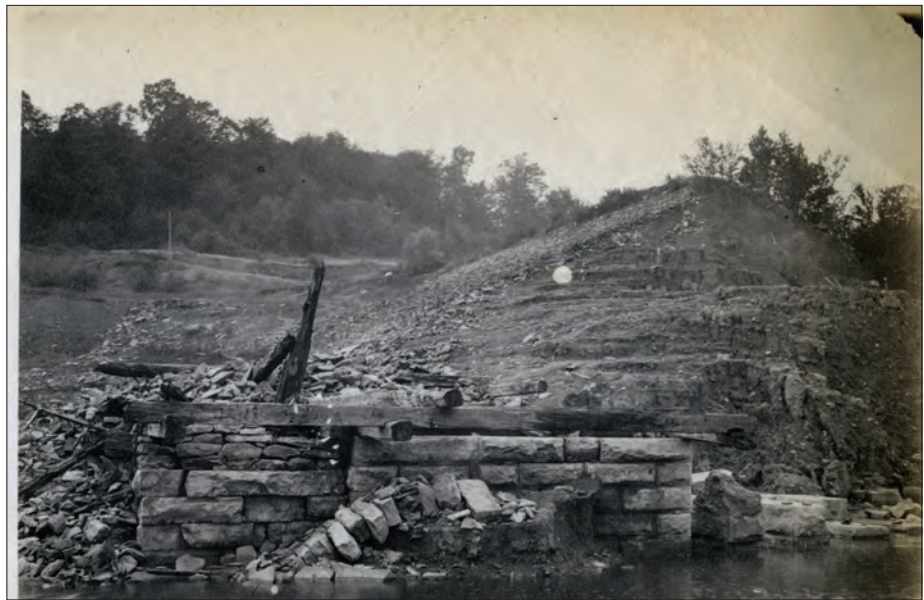
**Figure 1.68. The South Fork Dam Sluice, circa July 1889. (Johnstown Flood National Memorial)**

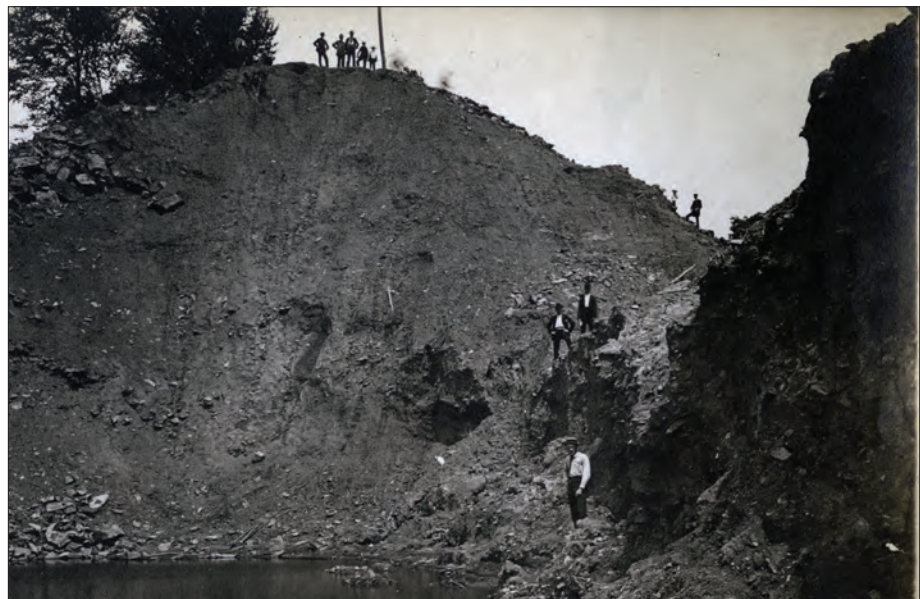
**Figure 1.69. The South Fork Dam, edge of the North Abutment, (East edge of the dam break) July 28, 1889. (Johnstown Flood National Memorial)**

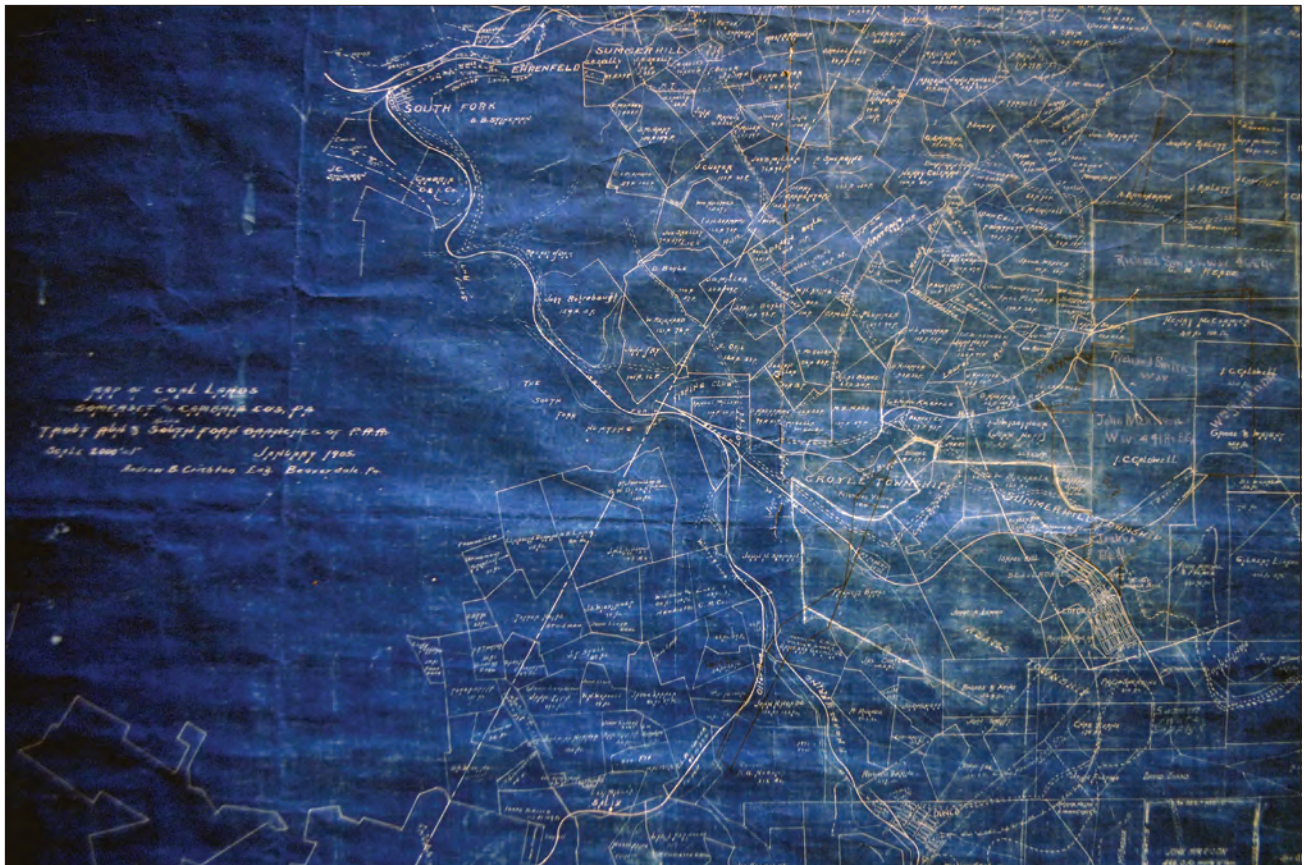
Figure 1.72. Map of Coal Lands Somerset and Cambria County, PA, January 1905, Trout and South Fork Branches shows the route of the South Fork Branch rail road through the former lake bed and well as the complicated nature of coal land ownership. (Cambria County Historical Society)

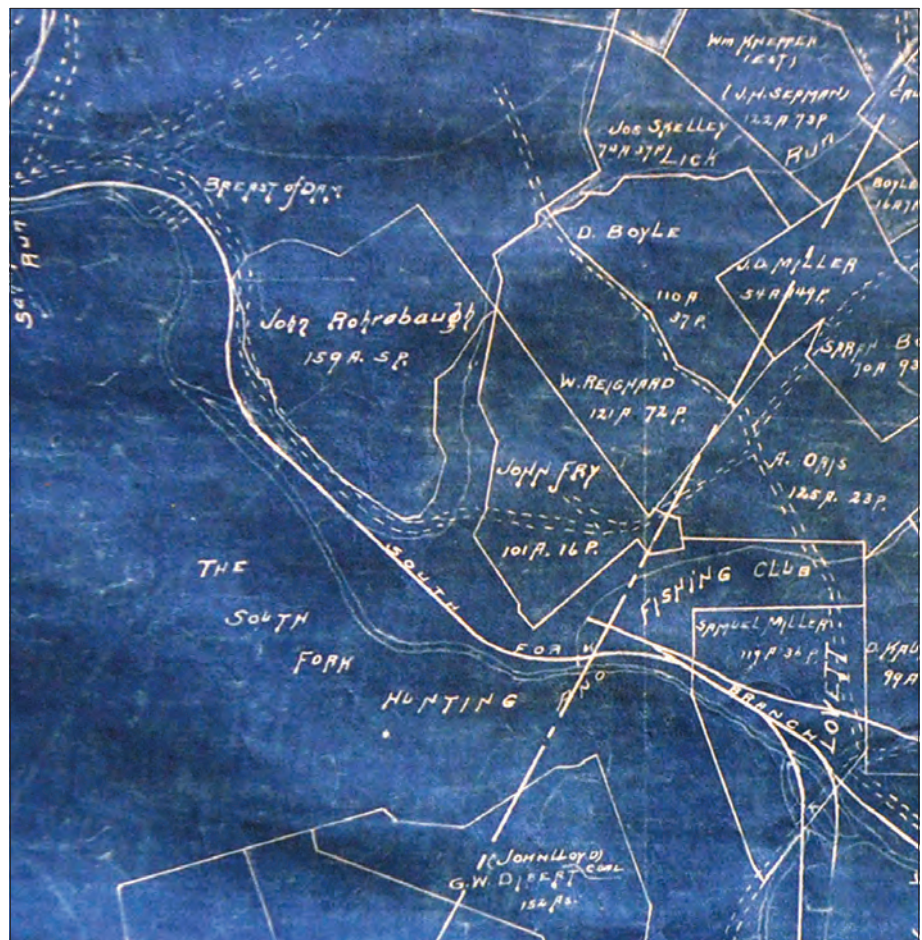
Figure 1.73. Detail from the Map of Coal Lands Somerset and Cambria County, PA, January 1905, Trout and South Fork Branches 1905, detailing the roads and rail road routes east of the lakebed. (Cambria County Historical Society)

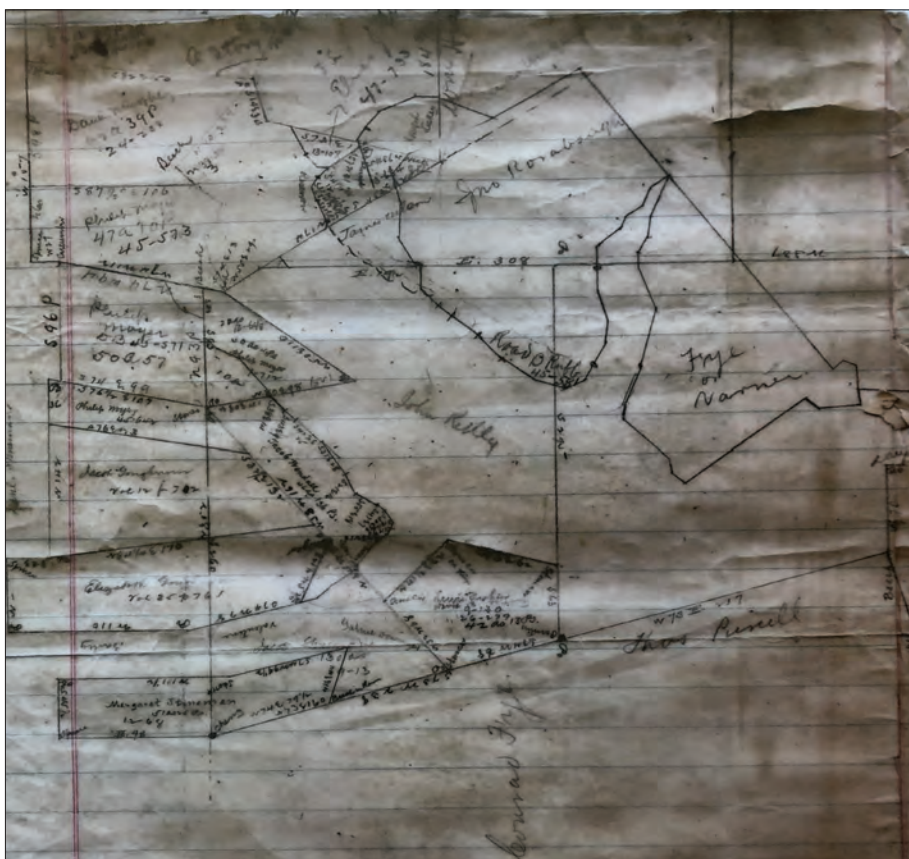
Figure 1.75. Sketch by Kephart of the land tracks purchased by the South Fork Fishing and Hunting Club as part of the title search, circa 1903. (Cambria County Historical Society)

trust by Alsop to identify any encumbrances to the property titles prior to its sale (Figure 1.75).

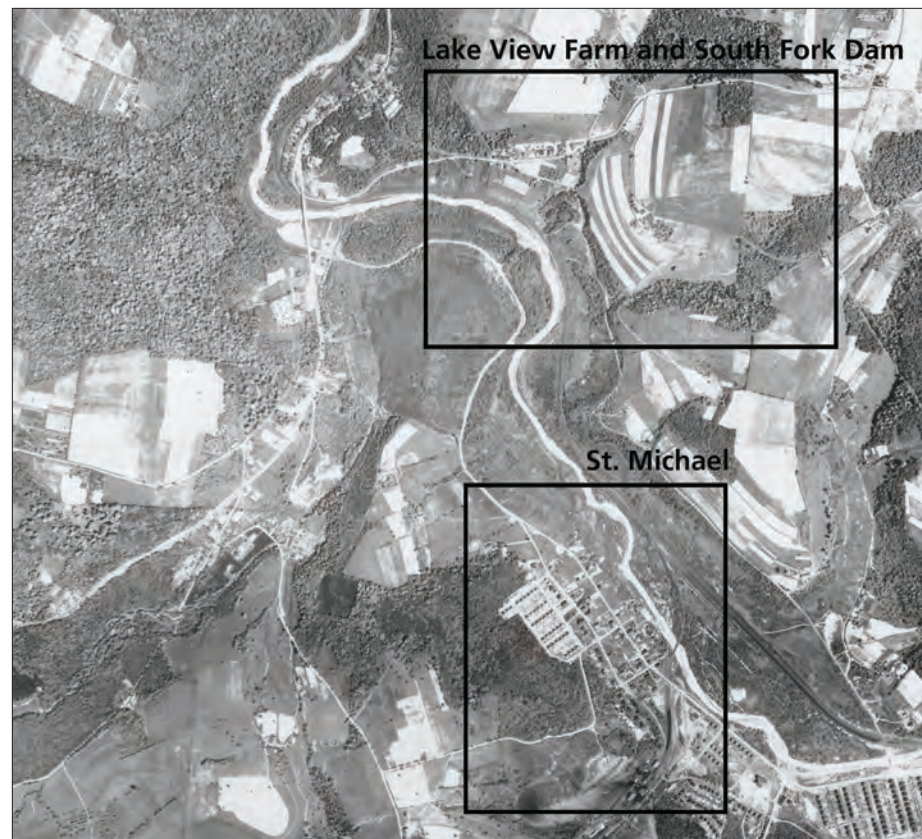
Figure 1.80. Detail of a 1939 aerial photograph revealing the successional vegetation on the hillside south of the South Fork Dam, as well as the terracing of the former Lake View Farm. (PennPilot Aerials)

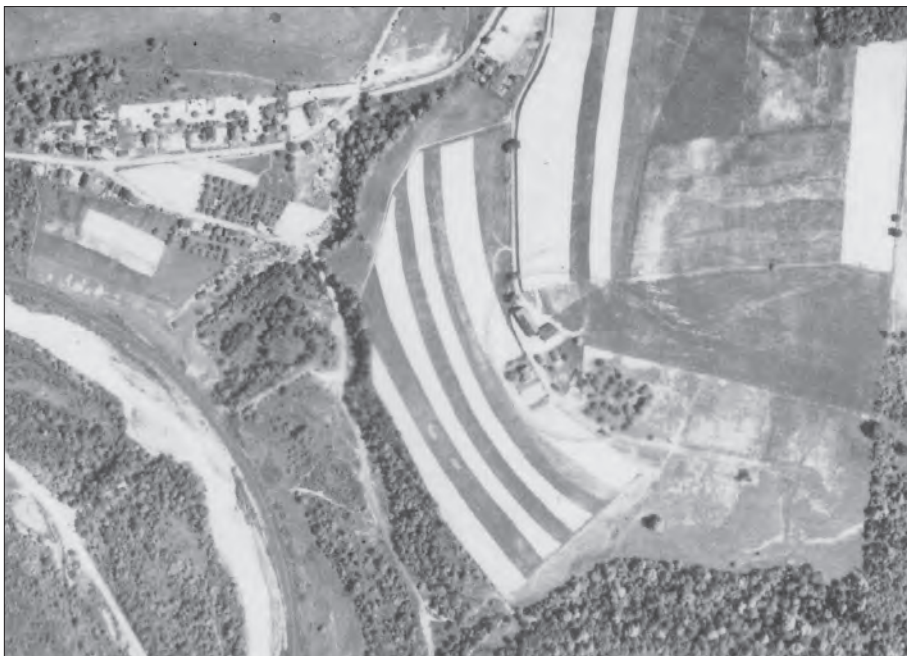
**Figure 1.83.** Aerial imagery from 1939 reveals the fields of the strip farming on the slope above the South Fork Dam remnants at Lake View Farm. (PennPilot Aerial Imagery)

from the barn. The family also sold milk, butter, eggs, apple cider, and apple butter, and raised thoroughbred horses.<sup>151</sup> To prevent erosion, the field south of the house and barn was cultivated in wide strip fields roughly parallel with the former edge of the lake (Figure 1.83).

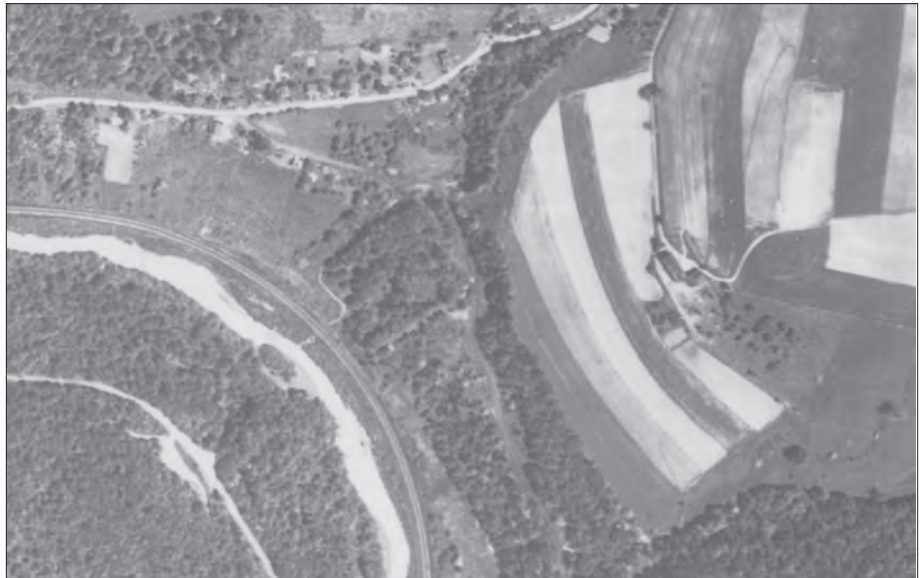
Figure 1.88. In this detail of the area of St. Michael from the 1958 aerial, note vegetation between the double cottage and club house. (PennPilot Aerial Imagery).

the 1950s reveals that the slopes of the former lakebed and surrounding hillsides to the south were now forested in successional vegetation, while Lake View Farm's land remained in agriculture. The area's road system remained relatively unchanged from the early twentieth century (Figures 1.86 – 1.88).

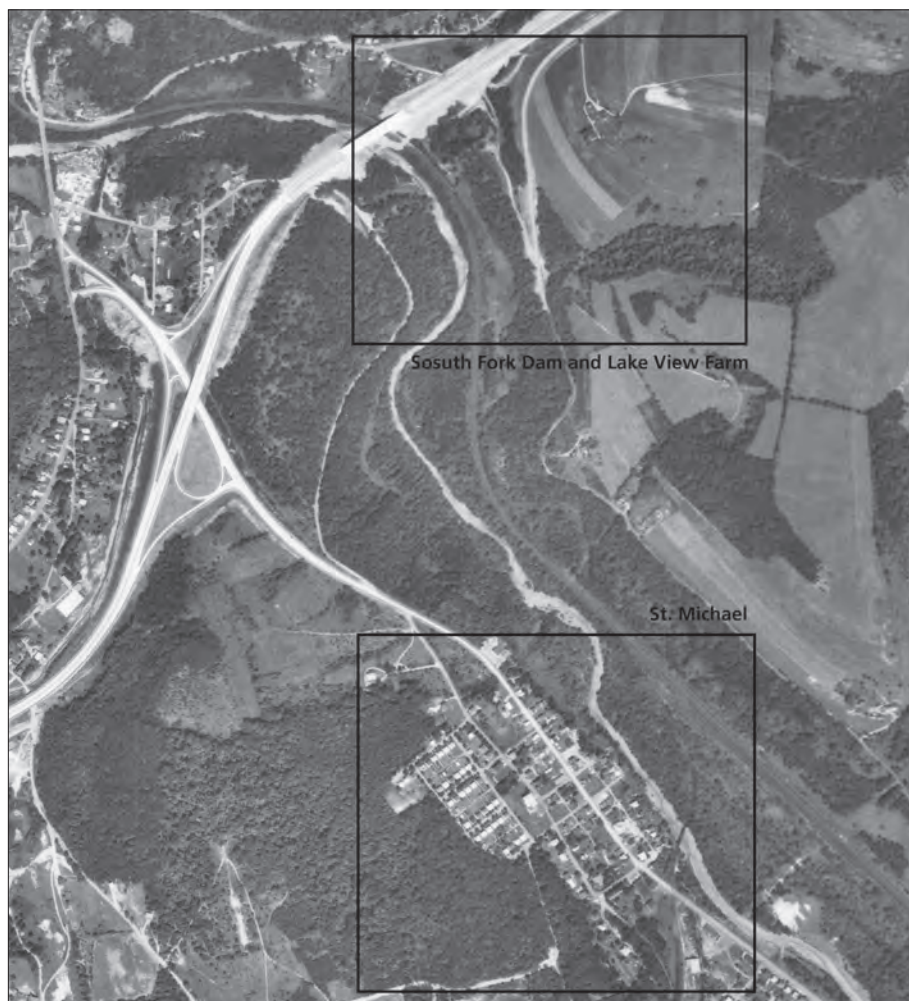
Figure 1.93. This 1967 aerial photograph shows the recent construction of US. Route 219. (PennPilot Aerial Imagery; OCLP)

As most park land was located west of the dam remnants, the park entrance was located off State Route 869. In 1968, park development plans proposed using abandoned Township Road 308 as the entrance road into the park, which would provide access to a hillside picnic area with a parking lot and comfort station, and to another parking lot near the south abutment (Figure 1.92). The plan indicated a contact station and small comfort station/maintenance building near the south abutment, and a visitor contact shelter at the spillway at the north abutment. Trails equipped with interpretative waysides connected both contact stations via an elevated pedestrian bridge attached to the south side of the Highway 219 bridge (not on park property) (Figures 1.93– 1.95).<sup>168</sup>

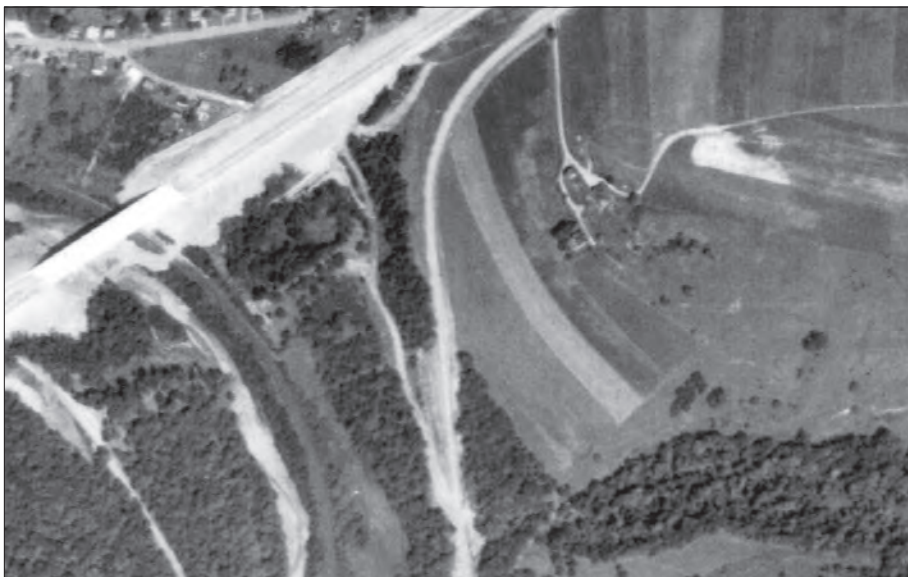
**Figure 1.94.** Detail of the South Fork Dam remnants, lakebed and Lake View Farm from the 1967 aerial photograph. (Penn Pilot Aerial Imagery)
