# CULTURAL LANDSCAPE REPORT FOR JOHNSTOWN FLOOD NATIONAL MEMORIAL

NATIONAL PARKS OF WESTERN PENNSYLVANIA

CAMBRIA COUNTY, PENNSYLVANIA

Olmsted Center for Landscape Preservation  
National Park Service, Boston, Massachusetts, 2021

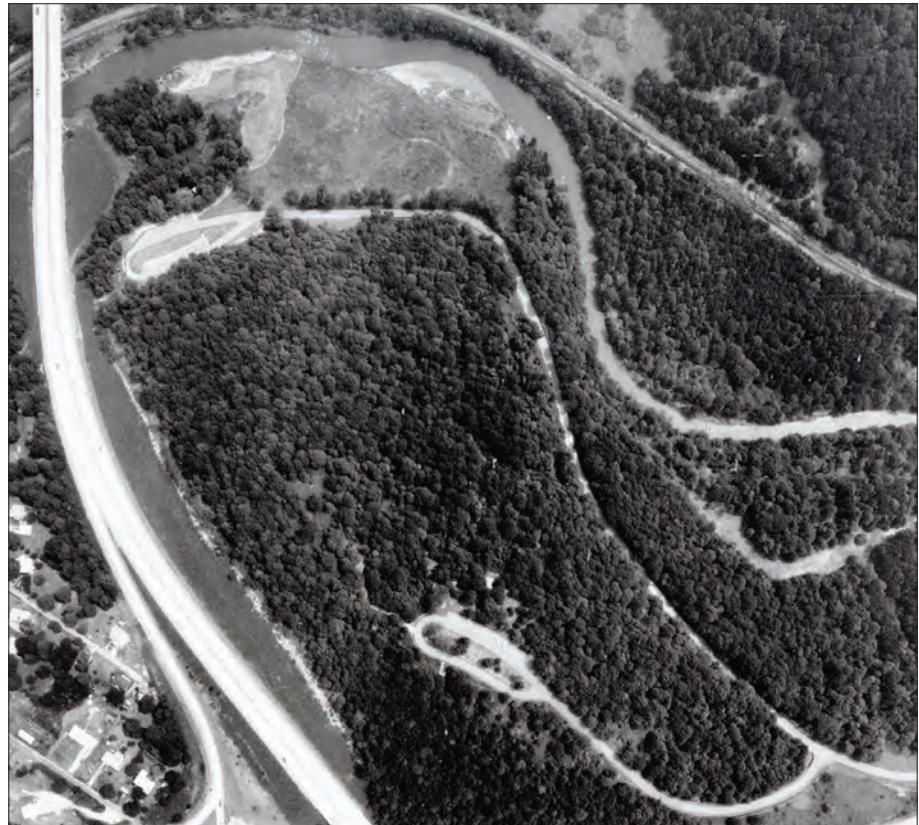
**Figure 1.96.** This 1977 aerial shows the newly constructed entrance drive, parking areas, and lakebed vegetation clearing at Johnstown Flood National Memorial. (Pennsylvania State University Archives)

Portions of the 1968 plan were constructed in between 1972 and 1973. The park entrance road (now South Abutment Road) was improved with steel guardrails, paved gutters, and additional culverts with stone headwalls to match the existing headwalls (Figure 1.96). At the hillside picnic area, trees were removed to construct a curving access road (now Picnic Grounds Road), terminating in an elongated loop in the location of a former cinder pit. The National Park Service built a thirty-space parking lot on the east side of the loop next to the picnic sites but did not install the comfort station at this time. Barbeque grills and picnic tables were spread out under the shade trees east of the parking lot<sup>169</sup>

The park also cleared trees within the lakebed to help visitors visualize the former lake (see Figure 1.96). A major flood in 1977 reportedly damaged several trails, footbridges, and walks in the park, which were repaired by park staff and the Youth Conservation Corps. Access to the north abutment at this time was likely along the abandoned portion of Township Road 352. However, the park only owned the section through the spillway and could not develop parking facilities off the new alignment of Township Road 352 until years later.<sup>170</sup>

the lakebed has been pursued as resources allow. In the 1930s, the lakebed was mostly open, though successional vegetation was appearing on the slopes and in the western portion of the land. By the 1950s, tree cover was dense and when the National Park Service acquired the property in the 1960s, plans were made to clear the lakebed vegetation. The first evidence of lakebed vegetation clearing is seen in the 1970s (see Figure 1.96). As the 1977 Draft General Management and Development Plan stated,

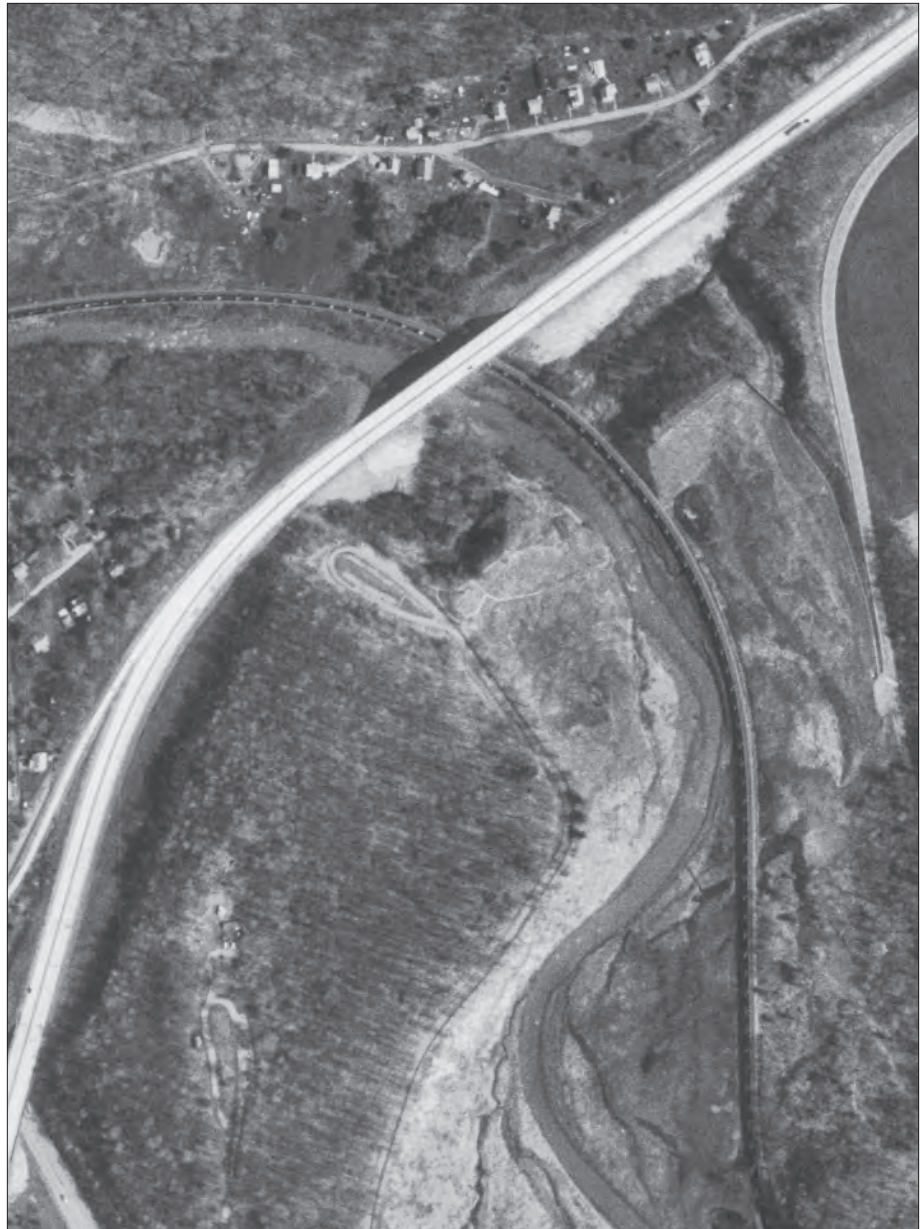
**Figure 1.102.** This 1993 aerial photograph reveals the trails through the newly cleared lakebed, as well as the picnic pavilion. (Johnstown Flood National Memorial).

sided picnic pavilion on the east of the loop amongst the picnic tables and grills. By this time there was also a horseshoe pit in the median of the loop (Figure 1.102).<sup>180</sup>

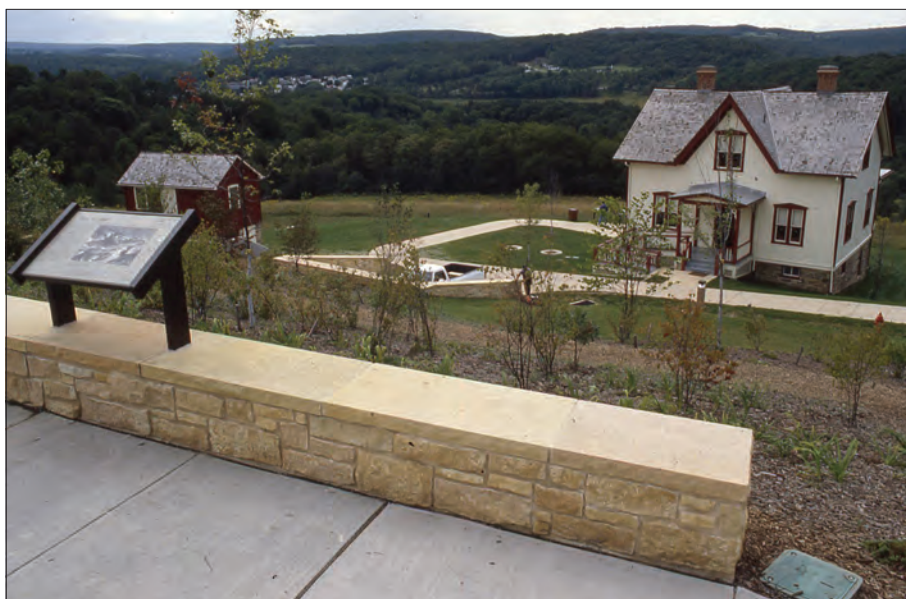
Figure 1.106. The rehabilitated Lake View Farmhouse (right) and Spring house (left), circa 1989. (Johnstown Flood National Memorial)

the collapsing foundation of the spring house between 1988 and 1989 and built a new but smaller structure like the style of the original on top of the northwest end of the original foundation (Figure 1.106). Based on recommendations in a 1986 Historic Structure Report, the park removed the Furlong garage (but not the fill) and the well house in the late 1980s.<sup>186</sup>

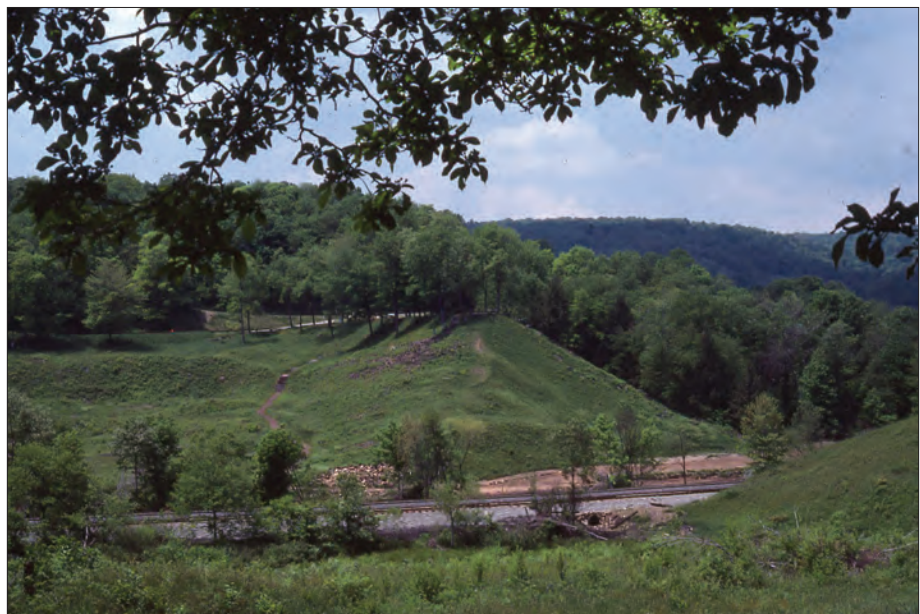
**Figure 1.107.** The lakebed and south abutment following clearing in 1989, evidence of scouring from flooding is visible along the river’s edge. (Johnstown Flood National Memorial).

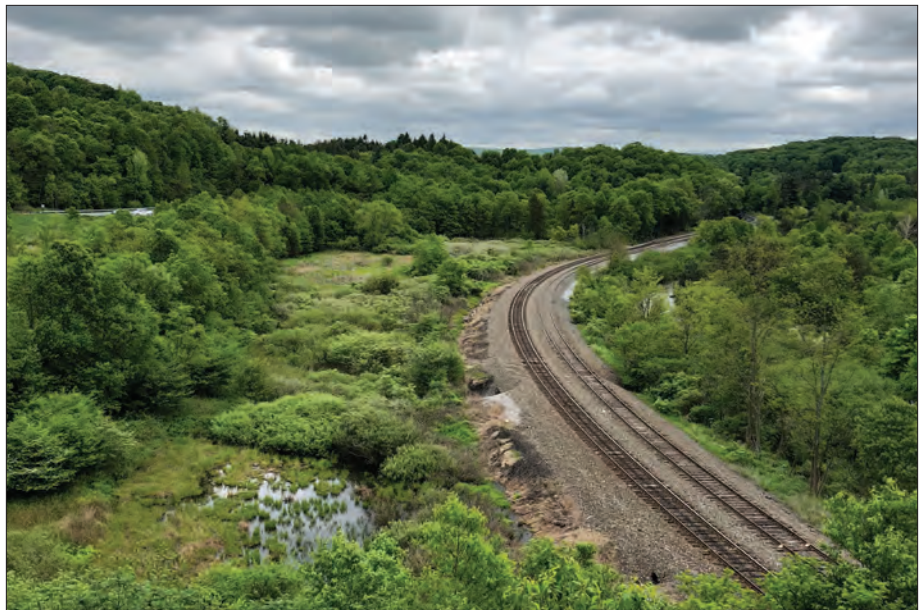
Figure 2.3. The culverts and berm from the late nineteenth century rail line concentrate water runoff in discrete areas of the lakebed supporting the growth of wetlands, 2019. (Olmsted Center for Landscape Preservation)

Both hydrology and soil type influence the revegetated lakebed. When a railroad was constructed in the late nineteenth century, a berm was built on the river's east side. This berm directs drainage from the tributaries on the east side of the lakebed into culverts positioned along the berms. This alteration impacts the area's hydrology by concentrating water in discrete areas (Figure 2.3). The South Fork Little Conemaugh River and its small tributaries in the park have been designated "cold water fisheries," but none are considered "high quality" waters. The South Fork Little Conemaugh River's entire length running through the park is listed as impaired by pH and metals from abandoned mine drainage by Pennsylvania's Section 303(d) list. The Section 303(d) list is of impaired and threatened waters that states submit to the Environmental Protection Agency.

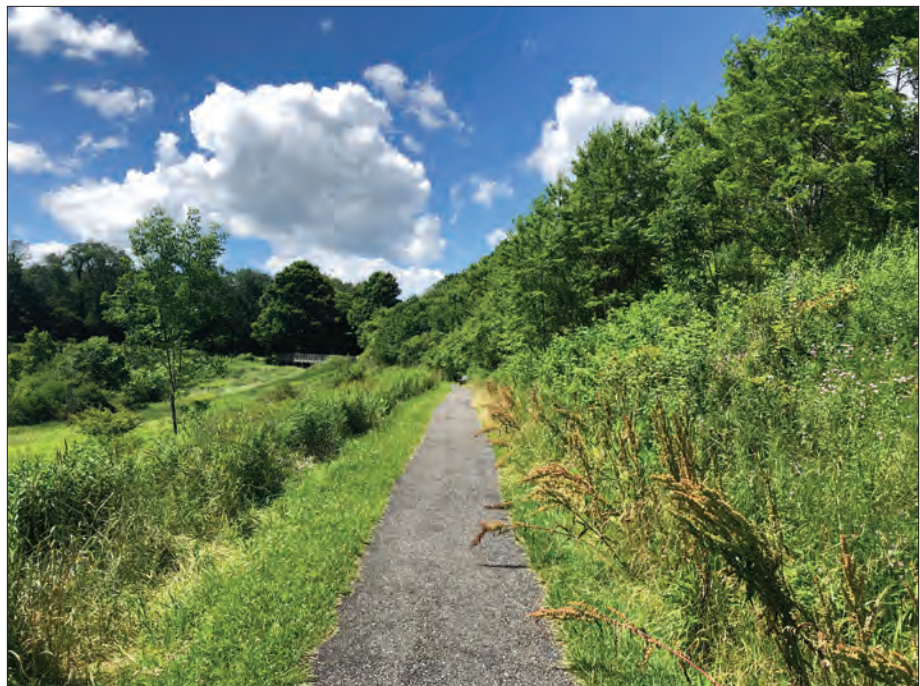
Figure 2.6. View north from the Lake Road Parking area, of the accessible trail to the north abutment. The trail alignment approximates the location of the former carriage road, 2018. (Olmsted Center for Landscape Preservation)

This asphalt-paved parking bay, striped for seven vehicles, is located where the alignment of Township Road 352 was shifted from its circa 1904 alignment, heading toward the spillway, to its 1960s era alignment heading up and around the Lake View Farm hillside. The six-foot-wide asphalt paved accessible trail leading between the parking lot and the North Abutment was built in the late 1980s. The trail's alignment approximates the route of the carriage road that led from the dam to the Lake View Farm when the property was owned by the South Fork Fishing and Hunting Club (Figure 2.6).

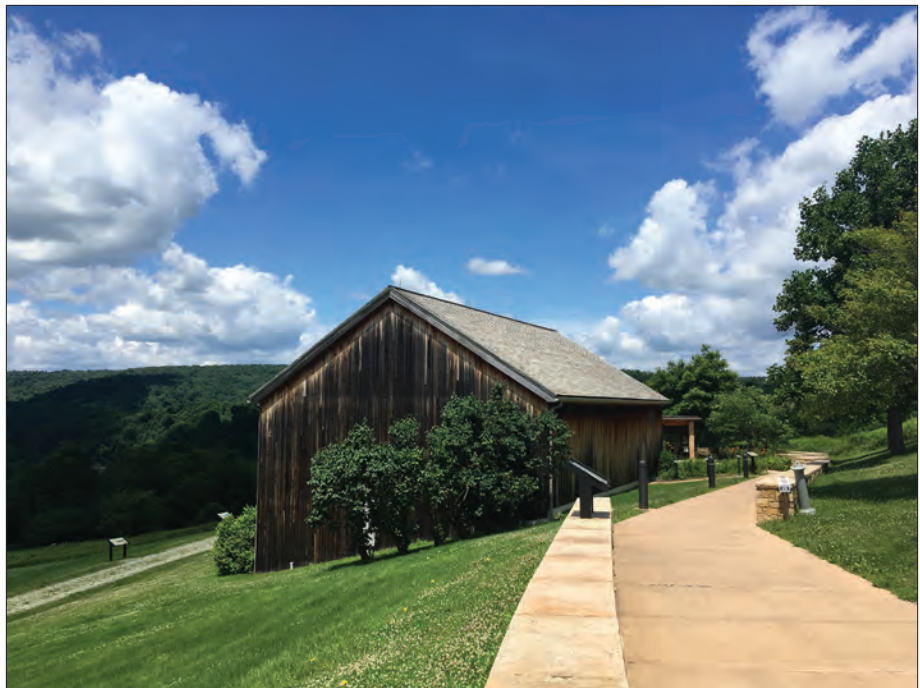
**Figure 2.7.** The entrance to the barn-like Visitor Center includes stone retaining walls, concrete sidewalks and plantings of herbaceous perennials and shrubs, 2018. (Olmsted Center for Landscape Preservation)

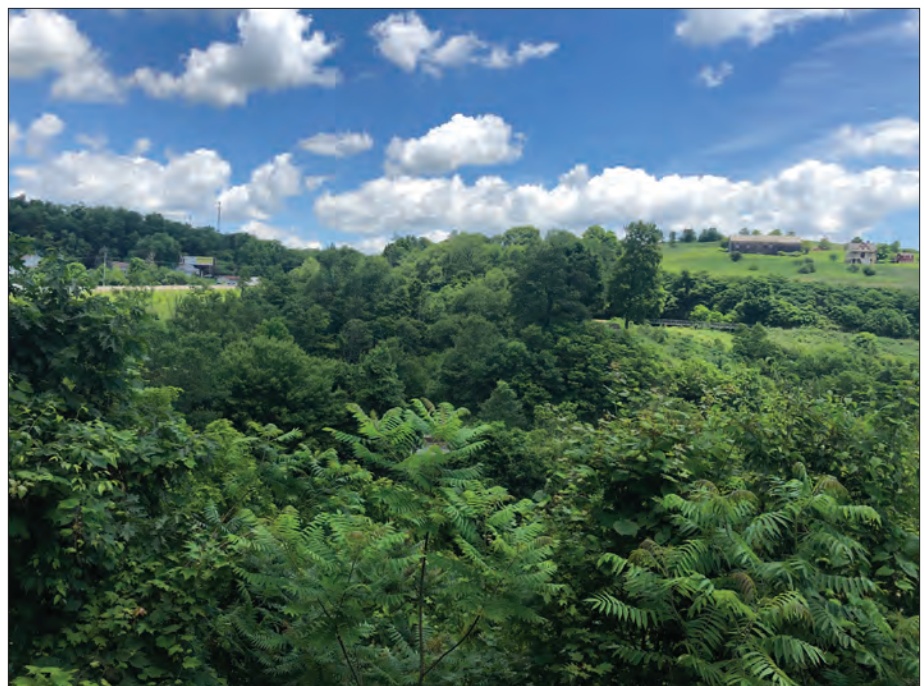
**Figure 2.8.** In this view of the north from the south abutment the enormous landforms are lost under the vegetation, 2019. (Olmsted Center for Landscape Preservation)

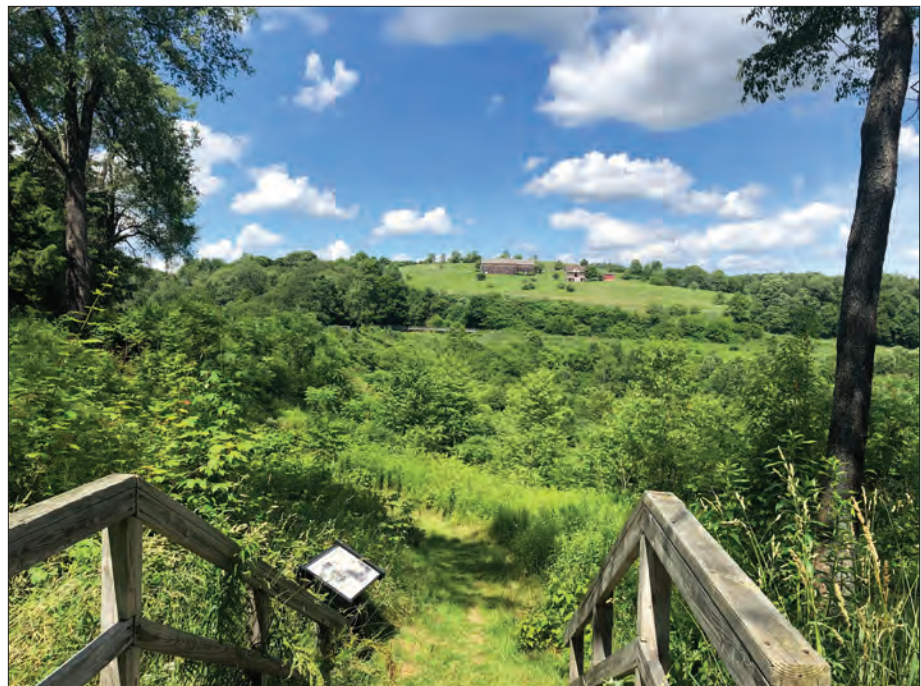
Figure 2.10. Woody vegetation covers the upstream sides of both abutments and mature trees, visible on the left side of the photograph, grow along its crest, 2019. (Olmsted Center for Landscape Preservation)

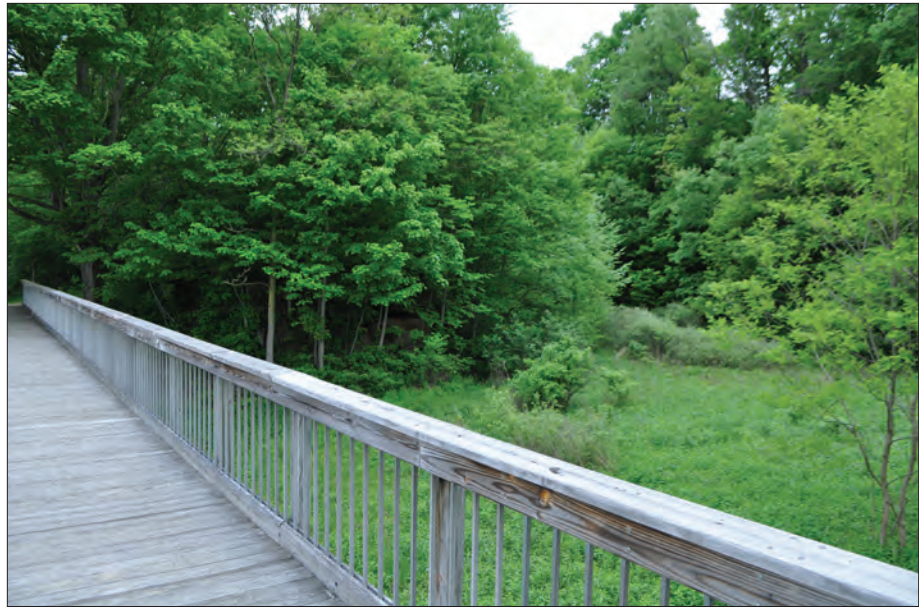
**Figure 2.11.** A National Park Service-era foot bridge spans the overflow spillway which is overgrown by shrubby growth, 2018. (Olmsted Center for Landscape Preservation)

The spillway is cut through the stone embankment just north of the dam to an approximate depth of ten feet below the crest of the former dam. The opening is two-hundred-eighty feet long and measures between sixty and one-hundred

feet in width. The spillway is largely overgrown by grass and shrubs and includes delineated wetlands (Figure 2.11).

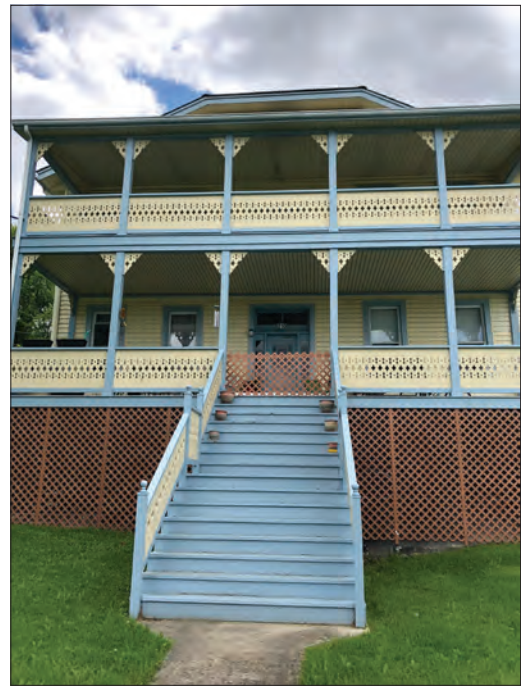
**Figure 2.13. A view of northeast facade of the Double Cottage, 2018. (Olmsted Center for Landscape Preservation).**

a two-story rectangular building with a raised basement and a two-story full-width front porch (Figure 2.13). It has a truncated end-gable roof with small gables centered on the east and west side elevations, asphalt shingles, and boxed overhanging eaves. The walls are clad in vinyl siding installed ca. 1995 and vertical boards in the gable ends. Three rows of concrete block and brick corner piers inserted between the original coursed stone foundation and the first-floor sill circa 1934 raised the building and front porch two feet. The front porch has a shallow shed roof supported on square wood posts with jigsawn brackets that articulate each of the five facade bays and jigsawn boards form the porch railings (Figure 2.14).

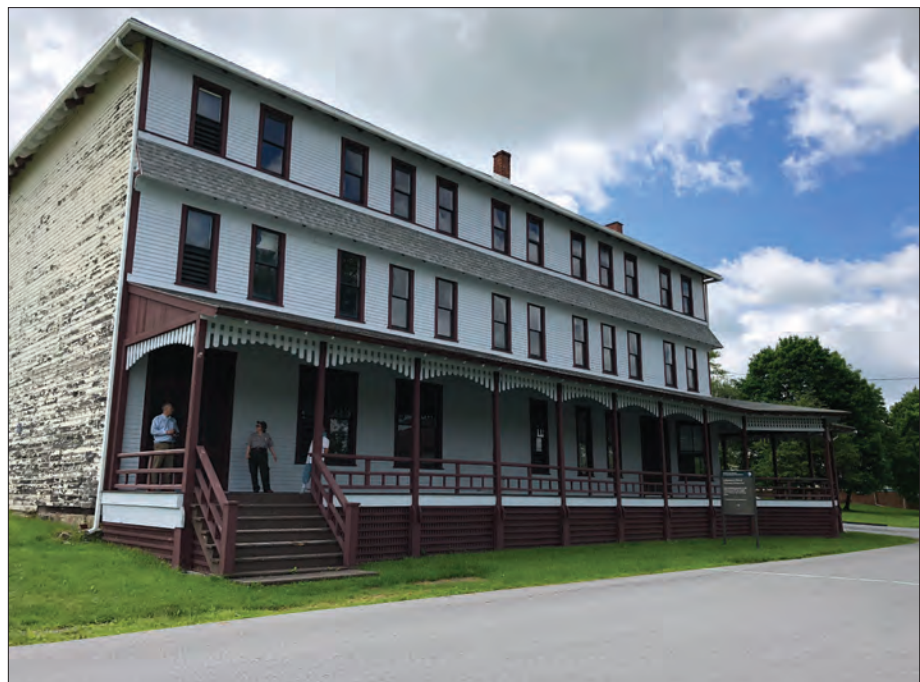
**Figure 2.14. In this view of the clubhouse, the gravel parking area is visible in the lower right hand corner of the photograph, 2018. (Olmsted Center for Landscape Preservation).**

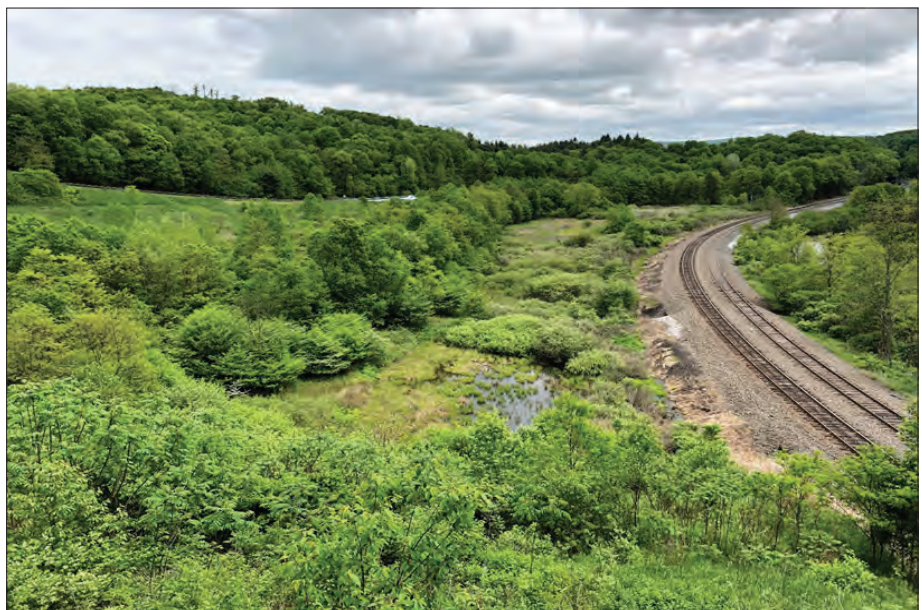
**Figure 3.2.** View from the north abutment of designated wetlands east of the South Fork Little Conemaugh River and the rail road, 2018. (Olmsted Center for Landscape Preservation)

*Post-historic and Existing Condition:* Within the lakebed of the former Lake Conemaugh, a total of twenty-three unique wetland features (17.84 acres) have been delineated including 11.10 acres of palustrine wetland habitat, four acres of riverine wetland habitat, and 2.74 acres of scrub-shrub riparian buffer. Of the palustrine wetlands, 7.96 acres were considered emergent wetland where vegetation tends to be low growing and where systems appear to be seasonally saturated or flooded. Palustrine scrub-shrub wetlands comprise another 2.88 acres of the palustrine wetlands (Figure 3.2). Within these areas, vegetation is dominated by tall shrubs including willow (*Salix sericea*) and alder (*Alnus incada sub. Rugose*).<sup>8</sup>

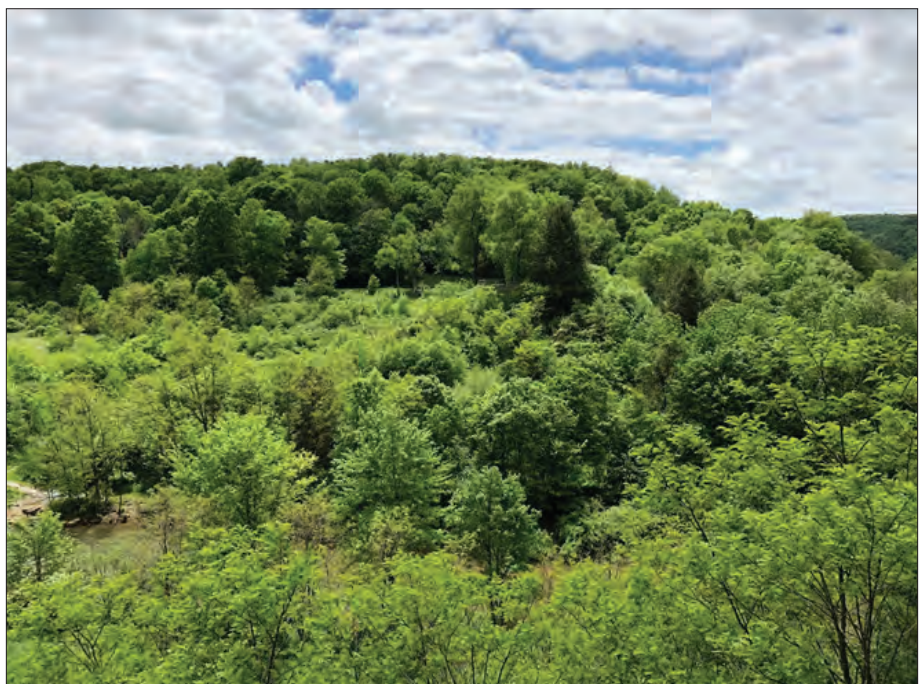
**Figure 3.3.** View of the lakebed, shrouded in woody vegetation, from the South Abutment, 2018. (Olmsted Center for Landscape Preservation)

*Post-historic and Existing Condition:* Following the failure of the dam, areas of the lakebed were used for cultivating crops and grazing. An area in the southern section of the lakebed owned by the National Park Service was planted out in a pine plantation, while successional shrubs and trees grew on fallow land. Beginning in the late 1970s, after the acquisition of the property by the National Park Service, occasional campaigns of tree clearing in the former lakebed began. This cycle of tree removal and growth continued through 2008, when tree removals from the lakebed ended. Today the lakebed consists of fifty acres of the original four hundred to five-hundred-acre bed of Lake Conemaugh, lying between Lake Road on the north and the South Abutment Road on the south. Though the contours of the lakebed are shrouded in woody vegetation the lakebed retains its character defining basin shape and location (Figure 3.3).

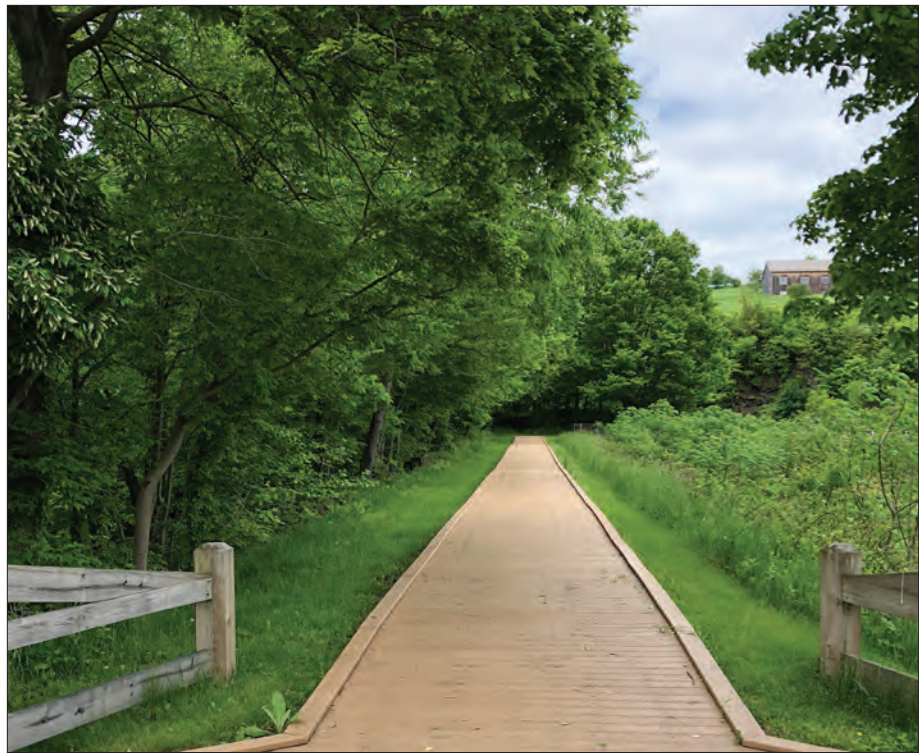
Figure 3.5. A view east along the north abutment PVC lumber boardwalk which approximates the location of the carriage drive over the dam, 2019. (Olmsted Center for Landscape Preservation)

*Post-historic and Existing Conditions:* Following the destruction of the dam the carriage road leading from Lake View Farm to the dam and on to the cottages on the southwestern shore of the former Lake Conemaugh was most likely not maintained. Following National Park Service acquisition, however, the trace of the carriage drive was incorporated into interpretation and circulation plans. Presently the longest and most intact segment of the Carriage Road Trace extends from the intersection with the Picnic Grounds access road to the parking lot at the south abutment. The carriage road trace follows the alignment of the existing pedestrian trails along the crests of the dam abutments to overlooks of the breach, river, and former lakebed. The trail along the crest of the south abutment is grassed except at the overlook where the surface is gravel. The trail along the crest of the north abutment is a universally accessible PVC lumber boardwalk (Figure 3.5). The segment of the trace descending the downstream face of the dam alongside the spillway is overgrown with vegetation and barely discernable. This segment was once part of a now-abandoned interpretive trail that the park built alongside the downstream toe of the north abutment to the river.

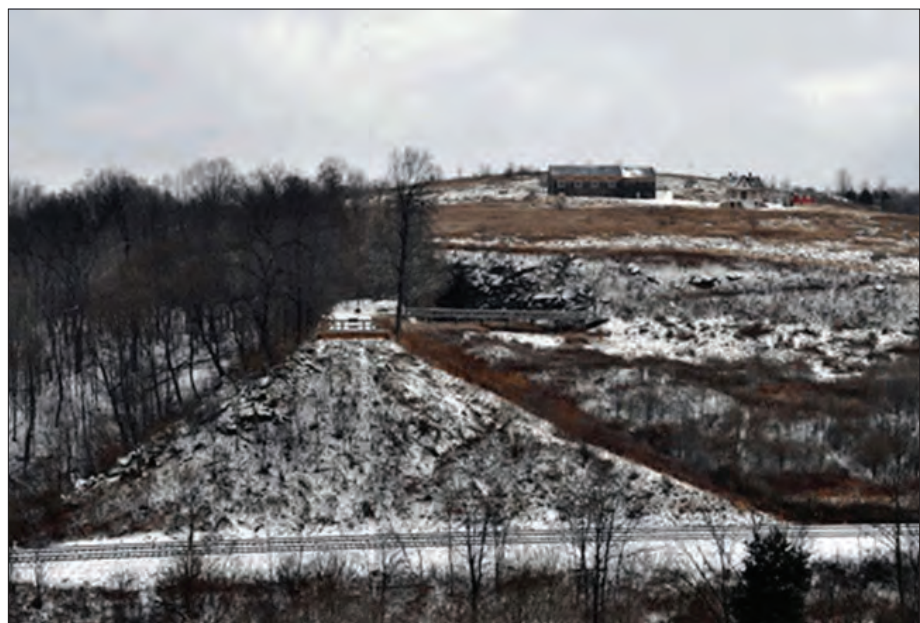
Figure 3.6. The winter landscape helps to reveal the topography of the earthworks of the south face showing the trapezoidal shape of the landform, 2014 (Olmsted Center for Landscape Preservation).

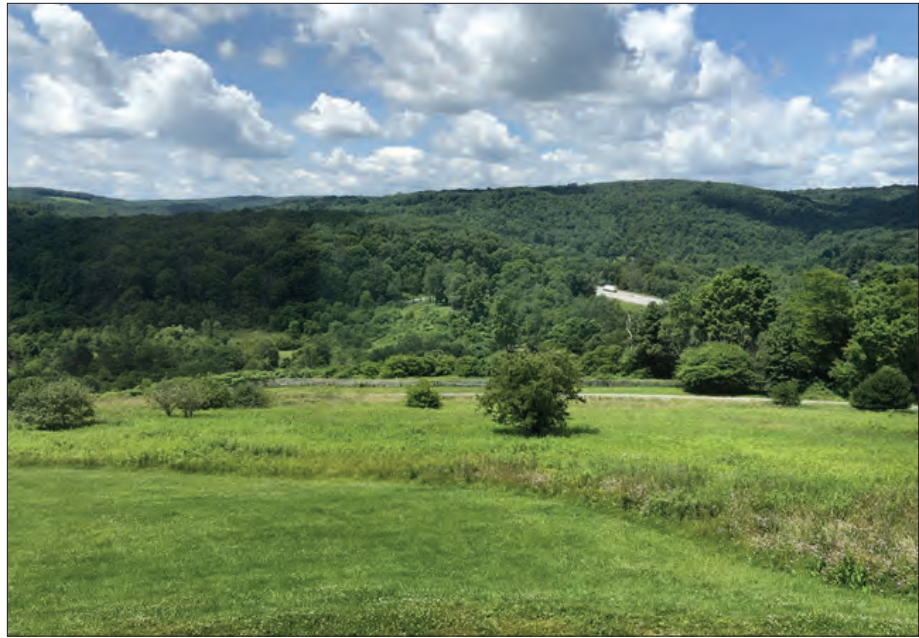
**Figure 3.7.** Highway 219 is visible in the center of the photograph, passing adjacent to the dam abutments. Trees between the dam abutment overlooks and the highway help to screen noise and visual pollution, 2018. (Olmsted Center for Landscape Preservation)

*Post Historic and Existing Condition:* Both large and small trees remain on the downstream sides of the North and South Dam Abutments. These trees suggest the tree growth present during the period of significance, as well as screen visual and noise pollution from the adjacent freeway (Figure 3.7).

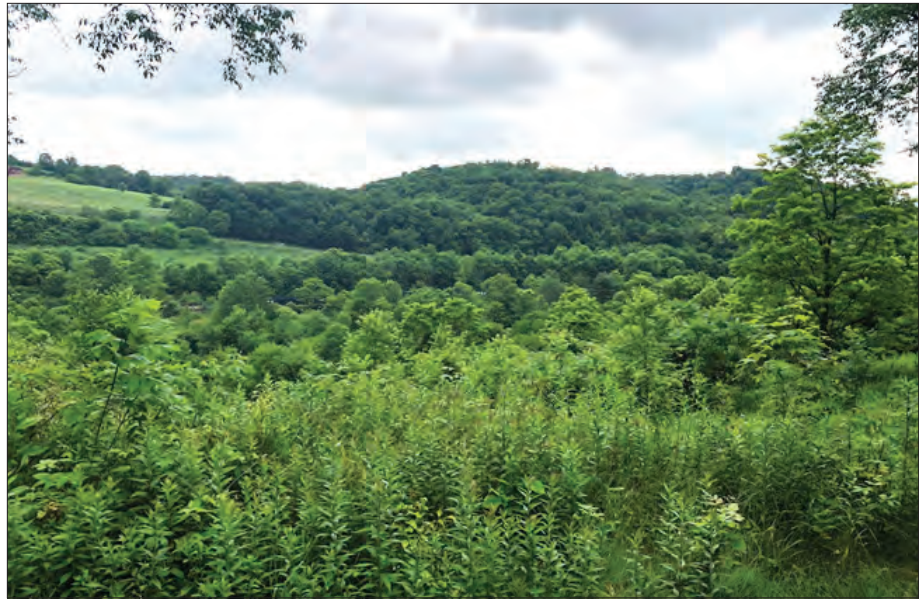
**Figure 3.8.** Typical grasses and forbs of “Old Field” vegetation in the foreground of this photograph, grow in areas of the lakebed, including here at the toe of the south abutment, 2019. (Olmsted Center for Landscape Preservation)

*Post-historic and existing conditions:* The low growing grasses and meadow forbs that make up the Old Field vegetation within the lakebed allow the magnitude of the former Lake Conemaugh to be revealed to visitors through the basin's contours. An herbaceous subtype identified as "Old Field" by the Pennsylvania Natural Heritage Program dominates this vegetative community. The "Old Field" vegetative community currently contains graminoid and herbaceous plants of both native and non-native species. Old Field vegetation is currently limited within the lake basin due to the growth of successional woody species (Figure 3.8).

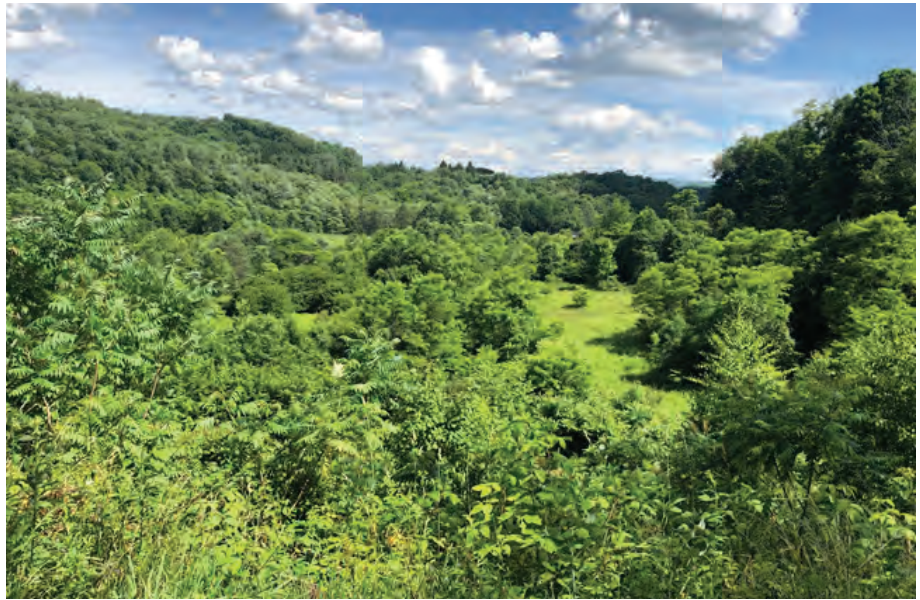
Figure 3.10. Woody vegetation growing within the lakebed, looking west from Lake Road parking area, 2018. (Olmsted Center for Landscape Preservation)

*Post-historic and existing condition:* Following the destruction of the South Fork Dam, this area was drained of water and grew up in hardwoods. Moreover, the vegetation screens the lake basin's contours and the dam abutments, preventing visitors from visualizing the extents of the former lake and the magnitude of the disaster and threatens the stability of the dam abutments. The woody vegetation on the upstream side of the dam abutments and within the lakebed does not contribute to the historic significance of the property and is incompatible with the historic setting (Figure 3.10).

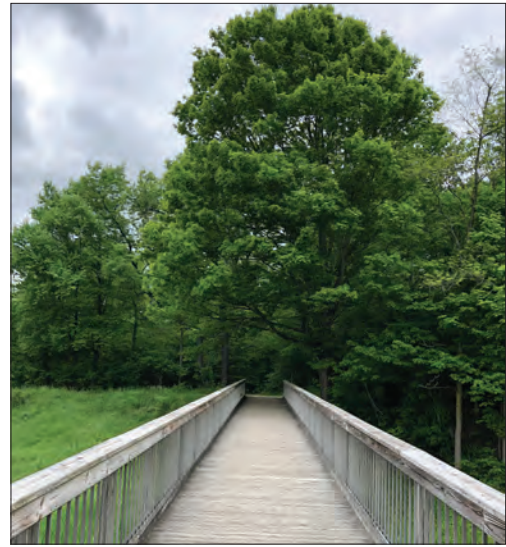
**Figure 3.13.** The maple tree at the northern end of the north abutment may be a witness tree, but further research is necessary, 2018 Olmsted Center for Landscape Preservation).

*Post-historic and existing condition:* The large maple tree, *Acer sp.*, located at the western end of the Pedestrian bridge on the crest of the Northern Dam Abutment, may date to the period of significance. Dendrological research is necessary to determine the age of the tree (Figure 3.13).

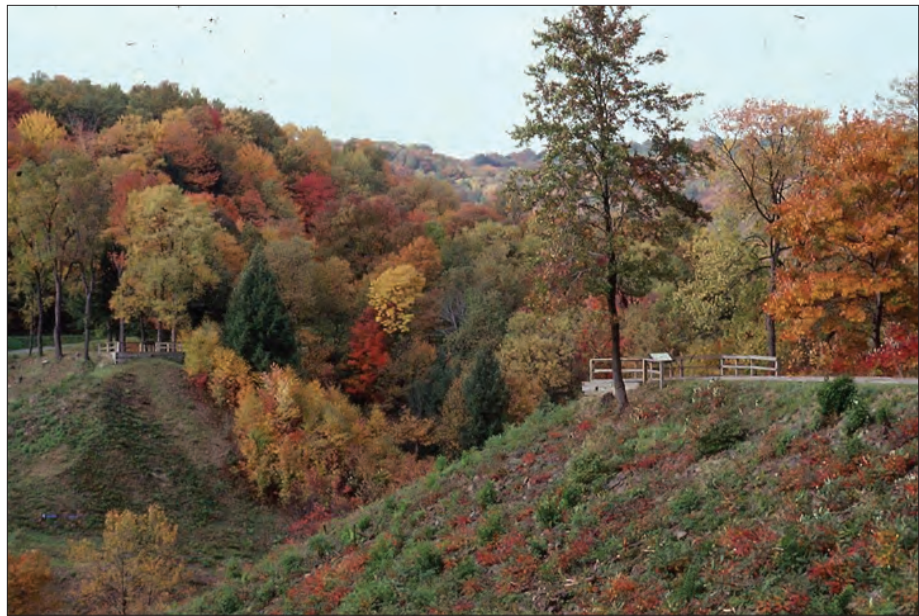
**Figure 3.14.** The dam abutments are visible here, circa 2000, when vegetation on the abutments was managed to control woody growth, circa 2000. (Johnstown Flood National Memorial)

*Post Historic and Existing Condition:* After May 1889, the remaining portions of the earthen and stone dam eventually became overgrown with grasses, shrubs, and trees. Remnants of the stone sluice culvert and timber support cushion of the valve control tower remained visible near the streambed that passed through the gap. It is possible that the construction of the first railroad track in 1891 through the breach, and/or the second track by 1904, may have required the removal of some of the dam ruins in the breach area. The earthen South Fork Dam Abutments are partially overgrown with grasses, brush, and trees. The west or downstream faces are covered with stone riprap pierced through by mid-sized deciduous and coniferous trees. The North Abutment measures twenty feet wide by 390 feet in length by seventy-two feet in height. The South Abutment measures twenty feet wide by 230 ft in length by seventy-two feet in height. The gap between the north and south abutments, marking the section of the dam that collapsed on May 31, 1889, is approximately two-hundred-and-fifty to three-hundred feet wide. Though now cloaked in vegetation, the dam abutments reveal the magnitude of the size of the former dam and contribute to visitor understanding of the tragedy (Figure 3.14).<sup>17</sup>

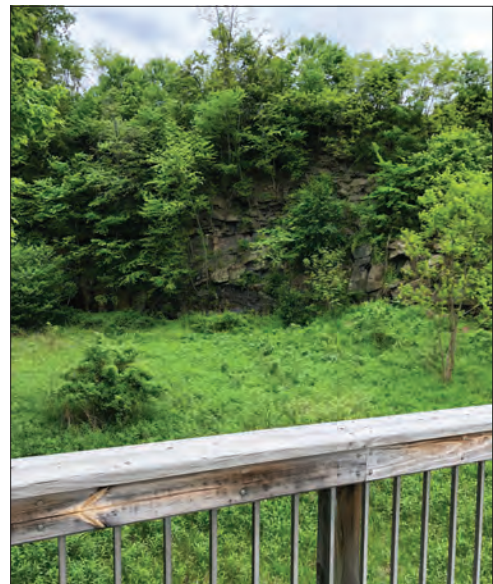
**Figure 3.15.** Woody vegetation grows from the embankments surrounding the former spillway, 2018, (Olmsted Center for Landscape Preservation).

the crest of the former dam. The opening is two hundred and eighty feet long and measures between sixty and one hundred feet in width. The spillway is overgrown by grass and shrubs and includes delineated wetlands (Figure 3.15).

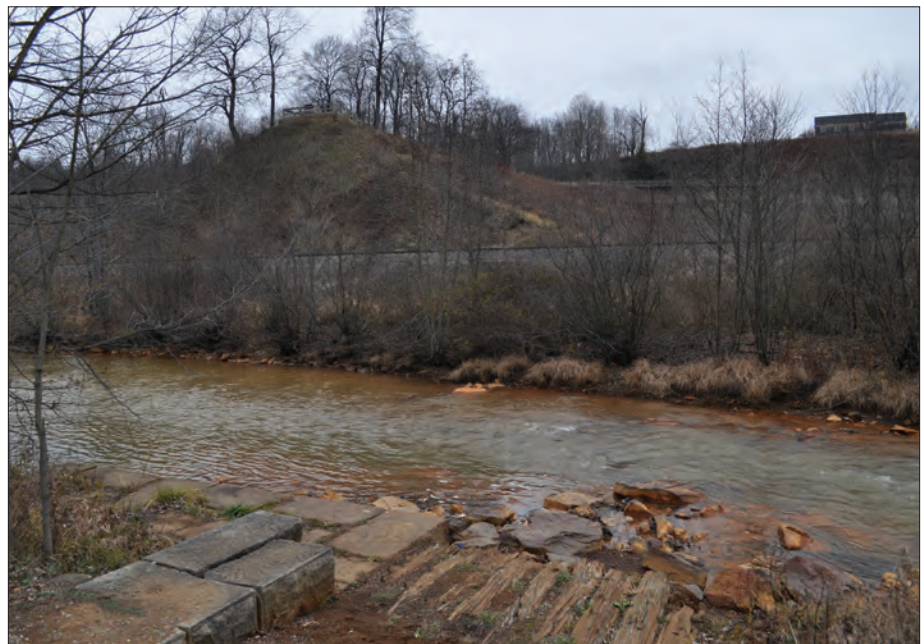
**Figure 3.16.** The remnants of the wood and culvert foundation stones are near the toe of the dam along the South Fork of the Little Conemaugh River, 2014. (Olmsted Center for Landscape Preservation)

*Post-historic and Existing Conditions:* The South Fork Dam Overflow Sluice Ruins consist of the masonry sluice control foundation ruins and the adjacent wood protective cushion ruins, located in the streambed immediately upriver (east) of the south abutment. In the winter the structure is submerged by ice and water. The cut, dressed, and coursed stones (each block is two feet wide by four feet long by one-and-one-half feet high) of the sluice control foundation ruins form a rectangle. The exposed section is fifteen feet wide by twenty-one feet long with a tiered section that is two-foot-wide by nine feet long by three feet high. A four-foot square section remains consistently submerged. Several six-inch square timbers remain from the eleven feet by fifteen ft wood cushion east of the foundation. Wood and culvert foundation stones near the river and at the bottom and center of the original dam mark the only remains of the original stone arch culvert that housed the sluice discharge pipes (Figure 3.16).<sup>18</sup>

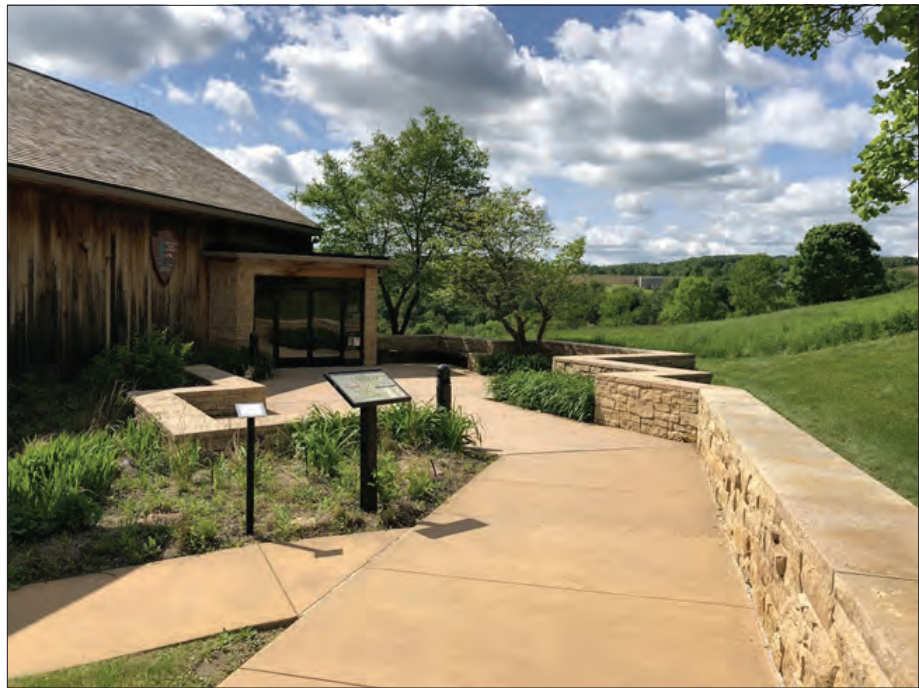
**Figure 3.18.** Shrubs, herbaceous vegetation and retaining walls, at Lake View House and the Visitor Center entrance, 2019. (Olmsted Center for Landscape Preservation).

*Existing Condition:* The visitor center was completed in 1989, the year of the 100th Anniversary of the Johnstown Flood. Designed as a replica of the barn, the two-story building's hillside location provided expansive views to the dam abutments and former lakebed. Today, the building contains a bookstore, museum exhibits, auditorium, restrooms, and utility areas. It features two offset rectangular blocks with asphalt-shingled side-gable roofs, vertical board walls, and a poured concrete foundation. A stone-clad entrance vestibule with a flat roof projects at an angle from the northeast end, where a small concrete patio and native plant garden are partially enclosed by a low stone retaining wall. Doors centered in the southwest wall of the west block provides access from the building's lower level to the farm lane at the rear that leads to the Lake View House and the spring house. Overall, the size, materials, and character of the building evoke the design of the original barn at the site (Figure 3.18).<sup>22</sup>

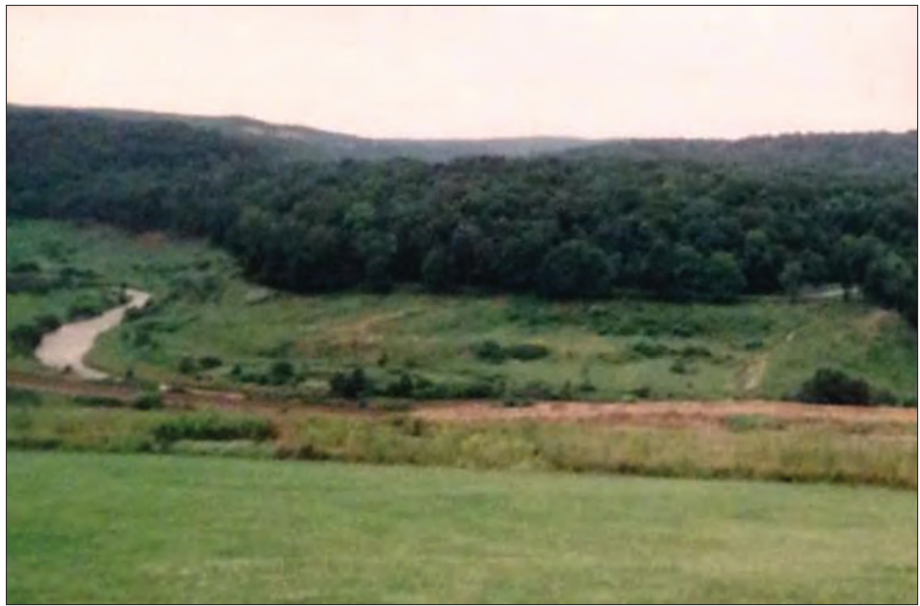
Figure 3.20. View from the Visitor Center, circa 2000, when the lakebed was cleared of woody vegetation. (Doug Bosley, Johnstown Flood National Memorial)

*Historic Condition:* Club president Elias Unger built his farmstead on the lake's northeastern shoreline and sited the house in a hillside field so the Unger family would have a panoramic view of the South Fork Dam, Lake Conemaugh and toward the South Fork Fishing and Hunting Club cottages on the distant shoreline (Figures 3.19 and 3.20).

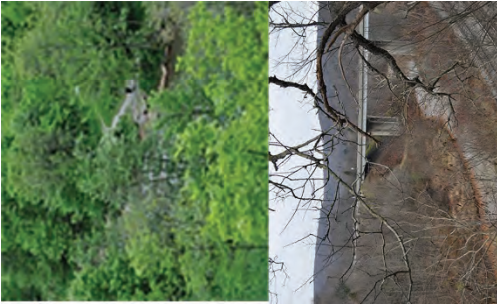
| Feature Name | Other Resource Inventory | FMSS Data<br>(Location / Asset records) | Evaluation Status | Evaluation Narrative<br>Period of Significance (1879 – 1889) | Graphic Reference |
|---|---|---|---|---|---|
| NS-1<br>South Fork Little Conemaugh River and its unnamed tributaries | | N/A | Contributing | <p><b>Historic Condition (1879 - 1889):</b> The natural course of the South Fork Little Conemaugh River was significantly altered by the construction of the South Fork Dam in 1853 and its reconstruction in 1879-81. As originally designed, the South Fork Dam impounded water from the river which was then released into five sluice pipes when the lake rose too high. The 1889 breach in the dam left behind the muddy basin of the former Lake Conemaugh with the South Branch Little Conemaugh River flowing through the bottom of the basin.</p> <p><b>Evaluation:</b> Today, the South Fork Little Conemaugh River flows through the lakebed bisecting the park. The course of the river has been altered since the period of significance by the presence of the railroad berm constructed in the 1890s on the east side of the river. This berm directs drainage from the unnamed tributaries on the east side of the lakebed into culverts positioned along the berm. Though the river's course has been slightly altered since the period of significance and the water quality has been severely impacted by subsurface mine drainage, the river retains its defining characteristics including its location in relation to the dam abutments and the lake basin.</p> | |

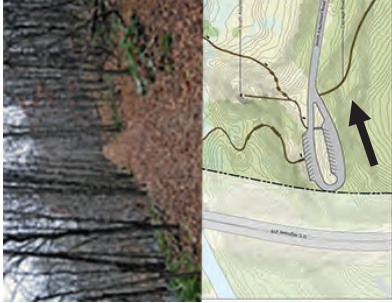
| Feature Name | Other Resource Inventory | FMSS Data<br>(Location / Asset records) | Evaluation Status | Evaluation Narrative<br>Period of Significance (1879 – 1889) | Graphic Reference |
|---|---|---|---|---|---|
| C-1<br>Carriage Road Trace | CLI No. 176750<br>LCS No. 081980<br>(JTCARRRD)<br>ASMIS No.<br>JOFL00001.000,<br>NR contributing structure | Location: 21661<br>Asset: 210171 | Contributing * | <p><b>Historic Condition (1879 – 1889):</b> ca. 1880; altered 1889, 1903–04. Historically the earthen carriage road led from South Fork, past Lake View Farm over the South Fork Dam to the South Fork Fishing and Hunting Club.</p> <p><b>Evaluation:</b> A remnant of the carriage road parallels and is part of the right-of-way for the South Abutment Road. In addition, an earthen trace of the carriage road, approximately 20 ft wide by 3,720 ft long, begins southeast of the park access road. It runs along a portion of the west side of the road as a pedestrian trail that cuts northwest through the woods to the south abutment parking area. The trace continues as a trail on the north side of the parking area across the top of the south dam abutment to an overlook of the breach and former lakebed. A handicap accessible trail follows the carriage road trace across the top of the north abutment to the spillway footbridge, where the unmaintained trace veers to the west through the woods along the downstream (west) side of the abutment.</p> | |

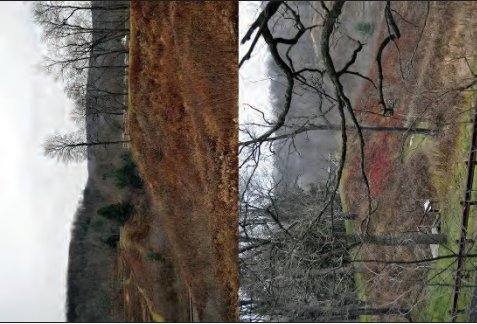
| Feature Name | Other Resource Inventory | FMSS Data<br>(Location / Asset records) | Evaluation Status | Evaluation Narrative<br>Period of Significance (1879 – 1889) | Graphic Reference |
|---|---|---|---|---|---|
| BS-1<br>South Fork Dam<br>Abutments | LCS No. 000747,<br>ASMIS No.<br>JOFL00003.000,<br>NR:<br>Contributing<br>structure | Location:<br>16325<br>Asset: 1690321 | Contributing * | <p><b>Historic Condition (1879 - 1889):</b> Constructed 1838-53; altered 1862, 1880, 1889. Historically the South Fork Dam was 931 feet long, 72 feet high, more than 500 feet wide at the bottom, and approximately ten feet wide at the top, which was wide enough for a wagon to pass. The top of the dam was ten feet higher than the water level of the reservoir. This puddled clay core was supported on both sides by stone and gravel layers. The downstream face of the dam was ripped with heavy loose rocks, while the upstream face was ripped with a layer of smaller stones 2.5 feet thick.</p> <p><b>Evaluation:</b> The earthen South Fork Dam Abutments are built in steep slope revetments with large stone riprap along the lower level to minimize erosion. They are partially overgrown with grasses, brush, and trees. The west or downstream faces are covered with stone riprap pierced through by mid-sized deciduous and coniferous trees. The North Abutment measures 20 feet wide by 390 feet in length by 72 feet in height. The South Abutment measures twenty feet wide by 230 ft in length by 72 feet in height. The gap between the north and south abutments, marking the section of the dam that collapsed on May 31, 1889, is approximately 250 to 300 ft wide. Though now cloaked in vegetation, the dam abutments reveal the magnitude of the size of the former dam and contribute to visitor understanding of the tragedy.</p> | |

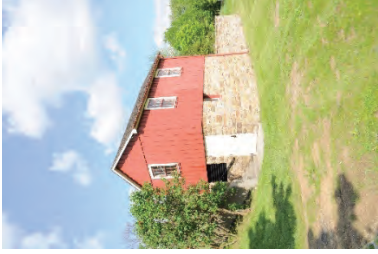
| Feature Name | Other Resource Inventory | FMSS Data<br>(Location / Asset records) | Evaluation Status | Evaluation Narrative<br>Period of Significance (1879 – 1889) | Graphic Reference |
|---|---|---|---|---|---|
| BS-5<br>Unger Spring House<br>Rubblestone<br>Foundation | CLI No. 176782<br>LCS No. 080058<br>(JBSPRING)<br>ASMIS No.<br>JOFL00006.000, | Grounds<br>Location:<br>16312<br>Building<br>Location:<br>16311 | Contributing * | <p><b>Historic Condition (1879 – 1889):</b> Constructed 1883-88; partially rebuilt 1888-89. The Spring House was constructed between 1883 and 1888 on a rubblestone foundation.</p> <p><b>Evaluation:</b> The spring house remains in its original location on its original foundation. Though the upper story of the structure is slightly smaller than the original, the design of the wood frame building is similar. The spring house was partially rebuilt 1888-89 on the original rubblestone foundation. In 1988 the National Park Service removed the deteriorated upper frame portion of the spring house replaced it with one similar in style to the earlier structure but smaller in size. The open west end of the remaining stone foundation was also stabilized. The spring house contributes to the integrity of the property through its integrity of location, materials, and design. Today, the spring house is used for storage.</p> | |

*Post-historic and Existing Conditions:* The spring house remains in its original location on a mostly reconstructed foundation. In 1988 the National Park Service removed the deteriorated upper frame portion of the spring house and replaced it with one similar in style to the earlier structure but smaller in size. At the same time the open west end of the remaining stone foundation was also stabilized. Though the upper story of the structure is slightly smaller than the original, the design of the wood frame building is similar. The spring house is currently used for storage.
