# CULTURAL LANDSCAPE REPORT FOR JOHNSTOWN FLOOD NATIONAL MEMORIAL

NATIONAL PARKS OF WESTERN PENNSYLVANIA

CAMBRIA COUNTY, PENNSYLVANIA

Olmsted Center for Landscape Preservation  
National Park Service, Boston, Massachusetts, 2021

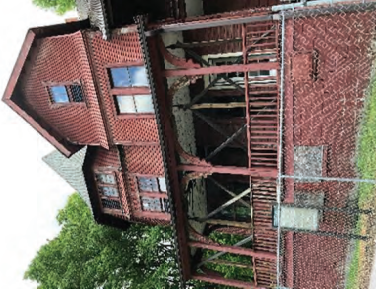
| TABLE 3.1. LANDSCAPE FEATURE INVENTORY:<br>JOHNSTOWN FLOOD NATIONAL MEMORIAL | | | | | |
|---|---|---|---|---|---|
| BS-9<br>Lippincott Cottage<br>(Moorhead Cottage) | CLI No. 176776<br>LCS No. 748636<br>(105) ASMIS No.<br>JOFL00009.000,<br>NR contributing<br>building | Location<br>Grounds:<br>16335<br><br>Location<br>Building:<br>16341 | Contributing* | <p><b>Historic Condition (1879-1889):</b> Constructed 1887; altered ca. 1930. The Lippincott Cottage was constructed possibly in 1887 as a summer residence for the Jesse Lippincott family as a Queen Anne-style building with asymmetric, hipped and gabled roof; a distinctive octagonal tower; and multiple projecting bays and porches. Like all the cottages within the South Fork Fishing and Hunting Club, the building was oriented toward Lake Conemaugh.</p> <p><b>Evaluation:</b> Though in poor condition, the Lippincott Cottage is in its original location and retains many of the defining characteristics including its building fabric, massing, and design and thus contributes to the integrity of the property.</p> | |

*Post-Historic and Existing Conditions:* The Maryland Coal Company acquired the Lippincott Cottage in 1907 for company housing, converting it into a side by side duplex in the 1930s. The company shortened the tower roof and removed a substantial portion of the front porch. The company sold the house in 1955, and when the Preservation Society acquired the property in the late 1980s or early 1990s, the building was vacant. The park stabilized the house in 2005 and officially purchased it the following year. The three-story, Queen Anne style building features an asymmetric, hipped and gabled roof; a distinctive octagonal tower; and multiple projecting bays and porches. The steeply pitched roofs have asphalt shingles and exposed eaves, while the tower has a polygonal roof with flared eaves. The walls are clad in aluminum siding applied irregularly over the original coved wood shiplap siding. Some original wood shingle cladding remains on two sides of the tower at the third-floor level. The foundation is constructed of a series of masonry piers with masonry block or glass block infill. A two-story, end-gabled wing with an enclosed shed-roof porch on the east side extends south from the rear (south) west elevation. A one-story shed-roof porch spans the eastern half of the facade (north) elevation, and a two-story porch continues across the setback northwest portion of the facade. A non-historic set of wood steps leads up to the two-story porch from the road.<sup>21</sup> The Lippincott Cottage is currently vacant and undergoing stabilization.

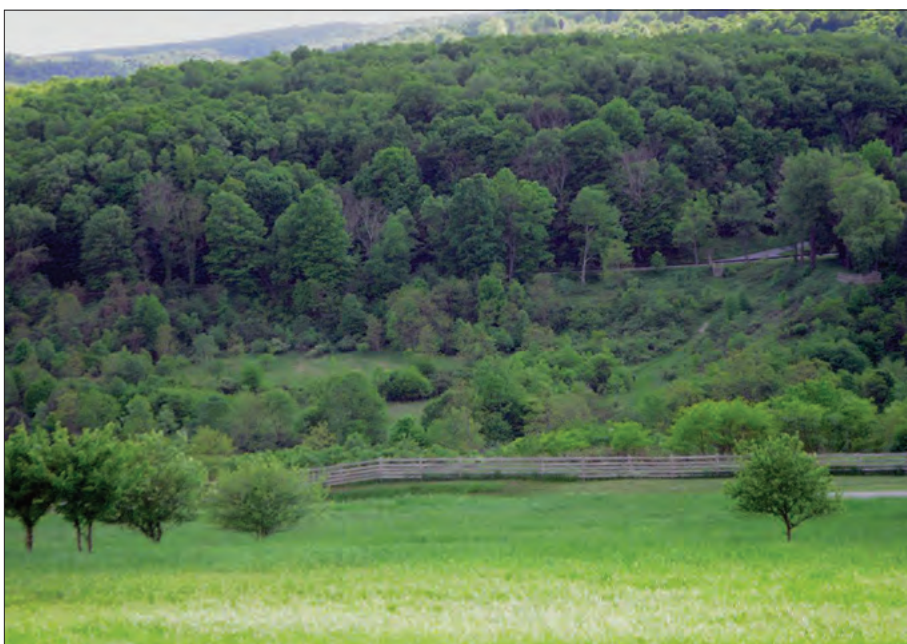
Figure 4.4. A view east from the parking area on Lake Road, toward the lakebed, prior to the clearing woody vegetation, 2019. (Olmsted Center for Landscape Preservation)

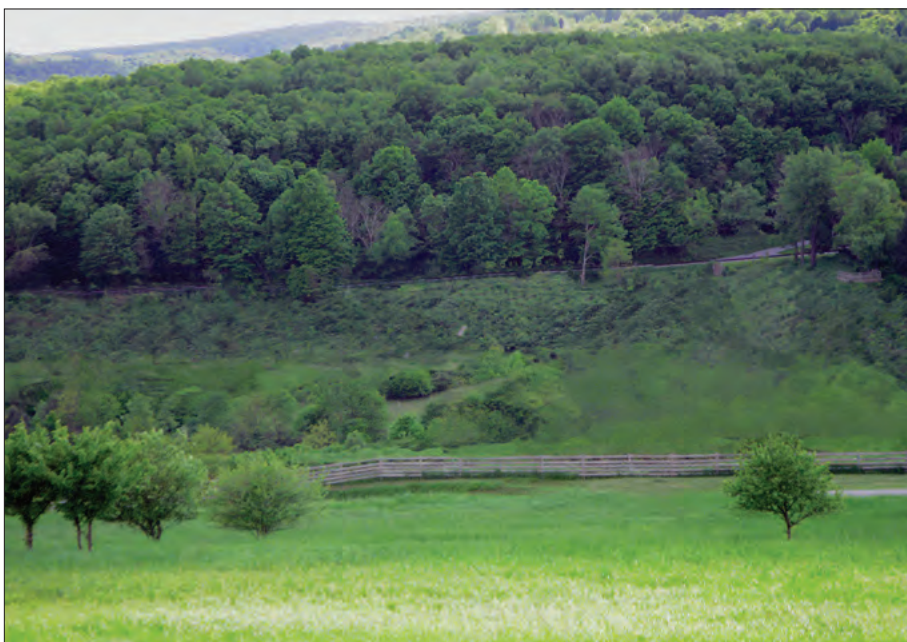
Figure 4.5. A photographic simulation of the cleared lakebed from the same vantage point. Note woody vegetation remains within the river buffer, 2019. (Olmsted Center for Landscape Preservation)

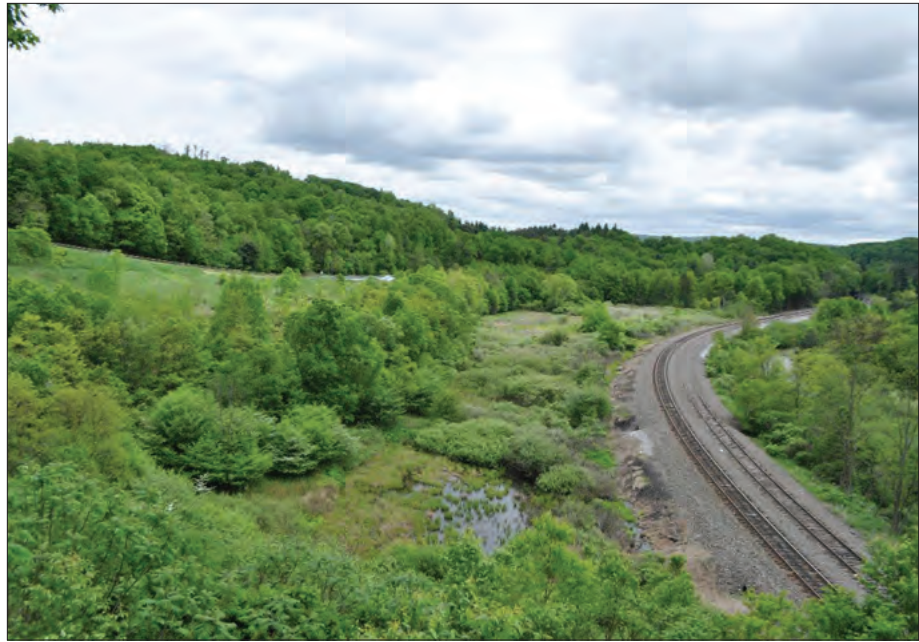
**Figure 4.6.** A view south from the northern abutment including the wetlands along the railline through the lakebed, prior to woody vegetation clearing, 2019. (Olmsted Center for Landscape Preservation).

In “The Basin” Treatment Alternative, all trees and shrubs above ten feet in height are removed to reveal the contours of the former lakebed. The edge of the former lakebed is defined as the 1600-foot contour, or the elevation of the water level in the lake in the moments before the destruction of the South Fork Dam in 1889. Therefore, all vegetation taller than ten feet growing below this contour is removed (Figures 4.6 and 4.7). On the dam abutments and historic sluiceway, all

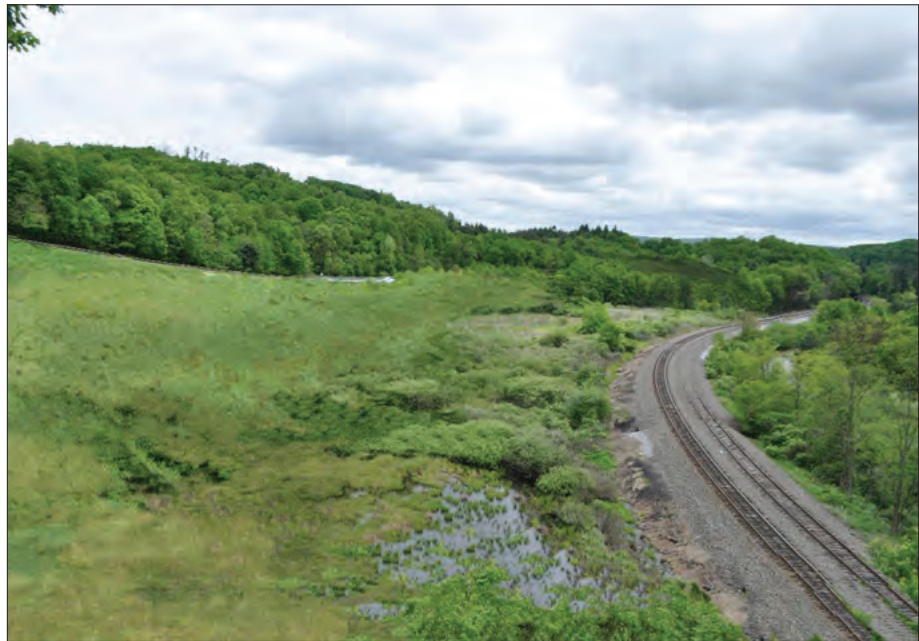
**Figure 4.7.** A photographic simulation illustrating the of same view along the railline south of the north dam abutment, with the woody vegetation removed, 2019. (Olmsted Center for Landscape Preservation)

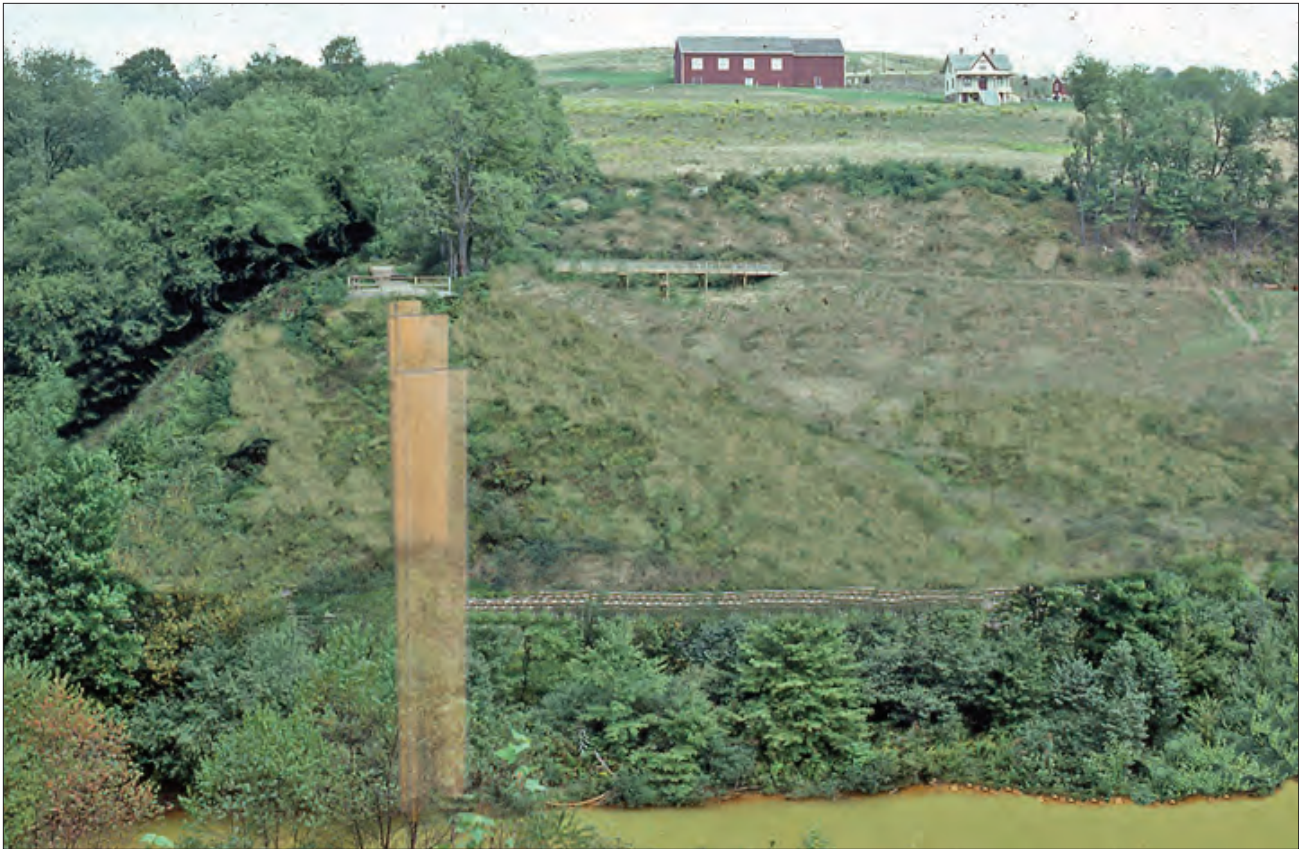
Figure 4.9. A photographic simulation of the shadow dam from the south abutment, 2019. (Olmsted Center for Landscape Preservation)

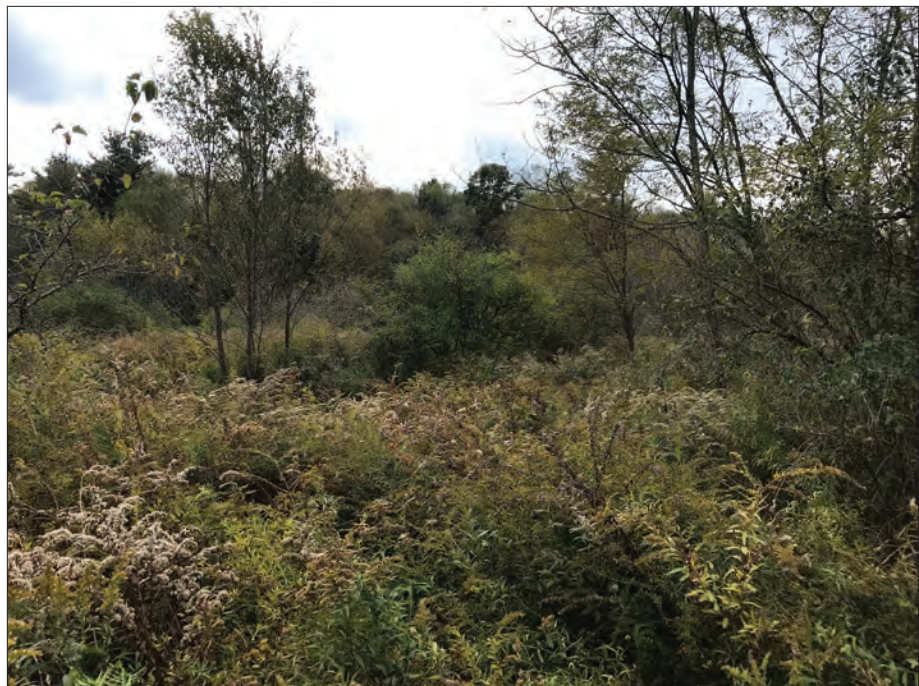
**Figure 4.10.** In the foreground of the image, Existing vegetation near the north abutment, includes typical “Old Field” vegetation, which will be encouraged following the removal of woody vegetation from the lakebed, 2019. (Olmsted Center for Landscape Preservation)

Most of the existing vegetation within the Old Field Restoration Zone is comprised of two vegetative communities. The first is dominated by successional vegetation including red maple and black cherry, with an understory made up of primarily nonnative Morrow’s honeysuckle (*Lonicera morrowii*), multiflora rose (*Rosa multiflora*), and Japanese barberry (*Berberis thunbergii*). The second vegetative community, from which the zone gets its name, is dominated by an herbaceous subtype identified as “Old Field” by the Pennsylvania Natural Heritage Program.<sup>10</sup> The “Old Field” vegetative community currently contains graminoid and herbaceous plants of both native and non-native species. The Old Field vegetative community is also prevalent on the gentle to steeply sloping fields above the former lakebed and surrounding the park’s visitor’s center (Figure 4.10).

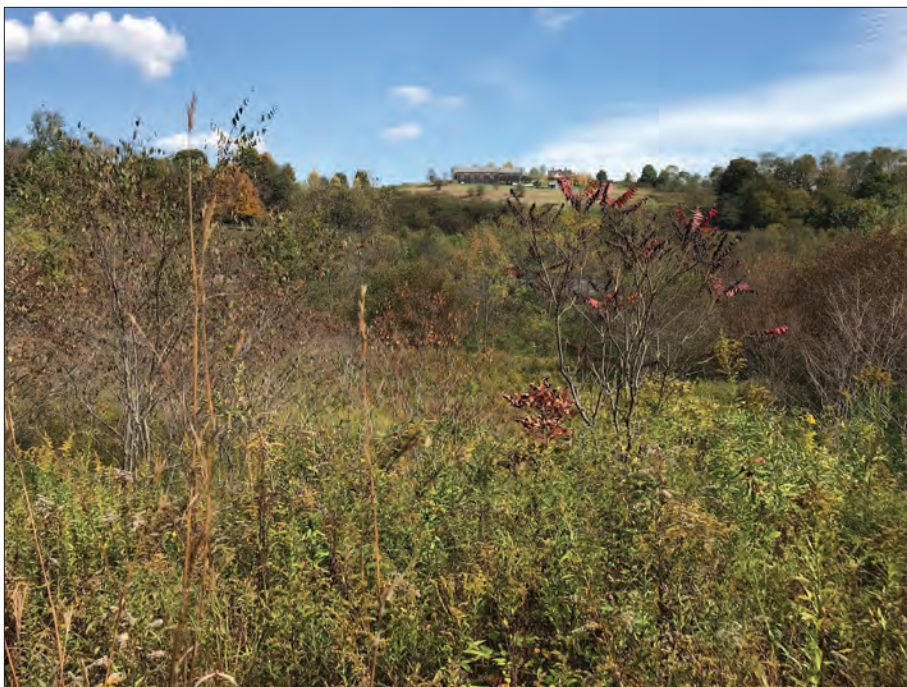
**Figure 5.1.** The view east to the Visitor Center from the bottom of the lakebed prior to clearing woody vegetation, 2020. (Johnstown Flood National Memorial)

Most of the area to be cleared through mastication is characterized by successional growth dominated by red maple and black cherry (Figures 5.1 and 5.2). Where this successional woody vegetation dominates, few grasses or forbs are present. Much of the woody understory is comprised of non-native, invasive shrubs, primarily Morrow's honeysuckle (*Lonicera morrowii*), multiflora rose (*Rosa multiflora*), and Japanese barberry (*Berberis thunbergii*). Therefore, treatment of invasive vegetation and the application of herbicide will be necessary.

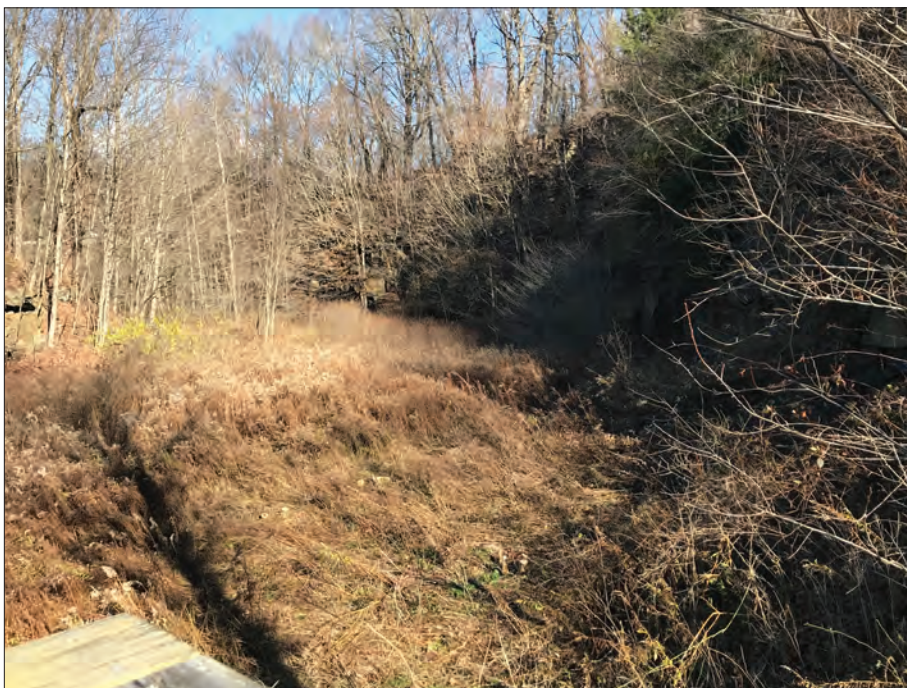
**Figure 5.2.** Looking north up the spillway just prior to clearing, 2020. (Johnstown Flood National Memorial)

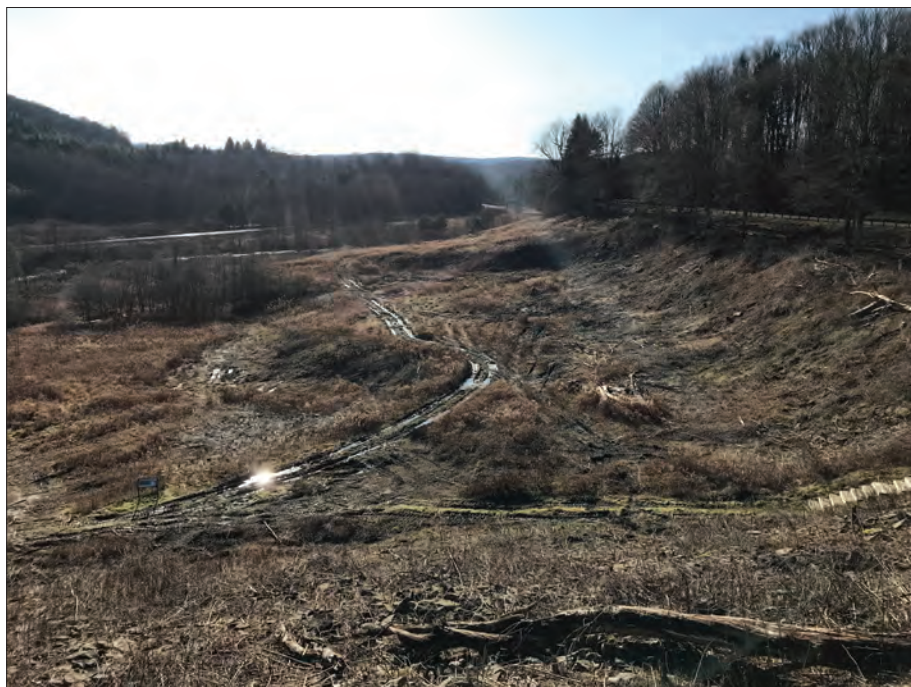
Figure 5.4. Here along the earthen embankment of the south abutment, removals included some large trees, that blocked views and also threatened to damage the historic earthworks, 2020. (Johnstown Flood National Memorial)

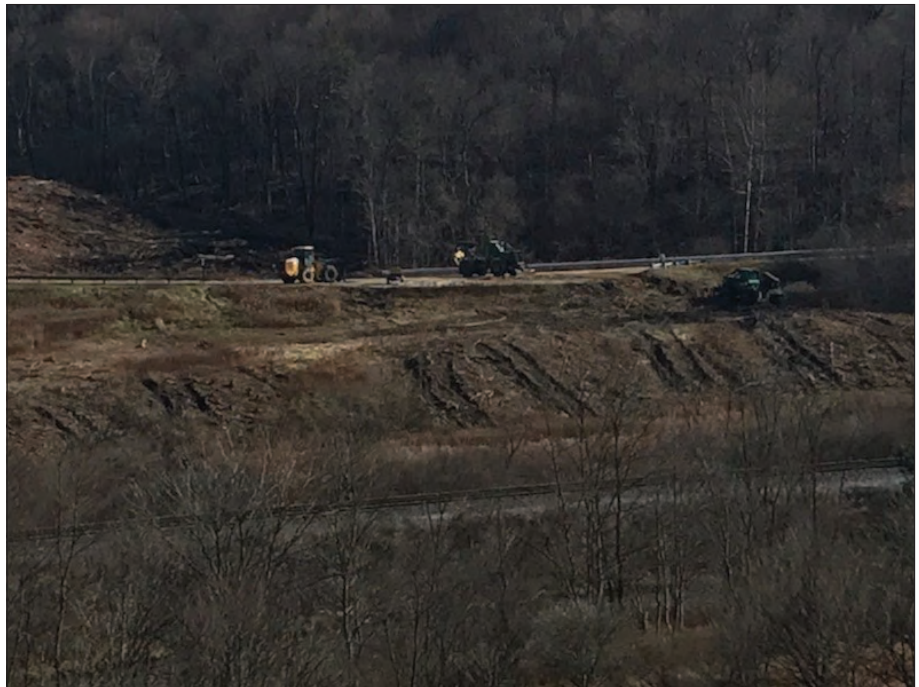
Figure 5.6. The cut trunks of trees lay on the ground in front of the rail line, post mastication, 2020. (Johnstown Flood National Memorial)

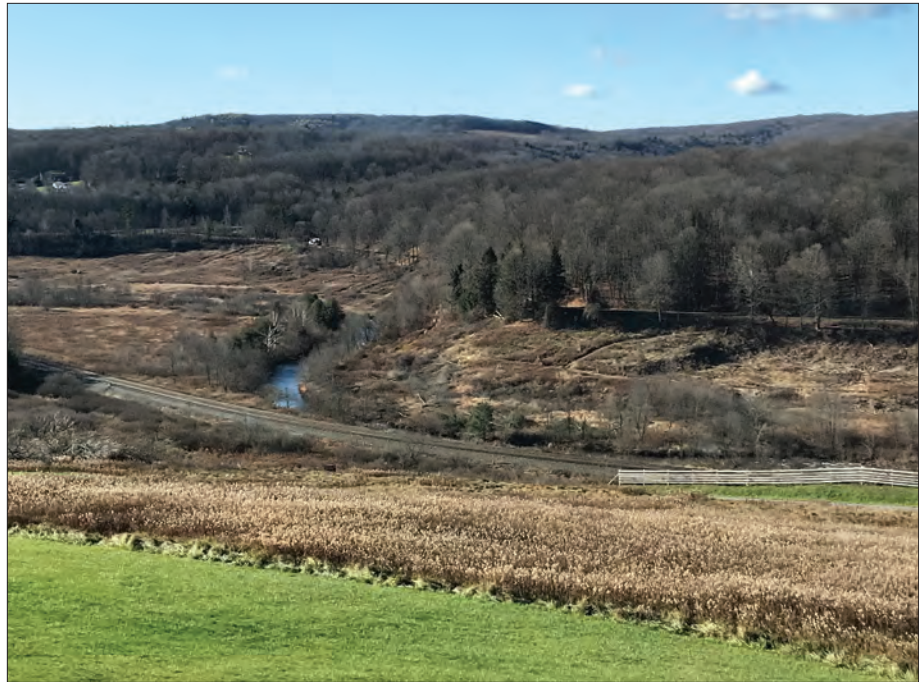
**Figure 5.7. The lakebed from the Visitor Center during the mastication phase, 2020. (Johnstown Flood National Memorial)**

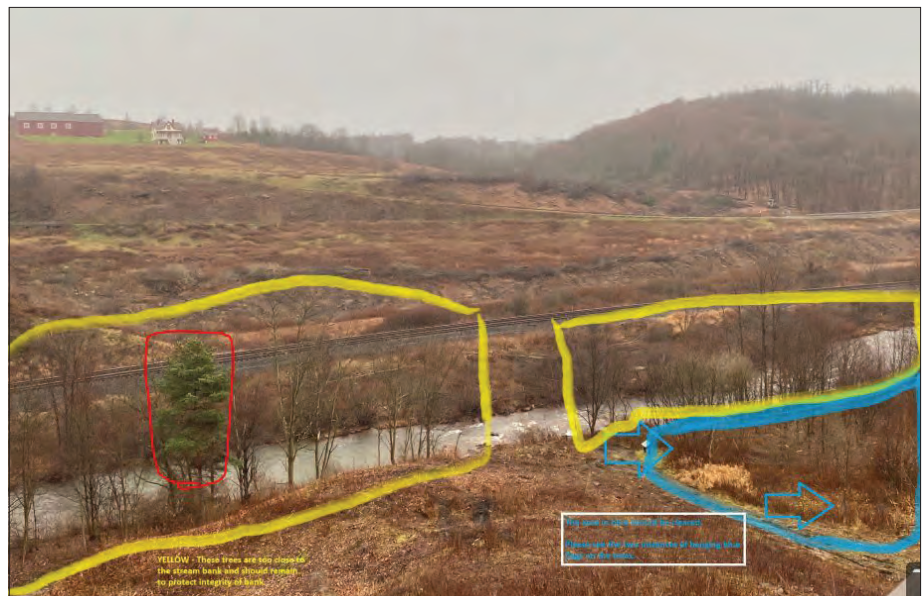
**Figure 5.8. Field notes for the crew undertaking selective clearing, highlighting the trees to be kept in the riparian zone, 2020. (Johnstown Flood National Memorial)**

designated wetlands, would be removed. In consultation with regional specialists, the Olmsted Center for Landscape Preservation further refined the preferred alternative to address concerns about vegetation removal within the riparian buffer and designated wetlands, ensuring that treatment recommendations met the regulatory requirements under Directors Order 77-1 Wetland Protection. Simultaneously, site field work was conducted to refine recommend seed mixes based on existing vegetative composition. In December 2019, once the refined treatment was approved, an Implementation and Maintenance Strategy was developed in coordination with park and regional staff to further define future maintenance required to keep the lakebed cleared of woody vegetation (Figures 5.8 and 5.9).

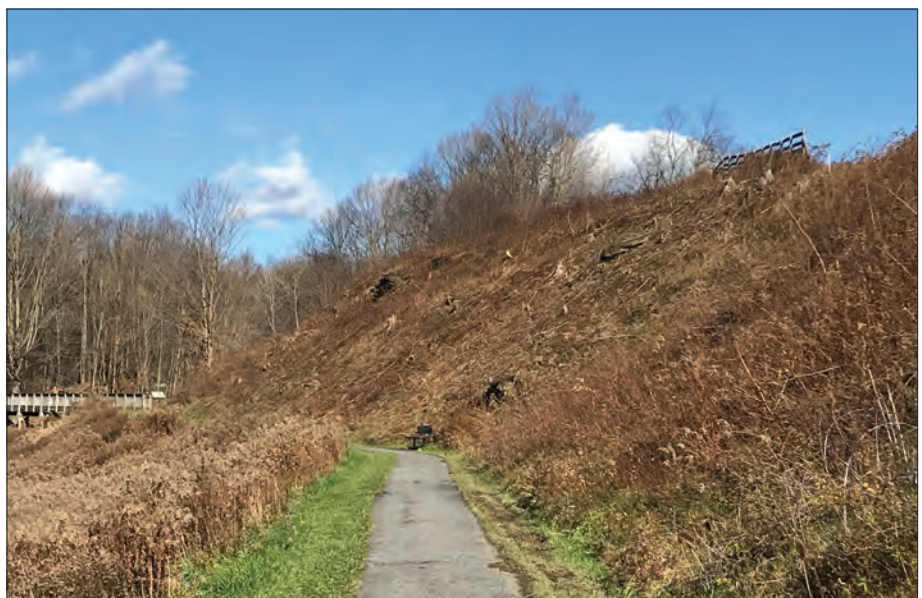
**Figure 5.9. The slope east of the north abutment, selective clearing, post mastication, 2020. (Johnstown Flood National Memorial)**

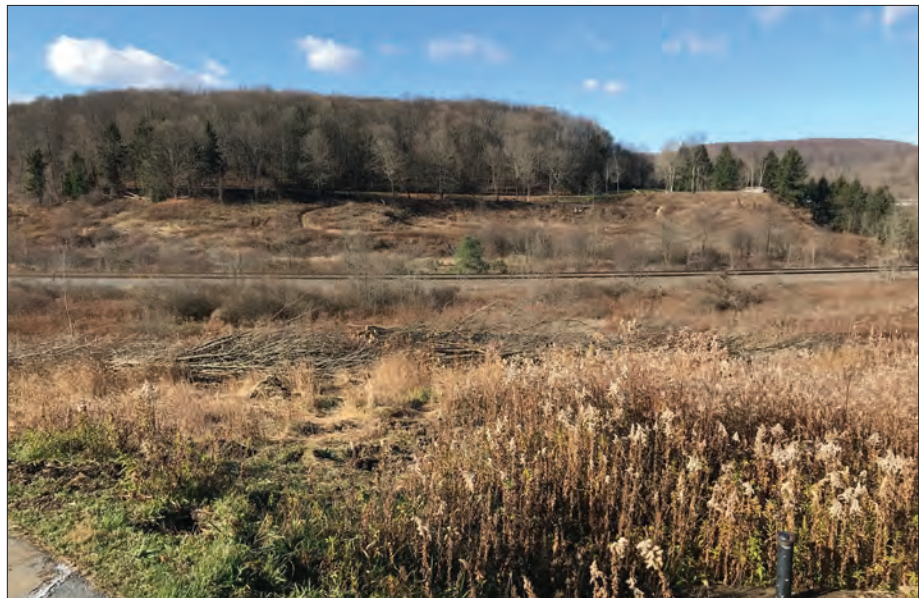
**Figure 5.10.** The lakebed along the accessible walk to the north abutment, Old Field vegetation is in the foreground, and the preserved evergreen trees are visible on the downstream side of the south abutment to provide a screen from the adjacent highway, Selective removals are still in process, 2020. (Johnstown Flood National Memorial)

Concurrently, the National Parks of Western Pennsylvania was planning implementation of the first phase of the “Restoration of the Lakebed” cyclical maintenance project in partnership with the NPS Regional Fire Management team (Figures 5.10 and 5.11). In December 2019, public comments were solicited by the National Parks of Western Pennsylvania in preparation for the initial phase of lakebed clearing. No public comments were received, and project NEPA and NHPA compliance was completed in December 2019. In late January 2020, the Region 1 Fire Management Team, led by Matthew Boss began the first phase of the cyclical project, “Restoration of the Lakebed” using a skid steer masticator on the frozen ground of the lakebed. Mastication was concentrated on an approximately nineteen-acre area, southwest of the South Fork of the Little Conemaugh River. The use of the masticator was limited to this area because steep slopes and wet

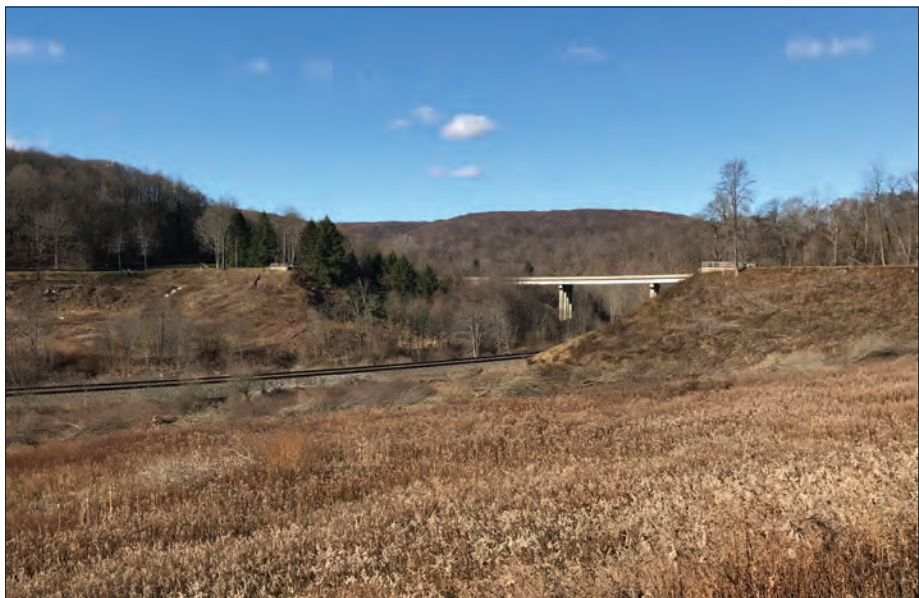
**Figure 5.11.** The north and south dam abutments are visible again, with tree clearing still in process, 2020. (Johnstown Flood National Memorial)

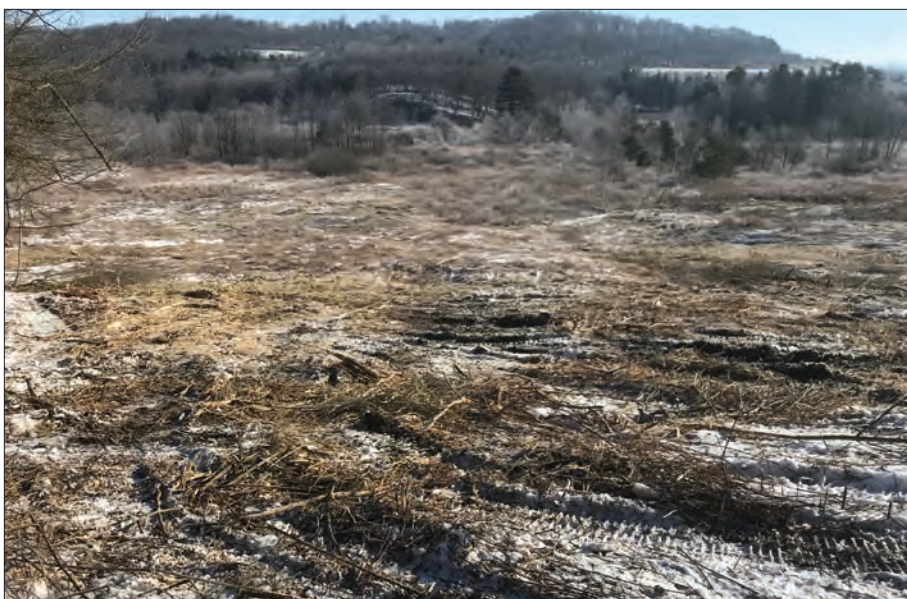
**Figure 5.12. Tire rutting caused from using machinery on soil that is too soft and wet, 2020. (Johnstown Flood National Memorial)**

ground resulted in unacceptable levels of ground rutting (Figure 5.12, Drawing 5.1).

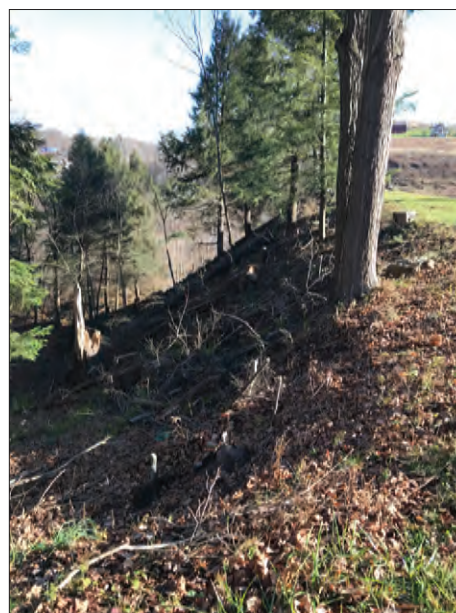
**Figure 5.13. In the selective removals process on the downstream side of the south abutment, some trees were retained to screen noise and visual pollution from the adjacent highway, 2020. (Johnstown Flood National Memorial)**

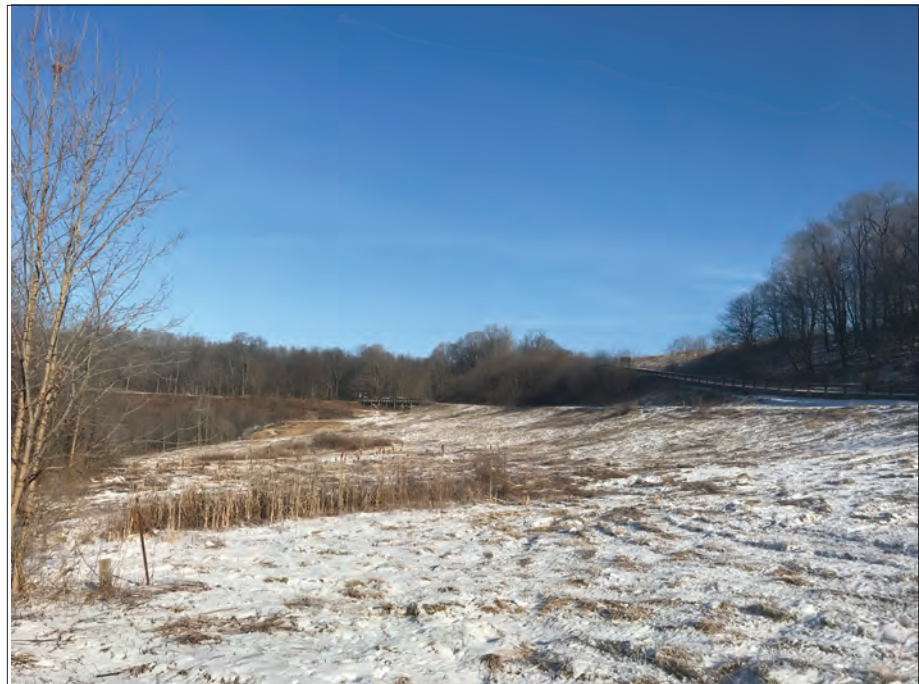
**Figure 5.14.** The cleared lakebed looking north toward the pedestrian bridge over the spillway, 2020. (Johnstown Flood National Memorial)

In April 2020, a contract was solicited to remove the remaining trees from the lakebed and was awarded in June to Russell Tree Experts for a start date in November. From November 10<sup>th</sup> to 25<sup>th</sup> 2020, Russell Tree Experts began working under the tree removal contract. Equipment used was determined by the lakebed terrain and included forestry clearing machines, masticators and hydraulic shearers, chainsaws, flail mowers, chippers, and feller bunchers (Figure 5.13). Finding the ground too soft and saturated to prevent compaction and wheel rutting, work was halted in late November. The contractor returned on January 26, 2021 and the contract to remove the woody vegetation was substantially complete as of February 1, 2021 (Figure 5.14).

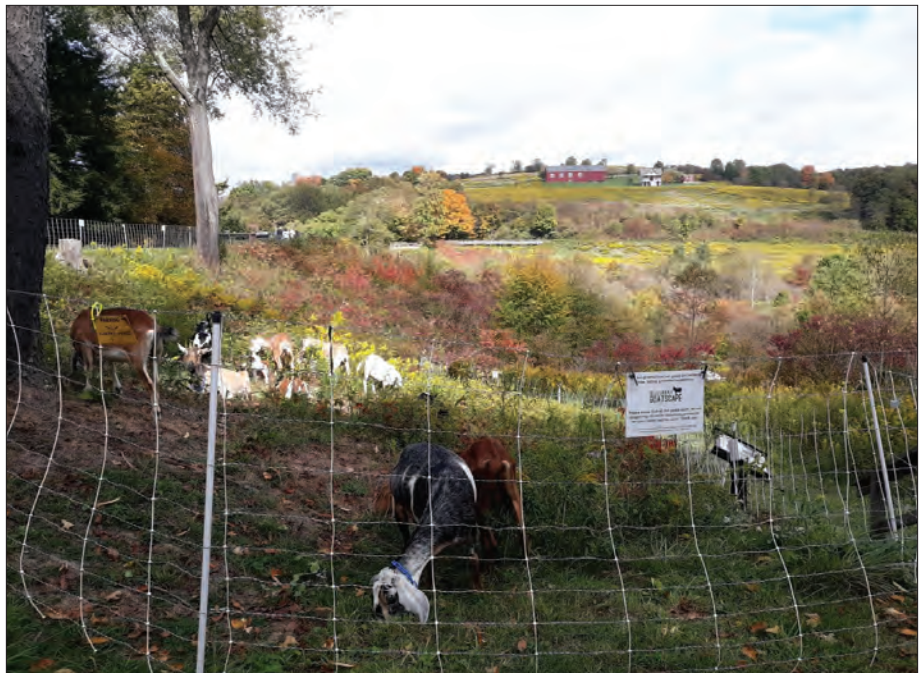
**Figure 6.1.** Goats on the slope of the southern dam abutment require fencing, water and temporary shelter, but they do an adequate job of removing woody vegetation on steep slopes. Goats, in addition to mowing of flatter areas, and future selective clearing efforts will help to maintain the meadows of the Johnstown Flood National Memorial, 2020. (Johnstown Flood National Memorial)

Preservation maintenance of the cleared lakebed requires the integration of many strategies. Annual mowing of the lakebed will be an effective way to manage many undesirable plants, including invasive herbaceous vegetation and young trees. However, because the lakebed includes areas of steep slopes over twenty-five degrees, rocky outcroppings, and uneven ground conditions, alternatives to mowing and additional tools will be needed. These tools and methods include chemical applications, seeding of tree cleared areas, prescribed fire, the monitoring of invasive vegetation, and even the use of goats on steep slopes of the Engineered Earthworks and Dam Abutment Zone. Goats, usually contracted out through a service provider, need park support and infrastructure to succeed, including fencing, water, and temporary shelter (Figure 6.1).
