National Park Service
Cultural Landscapes Inventory

Jumbo Rocks Campground
Joshua Tree National Park

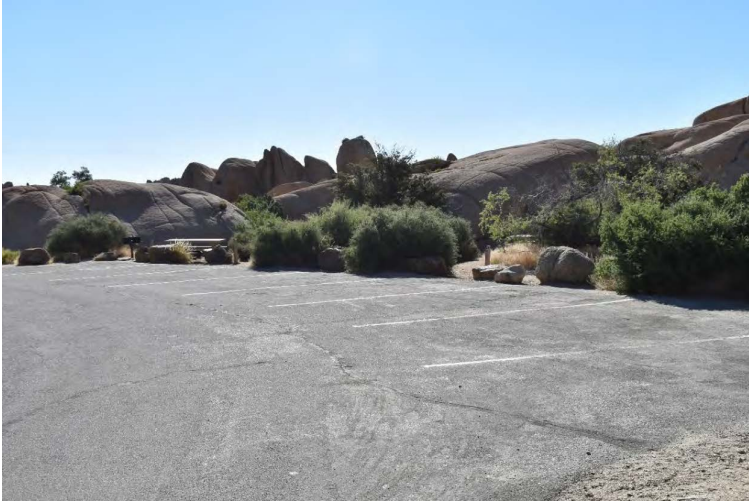
Boulder-lined parking area for Campsite Nos. 4–9, facing east (North Wind 2020).

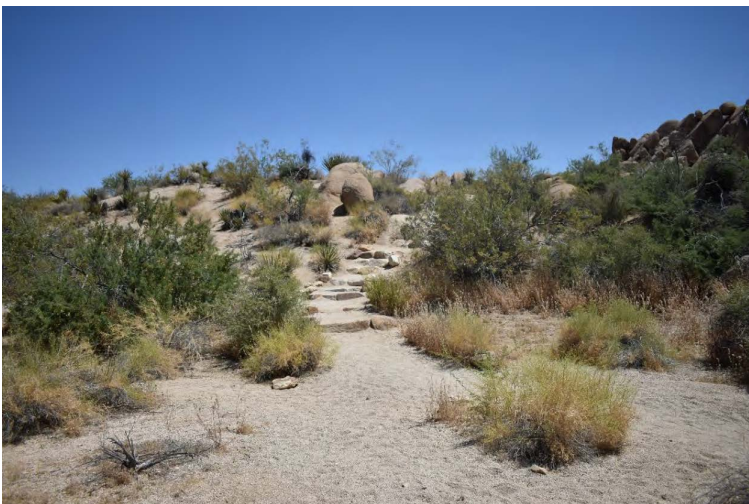
The 1.7-mile-long Skull Rock Nature Trail as it leaves the Jumbo Rocks Campground, facing northeast (North Wind 2020).

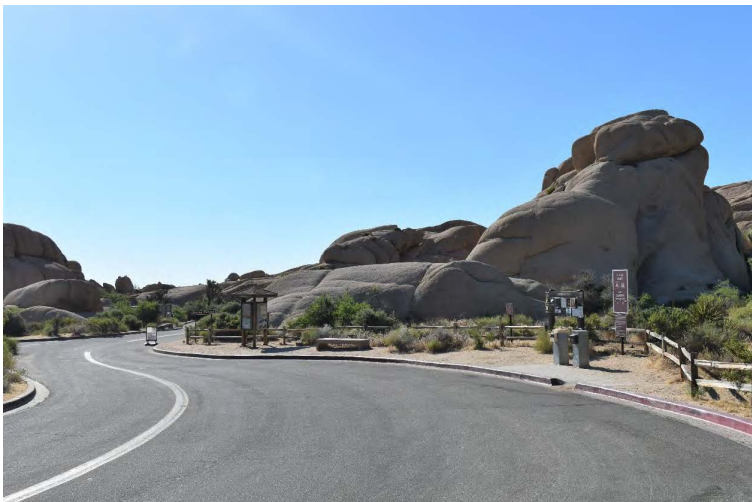
Informational kiosk and nearby information board and pay station at Jumbo Rocks Campground, facing southeast (North Wind 2020).

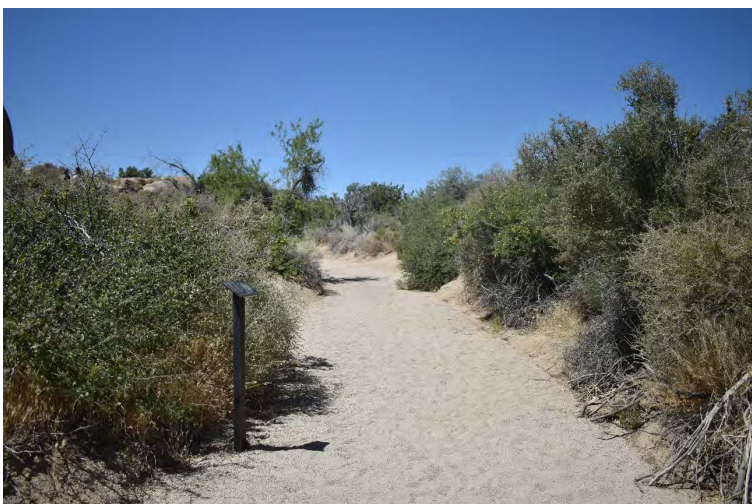
Pedestal sign along the Skull Rock Nature Trail, facing southwest (North Wind 2020).

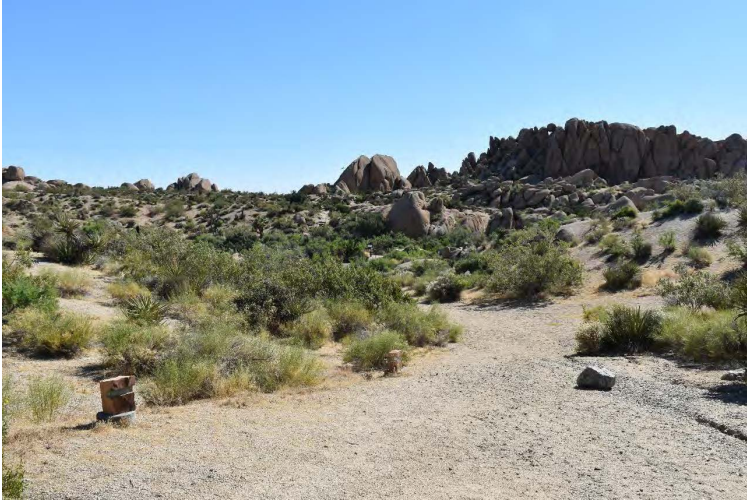
Dirt footpath leading to the amphitheater, facing northeast (North Wind 2020). Note the landscape lighting along the left edge of the footpath.

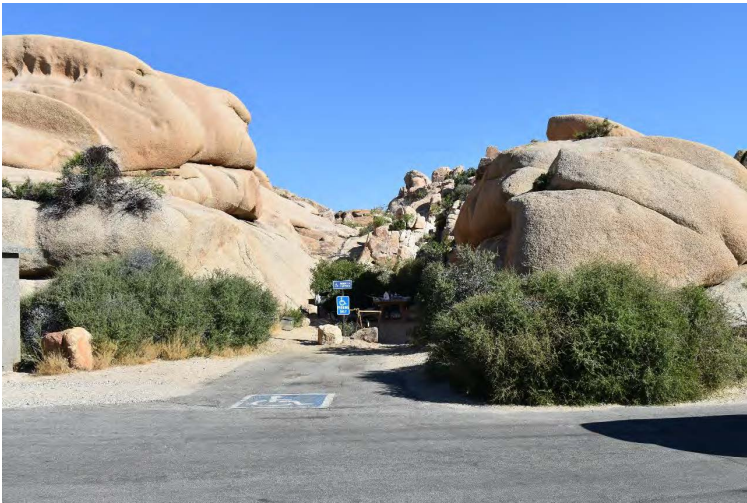
Overview of Campsite No. 122, the only wheelchair accessible site at Jumbo Rocks Campground, facing north (North Wind 2020).

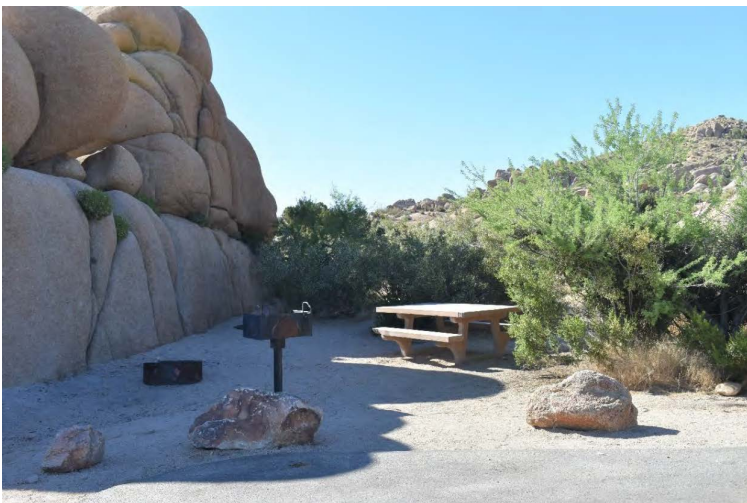
Campsite No. 60, showing large boulders present where the campsite borders the road, facing east (North Wind 2020).

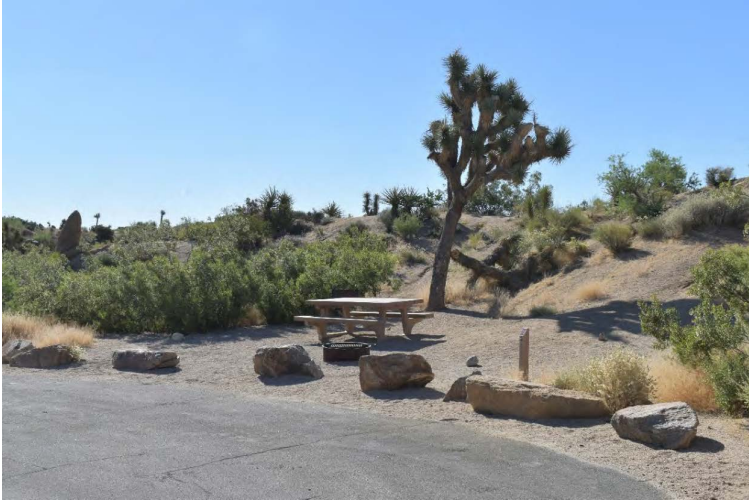
Campsite No. 71, showing boulders along the edge of the road and the wooden post on which the campsite number is displayed, facing east (North Wind 2020).

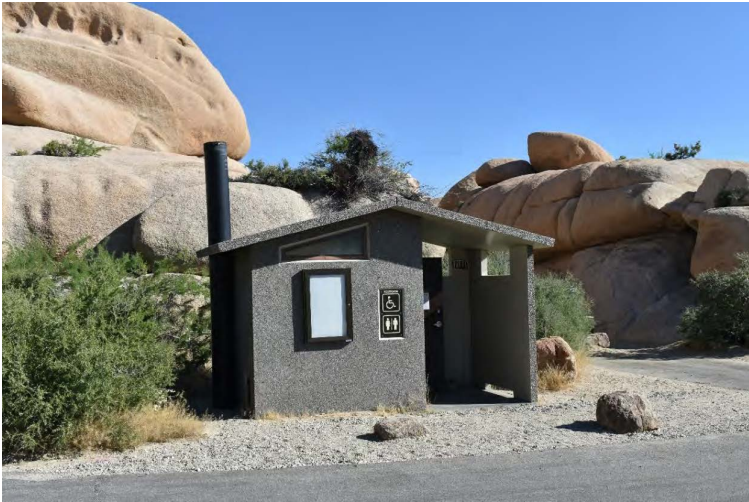
All of the vault toilets consist of precast concrete buildings with pebble-dashed exteriors, reinforced concrete foundations, and side-gabled roofs. The roof extends over the entrance, creating a covered porch on one half of the building (see Photograph 5). The roofs of the buildings are also precast concrete and have a single vent pipe at the end opposite the porch. At least one of the toilets (JR10) has a bulletin board in a locked case for rangers to post announcements for campers (Photograph 7). Records on file with the NPS confirm that all of the vault toilets were constructed in 2004.

JR10, a single vault toilet at Jumbo Rocks Campground, facing north. Note the bulletin board in a locked case on the building's front (south) façade (North Wind 2020).

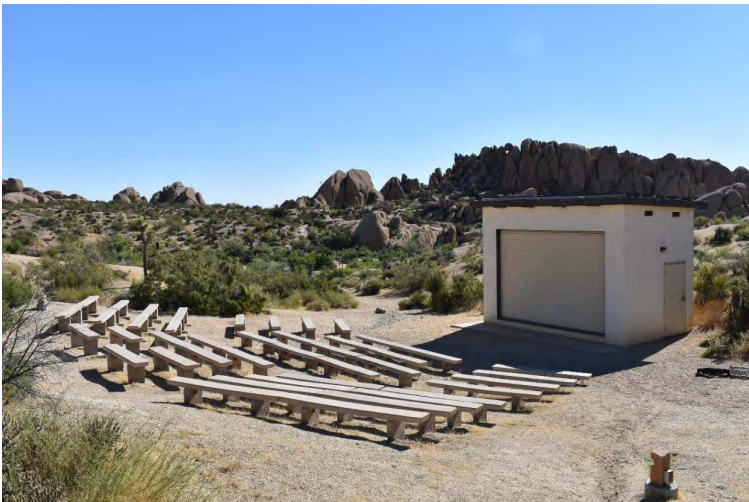
Jumbo Rocks Campground amphitheater, facing north (North Wind 2020).
