# DESIGN GUIDELINES

## SKAGWAY HISTORIC DISTRICT

KLONDIKE GOLD RUSH NATIONAL HISTORICAL PARK  
 SKAGWAY, ALASKA

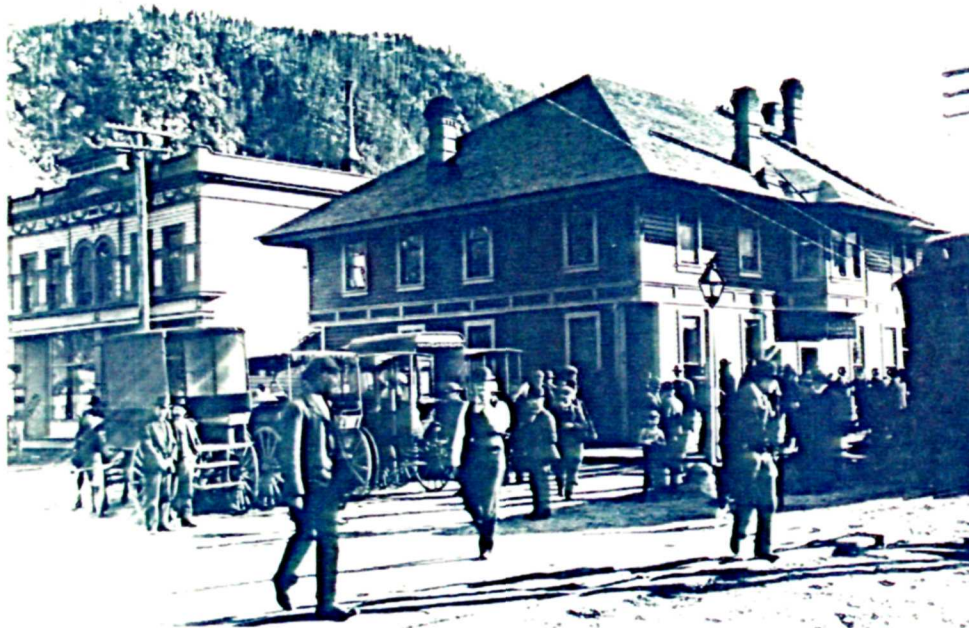
White Pass and Yukon Railroad Depot and  
Administration Buildings, 1901

The National Park Service, through its restoration and interpretive program in Skagway, has undertaken paint research to determine historic colors. The following comparative photographs portray historically-correct color schemes vs. that same scheme as shown in historic photographs on N.P.S.-owned buildings. These as well as the non-N.P.S. buildings shown point up this principle of the muted effect given from historic photographs as opposed to the true color identity of a streetscape.

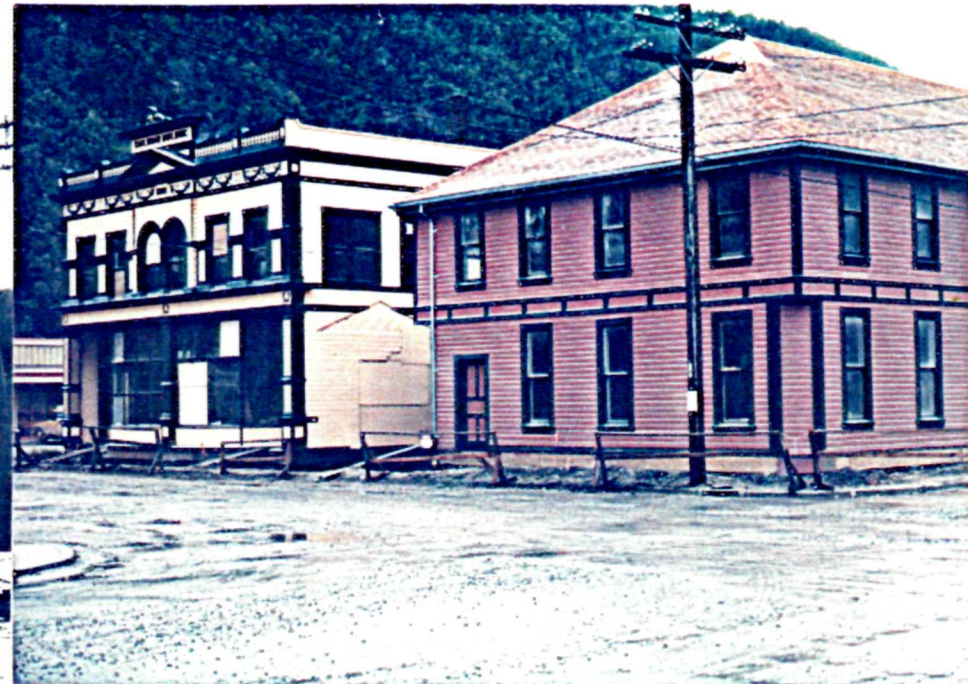
Park Accession No.  
RR 105/1,236

Klondike Gold Rush N.H.P. Visitor Center and  
Administration Buildings, 1981

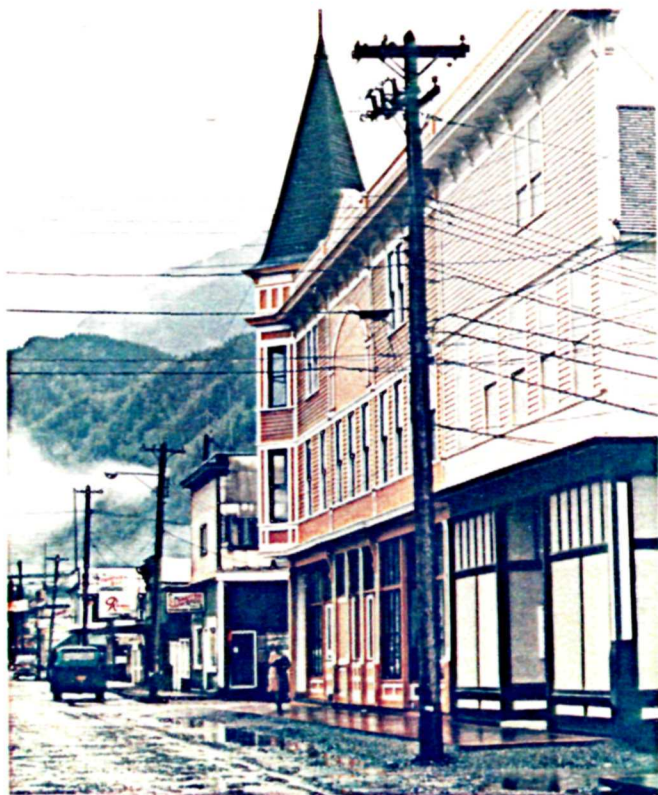
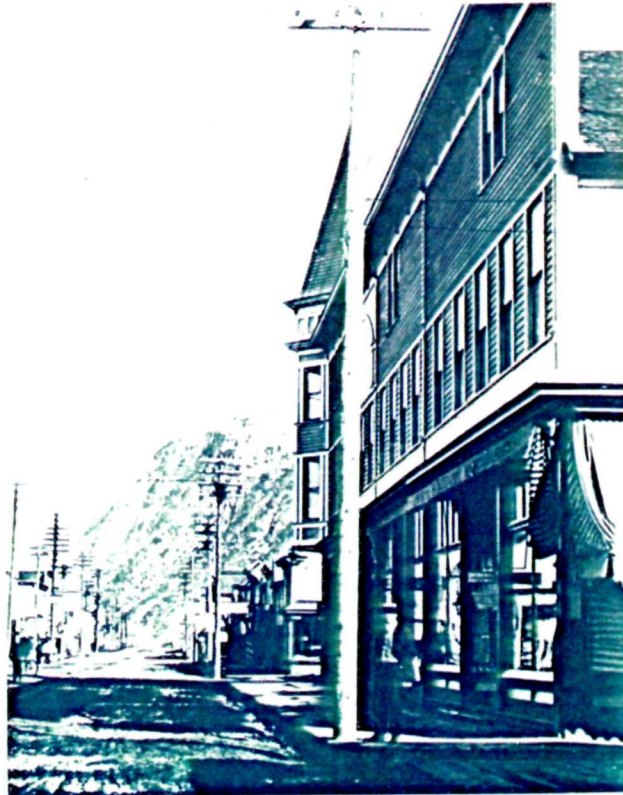
Park Accession No.  
B1 89/1181

PACK TRAIN/LYNCH & KENNEDY  
BLOCK

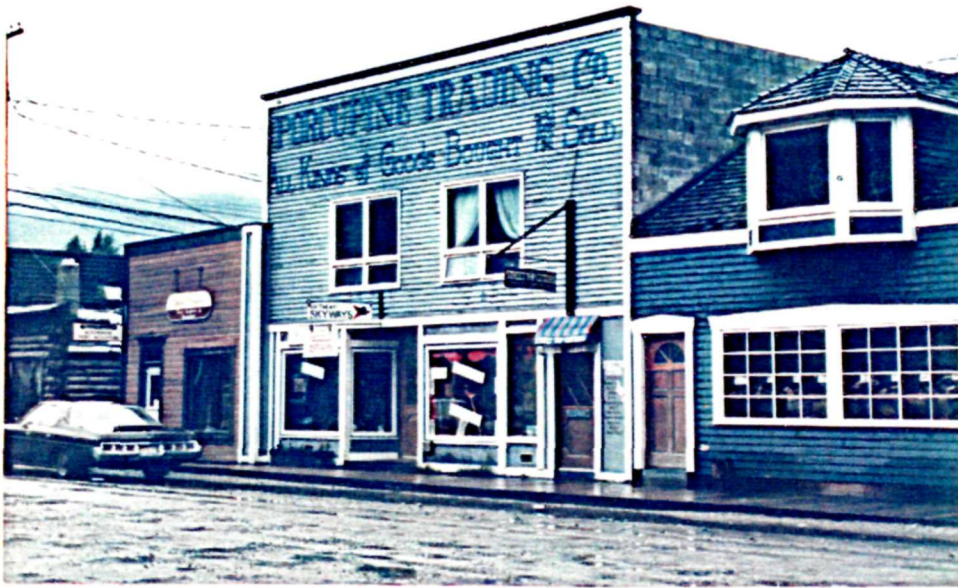
### Porcupine Trading Post

The Porcupine Trading Post sensitively fills in a previous void along the Broadway historic corridor. Although a contemporary building constructed of concrete block, the wood facade and building scale maintain the character of the streetscape. Horizontal siding, dominant ground floor windows and the recessed entryway are all typical of historic Skagway buildings. A Victorian color scheme and the painted signage are the finishing touches to a highly successful building. Only the doors on this building are considered out of character.

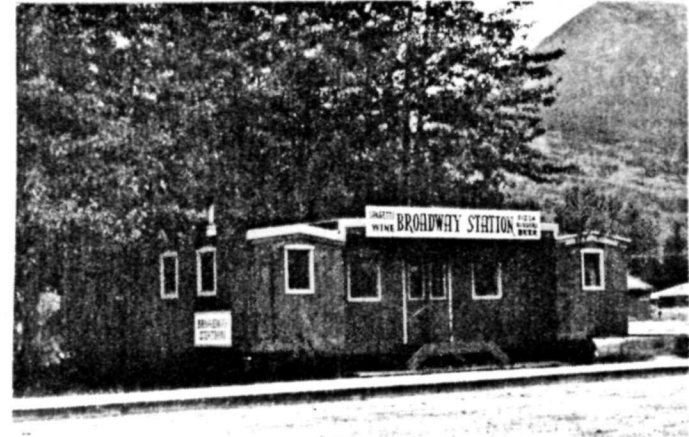
### Broadway Station

This building uses Skagway's historical association with the railroad as its design basis, a basis void of any historical precedent. In scale, color and overall "spirit," it lacks any sensitive association with the district's historic setting. Like the buildings below, this building could be acceptable elsewhere in a less obvious siting but not on the main corridor of the historic district.

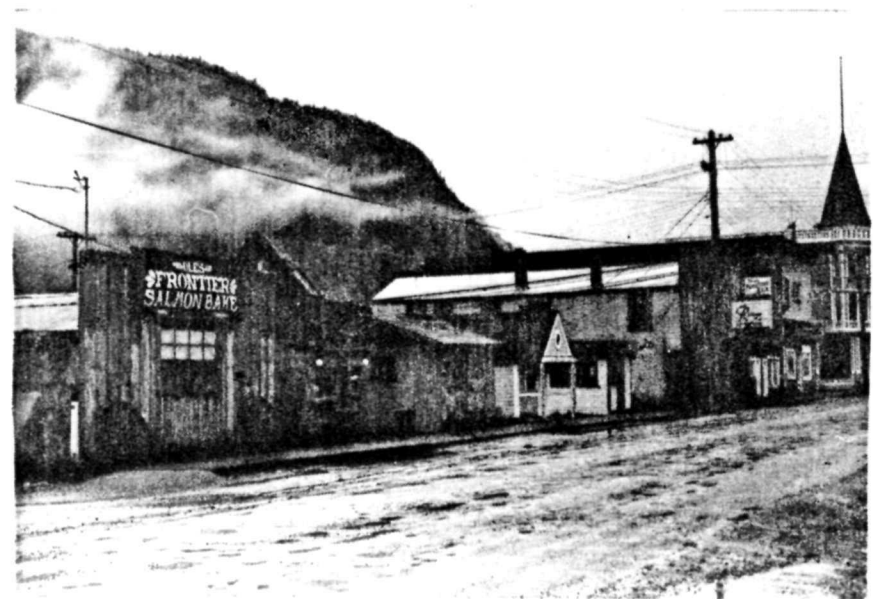
### Broadway and 5th Avenue

These buildings point out one of the difficulties of design without guidelines. These buildings meet most of the design criteria except for rhythm, but it's this major break in the streetscape rhythm, the alternate spacing and the decrease in scale, which makes this block totally out of character with the Broadway streetscape. These buildings could be more successful if sited individually or on another street where the historic scale is not so prevalent.

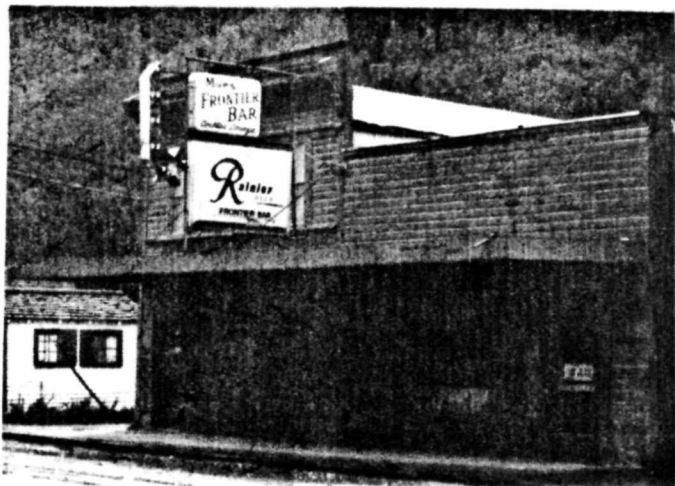
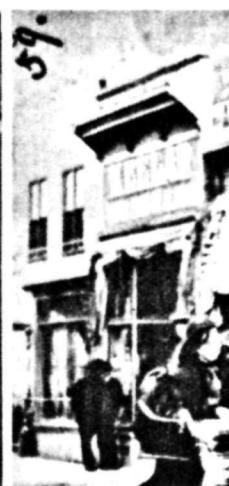
1981 ca. 1905  
Park Accession No.  
B4 21/12

These two highly significant structures have had their ground floor facades altered by changes in the ground floor window configurations. The turn-of-the-century pedestrian orientation to large open window spaces has been lost but not irretrievably. Historic photographs can be used to guide restoration of the ground floor level, a task probably easier than assumed. By removing the present covering, much of the original configuration and character may be revealed.

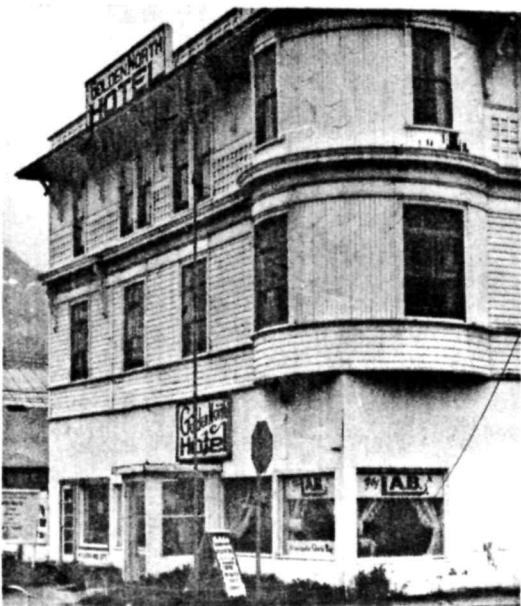
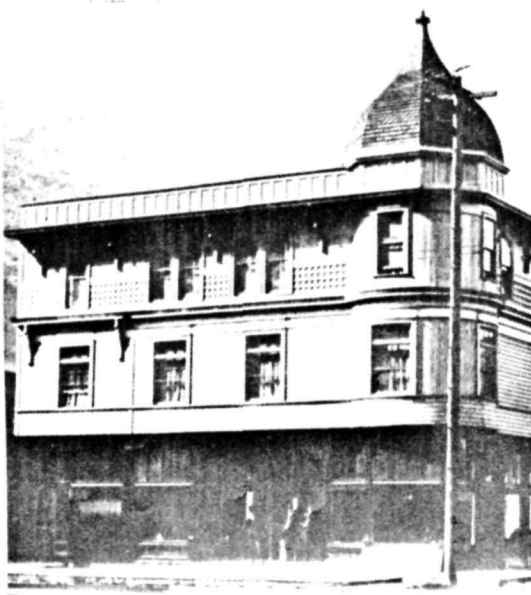
### Loss of Historic Storefronts

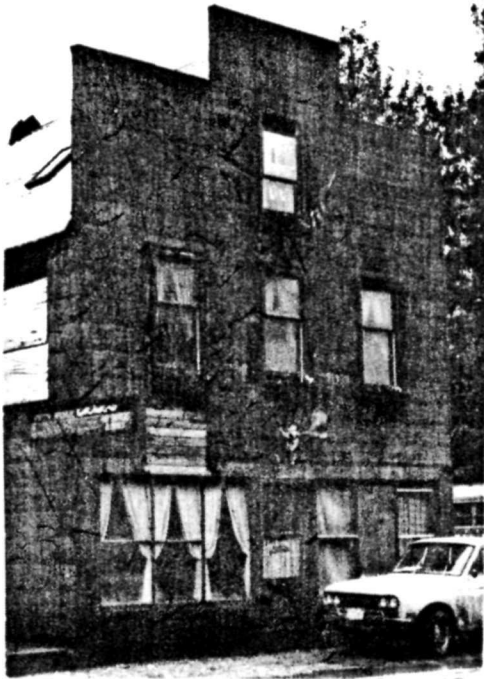
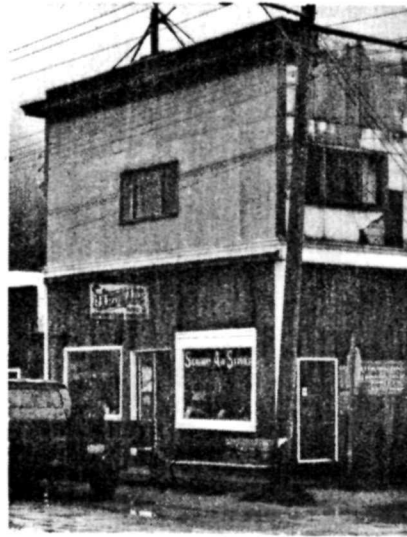
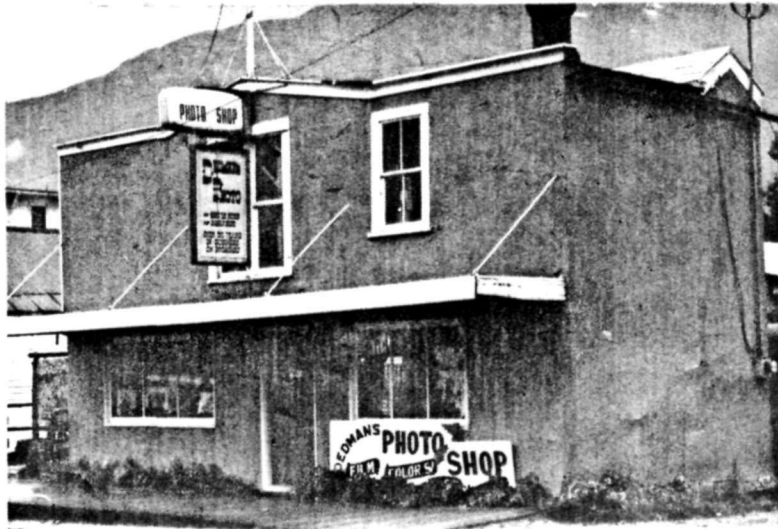
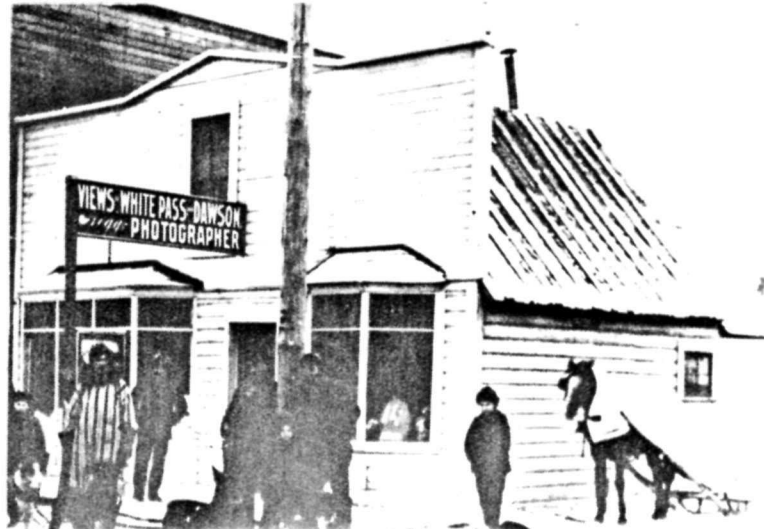
### Changes to Building Surface Texture

Stucco, asphalt shingles and asbestos siding are all in sharp contrast to the surface covering of early Skagway buildings. Fortunately, in many situations, these are merely surface applications; the original horizontal siding lies intact underneath. The asphalt shingles on the Seattle Hotel (5th Avenue Bunkhouse) could be easily removed as could the asphalt siding on Skagway Hardware's facade. The nationally significant Hegg Photograph Studio (Dedman's Photo Shop) would take more effort to remove the layer of stucco.

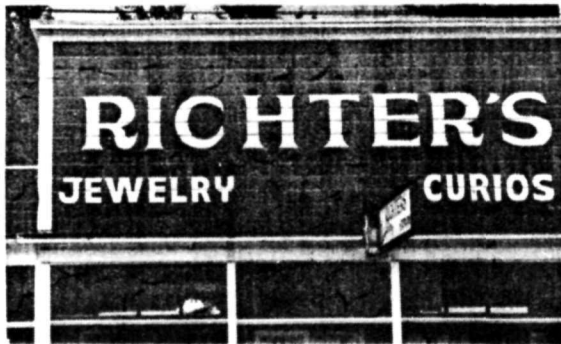
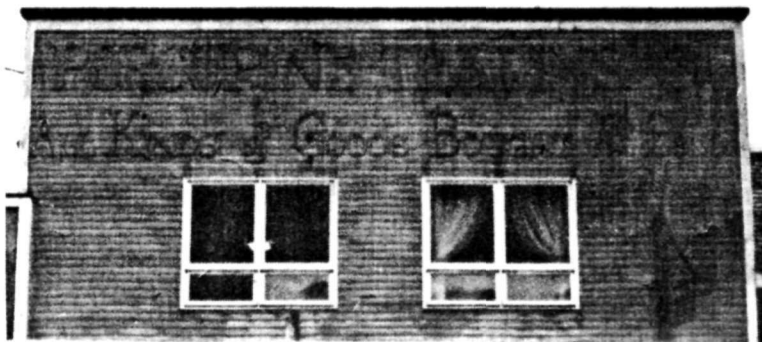
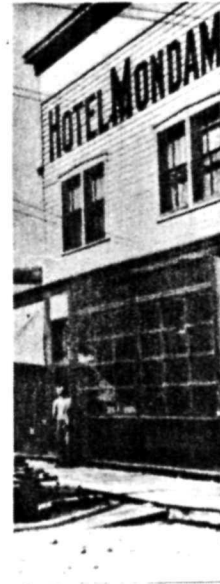
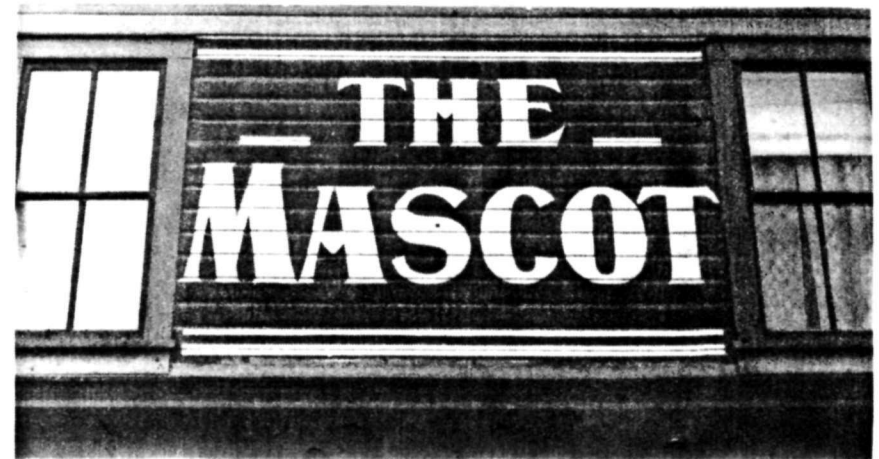
### Signs Painted Directly on Siding

Signs painted across the upper facade were oriented to pedestrians across the street and thus were larger in scale than those found elsewhere. Due to their large size, they were always simple and bold. Quite often these signs served as advertisements in addition to stating the enterprise name. They were normally located between the windows and cornice but were often located between the upper floor windows. Lettering in these signs ranged from 15 to 20 inches in height.

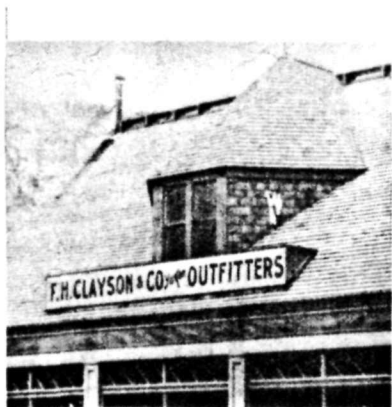
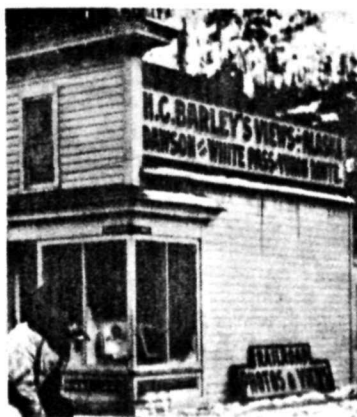
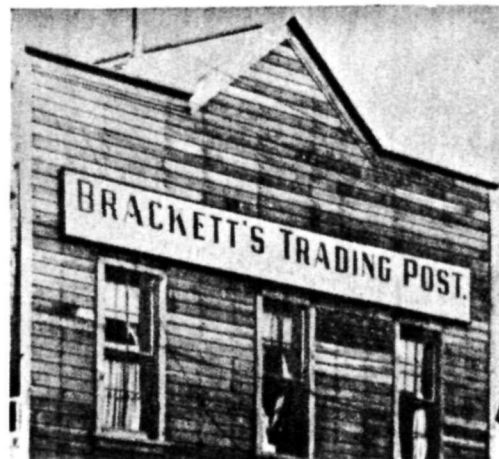
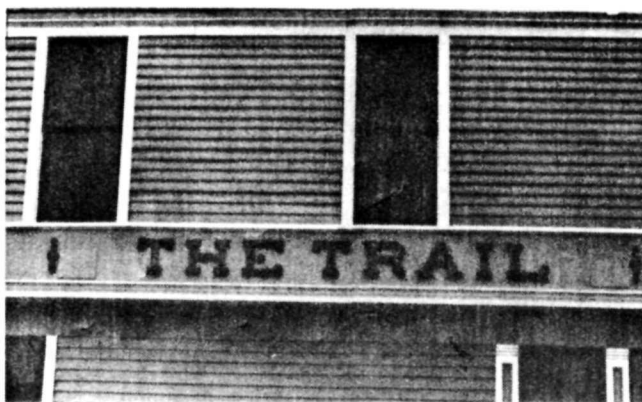
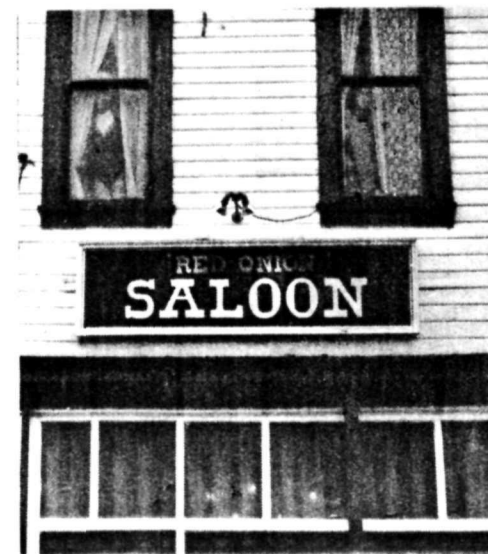
## Signs Hung Across the Facade

Of similar size and function to the above, these signs were normally painted on panels and hung on the facade. On corner buildings, these signs were often mounted on the roof to be seen from down the street. Other signs consisted of cutting out and mounting individual letters. To accentuate the sign, the background color on these signs was often a color different from, but in harmony with, the colors of the building.

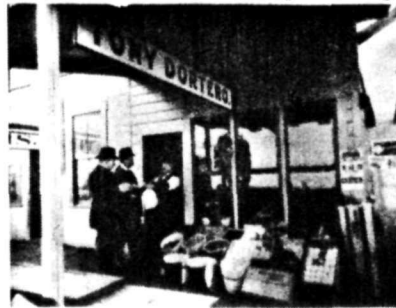
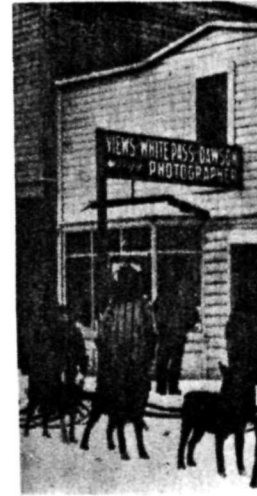
### Signs Suspended Across Boardwalk

A third major type of sign was that mounted perpendicular to the building facade and hanging across the boardwalk. As these signs were oriented to the pedestrian walking along the boardwalk, they were smaller in scale than the previous examples. Lettering in these signs ranged from 5 to 10 inches and retained a bold, simple message. The outside post for these signs often supported a balcony or projection above. This type of sign generally fell into disfavor with the advent of the automobile and curb parking.

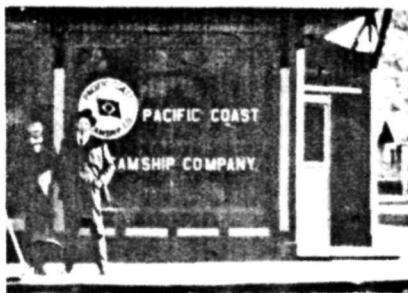
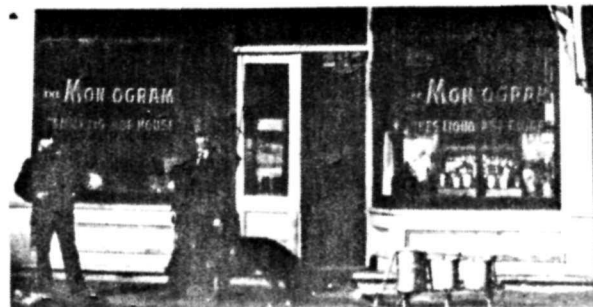
### Window Signs

A final category of sign types were those painted directly on windows. As these were the most intimate, they had the smallest lettering of the major sign types, often as small as several inches and up to 10 inches. These signs were not as prevalent as the other types because at this level of pedestrian orientation, window displays were the primary form of advertisement. Window lettering was occasionally more ornate than on the larger signs, but generally maintained the simple, upper case lettering found on all sign types.
