MCDERMOTT CABIN  
Klondike Gold Rush National Historical Park  
Dyea (historical town site)  
Skagway-Hoonah-Angoon Census Area  
Alaska

WRITTEN HISTORICAL AND DESCRIPTIVE DATA

### PATTERSON-MCDERMOTT CABIN (McDermott Cabin)

HABS No. AK-225

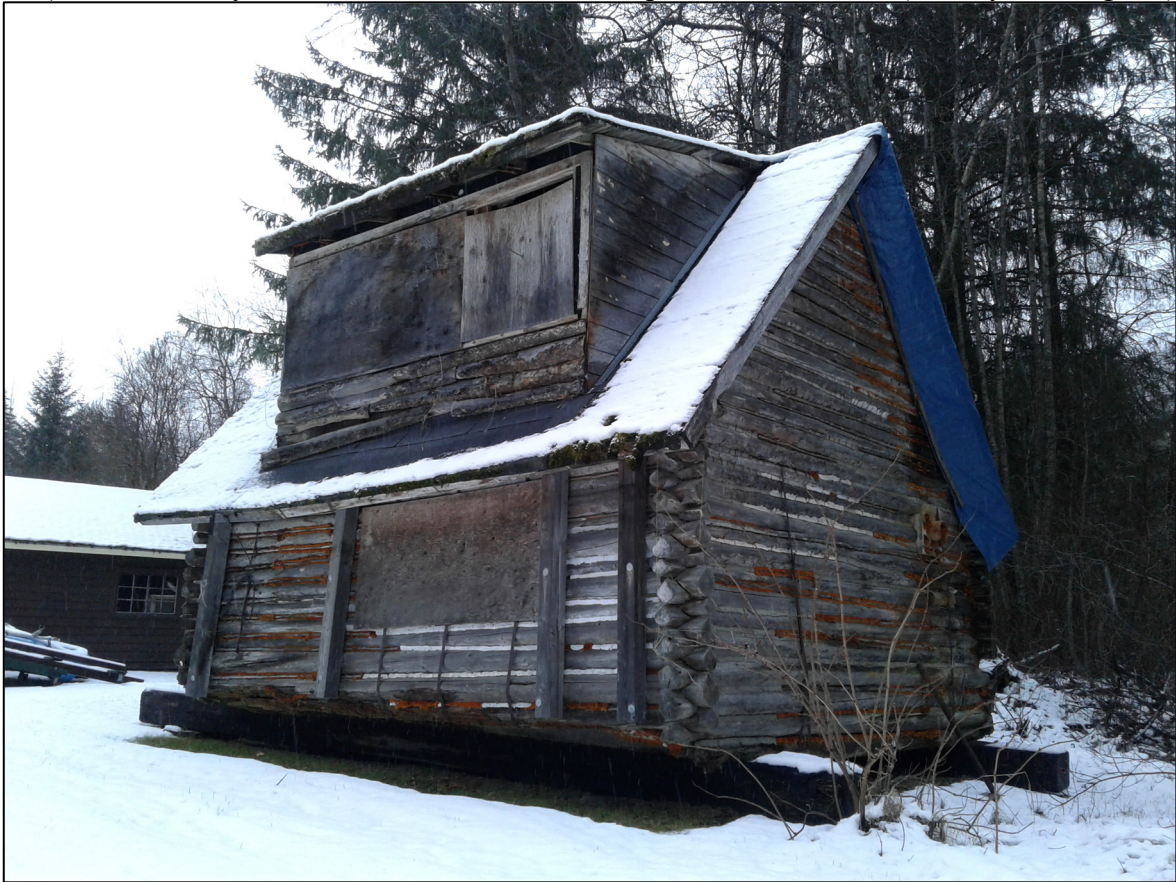
Figure 2: Southwest corner of Patterson-McDermott Cabin, showing McDermott era dormer  
Source: Field photograph by Anne E. Matsov, Chief of Resources, Klondike Gold Rush National Historical Park (KLGO), 2019 20191203\_133310

1. Architectural character: The Patterson-McDermott Cabin is a one-and-one-half story, gable-front, log structure. It currently faces north and is three bays by one bay with a dominant dormer addition on its west elevation. The rectangular footprint of the cabin measures 17'0" by 19'6". A steeply pitched, 12:12 rolled asphalt roof covers the structure. The cabin's walls are purportedly Sitka spruce logs with black cottonwood repairs.<sup>71</sup> Logs meet at the corners with V-notched log crowns. Walls feature pole-style chinking with fiberglass insulation. Some spray foam and Portland cement are also present. The NPS moved the cabin 500' to the east of its historic location in 2002 (Figure 1). Vertical metal strapping and wood bracing, which were installed to stabilize the structure during this move, remain on both the interior and exterior. It currently rests, mothballed, on two large timbers (Figure 2).

2. Foundations: Since NPS moved the Patterson-McDermott Cabin in 2002, the structure has rested on a temporary foundation comprised of two 13 ½" by 14" wood beams that run parallel to the ridge of the roof (Figure 2).
3. Walls: The exterior walls are load-bearing, untreated logs. Most of the logs are peeled but some retain their bark. An example of barked logs may be found in the gable peak of the cabin's north elevation (Figure 5). Log crowns measure roughly 8". However, there is variation at each of the corners. At fenestration—current and in-filled—the end cut of the logs is hewn.

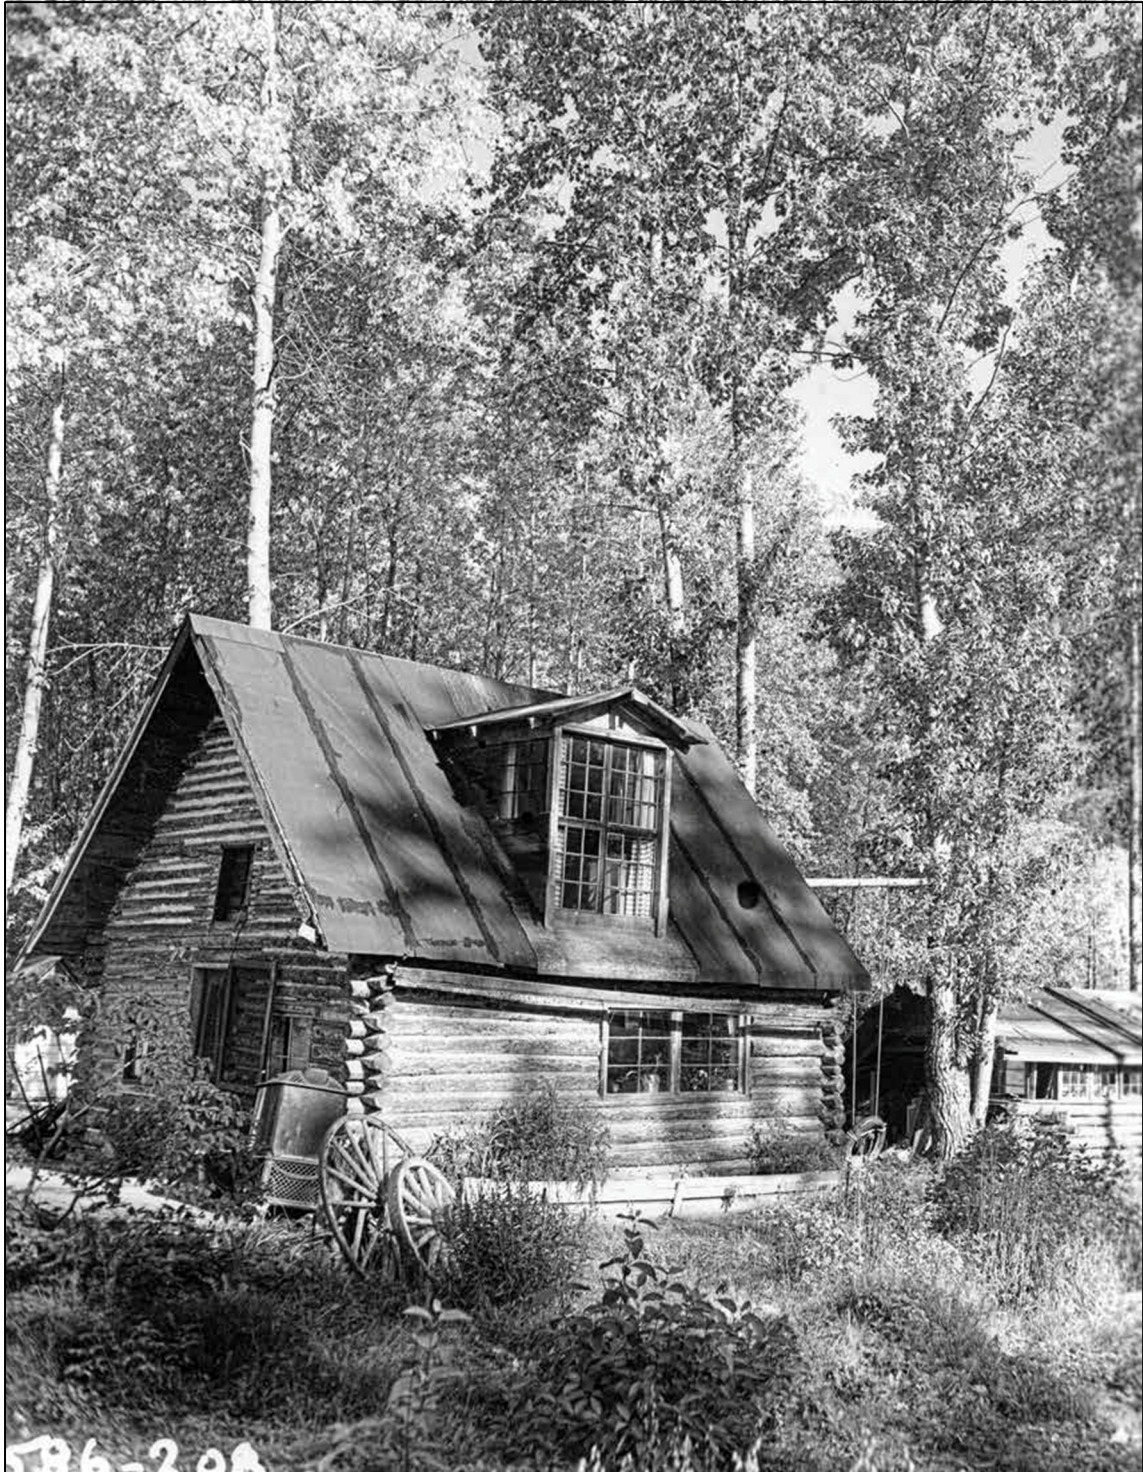
Figure 3: Patterson-McDermott Cabin showing Patterson era gambled dormer  
Source: Patterson Cabin, north and west elevations (586-208), photograph by Hunter Gruening, September 1952, National Park Service (NPS), KLGO Digital Library, Courtesy of Steve Hites Collection

peak. Fenestration included four nine-light windows along the front of the dormer and roughly square, six-light, wood frame windows on either side (Figure 3).<sup>57</sup> The Pattersons may have utilized wood boards from the Hosford Mill in Dyea to construct the upper floor within the cabin.<sup>58</sup> The Mill could be found just three miles north on the Chilkoot Trail and housed the Skagway Lumber Company from 1949 to 1956.<sup>59</sup>

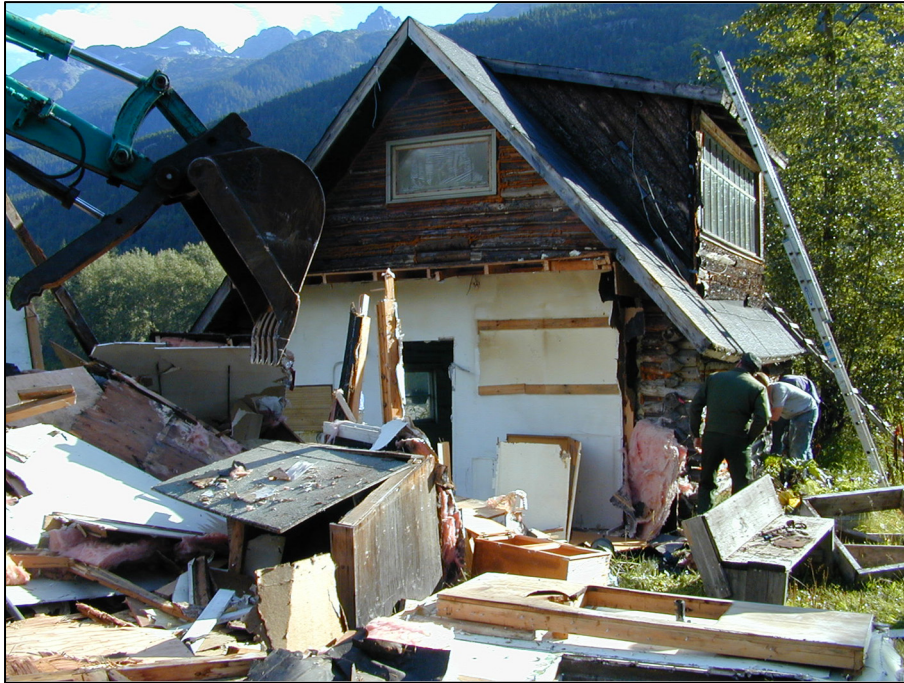
Figure 4: Patterson-McDermott Cabin relocation showing removal of kitchen addition  
Source: Unknown Photographer, NPS Staff Photo, September 2002, NPS, Alaska Regional Office (AKRO), Historic Architecture, Patterson Cabin Digital Files

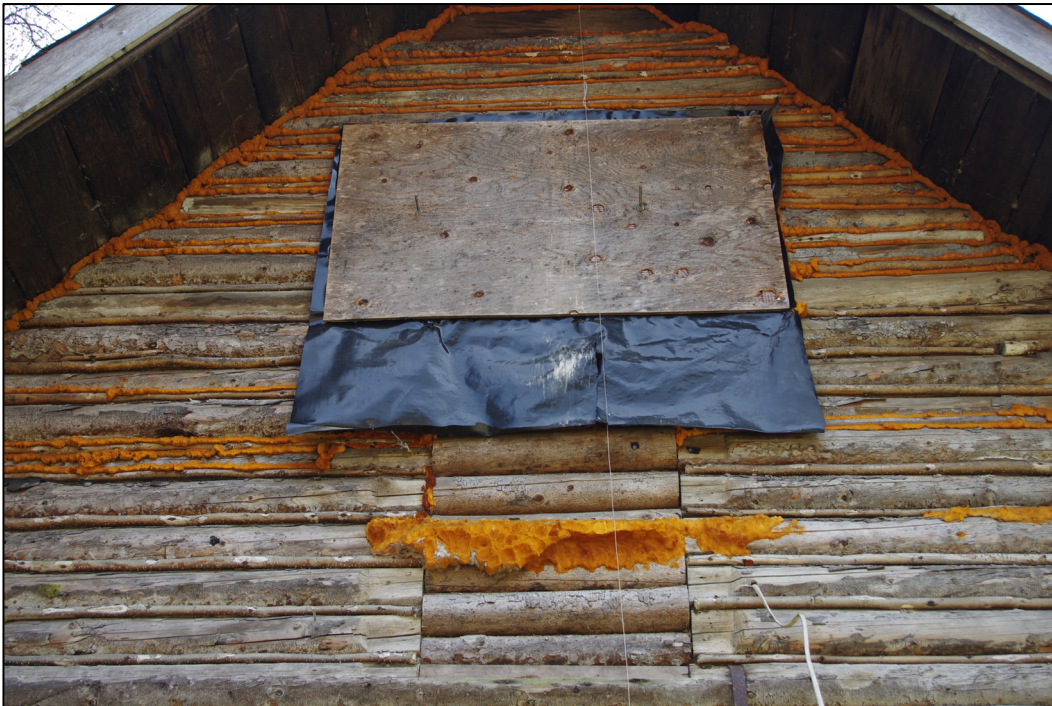
Figure 5: Gable peak of north elevation showing barked and peeled logs  
Source: Field photograph by Kathleen Wackrow, NPS, April 2016, NPS, AKRO, Historic Architecture, Patterson Cabin Digital Files IMGP6021

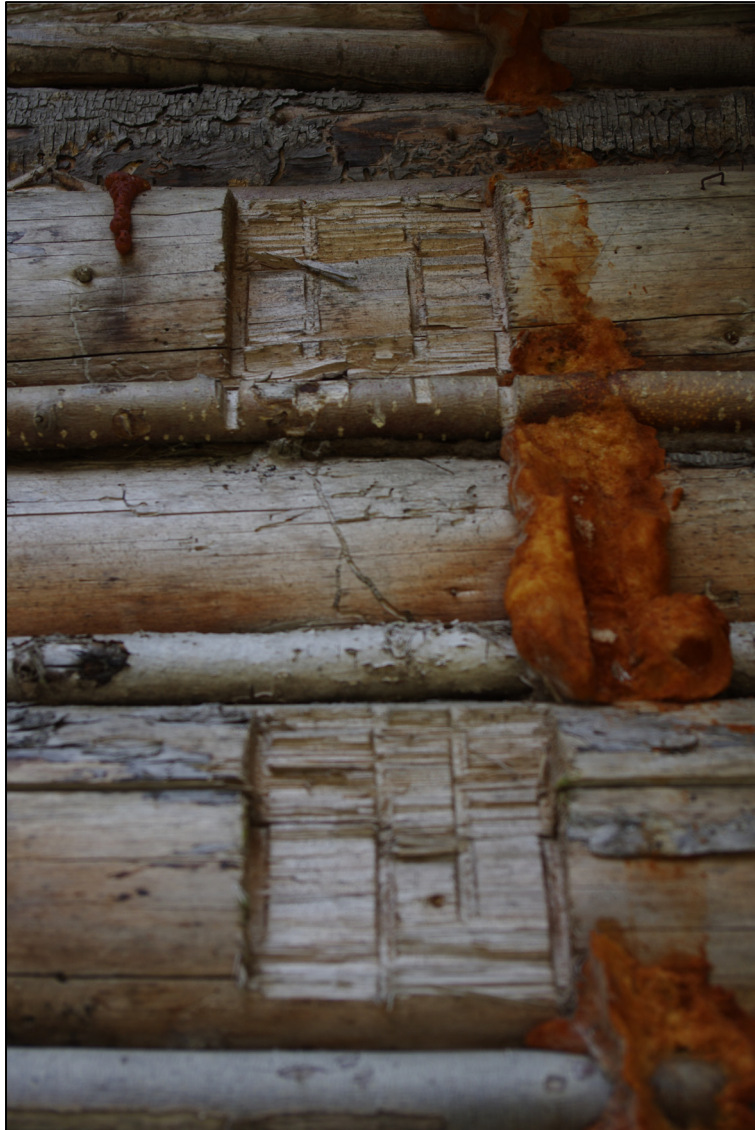
Figure 6: Signs of former shed-roofed kitchen addition from McDermott era along north elevation

Remnants of a shed-roofed kitchen addition, built by the McDermotts between 1977 and 1982, are found along the north elevation. Square-shaped hewn cut-outs running in two vertical strips between the first floor windows and the log crowns reveal how and where the McDermotts attached the kitchen addition to the cabin (Figure 6).

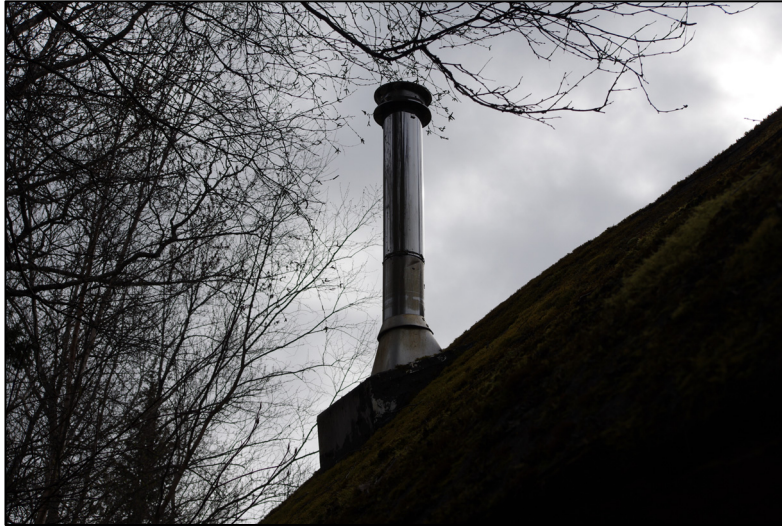
Figure 7: Insulated metal stove pipe from McDermott era  
Source: Field photograph by Kathleen Wackrow, NPS, April 2016, NPS, AKRO, Historic Architecture, Patterson Cabin Digital Files IMGP6068

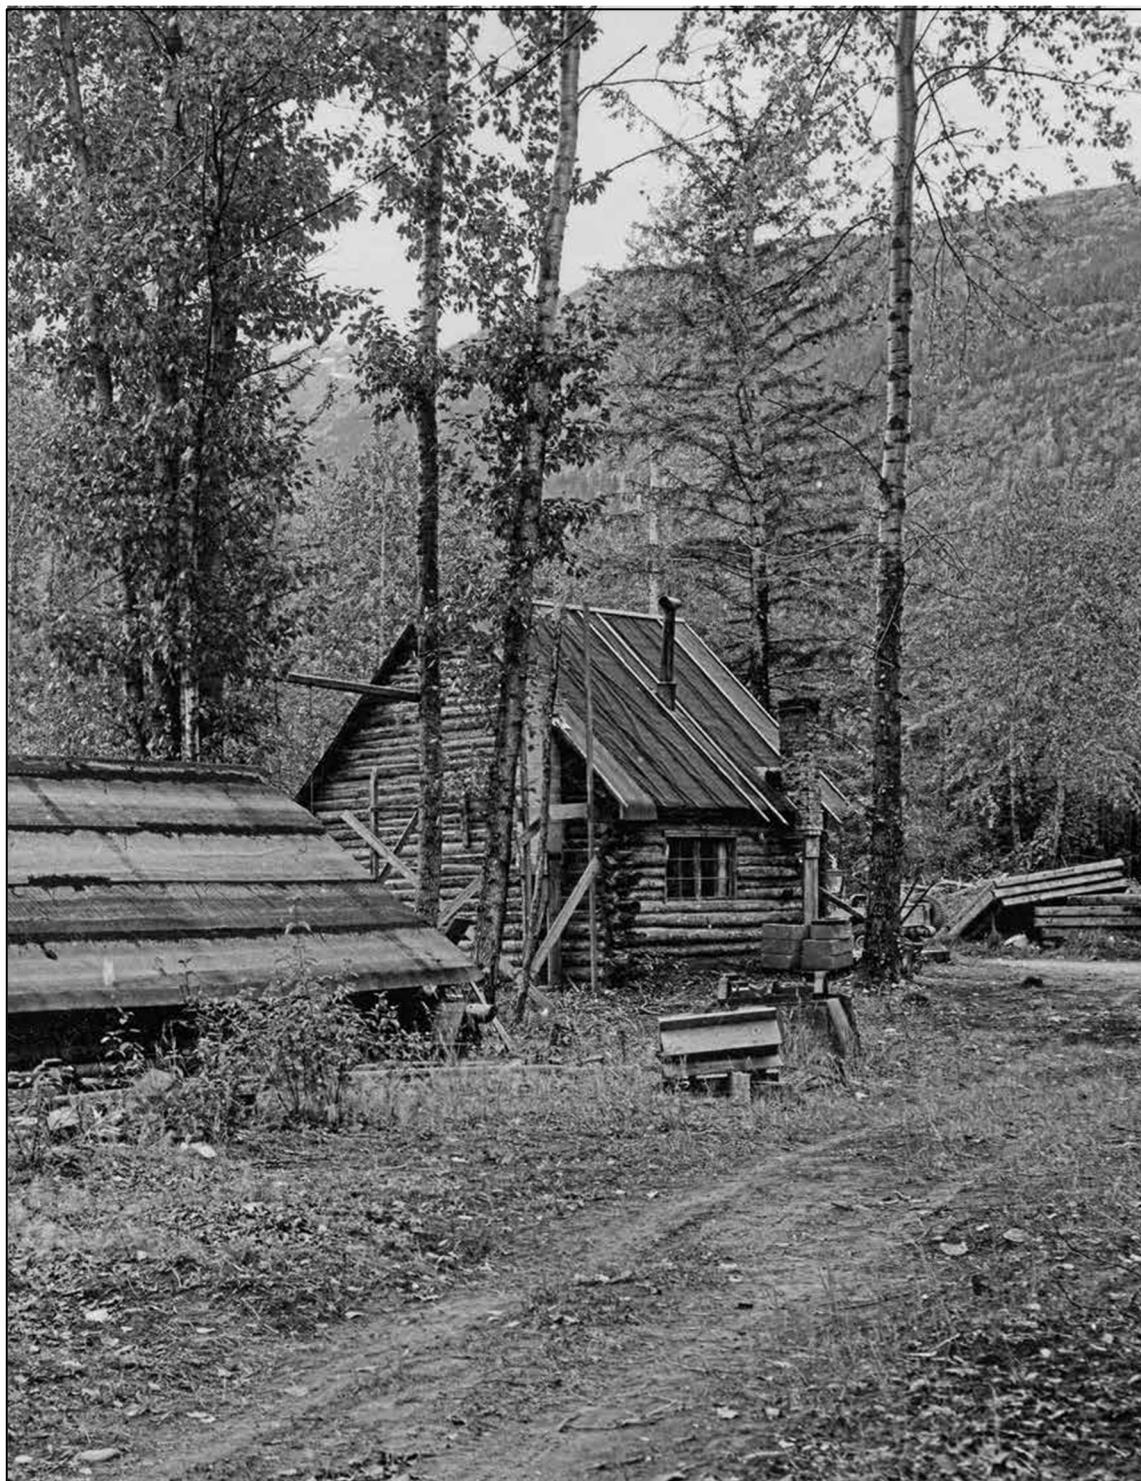
Figure 9: South and east elevations of Patterson-McDermott Cabin, showing no longer extant chimney

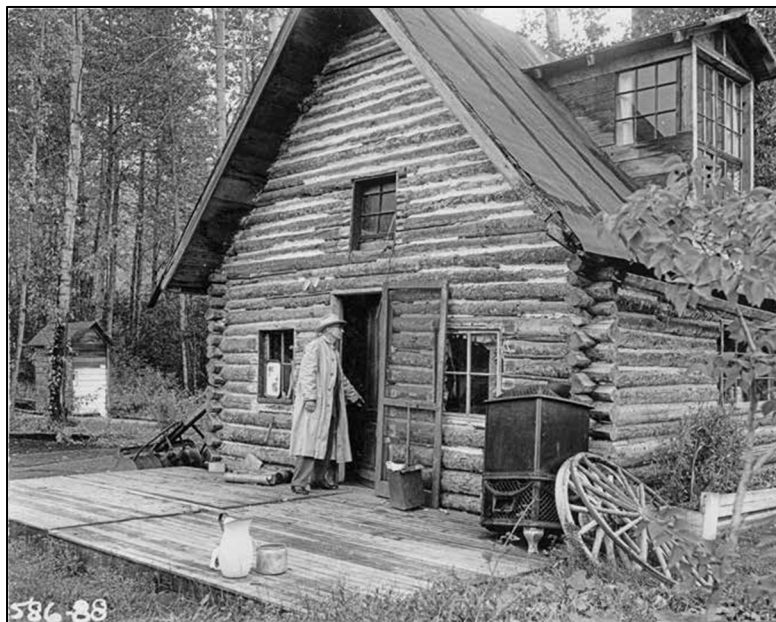
Figure 11: North and west elevations of Patterson-McDermott Cabin showing historic screen door  
Source: Photograph by Hunter Gruening, September 1952, NPS, KLGO Digital Library, Courtesy Steve Hites Collection (586-88)

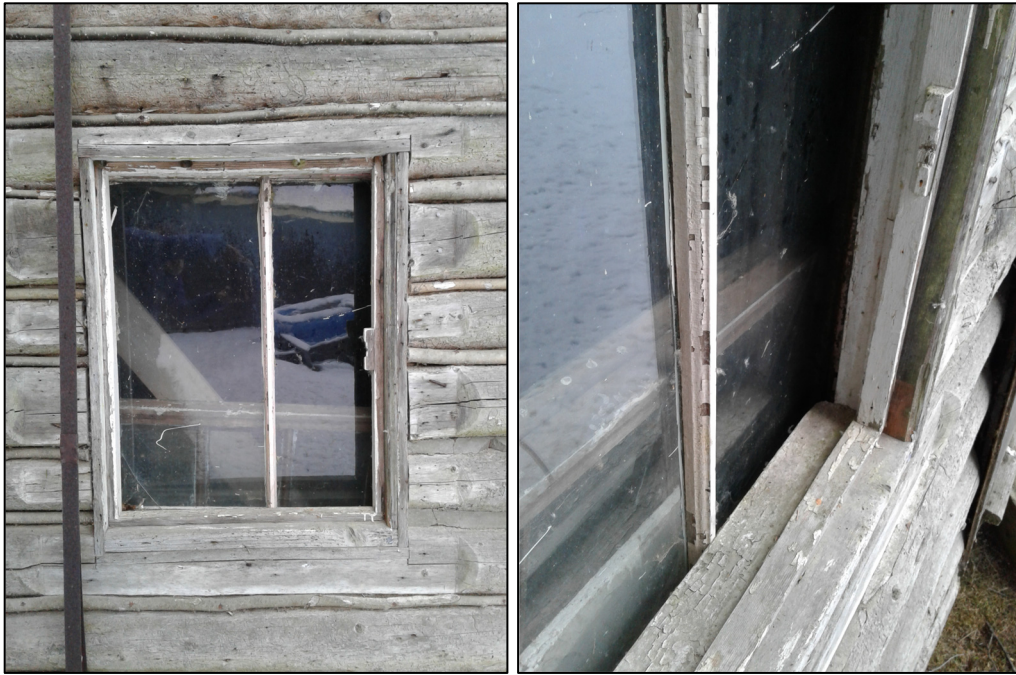
Figure 12: North elevation window, left of the door, showing window leaning against opening  
Source: Field Photograph by Anne E. Matsov, Chief of Resources, KLGO, 2019  
20191203\_133202 and 20191203\_133145

Two window openings and two in-filled window openings are found on the north elevation. The in-filled openings are located between the doorway and a gable peak window opening and to the right of the doorway. Both are roughly square, with the one above the door measuring smaller. Plywood and a black trash bag cover the large, horizontally oriented, rectangular window opening in the gable peak. The single light, wood trimmed window that filled this opening has been stored within the cabin. A single window opening remains uncovered on the north elevation, to the left of the doorway. A two-light, wood sash window that is too large for the opening has been leaned against it (Figure 12). Additional windows lean against this inside. The window that filled this opening was likely the single-paned, casement window found inside the structure.

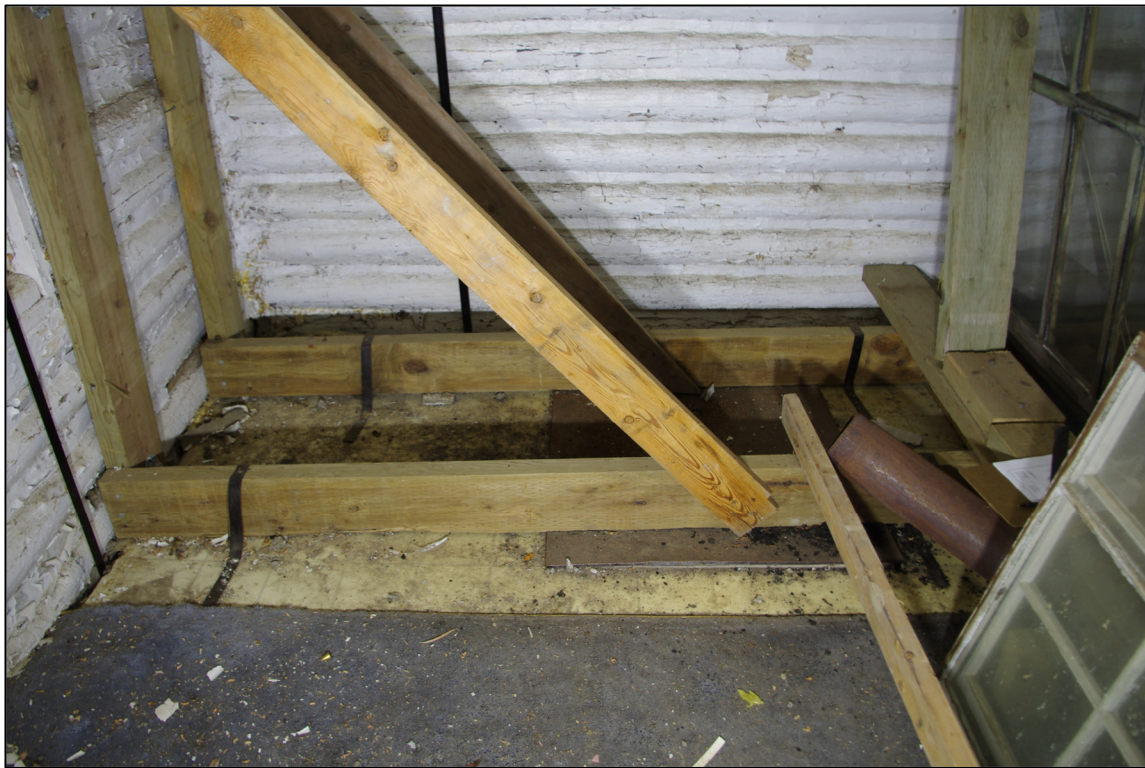
Figure 13: Interior southeast corner of first floor showing blue carpet, linoleum, and stove pad  
Source: Field photograph by Kathleen Wackrow, NPS, April 2016, NPS, AKRO, Historic  
Architecture, Patterson Cabin Digital Files IMGP6176

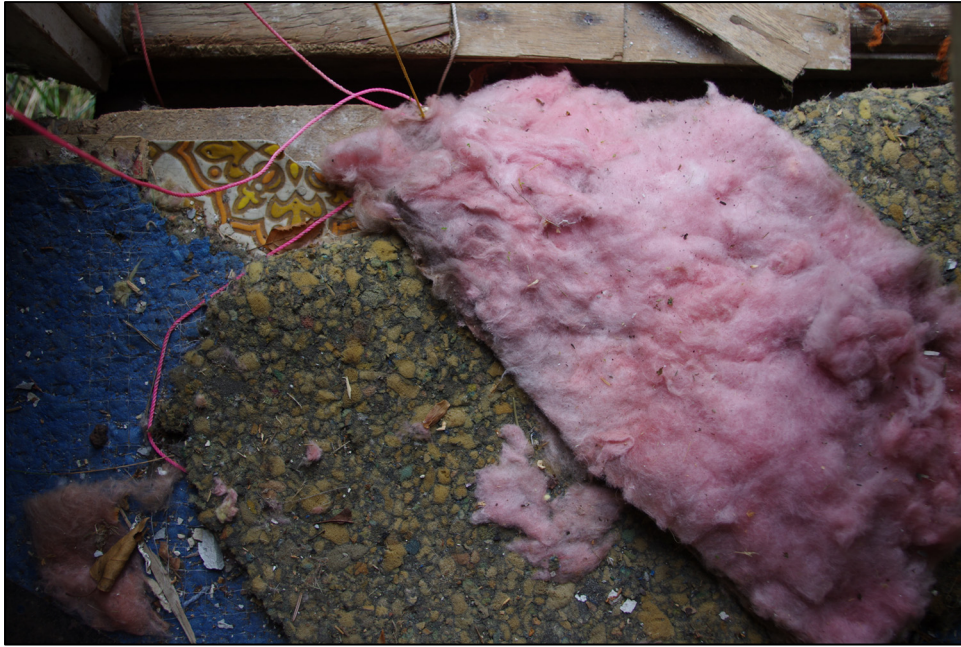
Figure 14: Second floor showing yellow, brown, and orange medallion pattern linoleum  
Source: Field photograph by Kathleen Wackrow, NPS, April 2016, NPS, AKRO, Historic Architecture, Patterson Cabin Digital Files IMGP6197

Blue wall-to-wall carpet is also found on the second floor. It covers linoleum with a yellow, brown, and orange medallion pattern, which sits atop wood floor boards (Figure 14).

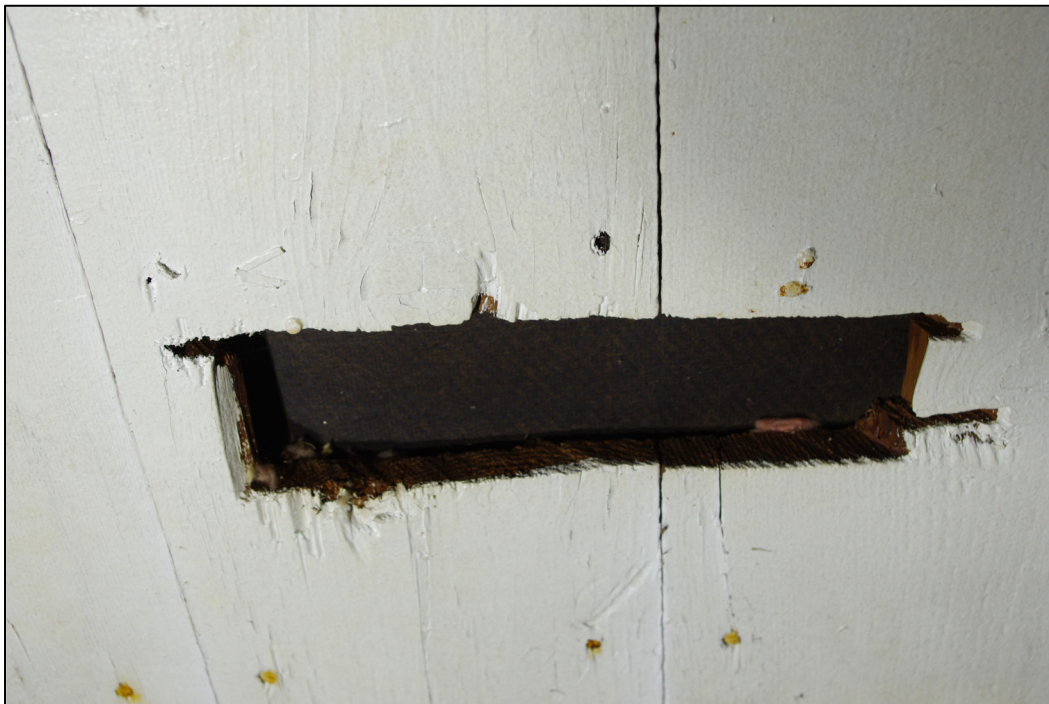
Figure 15: Rectangular cut out on ceiling of first floor, evidence of well point theft  
Source: Field photograph by Kathleen Wackrow, NPS, April 2016, NPS, AKRO, Historic Architecture, Patterson Cabin Digital Files IMGP6281

The ceiling of the first floor is sheathed in rough-sawn, wood planks that have been painted white. It is directly attached to the second floor joists. Two stove pipe holes penetrate the ceiling. Additionally, there is a rectangular-shaped cut-out in the center of the ceiling (Figure 15). The cut-out is evidence of damage caused when the well point—installed during the Patterson period—was stolen. The individual that removed the well point likely created a pulley system through the ceiling to lift it from the well, damaging the ceiling in the process.<sup>80</sup>

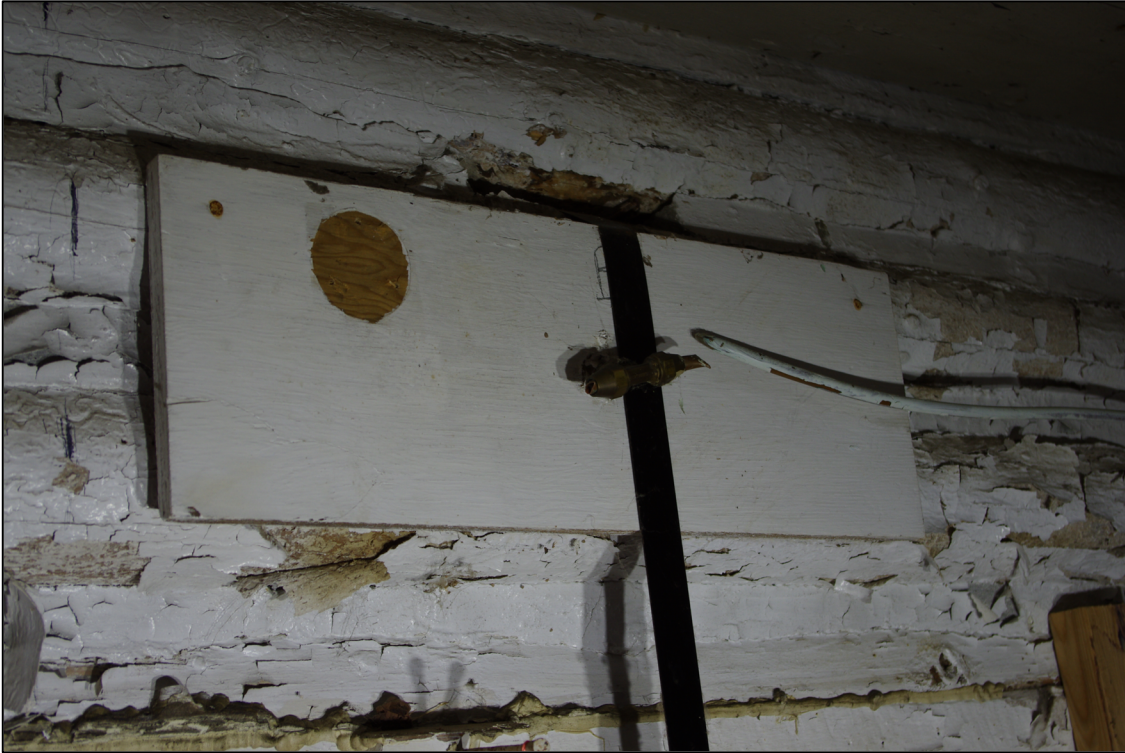
Figure 16: Rough-sawn wood board affixed to the east wall above the window. The circular marking on the left end of the board indicates where the base of a propane lantern was once attached

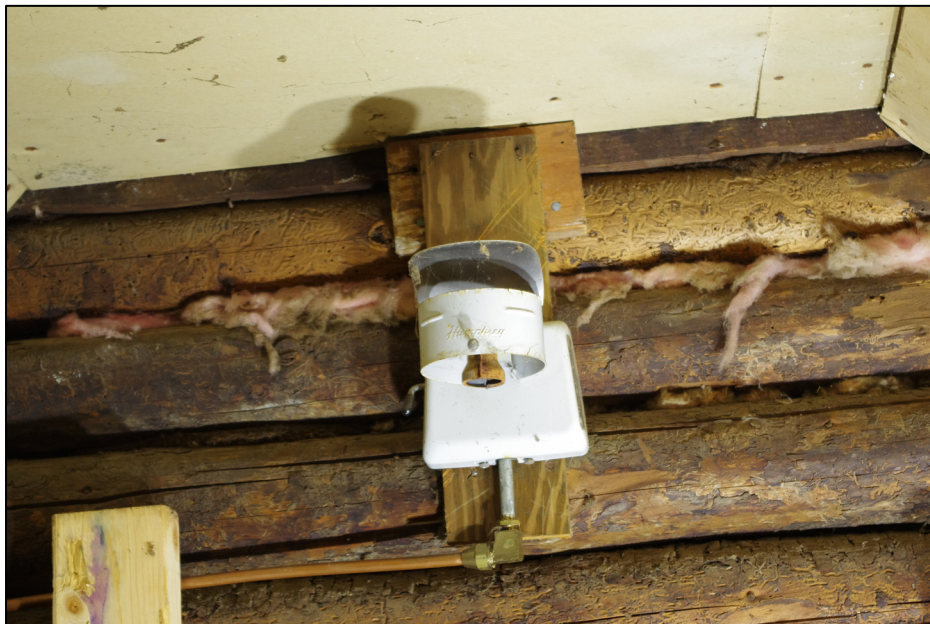
Figure 17: Remaining light fixture

- b. Lighting: Propane lamps primarily provided light for the Patterson-McDermott Cabin. Part of a light fixture, painted white, remains in the gable peak of the north wall of the second floor (Figure 17). While this is the only remaining fixture, other signs of propane lighting are found throughout the cabin. The McDermotts installed a propane conduit that still runs horizontally across interior walls. The ghost of a circular lantern base is found on a board affixed above the window of the east wall. There is copper piping and hardware associated with the McDermott-era propane lighting found on the board as well.
