**SKAGWAY CITY HALL  
(Old City Hall)**

**HABS No. AK-243**

**Location:** 350 Fifth Avenue, Municipality of Skagway Borough, Alaska

# SKAGWAY CITY HALL

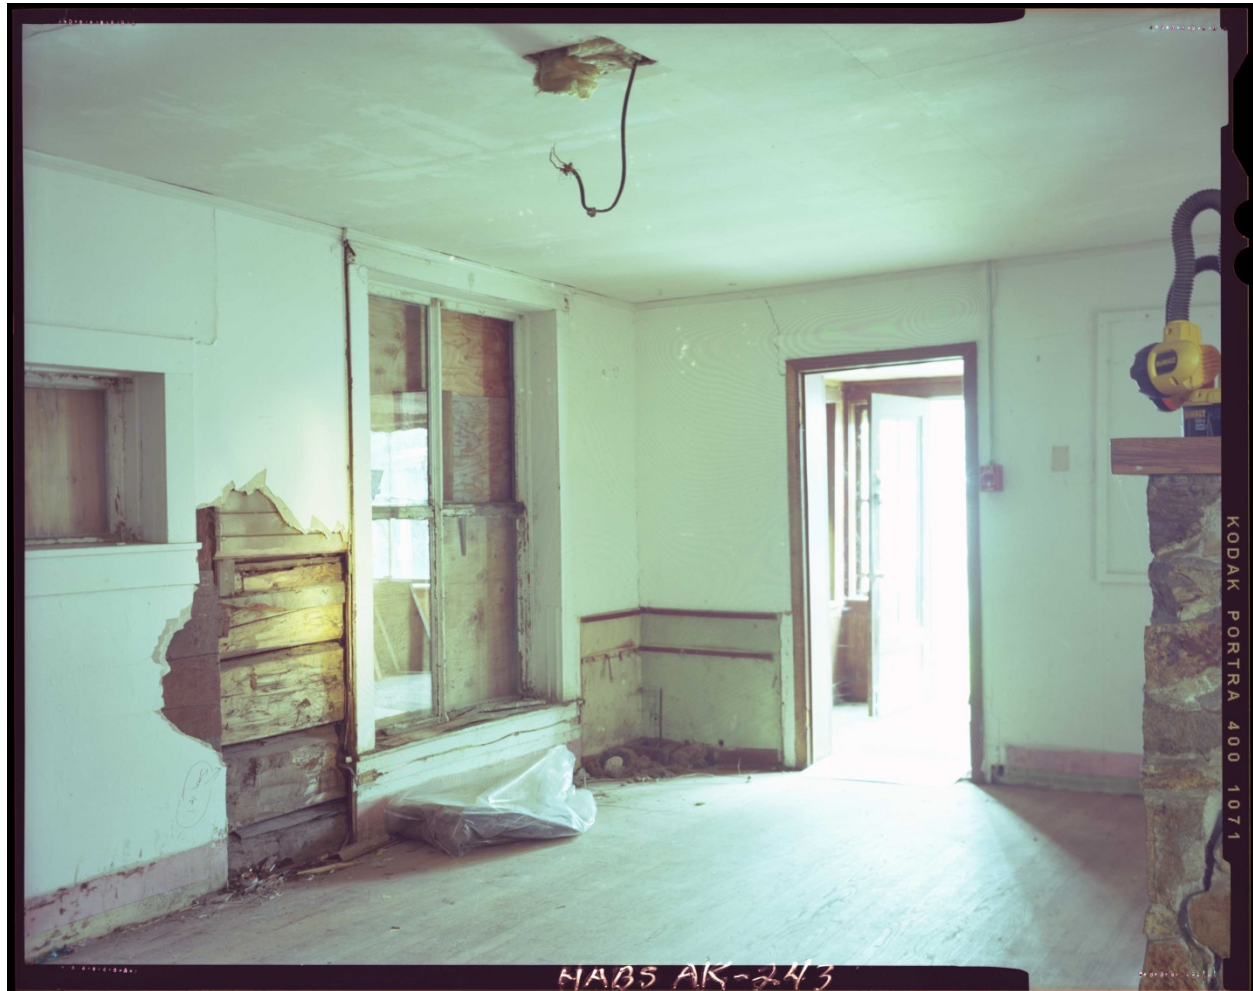
Fig. 1. Living room looking east to entry porch. Interior wall finish exposed to show heavy log construction. (Photographer: Robert Lyon, 2015)

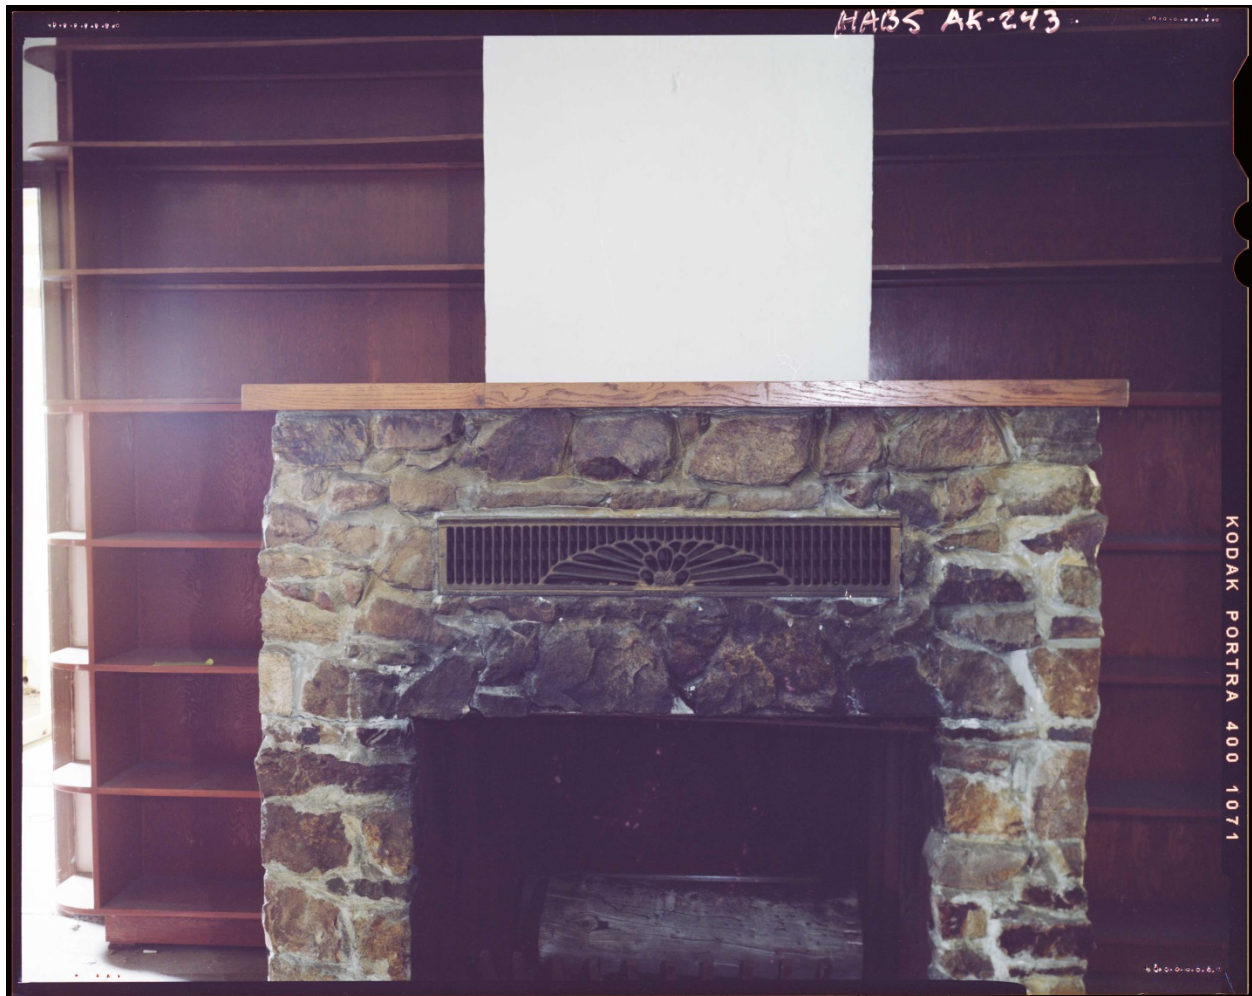
Fig. 3. Detail of fireplace grille. (Photographer: Robert Lyon, 2015)

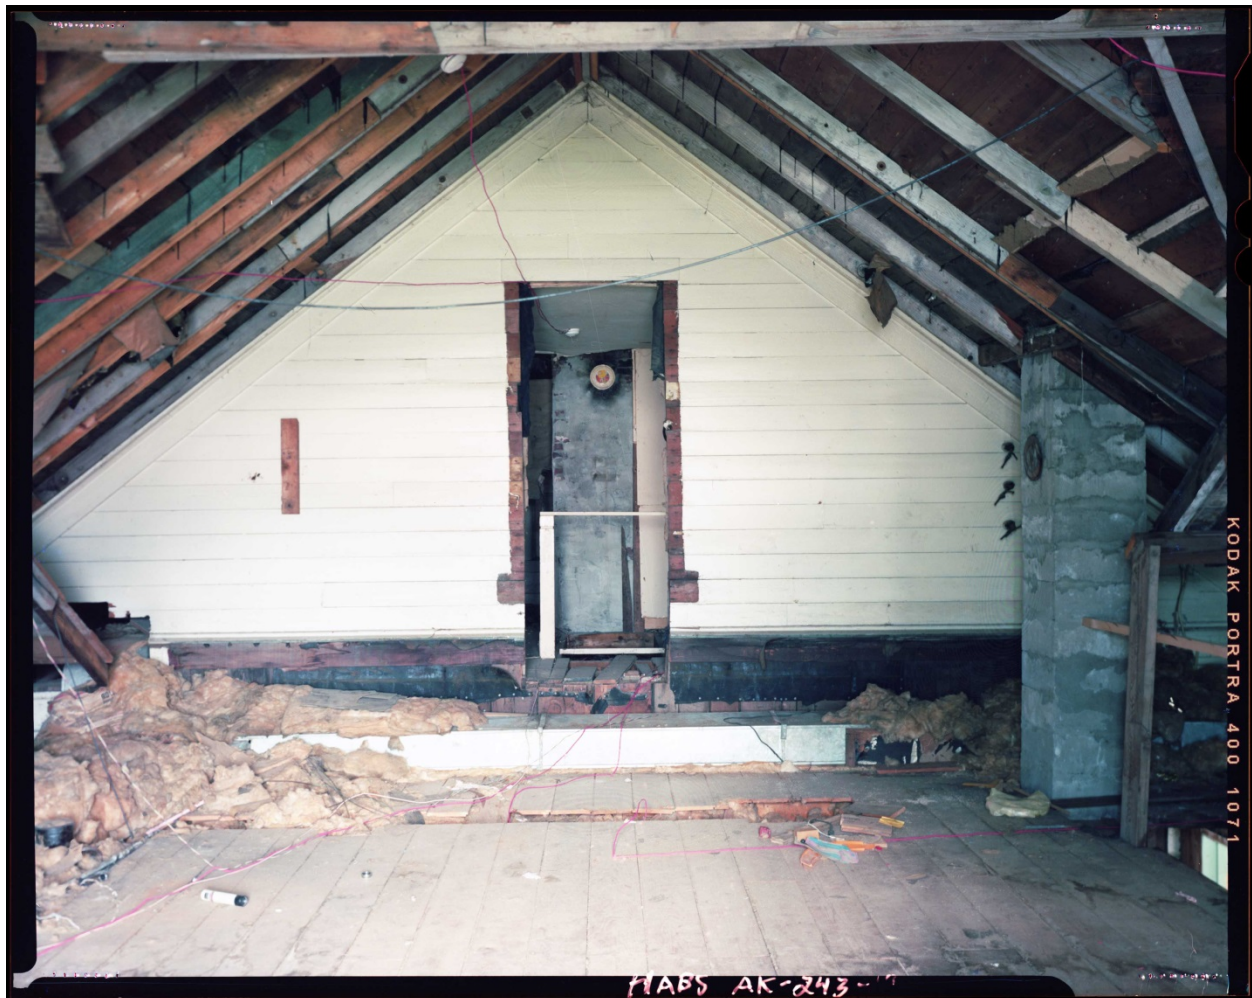
Fig. 8. Rear attic space looking southwest to gable end of original building. Original window cut to door opening. (Photographer: Robert Lyon, 2015)

| AK-243-10 | Rear attic space looking to southwest to gable end of original building; original window cut to door opening |

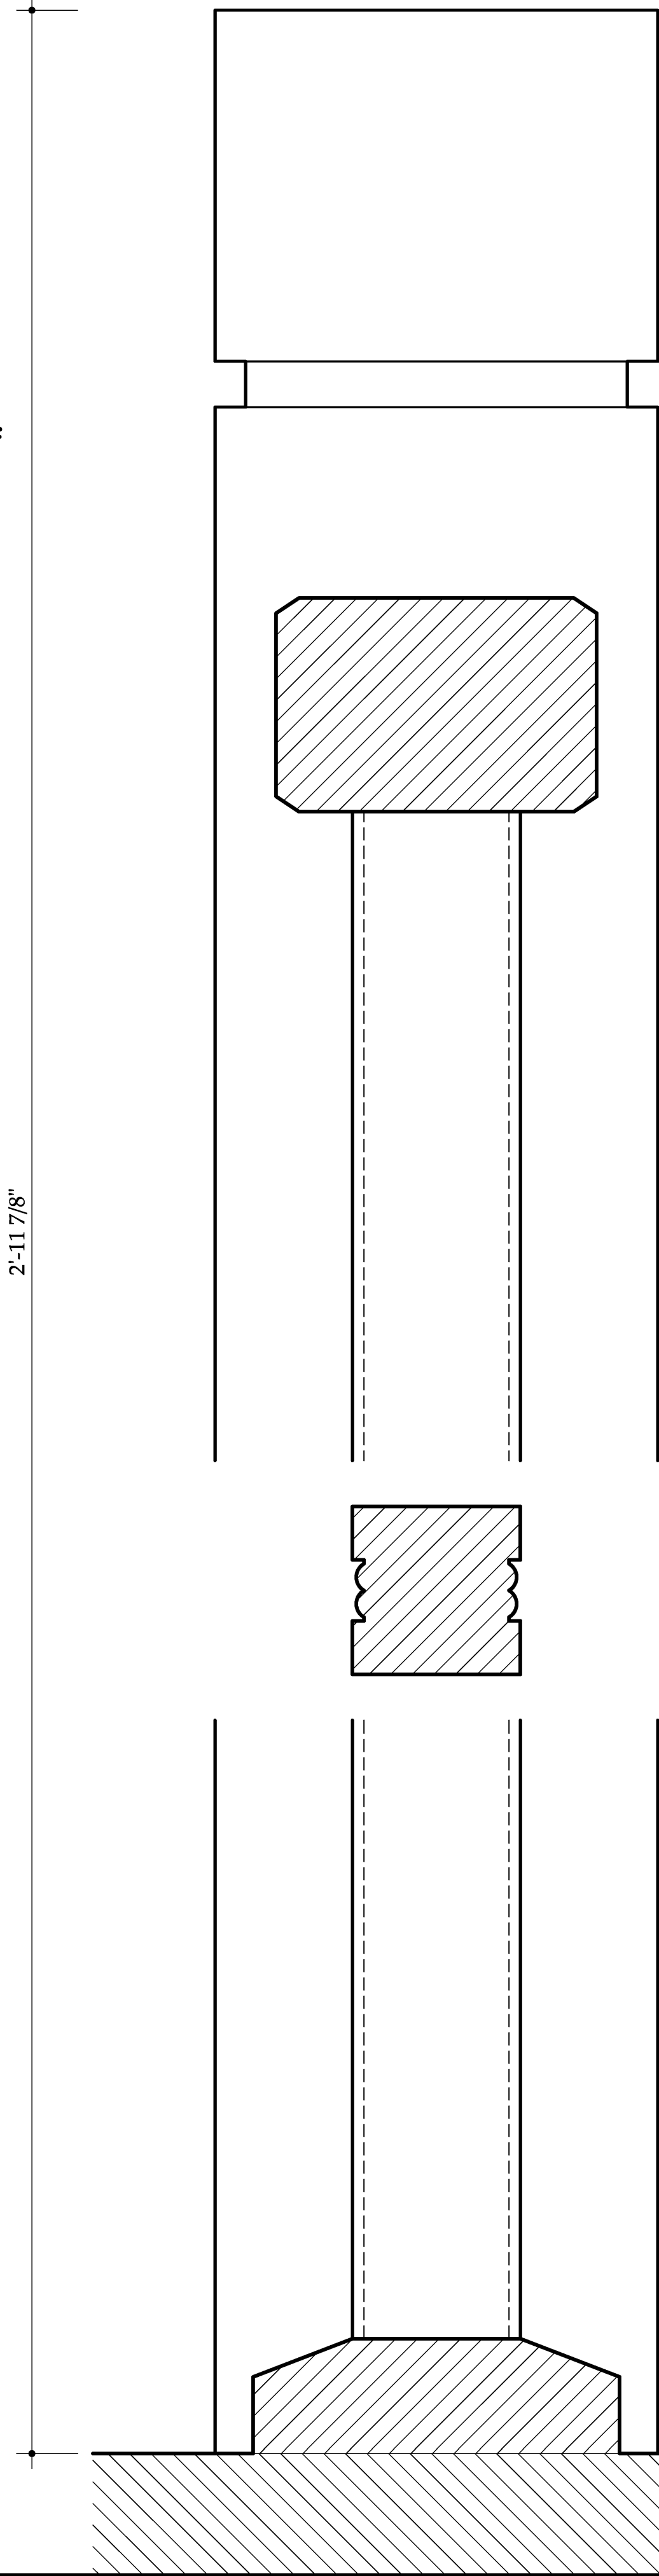
WINDOW MULLION  
SOUTHWEST ELEVATION  
12"=1'-0" 1:1

NEWEL POST AND BALUSTRADE  
ATTIC  
12"=1'-0" 1:1

WINDOW HEAD  
SOUTHWEST ELEVATION  
12"=1'-0" 1:1

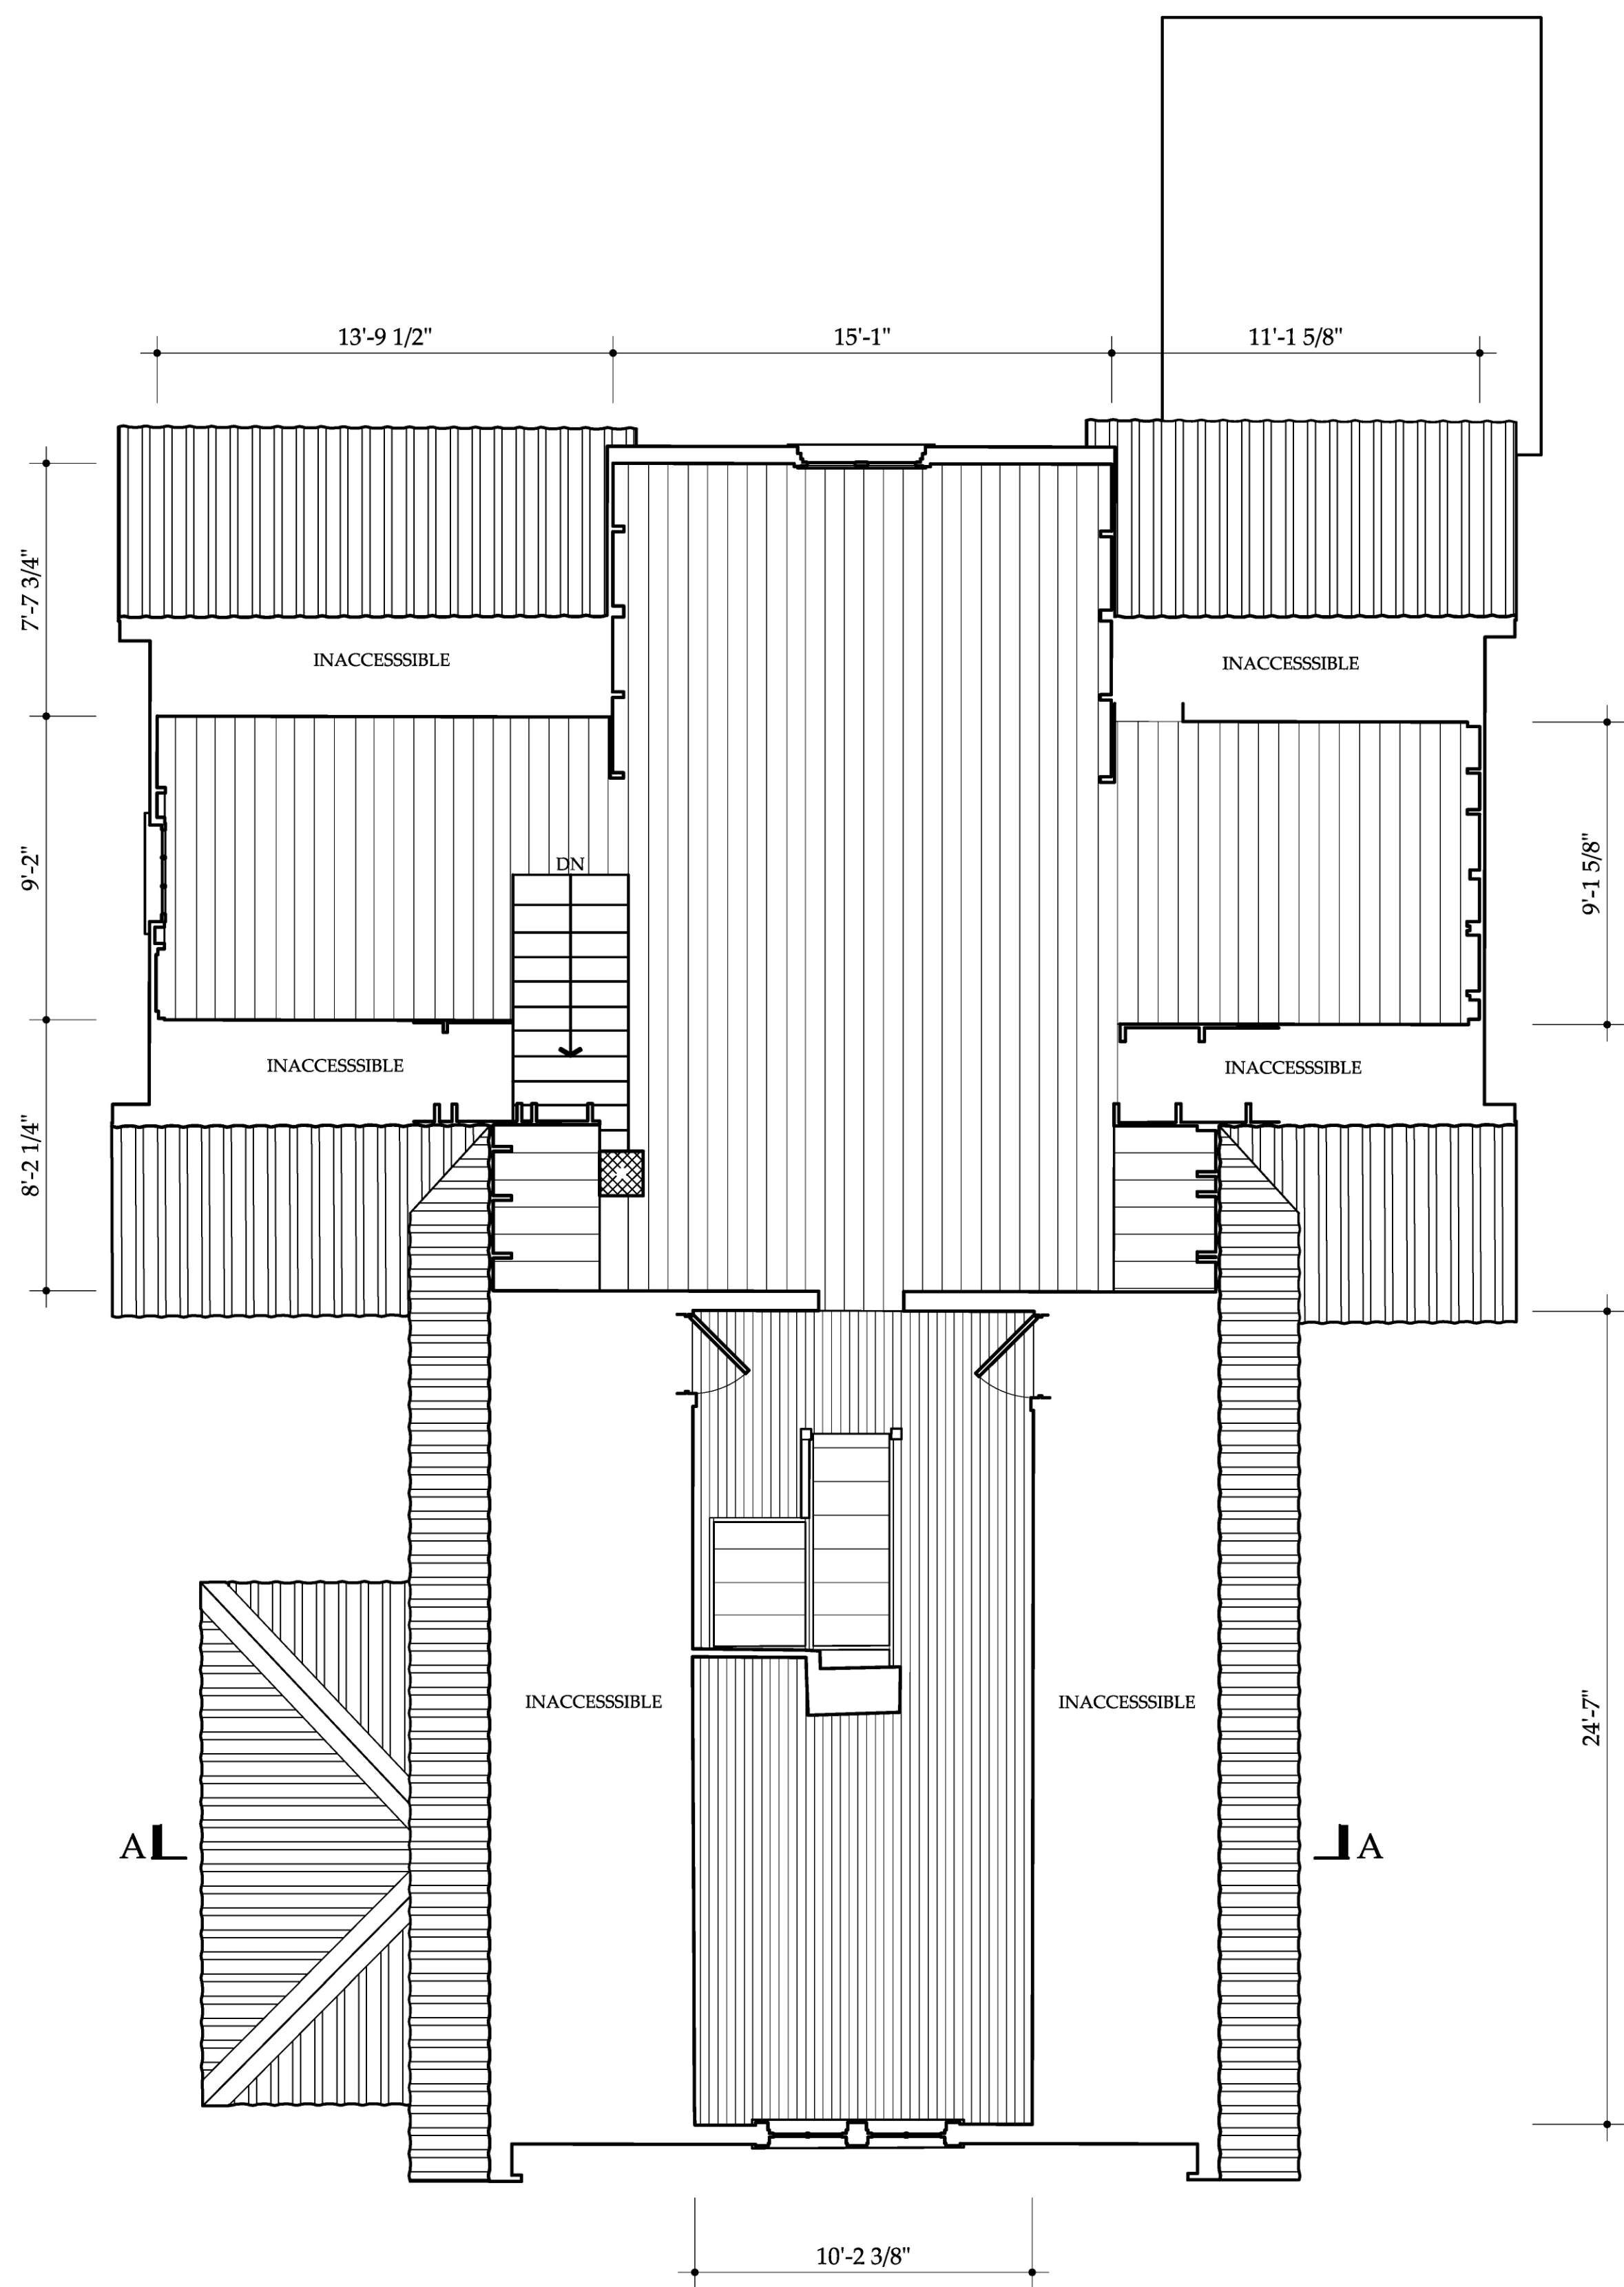
**ATTIC PLAN**  
1/4"=1'-0" 1:48

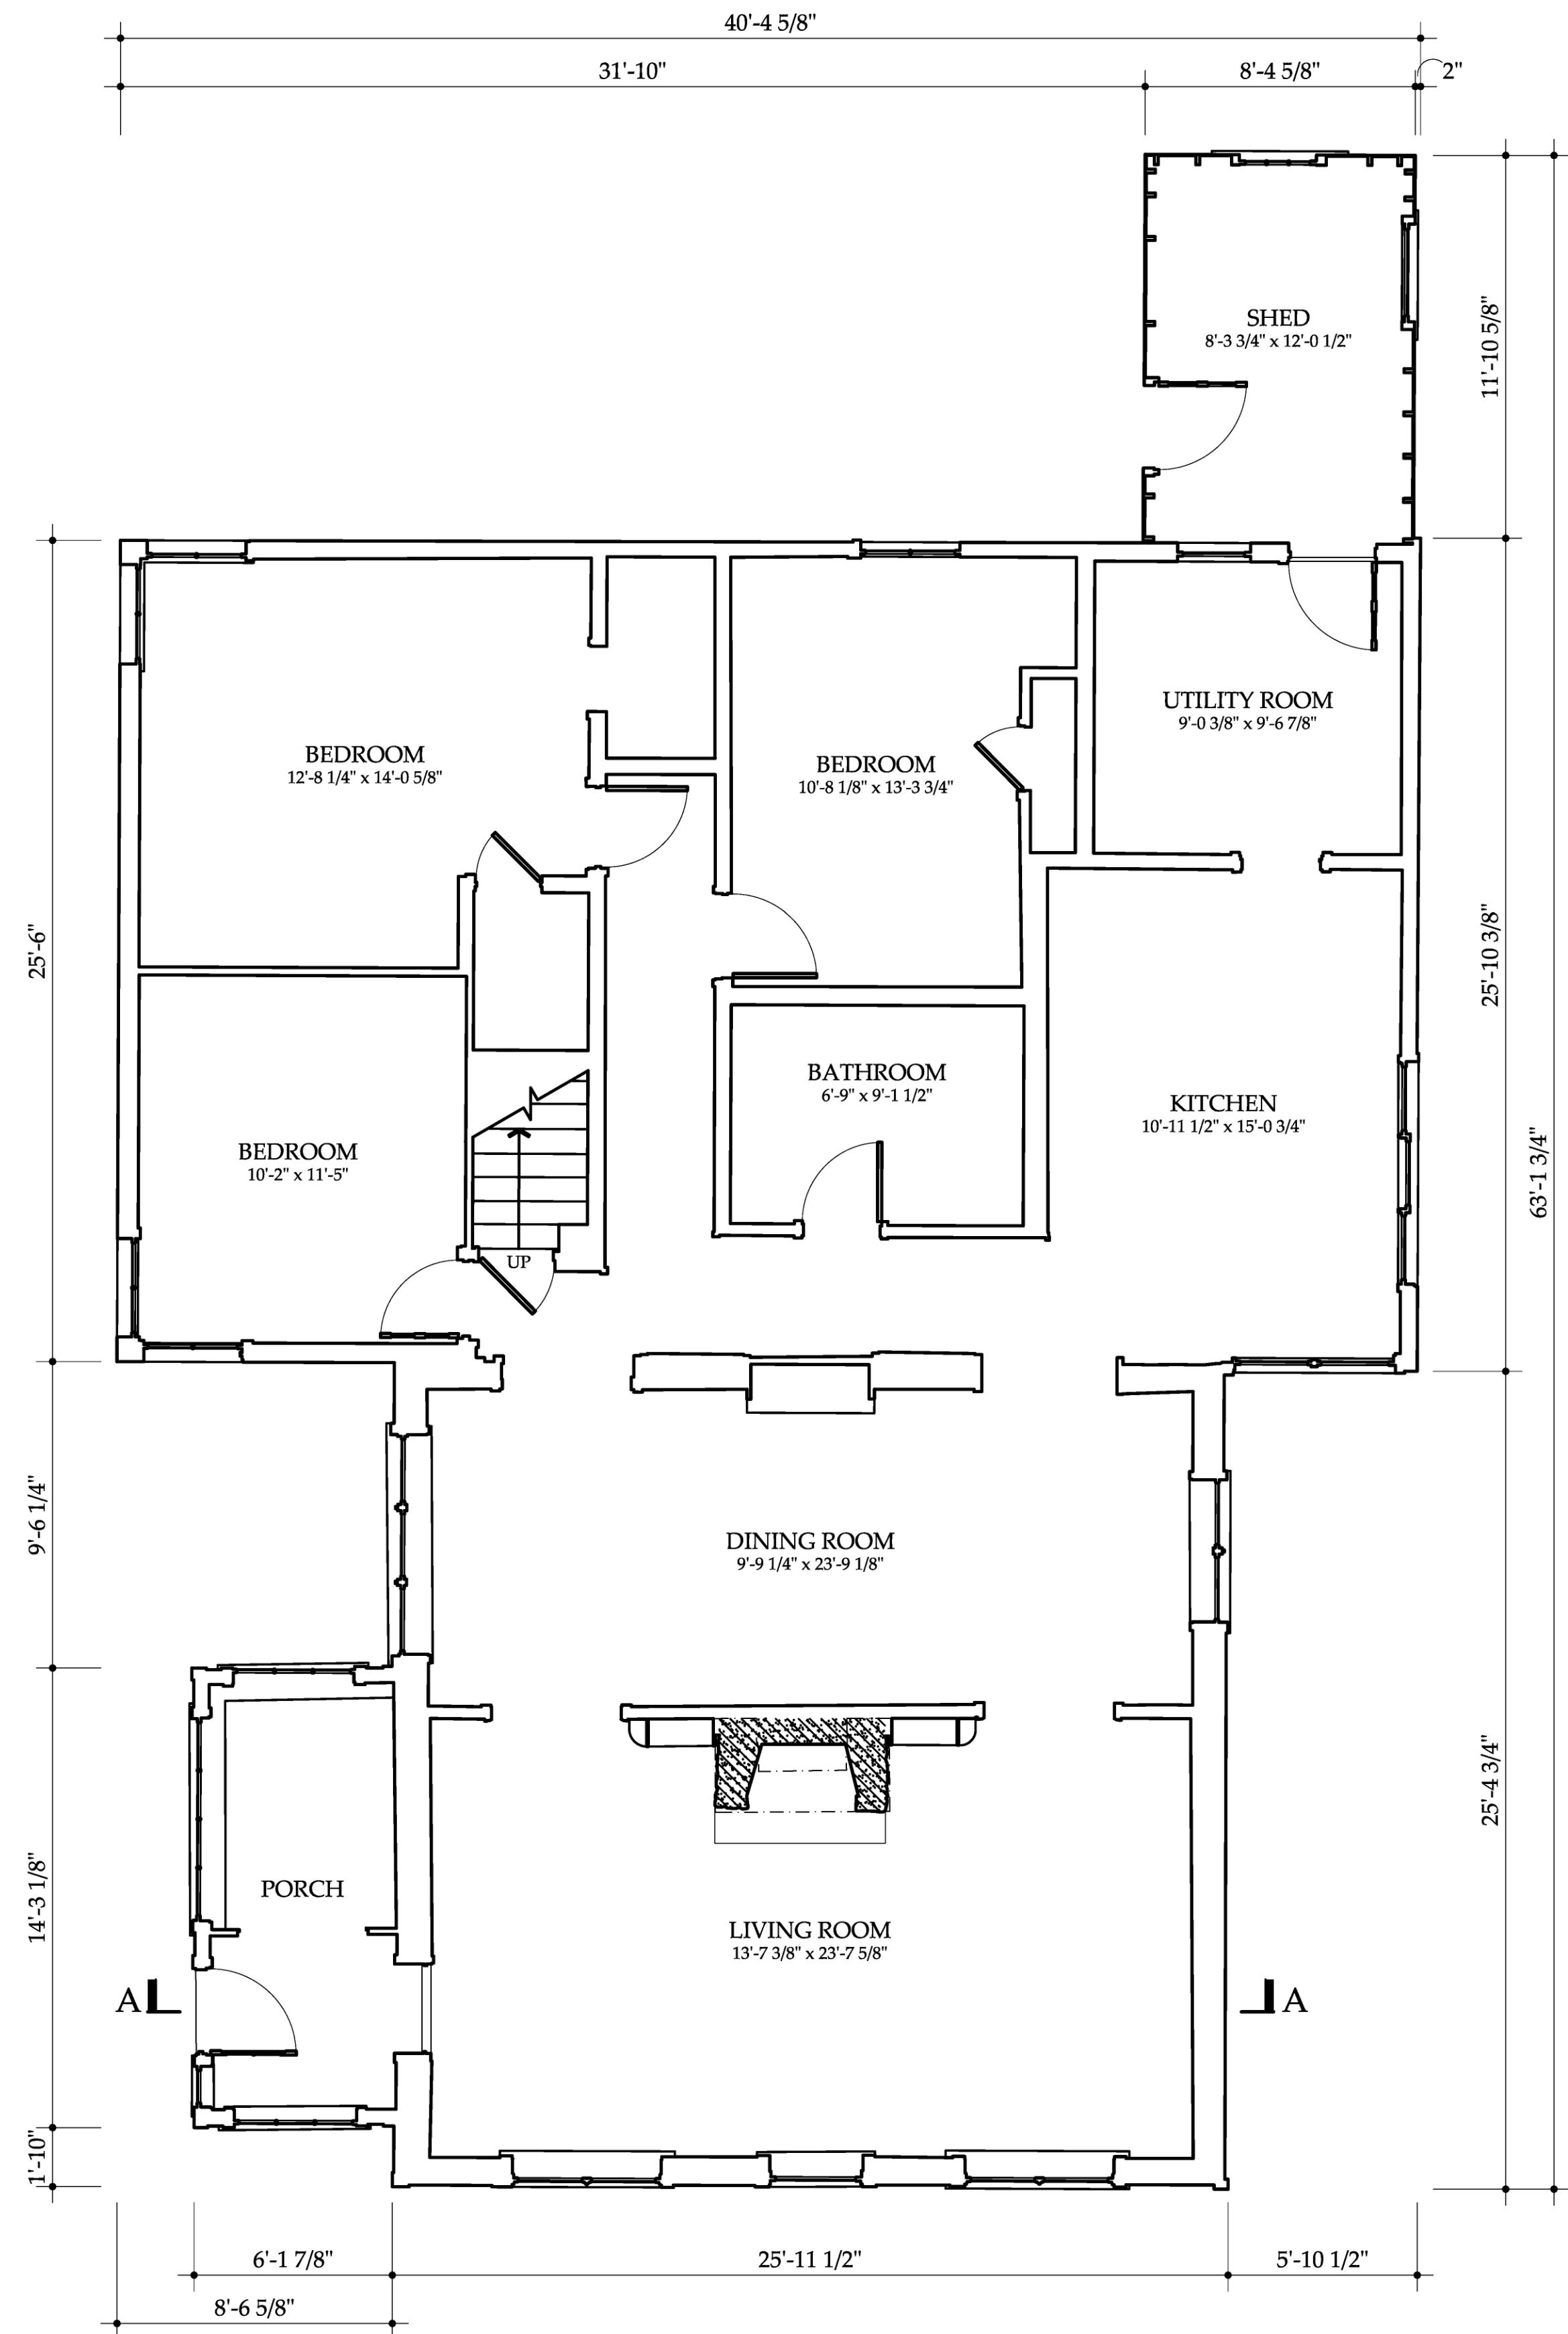
**FIRST FLOOR PLAN**  
1/4"=1'-0" 1:48

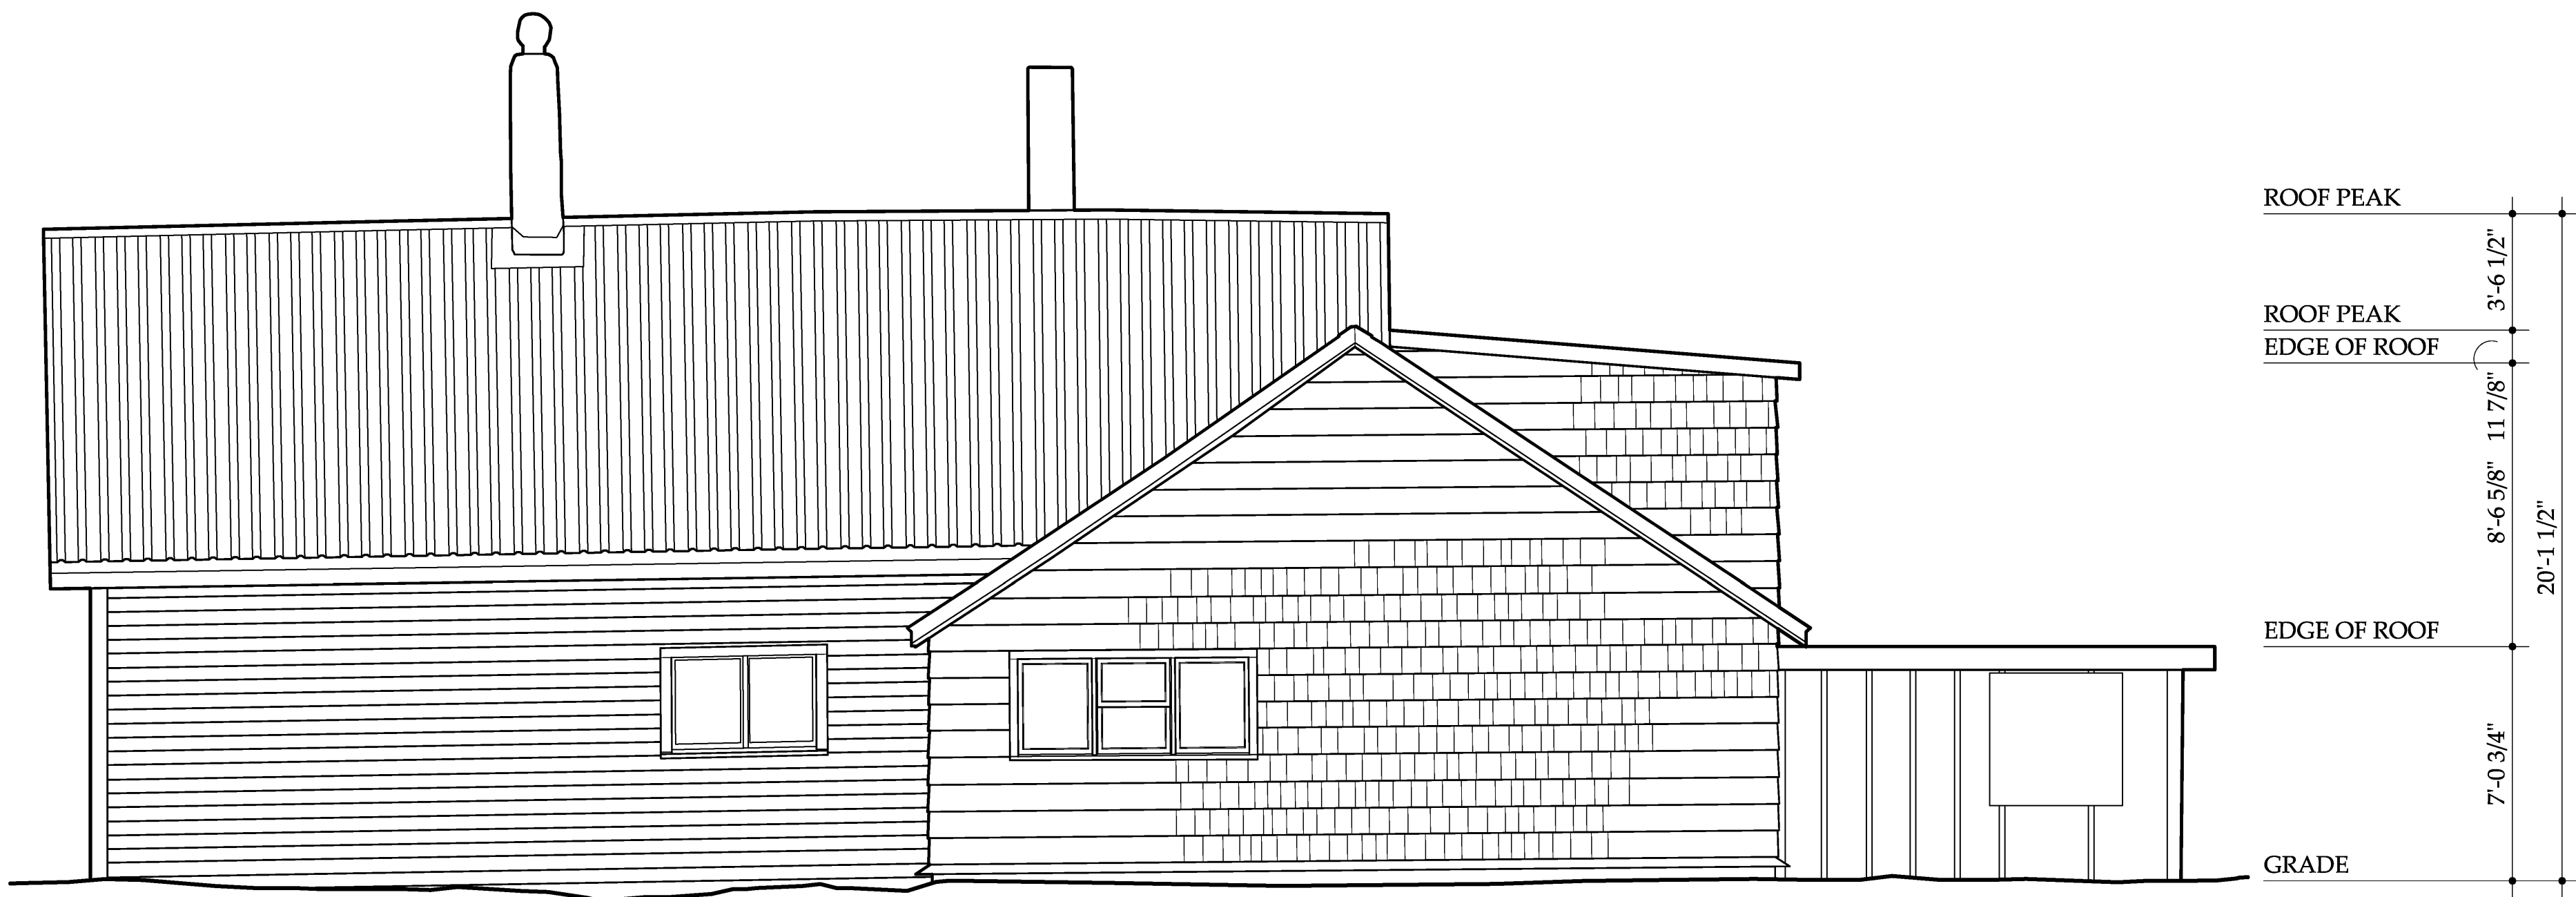
**SOUTHEAST ELEVATION**  
1/4"=1'-0" 1:48

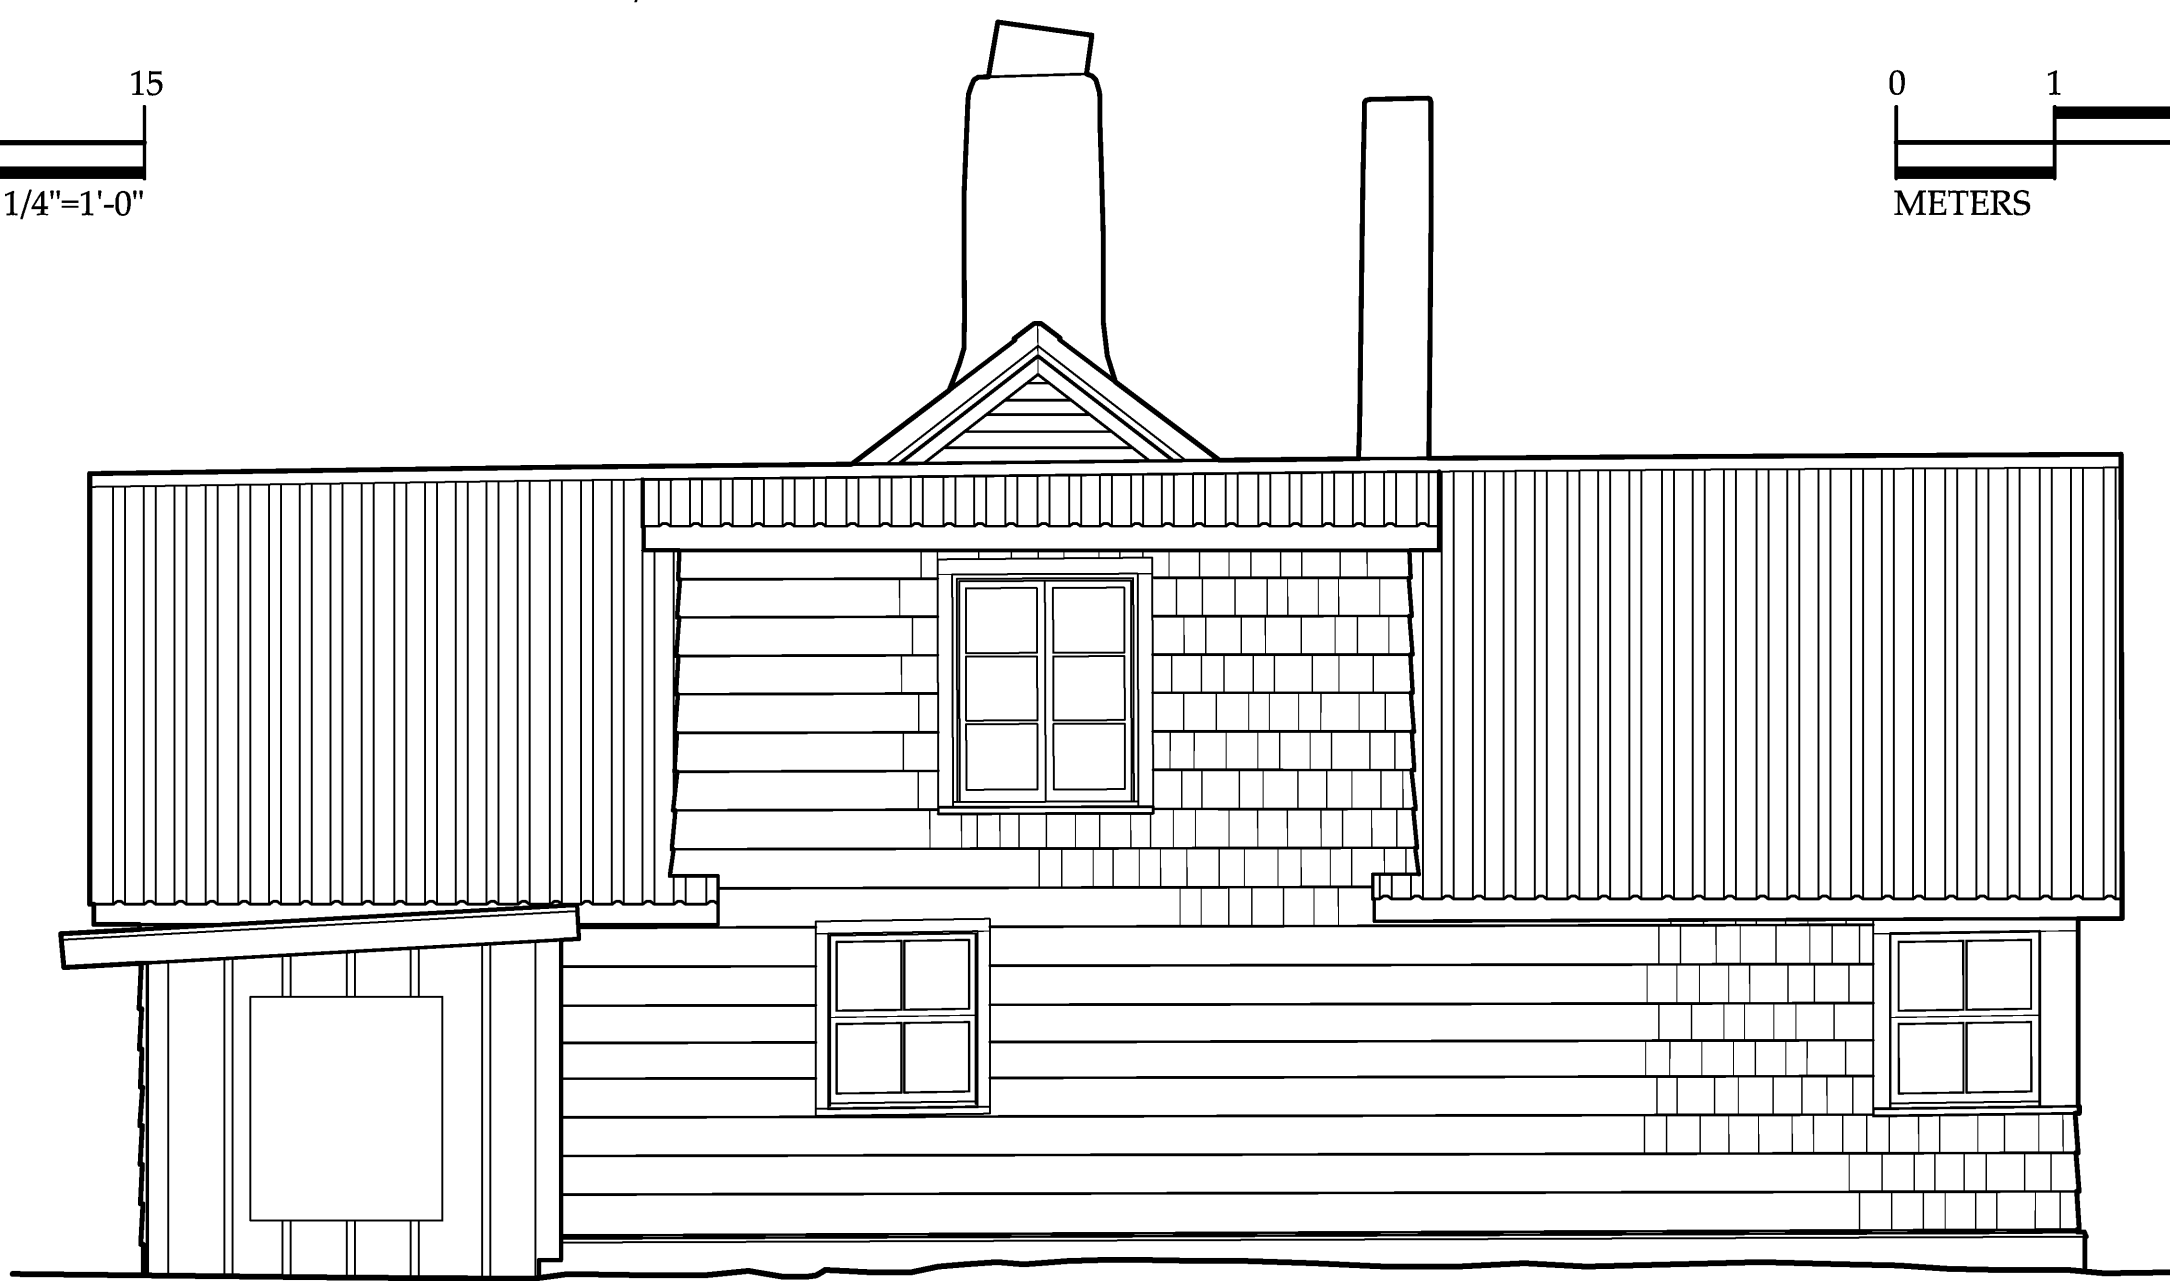
**NORTHEAST ELEVATION**  
1/4"=1'-0" 1:48

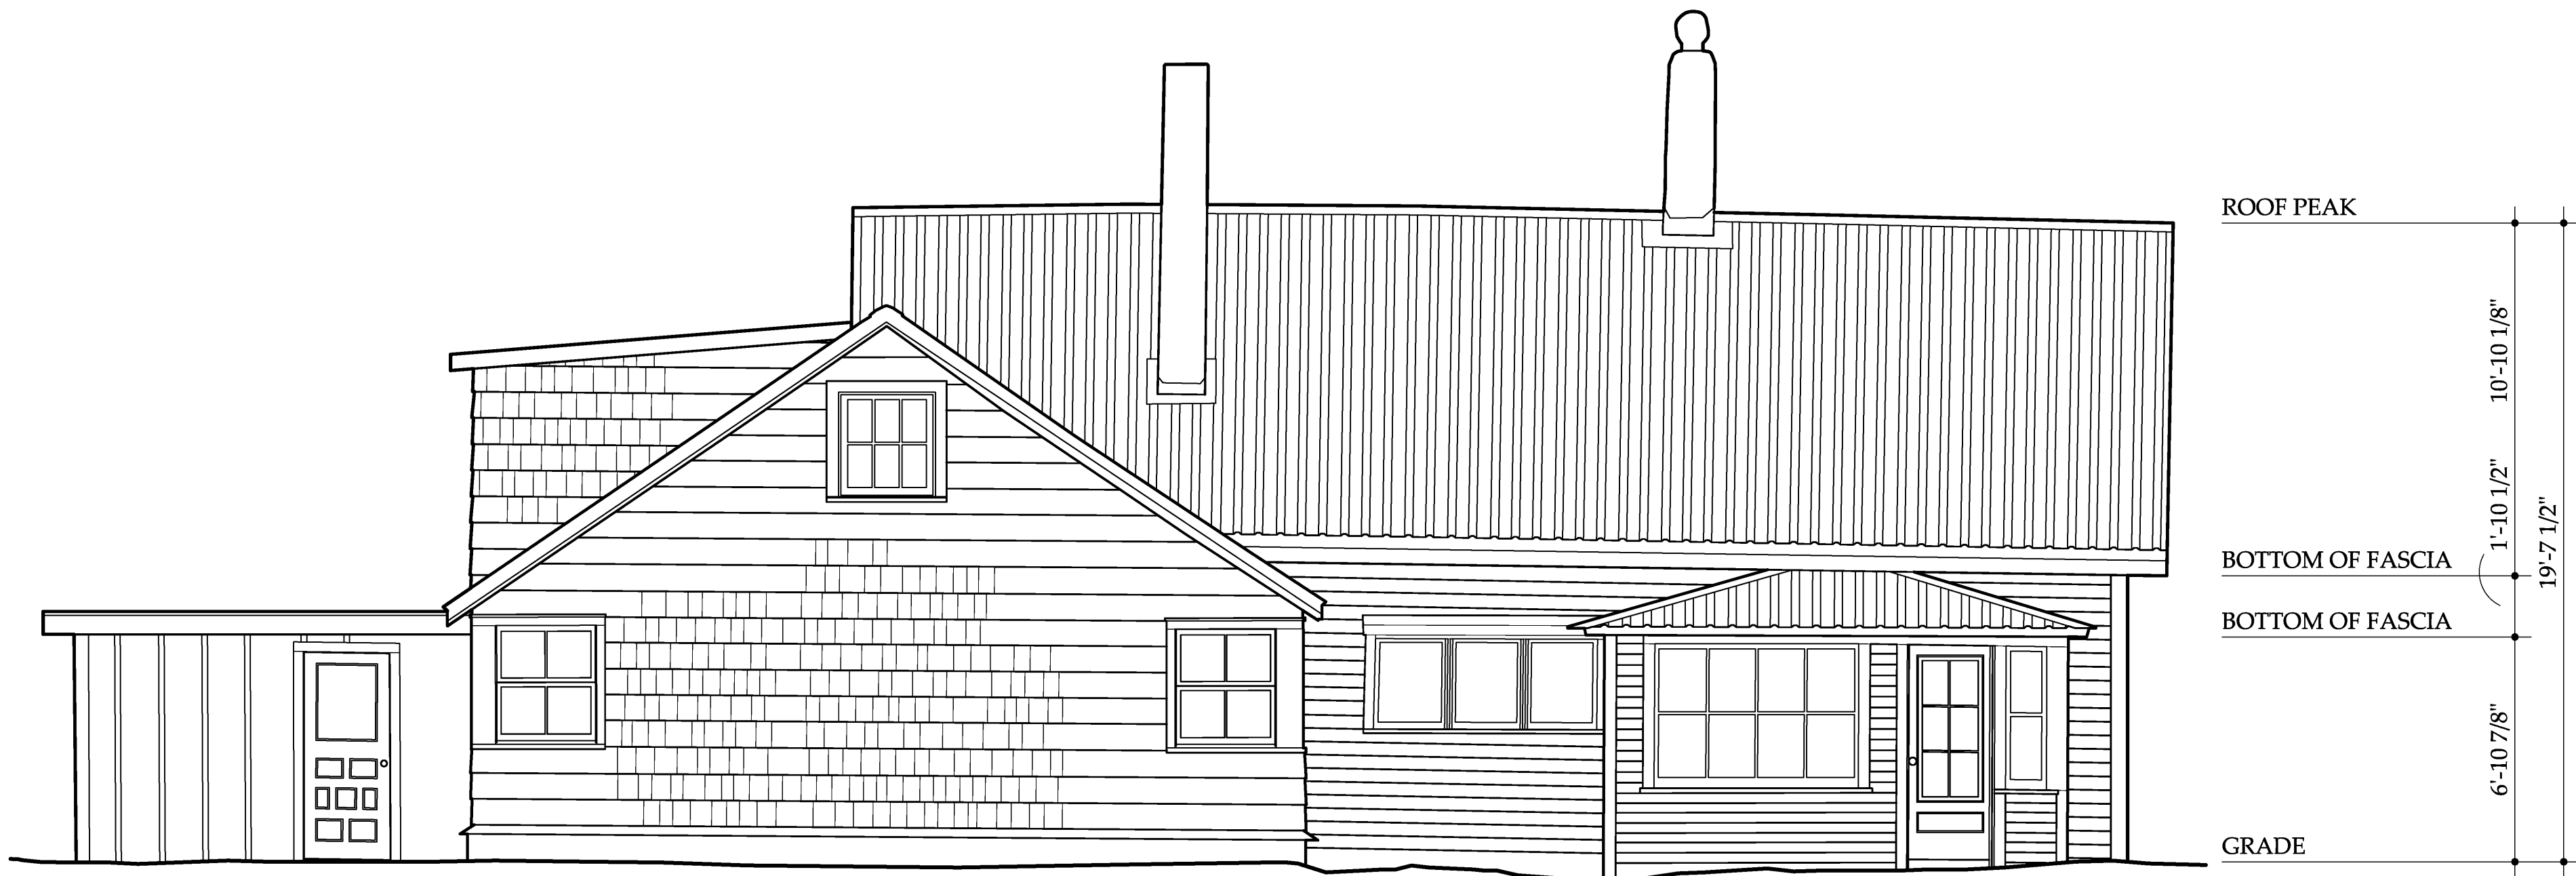
**NORTHWEST ELEVATION**  
1/4"=1'-0" 1:48

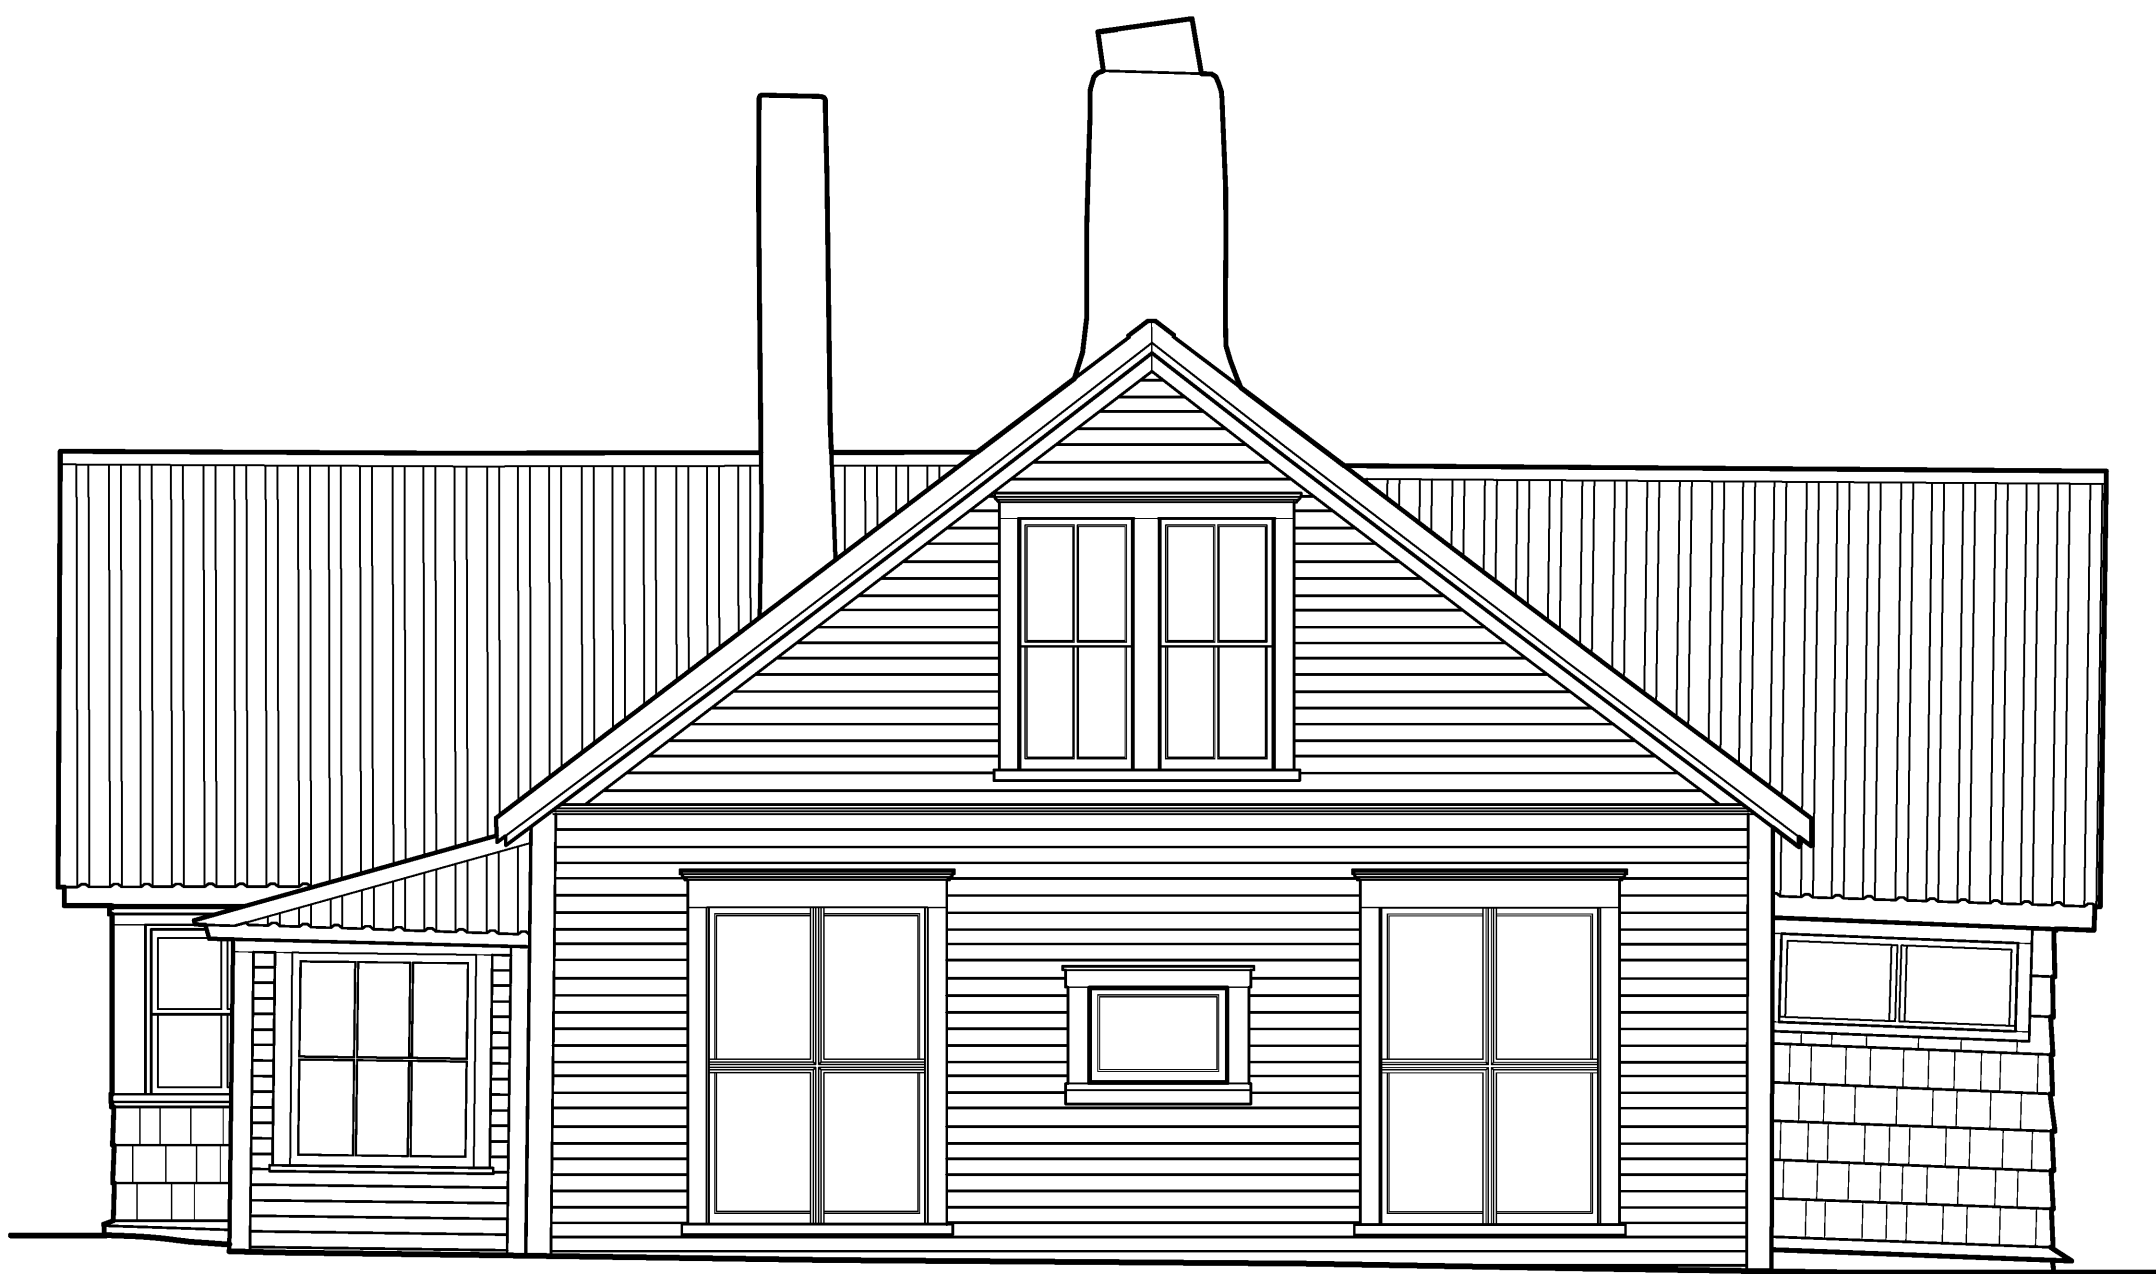
**SOUTHWEST ELEVATION**  
1/4"=1'-0" 1:48
