ADDENDUM TO:  
ALASKA STREET CRIB  
Klondike Gold Rush National Historical Park  
Skagway and White Pass Historic District  
Alley off east side of Broadway between Fifth and Sixth Avenues  
Skagway  
Municipality of Skagway Borough  
Alaska

WRITTEN HISTORICAL AND DESCRIPTIVE DATA

### ALASKA STREET CRIB

HABS No. AK-289

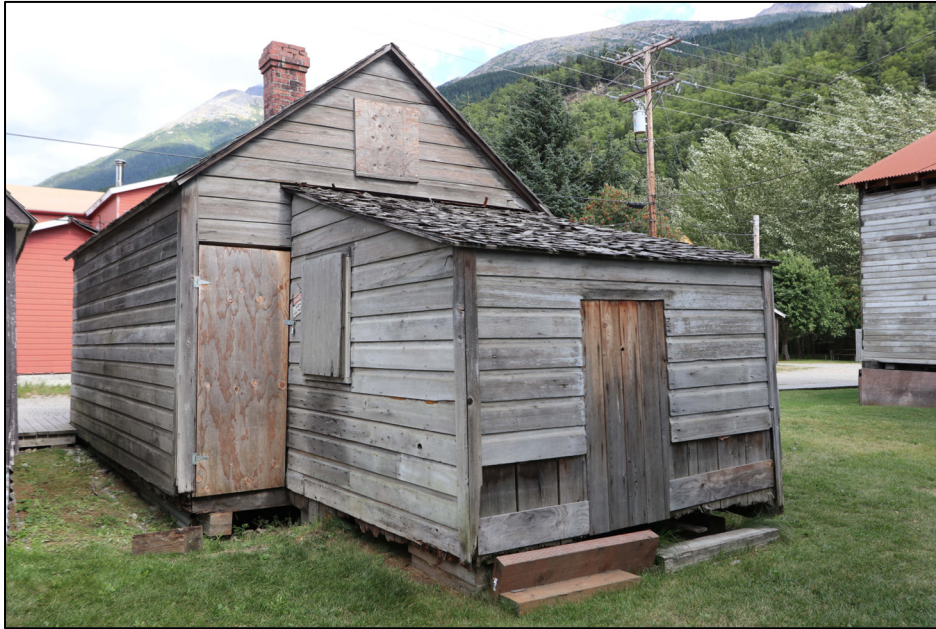
Figure 1: The Alaska Street Crib showing shed addition at rear, 2019

**Description:** The Alaska Street Crib is a roughly 20' 5" by 12' 4", one-story, wood-frame structure with a 9' 1/4" by 9' 5 7/8" shed attached at the back (Figure 1). It consists of two chambers with a third chamber located in the shed addition. The exterior walls of the structure are covered in untreated, double beveled shiplap siding (Figure 2). The crib has a wood-shingled, gable roof, currently oriented north-south, along the main structure and a shed roof sloped to the rear over the addition. A rectangular, red brick chimney is centered on the gabled roof of the main structure towards the south. The brick is laid in running bond with ten courses above the shingles, a four-course corbel, and a final top course (Figure 3).

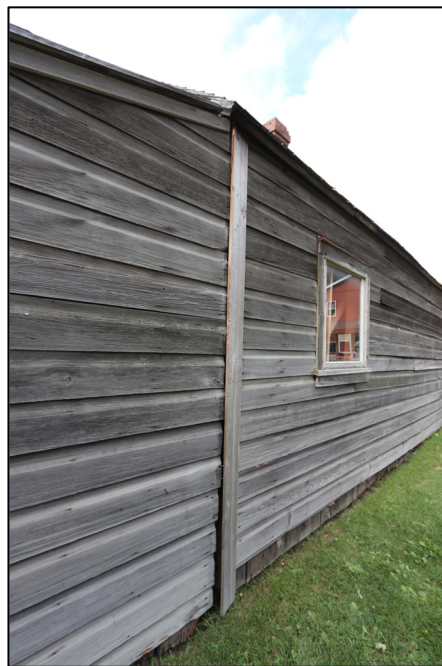
Figure 2: Alaska Street Crib, showing siding, 2019

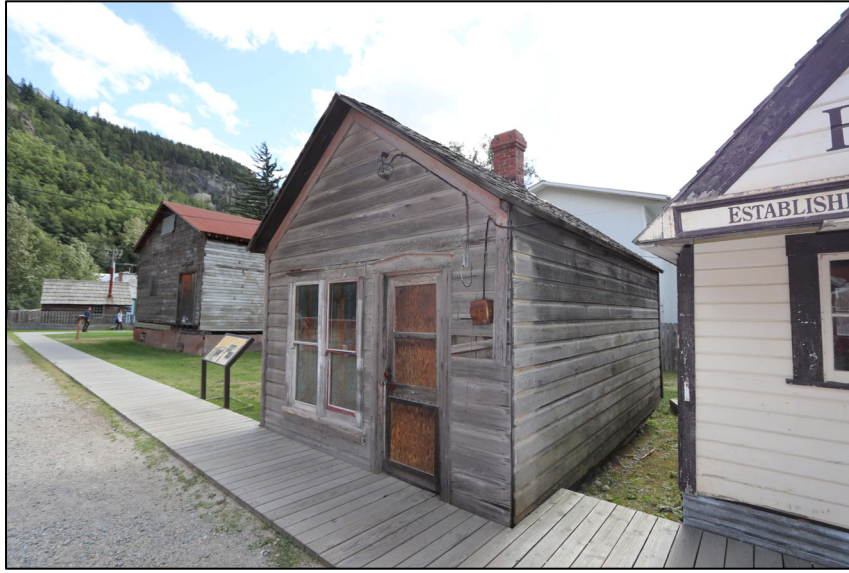
Figure 3: Alaska Street Crib, north elevation, 2019

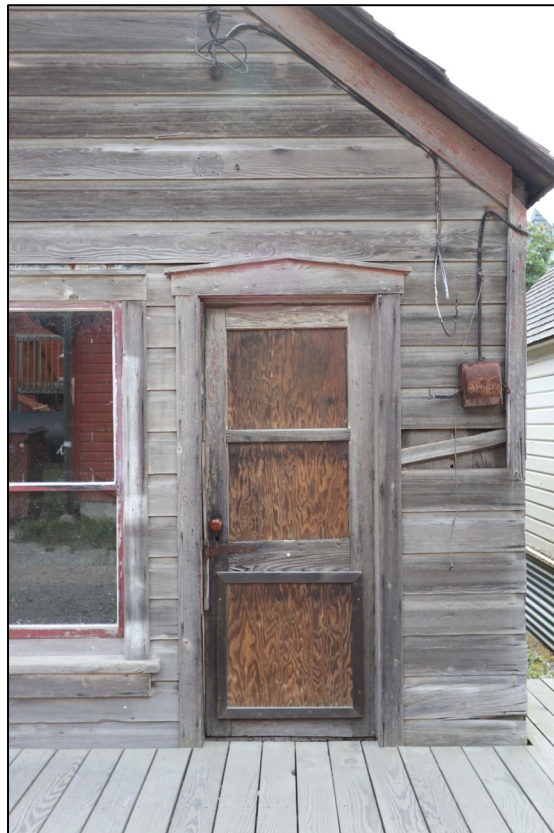
Figure 4: Alaska Street Crib, north elevation door detail, 2019

Three doorways provide entrance to the Alaska Street Crib—two accessing the main portion of the building, and one the shed. The doorway along the south elevation of the main structure is covered with a plywood door held in place with modern metal hinges and lock. This opening runs immediately up to the west elevation of the shed addition in such a way that the door is held in place with a padlock attached to the addition. The doorway to the shed is covered with five wood planks backed with plywood from the interior. The front door, along the building's north elevation, is the only remaining historical, exterior door. The wood door has three, roughly square, recessed panels. The bottom panel has been covered with a wood-framed piece of plywood. The top two panels have been replaced with plywood. The door has a butted wood frame, topped with a simple, wood relieving arch (Figure 4).

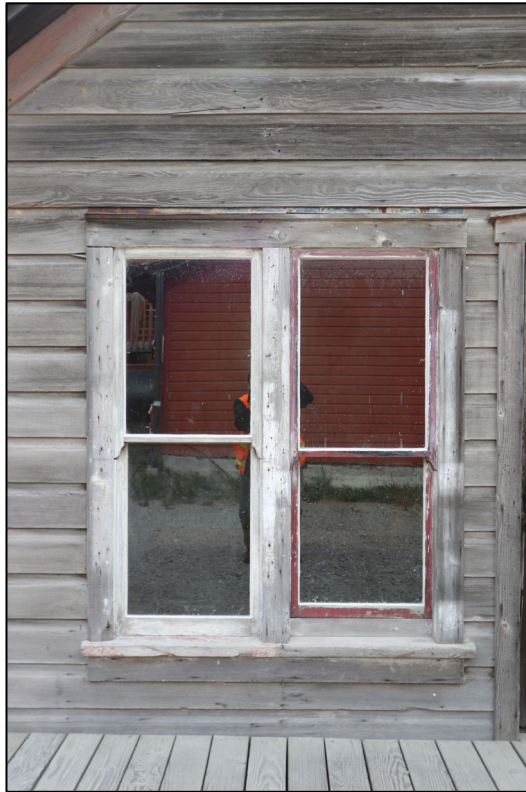
Figure 5: Alaska Street Crib, north elevation fenestration, 2019

The structure has five windows—one along the east elevation of the shed, one centered in the gable of the south elevation of the crib, one along the crib's west elevation, and two to the left of the door on the building's north, or front, elevation. The two windows along the north elevation are side-by-side, one-over-one, double hung, wood sash windows. They share a butted wood frame and sill (Figure 5). The remaining windows appear to be fixed and are roughly square. Two are covered on the exterior with plywood. The window along the crib's west elevation is visible. Its butted wood frame is trimmed with quarter-round molding on top and bottom, and a metal-covered strip of wood sits atop the frame (Figure 6). This likely served as weather protection.

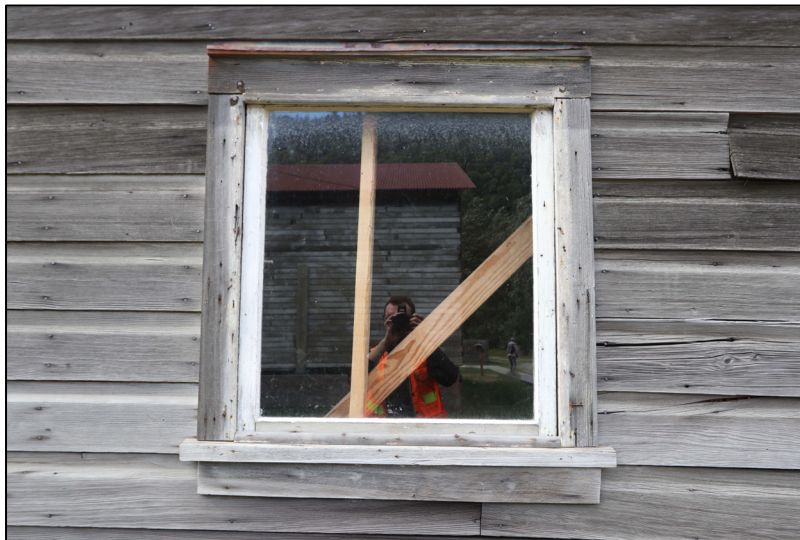
Figure 6: Alaska Street Crib, west elevation window, 2019

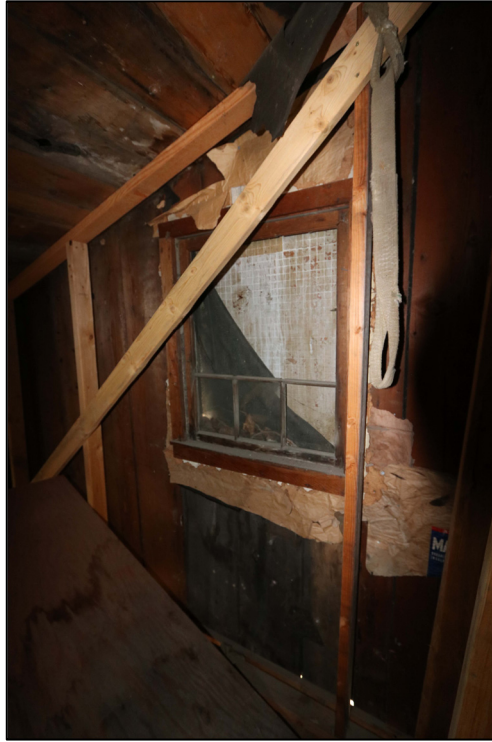
Figure 7: Alaska Street Crib, interior of shed addition showing window, 2019  
Source: Field Photograph by John Wachtel, Historical Architect, AKRO, HABS fieldwork, NPS, KLGO, IMG\_6676.

The interior walls and ceiling of the shed addition are wood and the floor is open with framing and the ground visible. The window in the shed has one large light above three, equally divided, roughly square lights. It has a butted wood frame and sill (Figure 7).

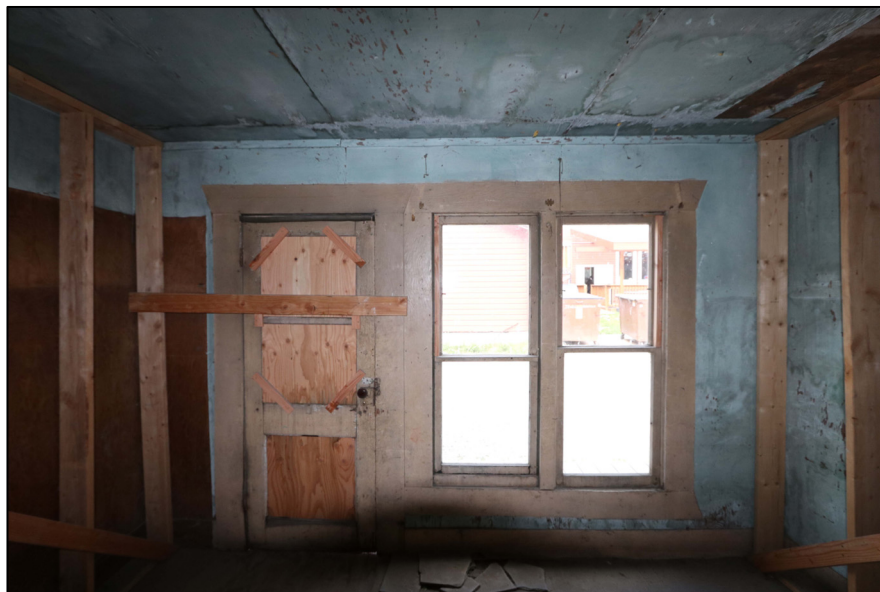
Figure 8: Alaska Street Crib, interior of front chamber, 2019  
Source: Field Photograph by John Wachtel, Historical Architect, AKRO, HABS fieldwork, NPS, KLGO, IMG\_6703.

The walls and ceiling of the front chamber are plywood, painted light blue (Figure 8). Remnants of off-white linoleum are visible in both chambers (Figures 9 and 10). A metal wall thimble remains, revealing where a stove historically connected to the crib's chimney (Figure 11). The walls and ceiling of the rear chamber are plywood, painted cream with dark green wood baseboards and trim covering plywood sheet divisions (Figure 12). The wall dividing the two chambers is plywood, painted cream. A portion of the chimney, currently covered with plywood, is visible on the dividing wall from the rear chamber. It is supported by wood shelving beneath (Figure 13).

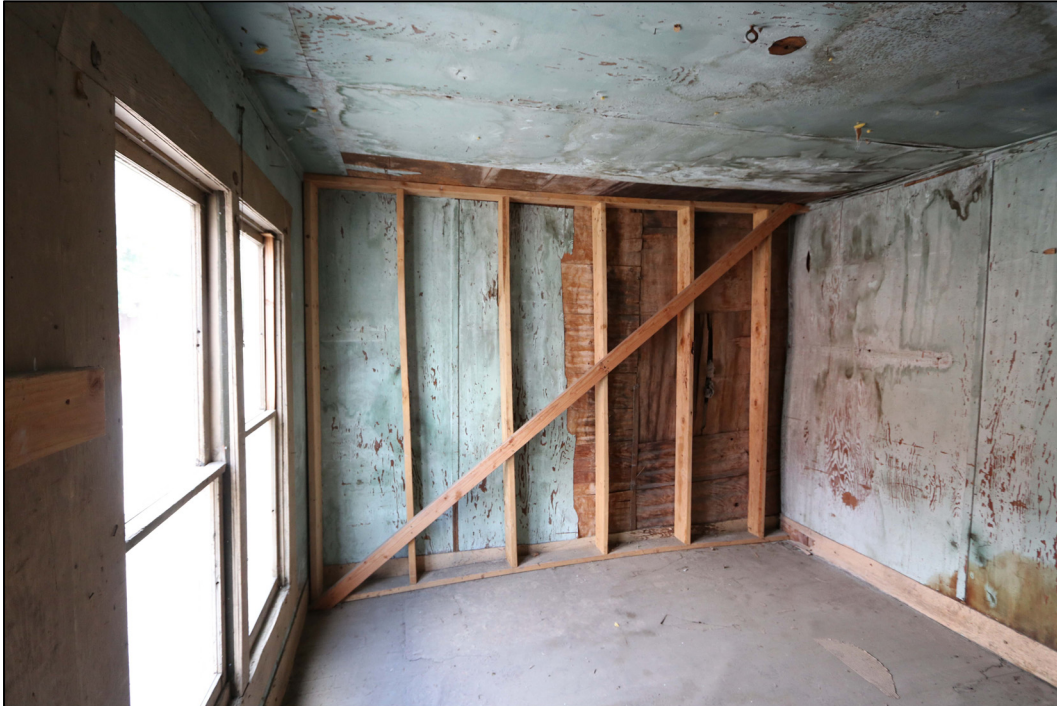
Figure 9: Alaska Street Crib, front chamber looking east, 2019  
Source: Field Photograph by John Wachtel, Historical Architect, AKRO, HABS fieldwork, NPS, KLGO, IMG\_6700.

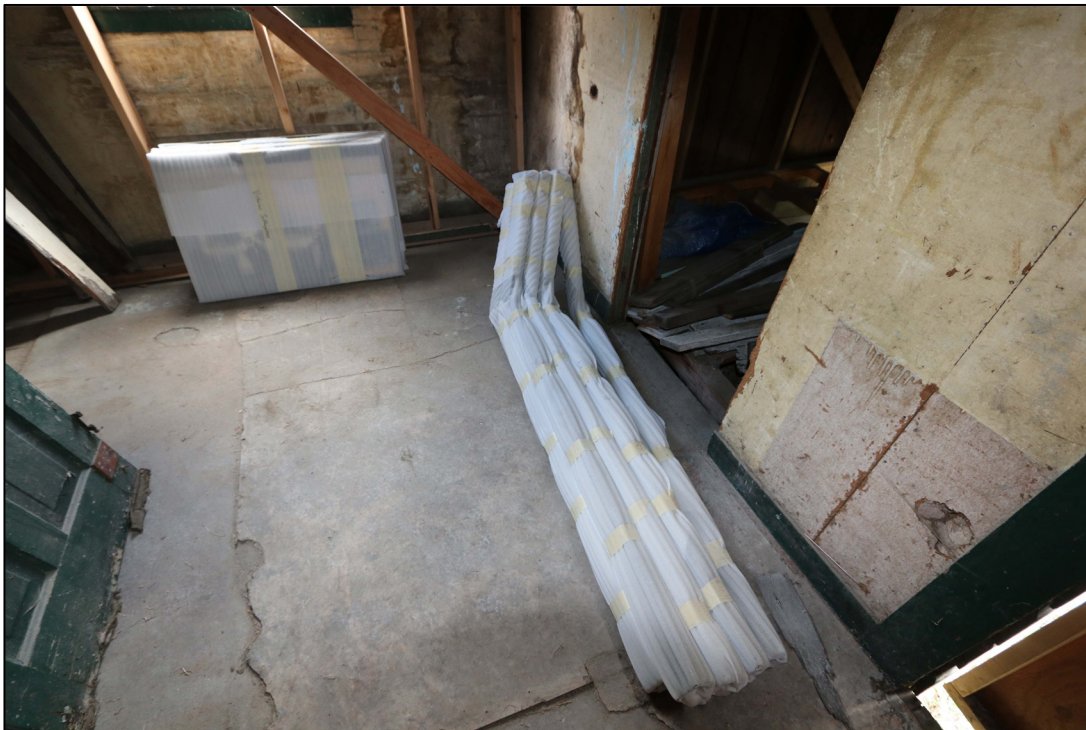
Figure 10: Alaska Street Crib, back chamber floor, 2019  
Source: Field Photograph by John Wachtel, Historical Architect, AKRO, HABS fieldwork, NPS, KLGO, IMG\_6689.

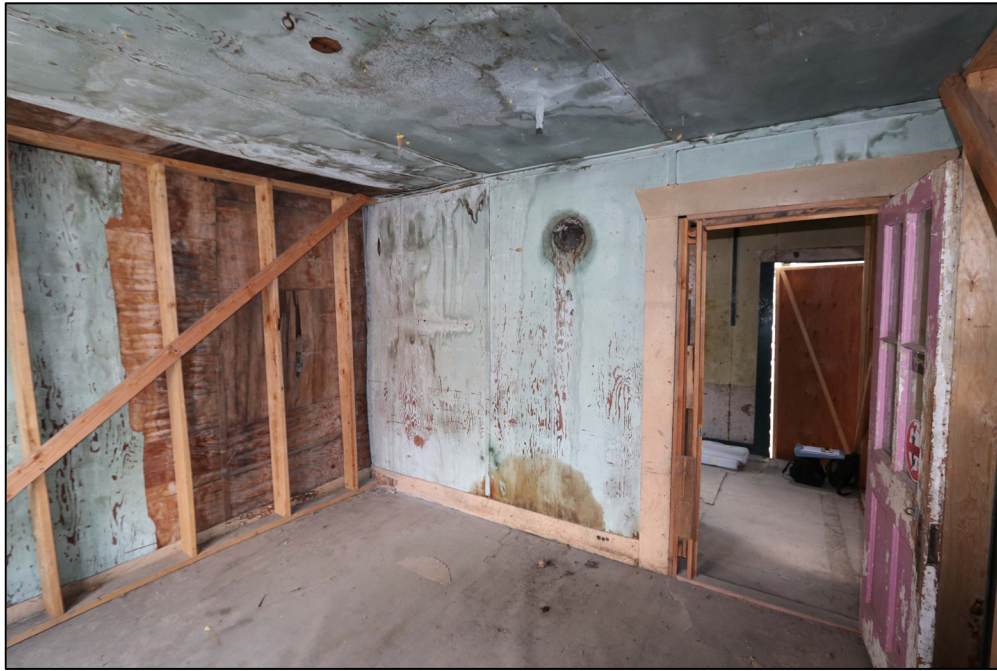
Figure 11: Alaska Street Crib, front chamber showing metal thimble, 2019  
Source: Field Photograph by John Wachtel, Historical Architect, AKRO, HABS fieldwork, NPS, KLGO, IMG\_6701.

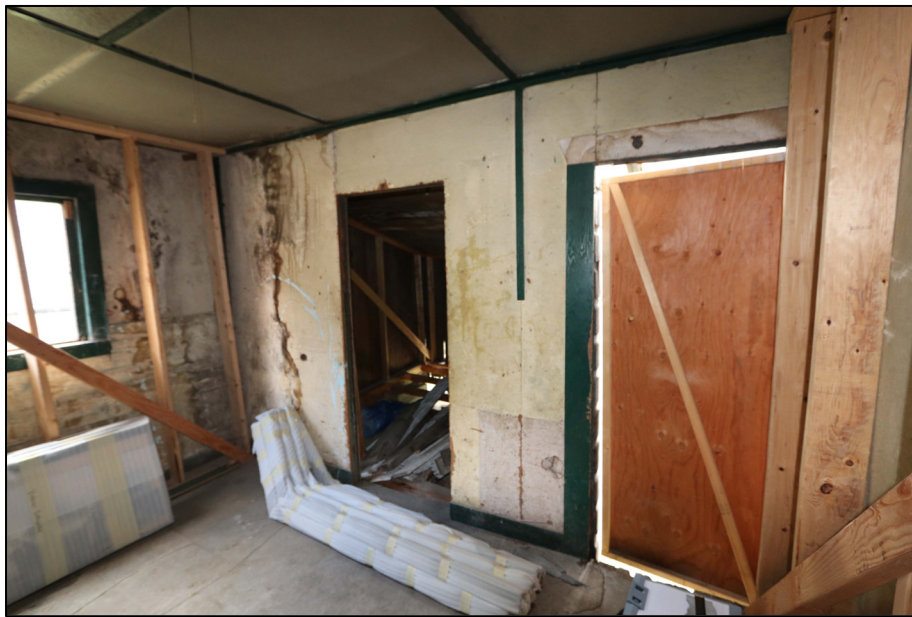
Figure 12: Alaska Street Crib, back Chamber to shed addition showing green trim, 2019  
Source: Field Photograph by John Wachtel, Historical Architect, AKRO, HABS fieldwork, NPS, KLGO, IMG\_6687.

All three interior doorways are framed in wood with the top board angling out, creating a simple winged appearance (Figure 14). In the rear chamber the frames are painted green, while the front door's frame is painted cream. The door separating the two main chambers appears to be a

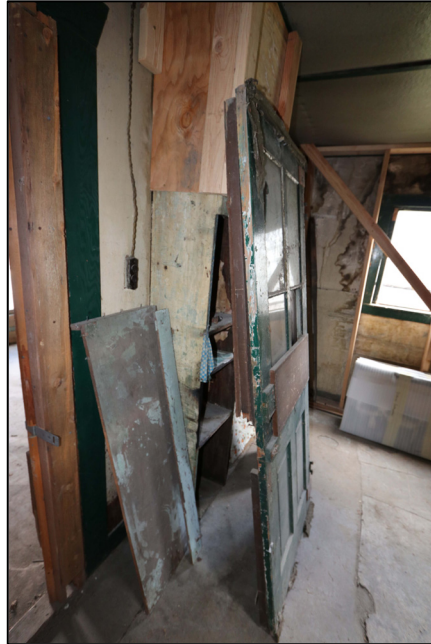
Figure 13: Alaska Street Crib, back chamber showing shelving support for chimney, 2019  
Source: Field Photograph by John Wachtel, Historic American Buildings Survey fieldwork, National Park Service, Klondike Gold Rush National Historical Park, IMG\_6692.

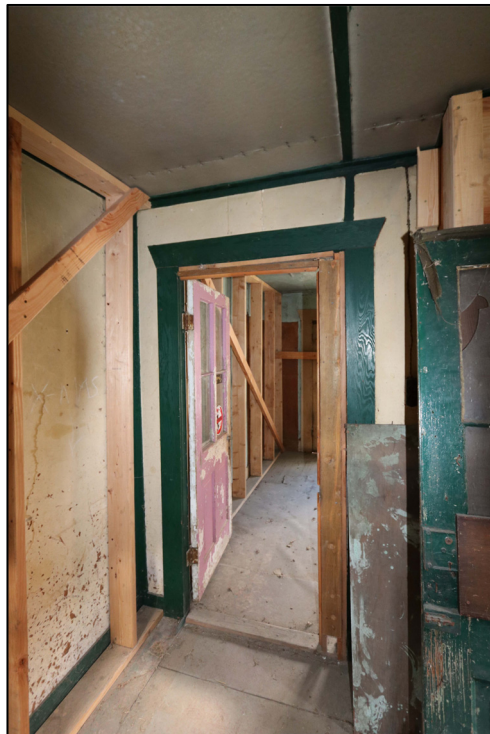
Figure 14: Alaska Street Crib, back chamber showing typical framing design, 2019  
Source: Field Photograph by John Wachtel, Historical Architect, AKRO, HABS fieldwork, NPS, KLGO, IMG\_6696.

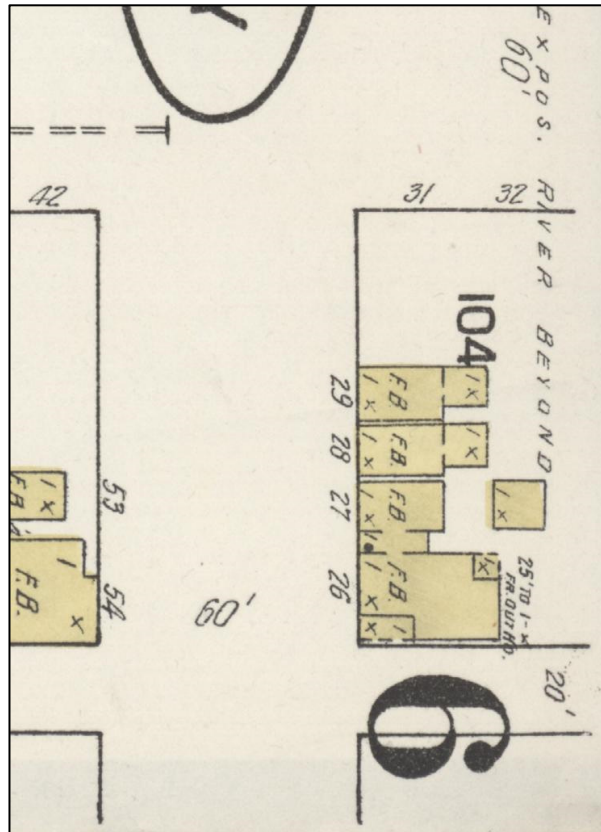
Figure 15: Sanborn Fire Insurance Map from Skagway, Skagway-yakutat Census Division, Alaska, showing Block 16, Lot 12 in box numbered 104, 1914  
Source: Library of Congress, Geography and Map Division, Sanborn Maps Collection.

Records confirm that the Alaska Street Crib was located on Alaska Street in 1914. The Sanborn Fire Insurance Map of Skagway, Alaska from that year shows the structure adjacent to what is believed to be the Essie Miller Brothel. The map indicates that the structure was used as “Female Boarding,” likely indicating that it was a house of prostitution (Figure 15).<sup>16</sup>
