Sheep Camp, Building S7  
Skagway  
Skagway-Yakutat Division  
Alaska

HABS No. AK-29-C

REDUCED COPY OF MEASURED DRAWING

NAME AND LOCATION OF STRUCTURE  
**SHEEP CAMP**  
BUILDING S7

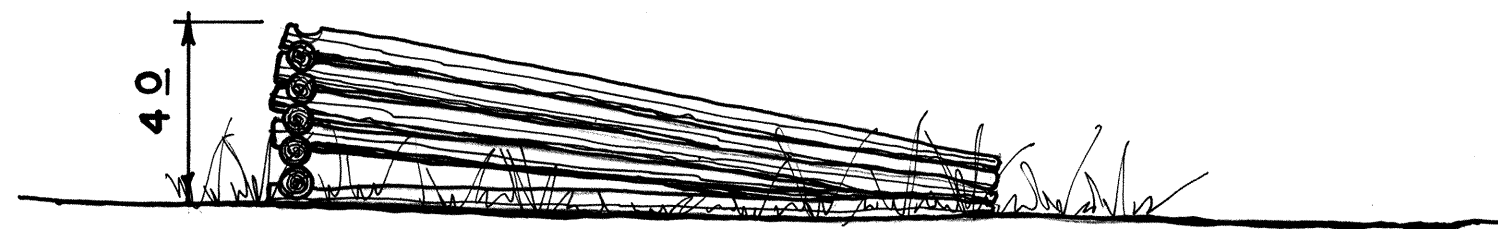
**NORTH ELEVATION**  
SCALE: 1/4" = 1'-0"

exterior chinking of small branches

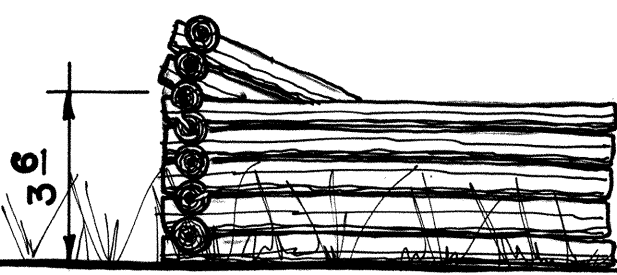
**SOUTH ELEVATION**  
SCALE: 1/4" = 1'-0"

decaying wood causing structure to collapse in direction of slope

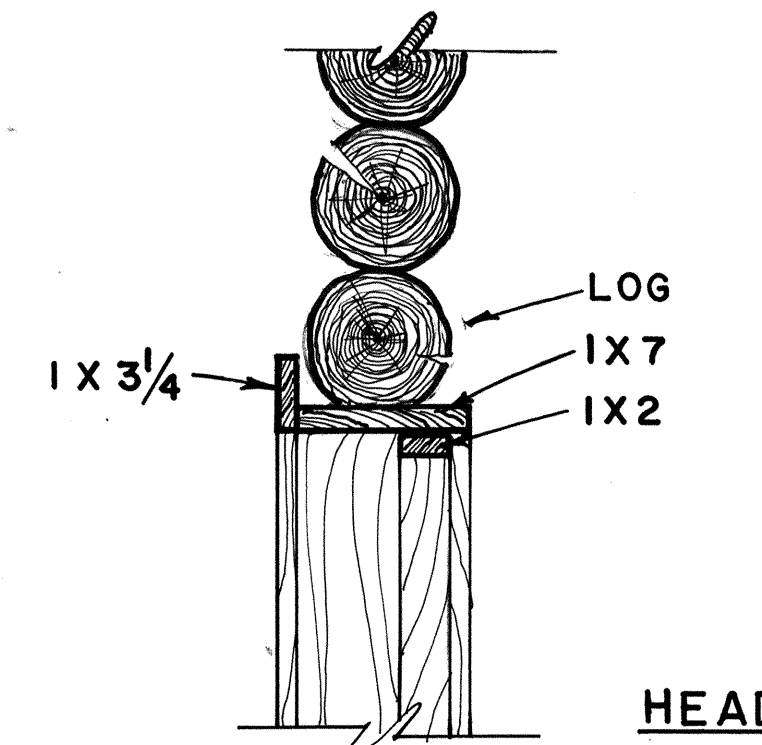
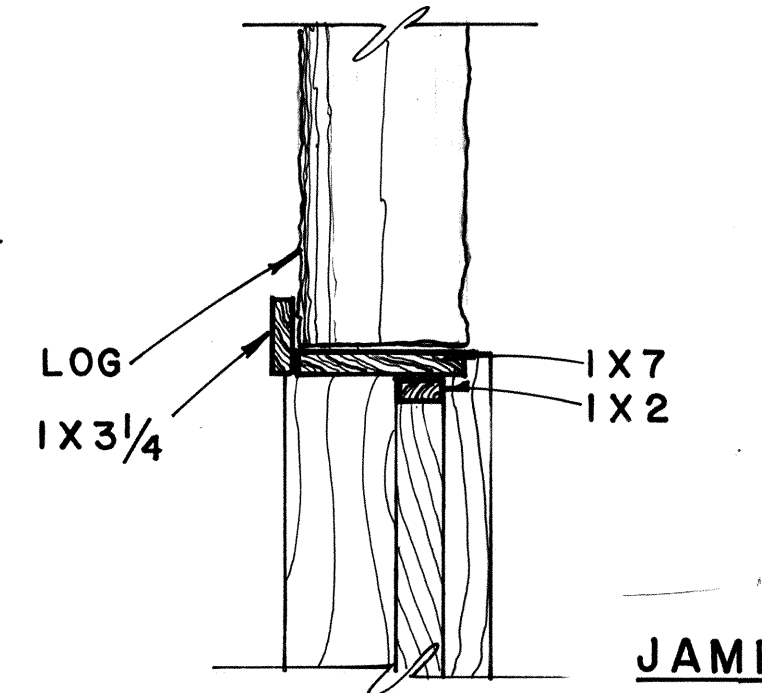
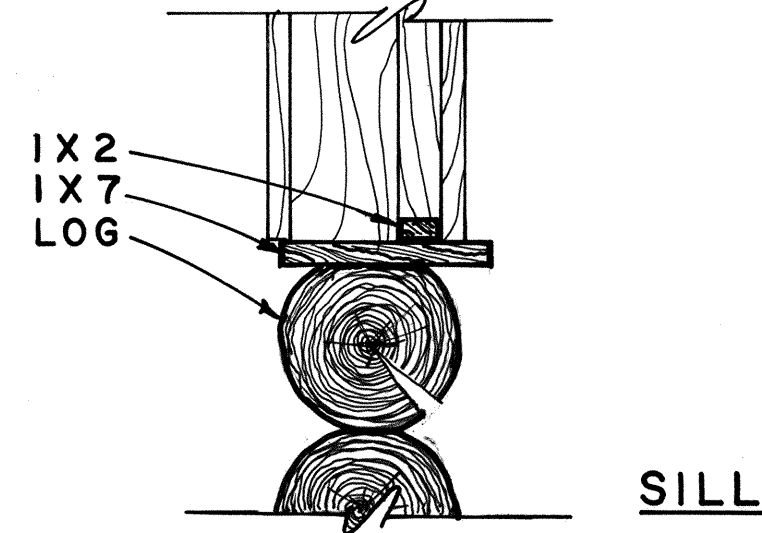
**WINDOW DETAIL**  
SCALE: 1/2" = 1'-0"

**HEAD**

**JAMB**

**SILL**
