NATIONAL REGISTER OF HISTORIC PLACES  
CONTINUATION SHEET

Lassen Volcanic National Park

Highway Historic District

**Additional Documentation: Current Condition Photographs (see also original photographs, attached)**

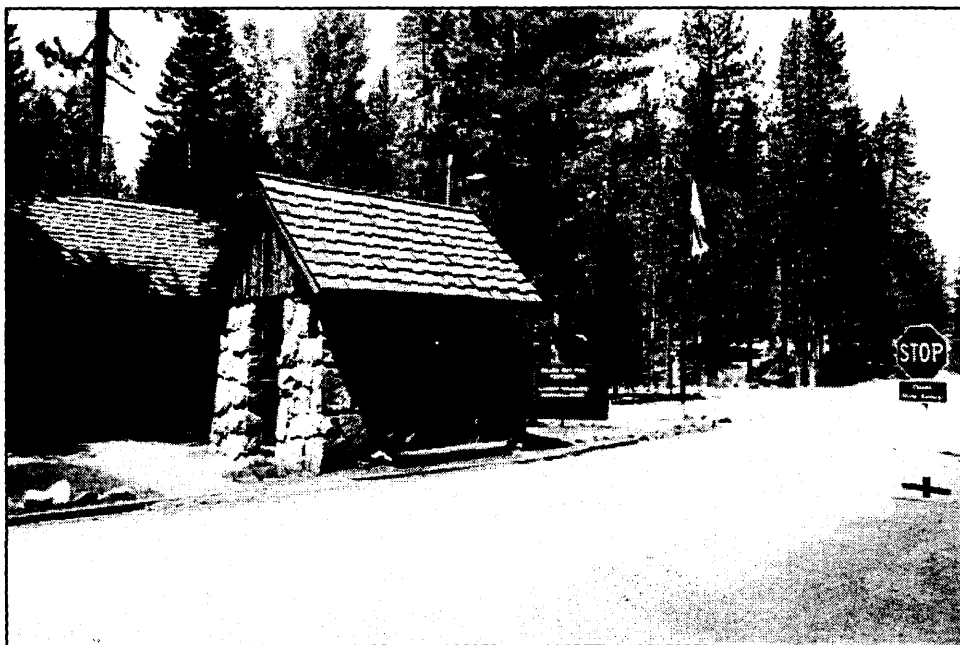
Photo 2: Northwest Entrance Station – Entrance Kiosk and residence, view to west.

The Northwest Entrance Checking Station, completed in 1931, is located near the western shore of Manzanita Lake. It is positioned in the center of the road, opposite the ranger residence, and serves entering and exiting traffic. The checking station features a rough-cut lava-rock foundation and walls and is surmounted by a steeply gabled, wood-shake roof. Exposed rafter tails, and vertical, split, unpeeled logs on the gable ends contribute to the building's rustic character. Details include mullioned windows and copper lanterns. A non-historic, narrow turf island edged with barrier rocks frames the checking station and accommodates a seasoned, peeled wood flagpole. A flagpole appears in the same location in historic photographs, and, although the age of the current example cannot be determined, it should be considered contributing.

The residence, designed and built in association with the entrance station, is of largely the same design. The residence features a rough-cut lava rock foundation and walls and is surmounted by a steeply gabled, wood-shake roof. Exposed rafter tails, and vertical, split, unpeeled logs on the gable ends contribute to the building's rustic character. Details include mullioned windows.

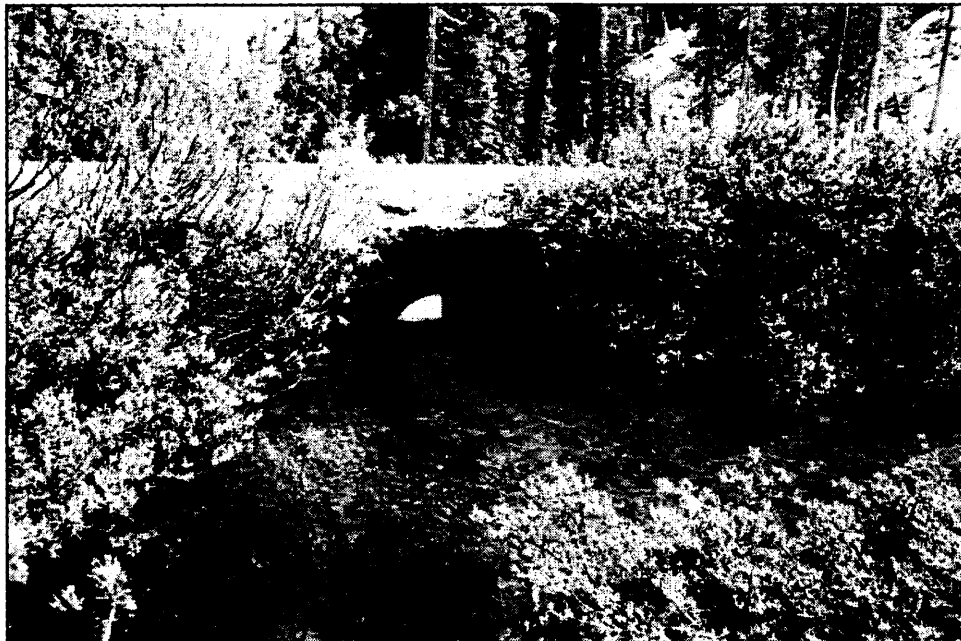
Photo 8: Stone Culvert – Kings Creek north side (upstream), view to SSW.

Kings Creek culvert, constructed during the 1928 and 1929 construction seasons, was built to span Kings Creek on the southern side of Reading Peak. Built as a four by four masonry arch, stone for its headwalls was excavated onsite and from a nearby rockslide. Its masonry details include lintels and ringstones. The culvert appears to be in good condition.

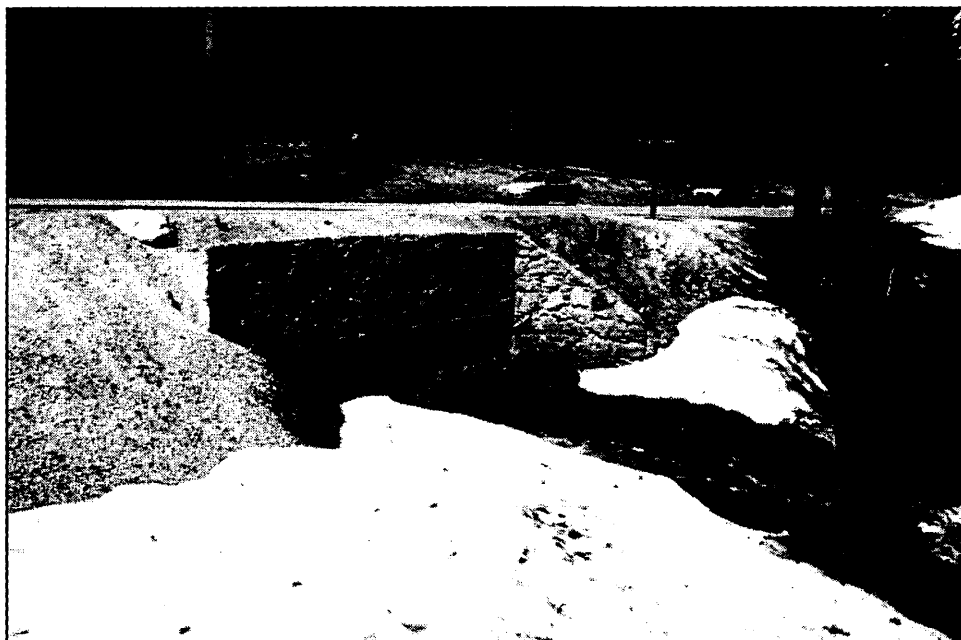
Photo 9: Stone Culvert – Kings Creek south side (downstream), view to NNE.

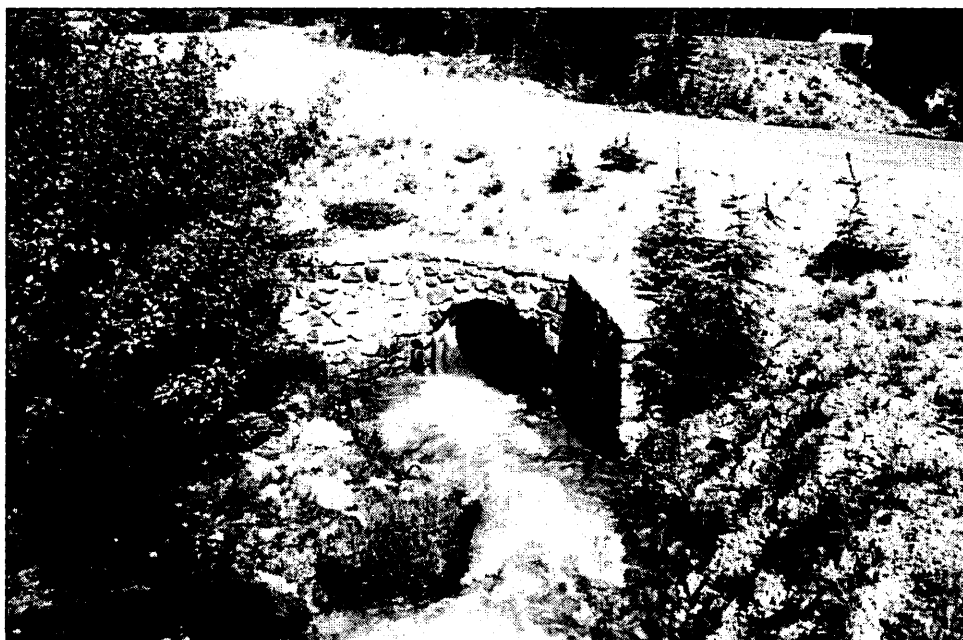
Photo 11: Stone Headwall on concrete culvert – on West Sulphur Creek, view to SE.

Culvert headwalls and drainage culverts are the predominant National Park Service rustic design feature on the road. Headwalls were designed to serve a practical function as well as to produce an aesthetic effect; they provided passage for perennial and intermittent streams while masking the corrugated iron pipes within. The use of locally obtained lava rock was both an economic expedient and a design contrivance as it was readily available and served to blend the structures into the landscape. While headwall dimensions vary in relation to culvert diameter, the majority of

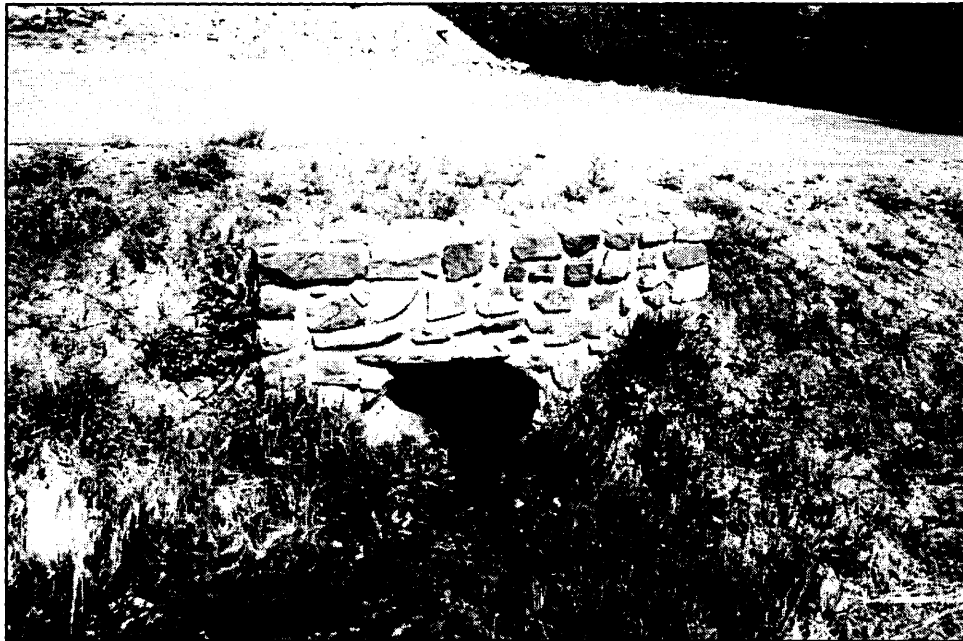
Photo 12: Stone Headwall on concrete culvert – on West Sulphur Creek, view to east.

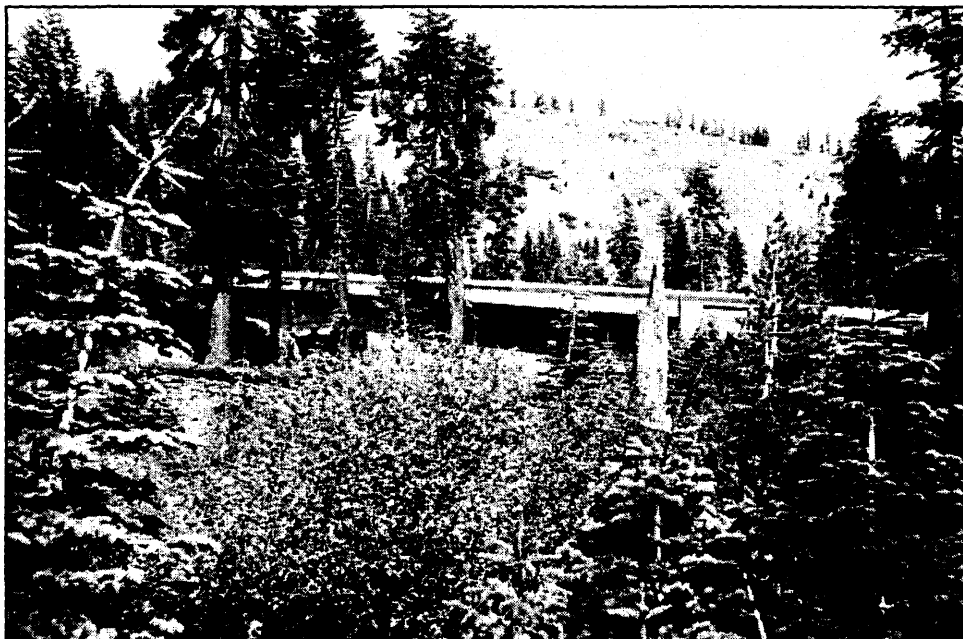
Photo 13: Bridge over West Sulphur Creek, view to east.

The Sulphur Works bridge replaced a large fill and culvert drainage system along the west fork of Sulphur Creek. Construction on the bridge began in 1964, and it was opened to traffic in the spring of 1966. The continuous deck steel stringer bridge spans 214 feet, 3 inches abutment-to-abutment. The design was based on the prevailing (1961) AASHO (American Association of State Highway Officials) standards for highway bridges. The concrete used for the footings and pier was classed as Type V Portland cement, a sulphate-resistant cementing material appropriate for the location.

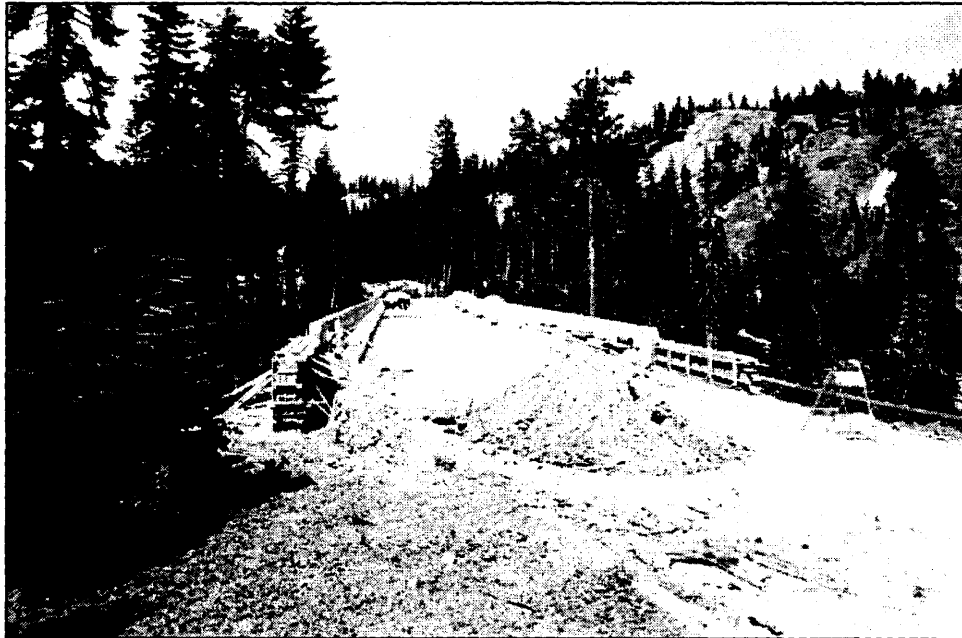
Photo 14: Concrete bridge deck, view to NW.
