ARCHEOLOGICAL INVESTIGATIONS AT THE LINCOLN HOME NATIONAL HISTORIC SITE, SPRINGFIELD, ILLINOIS

By
Floyd Mansberger

NORTHERN ILLINOIS UNIVERSITY
DEKALB, ILLINOIS

Prepared For The National Park Service
Midwest Archeological Center-Lincoln, Nebraska

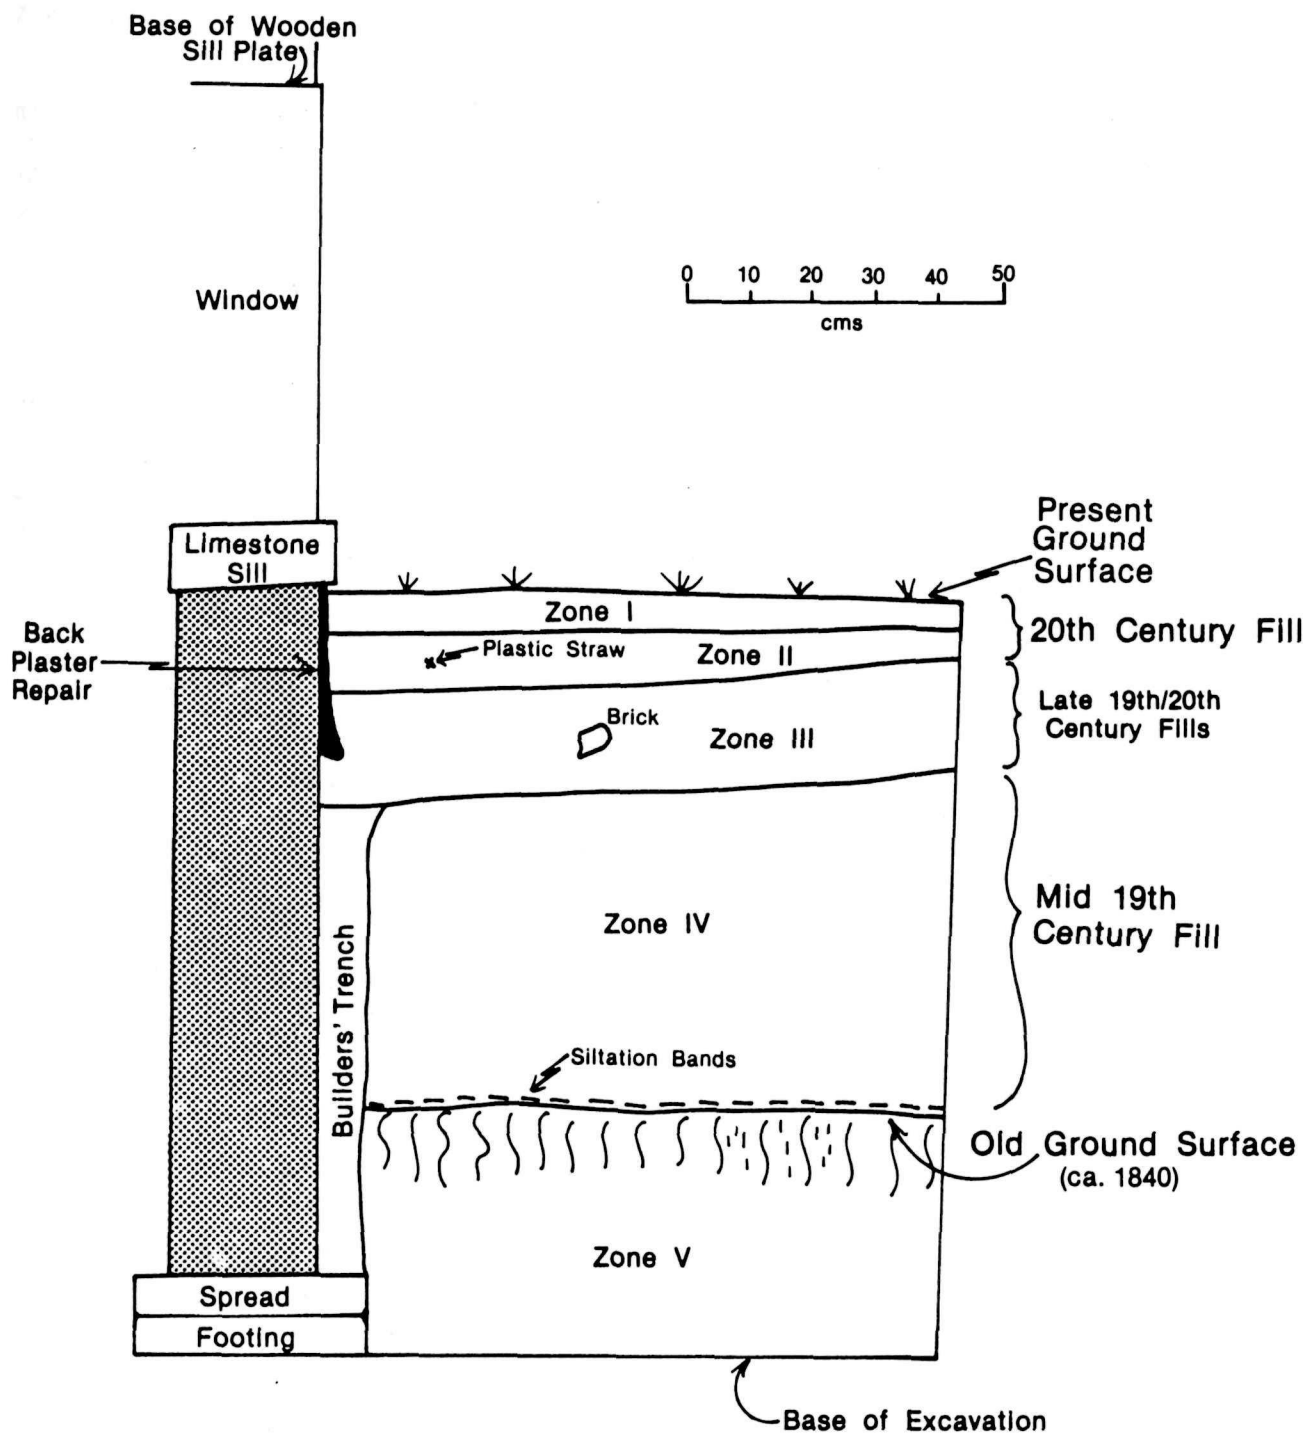
FIGURE 9. The Shutt Site, Test 1 Profile.

foundation construction. A distinct but narrow builder's trench was present along the foundation wall. The top of Zone V appears to represent the late-19th century ground surface.

The brick foundation wall at this location was laid from inside the cellar hole. Little cultural material besides brick fragments and mortar were found within the builder's trench. At the base of the foundations, the brick wall rested on a spread footing two brick-courses high.

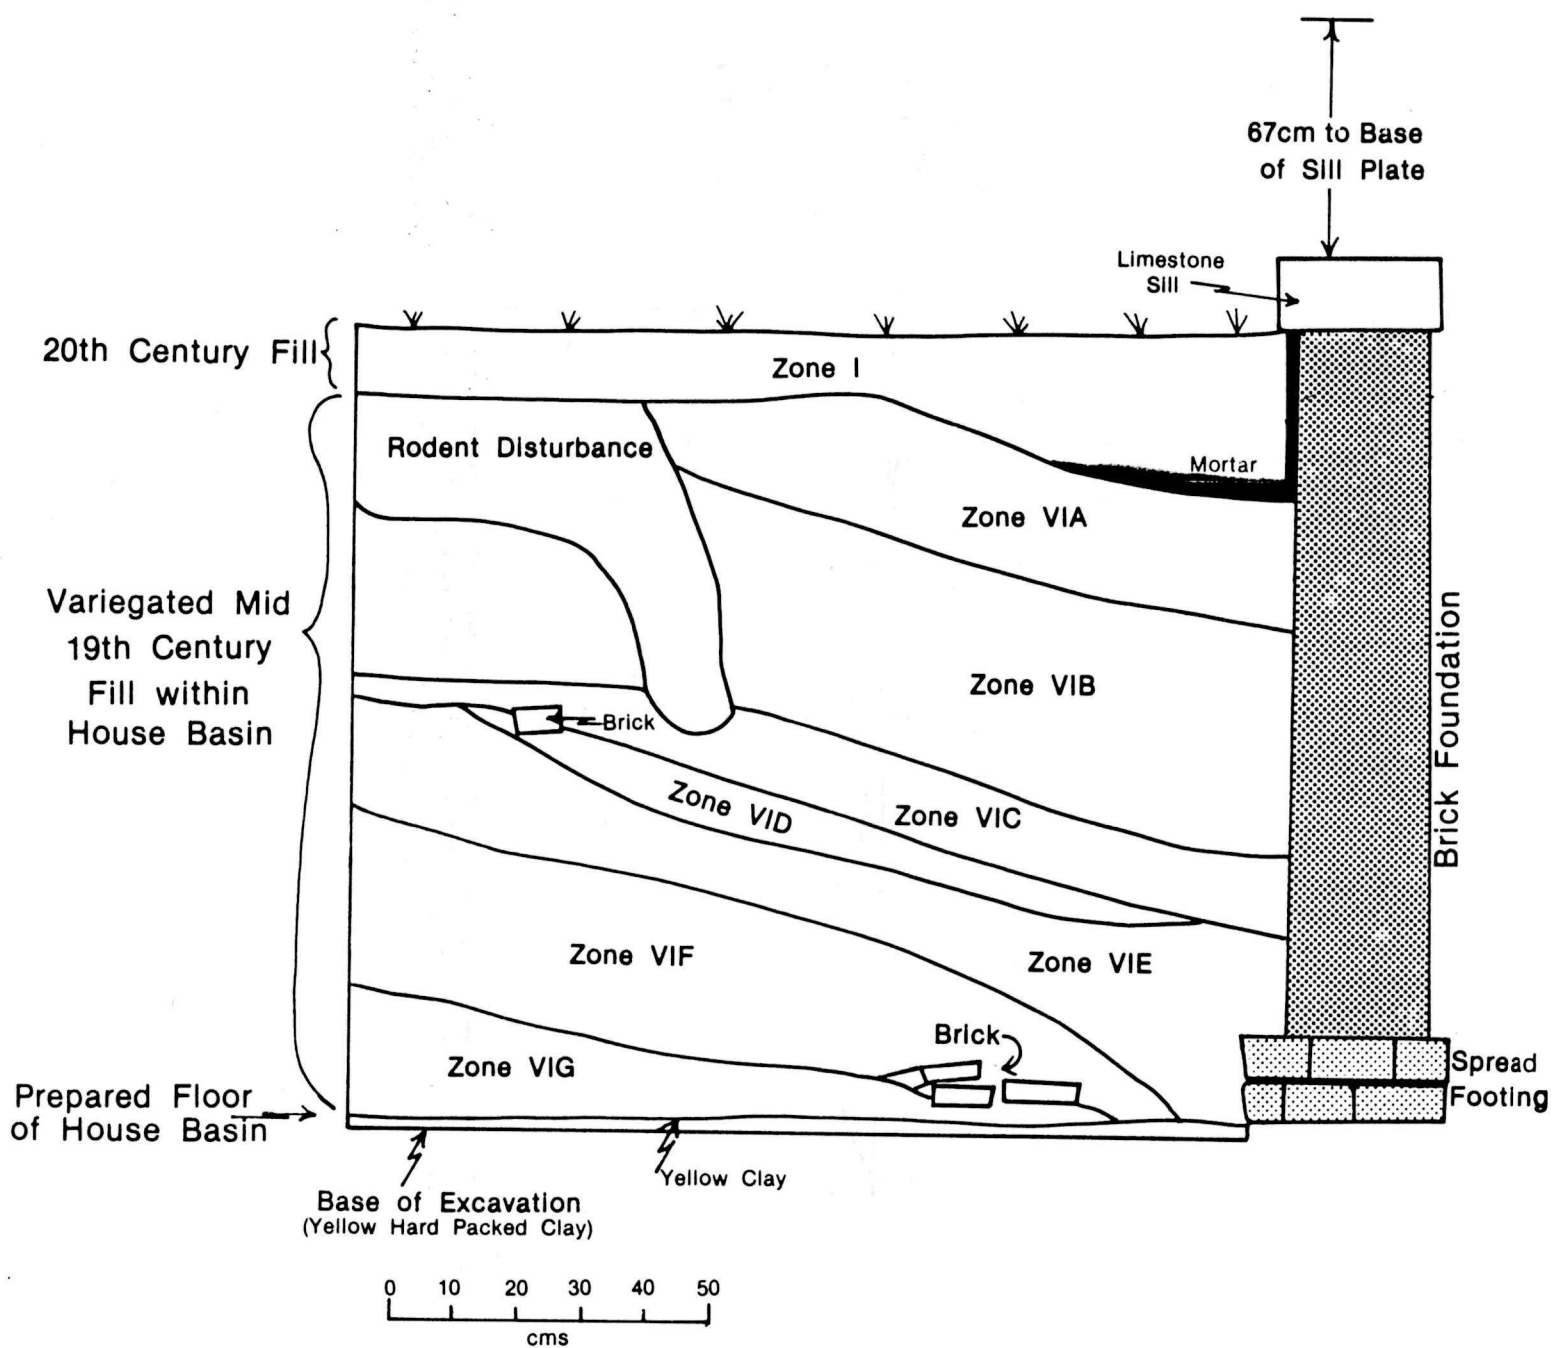
FIGURE 11. The Shutt Site, Test 3, West Wall Profile.

Test 3 was located along the south wall of the Shutt House just west of the bay window. Zone I represents 20th-century fill. Along the house wall, this zone dips to a depth of 25cm below the present surface. Indications of repointing and backplastering around the basement window sill were present. Beneath Zone I to the base of the brick foundation (125cm below surface) consisted of several lenses of variegated fills (Zone VI). Towards the base of the test, concentrations of mortar and brick were found. These lenses slope toward the Shutt House foundation, indicating that they were backfilled around the present structure. The floor of the test consisted of a hard-packed yellow clay directly beneath the spread footing associated with the foundation. Directly above this hard-packed clay was a thin layer (3cm) of clean yellow clay.

It is significant that the deep fill deposits end at the base of the present Shutt House foundation and that a wide, flat, and hard-packed prepared cellar floor is present beneath this fill. Above this is a concentration of brick rubble and mortar. It is thought that Test 3 was excavated within an earlier house basin that was filled after the demolition of this earlier structure and the construction of the Shutt House foundation. No builder's trench was apparent within this test.

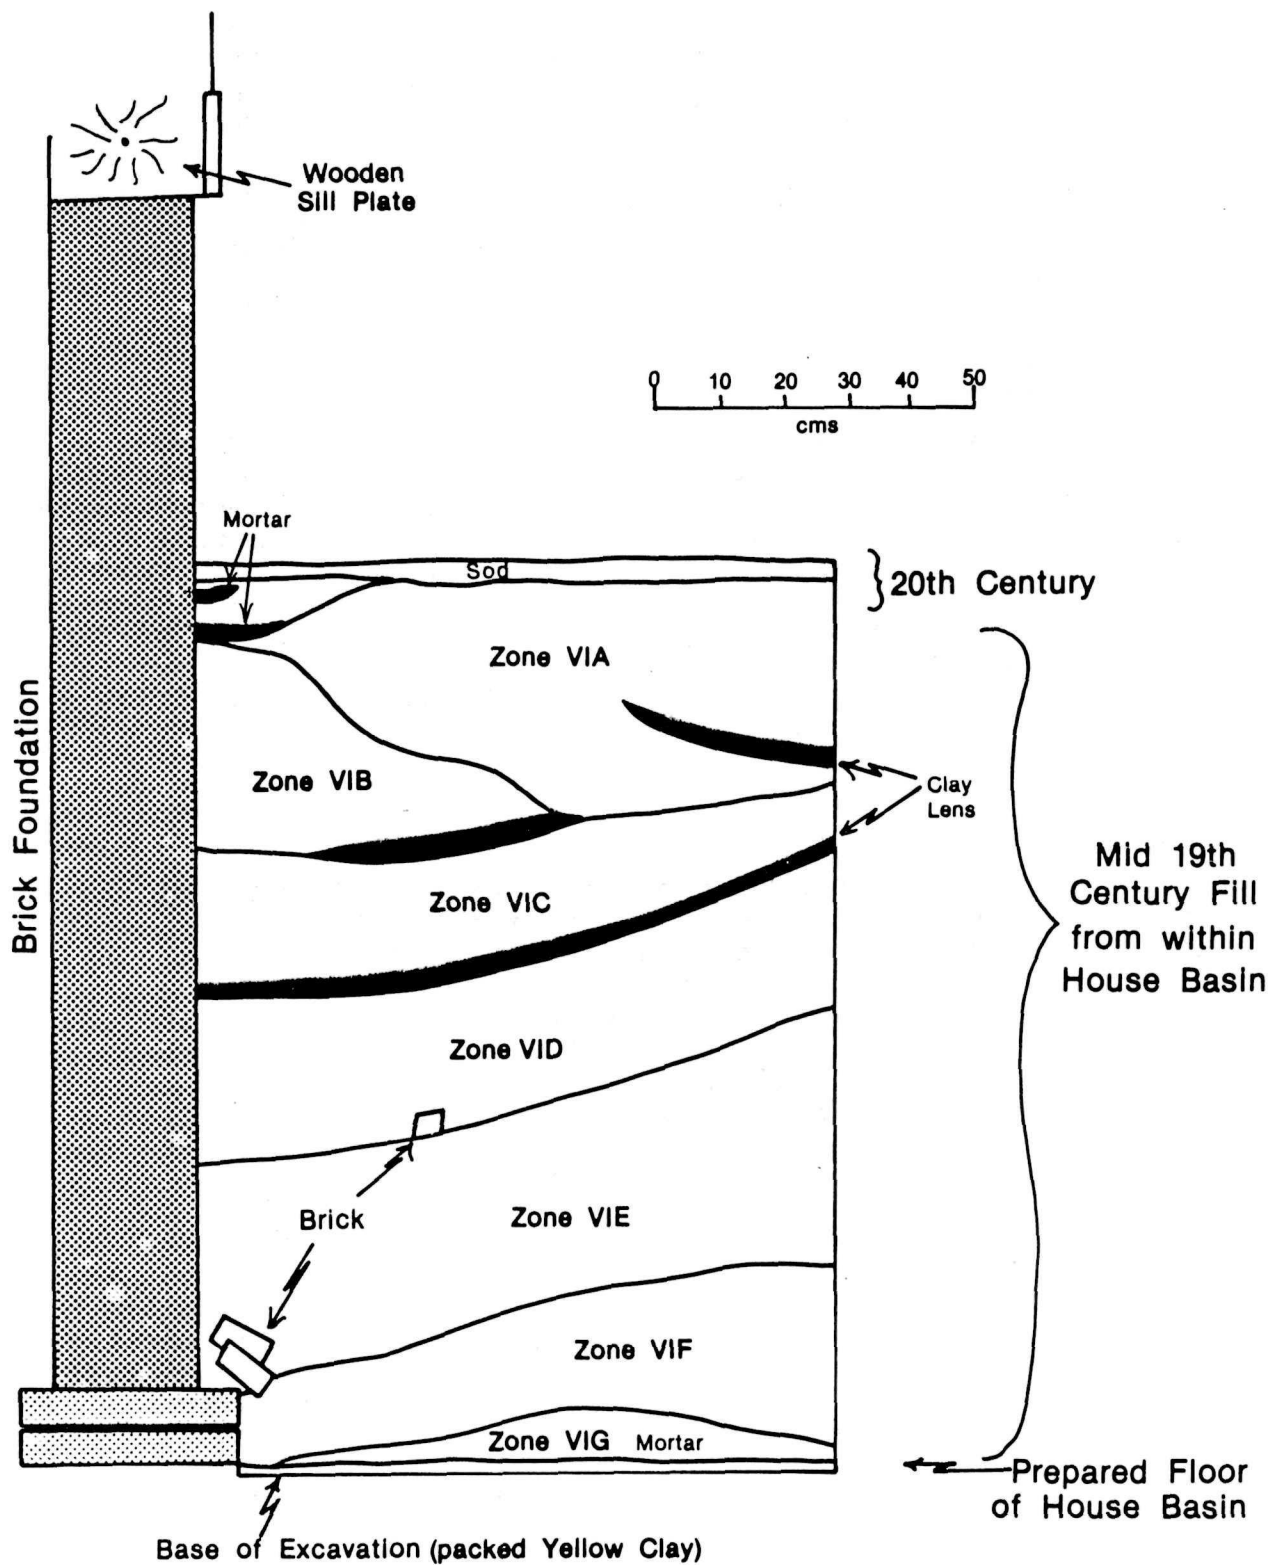
FIGURE 12. The Shutt Site, Test 4, South Wall Profile.

Test 4 was a deep test located along the back (west) wall of the Shutt House. It was located between Claflin's 1984 Ditchwitch trench and the newly reconstructed back porch and bulkhead entrance into the basement. Excavated to the base of the foundation, this test yielded results similar to Test 3. No builder's trench was encountered. A combination of mortar and soft mud brick fragments were located above a flat, hard-packed clay floor. Unlike Test 3, several lenses of yellow clay were present in this test. Like Test 3, the different fills sloped toward the foundation.

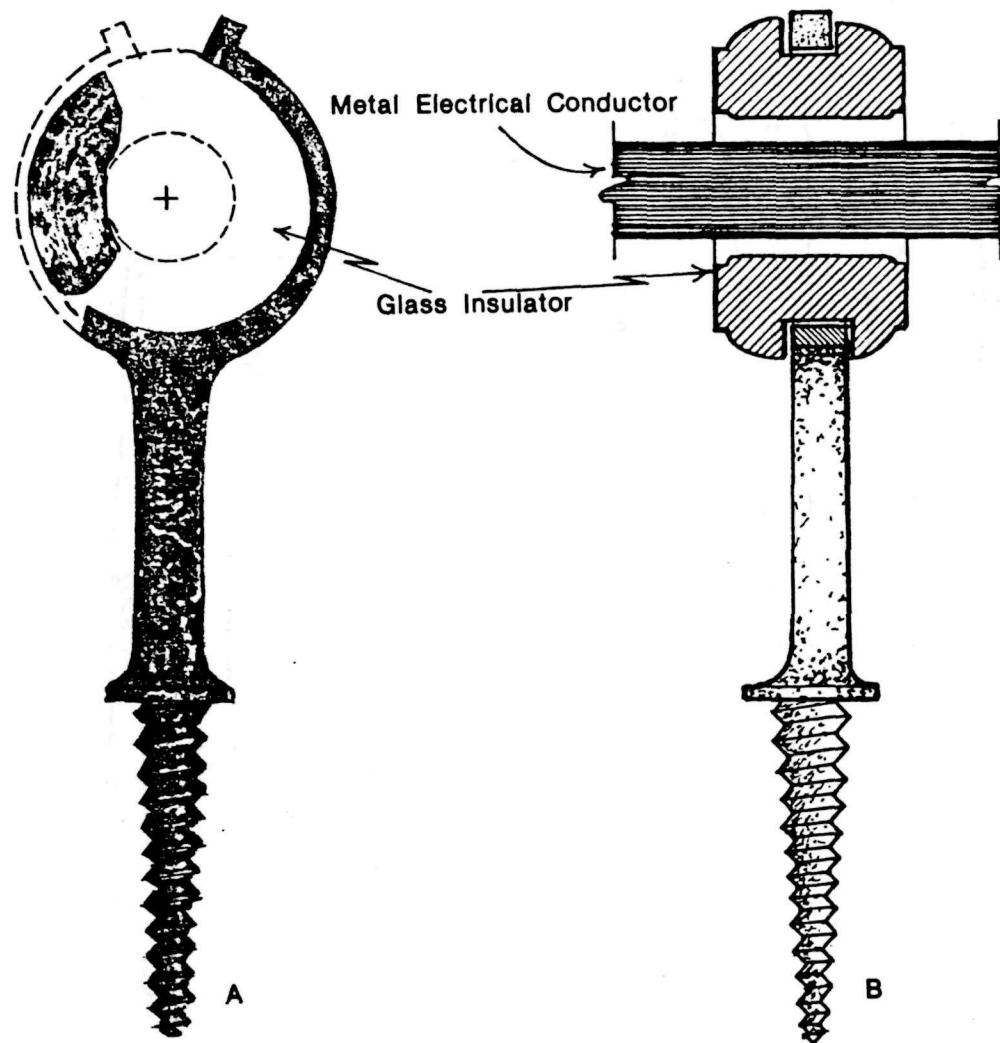
FIGURE 14. Lag Bolt For Ground Wire System Found at The Shutt Site, Test 6 (Drawing Courtesy of Fran Krupka, National Park Service).

Although badly disturbed, a significant artifact (Figure 14) was uncovered from this test. It was in Level II of Test 5 that an iron lag bolt for a lightening rod ground wire was found. Although present on mid-19th century photographs of the Lincoln Home, none of these artifacts have been located. Pieces of the glass insulator that was located within the end of the lag bolt in which the ground wire passed were also found in this test unit.

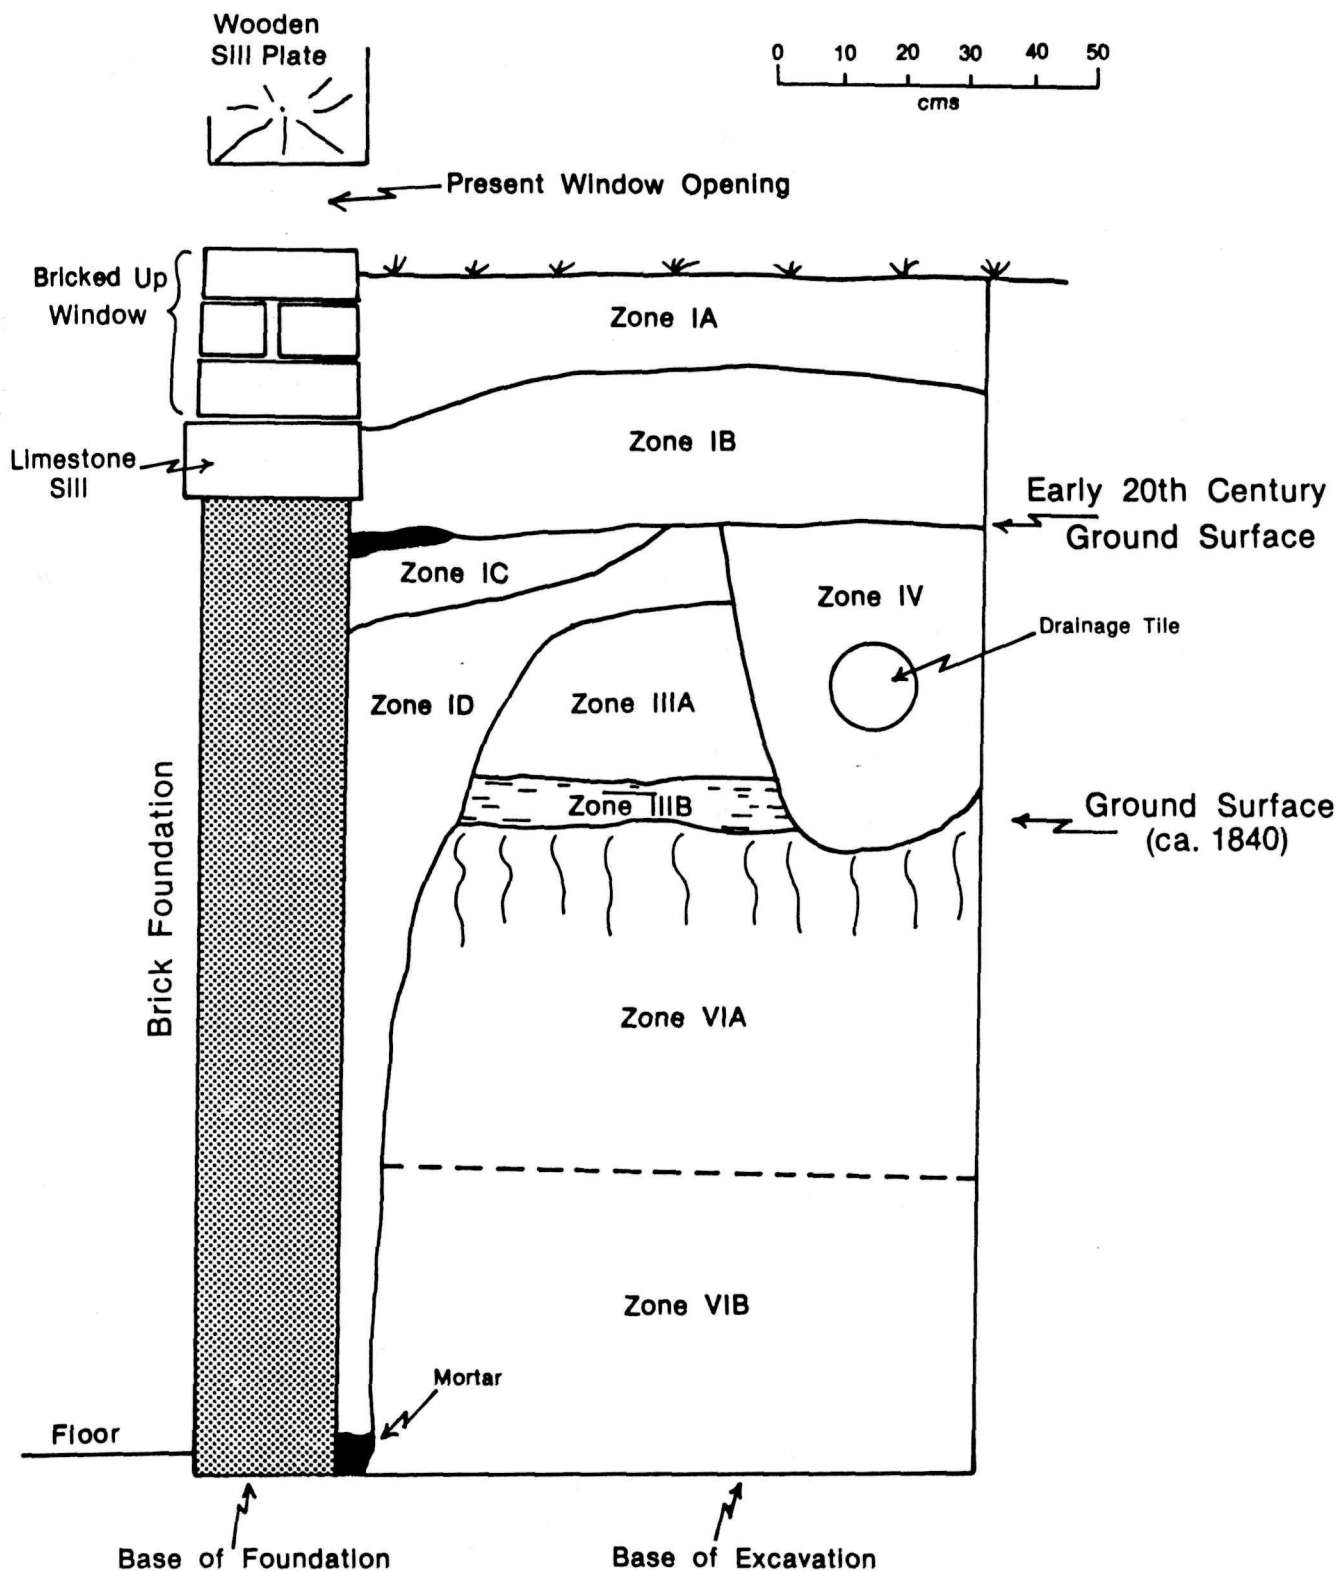
FIGURE 24. The Cook Site, Test 1, East Wall Profile.

A distinct builder's trench -- which cuts through both Zone III A and B as well as VI, was associated with the back foundation. No spread footing was present with this foundation. After the back extension of the house had been built and the basement added, a stoneware tile drainage system was installed around the house. It sloped toward the back of the structure and is represented by Zone IV.

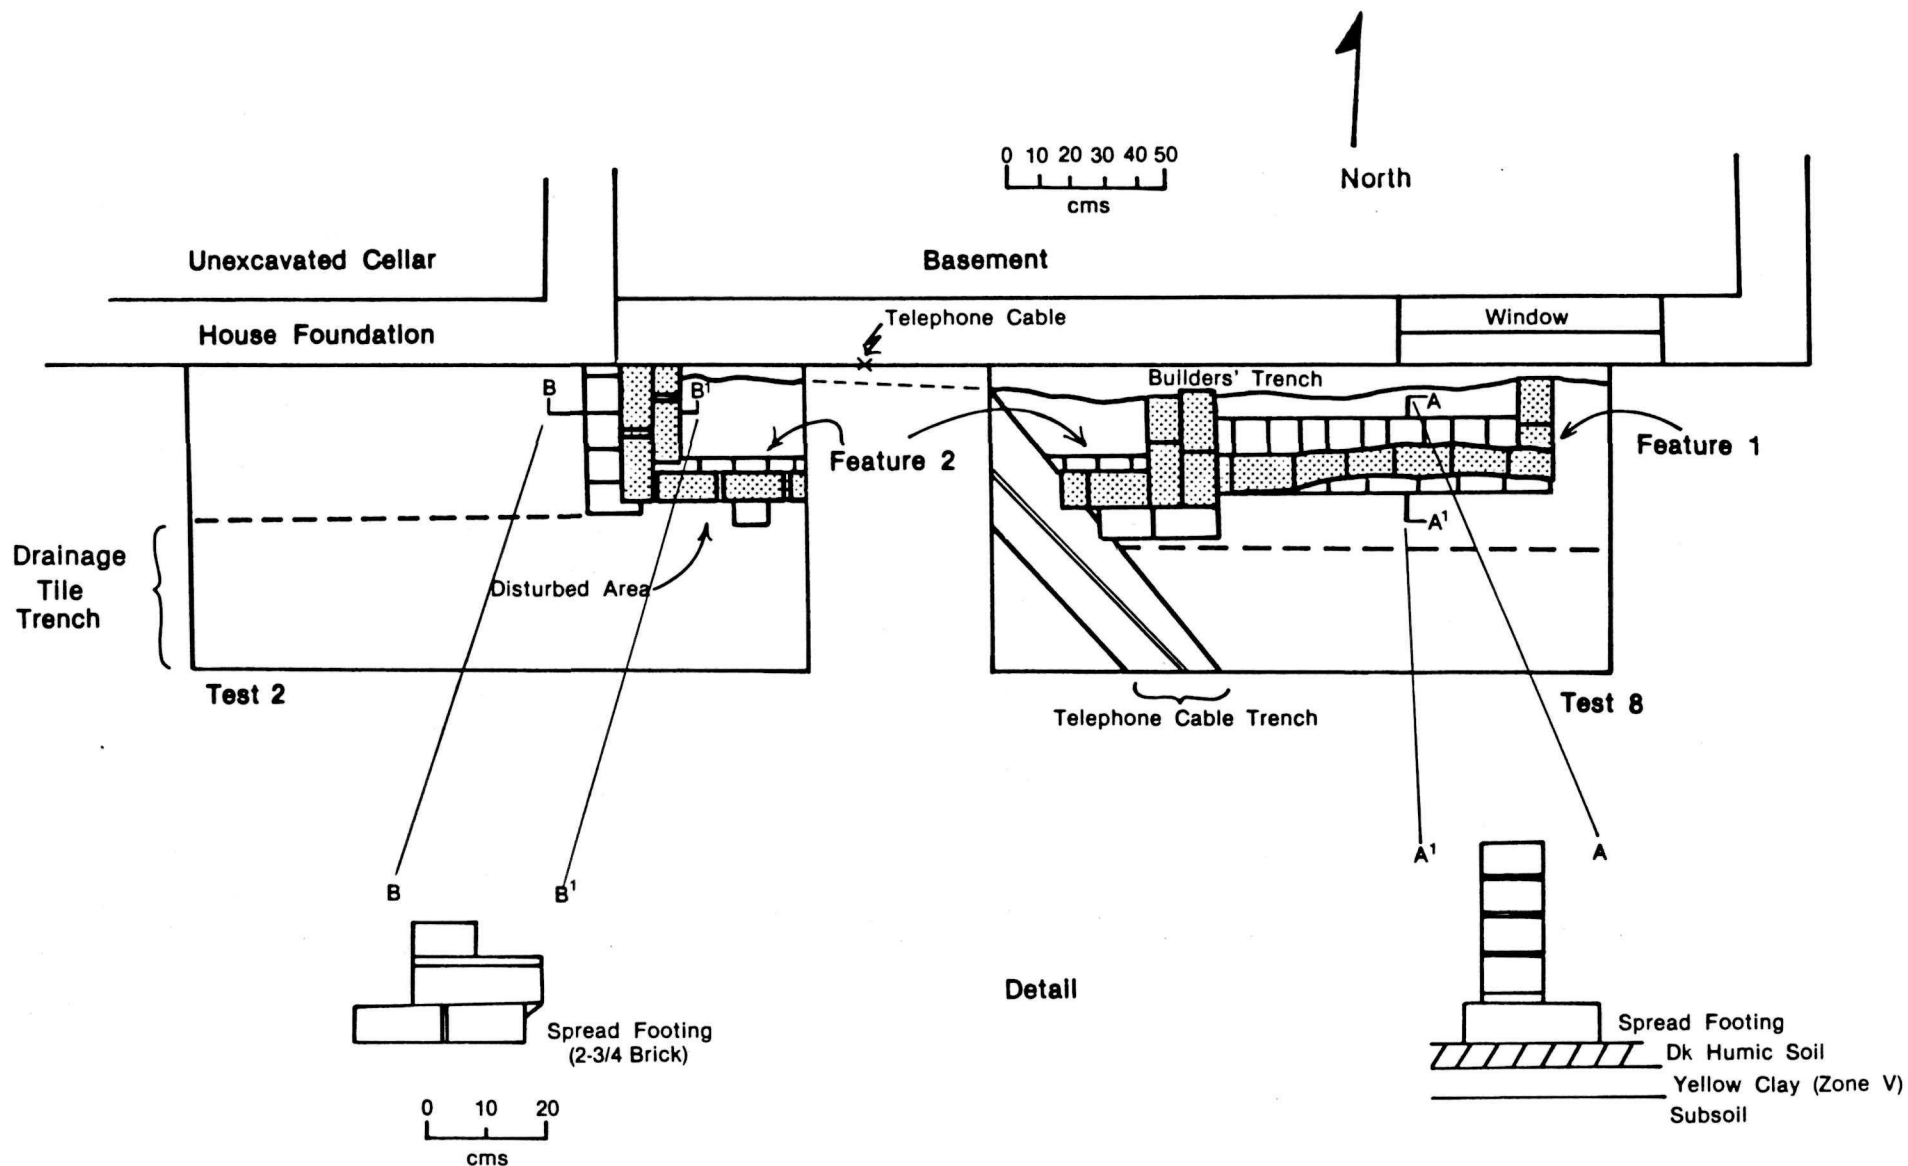
FIGURE 25. The Cook Site, Plan View of Tests 2 and 8.

At a depth of 40cm below surface, the remains of the documented rectangular bay window were uncovered (Figure 25). The brick footings had been badly disturbed by late 19th-/early 20th-century trenches for both drainage tile and telephone cables. Another test (Test 8) was excavated in order to completely expose the bay window. The brick foundations found in Test 2 and 8 appear to represent two separate episodes of construction. It is not known whether they ever functioned contemporaneously or not. The earlier footings (Feature 1) are those located in Test 8 and actually underlie those in Test 2 (Feature 2).

Feature 1 -- the eastermost feature -- was the oldest of the two brick structures found in Tests 2 and 8. At the time of the excavations it consisted of four single-width courses of soft mud brick set on a single-course spread footing (Figure 25c). Feature 1 measured approximately 1.2m (3'11") in length (east-west). The base of this feature rested on a thin lens of yellow clay fill similar to that which the main house foundation rested upon (Zone V). Within this clay lens in Tests 2 and 8 were several sherds from a clear-glazed yellow paste earthenware plate (Figure 27). These artifacts, as well as Feature 1, are probably associated with the early occupation (circa 1850-60) of the Cook House. The function of Feature 1 is not known.

Feature 2 -- the bay window foundation -- was the younger of the two features. It presently consists of two courses of double-width brickwork set on a single course of spread footing (Figures 25 a, b and 28). Feature 2 measures 1.9m (6'3") in length (east-west). Although the base of this feature was encountered much higher than that of Feature 1, except for a thin lens of dark brown silty clay loam topsoil, it rests on a similar but thicker lens of yellow clay fill. Apparently the yellow clay fill (Zone V) is thickest along the original house foundation. The common wall between the two features consists of the lower portion of Feature 1 and the more recent upper

portion of Feature 2 (Figure 25). The two walls were not tied together. Both features were disturbed by the construction of the present basement foundation, circa 1900-1920. The builder's trench for this foundation (Zone IIc) cuts directly through both features. The fill in Zone IIc consists of late 19th/early 20th century material including heavy concentrations of plaster, wire nails, amethyst glass, sponge decorated earthenware sherds and gold handpainted earthenware sherds.

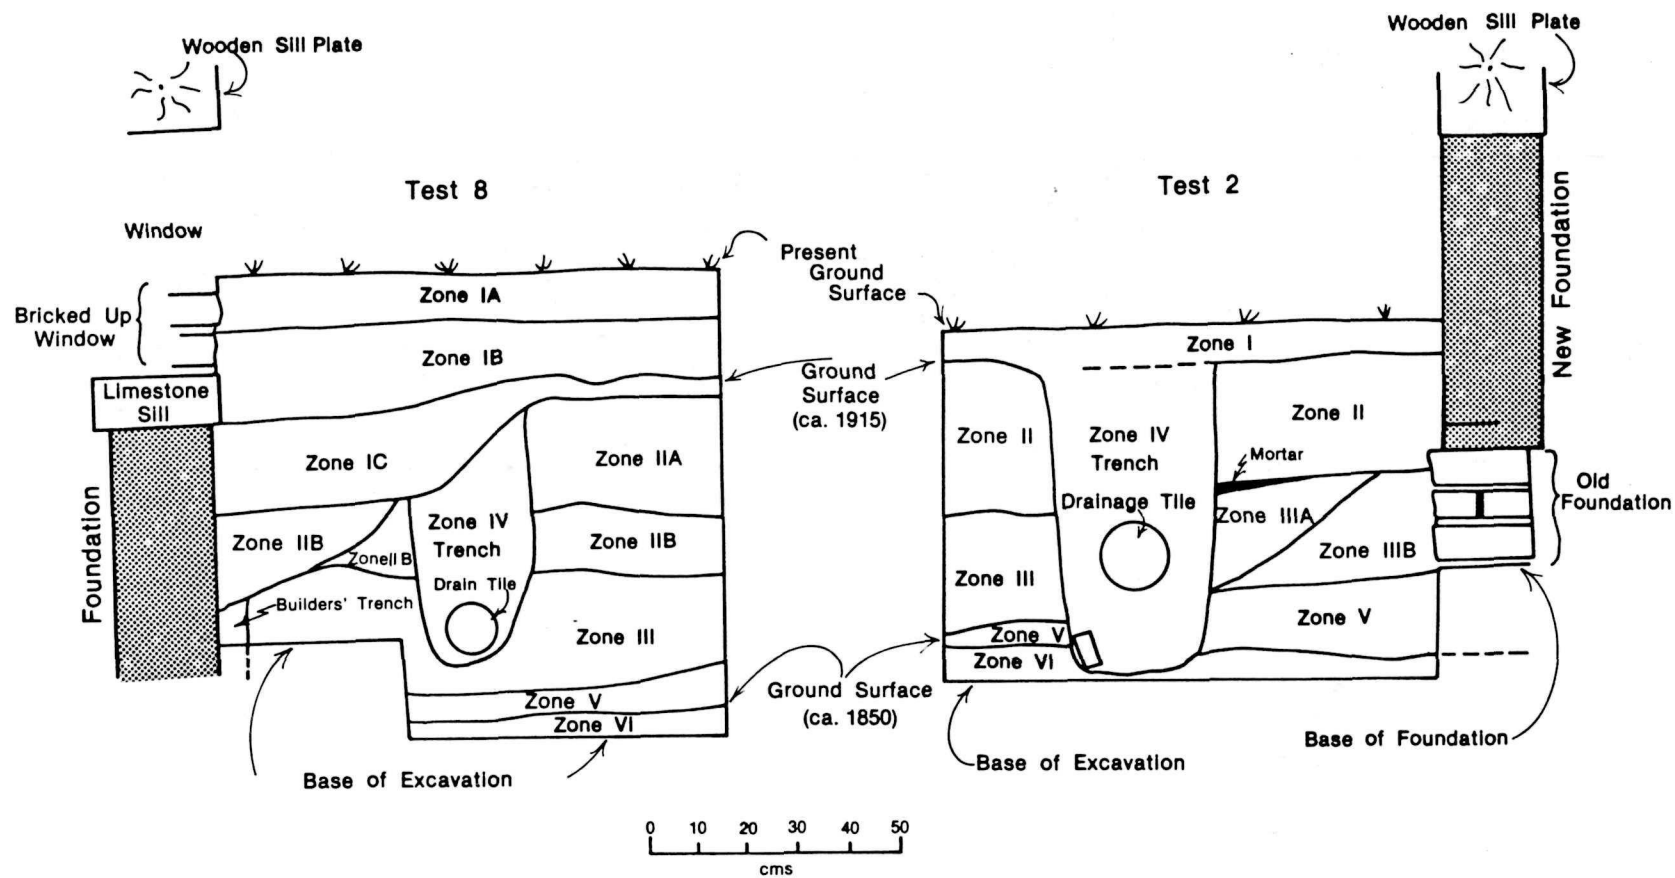
FIGURE 26. The Cook Site, Tests 2 (West Wall) and 8 (East Wall) Profiles.

Figure 26B illustrates the west wall profile of Test 2. The original ground surface (Zone VI) is situated approximately 60-65cm below the present ground surface. On top of this humic zone is situated a moderately thick deposit of silty clay subsoil; this material (Zone V) quickly fades to the south and may represent a prepared surface for the construction of the original house foundation. The original Cook House has no substantial footings or foundations. The original brick foundations extends only 45cm below the present ground surface -- clearly not below the frostline in this area. After the original house foundation had been built, the house was backfilled with approximately 20-25cm of fill (Zones III A and B). Currently, only three courses of old brick from the original foundation are present in this area. At some time -- probably during the early 20th century when the house was drastically altered to its present condition -- the foundations were "repaired." This consisted of jacking the house up, removing much of the old foundation and replacing it with new brick. Subsequently, fill (Zones I and II) was placed around the house after this construction work was accomplished.

The old house foundation does not align perfectly with the new. The result is that on the south side of the house the new foundation is set in from the old, while on the front it is set out from the old. I believe this was an attempt by the later masons to "square up" the old house after it had settled and moved for so many years. A series of brick headers turned on edge along the top of the old foundation wall in Test 2 were necessary to level-up the old foundation of the house before beginning with new brickwork.

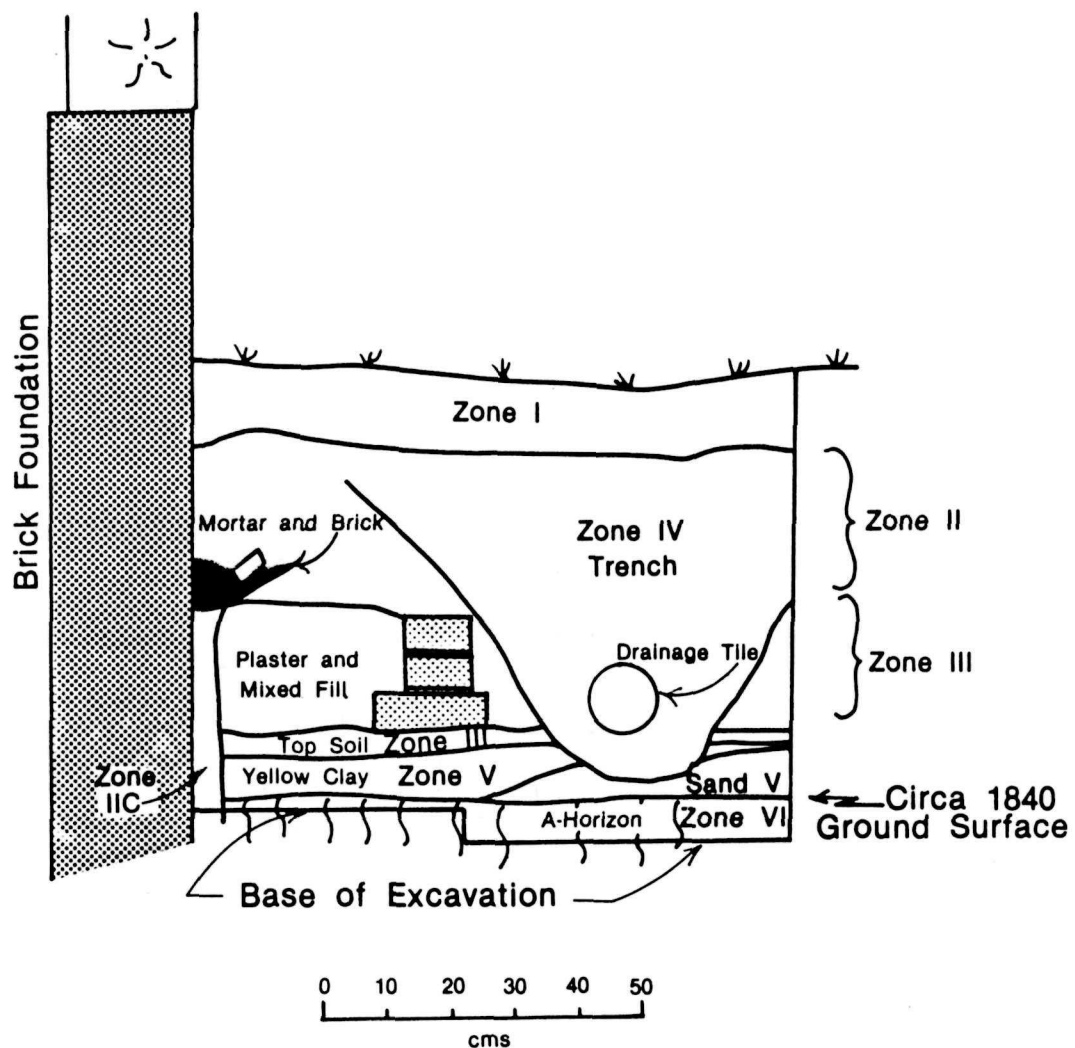
FIGURE 28. The Cook Site, Test 2, East Wall Profile.

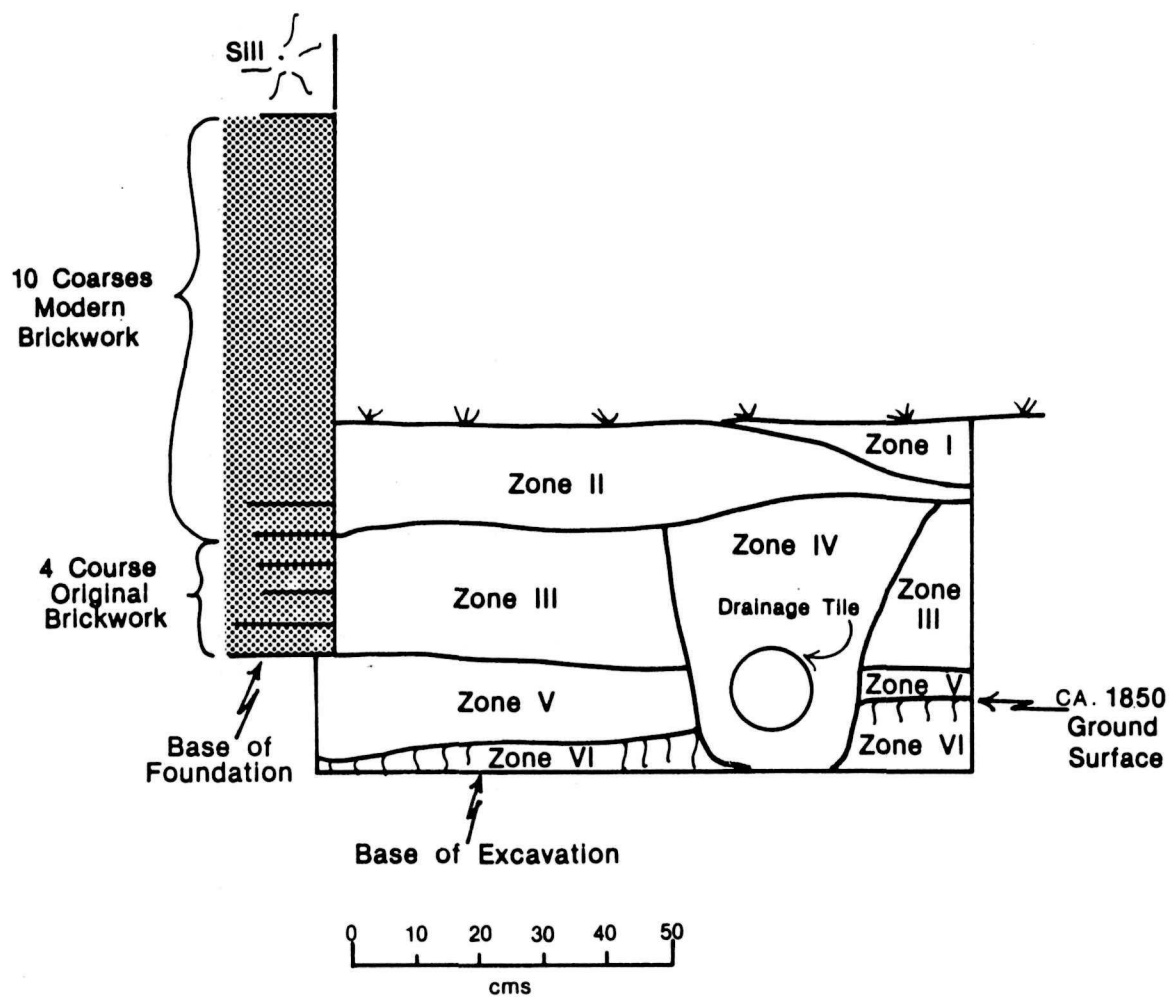
FIGURE 29. The Cook Site, Test 3, East Wall Profile.

Test 3 was located along the south wall near the southwest corner of the house. It was excavated to a depth of 55cm below surface. Figure 29 illustrates the east profile of the test. As with Test 2, four courses of old brick and mortar from the original house foundation were present. The base course was a mixed header/stretcher course; no spread footing was present. Again, it appears that the house was built on a prepared surface of yellow silty clay (Zone V).

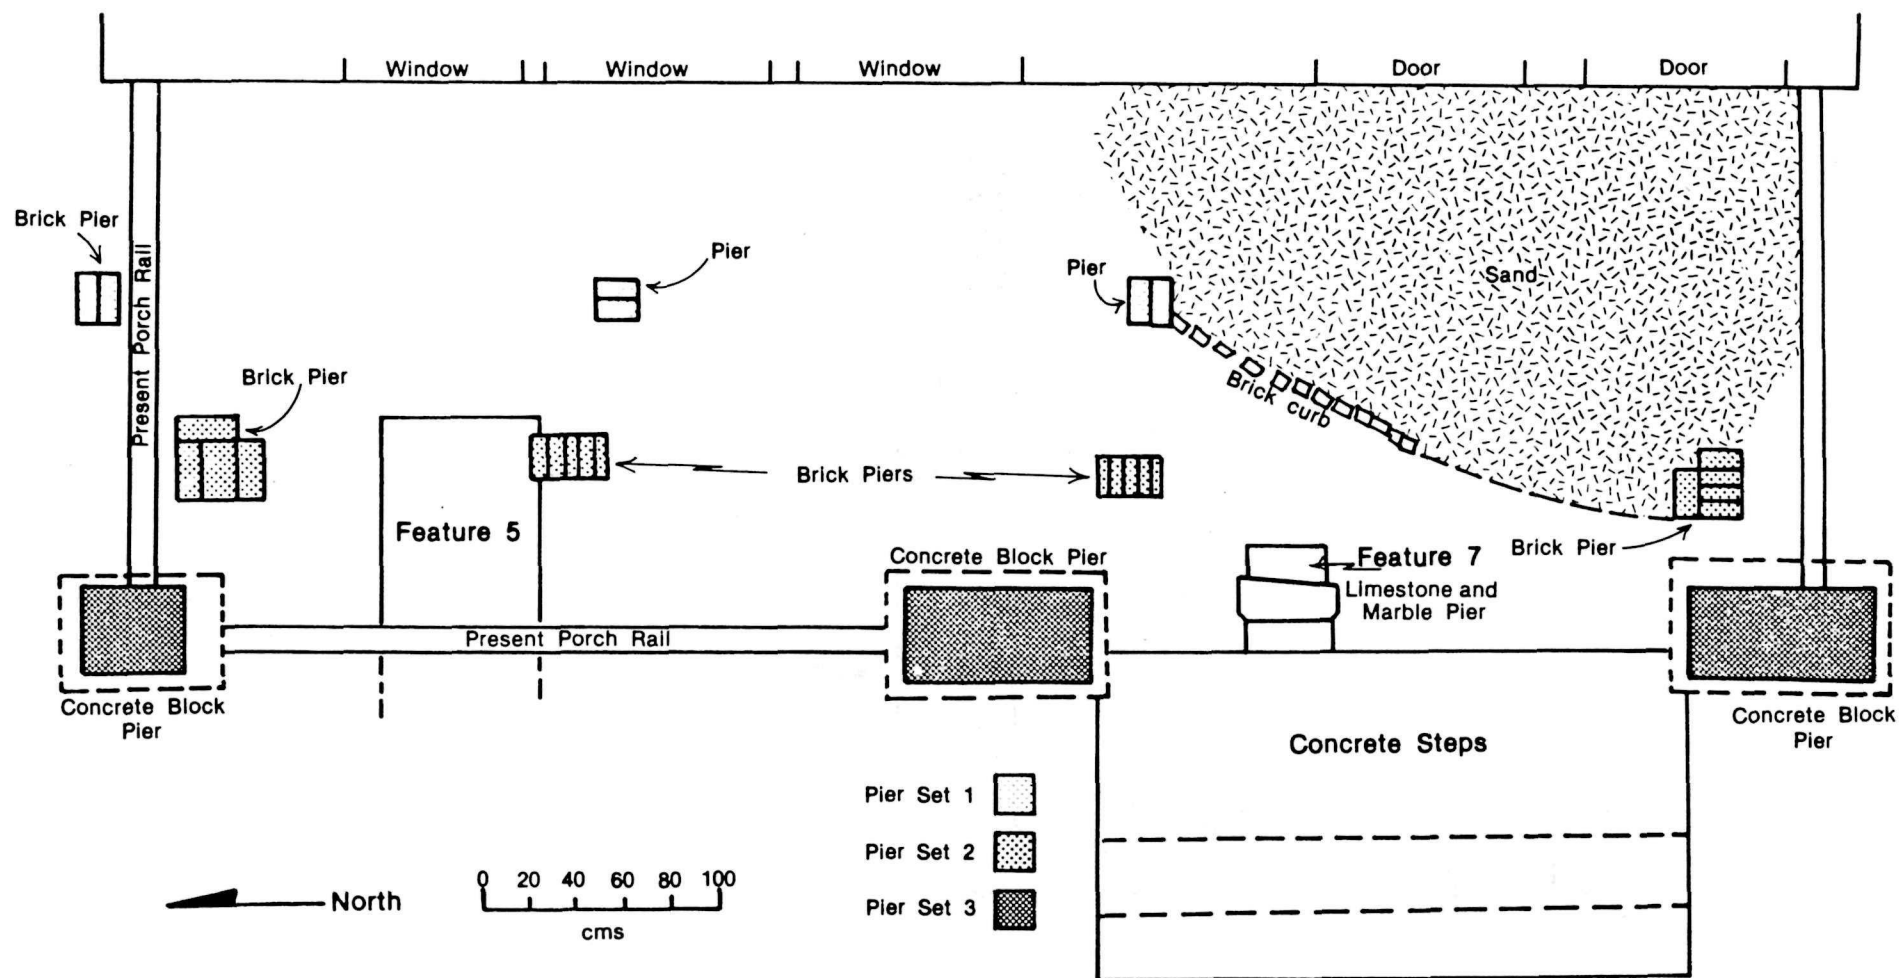
FIGURE 30. The Cook Site, Test 4 (Front Porch) Plan View.

Test 4 was a large area (2.5m x 7.4m) beneath the entire front porch. Initially, a small area in the center of the porch was opened up by the removal of a few porch floorboards. It quickly became apparent that these conditions were going to be extremely difficult to work "under." Also, this initial work exposed an earlier porch pier. With that discovery, the Park Service removed the floorboards from the entire porch. After the floorboards were removed -- but with the floor joist still in place -- the entire area beneath the porch was shovel scraped. Initially, a 10-15cm layer of soft mud brick rubble was removed. This rubble extended over the entire area of Test 4. Once the rubble was cleared out, a second shovel scraping and troweling episode was conducted. This resulted in defining three sets of brick piers, as well as several other features. The brick piers are evidence of two earlier porch sequences prior to the existing early 20th century porch.

Porch # 1 is represented by three small brick piers with old sandy mortar similar to that in the oldest part of the house foundation. These were approximately 8" x 8" (20cm x 20cm) and had no spread footings. The porch was a very narrow structure that extended only one meter (3'4") from the main body of the house. This porch only extended two-thirds the width of the house (approximately 2.5 meters) since no pier was found at the southwest corner of the structure. In this area a small curb of soft mud brick extended in an arch from the end pier. On the inside of this area a fine clean sand fill was present which contained several early artifacts including blue and brown transfer printed earthenware sherds, a single Rockinghamware sherd, and numerous redware sherds (both clear glazed bowls and unglazed flower pots). Glass associated with this feature

Porch #3 -- the existing porch -- is represented by three brick and concrete block piers, all with spread footings. This porch is larger than the two earlier structures, being approximately 2.5m x 7.4m in size. This porch was added during the early 20th century probably when the slate roof, ornamental dormers, new basement, and foundation were added.

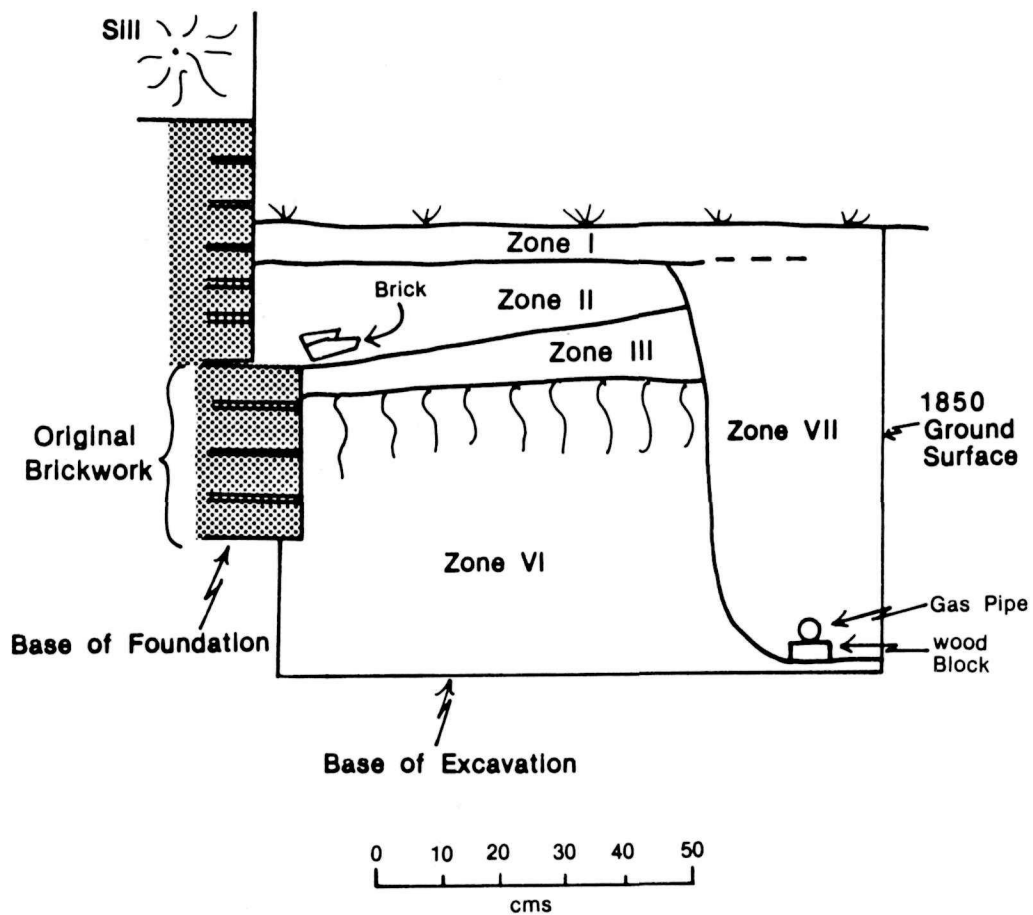
FIGURE 32. The Cook Site, Test 5, West Wall Profile.

In Test 5, just east of the west profile wall, the original portion of the brick foundation completely disappeared. From that point east, the wall consisted entirely of new brick laid during the early 20th century.

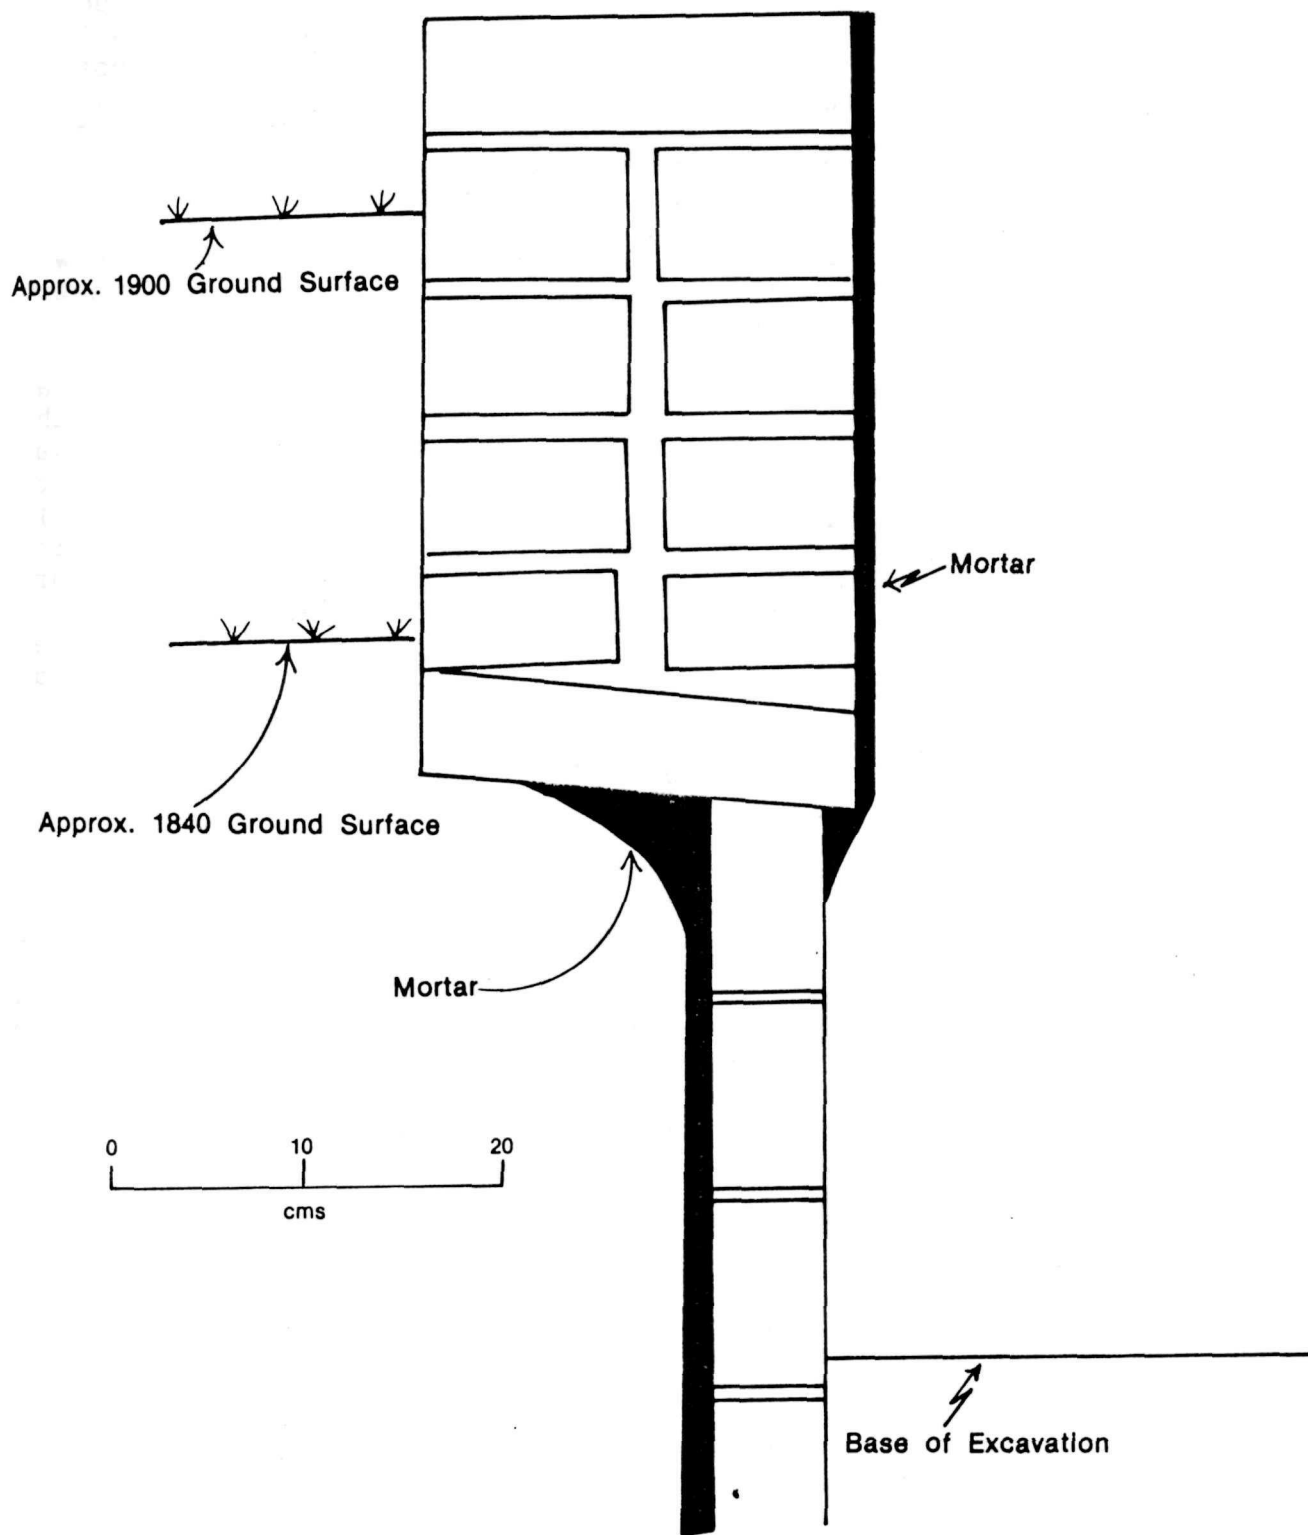
FIGURE 37. The Cook Site, Test 7, Detail of Cistern Construction.
