ARCHEOLOGICAL INVESTIGATIONS AT THE LINCOLN HOME NATIONAL HISTORIC SITE, SPRINGFIELD, ILLINOIS

By
Floyd Mansberger

NORTHERN ILLINOIS UNIVERSITY
DEKALB, ILLINOIS

Prepared For The National Park Service
Midwest Archeological Center-Lincoln, Nebraska

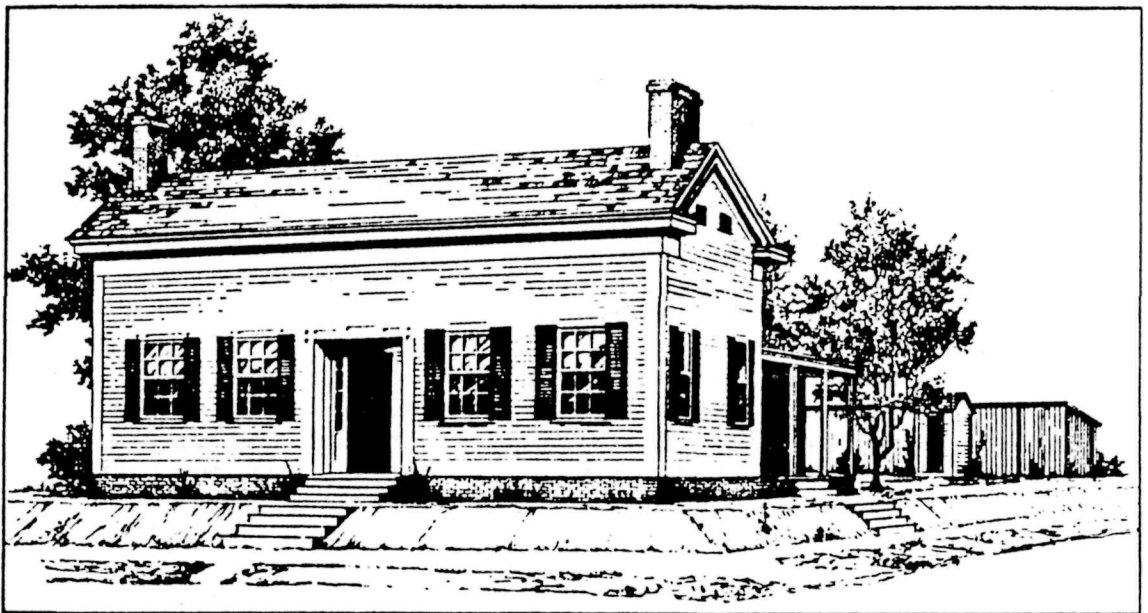
FIGURE 50. The Lincoln Home, Circa 1844 (Artist's Rendition From Hagen 1955).

The original house, as built by Charles Dresser, was a small 1-1/2 story Greek Revival cottage. Figure 50 is an artist's rendition of that early structure. The front part of the house originally contained downstairs two rooms and a stairwell -- similar to today's house. The upstairs of the front section contained garreted sleeping rooms. The back kitchen extension (or East Wing) of the Dresser home has always been a matter of interpretation. The most recent published interpretation, by Ferry and Henderson Architects (1981), illustrated an "L"-shaped kitchen extension, with the ell located perpendicular to and towards the north end of the main body of the house. Our excavations -- as well as recent structural investigations by Hahn and Associates (William Gran, personal communication) have shown this to be erroneous and have confirmed the existence of a 1-1/2 story kitchen extension (East Wing) which formed a "T"-shaped floor plan. The original 1-1/2 story structure, with its basement, contained approximately 2,950 square feet of living space.

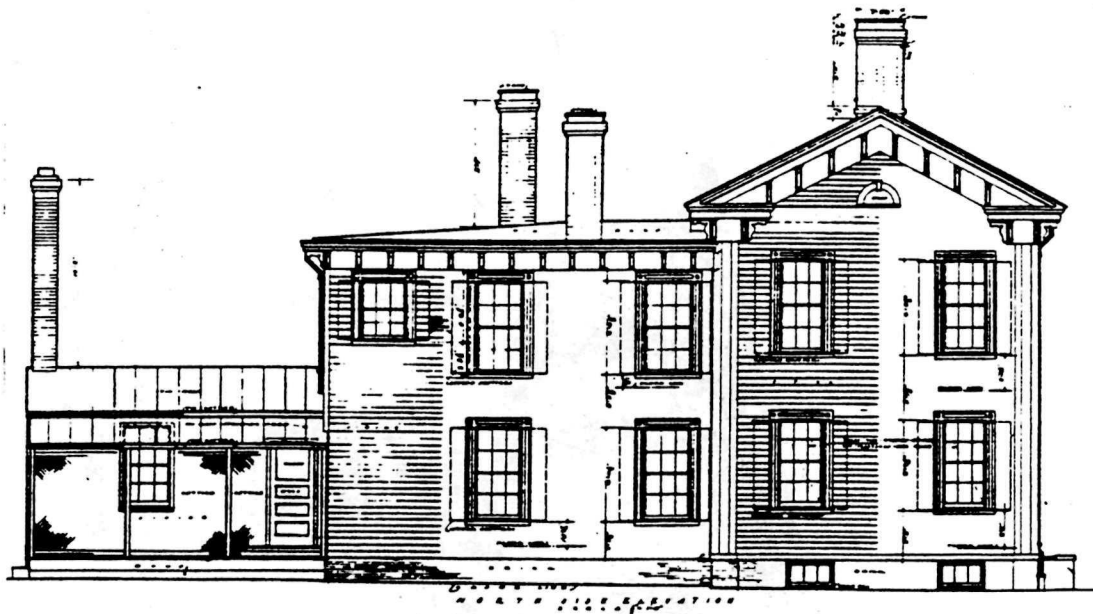
FIGURE 51. Lincoln Home Historic Drawing Illustrating the 1870's Kitchen (Courtesy of the National Park Service).

After Lincoln's death, the house was rented to several different families. From 1870 until 1880, the house was rented to the George Harlow family. During his occupation of the site, a back kitchen addition was added onto the house. Figures 51 and 52 illustrate this addition. This frame addition had a brick cellar with an exterior access stair, concrete floor, pump, and sink, and was used as a laundry room. The laundry room and kitchen were removed by the State of Illinois as part of the 1952-54 renovation of the Home. The brick cellar remains intact, buried in situ.

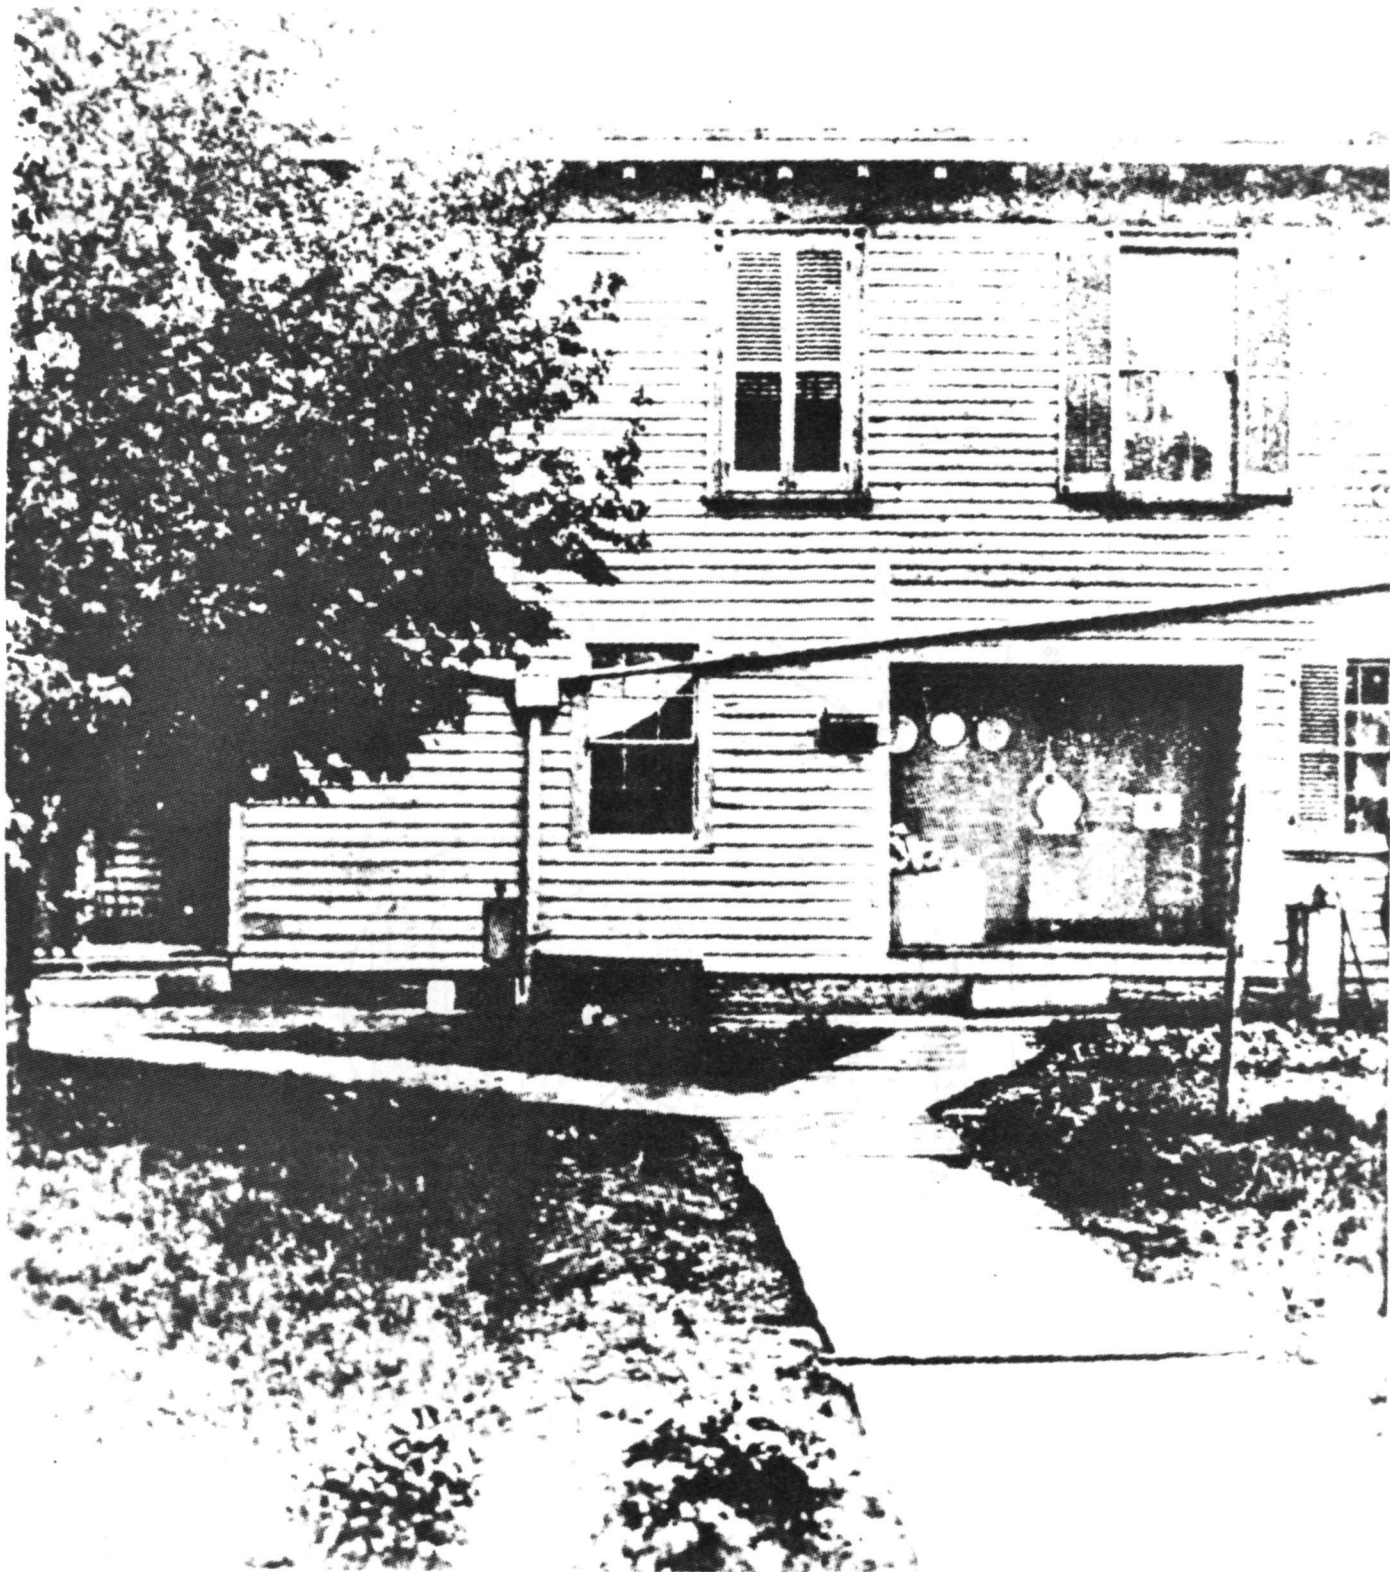
FIGURE 59. The Lincoln Home; Ridgeway Glover Stereopticon (1865; Courtesy of the Illinois Historic Preservation Agency).

Test 5 was located along the east wall of the house. From an inspection of the Ridgeway Glover Stereopticon (Figure 59) of the back of the Lincoln House (1865), it became clear that the gutter downspout ran directly into the ground and, more importantly, that the pumps were positioned very near to the house wall -- not several feet out from the wall, where they are currently positioned. Test 5 was excavated in hopes of locating the remains of a cistern that would have been associated with the southernmost 1860's pump.

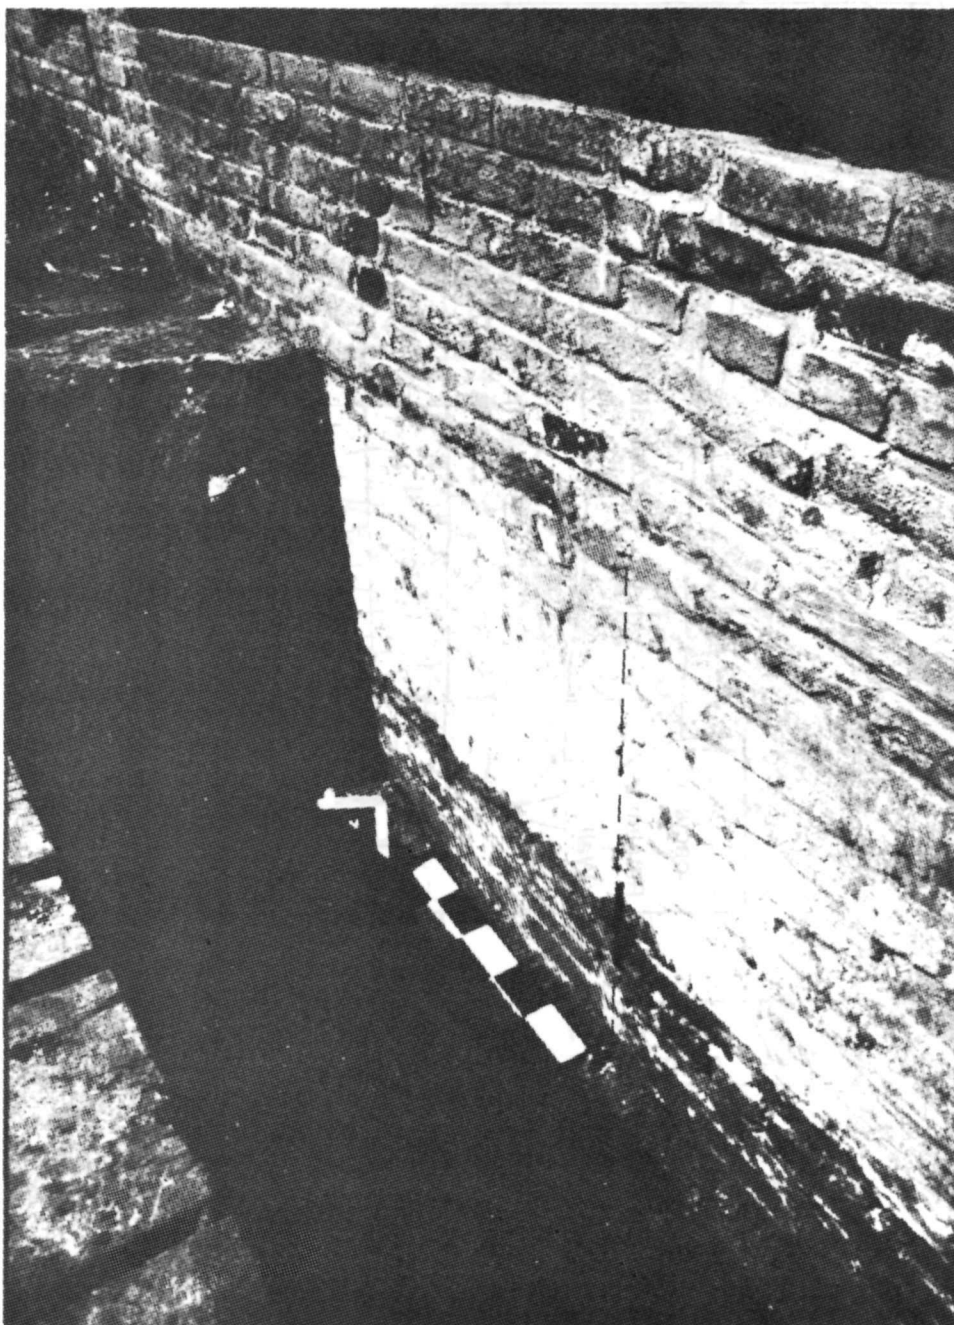
FIGURE 63. Lincoln Site, Test 8, Photograph of Foundation Wall Illustrating Circa 1848-53 Wall Butted onto Original Corner of Kitchen Wing Foundation.

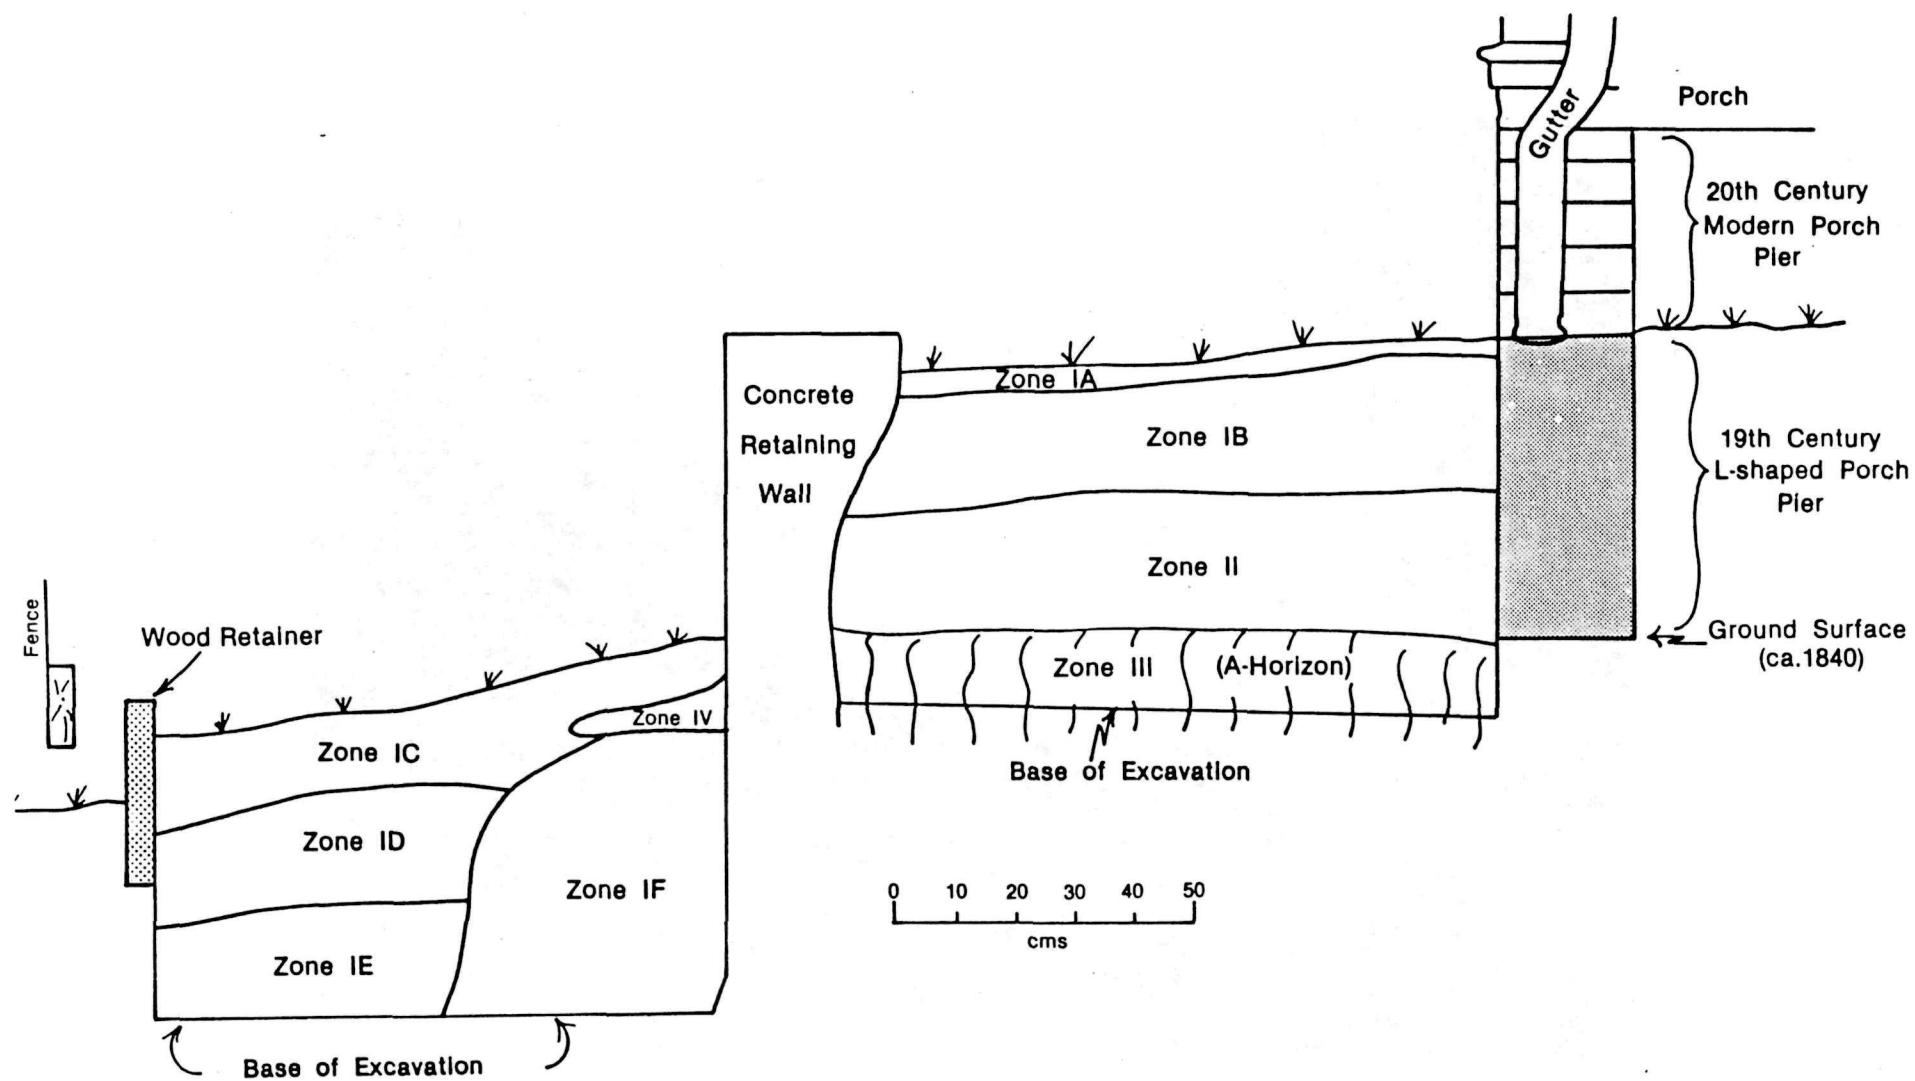
FIGURE 64. Lincoln Site, Test 9, West Wall Profile.

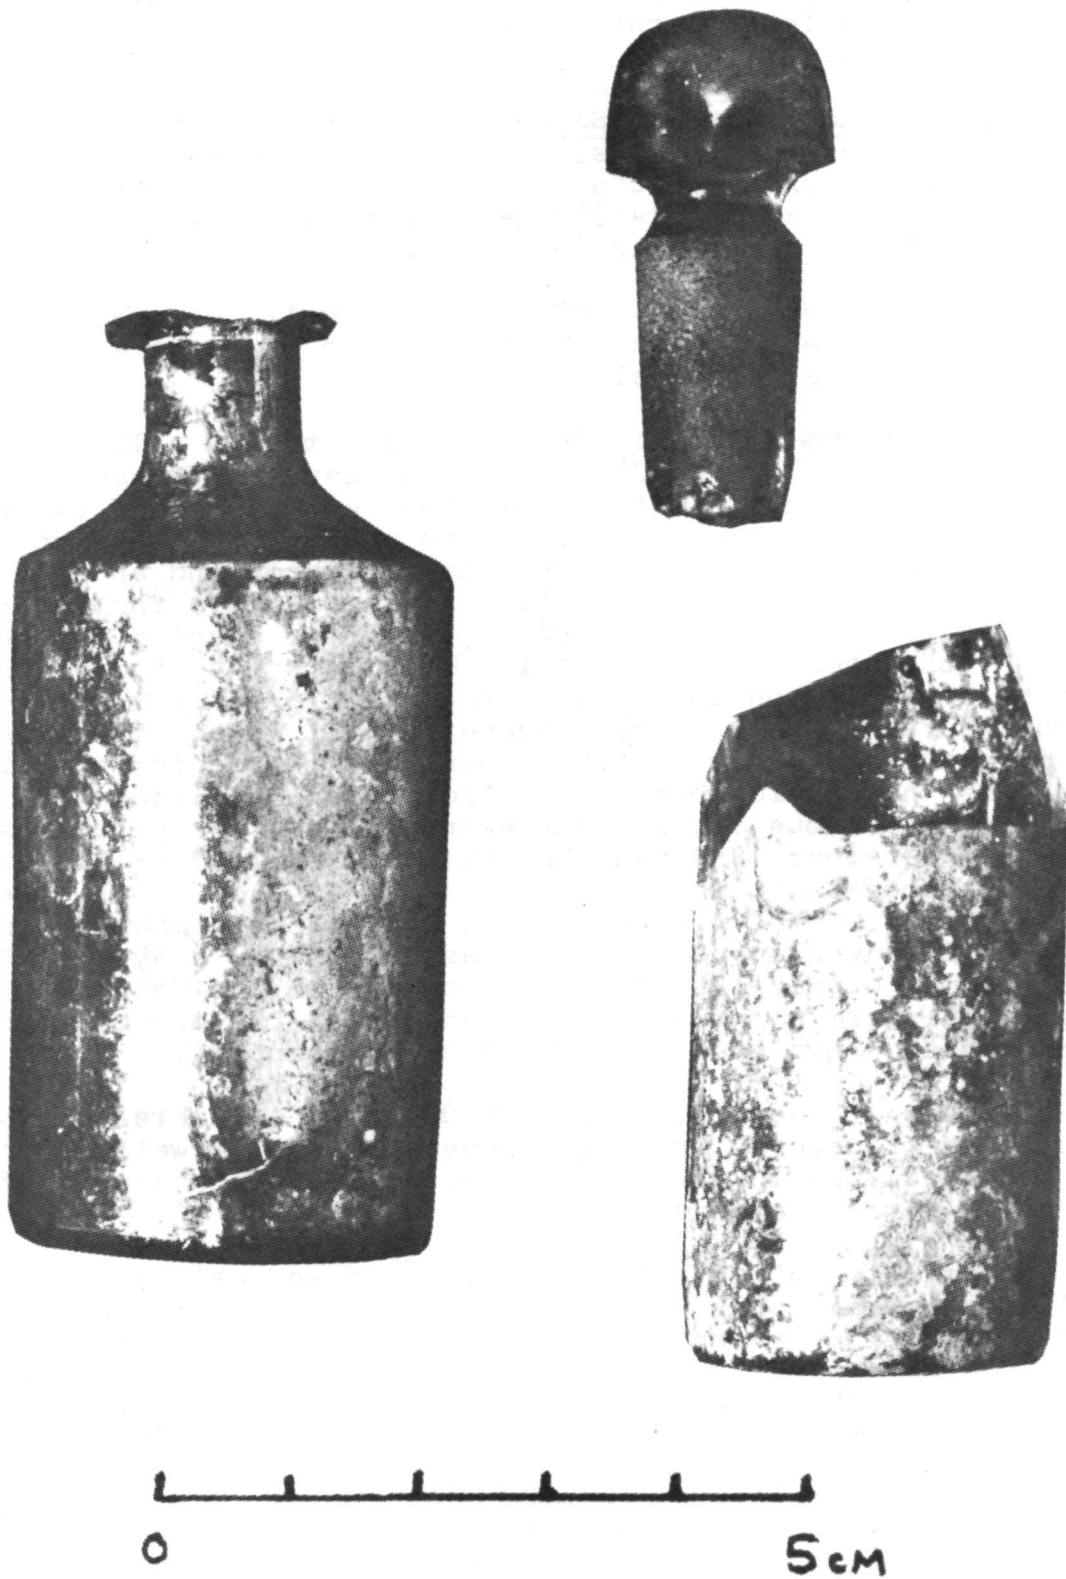
FIGURE 69. Lincoln Site, Glass Artifacts Recovered From the Well Located Beneath the East Porch.

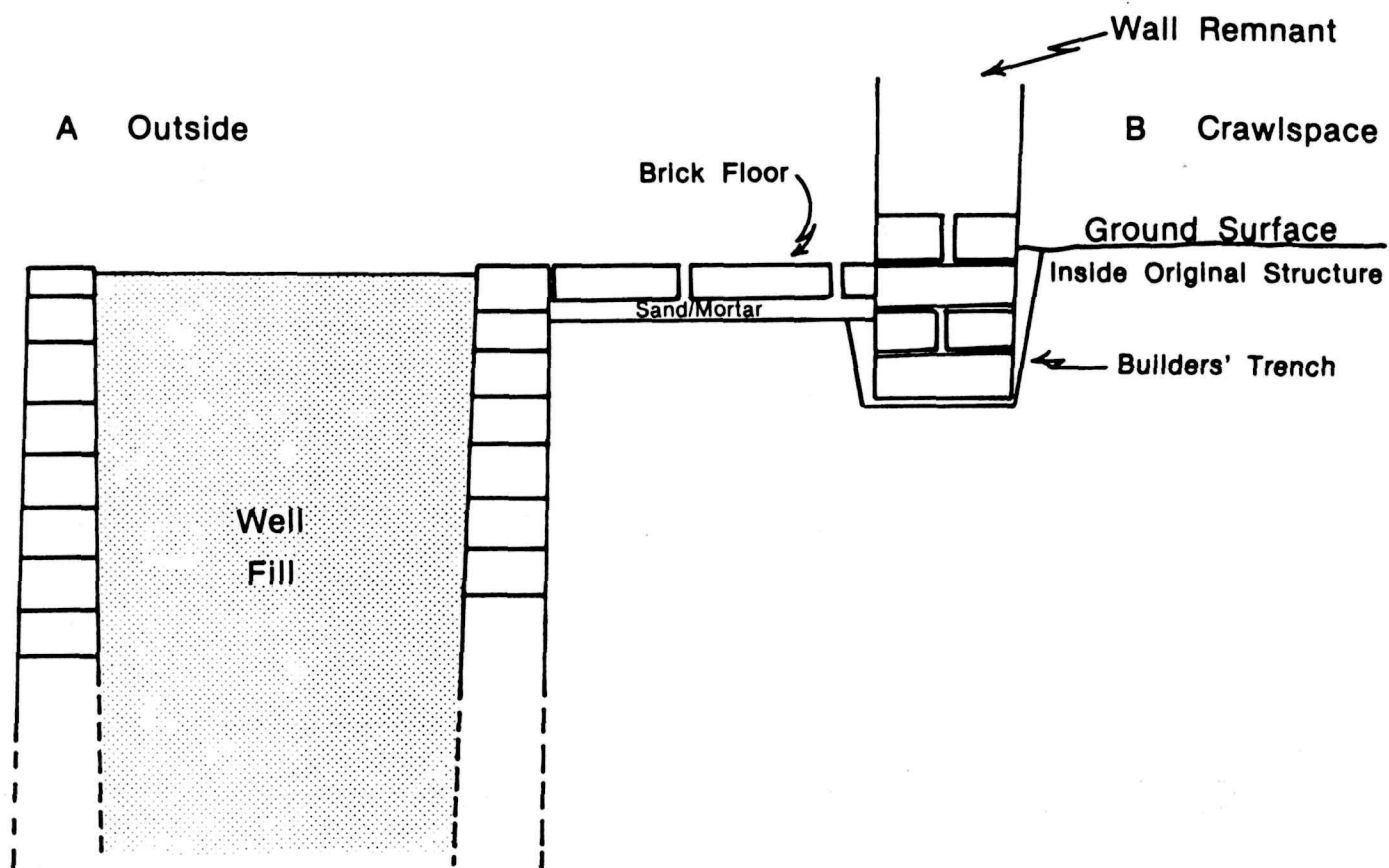
FIGURE 72. Lincoln Site, Idealized Relationship Between Original Brick Foundation Wall of East Wing (Kitchen) and the early Well Located Beneath the East Porch (See Figure 67 for Location).

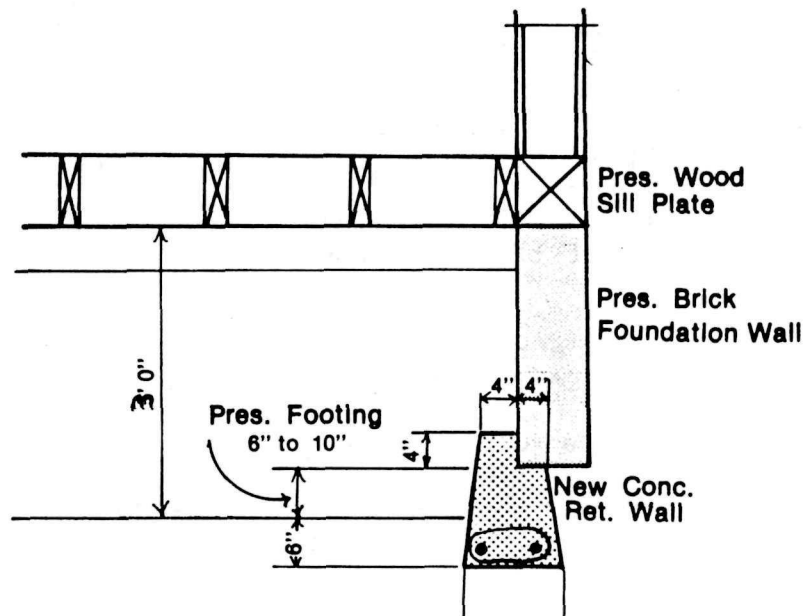
FIGURE 76. Lincoln Home, Specifications for Concrete Retaining Wall Located Beneath 19th Century Brick Wall (Courtesy of the National Park Service).

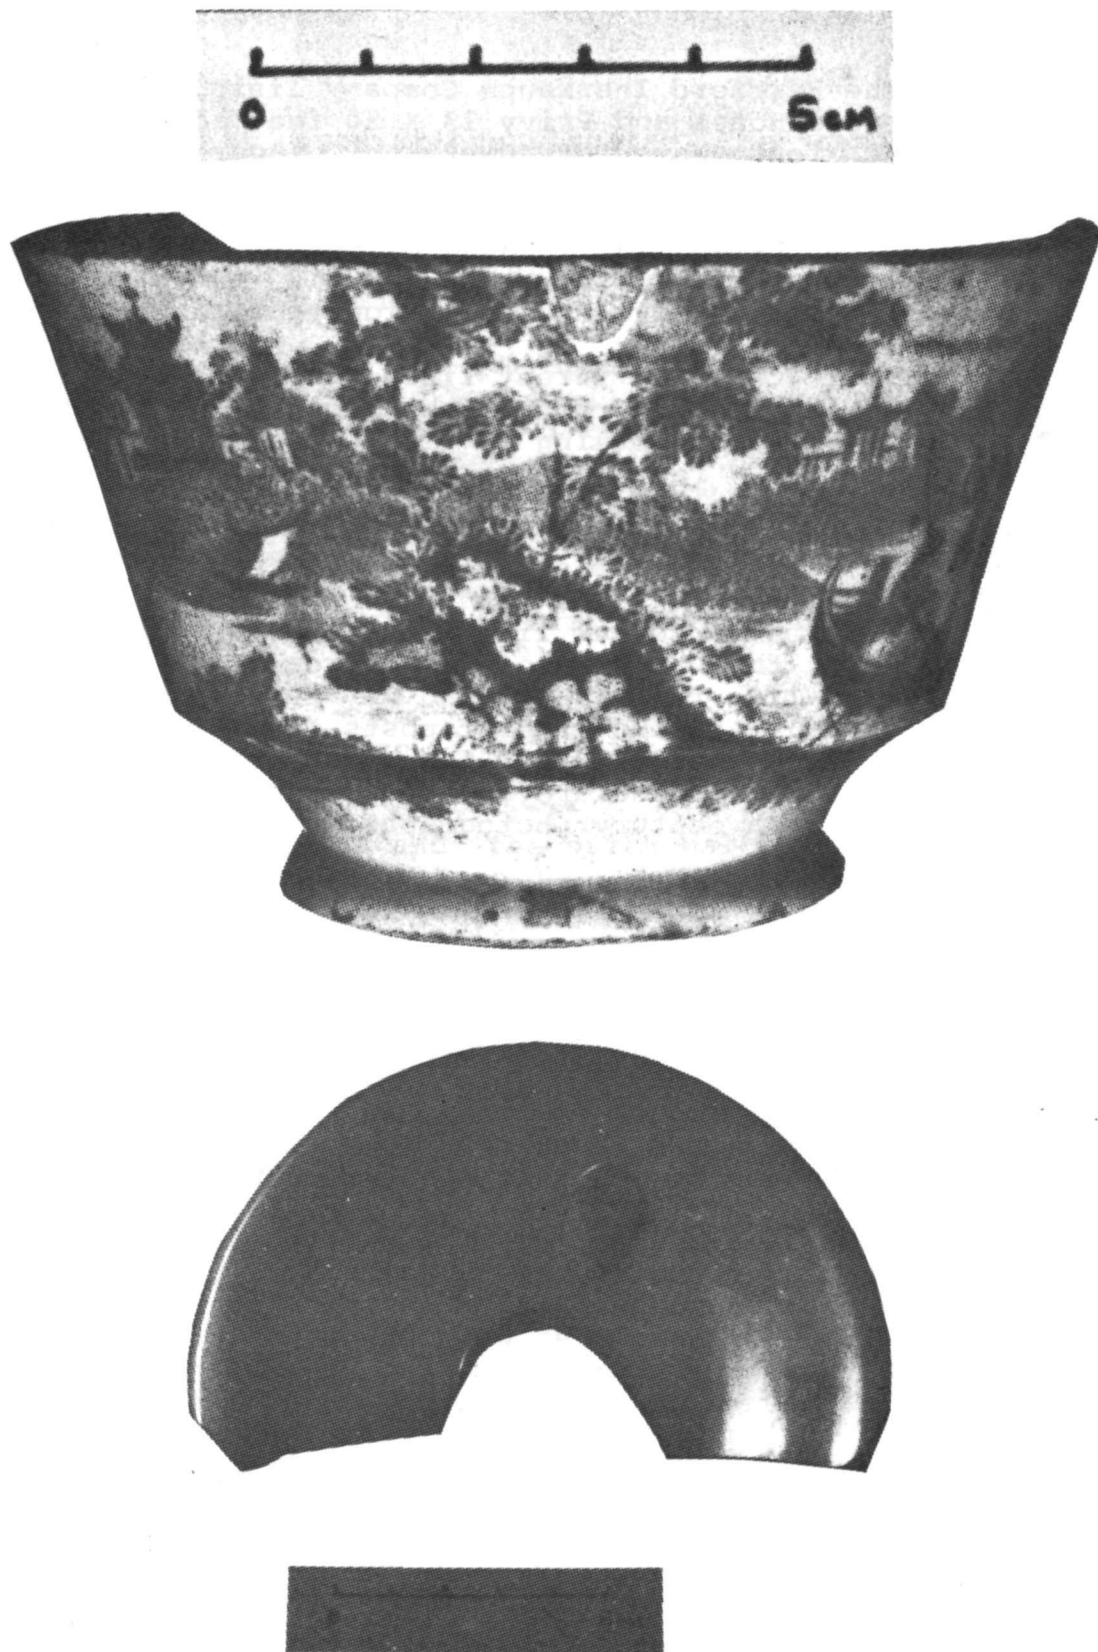
Figure 80. Porcelain Candle Holder and Earthenware Cup Recovered From Hagen's 1951 Excavations.

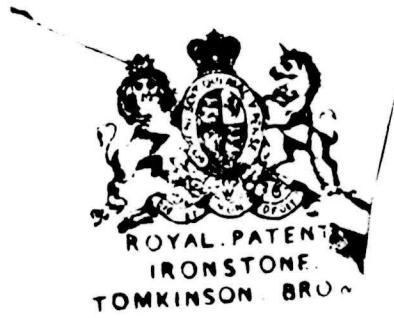
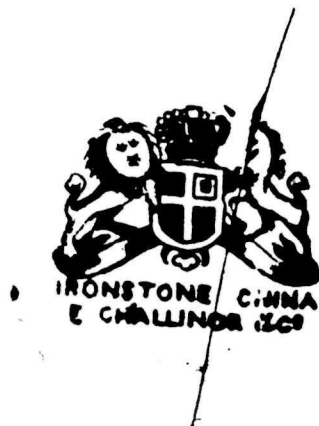
FIGURE 83. Ceramic Hallmarks From Vessels Recovered From the Rubbish Pit During Hagen's 1951 Excavations.

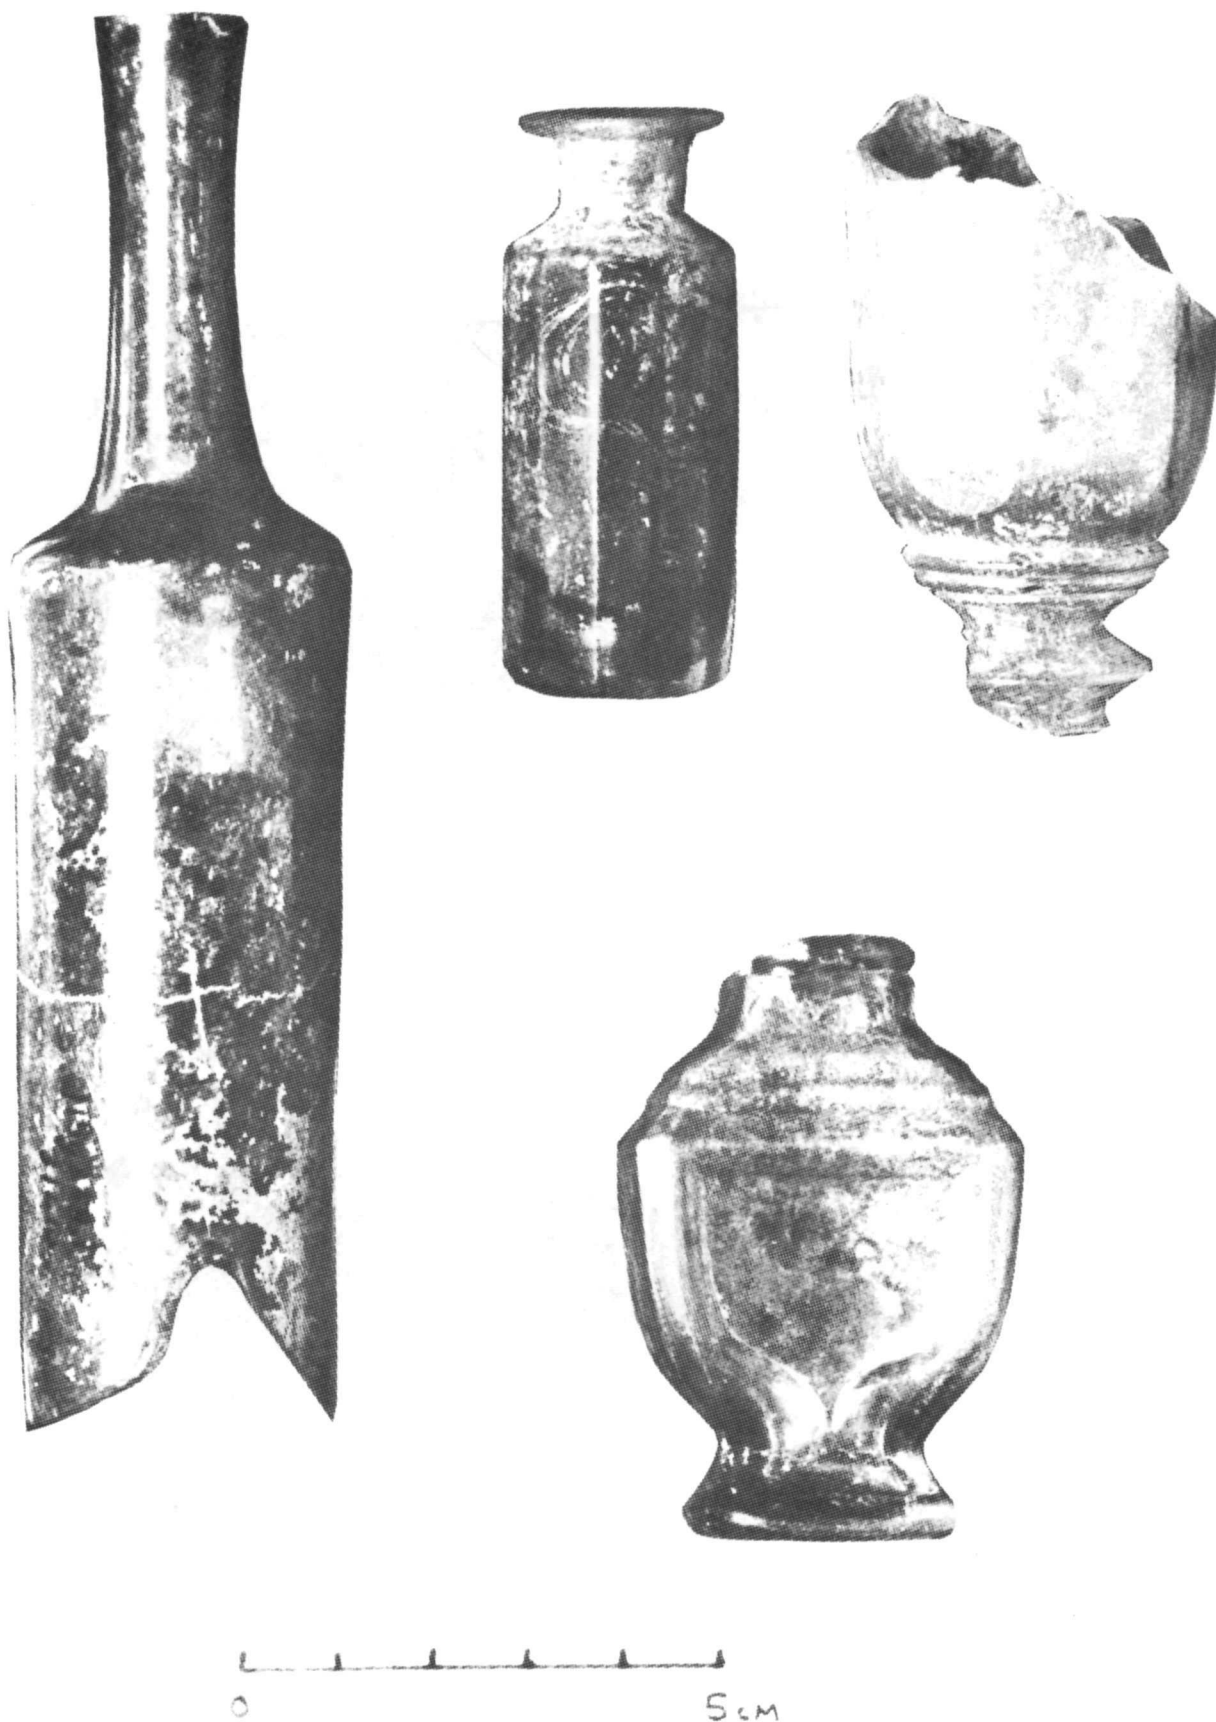
FIGURE 85. Miscellaneous Glass Items Recovered From Hagen's 1951 Excavations.

The largest single glass category was Tablewares (39.7%). The minimum number of tableware vessels from this pit consisted of 3 fluted tumblers (Figure 86), 2 cordial glasses (Figure 85), and 7 stemmed goblets (Figures 87-88). Two of the stemmed ware vessels did not have a pontiled base; these molded vessels had a decorative leaf design on their cup (Figure 89) and date probably from the 1860's or 1870's. The remainder of the stemware vessels (7) all had a rough pontil or ground pontil base. Of these pontiled vessels, Jane Shadel Spillman, Curator of American Glass at the Corning Museum of Glass, states that the stems appear more like those from the 1830's and 1840's than of the 1850's (personal communication).

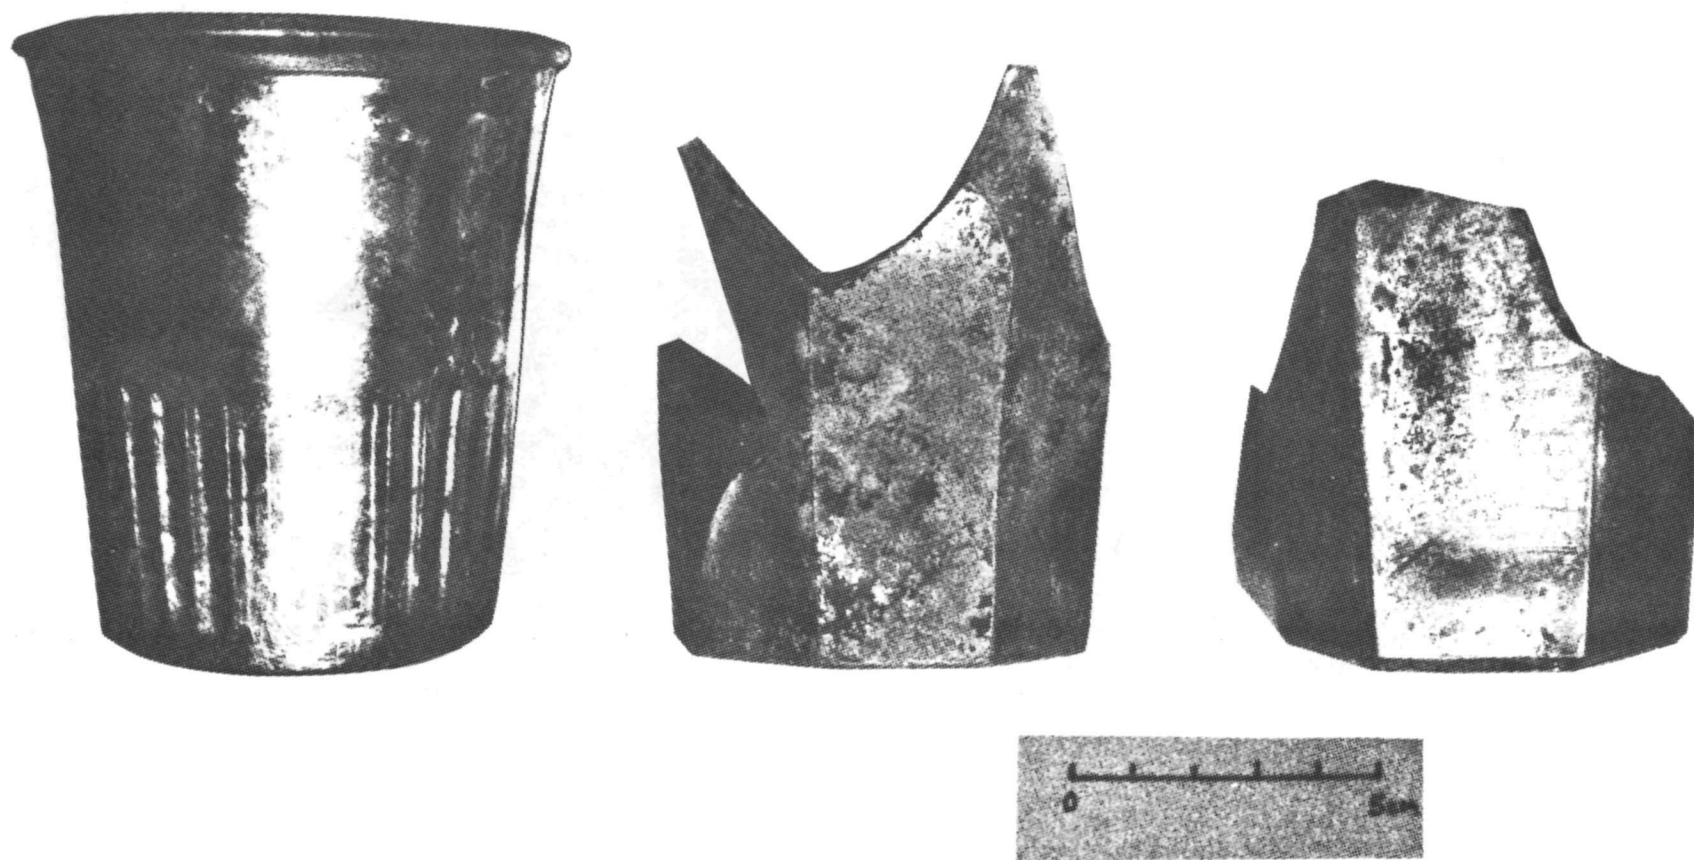
FIGURE 86. Glass Tumblers and Jelly Jar Recovered From the Hagen's 1951 Excavations.

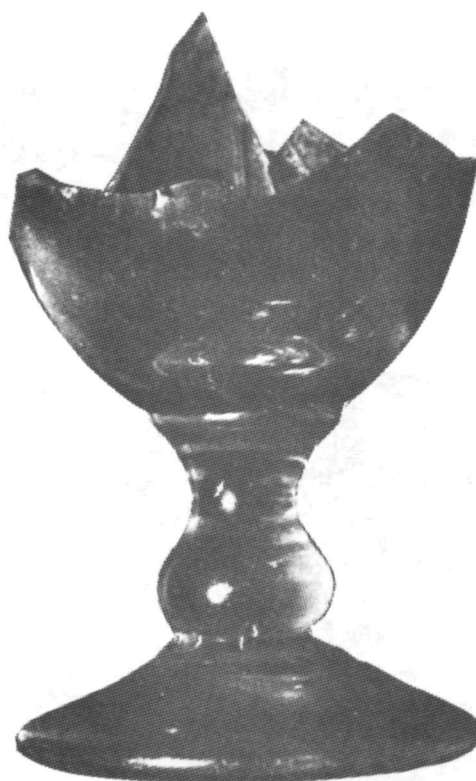
FIGURE 87. Glass Stemware (Goblet) Recovered From Hagen's 1951 Excavations at the Lincoln Site.

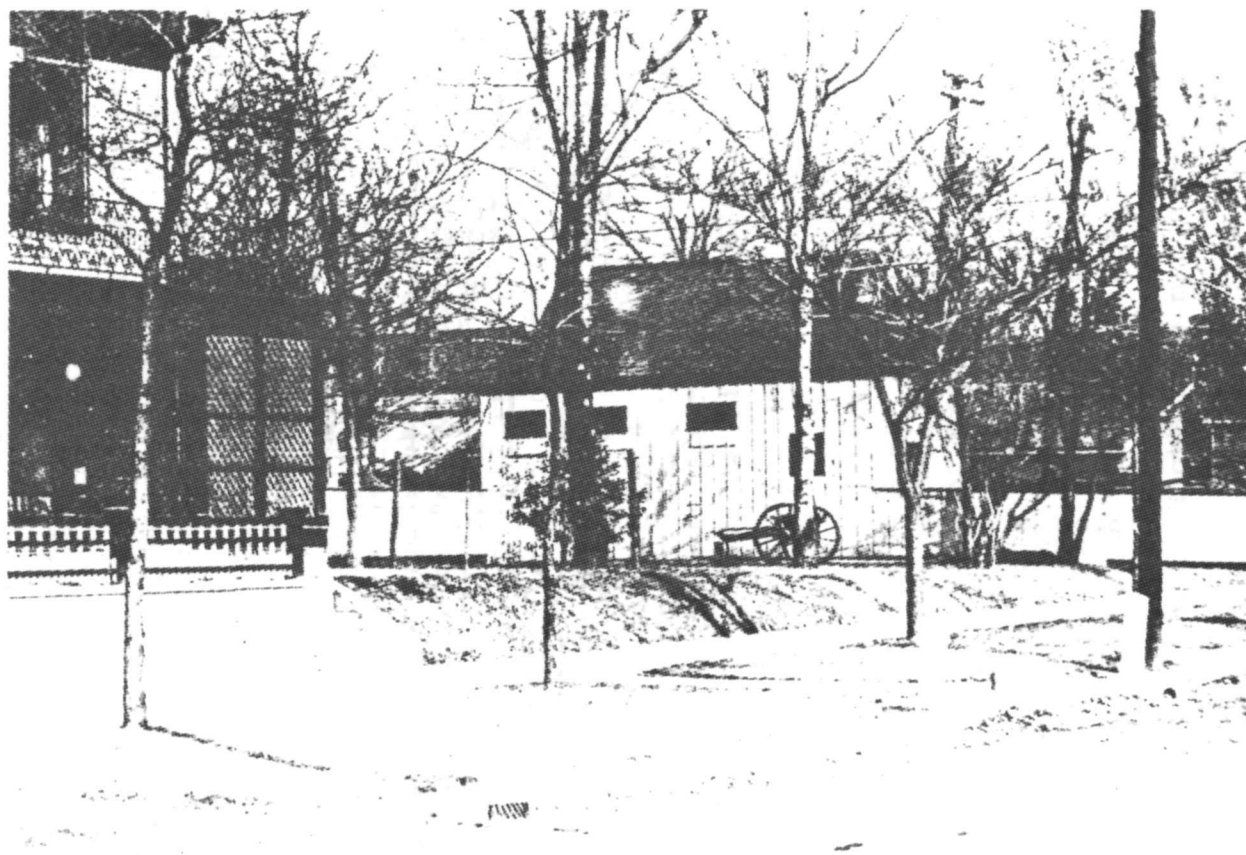
FIGURE 94. Photograph of the Oldroyd Barn, Circa 1890 (Courtesy of the National Park Service).

Oldroyd Barn (Figure 94). The Oldroyd barn, built circa 1889 to replace the Lincoln barn, was situated in the far northeast corner of the lot. This barn was probably built in 1889 by Buck and McKee for a cost of \$180 (Temple 1984: 105). Archeologically, the barn is represented by five brick foundation walls. The south wall does not connect to the remainder of the structure. This is difficult to interpret unless the unconnected area represents a disturbance where the bricks were removed after demolition of the barn. Hagen speculated from the lack of bricks that there was a door in the south wall near the back alley. A row of posts extend from the southwest corner of this barn suggesting that a fence was present.

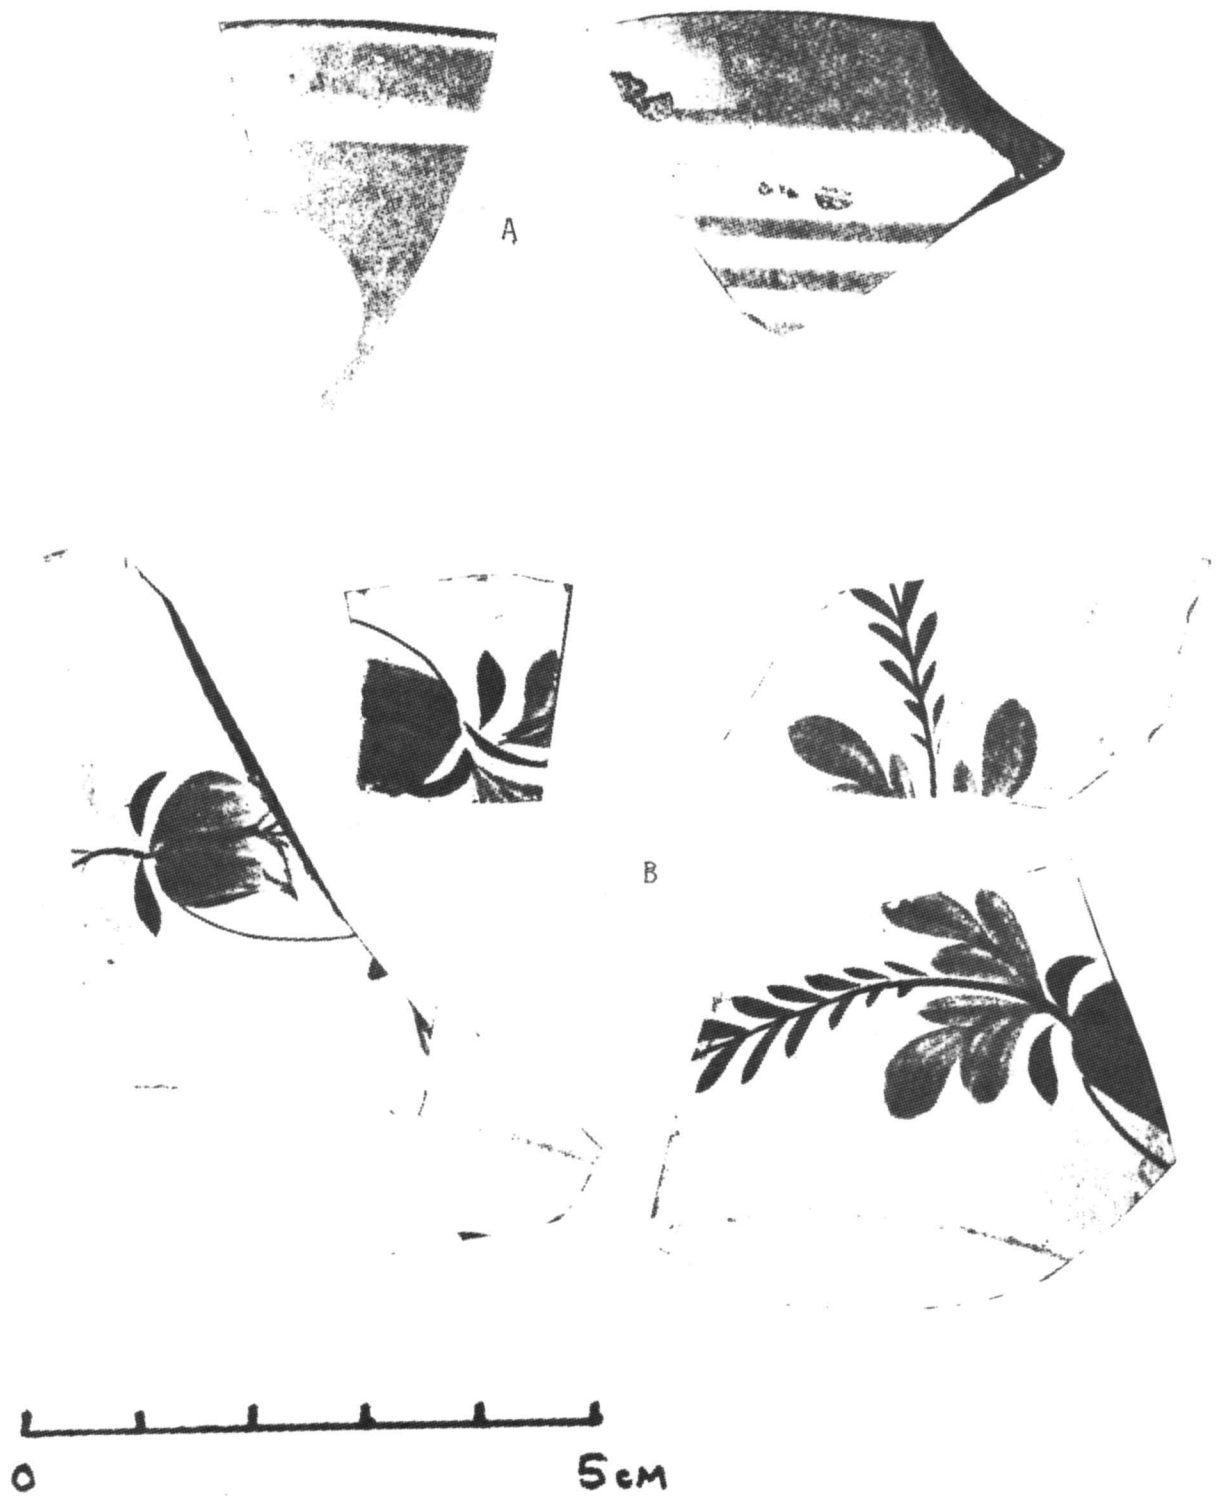
FIGURE 100. The Solomon Allen Barn Site, Selected Ceramics
A. Annular Decorated Whitewares
B. Handpainted Whitewares

The best evidence for dating the construction of the Allen Barn came from artifacts recovered from the fill around posts #11 and #12 near the southeast corner of the barn. Seven hand painted polychrome cup and saucer fragments -- possibly pearlware -- a relief decorated ironstone platter handle, and five pieces of stoneware crockery were found (Figure 100). The hand painted fine line floral motif are similar to mid 19th century examples uncovered elsewhere in Illinois (Figure 101). These fine line hand painted wares are common in the period 1830 to 1860. The presence of the ironstone handle in association with the hand painted wares suggests a slightly latter date, circa 1850 to 1860 for deposition of this fill and thus the construction of the Allen Barn.

Although not as common as the salt glazed stonewares, lead glazed redware crocks were present at the Allen Barn. Begun during the late 1820's and discontinued circa 1854, the local redware industry at Cotton Hill (Sangamon County) supplied much of the local market needs for crockery prior to 1850. Figure 100B illustrates typical redware crocks associated with the Cotton Hill Pottery (Sherman, personal communication).

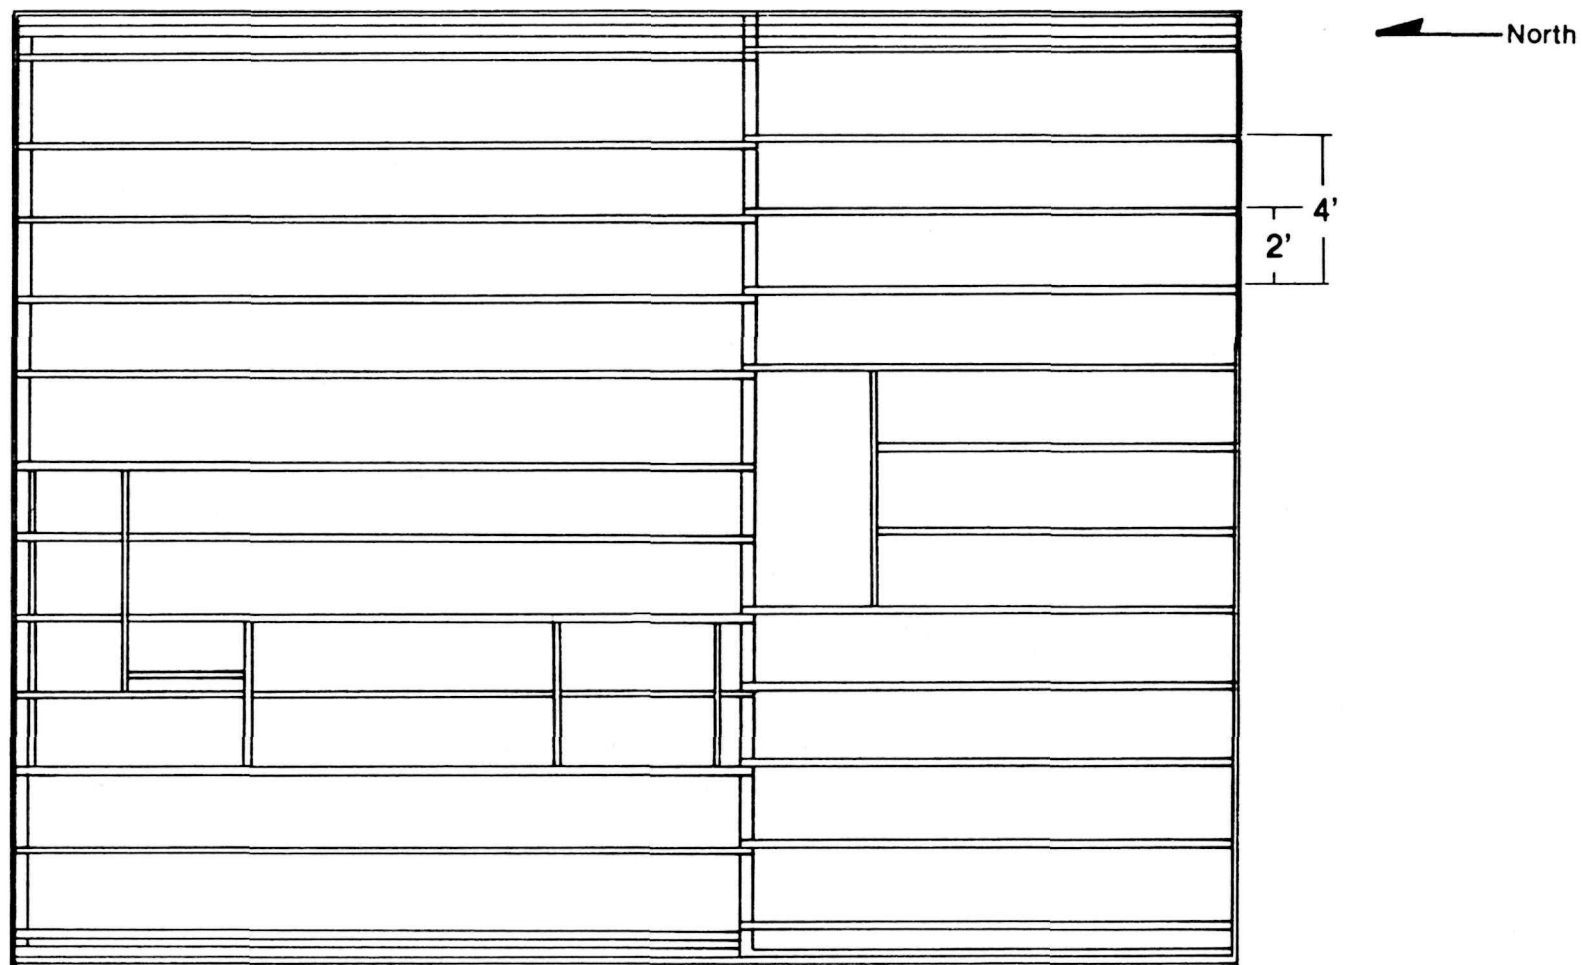
FIGURE 107. Solomon Allen Barn Floor Joist Pattern, Second Floor, 1985.
