ARCHEOLOGICAL INVESTIGATIONS AT THE LINCOLN HOME NATIONAL HISTORIC SITE, SPRINGFIELD, ILLINOIS

By
Floyd Mansberger

NORTHERN ILLINOIS UNIVERSITY
DEKALB, ILLINOIS

Prepared For The National Park Service
Midwest Archeological Center-Lincoln, Nebraska

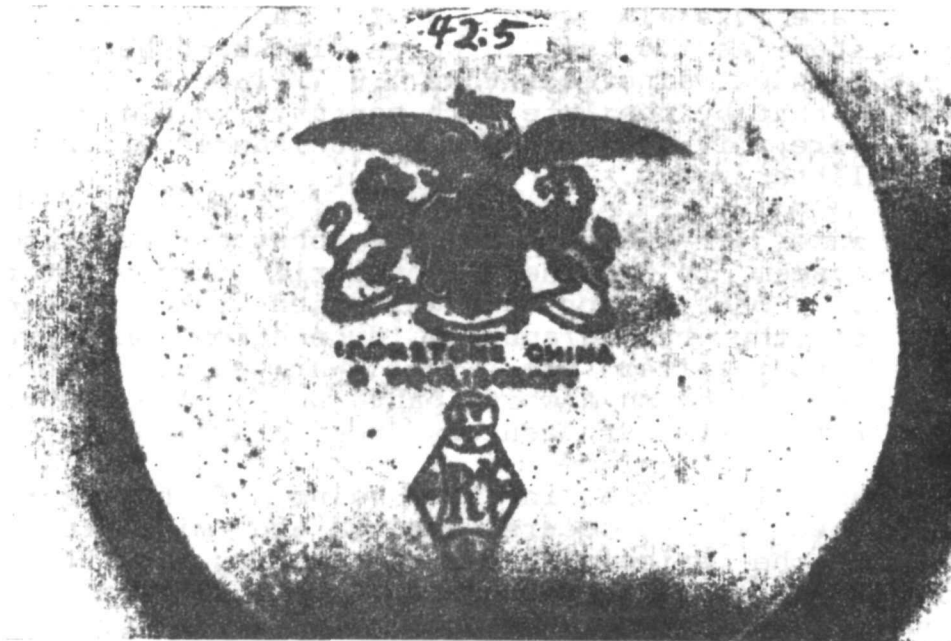
FIGURE 114. Relief-Decorated Ironstone Vessel, Registered 1855.

Plain White Stone China, or Ironstone (Figure 114), was recognized by Miller (1980: 3) as ranking above "c.c." wares. Initially, in the early to mid-1850's, when undecorated ironstones became popular, they appeared at a price comparable to transfer printed wares (level 4; Miller 1980: 4). By the late 1850's and through at least the late 1870's, few transfer printed wares were made. Miller (1980: 4) believes that the undecorated (or relief decorated) ironstones replaced the transfer printed wares in his economic scale. It is my opinion -- based on the comparison of ceramics from these excavations -- that a major shift in the economic ranking of these decorative techniques took place circa 1860 when transfer printed wares -- and the more common relief decorated wares of the 1860's and 1870's -- slide into a lower economic bracket (Level 3).
