Lincoln Home National Historic Site

Cultural Landscape Report

June 2014

Prepared by
QUINN EVANS ARCHITECTS
1037 Sherman Avenue
Madison, Wisconsin 53703
734-926-0419

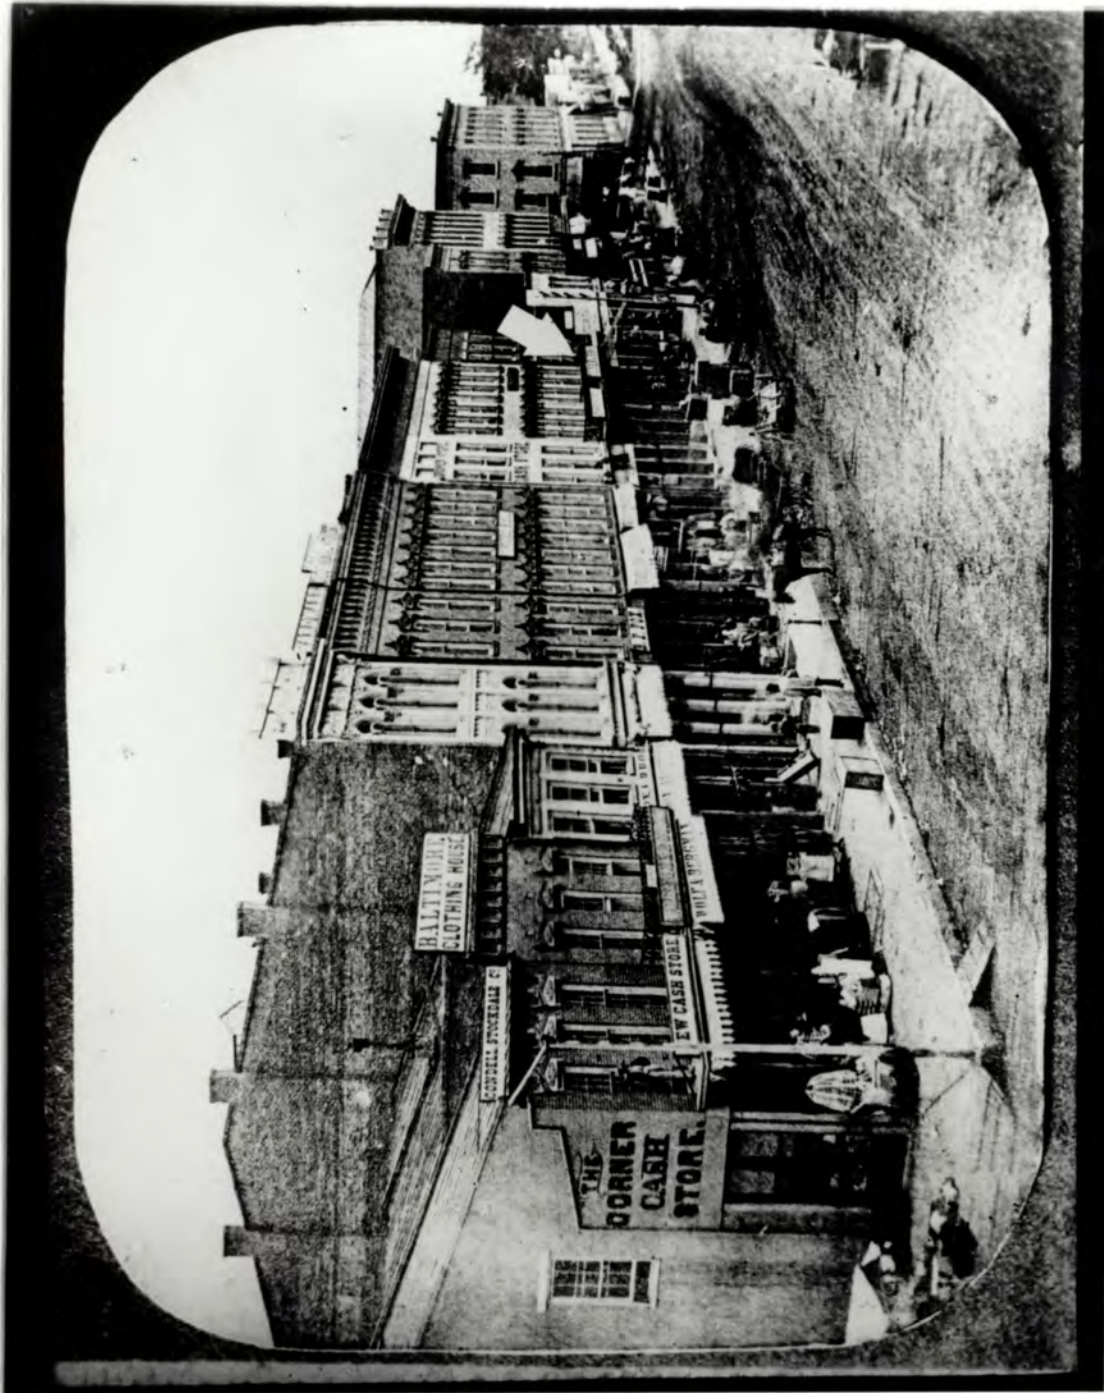
Figure 2-15. 1858 photograph by P. Butler, Springfield of the Springfield State House Square north side, ISHL.

The specific guideline for wide sidewalks are revealed in a series of 1859 views of the commercial center of the city (see Figures 2-15, 2-17, 2-19 and 2-21). These images show wide board sidewalks extending from the building line to the wood curb. Note also in some of these views the wood ramps at the end of the block to provide a transition from the boardwalk to street level. One of the first flagstone sidewalks was installed around the capital square in November of 1854.¹⁸⁷ A circa 1850s or 1860s view of the state house shows this walk with an irregular rectangular pattern of stone paving, which is edged by the stone base for the iron fence on one side and the stone curb along the street edge on the other (see Figure 2-30). An 1865 stereopticon view of a portion of the square shows stone curbs and walks that appear to be compacted earth or gravel walks (see Figure 2-26). The flagstone walks could have been in an area not pictured in this view or their surface pattern could be obscured by an overlay of sand or dust.

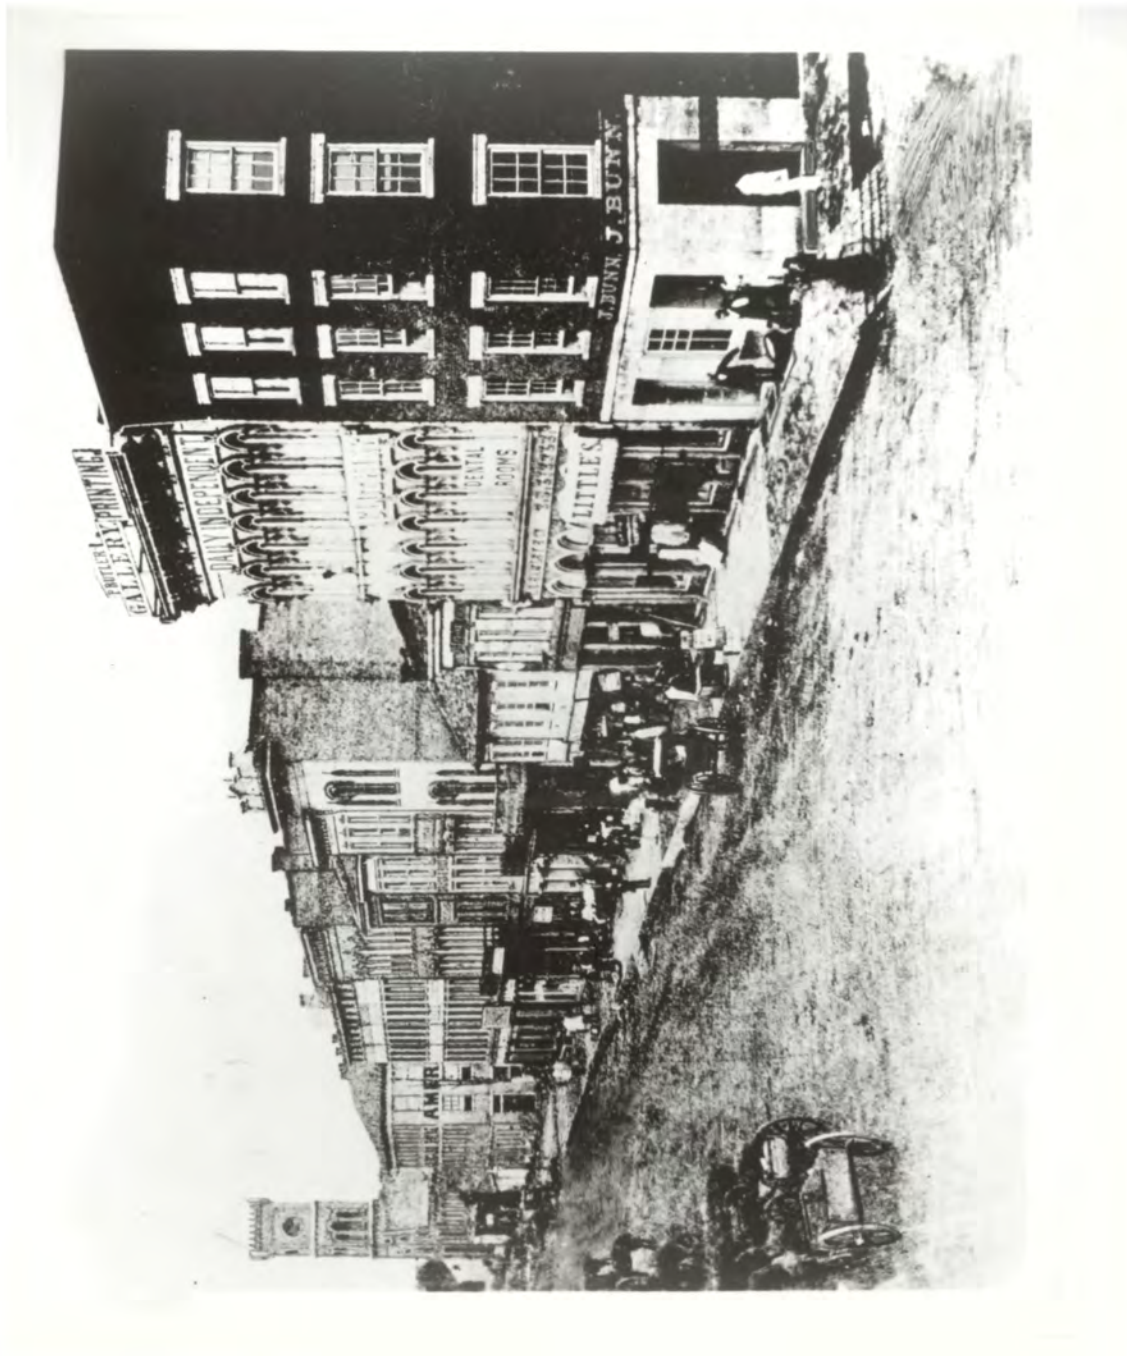
Figure 2-17. 1858, South side of State Square, photograph by P. Butler, John Bunn store at corner, ISHL.

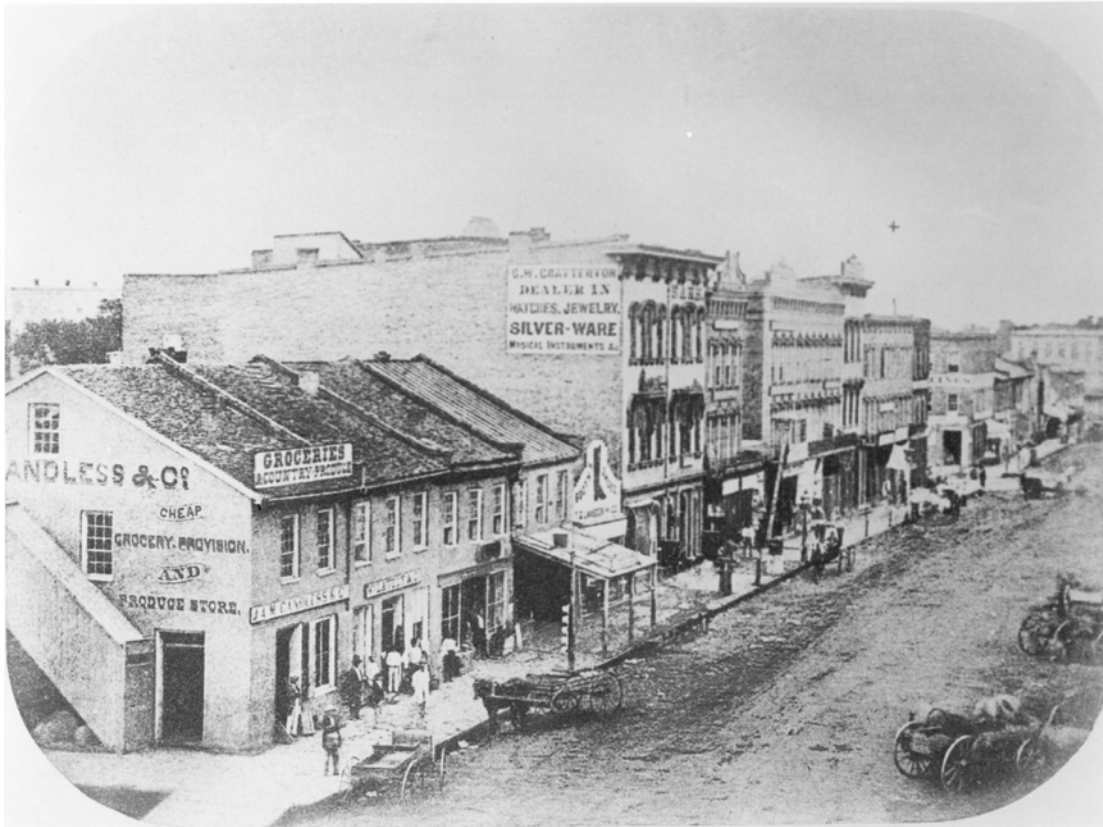
Figure 2-21. 1858, West side of State Square, photograph by P. Butler, Springfield, ISHL.

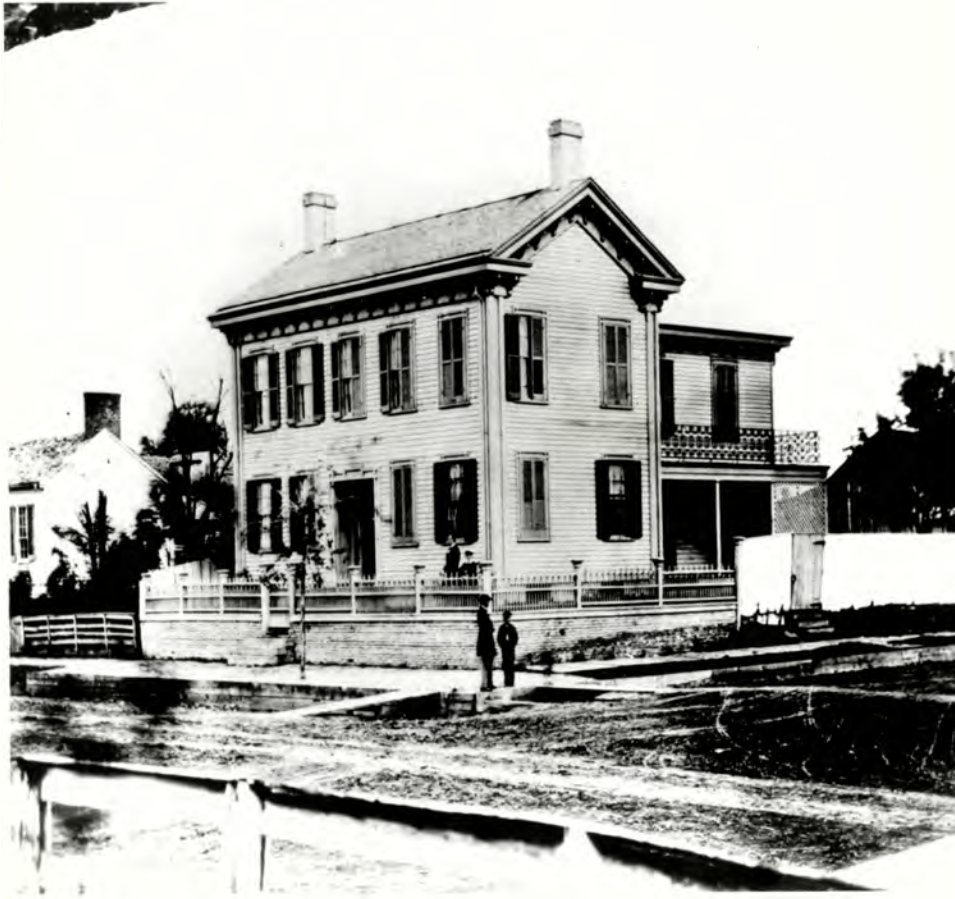
*Figure 2-24. 1860 Lincoln Home, and Carrigan and Corneau properties, Whipple photograph 1860, ISHL Lincoln Collection, (EB69 Plate IV).**

Two 1860 A. J. Whipple photographs show the Lincoln Eighth Street sidewalk as extending from the front retaining wall to the curb, with an elm tree planted in the walk toward the curb (see Figures 2-24 and 2-25). The sidewalk along Jackson Street is also visible and shows a fairly wide area of exposed soil between the walk and the curb, but no trees are visible. There are trees visible on the southern part of Lincoln's back yard. According to Bearss, there were two apple trees in this area.⁴¹⁷ These photographs show at least one tree located north of the Lincoln house between it and the Carrigan home. A photograph taken in the summer of 1860 during a Republican rally at Lincoln's house shows foliage between the Lincoln and Carrigan property (see Figure 2-26). An enlargement of this area shows the vegetation massing between the houses as well as a partial view of the Carrigan barn and portions of a Lincoln property privy and outbuilding (see Figure 2-28). Written records offer some detail the vegetation at the Lincoln Home for 1848, during the time, Lincoln was away at Congress, and the house was rented to Mason Brayman. In a June 8th, 1848 letter to his

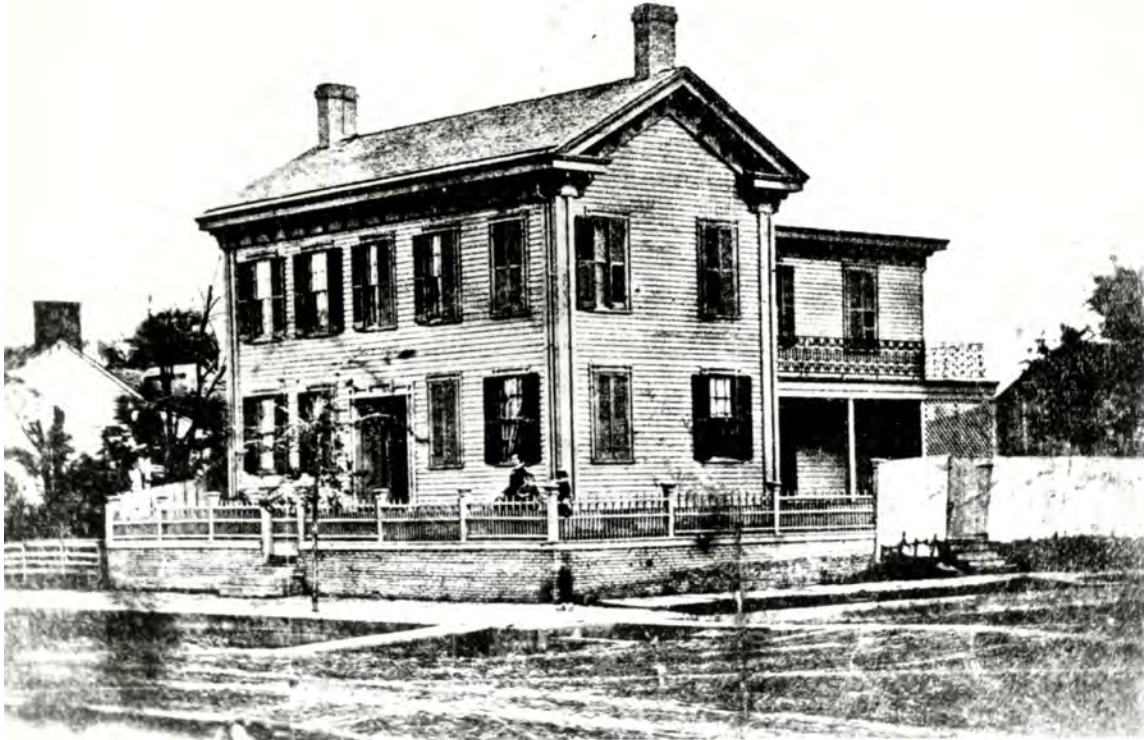
Figure 2-25. 1860 Lincoln Home view with Willie and Tad with their Father (Lincoln), Whipple photograph, ISHL, (FT), (EB69 Plate II)*.*

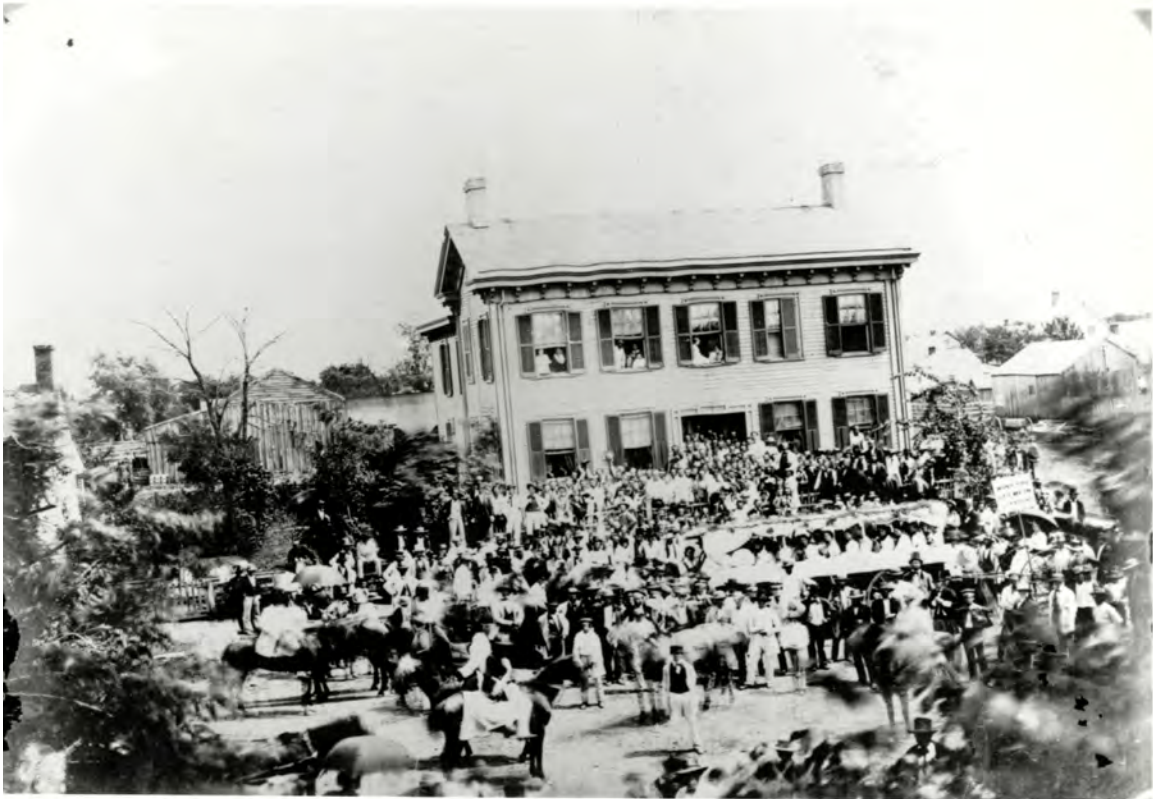
Figure 2-26. August 8, 1860, Republican rally at Lincoln Home, The Huntington Library, San Marino, California

Figures 2-26 and 2-28). Fawcett and his neighbor on lot 16 (north) shared a single-story shed that is visible in this photo.⁴⁶⁷

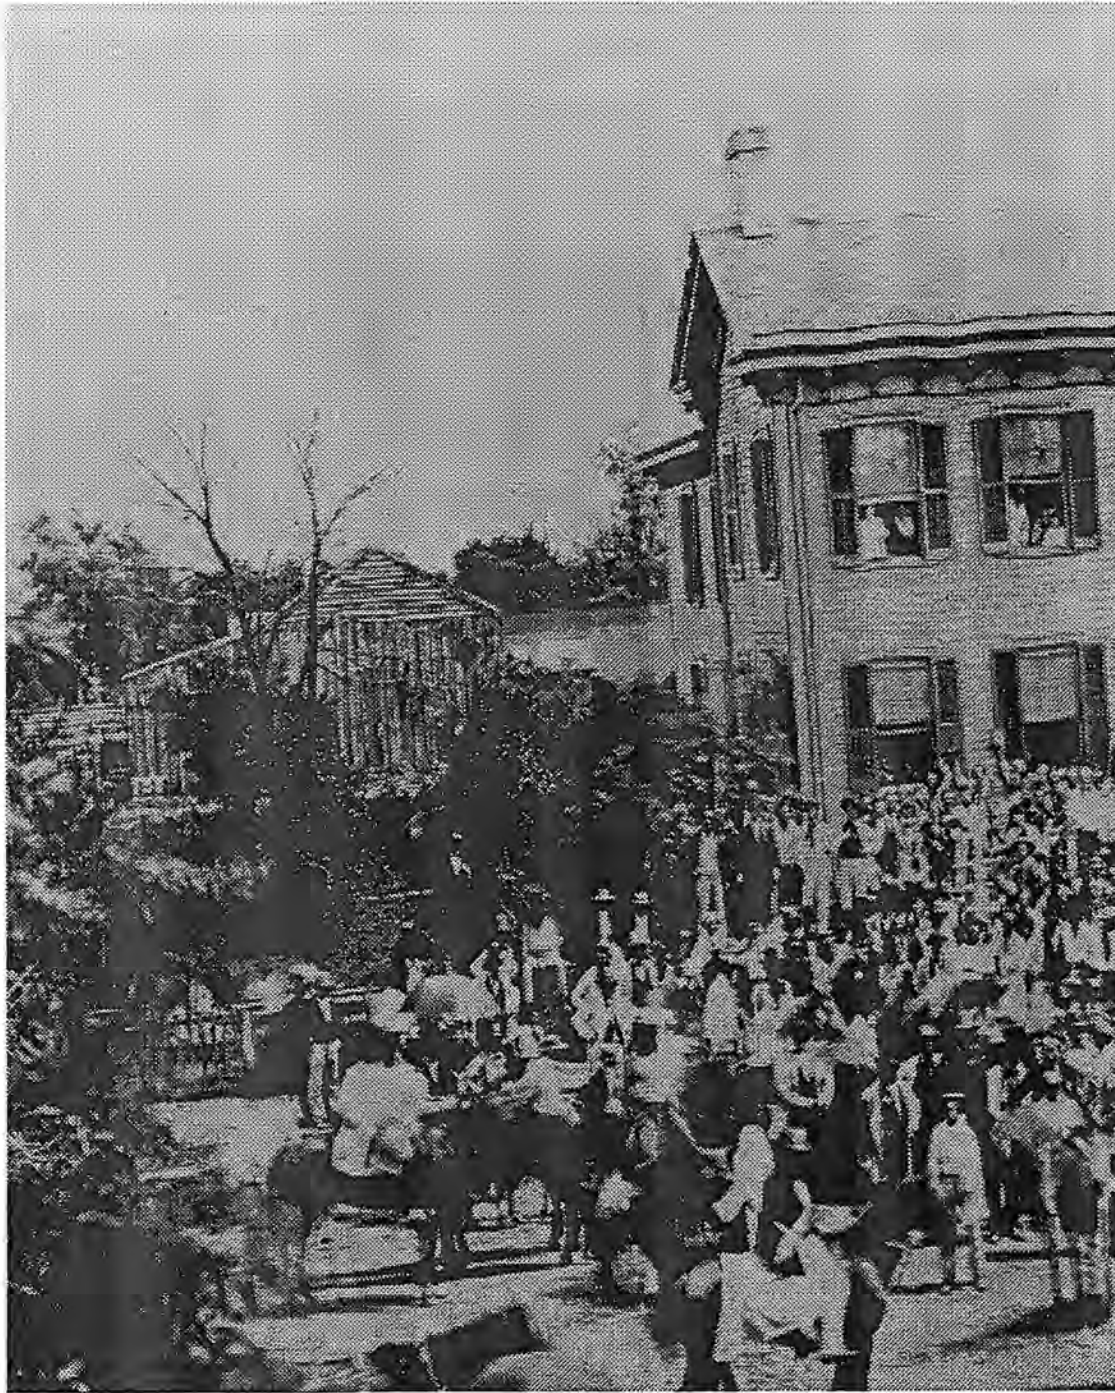
*Figure 2-27. Detail of August 8, 1860 photograph of Republican Rally at Lincoln Home, showing side yard of Carrigan House, with portion of back yard of Lincoln Home, woodshed and Carrigan Barn, Brown University, John Hay Library, (EB69 Plate III, LHNHS, EB69 Plate XXVIII.)**

Block 10, Lot 6 and North 3/4 of Lot 7 (Carrigan House): The property was a combination of Lot 6 and the north three-quarters (30 feet) of Lot 7 since 1839. Records indicate the house was probably constructed shortly after that date.³⁹⁸ The lot had 70 feet of frontage on Eighth Street, and the house was located about 35 feet back from the walk.³⁹⁹ The 1854 city map shows an L-shaped building with the long axis parallel to the north boundary of Lot 6. As can be seen in an 1860 photograph of the Lincoln House, the Carrigan house was a single-story with chimneys on the north and south ends, and a rectangular addition attached to the rear (see Figure 2-24).⁴⁰⁰ There were three outbuildings associated with the Carrigan House at this time. A small rectangular structure is shown on the 1854 city map to be directly adjacent to the north-east corner of the house, and up against the north property line.⁴⁰¹ A large frame barn on the south-east corner of the property fronted on the alley, and a woodshed was located on north-east corner of lot.⁴⁰² An 1860 photograph of a Republican rally at the Lincoln Home provides some detail of the Carrigan barn (see Figure 2-26). It was a one-story structure that appears to be constructed of unpainted wood.⁴⁰³ A detail of this photograph shows the southernmost part of the Carrigan fence fronting on Eighth Street is also visible in this photograph, and appears to be a four-board type (see Figure 2-27).

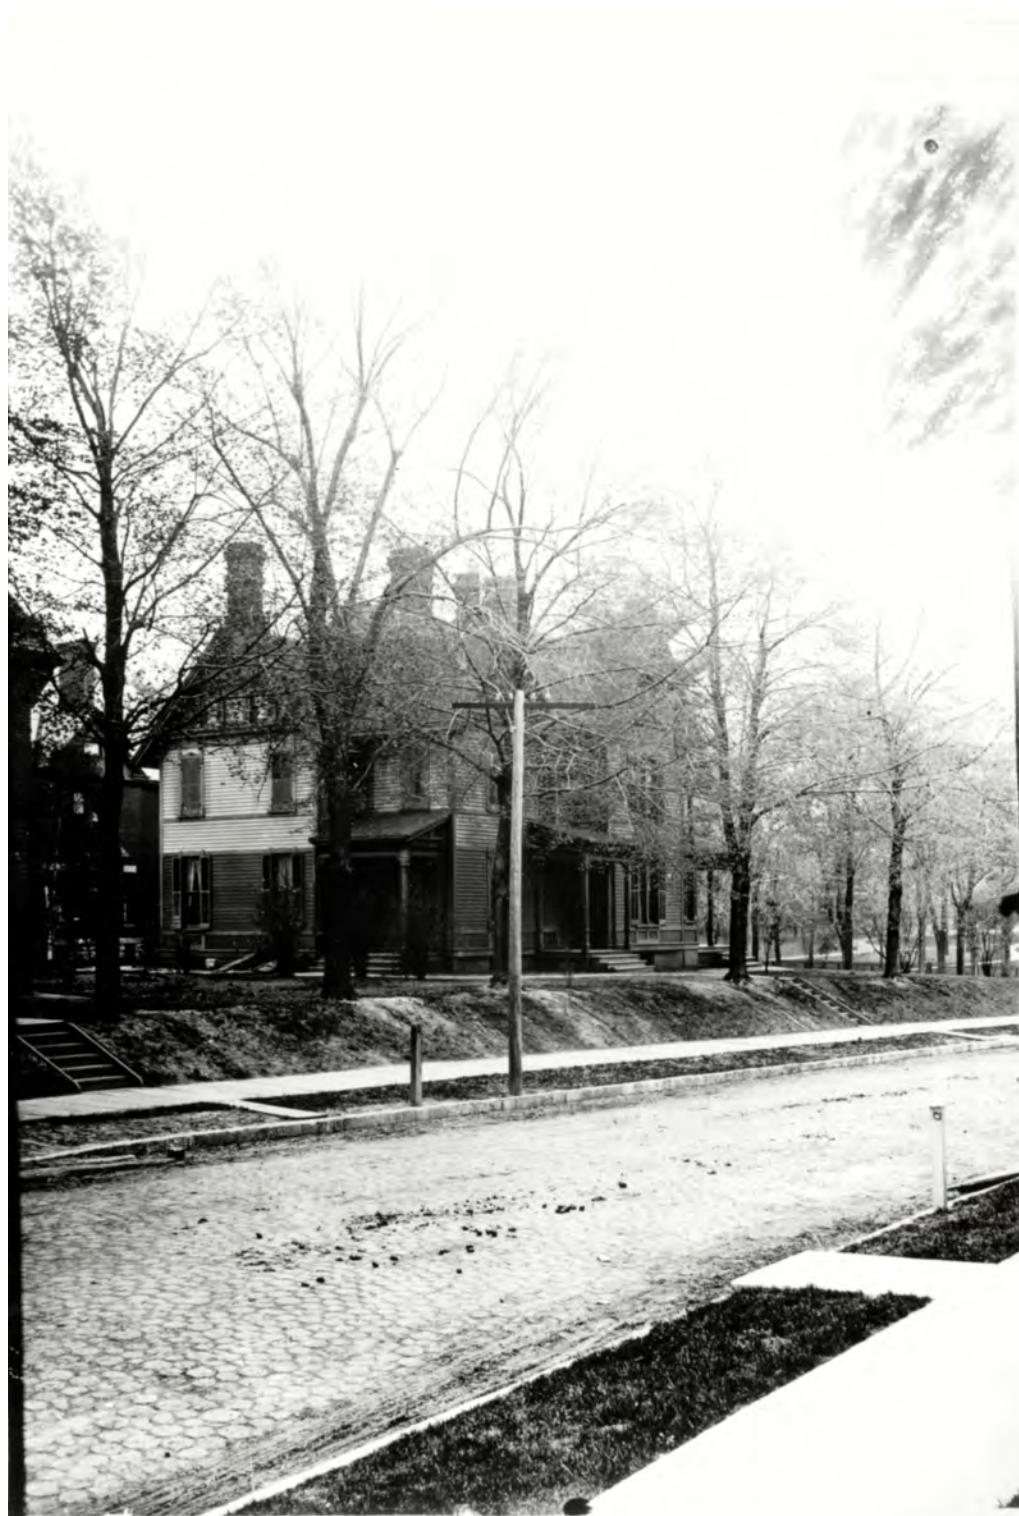
Figure 2-74. ca. 1880s photograph of the Selby residence at 2nd and Jackson, ISHL.

Later street improvements addressed the paving of city streets. Springfield used cedar blocks on twenty-five miles of streets in the 1880s. A circa 1880s photograph shows a street with round log sections forming the street pavement (see Figure 2-74). Two additional photographs show the compacted earth surfaces of Jackson Street at the Corneau House and Eighth Street looking north from Edwards Street in the 1880s, indicating that street pavement had not yet come to the Lincoln neighborhood (see Figures 2-91 and 2-106). Figure 2-106 does show that the earlier high wooden curbs have given way to lower stone curbs along Eight Street, although Figure 2-91 shows no curb on Jackson Street.

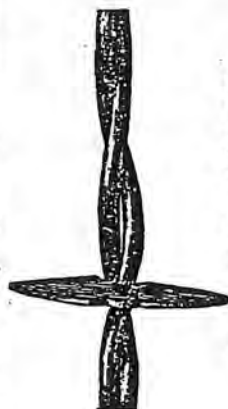
Fig. 58.—THE KELLY BARB WIRE.

ous injury to valuable domestic animals coming in contact with the sharp barbs. Many means have been devised for overcoming this evil. Some of them are illustrated in the next chapter. The direct advantages

of barb wire are: First—economy, not only in the comparative cheapness of its first cost, but also in the small amount of land covered by it. Second—effectiveness as a barrier against all kinds of stock, and a protection against dogs and wild beasts. Third—rapidity of construction and ease of moving. Fourth—freedom from harboring weeds, and creating snow drifts. Fifth—durability.

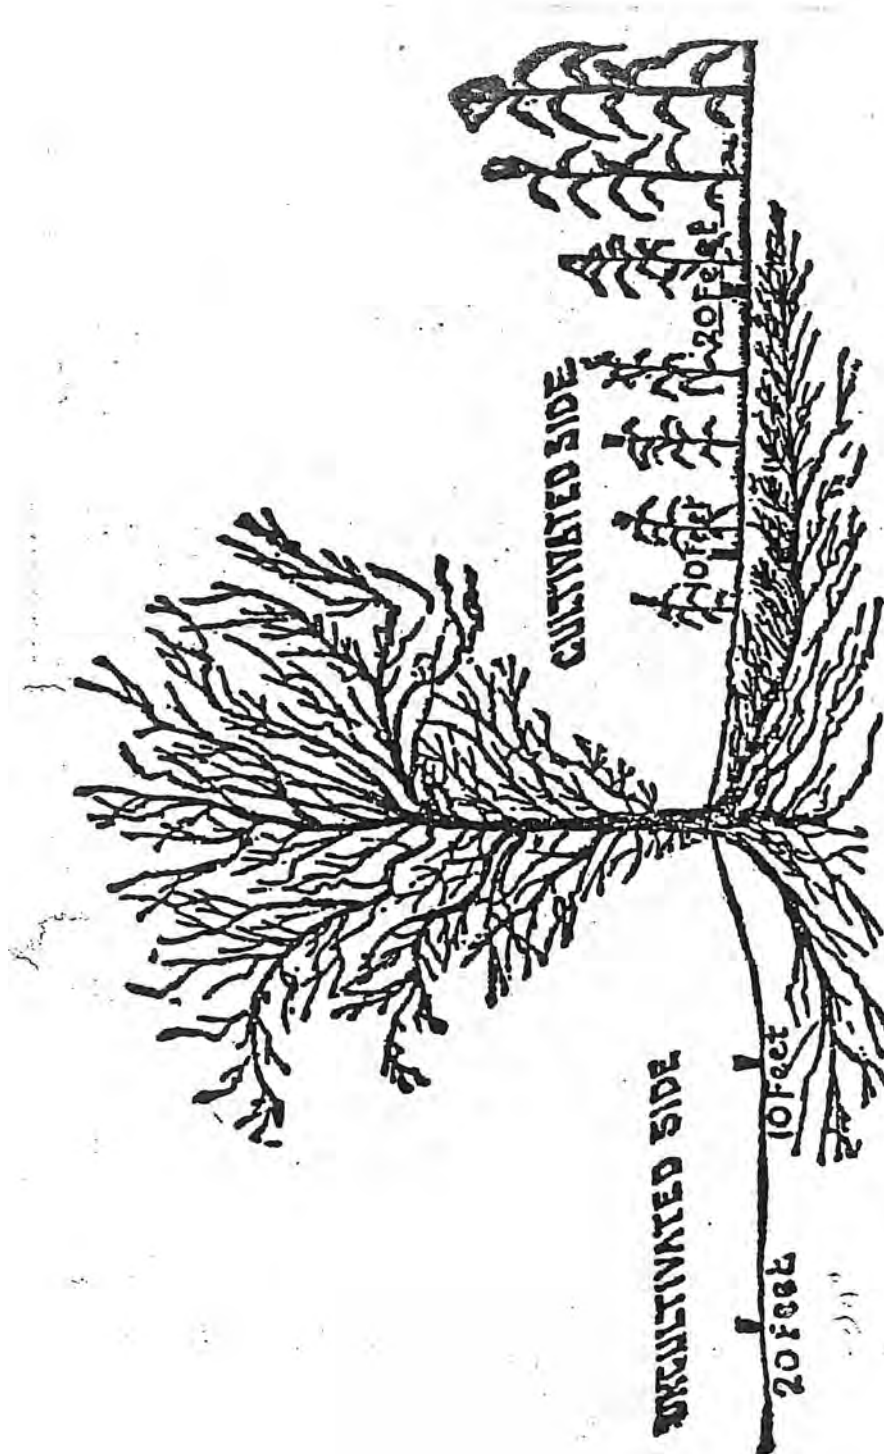
Fig. 110.—EFFECT OF CULTIVATION.

Figure 2-89. 1887, Osage orange plants were easily set out in long lines along the edge of fields. Furrows were dug and the plants laid out on the ground. Another furrow alongside the first turned the ground over to cover the roots, from *Fences, Gates and Bridges*, George Martin, reprinted 1974.

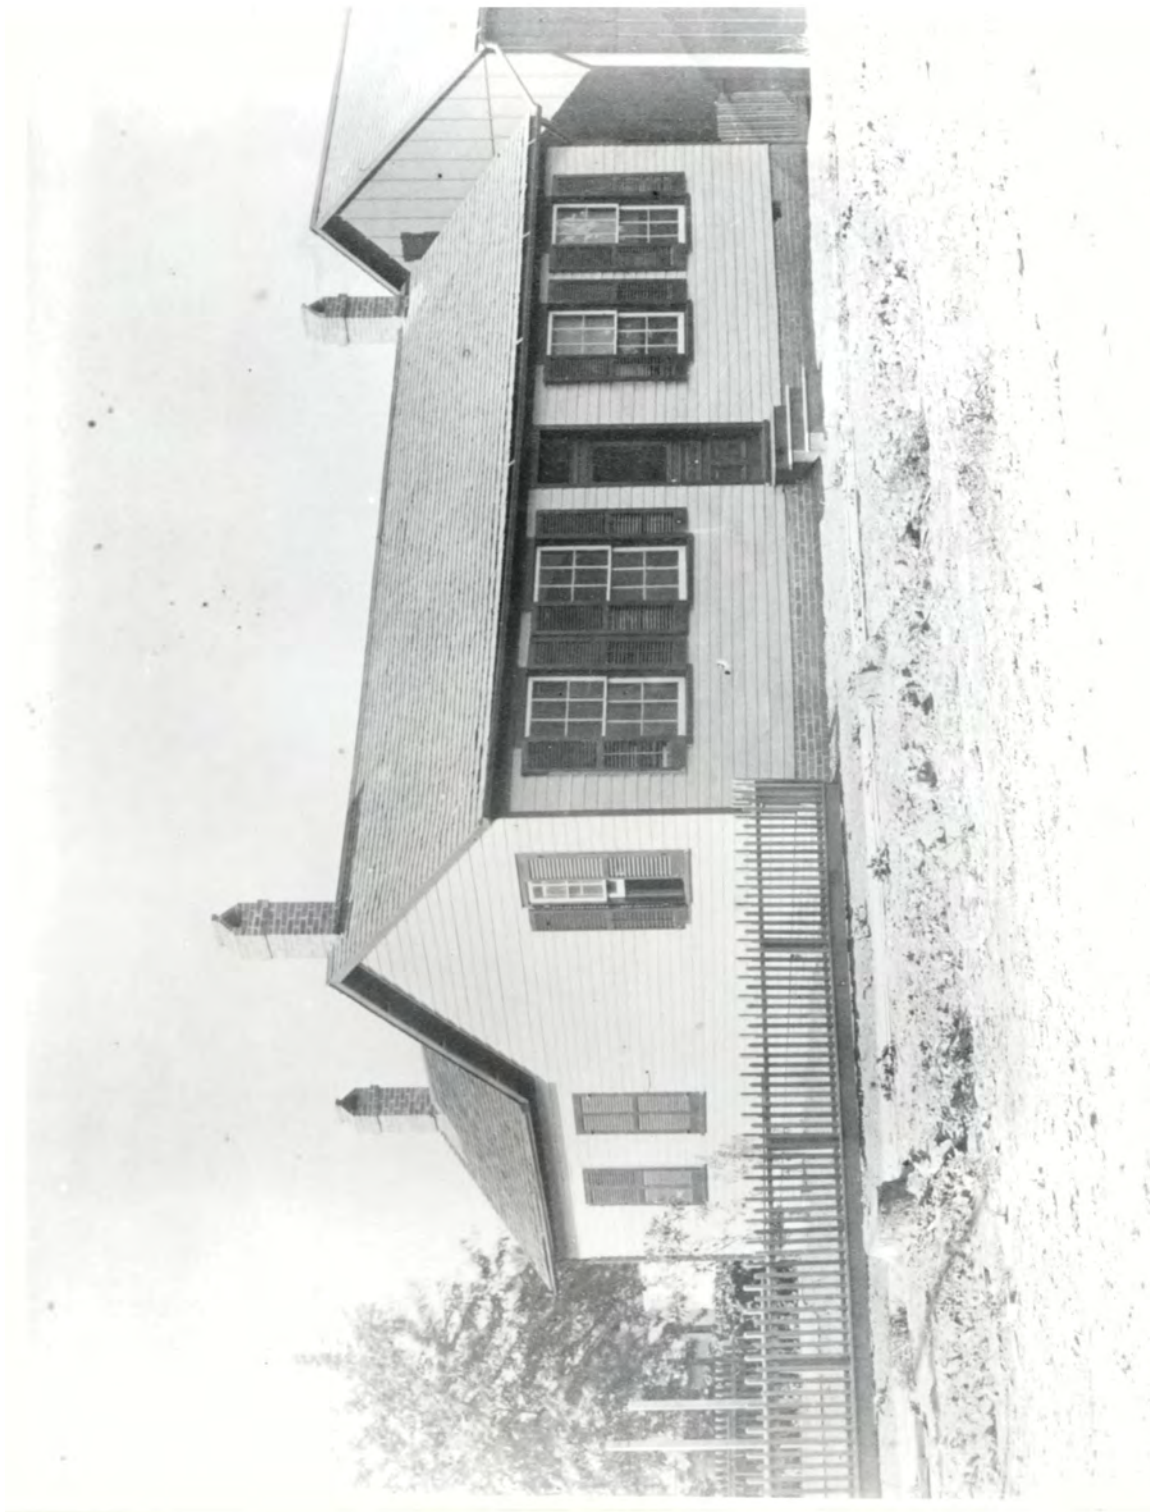
*Figure 2-91. ca. 1887, Charles S. Corneau House on rear of lot, ISHL, (EB69 Plate XXII).**

Block 6, Lot 9 (Lutz House): A period photograph of the south and east elevation of the John Lutz House ca. 1907 shows that this house remained relatively the same from the ca. 1898 photograph (see Figure 2-91). The enclosing picket and board fence in the earlier view was removed, with this view indicating a partially surround of a low, stone or cast stone curbing at the edge of the lawn. The plantings are meager with a few shrubs are evident at the southwest corner of the house. A clump of what appear to be perennials is planted along the porch foundation at the northeast corner of the house. The street trees along Edwards and Eighth Streets remain from the 1890s photograph and have gained additional size. By 1948 an apartment building was added to the west end of the lot, behind the existing house. These two structures remained through 1969.

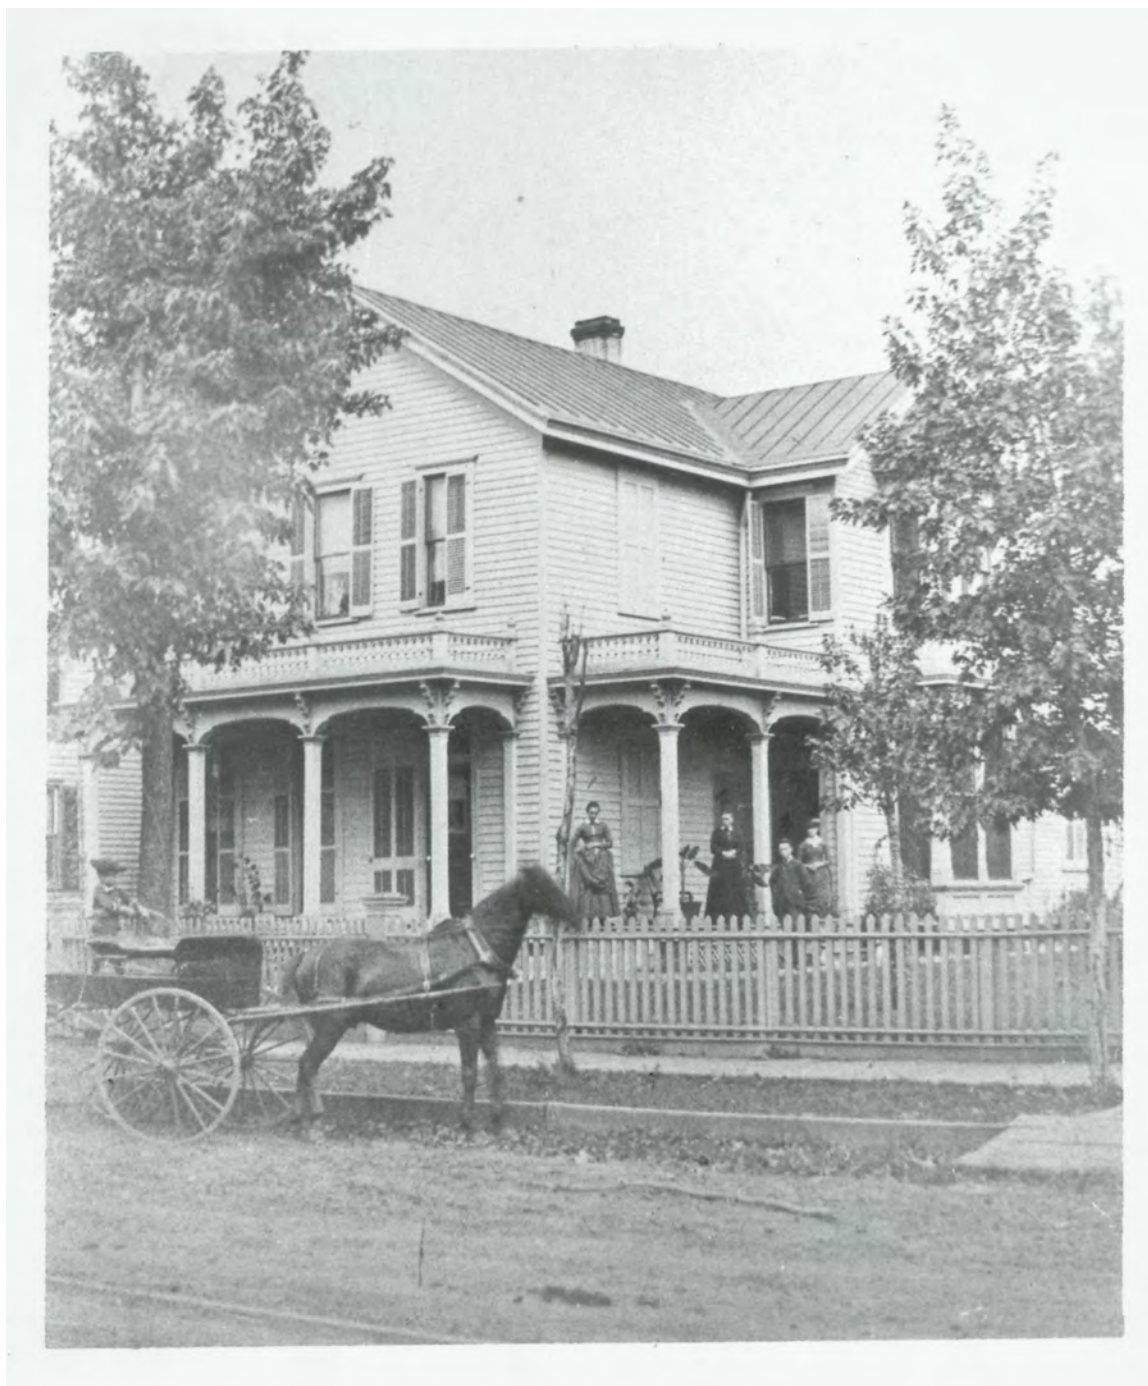
*Figure 2-92. ca. 1884-87, Henson Robinson House, southwest corner of yard, LHNHS, (FK91.)**

A circa 1884-1887 photograph of the house was taken just after the renovations and additions of a south porch (see Figure 2-92). The side yard landscape changed with the changes to the house. The grouping of trees and shrubs seen earlier were replaced with a single tree. Shrubs were planted at the foundation of the house. Several of the street trees adjacent to the Robinson lot look to be sycamores; by 1887 one of these was standing dead. A later street view ca. 1889 down Eighth Street from Edwards shows a portion of the Robinson House (see Figure 2-90). It is clearly evident that the width of the grass verge containing the street trees has changed from earlier views. Now the street trees seem to abut the boardwalks with a much wider grass area. The limestone curbs runs along the portion by the Robinson House a curb cut seems to be made directly in front of the Robinson lot. Wooden planks are still evident allowing crossing of the curbs in front of the Robinson House, these disappear in later photographs. Detail photographs of the side of the Robinson House indicate that the walks within the property were cast concrete. Steps leading up to the side porch were limestone.⁵⁹⁸ One photograph of the rear yard shows masses of shrubs planted along the edge of lattice fence (see Figure 2-129). Grass remains as the dominant vegetation around the rest of the property.

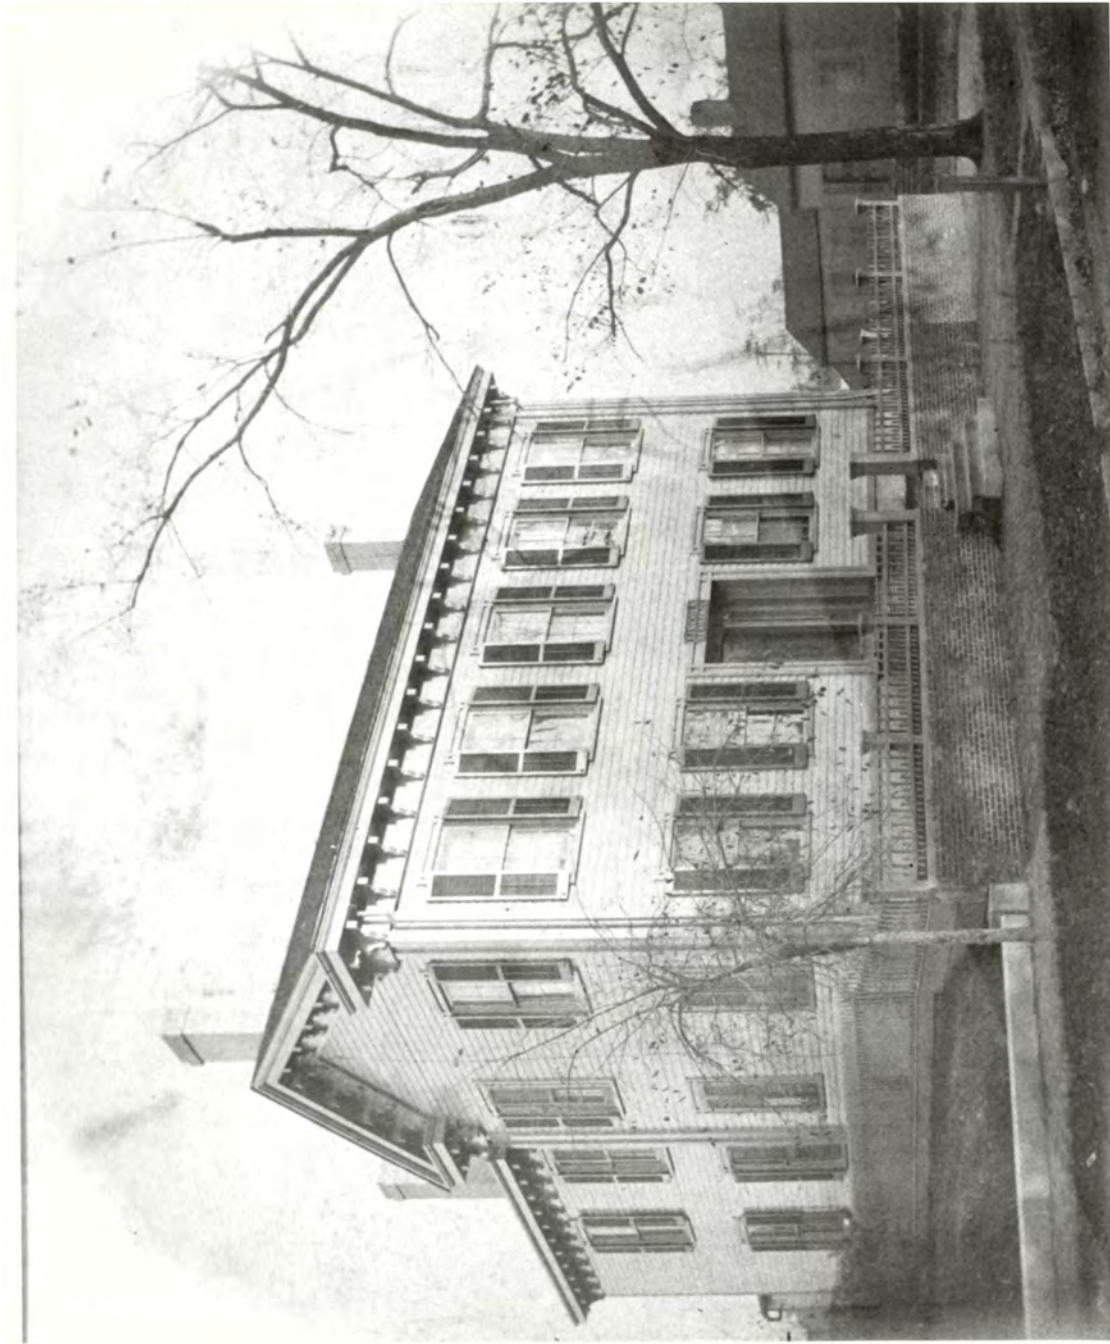
Figure 2-93. ca. 1888, "The Lincoln Homestead, Springfield, Ill., Osborn Oldroyd Coll, (LHNHS), (EB69 Plate XVIII.)*

The original stone steps leading up into the Lincoln house from the sidewalks on Eighth Street (see Figure 2-93) were replaced in 1889-90 by the Culver Marble company of Springfield. "Culver Marble was paid \$409 for labor and materials furnished for laying brick and stone walks, erecting hitching post, horse block, etc., and sodding and grading yard."⁵⁶⁴ The original wood steps were replaced with a set of five stone steps leading up from the sidewalk to the yard. Another set of three stone steps gave access from the yard to the front door. These Culver Marble replacement steps are not exact duplicates of the original Lincoln steps.⁵⁶⁵ A description of an artifact found in the Oldroyd collection indicates that the "stepping stone, removed from between the gate posts, Lincoln Homestead, Springfield during repairs to the walk in 1887. Size, 3 x 22 x 24 in."⁵⁶⁶ Architectural drawings by George W. Bullard from 1888 indicate that five stone steps were located at the front gate. This same reference shows a brick walk connecting these steps to the front porch steps and connects to the brick surface drains along the inner face of the brick retaining wall. No other references indicate this feature.⁵⁶⁷

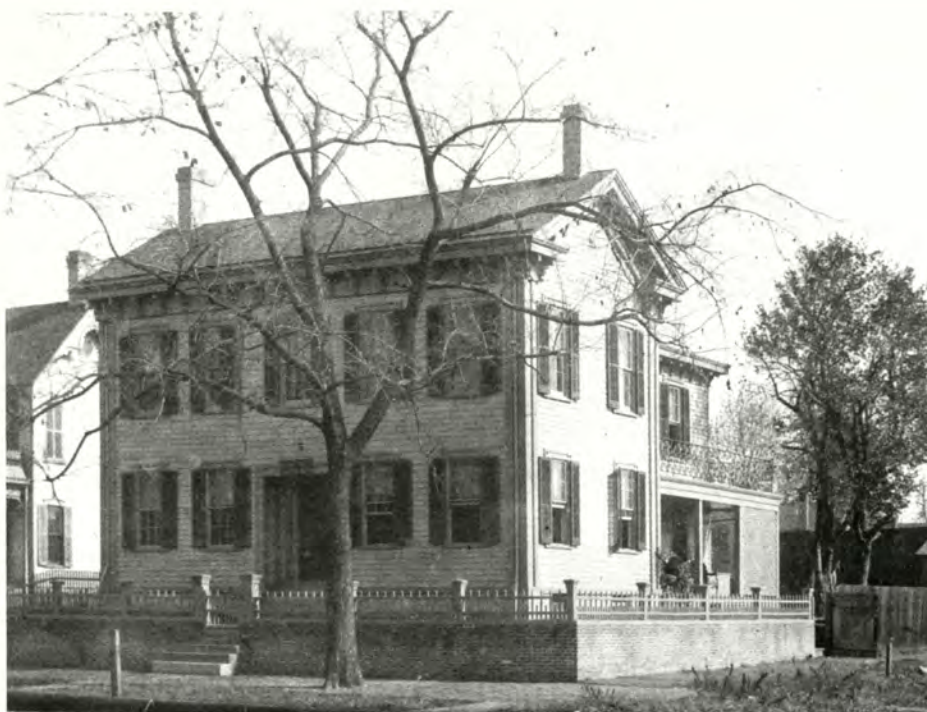
Figure 2-94. ca. 1888, Lincoln Home and Carriage House, photograph from Osborn Oldroyd Collection, FT. (EB69 Plate XVII).

An 1888 photograph of the Lincoln Home (see Figure 2-94) and an 1889 photograph (see Figure 2-95) show a two story house and a smaller outbuilding. A tall utility pole is evident along the Jackson Street side of the property. Little else can be seen of the lot from this photograph.

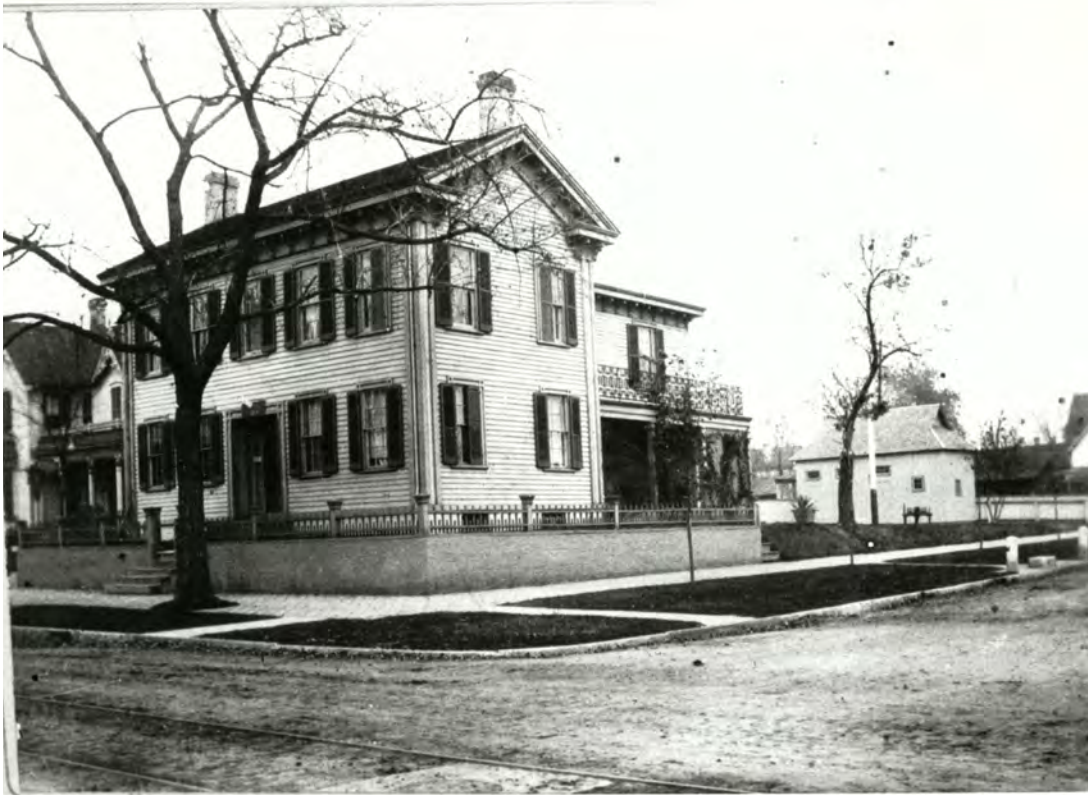
Figure 2-95. ca. 1889, southwest corner of Lincoln Home, photograph from Osborn Oldroyd Collection, FT.

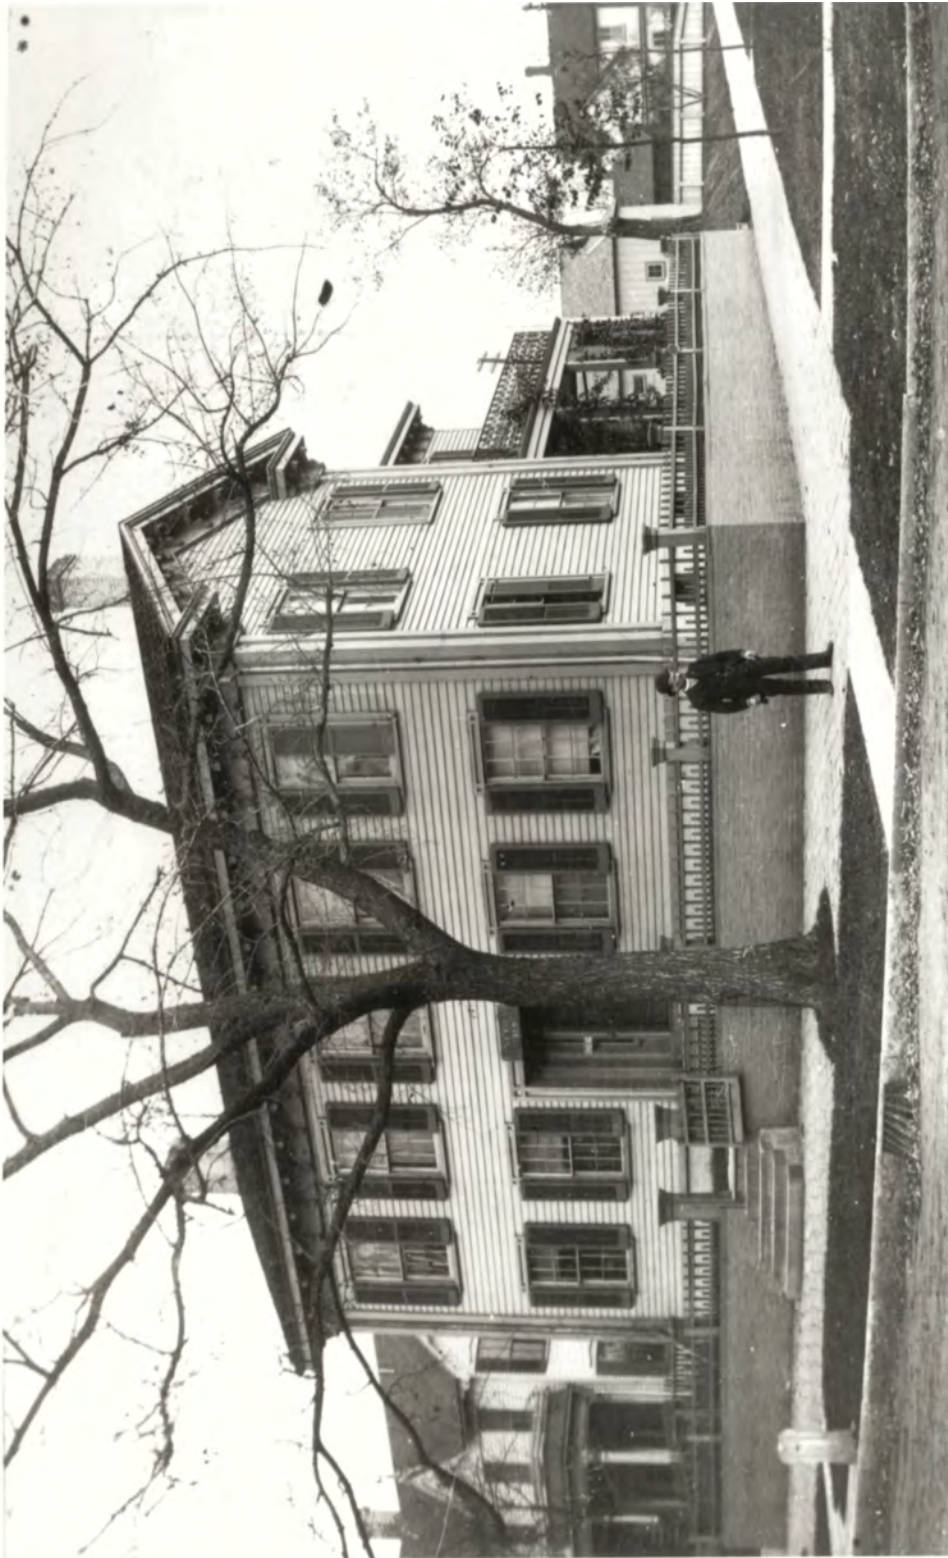
Figure 2-123. 1893 photo of Lincoln Home, Oldroyd standing in front of house, PK.

A later 1893 photograph of the Lincoln Home shows a new house on the Carrigan lot (see Figure 2-123). The house is set further back from Eighth Street than the Lincoln Home and appears to be two-stories. One relatively young tree is evident in the southwest corner of the lot. Little else is evident in this photograph.
