Lincoln Home National Historic Site

Cultural Landscape Report

June 2014

Prepared by
QUINN EVANS ARCHITECTS
1037 Sherman Avenue
Madison, Wisconsin 53703
734-926-0419

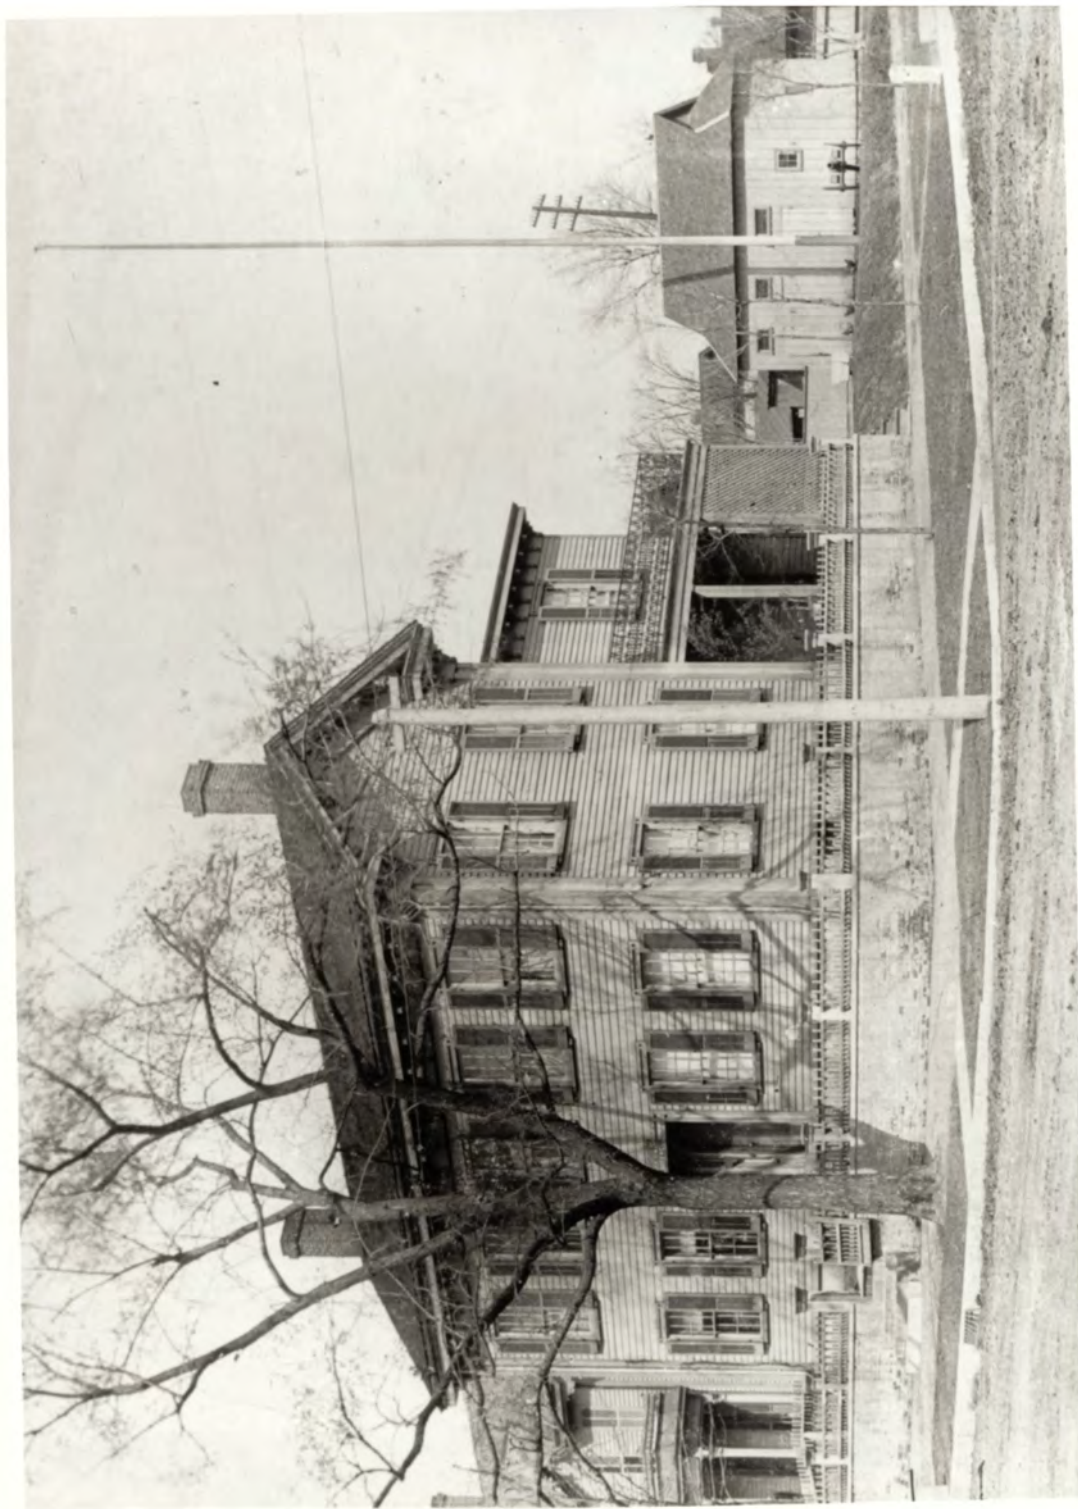
Figure 2-124. ca. 1893 photo of Lincoln Home, Flagpole and cannon in back yard & no apple tree, PK.

An 1889 Oldroyd photograph shows the new stone stairs leading up through the brick retaining wall (see Figure 2-124). A horse is hitched to the post set along the edge of the curb. At this time the grass verge has been widened, notice that the brick sidewalk does not meet the edge of the curb, instead there is an additional space of grass. The elm tree is still located along the Eighth Street sidewalk about 20' from the corner and has gradually matured. A new smaller street tree has been planted between Lots 7 and 8. A short wooden fence remains atop the brick retaining wall. Along the northern property line is a board fence.

By the 1890s the rear yard at the Lincoln Home had been opened to Jackson Street. Boardwalks lead from the side stairs and south porch around to the rear ell. A cannon decorated the lawn, between the apple tree and the outbuildings (see Figure 2-115). A flagpole was also added to the rear yard some time later (see Figure 2-124).

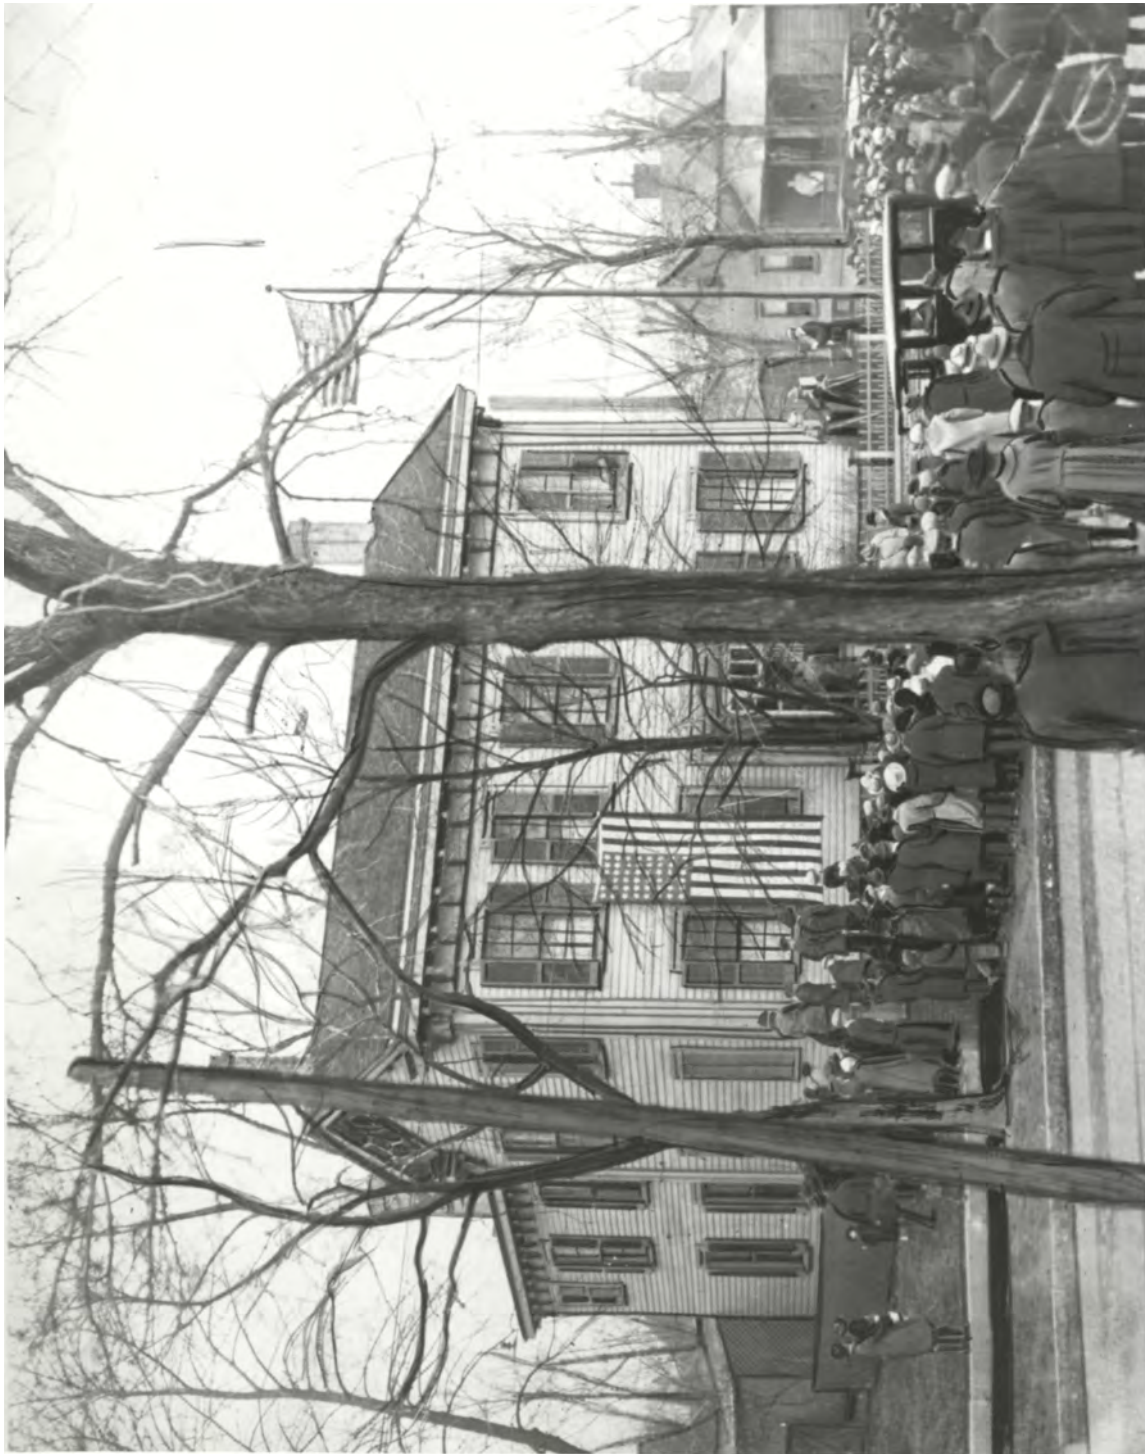
Figure 2-172. ca. 1920 view of Lincoln Home with honeymoon couple standing along brick retaining wall. From Kunhardt Collection.

A later photograph from ca. 1920s from the Mary Edwards Brown collection shows changes in the plantings at the home with a proliferation of vegetation along the street, in the front yard and on the walls of the house (see Figure 2-172).⁶³⁷ A wide assortment of shrubs was planted along Eighth Street in the grass verge. A replacement tree was planted in the location of the historic Lincoln Elm. The south porch is enclosed with screens and partially covered with vines. More vines cover the front facade of the house, partially obscuring it. A very tall flagpole stands at the extreme southwest corner of the yard, just inside the enclosing fence. A picket fence tops a brick retaining wall. The Oldroyd stable is just visible beyond the house. Overhead electric lines are evident, passing by the house along Eighth Street.

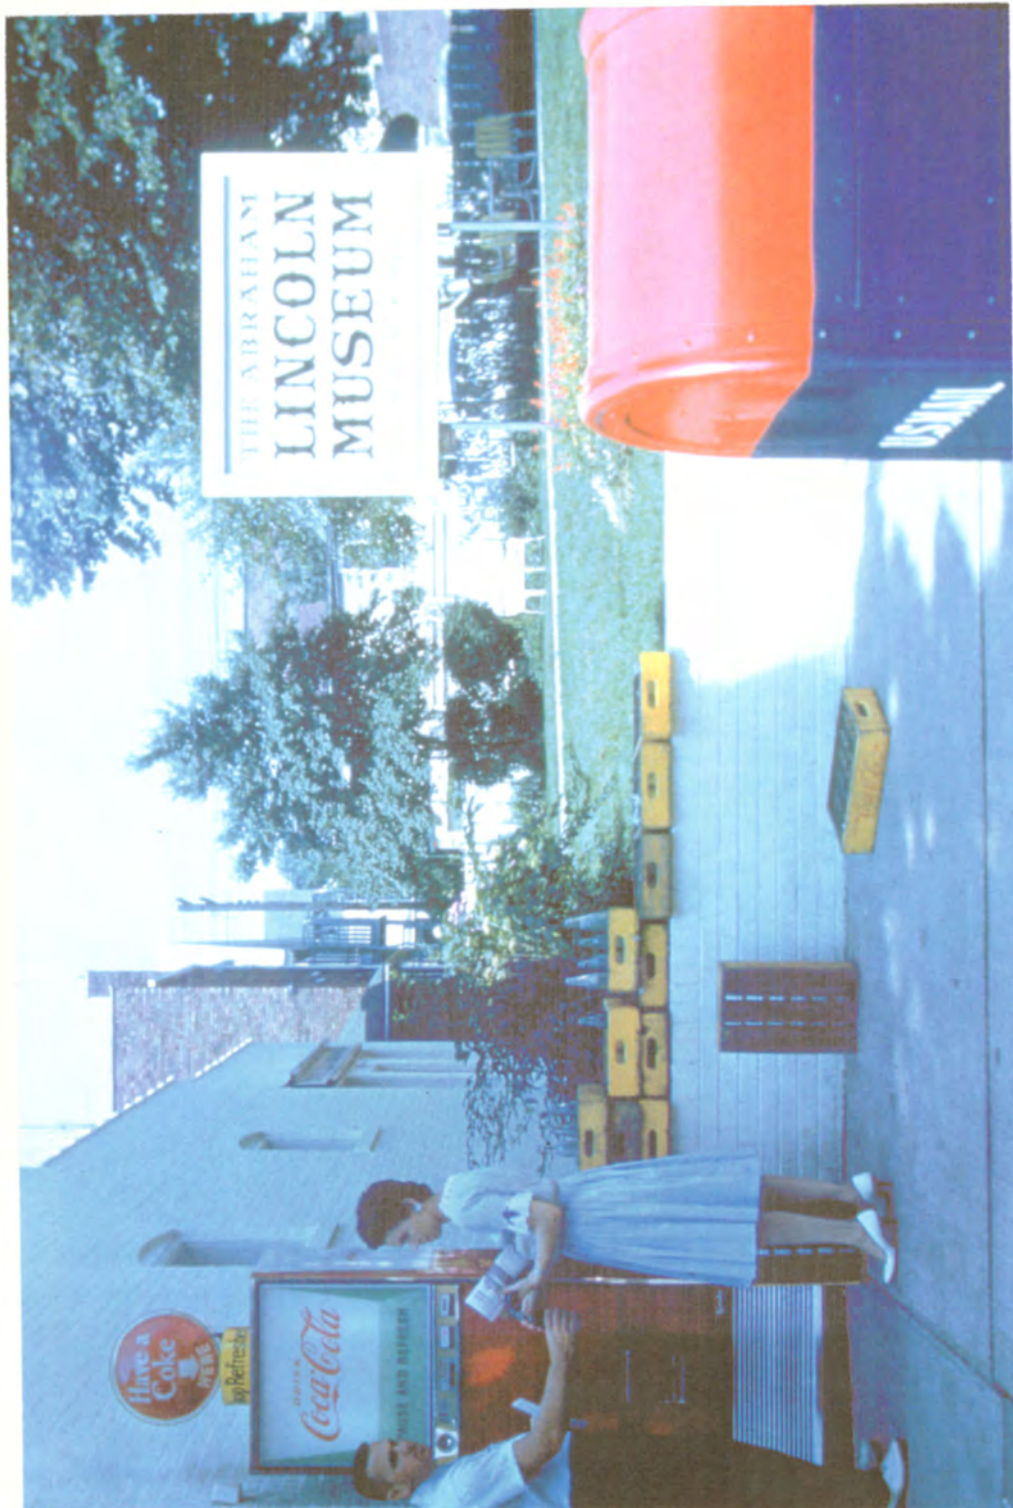
Figure 2-180. 1961 Burch Lot showing a Gift Shop covering almost the whole eastern half of the lot. SSPRCF.

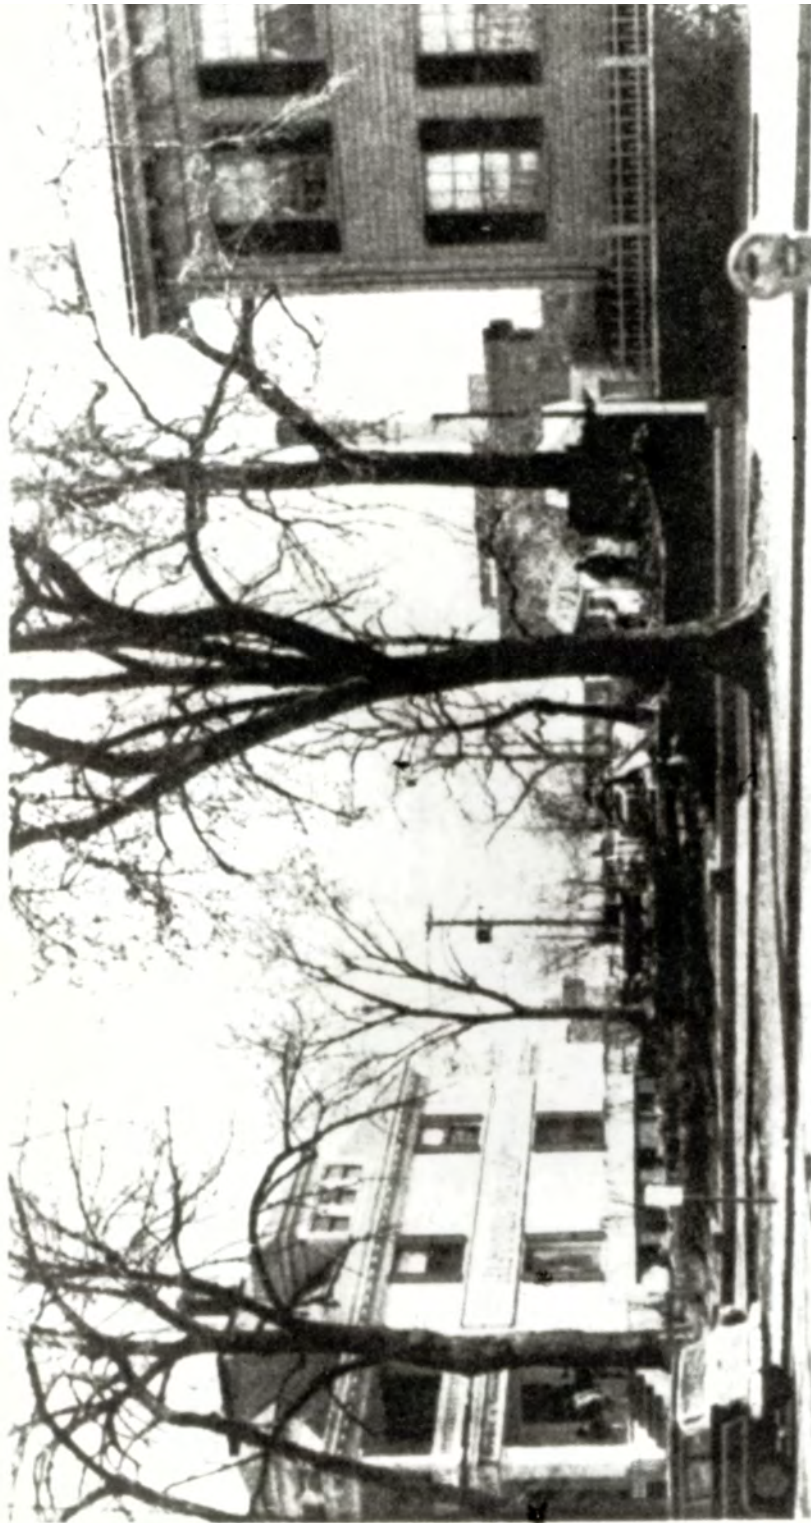
Figure 2-181. 1961 Ira Brown Lot. The lot is open lawn with a path leading from the museum shop towards the Dean House to the north. SSCRPC.

Block 7, Lot 10 (Ira Brown, Jr. House): A 1961 slide of this lot and Lot 9 shows that it is a wide open grassy area (see Figure 2-181). A concrete path leads from the north side of the adjacent museum building to the Dean House. A sign is placed in the open grass lawn area at the southeast corner,

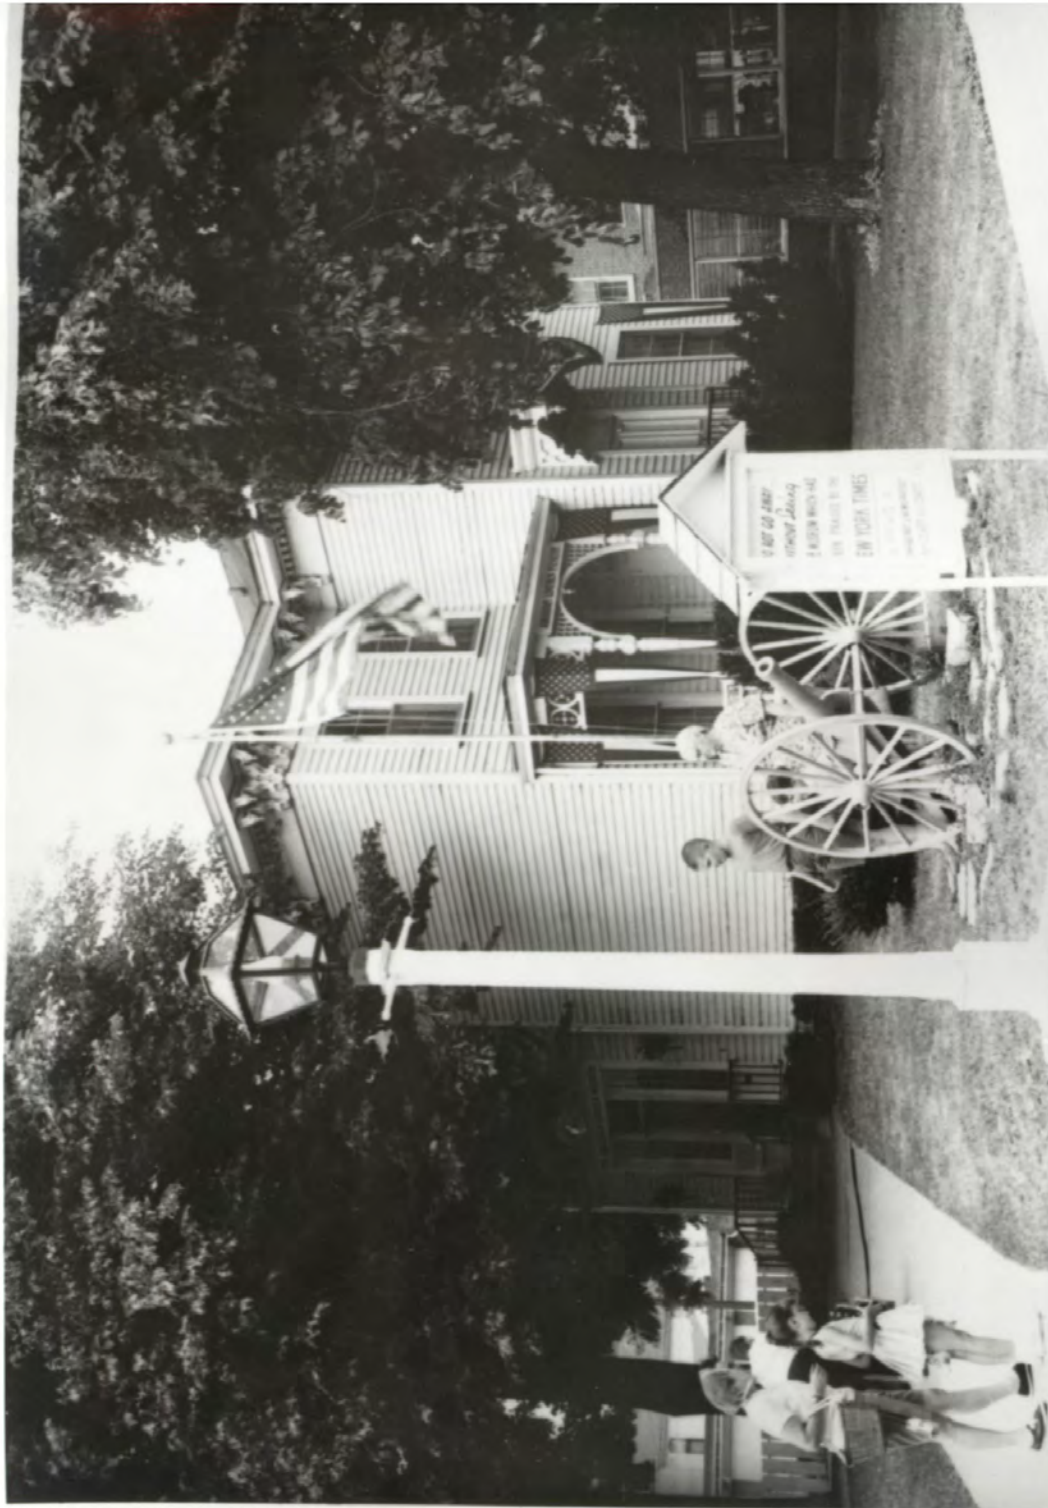
Figure 2-190. 1964 Lincoln Home from Eighth Street. Notice large flagpole in southwest corner of lot. Woodruff, ISHL.

By 1964 the Lincoln Home environs had been altered again. A Woodruff photograph from 1964 shows the Eighth Street facade of the home and a partial view of the side and back yards (see Figure 2-190). A flagpole is seen at the southwest corner of the lot. The brick retaining wall topped with a wooden picket fence remains and a board fence runs along the north boundary line starting from the edge of the brick sidewalk. By this date the wide brick sidewalk wraps around two sides of the home, along Eighth and Jackson Streets, as first seen in an 1889 view. Deciduous shrubs are planted at the foundation on along the south and north facades. No outbuildings are visible in the rear of the lot. Mature deciduous street trees are evident along Jackson at the intersection of the alley. Mature deciduous trees, probably the Basswood and a Silver or Sugar maple, are seen adjacent to the Corneau House. No elm tree is planted in the sidewalk in front of the Home. A 1969 photograph of Eighth Street, also by James Woodruff, shows the addition of the gas lights along both sides of the street (see Figure 2-203). Wooden curbs line the edge of the street. The Lincoln Home looks similar to the photograph from 1964.

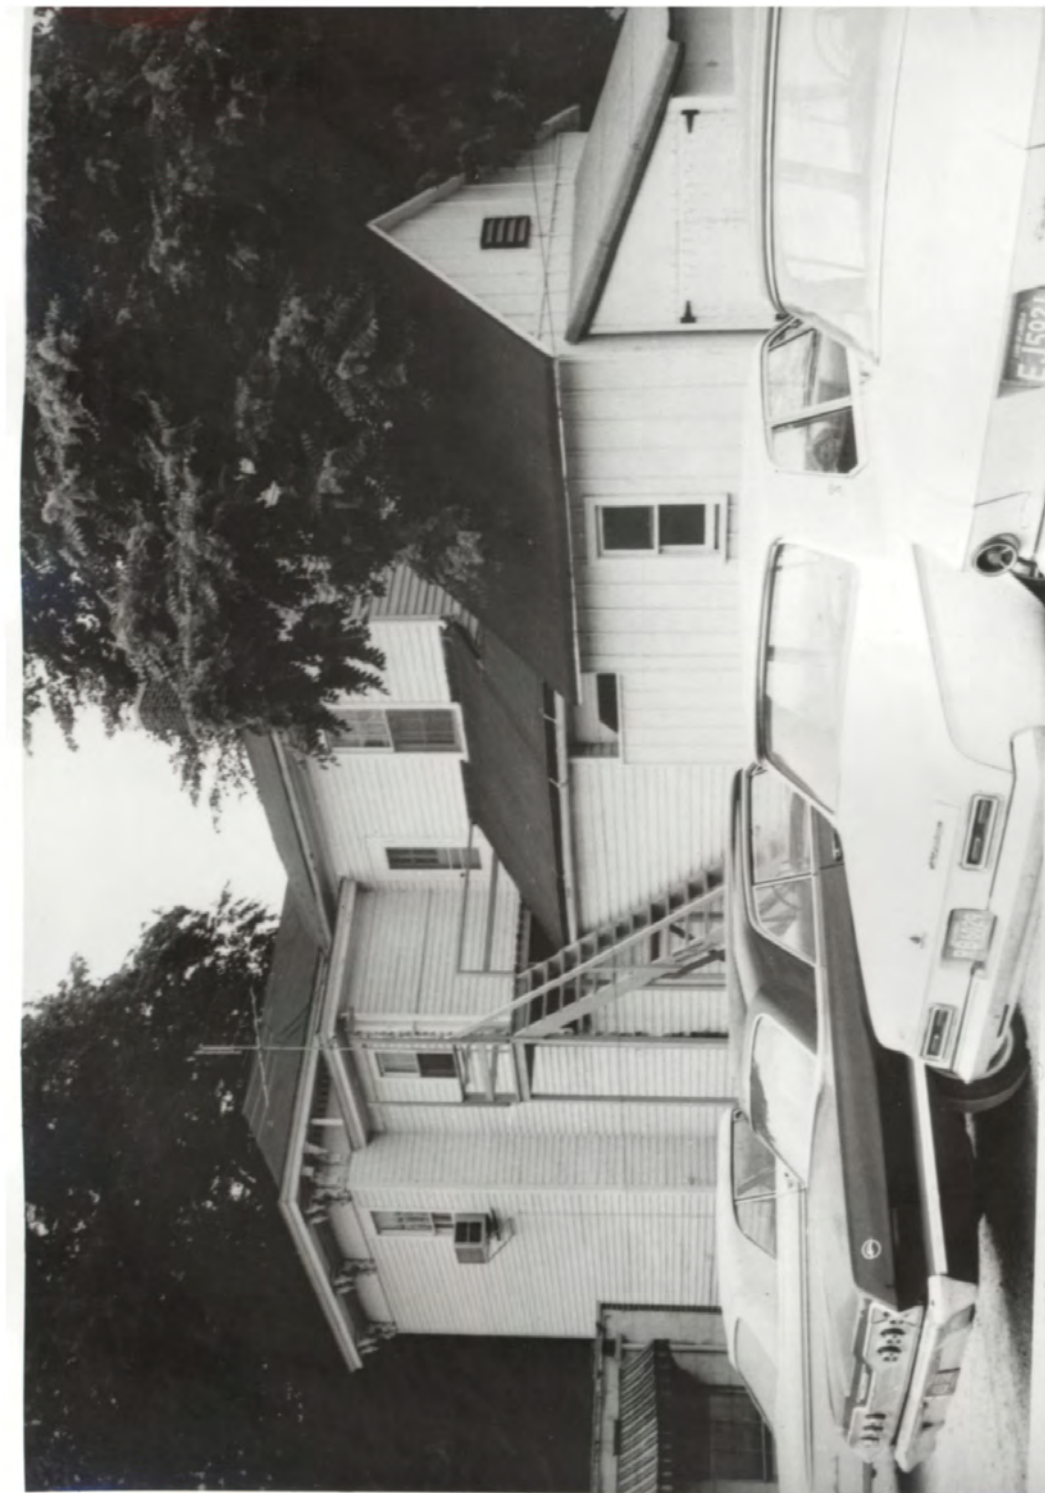
Figure 2-191. 1964 Dean House front facade. Two mature Lindens are visible in the front and side yards. Woodruff, ISHL.

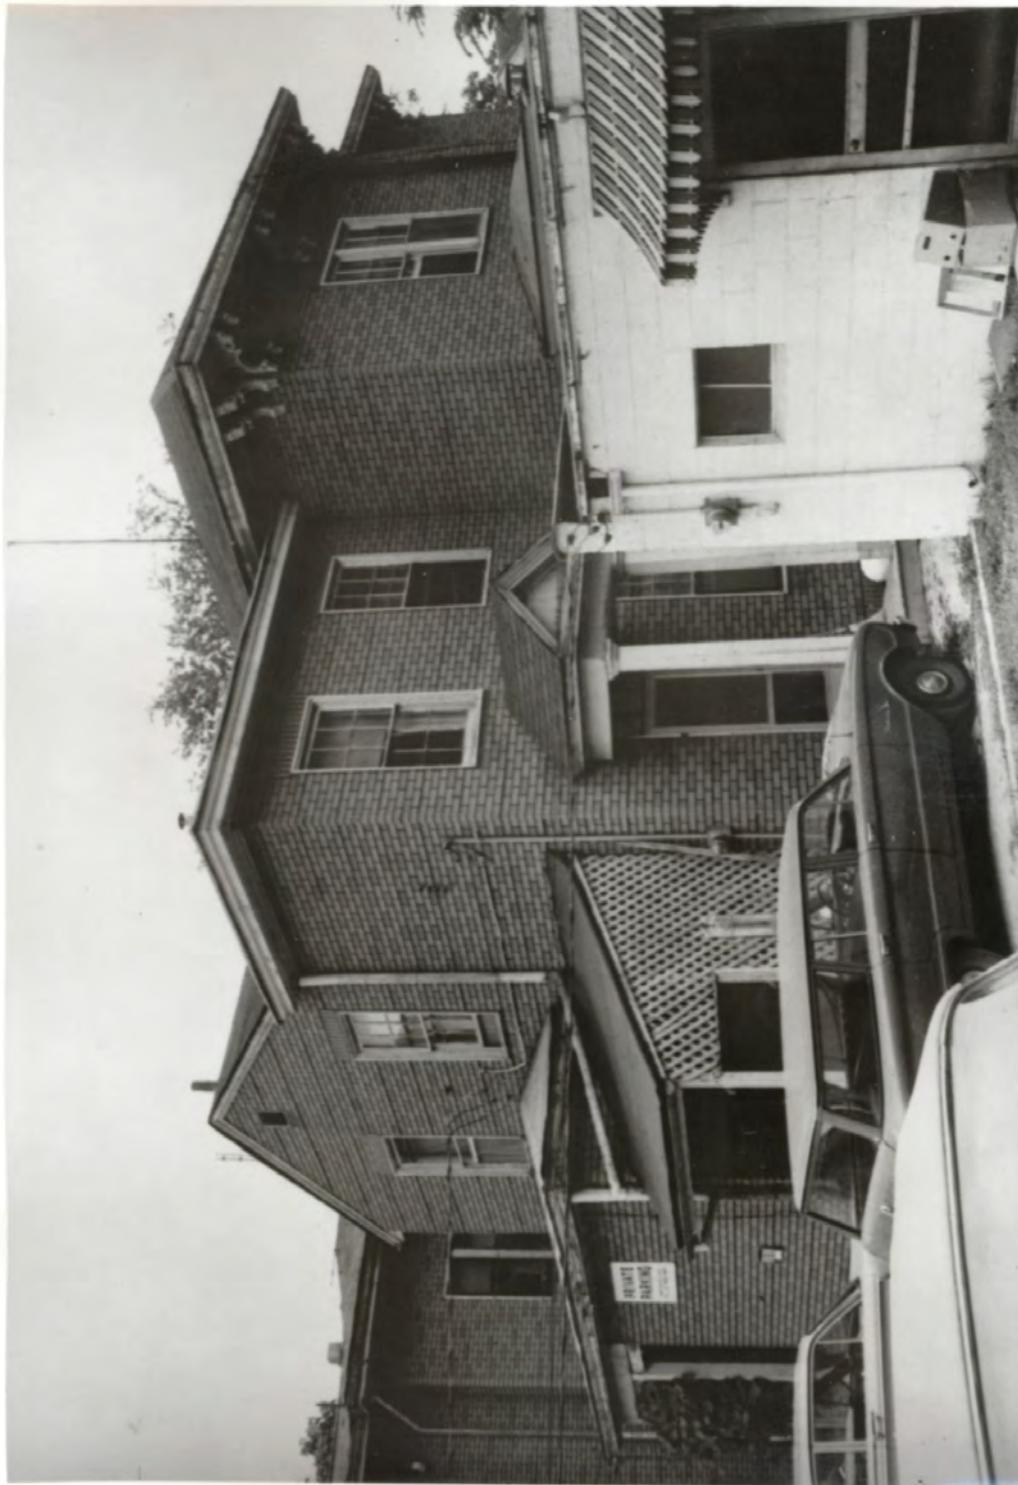
Figure 2-193. 1964 Lyon House front facade showing a hedge of shrubs along the front foundation. Woodruff, ISHL.

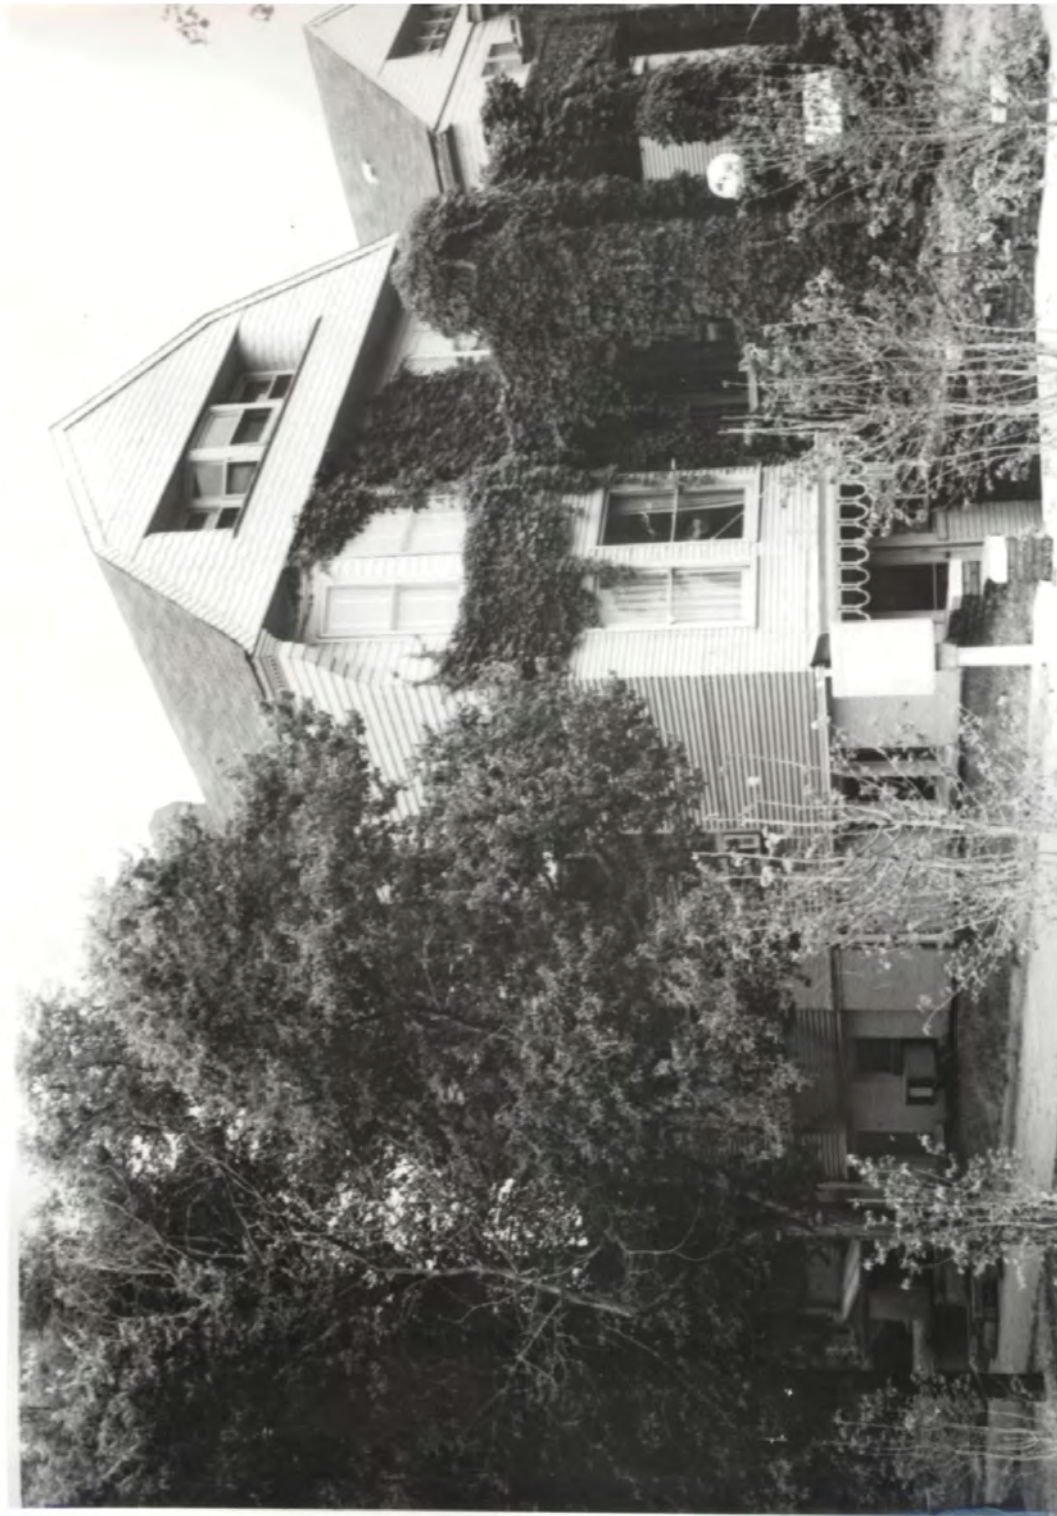
Figure 2-195. 1964 Beedle House front facade with invasive plants along the foundation and overgrown shrubs in the yard. Woodruff, ISHL.

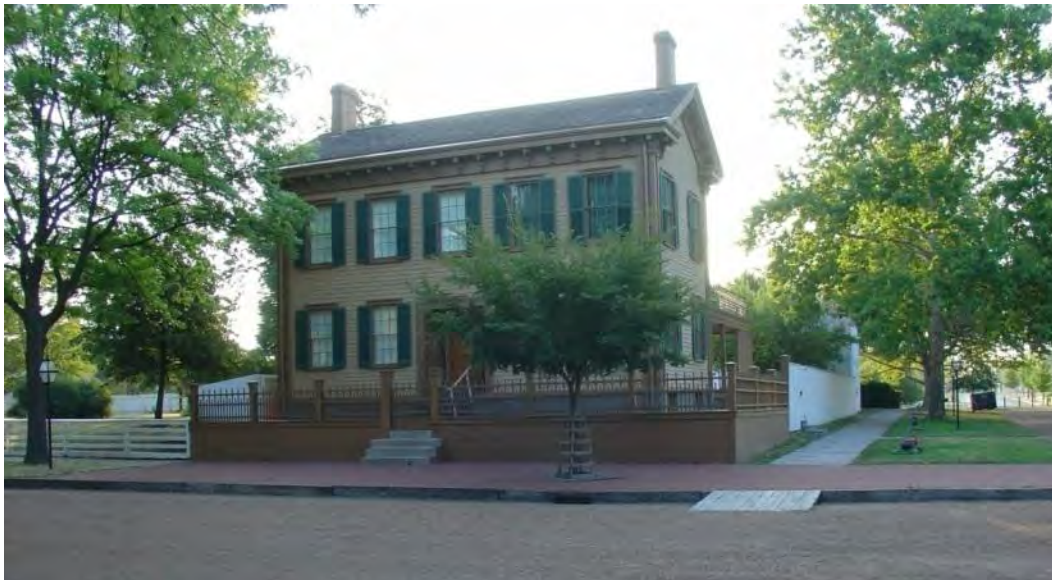
Over time the level of the streets has changed in relation to the sidewalks. Historically the streets were lower. Historic photographs illustrate a change in elevation of up to two feet at the curb. The streets have been altered with the addition of multiple layers of paving applied over the years. The brick base along Eighth Street is now covered with a layer of concrete and an asphalt aggregate layer with a surface chip seal of finely textured golden brown gravel embedded into the asphalt.

Archeological investigations at the Carrigan lot indicate the ground elevation has been raised by as much as 18 to 24 inches in some locations. It is likely that the ground elevation at the Bugg, Niles and Worthen lots have also been altered since the Lincoln period.

Figure 3- 1: Retaining walls and street grade at the Lincoln Home, facing east, July 2012 (source: QEA 00793)

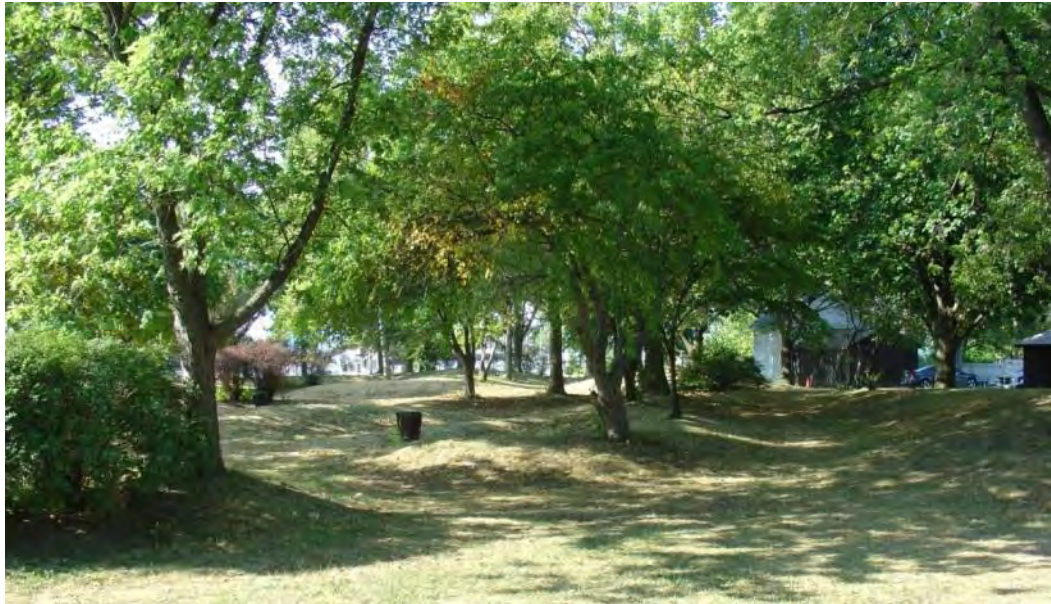
Figure 3- 2: Small earth mounds and vegetation in the southern portion of the Open Space / Recreation area, July 2012 (source: QEA 01943)

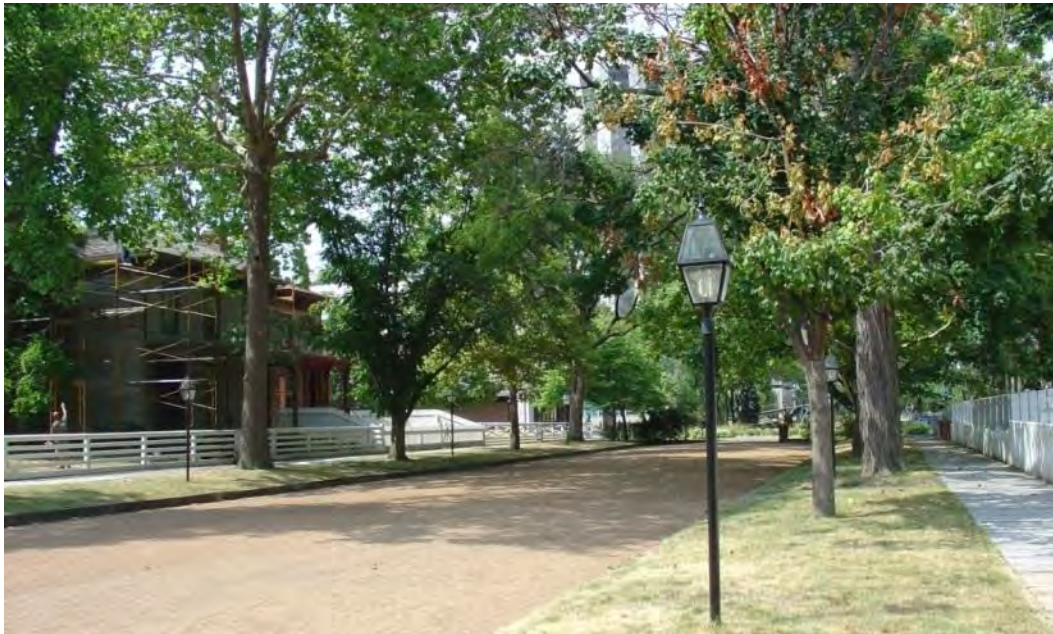
Figure 3- 3: Street trees on Eighth Street north of Jackson, facing northwest, July 2012 (source: QEA 0662)

In the northeast portion of the historic resource character area (Block 10), the street trees include a mixture of species of mature canopy trees along Eighth Street, again spaced evenly with a gap in front of the Carrigan lot. The street trees along Capital Avenue include the same mix of species as noted in Block 7. A mature *Quercus rubra*, red oak, is located along Capitol Avenue, in front of the Morse House. Scattered trees, mostly deciduous with one evergreen, are located within the individual lot boundaries. Shrubs are also scattered about within the individual lots. These are maintained as partial hedges, mostly paralleling the property lines.

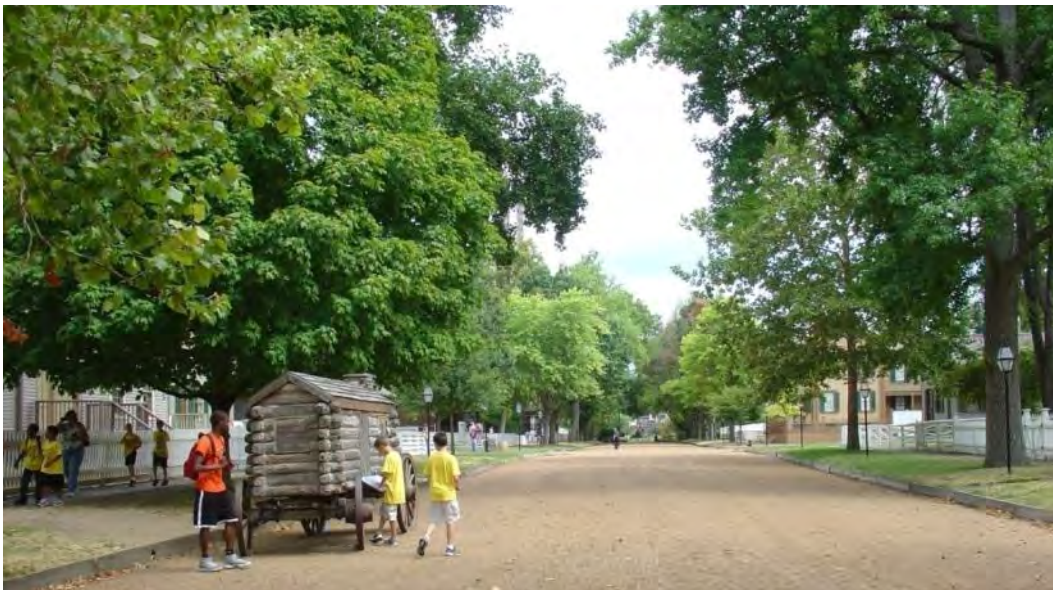
Figure 3- 5: Street trees on Eighth Street between Edwards and Jackson, facing north, July 2012 (source QEA 01374)

In the southern portion of the historic resource character area (Blocks 6 and 11), the trees along Eighth Street vary in species and size, older trees are interplanted with newer ones. The three largest trees are a *Acer saccharinum*, silver maple and two *Liquidambar styraciflua*, sweet gum. Scattered deciduous trees are located within the individual lot boundaries. Shrubs are placed in a random arrangement within the individual lots. Along Edwards Street the mature trees include *Ulmus parvifolia*, Chinese elm, *Fraxinus Americana*, white ash and *Platanus occidentalis*, sycamore.

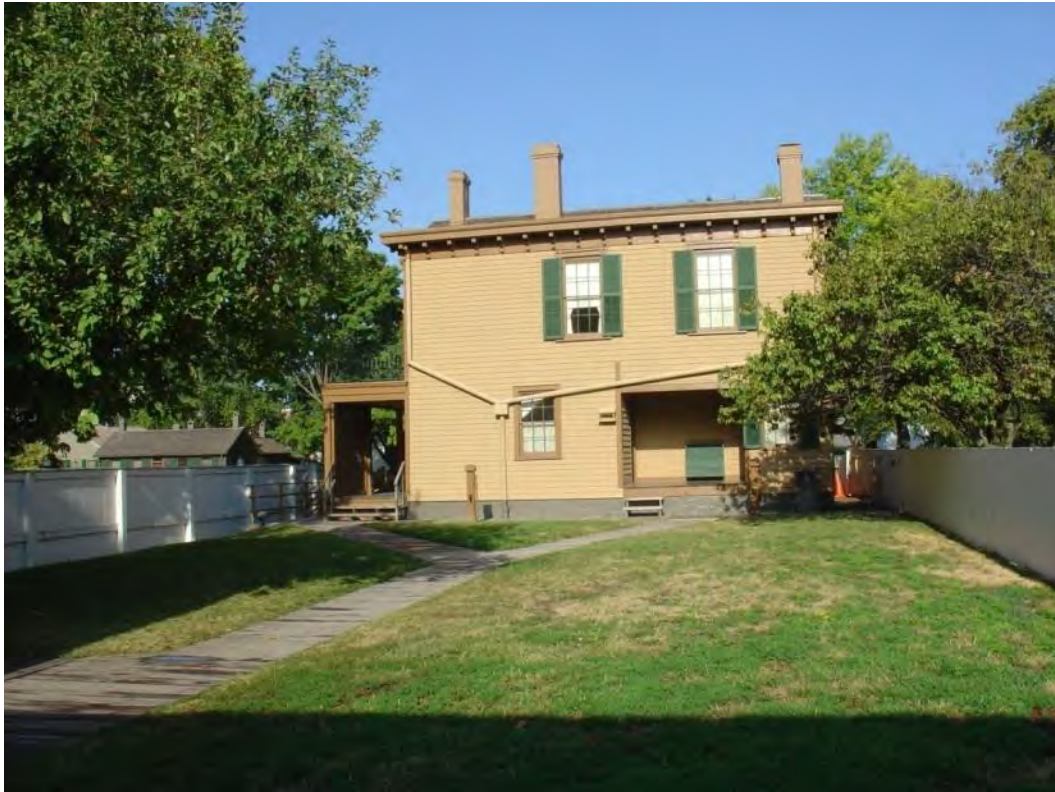
Figure 3- 6: Backyard of Lincoln Home, facing west, July 2012 (source: QEA 0867)

the house (adjacent to Jackson Street) there is a mature *Platanus x acerfolia*, London plane tree, and a small *Malus species*, flowering crabapple. The backyard of the Lincoln lot includes lawn, boardwalks, and a mature *Malus pumila*, apple tree.

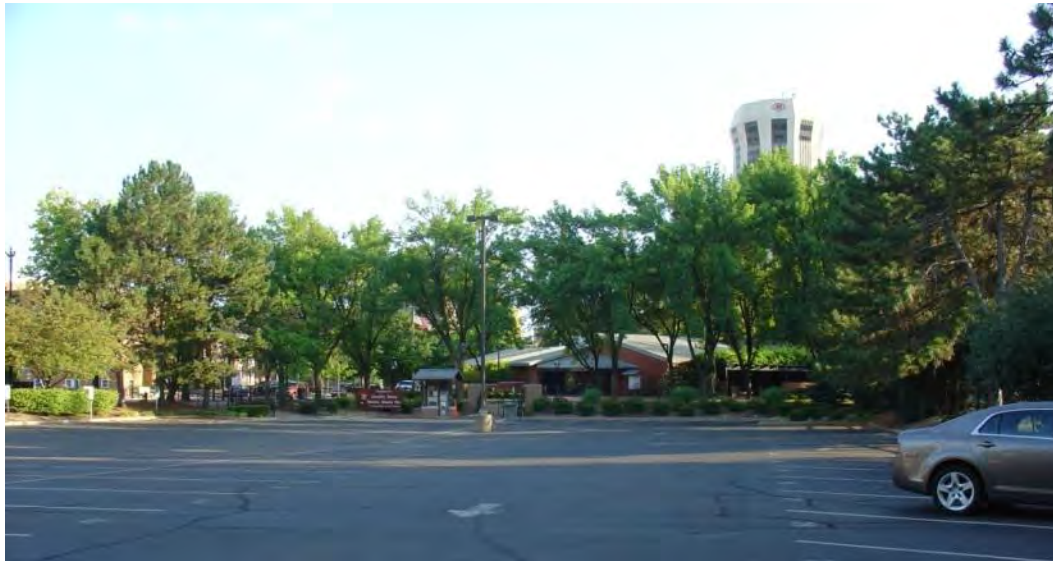
Figure 3- 11: Visitor Parking lot and surrounding vegetation, facing north with NHS Visitor Center in background, July 2012 (source QEA 01669)

The landscape surrounding the Visitor Center and the parking lots along Seventh Street is a dense informal planting of evergreen trees, flowering trees, shrubs and ground cover. The plantings encircle the building and the parking areas. *Fraxinus pennsylvanica*, green ash are planted along both sides of Jackson Street in the Visitor Services landscape character area. These trees were planted in the early 1980s and now range in size from 14" to 21" in diameter. A combination of *Quercus velutina*, black oak, *Quercus palustris*, pin oak, and *Platanus occidentalis*, sycamore are planted along Seventh Street. A combination of mature and immature deciduous trees are found along Edwards Street. These include *Acer saccharinum*, silver maple, smaller *Quercus velutina*, black oak, *Liquidambar styraciflua*, sweet gum, and *Platanus occidentalis*, sycamore.

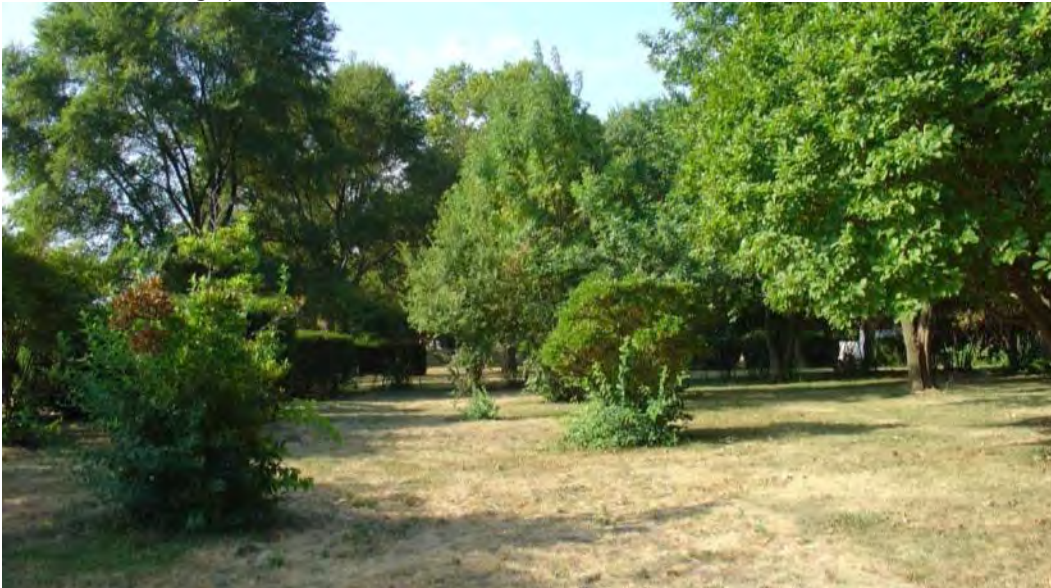
Figure 3- 13: Northern portion of the Open Space / Recreation Area, facing south, July 2012 (source QEA 01882)

The vegetation in the eastern portion of the park includes lawn interspersed with evergreen and deciduous shrubs and a limited number of deciduous trees. Along Ninth Street in the northern portion of this area, multi-stemmed *Crataegus* sp., hawthorn are clumped along the eastern edge of the space. The southern portion of the Open Space / Recreation area includes small earth mounds and ornamental vegetation implemented in the 1970s-80s. *Platanus x acerfolia*, London plane tree and *Acer saccharinum*, silver maple are found along the eastern portion of Jackson Street. These range in size from 15" to 34" diameter at breast height (dbh). Many of the plants in the Open Space / Recreation Area are oddly shaped, include suckers, dead sections, or have weedy species growing up at their bases. The placement of the plants is not well suited to use by visitors, as it neither creates welcoming spaces nor frames views.

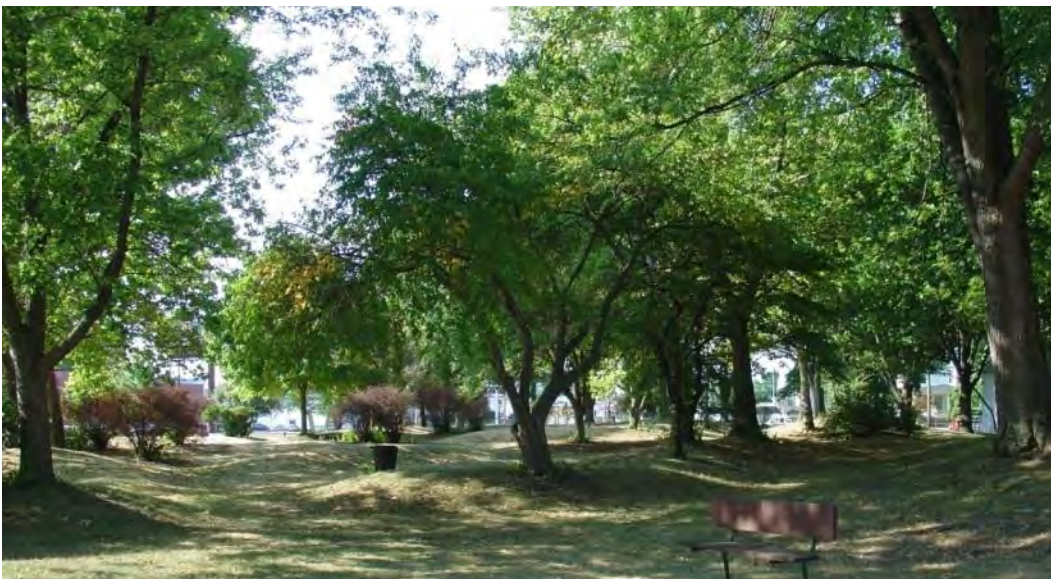
Figure 3- 14: Trees and shrubs in southern portion of the Open Space / Recreation Area, facing southeast, July 2012 (source QEA 01948)

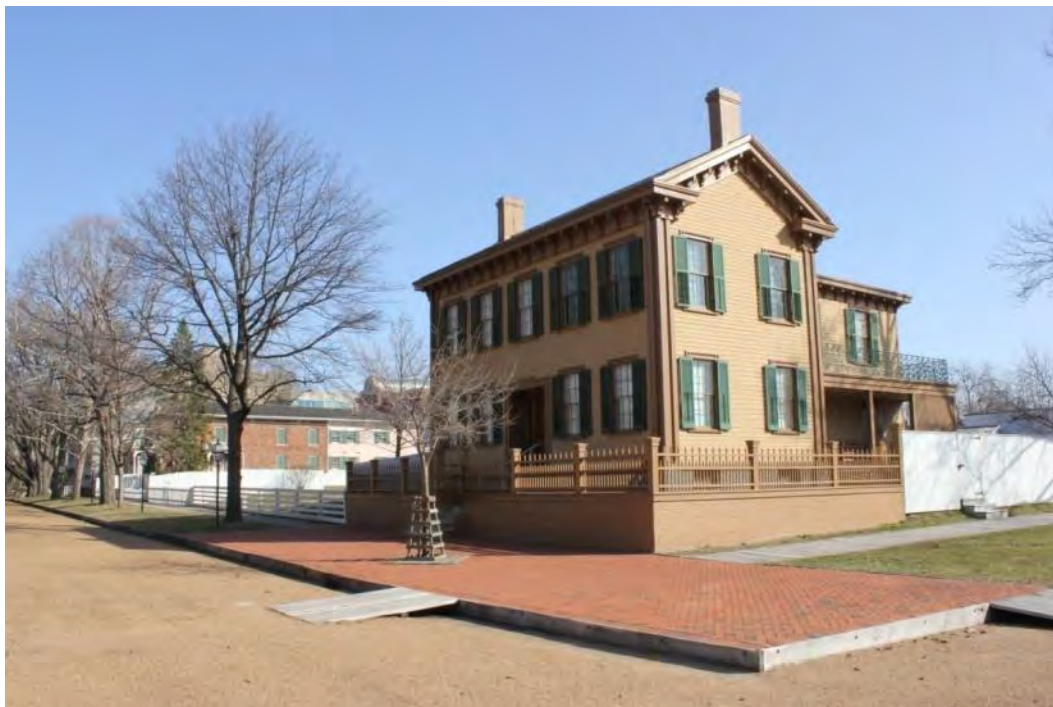
Figure 3- 15: ECV 1: Winter view of Lincoln Home from intersection of Eighth and Jackson Streets, facing northeast, March 2012 (QEA 018)

The view of the Lincoln Home from the intersection of Eighth and Jackson Streets, facing northeast, is a primary vantage within the NHS (see Figure 3-15, ECV1). Since visitors typically approach the Lincoln Home from the Visitor Center to the west, this view of the house sets an initial impression.

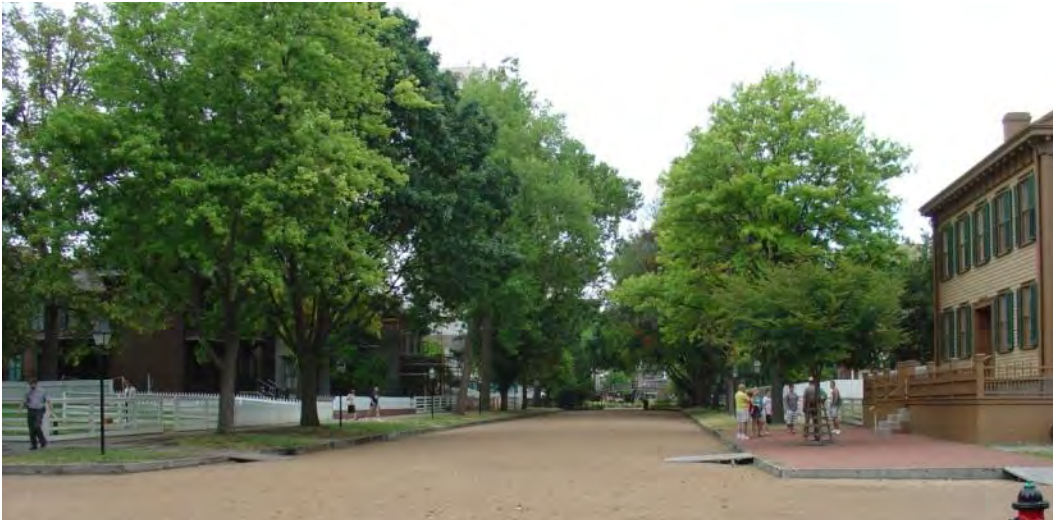
Figure 3- 16: ECV 2: Eighth Street at Jackson Street, facing north, July 2012 (source QEA 01225)

Eighth Street and the portion of Jackson Street immediately adjacent to Eighth are the primary areas that set the neighborhood scene for the NHS. The view from this intersection facing north presents a tree-lined street with fences, boardwalks, and houses during summer months when leaves on the trees screen views of nearby modern developments. In the winter months when the deciduous trees lose their leaves, buildings outside the NHS become more apparent, including the thirty-story Hilton Hotel (see EC-14).

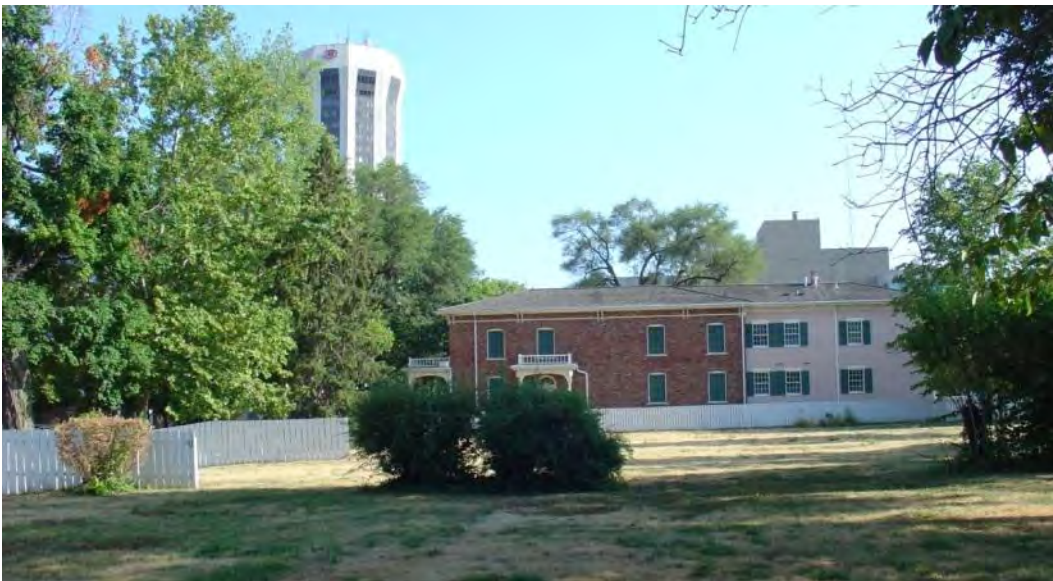
Figure 3- 17: ECV 3: View to the north from the Lincoln Home backyard, note the open lots, Education Center, and Hilton hotel, July 2012 (source QEA 0901)

The view to the north from the backyard of the Lincoln Home includes four vacant lots surrounded by white painted fences, a few shrubs and trees, and the non-historic Education Center and thirty-story Hilton Hotel in the background.
