Lincoln Home National Historic Site

Cultural Landscape Report

June 2014

Prepared by
QUINN EVANS ARCHITECTS
1037 Sherman Avenue
Madison, Wisconsin 53703
734-926-0419

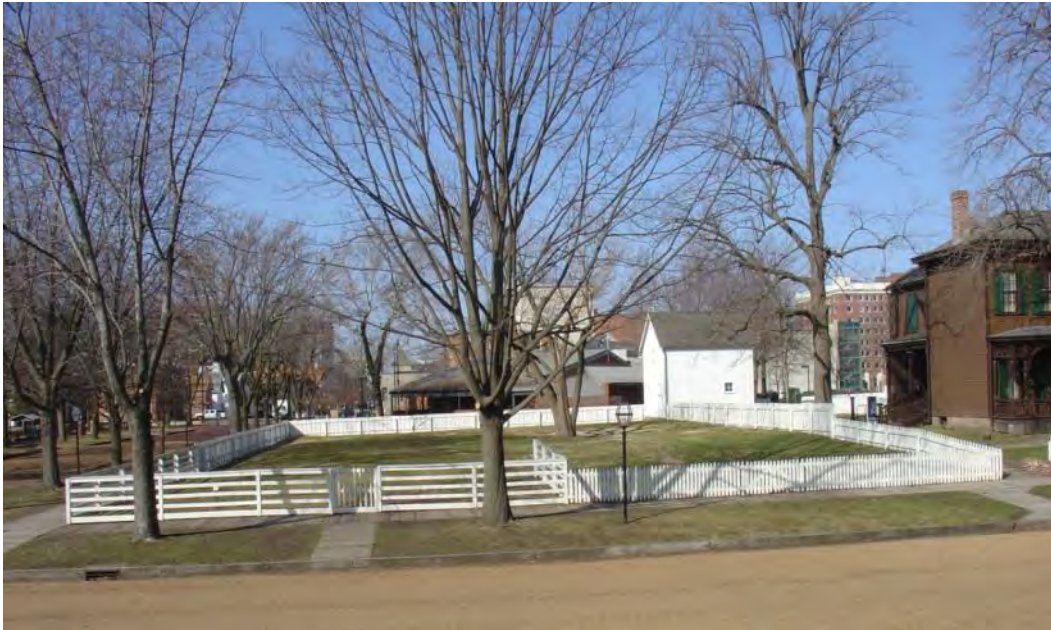
Figure 3- 18: ECV 4: Burch and Brown lots, with park Visitor Center in background, facing west from the front door of the Lincoln Home, March 2012 (source QEA 9644)

The view to the west from the front door of the Lincoln house presents the vacant Burch and Brown lots. The fences illustrate (partially) the historic lot locations and lawn is present where houses once stood. The NHS Visitor Center is in the background. The presence of lawn across the street and adjacent to the Lincoln lot creates an open character to the neighborhood that is not consistent with the historic conditions (see EC-11 and EC-13).

The view to the west from the front door of the Lincoln house presents the vacant Burch and Brown lots. The fences illustrate (partially) the historic lot locations and lawn is present where houses once stood. The NHS Visitor Center is in the background. The presence of lawn across the street and adjacent to the Lincoln lot creates an open character to the neighborhood that is not consistent with the historic conditions (see Figure 3-18: ECV 4).

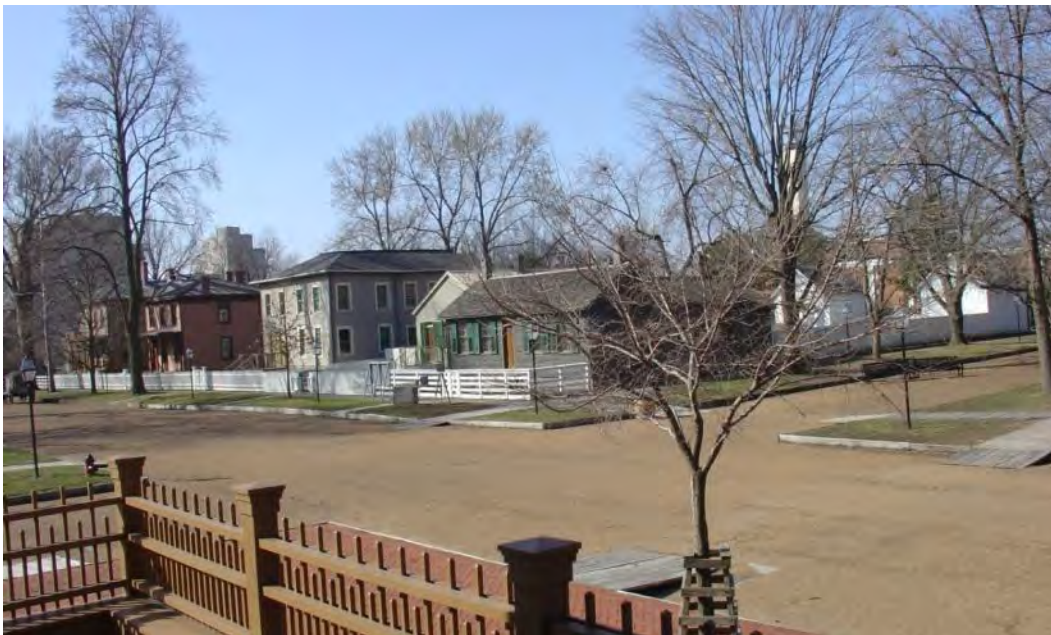
Figure 3- 19: ECV 5: View toward southwest from front door at Lincoln Home, March 2012 (source QEA)

The view to the southwest from the front door of the Lincoln house presents a residential neighborhood with houses, fences, lawn terraces, street trees, boardwalks, and the rough-surfaced street.

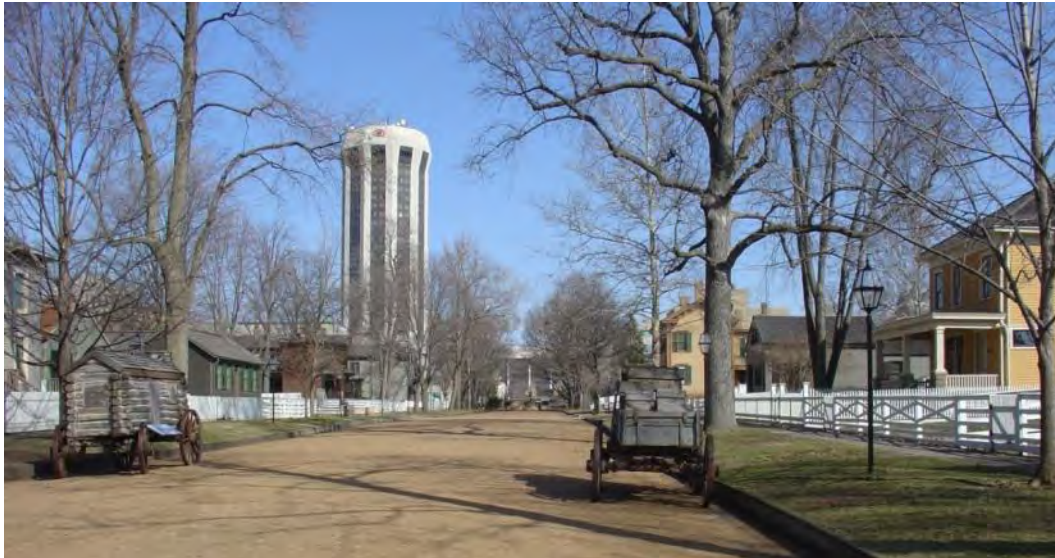
Figure 3- 20: ECV 6: Winter view, facing north on Eighth Street, March 2012 (source QEA 09719)

During the winter season when the leaves are off the trees, the views within the historic resource character area include more encroaching elements from the surrounding city. Facing north at any point on Eighth Street in the winter, the tall hotel imposes a strong presence on the historic neighborhood.

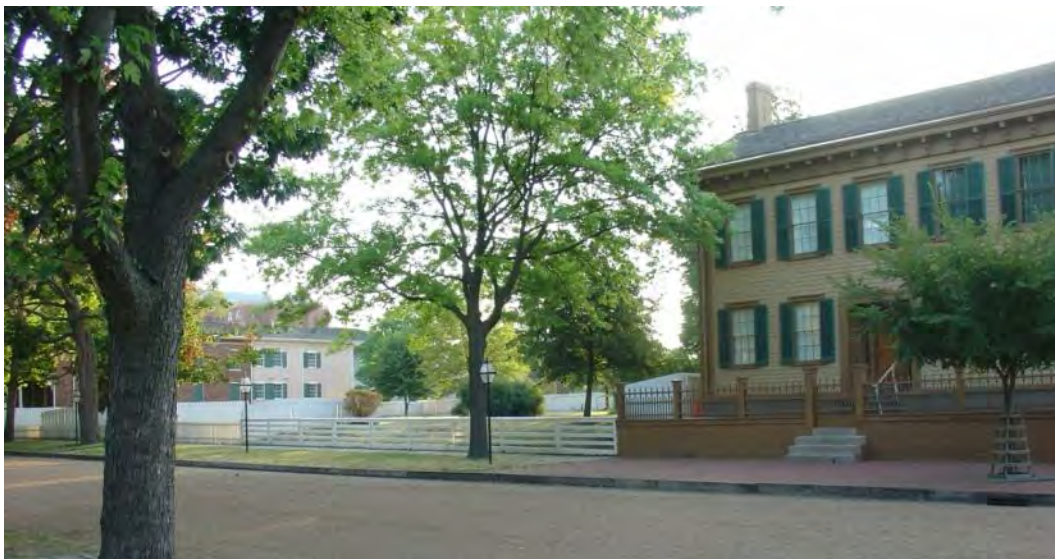
Figure 3- 21: ECV 7: Lincoln House (right) and Carrigan lot (to the left of the Lincoln House), facing northeast, July 2012 (source QEA 0794)

The area north of the Lincoln house presents an open, suburban character with fences, large expanses of lawn, shrubs and trees. The presence of lawn across the street and adjacent to the Lincoln lot creates an open character to the neighborhood that is not consistent with the historic conditions (see EC-12).

The area north of the Lincoln house presents an open, suburban character with fences, large expanses of lawn, shrubs and trees. The presence of lawn across the street and adjacent to the Lincoln lot creates an open character to the neighborhood that is not consistent with the historic conditions (see Figure 3-21: ECV 7).

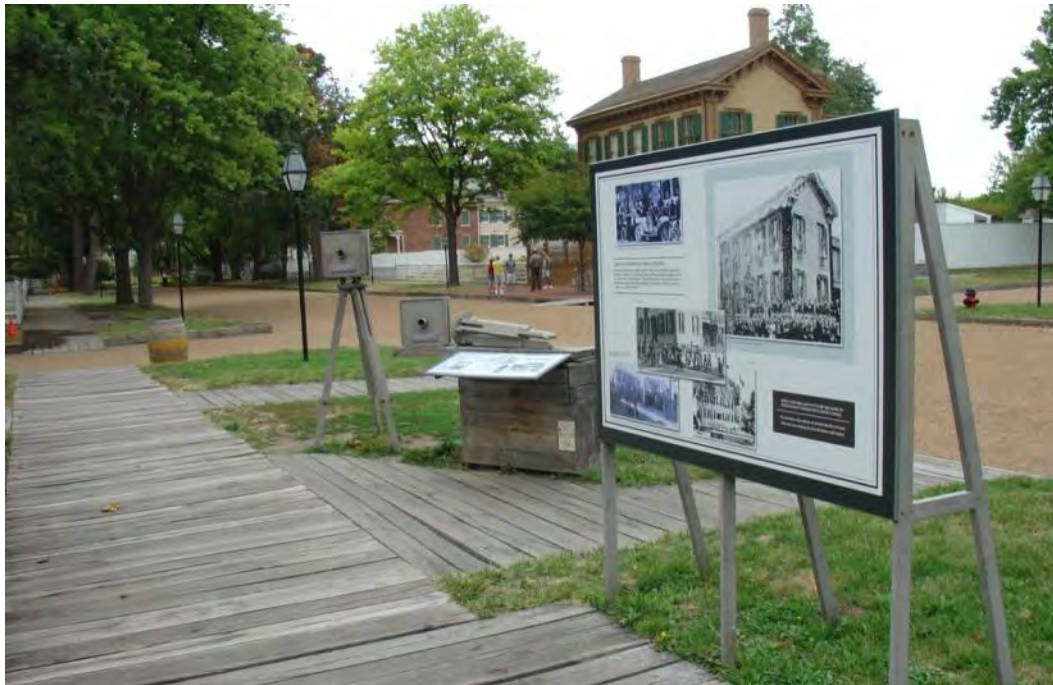
Figure 3- 22: ECV 8: Interpretive exhibit at the southwest corner of the intersection of Eighth and Jackson Streets, facing northeast (source QEA)

An interpretive exhibit at the southwest corner of Eighth and Jackson Streets provides information for visitors related to the popularity of this view for photographers during the historic period.

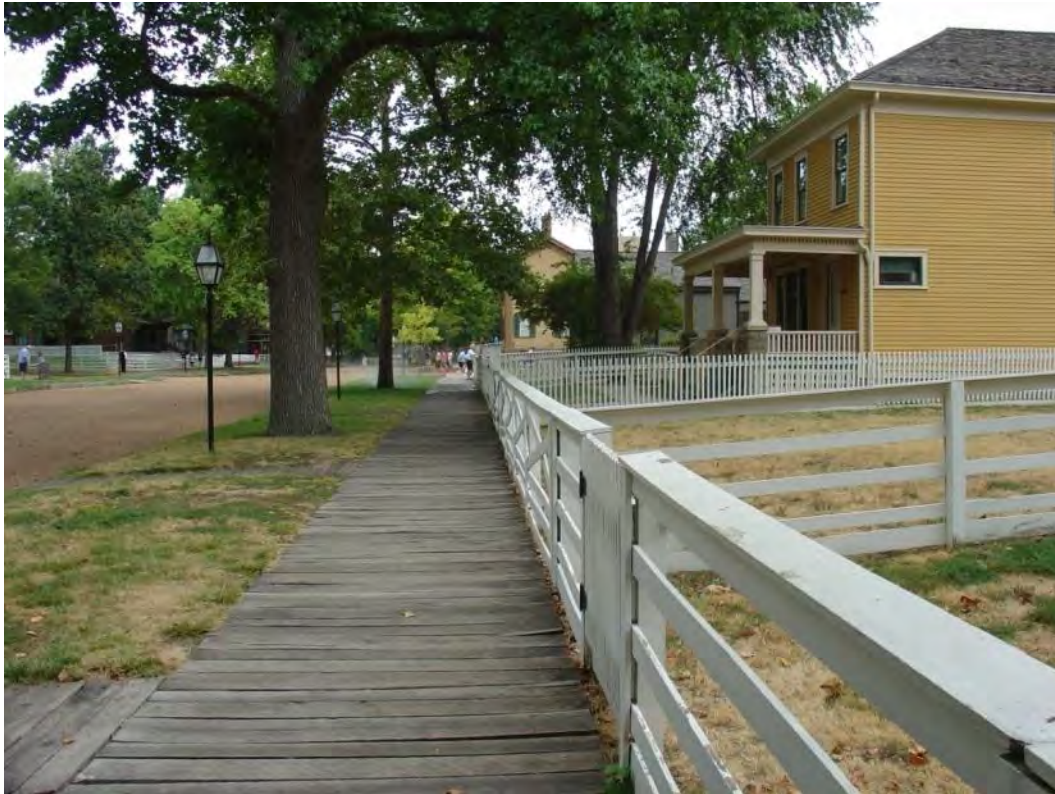
Figure 3- 24: ECV 10: Boardwalk, fences, street trees, lights, and Cook House, on East side of Eighth Street facing north, July 2012 (1528)

A typical view along Eighth Street within the historic resource character area presents fences, gates, boardwalks, historic houses, lawn, street trees, and the rough-surfaced road.

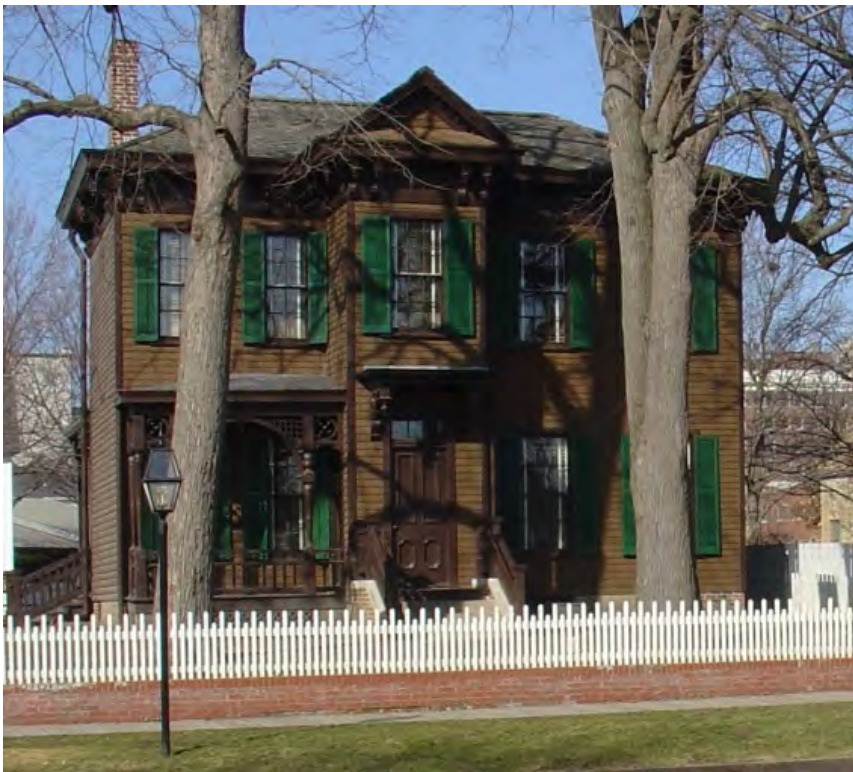
Figure 3- 26: Lyon House, east and north elevations, March 2012 (source QEA 9606)

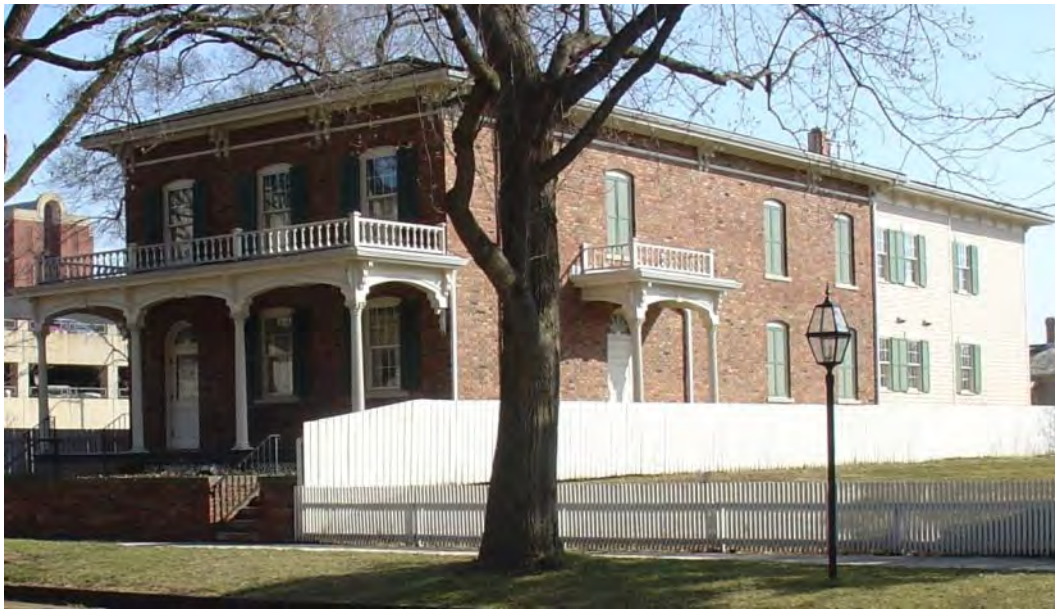
Figure 3- 27: Dean House, east elevation, March 2012 (source QEA 9636)

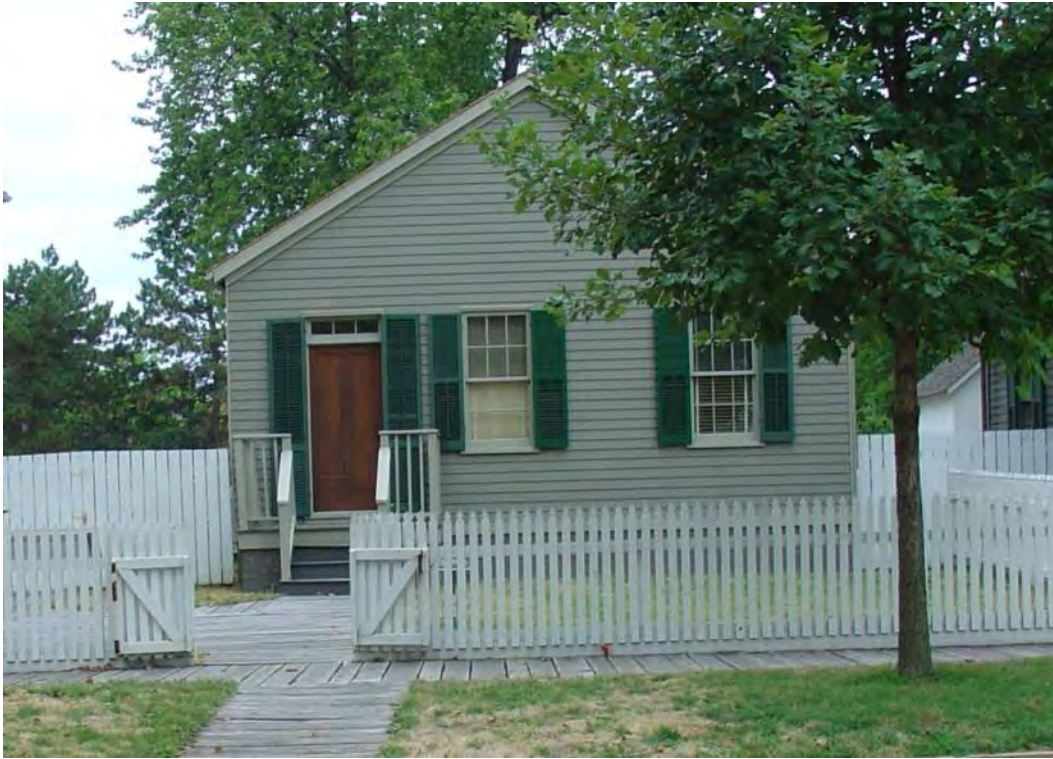
Figure 3- 29: Corneau House, east elevation, July 2012 (source QEA 1222)

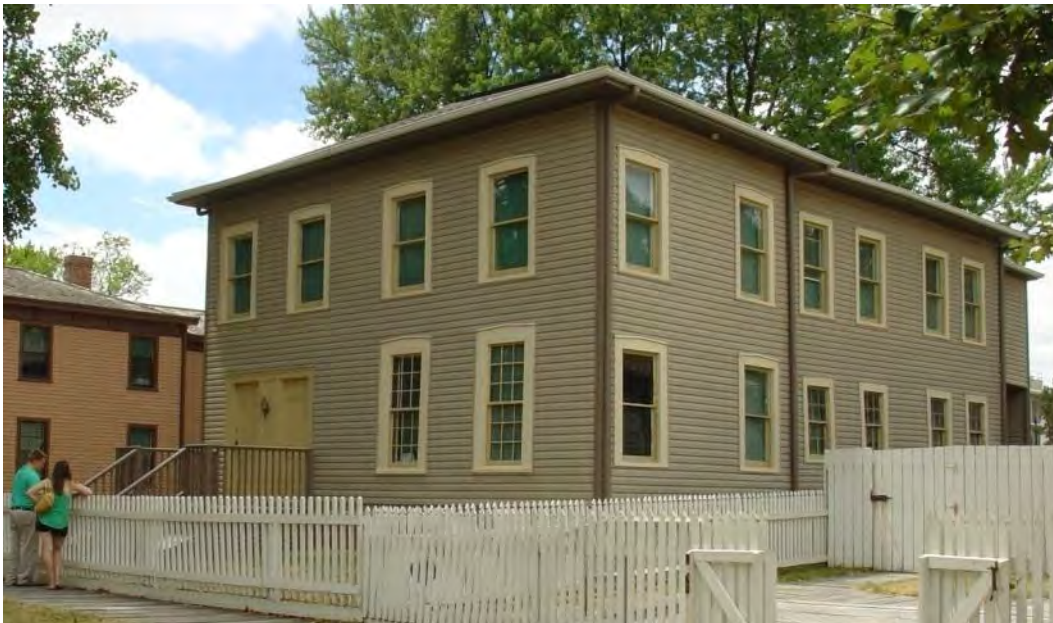
Figure 3- 30: Sprigg House, east elevation, July 2012 (source QEA 1229)

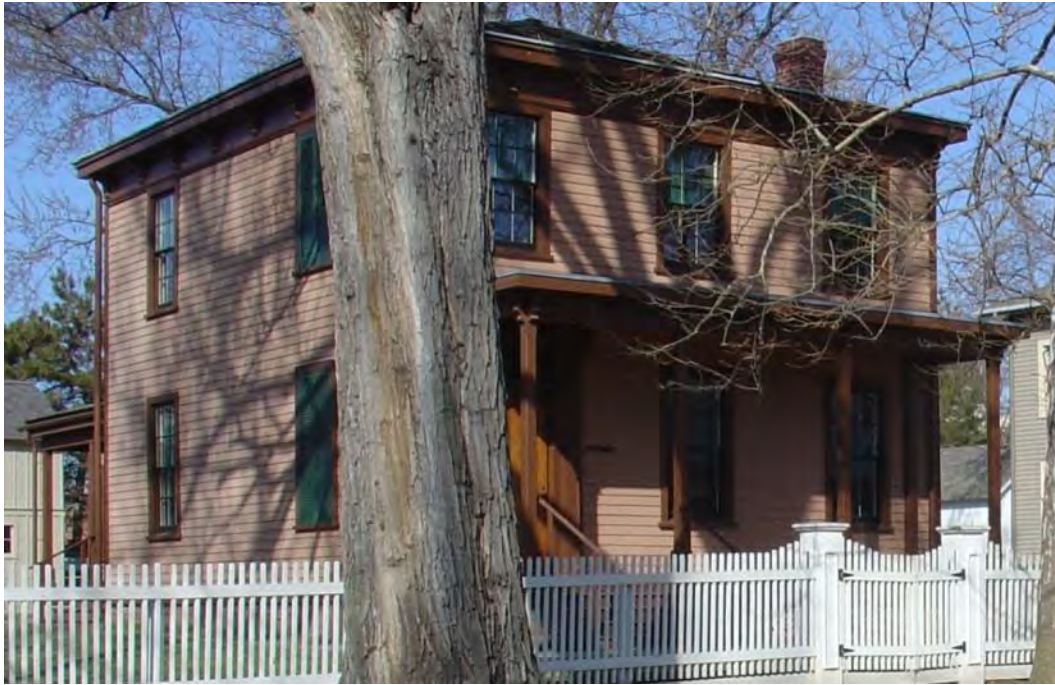
Figure 3- 31: Miller House, east and north elevations, July 2012 (source QEA 1491)

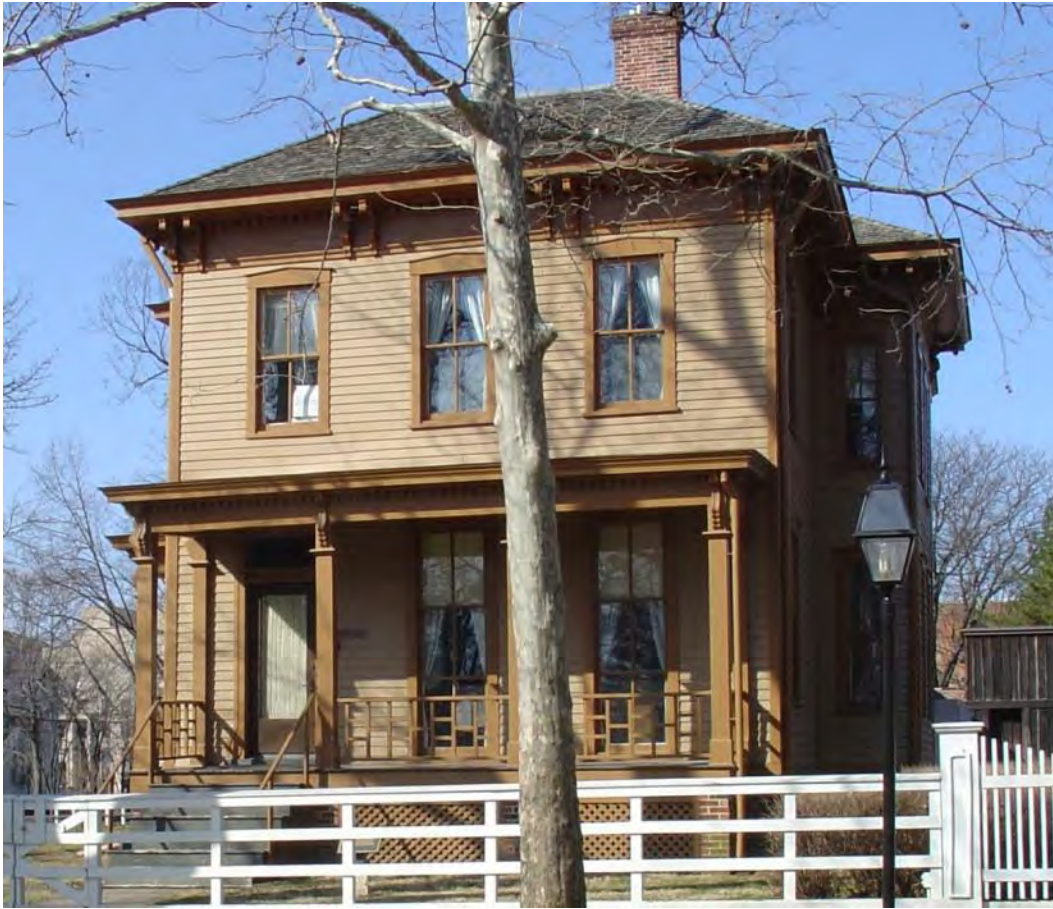
Figure 3- 32: Dubois House, south and east elevations, March 2012 (source QEA 9717)

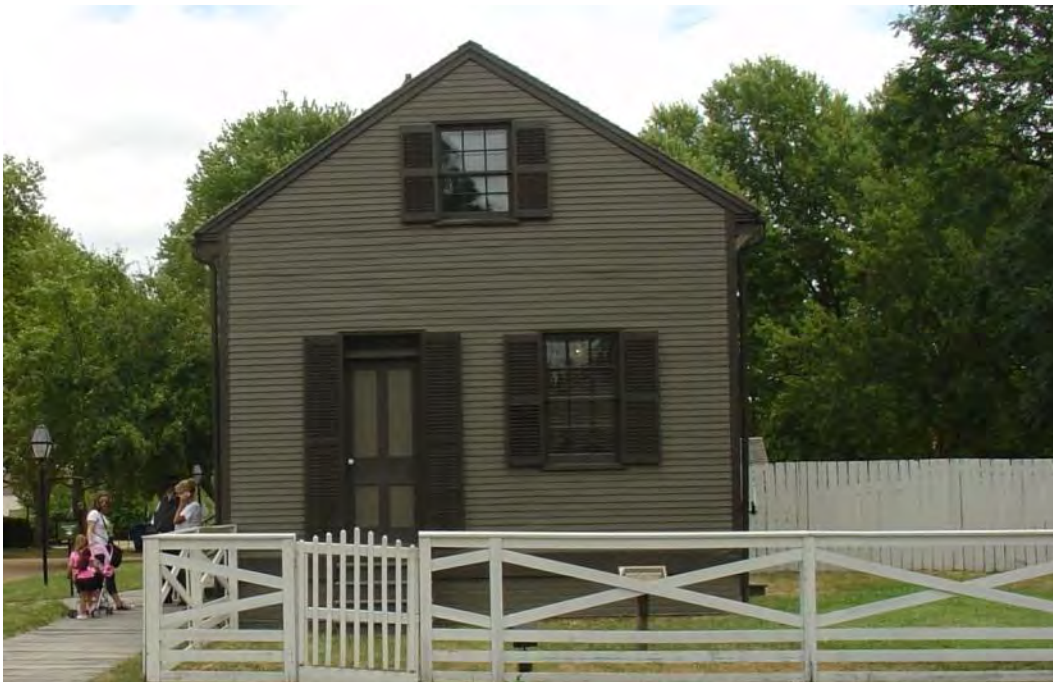
Figure 3- 33: Shutt House, east elevation, March 2012 (source QEA 9716)

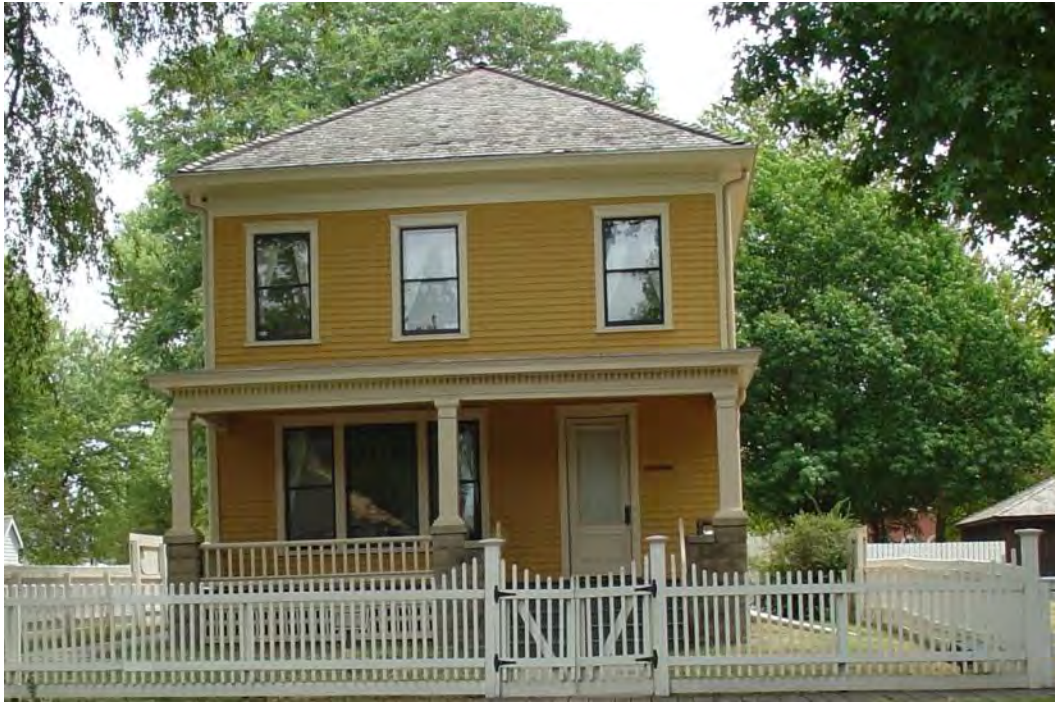
Figure 3- 34: Arnold House, west elevation, July 2012 (source QEA 1480)

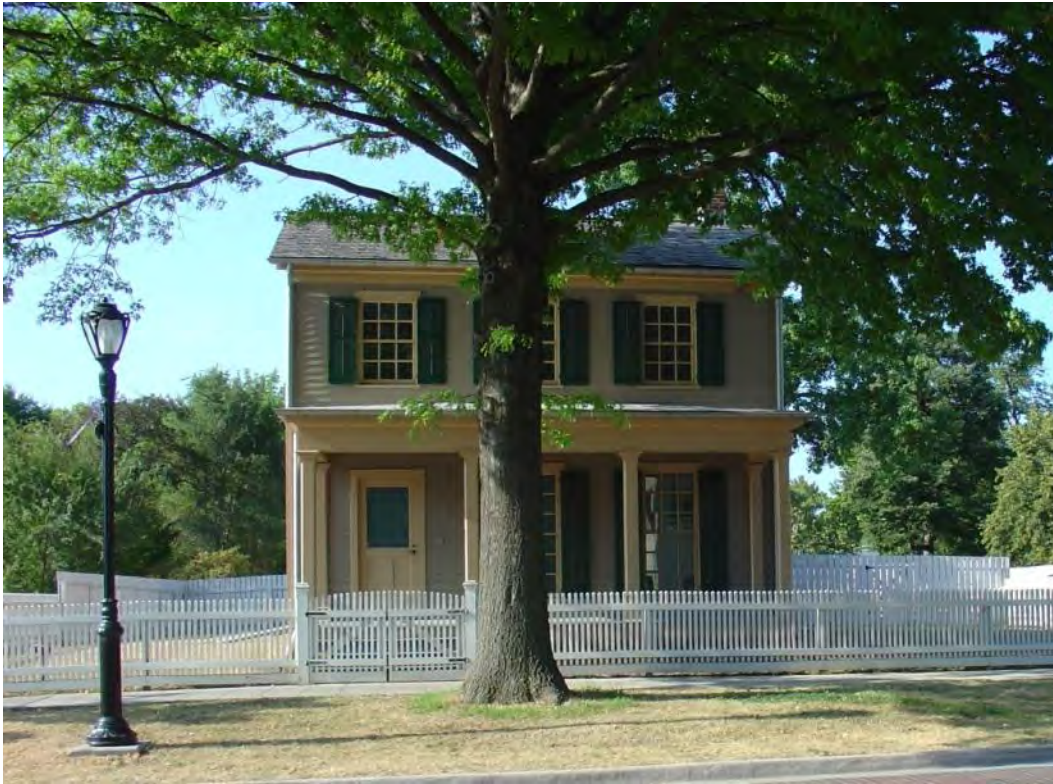
Figure 3- 36: Robinson House, west elevation, July 2012 (source QEA 1535)

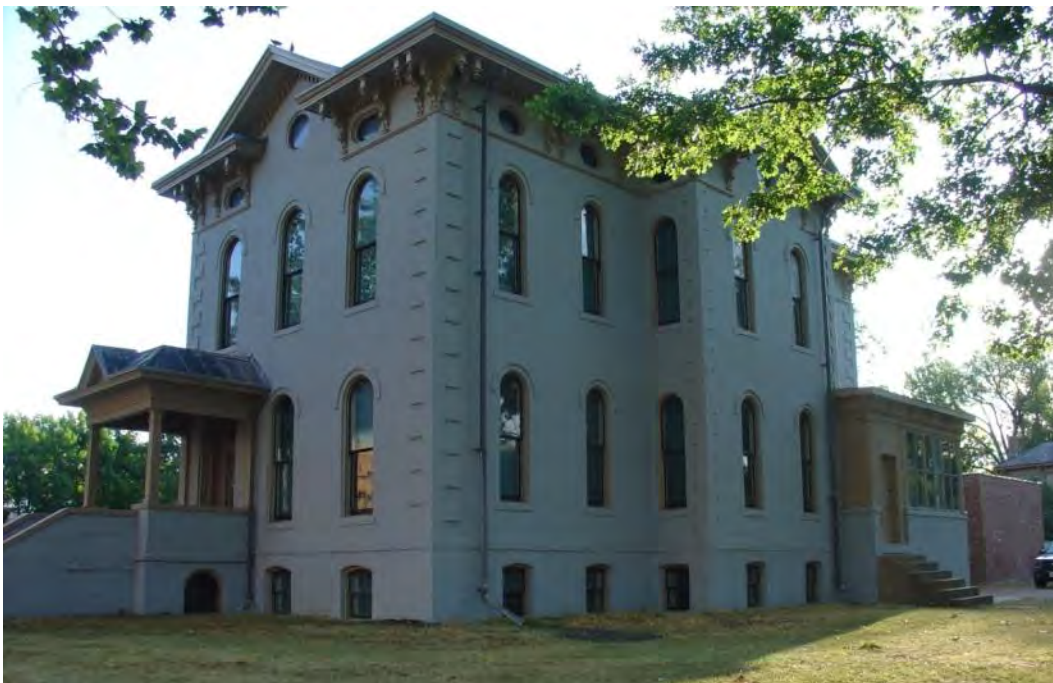
Figure 3- 37: Morse House, north elevation, July 2012 (source QEA 1854)

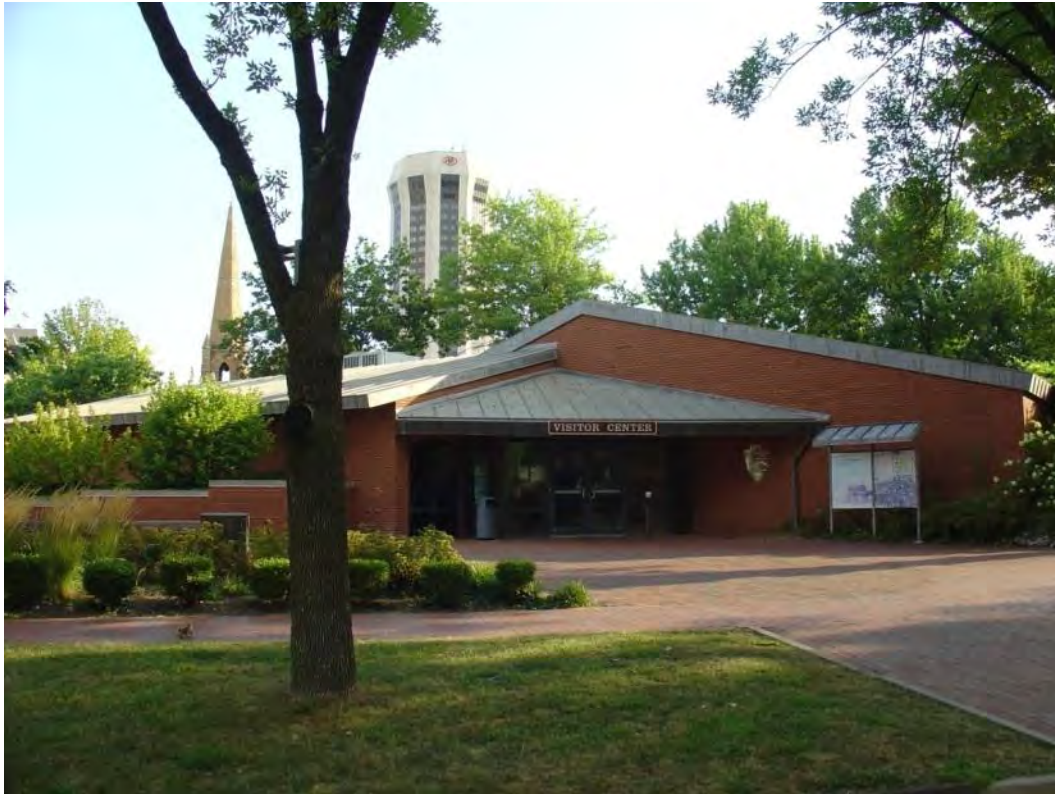
Figure 3- 38: Stuve House, west and south elevations, July 2012 (source QEA 1626)

Location	Building Name	Figure Number	Description	Condition/ Current Use
Block 6, lots 7 and 8 (Stuve Lot)	Stuve House, HS-05	Figure 3-39	Two-story brick Italianate house with the brick parged and tooled to simulate ashlar. The roof includes both hip and gable sections. The heavy eaves have brackets and pendants. Fenestration includes oval attic windows, and tall 1/1 windows with semi-circular heads on the lower floors.	Poor. NPS plans to rehabilitate for office use.
Block 6, lots 7 and 8 (Stuve Lot)	Stuve Garage		One-story brick building converted into a garage.	Fair. NPS plans to rehabilitate for office.
Visitor Services Area	Visitor Center	Figure 3-40	One-story brick building with standing seam metal roof and wide overhangs.	Good.
Visitor Services Area	Grace Evangelical Lutheran Church		This building is privately owned.	Good.

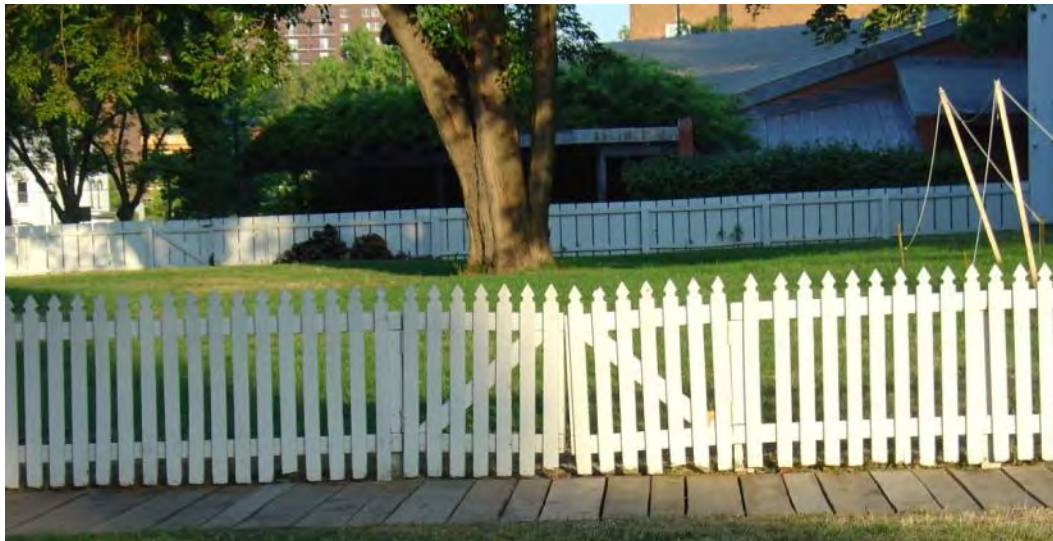
Figure 3- 40: Fence and gate at Brown lot, facing west, July 2012 (source: QEA)

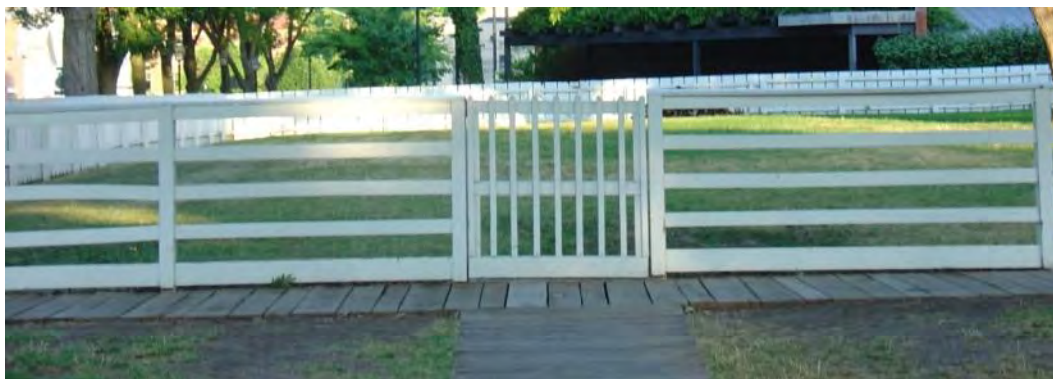
Figure 3- 41: Fence and gate at Burch lot, facing west, July 2012 (source: QEA)

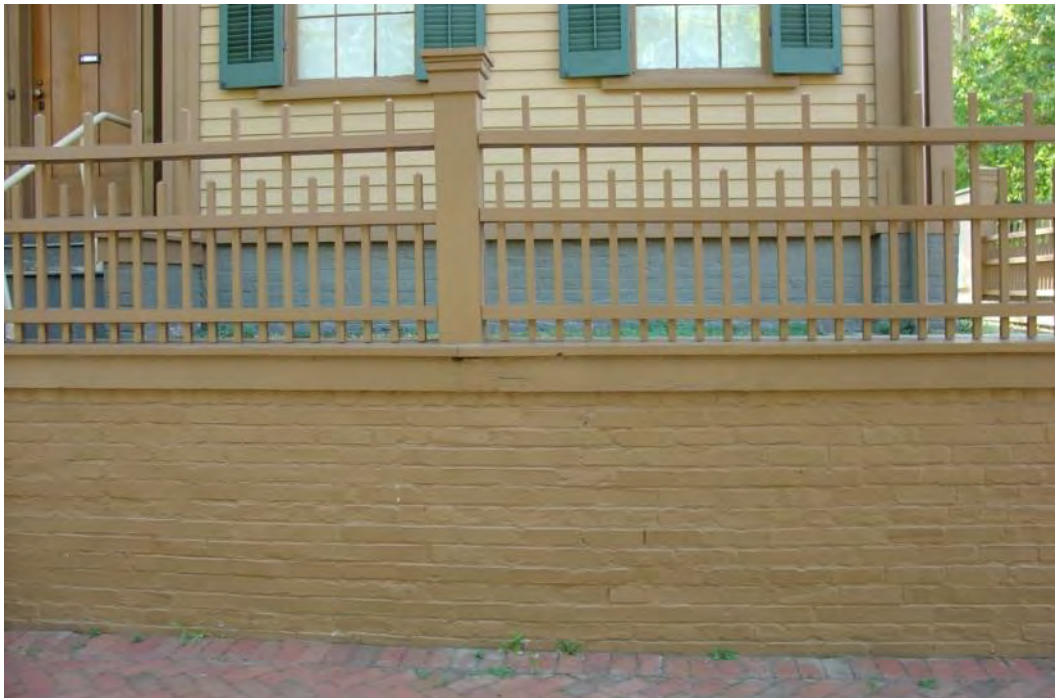
Figure 3- 42: Brick retaining wall and wood fence at front of Lincoln Home, facing east, July 2012 (source: QEA)

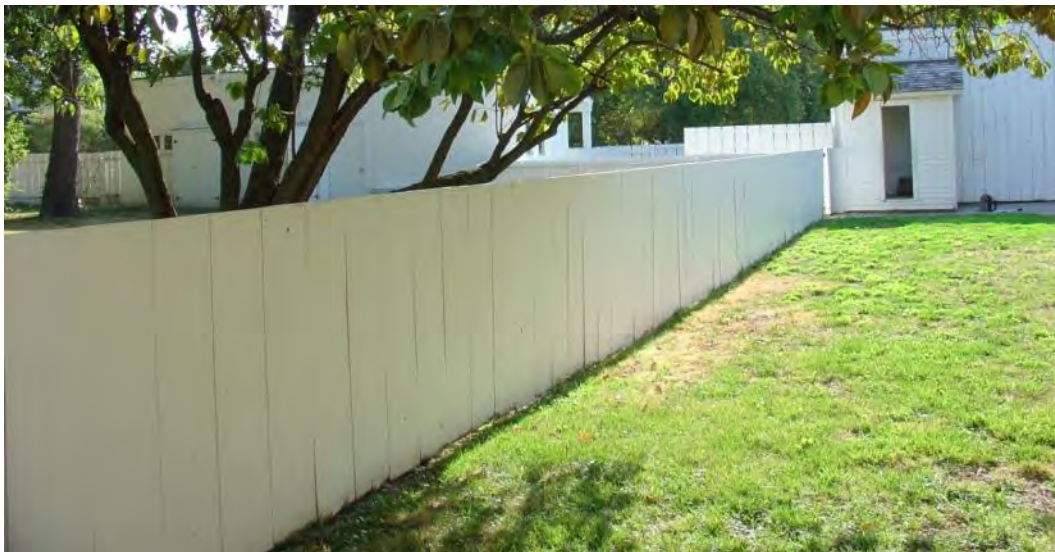
Figure 3- 43: Board fence at north side of Lincoln lot backyard, facing east, July 2012 (source: QEA)

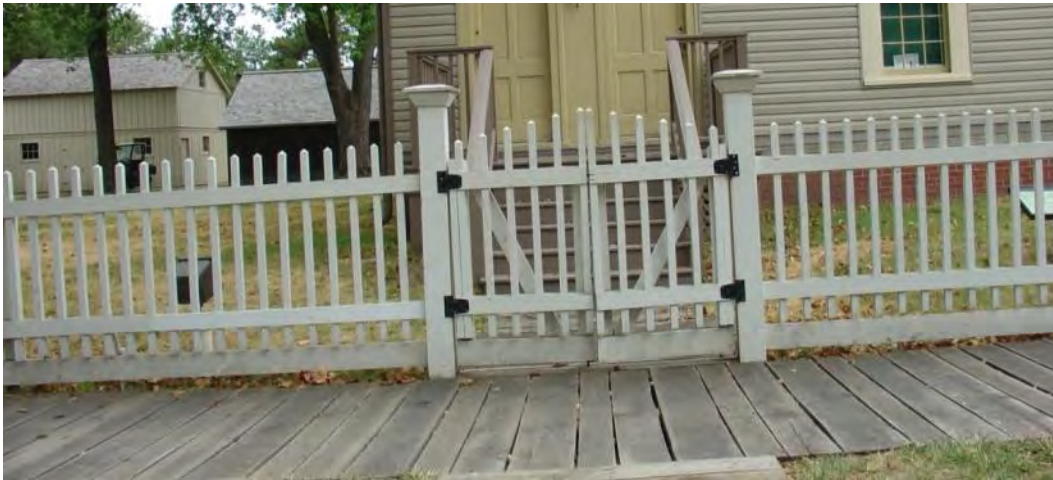
Figure 3- 44: Fence and gate at the Miller house, facing west, July 2012 (source: QEA)

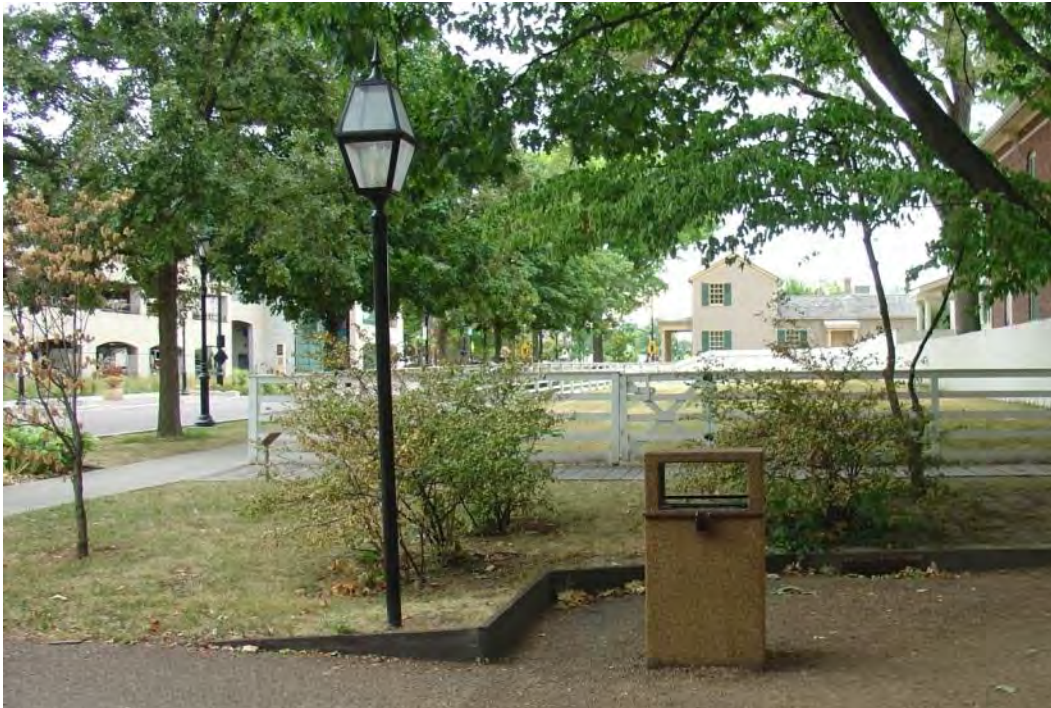
Figure 3- 49: Light post and fixture and trash receptacle at Eighth Street facing east, the Remann lot and Morse house are in the background, July 2012 (source: QEA)

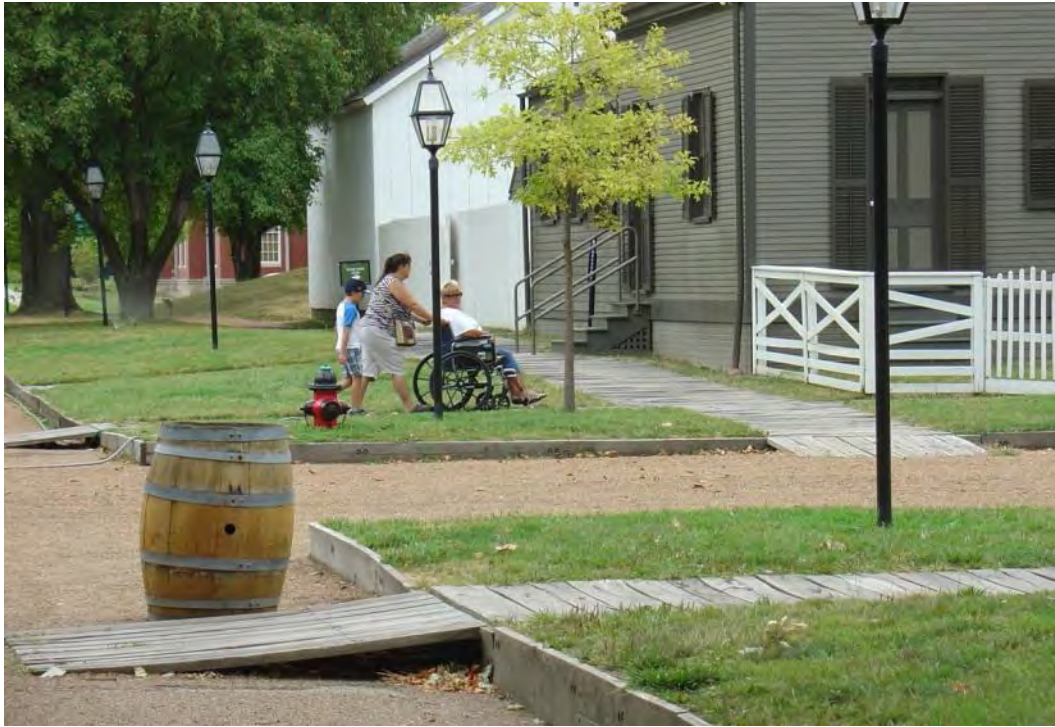
Figure 3- 51: Barrel trash receptacle, boardwalk ramp, and light posts and fixtures, July 2012
(source: QEA)

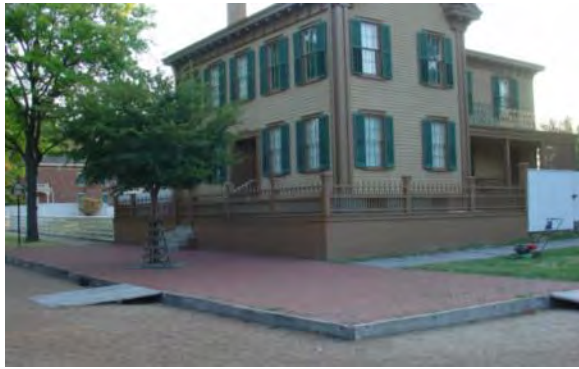
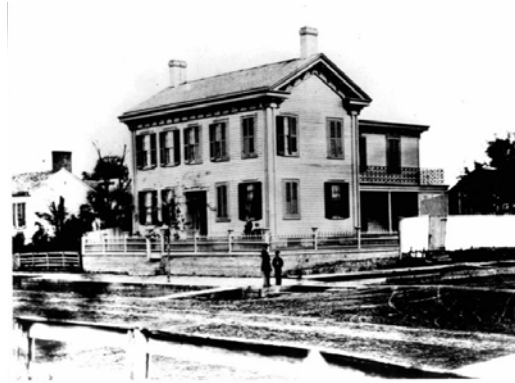
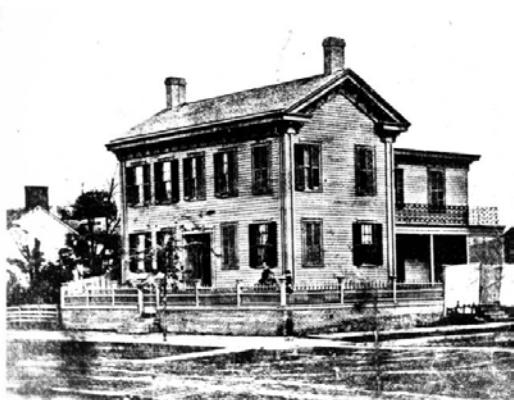
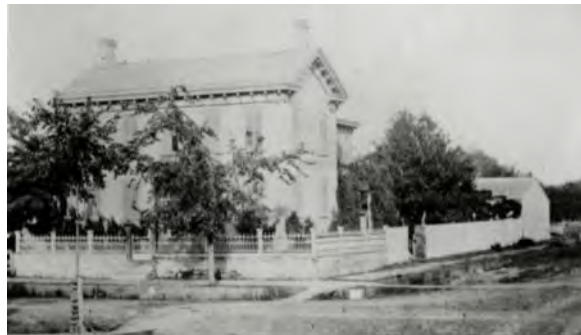
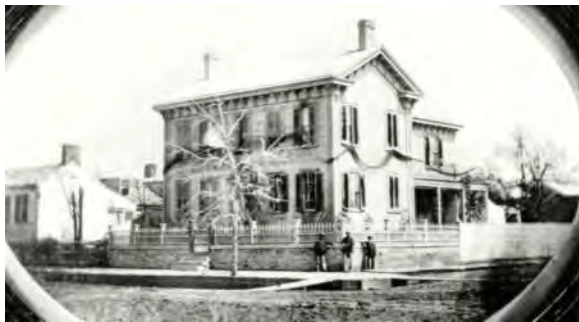
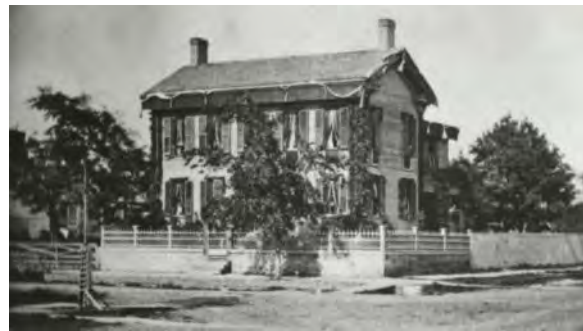
Figure 4- 1: Top Left: Front of Lincoln lot, 2012, Top Right: 1860 (same as Figure 2-24), Middle Left: 1860 (same as Figure 2-25), Middle Right, 1864 (same as Figure 2-35), Bottom Left: 1865 (same as Figure 2-36), Bottom Right, ca. late May 1865 (same as Figure 2-42)

The brick sidewalk along Eighth Street is wider today than it was during the Lincoln period. In the 1860s the space between the retaining wall and Eighth Street included a brick sidewalk that was between eight and ten feet wide with a 20-inch high board curb (see Figure 4-1 and Figures 2-24, 2-25, 2-35, 2-36, 2-37, 2-38, 2-40, and 2-42). Figure 4-2 is an enlargement of the area that clearly displays details described. At the north edge of the Lincoln property line, the board curb ended and the grade sloped back to the boardwalk adjacent to the Carrigan property. Today the brick sidewalk is 19 feet 5 inches wide in front of the Lincoln lot, and the street width is consistent along Eighth Street. Between ca. 1865 and ca. 1890 Eighth Street was altered. The street width was decreased from fifty-five to forty feet wide, and the curb on the east side of the street was shifted ten feet to the west (see Figure 2-48). This expanded the width of the area dedicated to the sidewalk and lawn terrace along the street. Also, the wood plank curbs were replaced with stone curbs. The height of the street has been raised, and the drainage ditches at the curbs have been replaced with storm drains, resulting in a shorter curb height. Although the street has not been restored to its 1861 width, a wood curb has been added to reflect the historic material.

The boardwalk and lawn terrace on the south side of the lot (along Jackson Street) is substantially wider today than it was in the 1860s (see Figure 4-1 and 2-24, 2-25, 2-35, 2-36, 2-37, 2-38, 2-40, and 2-42). In the 1860s, the boardwalk was approximately three to four feet wide and there was a strip of rough grass about two to three feet wide between the boardwalk and the curb. The boardwalk and grass terrace are both substantially wider today (see LA-5). The wood fence present at the south side of the lot during the Lincoln period was approximately twelve inches higher than the fence above the brick retaining wall, as it is today (despite being the same height by 1864 (compare Figures 2-24 and 2-25 to Figure 2-35). In 1860 there were three risers between the boardwalk and the gate near the house, as there are today (see Figures 2-24 and 2-25). There was one gate in the fence near the south porch. There was no second gate near the carriage house.

the tree on a regular basis. The tree trunk is protected by a wooden tree grate and guard. It is not possible to tell in historic images of conditions between 1844 and 1875 if a grate is present, but it is clear that no guard protected the tree in this location (see Figures 2-24, 2-25, 2-35, 2-36, 2-38, 2-40, 2-42, 2-59, and 2-60). Images taken in 1864 and 1865 illustrate a wooden tree guard around a tree at the front of the Burch lot across Eighth Street from the Lincoln lot (see Figures 2-35 and 2-42).

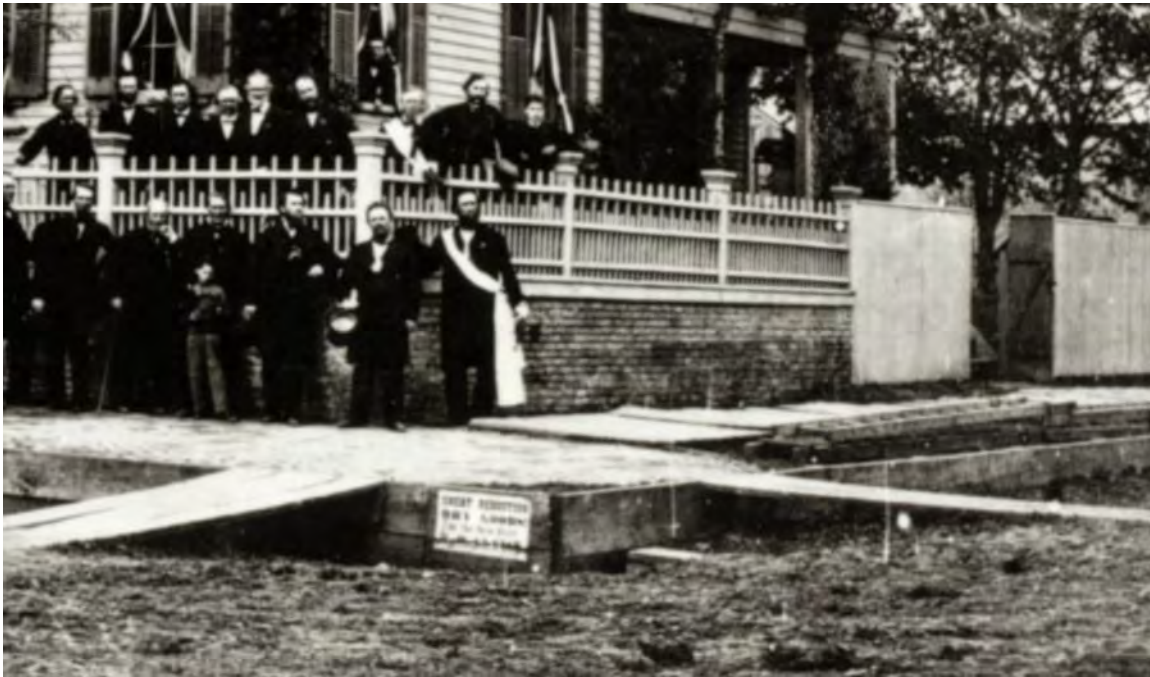
Figure 4-2: Detail of image, May 4, 1865, Mourners in front of Lincoln Home (same as Figure 2-40)

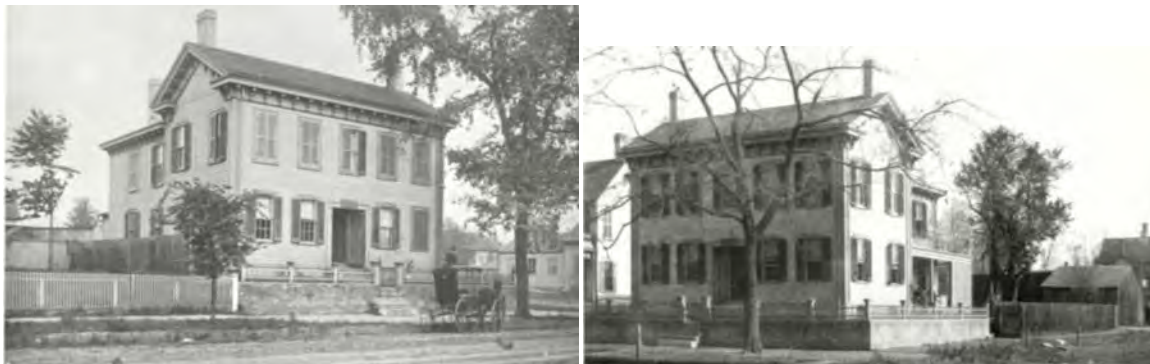
Figure 4- 3: Left: Front of Lincoln lot,(same as Figures 2-83 (ca. 1885) and 2-94 (ca. 1888)

- Based on the archeological evidence, it appears that the carriage house intersected a portion of the southwest corner of the original wood house, where the west wall of the woodshed abutted the north wall of the carriage house. This is confirmed by historic photographs from ca.1885 and ca. 1888 (see Figure 4-3 and Figures 2-83 and 2-94).

- In Figure 4-3 left (also Figure 2-83) the ridge line of the woodshed shed roof can be seen behind the Lincoln Home intersecting the sloping east roof rake of the carriage house approximately a third the way down the rake from the ridge line, which corresponds to the archeological evidence. The gabled roof of the privy is also seen in front of the west wall of the woodshed, north of the carriage house corresponding to the archeological evidence. Gables face east & west.

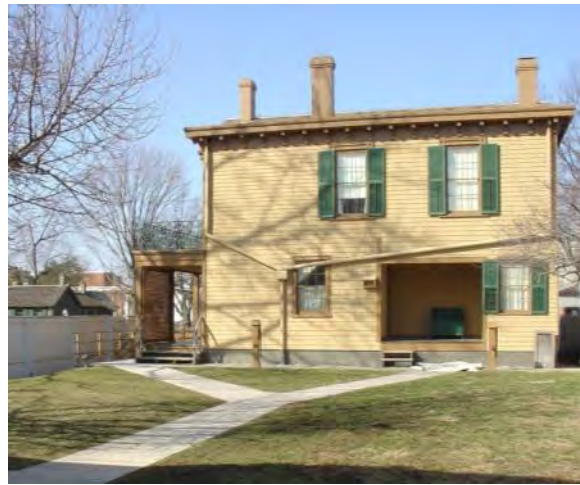
Figure 4- 4: Backyard of the Lincoln lot, 1865(left, same as Figure 2-41) and 2012 (right) (sources: Ridgeway Glover Stereopticon, from *Archeological ...* by Floyd Mansberger, 101, ISHL(left) and Quinn Evans Architects (right)).

The back yard of the Lincoln lot was less manicured during the historic period, compared to conditions today. A photograph taken in 1865 provides the most detailed illustration of conditions in the backyard at the Lincoln lot (Figure 4-4 allows for comparison of the image to a contemporary view, also see Figure 2-41). The lawn was irregular and included some small plants that cannot be identified. A boardwalk provided a dry route between the house and outbuildings. The current boardwalk is located roughly in the location of the historic route (see Figure 4-4 and LA-5). The Lincolns were not gardeners, and it is likely that the yard was mostly utilized for utilitarian purposes. Historic photographs indicate the presence of two small trees in the backyard. One was in the approximate location of the existing apple tree. A second tree was located between the existing apple tree and the house (see Figures 2-41, 2-35, 2-36 and 2-42). Two different cisterns were utilized during Lincoln's tenure at the property. The earliest was located adjacent to the southern end of the east building wall. A later cistern was located further east in the yard (see LA-5). Remnants of both of these features were located during archeological investigations and are extant under the back yard soil. The middle section of the yard has not been extensively investigated and has a high potential to contain significant archeological resources.⁶
