Lincoln Home National Historic Site

Cultural Landscape Report

June 2014

Prepared by
QUINN EVANS ARCHITECTS
1037 Sherman Avenue
Madison, Wisconsin 53703
734-926-0419

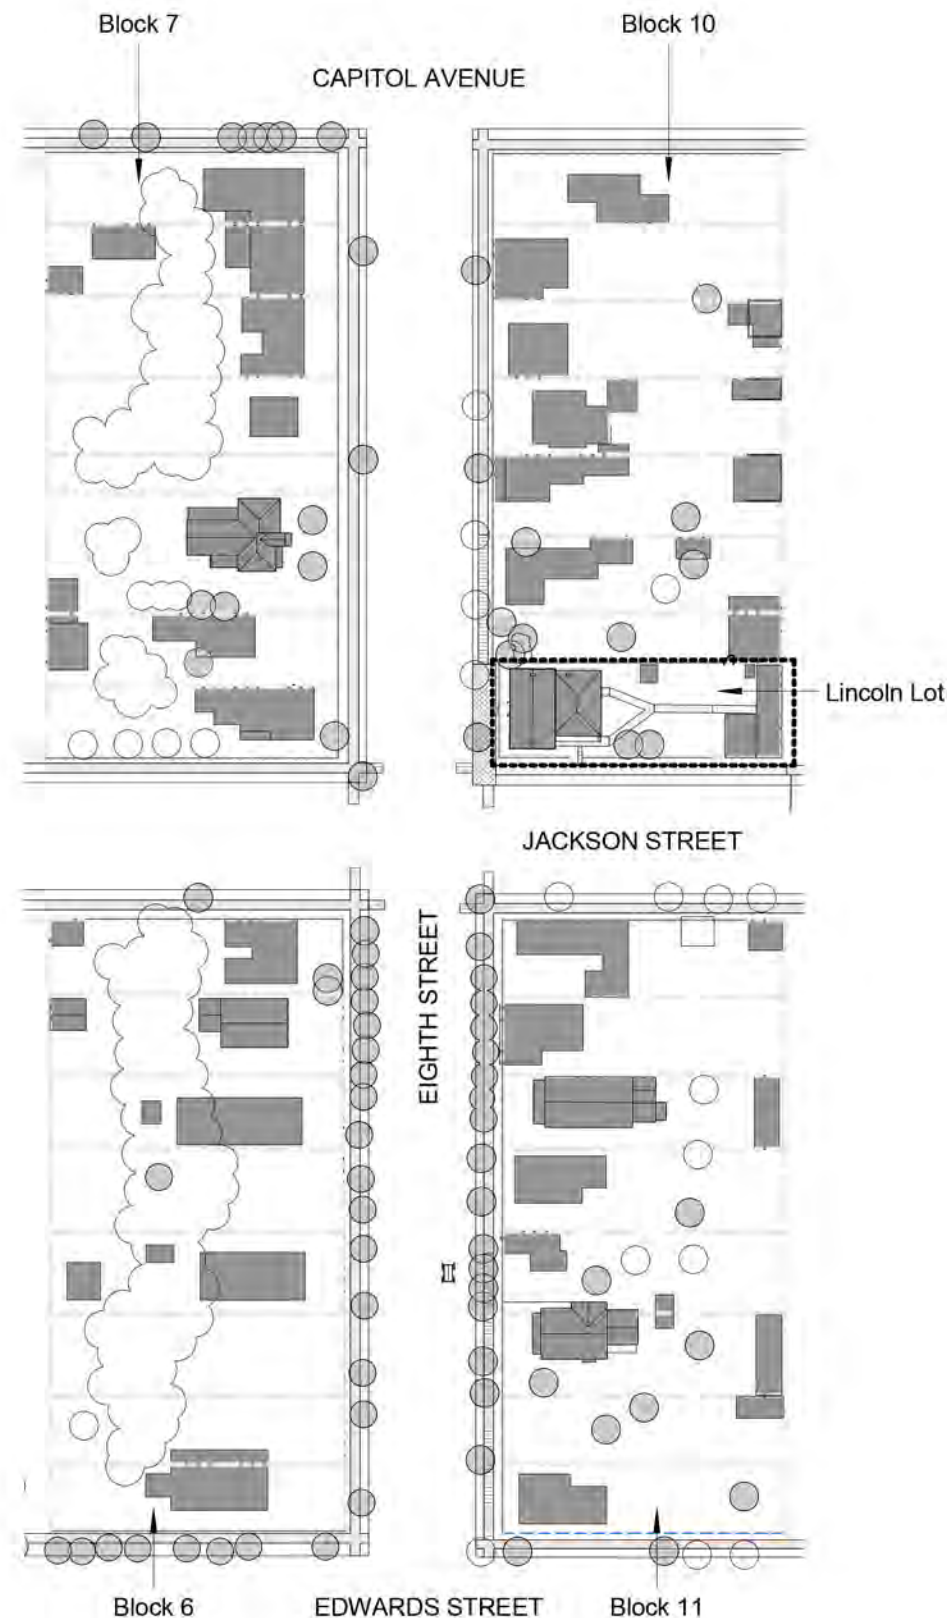
Spatial organization of buildings, streets, boardwalks, fences, and vegetation during the period of significance.

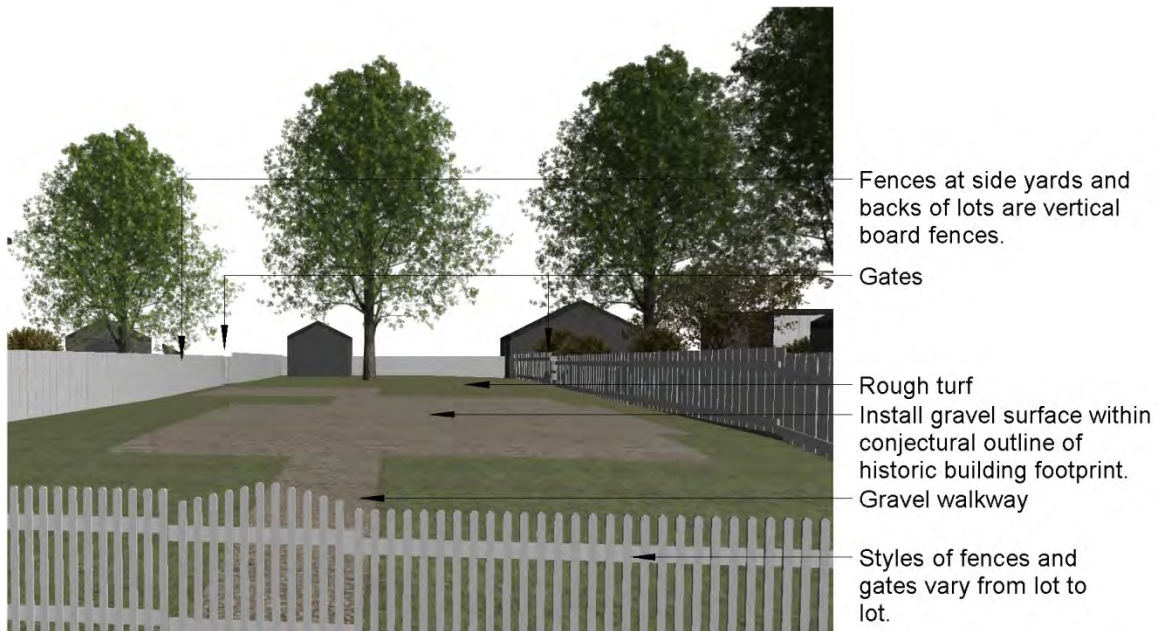
Figure 5- 2: Historic Yard Treatment Type 1

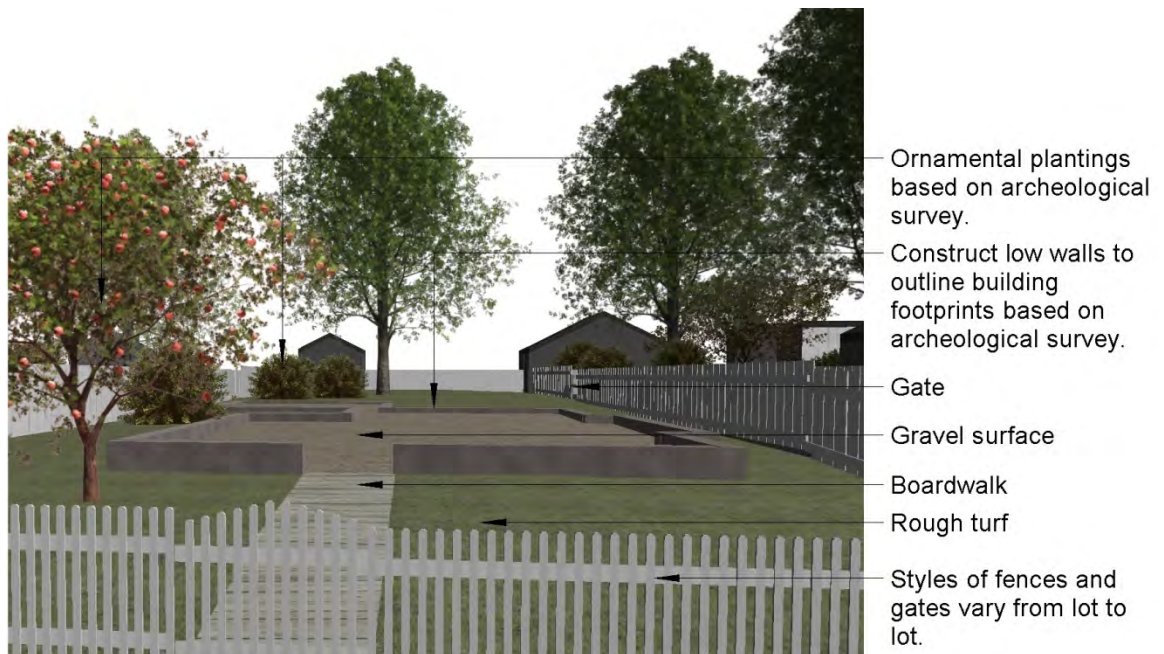
Figure 5- 3: Historic Yard Treatment Type 2

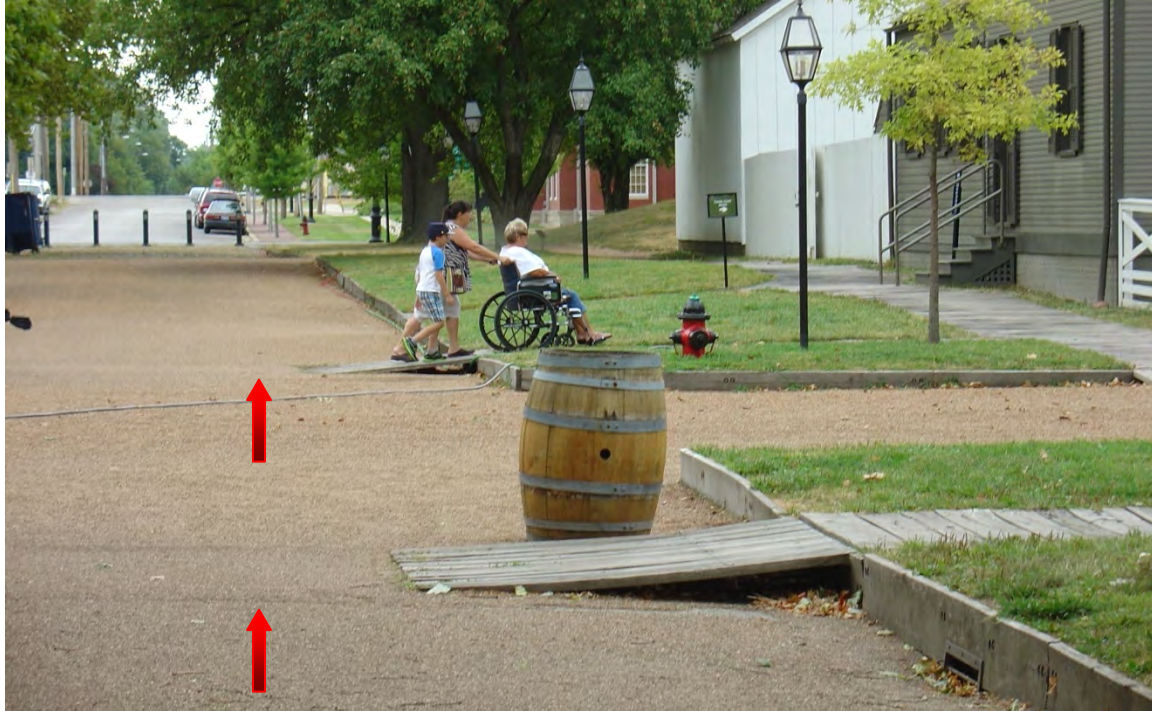
Figure 5- 7: Barrier-free access routes at Eighth and Jackson Streets.

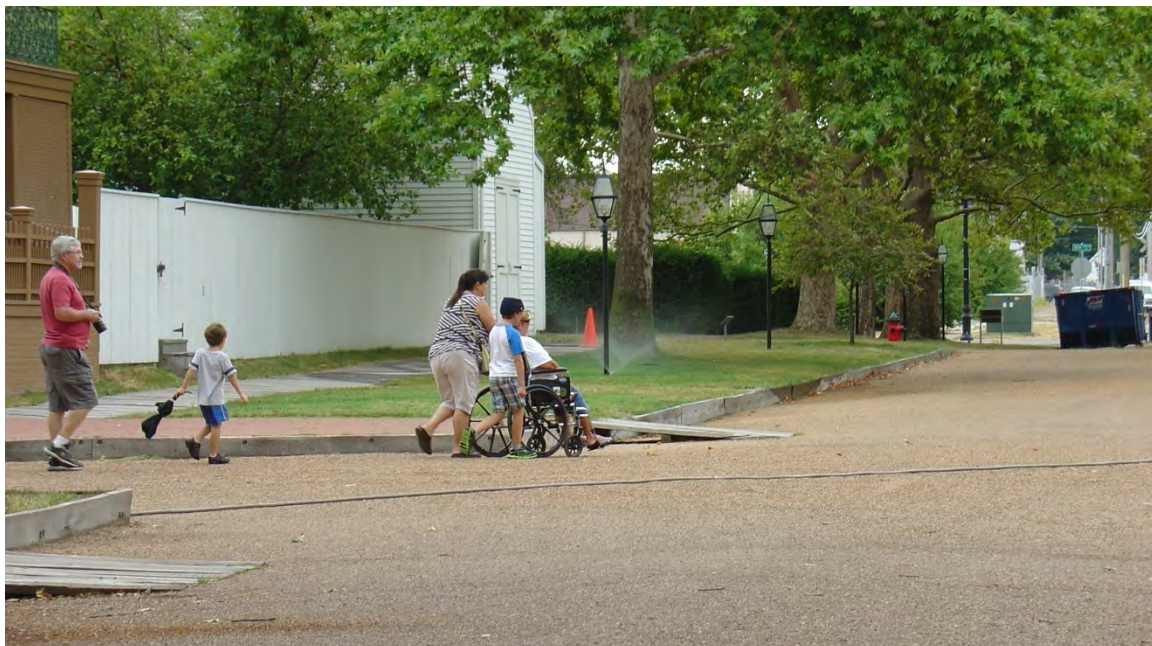
Figure 5- 8: Visitors with disabilities use other portions of Eighth and Jackson Streets as well but are limited in this use by the varying condition of the chip seal pavement.

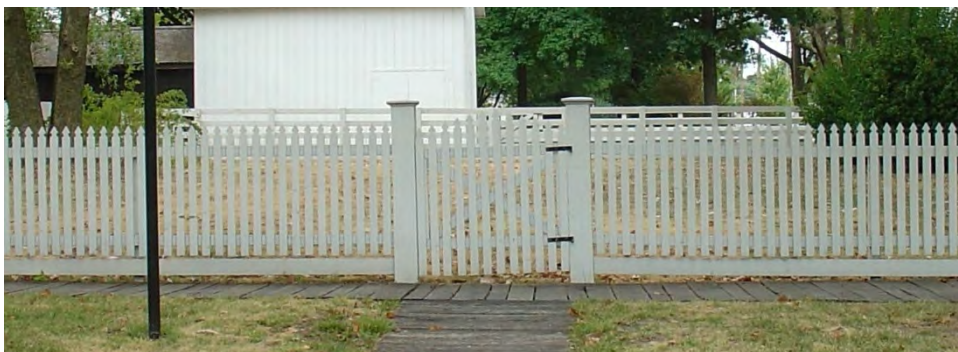
Figure 5- 9: Fence and gate at the Allen lot, July 2012. (QEA)

Task C5-d.2: Add a gate that matches the gate at the Allen lot. (CI)

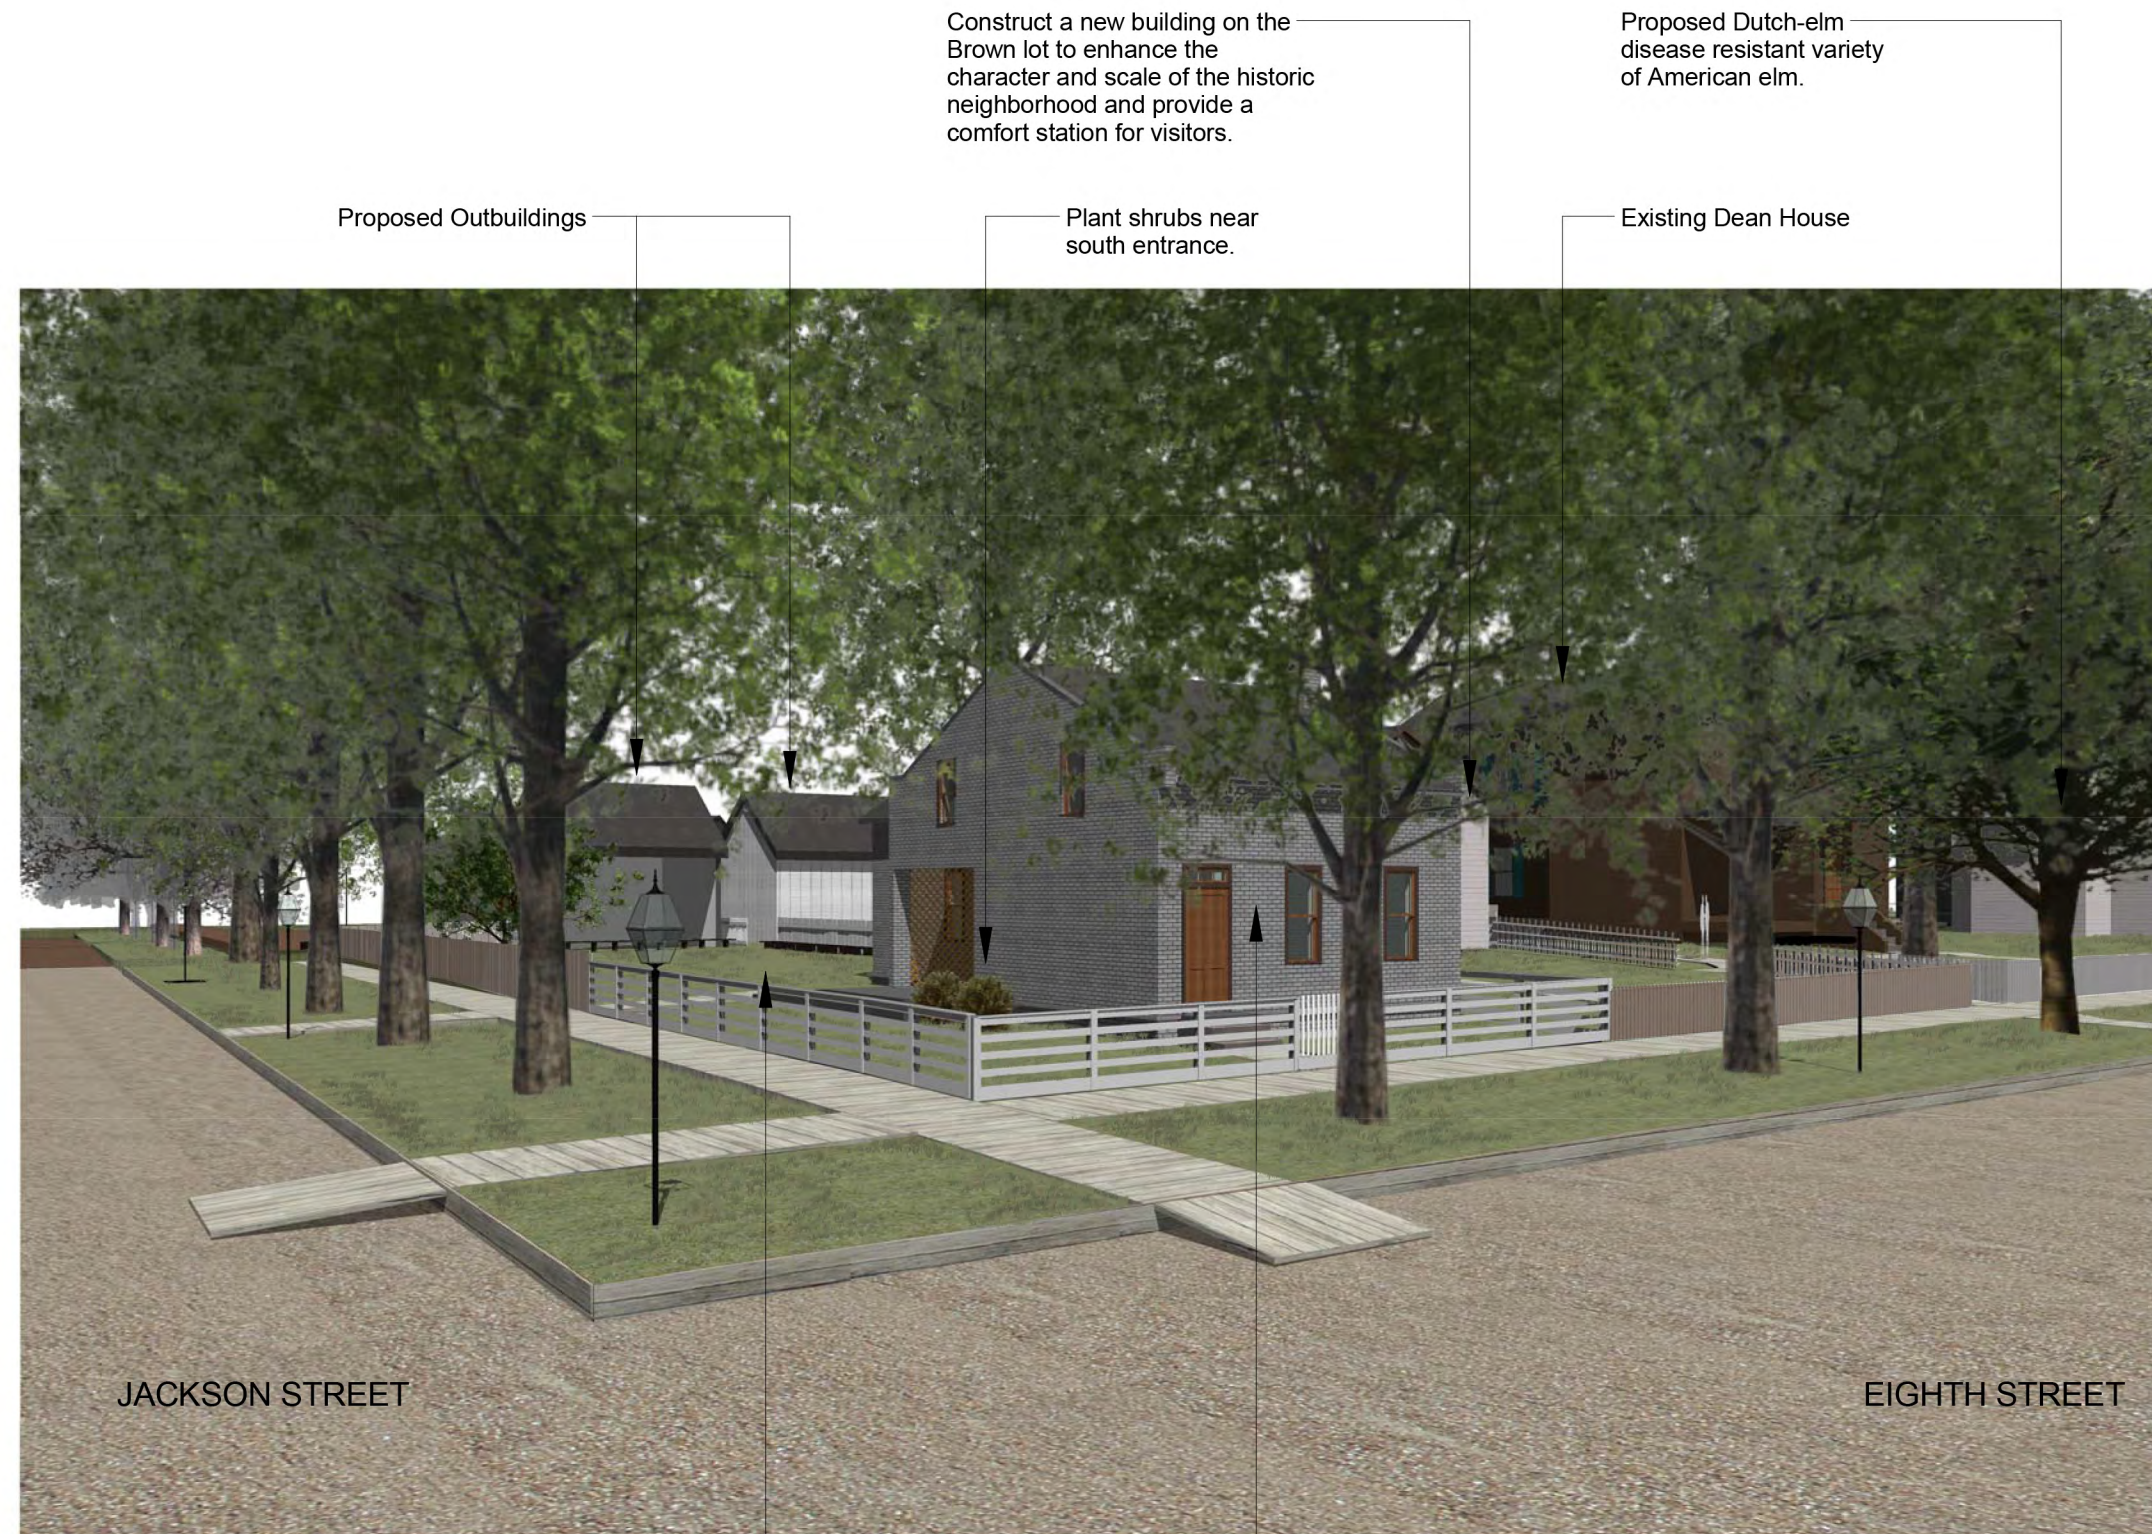
Construct a new building on the Brown lot to enhance the character and scale of the historic neighborhood and provide a comfort station for visitors.

Proposed Dutch-elm disease resistant variety of American elm.

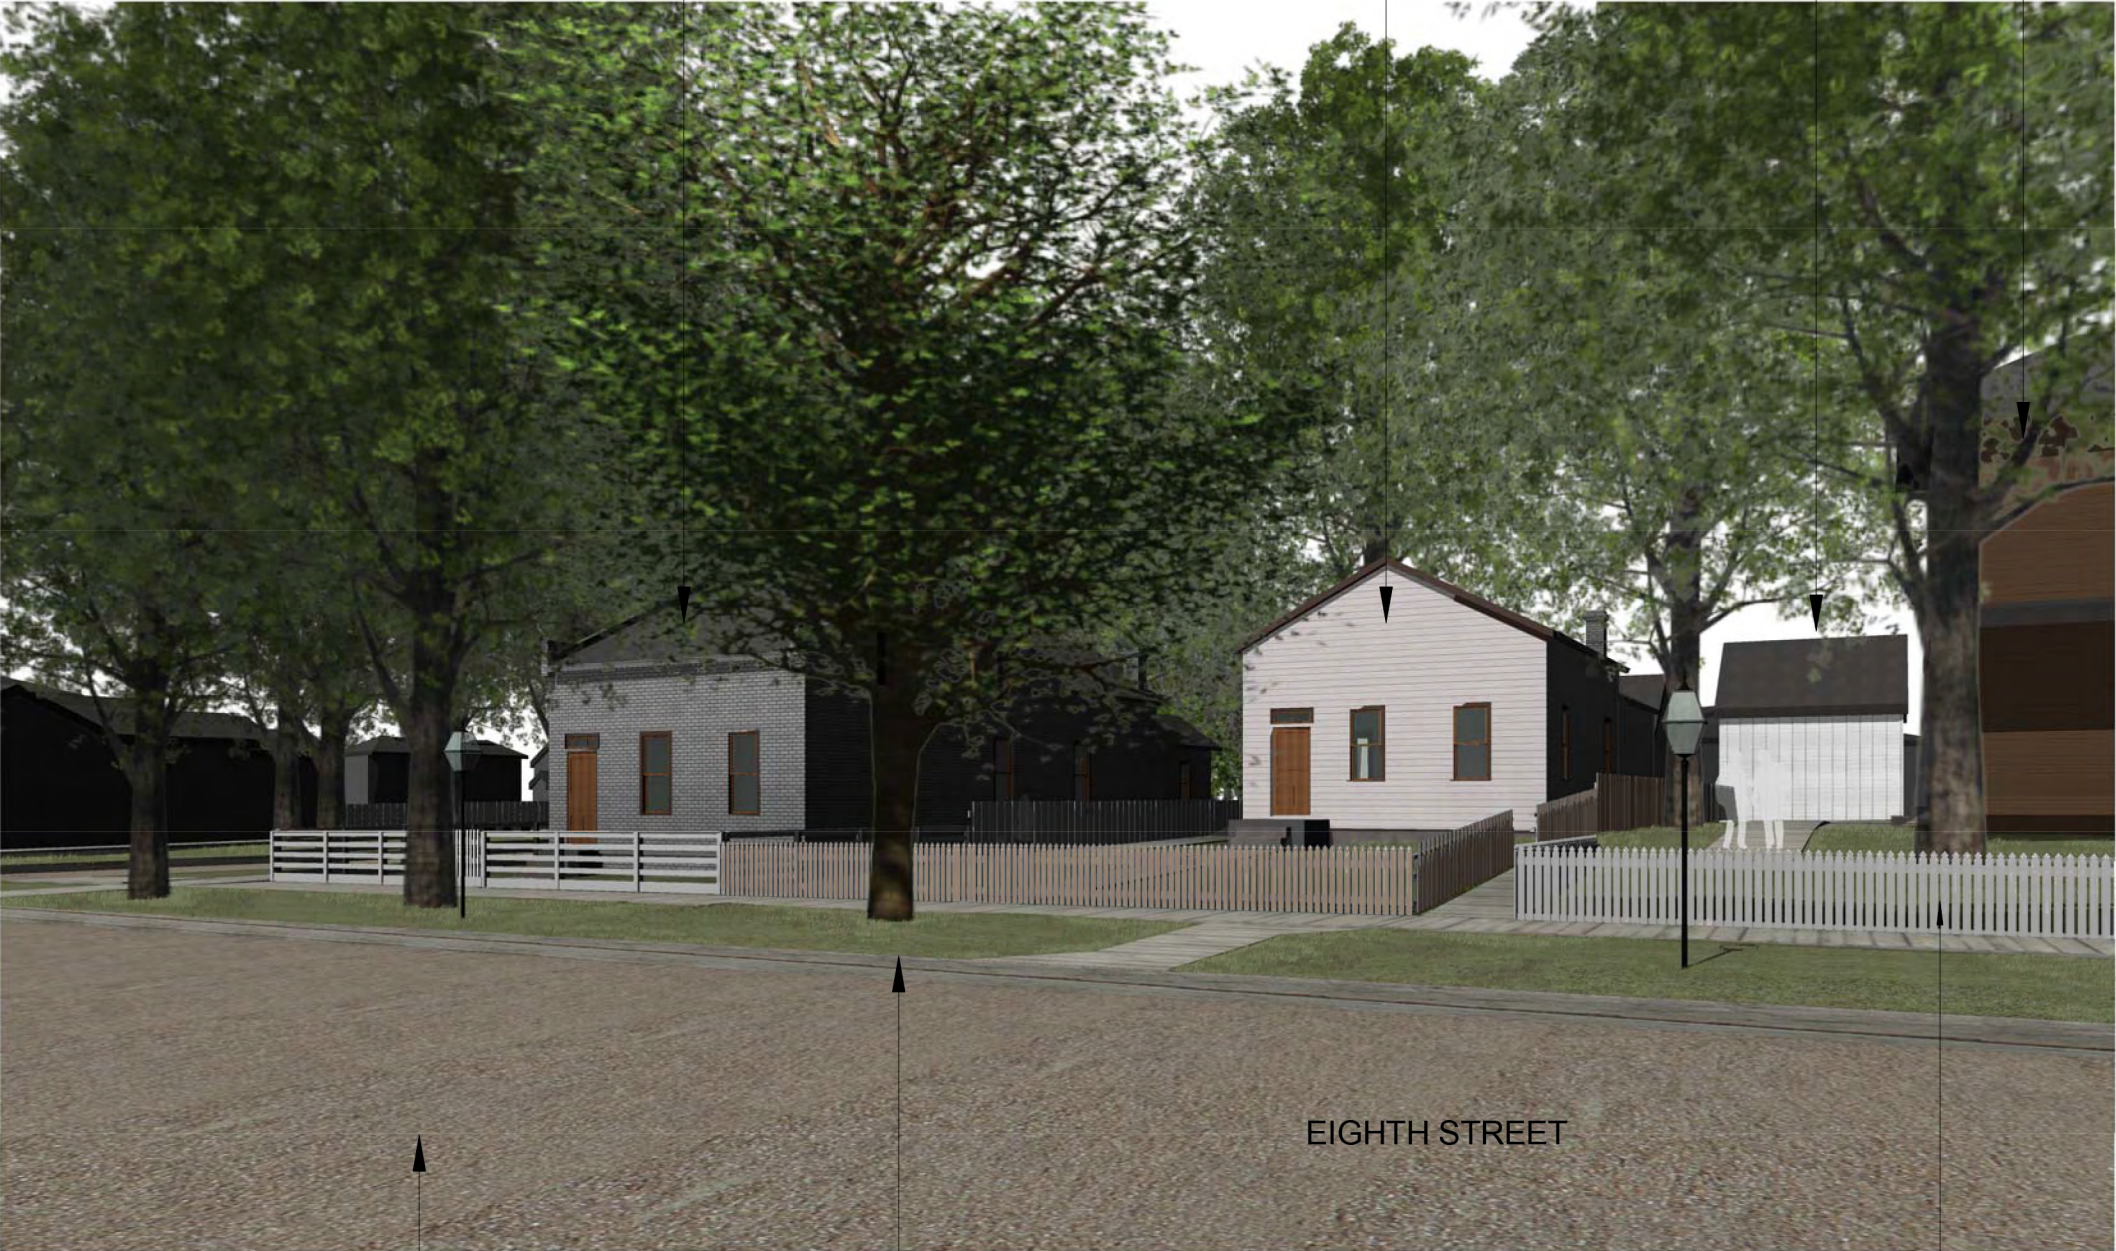
Maintain chip-and-seal pavement to provide a rustic-style surface that is universally accessible.

Proposed American Elm tree

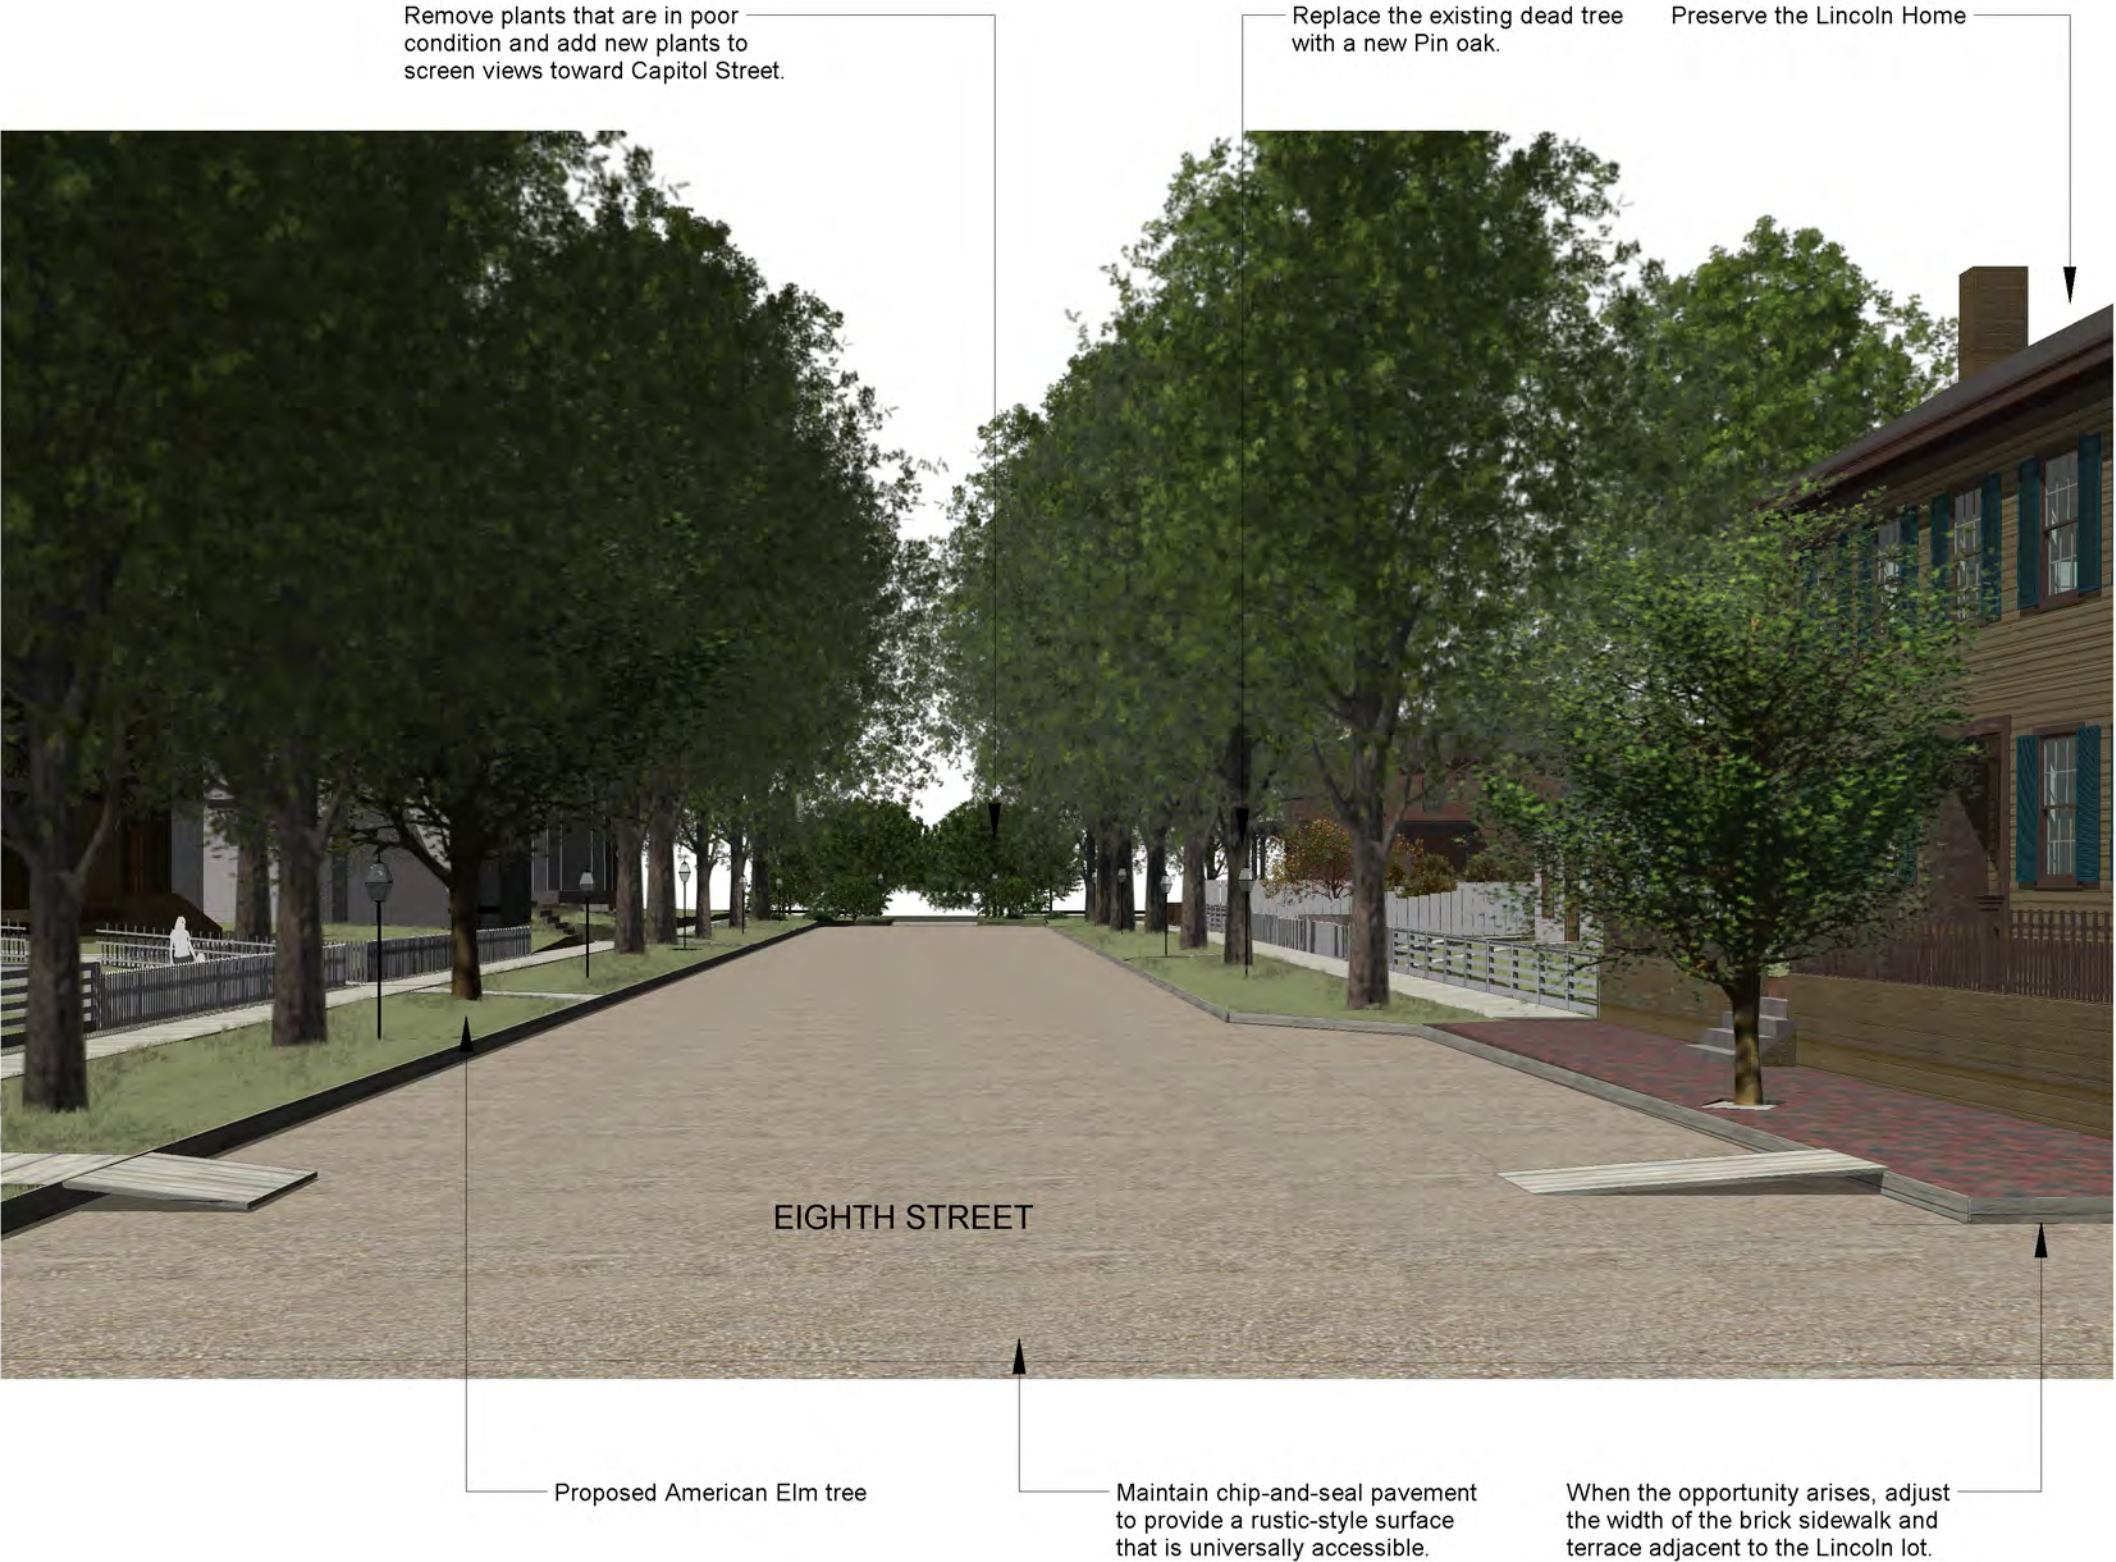
Recommended Treatment
Perspective 6

Recommended Treatment for Lincoln lot back yard, facing northwest from the intersection of Jackson Street and the alley.

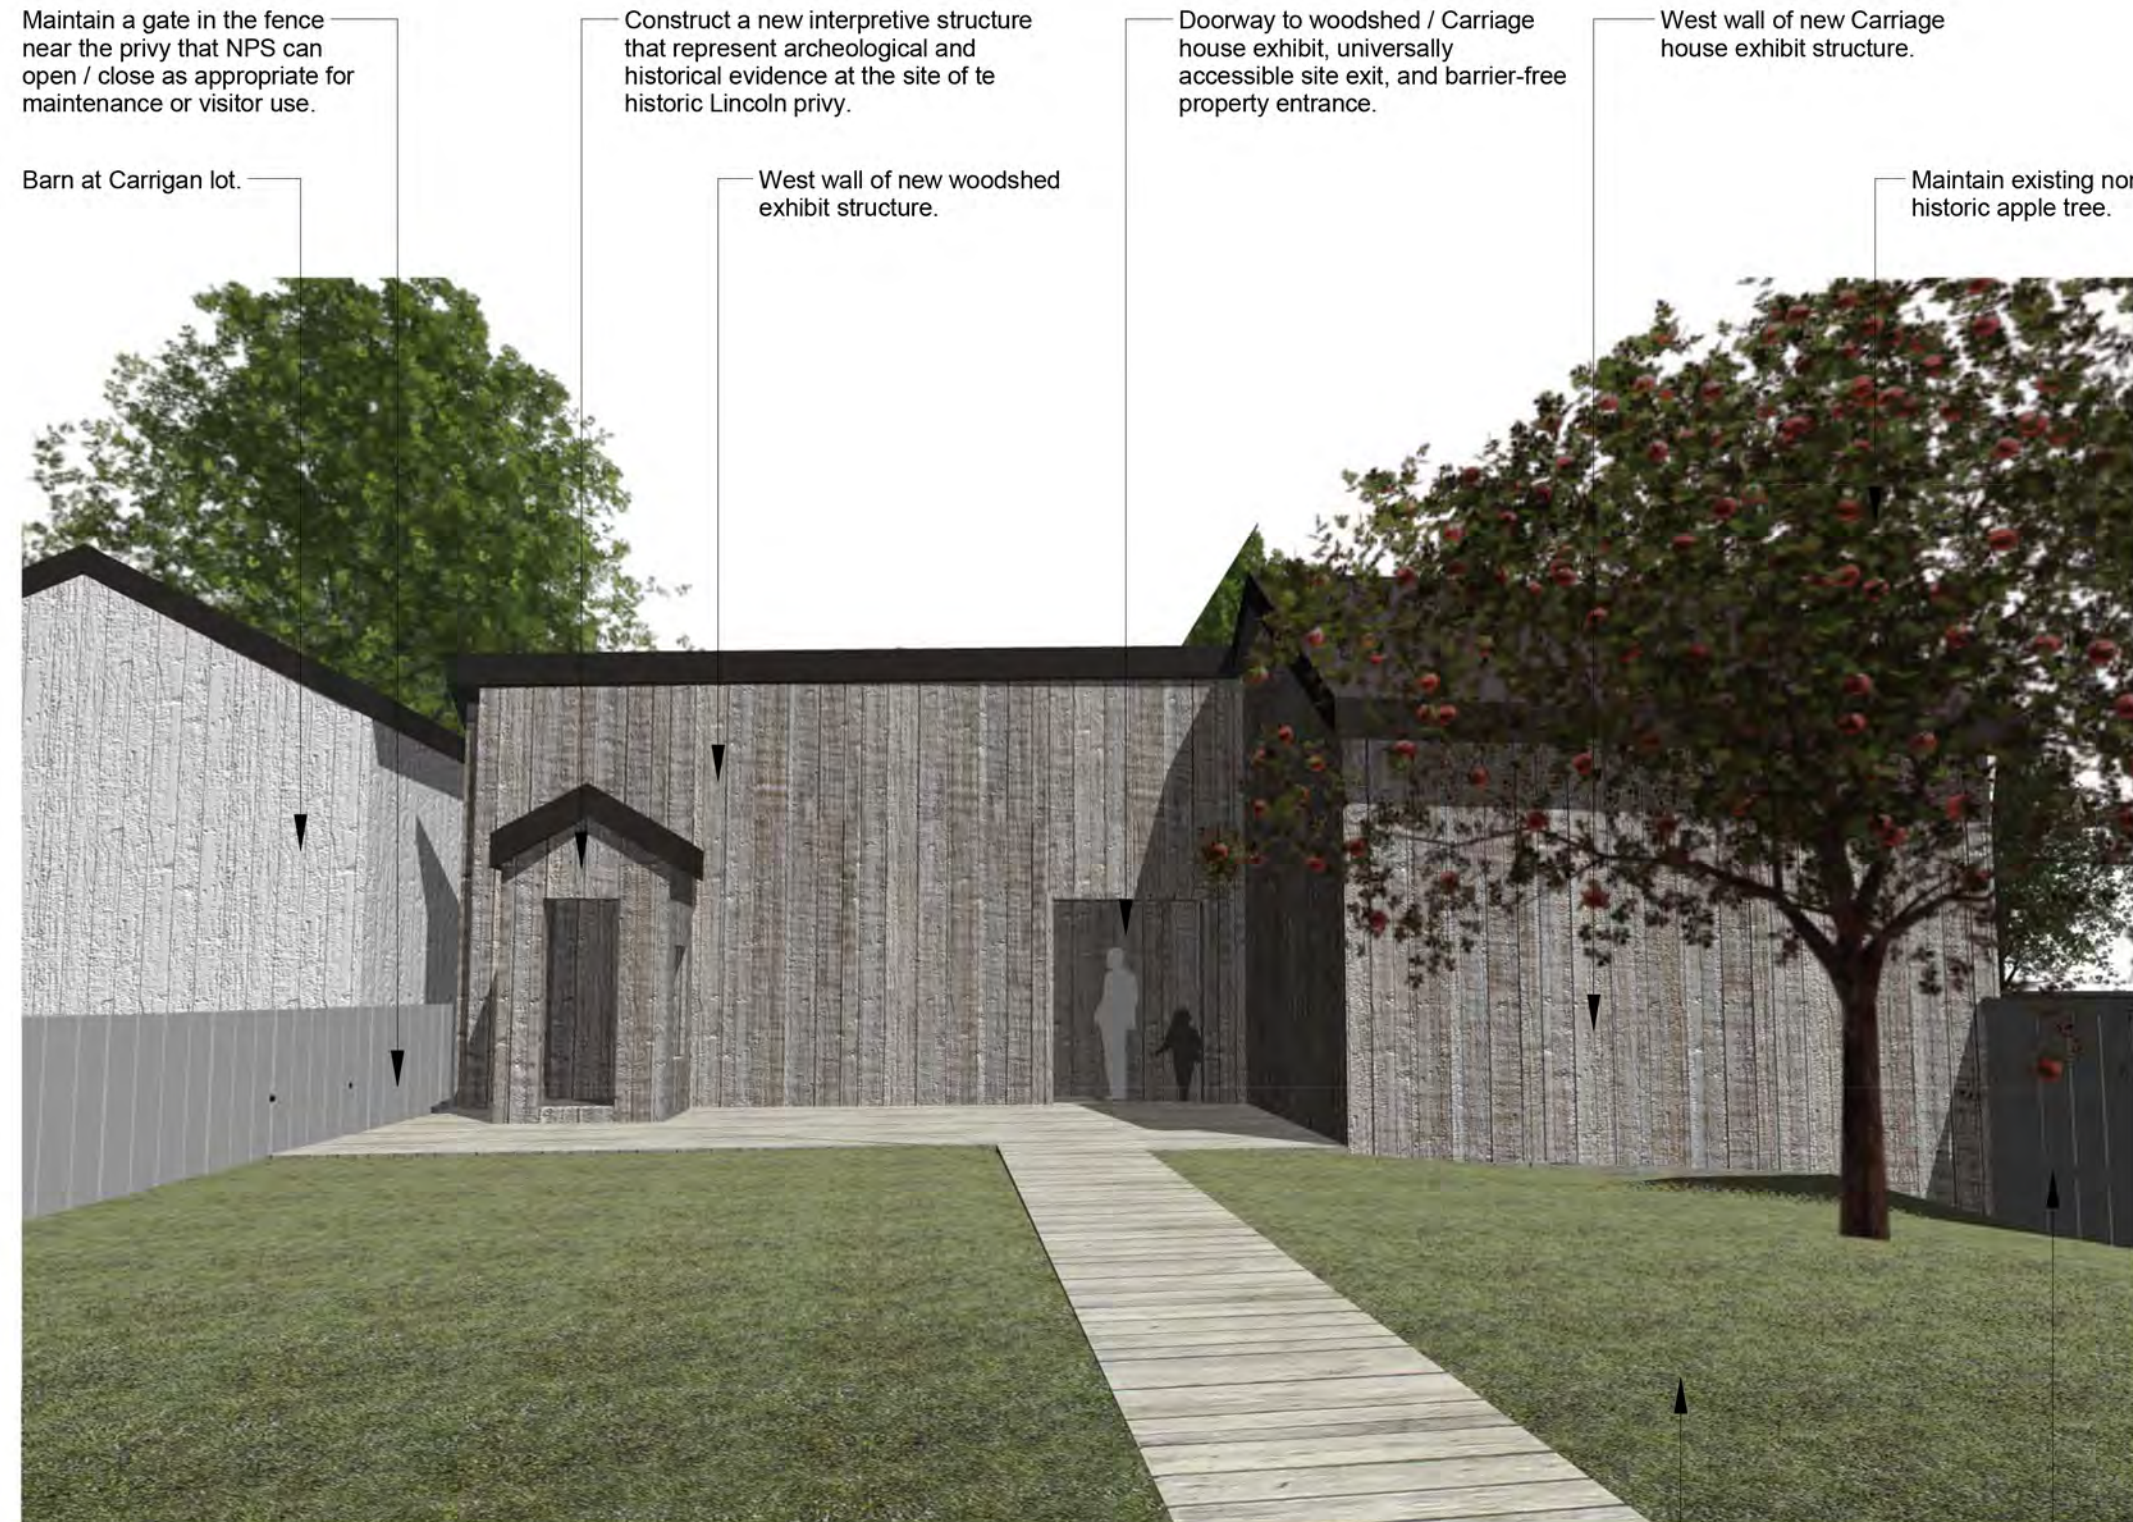
Recommended Treatment for Lincoln lot back yard, facing east.

Remove the existing carriage house and wood shed and construct a new building that reflects archeological and historical evidence, incorporates a barrier-free entry route to the property for visitors with mobility impairments, provides interpretive information regarding the outbuildings, and includes a universally accessible departure route for all visitors.

Maintain a gate in the fence near the privy that NPS can open / close as appropriate for maintenance or visitor use.

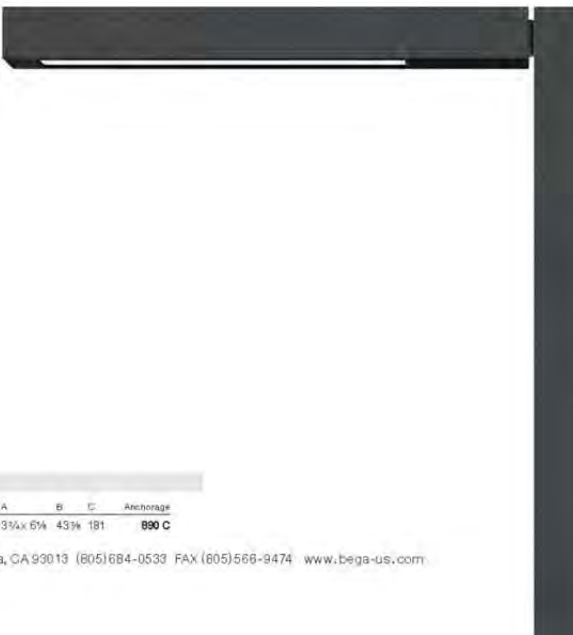
Single light building element

Lamp	LED	A	B	C	Anchorage
0977 LED 39W LED	LZ-1	3'4 1/4"	6 1/4"	43 3/4"	18"
					890 C
