**HISTORIC STRUCTURES REPORT**

**THE HENRIKER FINESS HOUSE**

**Minute Man National Historical Park Project**

**March, 1963**

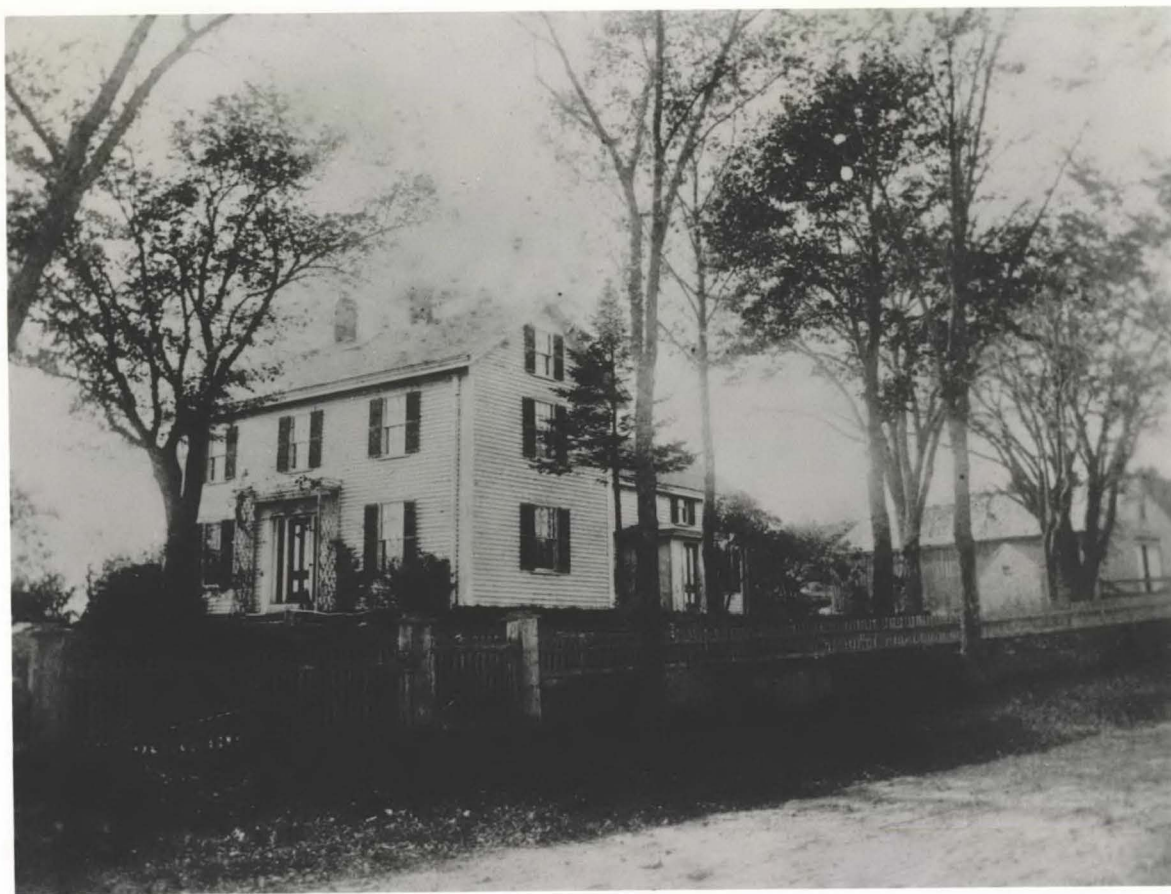
ILLUSTRATION NO. 1

View from east, taken about 1890

Note: Front portion of house reportedly original section. Alterations to rear. Noted on rear of photograph: "This is the Dudley (formerly Simpson) house on Mass. Ave. opp. Wood St. taken about 1890. In this yard is the 'Hayward' pump."

Mr. Haskins is of the opinion that the front portion of the house was the original structure. Alterations to the house had been made, especially at the rear (see Illustration No. 1). He also recalled that there had been a fire in the house, but did not know the exact date. The fire did not gut the house, but damaged portions of it.<sup>4</sup>

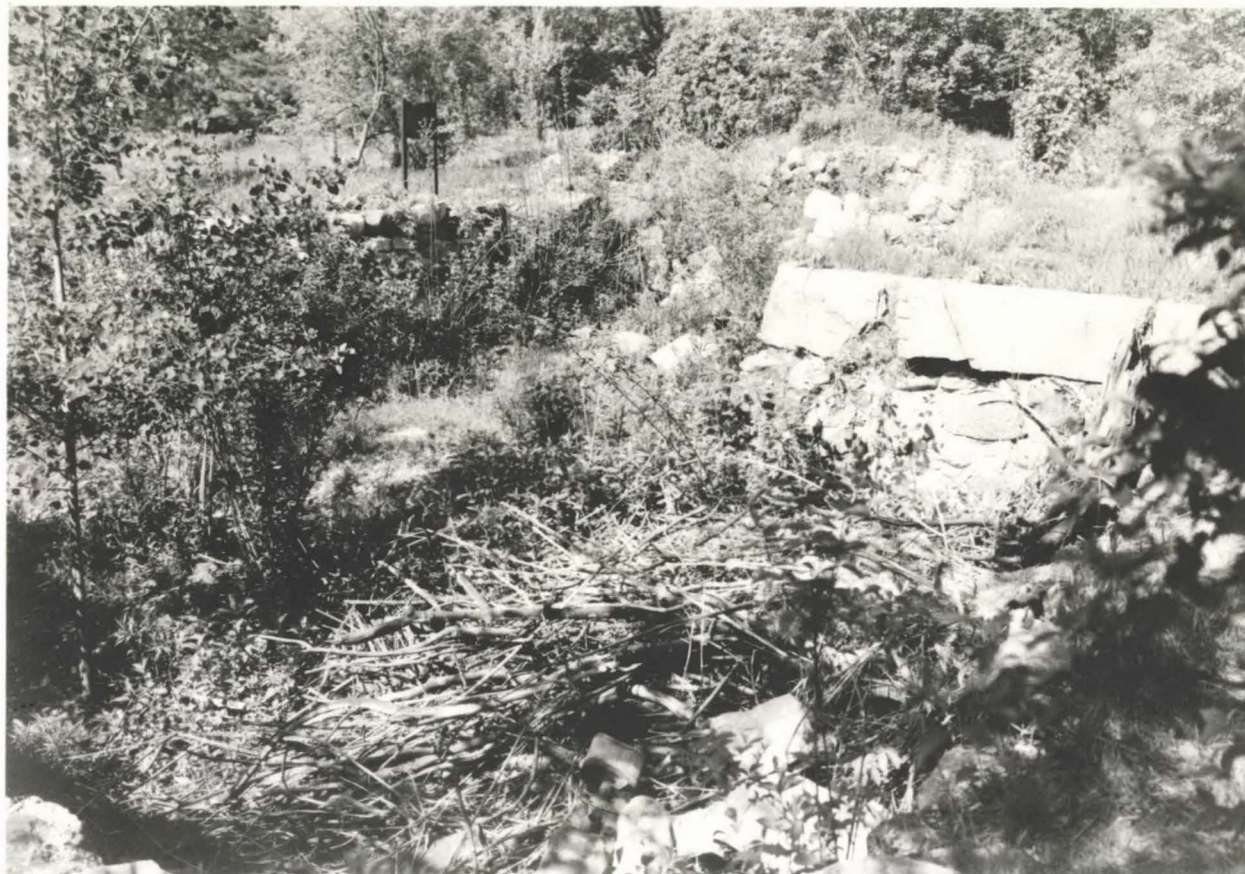
ILLUSTRATION NO. 2

Front portion of house foundation remains.

Note: View from east, overgrown base, random stone  
walls and remains of granite facing.

The house foundation walls are built of random stone ashlar, which was originally laid up dry and later pargecast. In plan, the rectangular front portion of the cellar measures approximately 18' x 36' with a rear ell measuring approximately 18' square which is centered on the front portion. The top of the foundation walls above grade have some sections of granite facing remaining in place; other sections have fallen into the cellar (see Illustration No. 2). The remains of early exterior stone cellar steps are visible in the southwest corner of the foundation; in

Following approval of both the Historical and Architectural Data Sections, Part I, it is recommended that an archeological survey be conducted to clear the cellar. The walls should be stabilized once this project is completed.

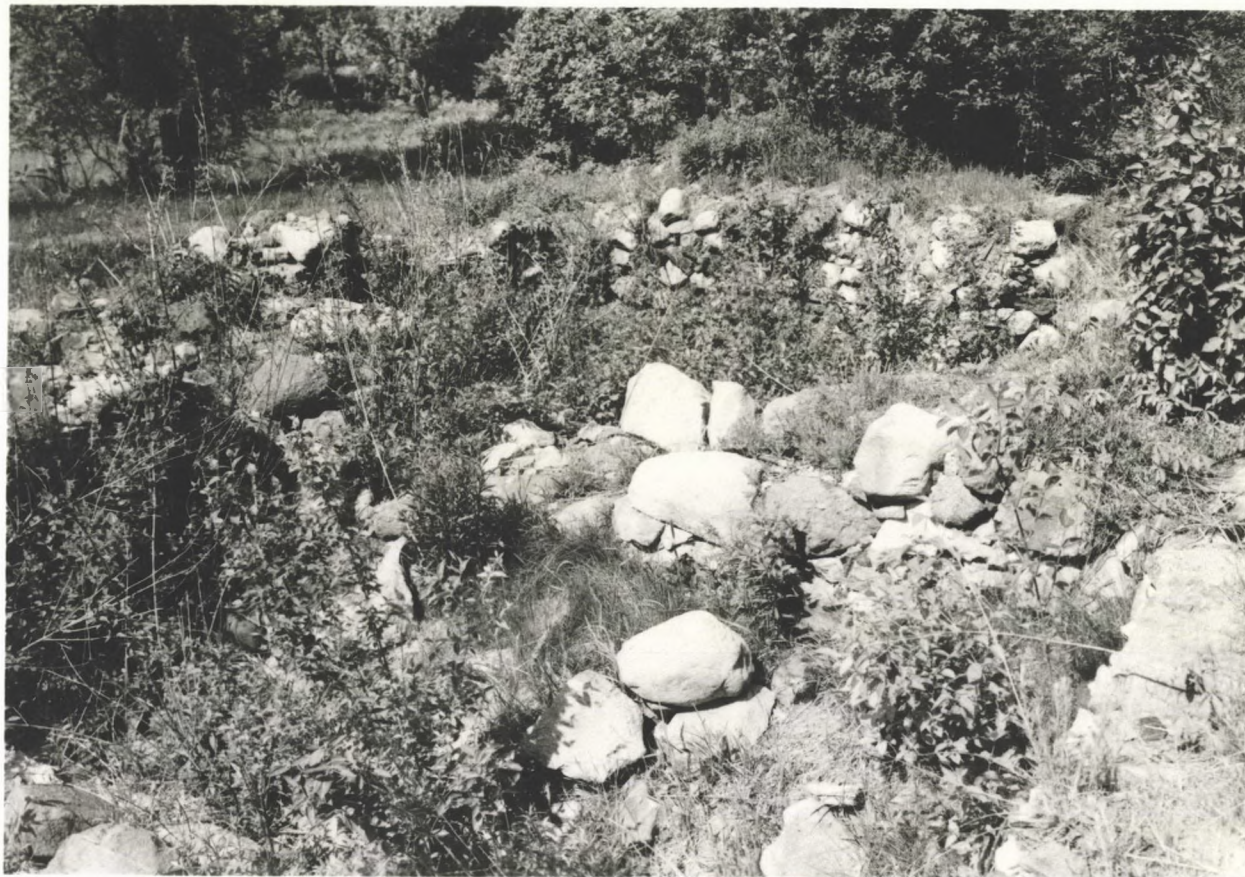
ILLUSTRATION NO. 3

Rear portion of house foundation remains.

Note: View from east, overgrown base, random stone  
walls.

To the rear of the foundations discussed above there is another foundation which appears to be a cellar, added perhaps to the front portion at a later date. These rubble stone walls are in a much poorer condition than those of the front and will require further investigation to determine their date of construction and purpose (see Illustration No. 3). The addition of these walls may have occurred during the period of Bulley's ownership when considerable alterations were made to the house.<sup>5</sup>

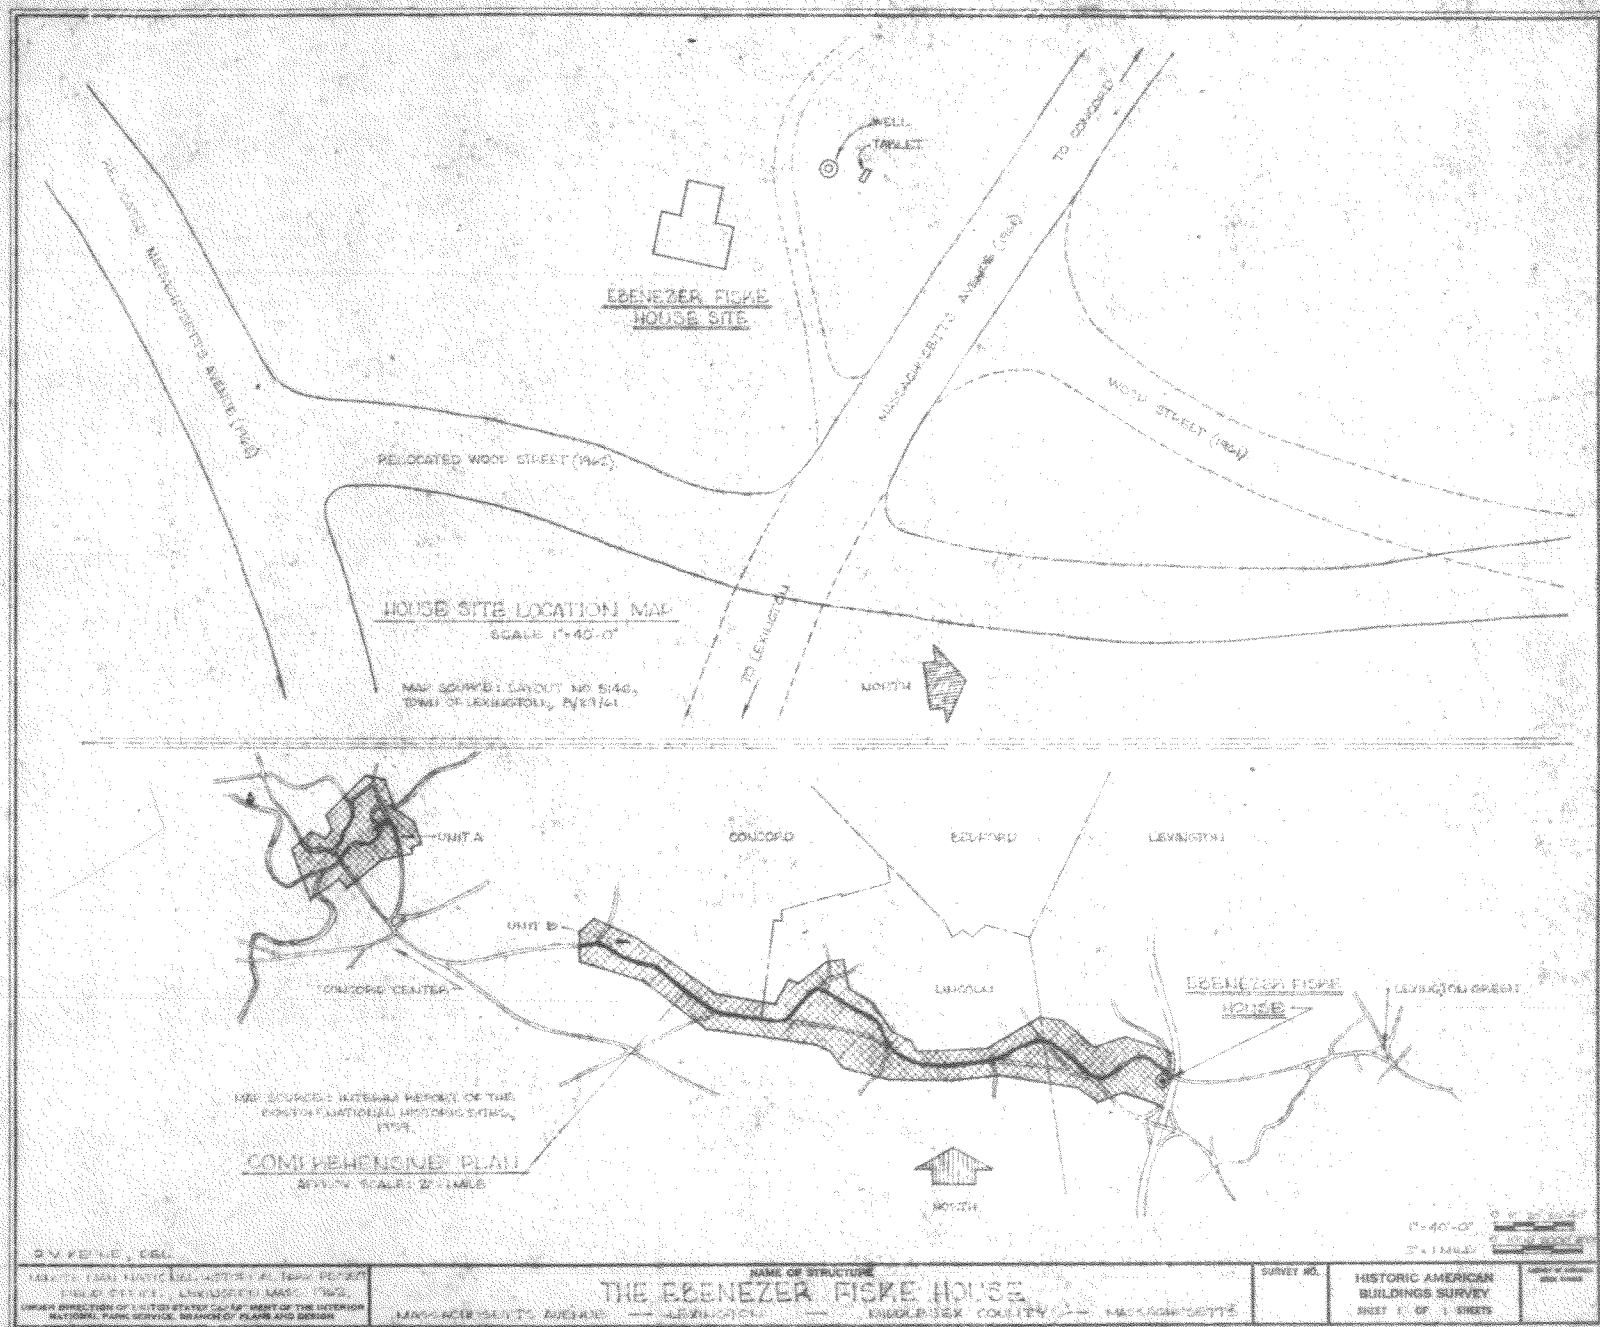
ILLUSTRATION NO. 5

Conjectural Floor Plans

ALL REFERENCES ON PLANS ARE THOSE  
FOUND IN DOCUMENTS SIGHTED ON P. 8

The most valuable documentary evidence brought to light regarding the physical aspects of this house consists of five documents found by Mr. Henshoin. They are: (1) Will of Ebenezer Fiske, February 10, 1777,<sup>7</sup> (2) Inventory, April 14, 1777,<sup>8</sup> (3) Inventory, April 11, 1785,<sup>9</sup> (4) Appraisal of Real Estate of the late Benjamin Fiske, March 27, 1786,<sup>10</sup> and (5) Administratrix Account, November 11, 1794.<sup>11</sup> By piecing together the references to the physical aspects of the house contained in these documents and comparing them with standing examples of structures of similar size, one can begin to develop a semblance of the eighteenth century character of the Ebenezer Fiske House. From information available at this time, it would appear that the Fiske House of 1775 consisted of a two-story wood structure, with a mortise and tenon frame, cellar and garret. It was rectangular in plan with one room to either side of a central brick chimney and had a kitchen all to the rear. The conjectural floor plans were prepared by the author and in no way are intended to serve as a final scheme; they may be revised by information which may become available at a later date (see Illustration No. 5).
