historic structure report

# The Wayside Barn

## Architectural Data Section

MINUTE MAN NATIONAL HISTORICAL PARK / MASSACHUSETTS

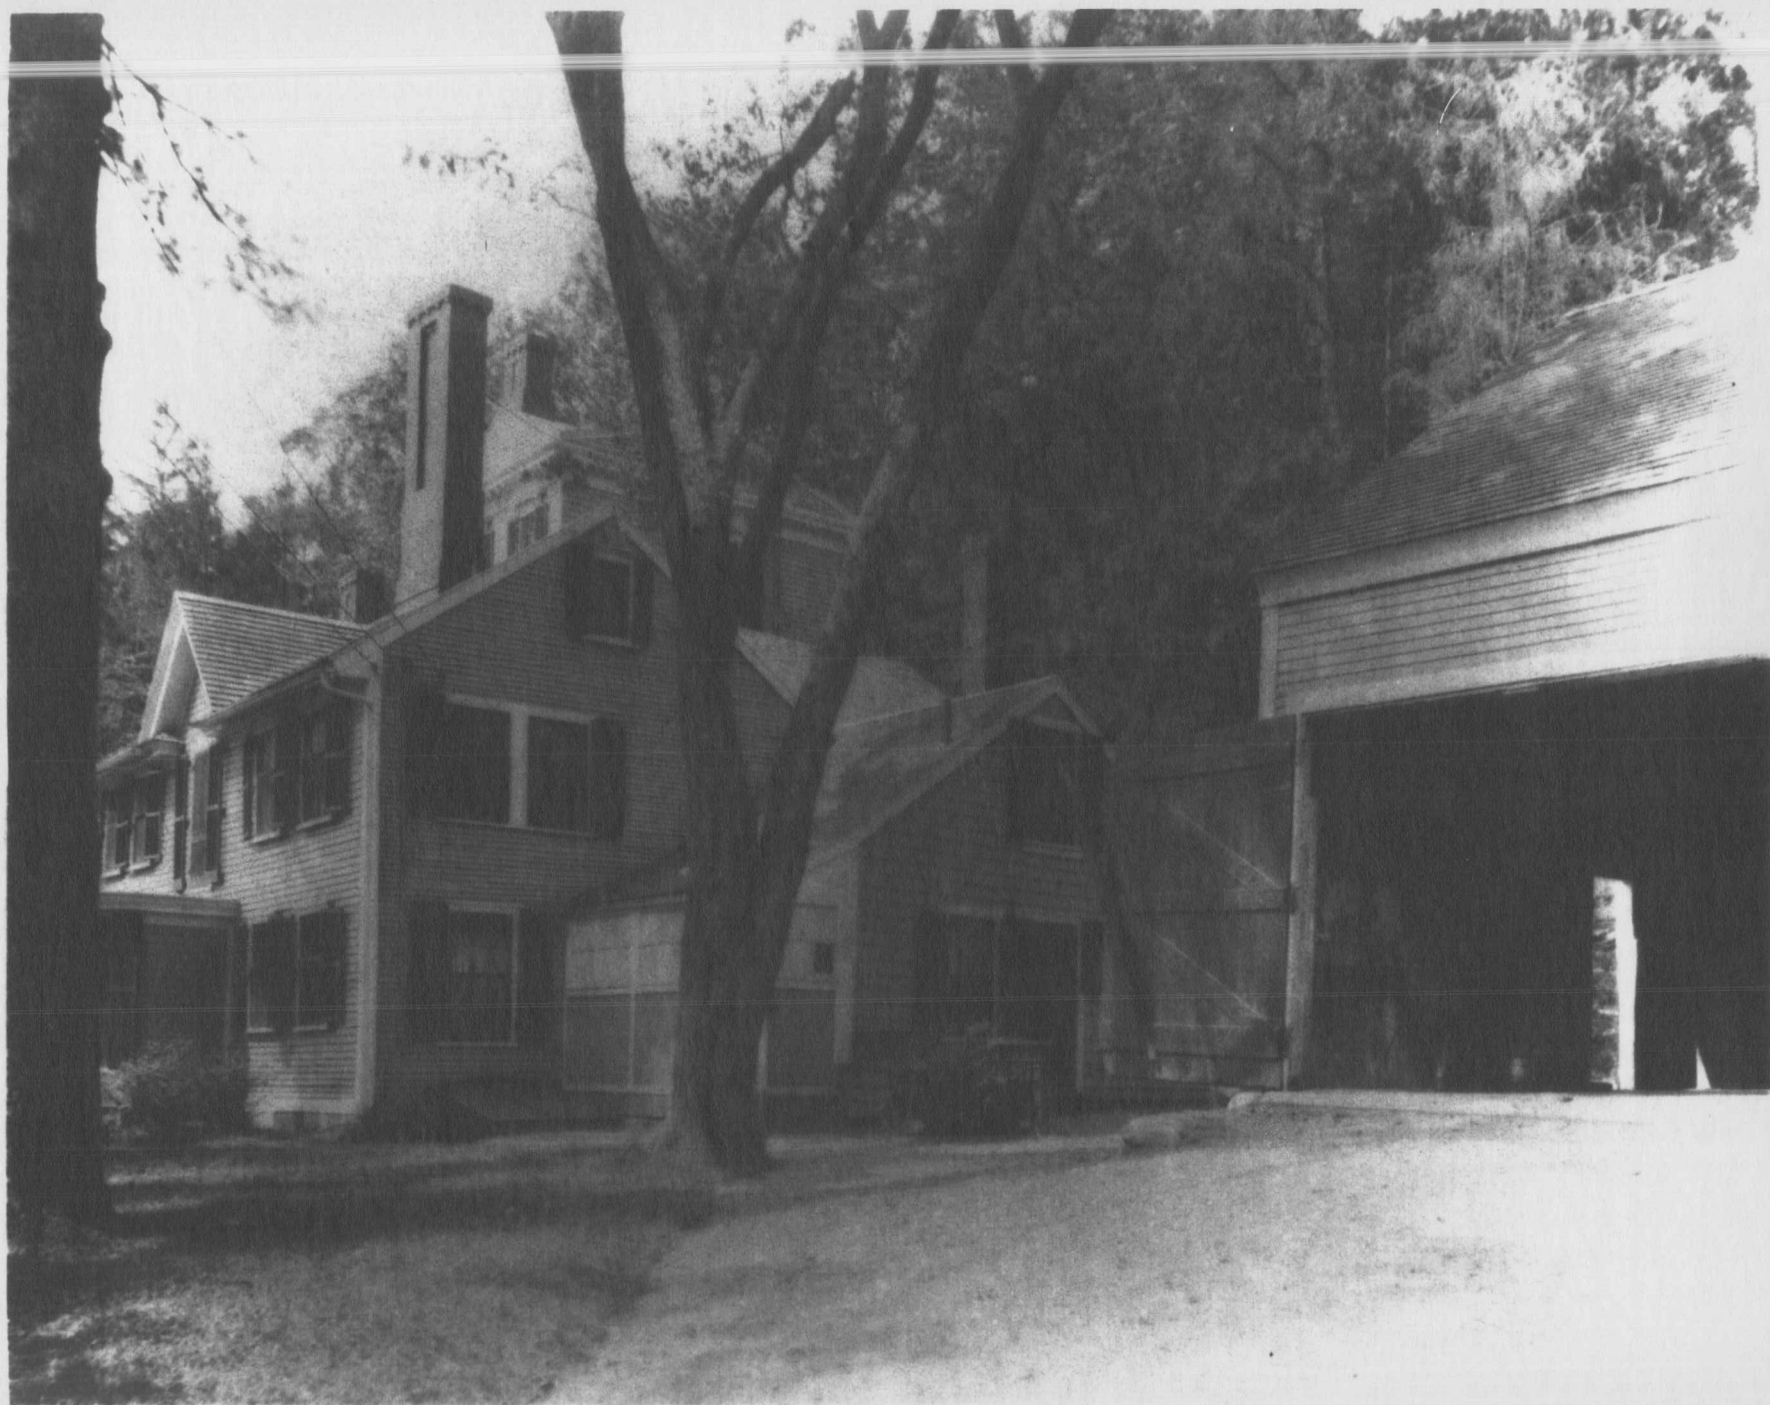
Plate 15.

Contemporary view of the Barn looking northeast before rehabilitation work was started on the structure in 1968. The six over six light double hung sash in the gable end and the single board and batten door below are the only openings in the west wall of the Barn. The west wall of the lean-to has two openings, a double hung window and a vent.

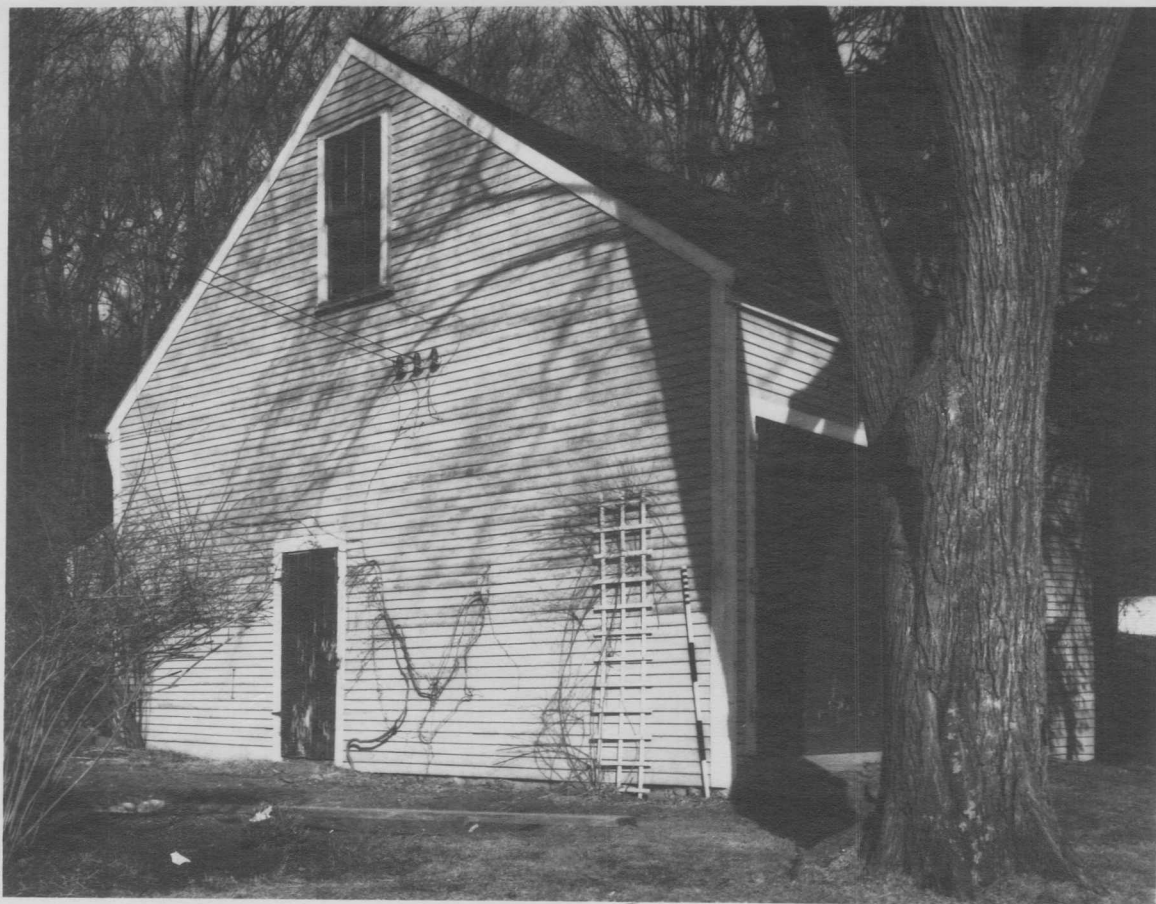
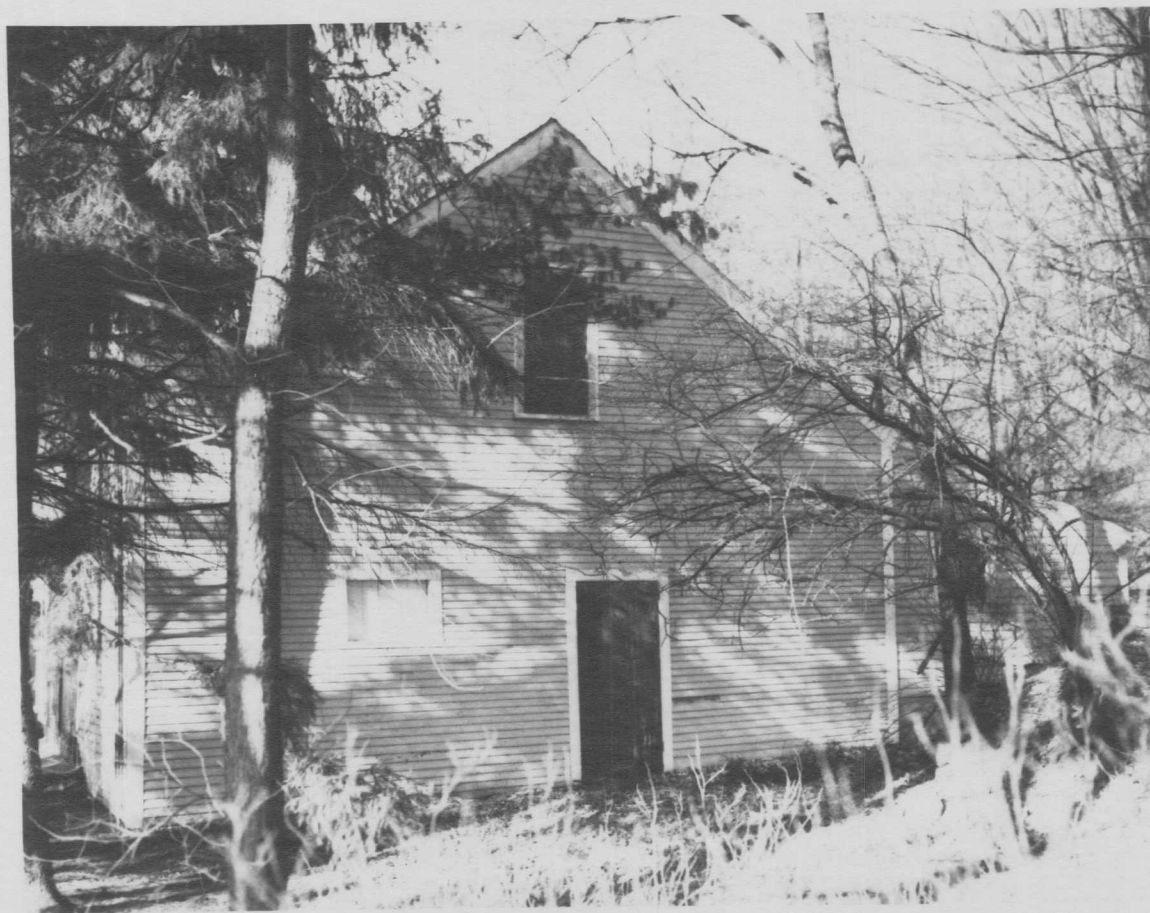
Plate 17.

The Barn and the lean-to as seen from the northwest. The rear portion of the yard has undergone many changes since the Barn was moved to this location in 1860. The lean-to was added to the Barn in the late 1890's or early 1900's.

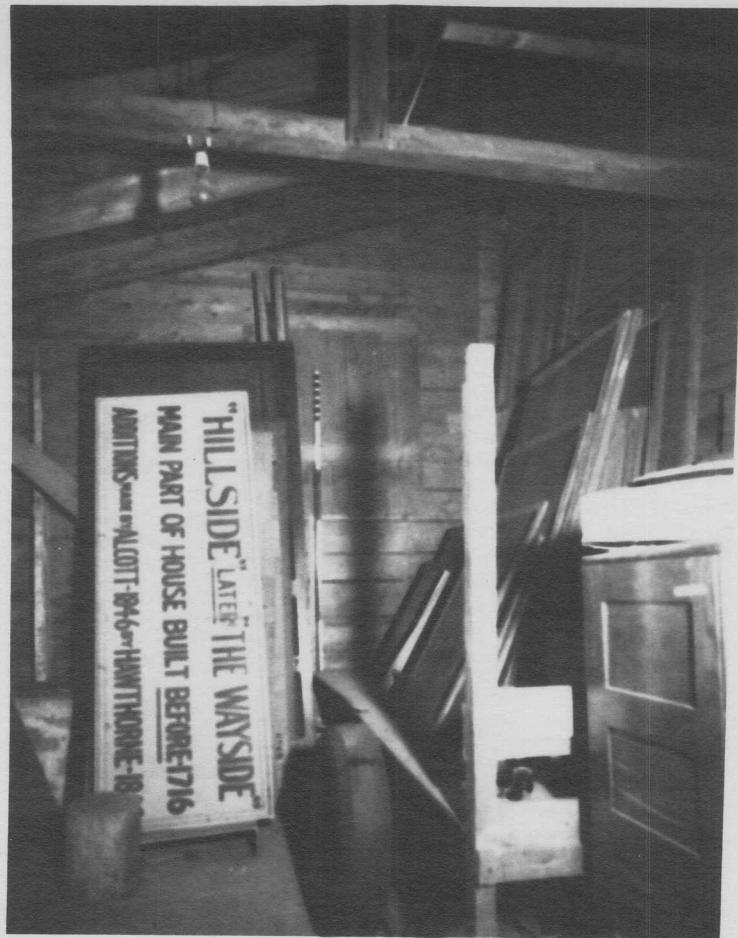
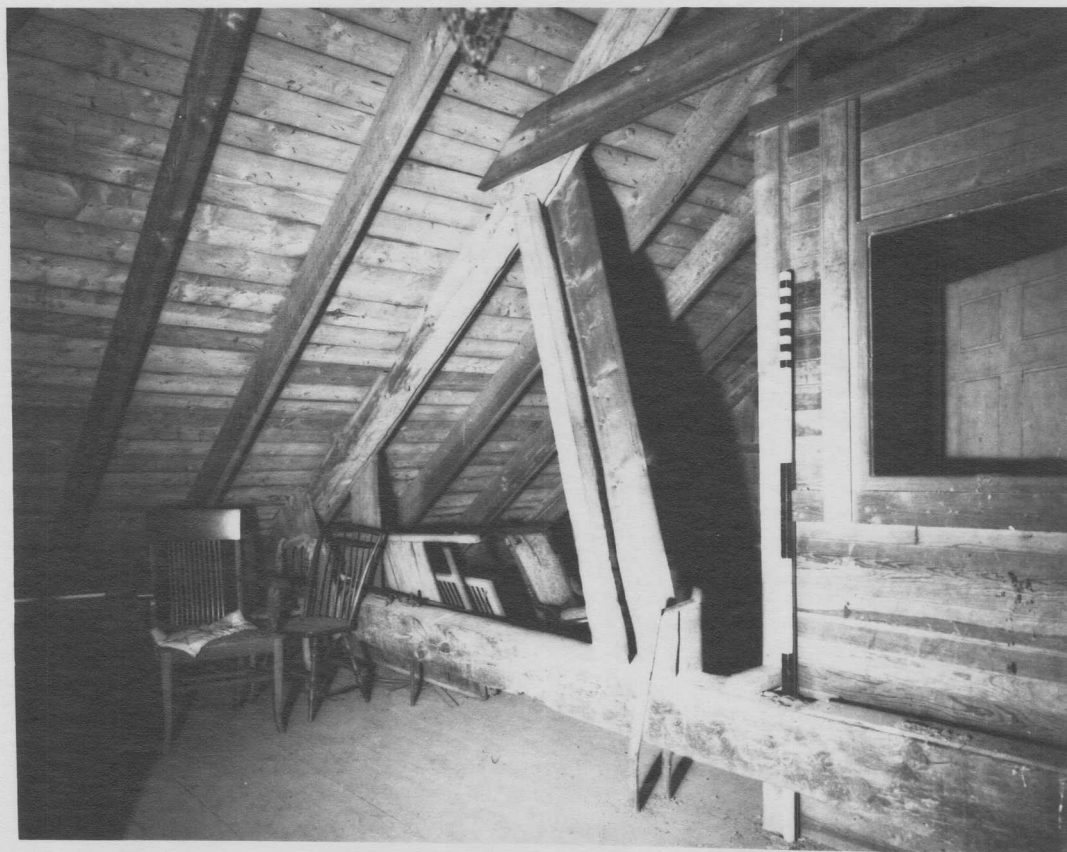
Plate 21.

A view of the west wall of the lean-to after repairs had been started in 1969. Extensive deterioration was encountered in the wall which required immediate repair work prior to painting of prime coat. The west wall of the Barn was rehabilitated at the same time.

Rehabilitation work on The Wayside began in April of 1968 and lasted through August of 1969. During this time, structural repairs were completed to the west wall of the Barn and rear addition to permit the permanent installation of a gas meter and regulator. This was located along the north wall of the Barn near the juncture of the lean-to (see Plate 21).

The northwest corner post of the Barn was found to be hollow. This was repaired by cutting away all but the interior surface of the post and inserting a pressure treated 6" x 6" laminated post in its place.

The laminated pine foundation sill (c. 1914?) at the northwest corner was also found to have rotted. This was replaced in part, along the north and west walls, with similar laminated 8" x 10" pressure treated pieces. A matching sill was placed under the track of the sliding door between the Barn and lean-to. A new concrete patch was required in the floor on both sides of the new sill to replace a previously broken part of the 1914 concrete work.

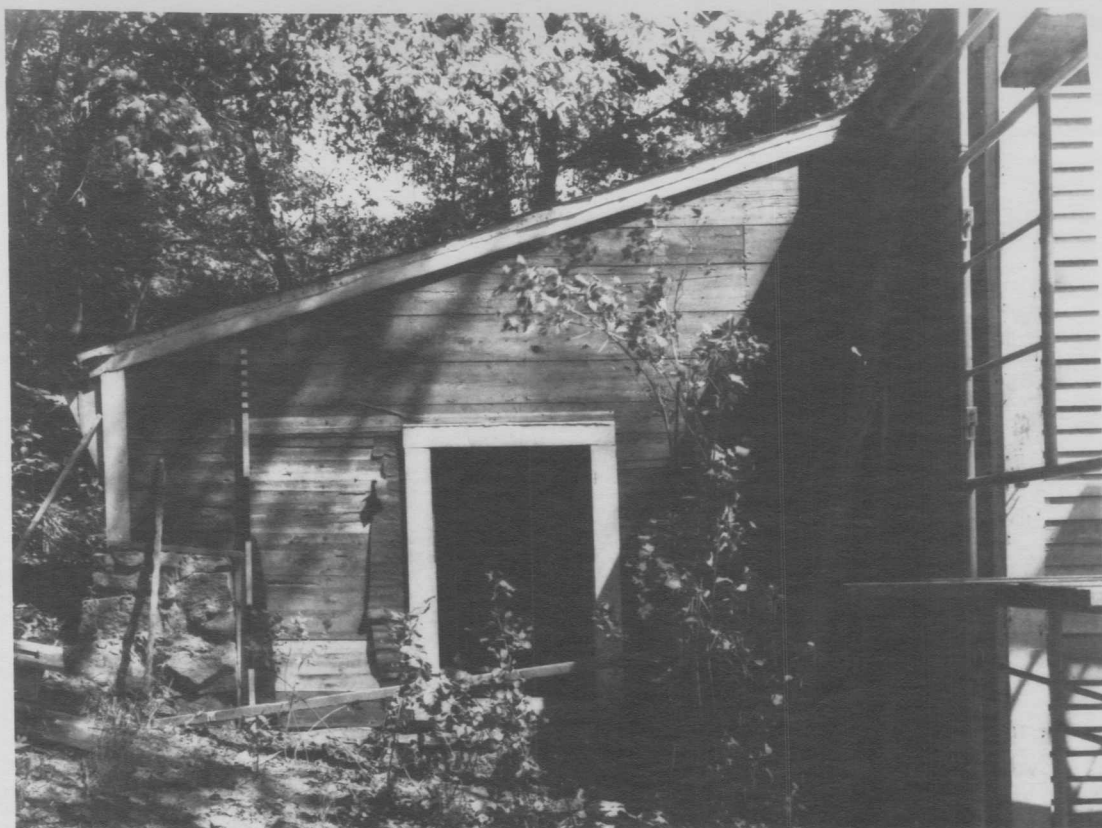
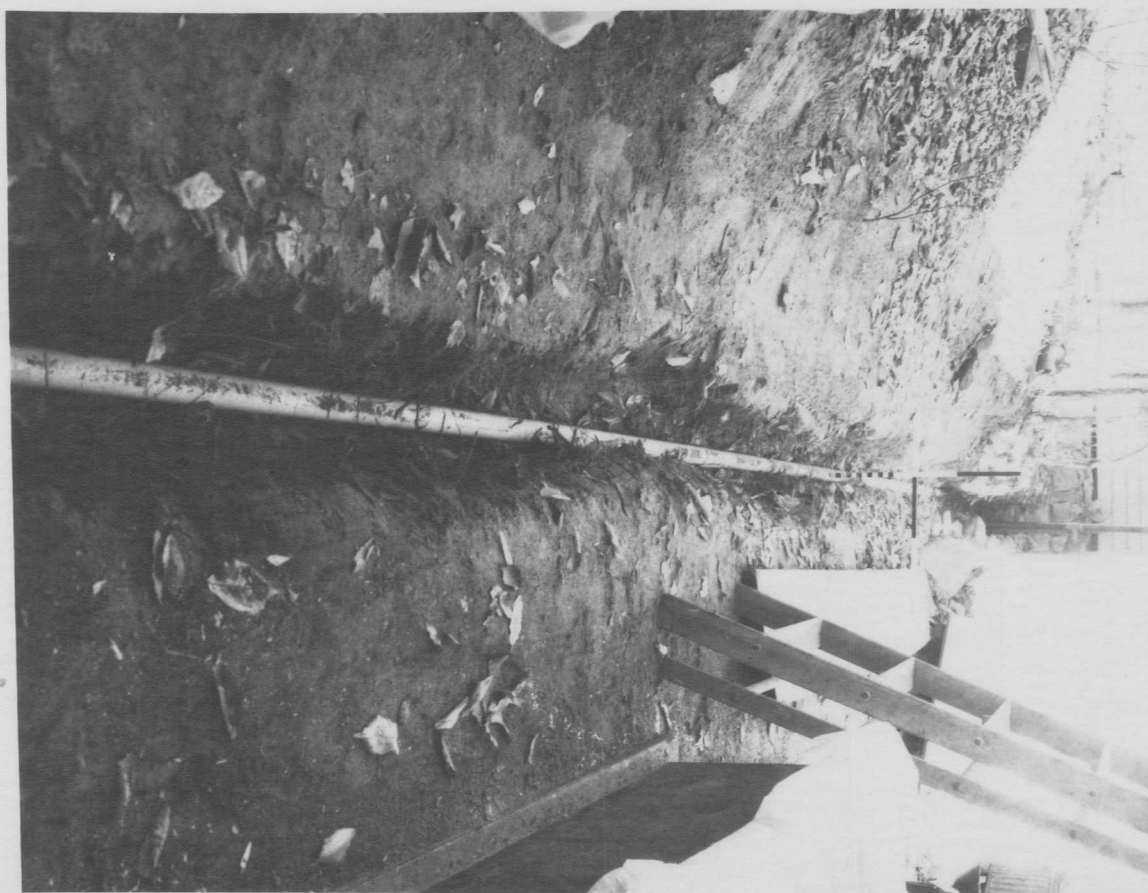
Plate 23.

The west walls of the Barn and the lean-to after repairs and prime coat painting were completed in September of 1969. Project was stopped because of lack of funds. The window sash in the gable end is a new replacement (1969). Note asphalt roof shingles.
