National Park Service  
Cultural Landscapes Inventory  
2001

Kelso Depot  
Mojave National Preserve

Kelso Depot Historic Site  
Mojave National Preserve  
Cultural Landscape Inventory: Level II

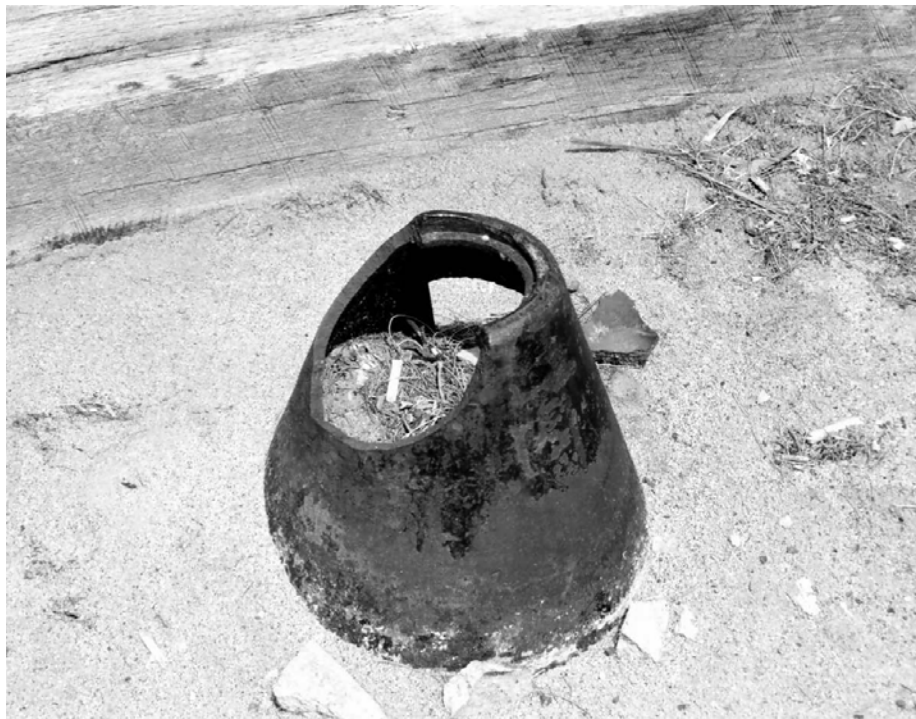
*Archeology #2: Base for lighted signpost. (PGSO, CLI negative #MOJA-N-0005-23, 1999)*

The base of one of the two lighted signposts that once bore a sign reading "KELSO" is located on the west end of the lawn. It consists of a metal cone on a concrete footing. The footing is 16 inches (.41 meters) in diameter and flush with the ground surface. The metal cone sits on top of the 11 inches (.28 meters) high footing. It has a rectangular hole in its side with wires sticking out. Although it is considered an archeological feature at this point, it provides important location information for the illuminated "Kelso" sign, should this sign be located, or a replacement sign fabricated and reinstalled. The same type and vintage sign still exists at Yermo and could be used as a basis to fabricate replacement signs. The sign post base is considered a contributing archeological feature of the site. (see photos, Archeology #2 and Vegetation #12)

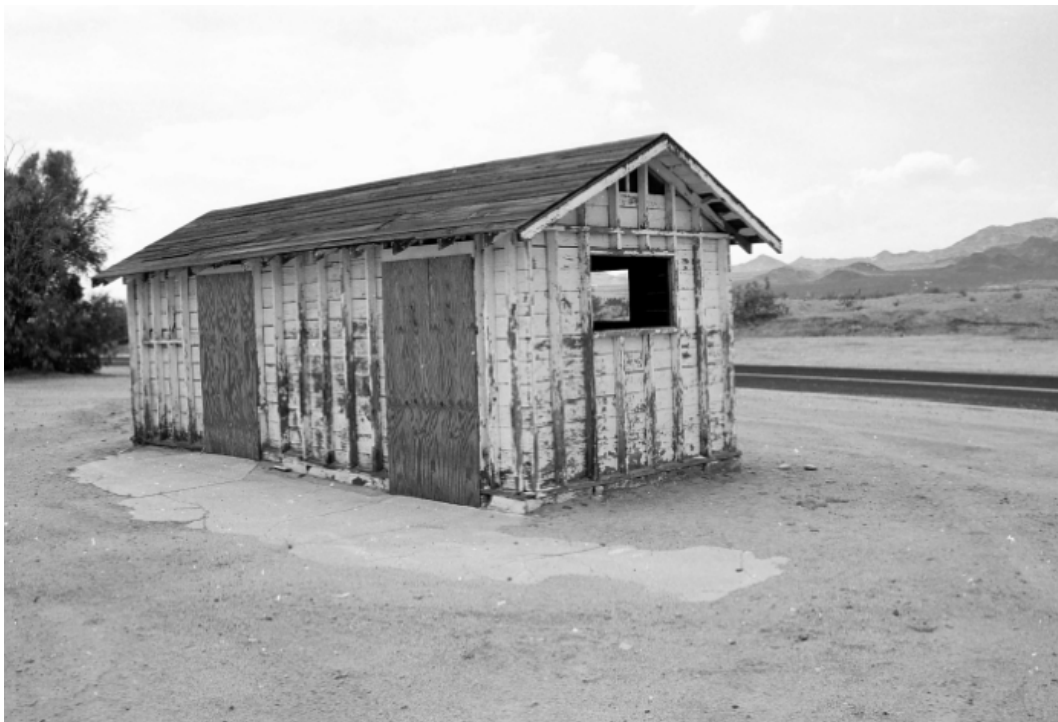
*Buildings and Structures #3: Coal Shed and concrete walkway, looking west. (PGSO, CLI negative #MOJA-N-0005-21, 1999)*

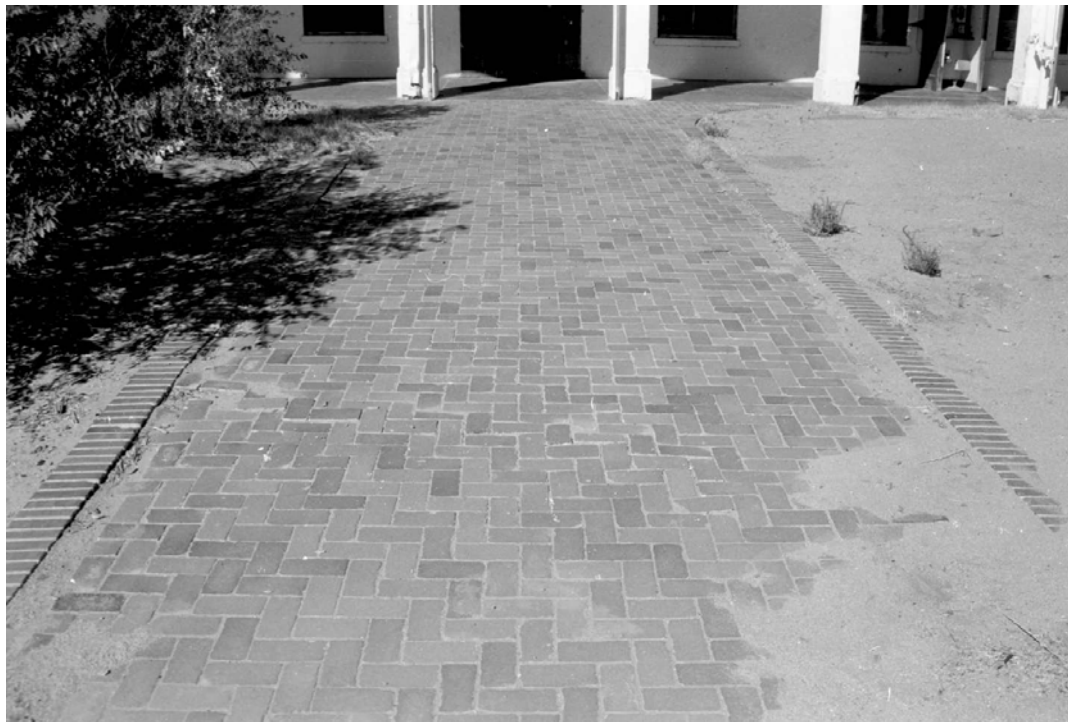
Circulation #4: Herringbone pattern on brick walkway, looking north. (PGSO, CLI negative #MOJA-N-0010-22, 1999)

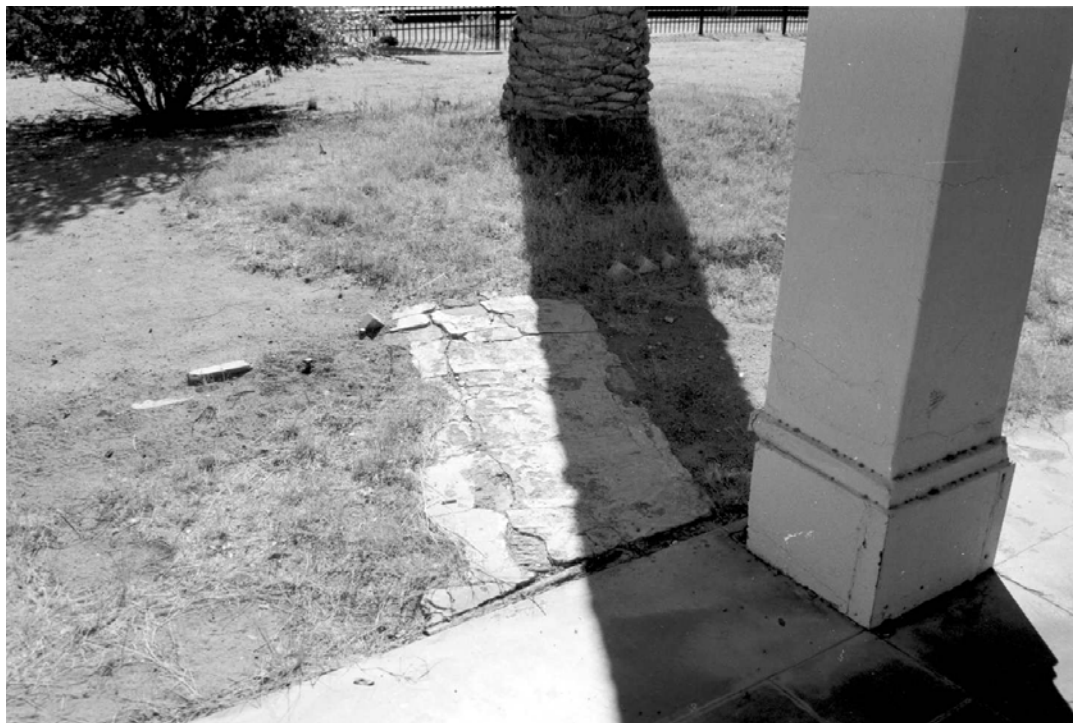
*Circulation #7: Concrete walkway, looking south. (PGSO, CLI negative #MOJA-N-0009-05, 1999)*

Two small concrete walkways angle off the arcade to provide access to the central lawn areas on the south side of the depot. No historic documentation has been found that dates the construction of these features, however it is highly likely that they were built during the period of significance. The brick sawtooth borders, which were installed in the 1940's, have gaps where these paths provided access to the lawn areas from the arcade. Photos from the period of significance show gaps in hedging where these paths occurred, indicating that some sort of access from the arcade to the lawn was present. (see photo, Circulation #7)

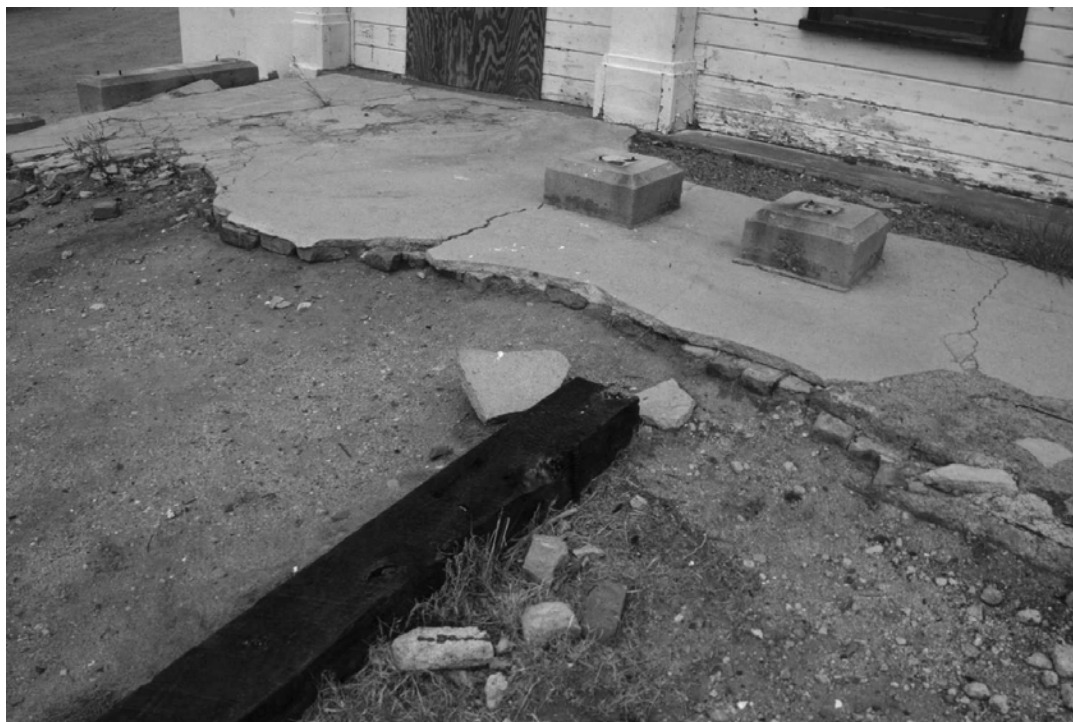
*Circulation #8: Concrete walkway, west side of depot, looking east. (PGSO, CLI slide #MOJA-S-0002-22, 1999)*

A concrete walkway on the west side of the depot was laid over a brick substrate which may be an earlier configuration of this feature, however no documentation was found indicating when the sidewalk was constructed. It may have provided a paved surface for baggage handling and passenger access from a drop-off area to the west to the arcade and station platform area to the south; or it may have been installed as a base for the fire escape formerly located there. (see photo, Circulation #8) Further research should be conducted to evaluate its historic significance prior to any action.

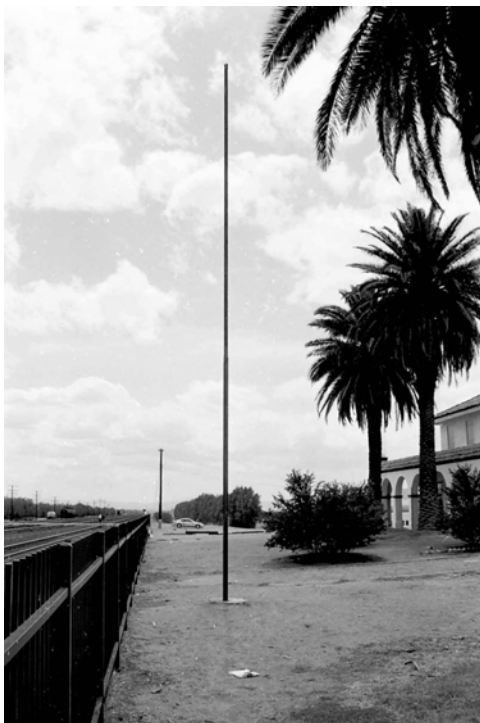
*Small Scale Features #4: Flagpole and metal fence, looking west. (PGSO, CLI negative #MOJA-N-0005-18, 1999)*

The flagpole is located forty-five feet (13.77 meters) south of the depot and fifteen feet (4.57 meters) east of the eastern brick walkway. The flagpole consists of two round metal cylinders, each appears to be approximately twelve feet (3.66 meters) long, stacked one on top of the other. It sits on a twenty-three inch (.6 meter) square concrete foundation. The flagpole does not appear in any historic photos dating into the 1960s and appears to have been erected after the period of significance. Until other evidence is found, the flagpole does not appear to be a contributing feature of the historic site.

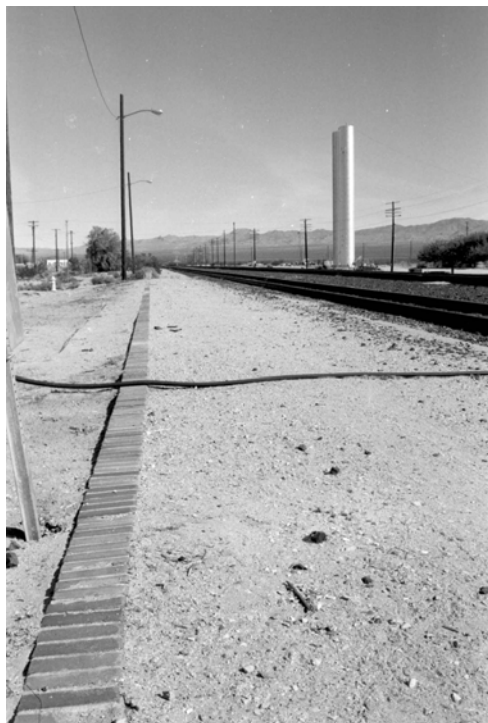
*Small Scale Features #6: Line of mortared bricks and platform remnant, looking east. (PGSO, CLI negative #MOJA-N-0005-14, 1999)*

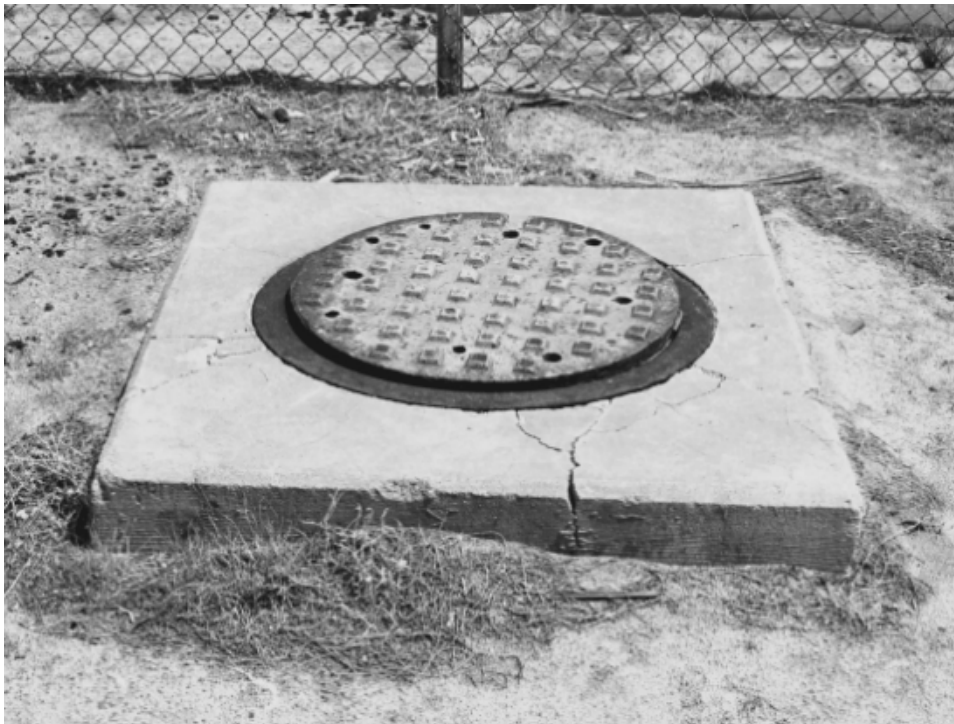
*Small Scale Features #7: Concrete shaft with manhole cover. (PGSO, CLI negative #MOJA-N-0005-25, 1999)*
