National Park Service
Cultural Landscapes Inventory
2004

Mowich Lake Entrance Road
Mount Rainier National Park

MANAGEMENT CATEGORY: **Should be preserved and maintained**

CONDITION ASSESSMENT: **Good**

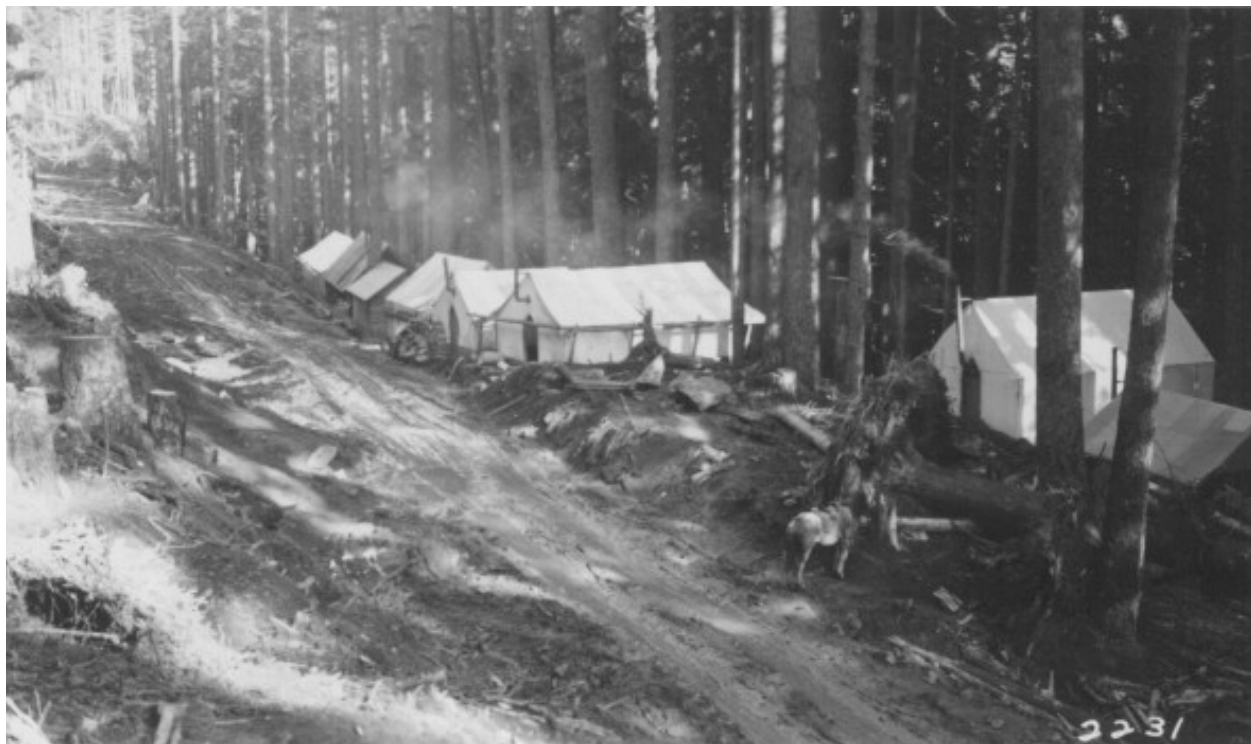
Historic photograph showing a campsite for construction workers located along road during its clearing and grubbing stage, c. 1928. (MORA Archives, ps 2231)

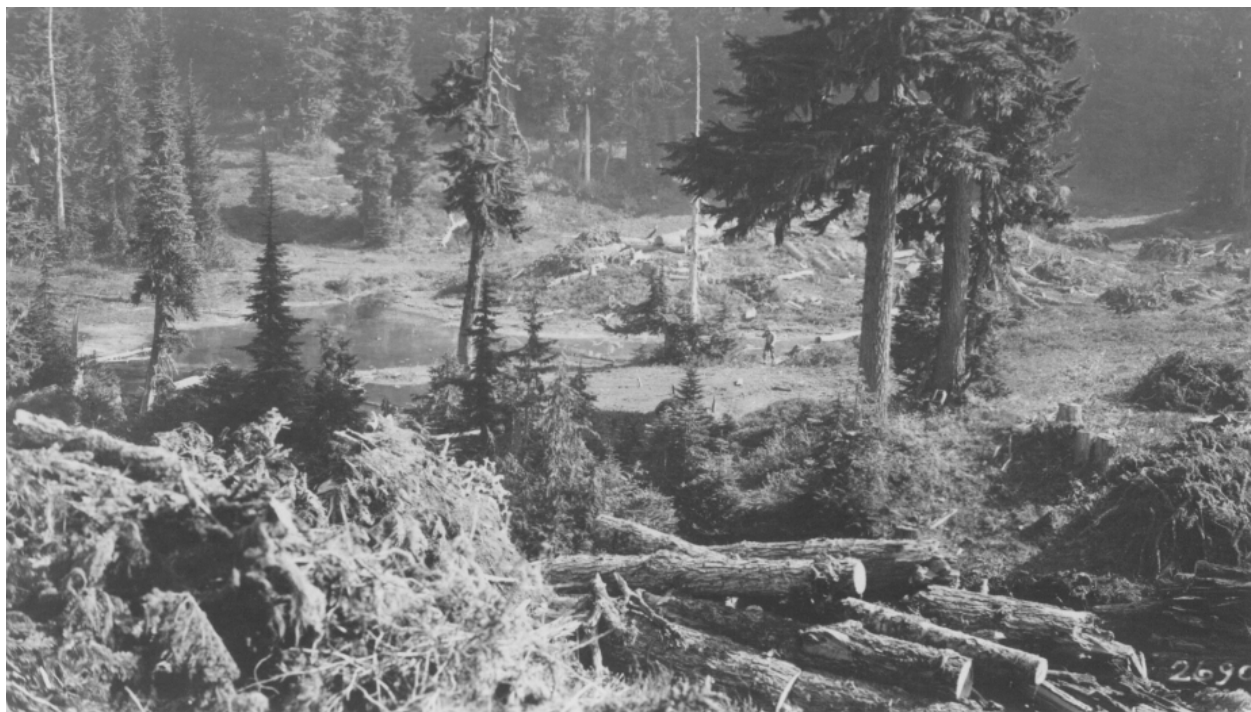
Historic photograph showing the road's terminus at the lake during its clearing and grubbing stage, c. 1928. (MORA Archives, ps 2690)

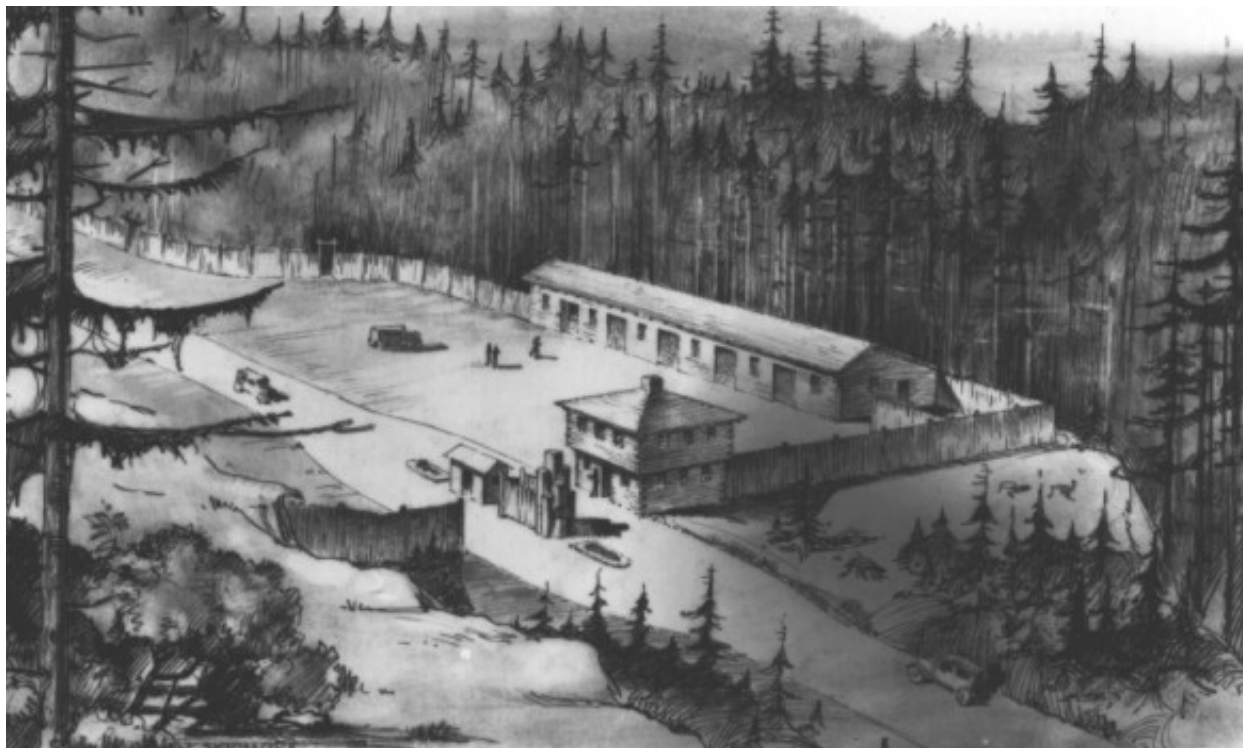
Historic architectural rendering showing a Hudson's Bay-styled fort in honor of William Fraser Tolmie, planned as an official entrance into the northwest portion of the park in the early 1930s. (Courtesy Carl Fabiani))

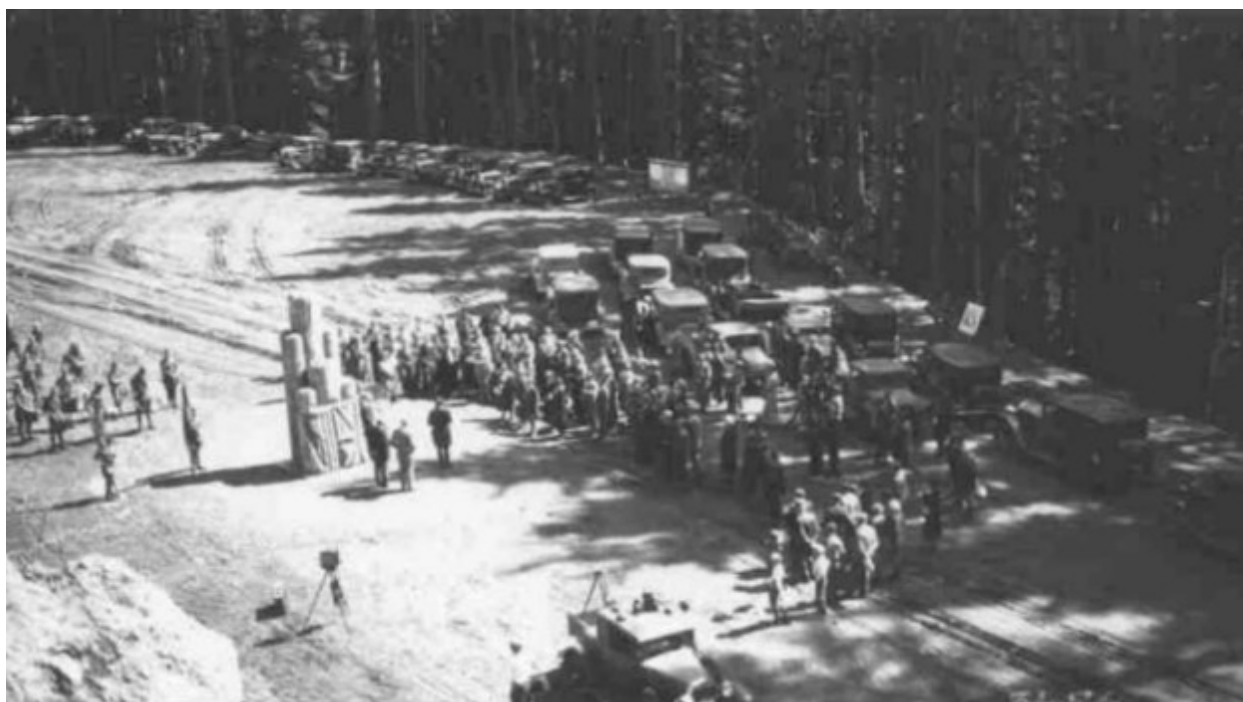
Historic photograph showing the Paul Peak Entrance Station dedicated in honor William Fraser Tolmie in 1933. Note the wood pylon monument and graded parking area. (MORA Archives 3656 SF, Box 5)

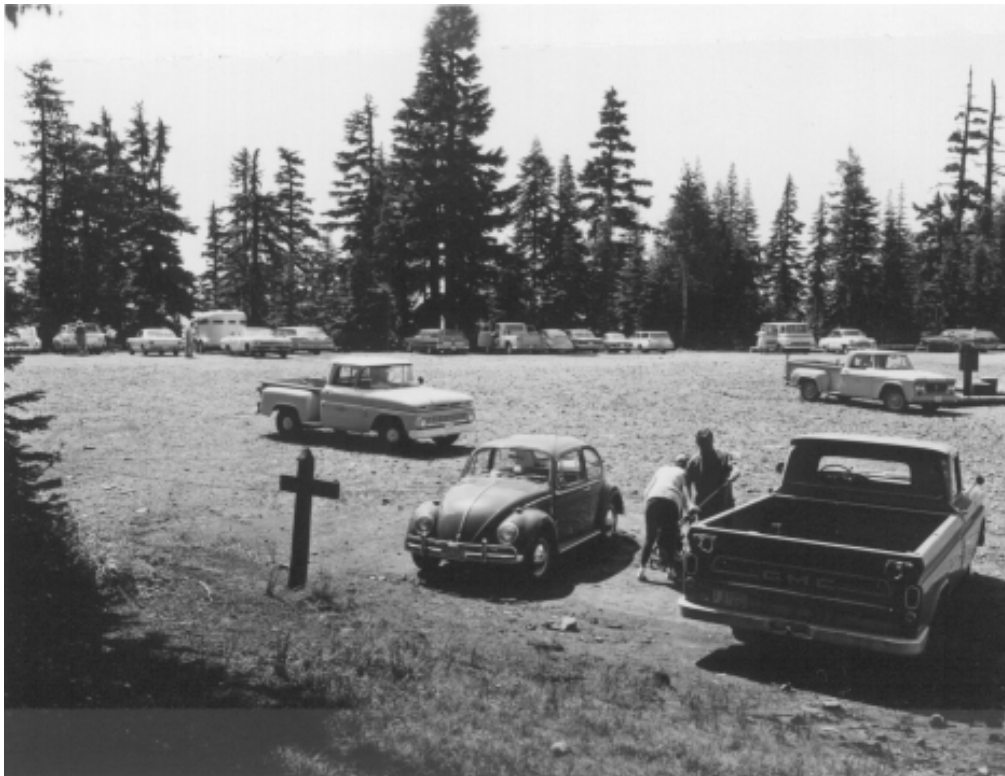
Historic photograph taken in the early 1960s indicates parking was designated at the terminus of the Mowich Lake Entrance Road, east of Crater Creek. (MORA Archives, ps collection))

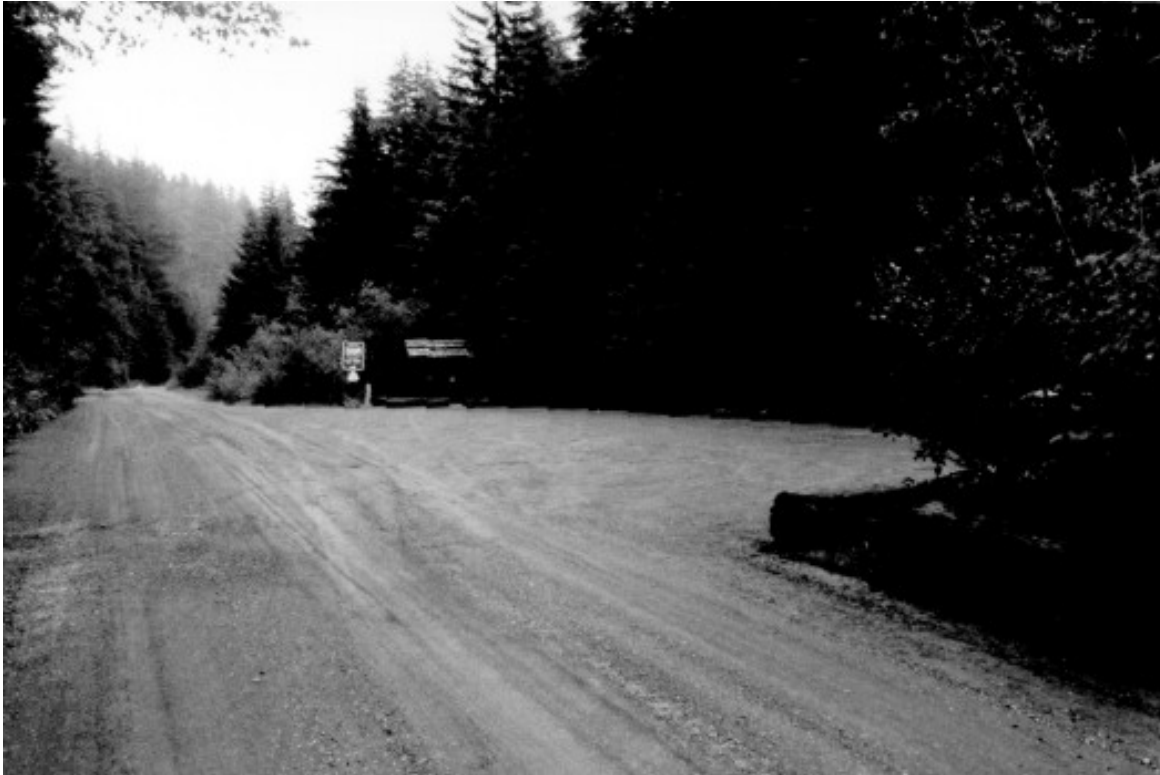
Contemporary photograph showing that some of the area cleared and graded during the 1920s and 1930s has revegetated at the Paul Peak Entrance Station. (CCSO 2001)

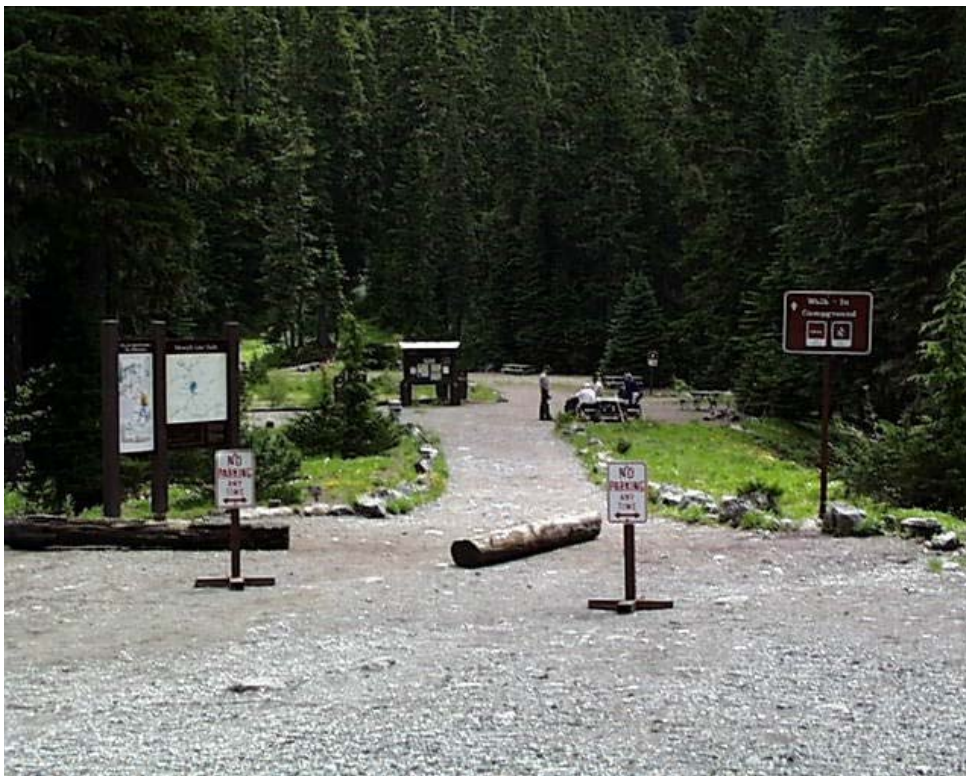
Contemporary photograph showing entrance to the Mowich Lake Campground. (CCSO, 2001)

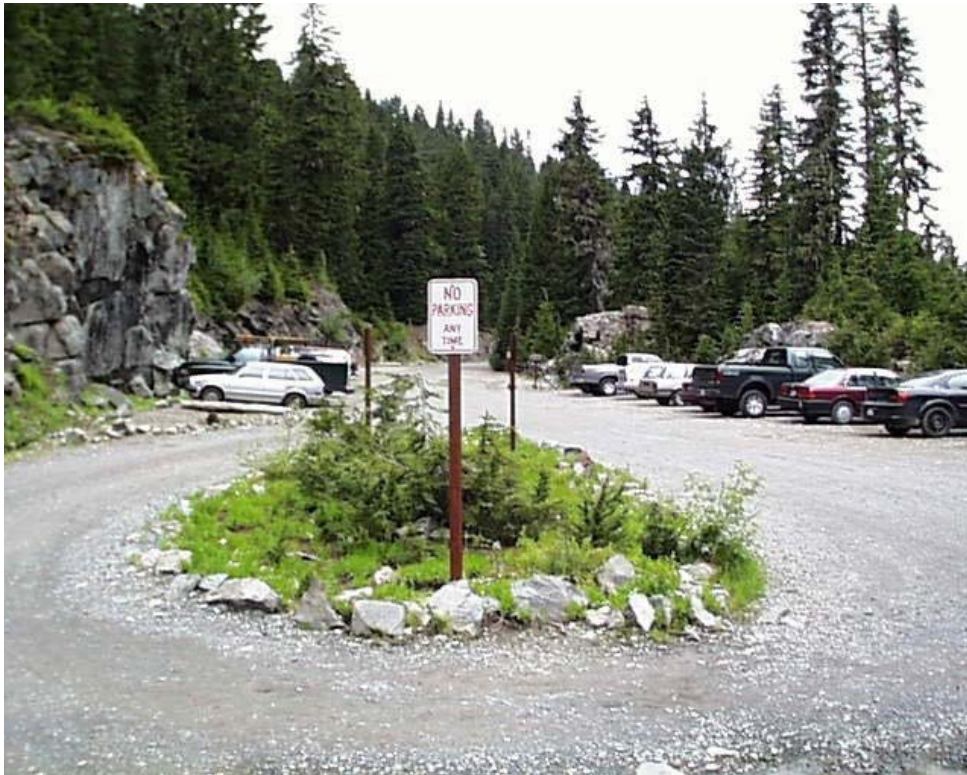
Contemporary photograph of the Mowich Lake parking lot and turnaround. (CCSO, 2001)

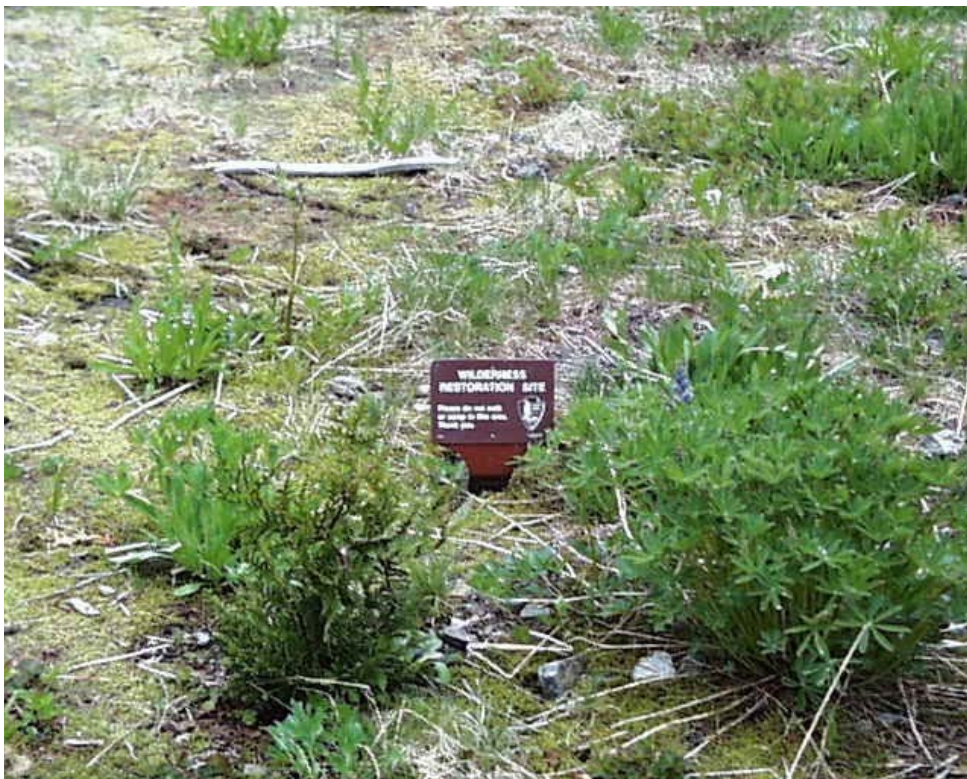
Contemporary photograph showing a Mowich Lake revegetation sign. (CCSO, 2001)

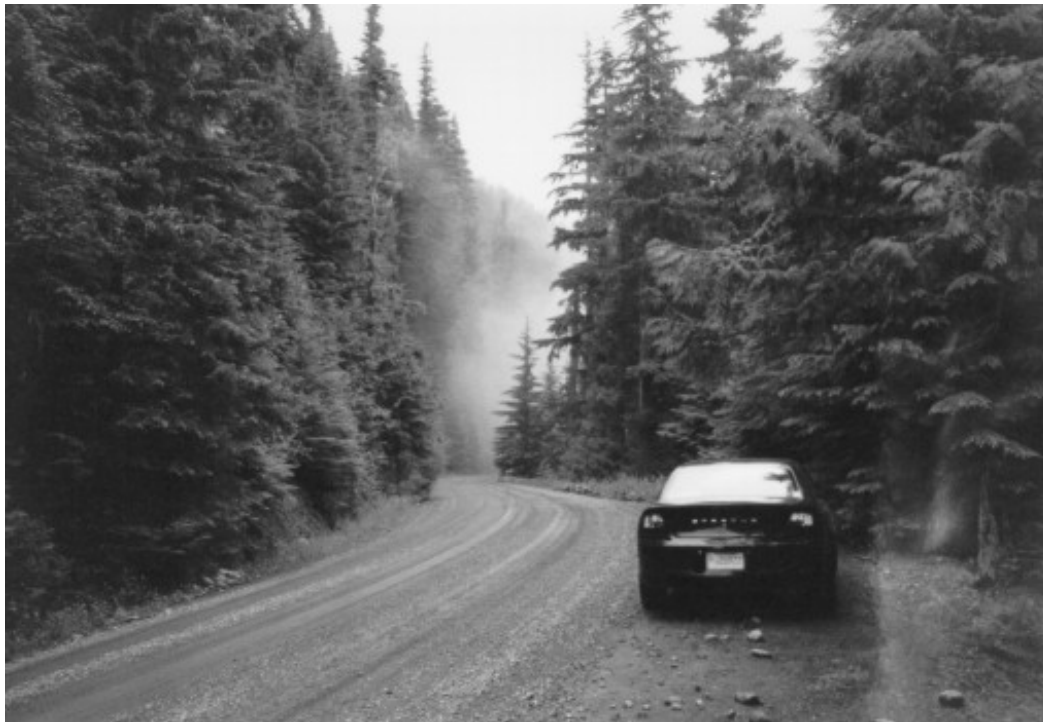
The roadbed is currently surfaced with a thin layer of gravel. At the entrance, the layer of gravel is approximately ¼" thick with bare spots due to wear along the tire tracks. After 2.3 miles, the amount of gravel increases, but is mostly swept to one side of the road and the tire tracks are still bare. At four points along the road, there are short segments (1/5 mile or less) of washboarded surface.

Contemporary photograph of a typical pullout on the Mowich Lake Entrance Road. The circulation conditions that exist today are almost identical to those during the period of significance. (CCSO 2001)

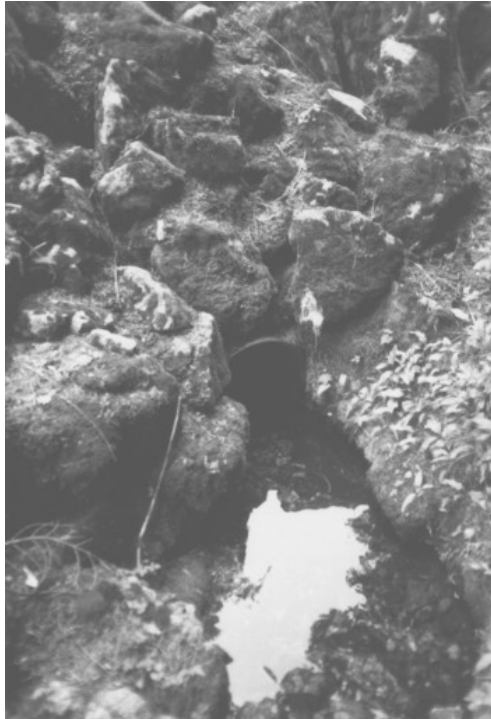
Forty-nine culverts are located along the approximately 6 mile-long road, indicative of the heavy rain flows on the west-side of the mountain. 39 of these culverts are original. Built from 1928 to 1935, these culverts reflect the naturalistic-style of that era. Each culvert is constructed with a carefully fitted, mortared stone headwall on the uphill cut-side of the road and a loosely stacked stone headwall on the downhill fill-side of the road. The stonework masks an 18" concrete or corrugated steel pipe inside. The headwalls are generally 5-6' wide and 3' high, constructed with three horizontal layers of cut stones. The majority of the original culverts along the road fit this description with two interesting exceptions.

Contemporary photograph showing a typical culvert outfall. Note that the pipe is covered by loosely piled rock. All original culverts on the Mowich Lake Entrance Road have outlets such as this one. (CCSO 2001)

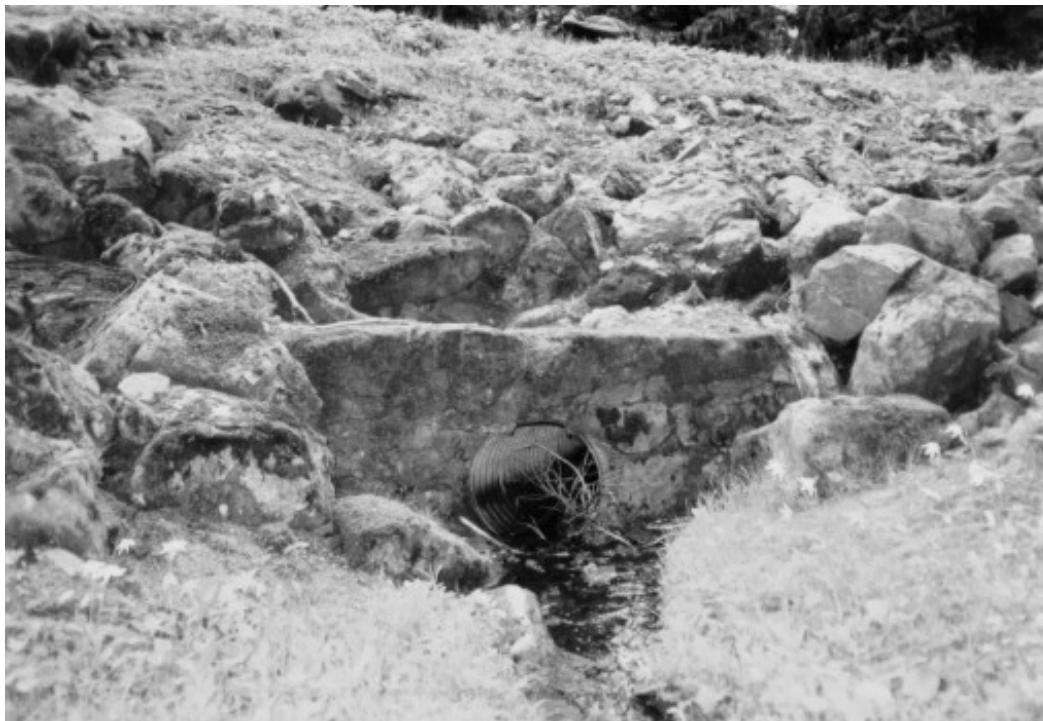
Contemporary photograph showing a typical culvert inlet. Note that the pipe is surrounded by a mortared stone headwall. All original culverts on the Mowich Lake Entrance Road have inlets such as this one. (CCSO 2001)

- (2) Uncover weep holes at base of wall at the road grade by digging away debris with a shovel.
- (3) Repair one culvert stone headwall at the 5.25-mile mark along the road. Some of the cut stones have fallen off and need to be re-mortared into place.

Allow 1 day for a skilled mason to repair culvert headwall. Approximately \$200.00

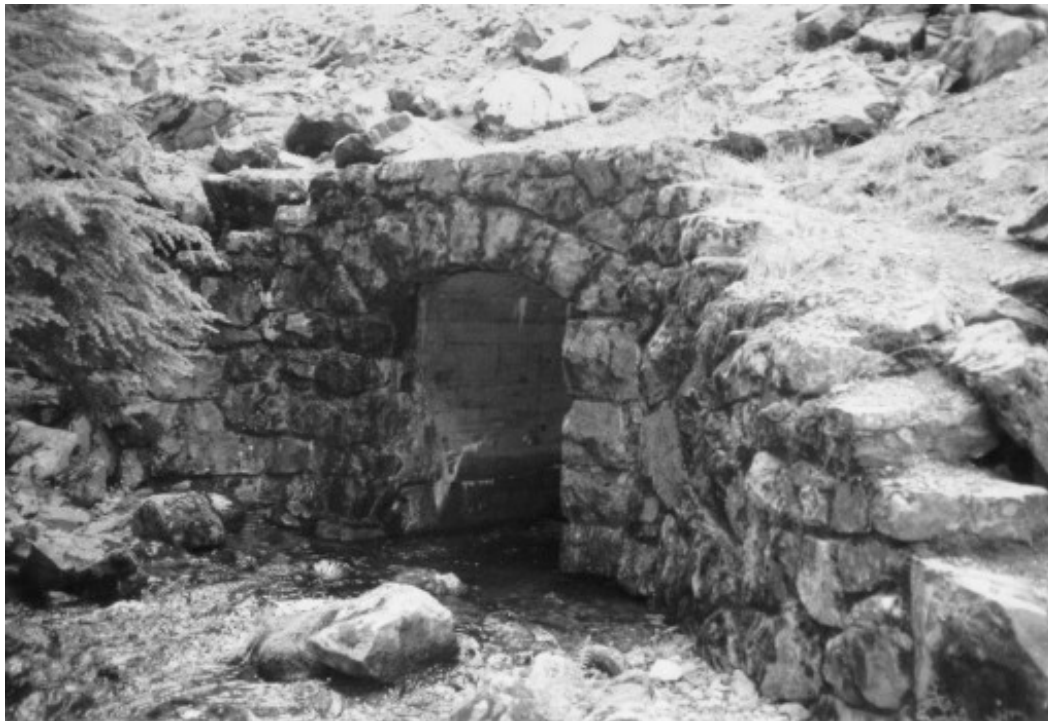
The other exceptional culvert is located near the campground. This is an extremely large reinforced concrete box culvert with a 10' high headwall, built to allow Crater Creek to flow under the roadbed. The culvert's concrete opening measures 6' high and 4' wide to allow water debris flow. The roadbed is raised as a superelevation an additional 10' above the headwall. Unlike the typical pattern seen in the culverts found along the road, this culvert was constructed with mortared stonework method on both ends.

Contemporary photo of Crater Creek stone culvert located at Mowich Lake campground. (CCSO 2001)

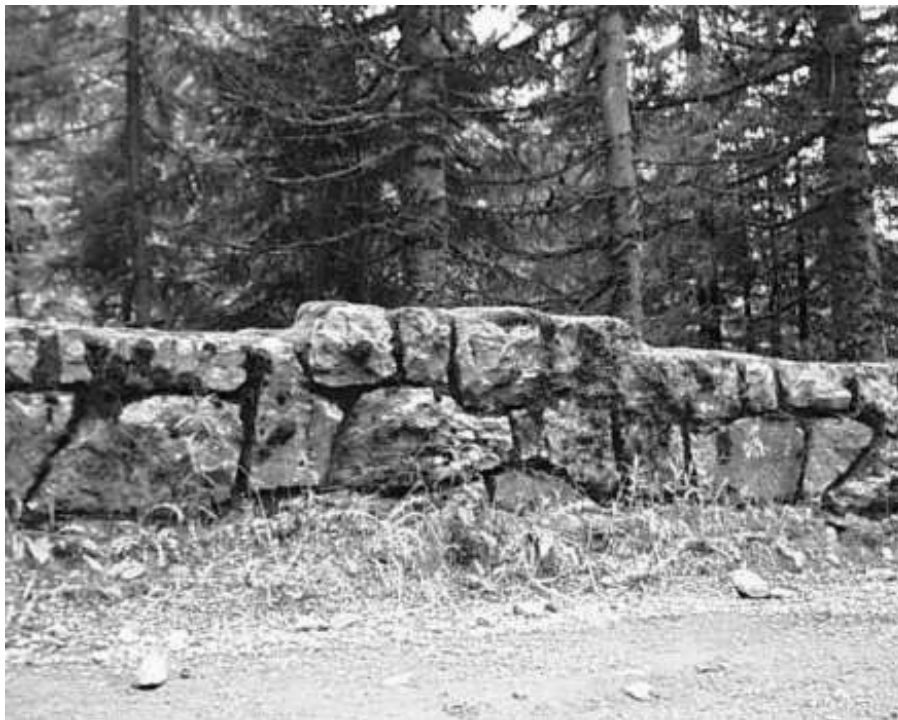
Contemporary photo of guardwall showing crenellation detail. (CCSO 2001)

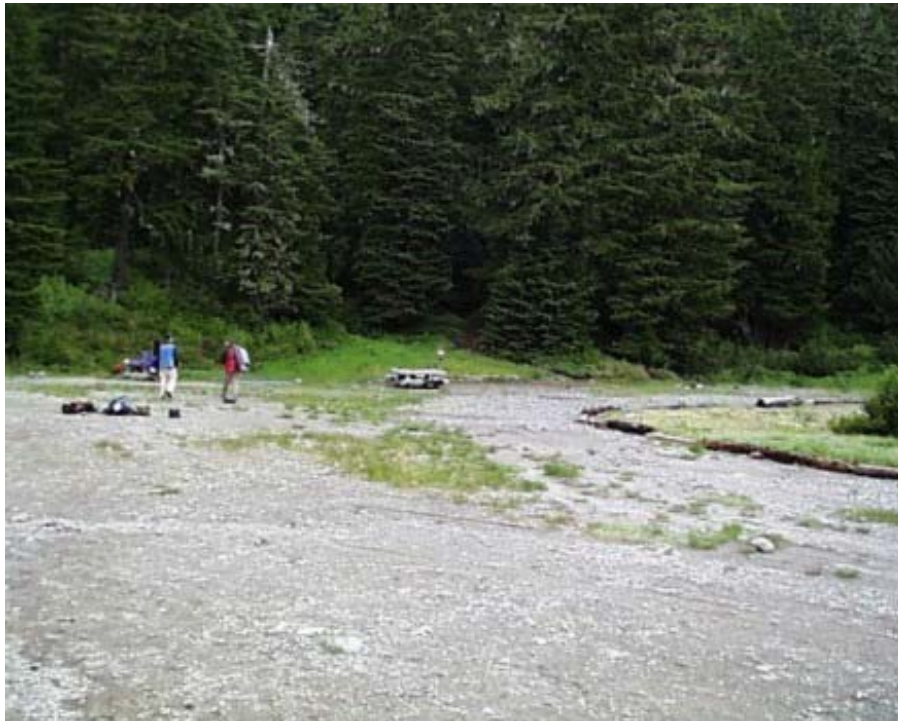
Contemporary photograph showing the terminus of the road, east of Crater Creek. The parking lot has been converted for use as the walk-in campground. (CCSO 2001)

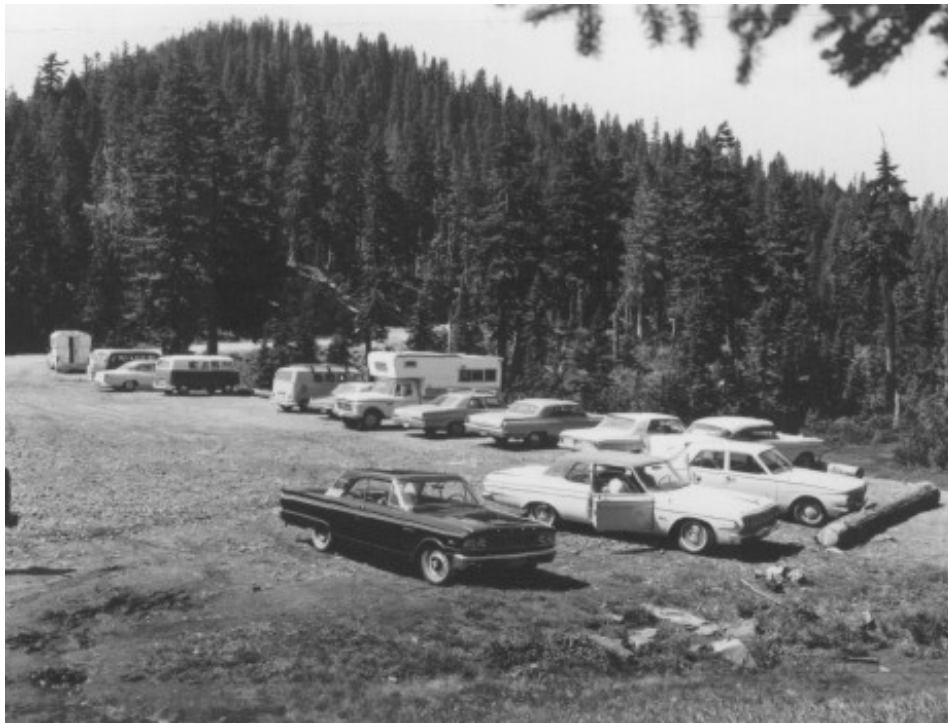
Historic photograph taken in the early 1960s indicates parking was designated at the terminus of the Mowich Lake Entrance Road, east of Crater Creek. (MORA Archives, is 807)

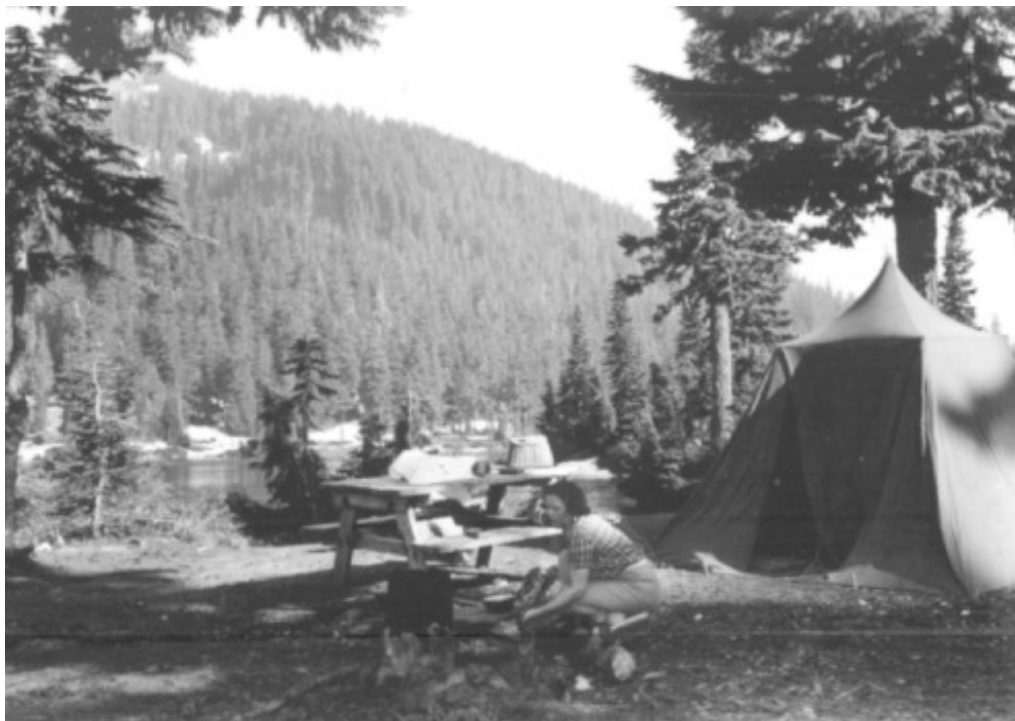
Historic photograph taken during the Mission 66 era indicates camping along the lakeshore was made possible for park visitors arriving by car. (MORA Archives, is 681)

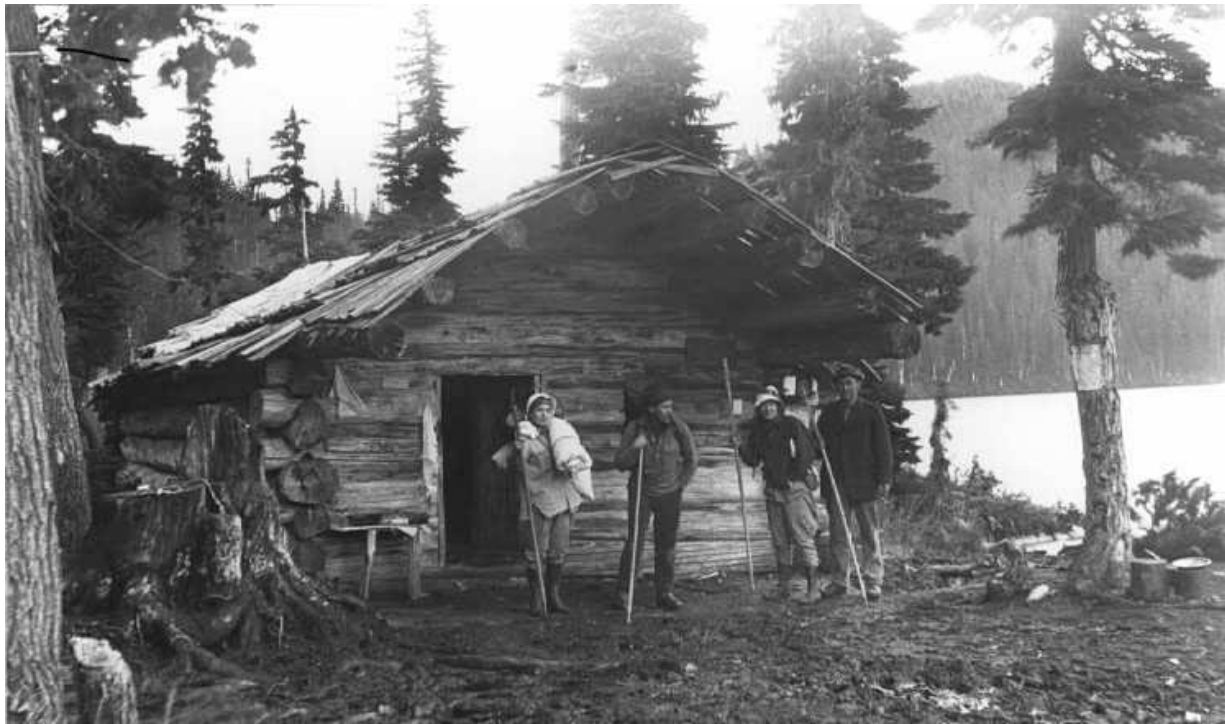
Historic photograph of shelter cabin located at the terminus of the Grindstone Trail constructed in the c. 1883 (Fabiani 2001). The cabin no longer exists. (Photo courtesy of Carl Fabiani)
