National Park Service
Cultural Landscapes Inventory
2004

Narada Falls
Mount Rainier National Park

**National Park Service
Cultural Landscape Inventory
1998**

**Narada Falls
Mount Rainier National Park**

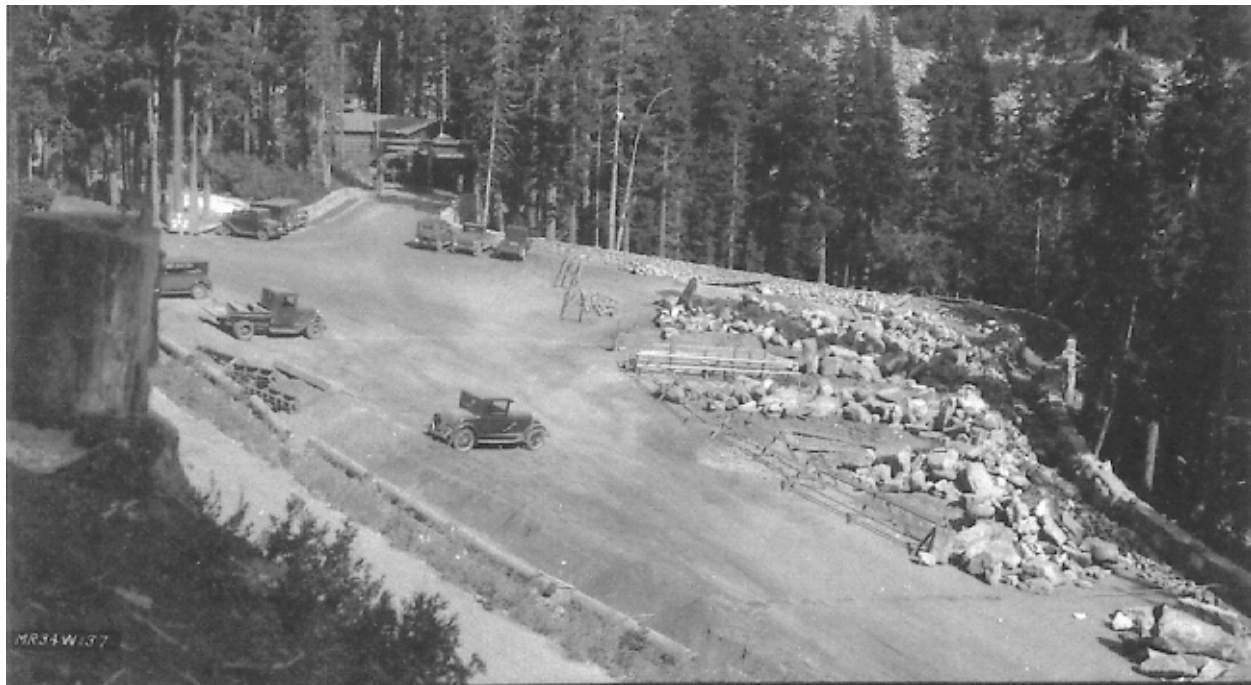
Historic photograph of the Narada Falls parking area, under expansion by the CCC in 1934. Note the stock-piled rubble, for the construction of a guardwall; and the temporary ECW camp across the bridge in the distance. MORA, photo file, neg. 4019.

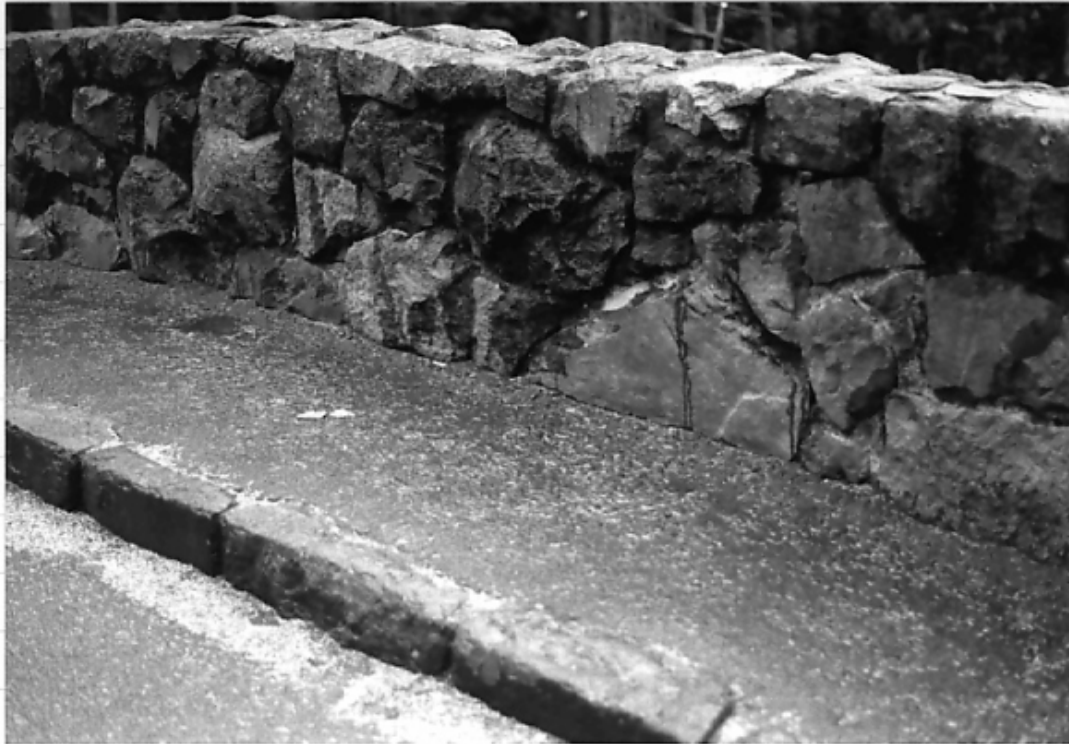
Contemporary photograph of the stone curbing and bituminous sidewalk on the Narada Falls bridge. CCSO, 1994.

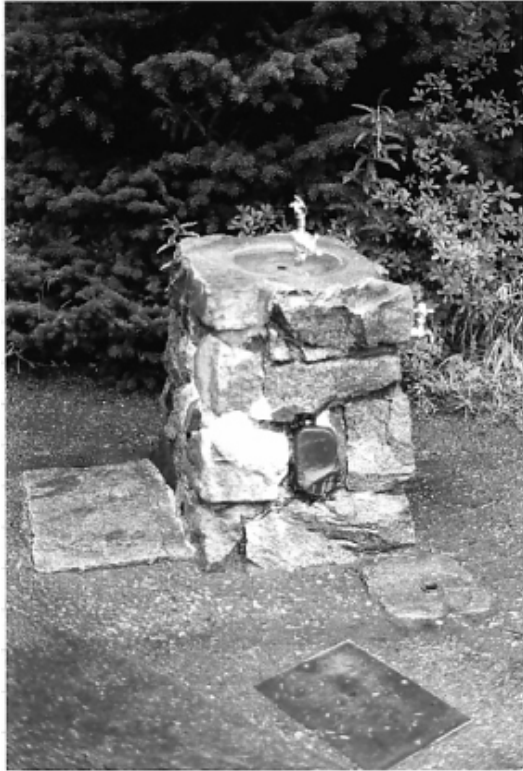
Contemporary photograph of the rustic stone drinking fountain built by the CCC at Narada Falls. The fountain is located at one side of the parking area. CCSO, 1994.

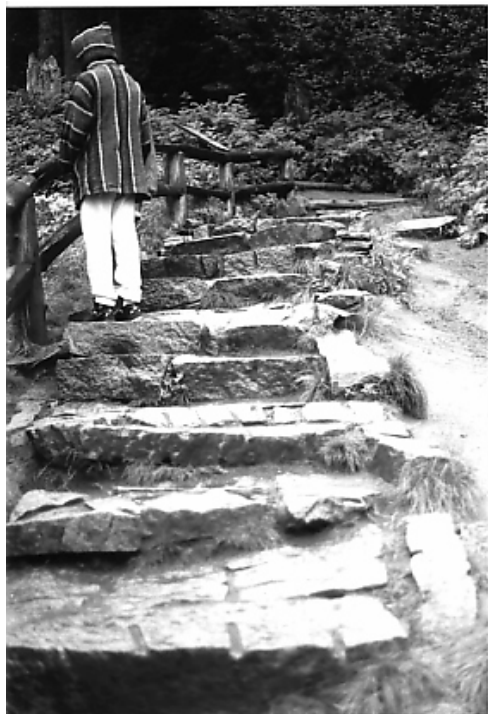
Contemporary photograph of the stone steps at the scenic overlook, created by the CCC in the 1930s. (CCSO, 1994.)

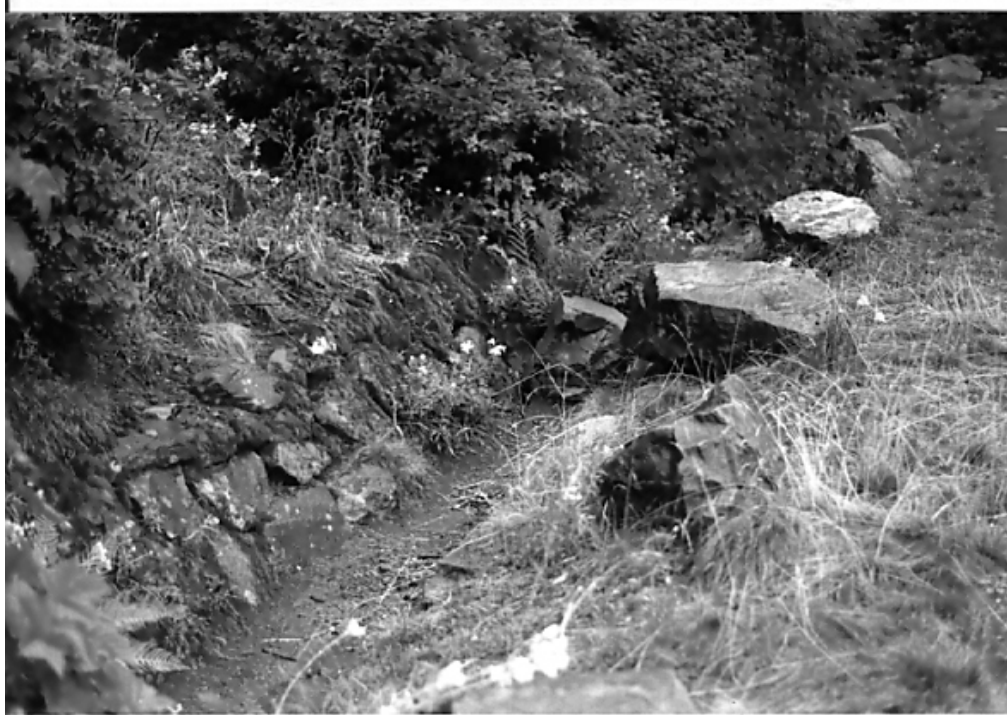
Contemporary photograph of culvert within island plant bed in parking area. (CCSO, 1994.)

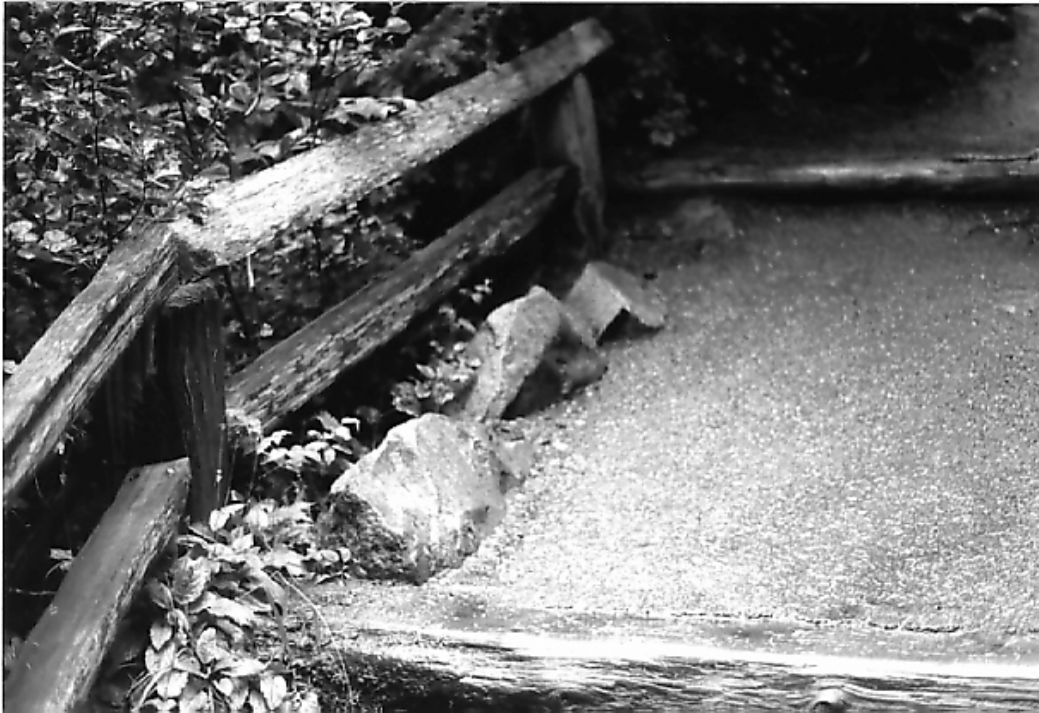
Contemporary photograph of wooden handrail at scenic overlook area. (CCSO, 1994.)

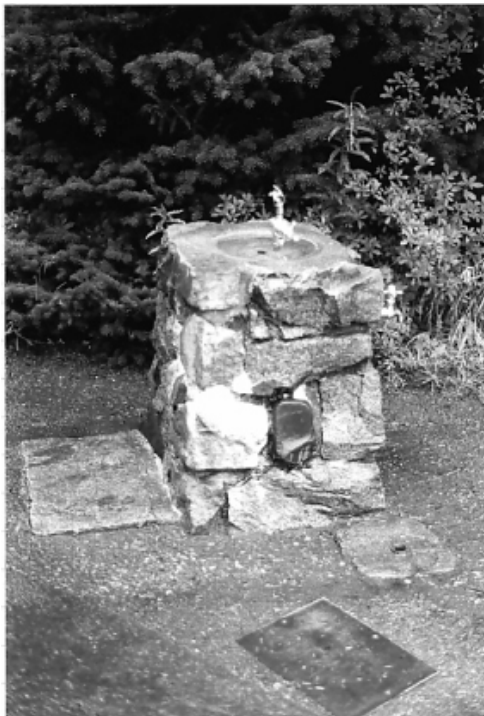
Contemporary photograph of the stone-faced drinking fountain in the parking area at Narada Falls.
