# Paradise Camp

## Archaeology in the Paradise Developed Area

Mount Rainier National Park

February 2008

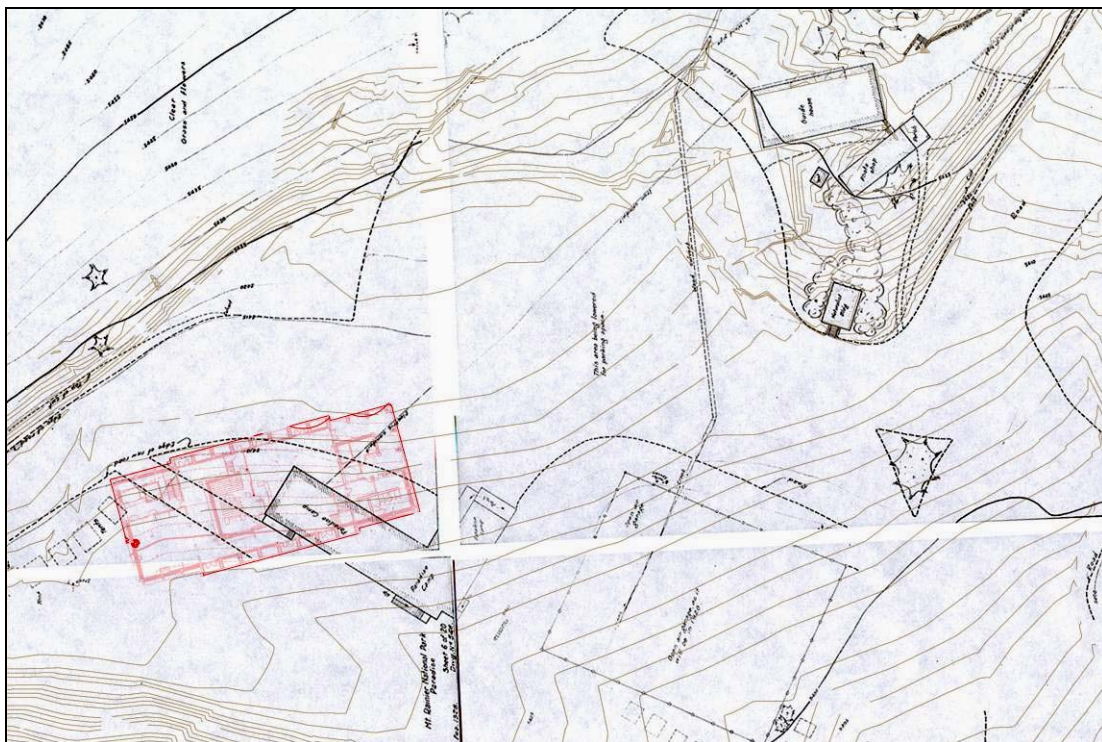
**Figure 16. Jackson Visitor Center (Red) and Paradise Camp Lodge (as mapped in 1928).**

The near-proximity of the new Jackson Visitor Center to the site of the original Paradise Camp Lodge (later Tatoosh Club) was understood early in the planning process. Indeed, the desire to recreate some of the area's historic landscape figured significantly in the decision to build the visitor center in that place. By overlaying construction plans atop historic maps (e.g., Figure 9), Larry Beal with the NPS Denver Service Center, was the first to observe the direct overlap of the two buildings. To more accurately estimate the extent of the overlap, we used Global Information System (GIS) technology to geo-reference a 1928 topographic survey of the eastern Paradise Developed Area against plan maps for the new visitor center. Figure 16 shows the result; suggesting that a significant portion of the 1925 Paradise Camp lodging addition was situated directly beneath the new construction footprint.

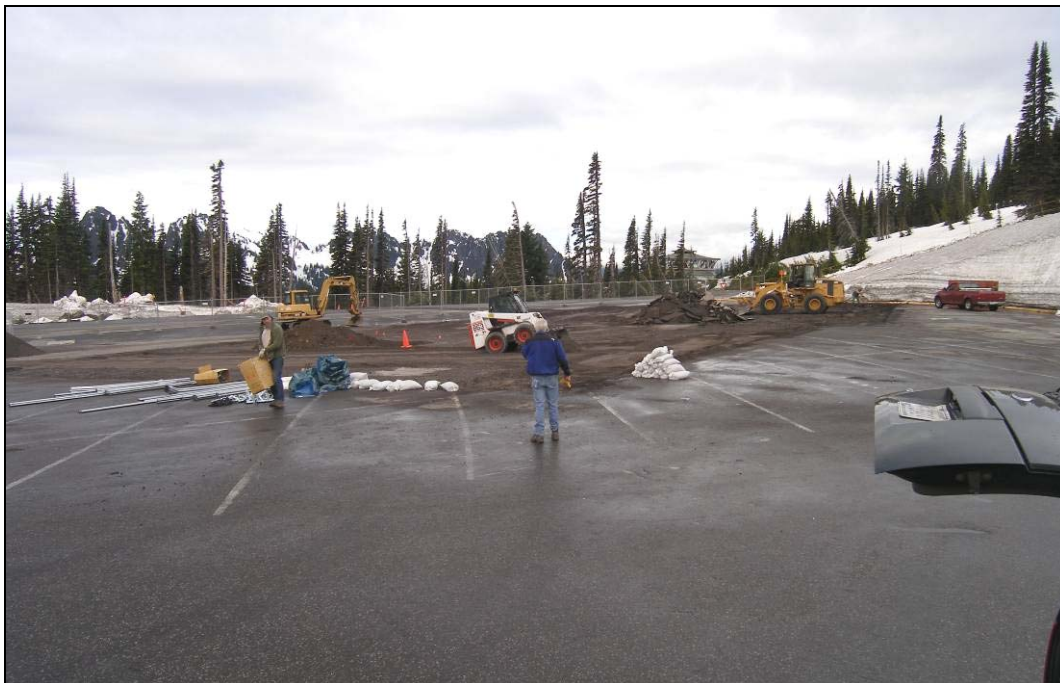
**Figure 17, Asphalt Removed from the Visitor Center Footprint. (View Facing West.)**

In order to gain access to subsurface sediments, the maintenance crew first cut and removed asphalt around the building footprint; creating an irregularly rectangular 89 by 197 foot (27 by 60 meter) working space. Previously, pre-construction sediment cores had indicated that from one to five feet of boulder and mixed sediment fill would be found between the asphalt and the original natural ground surface. Because of the massive, boulder-dominated nature of this fill, we were obliged to conduct investigations within a series of mechanically excavated trenches laid out to cross-cut the probable Paradise Camp Lodge foundation, and to sample the footprint area more widely. An initially planned uniform test trench pattern, was adjusted in the field to accommodate standing water, boulder rubble, and unexpectedly deep fill in the southwestern corner of the footprint. Figure 17 is a west-facing photograph showing the building footprint/testing area with asphalt paving removed and trenching in progress. Figure 18 shows the final test trench pattern plus an enlarged block excavation area (Block 1) from which fill was removed to expose Paradise Camp Lodge foundation elements. Sections that follow address test procedures and results for each of the three Paradise Camp objectives listed above.

United States Geological Survey geologist/volcanologist, James Vallance, visited the site on June 7, 2006; identifying the stratigraphic (predominantly volcanic and lahar-related) sequence exposed on the trench end wall. He prepared the following depositional profile based on those observations. The sequence is common to the Paradise area generally. However, the abrupt boundaries shown in the profile exhibit a surprisingly intact stratigraphic sequence that illustrates the area's geological history from the modern parking surface to the Reflection Lakes lahar about 6,400 radiocarbon years ago (circa 7,500 calendar year ago). Please refer also to Figures 17, 18 and 19 in the body of this report for additional visual detail.

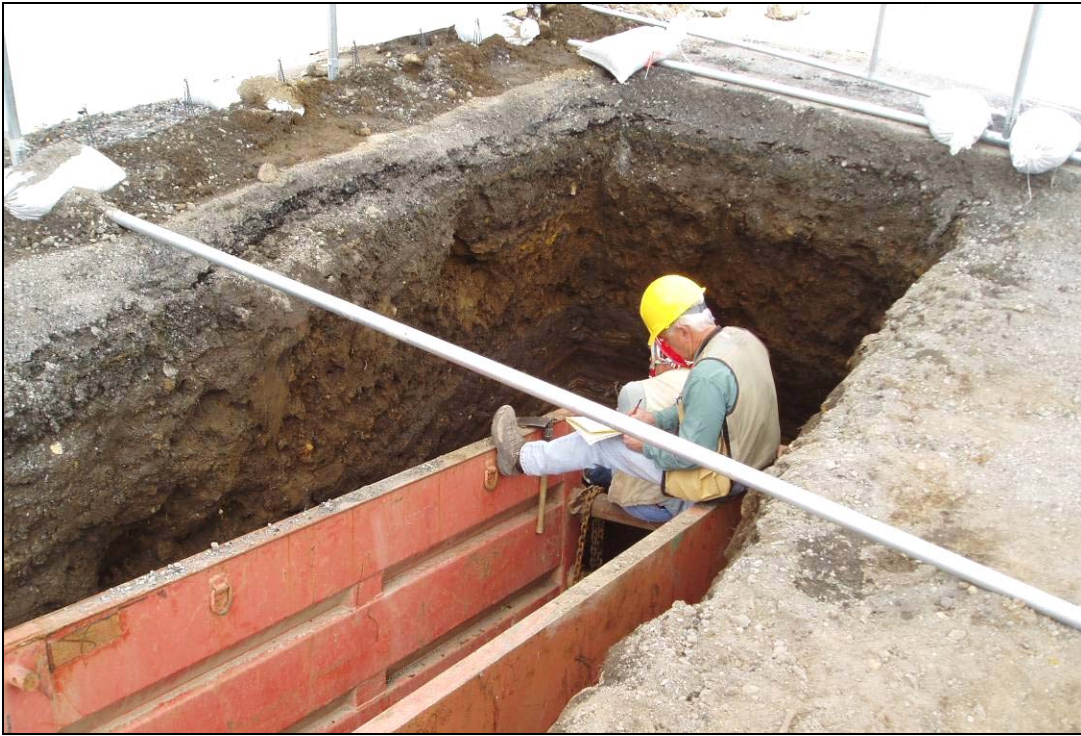
**Figure 19. Upper Parking Lot Fill Layers in the Stratigraphic Trench**

We exposed the area's natural stratigraphic sequence in the side walls of a 2.6 meter deep excavation trench located at the northeastern corner of the construction footprint (the easternmost section of Trench 3 above). Viewed through a steel trench safety-box the profile revealed that upper sediment layers to a depth of approximately 1.5 meters consisted entirely of asphalt, imported silt, sand, and gravel fill. These materials were the by-product of repeated resurfacing episodes --earlier with gravel, later with asphalt--plus additional fill used to raise the height of the parking surface in front of Paradise Camp. Figure 19 shows the stratigraphic test trench, trench safety-box, and 20th Century fill and resurfacing layers. The lowest fill layer, marked by a color change from yellowish brown to charcoal gray more-or-less parallel with Burtchard's foot, is a 20 cm thick layer of local material that probably was scraped into place to level the area's first formal parking surface in the early 1900s (this layer appears again in Figure 20).

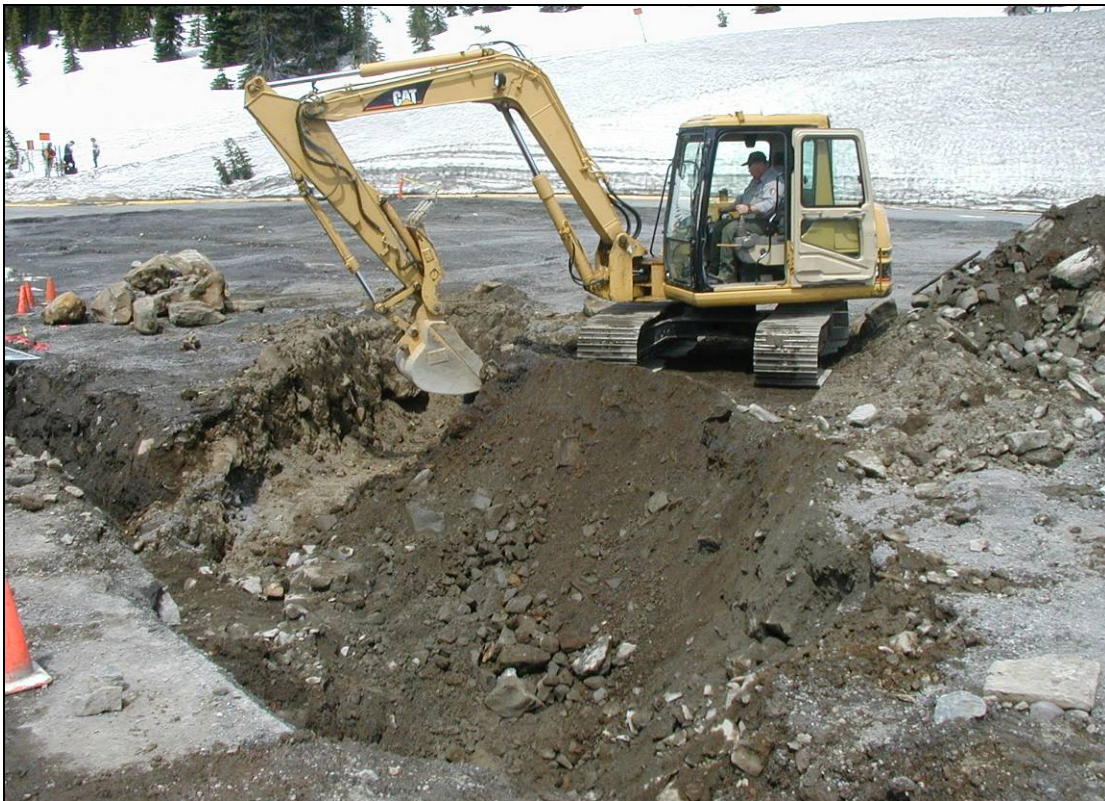
**Figure 22. Backhoe Exposure of Paradise Camp Stem Walls. (Jim Hooper operator.)**

The trenching system worked well. Paradise Camp Lodge front foundation elements were found approximately three meters west of the southeastern corner of the footprint area shown on Figure 21. The foundation consisted of concrete capped stone masonry pilasters and stem walls visible in the trench fill material. Leaving the front wall intact, we continued the trench until the rear (southwest-facing) foundation wall was located in the same fashion. Once located, the backhoe was used to search for, and roughly define, all front, end, and rear foundation walls and support pilasters in the exposed construction footprint. Figure 22 shows the original discovery trench (lower photo left) and excavation to expose additional foundation walls along the northeast-facing front of the 1925 lodge addition.

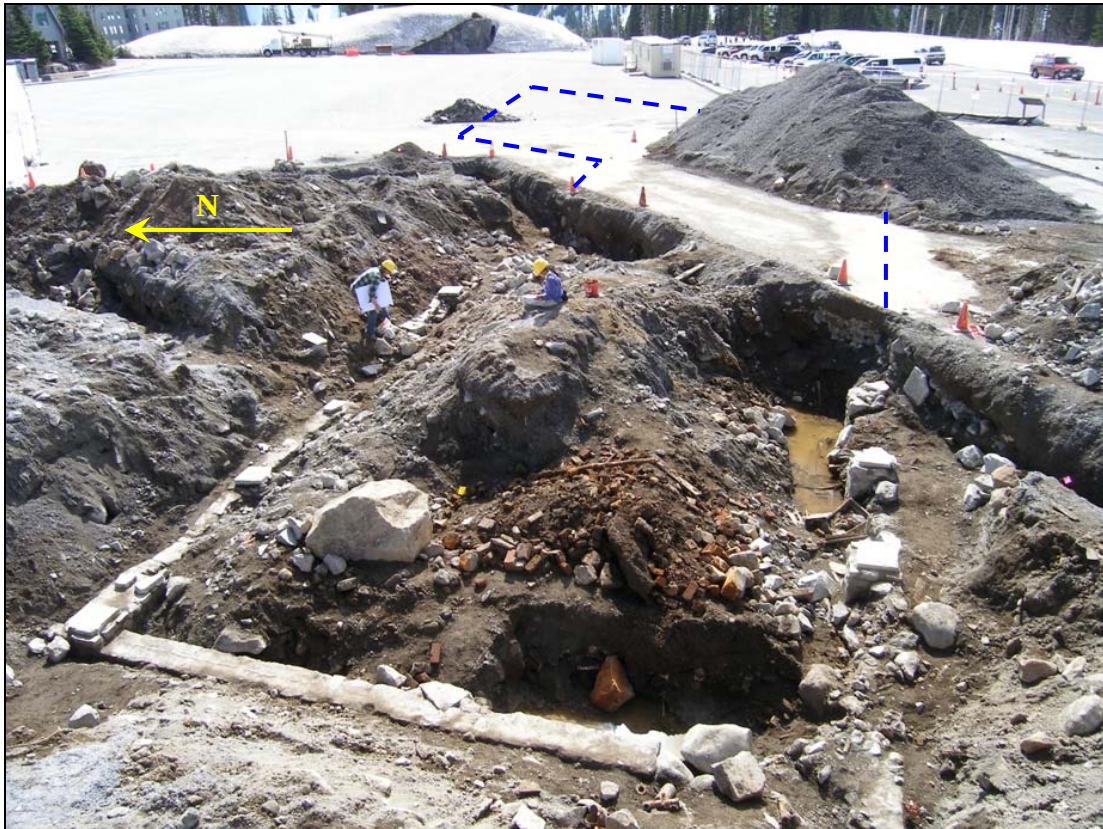
**Figure 23. Paradise Camp Lodge, Stem Wall and Pilasters.**  
(Photo faces southeast from the end of the 1925 addition.)

Even so, remnant stem wall foundations of the Paradise Camp lodge addition remained largely intact approximately one meter below the parking lot surface. Once exposed by the backhoe, the walls, pilasters, sections of plank flooring and associated water and electrical features were further defined by hand. Figure 23 shows the foundation wall almost completely exposed. The rectangular pit in the northwest corner of the building (lower right) exposes stem wall and floor section for illustration. A basement door opening is located in the lower right corner. Water is pooled on additional flooring and plumbing fixtures inside the rear wall of the building. Eric Gleason (holding the map board) is standing near a front basement door on the northeast face of the building. Remaining, undisturbed sections of the 1925 addition and part of the original 1918 Paradise Camp building continue under the large gravel pile. The front of the 1918 building turn at a right angle and lie approximately under the smaller gravel pile in the parking lot at upper photo center as indicated by the dashed blue line.

Foundation walls shown above (recorded in aggregate as Paradise Camp Feature 1) were constructed of minimally shaped angular cobbles –predominately andesite– mortared in place and capped with concrete. Because of high water level during the excavation period, we could not determine whether the stem walls were built on a concrete footing or on stone rubble. Stem walls

measured 2½ to 3 feet high above a plank floor. At approximate eight foot intervals, two foot square to rectangular mortared stone pilasters with concrete caps provided structural support for vertical beams or posts. Except on the northwest end, the pilasters and caps rose 6 to 12 inches above the height of the stem walls. Figure 24 illustrates the northwest stem wall, pilaster and plank floor construction. Note that, here, the pilasters and stem wall are the same height, save for the cap. Note, too, that the plank floors are placed atop horizontal sub-floor planks which lie directly on the ground surface.

As shown in Figure 23 and located as shown Figures 25 and 26 below, all of the northwest (short end) of the 1925 Paradise Camp addition was exposed in the construction area. This wall section was perhaps the best preserved of the mortared stone foundations at the site. It contained three pilaster columns and a basement door opening in the northwest corner. The exposed section measured 28.5 feet long from the center of its corner pilasters.

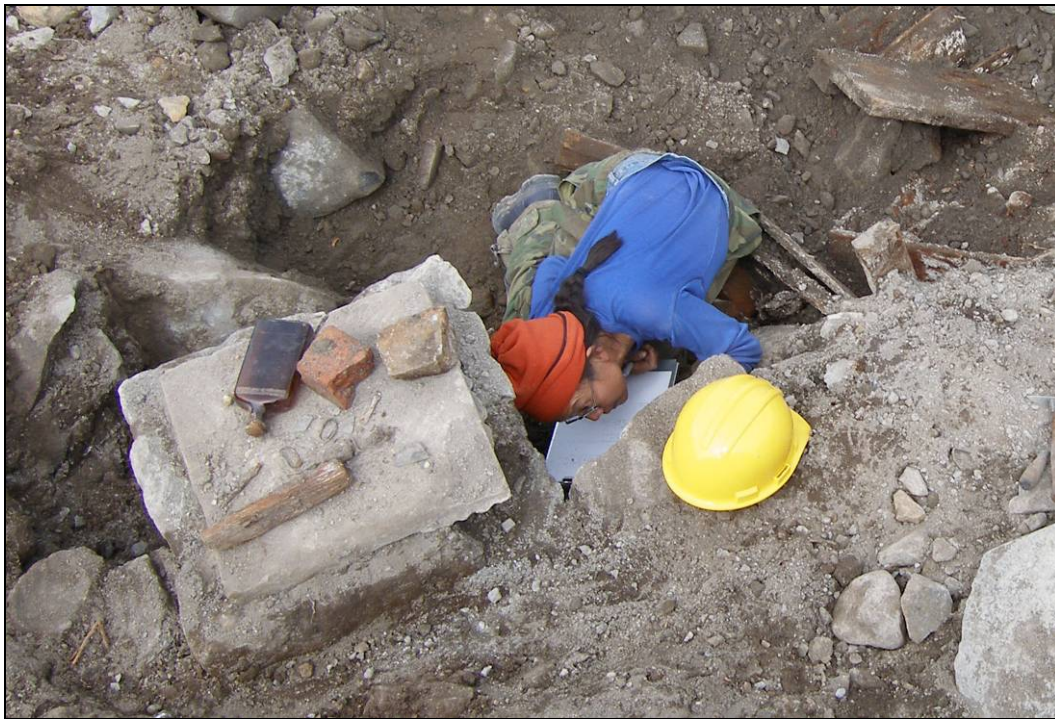
**Figure 27. J. Cheung Excavates Preserved Section of Stem Wall and Pilaster.** Bits of broken glass, wood and metal fragments, bricks, liquor bottle, and rolled condom set on pilaster cap.

Cultural litter, including intact light bulbs, wire, porcelain and fragments of dishes, among other things, littered the basement floor and fill. Of some human interest, preserved in a small niche next to a pilaster on top of the stem wall was a partially filled whiskey bottle and a rolled condom; suggesting that the basement was, on occasion, useful for more than simply storage purposes. Figures 27 and 28 below show a few of the artifacts and features recovered from Paradise Camp in 2006.

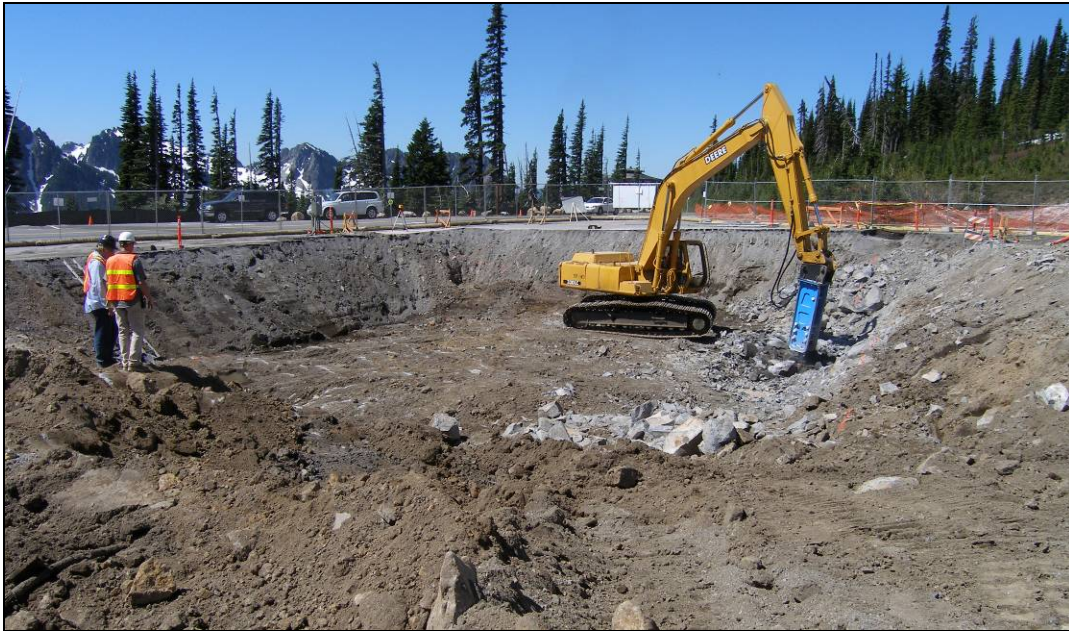
**Figure 31. Excavating Paradise Visitor Center Foundation.**

All excavation associated with construction of the new visitor center building was carried out in the area contained within and immediately surrounding the planned footprint shown in various illustrations throughout this report. Because it directly impacted the Paradise Camp Lodge location, we were particularly concerned with the removal of up to 14 vertical feet of sediments prior to construction of the building foundation (see Figure 31). We had hoped that the lodge's foundation could be preserved under the floor of the new visitor center. Unfortunately,

however, underlying sediments proved to be too unstable to support the weight of the new structure without deeper excavation and subsurface structural preparation. Fortunately, much of the lodge's structural information had been retained as reported above. Our intent as the 2006 construction season progressed was to retain as much archaeological information and as many Paradise Camp artifacts as possible.

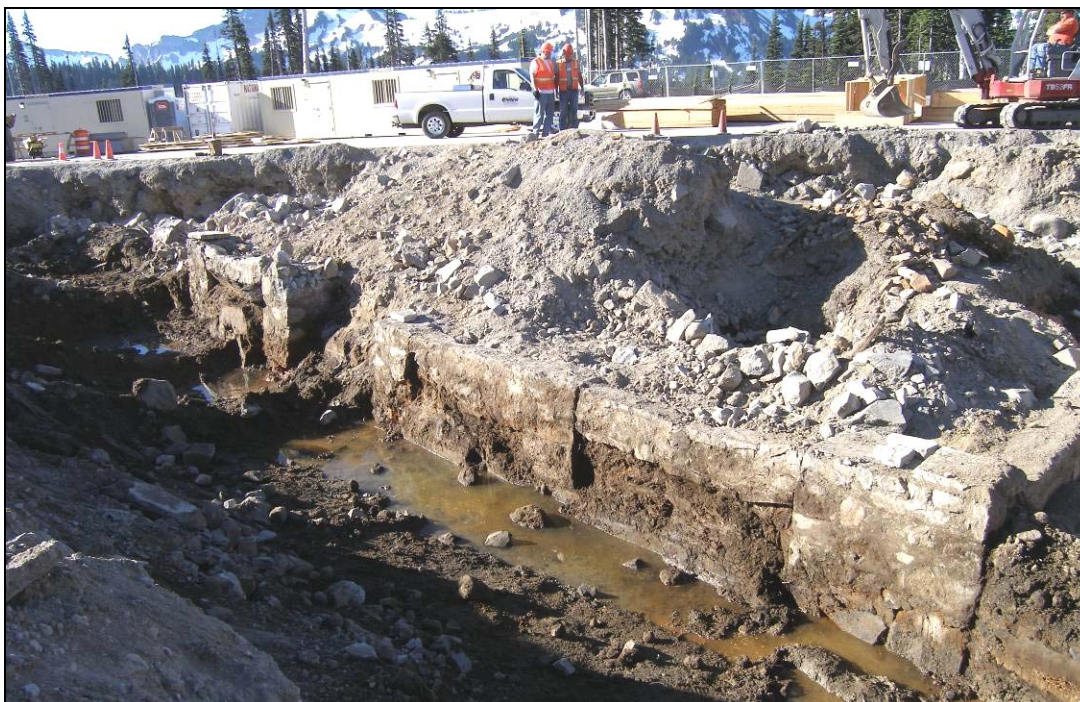
**Figure 32. Paradise Camp Lodge, Exposed Eastern Foundation Wall**

Exposing the pilaster and stem-wall in this fashion along the eastern wall of the 1925 lodge addition to Paradise Camp provided a substantially improved exposure of structural elements than we were able to obtain during the original archaeological excavation process. Figure 32 shows the eastern pilaster and stem-wall foundation exposed on the eastern face. The photo clearly shows the load-bearing pilasters deeply set to provide structural support to the overlying lodge. Intermediate stem-walls are shallow, simply providing an interior basement ledge and surface to join non load-bearing structural elements.

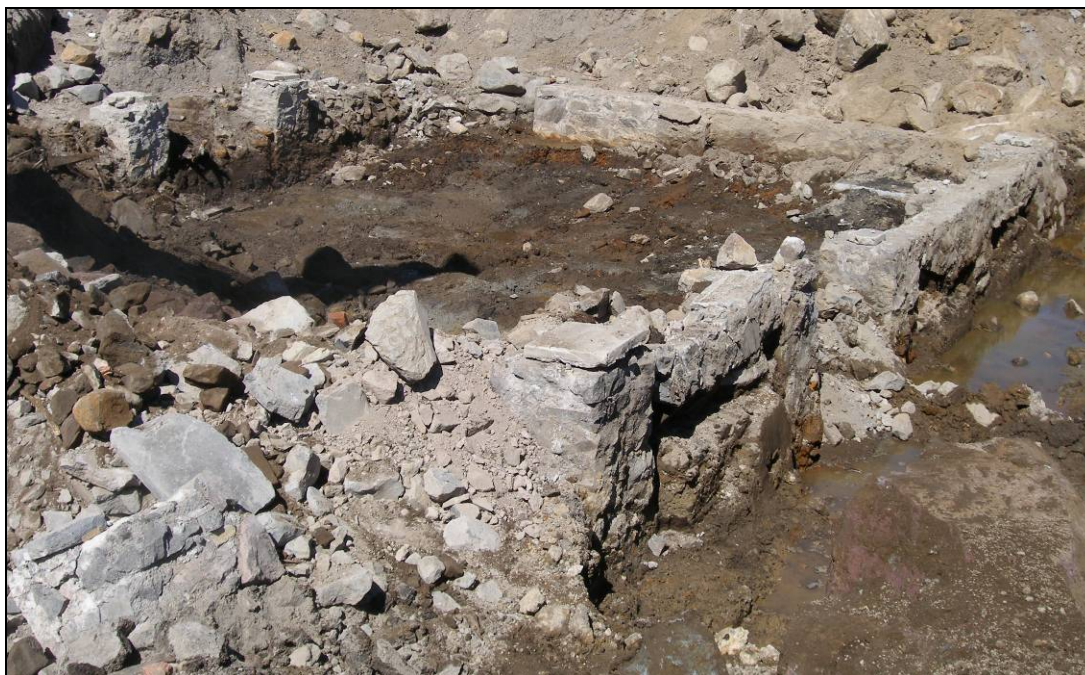
**Figure 33. Paradise Camp Lodge, Interior Fill Removed. Photo faces west.**

Due to the length of time associated with exposing the east foundation wall in the manner described above, it was deemed impractical to apply the same strategy to the north and west walls. Instead, fill from inside the foundation was excavated to expose the interior surface of the walls as shown in Figure 33 below.

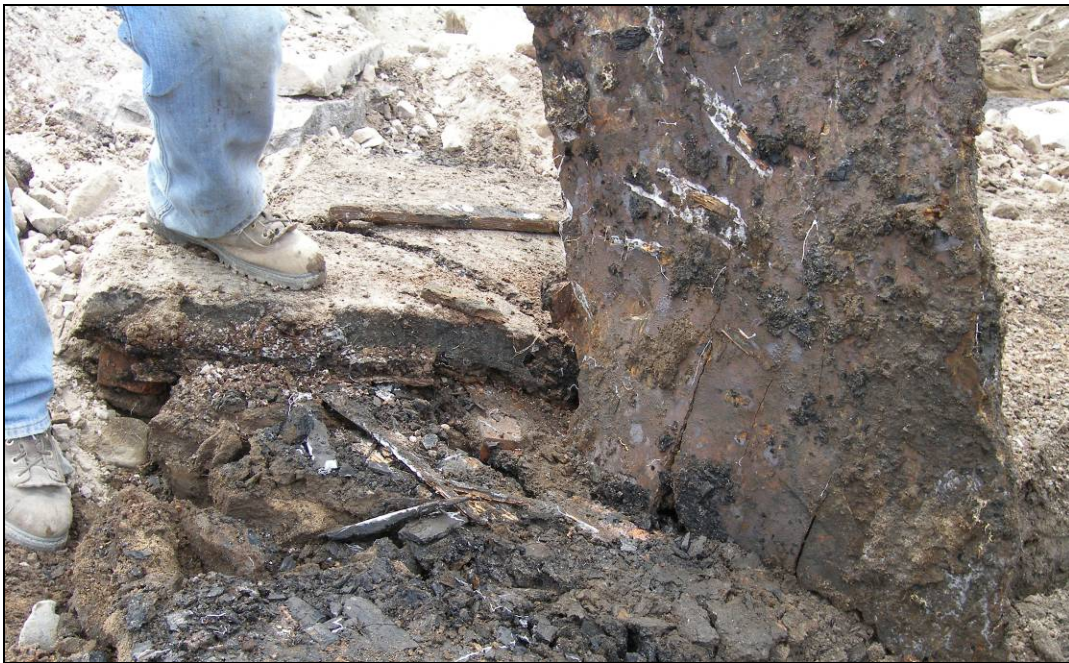
**Figure 34. Cork and Stucco Paradise Façade Material** (Oriented horizontally with plaster surface on top, and measuring approximately 3m (L) x 1m (W) x 12cm (thick); sample recovered)

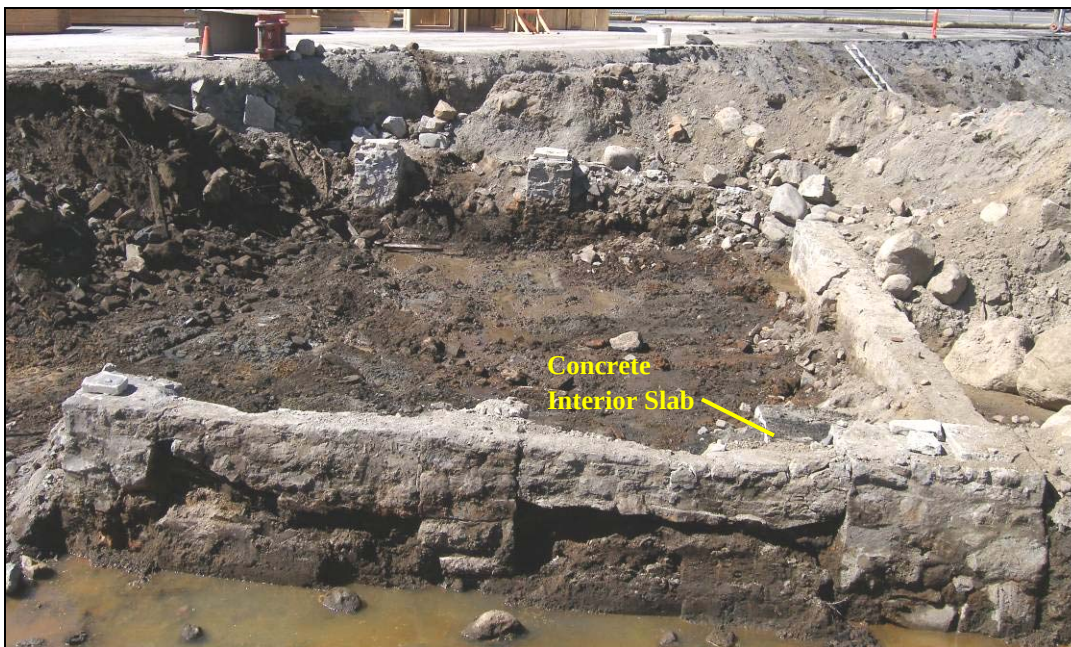
**Figure 35. Paradise Camp Lodge Concrete Basement Flooring/Slab and Foundation Walls.**  
(Photo faces SW. Slab remnant in northeast corner, oriented horizontally, and measuring approximately 3 m (L) x 2m (W) x 20cm (thick).)

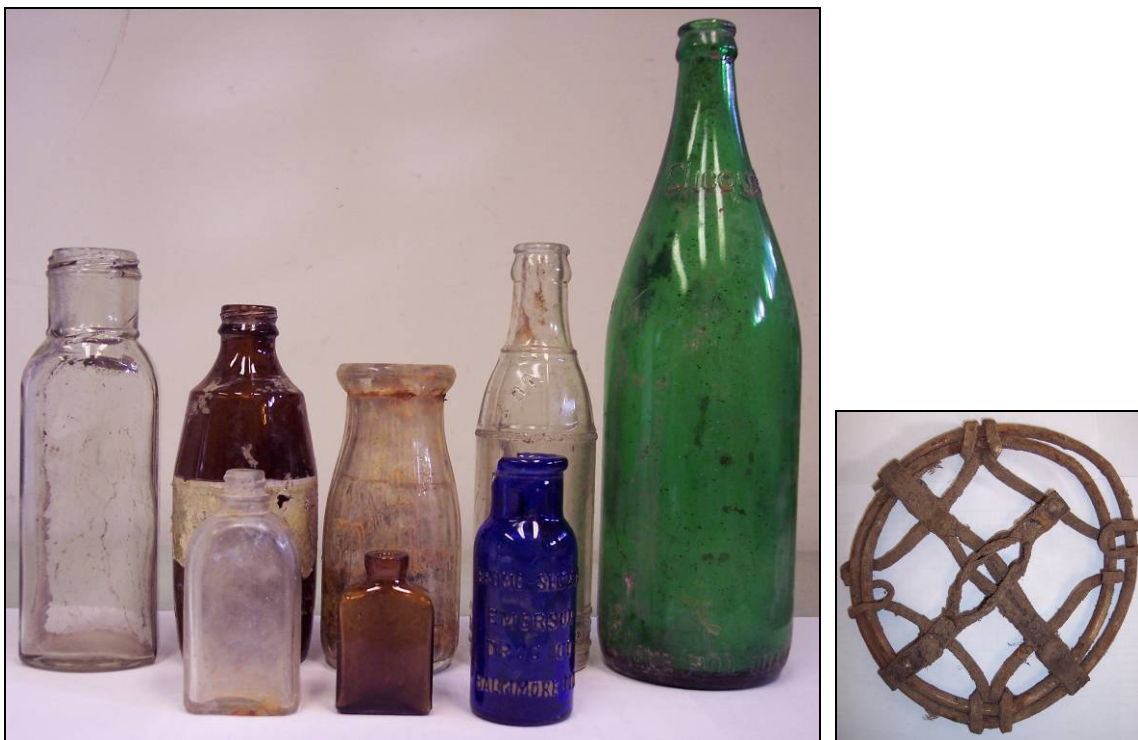
**Figure 36. Bottles and Ski Pole Basket Recovered from Paradise Camp/Tatoosh Club Area**

All artifacts collected during the Paradise Camp construction monitoring effort, and included in Tables 1 and 2 above, were cleaned and stored at the curation facility in the park's administrative headquarters in Tahoma Woods. Primary authentication references for bottle descriptions were Jones and Sullivan (1989), and Toulouse (2001). Objects shown in Figure 36 below provide examples of the range of artifacts found. Please note that these materials could reflect the entire use range of the building beginning as early as 1917. However, because they were found in association with the 1925 addition, and because the building continued in use through the 1950s, most of the materials probably reflect that time-frame.

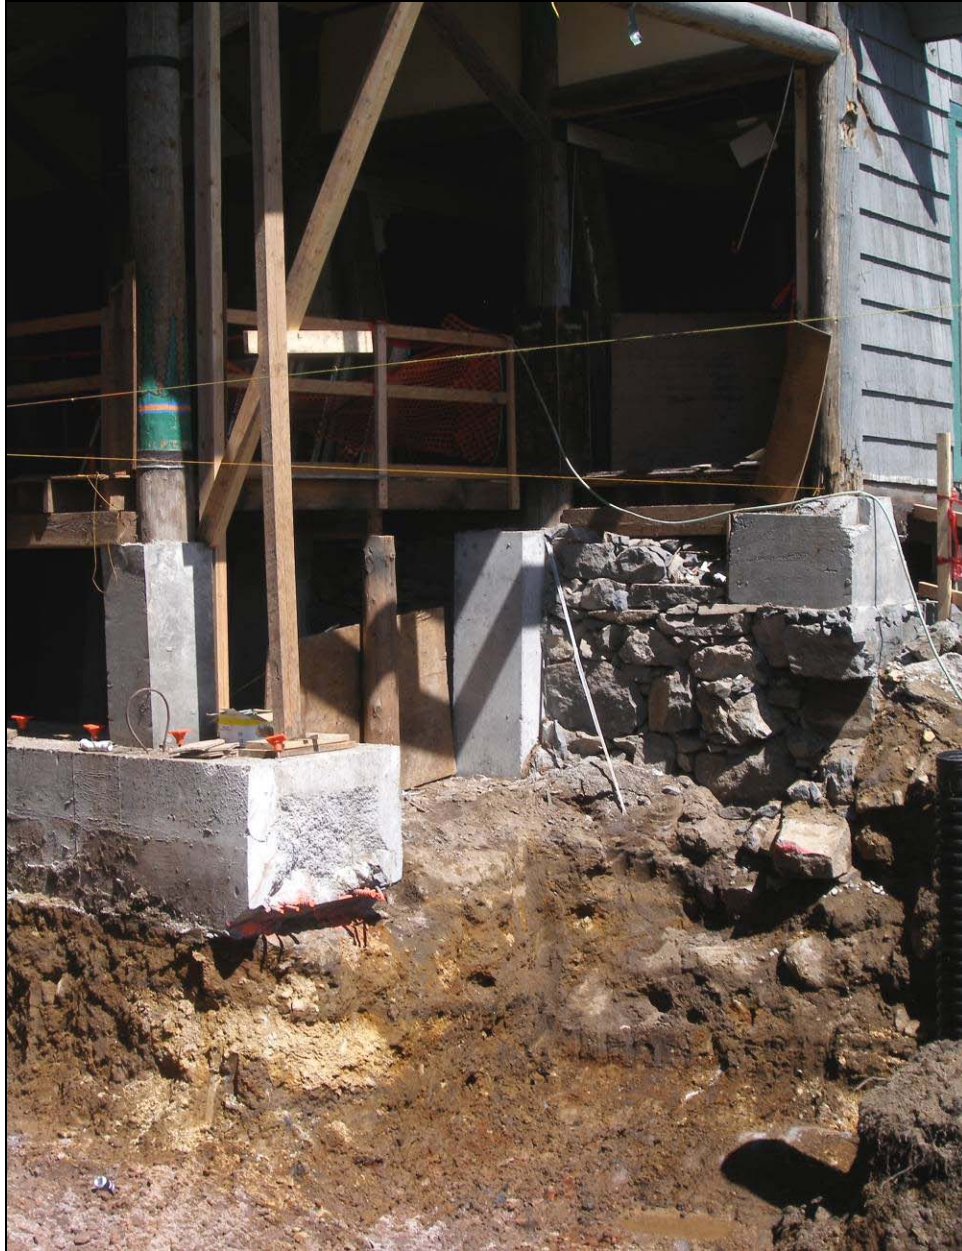
**Figure 37. South Chimney Foundation Excavation**

Other activities with the potential for impacting subsurface archaeological deposits consisted of excavations in association with foundation construction beneath the north, south, and dining room chimneys, storm and footing drain installations along the western exterior (also storm drain trenching along northern end) of the building, and footing construction beneath the east wing. Figure 37 below shows foundation excavation for the south chimney. By the end of the season, the footing and storm drain installations were 75% and 25% completed, respectively. These were finished during the 2007 construction season, along with fuel tank and water line installations and extensive foundation construction.

The excavation of the south chimney foundation was monitored in order to ensure recovery of any archaeological data from the deep and intact unconsolidated sediment deposits observed in that area (see Figure 38). The stratigraphic sequence essentially is identical to that observed near the visitor center (Figure 20); preserving a similar 6500 year old depositional history. Given the increasingly shallow level of bedrock to the north, and correspondingly minimal deposits below the north and dining room/lobby chimneys respectively, we concluded that intermittent monitoring of excavation in those areas was sufficient.

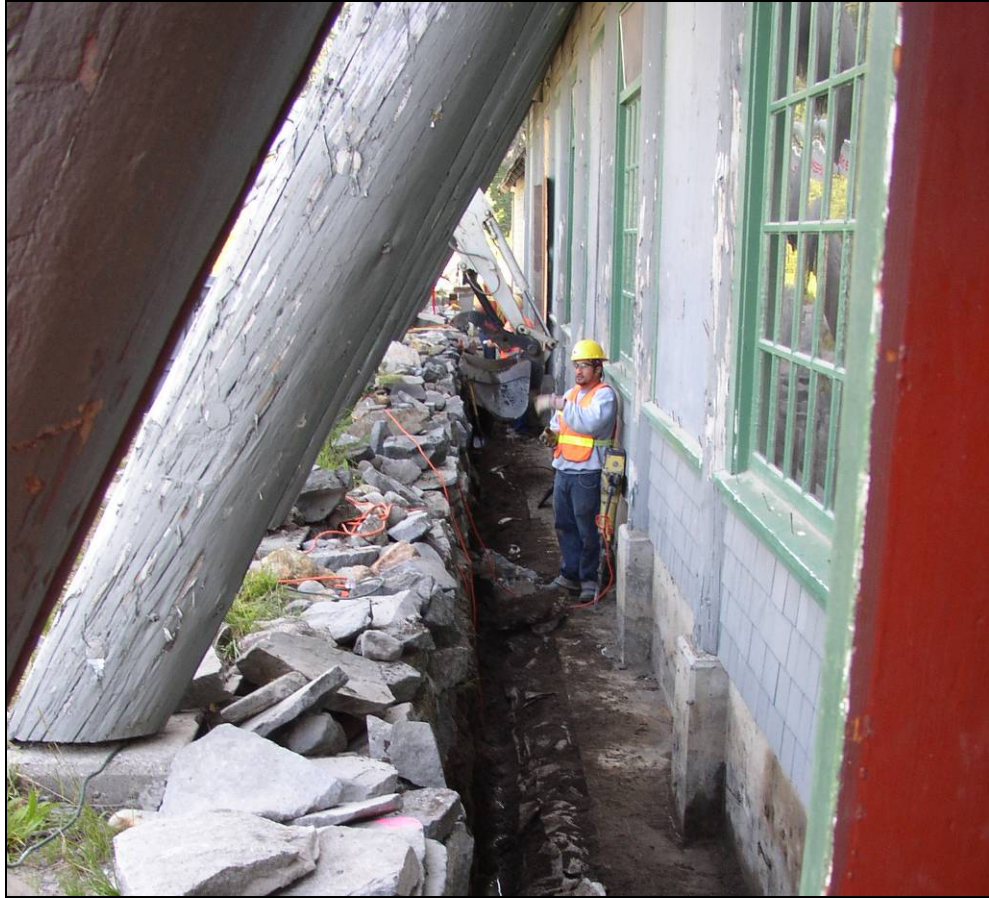
**Figure 39. Paradise Inn Storm Drain Trench West of Dining Room and Kitchen**

The section of storm and footing drain trench excavated parallel to the Paradise Inn lobby was not monitored since the work was completed in material that had been previously disturbed. The section excavated to the west of the dining room and kitchen area was intermittently inspected and photographed. The remaining section of storm drain trench along the northern end of the building was excavated partially in previously disturbed material. The trench was observed, but was not monitored intensively. The same consideration applied to footing excavations beneath the east wing. Figure 39 shows the storm drain trench outside the kitchen and dining room area of the Inn.

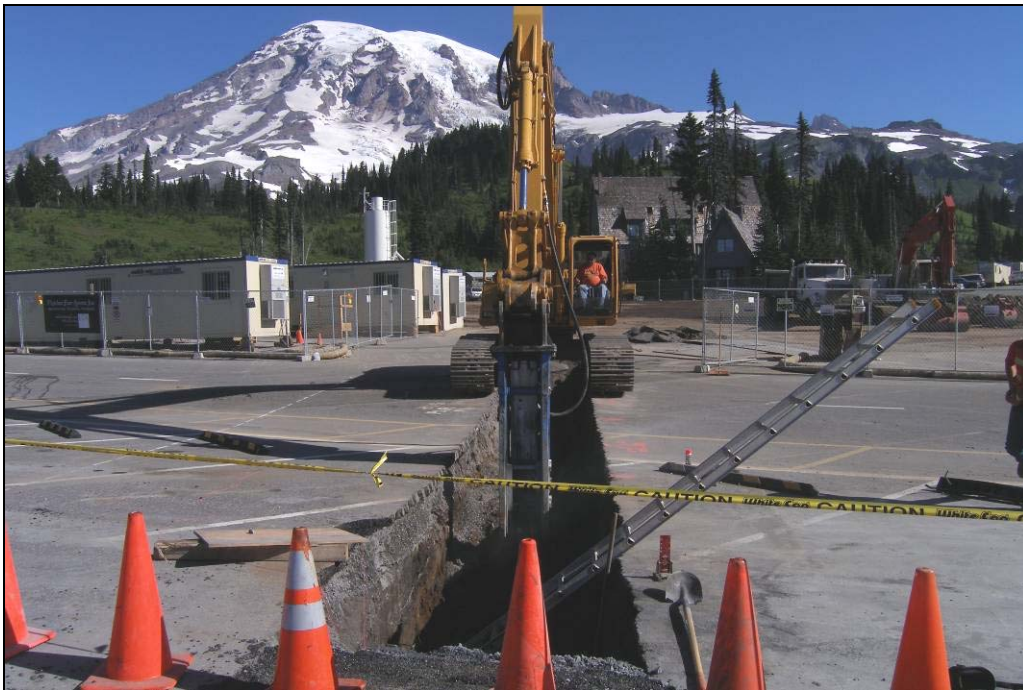
**Figure 44. Trenching for Storm Drain**

Extensive trenching was conducted across the Paradise Project area in 2006. Most of these trenches were dug to construct a storm drain system that would channel water away from the new visitor center, landscaped areas, the parking lot, and Paradise Inn. Figure 44 shows a segment of storm drain trench being excavated across the Paradise Valley Road.

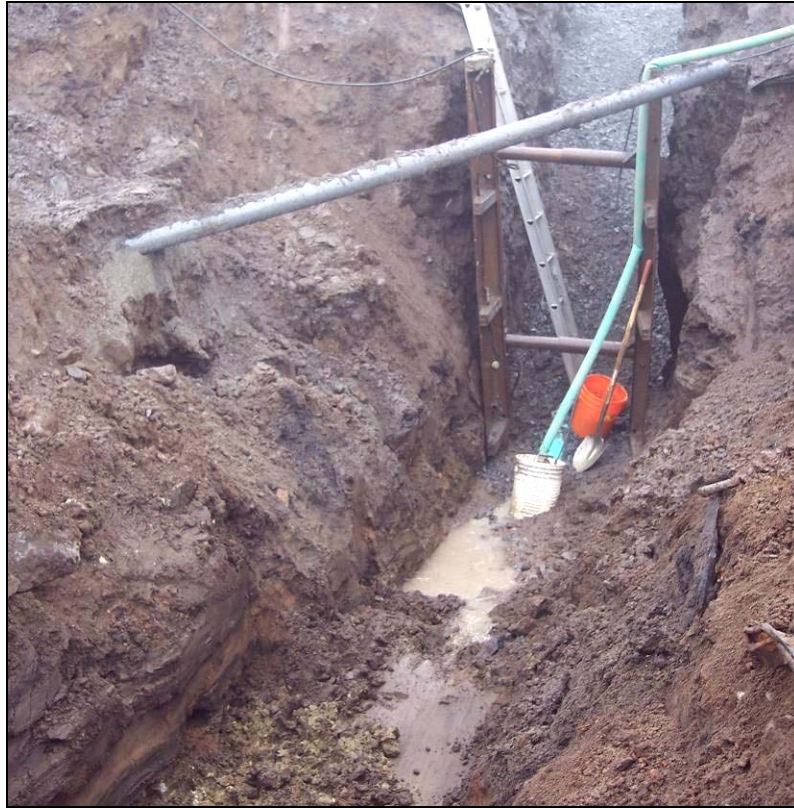
**Figure 47. New Sewer Line Trenching in Progress.**

Note intact sediments at lower photo-left.

The essentially horizontally bedded natural stratigraphy preserved below modern asphalt and fill suggest that this area occupied relatively flat elevated ground between two small drainage channels. The combination of near-level ground, access to water and subalpine context increased the probability that precontact artifacts or features could be encountered in this area. While no precontact remains were found during the trench monitoring process, the following five historical features were encountered and documented.

During the course of the construction process, trenches were monitored with particular attention given to areas where potentially intact subsurface deposits would be impacted, or where it was unknown whether excavation would take place in fill or undisturbed sediment. Features and artifacts encountered in the trench or exposed in the sidewalls were documented, photographed, and when possible, retrieved for curation and possible interpretative use. In addition, samples of undisturbed sediments were screened through 1/8" mesh from areas with the potential for prehistoric use such as in the lower portions of the trench shown below.

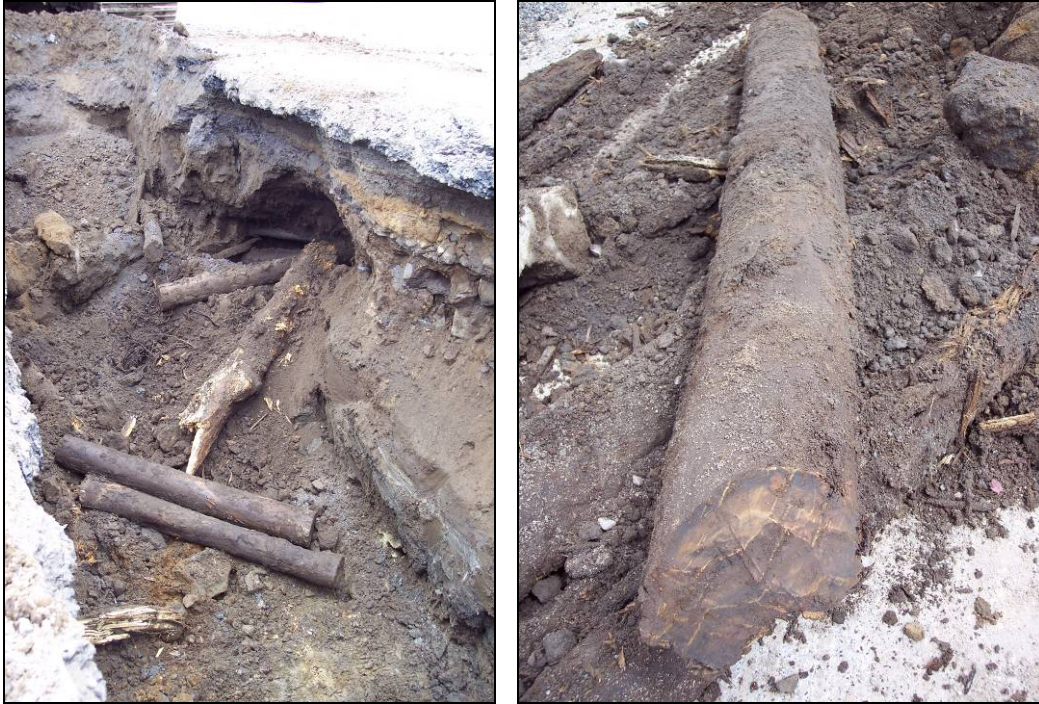
**Figure 48. Log Feature 6 in Exposed Parking Area Storm Drain Trench**

Feature 6 is an accumulation of axe and saw-cut logs that appeared to be lying adjacent to one another. The original orientation of the logs was unclear as they were disturbed by the backhoe during the initial exposure. Most of the logs were relatively short, measuring about 1.5 meters in length with an average diameter of 10 centimeters. There were also a few longer logs, measuring at least 4 meters in length with diameters ranging from 30 to 40 centimeters. All the

logs retained their bark exterior. Log Feature 6, shown below, was located in the main storm drain trench, approximately 11.2 meters northwest of the trench fork approximately as indicated on Figure 48.

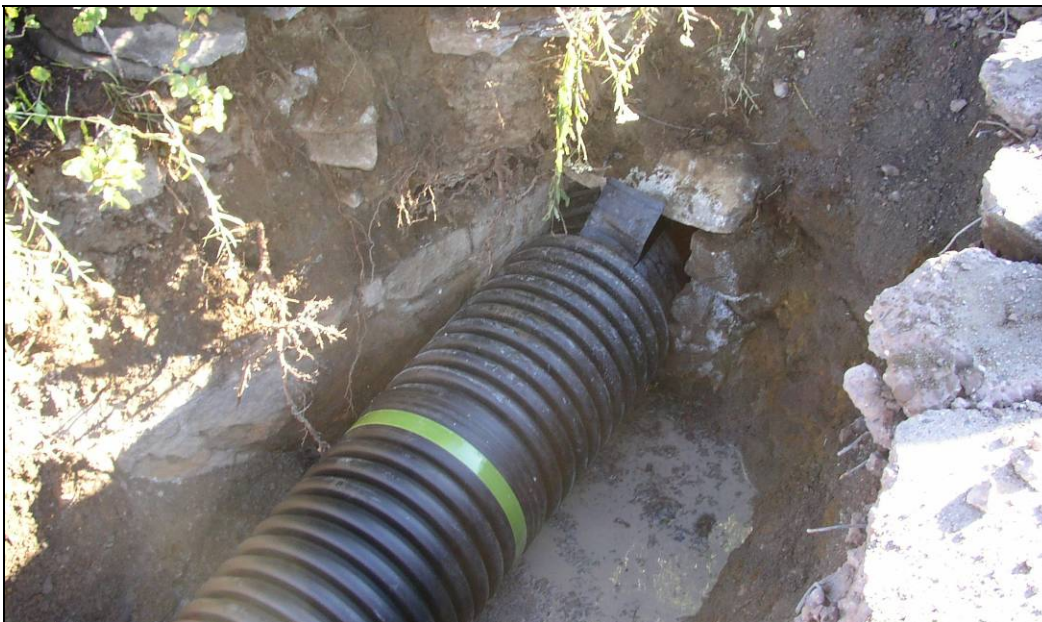
**Figure 49. Slab Lined Aquaduct/Drain Feature 7.**

Feature 7 is a functioning section of an historic aquaduct or drain that appears to drain the higher ground in the Paradise area occupied by the Inn, Guide House, and Ranger Station

approximately as shown on Figure 46. The slab-lined drain, shown in Figure 49 above was discovered during excavation of a lateral storm drain trench southeast of the Ranger Station. The exposed section consisted of an outer basalt boulder/cobble and mortar box with granite slab cover enclosing a corrugated metal culvert pipe. It is unclear whether the enclosed pipe and outer box were installed at the same time, or if the pipe represents a younger component. During excavation, one of the walls and the slab top were removed, leaving one wall and the pipe *in situ*. The newly installed plastic drain pipe was grouted directly onto the extant metal pipe; reusing part of the existing, and still intact, stone drainage system.

Another section of the slab-lined aquaduct, remains intact and covered with metal grates. This may be observed upslope to the northeast of Feature 7. The aperture of this section measures 85 centimeters wide by one meter deep and is contained by walls 35 centimeters thick.

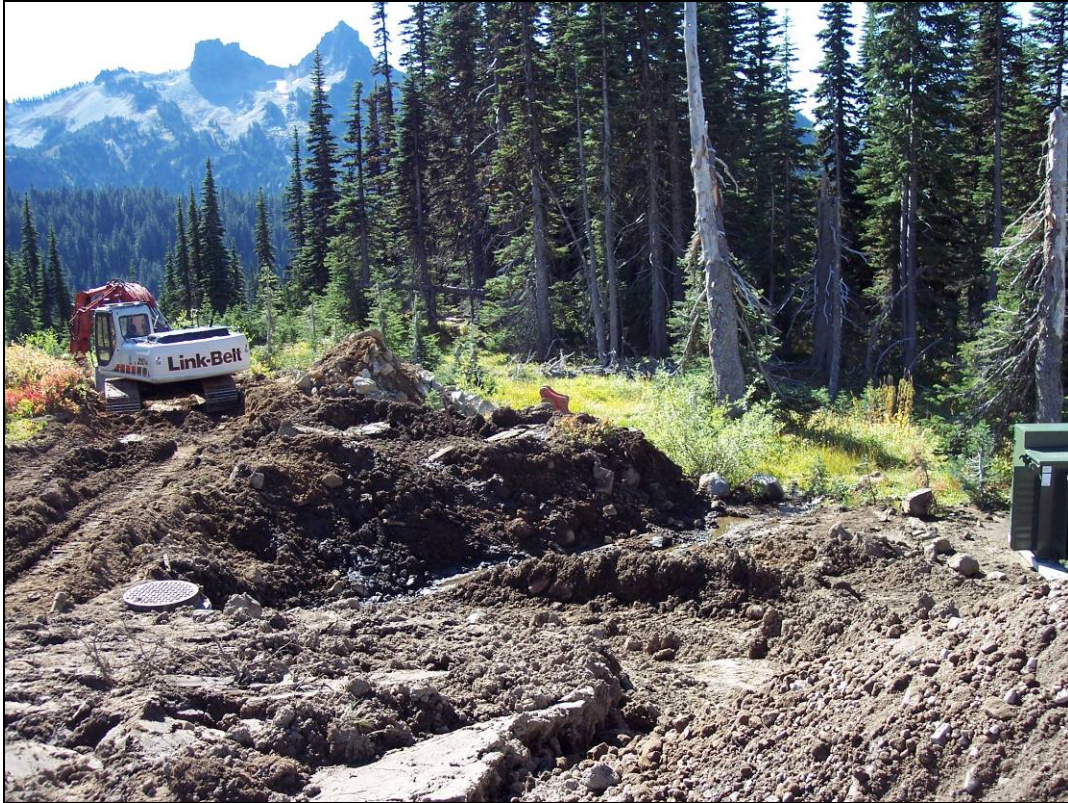
**Figure 50. Feature 8 and 9 Structural Remains.** (Note charred, broken convex log and wooden planks probably related to the warehouse or residence once located south of Paradise Camp.)

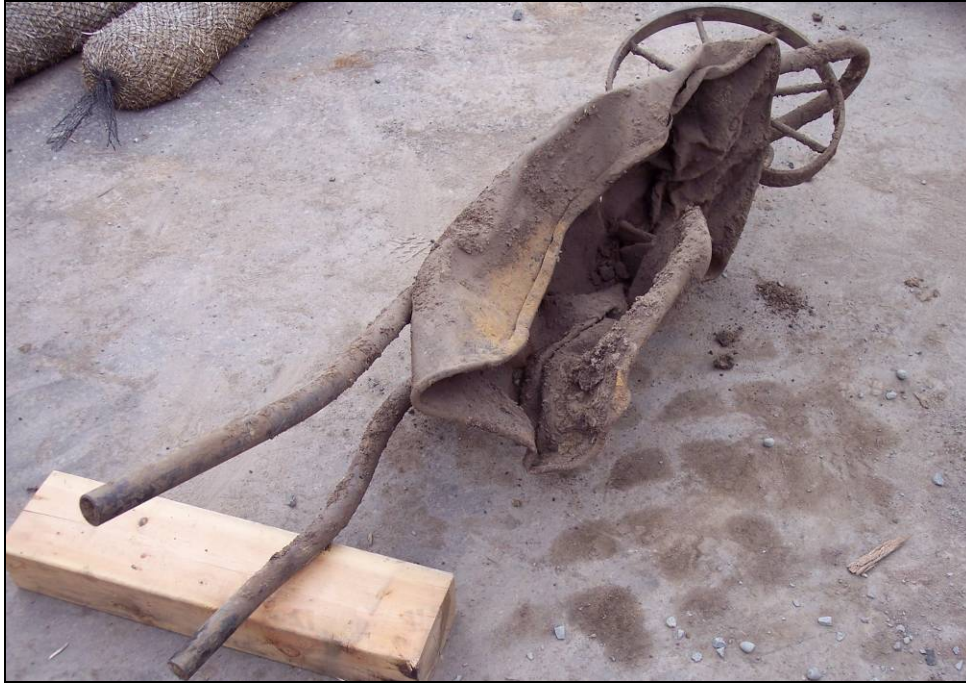
**Figure 52. Early to Mid-1900s Wheelbarrow**

No artifacts were recovered directly from those features or sediments exposed in the storm-drain trench. Artifacts retrieved during sewer trenching, not associated with features described above are summarized below in Table 5. Figure 52 shows a mid-1900s wheelbarrow recovered in the “Tatoosh Locus”/Feature 8, 9, 10 area south of the Paradise Valley Road. That artifact was the last cultural item recovered during the 2006 field season.

| Artifact | Description | Location Found |
|---|---|---|
| metal wheelbarrow | collapsed; features broad metal spokes and wheel | (sewer trench) |

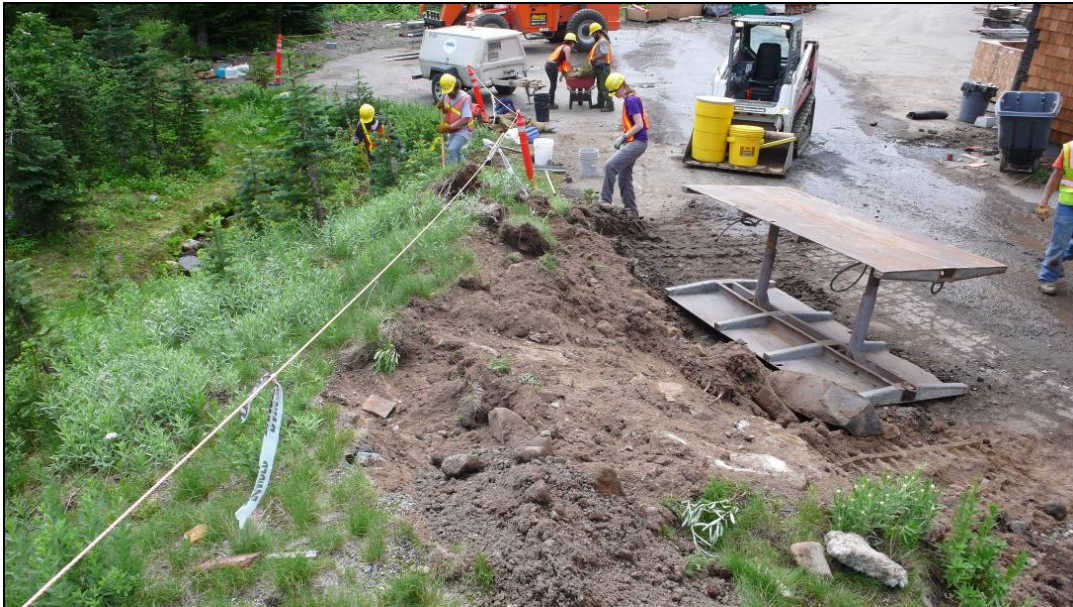
**Figure 55. Tank Replacement Excavation in Vegetated Fill North of Paradise Inn**

The second monitoring project focused on excavation, removal and replacement of subsurface tanks on the north side of Paradise Inn as shown on Figures 54 and 55. The tanks were buried beneath a large vegetated mound of fill. Excavation revealed no intact stratigraphy in the tank deposits. No cultural resources were documented during the work.

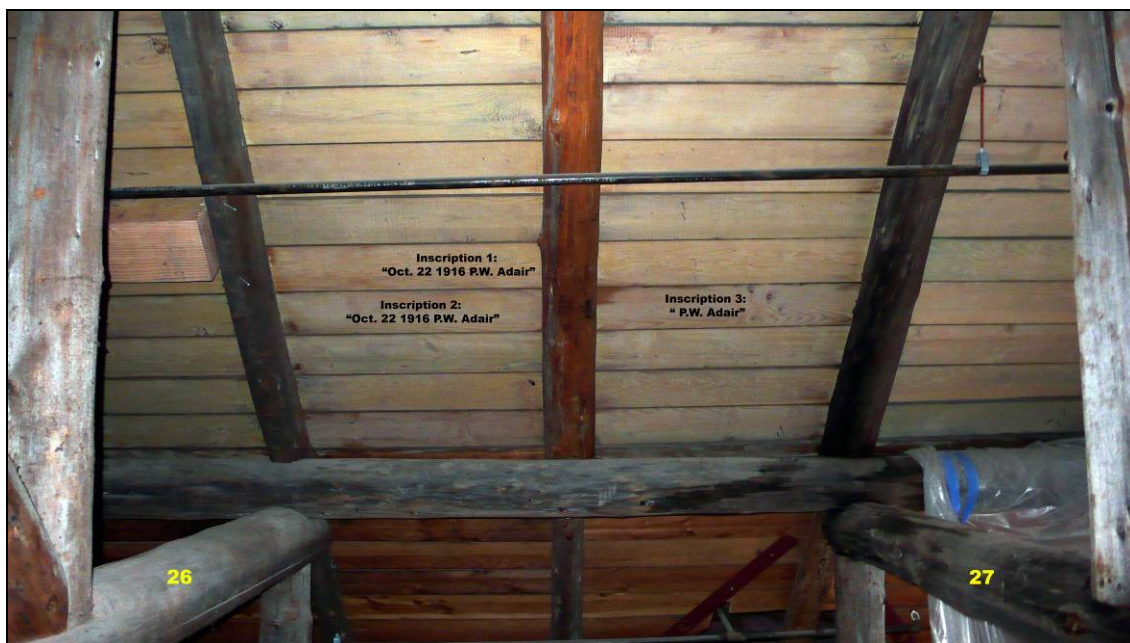
Figure 57. Location of Inscriptions on the Dining Room Ceiling

Feature 1, recorded in late March, consisted of three inscriptions written in blue pencil on the western interior roof boards of the Inn's dinning room near the kitchen as shown on Figure 56 below. Because the inscriptions were to be covered by the contractor, they were photo documented, sketched to scale, and plotted on the Inn's construction plan drawings. All three inscriptions appear to have been completed during one event; probably graffiti memorializing an original Paradise Inn construction worker. They are shown on Figures 57 though 60, and read as follows:

Completion of ceiling repair work did not impact the signatures which remain preserved between the roof planks and the new interior surface.
