# Paradise Camp

## Archaeology in the Paradise Developed Area

Mount Rainier National Park

February 2008

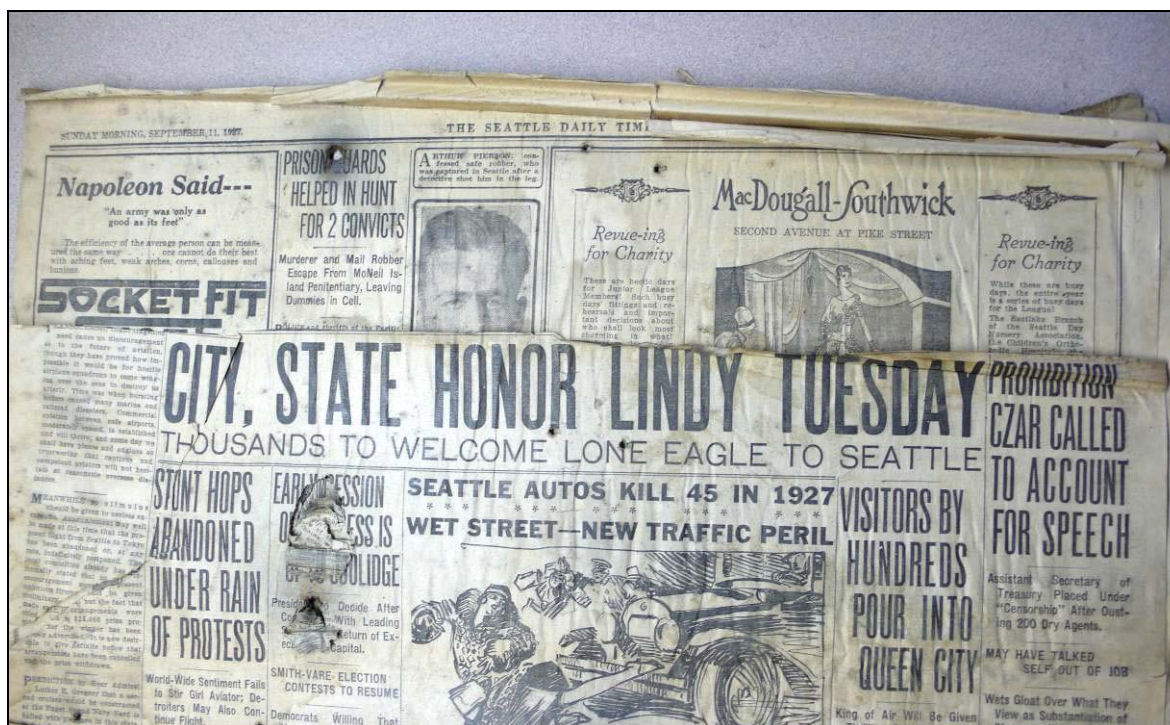
**Figure 62. September 11, 1927 *Seattle Daily Times***

It appears that the composite floor provided some protection to the news sheets. While brittle and somewhat brown with age most of the sheets are quite legible. As such, they provide a glimpse into historical events that were current in the late 1920s when the floor was installed. Table 6 lists curated sections with section titles. Also included are a few other artifacts collected from the Inn, and curated, during the 2007 season. Figure 62 shows the front of Section 17, the September 11, 1927 front page and main section.

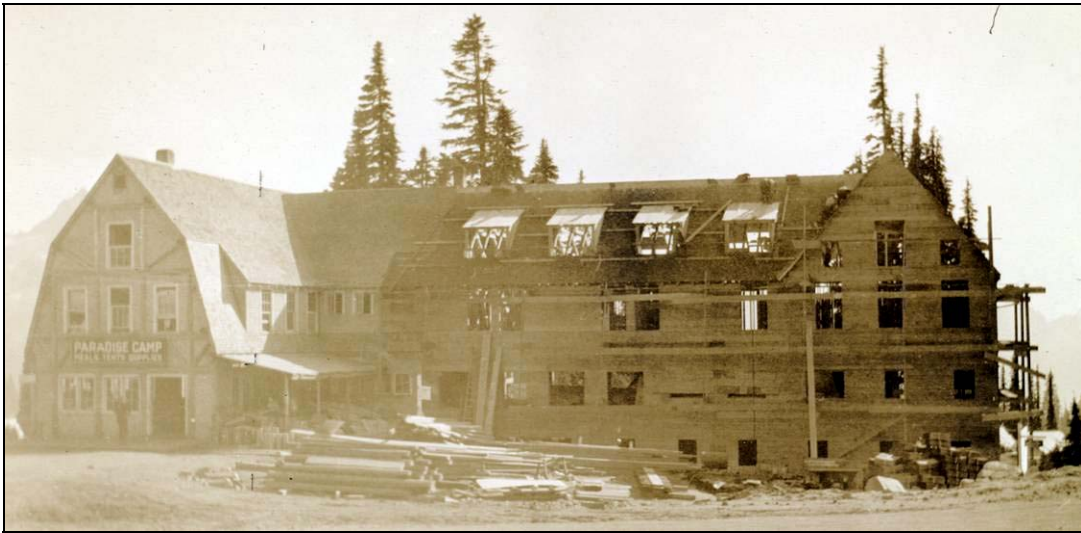
The procedure for documenting foundation elements (Feature 1) related to Paradise Camp Lodge involved locating and determining the horizontal and vertical extent of the feature within the new construction footprint. Based on available maps, the Paradise Camp building was projected to lie within the southeast section of the construction footprint; with a portion also lying directly within the new building foundation. The section of the Paradise Camp building directly impacted by the new construction consisted of the 1925 addition shown under construction below.
