# National Park Service Cultural Landscapes Inventory 2023

**East Potomac Park**

**National Mall & Memorial Parks**

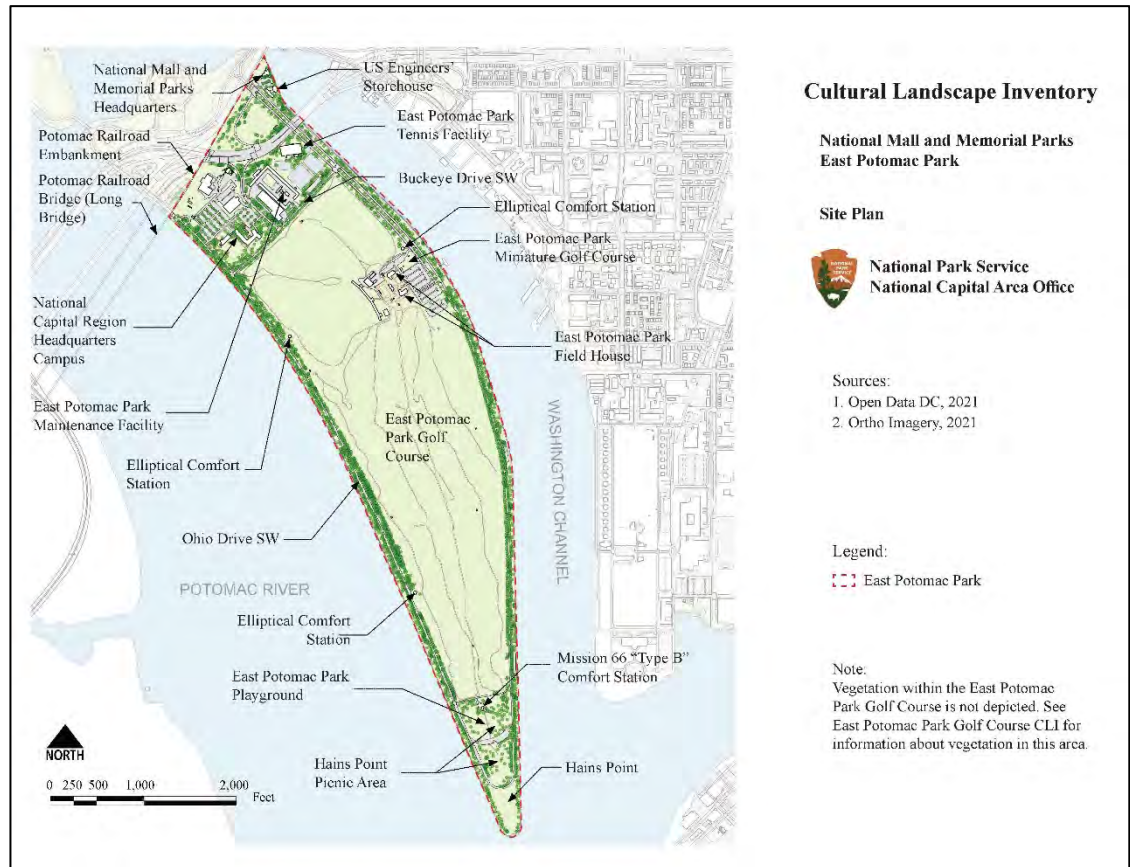
Fig 2. Site Plan depicting major features in the East Potomac Park cultural landscape (SmithGroup, RHI, and Gray & Page 2022).

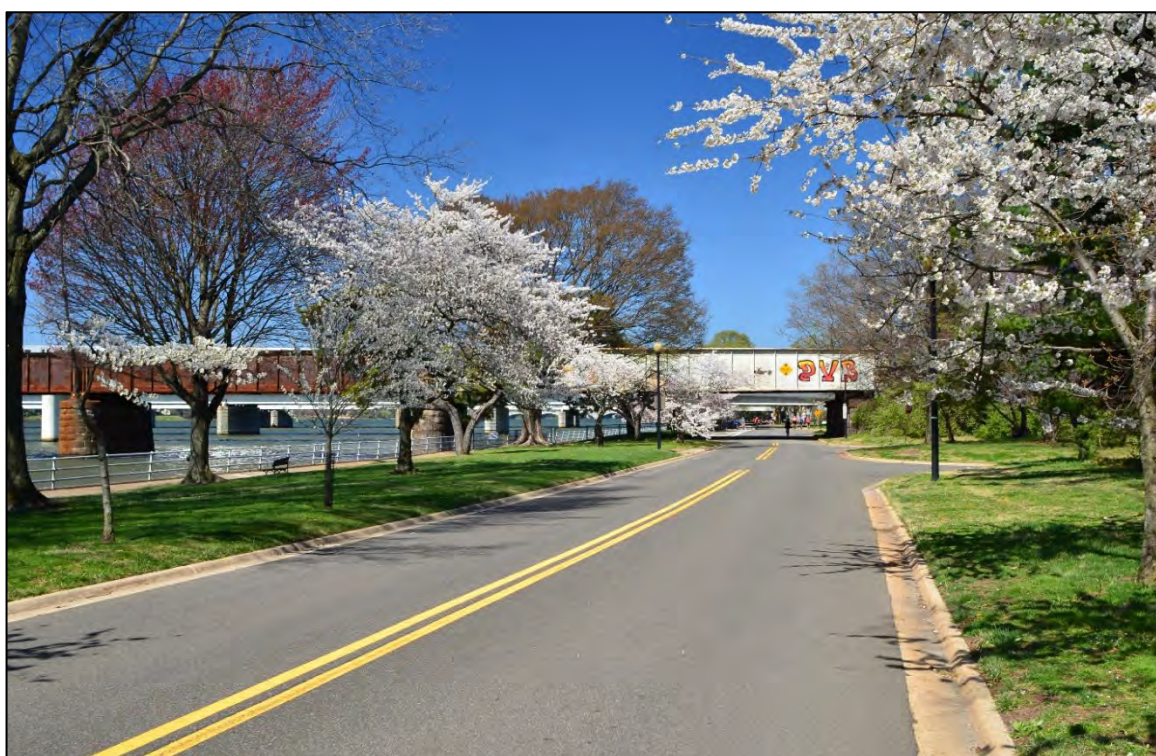
*Fig 7. Photo looking northwest along Ohio Drive SW depicting Potomac Railroad Bridge as it crosses the Potomac River and enters East Potomac Park (Matthew Traucht 2021).*

stone abutments was originally built as a full truss (NPS 2001, 46). Later a series of steel plate girders replaced the trusses in all but the central span. It is still used to carry rail traffic over the Potomac River today. In addition to CSX Transportation freight trains, the bridge is also used by Amtrak and the Virginia Railway Express (VRE). Because the bridge is only two tracks, substantial delays occur on a regular basis. Routine maintenance and repairs have occurred over time, but because the two tracks are so close together, maintenance requires both tracks to be closed during the repairs (NPS 2001, 46).

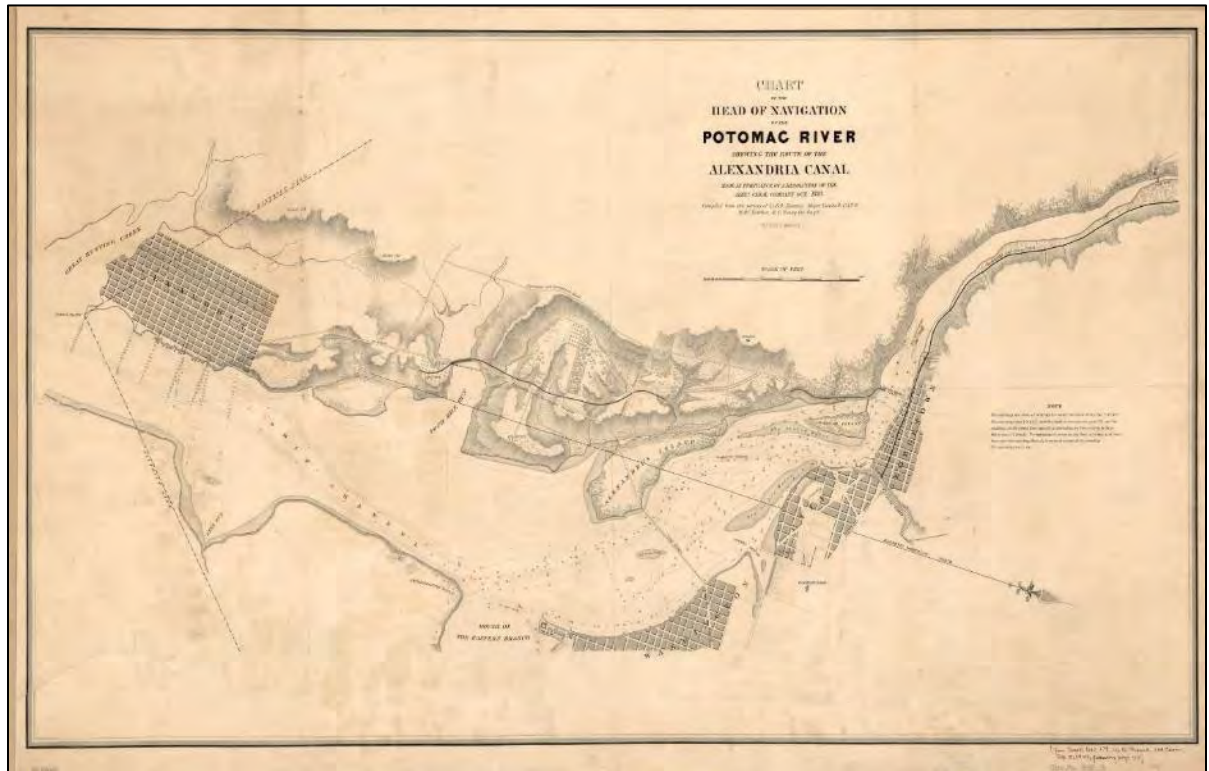
Fig 8. "Chart of the head of navigation of the Potomac River shewing [sic] the route of the Alexandria Canal" (Stone et al. 1838).

transforming it into a dead-end waterway, which continued to provide access to the wharves from the downstream side (Fig 8).

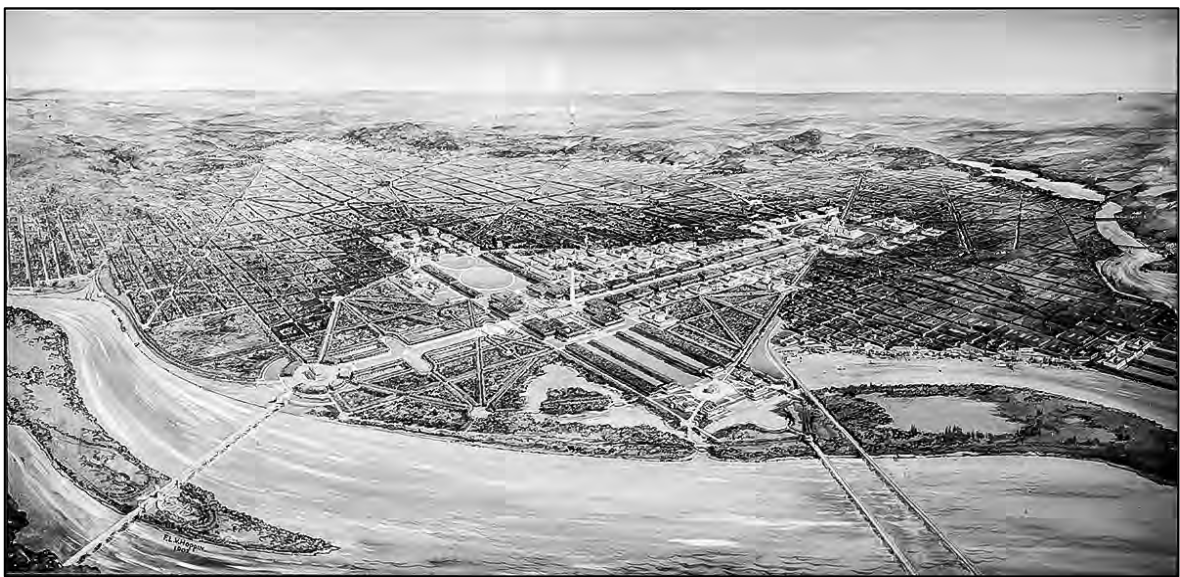
*Fig 13. Senate Park Commission rendering of the plan from a point 4,000 feet above Arlington (Hoppin 1902).*

meadow area into a series of connected compositions without completely obscuring its extent” (Moore 1902, 119). The Commission recommended that the principal drive be laid out beneath tall trees that would provide shade while allowing breezes to be enjoyed and suggested that a continuous line of foliage should be planted along the Washington Channel (a recommendation that was not, apparently, heeded) (Fig 13). Overall, the Commission asserted that:

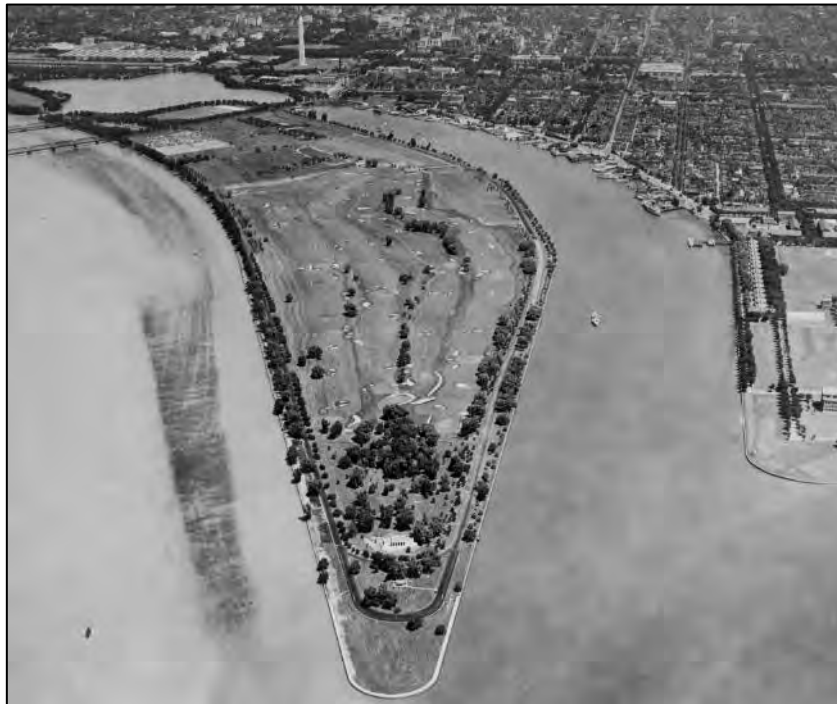
*Fig 19. East Potomac Golf Club East Potomac Park, Washington, DC, aerial view from above Hains Point looking north toward the Mall (s.n. 1935). Note locations of tourist camp near the top of the image and the Teahouse at Hains Point near the bottom of the image.*

In 1933, the CCC was established as part of the Emergency Works Program and began working on projects in Washington, DC, that same year, under the supervision of the Regional Park Service office in Richmond, Virginia. In 1939, the supervisory organization was revised so that the National Capital Parks could directly oversee the work of the CCC in the National Capital area. Between 1938 and 1942 workers from the CCC installed tennis courts and ballfields to the east of the tourist camp (Davidson et al. n.d.). The tennis courts followed the alignment of the railroad embankment rather than the existing grid pattern that was defined by the island's perimeter road. Workers for the CCC also laid drainage tile in the East Potomac Park Golf Course, improved greens and tees, and planted 36 cedar trees in pairs 200 feet from the tees to mark a well-hit shot (NPS 2017, 56) (Fig 19).

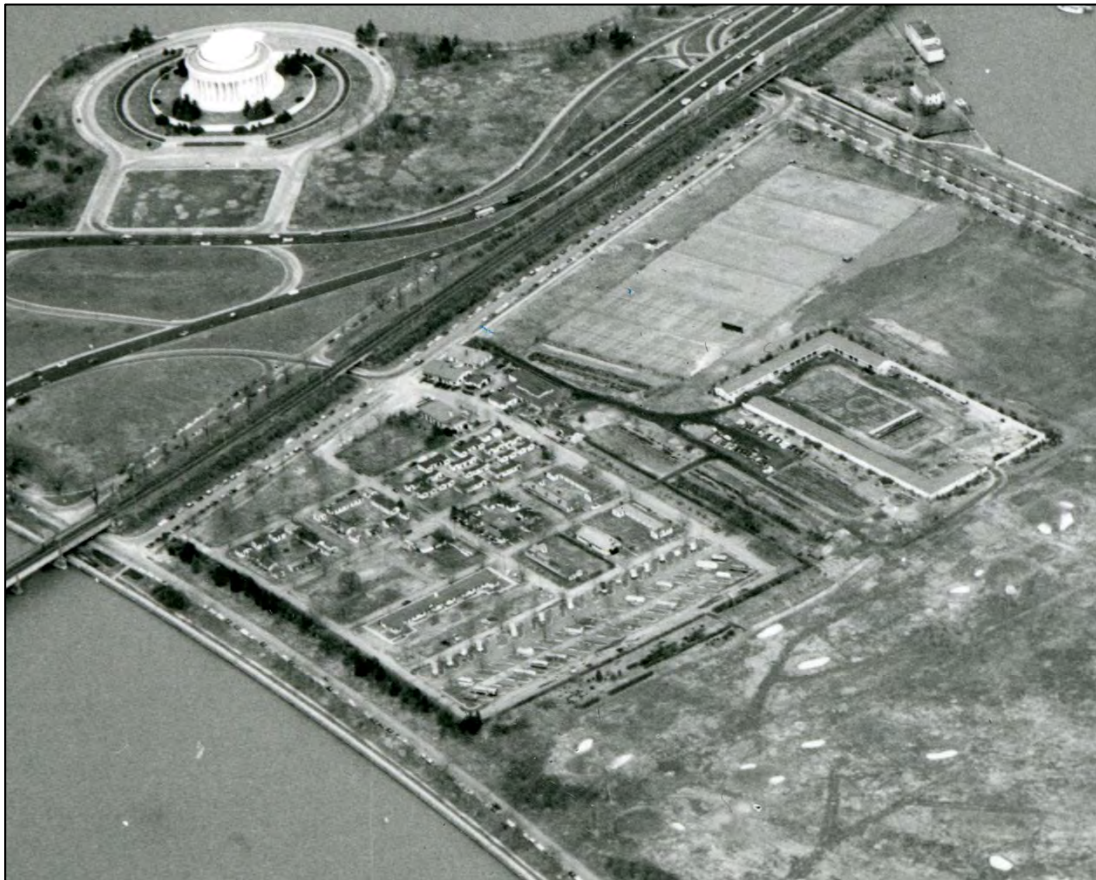
*Fig 22. 1955 aerial image showing the Potomac Park Tourist Camp, CCC-built tennis courts, and the partially built maintenance yard. (AE0070D, Whetzel Aerial photograph collection, DC History Center).*

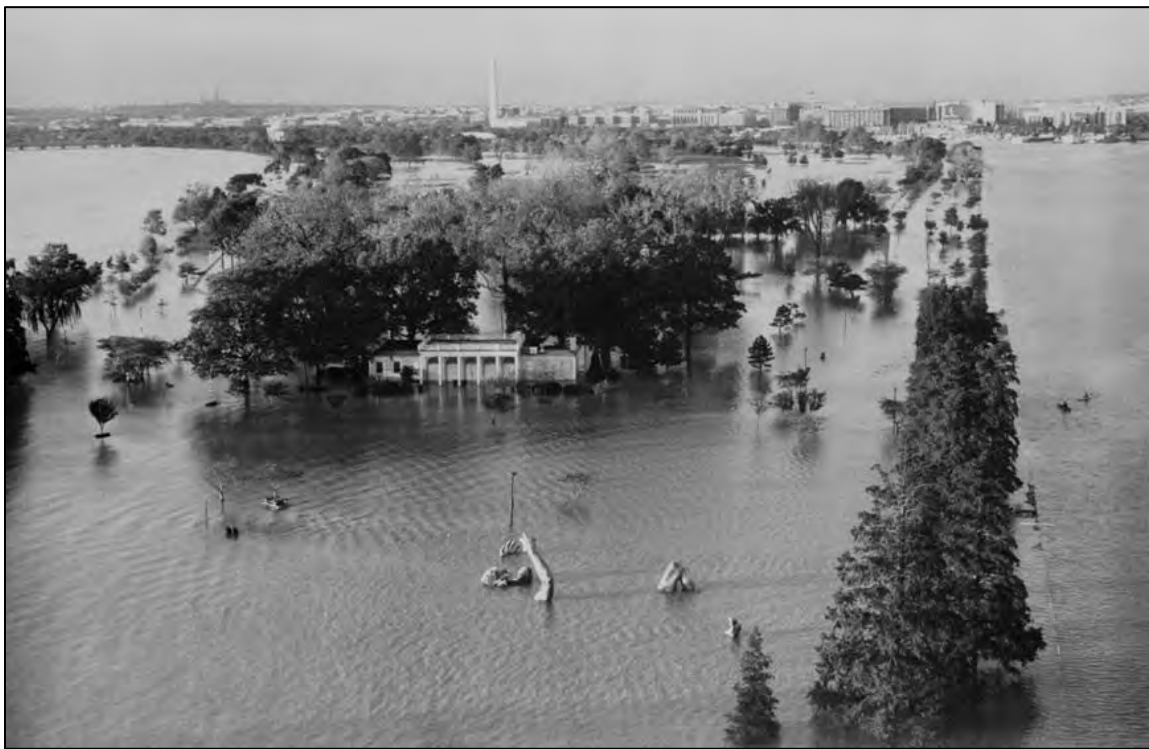
*Fig 24. 1985 Aerial view of flooding on Hains Point (Library of Congress 1985). Image shows most of the island inundated by flood waters. The Teahouse and “The Awakening” are visible just above the flood waters.*

In 1985, a massive flood inundated East Potomac Park, which was the result of storm surges in the Potomac River caused by Hurricane Juan. The US Geological Survey reported that the

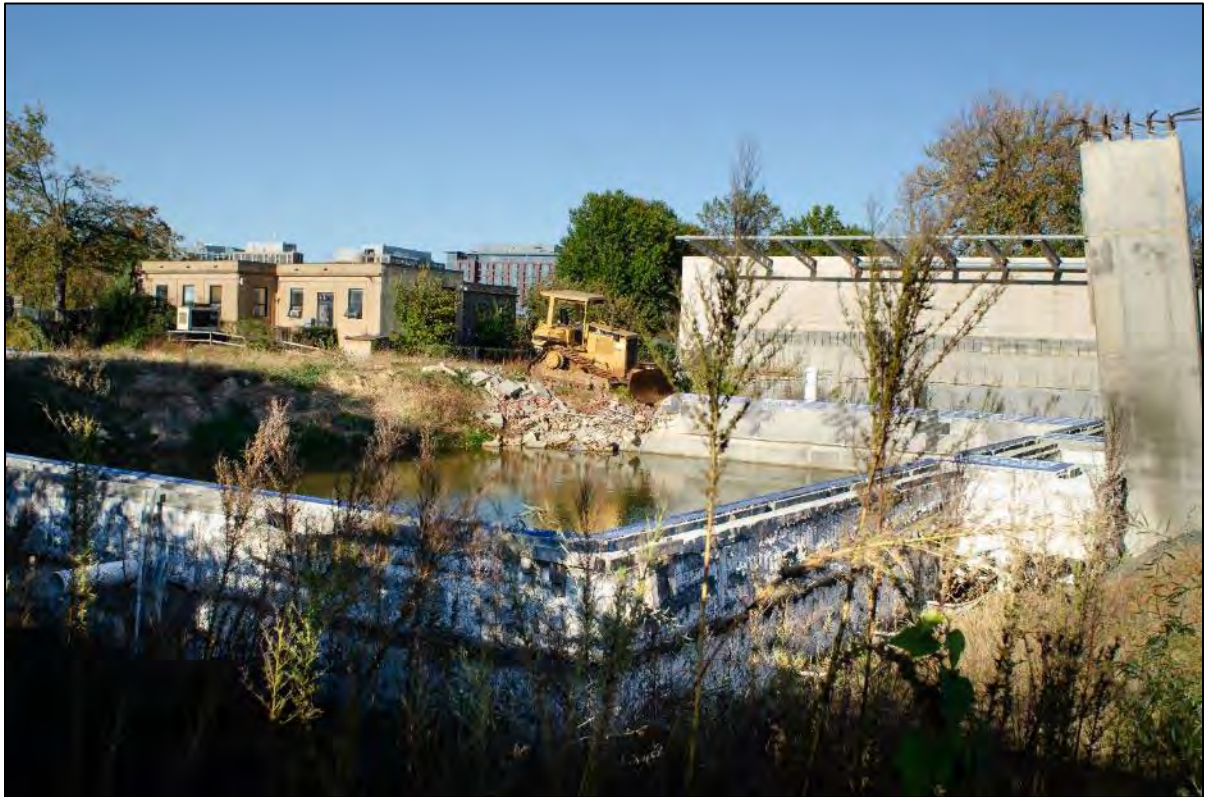
*Fig 25. Photo looking east toward the East Potomac Park Swimming Pool under demolition in 2021, note East Potomac Park Bathhouse in the distance on the right and the north wing of the Field House on the left (Matthew Traucht 2021).*

During the 1990s two buildings were constructed in the park, the East Potomac Driving Range building and the Administrative Building at the tennis facility. Since that time, the landscape has remained relatively unaltered. Recent changes to the landscape include the aforementioned relocation of “The Awakening” statue in 2008 outside of East Potomac Park, the construction of a new USPP Central District Station that began in 2017 and was completed in 2020, and the demolition of the East Potomac Park swimming pool in 2018. Designs for a new pool and pool house were submitted to the NCPC and the CFA in 2015. The project included the modernization of the pool, the addition of a deeper diving area and diving boards, and improved new pool facilities and landscaping all within the footprint of the existing pool, Bathhouse, and entry courtyard. The proposed new pool house would provide locker rooms with showers, family changing rooms, offices, retail and food service functions, and provide spectator seating for viewing aquatic events (NCPC 2015). The future of the swimming pool and Bathhouse which was built in 1978 remain uncertain, as groundwater intrusion has thus far prevented construction of a new pool and pool house, and the current Bathhouse remains vacant (Fig 25).

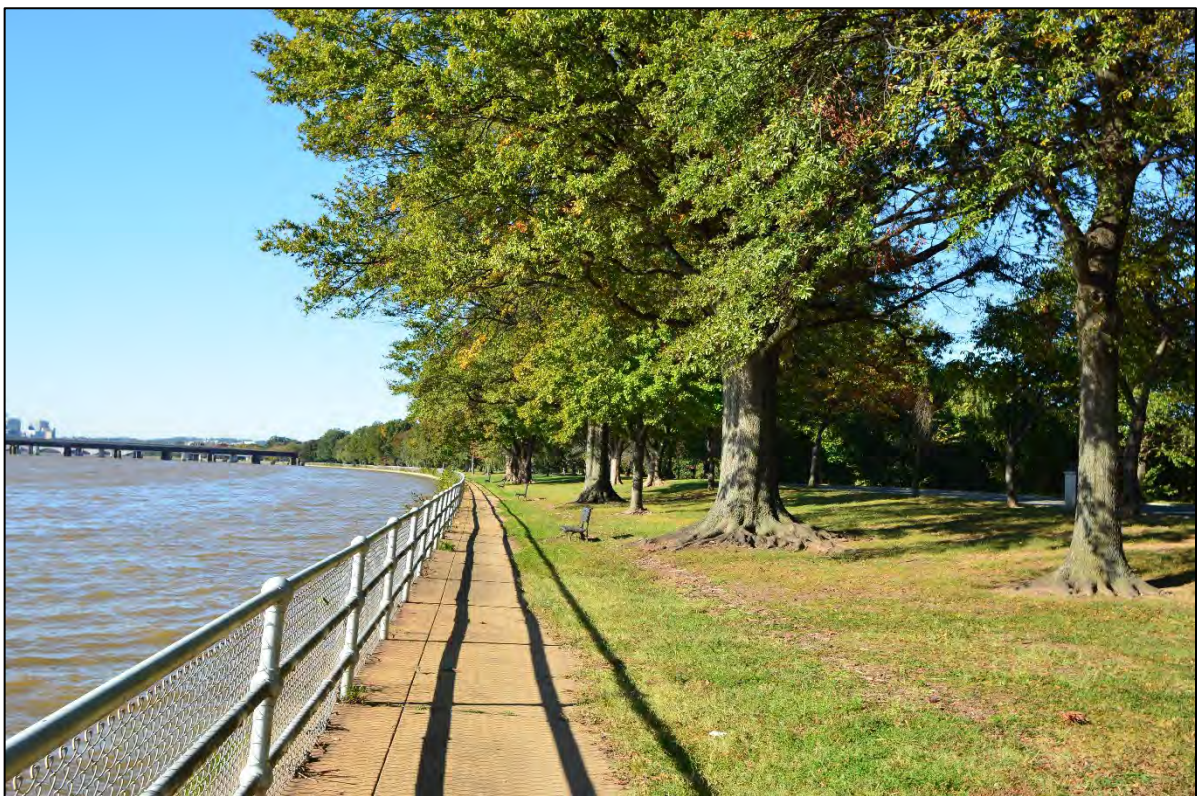
*Fig 26. Photo looking northwest at the edge of the island along the Potomac River. Note the subtle bend in the shoreline of the island (Matthew Traucht 2021).*

The morphological aspects of the East Potomac Park landform are a character-defining feature of the cultural landscape. In plan, the island has a triangular shape, narrowing from its widest dimension at the northern part of the park to a rounded point at its southern end (Fig 26). The eastern shoreline of the island bends to follow the alignment of the Washington Channel, and the Southwest Waterfront beyond, while the western side of the island is much straighter, responding to the character of the Potomac River. The profile of the eastern side of the constructed island was developed in the 1880s with the specification that the newly built landform would lie at sufficient distance from the opposite side of the Washington Channel to ensure navigability. Thus, the eastern side was constructed at a 900-foot offset from the opposite side of the channel. Similarly, as shown in Figure 9, the western side of the island was formed in relation to the navigable Virginia Channel in the Potomac River. The shape of the island comes to a rounded point at the confluence of the Washington Channel and the Potomac and Anacostia Rivers, which establishes a unique promontory to view these waterbodies and local landmarks.

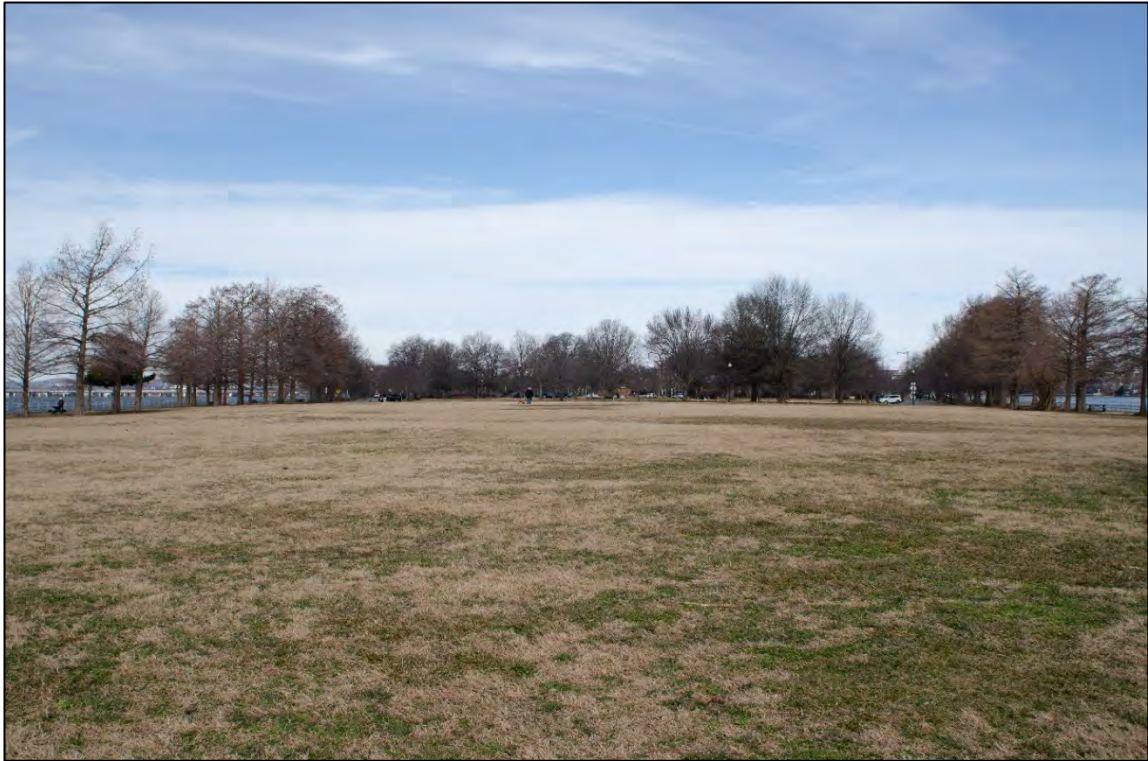
*Fig 33. Photo from Hains Point looking north depicting the characteristically flat terrain of East Potomac Park (Matthew Traucht 2021).*

Since the period of significance, no major grading activities have occurred at East Potomac Park. Overall, the park retains the relatively flat, human-made topography that was established with the completion of the reclamation of the landform (Fig 33).

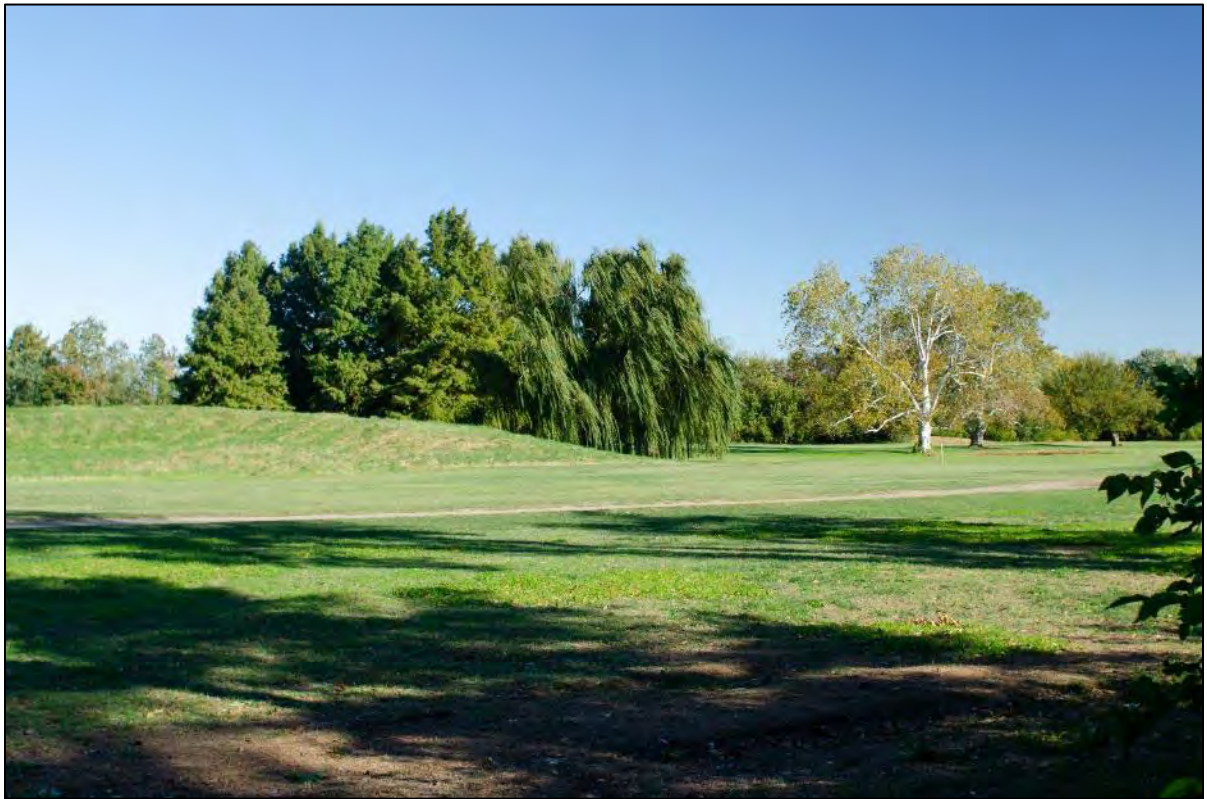
*Fig 34. Photo looking west of the level topographic character of the East Potomac Park and an example of a mounded bunker (Matthew Traucht 2021).*

The topography at the East Potomac Park Golf Course remains much as it was during the period of significance. Although minor topographic changes have occurred with routine redesign of the various courses, bunkers, and sand traps, overall, the golf course retains its relatively flat topographic character (Fig 34).

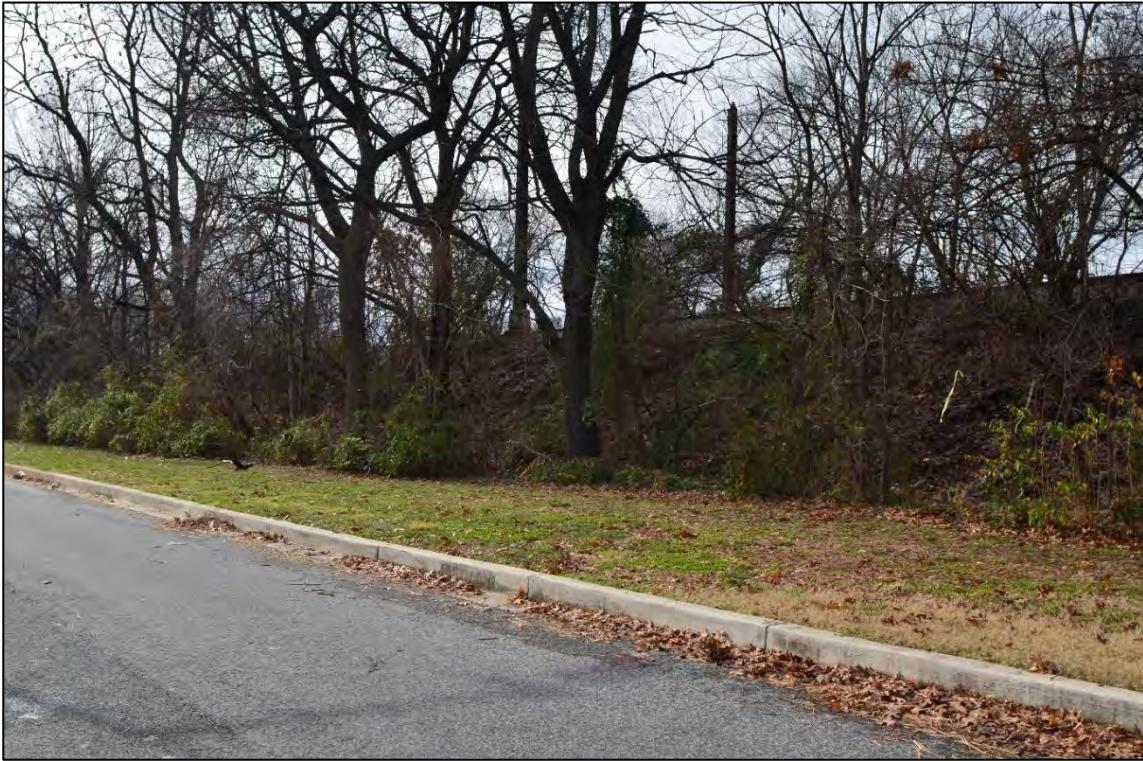
*Fig 35. Photo depicting the railroad embankment at the northern edge of East Potomac Park (Matthew Traucht 2022).*

Overall, the appreciably level terrain of East Potomac Park is a character-defining feature. Throughout the cultural landscape, and notably in the golf course, the flatness of the land is considered for the purposes of this CLI to be a contributing resource. Additionally, the railroad embankment, which rises sharply from the adjacent terrain to a height of about fifteen feet, serves as a physical, visual, and administrative dividing line between East Potomac Park and its counterpart to the west (Fig 35 and Fig 36). The embankment, predating the establishment of the park, is a major topographic feature at the edge of the park, but because it is not owned or managed by NPS, it is not considered a contributing feature.

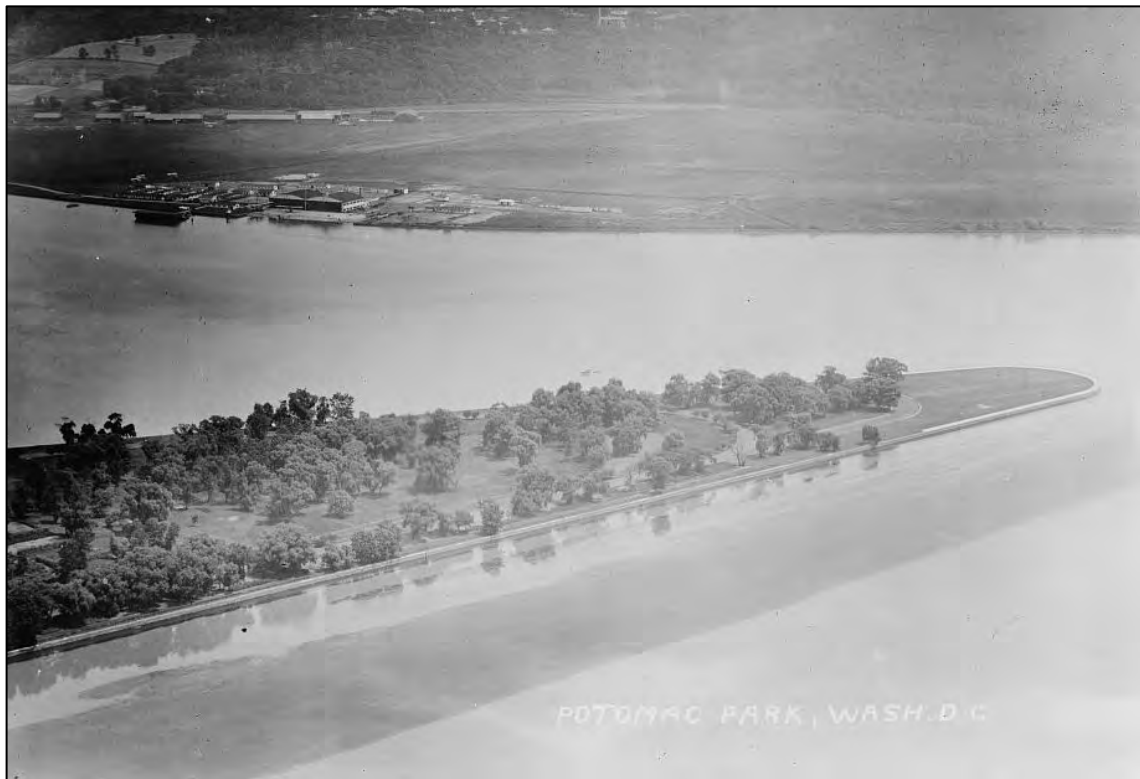
*Fig 38. East Potomac Park, Wash., D.C. (Bain News Service 1920). Photo looking east, note groves of trees in the golf course and along the perimeter contrasted with the absence of vegetation at Hains Point.*

In 1916, Colonel William W. Harts, Officer-in-Charge of the Office of Public Buildings and Grounds, prepared a detailed plan for East Potomac Park to be developed as recreational grounds. Harts' plan, developed by landscape architect James G. Langdon under the supervisions of the CFA, noted "the soil, of which is composed of the richest alluvium, promising excellent planting possibilities for landscape adornment... In parts of the island volunteer trees have already grown to considerable heights; many of these trees can well be preserved and incorporated into the final development" (East Potomac Park Development Plan 1916, 11–12). The illustrated plan depicted a regular rhythm of trees planted in linear groupings along the river's edge, with similarly sized areas left unplanted in between the groves. Although the central area of the plan was shown as a golf course with very few trees—those that were shown occur in groupings of vegetation—a much more forested area was depicted towards the southern area of the island (Fig 38). The same year that this plan was presented, some 88 acres of the park to the

1923, 109 twelve-foot-tall poplars were planted along the railroad embankment to screen the railroad from the tourist camp. As visible in an aerial photograph from circa 1920 (see Fig 38), trees at the southern end of the golf course and along the perimeter of the island were well established by this time. Planting plans or documentation about these trees, and about general landscape improvements between the 1920s and 1960s, were not discovered in the research for this CLI. In the northern part of the park, aerial photographs from 1949 and 1957 (NETR 1949 and 1957) show a rhythm of trees in the median and along the west side of Ohio Drive SW between the railroad embankment and the access road to the golf course. The trees are shown as existing in a 1961 plan for the reconstruction of the road in this area (eTIC 805/82039).

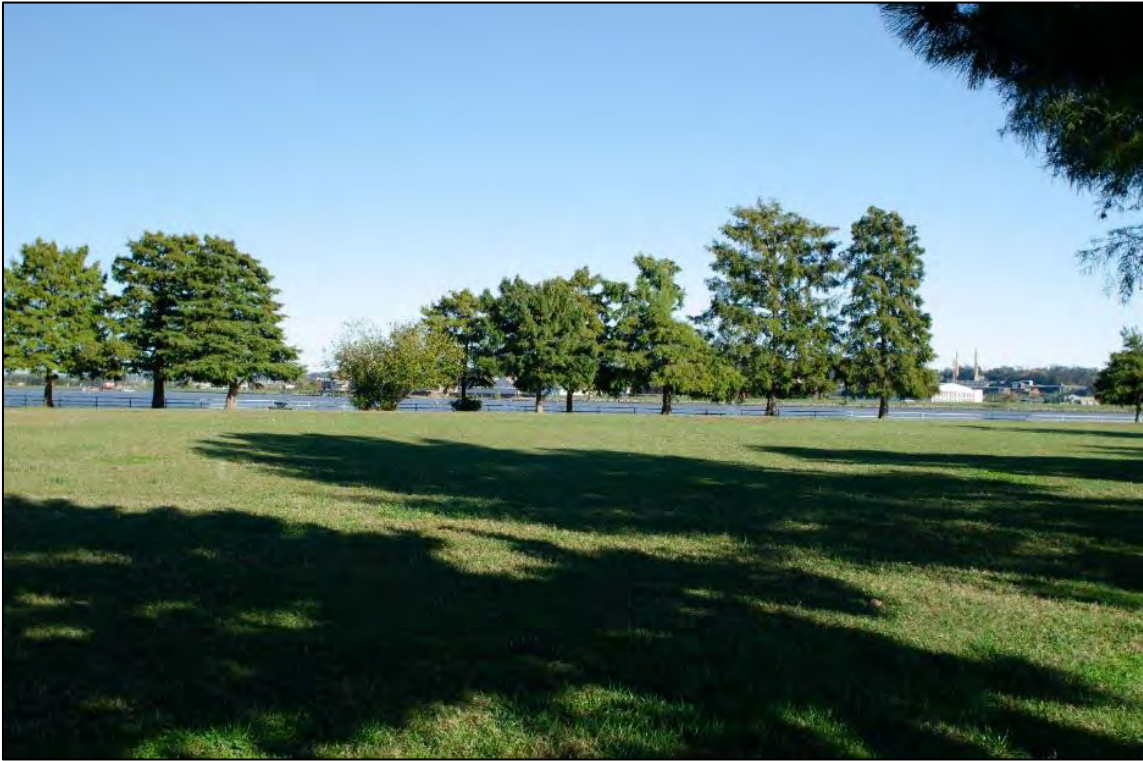
*Fig 42. Photo looking southeast of bald cypress and white oak on the Washington Channel side of Hains Point. These trees date to the 1966-67 planting plan (Matthew Traucht 2021).*

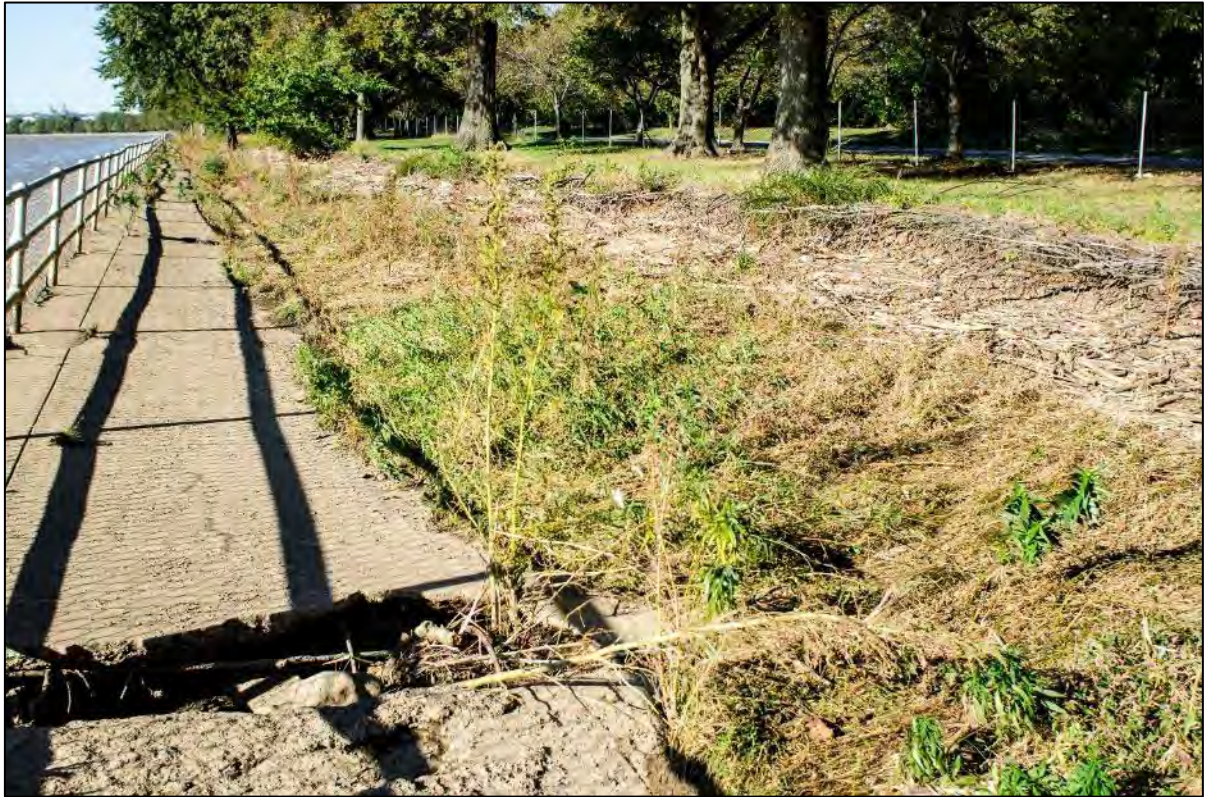
*Fig 43. Photo looking north depicting soil erosion on Potomac River side of the park, which has exposed tree roots leading to decline and poor health of mature, contributing vegetation (Matthew Traucht 2021).*

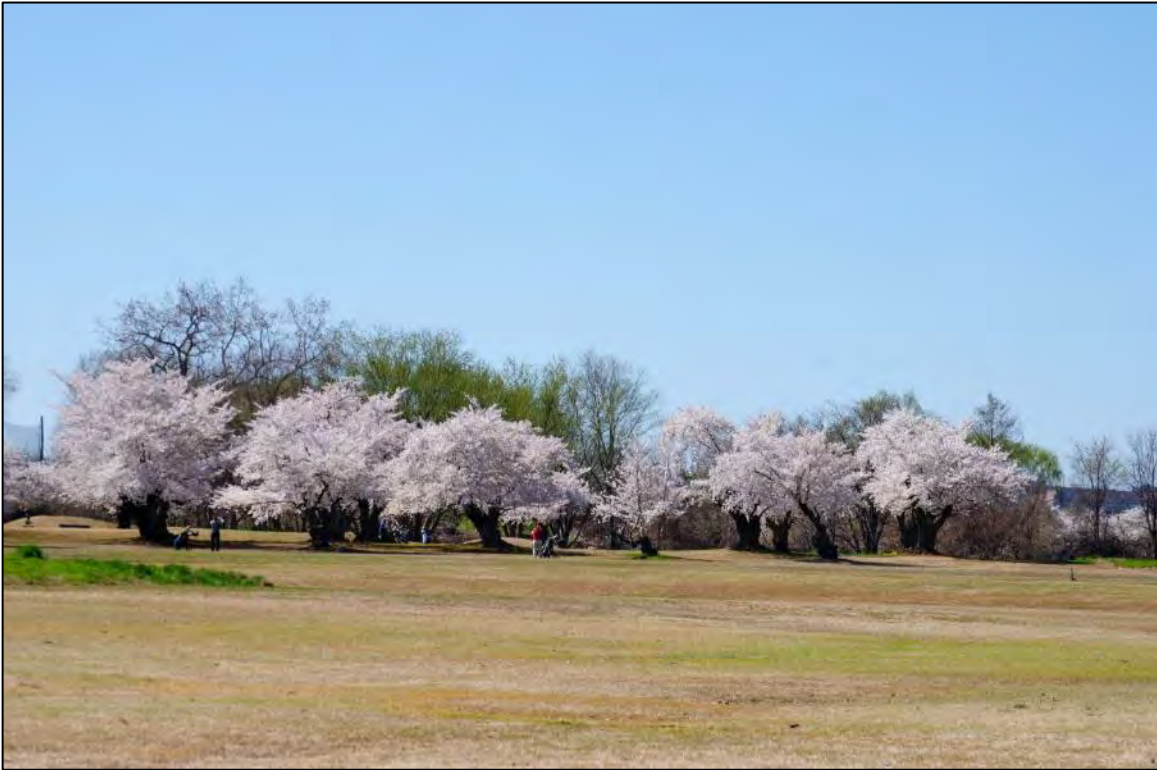
*Fig 44. Photo looking west depicting Yoshino cherry trees in East Potomac Park Golf Course. The stand shown may date to the 1910 shipment of trees gifted to the U.S. by the City of Tokyo (Matthew Traucht 2021).*

Some evidence exists that supports the claim that several of the cherry trees from the original 1910 shipment of trees from Tokyo may have been planted in East Potomac Park (Fig 44). The trees, numbering between 15 and 20, are planted approximately 50-feet apart in legible rows in the East Potomac Park Golf Course between the intersection of Ohio Drive SW/Buckeye Drive SW and the Field House. The alignment and spacing of the trees indicate intentional planting that exceeds the usual intervals found in nurseries but may indicate that they were sited as part of a quarantine study (Fig 45 and Fig 46). Additionally, the amount and type of decay present on all the trees is consistent with pest infestation, which further supports the argument that these trees are from the 1910 shipment (Pliska 2008). These Yoshino cherry trees are significant because they may be the last surviving specimens of the gift from the City of Tokyo and because they are more than twice the average age of this species of trees.

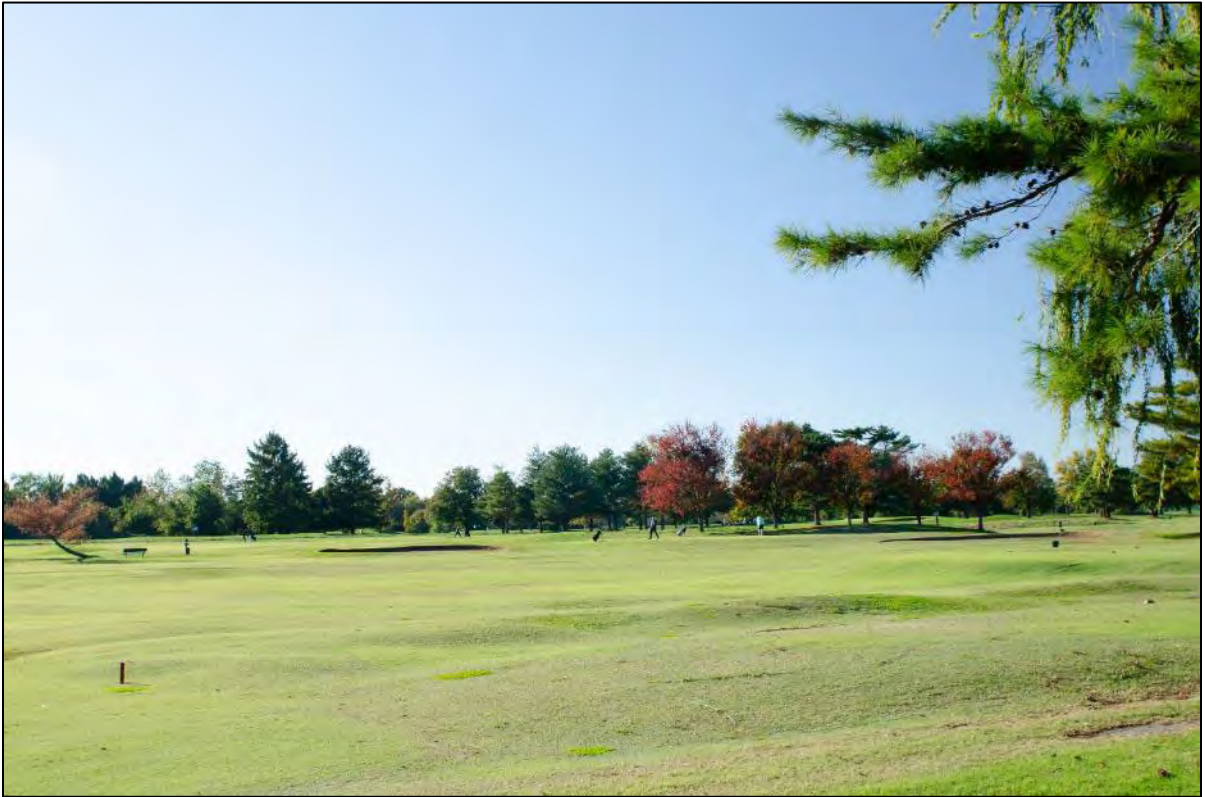
*Fig 45. Photo looking northwest depicting sparse plantings, which are a character defining feature of the East Potomac Park Golf Course. Trees in the distance likely date to the 1940s and 1950s (Matthew Traucht 2021).*

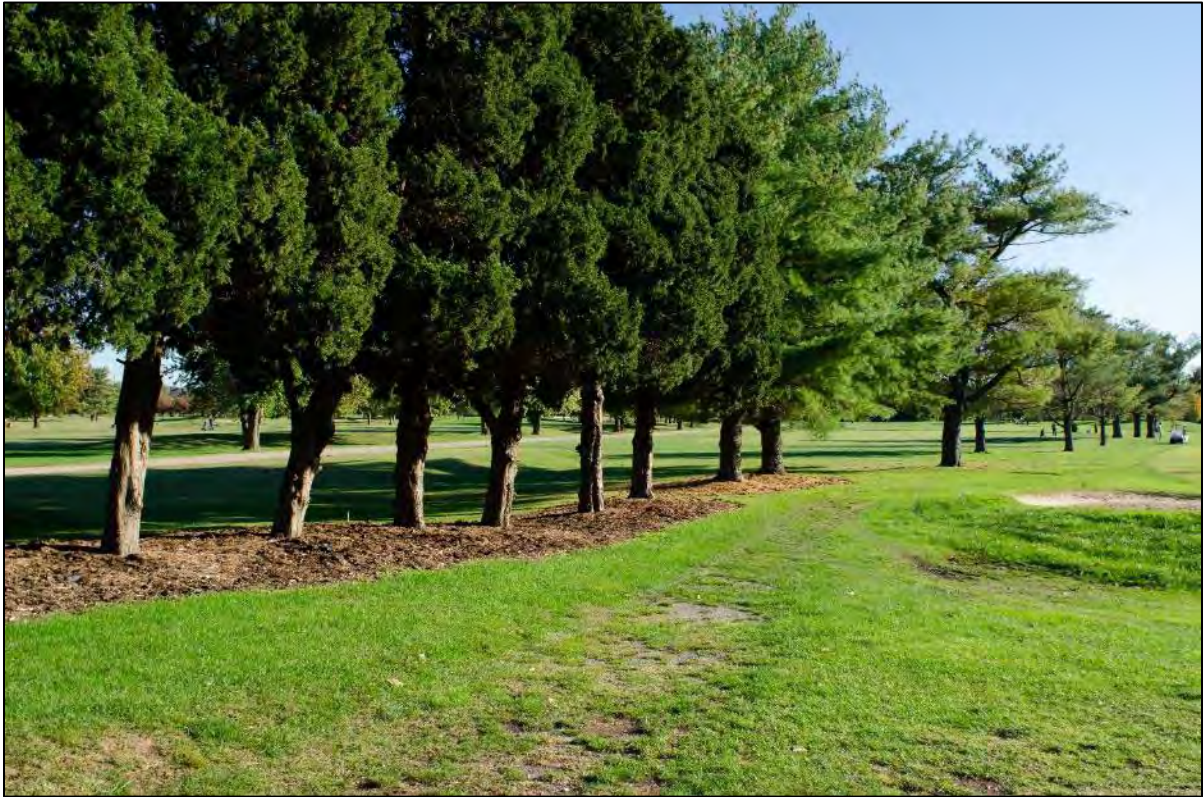
*Fig 46. Photo looking southerly depicting cedars planted in a row in the East Potomac Park Golf Course. These date to the 1930s and were planted by the Civilian Conservation Corps (Matthew Traucht 2021).*

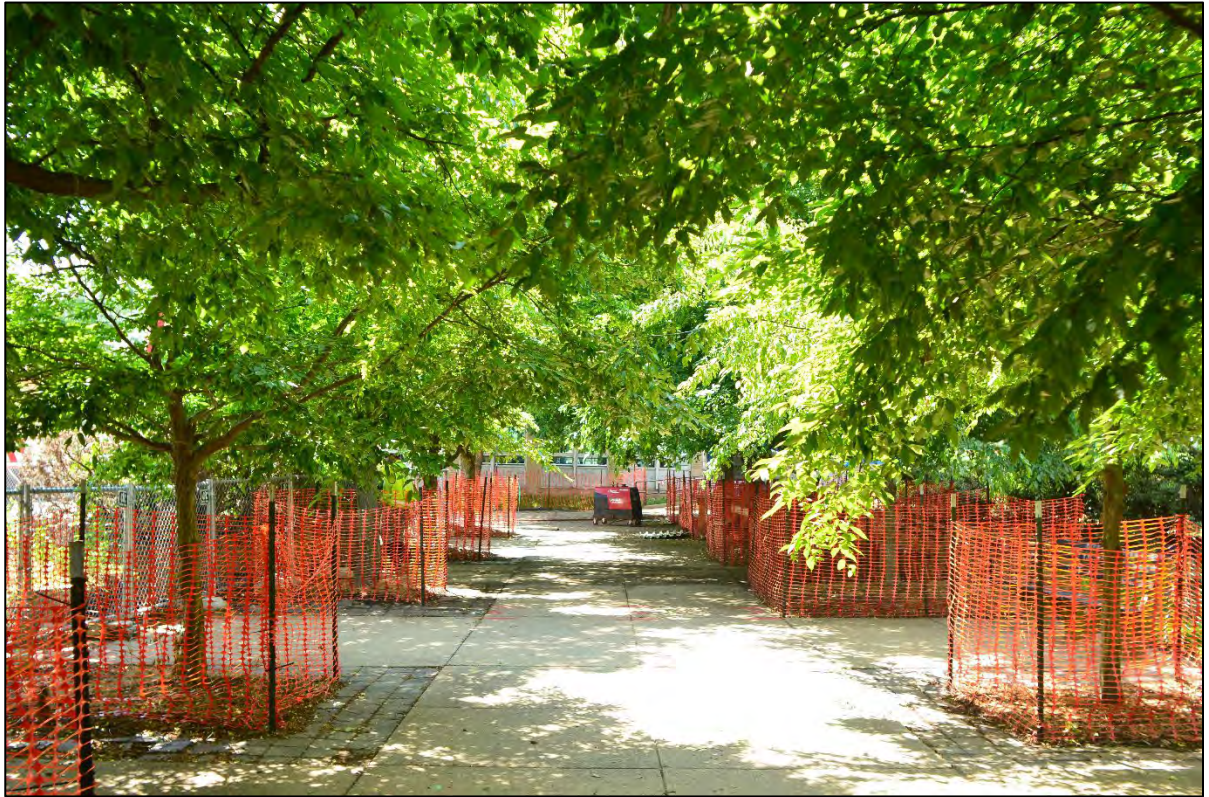
*Fig 47. Photo looking south depicting the grid of pollarded European hornbeams at the fountain terrace (renovation of NCR and USPP Headquarters underway) (Matthew Traucht 2021).*

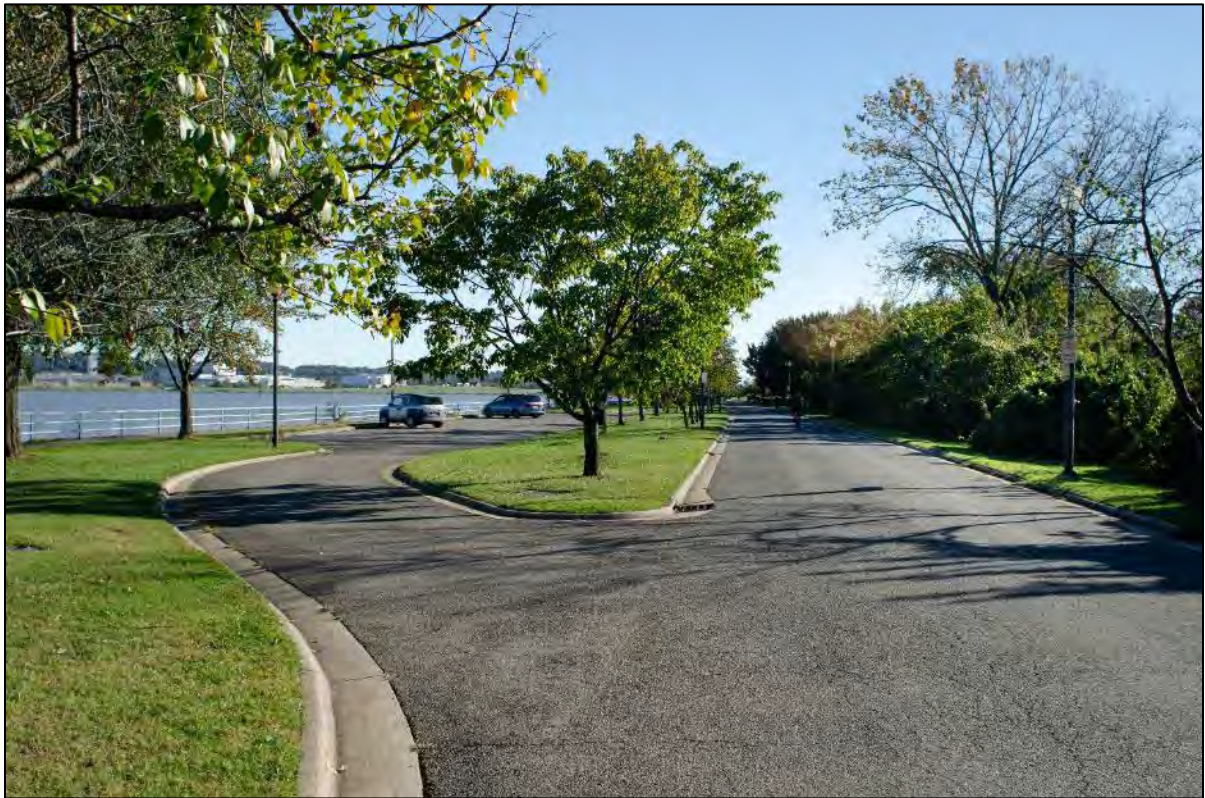
*Fig 53. Photo looking south depicting off-street parking area on Ohio Drive SW, Washington Channel side of the island (Matthew Traucht 2021).*

Along the Washington Channel side of Ohio Drive SW, two off-street, angled parking lots are accessed via short entrance and exit spurs (Fig 53). These were installed as part of the Ohio Drive SW rehabilitation project in 1966–1967, which falls within the period of significance, and they are considered contributing features.

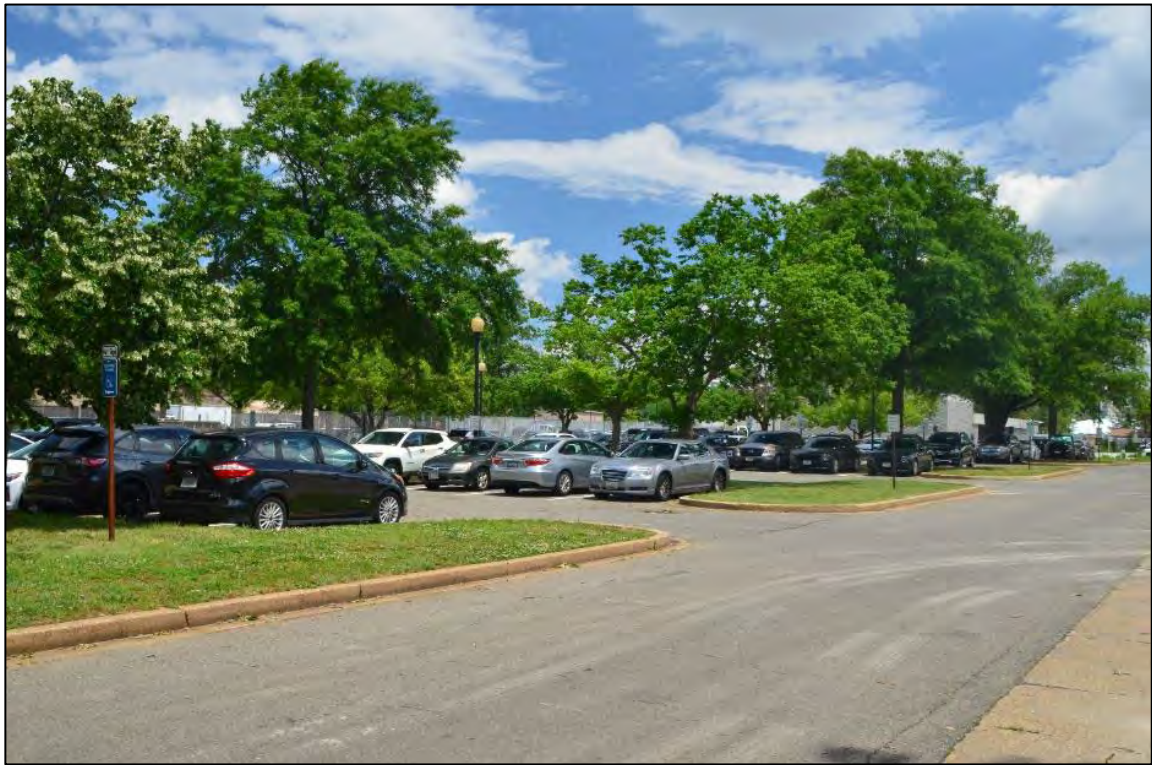
*Fig 54. Photo looking northeast depicting the North Parking Lot at the National Capital Region Headquarters Campus (Matthew Traucht 2021).*

Between 1978 and 1980, the southern half of the parking lot to the north of the NCR and USPP Headquarters buildings was expanded to the west, which added six rows of parking (Kuhn et al 2020, 39). Between 2017 and 2018, the eastern half of the northern parking lot was demolished for the construction of the USPP Central District Station. The alignment of the access road, which extended east from Ohio Drive SW to the unnamed road and provided for internal vehicular circulation between the north parking lot and the west parking lot, was retained (Fig 54). The
